# IMPROVED METHODS AND EQUIPMENT TO CONDUCT PAVEMENT DISTRESS SURVEYS

Report No.  
FHWA-TS-87-213

Final Report  
April 1987

<b>16. Abstract</b> <p>This report documents the second phase of an FHWA study, entitled "Pavement Condition Monitoring Methods and Equipment". In this phase selected distress survey methods and devices, representing a range in automation, were tested from July to September 1986. The following methods and devices were included in the testing: manual mapping, detailed visual surveys using manual recording and automatic data logging, PASCO ROADRECON survey vehicle, the GERPHO survey vehicle, the ARAN survey vehicle, and the Laser RST survey vehicle. The field tests were conducted on flexible, rigid, and composite pavements exhibiting a range of pavement distresses.</p> <p>The survey devices were evaluated using performance, capability, efficiency, and cost-effectiveness criteria. The study concluded that, at present, the GERPHO and PASCO ROADRECON are best suited for pavement performance research studies due to factors such as the permanent film record, cost-effectiveness, and data quality. The GERPHO and PASCO ROADRECON are also judged to be suitable for net

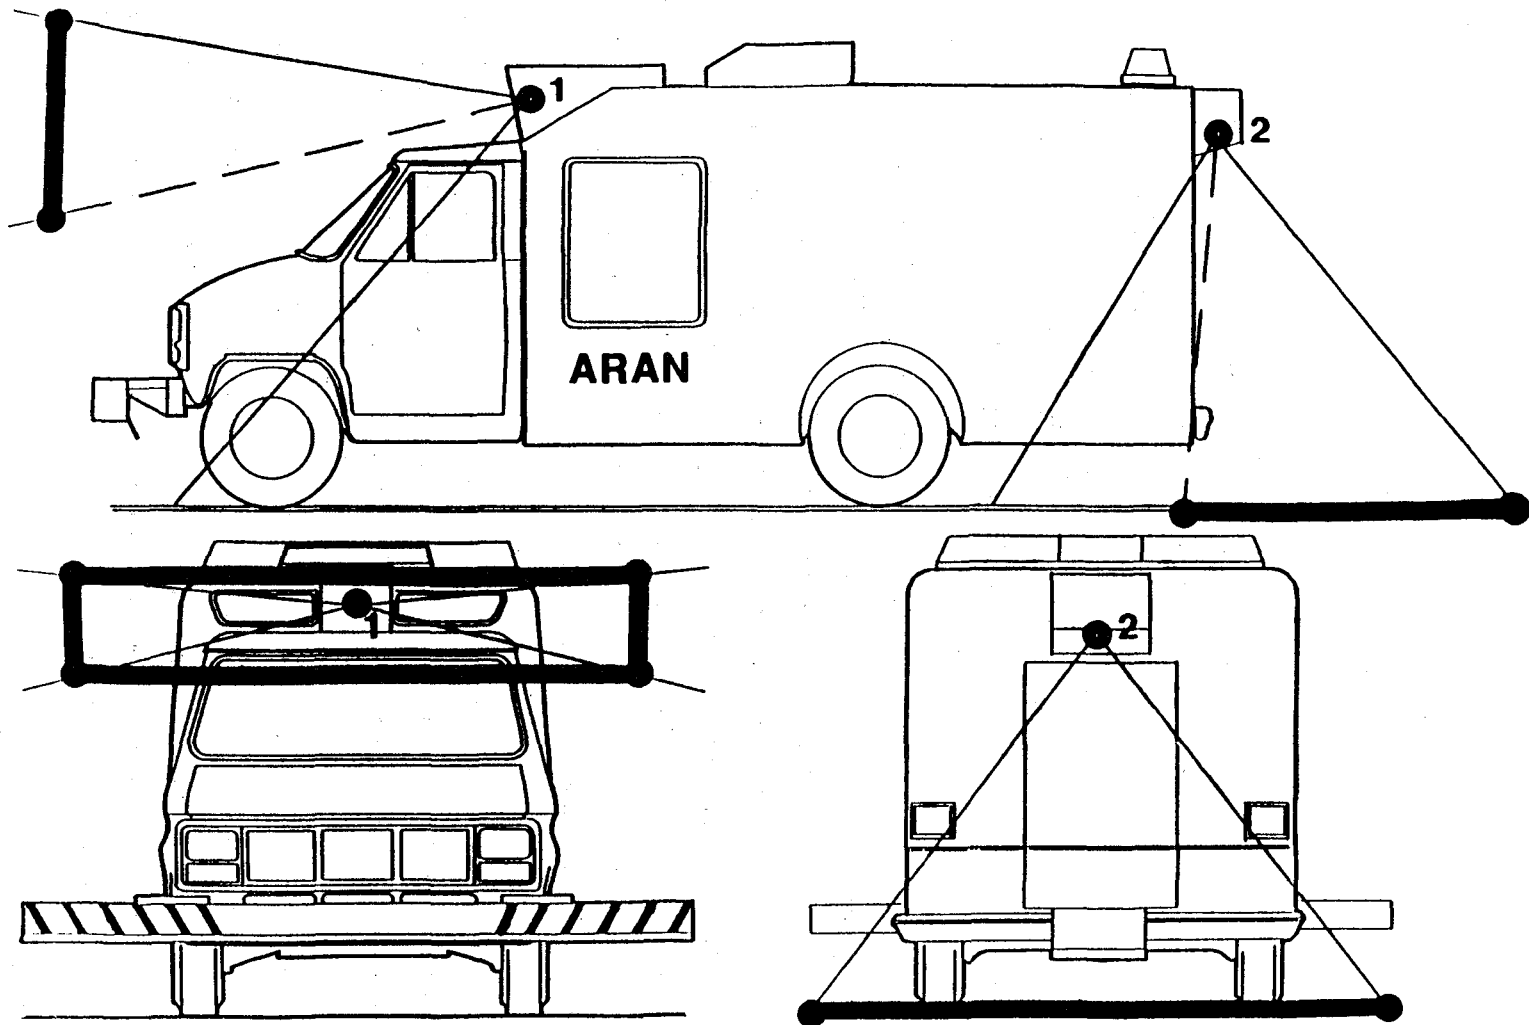
Figure 21. Schematic illustrating right-of-way and road surface view captured by ARAN'S video equipment (Ref 11).

There are two video logging cameras (Figure 21). One camera is mounted on the rear of the van and produces an image of the pavement surface. The camera is a Sony DXC-M3 with a Panasonic special effects

generator WJ-4600C. A Panasonic NV 8420 Recorder is used. A wide angle lens is used. Thirty picture frames per second are taken. Each frame indexes 2.5 feet (0.8 m). The shutter takes 30 stills per second. The camera is black and white. The second camera is mounted inside the van and provides a through-the-windshield roadway right-of-way view in color. In the rear work area of the van, a video monitor displays the pictures as they are being recorded. When viewing the video picture, the two camera images are merged, with the right-of-way image being inserted into the top one-third of the pavement surface view. Header information is superimposed over the camera right-of-way image.

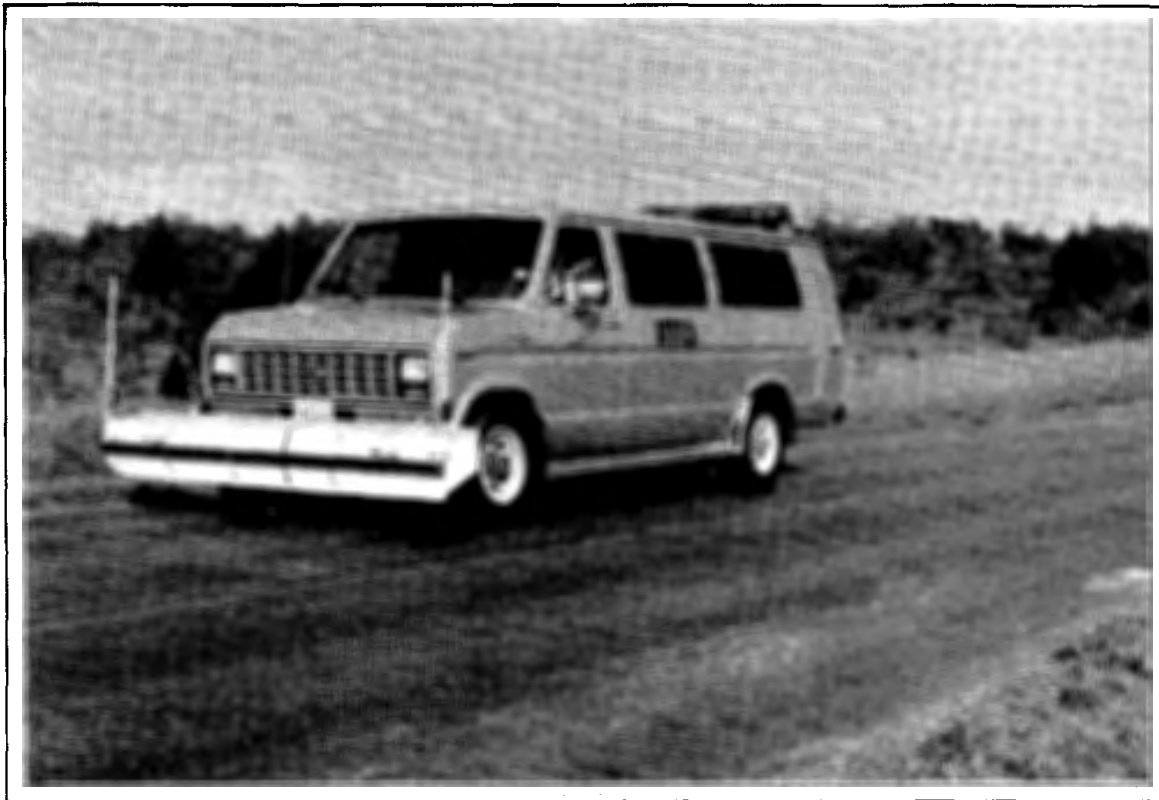
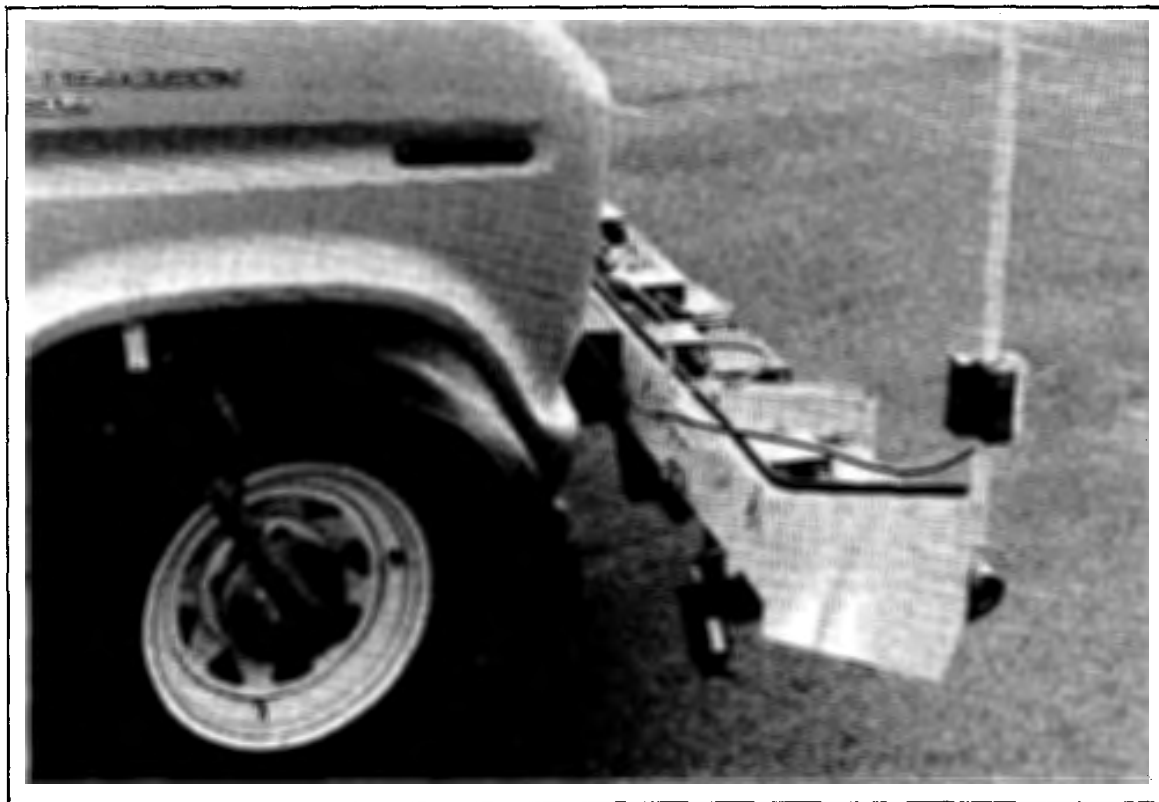
Figure 23. Side view of IMS Laser RST (top) and laser support beam and distance recorder (bottom).

The Laser RST originates from Sweden and is used by IMS in North America. Two RST units are presently in service in the United States. The unit used in the field tests was completed in mid-1986 and had traveled over 31,000 miles (50,000 km). Figure 23 shows the RST device used in this study. The material presented here is based on Reference 13 and discussions with the IMS team.

The RST is mounted on a dedicated van, powered by the van battery and the Onan generator. Other components are listed below.

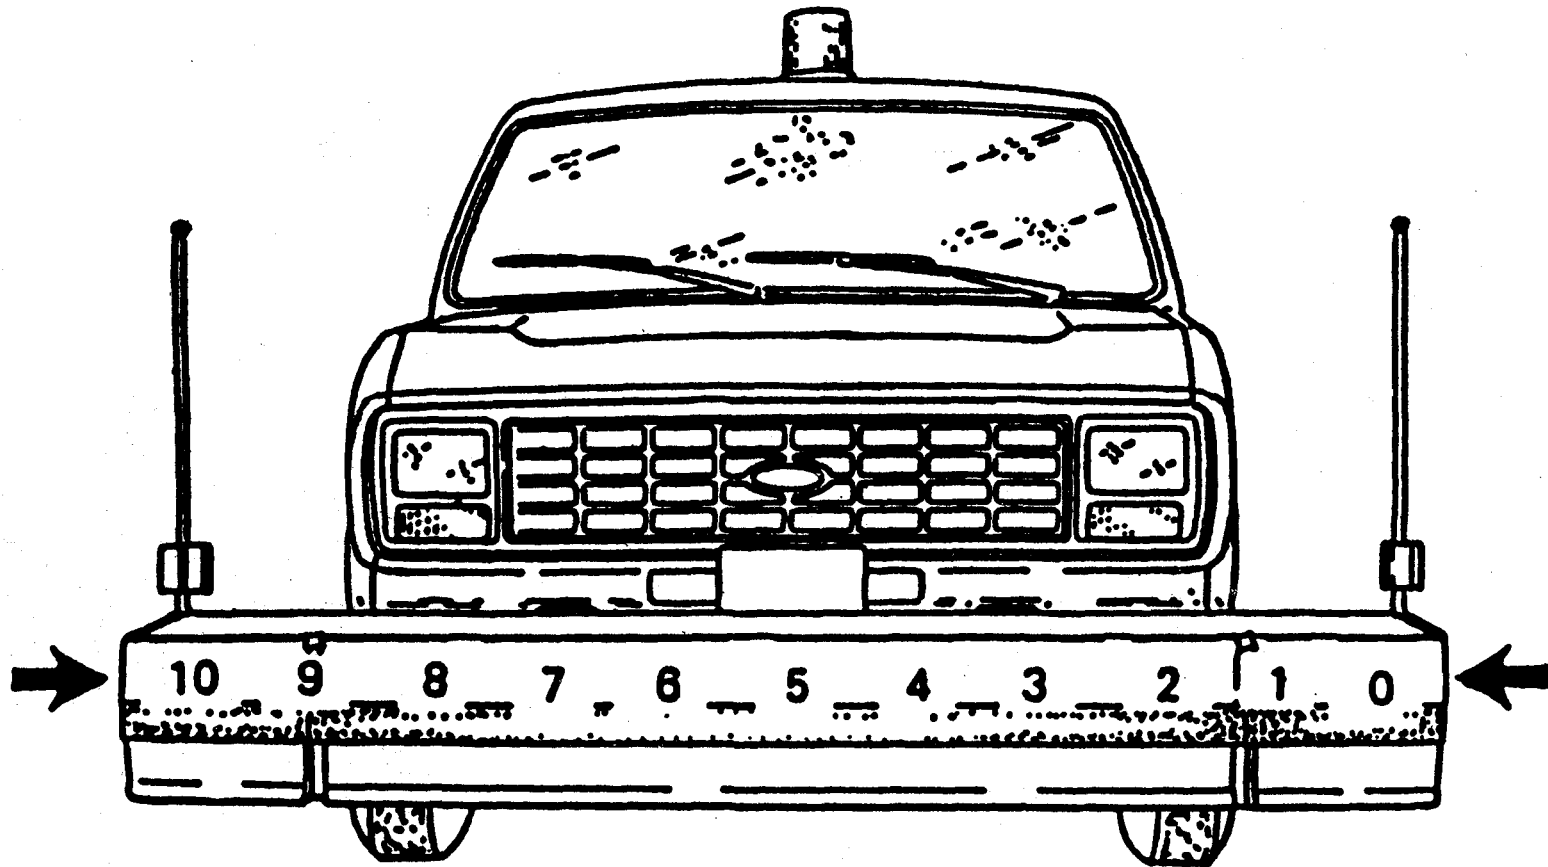
Figure 24. Schematic illustrating the eleven lasers mounted on front bar of IMS' Laser RST (Ref 13).

The RST uses eleven laser sensors mounted on the front of the van as illustrated in Figure 24 for measuring distress data. All eleven lasers supply data to measure rut depth. The on-board processing computer simulates a transverse profile and records the deepest rut every 4 inches (10 cm) using the wire method. Lasers are also used for texture measurements. Four lasers supply signals for measuring cracks and categorizing cracks according to its width and depth. The special crack-measuring cards essentially determine that amplitudes greater than the texture are cracks. Depth and width of cracks are stored in several categories in real time. Longitudinal and alligator cracking and patches are identified and recorded visually by using eight manual switches.

Laser Bar. Eleven lasers (Selcom/AB) are mounted on a support beam at the front as illustrated in Figure 24. The operation of a laser sensor is shown in Figure 25. The lasers are numbered from 0 to 10 looking from the drivers position. Laser No. 10 can easily be turned off by the operator. Regular lasers 1, 3, 5, 7 and 9 operate at 16 kHz. Angled lasers 0 and 10 also operate at 16 kHz and are positioned at a 45 degree angle outward to measure a width of 10 feet (3.1 m) with the laser bar only 8.5 feet (2.6 m) wide. Combination lasers 2, 4, 6 and 8 operate at 32 kHz. Each laser is covered by a shield during long transport distances and has a red indicator lamp that glows when voltage is supplied to the laser.

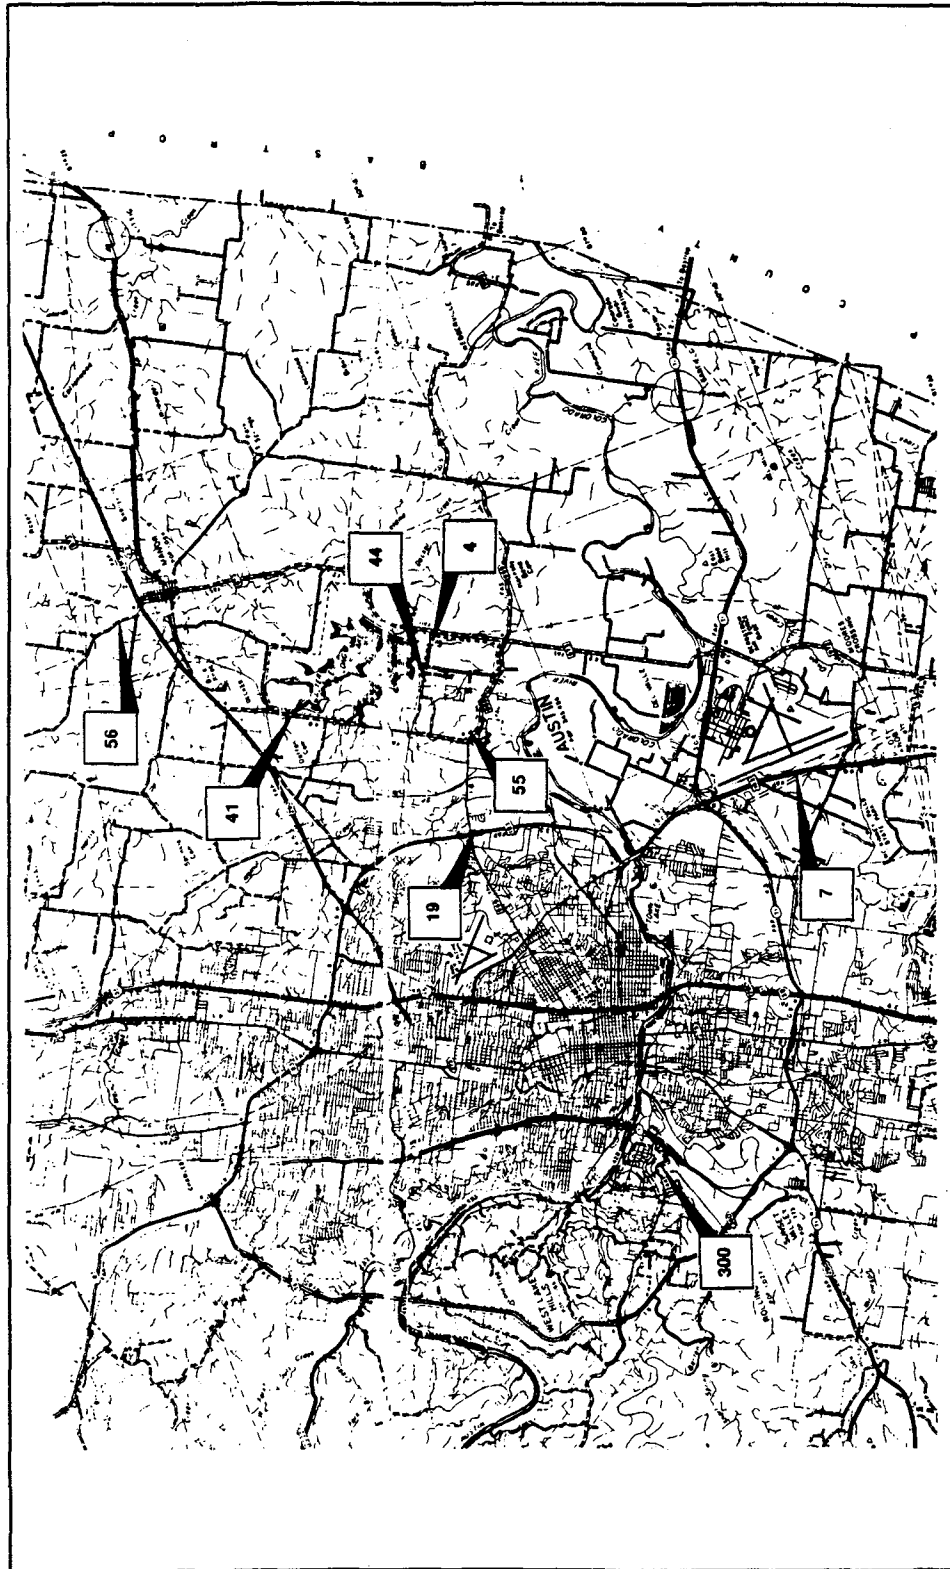
Figure 28. Location of distress survey test sections in Travis county.

FHWA PROJECT: PAVEMENT CONDITION MONITORING METHODS & EQUIPMENT ARE PROJECT NO.FH67  
DISTRESS SURVEY LOCATION  
CHART 2 17 JULY 1986

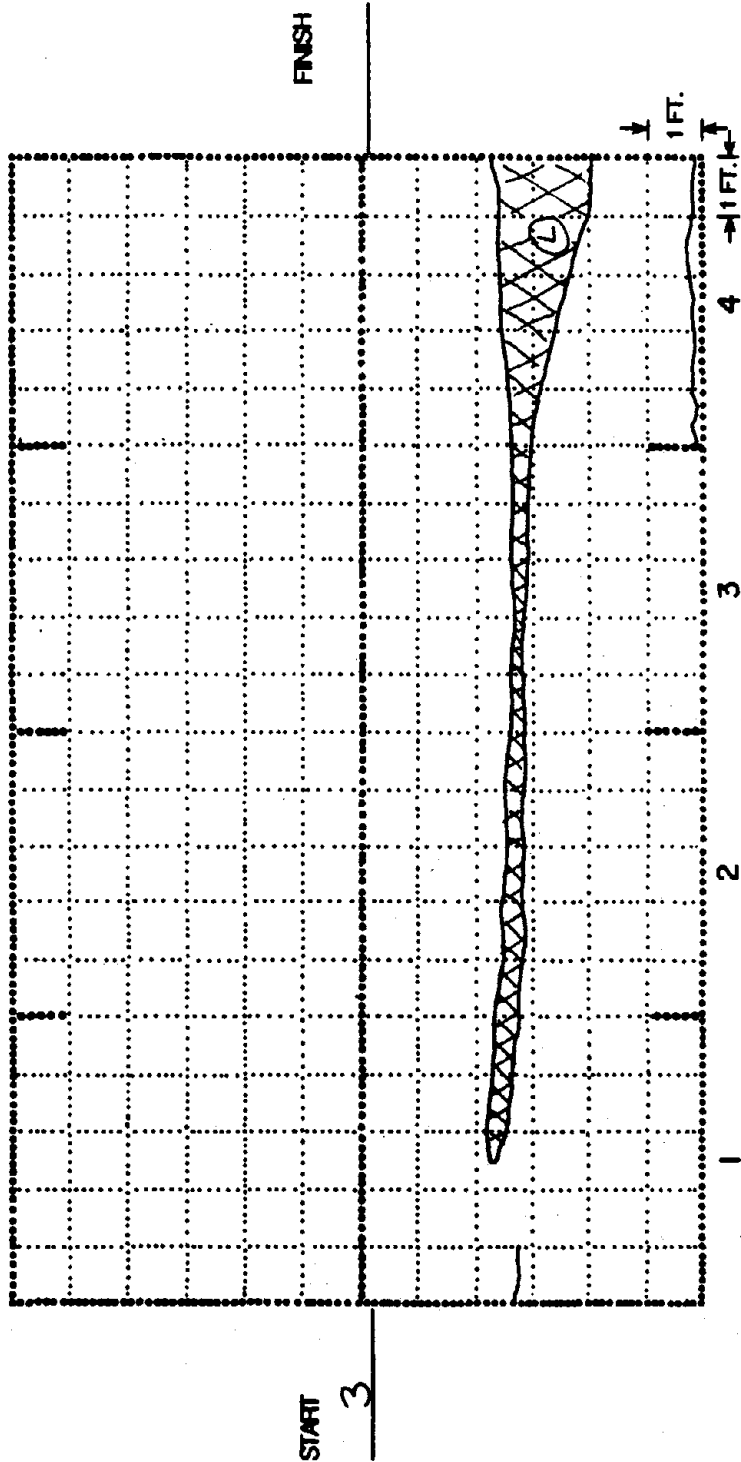
Section No. and Identification 44  
 Subsection Identification 3

Comments: MODERATE RUTTING IN BOTH LIP THRU OUT.  
ALL CRACKS LOW SEVERITY UNLESS  
OTHERWISE INDICATED. EDGE DEGRADATION  
IN LOCAL AREAS.

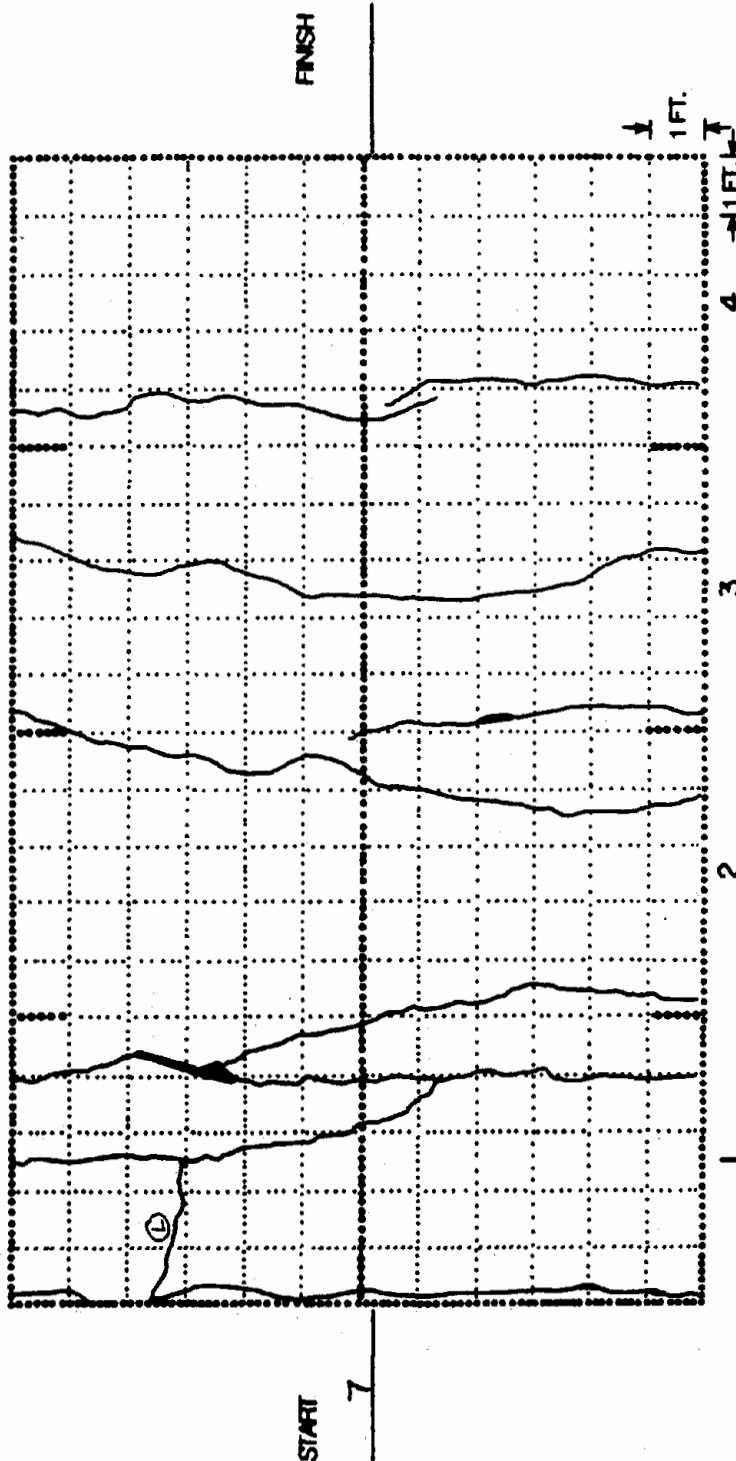
Section No. and Identification R 8  
 Subsection Identification 7

Comments: LOW SEVERITY MAP CRACKING THROUGHOUT SECTION.  
ALL UNLABELED CRACKS ARE MEDIUM SEVERITY.

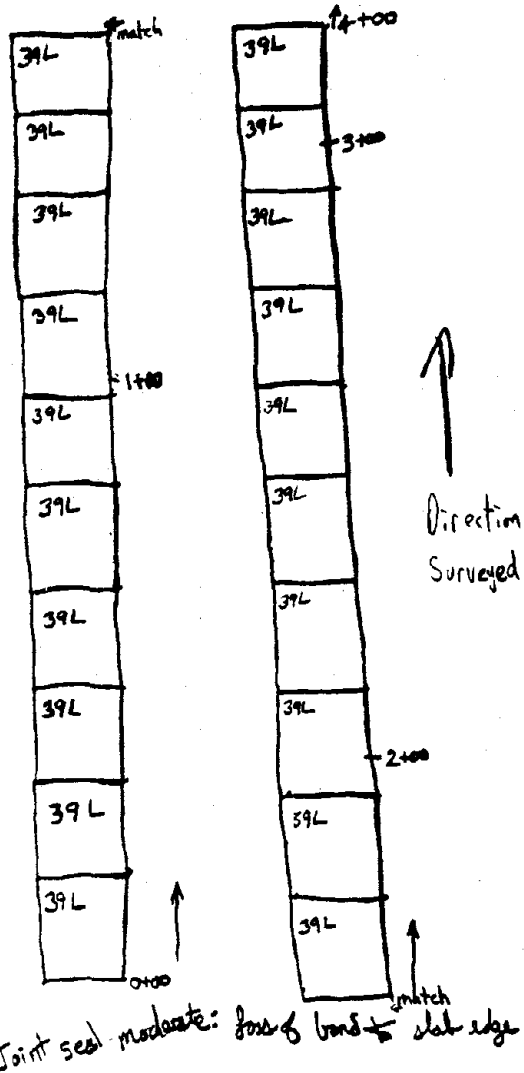
Figure 33. "PAVER" condition survey field data sheet, Section R7.

## JOINTED CONCRETE PAVEMENT CONDITION SURVEY DATA SHEET FOR SAMPLE UNIT

BRANCH 5160 (R7) SECTION 1  
 DATE 8/13/66 SAMPLE UNIT 1  
 SURVEYED BY LC/MC SLAB SIZE 20

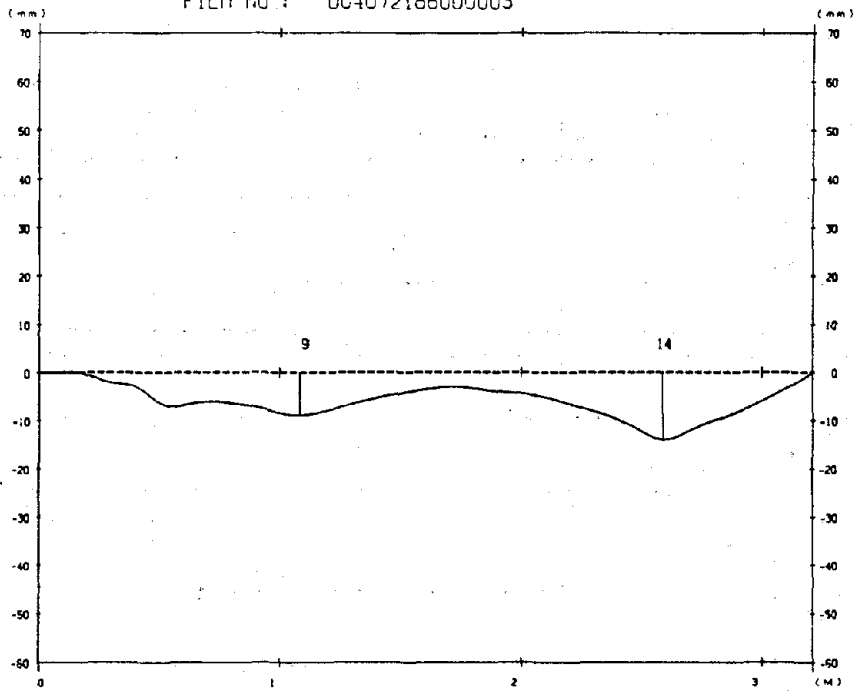
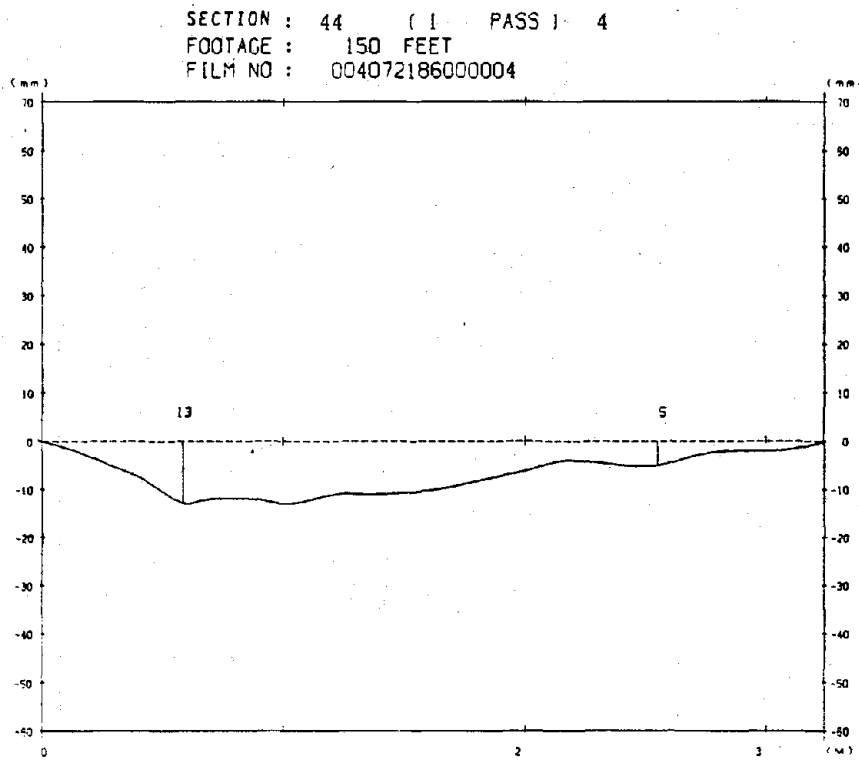
Figure 44. PASCO'S ROADRECON-75 output, cross profile of Section 44.

SECTION : 44 (1 PASS) 4  
FOOTAGE : 100 FEET  
FILM NO : 00407218600003

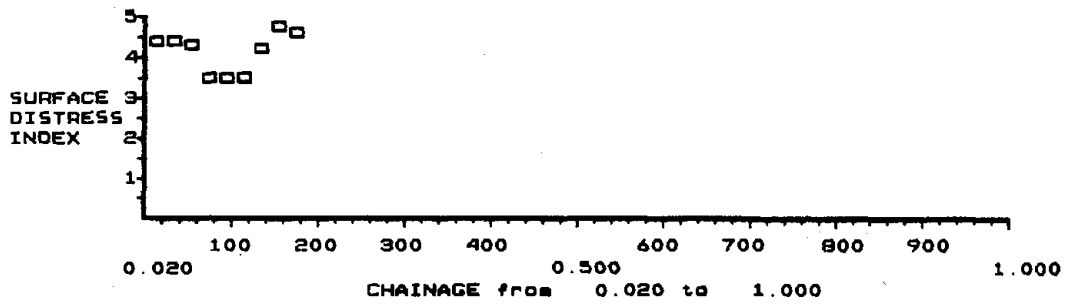
ROUTE : S044-A: Inner Eastbound

SECTION SUMMARY

Mean SDI : 4.1 Minimum SDI : 4 At 0.080  
Std. Deviation : 0.3 Maximum SDI : 5 At 0.160

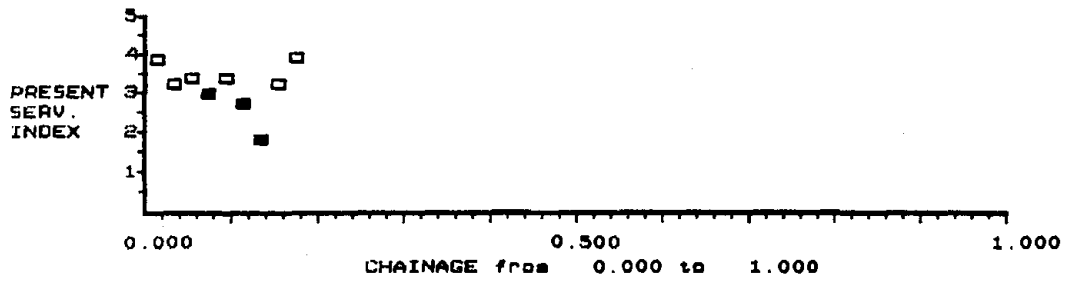
ROUTE : 5044-C: Inner Eastbound

SECTION SUMMARY

Mean PSI : 3.2                      Minimum PSI : 1.8 At 0.140  
Std. Deviation : 0.6                Maximum PSI : 3.9 At 0.180
