Publication No. FHWA-RD-94-098  
August 1995

# Issues Impacting Bridge Painting: An Overview

U.S. Department of Transportation  
**Federal Highway Administration**

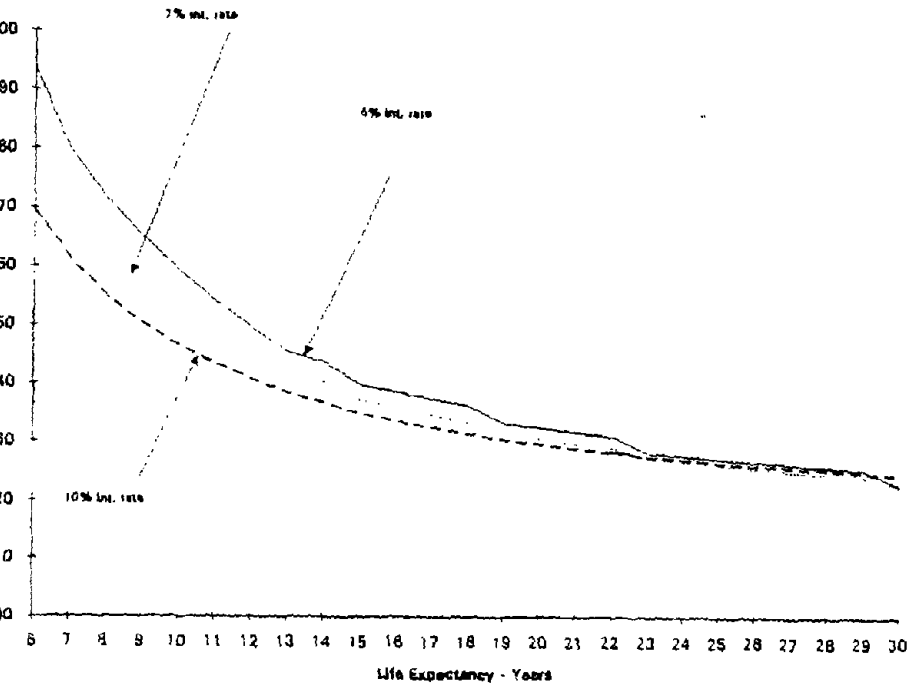
Figure 1. EUAC versus life expectancy for various interest rates.

$i = 7\%$  ;  $acc. rate = 4\%$  ; Remaining life of bridge = 90yr

years. The results of the analysis are summarized in figure 1.

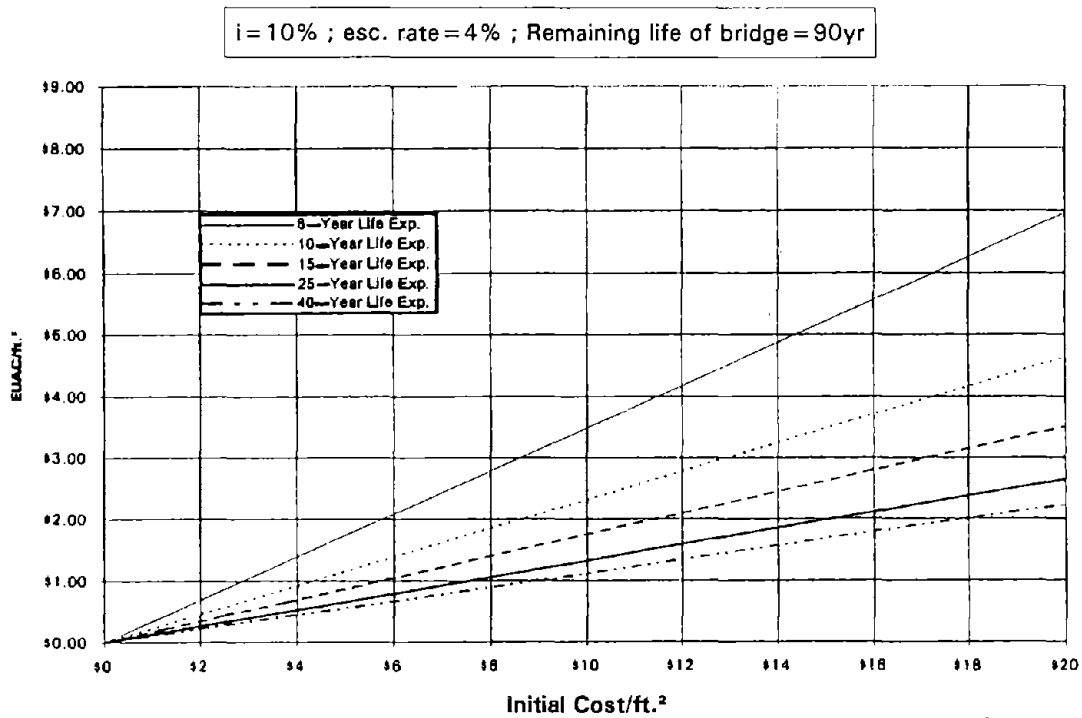
Figure 3. EUAC versus initial cost for various life expectancies,  $i=10\%$ ,  $e=4\%$ .

This figure shows the same range of initial costs and life expectancies as shown in figure 2 except that the interest rate has been increased to 10 percent and the inflation rate is held at 4 percent. The effect of changing the inflation rate can be seen in figure 4, where we have held interest constant at 10 percent and reduced the inflation rate to 0 percent.

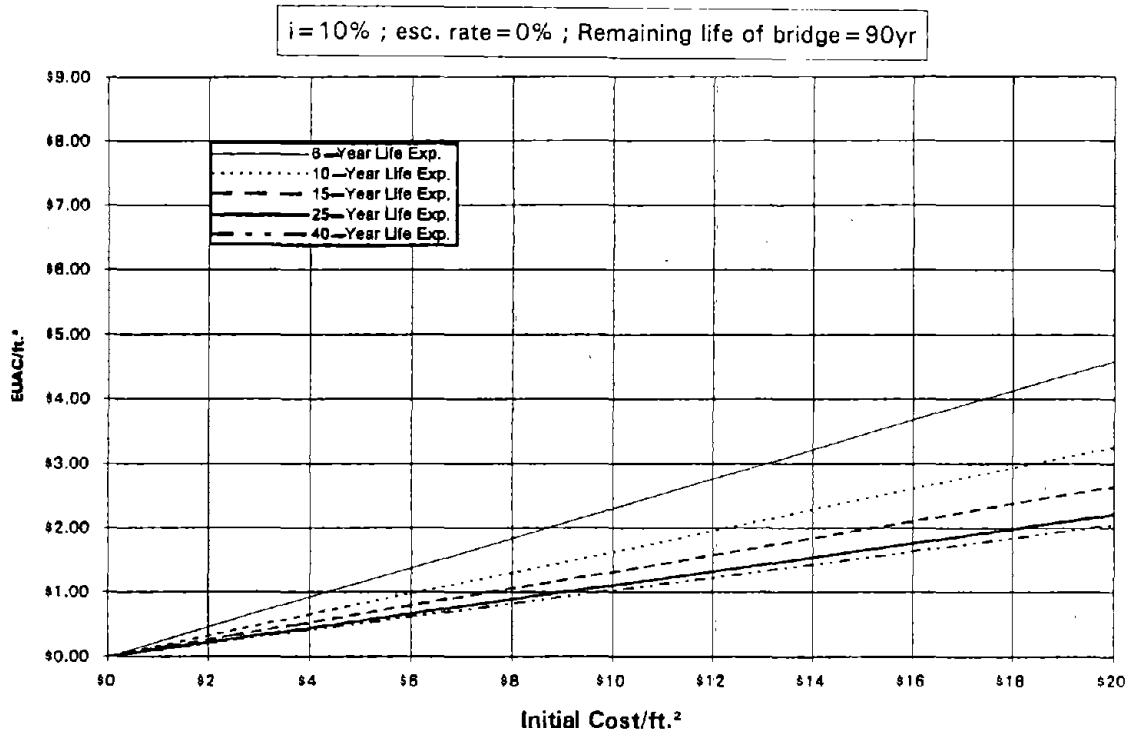
Figure 4. EUAC versus initial cost for various life expectancies,  $i=10\%$ ,  $e=0\%$ .

Here we can clearly see that the slopes are decreased and any advantage between 25- and 40-year life expectancy has disappeared and, in fact, there is little advantage to extending life expectancy beyond 15 years under these financial conditions. In any case, one has no control over these purely financial factors and, furthermore, over an extended lifetime of a structure, we can be certain that significant variation will occur. The purpose of this model is simply to allow uniform comparisons to be made under present conditions.

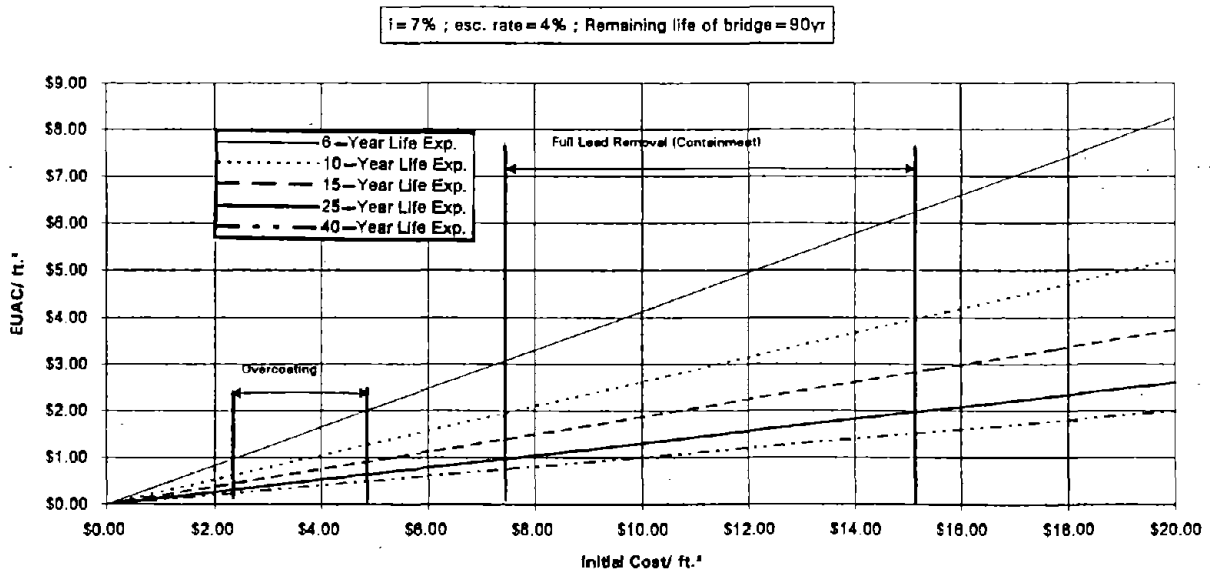
Figure 5. EUAC for overcoating compared to full lead removal.

The EUAC versus initial cost chart can also be used to compare coating alternatives and to define the allowable ranges of initial cost and life expectancy for a candidate to be competitive on the basis of life-cycle costs with another candidate. In figure 5, we see the chart for an interest rate of 7 percent and an inflation rate of 4 percent, with two regions of the chart that represent overcoating and full lead removal.

In this figure, we can see that for the cheapest overcoat job with a poor performance of only 6 years life expectancy, we would have to get 25 years out of even the cheapest total lead-removal job for the two approaches to be competitive on the basis of life-cycle costs. This approach could be used to evaluate any new coating alternative with an existing one. The chart would tell us what we would have to get in life expectancy out of a new candidate system that might be more expensive than an existing system for it to be life-cycle cost-competitive. This approach could also be used to tell us how much we can afford to spend to increase the life expectancy of a system. For example, if a \$21.52/m<sup>2</sup> (\$2.00/ft<sup>2</sup>) system is giving us only 6 years of life expectancy, we can afford to spend up to \$43.04/m<sup>2</sup> (\$4.00/ft<sup>2</sup>) to extend the life to only 10 years. This latter observation should have an impact on how State highway departments look at the question of warranted paint jobs. Some paint companies offer warranties that typically cover 10 years. The warrantee adds a cost increment to the paint job. The life-cycle cost approach of comparing these two alternatives says that the increment could be

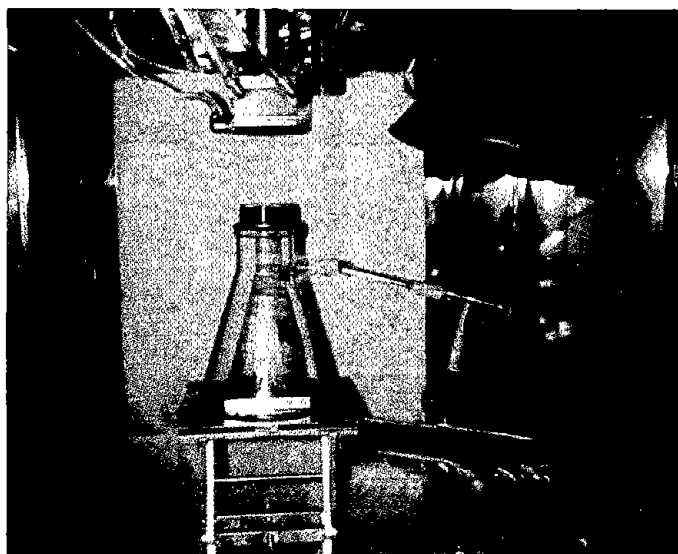
Figure 12. Laser paint-removal test apparatus set up beneath the laser beam.

painted steel cut from bridge girders that had been taken out of service and stored by the Illinois Department of Transportation. The existing paint was a three-layer system consisting of a red-lead/alkyd primer, a leafing aluminum/phenolic matrix intermediate coating, and a green-pigmented, non-leafing aluminum/phenolic topcoat. The test samples were placed within a glass confinement system with a zinc selenide (ZnSe) window so that all byproducts from the removal process were contained. The containment system consisted of a 2-L glass filter flask with side tubulation and the bottom cut off. The test sample was placed on a steel-base plate to which the flask was sealed by vacuum-bagging tacky tape. The ZnSe window was sealed to the top of the flask and the side arm led through a Tenax™ adsorbent tube to a Tedlar™ gas bag. The apparatus is shown in figure 12.

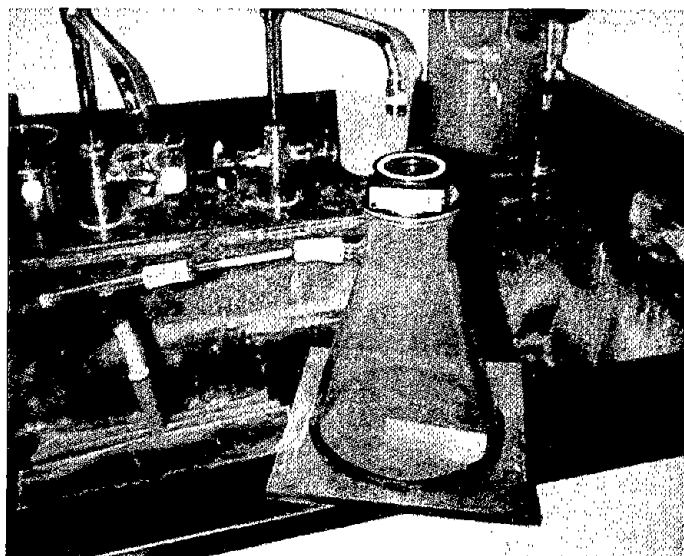
Figure 13. Flask used for laser paint removal (after treating the painted steel surface for 15 min).

Each time the laser beam impinged upon the painted surface, the paint burned with a yellow, sooty flame that rose 76 to 102 mm (3-4 in) above the painted surface. Visibility through the flask was reduced with each application of the laser. This was due to the fine soot that formed and was deposited on the sides of the flask. It scattered light within the flask and was deposited on the inner walls of the flask as shown in figure 13. Larger, heavy soot particles fell to the bottom of the system, depositing on the base plate as well as on the painted sample itself.

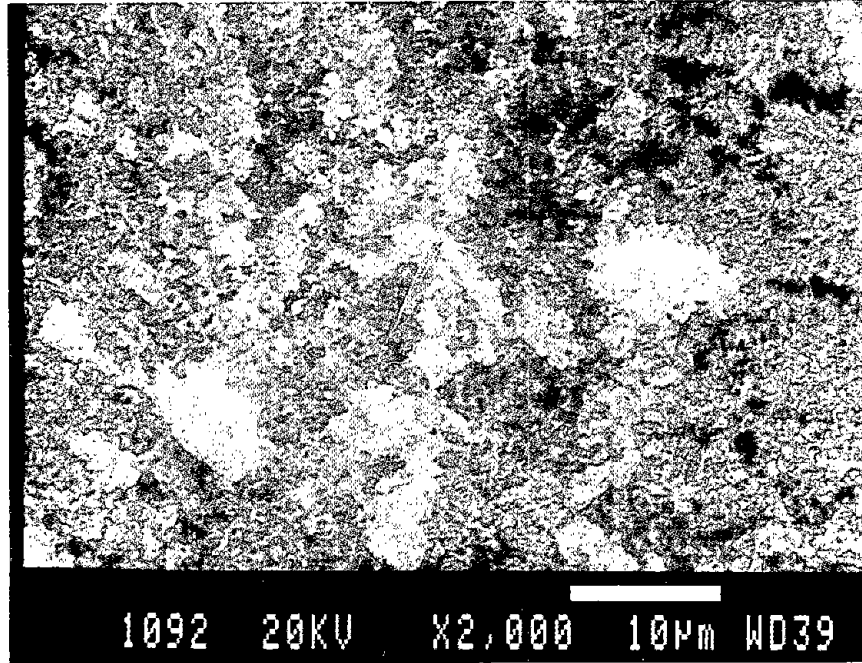
Figure 14. SEM photomicrograph of fine soot deposited on the interior walls of the containment flask.

Samples of the soot were collected from various parts of the apparatus and were analyzed by scanning electron microscopy (SEM) and energy dispersive x-ray (EDX). SEM micrographs of soot from the walls of the flask, from the base plate, and from the area where the byproduct gases escaped from the flask are shown in figures 14, 15, and 16, respectively. By comparing the particle sizes with the 10- $\mu\text{m}$  bar on the photos, it is evident that particles with diameters much less than 1  $\mu\text{m}$  are prevalent. In fact, the larger particles appear to be agglomerates of finer particles.

EDX analysis of soot samples shown in figures 14, 15, and 16 demonstrated that the soot contains lead. The other elements detected by EDX were silicon and aluminum.

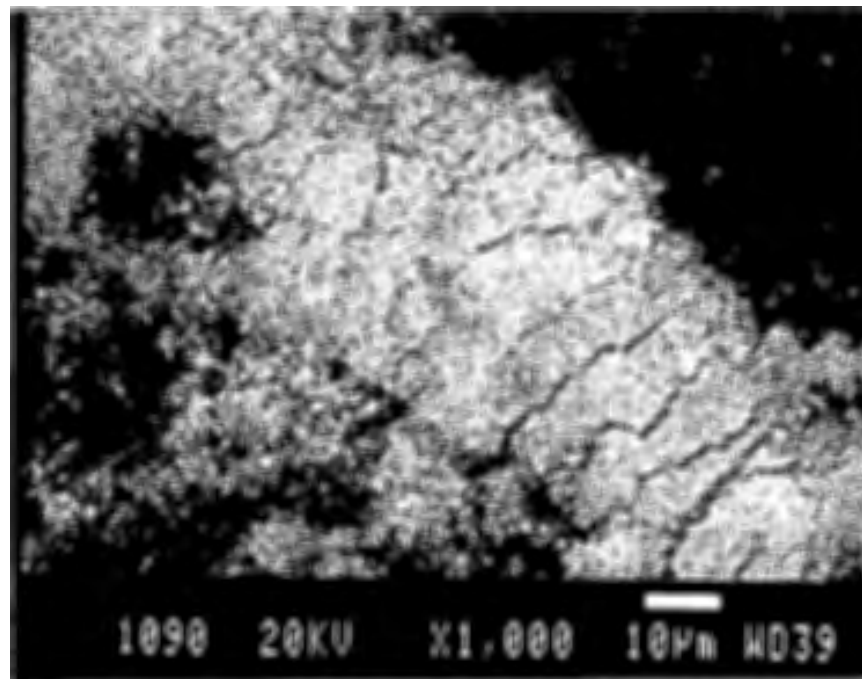
Figure 15. SEM photomicrograph of fine soot deposited on the stainless steel base of the containment flask.

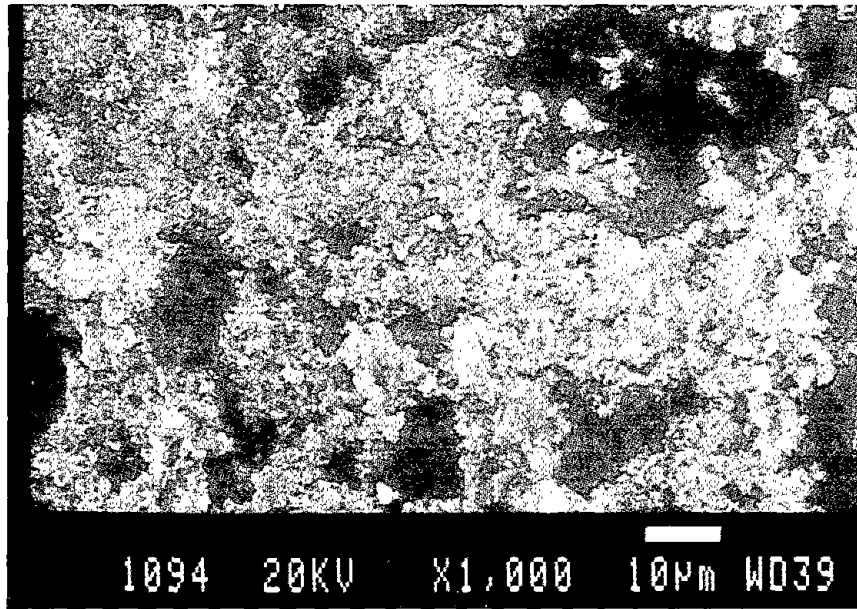
Figure 16. SEM photomicrograph of fine soot deposited on the vacuum seal of the containment flask.

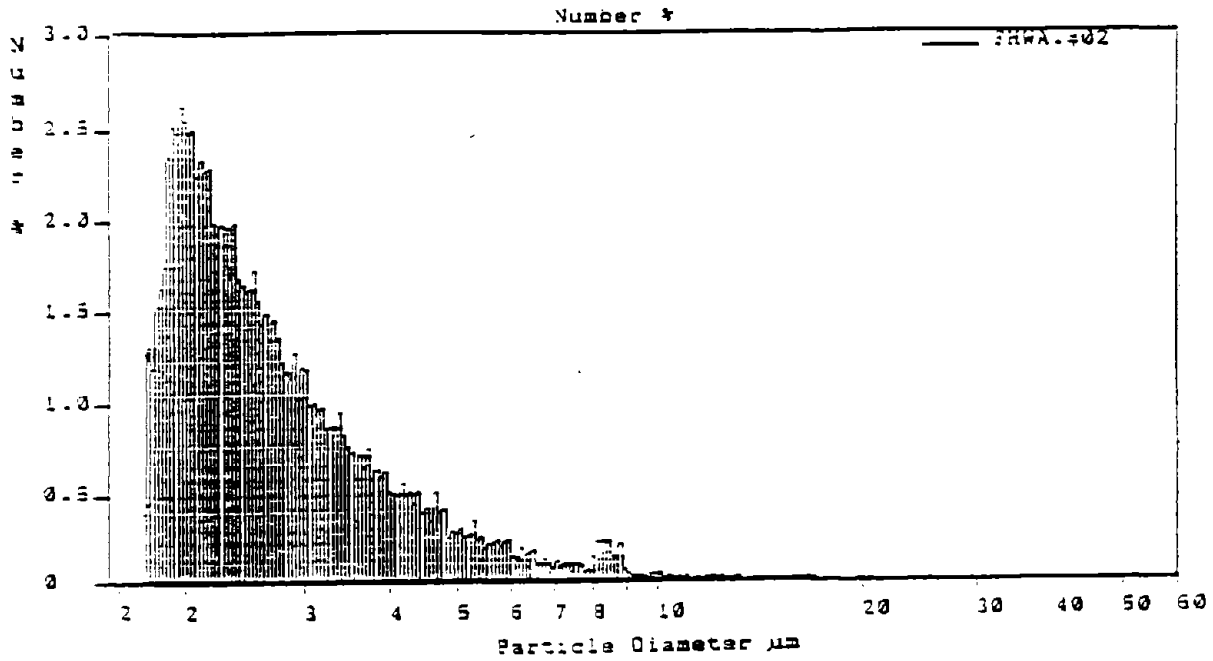
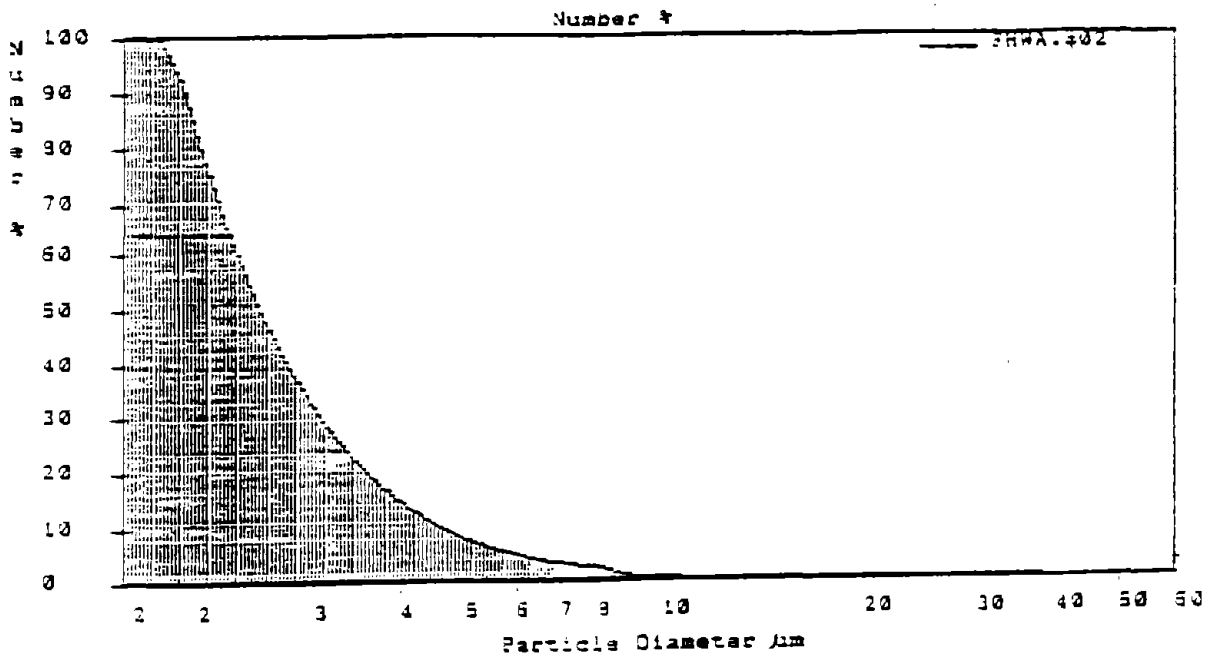
(a) Sample #1.

(b) Sample #2.

Figure 19. Coulter number percentage particle-size histogram of airborne dust samples collected within grit-blasting confinement zone during blasting.

Coulter particle-size analysis: Filter-cake particulates were dispersed in a saline solution using an anionic surfactant to prevent the particles from agglomerating. The Coulter Counter particle-sizing system allows for a measurement of a size distribution between certain minimum and maximum particle-size diameters depending on the orifice sizes chosen. A range of 2 to 60  $\mu\text{m}$  was chosen for analysis because preliminary SEM analysis indicated that the smaller particles tended to be more rich in lead. Figures 19(a) and (b) depict the particle-size distribution obtained for two samples taken from different areas on a single filter cake. Sample #1 was taken from an area near the outer edge of the filter, while sample #2 was taken from an area near the center of the filter. The plots in figure 19 are most easily understood by imagining the particles passing through a series of sieves with mesh sizes indicated on the horizontal axis. The height of each vertical line (or bar) represents the number of particles of that size. Neither sample contained many particles with diameters greater than 10  $\mu\text{m}$ . The plot in figure 19(a) indicates that 50 percent of the particles are smaller than 2.5  $\mu\text{m}$  in size. The plot in figure 19(b) indicates that of all the particles measured in the 2- $\mu\text{m}$  to 60- $\mu\text{m}$  range, the largest number occurred at the 2- $\mu\text{m}$  cutoff. Since this strongly suggests that a large portion of the particulates have diameters less than 2  $\mu\text{m}$ , samples were sent out for analysis by the Elzone™ system, which was capable of measuring sizes down to well below 1  $\mu\text{m}$ . These samples were representative of the remainder of the filter cake after having removed the two small samples analyzed in figures 19(a) and (b).

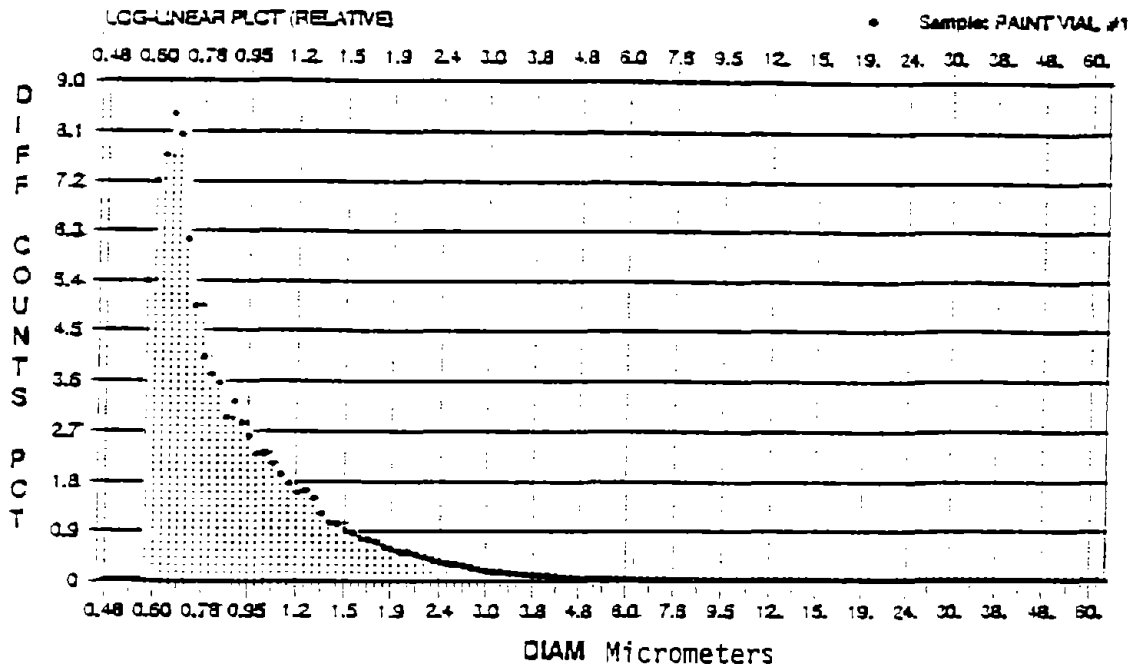
Figure 20. Elzone™ number percentage particle-size analysis of airborne dust sample #1 collected within grit-blasting confinement zone during blasting.

Elzone™ particle-size analysis: The Elzone™ technique is similar to the Coulter technique. The difference was that in the Elzone™ case, a smaller orifice (capable of detecting particle diameters down to 0.6  $\mu\text{m}$ ) was used. Two samples were analyzed and the results are shown as number percentages in figures 20 and 21 and volume percentages in figures 22 and 23. For the sample corresponding to figure 20, more than 50 percent of the particles detected had diameters less than 0.8  $\mu\text{m}$  and the highest number count occurred at 0.65  $\mu\text{m}$ . For the sample shown in figure 21, more than 50 percent of the particles had diameters less than 1.0  $\mu\text{m}$  and the highest number counts occurred between 0.65  $\mu\text{m}$  and 0.73  $\mu\text{m}$ . Although neither sample contained a large number of particles with diameters greater than 6  $\mu\text{m}$ , the larger particles make up a significant volume of the total particulate volume as shown in figures 22 and 23. Note that the sample in figure 22 contained a 10- $\mu\text{m}$  latex marker.

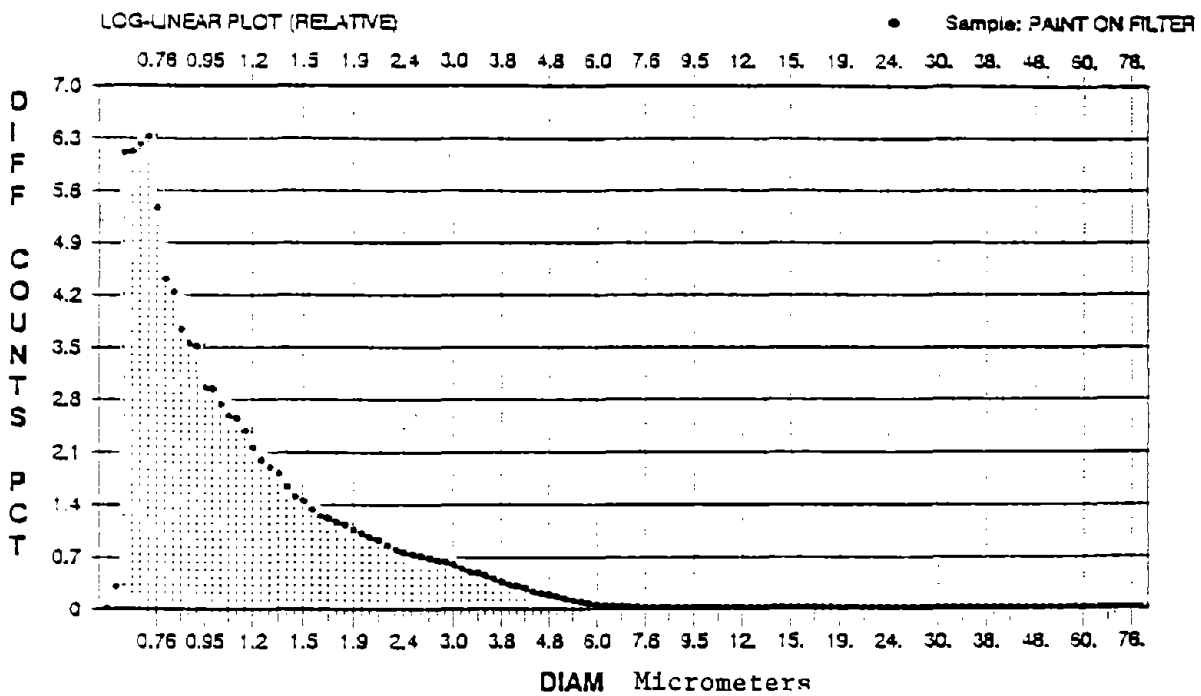
Figure 21. Elzone™ number percentage particle-size analysis of airborne dust sample #2 collected within grit-blasting confinement zone during blasting.

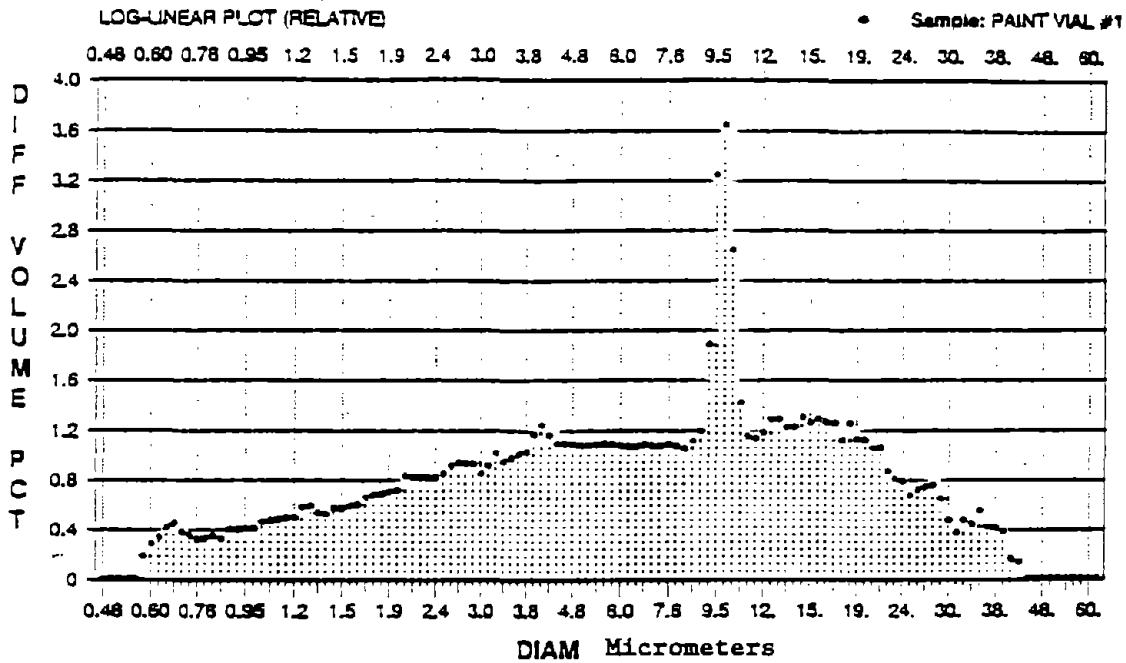
Figure 22. Elzone™ volume percentage particle-size analysis of airborne dust sample #1 collected within grit-blasting confinement zone during blasting.

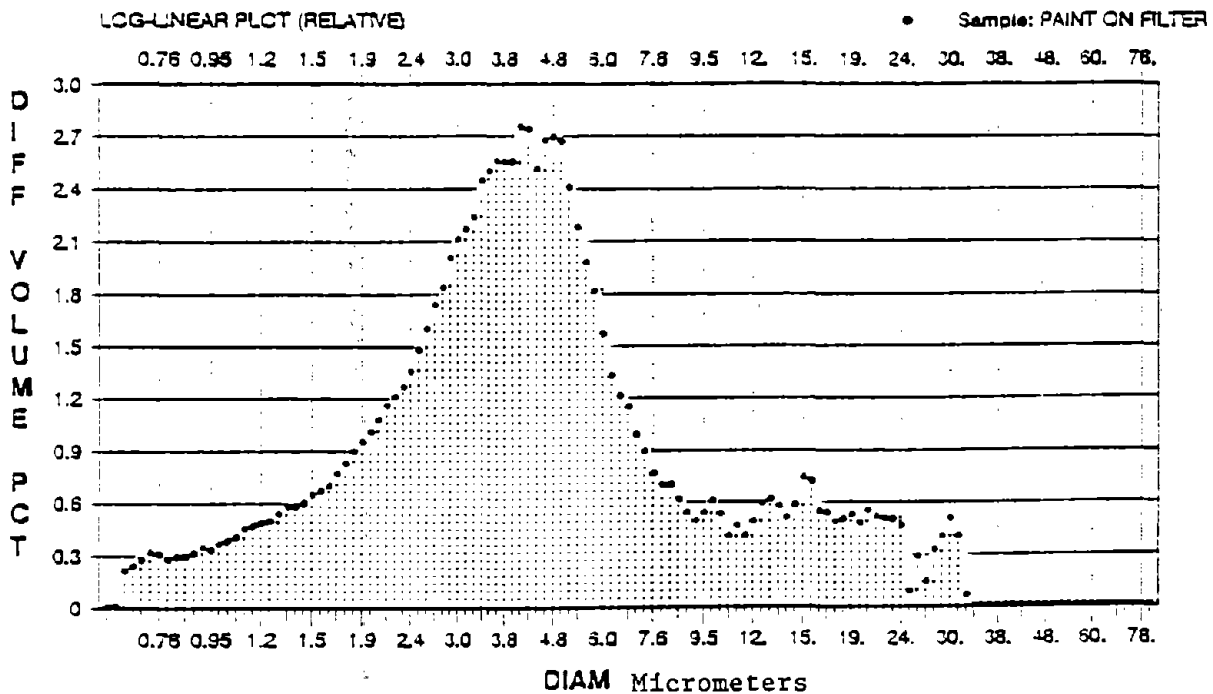
Figure 23. Elzone™ volume percentage particle-size analysis of airborne dust sample #2 collected within grit-blasting confinement zone during blasting.

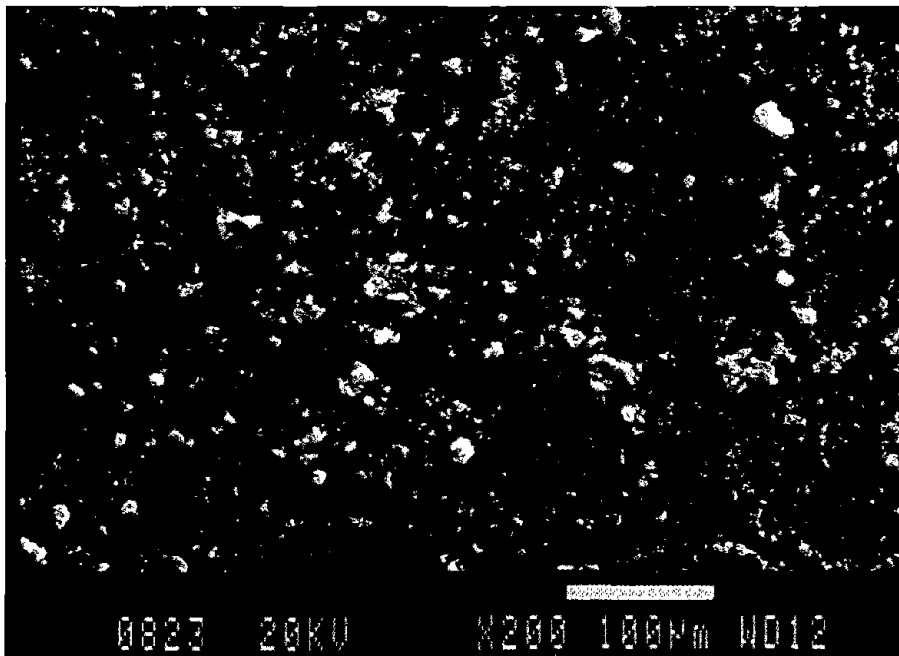
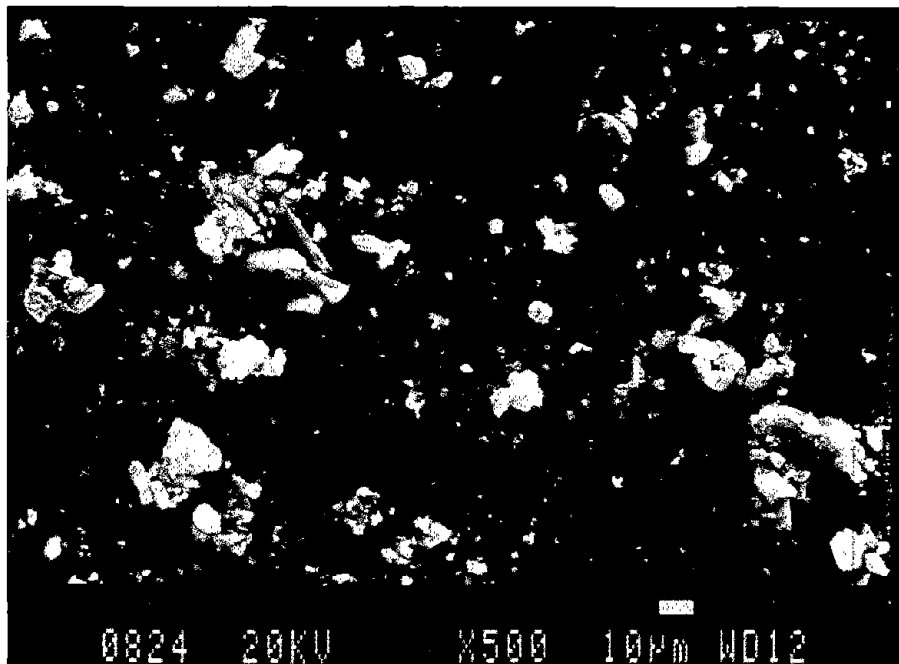
(a) x 200 magnification.

(b) x 500 magnification.

Figure 24. SEM micrograph showing particle sizes using the acetone dispersion technique.

SEM and EDX microanalysis: The air filter was heavily loaded with particulates. Sample particles were prepared for analysis in the SEM using two different techniques. The first technique entailed scooping particulates from the filter and dispersing them in semiconductor-grade acetone. The suspension was then transferred via pipette to a spectroscopically pure carbon plate. The second technique relied on electrically conductive adhesive carbon tape that was gently pressed against the surface of the filter and then mounted on a carbon plate. Both techniques produced satisfactory dispersions as indicated in figures 24(a) and 24(b) that show the acetone dispersion at

x 200 and x 500 magnifications and figures 25(a) and 25(b) that show the carbon tape dispersion at x 200 and x 250. The SEM photomicrographs indicate that a wide variation in particle size is present in the airborne grit-blast debris.

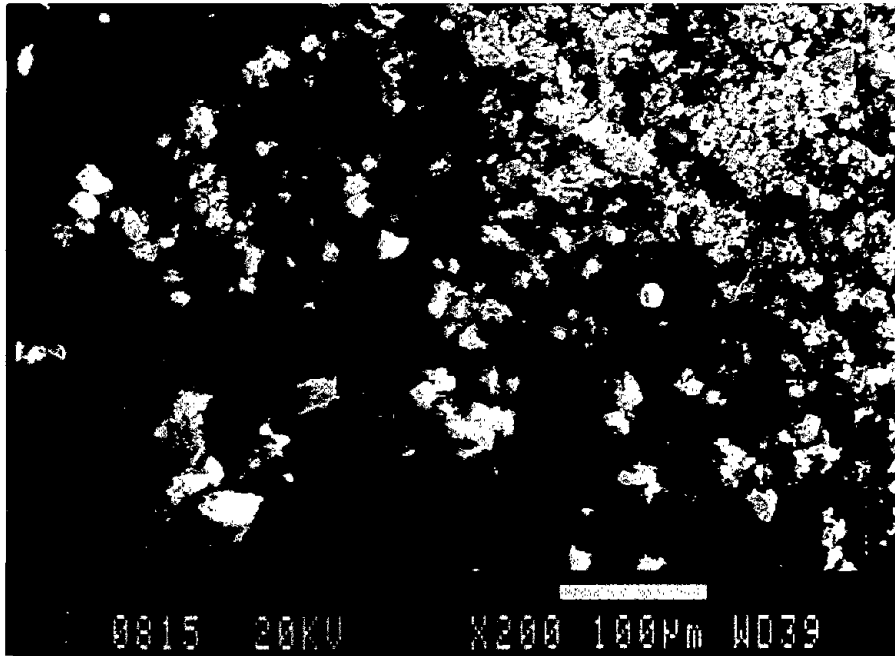
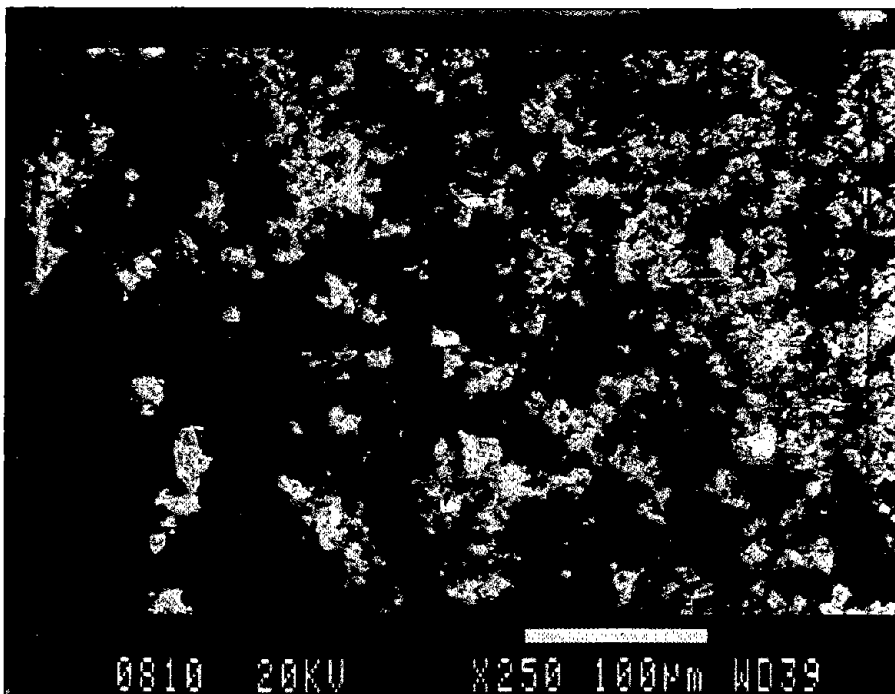
(a) x 200 magnification.

(b) x 250 magnification.

Figure 25. SEM micrograph showing particle sizes using carbon tape dispersion technique.

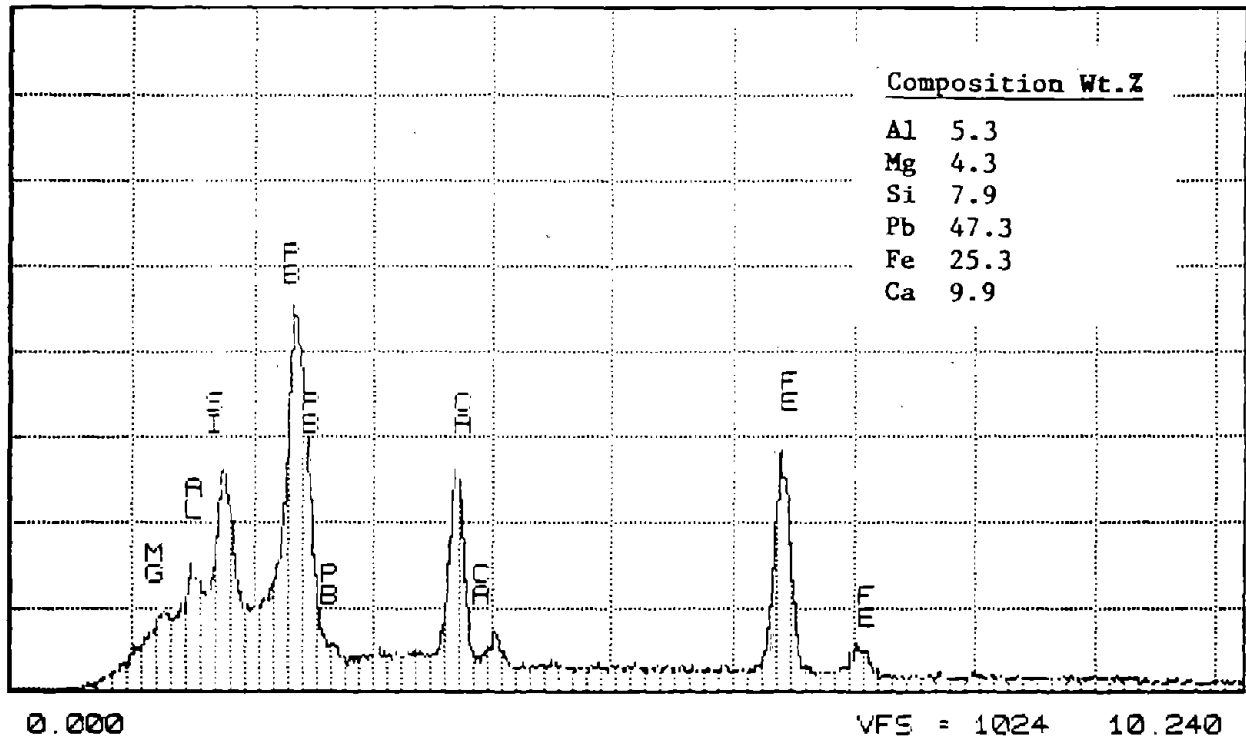
Figure 26. EDX analysis and SEM micrograph of airborne particulates collected within confinement zone during blasting.

Figure 26 shows the top surface of the filter cake together with its energy-dispersive x-ray spectrum (EDX) and composition. The primary constituents are lead and calcium from the paint; iron from the steel grit and rust, and minor amounts of aluminum and magnesium that may come from the paint or from residual dust. The detection of silicon separately and in combination with aluminum is nearly always due to ambient dust. Note that this x-ray spectrum and the spectra that follow were acquired with an x-ray detector that uses a beryllium window to insulate the x-ray detecting crystal from the vacuum in the SEM. Although the beryllium window ensures proper operation of the detecting crystal, it completely absorbs low-energy x-rays from elements lighter than sodium. Therefore, elements such as oxygen, nitrogen, carbon, and hydrogen are not detectable. Three large fragments of steel grit found in the filter cartridge are shown in figure 27. Note that no lead was detected on the steel grit within the detection limits of the system. Smaller iron-containing particles were also detected, typically in the size range down to approximately 10  $\mu\text{m}$ . Two such particles are shown in figures 28 and 29. The iron-rich particle shown in figure 29 also contains lead and silicon. These two particles may contain significant amounts of rust since they are morphologically different compared with the steel grit in figure 27.

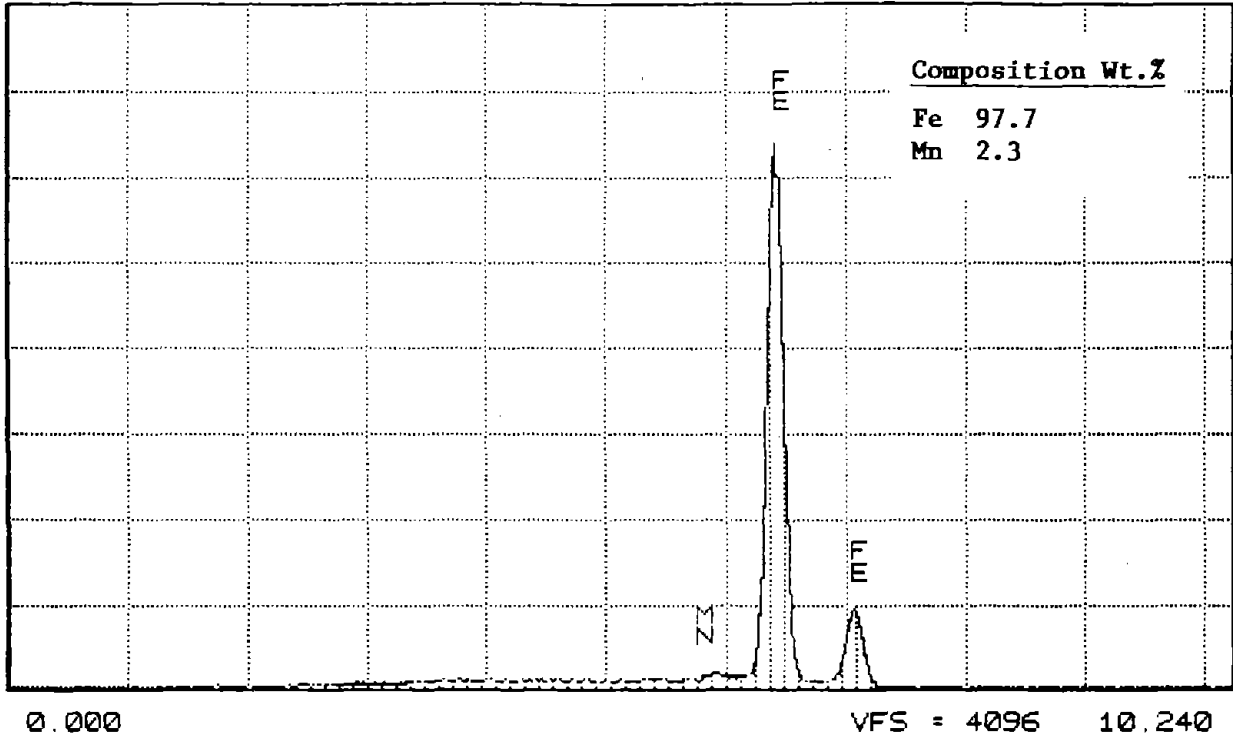
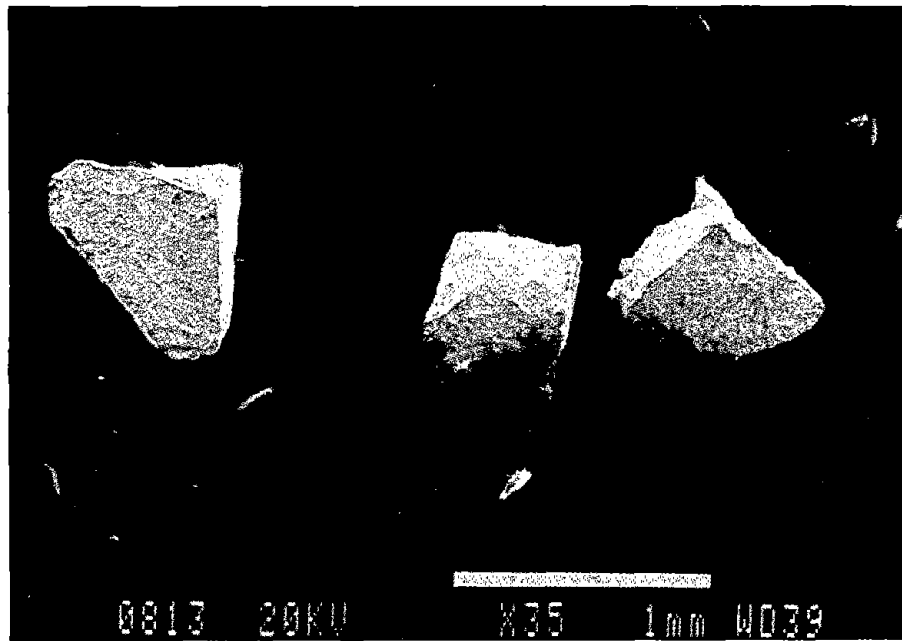
Figure 27. EDX analysis and SEM micrograph of 650- $\mu$ m particles collected on filter within confinement zone during blasting.

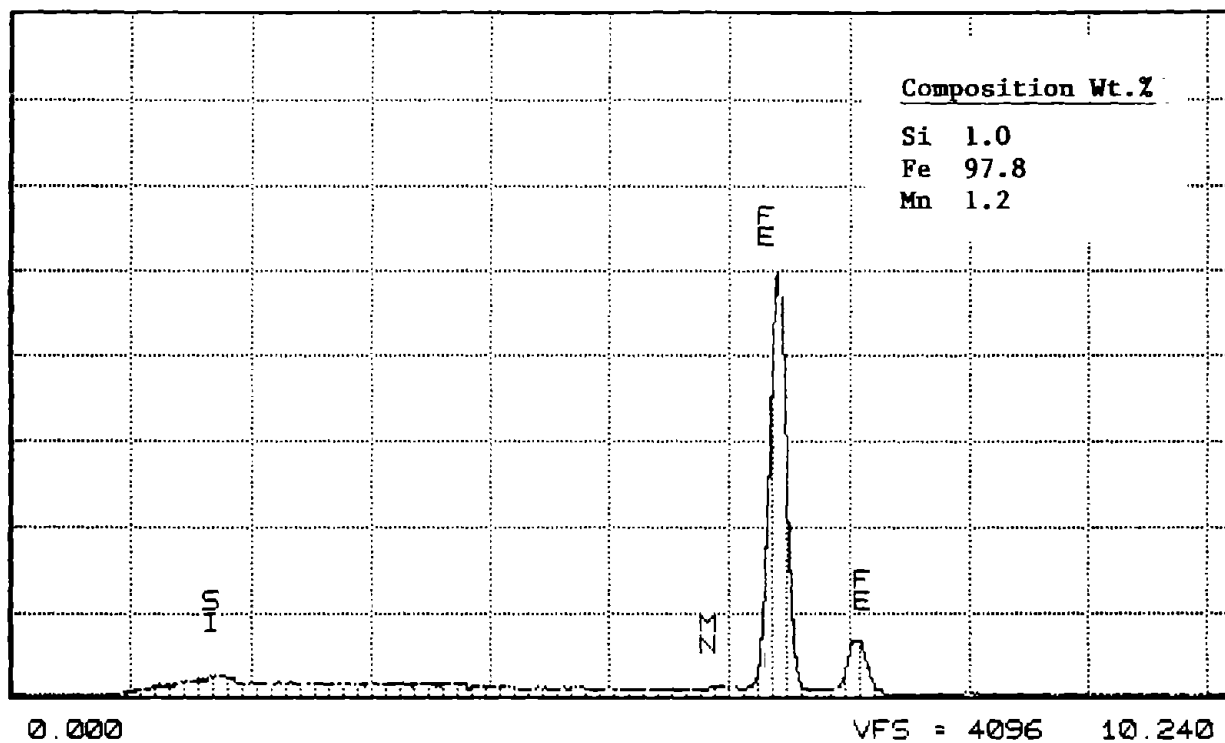
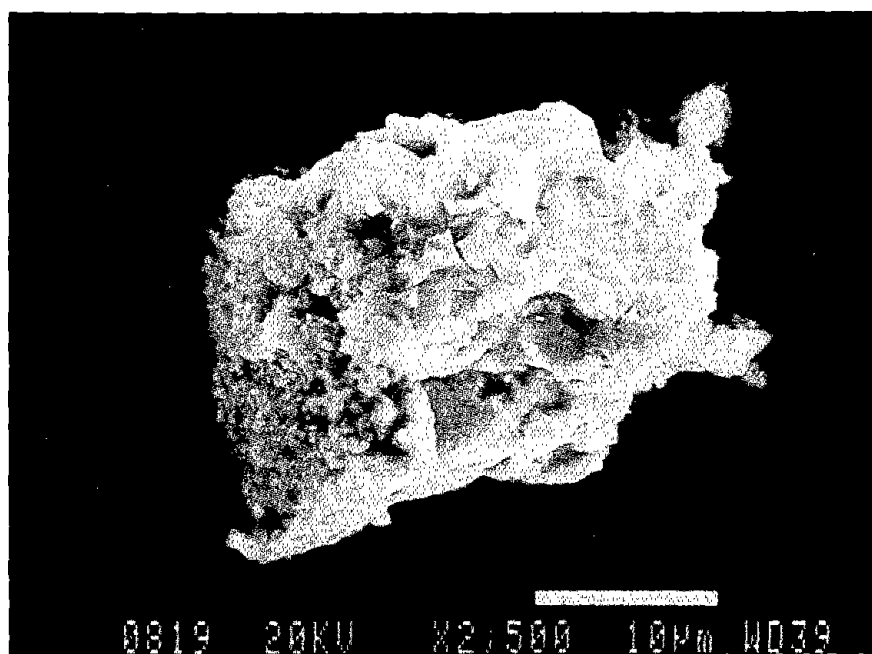
Figure 28. EDX analysis and SEM micrograph of 25- $\mu$ m particle collected on filter within confinement zone during blasting.

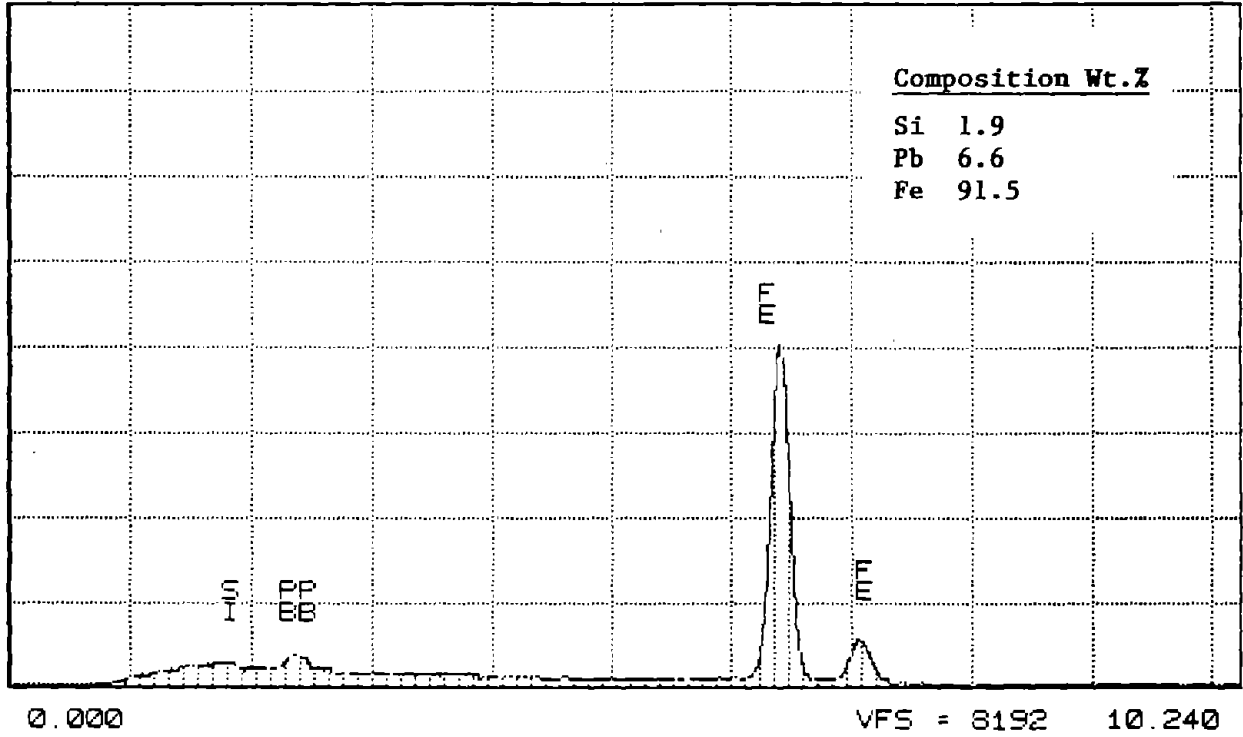
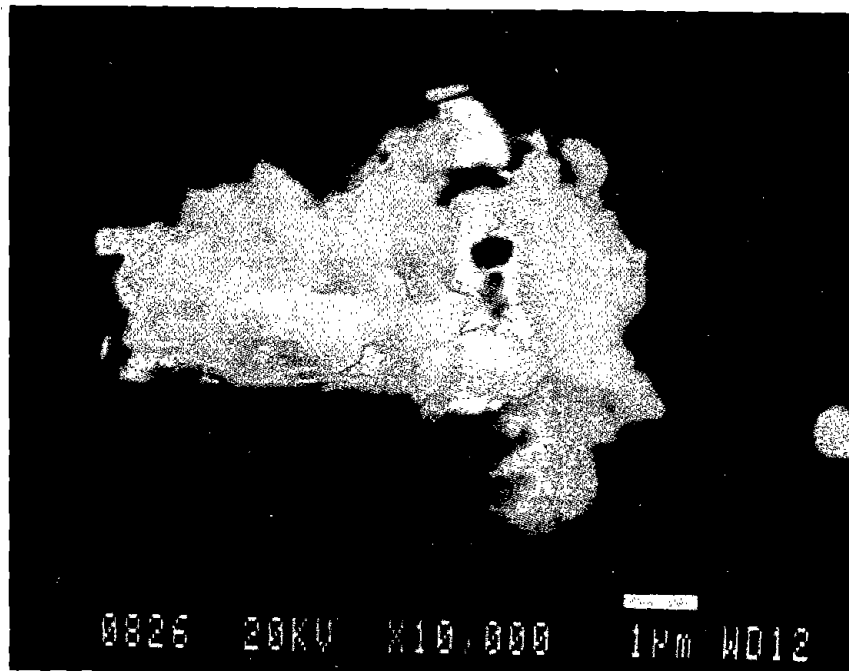
Figure 29. EDX analysis and SEM micrograph of 5- $\mu$ m particle collected on filter within confinement zone during blasting.
