Publication No. FHWA-RD-94-098  
August 1995

# Issues Impacting Bridge Painting: An Overview

U.S. Department of Transportation  
**Federal Highway Administration**

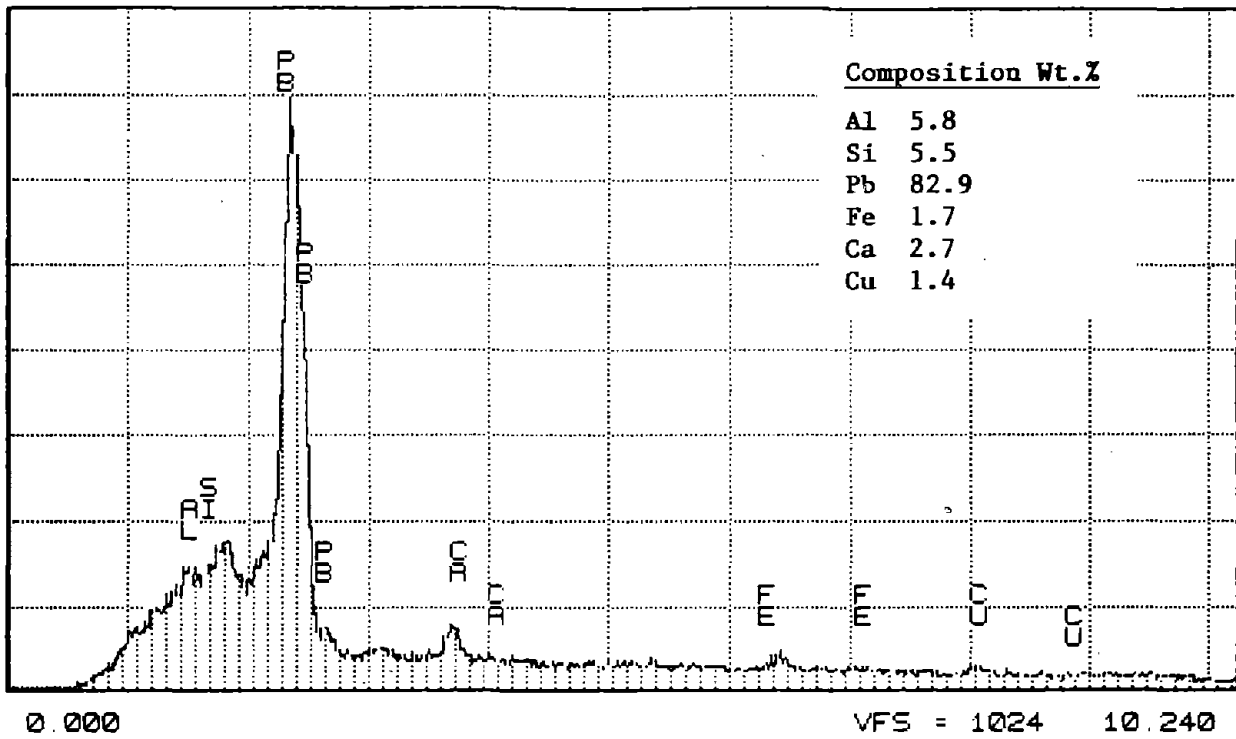
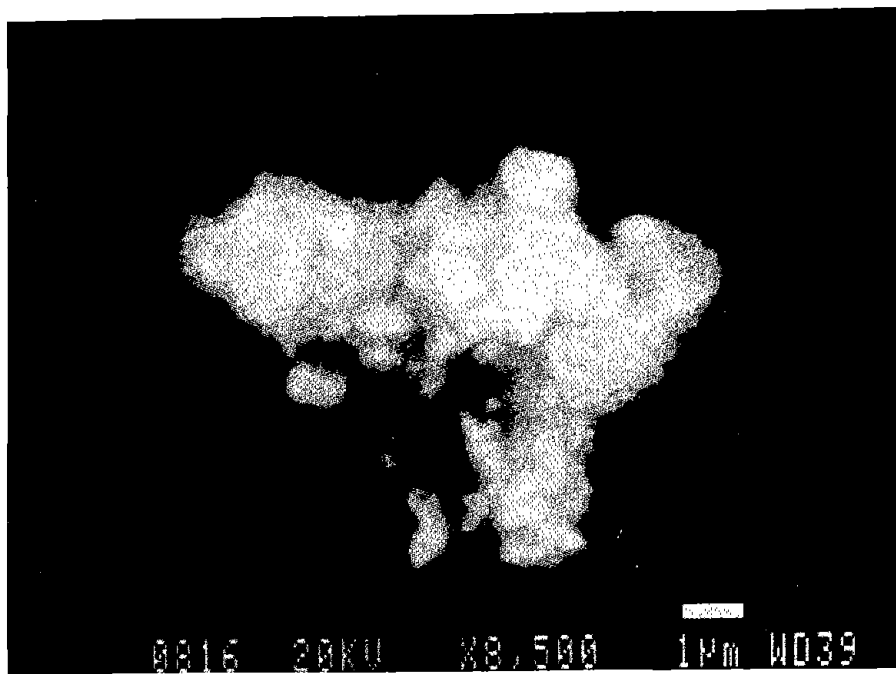
Figure 30. EDX analysis and SEM micrograph of 6- $\mu$ m particle collected on filter within confinement zone during blasting.

The majority of particles analyzed contained lead, although some did not. Representative samples of particles are shown in figures 30 through 35. The particle in figure 34 contains significant amounts of lead and silicon together with iron, magnesium, calcium, and zinc. It may have come from the topcoat that had dust blown on it before it had cured. Figure 35 shows a particle that is primarily zinc and probably originated from an intermediate layer of paint between the primer and the topcoat.

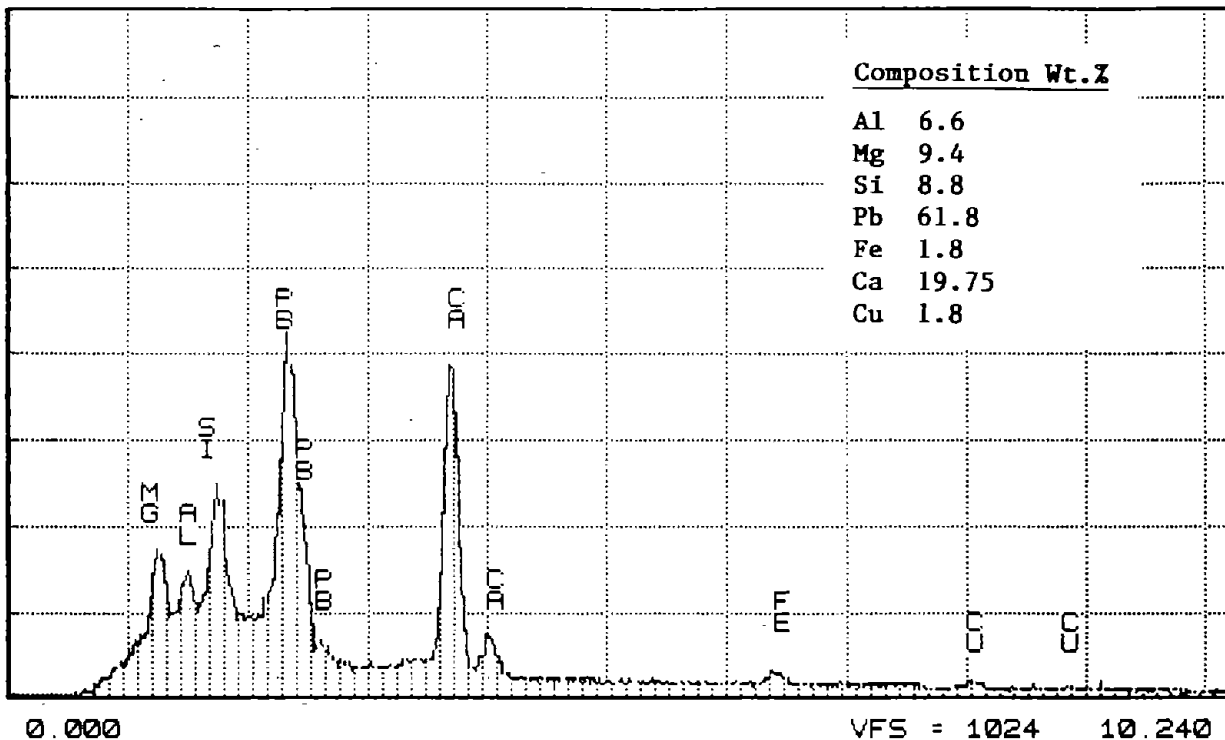
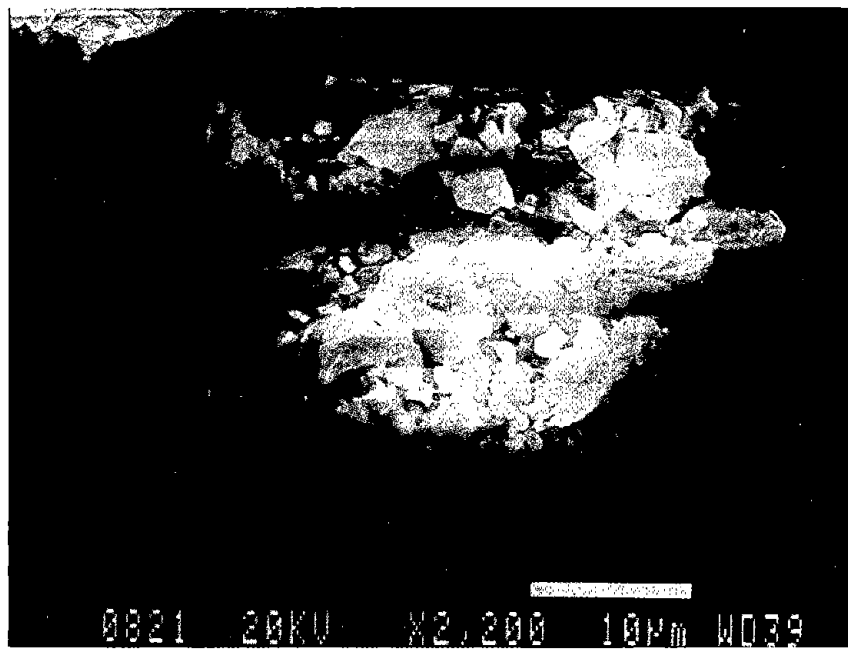
Figure 31. EDX analysis and SEM micrograph of 35- $\mu\text{m}$  particle collected on filter within confinement zone during blasting.

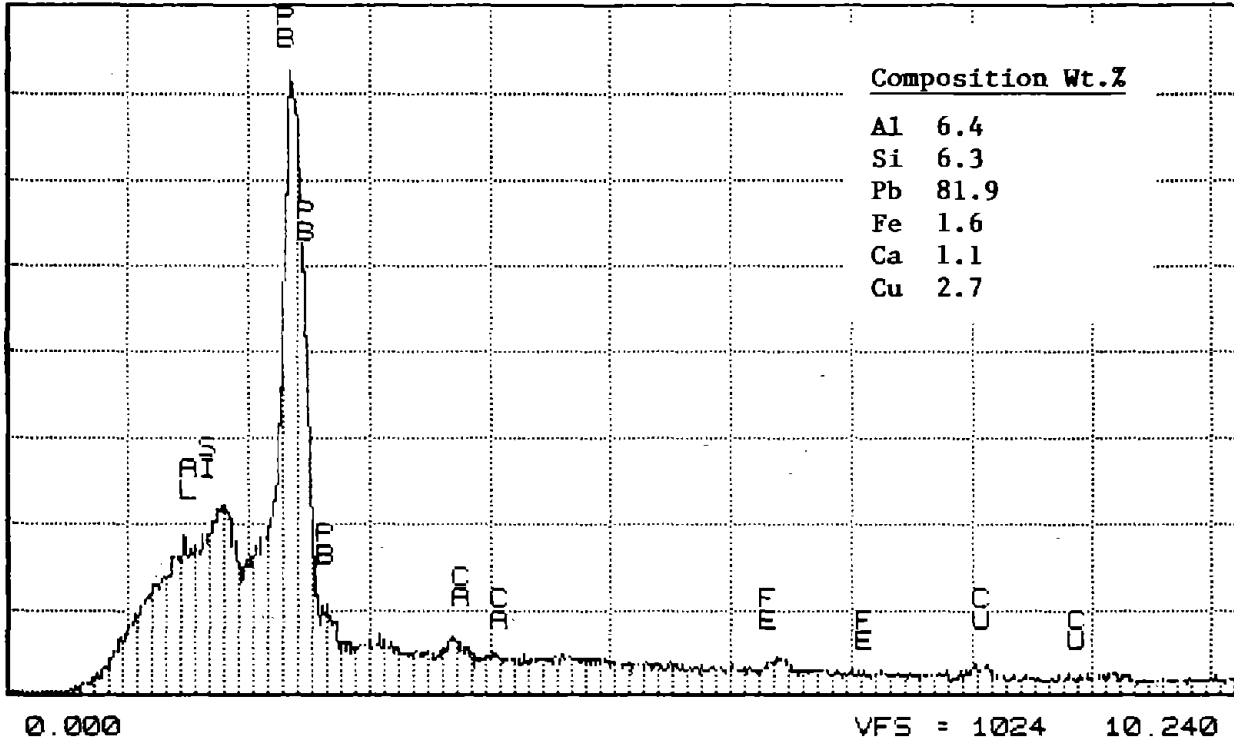
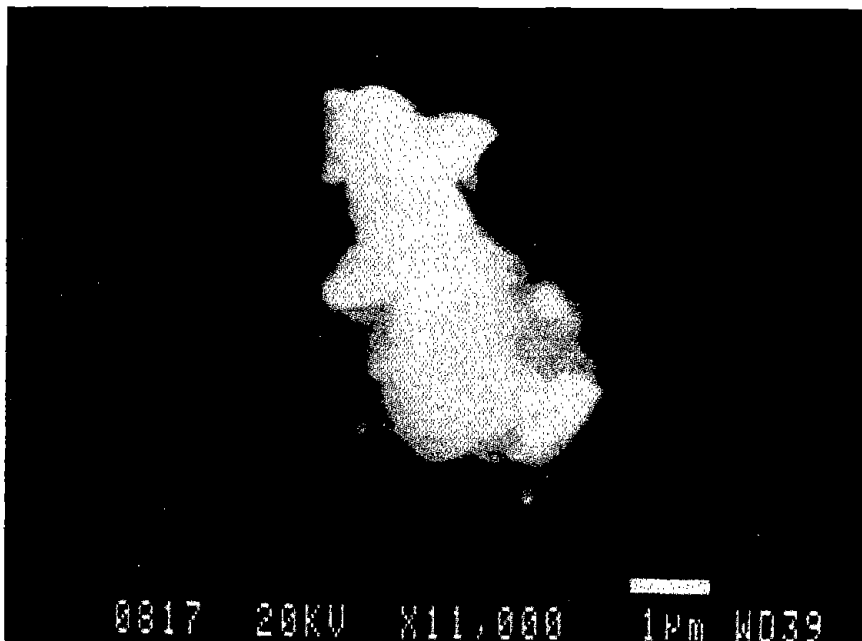
Figure 32. EDX analysis and SEM micrograph of 4- $\mu$ m particle collected on filter within confinement zone during blasting.

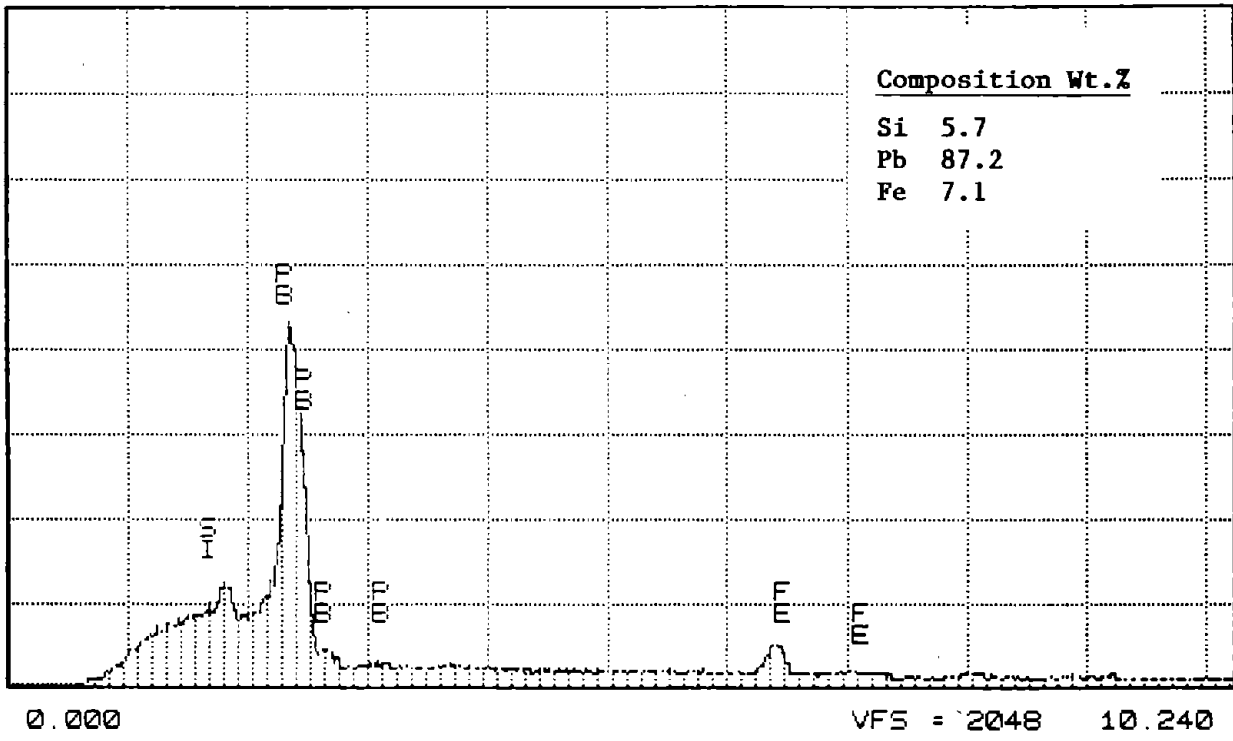
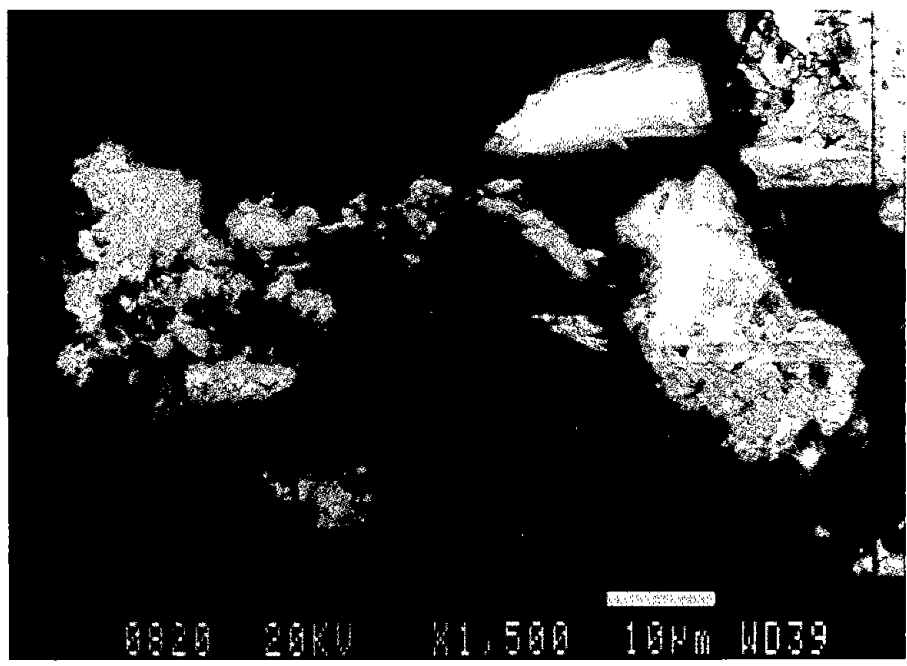
Figure 33. EDX analysis and SEM micrograph, 50- $\mu$ m particle collected on filter within confinement zone during blasting.

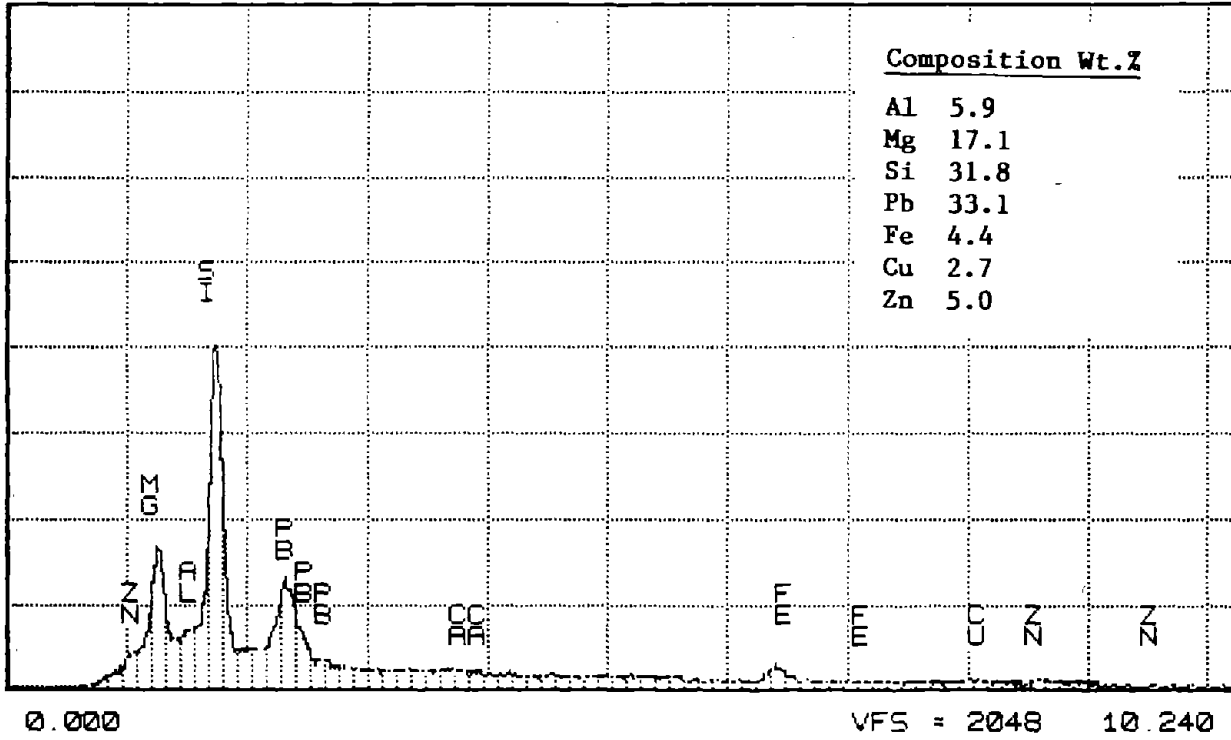
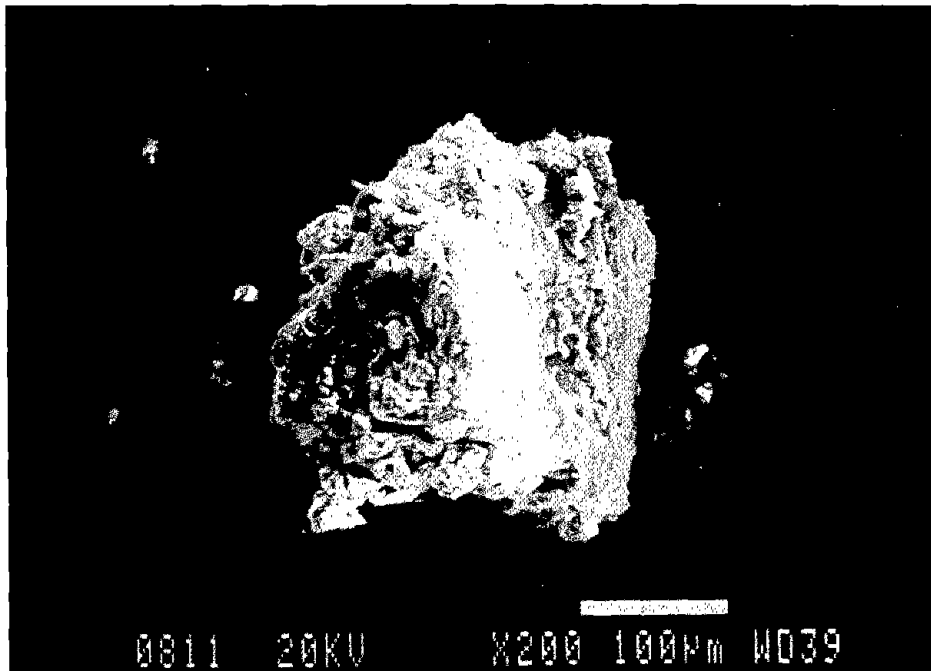
Figure 34. EDX analysis and SEM micrograph of 270- $\mu\text{m}$  particle collected on filter within confinement zone during blasting.

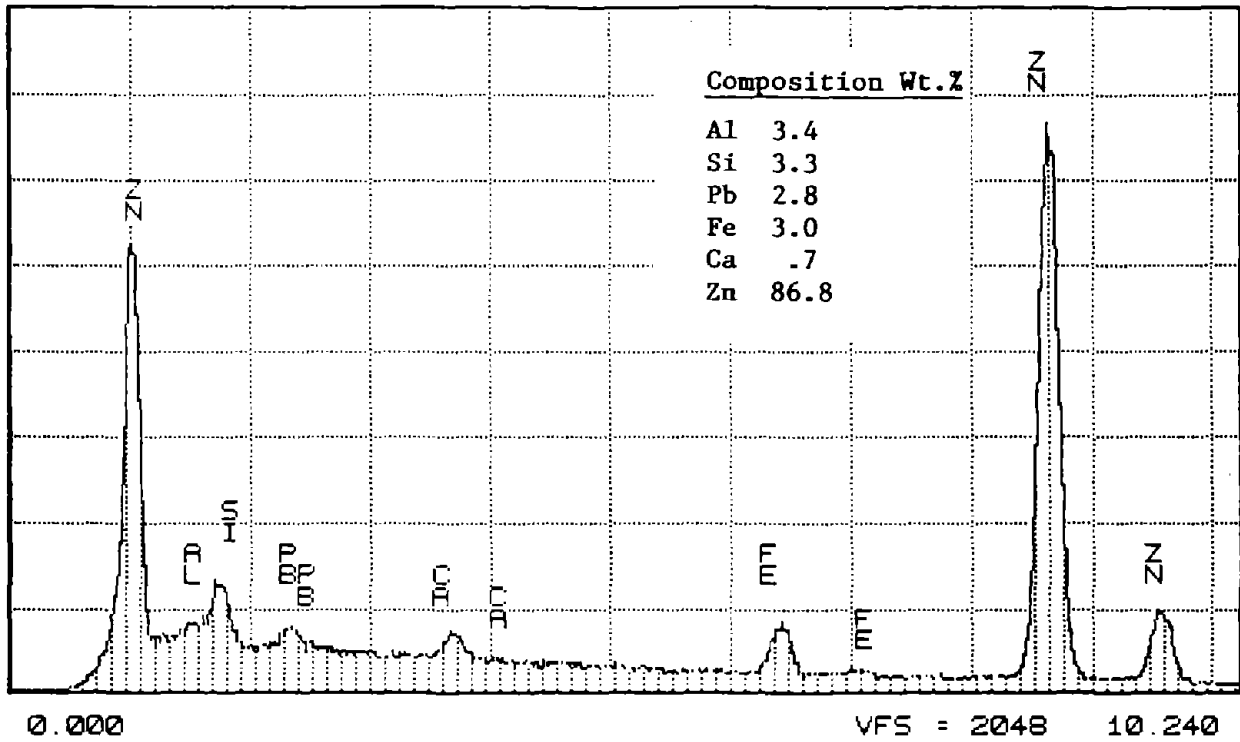
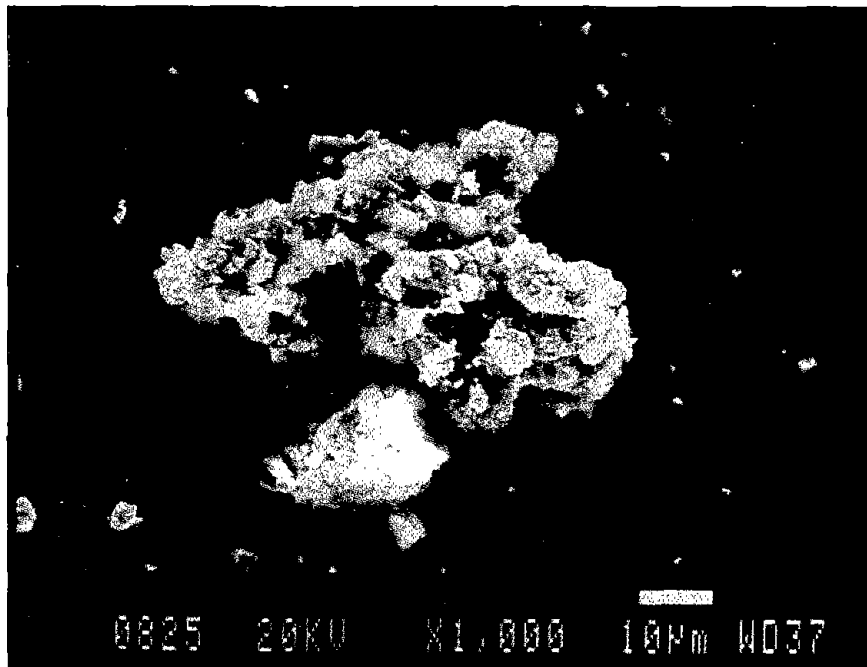
Figure 35. EDX analysis and SEM micrograph of 55- $\mu\text{m}$  particle collected on filter within confinement zone during blasting.

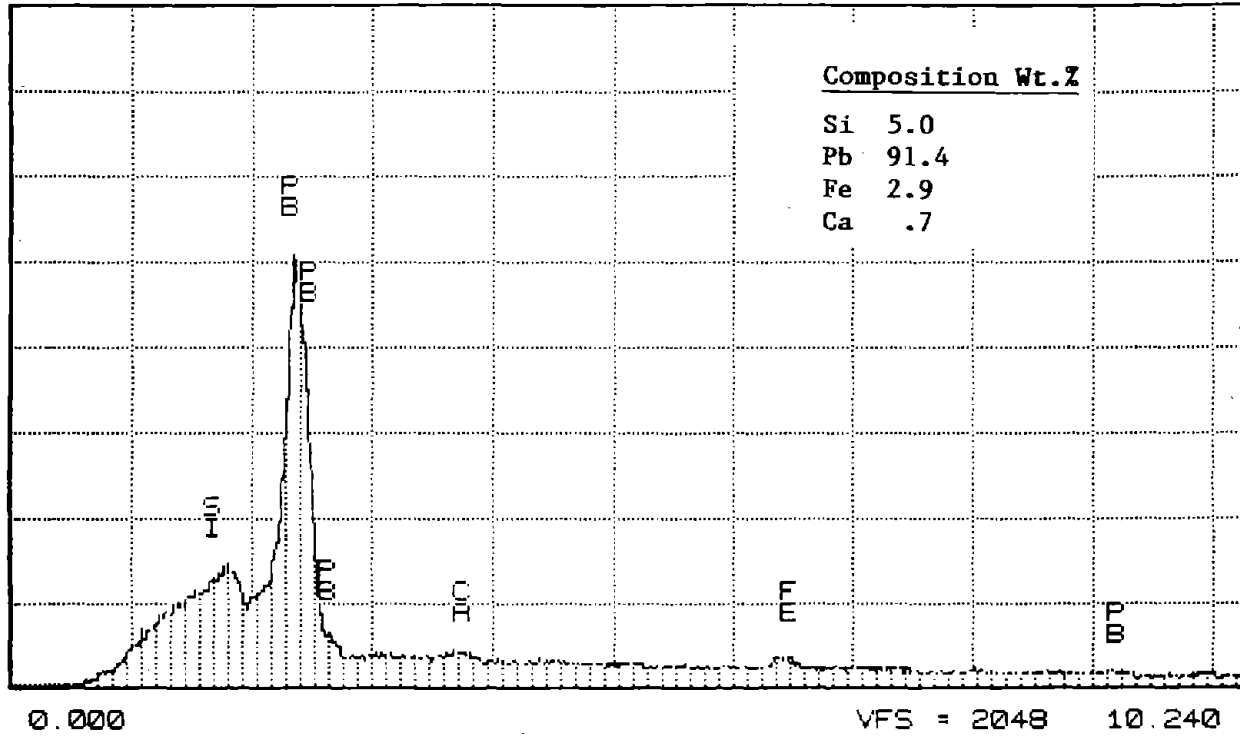
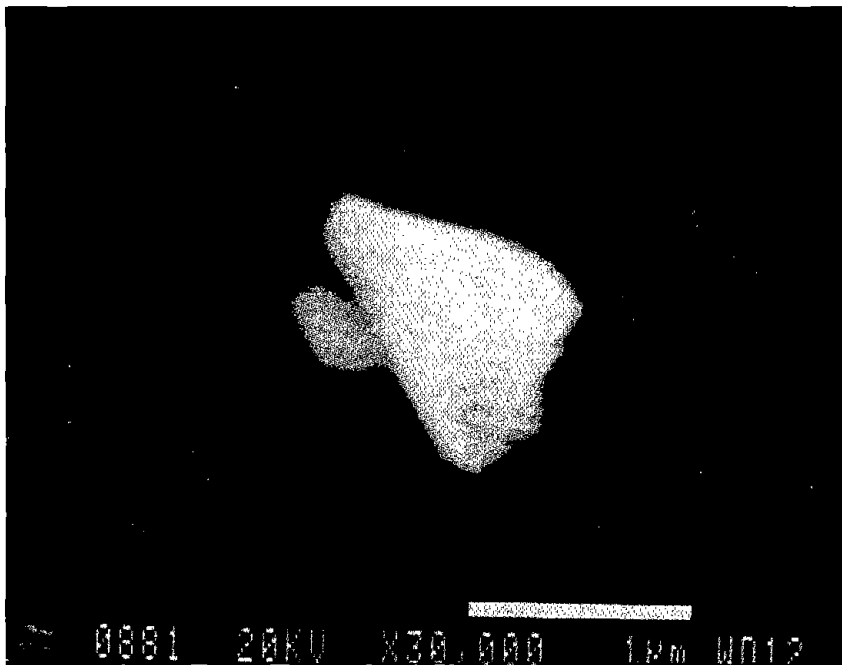
Figure 36. EDX analysis and SEM micrograph of 1- $\mu$ m particle collected on filter within confinement zone during blasting.

The proportion of particles that contain lead as a major constituent appeared to increase with decreasing size. Smaller particles, down to approximately 1  $\mu\text{m}$ , are shown in figures 36 through 39. The angular morphology, together with the cleavage step appearance of these smaller particles, suggest that they originate from a brittle layer, possibly the primer that is fractured by impingement of steel grit. Table 4 gives the composition of various sizes of particles collected on the filter within the grit-blast confinement area. The figure number of the corresponding SEM and EDX analyses also is listed in table 4.

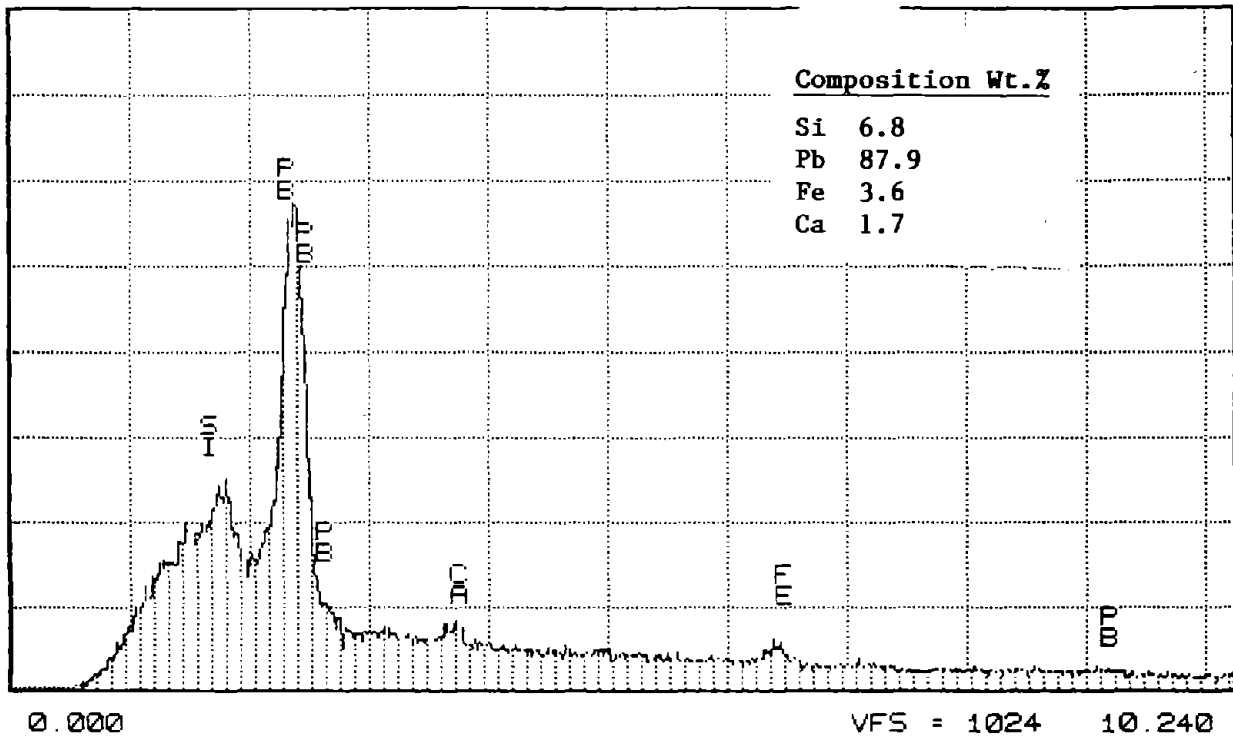
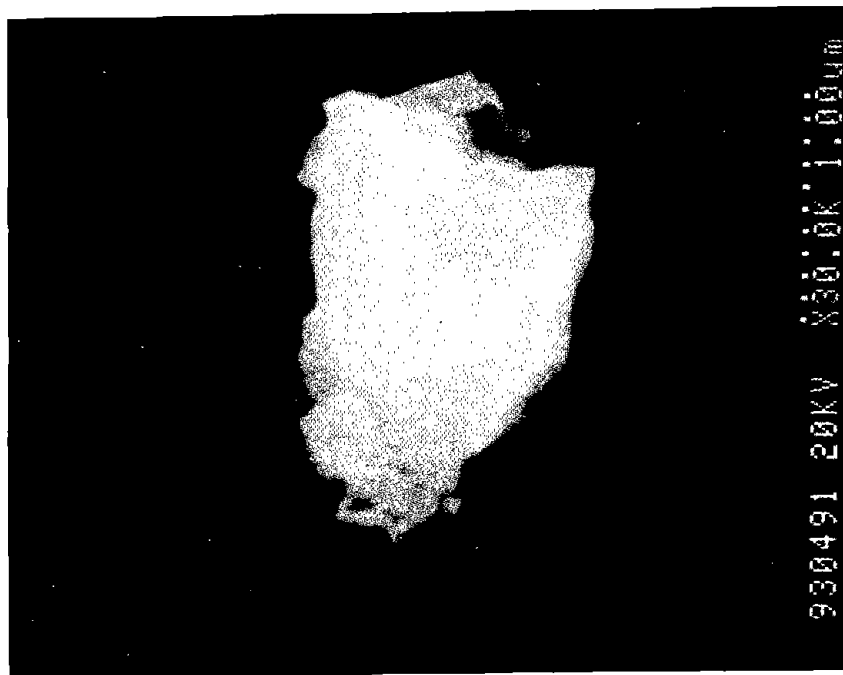
Figure 37. EDX analysis and SEM micrograph of 1- $\mu$ m particle collected on filter within confinement zone during blasting.

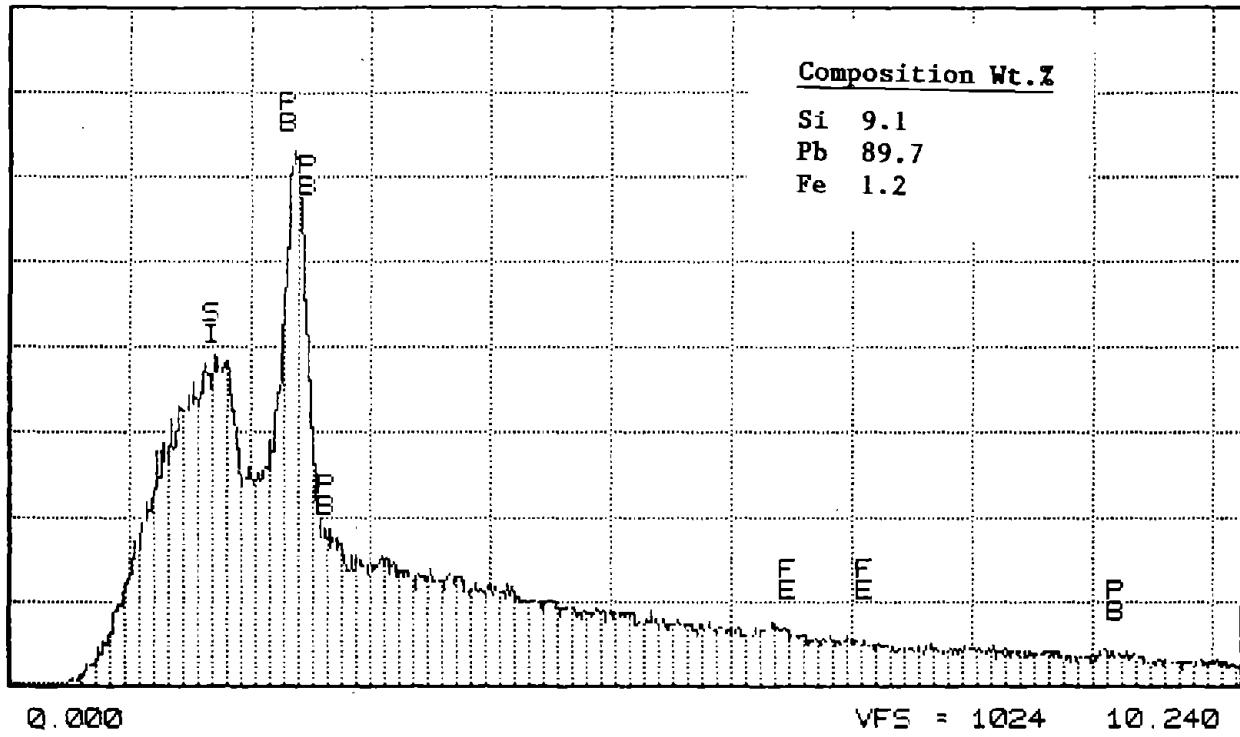
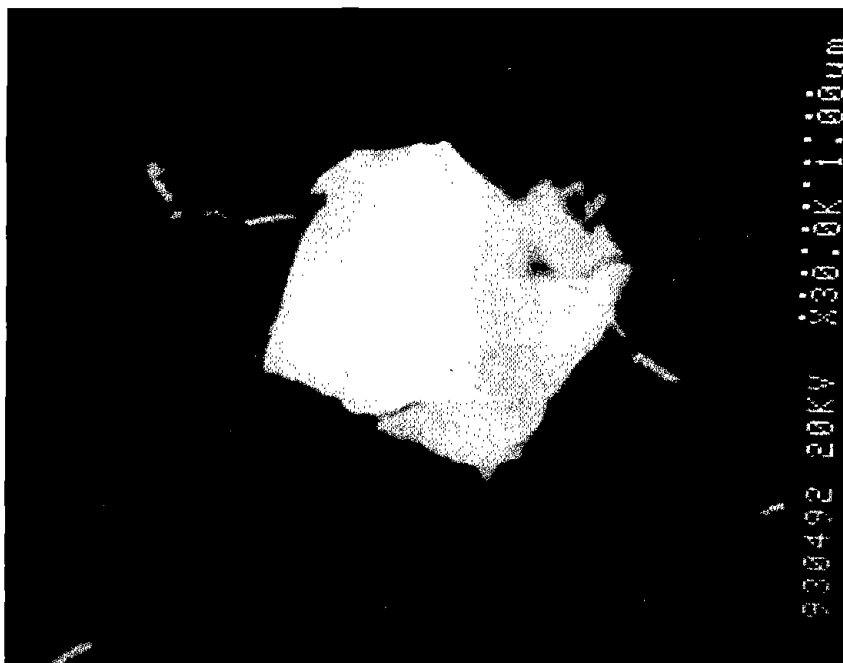
Figure 38. EDX analysis and SEM micrograph of 1- $\mu$ m particle collected on filter within confinement zone during blasting.

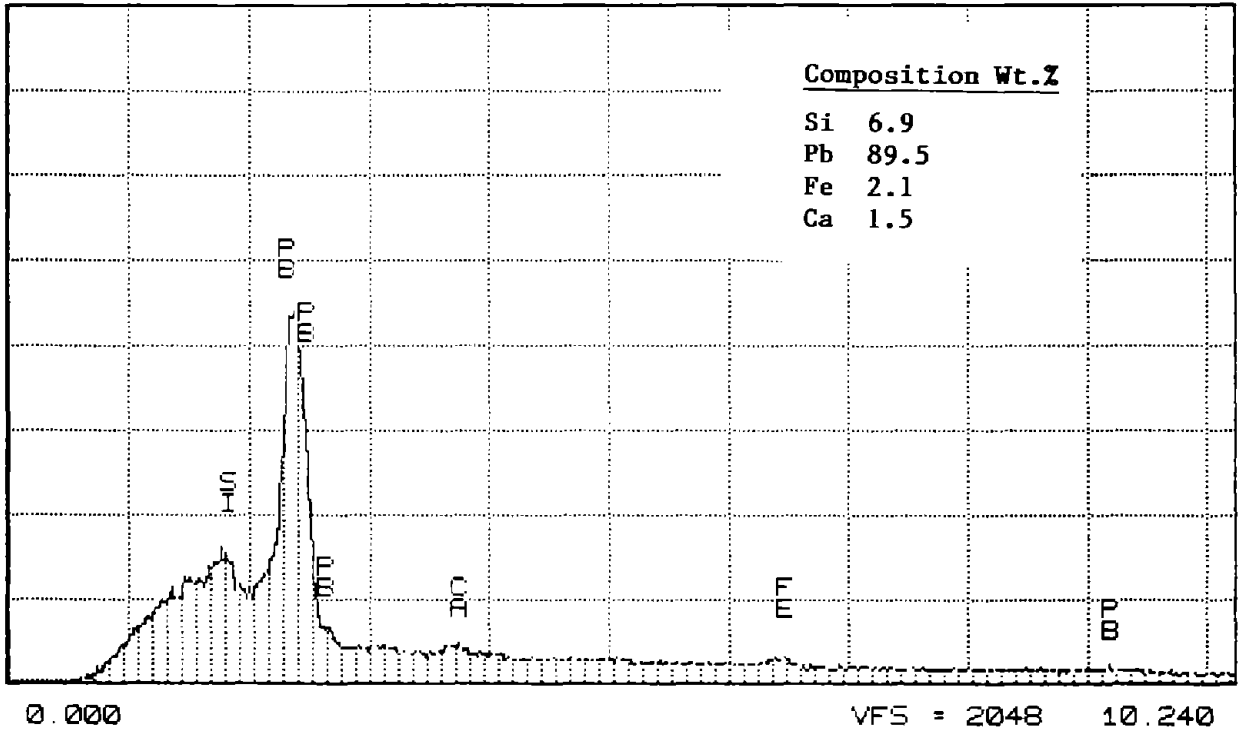
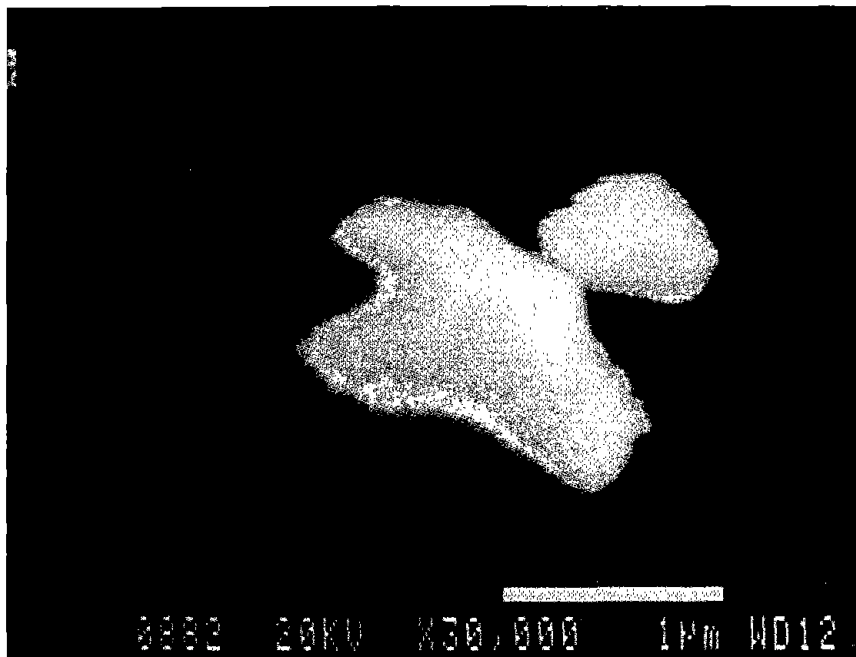
Figure 39. EDX analysis and SEM micrograph of 1- $\mu$ m particle collected on filter within confinement zone during blasting.

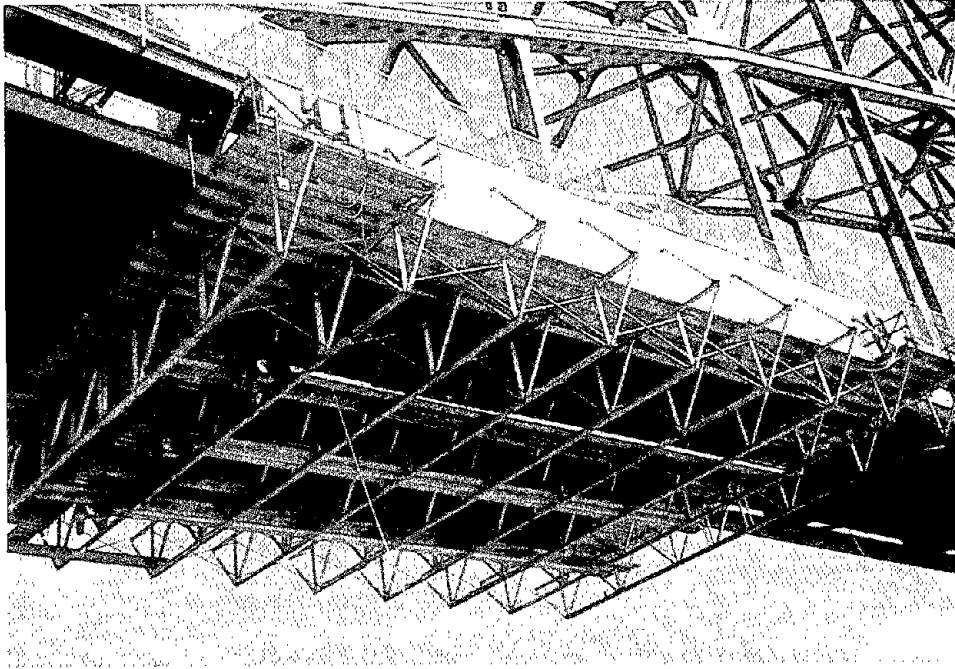
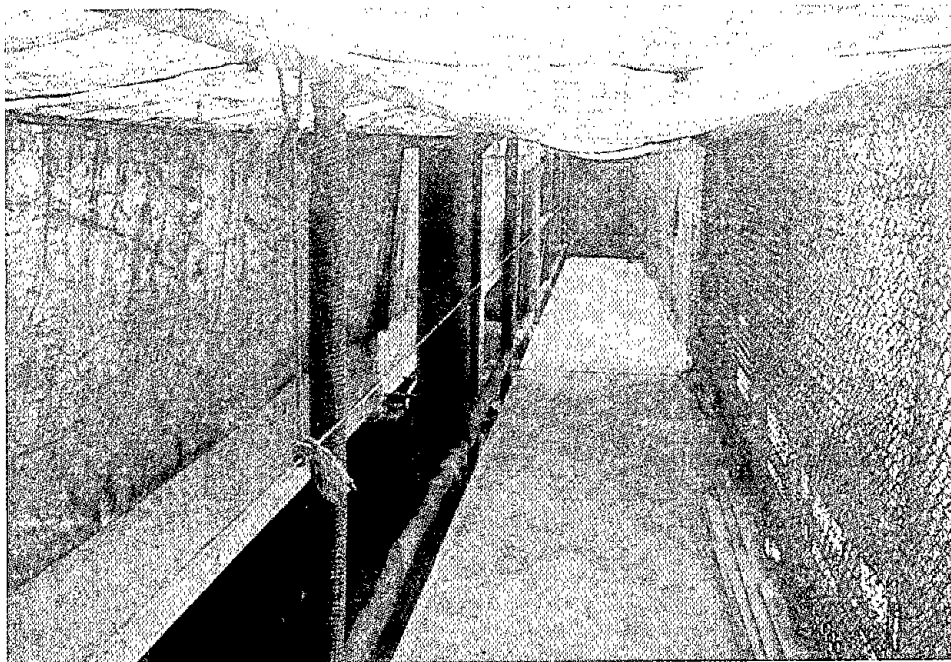
**Figure 40. Scaffolding and grit-blasting confinement structure built for Julien Dubuque Bridge paint-removal job.**

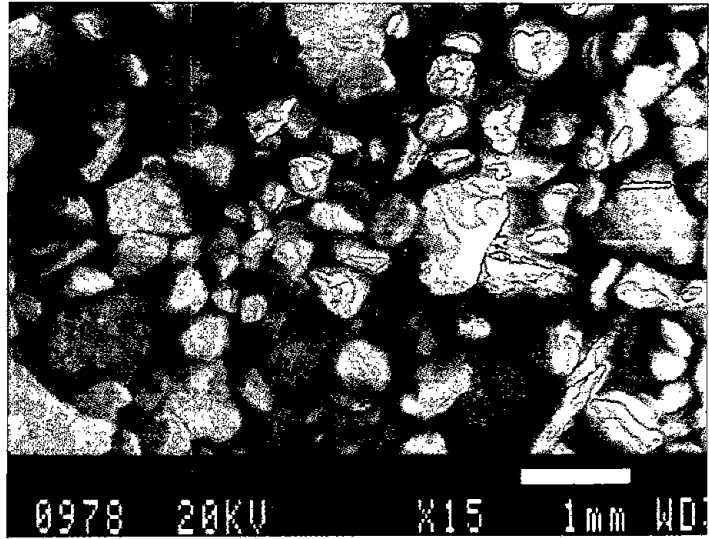
(b) Debris magnetically separated from steel grit after initial treatment by air separation/recycling equipment.

Figure 41. Low-magnification SEM photomicrographs of paint debris samples.

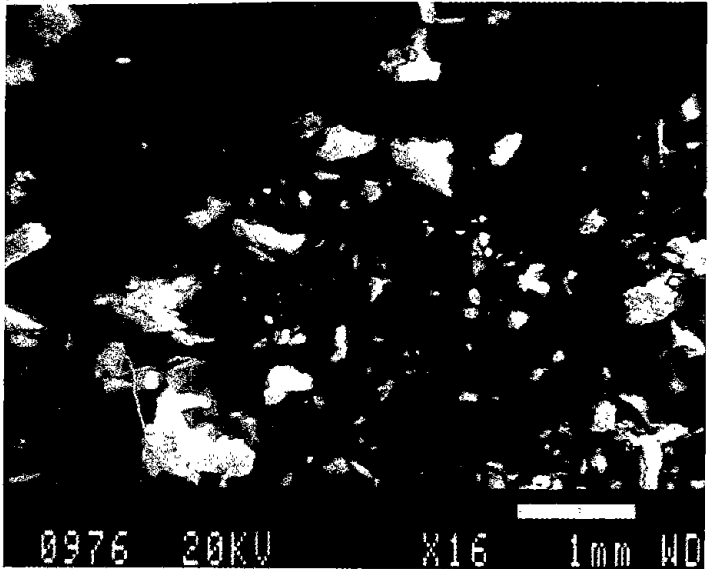
(c) Paint debris from steel-grit vacuum blasting.

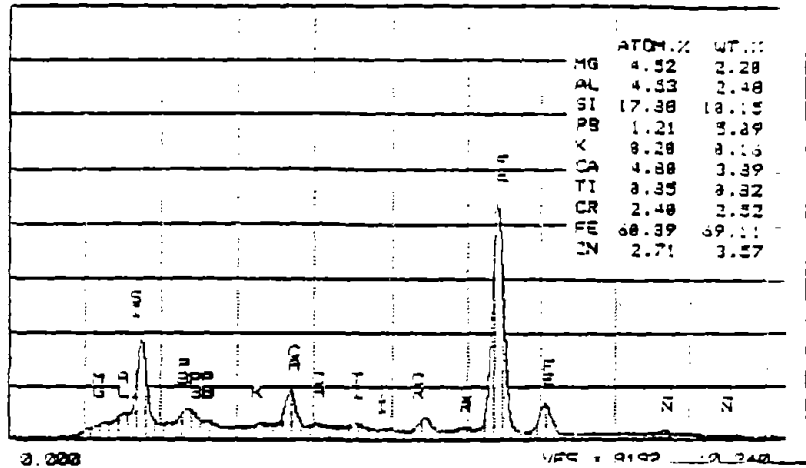
(b) EDX of paint waste.

Figure 43. EDX analysis of paint debris samples from Julien Dubuque job.

The paint waste sample (figure 43(b)) is very high in iron. This sample also contains silicon, although at a much reduced level compared to the magnetically separated sample described above. Lead, zinc, and chromium as well as magnesium, aluminum, calcium, and titanium were also found. The relatively low levels of lead in the paint waste are consistent with the fact that most of the lead had been previously removed. This sample contained the largest amount of fines. More than 20 percent of the sample passed through a  $45\text{-}\mu\text{m}$  screen.

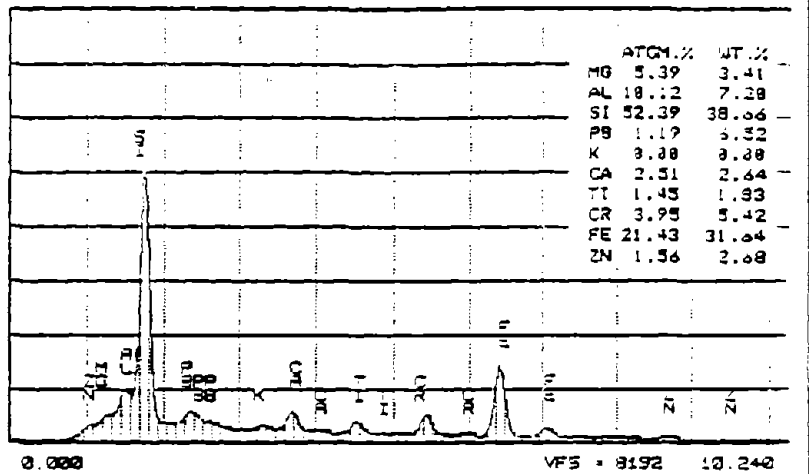
(c) EDX of vacuum-blast debris.

The vacuum blast debris sample (figure 43(c)) contains many elements, including lead, chromium, iron, and zinc, that are present in relatively large

amounts. This analysis is consistent with the paint records that show that both red-lead and zinc chromate pigments were used in the paints. Again, the iron most likely comes from steel or rust. This is the only paint-waste sample from the Dubuque site that actually looks like it contains paint. Some of these paint particles clearly show four layers of paint under optical microscopic examination. Approximately 16 percent of this sample was finer than 325 mesh (45  $\mu\text{m}$ ).

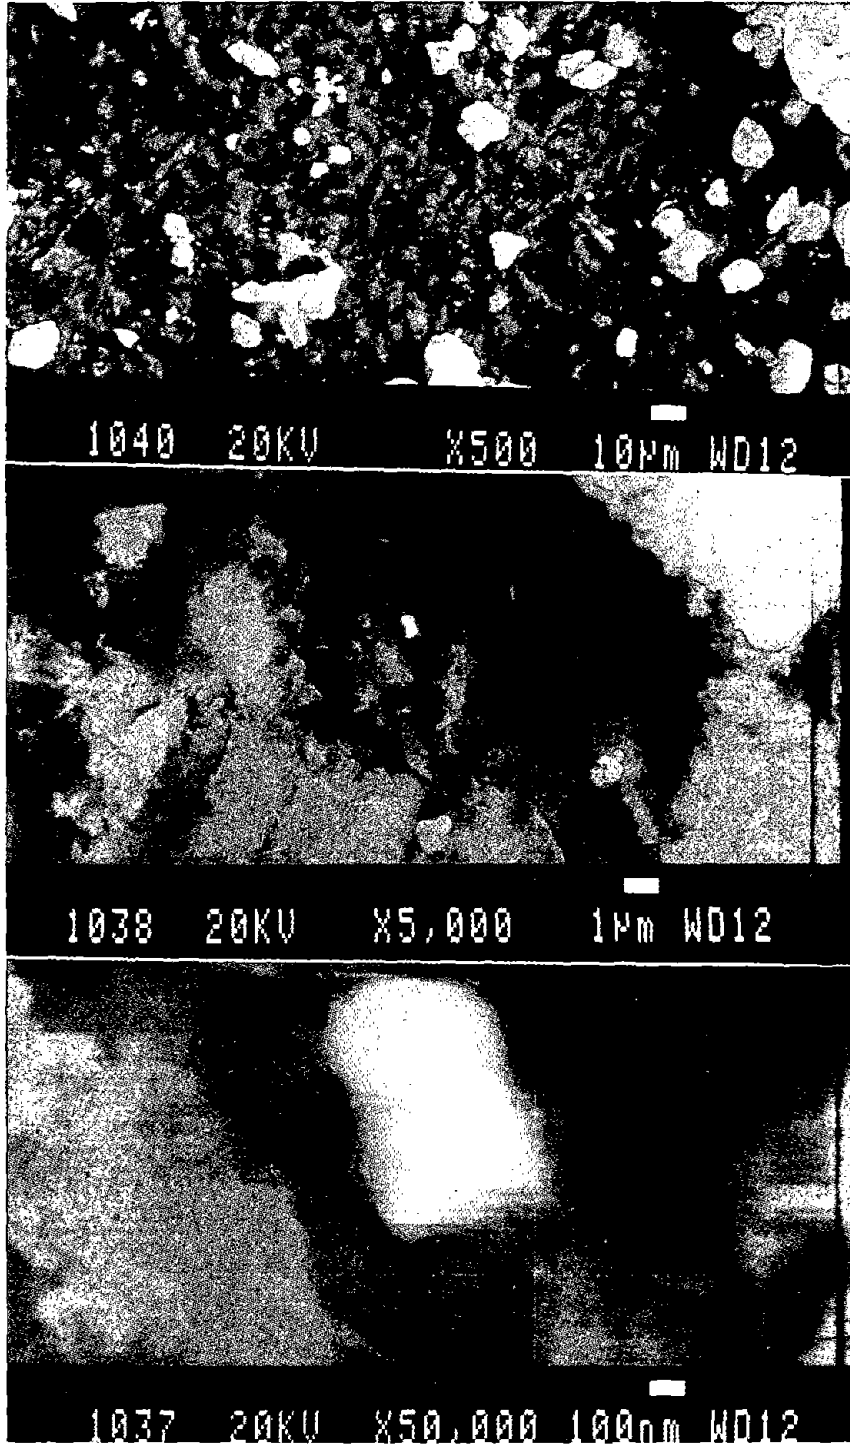
Figure 44. SEM photomicrographs of magnetically separated paint debris particles <math>< 45 \mu\text{m}</math> in diameter at magnifications of x 500, x 5,000, and x 50,000.

The fines (the portions that passed through the 325-mesh sieve screen) from each of the above three samples were also examined by SEM. Figure 44 shows the <45- $\mu\text{m}$  particles in the magnetically separated material at magnifications of x 500, x 5,000, and x 50,000. In the x 500 photomicrograph, particles ranging in size from less than 1  $\mu\text{m}$  up to about 30  $\mu\text{m}$  are clearly discernable. The x 5000 photo shows a less than 0.5- $\mu\text{m}$  particle nest to an approximately 10- $\mu\text{m}$ -diameter particle. The x 50,000 photo shows only the 0.4- $\mu\text{m}$ -wide particle.

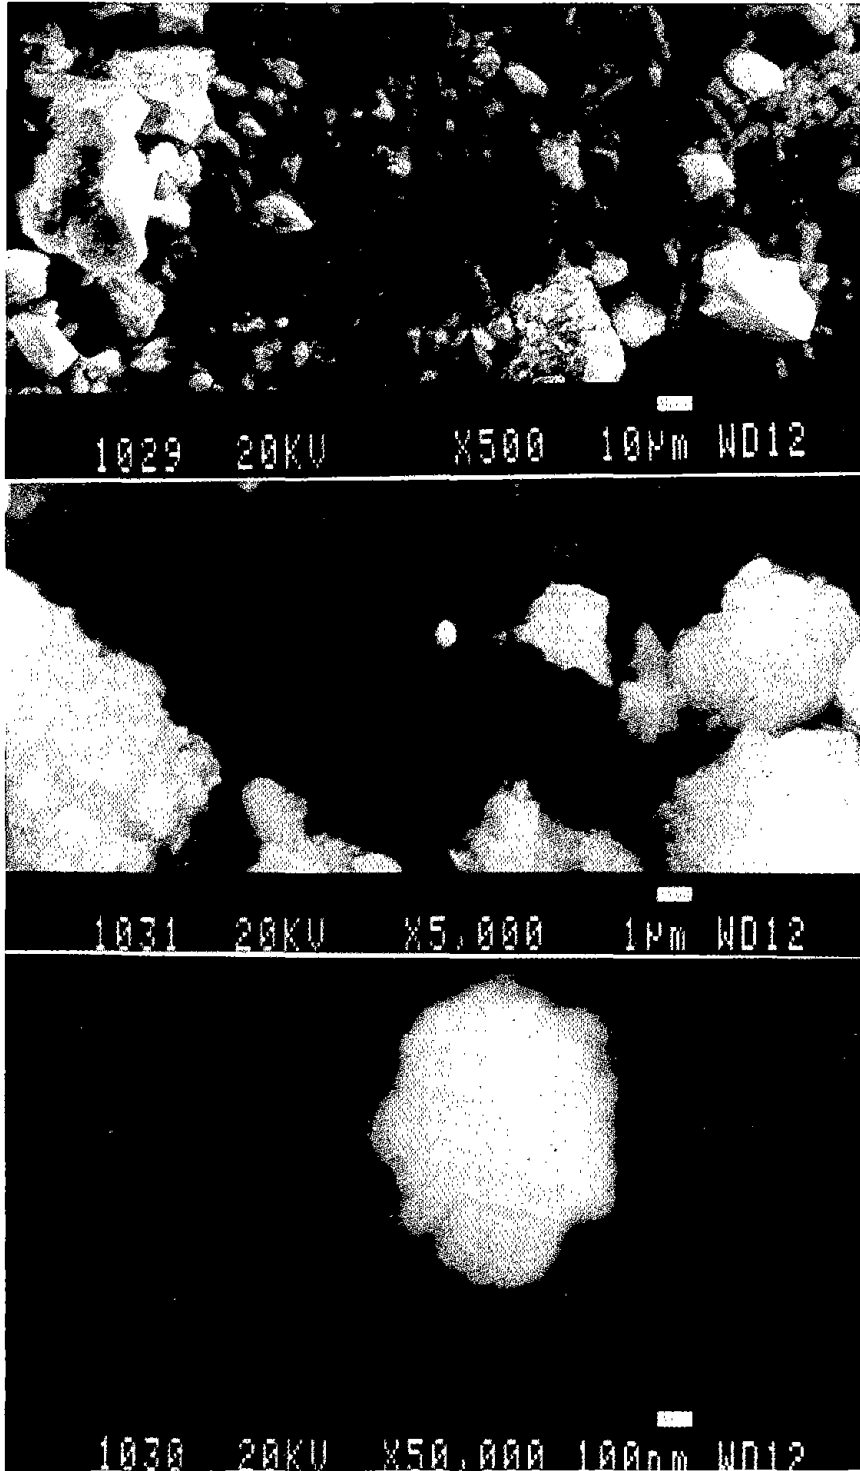
Figure 45. SEM photomicrographs of air-separated paint debris particles < 45  $\mu\text{m}$  in diameter at magnifications of x 500, x 5,000, and x 50,000.

Figure 45 shows a similar set of photomicrographs for the paint-waste particles that passed through the 325-mesh screen. Figure 46 presents the results for the vacuum blast fines. In each of the three sets of figures, the particle featured at x 50,000 can be identified in the x 5,000 and x 500 photos upon close examination. Particles smaller than 0.3  $\mu\text{m}$  in diameter appear to exist in each of the samples, but since this size is near the limit of resolution of the instrument, further study is needed to establish whether or not such small particles are present, and if so, how many.
