Publication No. FHWA-RD-94-098  
August 1995

# Issues Impacting Bridge Painting: An Overview

U.S. Department of Transportation  
**Federal Highway Administration**

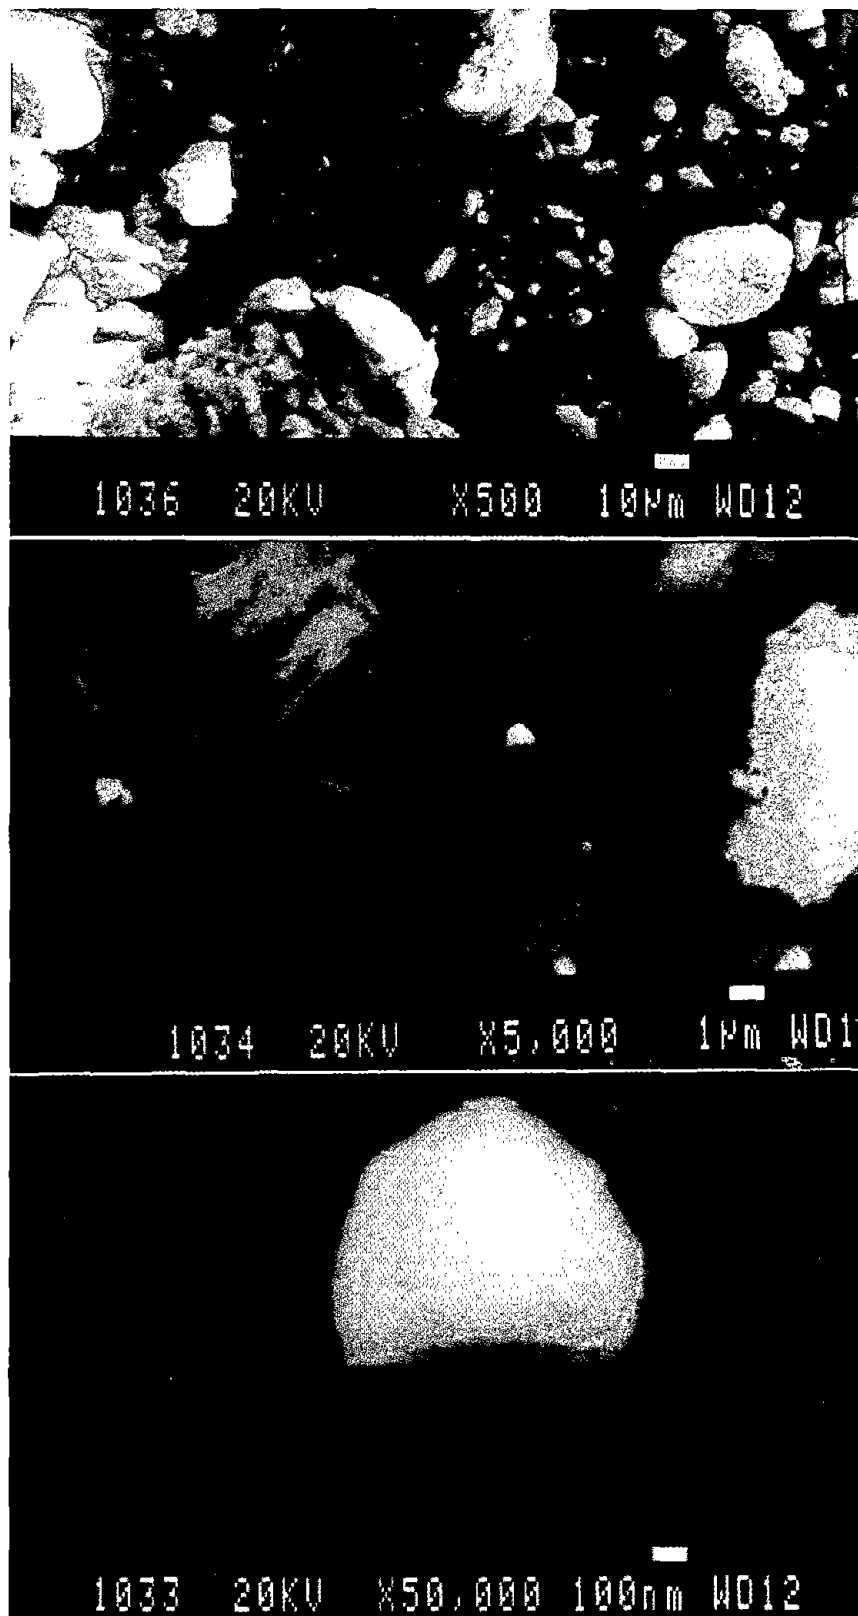
Figure 46. SEM photomicrographs of vacuum-blast paint debris particles < 45 μm in diameter at magnifications of x 500, x 5,000, and x 50,000.

Figure 45 shows a similar set of photomicrographs for the paint-waste particles that passed through the 325-mesh screen. Figure 46 presents the results for the vacuum blast fines. In each of the three sets of figures, the particle featured at x 50,000 can be identified in the x 5,000 and x 500 photos upon close examination. Particles smaller than 0.3  $\mu\text{m}$  in diameter appear to exist in each of the samples, but since this size is near the limit of resolution of the instrument, further study is needed to establish whether or not such small particles are present, and if so, how many.

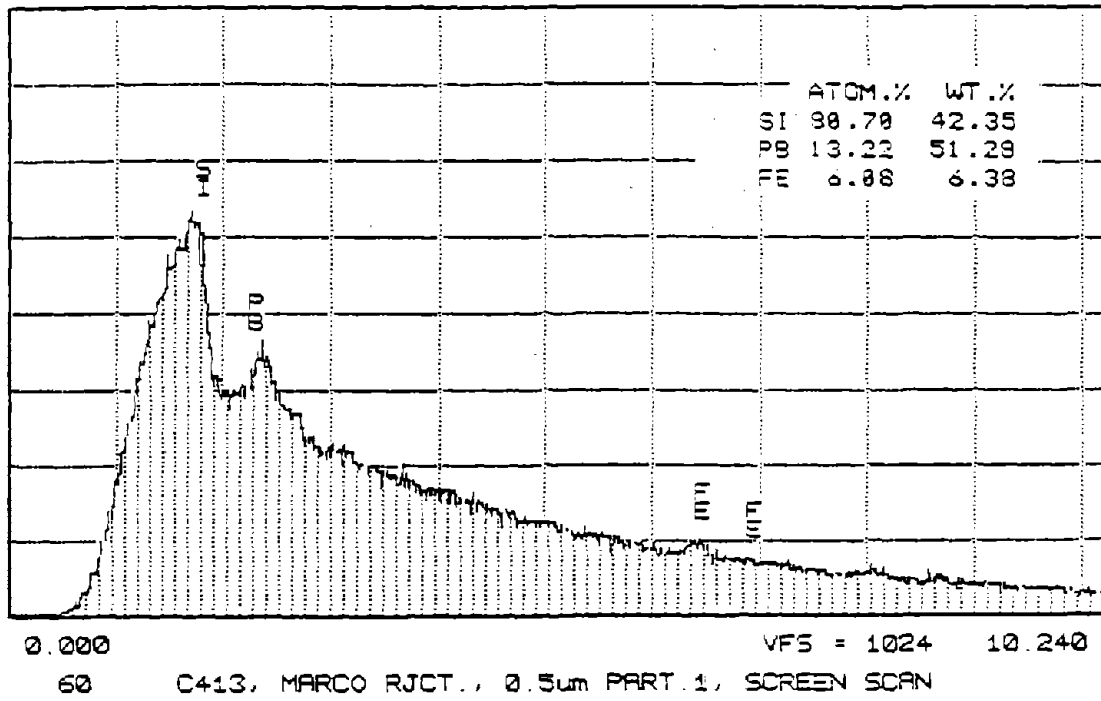
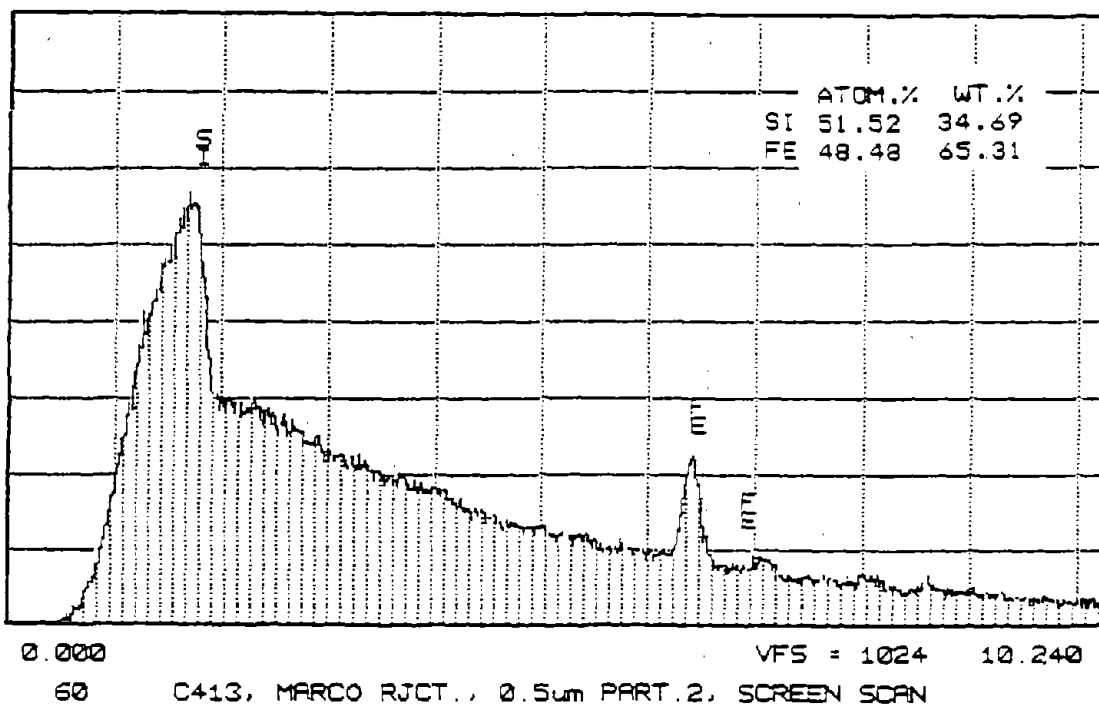
Figure 47. EDX analysis of 0.5- $\mu$ m magnetically separated particles.

Two particles, approximately 0.5  $\mu\text{m}$  in diameter, from each of the above three samples were analyzed by EDX. The results are presented in figures 47, 48, and 49. For the paint-waste samples separated from the grit by air and magnetically, one particle contained lead and the other did not. For the vacuum blast debris, both particles contained lead. Again, these results demonstrated that the fine particles produced during grit-blasting operations contained lead.

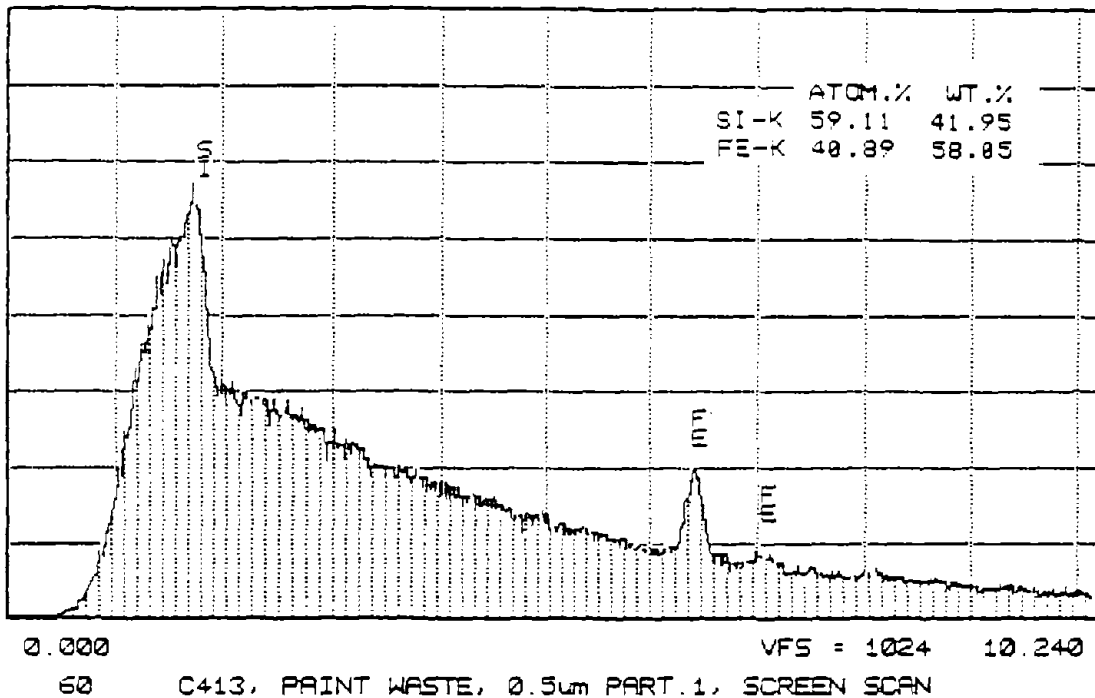
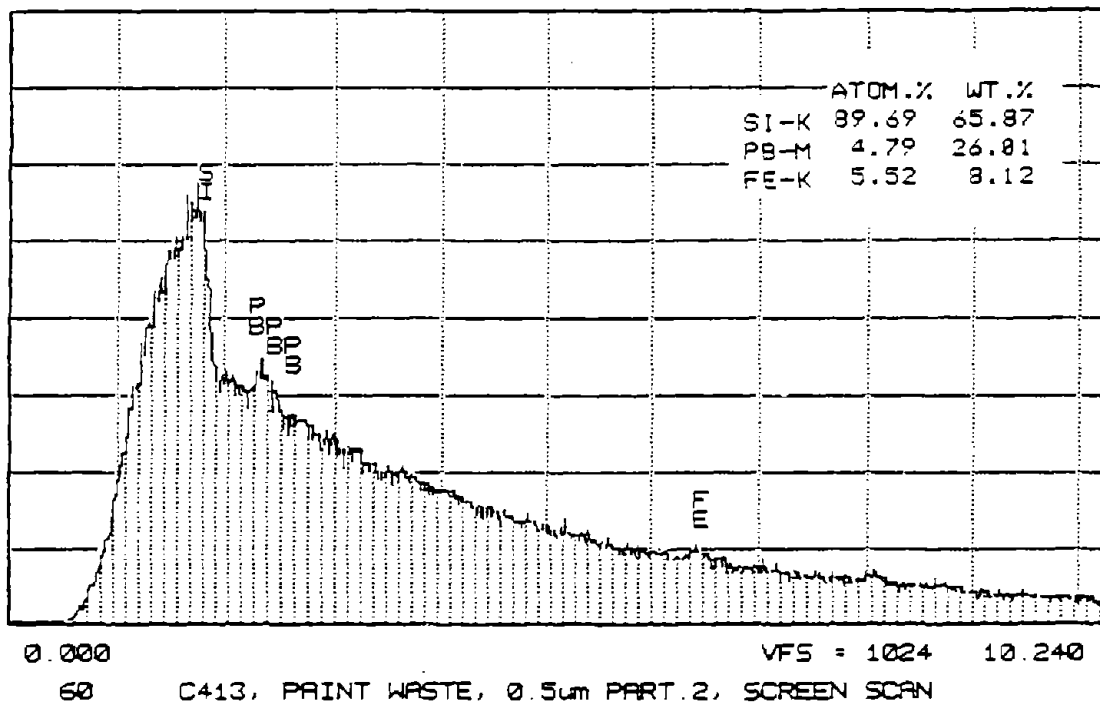
Figure 48. EDX analysis of 0.5- $\mu$ m air-separated particles.

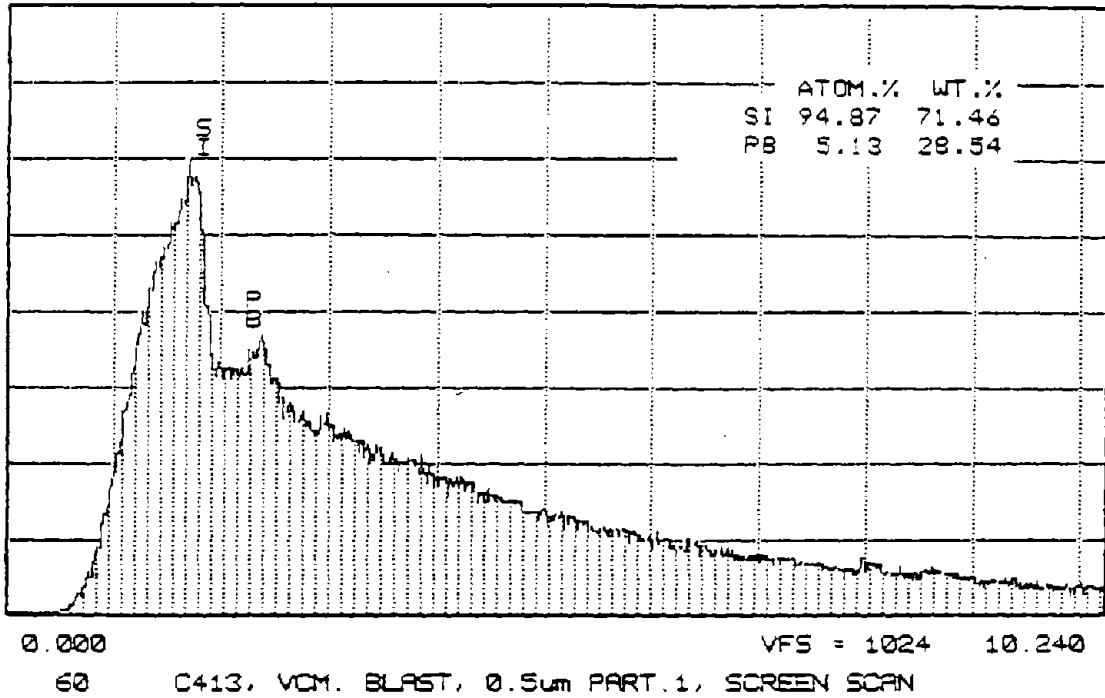
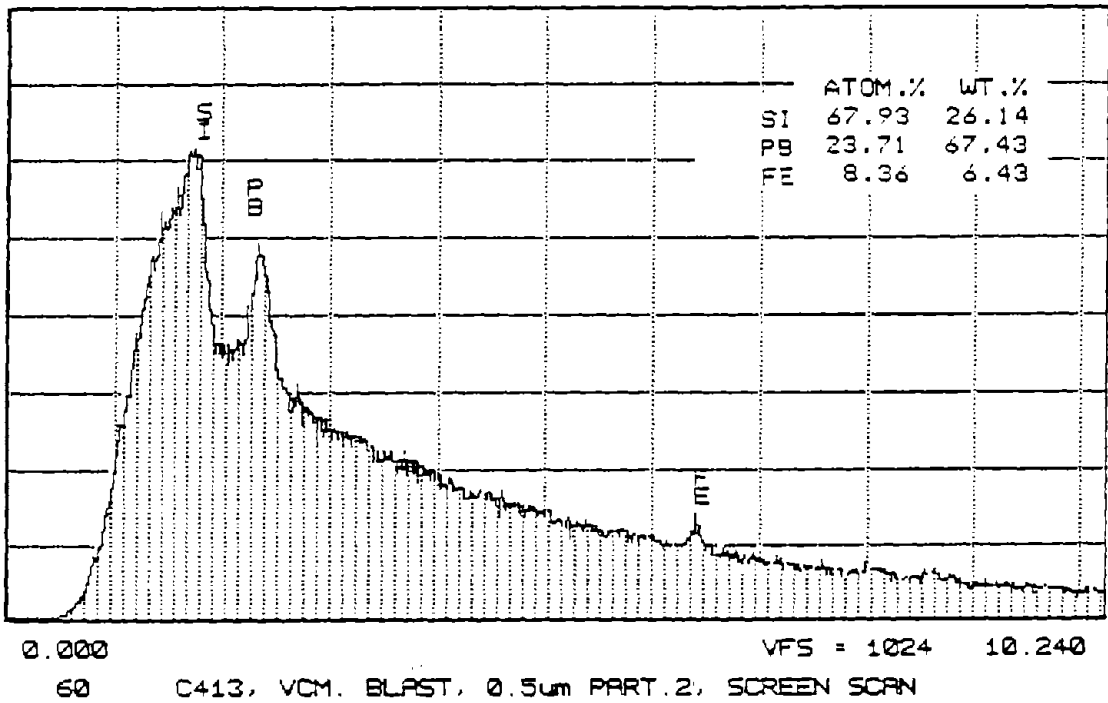
Figure 49. EDX analysis of 0.5- $\mu\text{m}$  vacuum-blast particles.

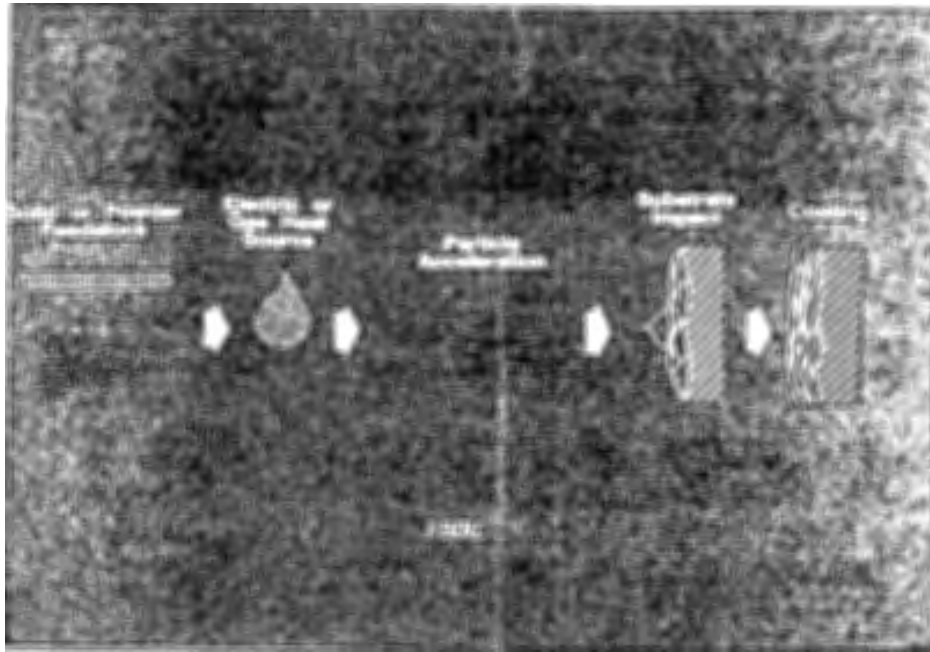
Figure 53. Thermal spray process.

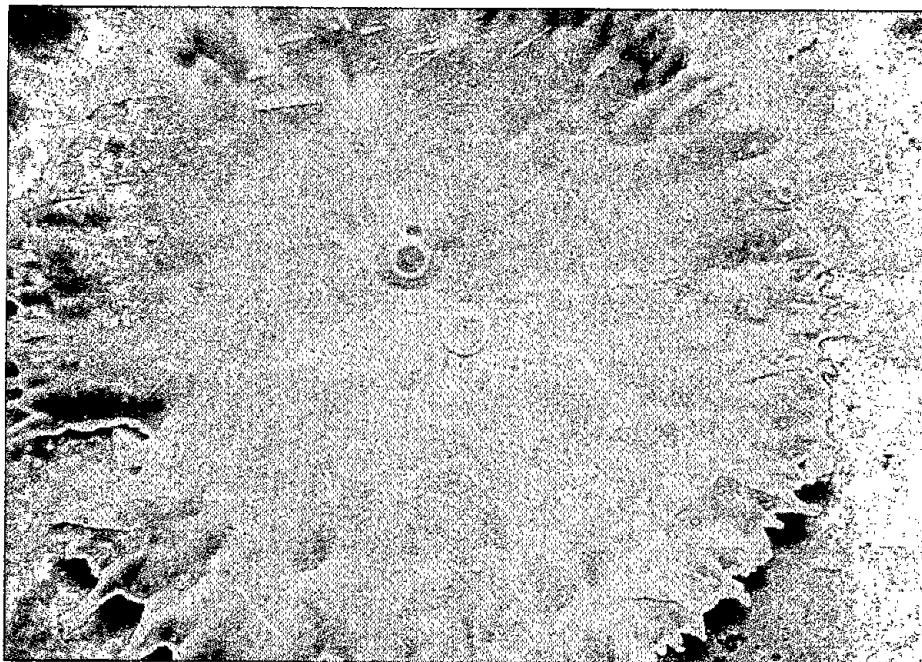
Figure 54. Splat structure.

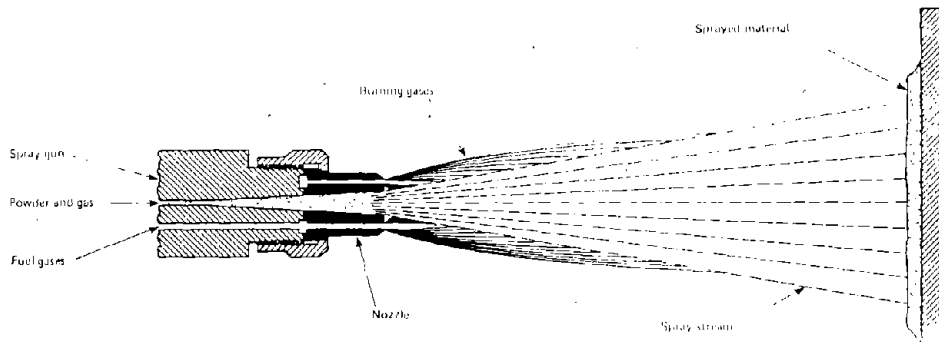
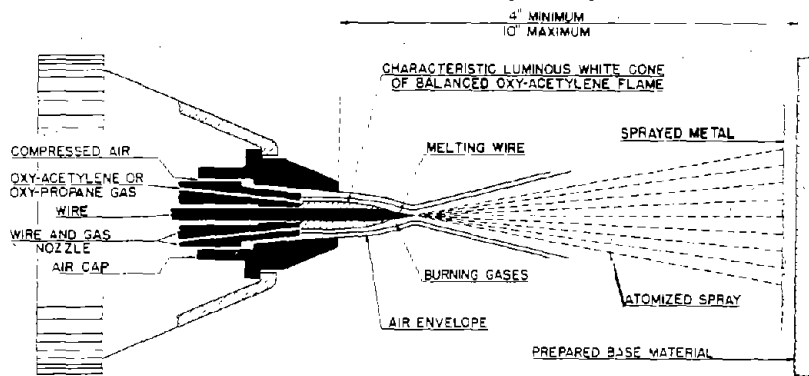
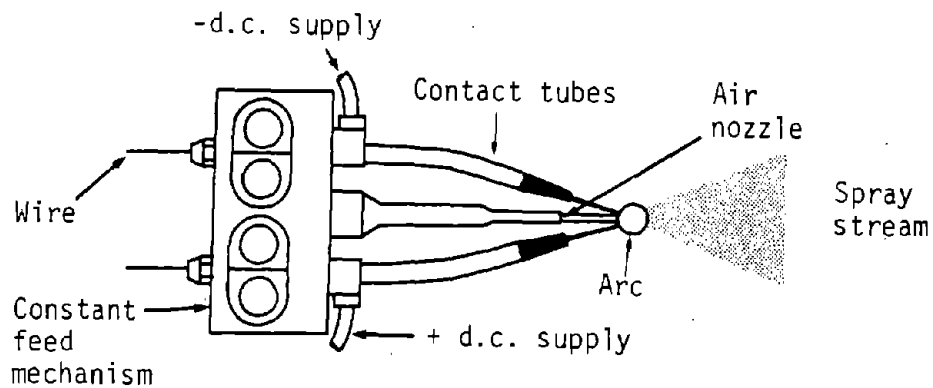
(a) Powder flame spray process.

(b) Wire spray process.

(c) Wire arc spray process.

Figure 55. Relevant thermal spray processes.

The electric arc process is illustrated in figure 55(c) and involves the continuous feeding of two wires into a device such that the wires converge at a point in space. The wires are held at different electrical potentials, such that an electric arc is generated between them. These wires are, in essence, consumable electrodes and are continuously melted. A jet of gas, usually compressed air, is used to atomize the molten material and accelerate the resultant droplets onto the component surface. It is not necessary for both wires to have the same chemical composition resulting in alloyed coating, however, adjustments to the feeding mechanism are necessary to compensate for these differences. Very high deposition rates are achievable by this process, but the atomization process generates more fumes than other thermal spray processes. In addition, this process frequently results in porosity levels of 25 percent by volume. Recent advances in the design of electric arc equipment have incorporated the use of Coanda accelerators. The Coanda accelerators use the geometry of the flow chamber to enhance the syphoning action of the atomizing gas, thereby increasing the volumetric flow through the same cross-sectional flow area. This results in higher particle velocities and coatings of higher density.

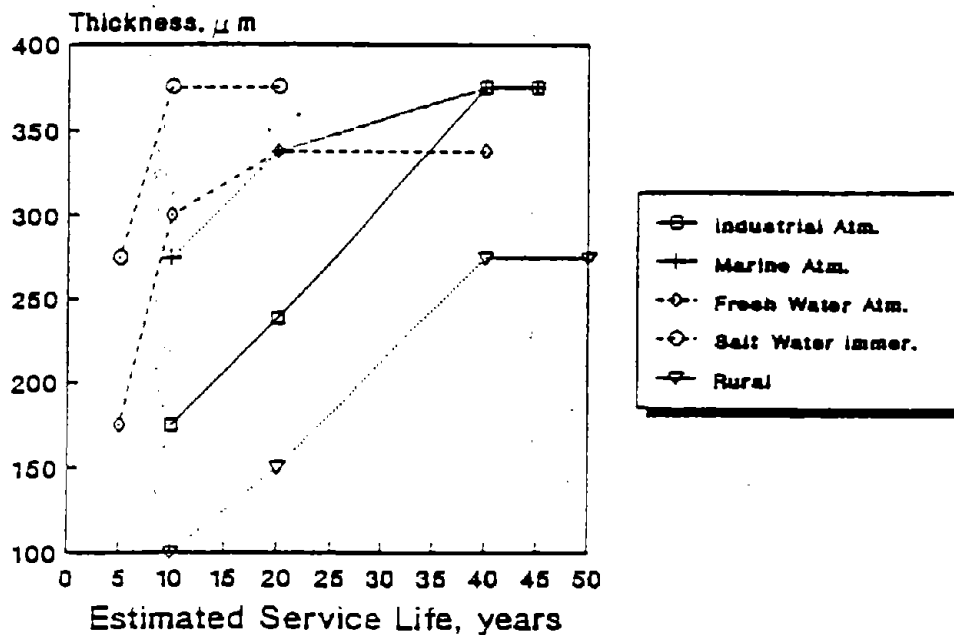
Figure 56. Estimated service life for Al and Al MCC thermal spray coatings.

Aluminum. Aluminum provides a barrier to the corrosion of steel by the formation of an inert aluminum oxide layer on the surface of the coating. When damaged, this coating is self-healing. Like zinc, aluminum has a lower oxidation potential than steel with respect to iron and therefore provides galvanic protection to the steel substrate. Unlike zinc, pure aluminum has not been extensively thermally sprayed onto steel bridges and structures, although extensive use by the U.S. Navy indicates that aluminum is more corrosion-resistant than zinc in marine environments. Figure 56 describes the estimated service life for aluminum thermal spray coatings.

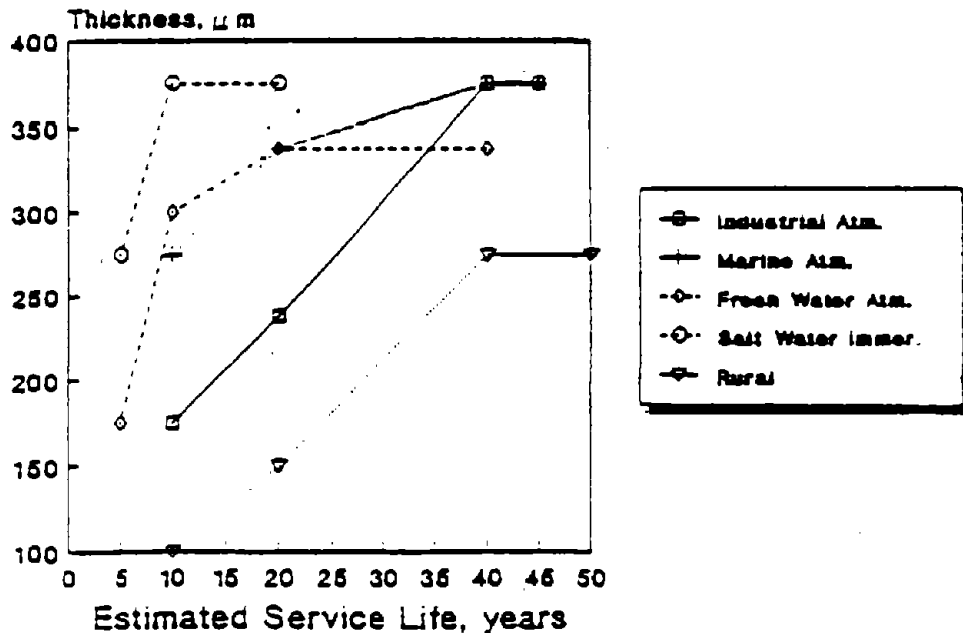
Figure 57. Estimated service life for Zn and 85/15 Zn/Al thermal spray coatings.

Zinc/Aluminum. With the proven protection associated with zinc and the implied improved performance of aluminum in salt environments, alloys of zinc and aluminum have been developed. Initial work in Japan indicates that such alloys, particularly 85 percent zinc/15 percent aluminum alloy, have advantages over all-zinc coatings. This alloy has successfully been applied to steel bridges within the United States. Figure 57 describes the estimated service life for Zn and 85/15 Zn/Al thermal spray coatings.

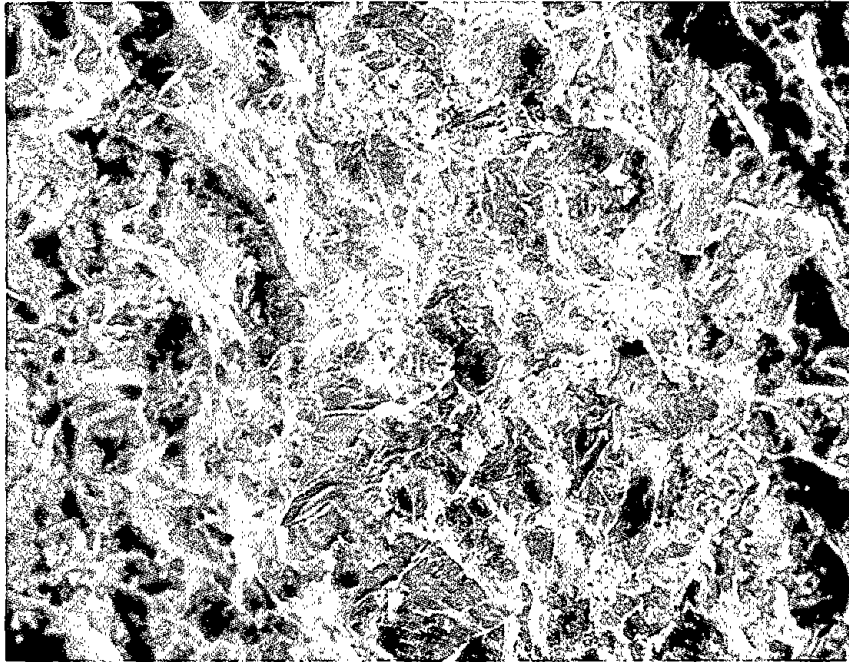
Figure 58. Grit-blasted surface of steel plate.

All coatings were applied onto standard 102-mm by 152-mm by 4.76-mm (4-in by 6-in by 3/16-in) A-36 steel panels purchased from KTA Tator. All samples were degreased in a vapor degreaser/ultrasonic bath containing 1,1,1 trichloromethane. They were then grit-blasted using 36 grit aluminum oxide at 511 kPa (80 lb/in<sup>2</sup>) to a SP-5 white metal finish with at least a 0.051-mm (0.002-in) profile as shown in figure 58. Using ANSI/AWS C2.18-93, *Guide for the Protection of Steel with Thermally Sprayed Coatings of Aluminum, Zinc, and their Alloys and Composites*, the zinc (figure 59), aluminum (figure 60), and 85/15 zinc/aluminum (figure 61) samples were prepared. The EAA coating (figure 62) was applied using manufacturer supplied parameters. In addition, the paint systems were applied following manufacturers' guidelines.

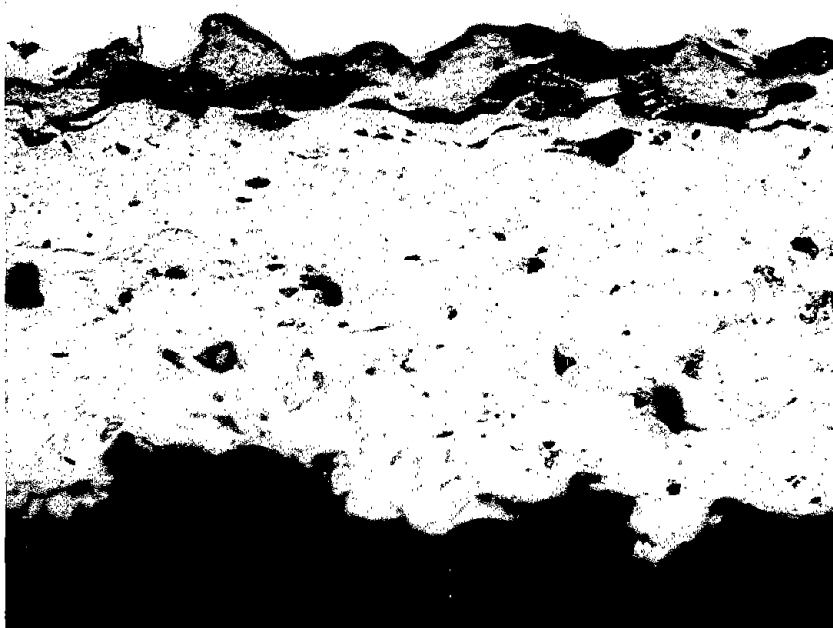
Figure 59. Thermally sprayed zinc coating.

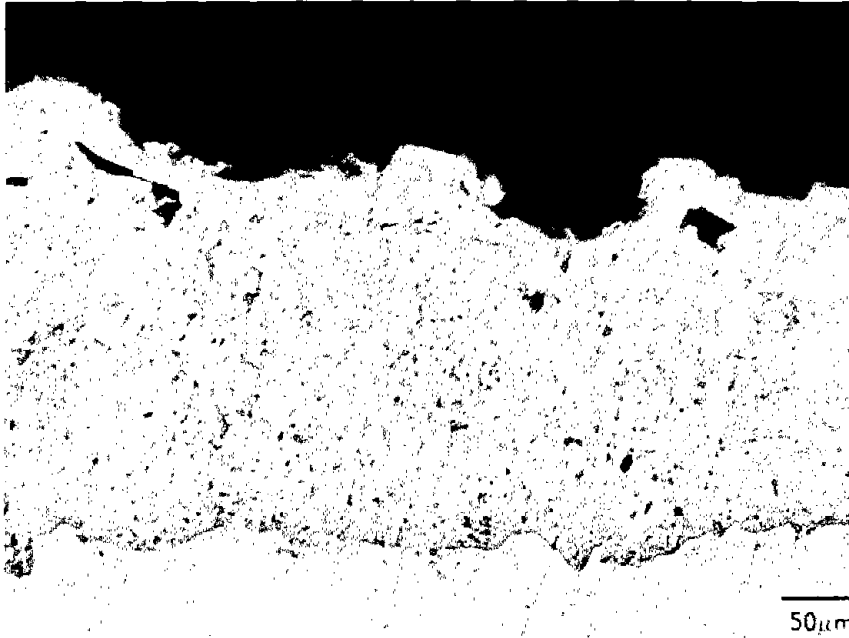
Figure 60. Thermally sprayed aluminum coating.

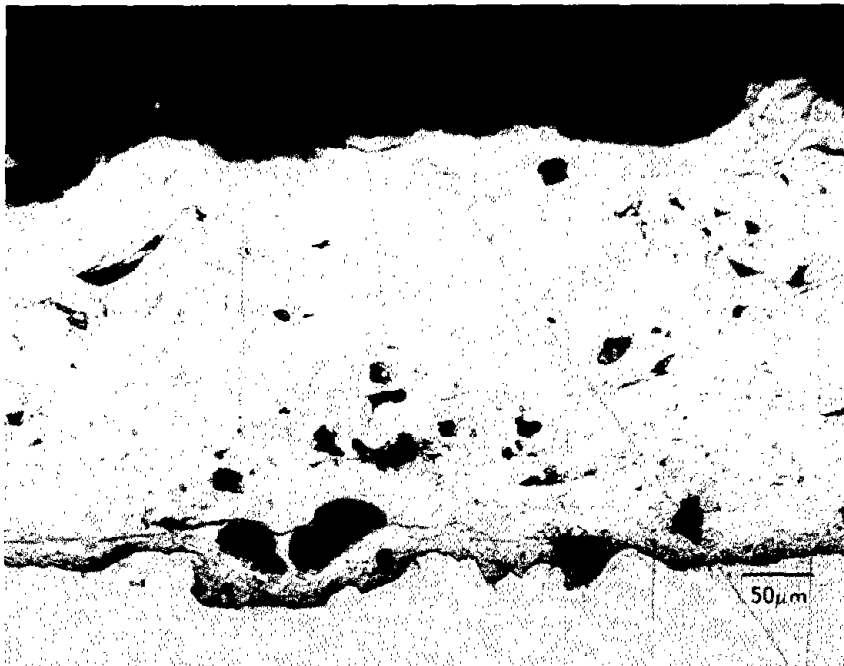
Figure 61. Thermally sprayed 85/15 zinc/aluminum alloy.

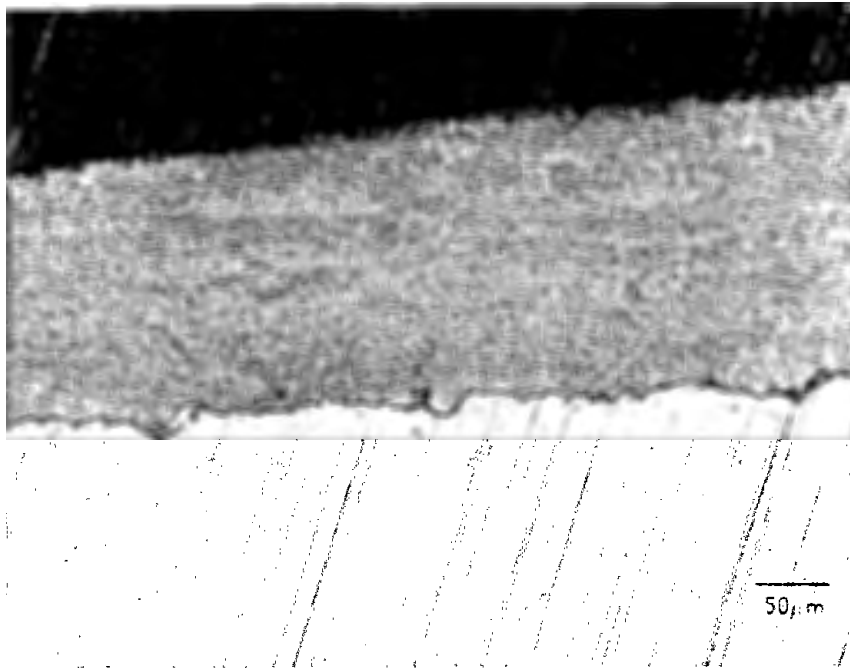
**Figure 62. Thermally sprayed EAA copolymer.**

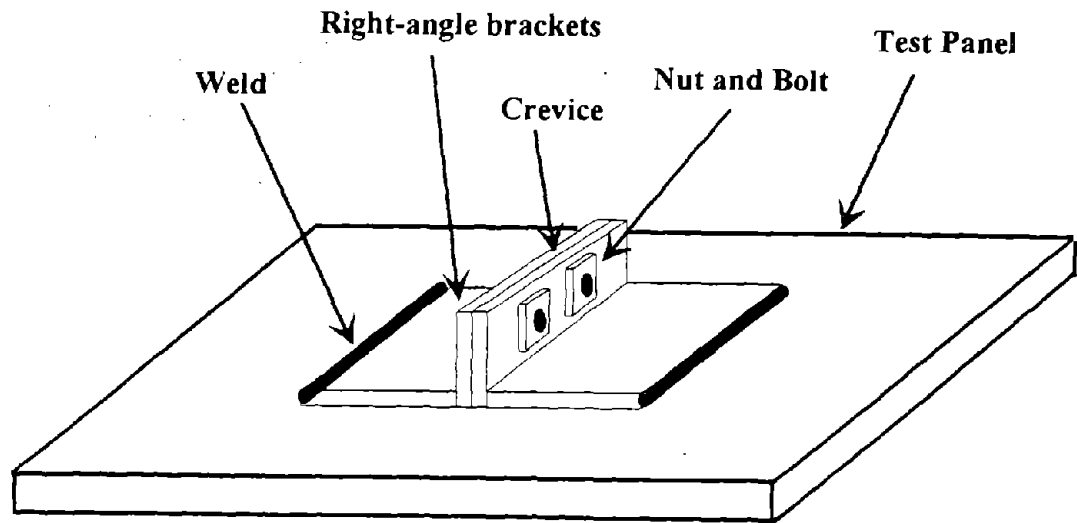
Figure 63. Steel test panel with typical bridge geometries.

Experimenters prepared 99 coated test panels for exposure in the 3 accelerated tests. Of these test specimens, 94 were 10.0-by 15.0-by 0.64-cm (4-by 6-by 0.25-in), ASTM A36, hot-rolled, carbon steel plates that were either grit-blasted with a G-40 grit to a white-metal finish (SP-5), or were left with as-received millscale. The remaining five test panels were cut from a coated bridge section that had been taken out of service. Of the test panels, 52 contained either of 2 modifications: a welded steel support or 2 right-angle brackets welded to the panel and attached to each other with 2 nuts and bolts (as shown in figure 63). The non-flat geometries were used in the two cyclic tests to simulate welded sections and bolted, faying configurations (surfaces that are difficult to coat properly). Table 13 summarizes the test specimens used in the experiments. The flat panels and flat panels with the welded steel supports were purchased from KTA-Tator Company. Additional KTA-Tator-supplied flat panels were modified to construct the welded and bolted right-angle bracket configurations.

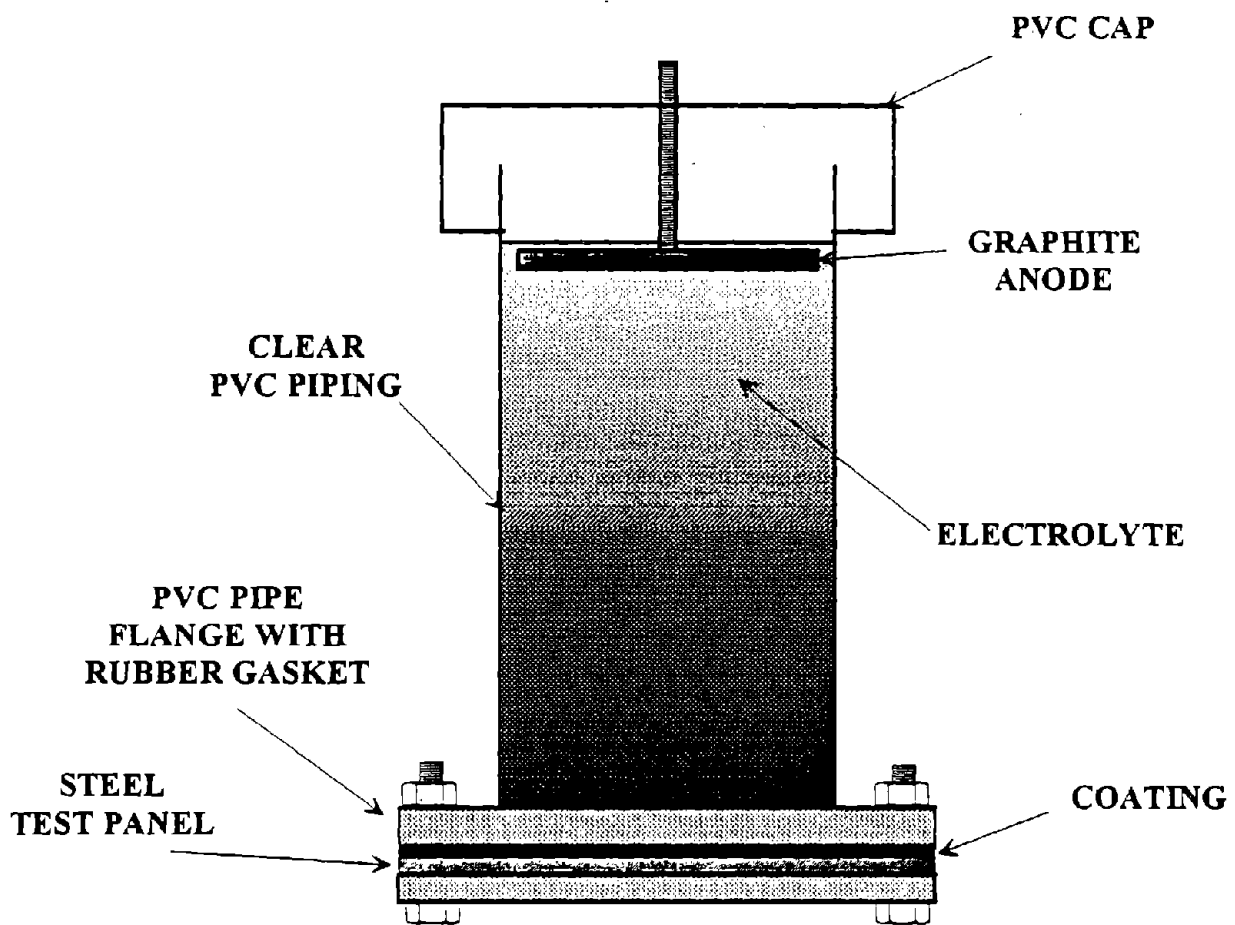
Figure 64. Corrosion cell used in immersion experiments.

The immersion cells consisted of a 20-cm (8-in) long, 8-cm (3-in) diameter, translucent polyvinyl chloride (PVC) pipe to which an 8-cm (3-in) PVC flange was attached. The coated test panels were placed between the flange and tightened with four bolts, as seen in figure 64. A rubber gasket between the upper flange and the coated test panel prevented electrolyte leakage from occurring. A PVC cap was placed on top of the cell to prevent evaporation of the electrolyte. Periodic EIS measurements were performed using a graphite anode and a saturated calomel reference electrode (SCE) placed at the top of the cell.

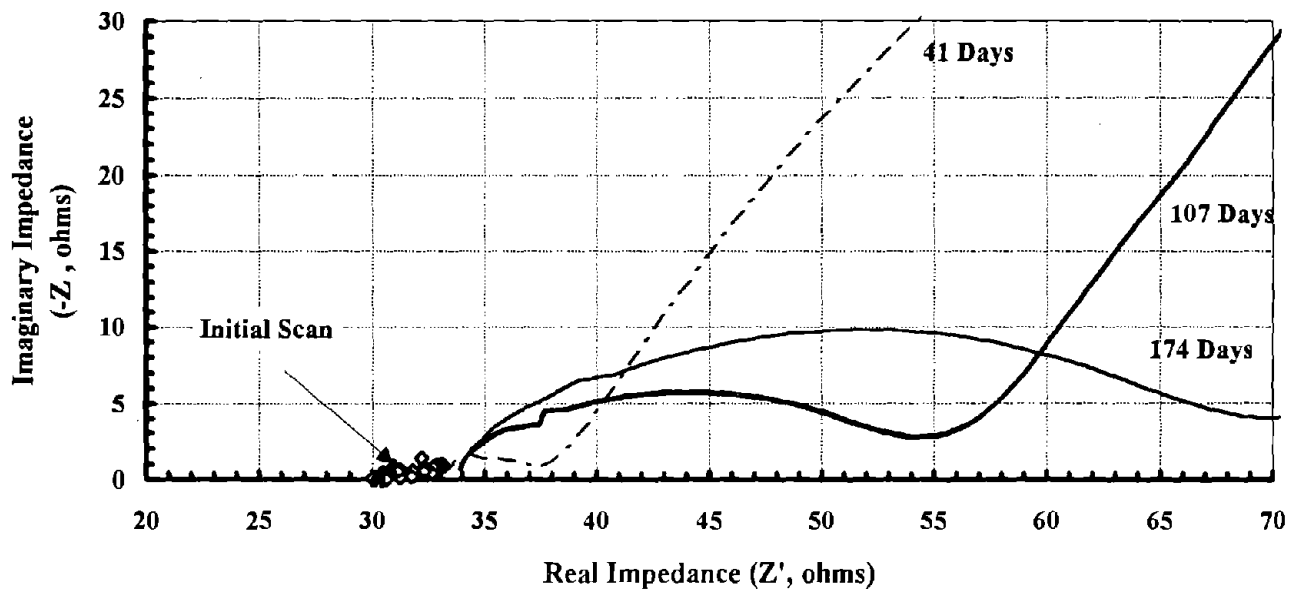
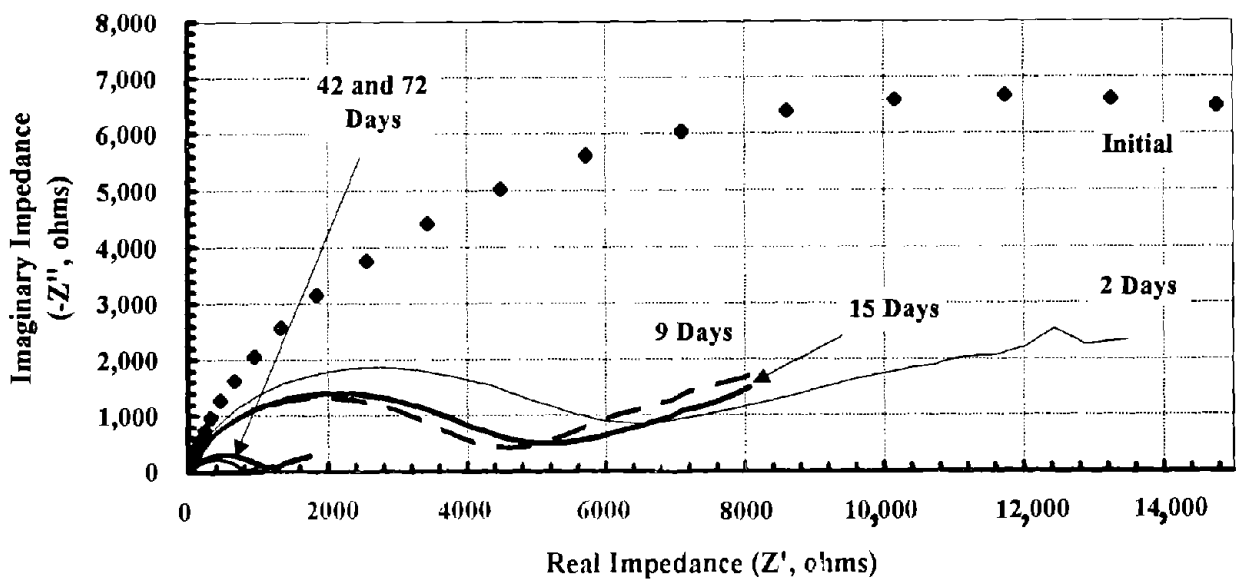
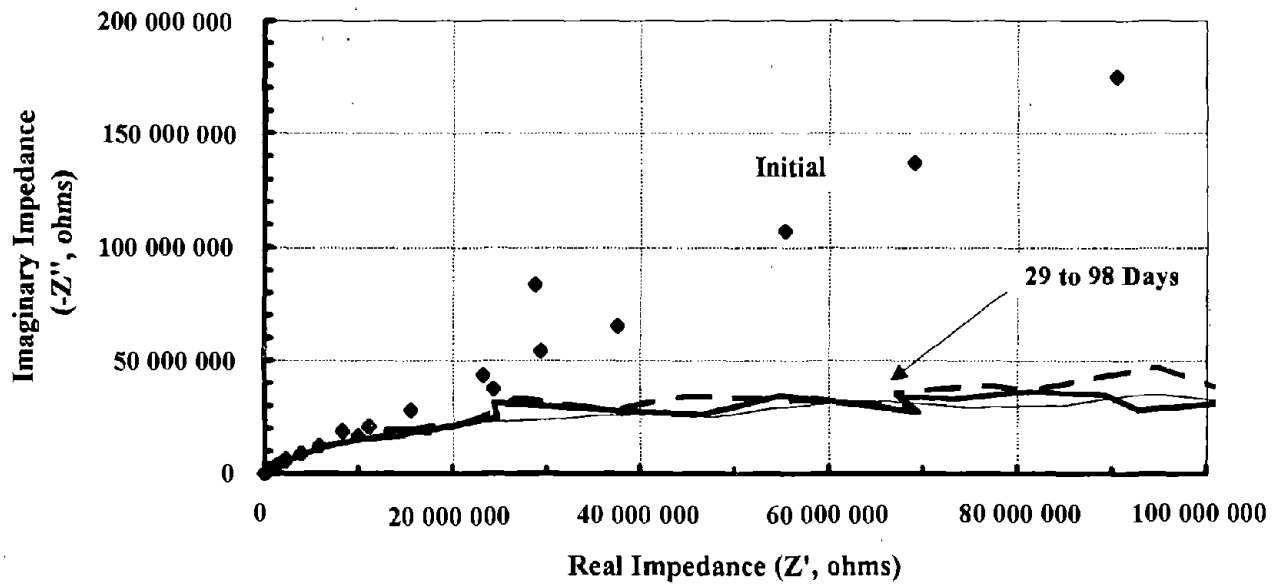
(a) High-frequency detail for thermally sprayed zinc.

(b) Pb/Alkyd coating from weathered bridge section.

Figure 65. Representative EIS Nyquist plots for the immersion experiments.

(c) VOC-compliant coating.

Immersion experiments were performed on eight thermally sprayed (TS) test panels, four test panels coated with a VOC-compliant coating, and two test panels cut from a weathered bridge section containing a lead (Pb) primer and alkyd topcoat. The TS-coated test panels were immersed for 174 d, two each of the VOC-compliant coatings were immersed for 92 and 98 d, respectively, and the two weathered bridge sections were immersed for 72 d. Figures 65(a) through (c) show representative EIS Nyquist plots for the TS-Zinc, Pb/Alkyd, and VOC-compliant coatings as a function of immersion time.

Pb/Alkyd and VOC-Compliant Coatings. Figure 65(b) shows EIS Nyquist plots for the Pb/alkyd coatings as a function of immersion time. Initially, one semicircle was observed. After 2 d of immersion, two semicircles were measured that continually became smaller with time. The first semicircle is representative of the Pb/alkyd coating and the second is due to the steel substrate. Theoretically, for a weathered coating, one would expect an EIS scan with three semicircles representing the alkyd topcoat, the lead primer, and the steel substrate properties. However, visual observation of the test-panel surface under immersion showed areas of exposed steel where significant corrosion was occurring. This provides evidence that the second semicircle on the EIS scan is due to steel corrosion and not to the lead primer. The Pb/alkyd coating properties appear to be lumped together into a single semicircle on the EIS scans and can be represented by one coating resistance.

Figure 65(c) shows EIS Nyquist plots as a function of immersion time for the VOC-compliant coatings. One high-impedance semicircle was obtained, indicative of a highly insulative coating. However, the high initial coating resistance decreased after 29 d, indicating that there was an initial uptake of electrolyte into the coating. Further changes in the coating resistance were small, but they still indicated further electrolyte penetration into the coating.

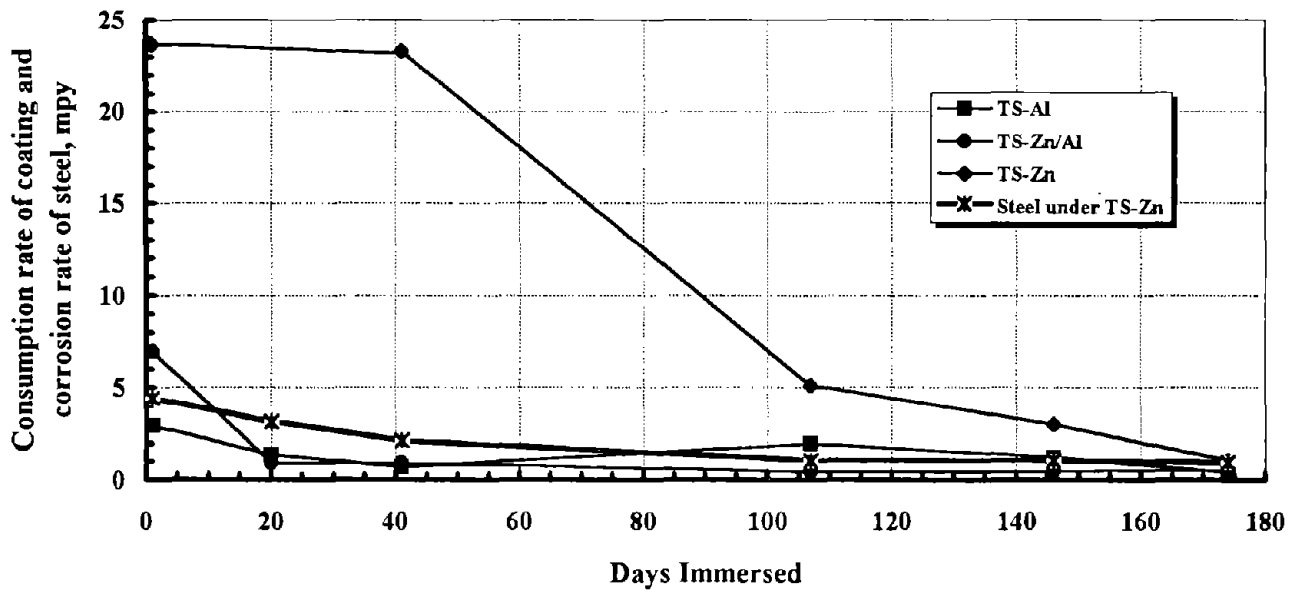
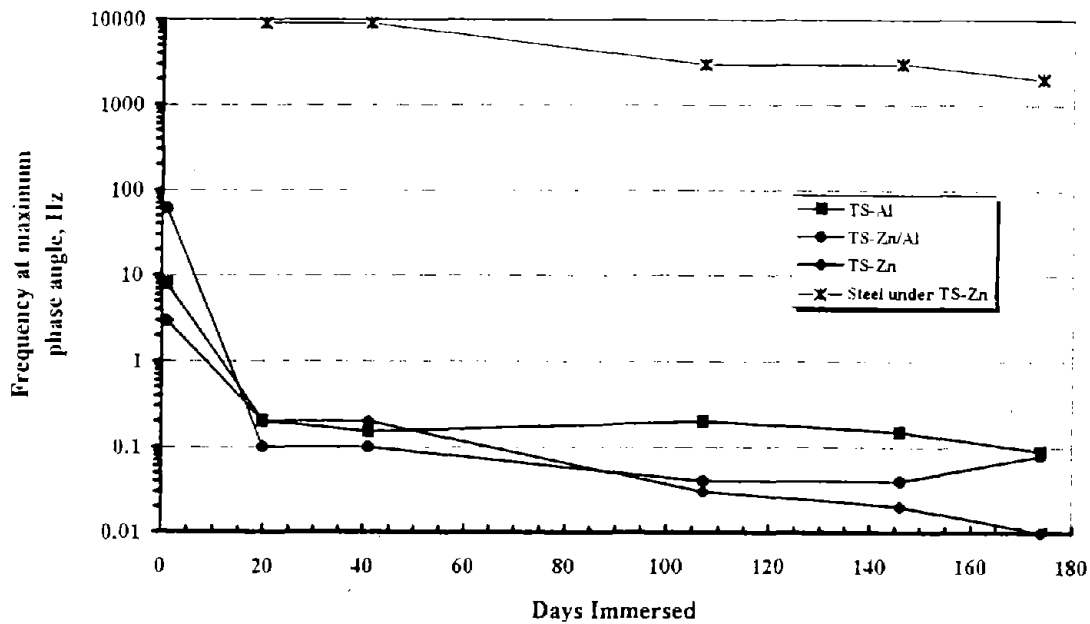
(a) Consumption rate of thermally sprayed coatings and corrosion rate of steel underneath coating.

(b) Frequency at maximum phase angle.

Figure 66. Electrochemical properties for the thermally sprayed coating in the immersion experiments.

Figure 66(a) shows a plot of the high-frequency section of the EIS scan for a TS-zinc-coated test panel illustrating the increase in coating resistance as given by the increasing semicircle. The straight line going off of the scale is actually a second semicircle at the lower frequencies due to the steel corrosion rate. The second semicircle was absent on the EIS scans for the TS-Al- and TS-Zn/Al-coated test panels, indicating that steel corrosion was not yet measurable on these coatings.

Figures 66(a) and 66(b) show the consumption rate of the thermally sprayed coatings; the corrosion rate of the steel underneath the TS-zinc coating; and  $\omega_{\max}$ , the frequency at maximum phase angle versus immersion time. The TS coatings initially showed a high coating consumption rate of 102 to 635  $\mu\text{m}/\text{yr}$  (4 to 25 mil/yr (mpy)), which decreased with time to approximately 25  $\mu\text{m}/\text{yr}$  (1 mpy). The sacrificial coatings are actively corroding and protecting the steel substrate. Assuming a constant consumption rate, the 300- $\mu\text{m}$  (4-mil) thick coatings would be completely consumed in 12 years of electrolyte immersion. The immersion test has accelerated the coating consumption rate threefold, given an estimated service life of 40 years for a 300- $\mu\text{m}$  thermally sprayed coating thickness.

The frequency at the maximum phase angle,  $\omega_{\max}$ , is plotted in figure 66(b). The  $\omega_{\max}$  decreased with time and with decreasing consumption rate for the thermally sprayed coatings, amplifying the change from a fivefold decrease in consumption rate to a three to four order-of-magnitude decrease in  $\omega_{\max}$ . On the other hand,  $\omega_{\max}$  due to the steel under the TS-zinc coating stayed relatively constant, although the corrosion rate decreased from 128 to 25  $\mu\text{m}/\text{yr}$  (5 to 1 mpy). As noted earlier, the TS-zinc is protecting the steel, which is reflected in the relatively constant value of  $\omega_{\max}$ . A significant change in  $\omega_{\max}$  would probably not occur until the TS-zinc coating had been consumed or was not sacrificially protecting the steel, causing the steel corrosion rate to increase to higher values.

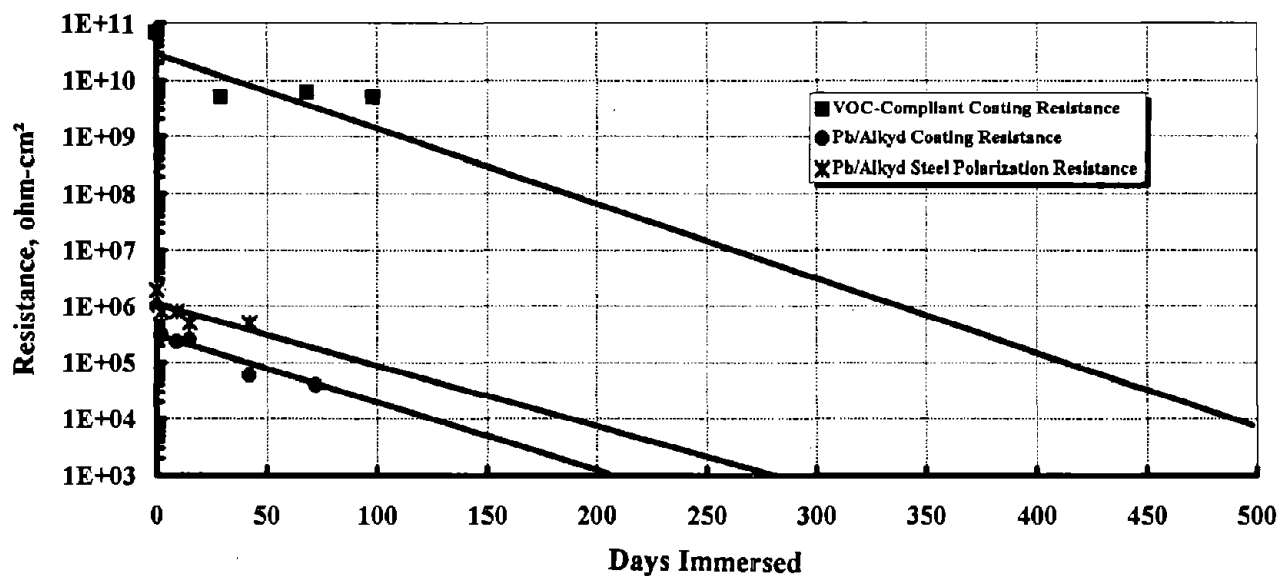
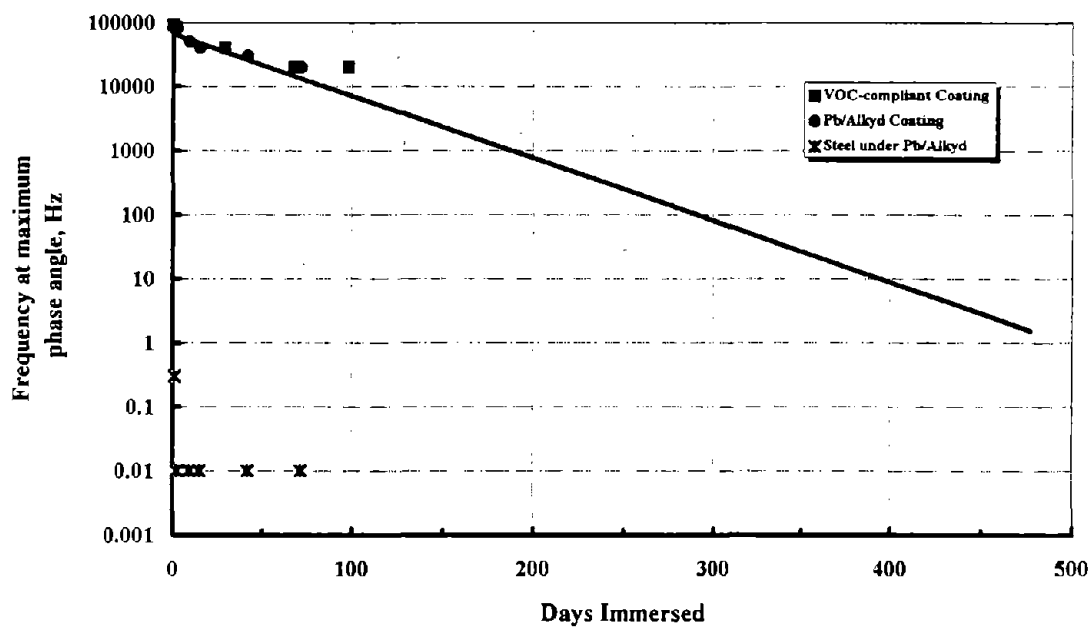
(a) Coating and polarization resistance.

(b) Frequency at maximum phase angle.

Figure 67. Electrochemical properties for the Pb/alkyd and VOC-compliant coatings in immersion experiments.

Figures 67(a) and (b) show the coating and polarization resistance, and  $\omega_{\max}$  as a function of immersion time for the Pb/alkyd and VOC-compliant coatings. Figure 67(a) shows coating resistance decreasing for both coatings. This is indicative of a coating absorbing electrolyte and becoming less resistive. However, the VOC-compliant coating is still five orders of magnitude higher in resistance than the Pb/alkyd coating, meaning it is still insulative and providing a barrier for moisture penetration toward the steel substrate. Steel corrosion was not observed under the VOC-compliant coatings. On the other hand, the Pb/alkyd coating gave a relatively low coating resistance that continued to decrease with time, indicating that the coating had degraded. In addition, corrosion of the steel substrate was observed from the EIS measurements and confirmed visually. However, the polarization resistance,  $R_p$ , appeared to be high—three orders of magnitude higher than obtained from experiments done on bare-steel rods of known area in the same electrolyte. A

Figure 67(b) shows  $w_{max}$  as a function of immersion time for the Pb/alkyd and VOC-compliant coatings. The  $w_{max}$  for the steel under the Pb/alkyd coating shows values indicative of a significant corrosion rate, i.e., above 25  $\mu\text{m}/\text{yr}$  (1 mpy). This confirms that the apparent polarization resistance measured is incorrect due to the area term. On the other hand,  $w_{max}$  for the two coatings shows the same trend even though the coating resistances are much different in value. This suggests that  $w_{max}$  is a useful parameter for determining the onset and extent of steel corrosion underneath a coating, but not necessarily for characterizing the level of coating degradation. Fortunately, however, coating resistance is an excellent parameter to characterize the state of the coating. In addition, the coating capacitance can be used to further quantify water penetration into the coating, however it was not calculated in this task.
