Publication No. FHWA-RD-94-098  
August 1995

# Issues Impacting Bridge Painting: An Overview

U.S. Department of Transportation  
**Federal Highway Administration**

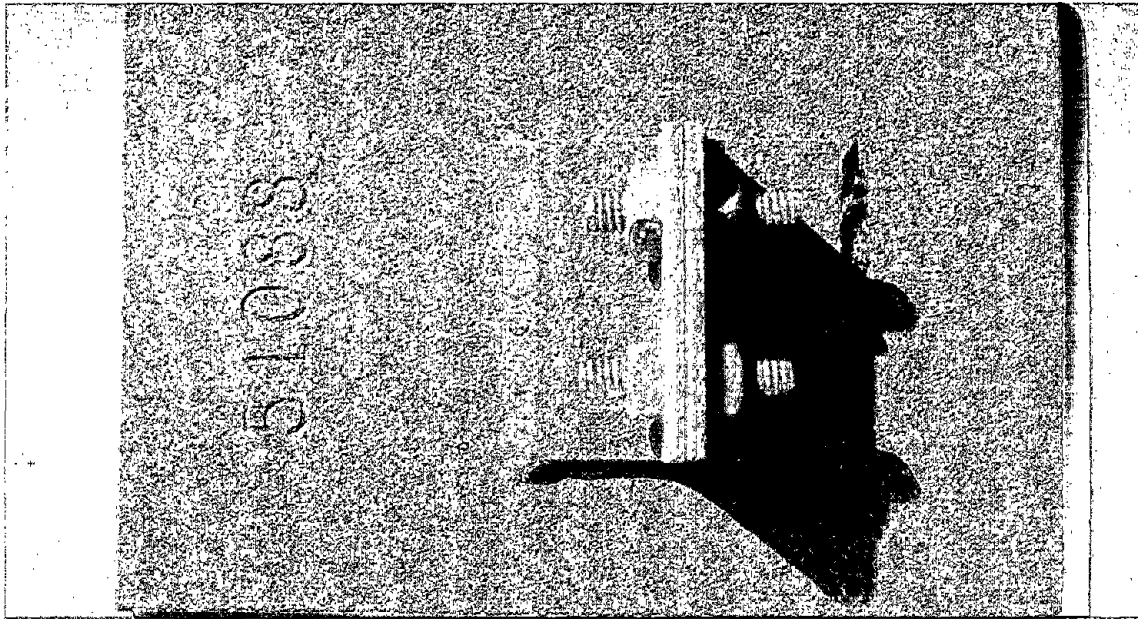
(c) Thermally sprayed zinc, cyclic test II.

Figure 68. Before-and-after photographs of the coated, non-flat test panels subjected to cyclic tests I and II (continued).

Non-Flat Panel Results. Figures 68(a) through (d) show representative before-and-after photographs of the four coatings on the two non-flat test panels subjected to cyclic tests I and II. Table 17 lists the corrosion rating of each coating and test panel on a scale of 1 to 10 according to the ASTM-D610 visual corrosion rating standard, with 10 representing a coating of excellent performance and durability, and 1 indicating a coating of poor performance and durability.

The VOC-compliant and TS-zinc coating performed the best of the four coatings, showing excellent coating performance. The TS-zinc showed excellent durability and the VOC-compliant coating showed better-than-average durability. Both coatings had visual ratings of between 8 and 10, performing well in the accelerated tests with virtually no corrosion occurring on the surface. Some yellow staining was observed on one of the TS-zinc-coated test panels that was due to the consumption of the zinc. However, several of the VOC-compliant coated test panels showed several small areas of steel corrosion on the welded bracket or the nut-and-bolt area. Though these corroded spots were not enough to decrease the rating significantly, they are noted because they probably occurred due to the difficulty in uniformly coating the non-flat area. The coating thicknesses in these areas were thinner compared to the rest of the flat panel area. In addition, one of the VOC-compliant coated test panels subjected to cyclic test II showed cracking along a nut and bolt as well as on the welded bracket. The cracking was caused by the thermal stressing from the freeze/thaw cycle and subsequent UV exposure at elevated temperatures and this decreased the durability rating of the coating. These results highlight the usefulness of using non-flat test panels to rate coating performance because such observations were not seen on the TS-zinc or VOC-compliant coated flat test panels.

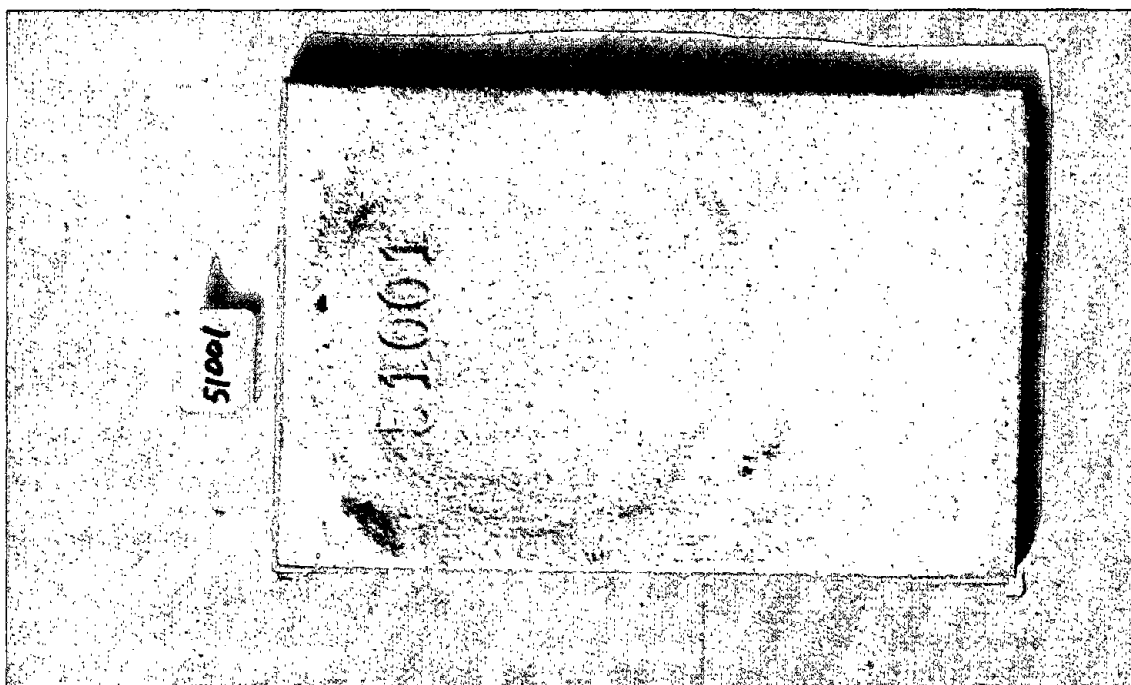
(c) Thermally sprayed zinc, cyclic test II.

Figure 69. Before-and-after photographs of the coated non-flat test panels subjected to cyclic tests I and II (continued).

Visual Rating. Figures 69(a) through (d) show representative before-and-after photographs of the five coatings on the flat test panels subjected to cyclic tests I and II. Table 18 lists the corrosion rating of each coating and test panel on a scale of 1 to 10, according to the ASTM-D610 visual corrosion rating standard.

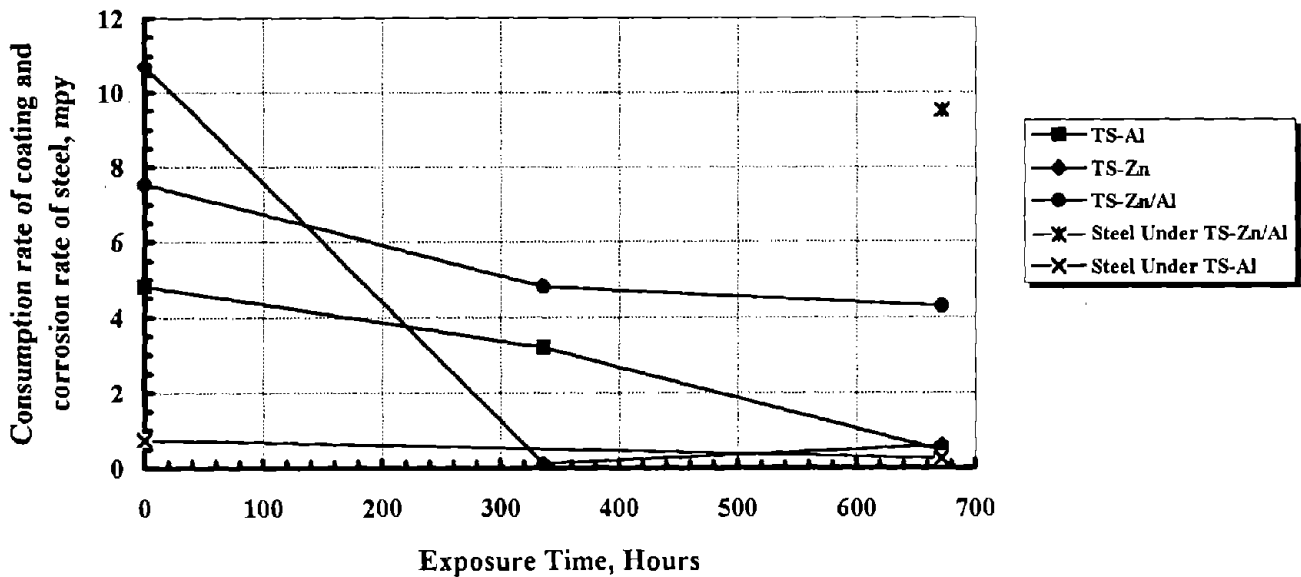
(a) Consumption rate of the coating and corrosion rate of the steel, cyclic test I.

Figure 70. Electrochemical parameters for the thermally sprayed coatings in the cyclic tests.

substrate underneath. Steel corrosion rates were not observed for the test panels in cyclic test II, however. As noted earlier, the salt-spray exposure time is half of the cyclic test, or 360 h. Increasing the total exposure time of cyclic test II would provide a longer salt-spray exposure that when coupled with freeze/thaw cycling and UV exposure, would accelerate the onset of corrosion under the coatings.

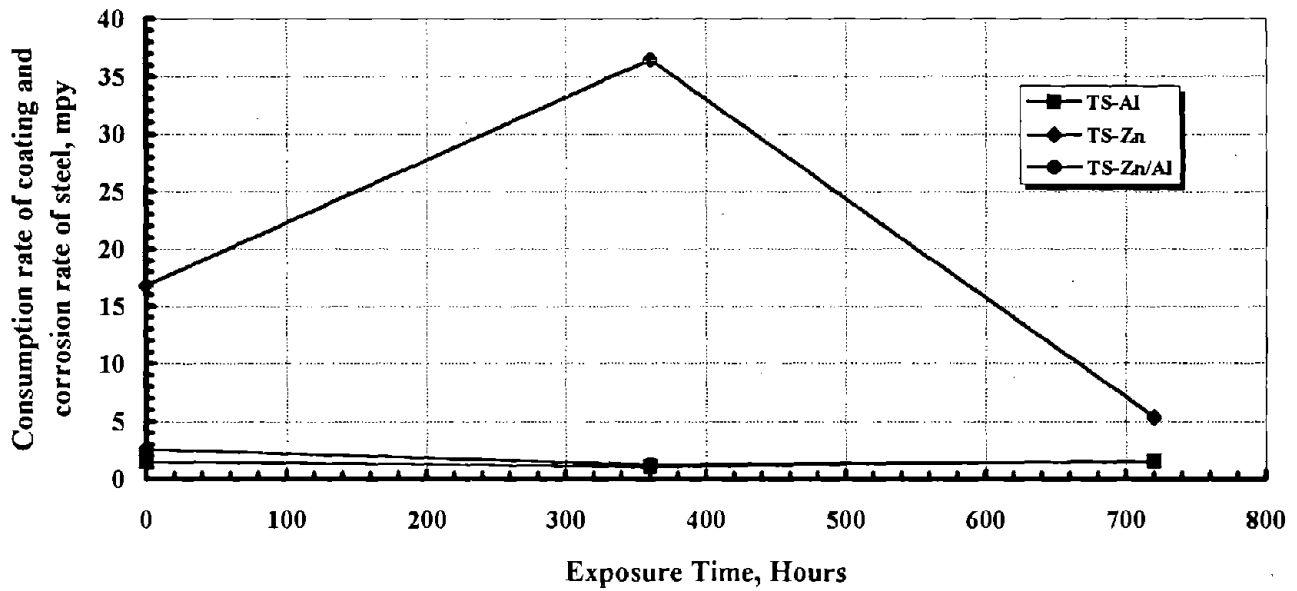
(b) Consumption rate of coating and corrosion rate of steel, cyclic test II.

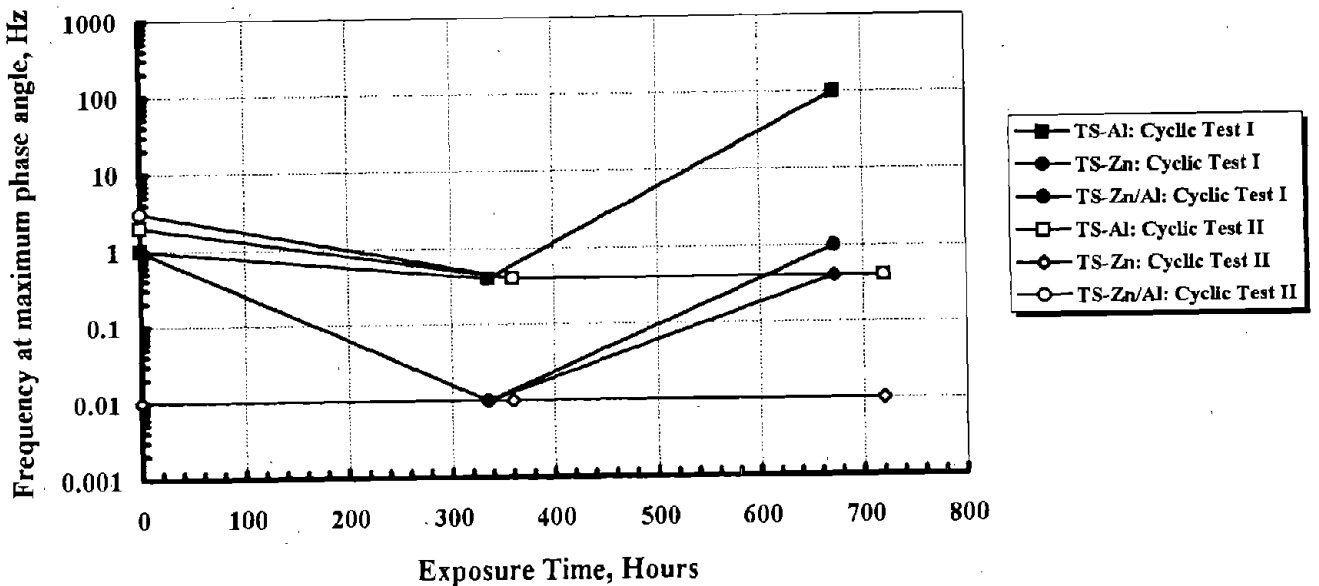
(c) Frequency at maximum phase angle.

Figure 70. Electrochemical parameters for the thermally sprayed coatings in the cyclic tests (continued).

Figure 70(c) shows  $w_{\max}$  for the three TS coatings subjected to cyclic tests I and II. In general, the low values of  $w_{\max}$  indicate active, corroding metals. The values also agree with the results from the immersion experiments that showed similar consumption rates and values of  $w_{\max}$ . As noted earlier,  $w_{\max}$  appears to be a sensitive indicator of the consumption rates of the TS coatings. In addition, the onset of steel corrosion was observed by EIS in approximately 670 h of accelerated exposure time. Increasing the total exposure time to 1400 h (2 mo) would be sufficient to further quantify steel corrosion underneath the coatings and determine how long the TS coatings can adequately protect the steel substrate.

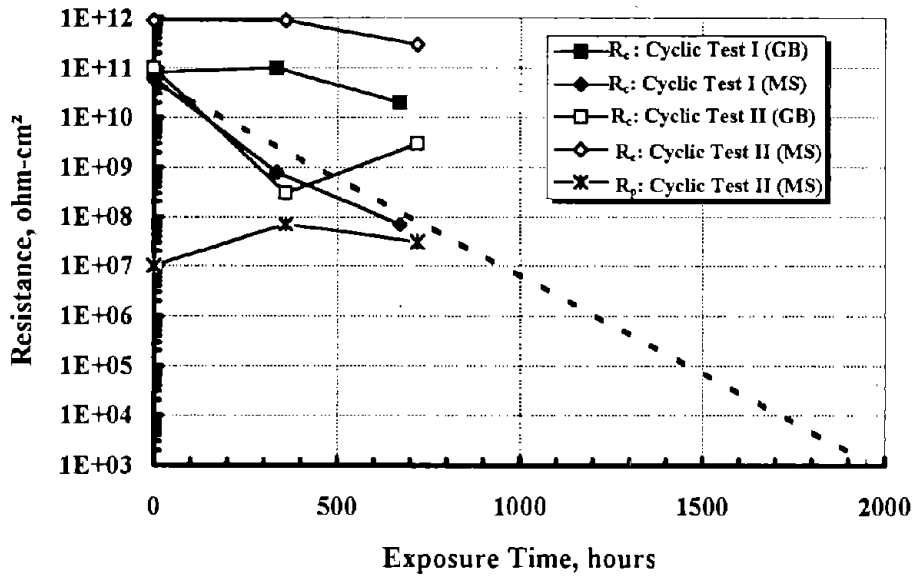
(a) Coating and polarization resistance.

Figure 71. Electrochemical parameters for the VOC-compliant coating in the cyclic tests (GB means grit-blasted surface, MS means millscale surface).

The coating resistance, polarization resistance, and  $w_{\max}$  for the VOC-compliant coating subjected to cyclic tests I and II are given in figures 71(a) and (b). The coating resistance was high for all of the test panels, but decreased by two to three orders of magnitude for several of the test panels. Electrolyte penetration into the coating was occurring, but there did not appear to be any trend for surface condition or accelerated test method. In addition, a test panel with a millscale surface subjected to cyclic test II showed measurable steel corrosion underneath the coating, even though corrosion was not observed visually. Thus, it is necessary to measure the onset of steel corrosion underneath organic coatings before it is visually seen. Still, a longer exposure period is needed to further validate steel corrosion and coating degradation. Extrapolation of the coating resistance for two of the test panels showed that a total exposure time of 1500 to 1900 h (2 to 2-1/2 mo) would be needed to reduce the coating resistance to values similar to a degraded coating.

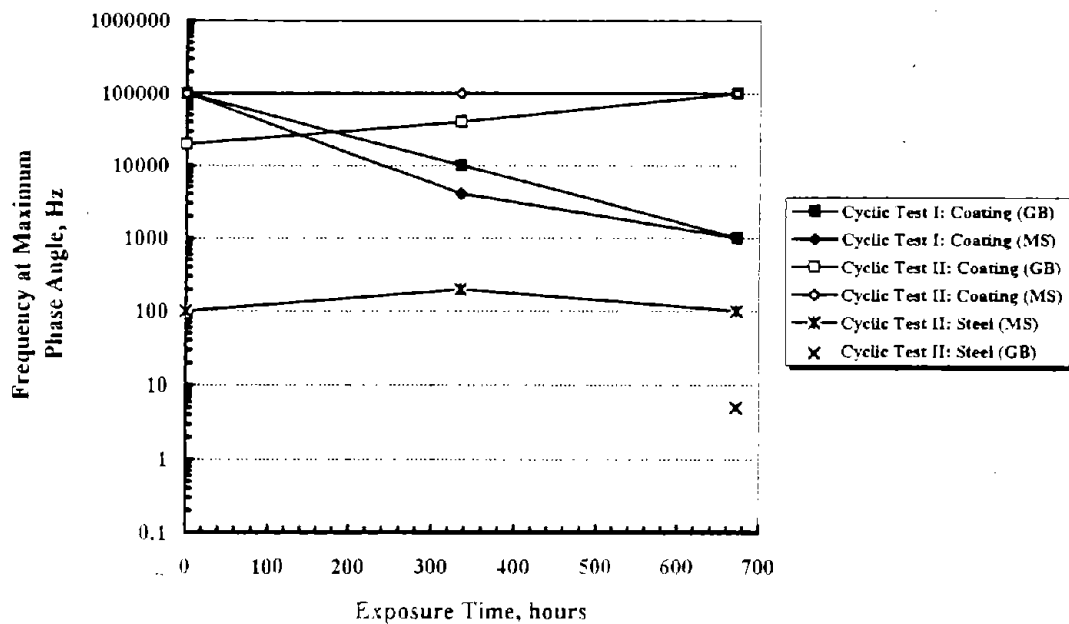
(b) Frequency at maximum phase angle.

Figure 71(b) shows  $w_{\max}$  for the VOC-compliant coatings subjected to cyclic tests I and II. The  $w_{\max}$  due to the coating decreased two orders of magnitude for the test panels subjected to cyclic test I, following the trend of decreasing coating resistance and indicating that the electrolyte is penetrating the coating. The  $w_{\max}$  due to steel corrosion on a coated panel with a millscale steel surface was low, indicating that significant corrosion was occurring underneath the coating. A coated test panel with a grit-blasted surface gave a measurable  $w_{\max}$  due to steel corrosion after testing, which suggests that the onset of corrosion occurred sometime between 360 and 720 h of exposure time.

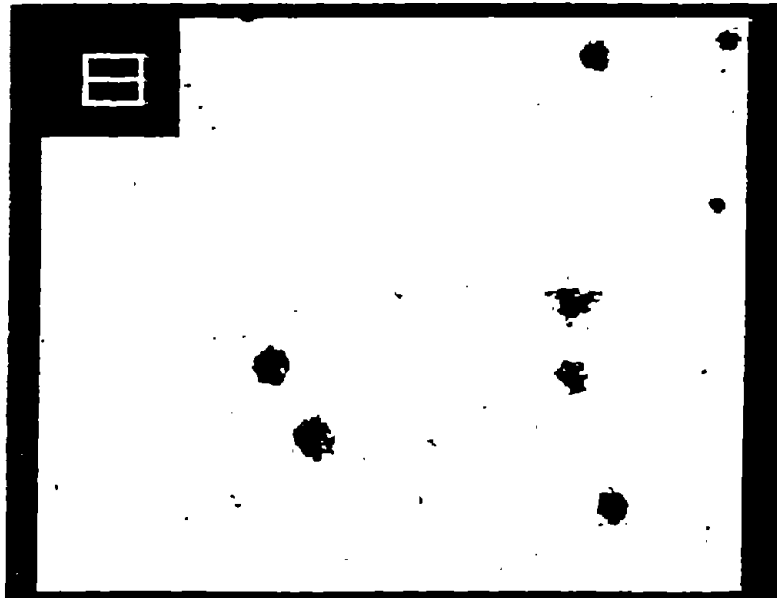
Figure 73. Results of image analysis of standard for rust grade 8 (.01-percent rust).

Structures Painting Council (SSPC) photographic standards as test samples is shown in figures 72 through 75. A contouring algorithm was used to compute the percentage of rust in an area and the corresponding rust grade is automatically printed in the upper left-hand of the recorded image. This approach can be made to easily sort the photographic standards. After calibration to the ASTM D610-85 photographs, verification of the technique was performed on actual steel panels used as an equivalent National Association of Corrosion Engineers (NACE) standard. How well it will function on actual bridge areas where the contrast and the recorded gray scales may not be as good as these photographic standards needs to be determined. This technique needs to be applied to actual bridge surfaces or pieces of bridges where comparison to manually measured rusted area can be performed. Tests of this type would allow evaluation of performance under conditions that include aged or faded paint, dark colors, and surface contaminants such as grease or dirt stains. Tests also need to be performed under typical field conditions to determine minimum lighting requirements.

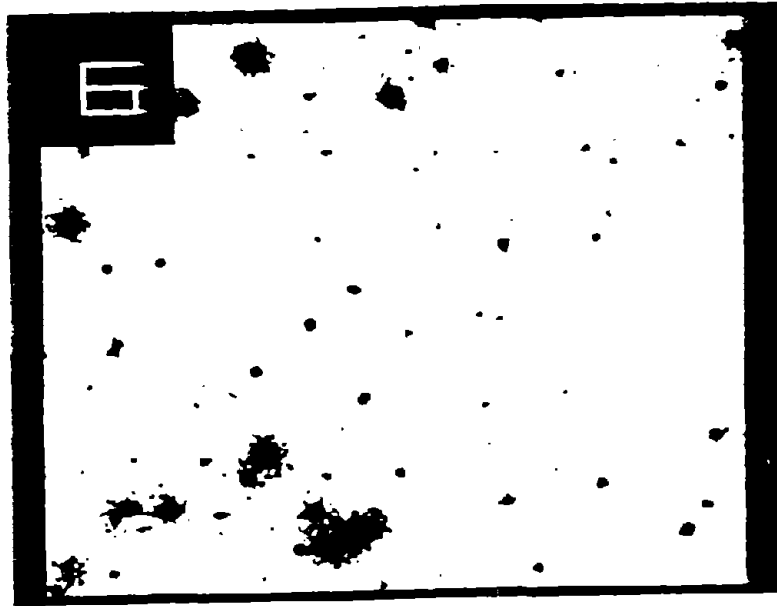
Figure 74. Results of image analysis of standard for rust grade 6 (1-percent rust).

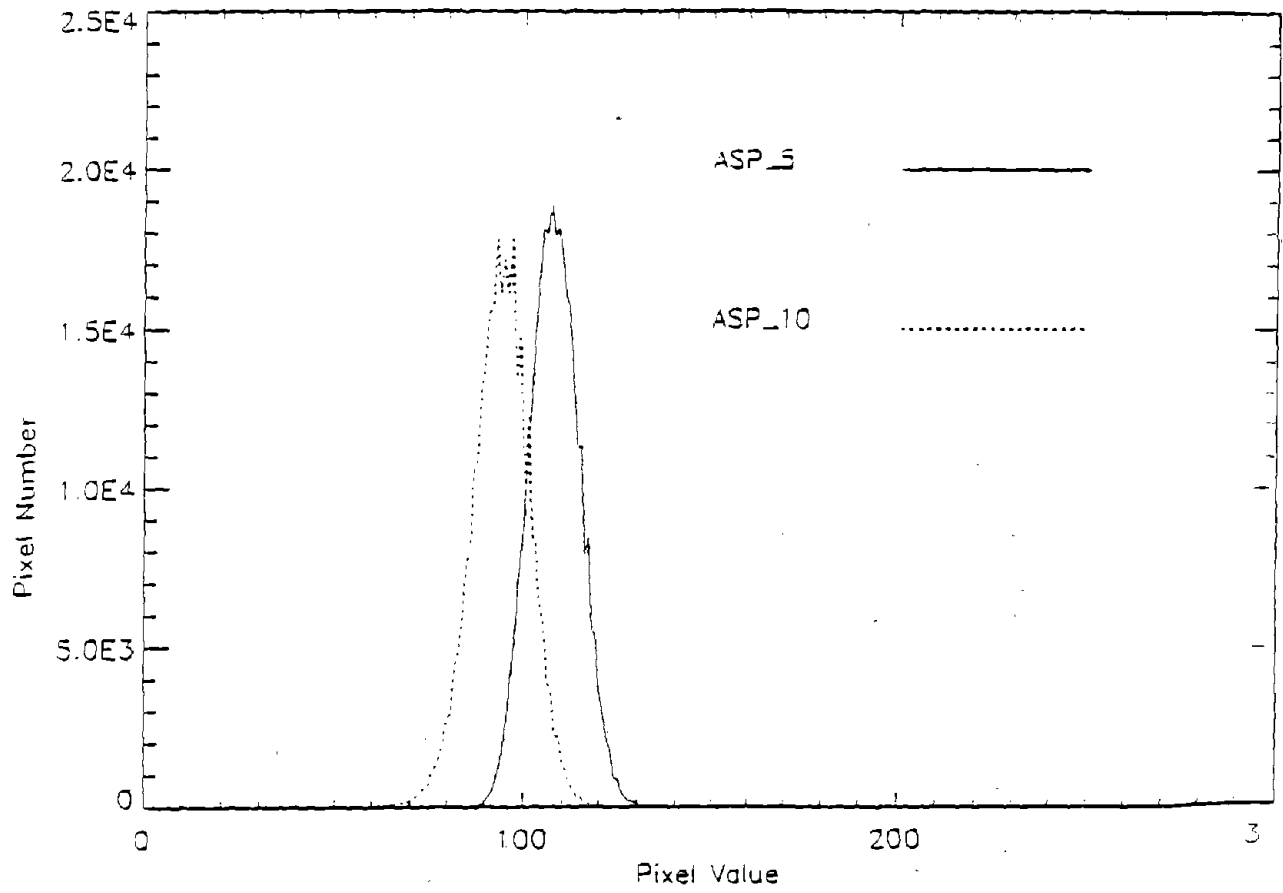
Figure 76. Histogram of red element.

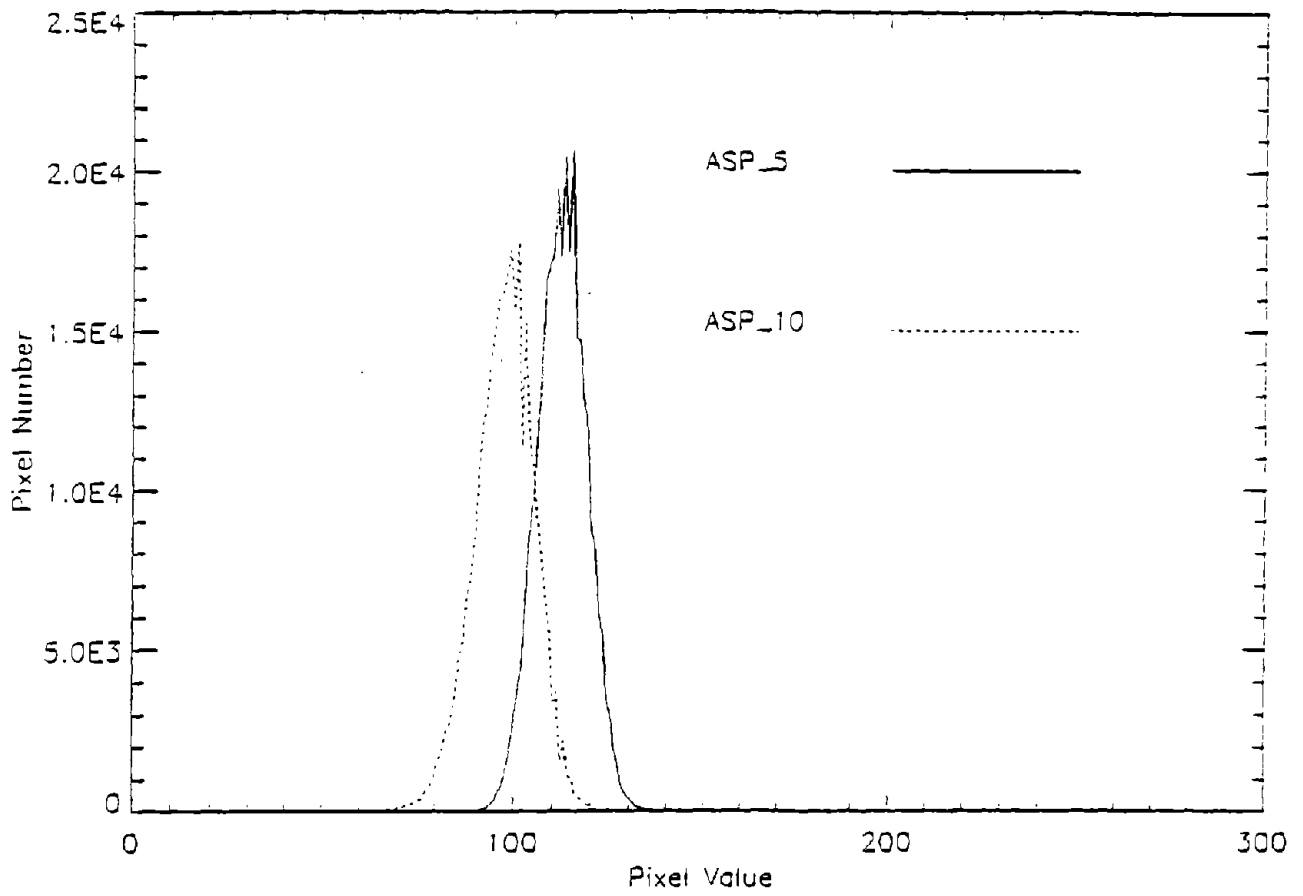
Figure 77. Histogram of blue element.

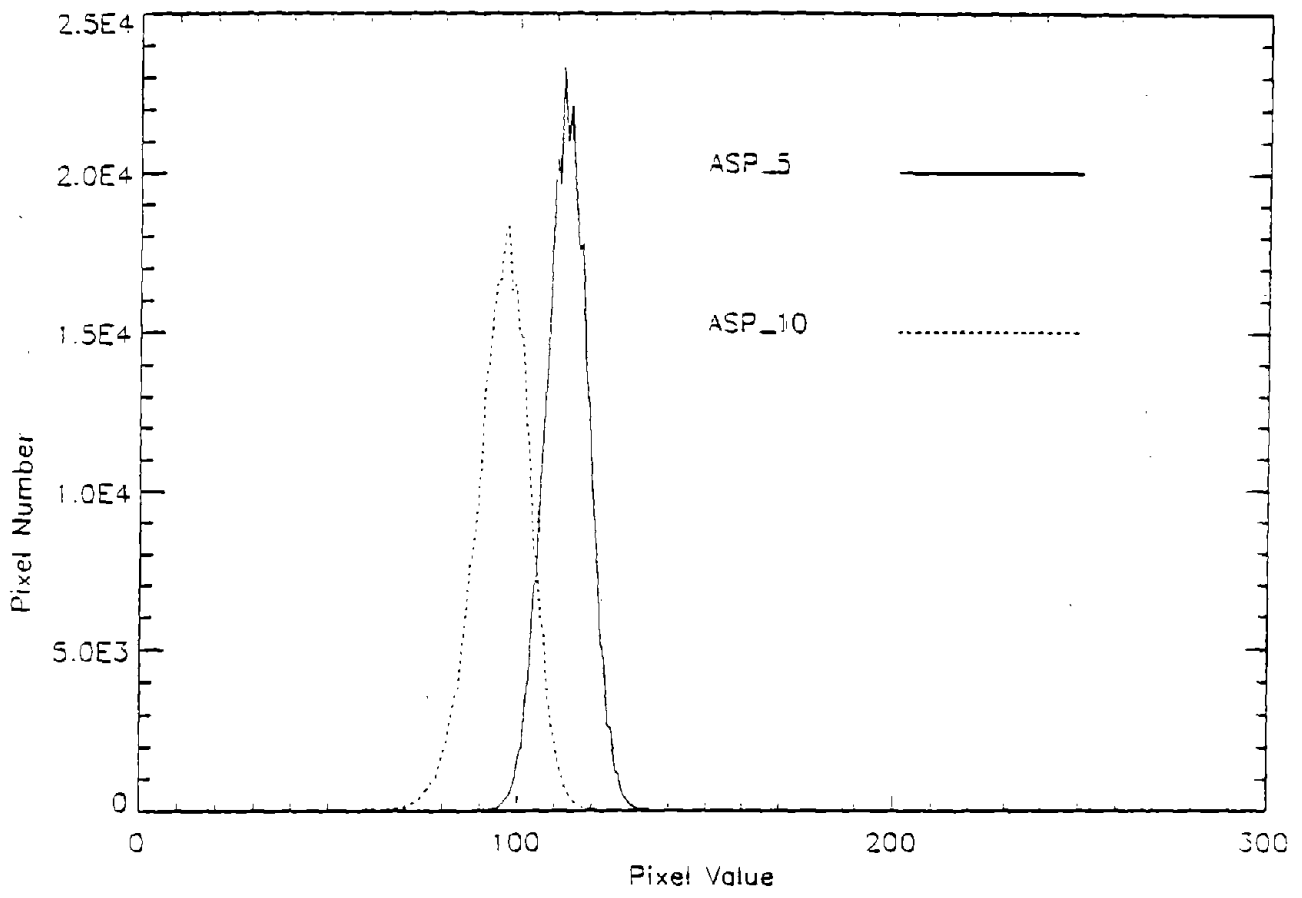
Figure 78. Histogram of green element.

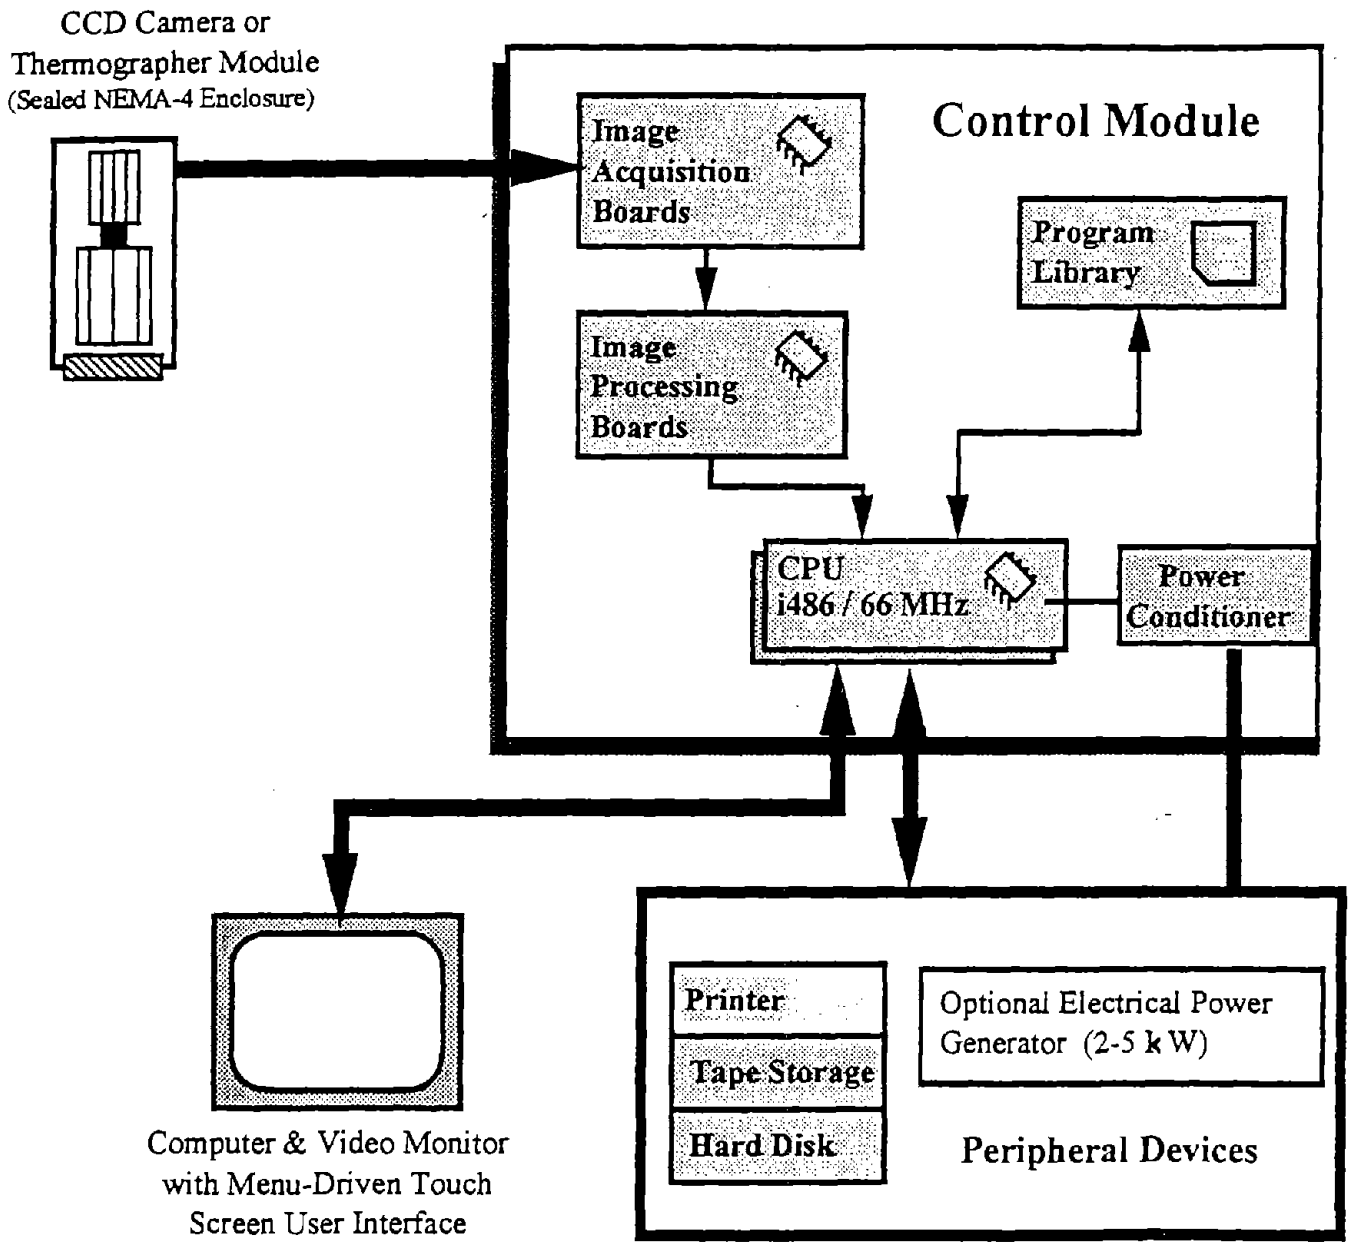
Figure 79. Schematic of color CCD camera system to measure damaged area.

A visual evaluation procedure has been developed (based on the red/green/blue techniques described above) and tested that can determine the percentage of rusted and/or damaged paint. In this procedure, the image is acquired by use of a color CCD camera (figure 79). The recorded images are enhanced by state-of-the-art techniques pioneered by NASA and the military. These techniques

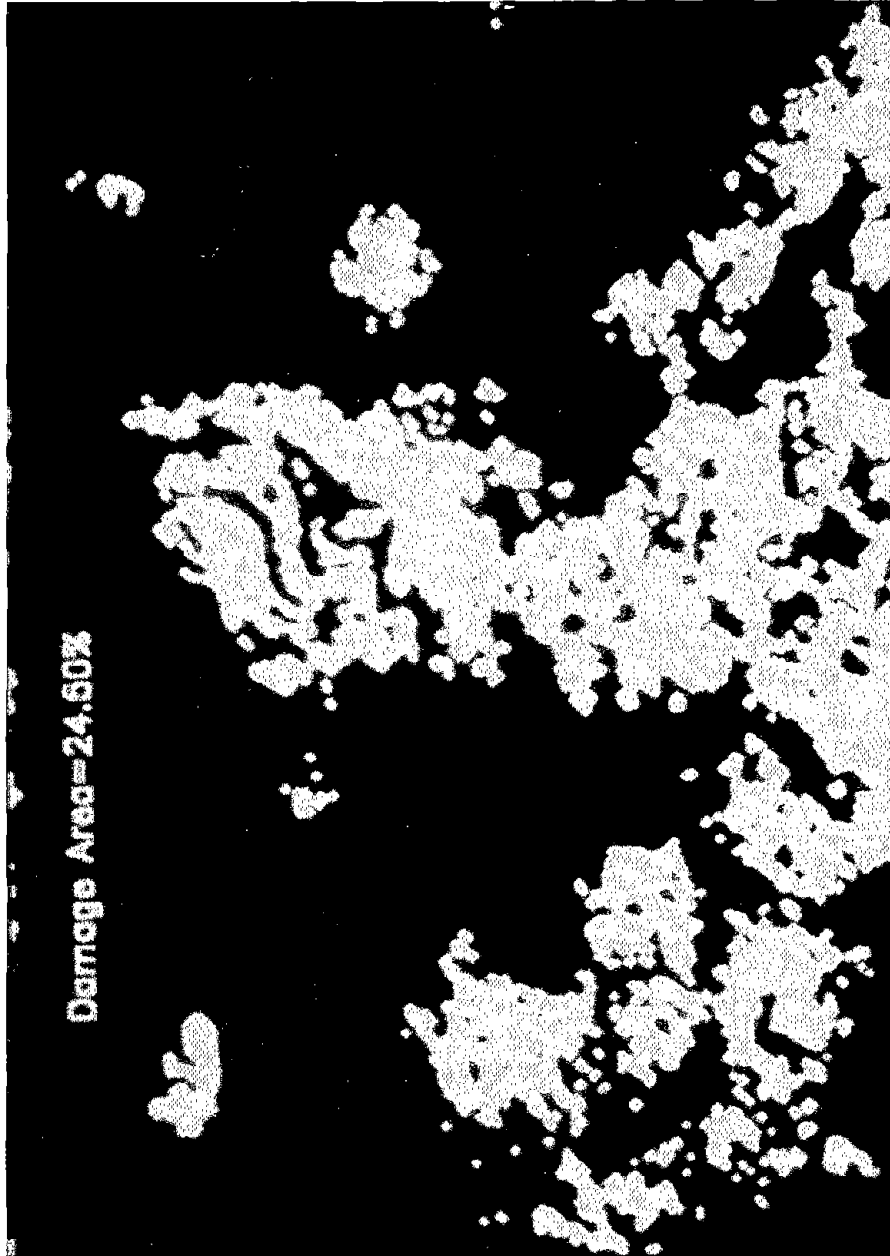
Figure 81. Calculated damaged area.

All image pixels that have values that are lower than a selected threshold are considered representative of damaged area and are assigned a value of 1. The remaining image pixels that have values that are greater than or equal to the threshold value are assigned the value of 0. The resulting binary image shows the damaged area of the original image. The percentage of damaged area is calculated by first counting the number of pixels that have a value of 1 and then dividing that sum by the total number of pixels. A portion of a girder (figure 80) from the IDOT storage yard was used to evaluate the technique and the results are shown in figure 81.

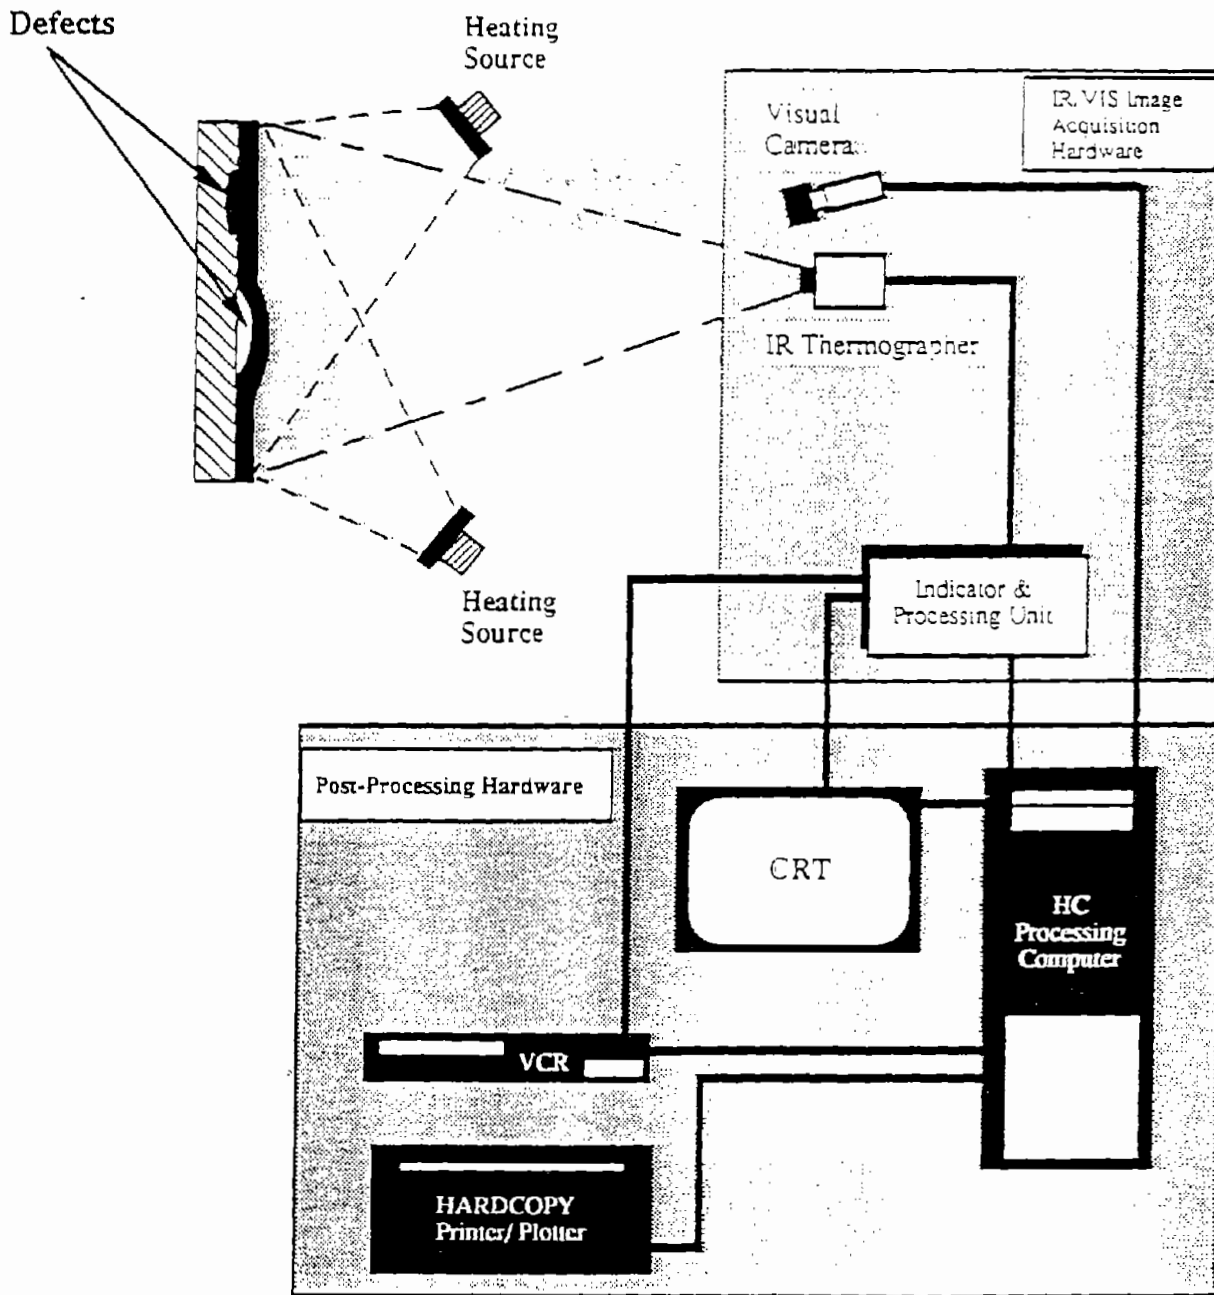
Figure 82. Schematic of infrared thermography system.

Thermal-wave imaging was evaluated to determine its ability to detect debonded paint areas. The thermographic system is schematically represented in figure 82 and is employed not only as an infrared sensor, but also as a high-resolution color camera. The camera is used to identify an area and act as a reference for the thermographic image. The panels used in this evaluation were obtained from a bridge girder supplied by IDOT. The surfaces were in a bad state of degradation. Figure 83 shows a typical sample area. As can be seen, there are areas of bare metal, rust, millscale and blister, and intact original paint. After the panel was heated, the image was obtained and enhanced by computer software. The areas of damaged and delaminated paint are easily seen (white and light shaded areas (figure 84)). In the preceding example, a continuous heat source was employed. However, if it had been replaced by a pulsed source and the gradient of heat flux was monitored, it would be possible to identify and differentiate between voids and delaminations and also to determine relative bond strengths.

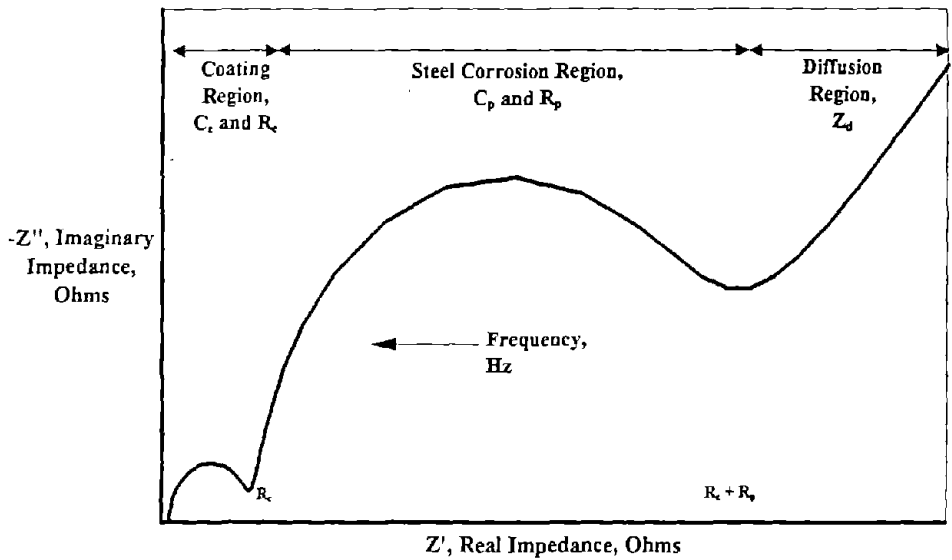
(a) Idealized Nyquist plot.

Figure 85. Some elements of electrochemical impedance spectroscopy.

An important part of the EIS analysis is to create an "equivalent circuit" of the system using resistors and capacitors in series and in parallel. The physical behavior of the corrosion system can be simulated and quantified with this circuit to gain insight into the important processes of the corrosion system. Figure 85(b) shows an equivalent circuit simulating the ideal Nyquist plot for the metal coated with a porous coating shown in figure 85(a).

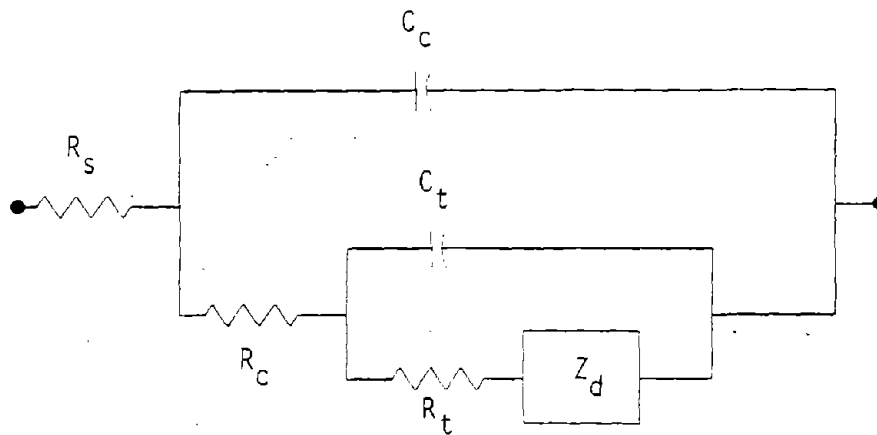
(b) Equivalent circuit for the idealized Nyquist plot.

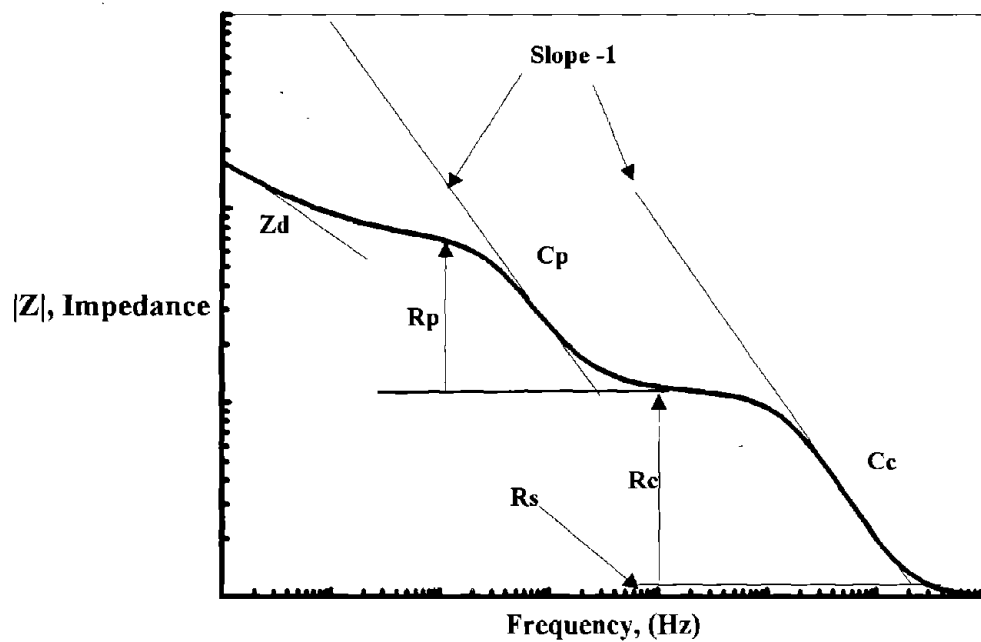
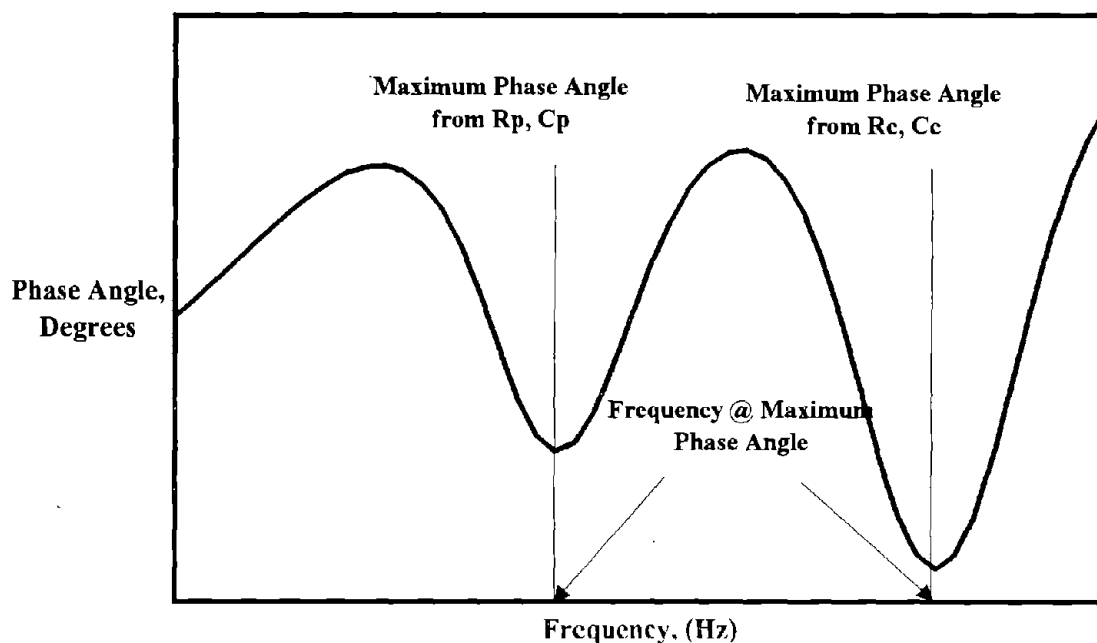
(c) Idealized Bode plot.

Figure 85. Some elements of electrochemical impedance spectroscopy (continued).

The EIS spectrum can also be presented in the Bode plot form, which gives the logarithm of the impedance,  $|Z|$ , and the phase angle,  $\phi$ , versus the logarithm of frequency. Figure 86(c) shows an idealized Bode plot for a metal coated with a porous coating. The Bode plot is useful when determining the frequency at maximum phase angle,  $\omega_{max}$ , because the maximum phase angle is immediately apparent on the plot. In the case of a metal with a porous coating, there are two maxima, one representative of the coating and the other representative of the corrosion reaction. The change in frequency at maximum phase angle can then be followed as the coating degrades and corrosion begins to occur.

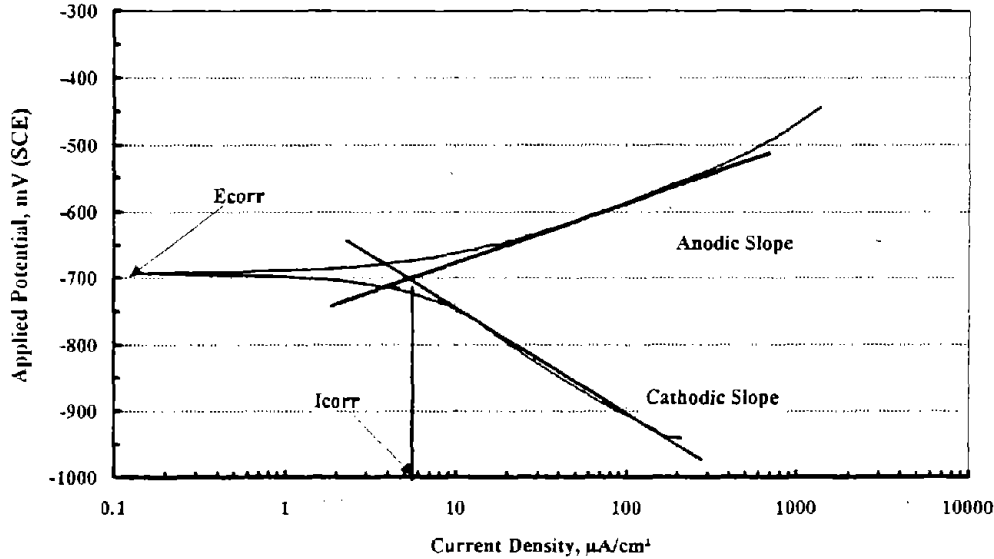
Figure 86. Representative potentiodynamic polarization scan for mild-steel rod in electrolyte.

Potentiodynamic polarization is a well-established electrochemical technique where a potential scan of 250 mV, positive and negative, of the free-corrosion potential is imposed on a metal sample and the current is recorded. The current in this potential range varies logarithmically with potential. Figure 86 shows a typical potentiodynamic polarization scan for a mild steel rod in electrolyte. The Tafel slopes of the anodic and cathodic reactions are obtained from the linear portions of the scan and together with the corrosion current,  $i_{corr}$ , the corrosion rate can be calculated. The corrosion current is obtained from the plot where the two slopes join, which is at the free-corrosion potential. In addition, the anodic and cathodic Tafel slopes can be used with  $R_p$ , obtained from linear polarization, and a corrosion rate can also be calculated.
