Publication No. FHWA- RD-91-060
September 1992

Environmentally Acceptable Materials for the Corrosion Protection of Steel Bridges:

Task C, Laboratory Evaluation

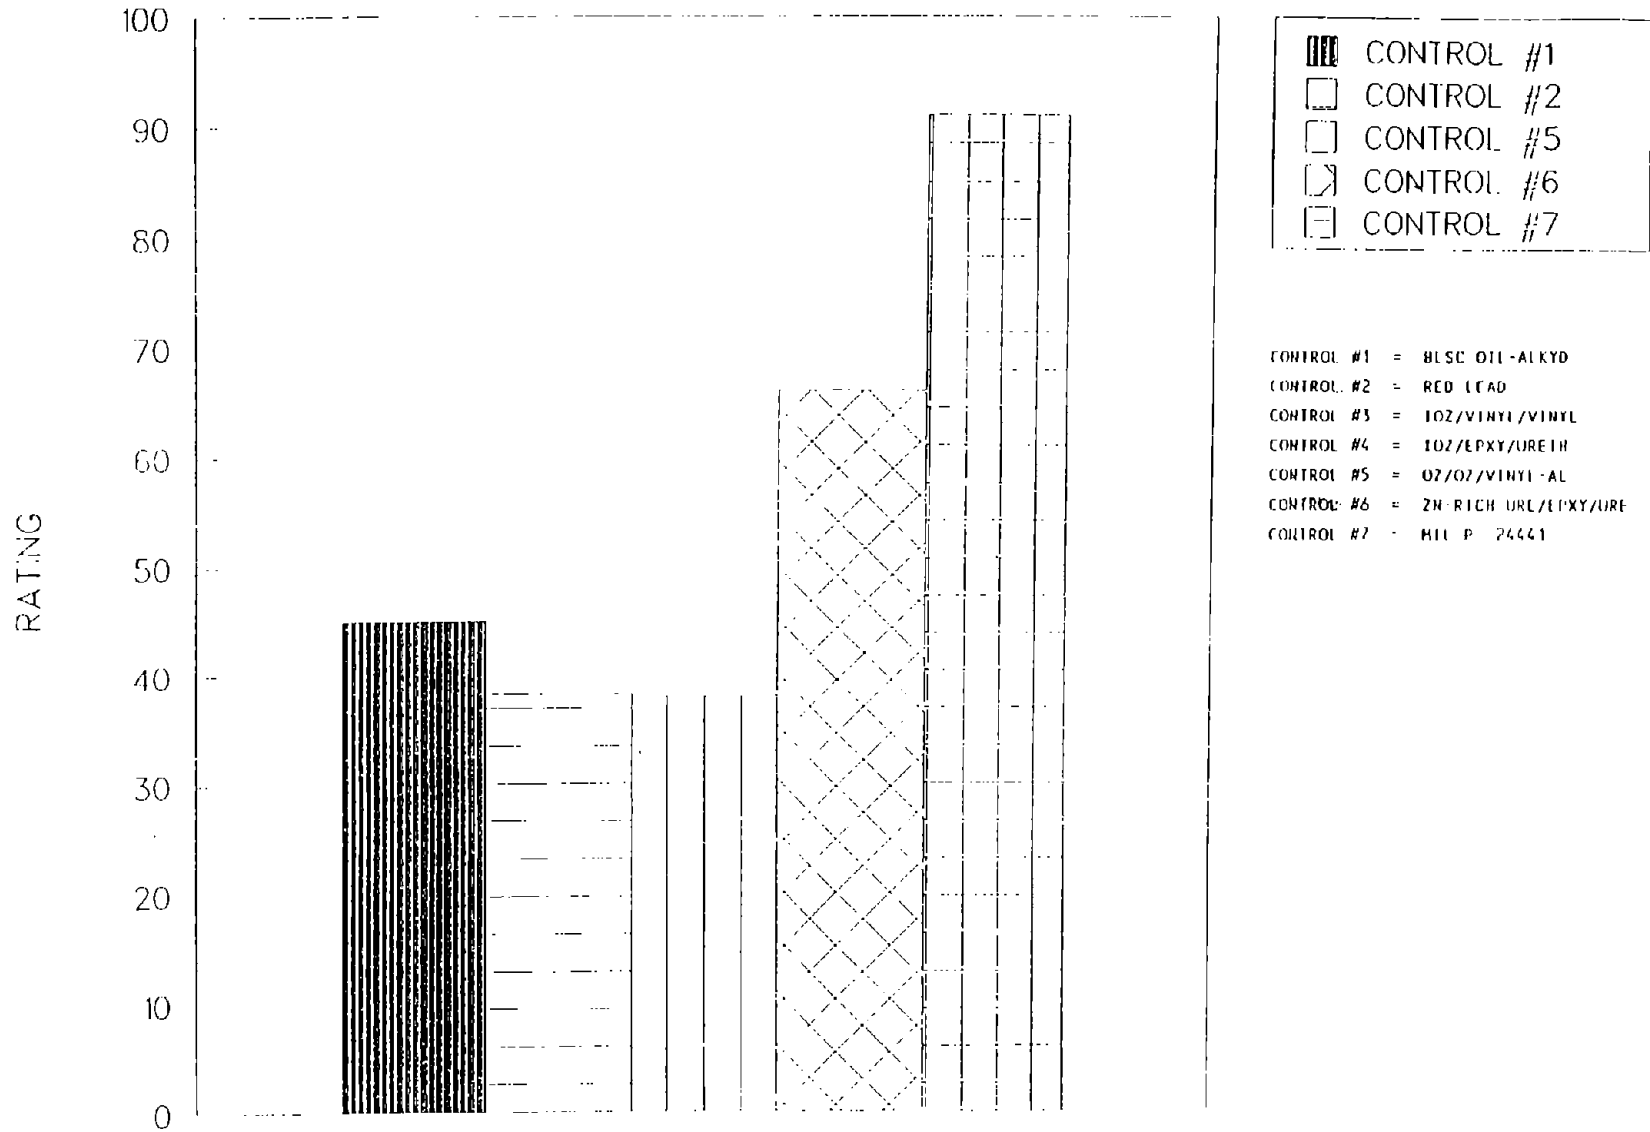
Figure 29. A36 test panels; performance rating for all tests, SP-2 surface prep., (control systems).
