# LRV Bumper Safety Technology Deployment

Applied Research Associates, Inc.

FTA Report No. 0247

The objective of this project is to design, build, and test a prototype LRV end enclosure, or bumper, as a retrofit to an existing LRV operated in the U.S. to reduce potential for injury to automobile occupants, damage to the LRV, and lower costs to operators from crashes. Three transit agencies provided significant contributions to the project and a complete prototype design was developed and tested for the Siemens SD660 operated by TriMet (Type 2 and Type 3 LRVs).

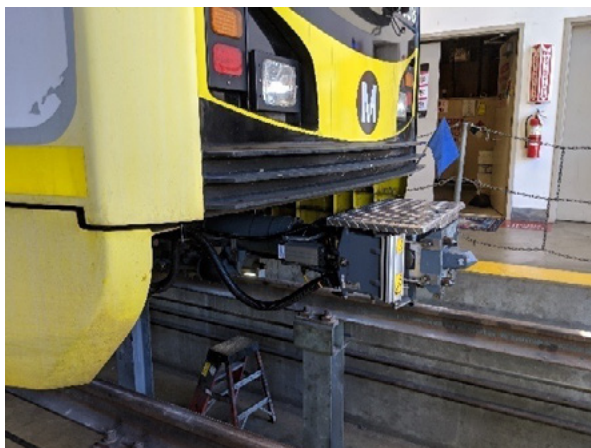
The front end of Metro's Kinkisharyo (KI) P3010 is shown in Figure 2-1. The open-ended design with the coupler protruding well ahead of the anti-climber makes the P3010 well suited for retrofit. Metro has 235 open-ended KI vehicles that have all been built since 2014. These vehicles represent a significant percentage of the Metro fleet and are newer vehicles that will remain in service for a long time. The Siemens SD660 Type 3 LRV operated by TriMet is shown in Figure 2-2. These vehicles are also operated in a shared right-of-way environment on the Blue and Yellow lines in Portland, Oregon, as shown in Figure 2-3. TriMet operates almost 62 miles of light rail service in the

**Figure 2-1** Metro P3010 Front End

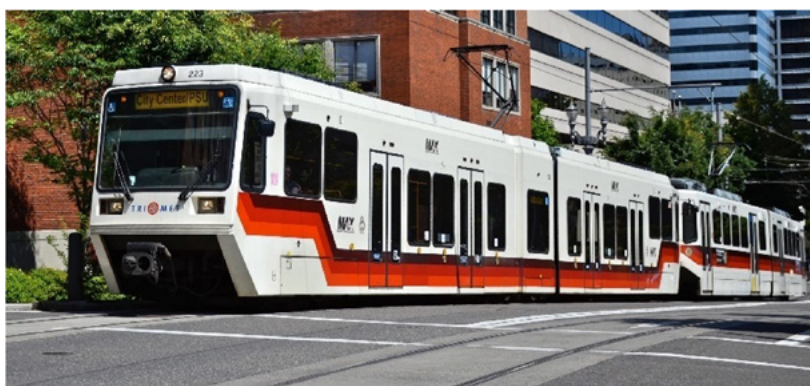
**Figure 2-3** Portland SD660 Operating on Shared Right-of-Way  
(photographed by Steve Morgan)

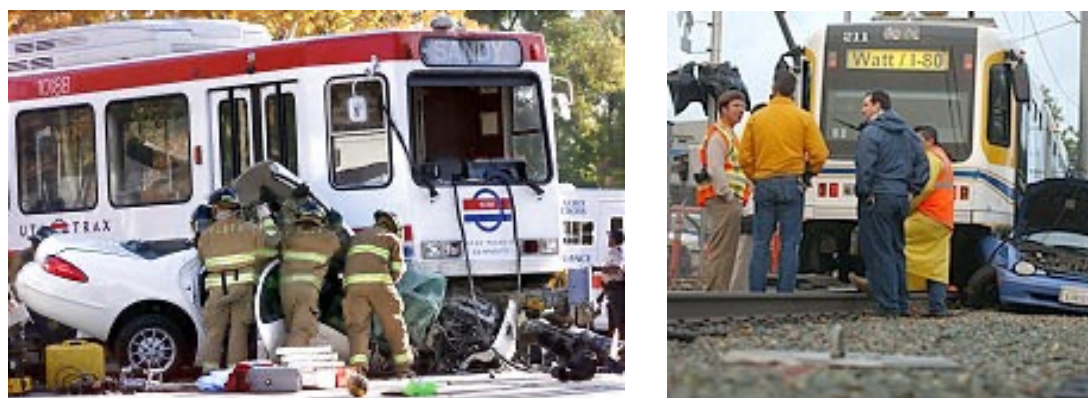
These are fixed (non-retracting/folding) coupler LRVs with an open front end that has an aggressive profile when impacting automobiles. The high anti-climber and vertically sloping front-end profile have a significant potential to override automobiles in frontal collisions, as shown for other vehicles in Figure 2-4. The high anti-climber can also directly impact the automobile passengers. The fixed coupler impacts the door of the automobile in side-on crashes.

**Figure 2-4** *Example Collisions between LRV and Automobiles [6]*

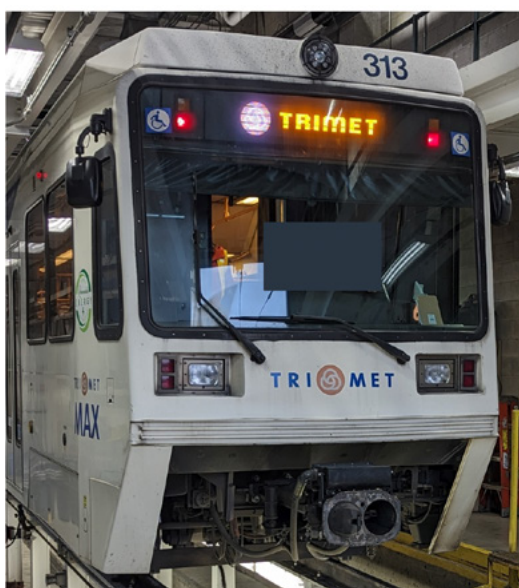
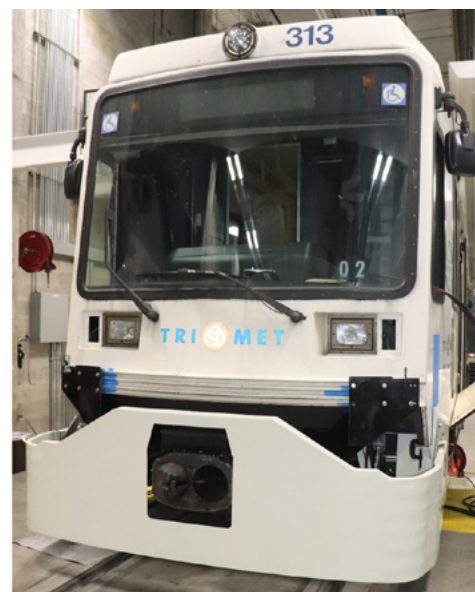
The final design installed for operational testing (discussed in the next section) is shown in Figure 3-5 to Figure 3-8. Permanent retrofit components are painted white and temporary attachments are painted black. Installation only requires removal of the side skirts, shown in Figure 3-7 without the enclosure installed, which are easily unbolted in the Type 3 vehicles.

**Figure 3-7** Type 3 LRV with and without Front Enclosure

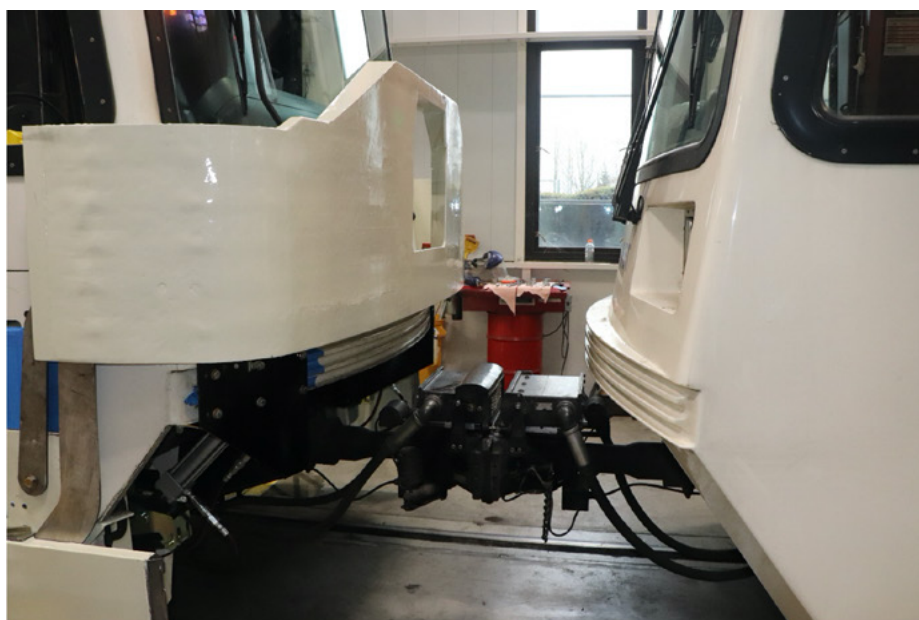
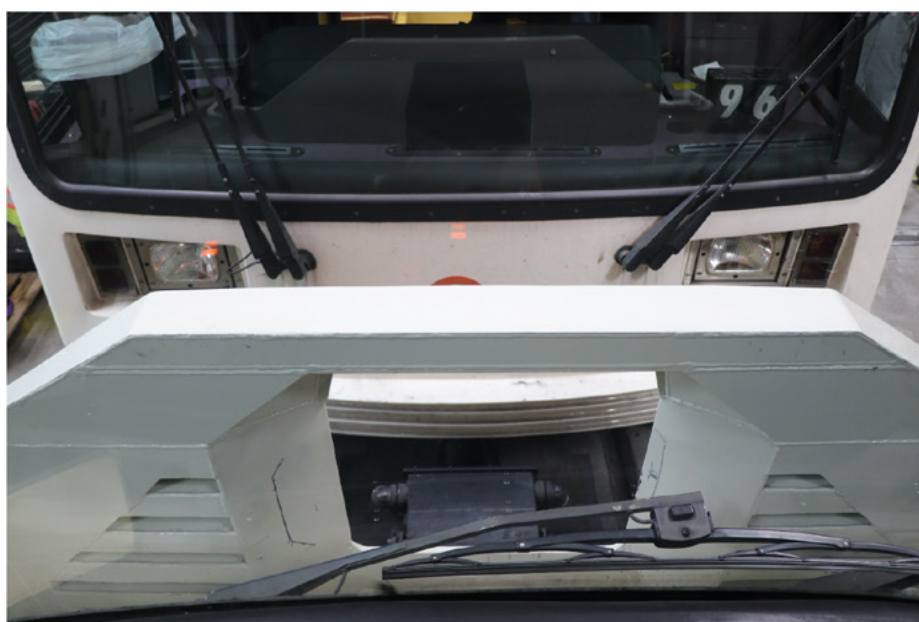
**Figure 4-4** Coupled Type 3 LRVs with a Temporary Front Enclosure Retrofit

A coupling test was then performed with a second LRV, as shown in Figure 4-4. The operator in the retrofitted car noted that coupling was an easy process, and their view was not hindered by the raised enclosure. Note that the coupler cutout, needed so couplers can actuate fully during hard coupling events, also serves to provide good visibility for the operator of the coupling faces.

(a) coupled clearance

(b) operator view when coupling

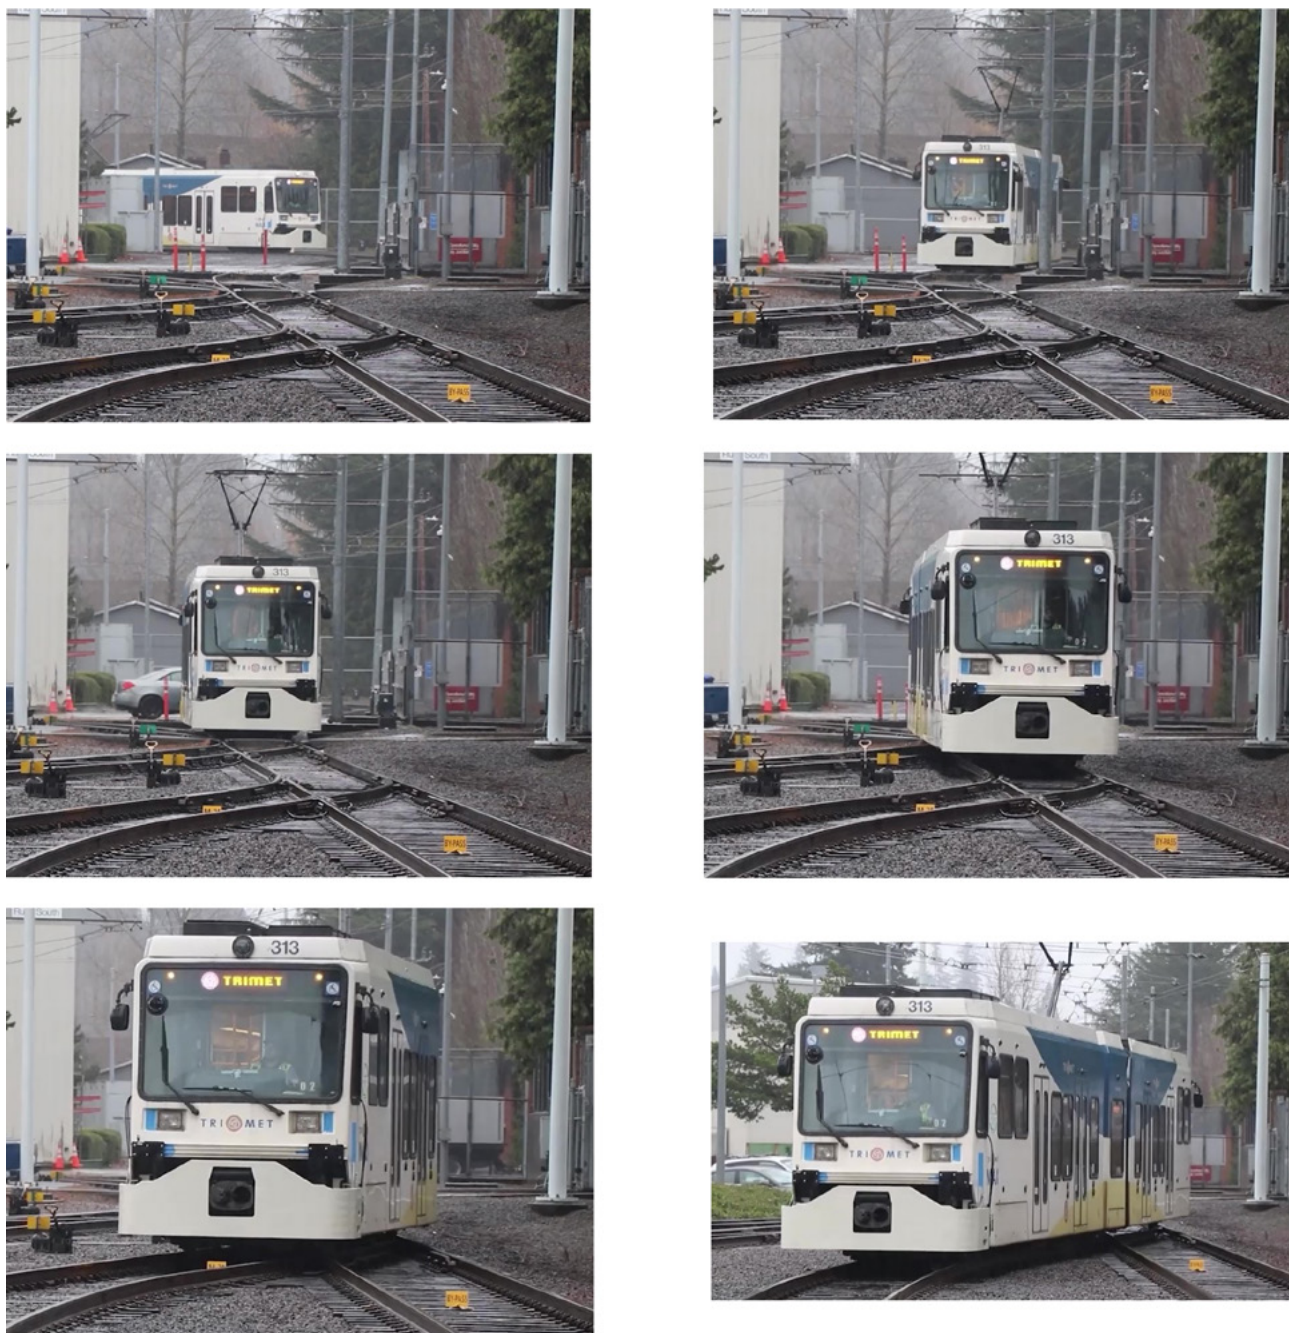
**Figure 4-5** Type 3 Ride Test with a Temporary Front Enclosure Retrofit

Finally, a ride test was performed at the Ruby Junction Rail Yard. The LRV was driven through the yard at slow speeds (5 mph), as shown in Figure 4-5. No issues were noted by the operator and good clearance with track-side equipment was recorded with video cameras attached to the LRV.

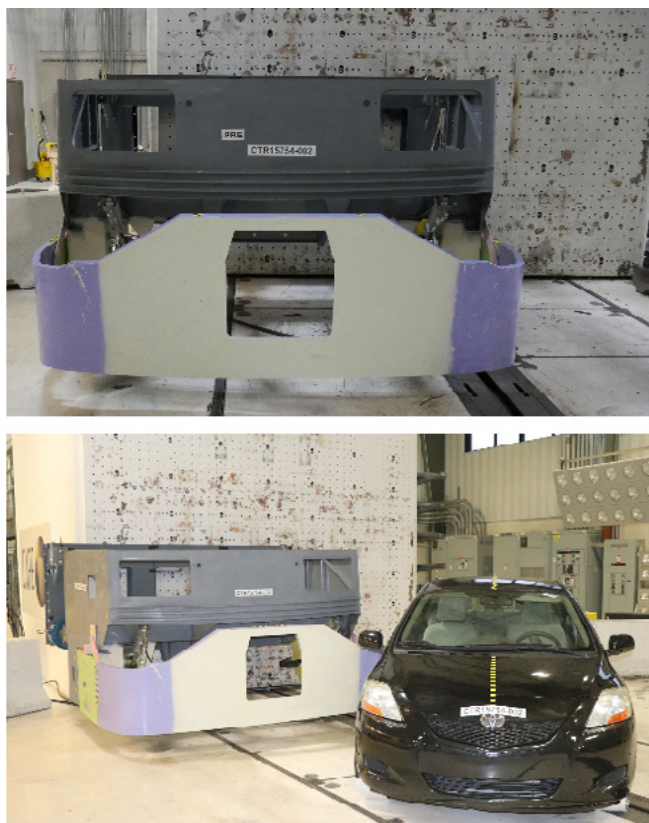
**Figure 5-16** Test Article Positioned on the Barrier Wall for Test 2

The test article was positioned off center of the track centerline, as shown in Figure 5-16 to accommodate the corner-focused oblique impact. Vertical positioning was the same as Test 1. The Yaris was positioned at an angle of 45 degrees to the track line and 105 mm off center of the tow hook, as shown in Figure 5-17.

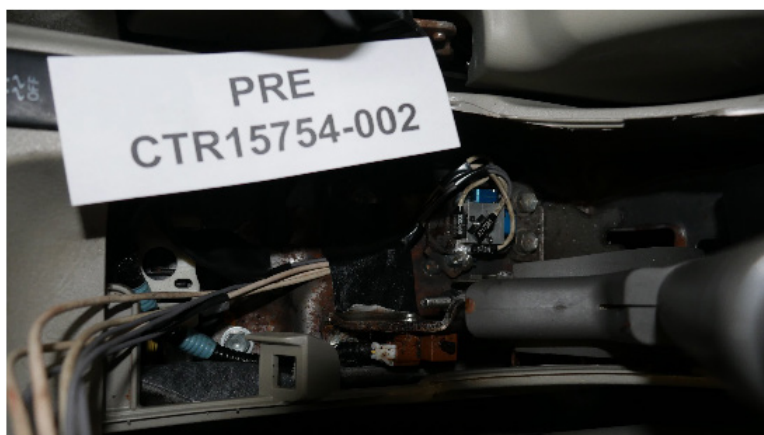
**Figure 5-18** Test 2 Accelerometers Mounted at the Base of the Center Console

Triaxial accelerometers were positioned at the longitudinal CG of the automobile to measure translational and rotational accelerations. These are shown mounted at the base of the center console in Figure 5-18. Load cells were mounted between the test article and the mounting frame to measure the reaction load at the barrier wall, as shown Figure 5-19. Two (2) laser speed traps were used, as described for Test 1, as shown in Figure 5-20. Tape contact switches were attached to the front enclosure and to the Yaris door to trigger and synchronize the data acquisition equipment, as shown in Figure 5-21. High-speed photography was taken at overhead, left/right sides, and beneath the test article to view the side panels, as shown in Figure 5-12.

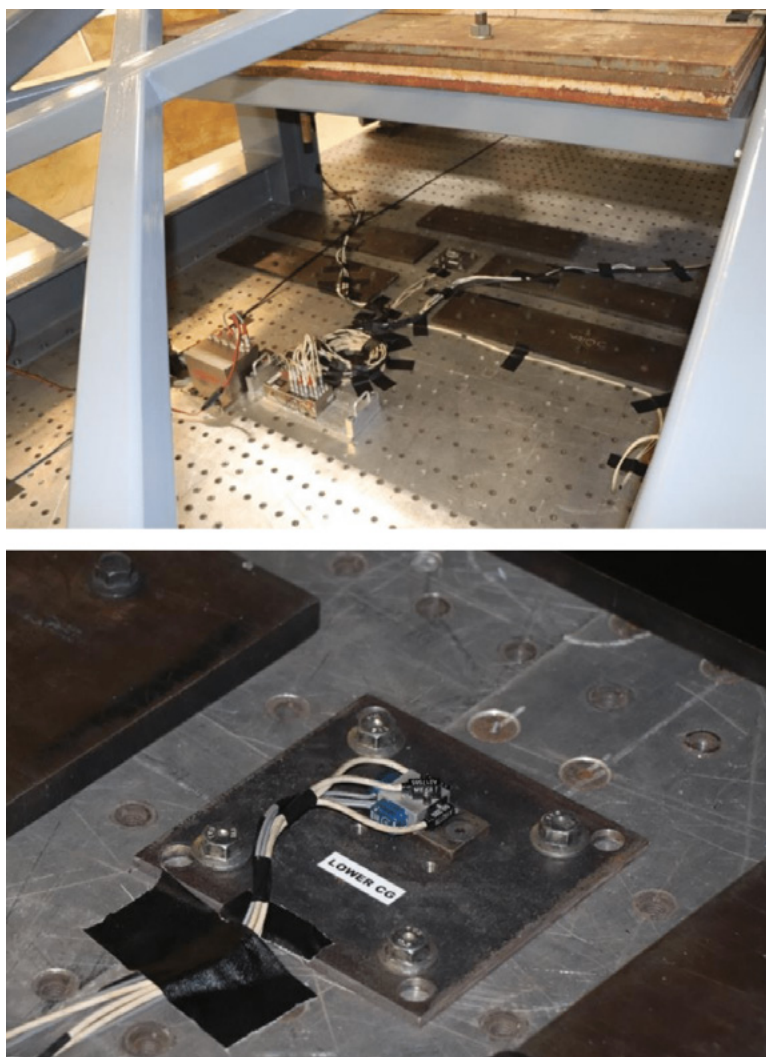
**Figure 5-28** *Test 3 Accelerometers Mounted to the Test Sled*

Triaxial accelerometers were positioned at the longitudinal CG of the test sled at two heights to measure translational and rotational accelerations. These are shown mounted at the base of the center console in Figures 5-28 and 5-29. Load cells were mounted between the test article and the mounting frame to measure the reaction load on the sled, as shown Figure 5-30. Two (2) laser speed traps were used to measure the impact speed by measuring the time between interruption of the laser. Tape contact switches were attached to the barrier wall beneath the ACEA to trigger the data acquisition equipment, as shown in Figure 5-27 and on the front enclosure, as shown in Figure 5-31. High-speed photography was taken at overhead, left/right sides, and left/right oblique positions.

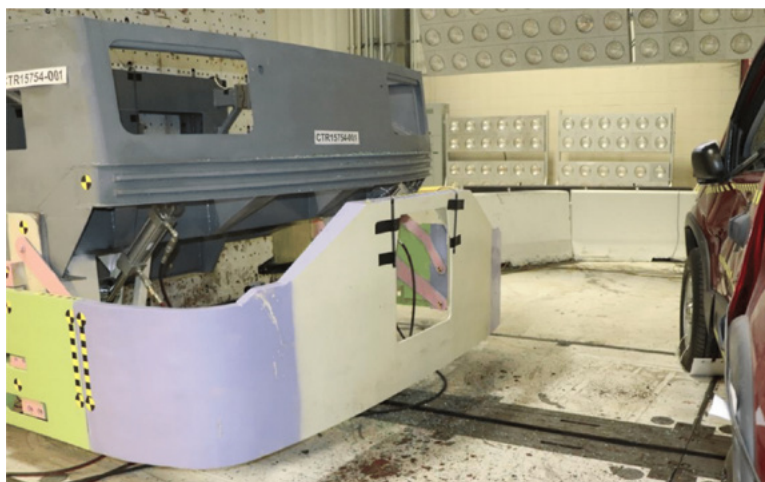
**Figure 5-33** *Front Enclosure Post-Test 1*

The response of the front enclosure and Explorer in Test 1 is shown in Figure 5-32. The front enclosure after the crash test is shown in Figure 5-33. There was some small scratching on the paint, but no other visible damage. There was a negligible change in measurements to each marker position before and after each test, indicating no permanent deformation to the structure. The front enclosure was retracted and deployed with no loss in function. Forces and accelerations measured during the test are provided in Appendix C.

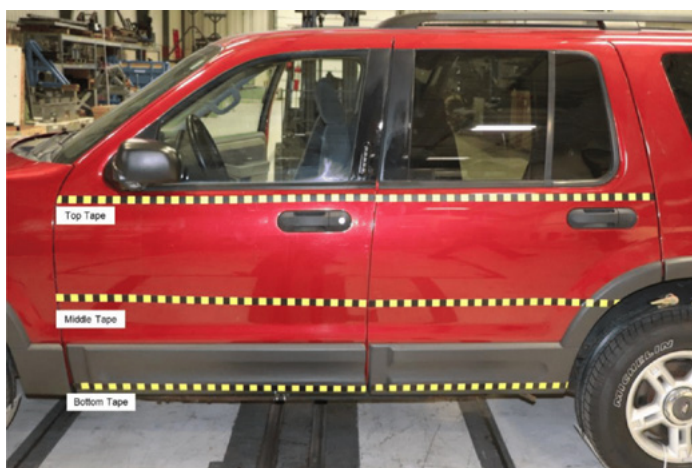
**Figure 5-34** *Location of Inch Tape on the 2003 Ford Explorer (pre-test)*

Surface profile data of the front and rear driver side doors were measured before and after the test. This was accomplished by placing inch tape across both doors at three different heights, as seen in Figure 5-34. Using a Leica Disto laser measurement tool, distance data were collected every 6-inches along the inch tape with reference to a planar surface. Figure 5-35 shows the location at which the laser was directed while maintaining perpendicularity to the plane, both vertically and horizontally. Deformation on the impact side of the Explorer post-test is shown in Figure 5-36.

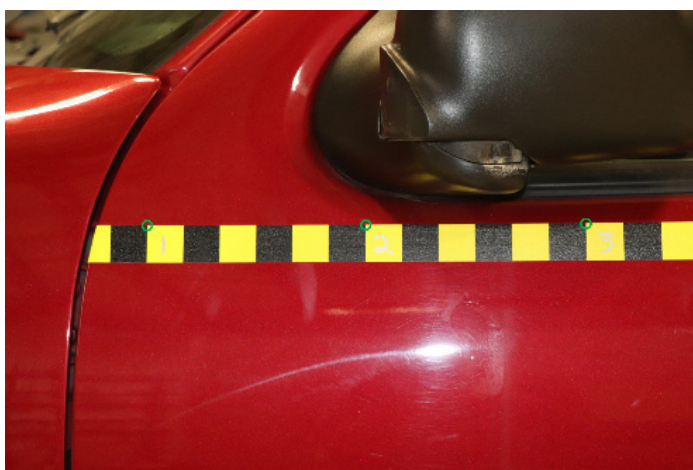
**Figure 5-35** Location of Inch Tape Measurements with the Laser (Test 1)

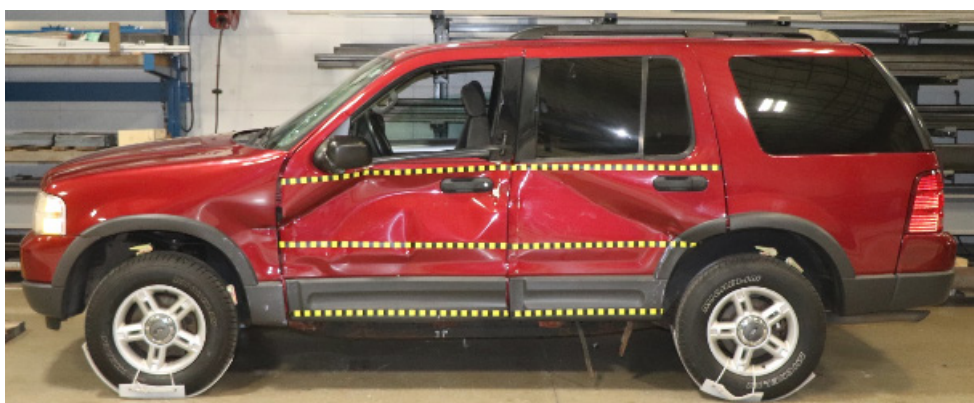
**Figure 5-36** Impact Damage to the Explorer in Test 1 Where Inch Tape Measurements Were Made

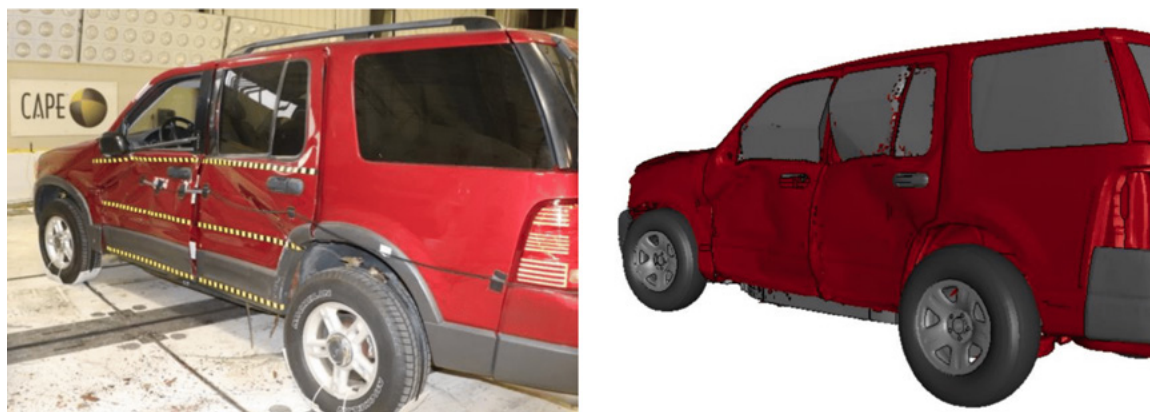
**Figure 5-40** *Explorer Deformations Compared with Simulated Response*

Laser measurements along each inch tape pre- and post-test are shown in Figures 5-37 to 5-39. The datum for the longitudinal position is the first tape measurement location at each height. Lateral positions are measured relative to the first and last measurement locations. Deformation of the tested Explorer compared with the computer simulated response in Figure 5-40 illustrates similar magnitude of intrusion and deformed shape. The largest discrepancy is seen in the bottom tape measurements (Figure 5-39). These are likely due to the molding on the test vehicle that is not included in the FEA model.

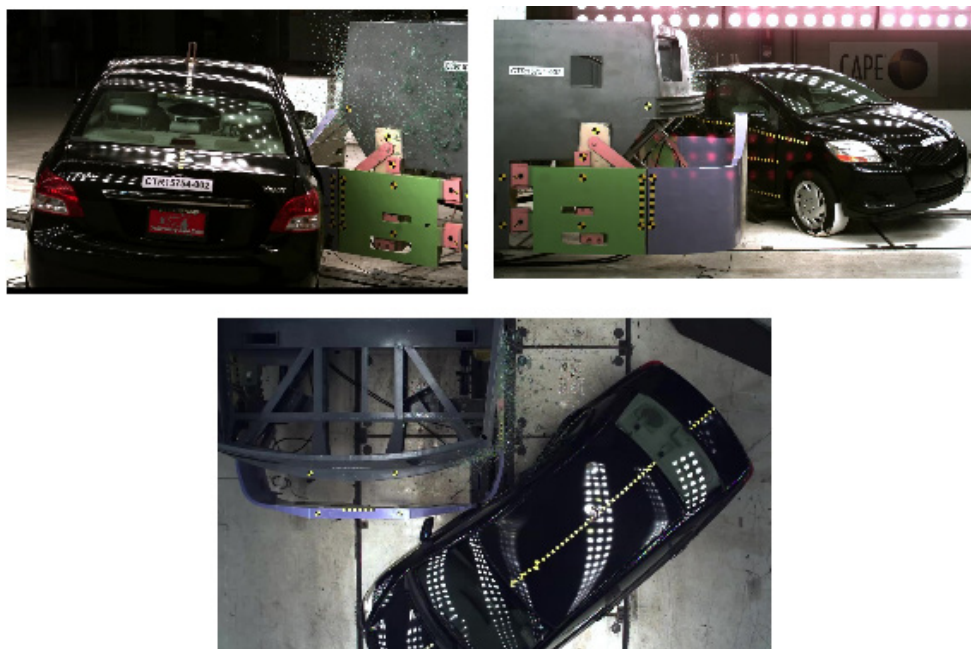
**Figure 5-43** Test 2 High-Speed Video

The response of the front enclosure and Yaris in Test 2 is shown in Figure 5-43. The front enclosure after the crash test is shown in Figure 5-44. There was some small scratching on the paint, but no other visible damage. There was a negligible change in measurements to each marker position before and after each test, indicating no permanent deformation to the structure. The front enclosure was retracted and deployed with no loss in function. Forces and accelerations measured during the test are provided in Appendix C.

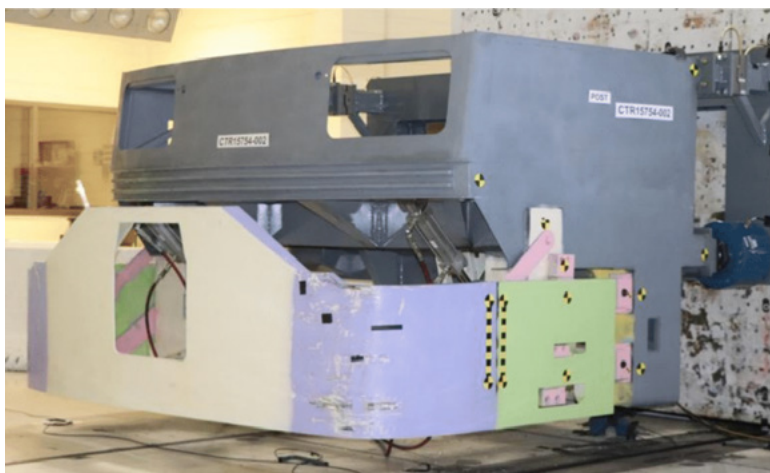
**Figure 5-44** Front Enclosure Post-Test 2

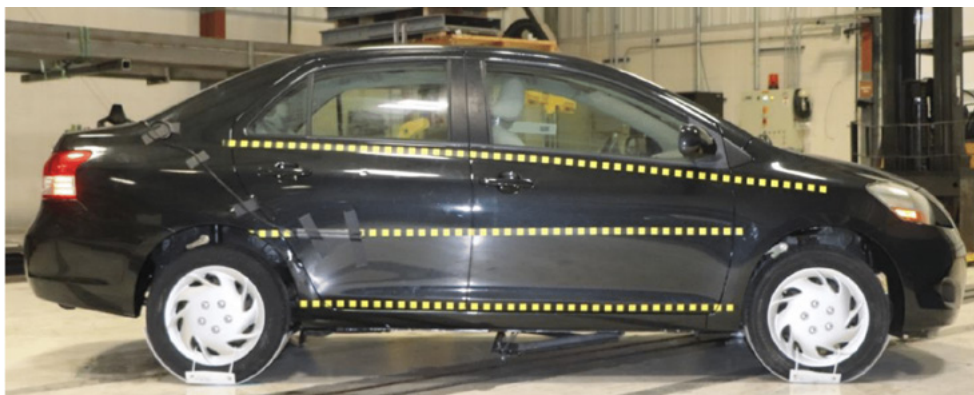
**Figure 5-45** Location of Inch Tape on the 2010 Toyota Yaris (pre-test)

Surface profile data of the front and rear driver side doors were measured before and after the test. This was accomplished by placing inch tape across both doors at three different heights, as seen in Figure 5-45. Using a Leica Disto laser measurement tool, distance data were collected every 6 inches along the inch tape with reference to a planar surface. Deformation on the impact side of the Yaris post-test is shown in Figure 5-46.

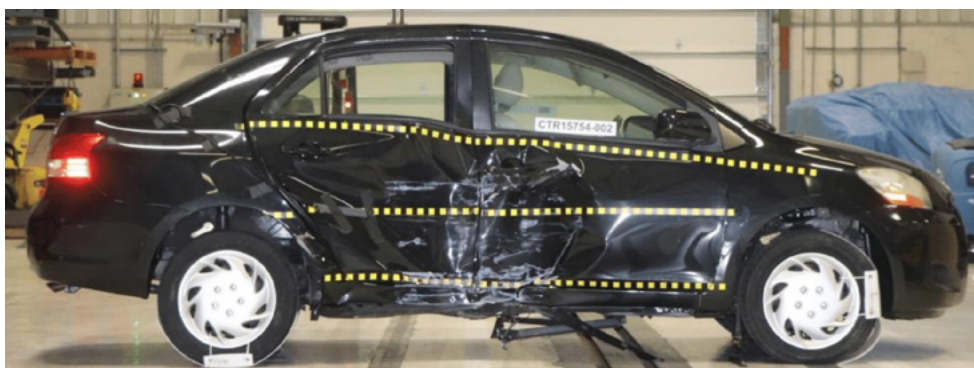
**Figure 5-46** Impact Damage to the Yaris in Test 2 Where Inch Tape Measurements Were Made

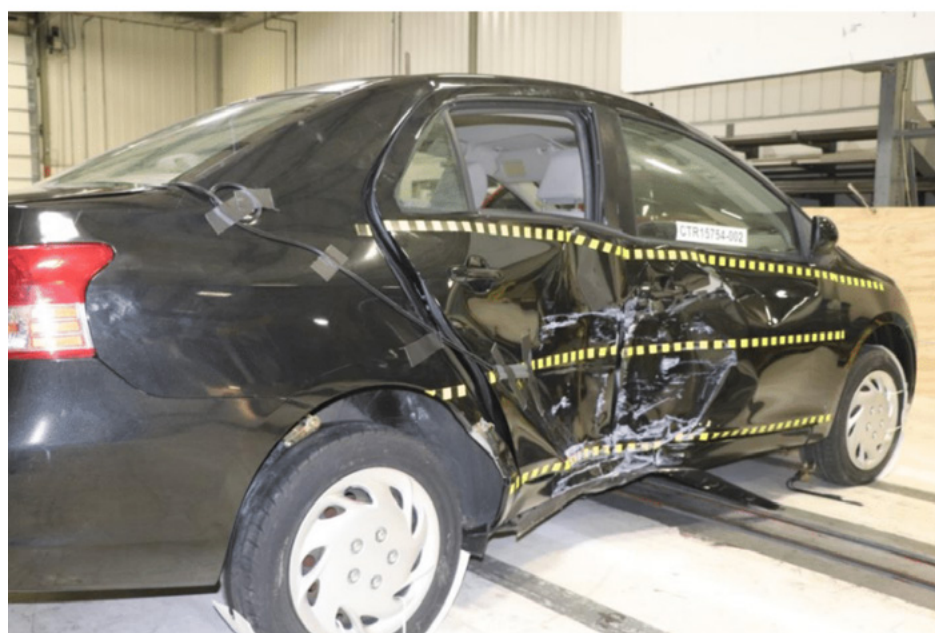
**Figure 5-50** *Yaris Deformations Compared with Simulated Response*

Laser measurements along each inch tape pre- and post-test are shown in Figures 5-47 to 5-49. The simulated response is also shown and in good agreement. The datum for the longitudinal position is the first tape measurement location at each height. Lateral positions are measured relative to the first and last measurement locations. Deformation of the tested Yaris compared with the computer simulated response in Figure 5-50 illustrates similar magnitude of intrusion and deformed shape.

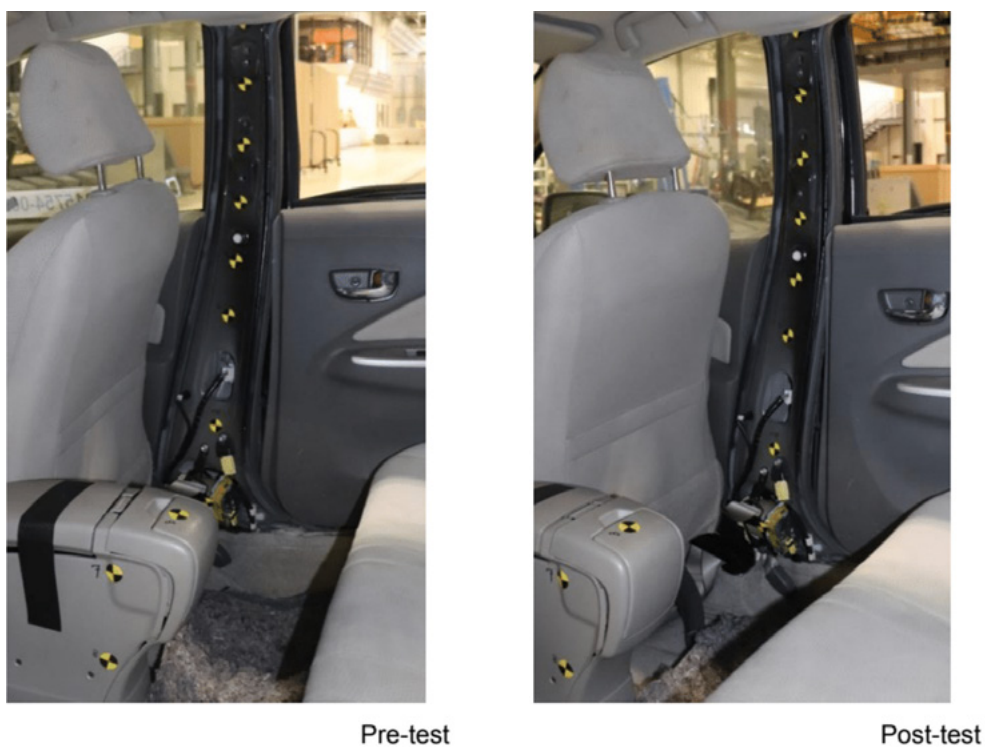
**Figure 5-51** B-Pillar Deformation in the Yaris

B-pillar deformation during the test was measured at set heights, as shown by the markers in Figure 5-51. The distance between markers on the passenger and driver side was measured with a Leica Disto laser to measure the pillar shape. Note that the bottom two locations were measured to the center console. The passenger side pillar after the test is also shown in Figure 5-51. The laser was directed at the center of the target on the driver side with the base of the laser located on the passenger side target center with measurements taken before and after the test. The distance from the center of the automobile was then calculated, as are shown in Figure 5-52. Peak deformation was 193 mm at the bottom measurement location.

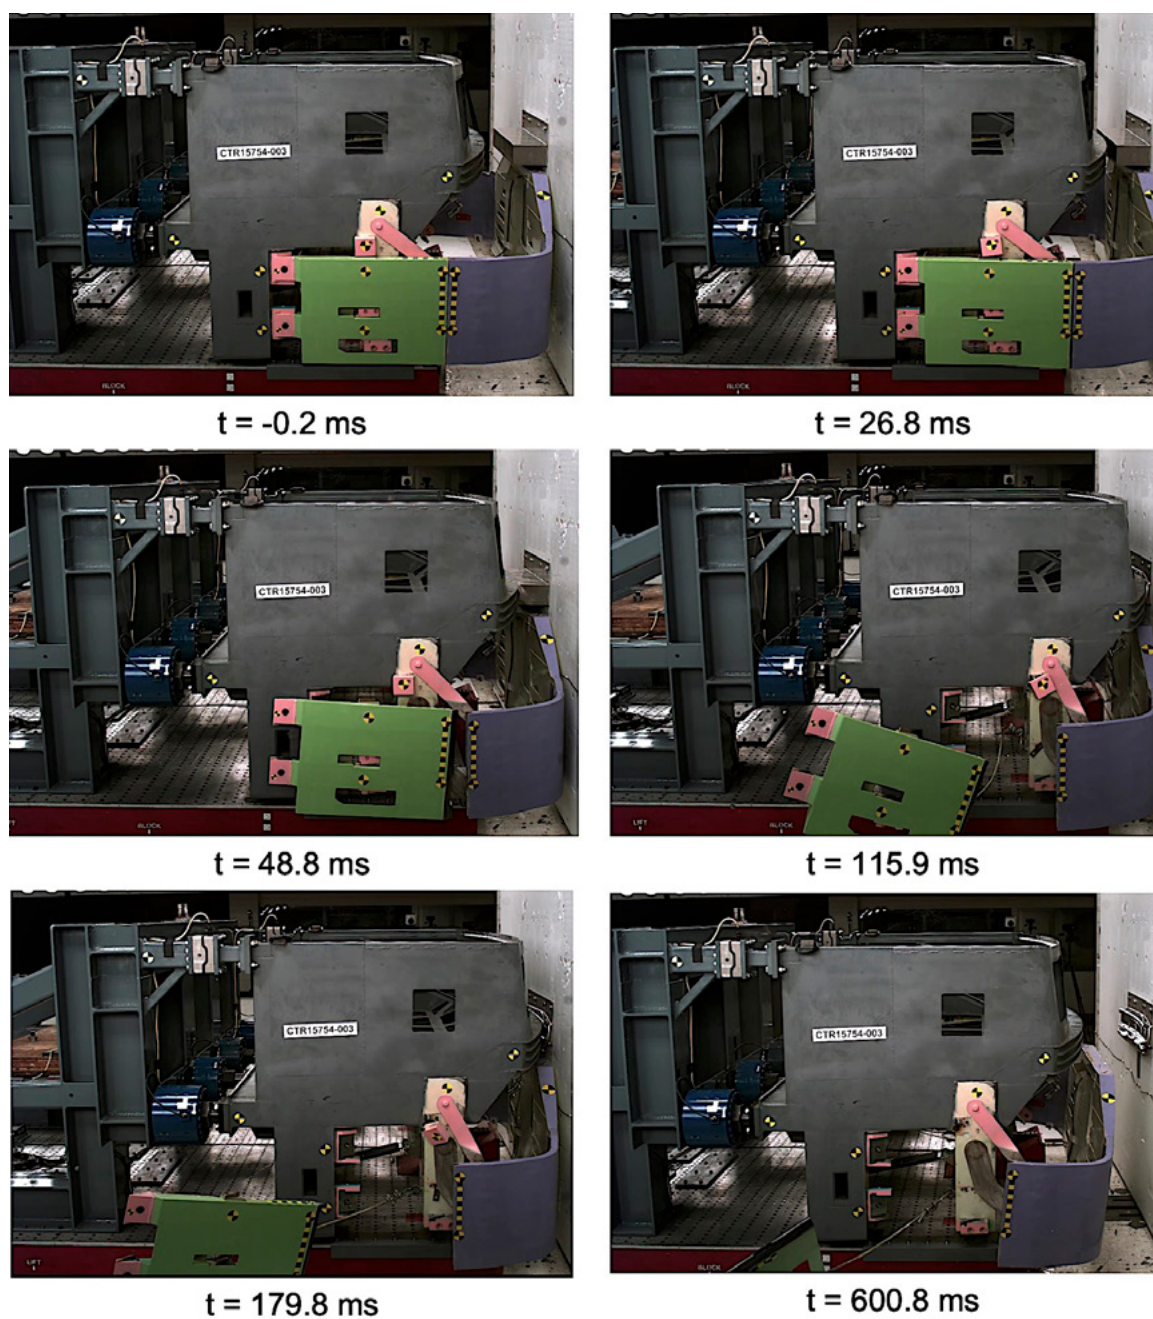
**Figure 5-53** High-Speed Video (right) of Test 3

The response of the front enclosure when impacting the barrier wall is shown in Figures 5-53 to 5-56. The side panels sheared back as designed and the front enclosure pushed back beneath the anti-climber. The panels released nearly simultaneously at approximately 25 ms (left) and 27 ms (right) from the time of wall impact. This release time is most easily seen in the side views of Figures 5-53 and 5-54. The panels were directed rearward and outward by the shear blocks, such that they cleared the carbody without contact, as seen in Figure 5-56. This allowed the front enclosure to push backward beneath the anti-climber without obstruction.

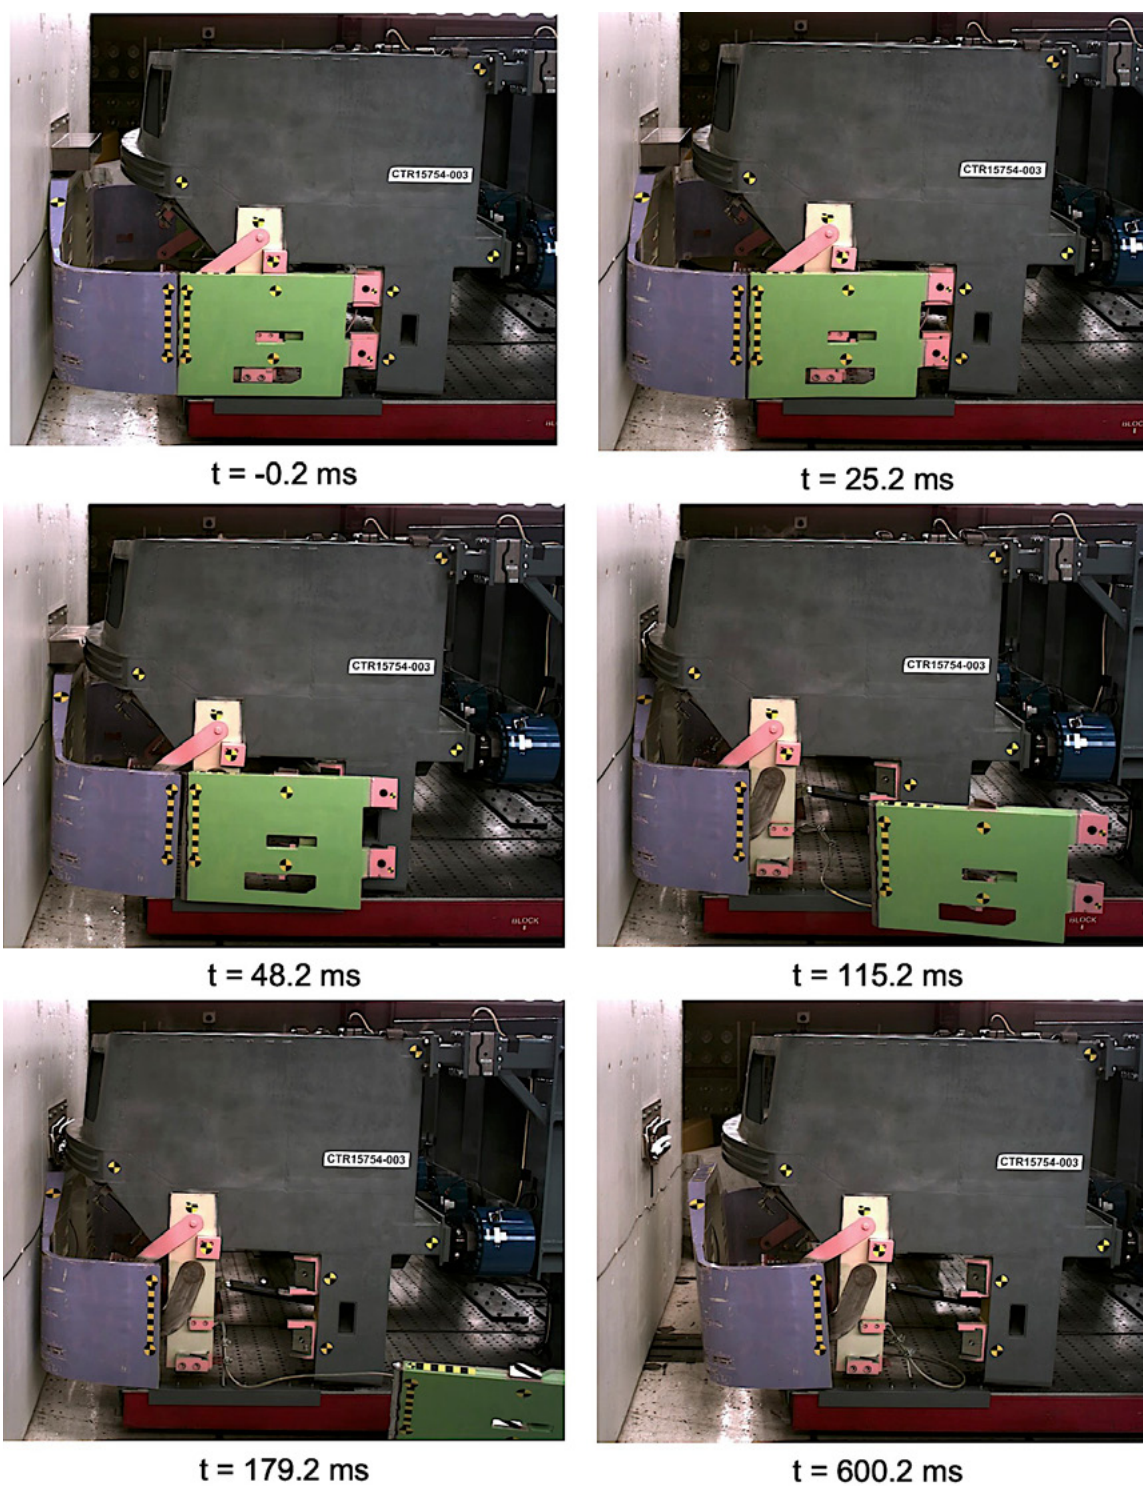
**Figure 5-54** High-Speed Video (left) of Test 3

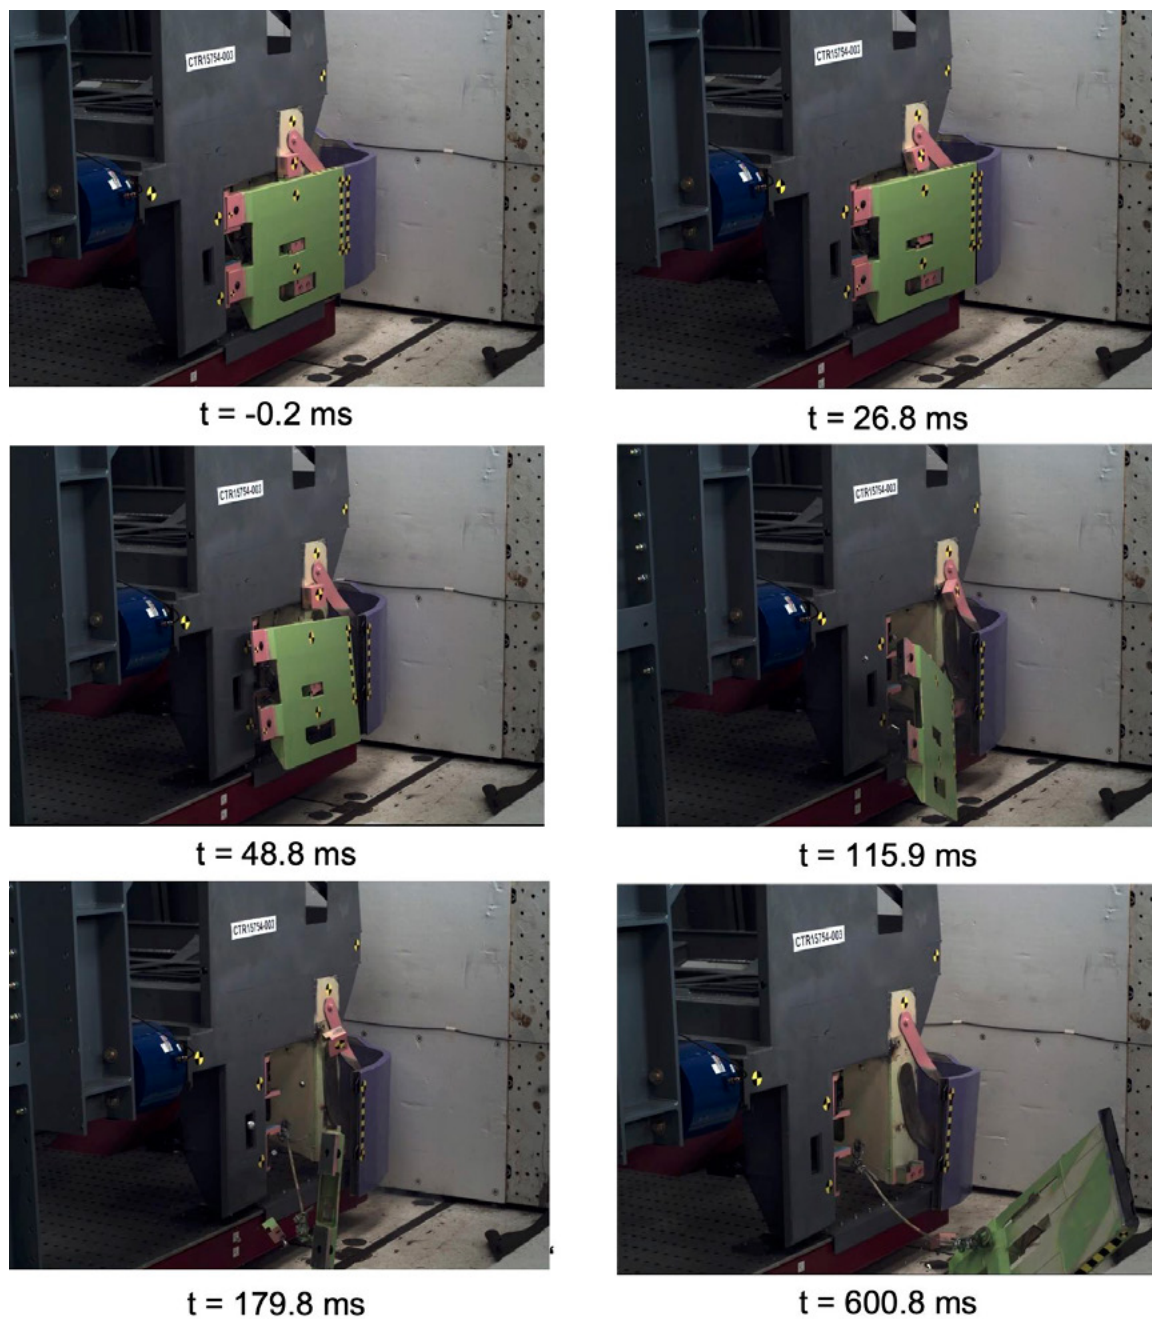
**Figure 5-55** High-Speed Video (right-oblique) of Test 3

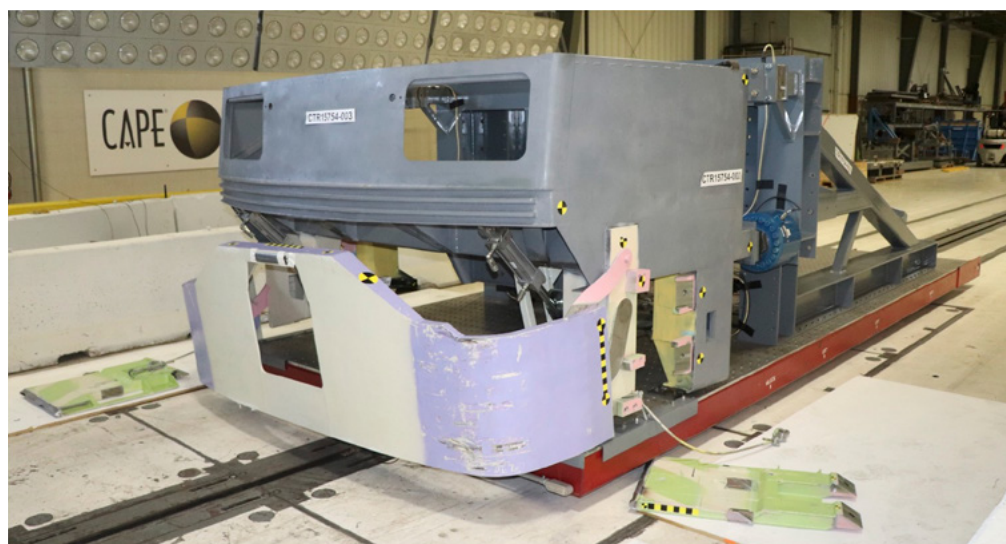
**Figure 5-57** Final Resting Position of Test Sled in Test 3

The test sled in its final resting position is shown in Figure 5-57. The front enclosure remained attached to the upper linkage arms, which bent backward but did not separate. There was no damage to the carbody of the SD660 end frame or the linkage mounts due to the crash loads and they are completely reusable. The gas springs and hydraulic cylinders remained attached to their anchored locations and the swivel arm. Return to service would require replacing the linkage arms, new or refurbished side panels, and a new or refurbished front-end enclosure.

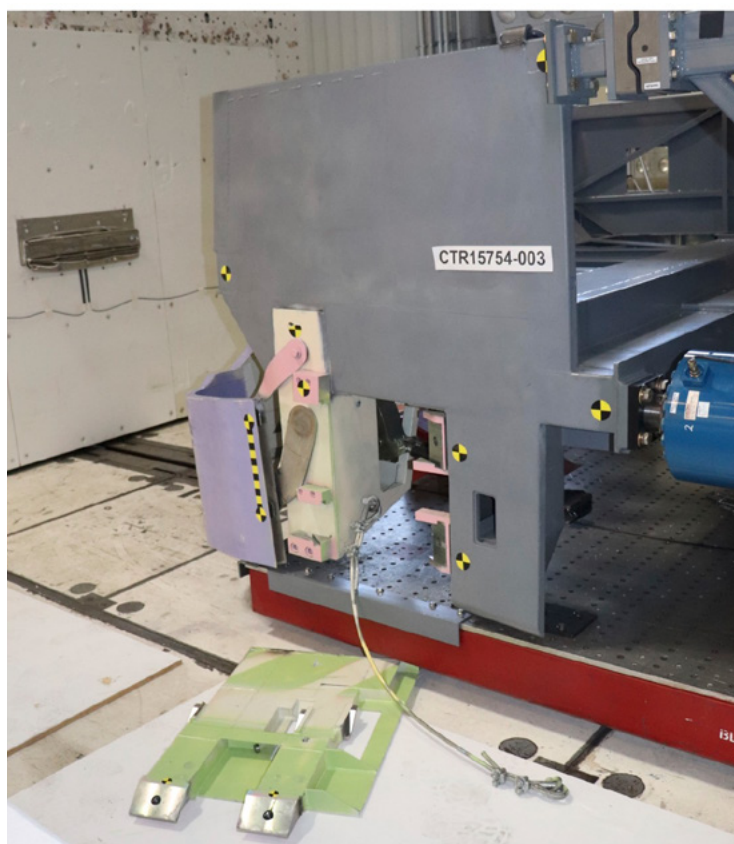
**Figure 5-59** Final Position of Side Panel (left)

The tethers attached to the side panels restrained the panels to land within 2 feet of the test sled. Their final resting positions are shown in Figures 5-58 and 5-59. There were only two anomalies in the designed behavior. First, the tether eye bolt failed on the left side and should be sized to a larger diameter for production. Second, two of the sliding blocks, that attach the side panel to the linkage mount, separated on the right side. However, this happened late in the push-back process such that both sides broke away nearly identically. These should be changed to a larger diameter for production to minimize the risk of uncontained impact debris.

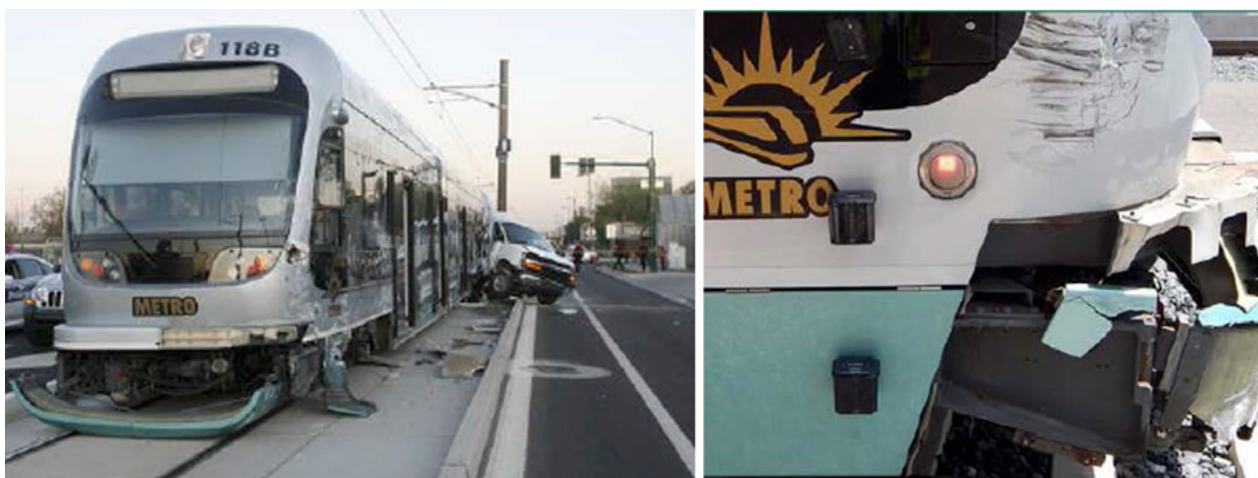
**Figure 6-2** Example of Damage to the Front Enclosure of the KI LRV After Impact with an Automobile [8]

The KI Low Floor LRV with a front enclosure operated by Valley Metro is shown in Figure 6-1. This design displayed significant damage during automobile collisions during this period where thirty-five bumpers were replaced due to automobile collisions. An example of damage after a crash is shown in Figure 6-2. The following items were considered in the cost analysis: (1) repair costs to LRVs, (2) loss of LRV use, and (3) value of statistical life (VSL). Legal and insurance costs were not considered since they were not available.

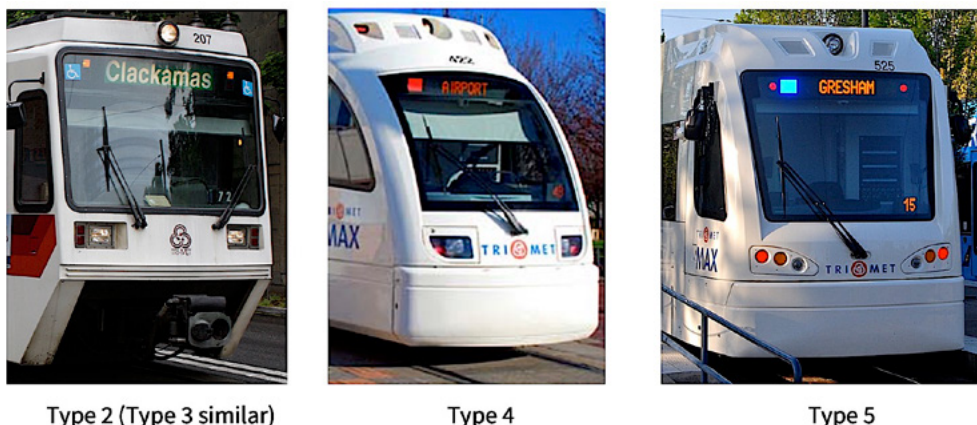
Type 2 (Type 3 similar)

Type 4

**Figure 6-3** TriMet MAX LRVs

TriMet collects collision data for its entire MAX LRV fleet on a monthly basis [22]. These data, shown in Figure 6-3, are not differentiated by line or car type. Types 2 and 3 are the SD660 LRV evaluated in this project. Types 4 and 5 are newer and

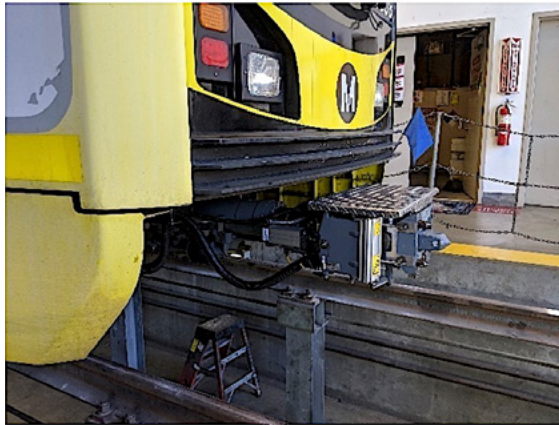
**Figure B-1** Metro P3010 Front End

The front end of Metro's Kinkisharyo P3010 is shown in Figure B-1. The open-ended design with the coupler protruding well ahead of the high anti-climber makes the P3010 well-suited for retrofit. With cooperation from Metro, a preliminary design for the enclosure was developed. The design of the end enclosure is shown in the deployed and retracted positions in Figure B-2. Note that a final facia design would blend with the carbody to improve aesthetics. The structure with the facia removed is shown in Figure B-3.

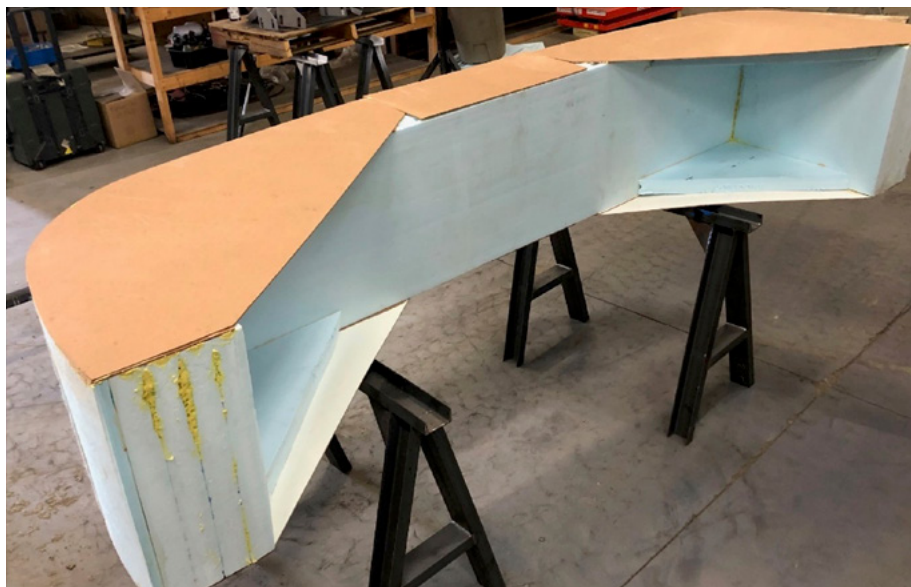
**Figure B-14** *Frangible Prototype Test Article*

A frangible end enclosure was developed and built for envelope testing of the Kinkisharyo P3010 on the Blue Line. The frangible prototype is made of foam board, PVC pipe, clamps, plywood, and carbon fiber (CF) tubing shown in Figure B-12 and has the same external geometry as the preliminary enclosure design. The foam is covered in grease paint, and the total weight is estimated to be 130 lbs. To transition from the foam board to the PVC, a plywood bumper receptacle is used for the bonded connection, shown in Figure B-13. The constructed frangible prototype test article is shown in Figure B-14.
