# LRV Bumper Safety Technology Deployment

Applied Research Associates, Inc.

FTA Report No. 0247

The objective of this project is to design, build, and test a prototype LRV end enclosure, or bumper, as a retrofit to an existing LRV operated in the U.S. to reduce potential for injury to automobile occupants, damage to the LRV, and lower costs to operators from crashes. Three transit agencies provided significant contributions to the project and a complete prototype design was developed and tested for the Siemens SD660 operated by TriMet (Type 2 and Type 3 LRVs).

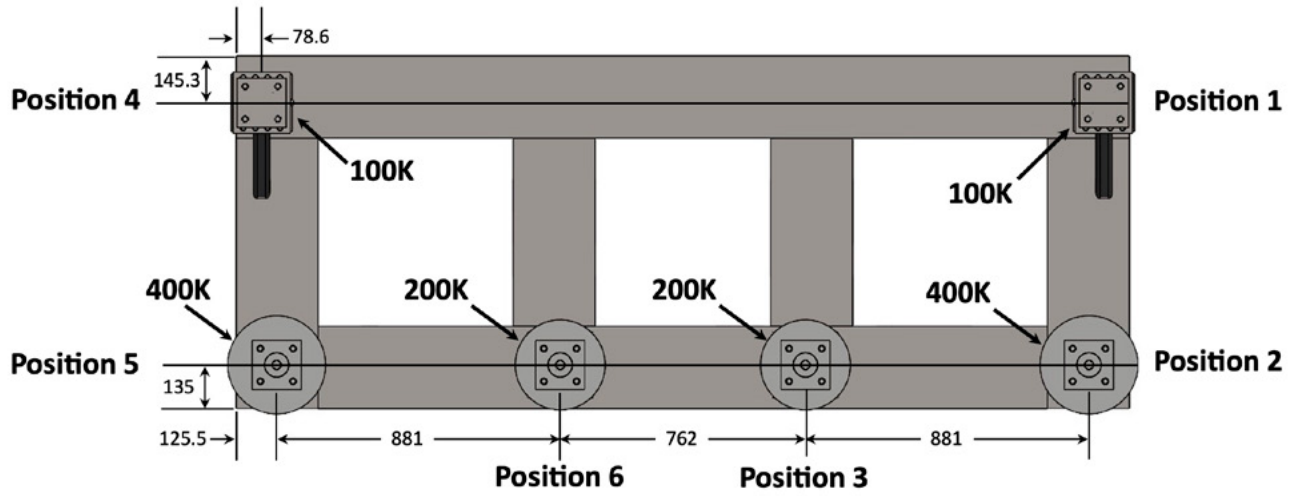
**Figure C-1** Load Cell Positions While Facing Crash Test Wall
