Rehabilitation of Prestressed Concrete Bridge Components by Non-Electrical (Conventional) Methods

PUBLICATION NO. FHWA-RD-98-189

FEBRUARY 1999

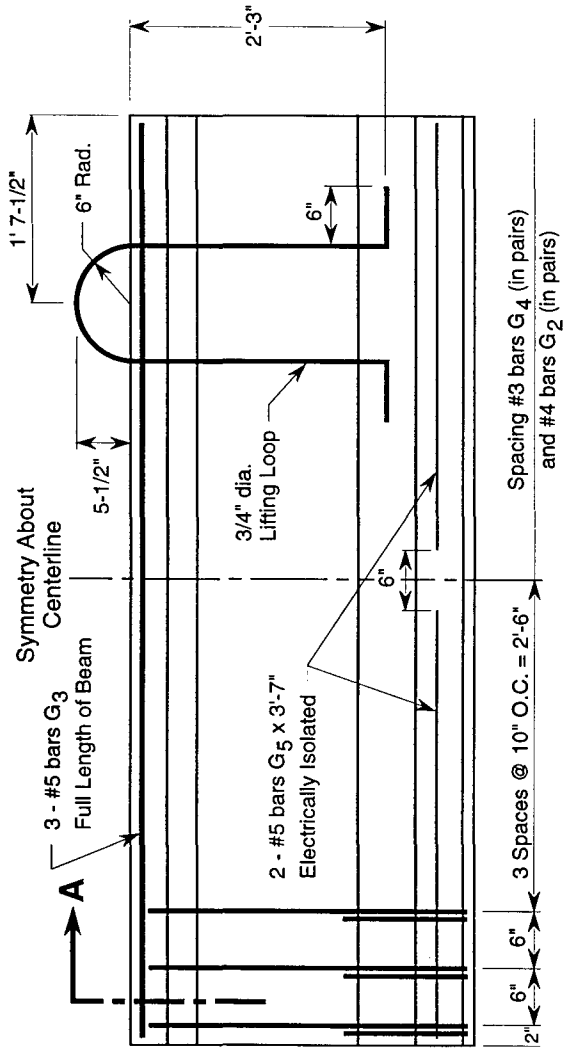
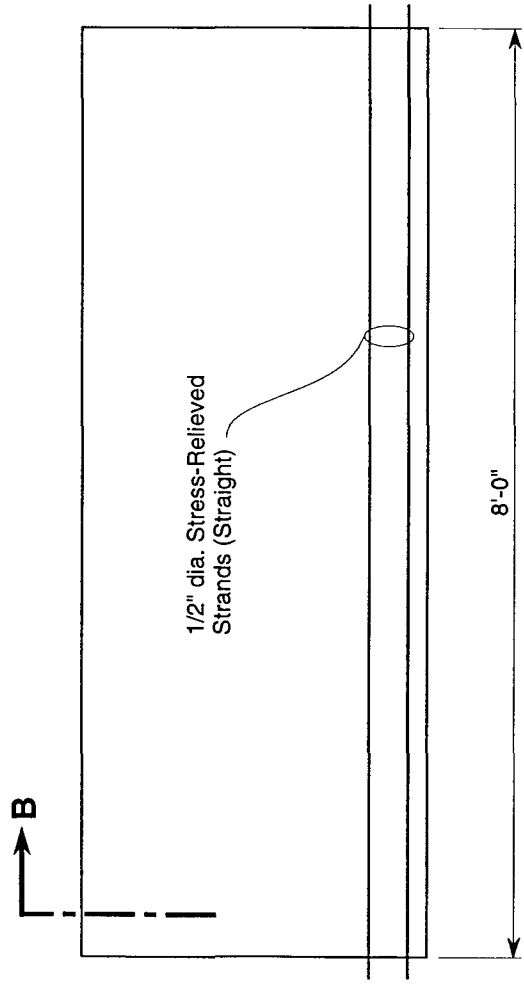
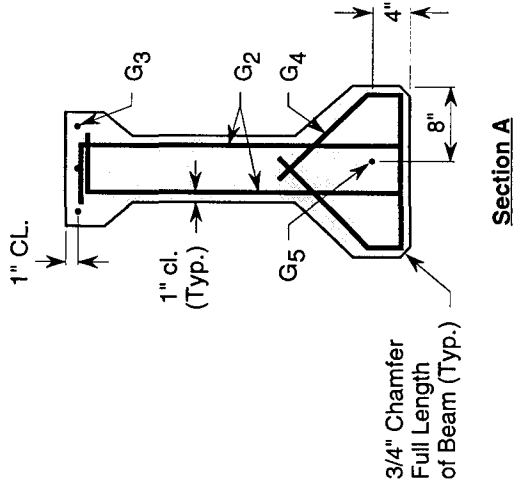
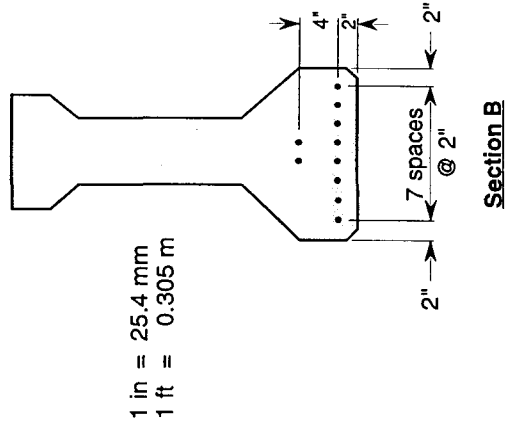
Elevation of Beam
(Showing Steel Reinforcement)

Elevation of Beam
(Showing Prestress Steel)

Section A

Section B

Figure 1. Design details for pretensioned concrete beam specimens.

Pre-tensioned concrete beam specimens consisted of 2.4-m- (8-ft-) long AASHTO Type II sections as shown in Figure 1. The girders contained ten 12-mm (0.5-in), grade 270 low-relaxation seven-wire prestressing strands. The magnitude of force in each strand prior to prestress transfer was 75% of the guaranteed ultimate tensile strength (GUTS) or approximately 137,800 N (30,980 lbf). All strands were straight (not draped) and were subsequently cut flush with the ends of the beams. The beams also contained stirrup and longitudinal plain reinforcing bars as shown in Figure 1. Two longitudinal bars were deliberately left electrically isolated from the main cage for the purpose of making macrocell measurements (i.e., measurements of electrical current developed between bars in chloride-contaminated and chloride-free concrete). A total of 10 such beam specimens were constructed.

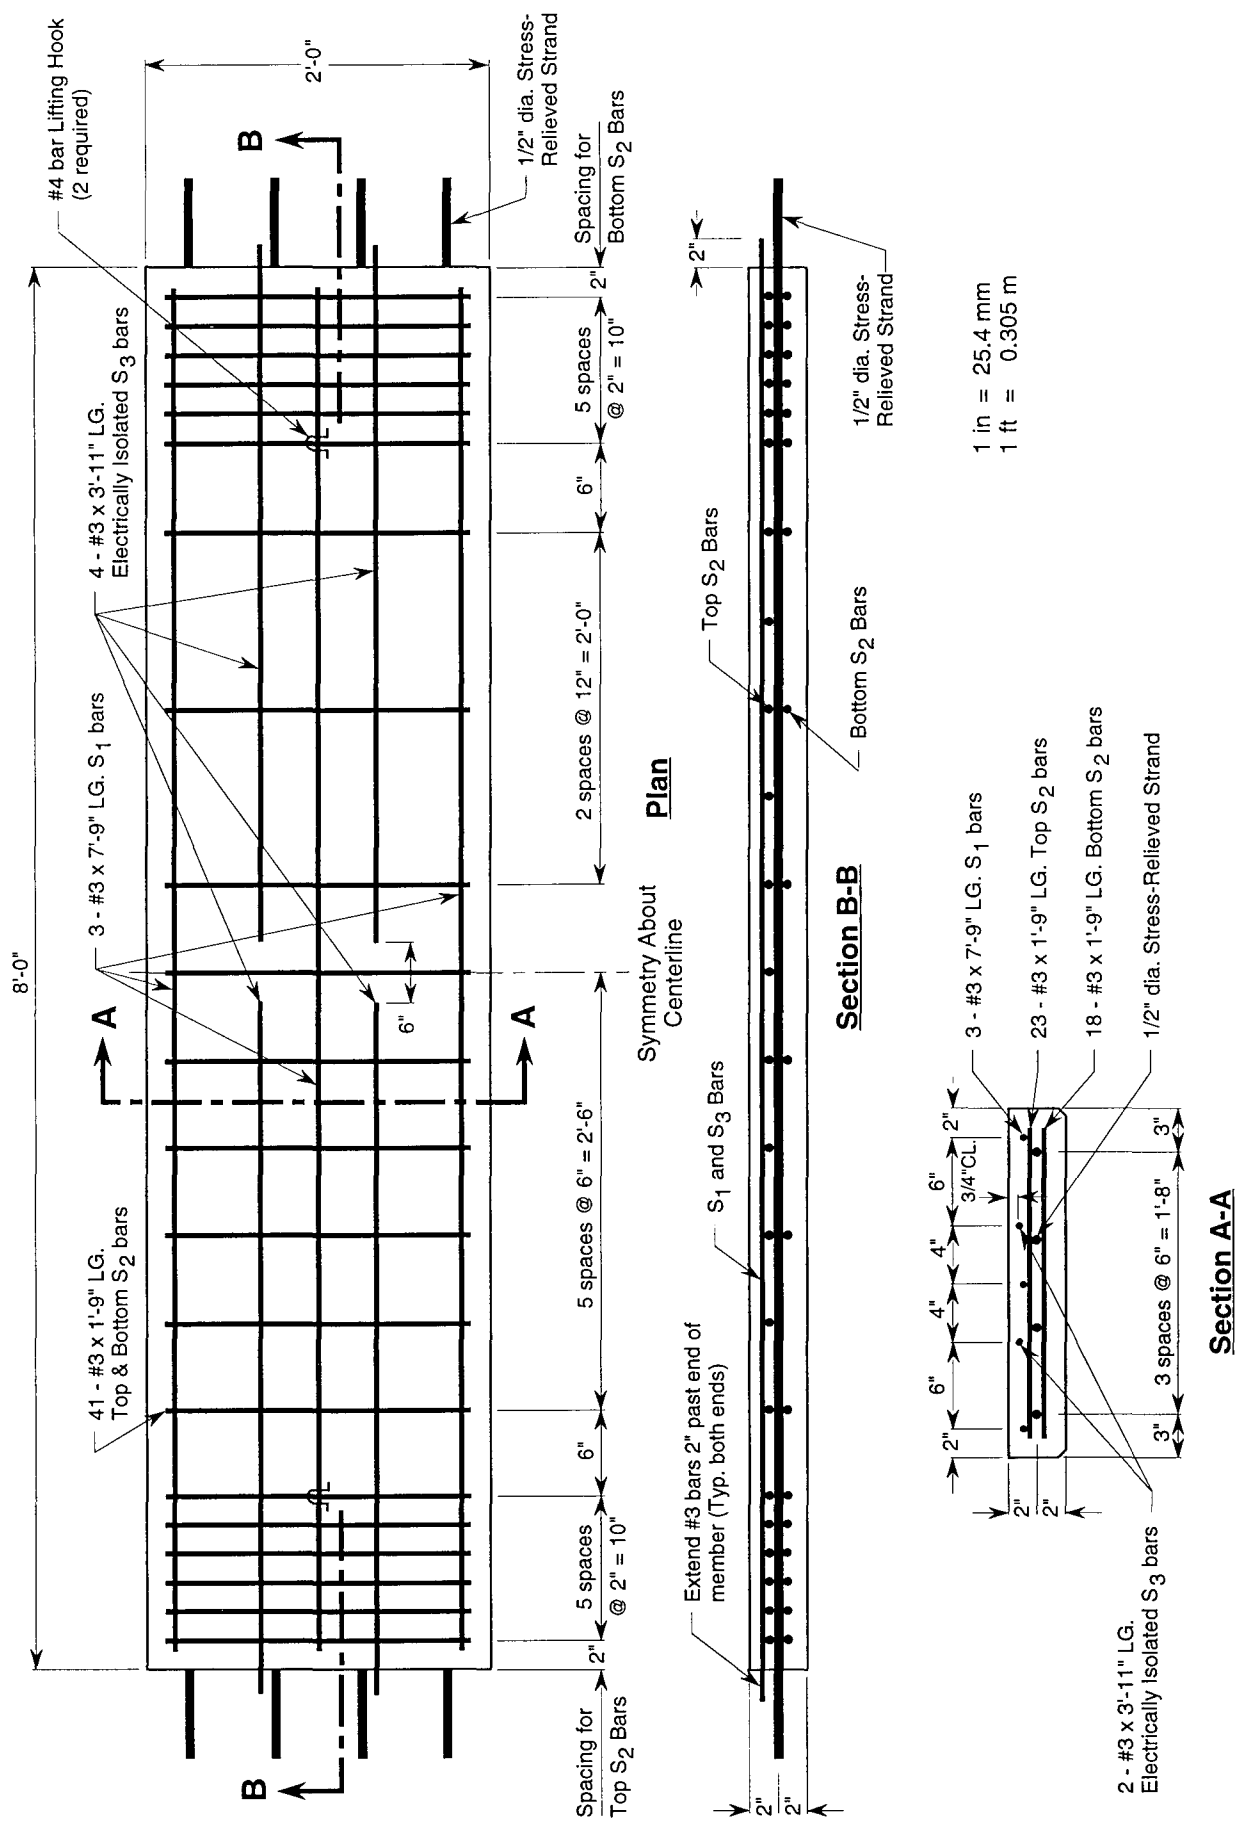
Figure 2. Design details for pretensioned concrete slab specimens.

Pre-tensioned concrete slab specimens consisted of 2.4-m- (8-ft-) long by 0.6-m- (2-ft-) wide by 100-mm- (4-in-) thick elements as shown in Figure 2. The slabs contained four 12-mm (0.5-in), grade 270 low-relaxation seven-wire prestressing strands. The magnitude of force in each strand prior to prestress transfer was 75% of the GUTS or approximately 137,800 N (30,980 lbf). All strands were straight and were subsequently cut flush with the ends of the slabs. The slabs also contained transverse and longitudinal plain reinforcing bars as shown in Figure 2. Four longitudinal bars were deliberately left electrically isolated from the main cage for the purpose of making macrocell measurements. A total of five such slab specimens were constructed.

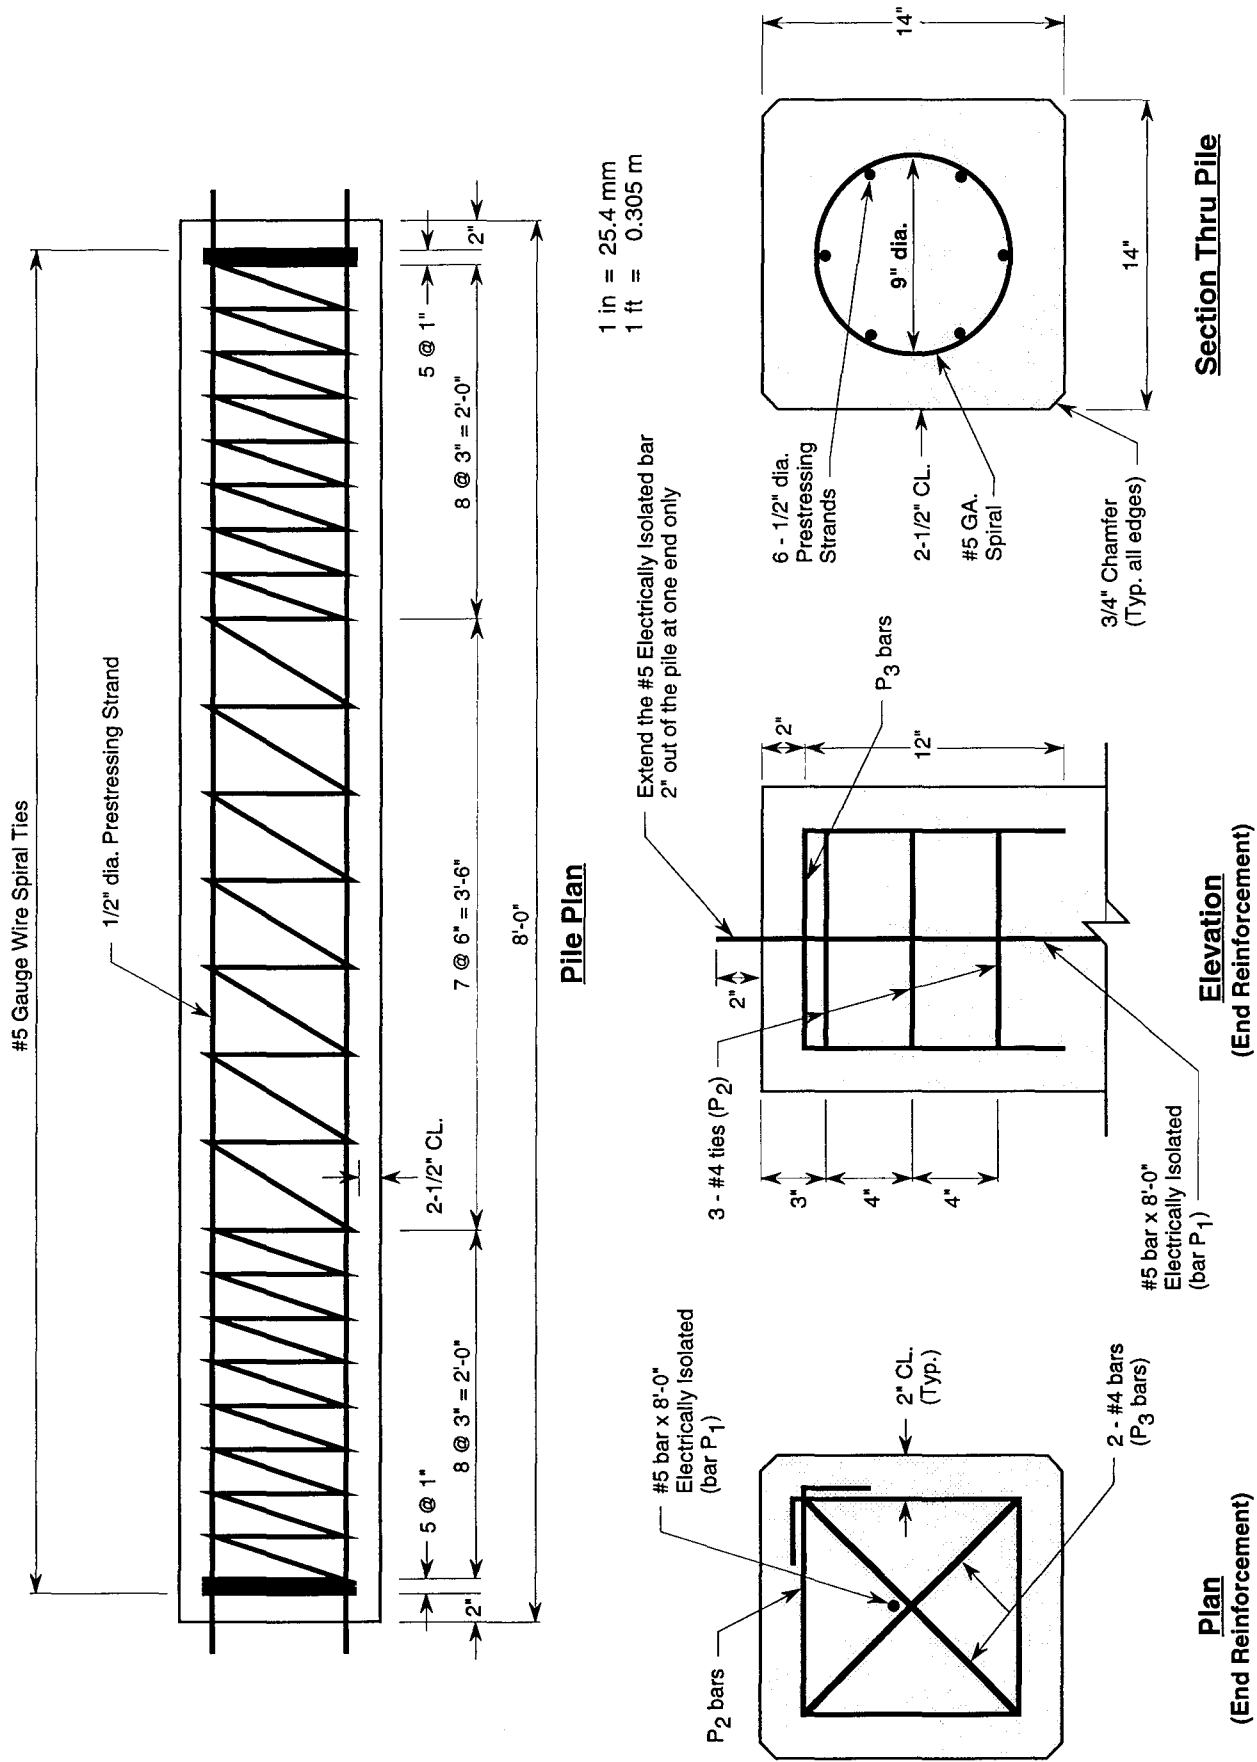
Figure 3. Design details for pretensioned concrete piles.

Pre-tensioned concrete pile specimens were 2.4 m (8 ft) long and 355 by 355 mm (14 by 14 in) in cross section as shown in Figure 3. The piles contained six 12-mm (0.5-in), grade 270 low-relaxation seven-wire prestressing strands. The magnitude of force in each strand prior to prestress transfer was 75% of the GUTS or approximately 137,800 N (30,980 lbf). All strands were straight and were subsequently cut flush with the bottom end and protruded approximately 200 mm (8 in) from the top of the piles. The piles also contained spiral reinforcement along the length of the pile and additional plain steel reinforcement at both ends as shown in Figure 3. A single electrically isolated plain steel bar was placed along the central axis of the piles; however, this was not used, as no macrocell measurements were conducted on the piles. A total of five such piles were constructed.

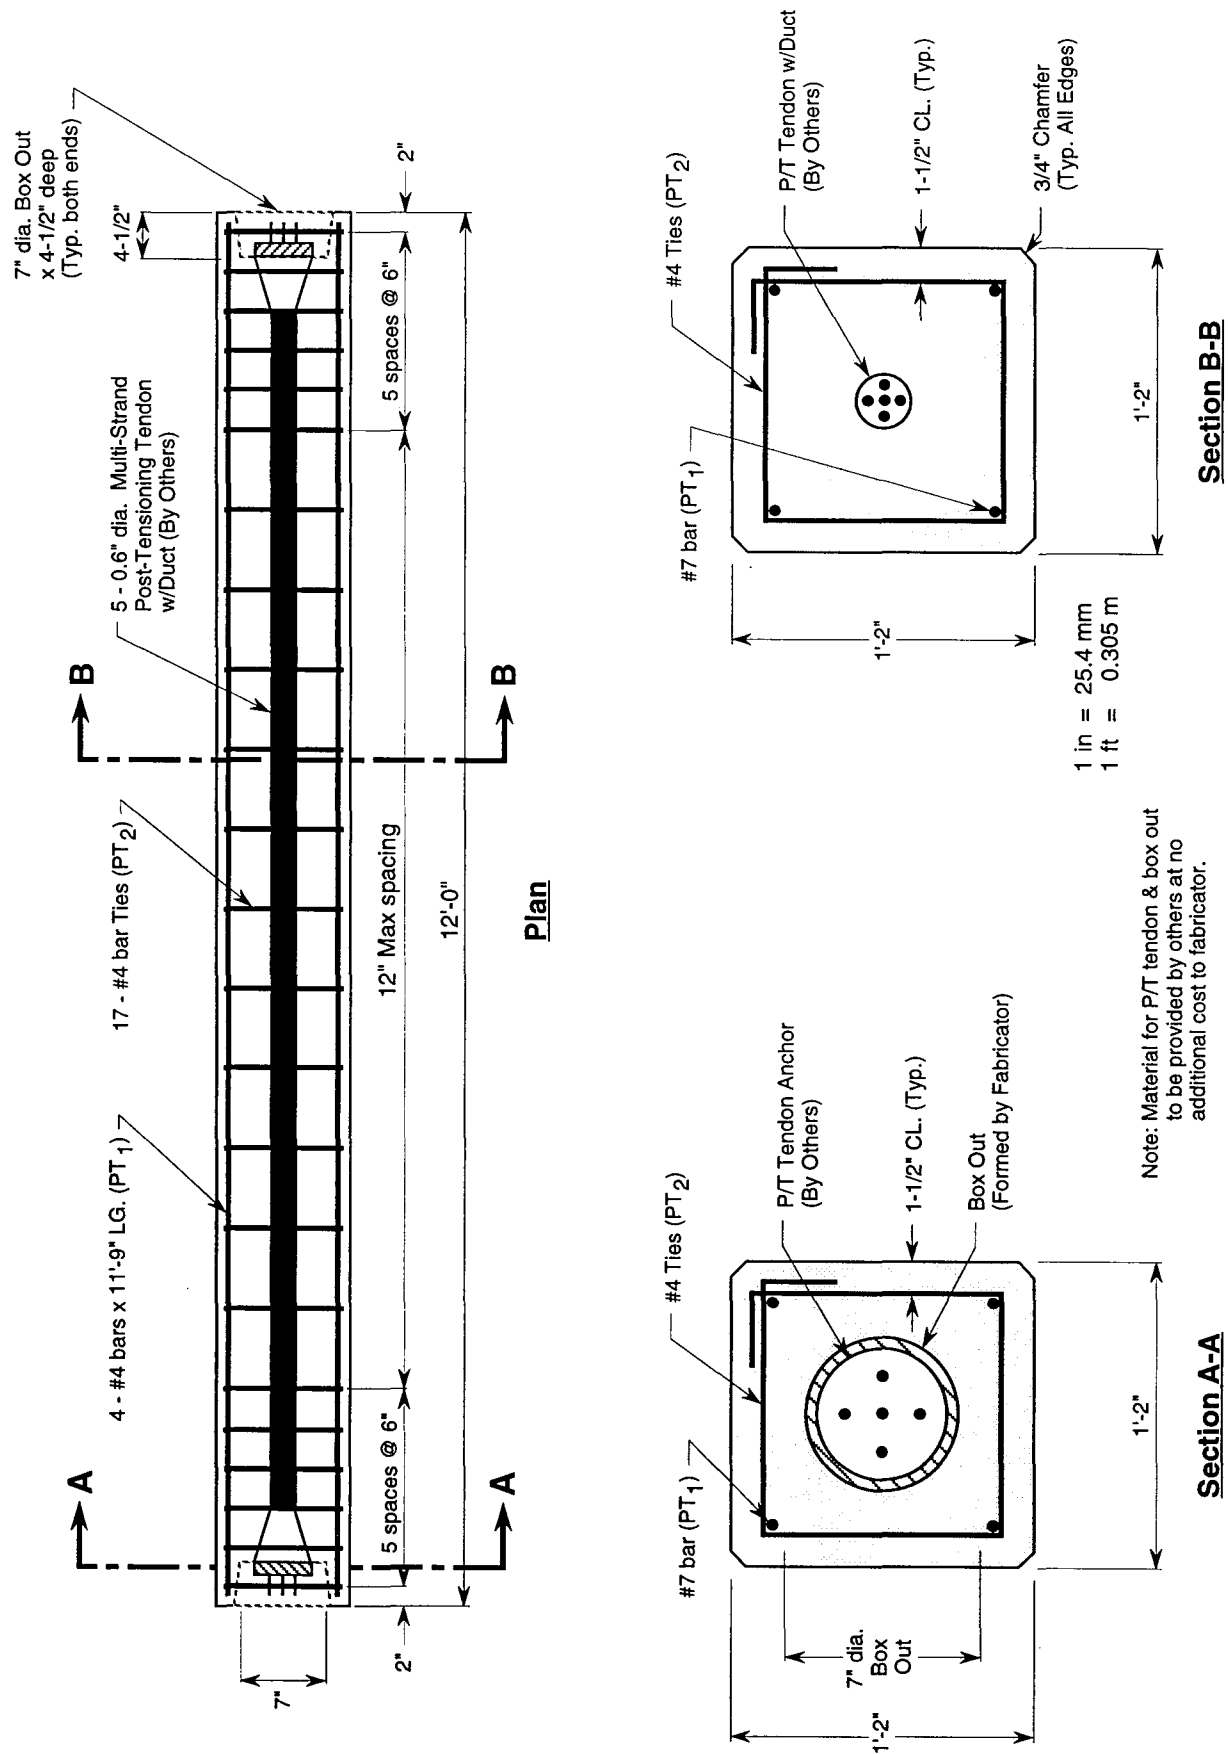
Figure 4. Design details for multi-strand post-tensioned concrete beam specimens.

Post-tensioned concrete beam elements were 3.6 m (12 ft) long and 355 by 355 mm (14 by 14 in) in cross section as shown in Figure 4. The beams contained five 15-mm (0.6-in), grade 270 low-relaxation wire strands. After fabrication of the concrete beams, they were transported to the test laboratories where the strands were tensioned to a total of 1,040,840 N (234,000 lbf). All five strands were anchored with three-piece wedges inside an anchor plate at each end. Ducts consisted of corrugated metal tubes 50 mm (2 in) in diameter. A cement paste grout having a w/c of 0.42 and containing a proprietary grout intrusion aid was used to fill the duct and end pocket. The multi-strand specimens also contained tie reinforcement along the length of the beam and plain longitudinal steel reinforcement as shown in Figure 4. A total of two such beams were constructed.

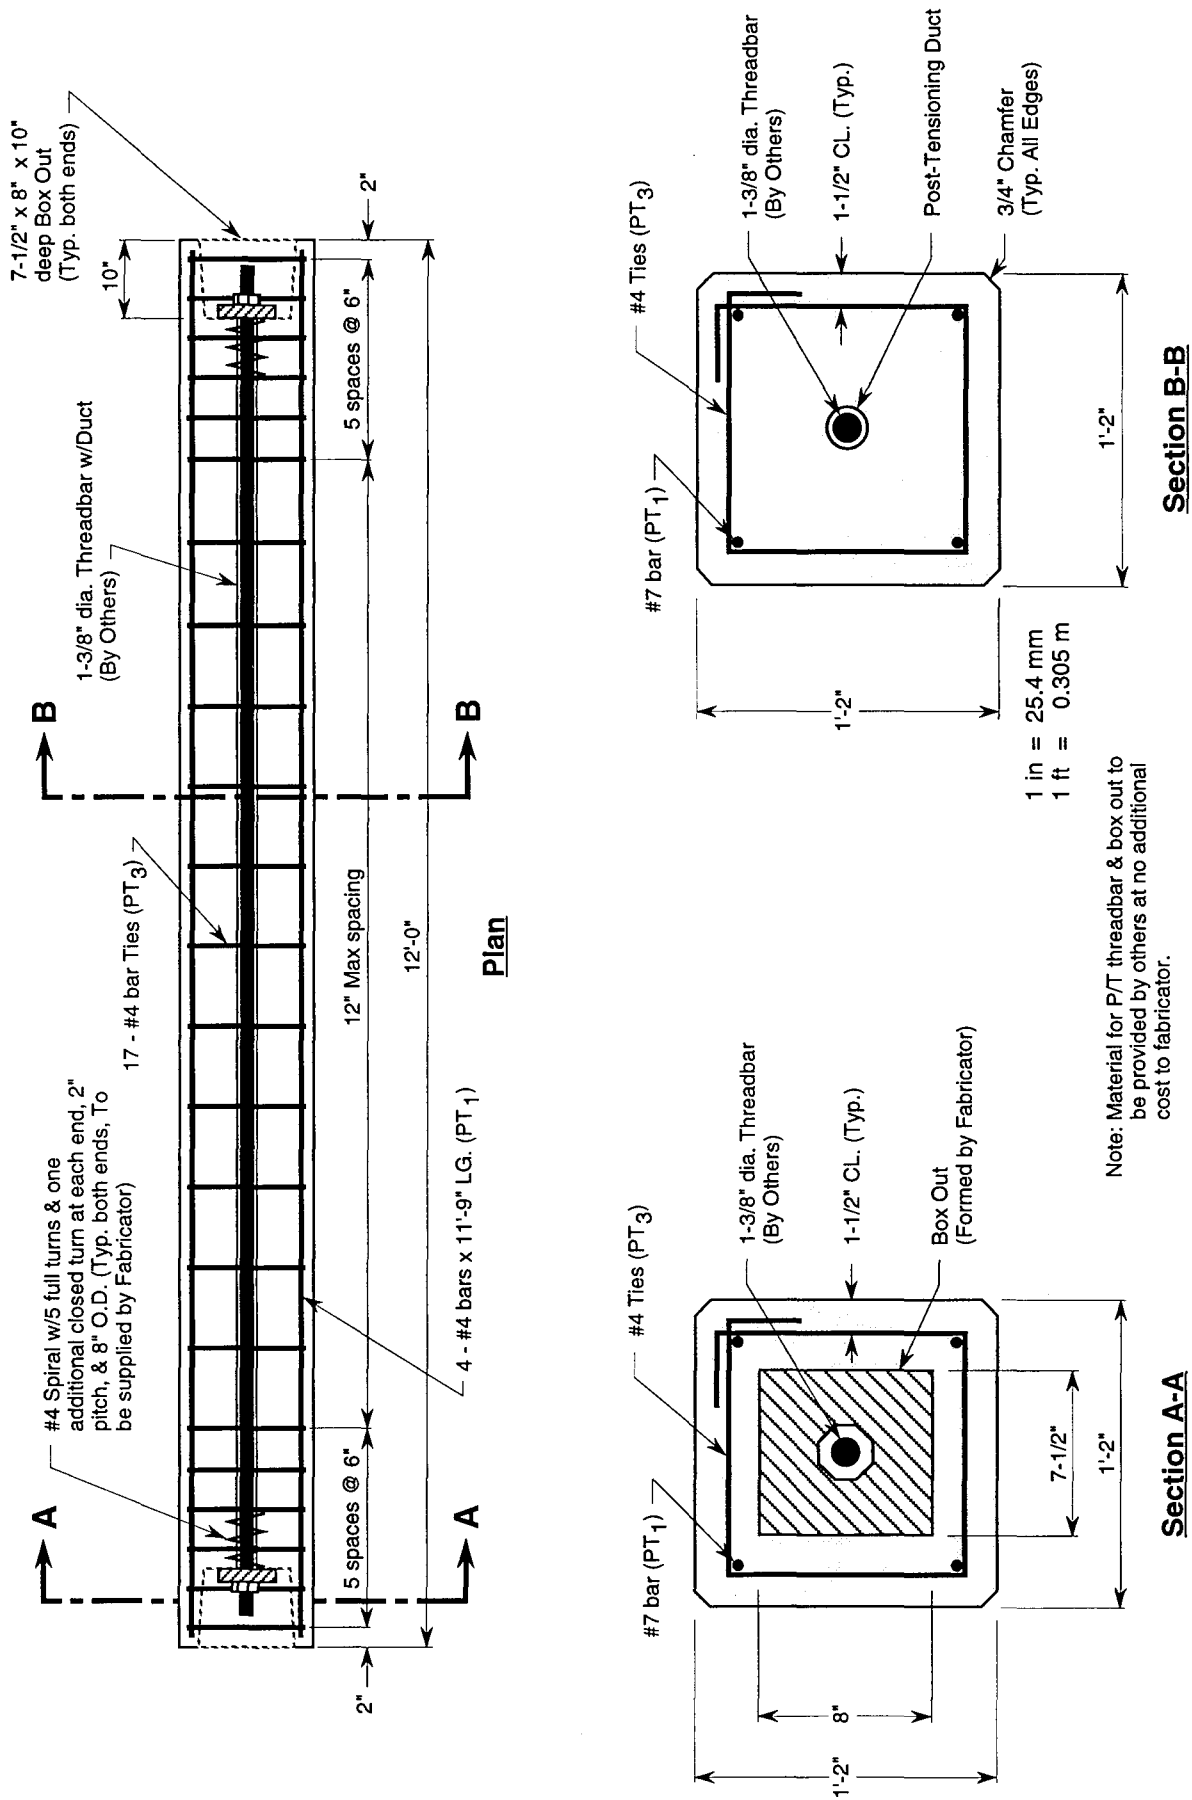
Figure 5. Design details for threadbar post-tensioned concrete beam specimens.

Post-tensioned concrete beam elements were 3.6 m (12 ft) long and 355 by 355 mm (14 by 14 in) in cross section as shown in Figure 5. The beams contained a single 35-mm (1.375-in), grade 150 bar that was threaded at both ends, allowing for anchorage to end plates. After fabrication of the concrete beams, they were transported to the test laboratories where the strands were tensioned to a total of 667,200 N (150,000 lbf). Ducts consisted of corrugated metal tubes 50 mm (2 in) in diameter. A cement paste grout having a w/c of 0.42 and containing a proprietary grout intrusion aid was used to fill the duct and end pocket.

The threadbar specimens also contained tie reinforcement along the length of the beam and plain longitudinal steel reinforcement as shown in Figure 5. A total of two such beams were constructed.

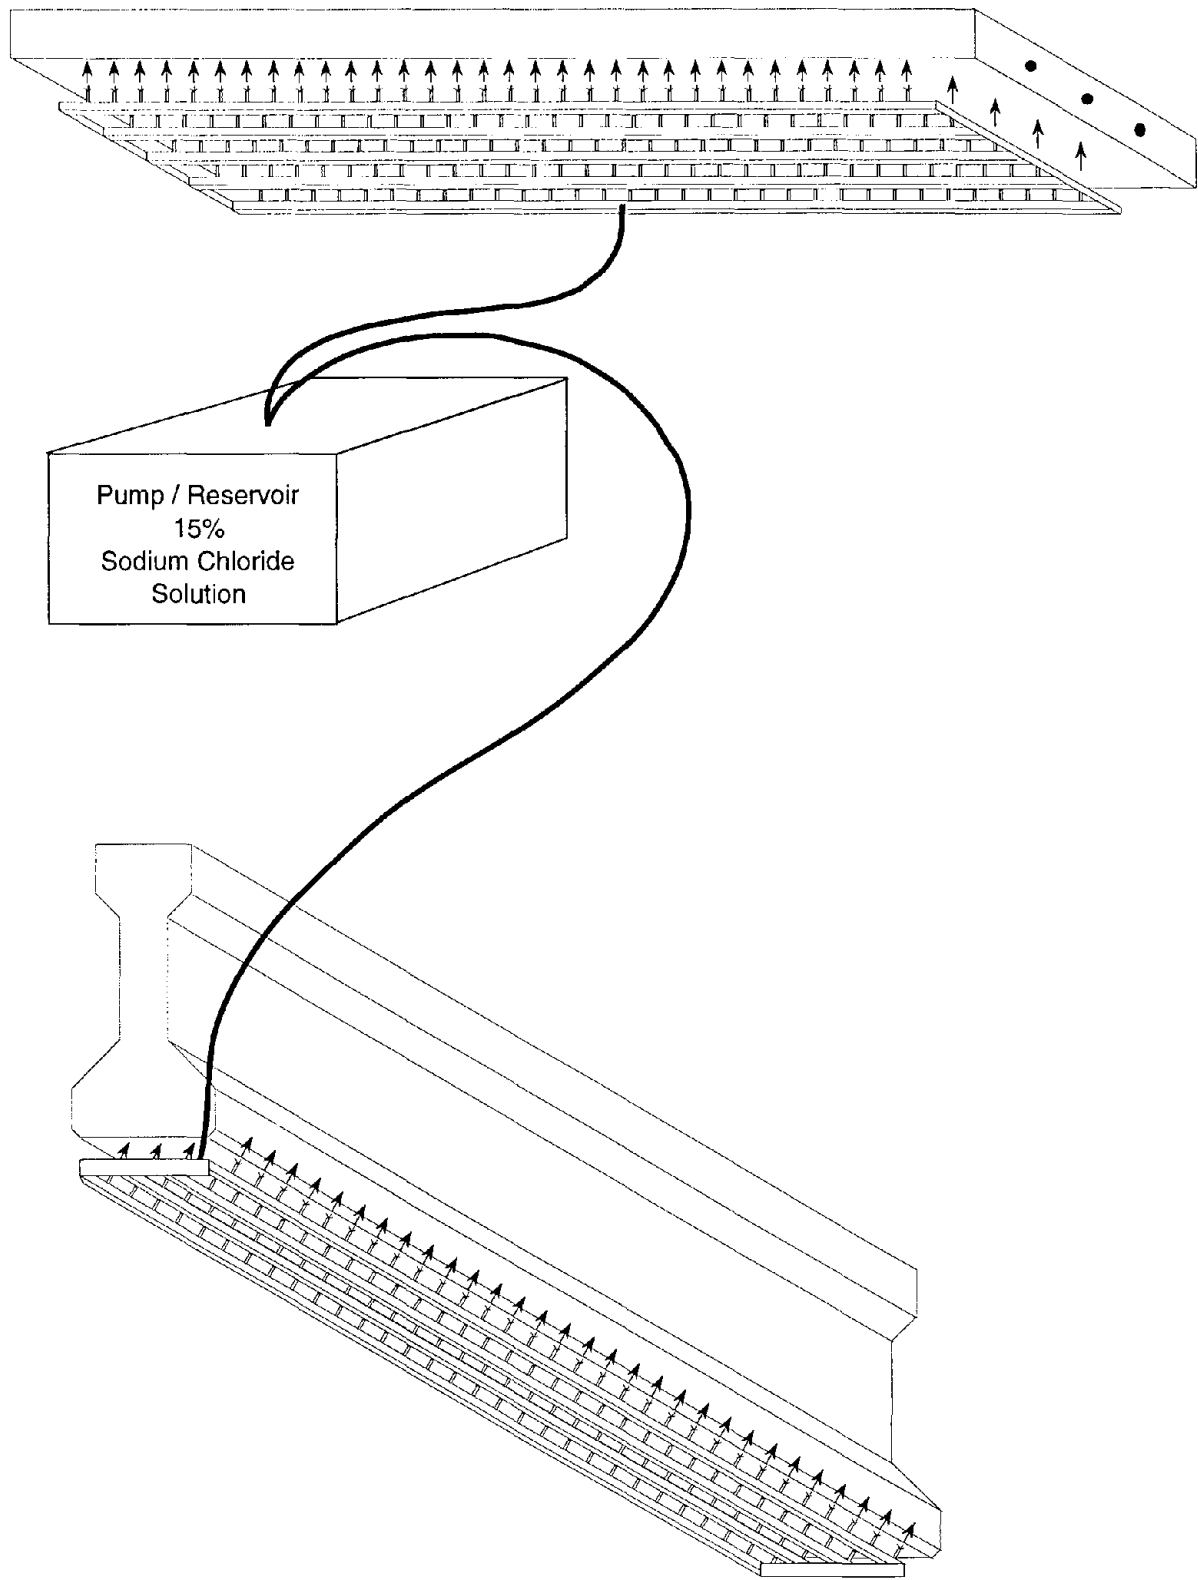
Figure 7. Splash system for exposure of soffits of AASHTO beams and pretensioned slabs.

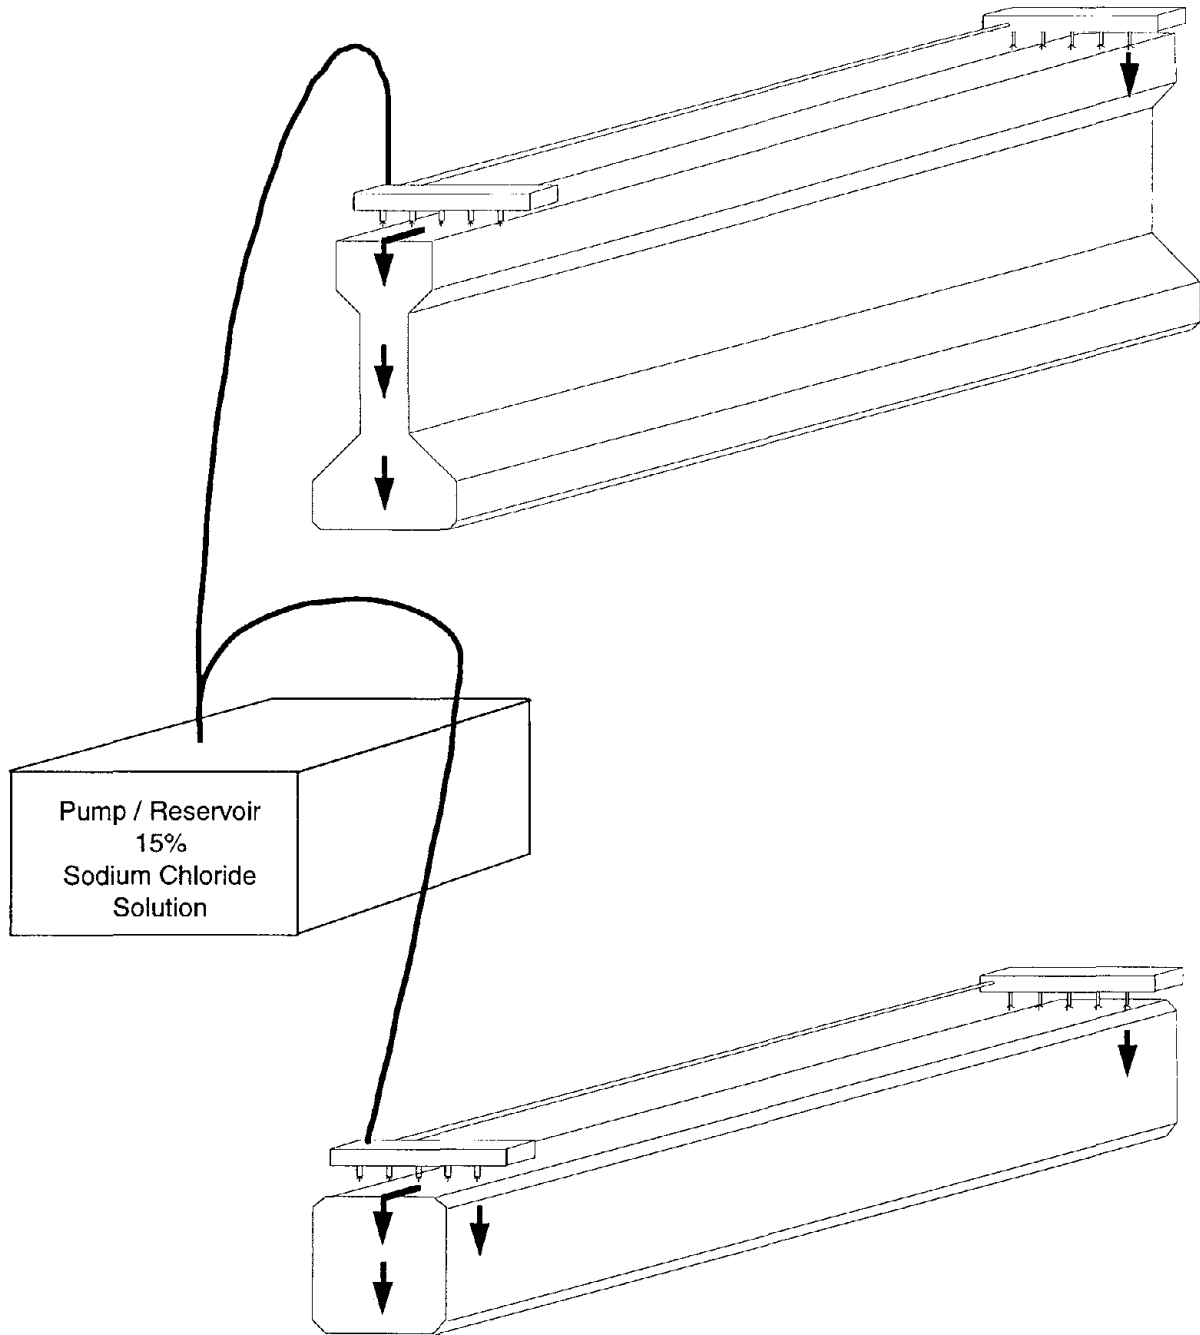
Figure 8. Spray applications of sodium chloride solutions at beam ends.

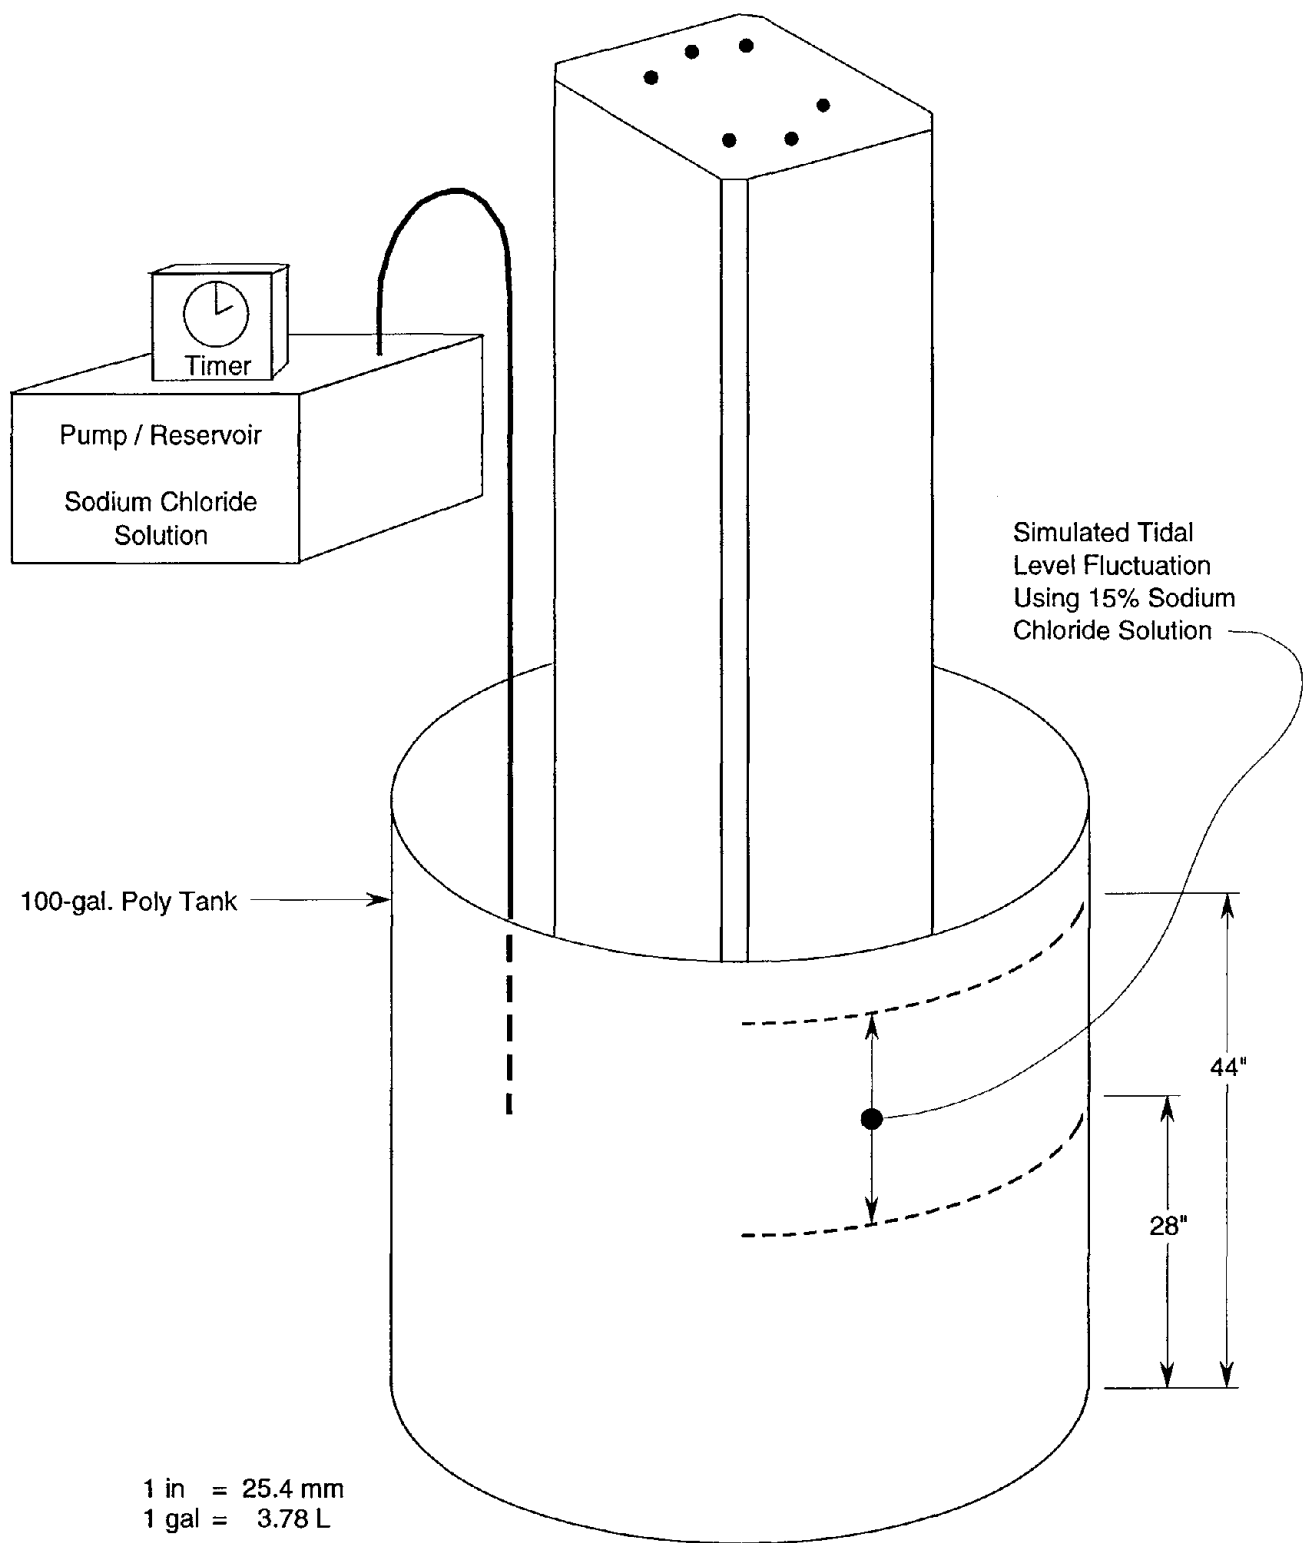
Figure 9. Tanks for simulation of marine tidal exposure for pretensioned piles.

tidal zone extending from 710 to 1110 mm (28 to 44 in) from the bottom of each pile, as shown in Figure 9. Those portions of the pile below this zone were continuously immersed in saline solution; those portions above this zone were atmospherically exposed.

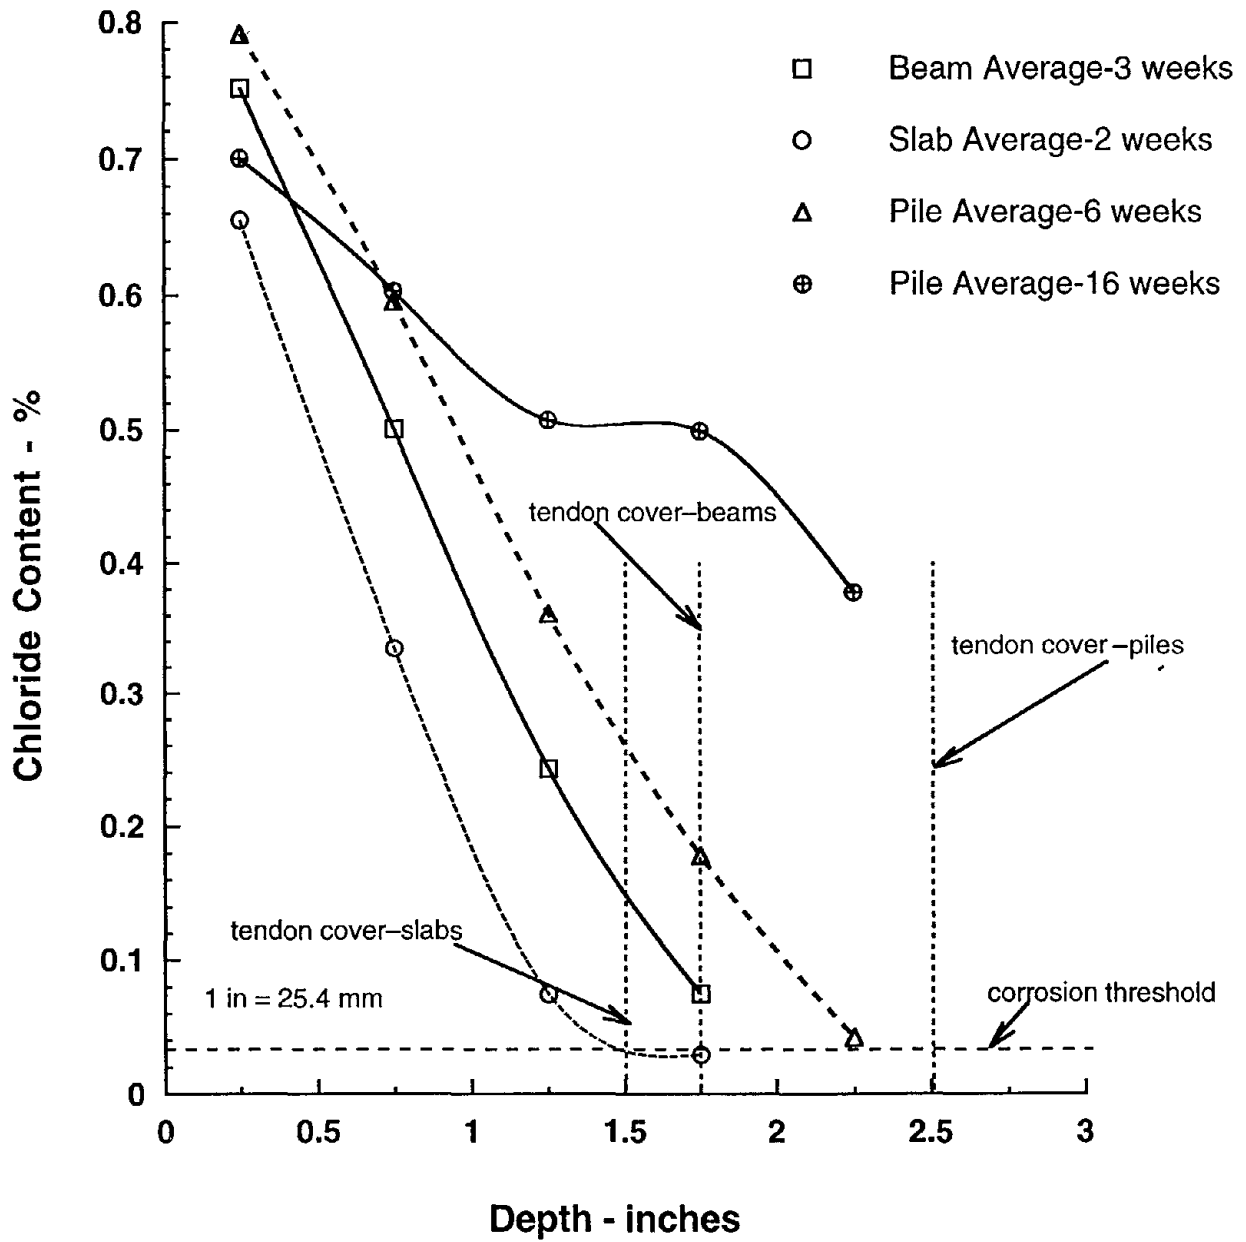
Figure 10. Average chloride contents measured on specimens after electrical acceleration.

Chloride drill samples were taken at various times during the application of current as an aid in determining the exact length of the acceleration process. Final chloride profiles, immediately after application of electrical current was discontinued, are shown in Figure 10. Results are shown as the average of samples taken at two positions on two specimens from each set of slabs, beams, and piles. The periods of application of electrical current, in weeks, are shown on the figure. All chloride contents are at, or above, corrosion threshold at the level of the tendons. It should be noted that actual average clear covers over tendons are shown, which deviated somewhat from the design cover shown in the plans (Figures 1 through 3). Application of anodic electrical current to slabs and beams was discontinued after 2 and 3 weeks, respectively. Half-cell readings taken a few days after cessation of applied voltage were in the range of -400 to -500 mV vs. CSE (Copper/Copper Sulfate reference electrode) for slabs and beams and -500 to -700 mV vs. CSE for pilings. The more electronegative values for pilings were likely due to the submerged condition restricting oxygen flow to the cathodes of the corrosion cells. At this time, considerable amounts of corrosion products could be seen exuding from holes drilled for plastic inserts used to affix the cathode mesh to the slab and beam surfaces. These half-cell data, the chloride contents, and the presence of corrosion products exuding from the ends of the tendons all indicated that the steel was indeed in a corrosive condition.

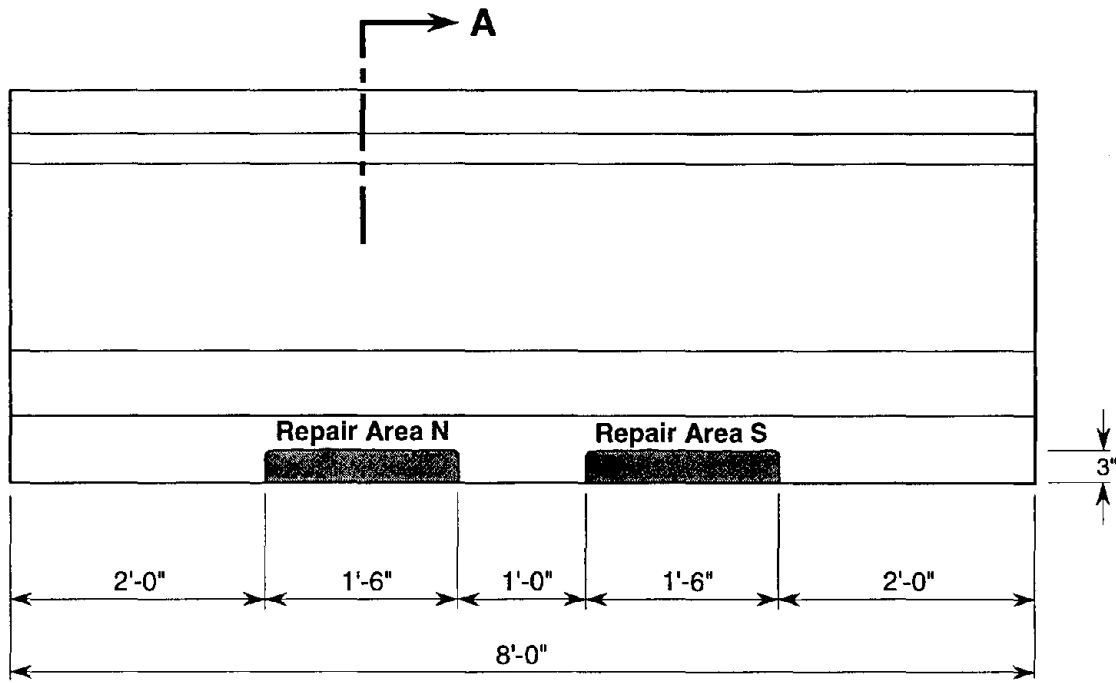
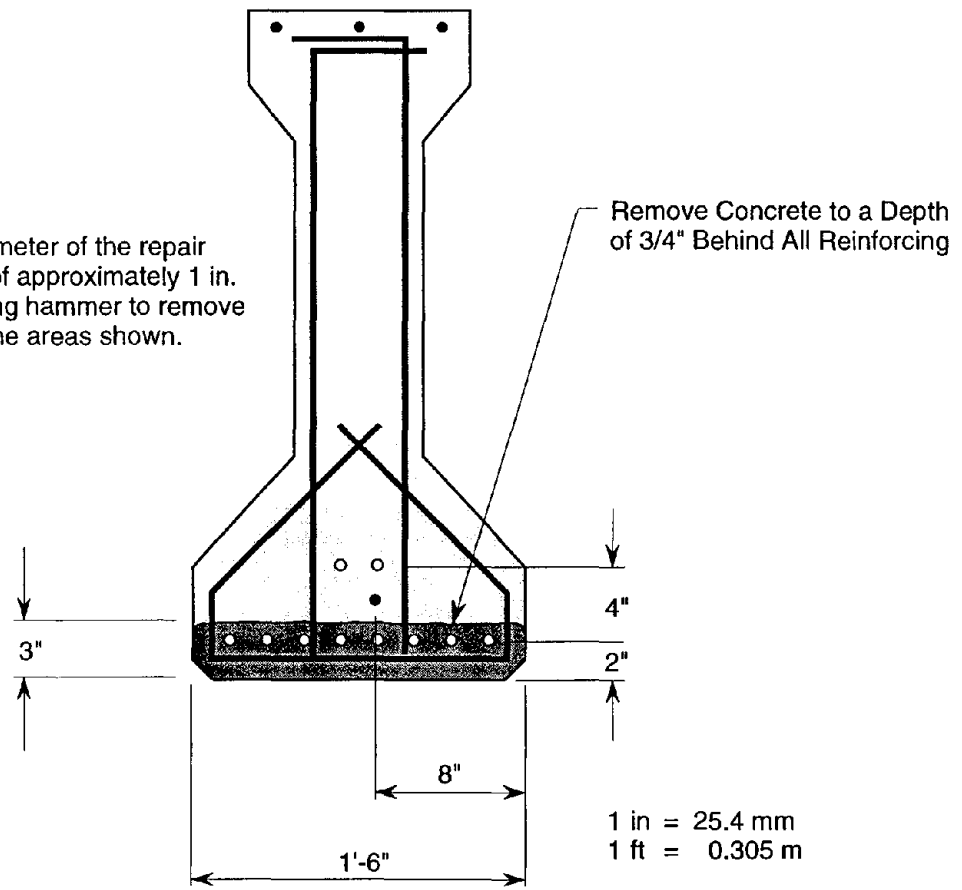
Note: Saw cut the perimeter of the repair area to a depth of approximately 1 in. Then use chipping hammer to remove the concrete in the areas shown.

Section A

Figure 11. Repair area details for pretensioned beam specimens.

While application of anodic current had induced corrosion of embedded prestressed and plain reinforcement as planned, the amount of concrete distress necessary to allow for repairs to be made had not occurred. It was necessary, therefore, to artificially create spalls in the concrete that could then accept the repair materials. The spalls were made by cutting around the desired repair area with a concrete saw to a depth of 12 to 25 mm (1/2 to 1 in), then chipping out the concrete to a level of 19 mm (3/4 in) behind the tendons. Two repair areas were created on each specimen. These were denoted by their location on the specimens relative to the position of the specimens in the test room, either north (Area N) or south (Area S). Drawings showing location, size, and detailing of each repair are included as Figures 11 through 14.

Category A (Patch Repairs). Category A specimens were oriented so that all repairs could be carried out on horizontal surfaces. Repair area dimensions were marked on each specimen as previously shown in Figures 11 through 14. A masonry saw was used to cut around each area to a depth of about 12 to 25 mm (1/2 to 1 in). The saw was also used to make a series of cuts inside each area to allow for easier removal of the concrete by chipping. A small 2-kg (5-lb) air-powered chipping hammer was then used to chip out each area and to leave a clearance of about 19 mm (3/4 in) behind all tendons running through the area. While all tendons were adequately exposed, some plain reinforcement was partially uncovered at the back of some of the patches. This steel was not fully chipped out because exposure of this steel would have resulted in an unusually deep patch and might have damaged the members. Tendons did show evidence of corrosion rust staining and fractures in a few of the wires. The plain reinforcement appeared to be more heavily corroded than the pretensioned steel. After all chipping had been completed, all exposed concrete and steel surfaces were sandblasted to remove corrosion products and to prepare the surfaces for patch materials. While steel was blasted to clean metal, no particular profiling was done, such as is used when preparing metal surfaces for installation of protective coatings.
