Rehabilitation of Prestressed Concrete Bridge Components by Non-Electrical (Conventional) Methods

PUBLICATION NO. FHWA-RD-98-189

FEBRUARY 1999

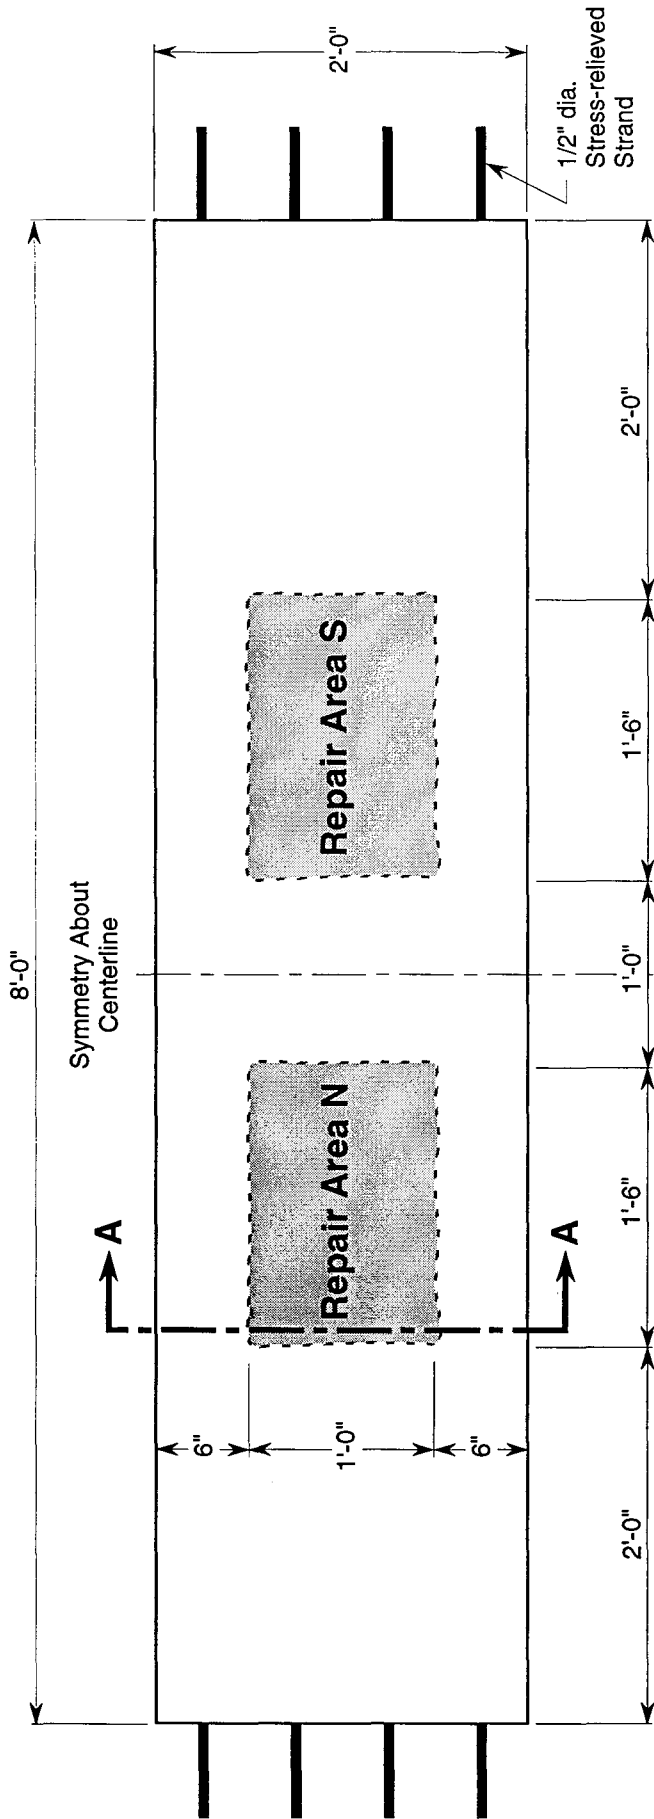
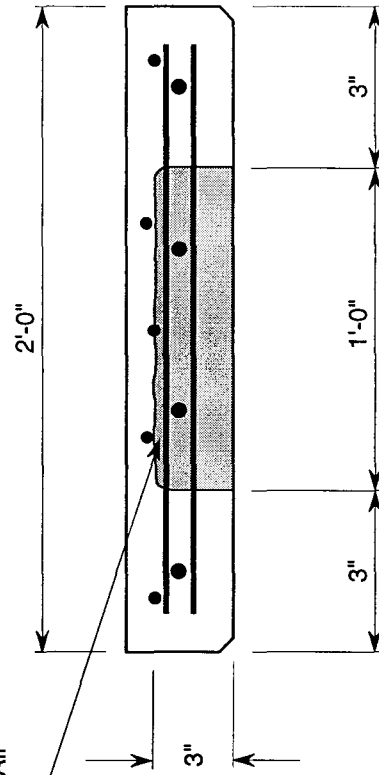
Plan

Remove Concrete to a Depth of 3/4" Behind All Reinforcing

Note: Saw cut the perimeter of the repair area to a depth of approximately 1 in. Then use chipping hammer to remove the concrete in the areas shown.

Figure 12. Repair area details for pretensioned slab specimens.

While application of anodic current had induced corrosion of embedded prestressed and plain reinforcement as planned, the amount of concrete distress necessary to allow for repairs to be made had not occurred. It was necessary, therefore, to artificially create spalls in the concrete that could then accept the repair materials. The spalls were made by cutting around the desired repair area with a concrete saw to a depth of 12 to 25 mm (1/2 to 1 in), then chipping out the concrete to a level of 19 mm (3/4 in) behind the tendons. Two repair areas were created on each specimen. These were denoted by their location on the specimens relative to the position of the specimens in the test room, either north (Area N) or south (Area S). Drawings showing location, size, and detailing of each repair are included as Figures 11 through 14.

Category A (Patch Repairs). Category A specimens were oriented so that all repairs could be carried out on horizontal surfaces. Repair area dimensions were marked on each specimen as previously shown in Figures 11 through 14. A masonry saw was used to cut around each area to a depth of about 12 to 25 mm (1/2 to 1 in). The saw was also used to make a series of cuts inside each area to allow for easier removal of the concrete by chipping. A small 2-kg (5-lb) air-powered chipping hammer was then used to chip out each area and to leave a clearance of about 19 mm (3/4 in) behind all tendons running through the area. While all tendons were adequately exposed, some plain reinforcement was partially uncovered at the back of some of the patches. This steel was not fully chipped out because exposure of this steel would have resulted in an unusually deep patch and might have damaged the members. Tendons did show evidence of corrosion rust staining and fractures in a few of the wires. The plain reinforcement appeared to be more heavily corroded than the pretensioned steel. After all chipping had been completed, all exposed concrete and steel surfaces were sandblasted to remove corrosion products and to prepare the surfaces for patch materials. While steel was blasted to clean metal, no particular profiling was done, such as is used when preparing metal surfaces for installation of protective coatings.

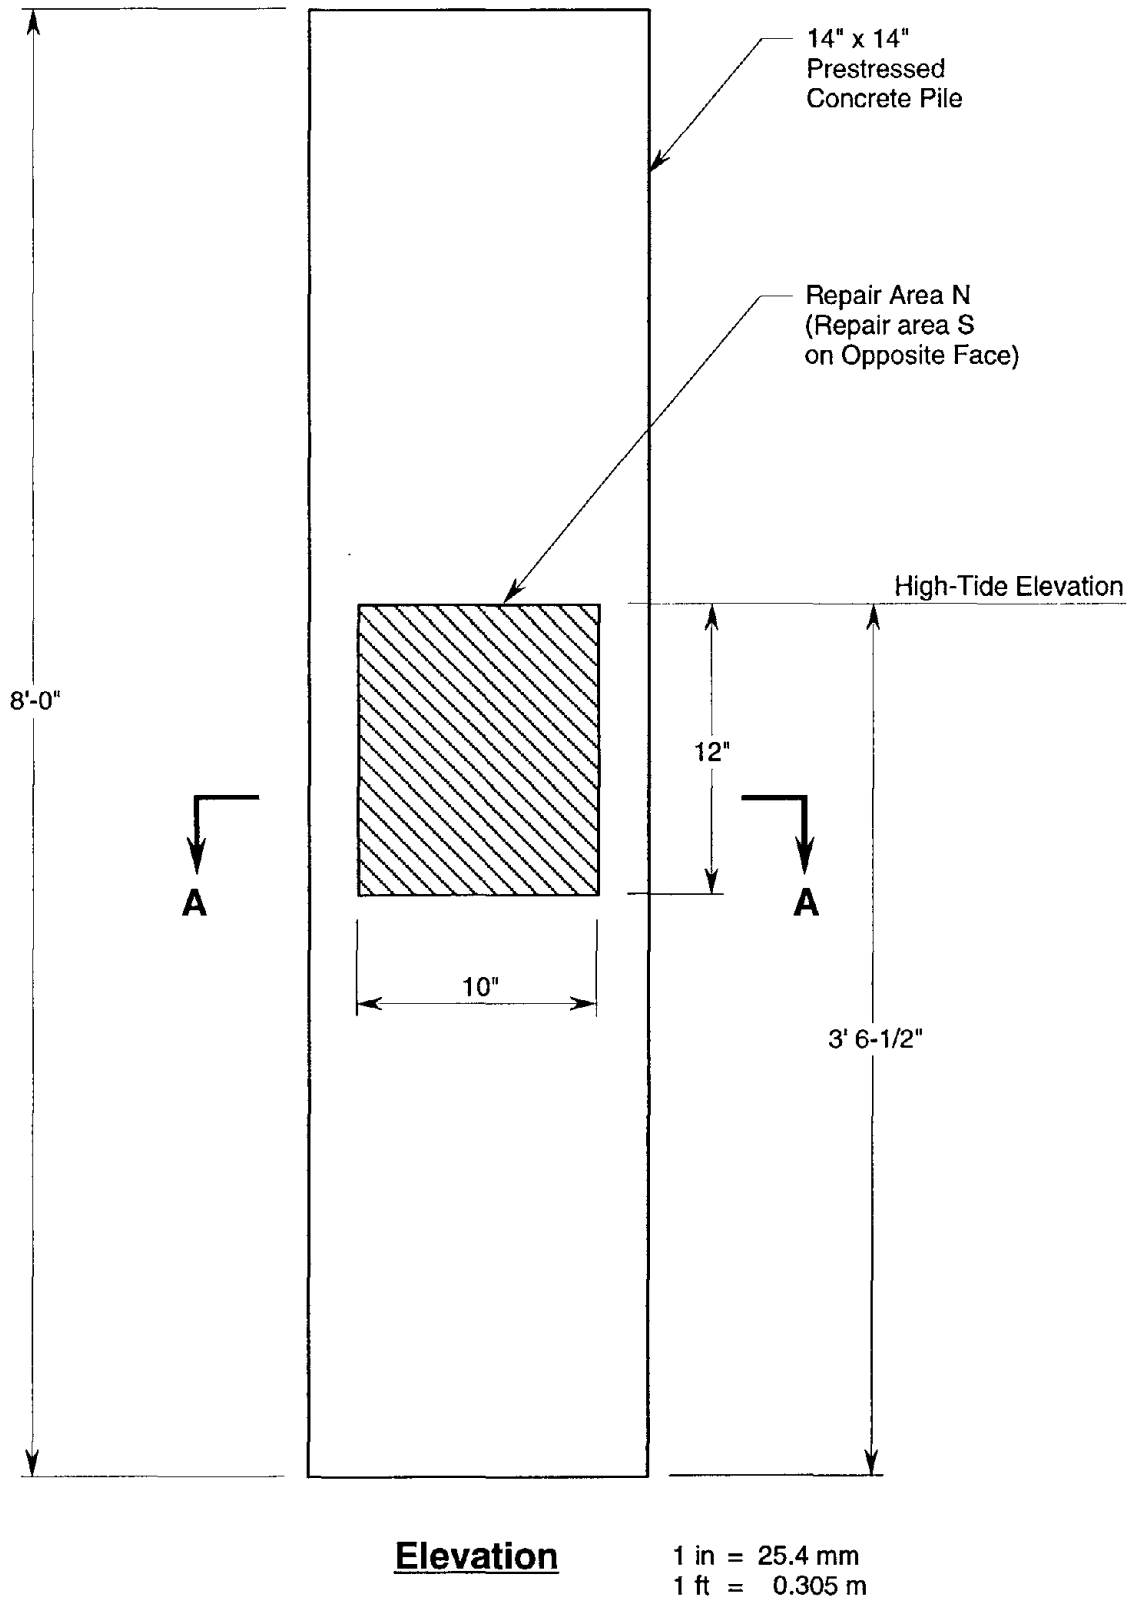
Figure 13. Elevation view of repair area details for pretensioned pile specimens.

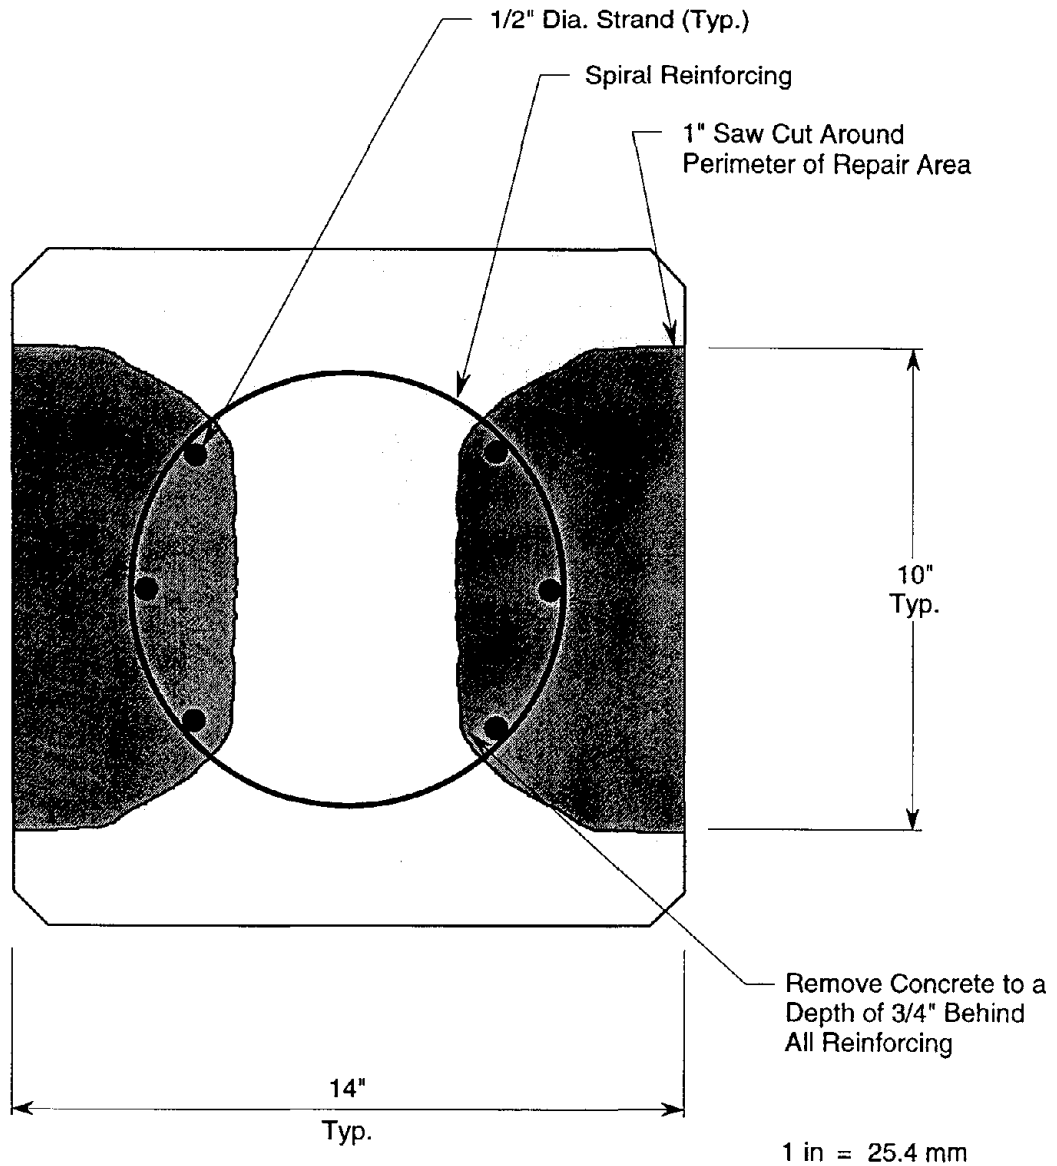
Section A-A

Note: Saw cut the perimeter of the repair area to a depth of approximately 3/4". Then use a chipping hammer to remove the concrete in the area shown.

Figure 14. Plan view of repair area details for pretensioned pile specimens.

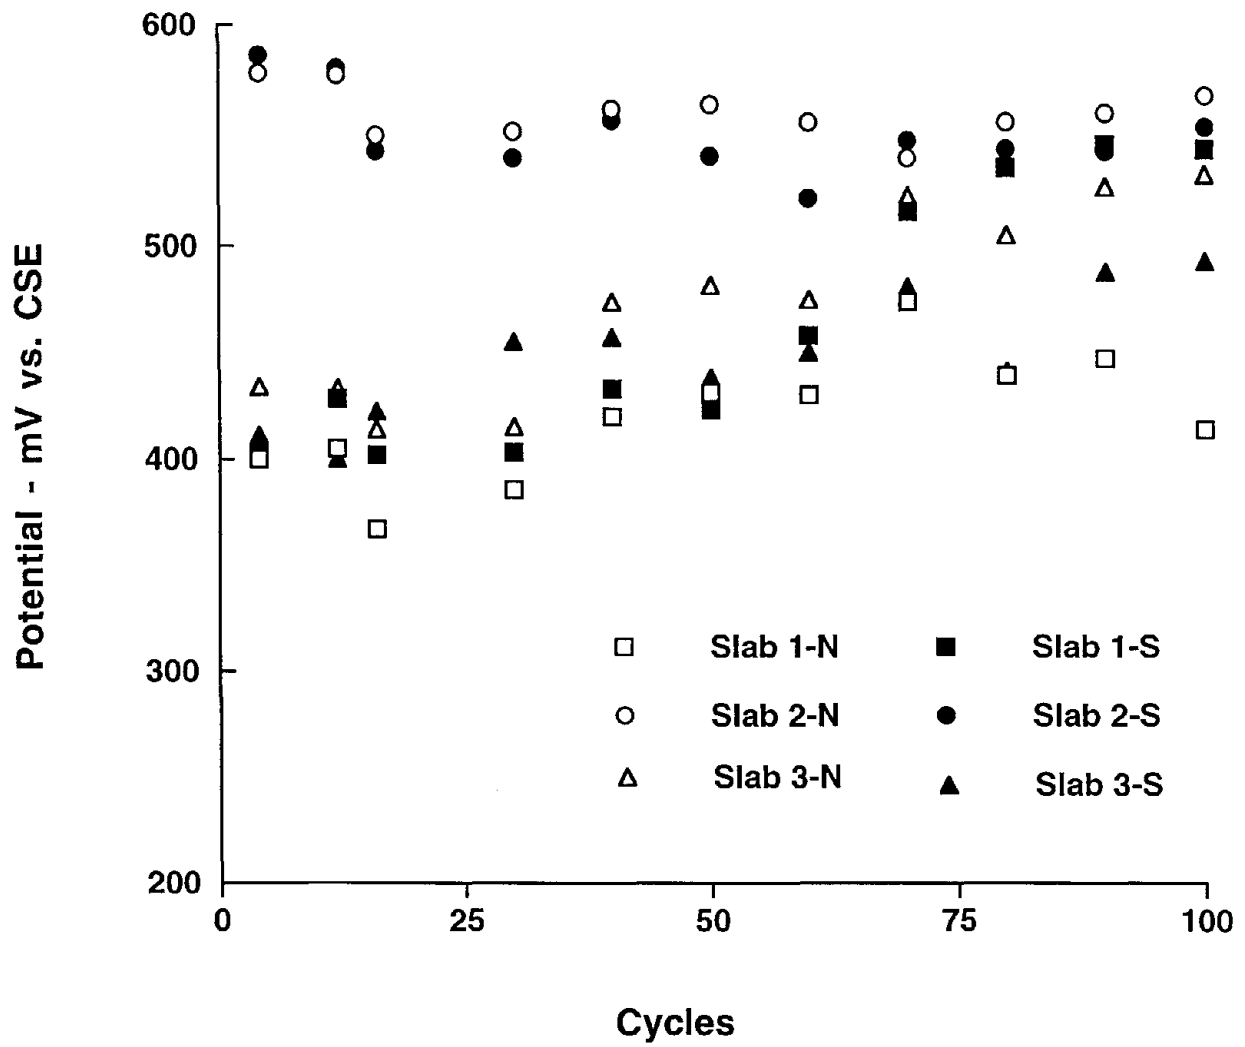
Figure 15. Average half-cell potentials in slab repair areas over 100 cycles of testing.

The trend of the potentials within the slab repair areas over the entire 100 cycles of testing is shown in Figure 15. Initially, there was a significant difference in potentials for slab 2 vs. slabs 1 and 3 until about halfway through the exposure program. After about 60 cycles, potentials for all of the slabs began to converge, though the "N" patch on slab 1 did continue to exhibit the lowest potentials in the set throughout the course of monitoring. The generally higher potentials for slab 2 repairs throughout most of the monitoring appear to be reflected in cracking and visual appearance of the repair areas. Figures 16, 17, and 18 show crack maps at 100 cycles for all repair slabs. Cracking is more extensive in slabs 2 and 3 than it is in slab 1. A visual comparison of the surface of repair areas in slabs 1 north vs. slab 2 north is given in Figures 19 and 20. There is more efflorescence and exudation of corrosion products from slab 2 (Figure 20) than from slab 1 (Figure 19).

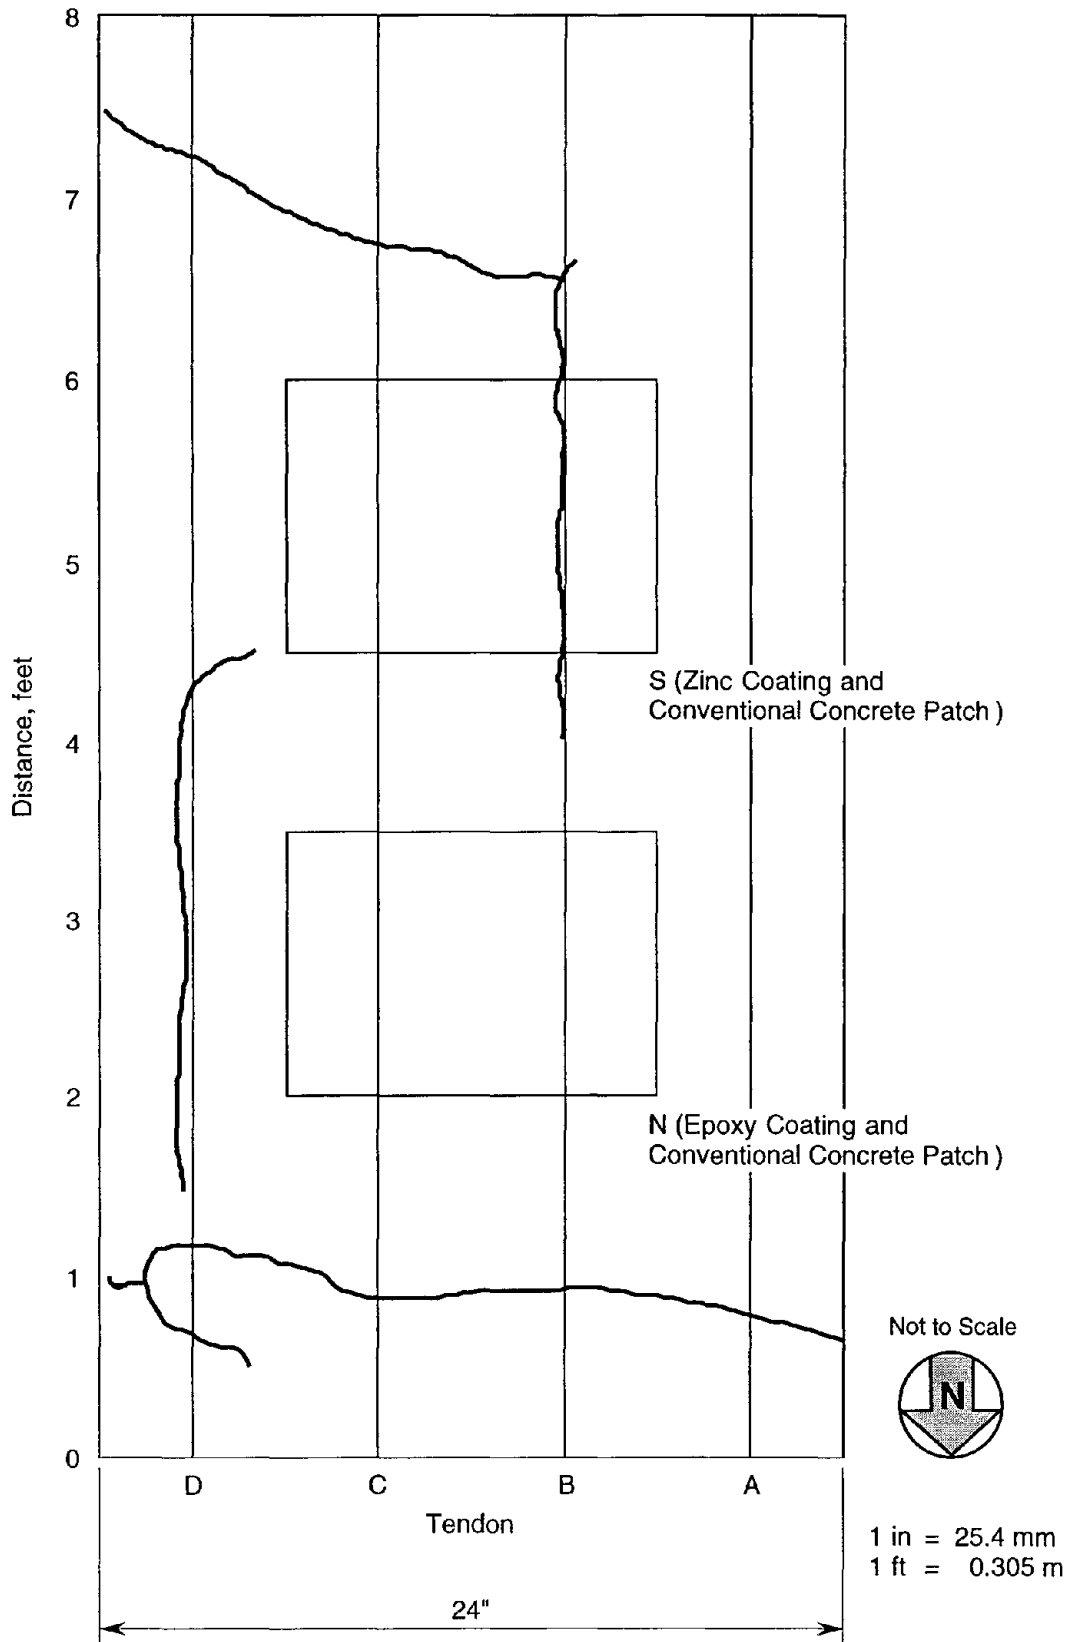
Figure 16. Crack map for slab 1 at 100 cycles of exposure.

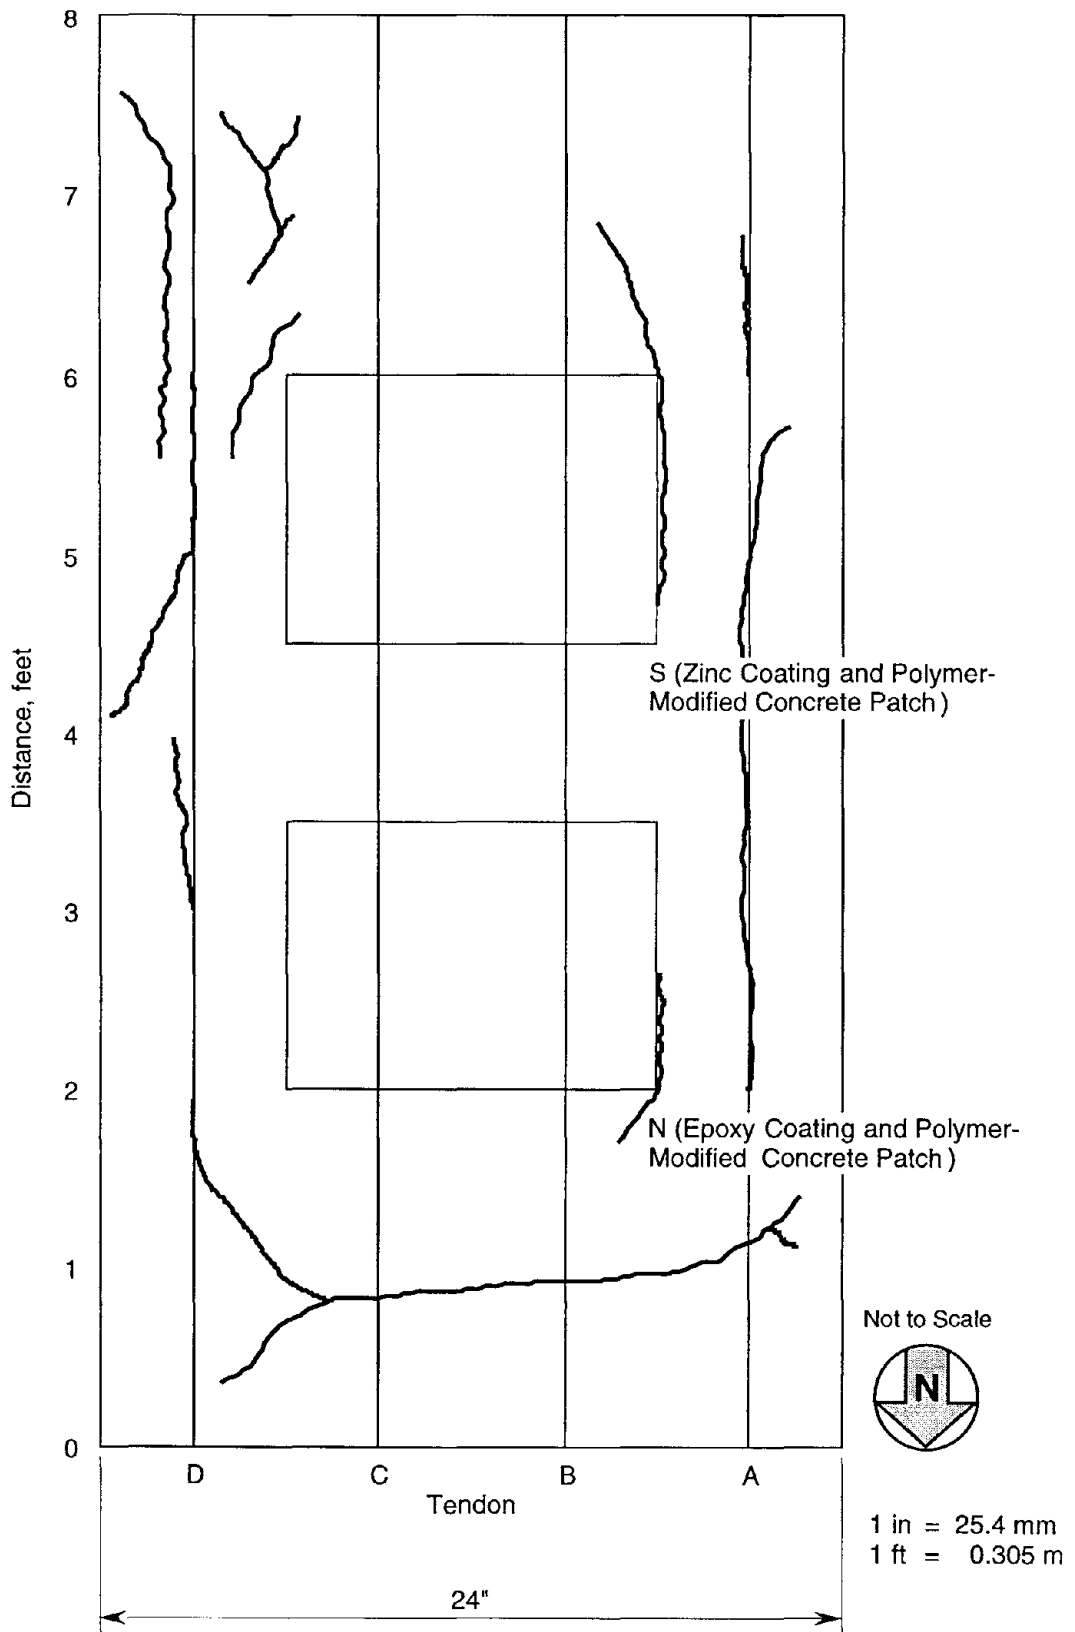
Figure 17. Crack map for slab 2 at 100 cycles of exposure.

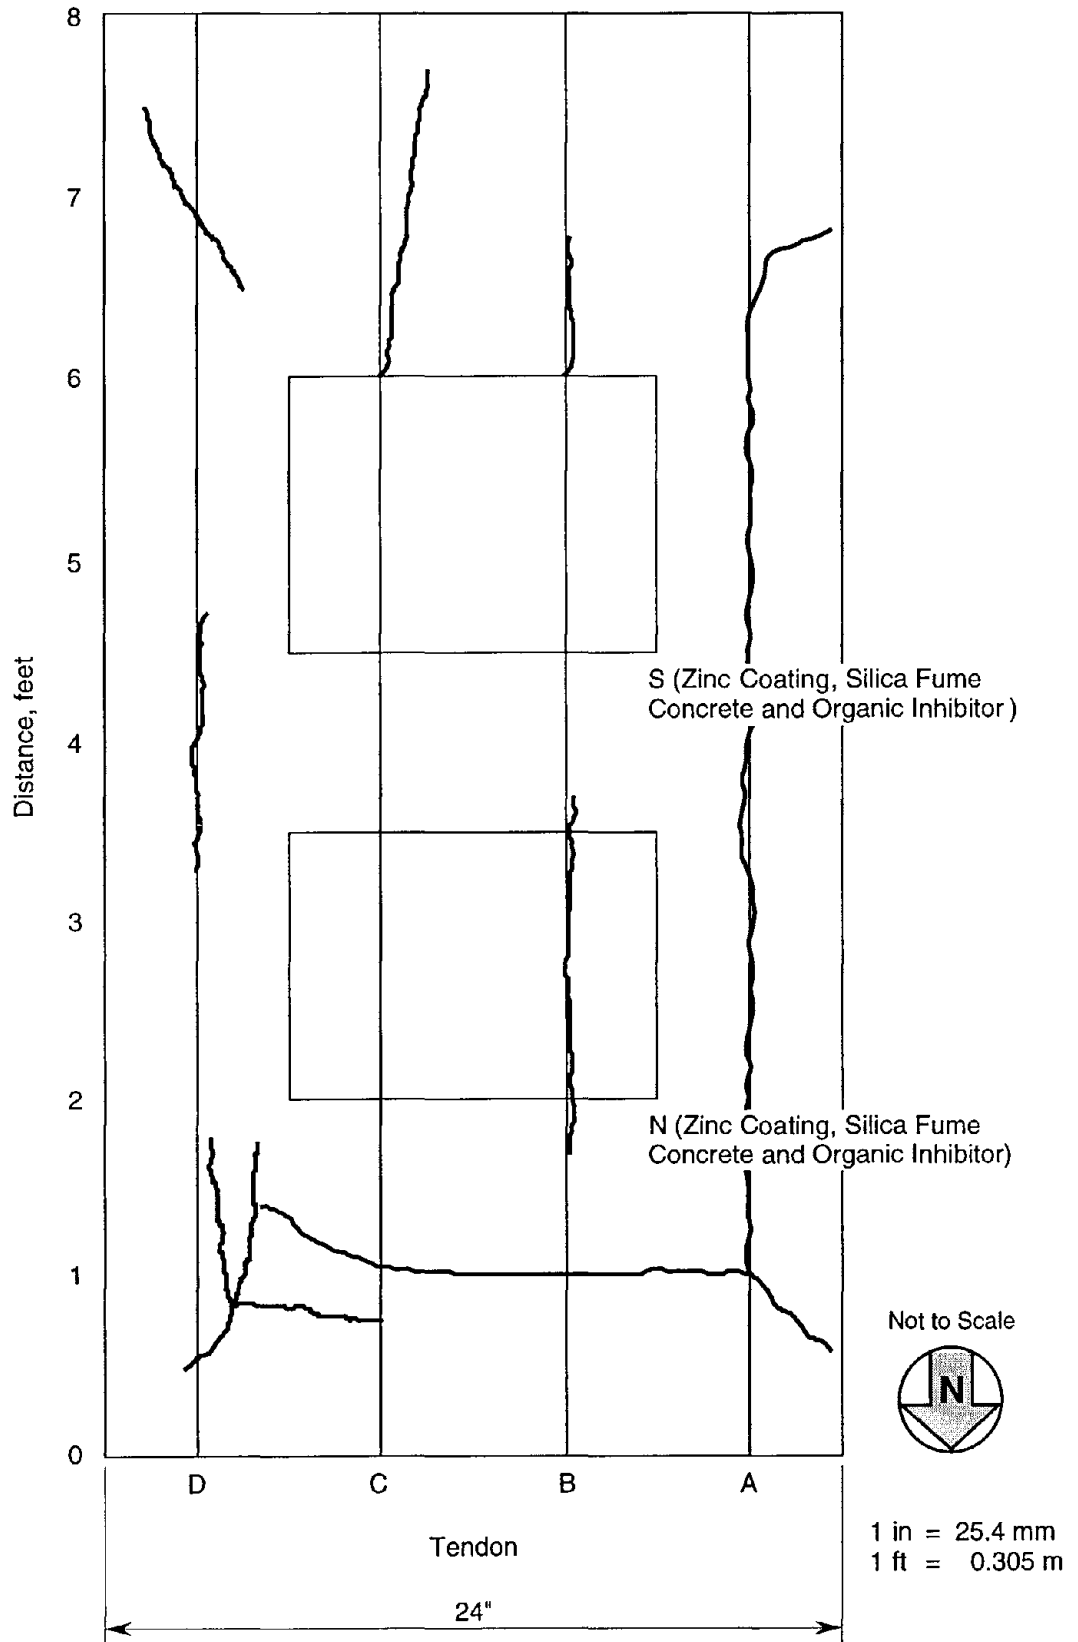
Figure 18. Crack map for slab 3 at 100 cycles of exposure.

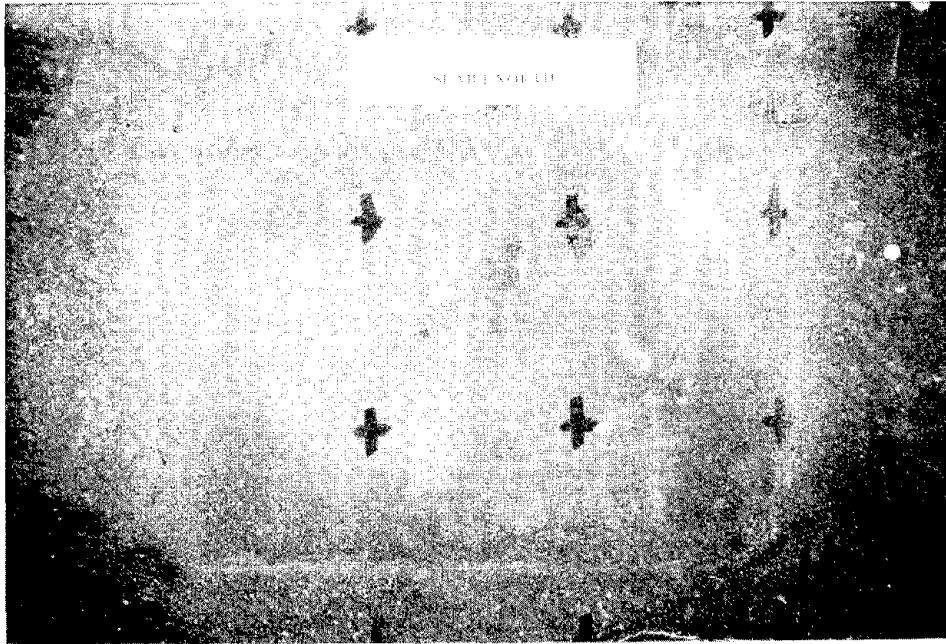
Figure 19. Appearance of north repair area, slab 1, after 100 exposure cycles.

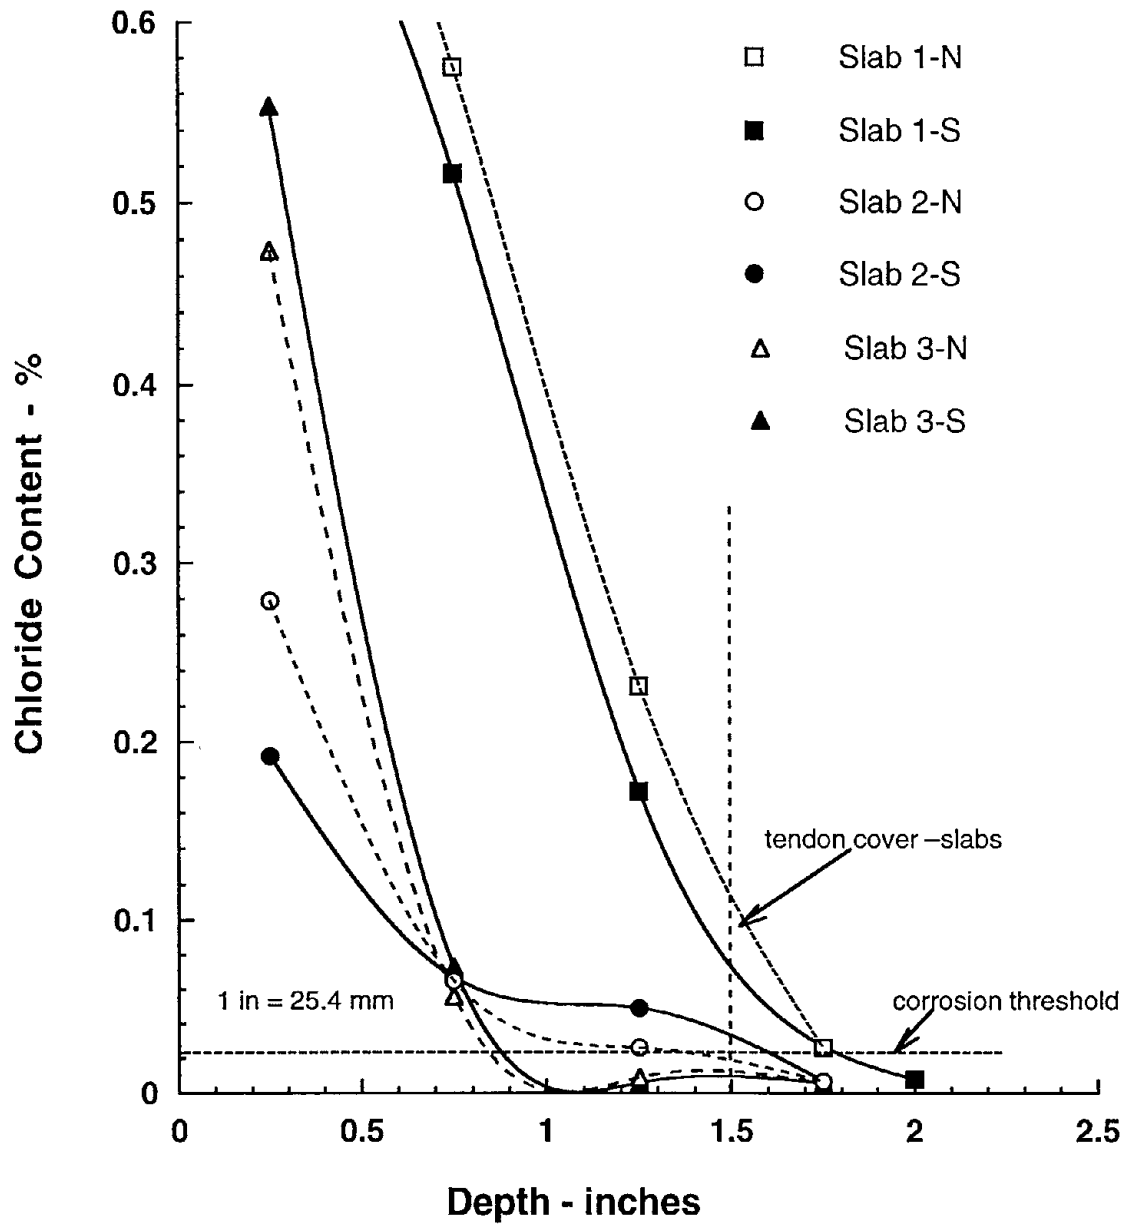
Figure 21. Chloride contents measured on slab repair specimens.

Below 25 mm (1 in), there were detectable amounts of chloride in slab 2, but only baseline amounts in slab 1. The corrosion threshold shown in Figure 21 is based on a value of 0.2% acid-soluble chloride by mass of cement as recommended by ACI Committee 222.⁽⁸⁾ The threshold is significantly exceeded at the average level of strand cover only for slab 1.

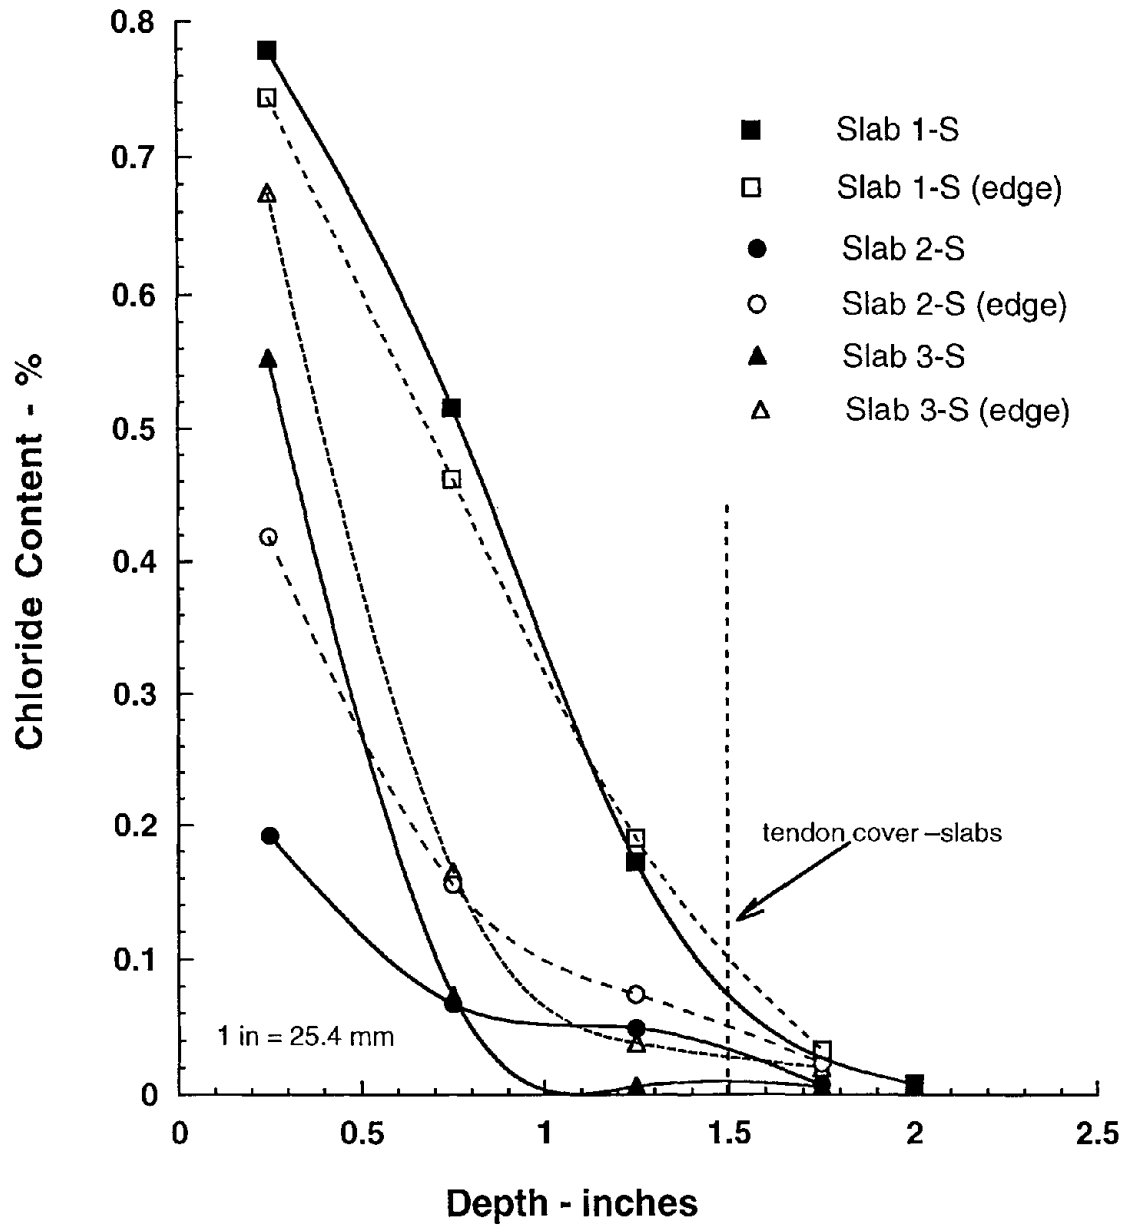
Figure 22. Comparison of chloride contents measured at center and near edges of slab repair patches.

A series of additional drill samples were obtained in positions approximately 40 mm (1.5 in) in from the edge of one of the two patches on each slab. Chloride profiles were obtained at each of these locations. Results are shown in Figure 22. For slab 1, there was little difference between the chloride content at the edge of the slab and that in the interior of the patch. For slabs 2 and 3, however, values near the slab edges appear to be greater than those at the center of the patch. As noted earlier, there was more cracking and efflorescence near the edges of slabs 2 and 3 than slab 1. It is possible that chlorides were able to penetrate into these slabs at the edges of the repairs, and then migrate laterally into the slab repair areas. A limited amount of work was done in an attempt to define the extent of lateral penetration of the chloride in slabs 2 and 3. It appears that chloride is able to penetrate approximately 75 mm (3 in) in from the repair edge. Beyond this point, chloride levels are the same as for the interior of the patch.

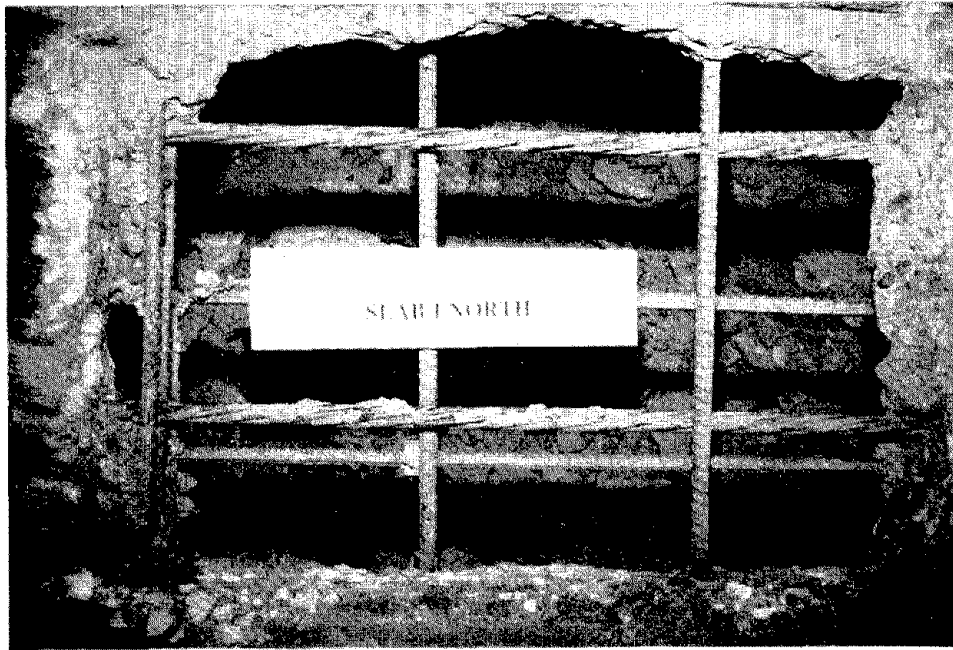
Figure 23. Appearance of uncovered tendons and reinforcing steel in north repair area, slab 1, after 100 exposure cycles.

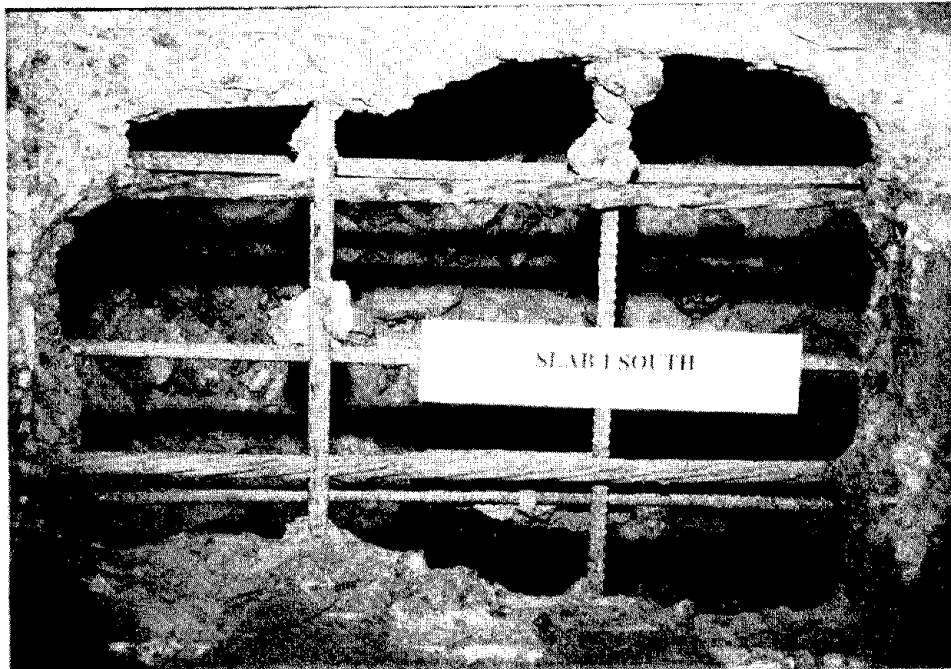
Figure 24. Appearance of uncovered tendons and reinforcing steel in south repair area, slab 1, after 100 exposure cycles.

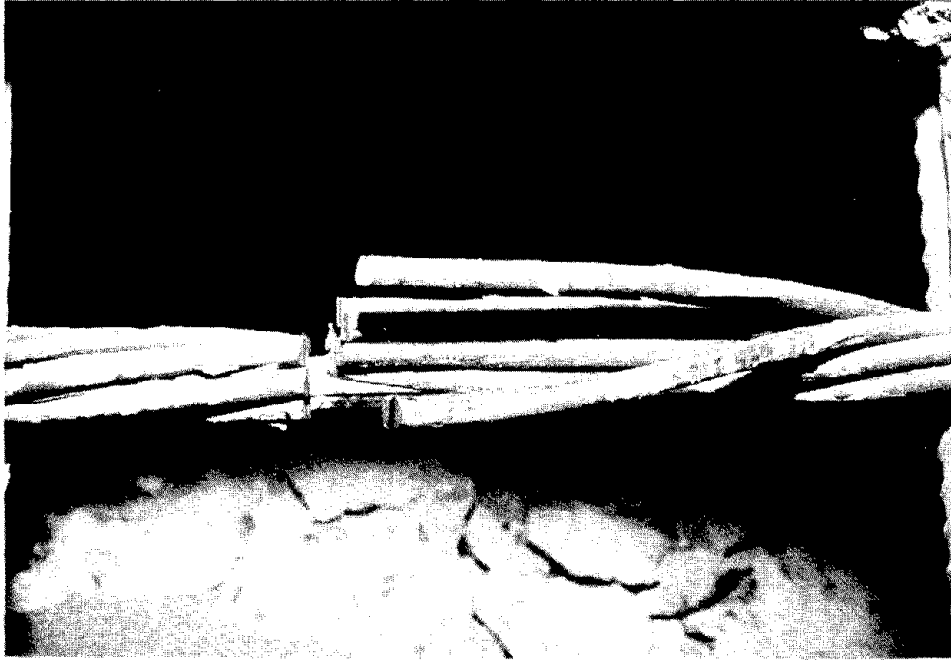
Figure 25. Appearance of interior of tendon bundle in north repair area, slab 1, after 100 exposure cycles.

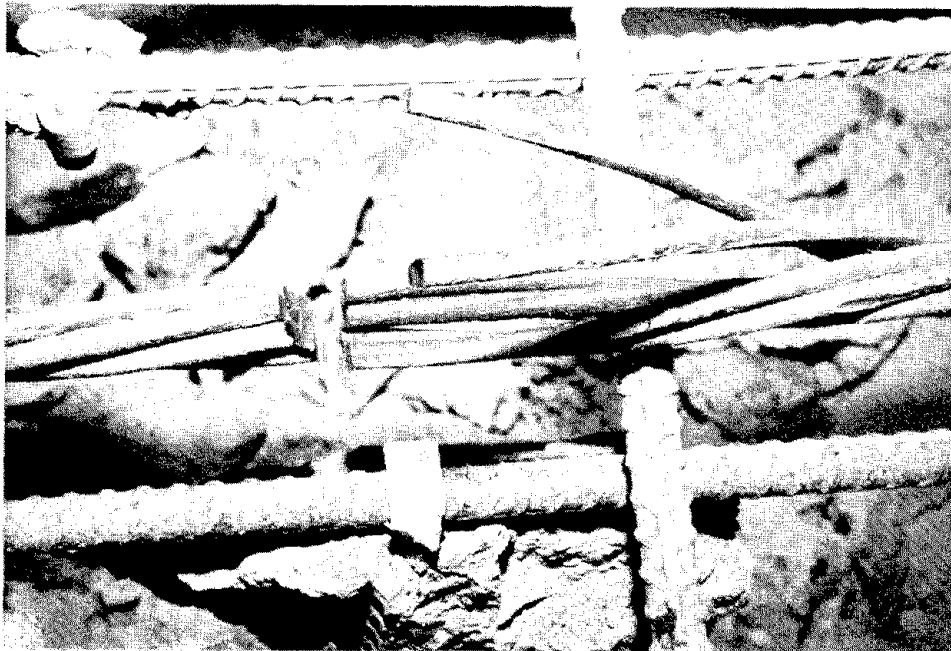
Figure 26. Appearance of interior of tendon bundle in south repair area, slab 1, after 100 exposure cycles.

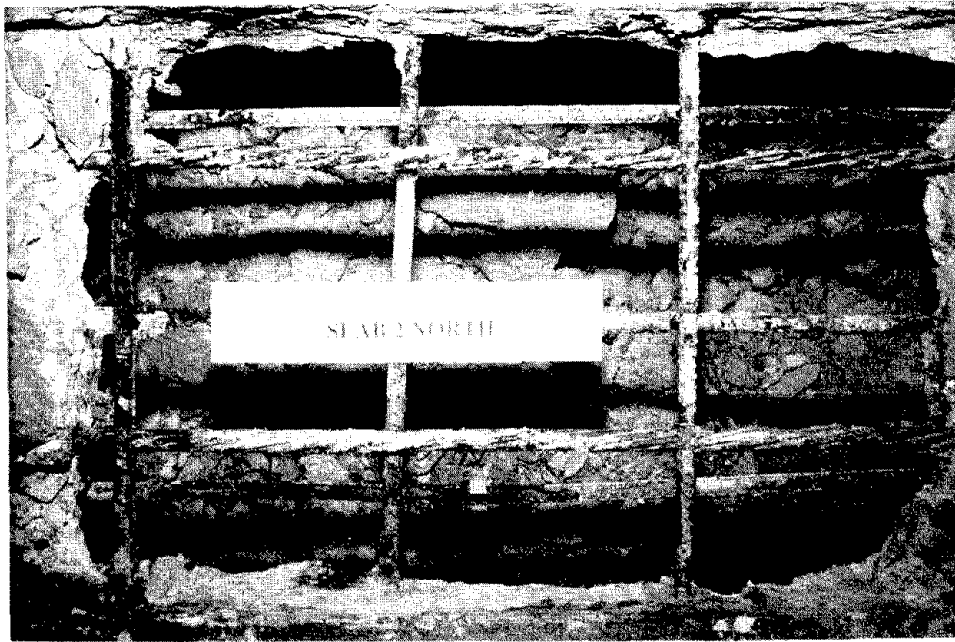
Figure 27. Appearance of uncovered tendons and reinforcing steel in north repair area, slab 2, after 100 exposure cycles.

Uncovered tendons and reinforcing steel in patches on slab 2 (latex-modified concrete patches) are shown in Figures 27 (north patch - epoxy) and 28 (south patch - zinc). On the epoxy-coated tendons, the coating disruption and corrosion are more extensive and severe than on the

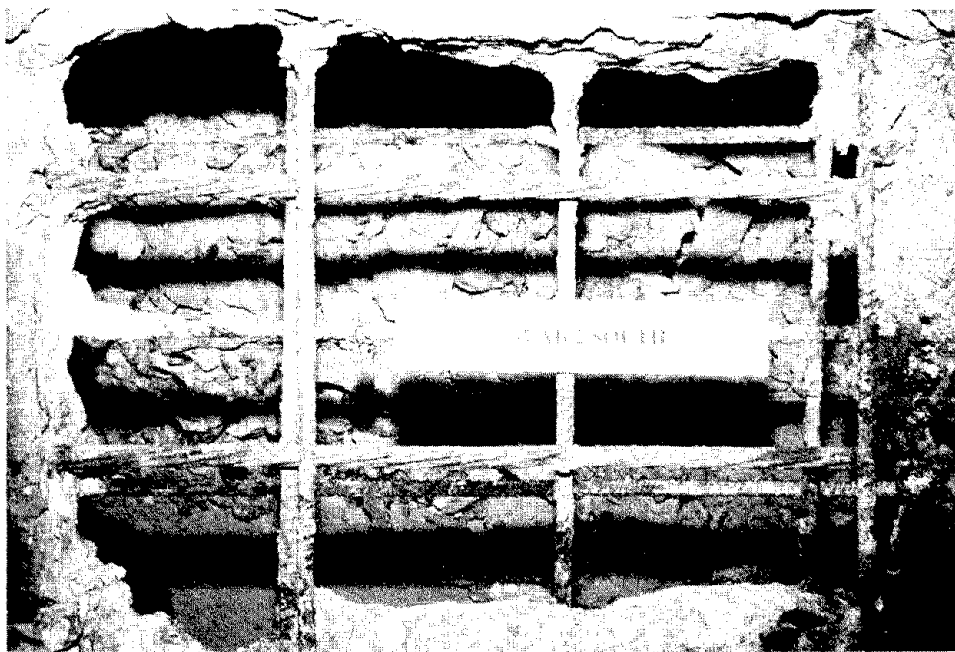
Figure 28. Appearance of uncovered tendons and reinforcing steel in south repair area, slab 2, after 100 exposure cycles.

corresponding steel on slab 1. The coating was found to be extensively flaking away from the steel and was easily removed with a knife. In the south patch, there is corrosion on both the upper and lower tendons; however, it is of a lesser magnitude than in the north repair area. On the lower tendon, most of the zinc appeared to have been consumed. Upon cutting and peel-back of the individual strands from the lower tendon in the north repair area, extensive corrosion of the interior of the bundle was observed (Figure 29). When this was done for the zinc-coated tendons in the south repair area, the severity of corrosion was seen to be less (Figure 30).

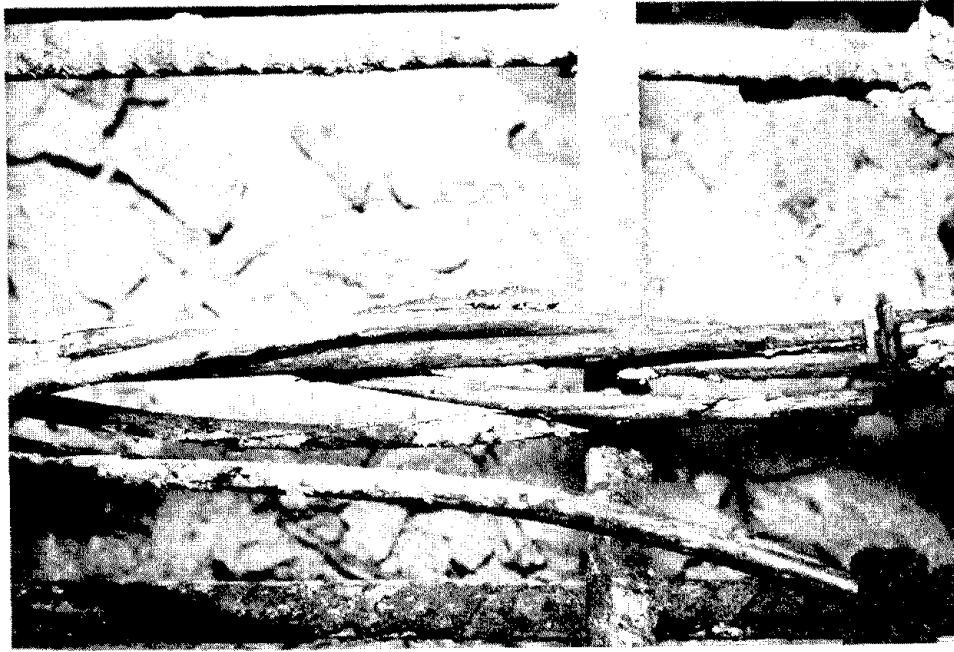
Figure 29. Appearance of interior of tendon bundle in north repair area, slab 2, after 100 exposure cycles.

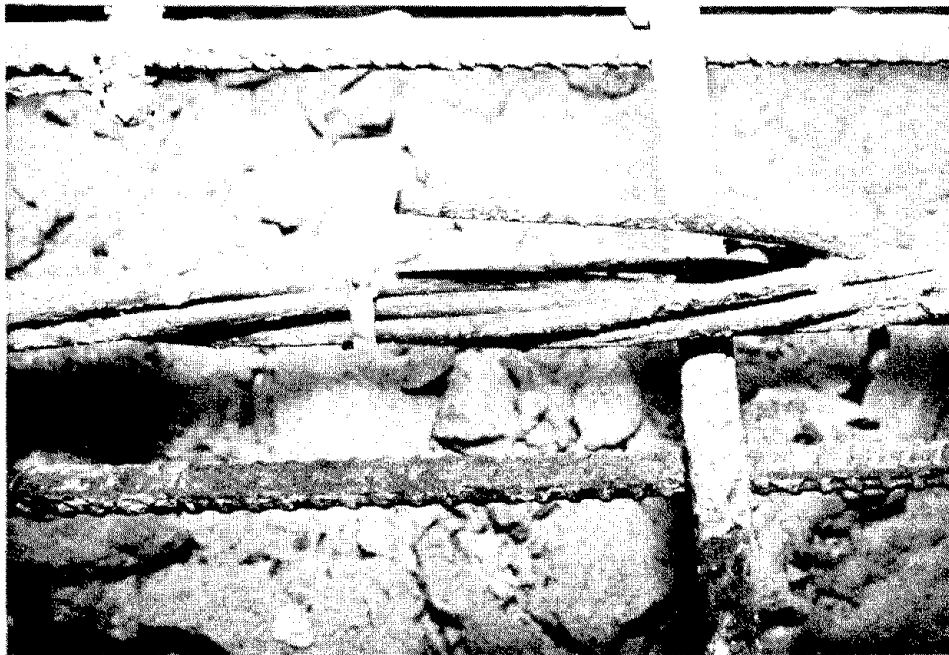
Figure 30. Appearance of interior of tendon bundle in south repair area, slab 2, after 100 exposure cycles.

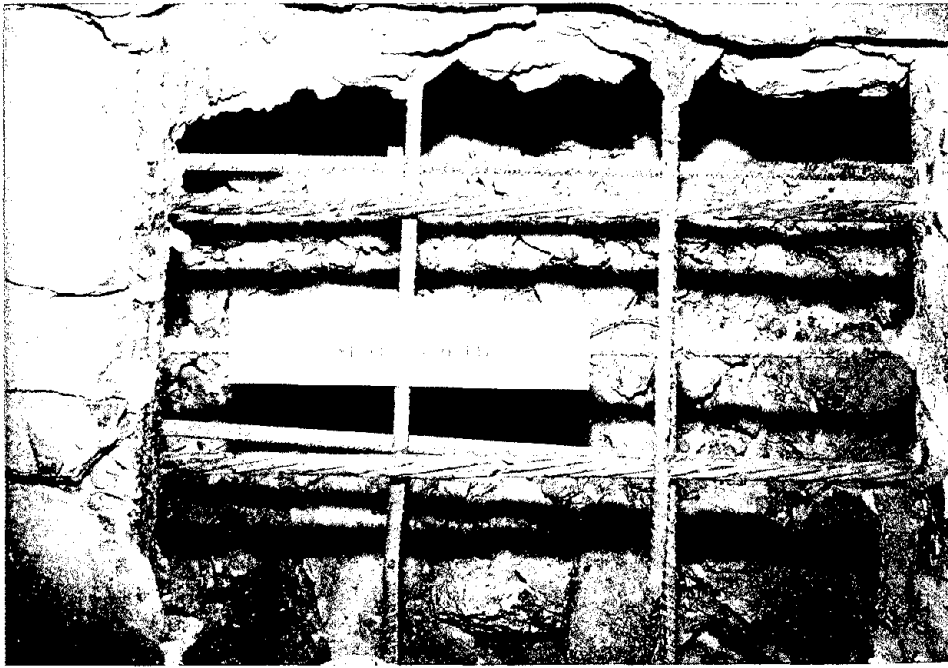
Figure 31. Appearance of uncovered tendons and reinforcing steel in north repair area, slab 3, after 100 exposure cycles.

Uncovered tendons and steel in slab 3 (silica fume concrete with organic corrosion inhibitor) are shown in Figures 31 and 32 for epoxy-coated and zinc-coated steel, respectively. The epoxy coating on the upper tendon in the north patch has been completely destroyed, and extensive corrosion is evident on the strands. There is also exterior corrosion on the lower tendon, and corrosion is seen in spots. The zinc-coated tendons in the south patch (Figure 32) appear to have performed better than the epoxy. Most of the corrosion in this area is confined to the left-most side of the lower tendon. Figures 33 and 34 show the interiors of the tendon bundles in slab 3. Again, there is corrosion evident on the interior surfaces for both epoxy- and zinc-coated strand.
