Rehabilitation of Prestressed Concrete Bridge Components by Non-Electrical (Conventional) Methods

PUBLICATION NO. FHWA-RD-98-189

FEBRUARY 1999

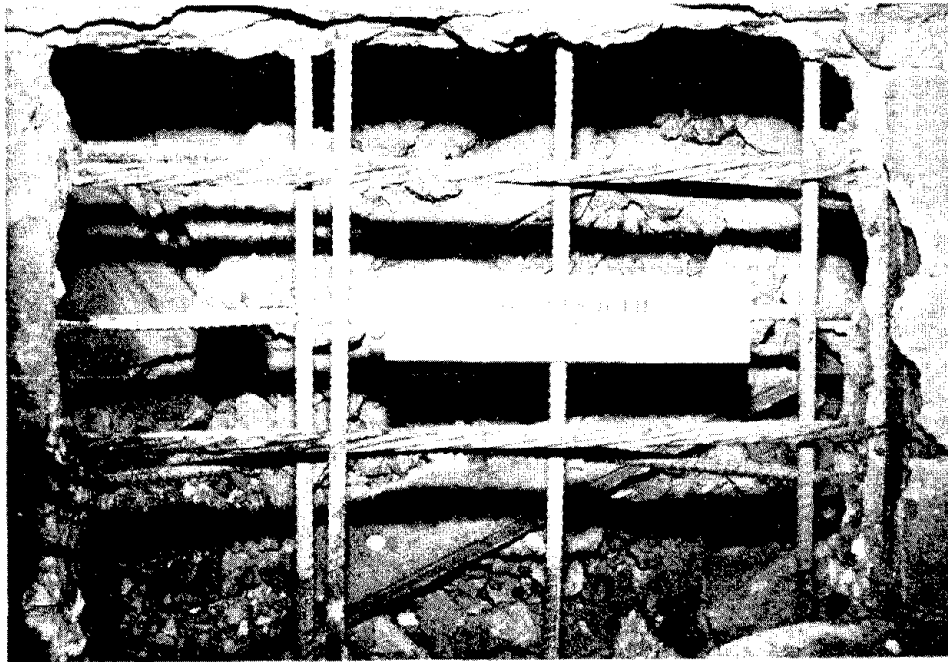
Figure 32. Appearance of uncovered tendons and reinforcing steel in south repair area, slab 3, after 100 exposure cycles.

Uncovered tendons and steel in slab 3 (silica fume concrete with organic corrosion inhibitor) are shown in Figures 31 and 32 for epoxy-coated and zinc-coated steel, respectively. The epoxy coating on the upper tendon in the north patch has been completely destroyed, and extensive corrosion is evident on the strands. There is also exterior corrosion on the lower tendon, and corrosion is seen in spots. The zinc-coated tendons in the south patch (Figure 32) appear to have performed better than the epoxy. Most of the corrosion in this area is confined to the left-most side of the lower tendon. Figures 33 and 34 show the interiors of the tendon bundles in slab 3. Again, there is corrosion evident on the interior surfaces for both epoxy- and zinc-coated strand.

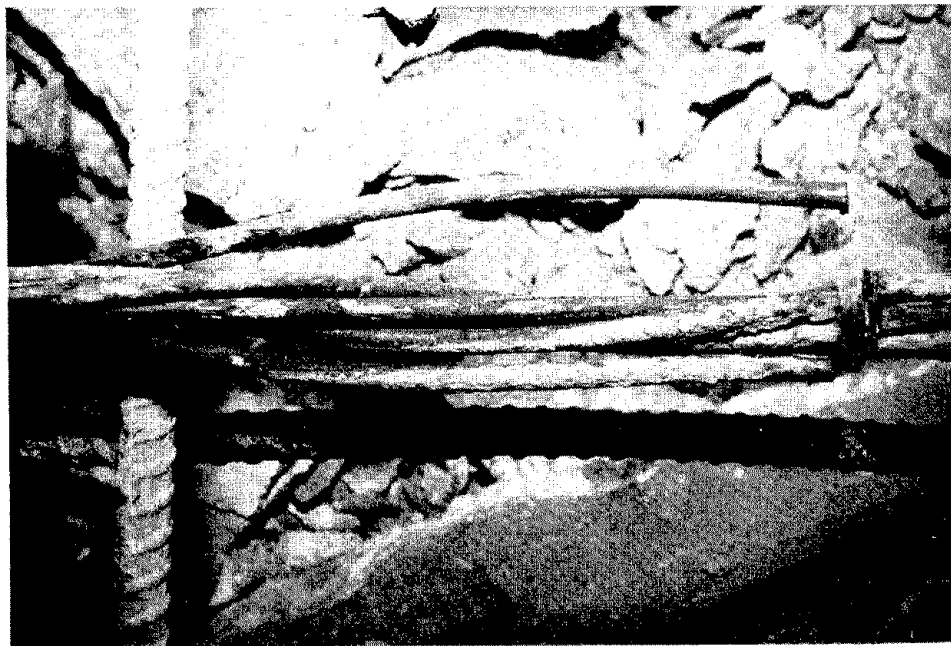
Figure 34. Appearance of interior of tendon bundle in south repair area, slab 3, after 100 exposure cycles.

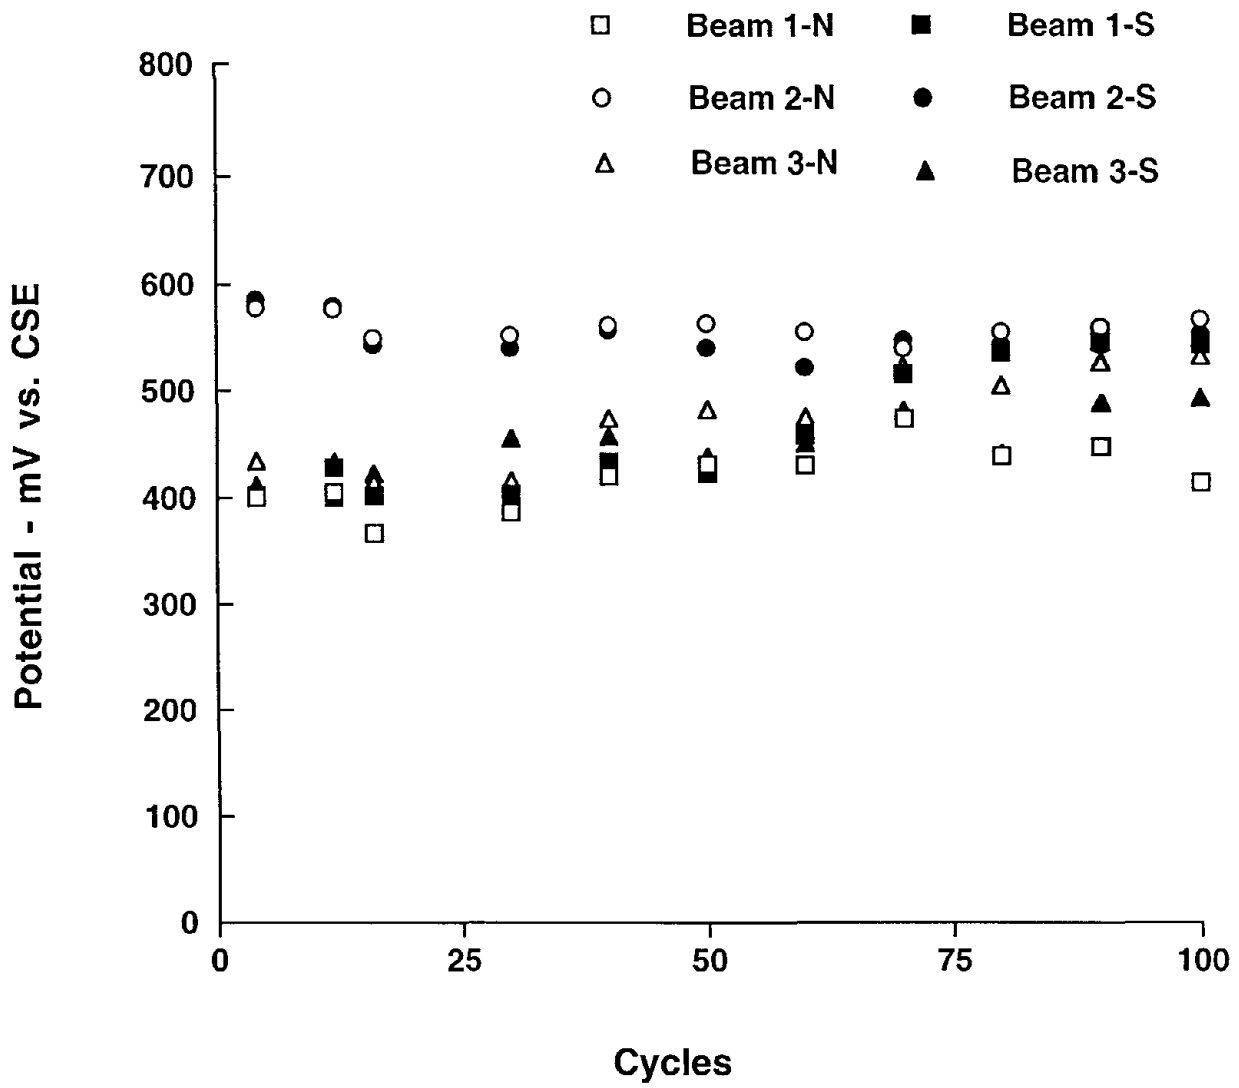
Figure 35. Average half-cell potentials in beam repair areas over 100 cycles of testing.

Trend of potentials within the beam repair areas over the entire 100 cycles of testing is shown in Figure 35. Potentials for beam 2 in both repair areas stay the highest throughout the course of monitoring. While potentials for beams 1 and 3 were comparable to 30 cycles, at the 40-cycle point, a dramatic decrease in potentials for beam 3 was noted. However, there were no dramatic differences in the appearance of the surfaces of the repair areas in these beams. In fact, as can be

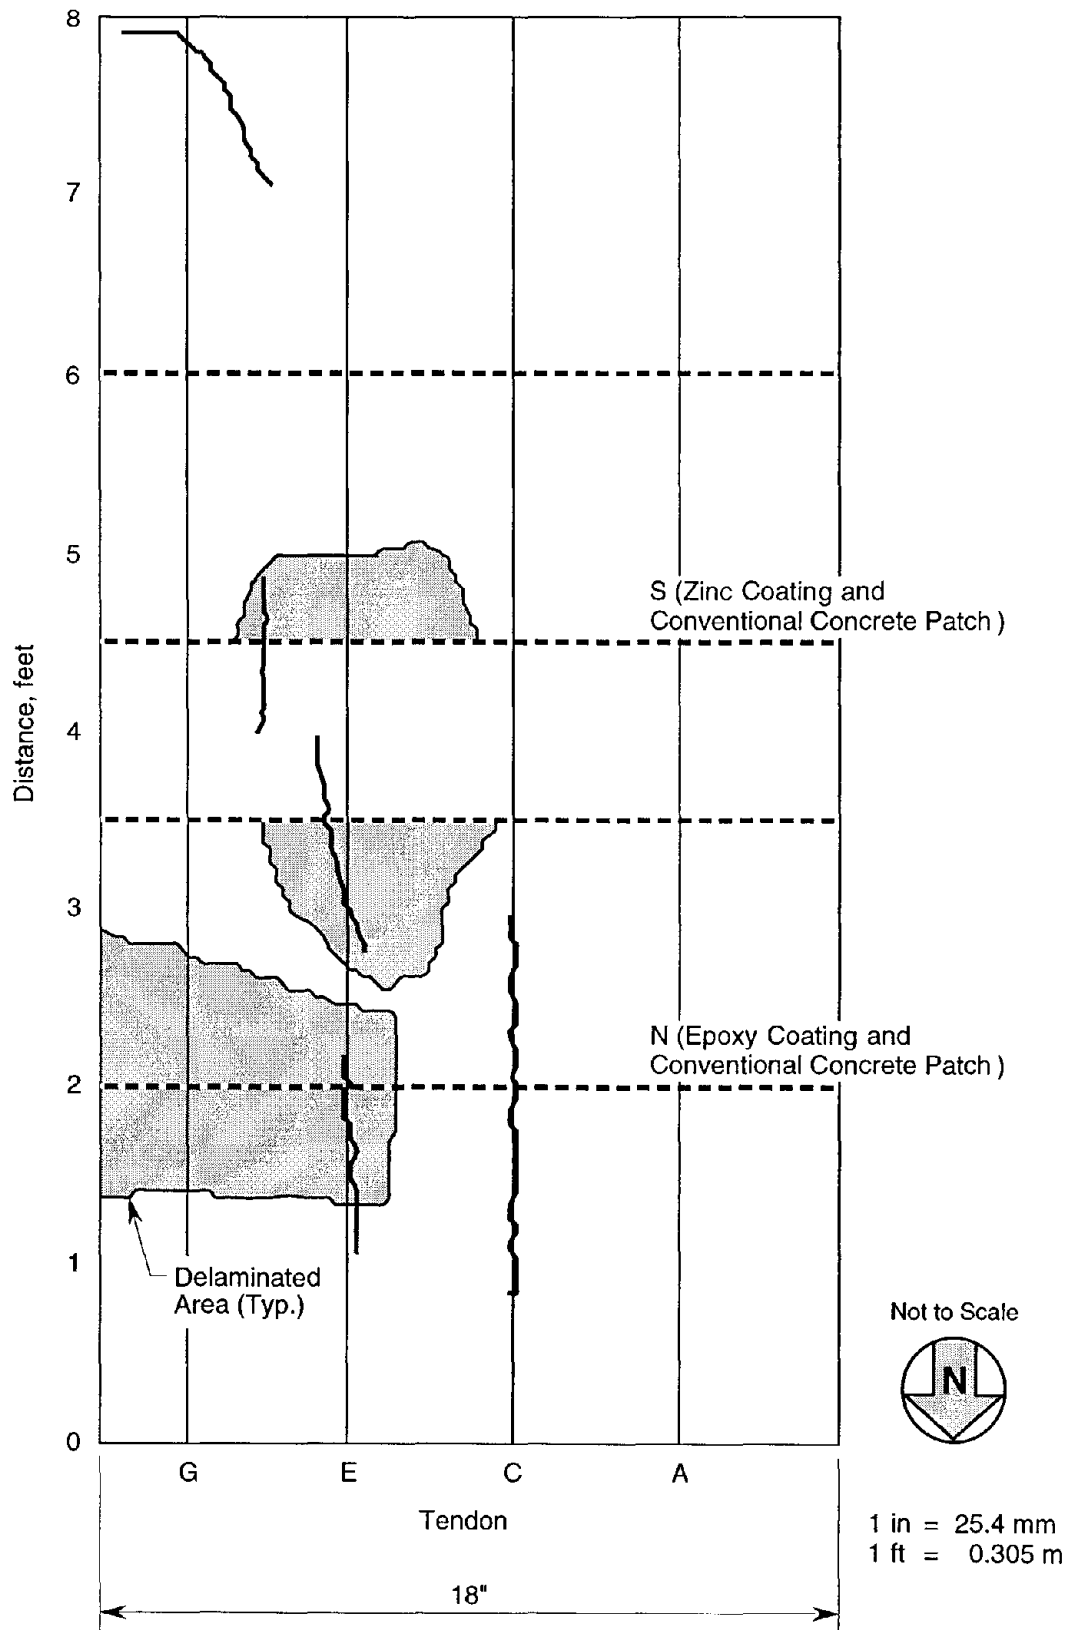
Figure 36. Crack map for beam 1 at 100 cycles of exposure.

seen in Figures 36 through 38, cracking and delamination were just as prevalent, if not more so, in beams 1 and 3 than in beam 2.

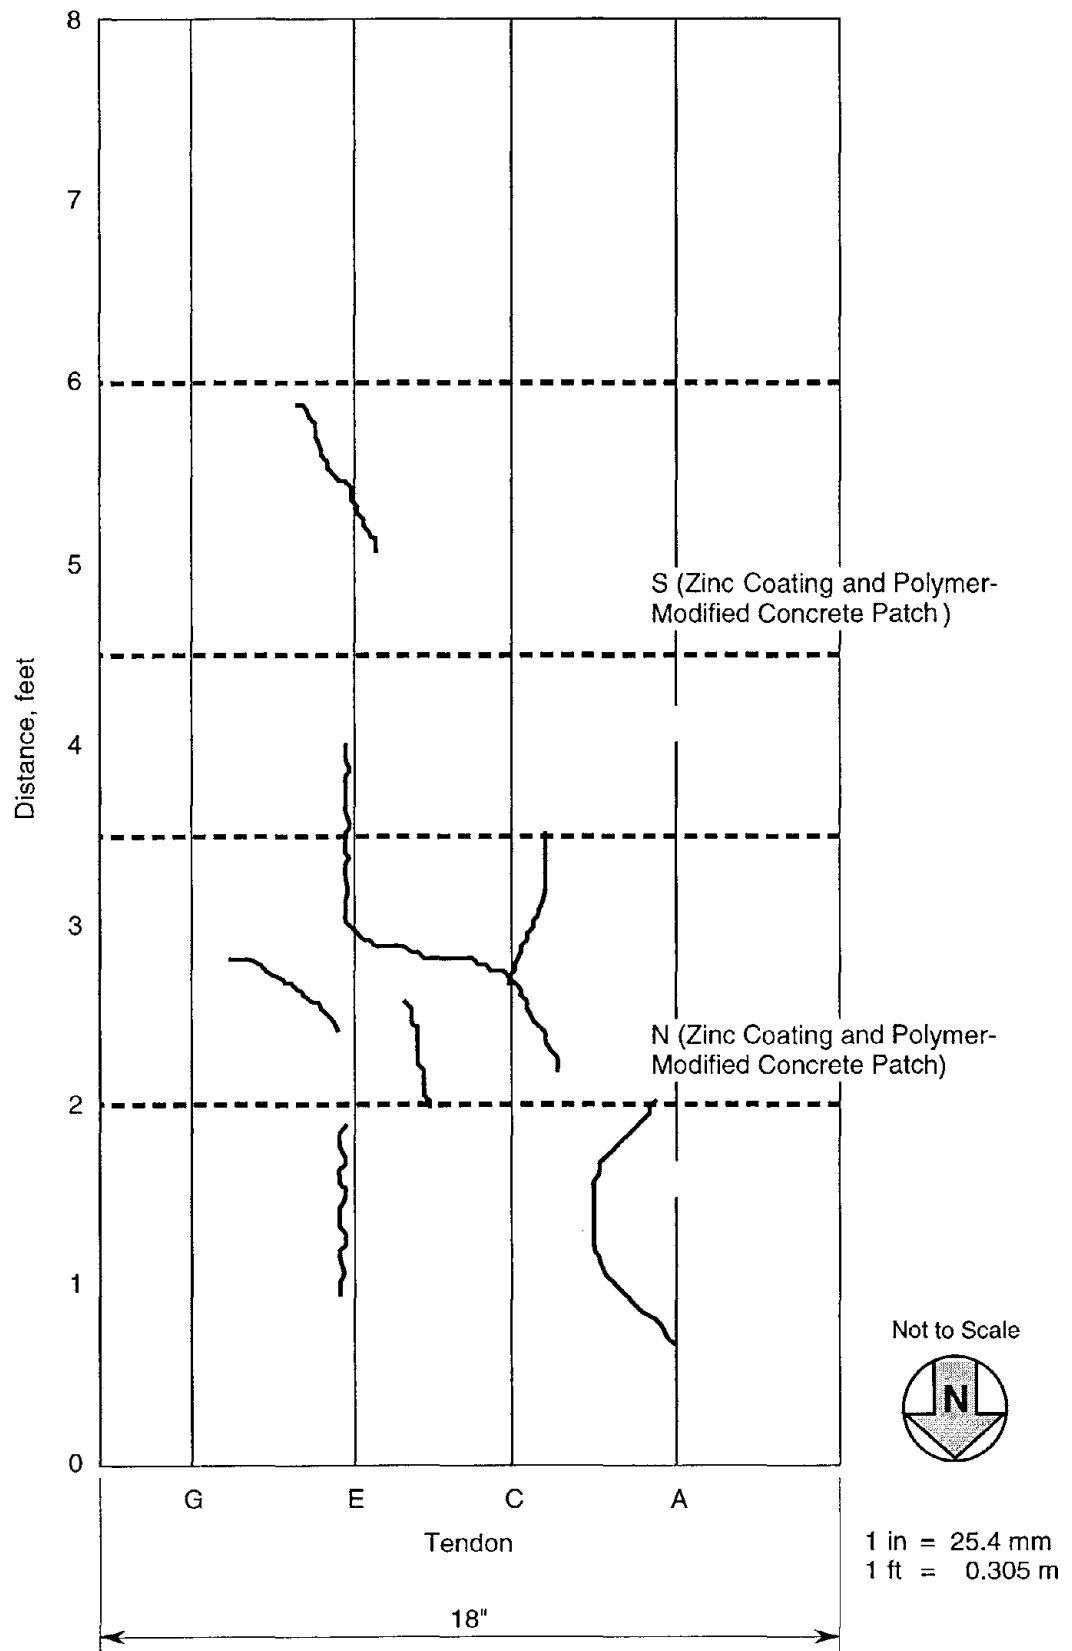
Figure 37. Crack map for beam 2 at 100 cycles of exposure.

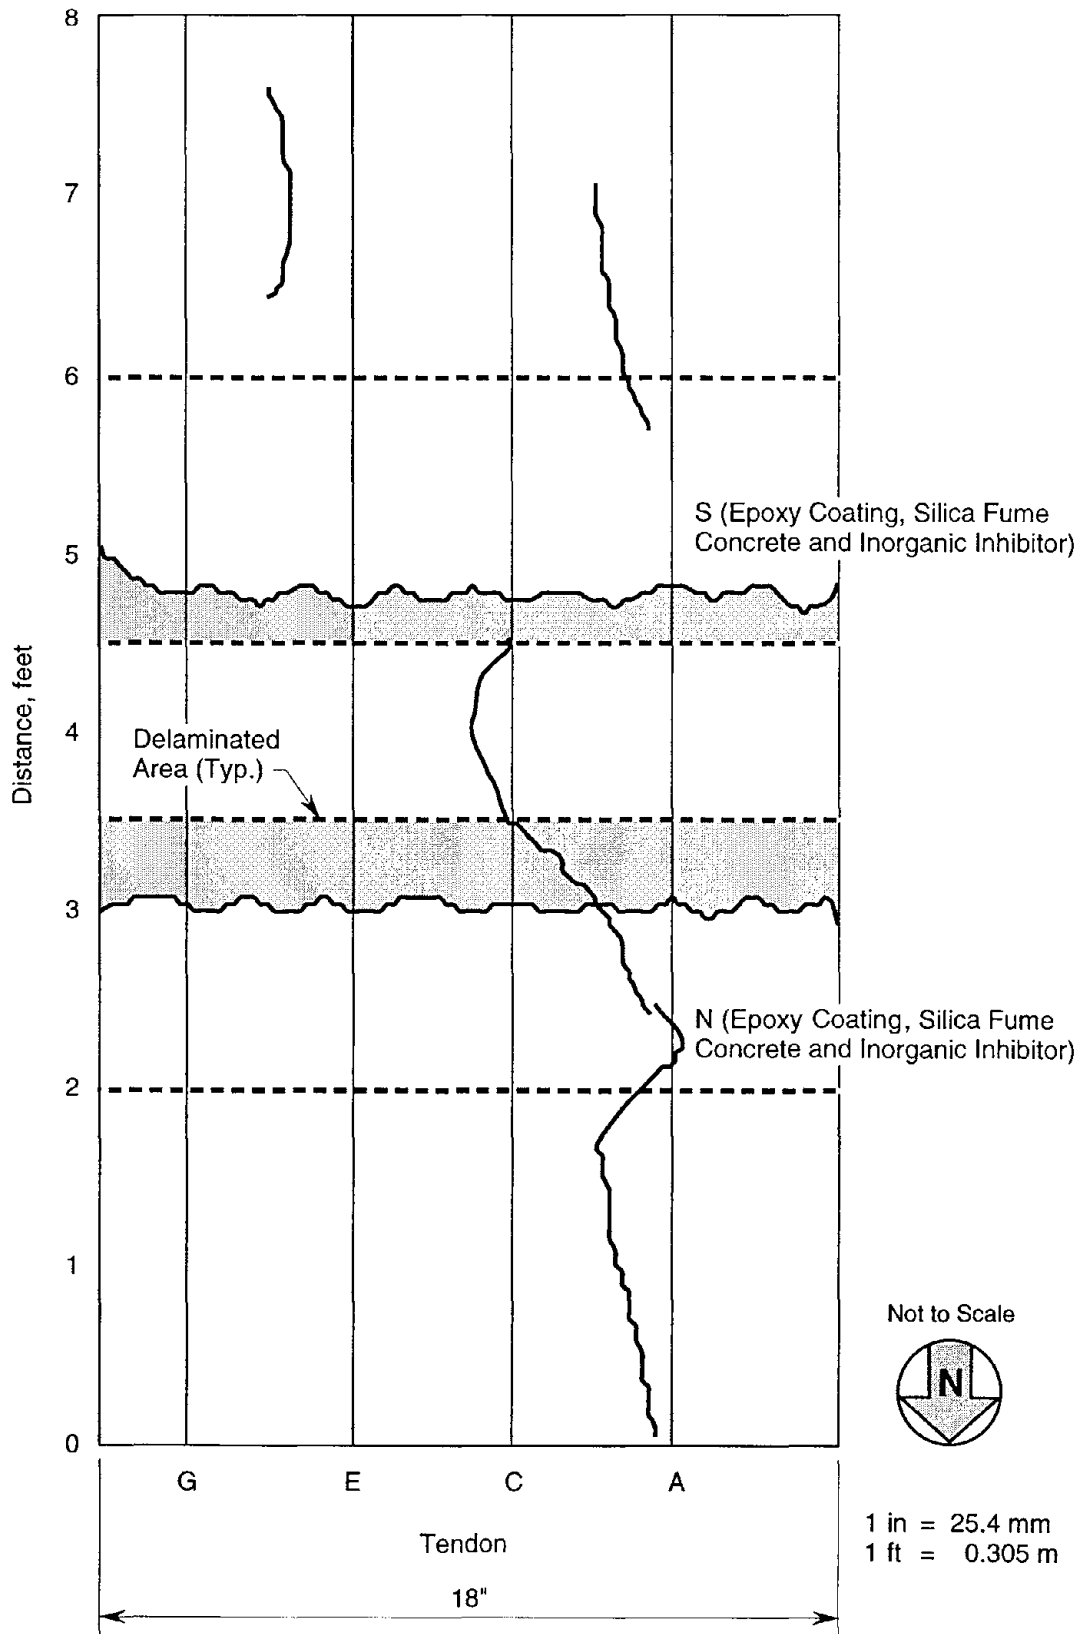
Figure 38. Crack map for beam 3 at 100 cycles of exposure.

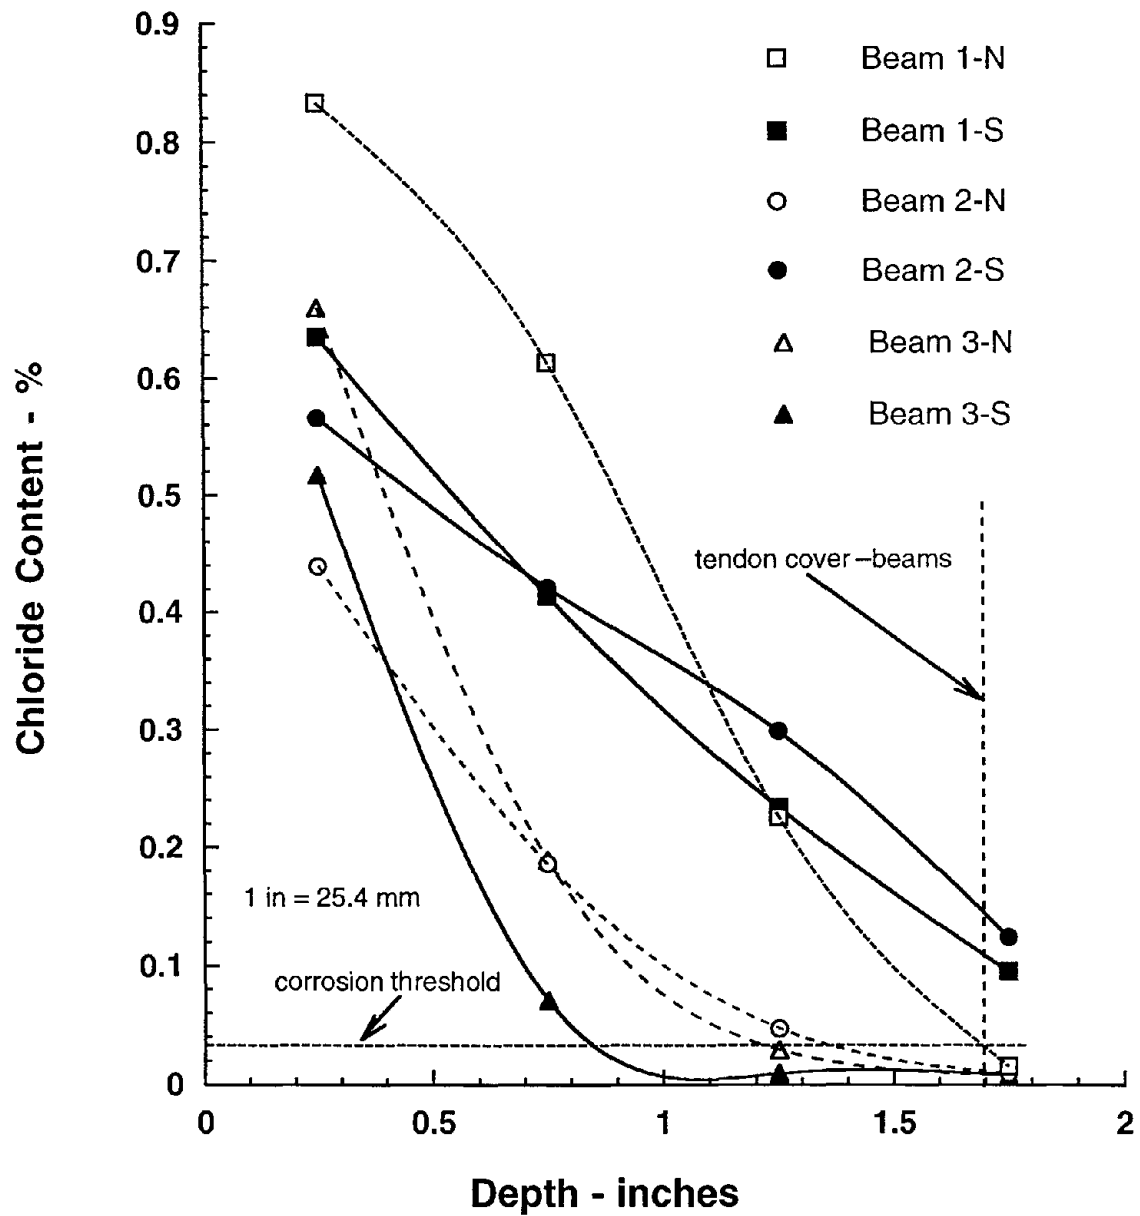
Figure 39. Chloride contents measured on beam repair specimens.

Results are shown in Figure 39. In contrast to the slab specimens, the chloride contents vary considerably between the two locations on the same specimen. This may be a function of the greater amount of cracking observed on the beam as opposed to the slab repairs. This tends to be supported by the shape of some of the chloride profiles. Some, such as that for beam 1-N, start at relatively high values of chloride, but fall well below threshold at tendon depth. Other profiles are somewhat "flatter" across the depth, indicative of cracks that may let chloride in to greater depths faster than would penetrate into a crack-free material. Areas 1-S and 2-S show chloride contents that exceed the corrosion threshold at tendon level. All other areas show chloride contents less than threshold at this depth. However, in at least one case (1-N), there is a considerable "reservoir" of chloride that has entered the repair area, and it is likely that the threshold would have soon been exceeded at tendon level for this specimen.

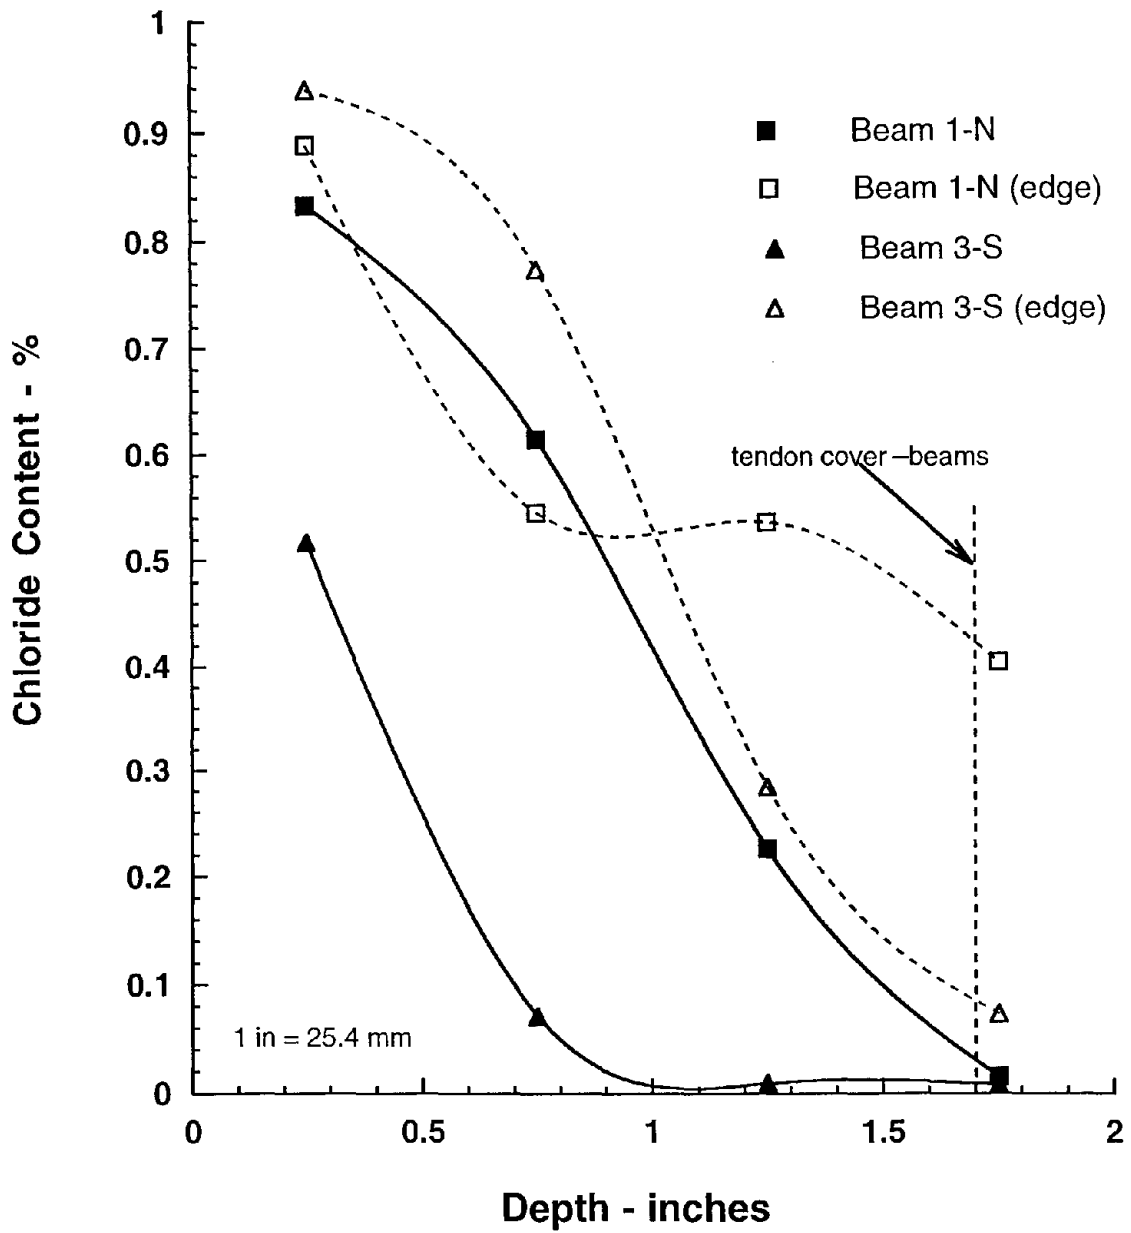
Figure 40. Comparison of chloride contents measured at center and near edges of beam repair patches.

As was done for the slab repairs, a series of additional drill samples were obtained in positions approximately 40 mm (1.5 in) in from the edge of one of the two patches on each slab. Chloride profiles were obtained at each of these locations. Results are shown in Figure 40. Data for slab 2 are not included, as unexpectedly high chloride contents (1 to 2 percent) were obtained. It is likely that this was due to cracking at the patch edge that brought large amounts of chloride into this locality. As can be seen for the remaining two patches, chloride contents at the edge of the slab exceed those at the center for beam 3 at all depths and for beam 1 at the last two sampling increments. As for the slabs, lateral penetration of chloride was found to extend approximately 75 mm (3 in) from the patch edges into the patch.

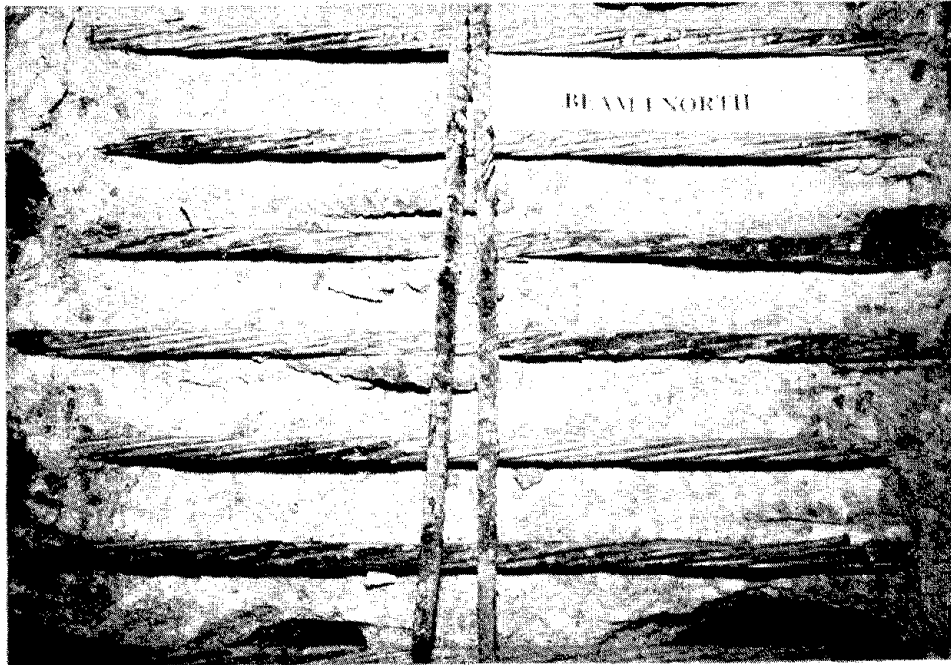
Figure 41. Appearance of uncovered tendons and reinforcing steel in north repair area, beam 1, after 100 exposure cycles.

Dissection. After all drill samples had been obtained and analyzed, the tendons and reinforcing steel in the patch areas were uncovered by air-hammer removal of the concrete cover. In comparison with the slabs, it was possible to remove the patch without breakout of the concrete substrate. Photographs of steel in beam 1 (conventional concrete patches) in the north (epoxy coating) and south (zinc-rich coating) patches are shown in Figures 41 and 42. There is significant loss of coating on the tendons in the north patch, and corrosion on the underlying tendon surface, especially near the edge of the patch. The plain reinforcement has also suffered loss of coating and corrosion. In the south patch (Figure 42), coating has also been lost, and there are spots showing corrosion of the tendons. After documentation of the external appearance of the tendons, cuts were made in each tendon and the individual strands pulled back from the bundles. Figure 43 shows some of the interior portions of the strands in the north patch. As in the slab patches, considerable rusting of the tendons in the interior of the bundle is obvious when the strands are pulled back, as can be seen in the middle tendon shown in Figure 43. This can be compared with the exterior surface of the tendon at the bottom of the photo, where, although coating has been lost, no corrosion can be seen on the exterior strand surfaces. The same procedure was carried out on the zinc-coated strands in the south patch. Figure 44 shows strands pulled back from the lower bundle, which had not shown any exterior corrosion. Rusting is noticeable on the interior of the strands.

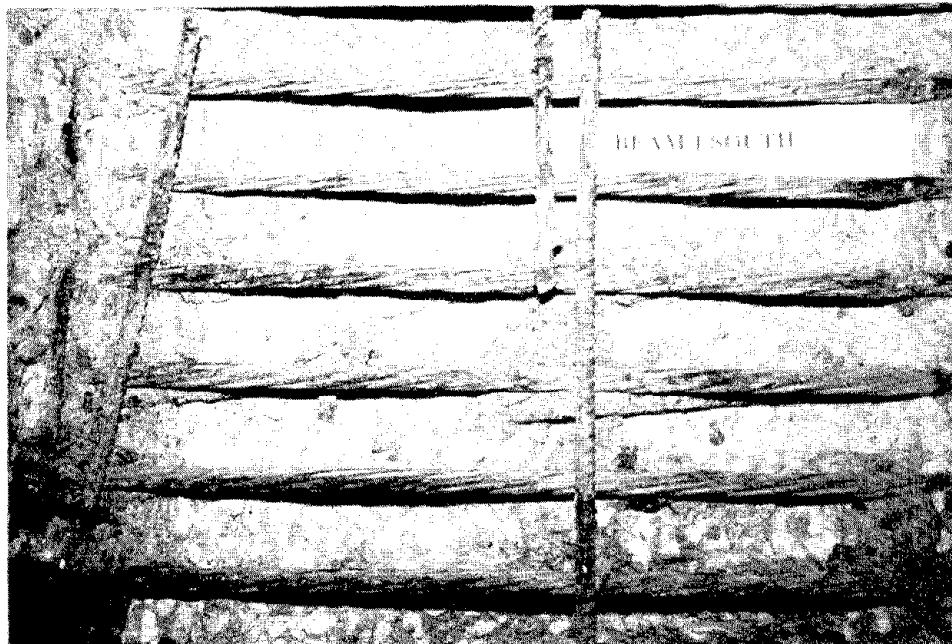
Figure 42. Appearance of uncovered tendons and reinforcing steel in south repair area, beam 1, after 100 exposure cycles.

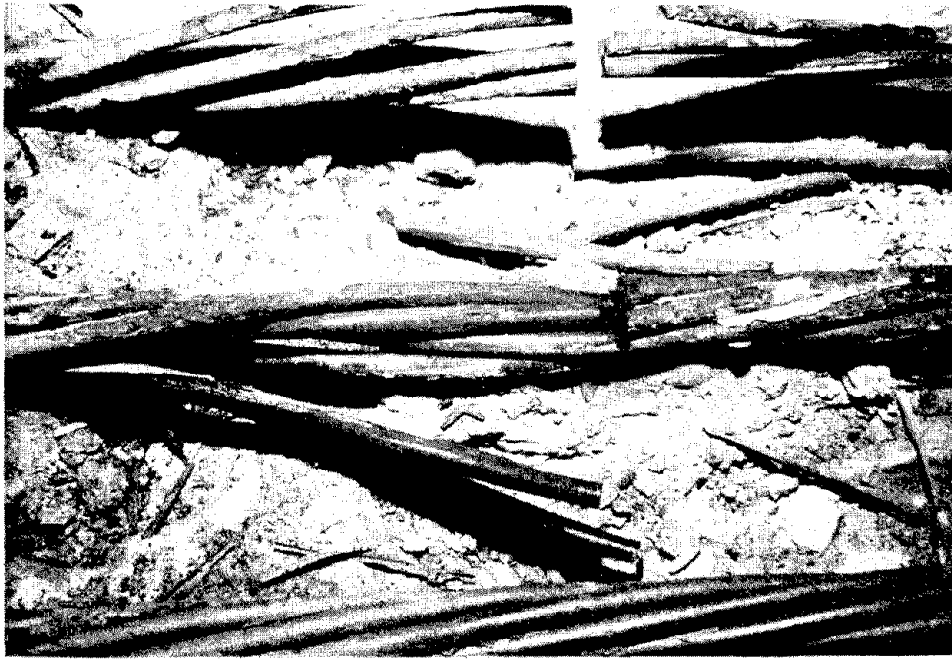
Figure 43. Appearance of interior of tendon bundle in north repair area, beam 1, after 100 exposure cycles.

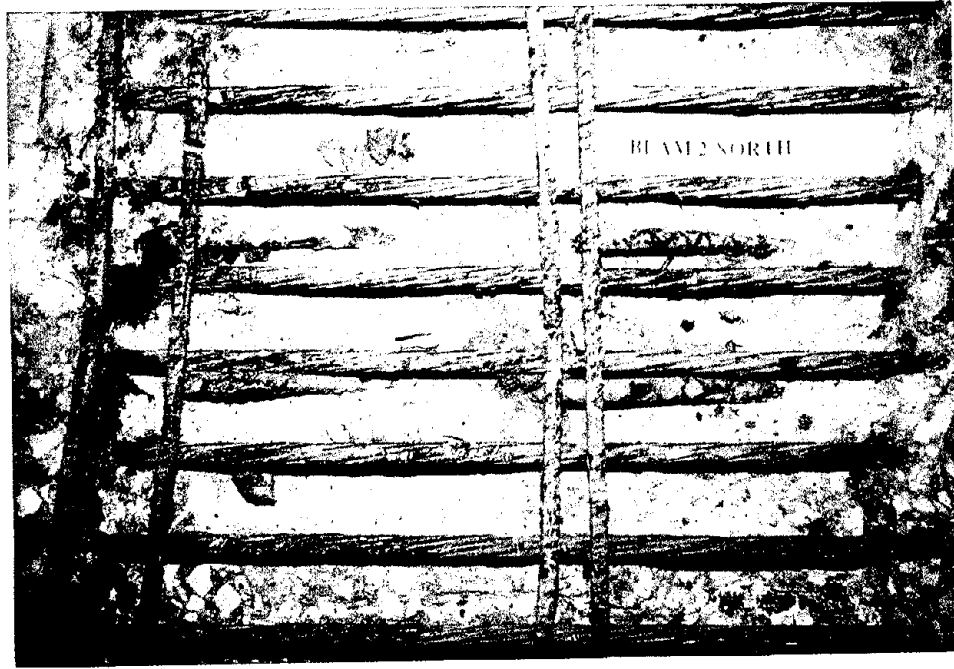
Figure 45. Appearance of uncovered tendons and reinforcing steel in north repair area, beam 2, after 100 exposure cycles.

Uncovered tendons and reinforcing steel in patches on beam 2 (latex-modified concrete patches) are shown in Figures 45 (north-patch epoxy) and 46 (south-patch zinc). On the epoxy-coated tendons, the coating failure is similar to that for the corresponding beam 1 patch; however, there is more corrosion on the tendons, especially at the patch edges. The rebar at the edge of the patch shows significant coating failure and numerous areas of corrosion. In the south (zinc) patch, there is more loss of coating than in the corresponding beam 1 patch and more corrosion at the patch edges. There are areas of corrosion on the reinforcing steel that lies below the level of the tendons. Upon cutting and peel-back of the individual strands from one of the tendons in the north repair area, extensive corrosion of the interior of the bundle was observed (Figure 47). Corrosion of interior strands was also observed in the zinc-coated area (Figure 48).

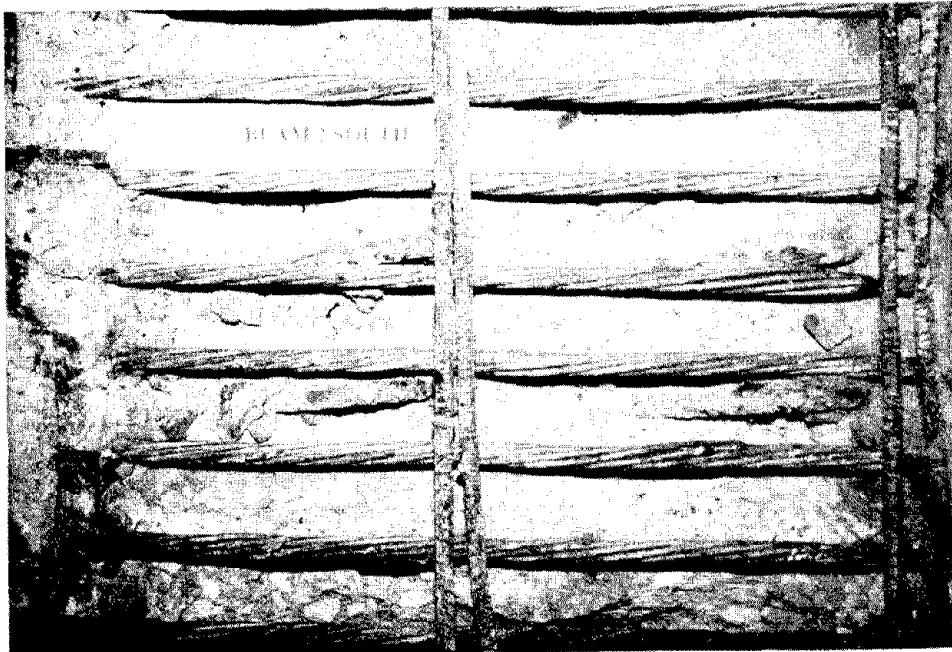
Figure 46. Appearance of uncovered tendons and reinforcing steel in south repair area, beam 2, after 100 exposure cycles.

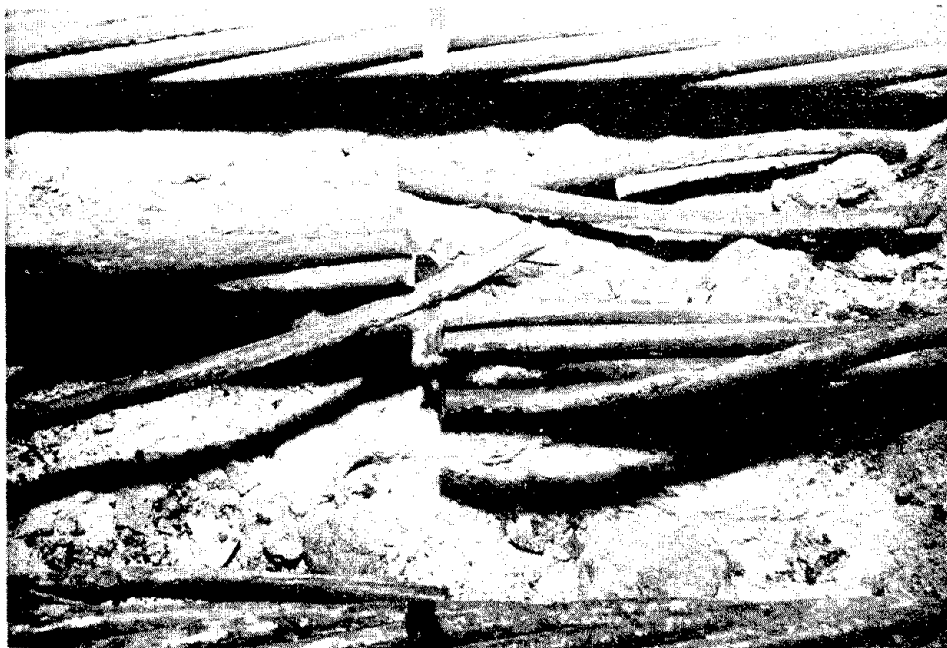
Figure 48. Appearance of interior of tendon bundle in south repair area, beam 2, after 100 exposure cycles.

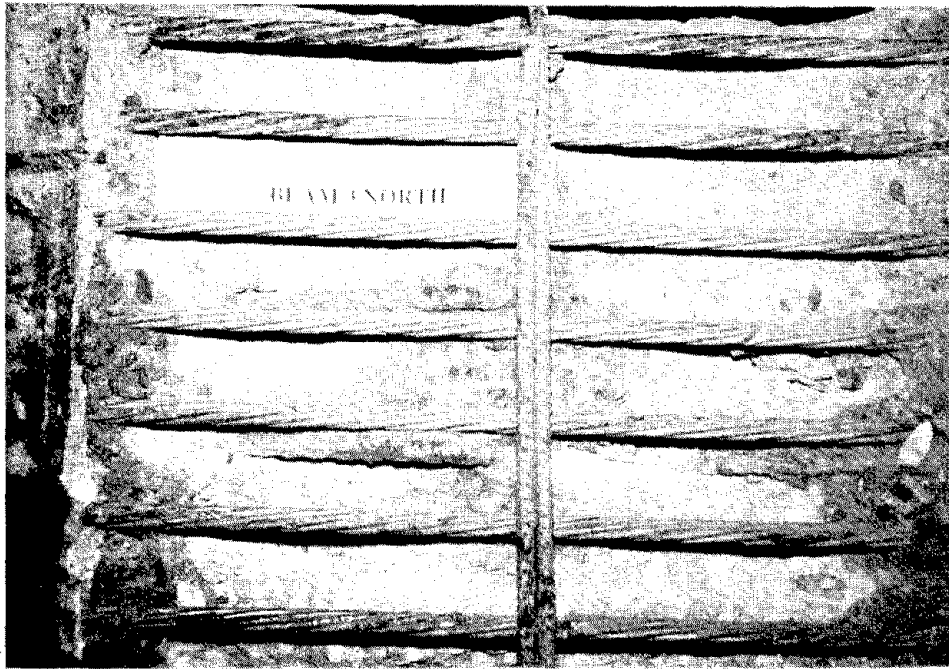
Figure 49. Appearance of uncovered tendons and reinforcing steel in north repair area, beam 3, after 100 exposure cycles.

Uncovered tendons and steel in beam 3 (silica fume concrete with inorganic corrosion inhibitor) are shown in Figures 49 and 50 for epoxy-coated and zinc-coated steel, respectively. Here, in both areas, while there appears to be loss of coating, corrosion is much less prevalent than for the previous two beams. There is no corrosion visible on the reinforcing steel in the epoxy-coated area, and only a couple of minor spots of corrosion on the reinforcing steel in the zinc-coated area.

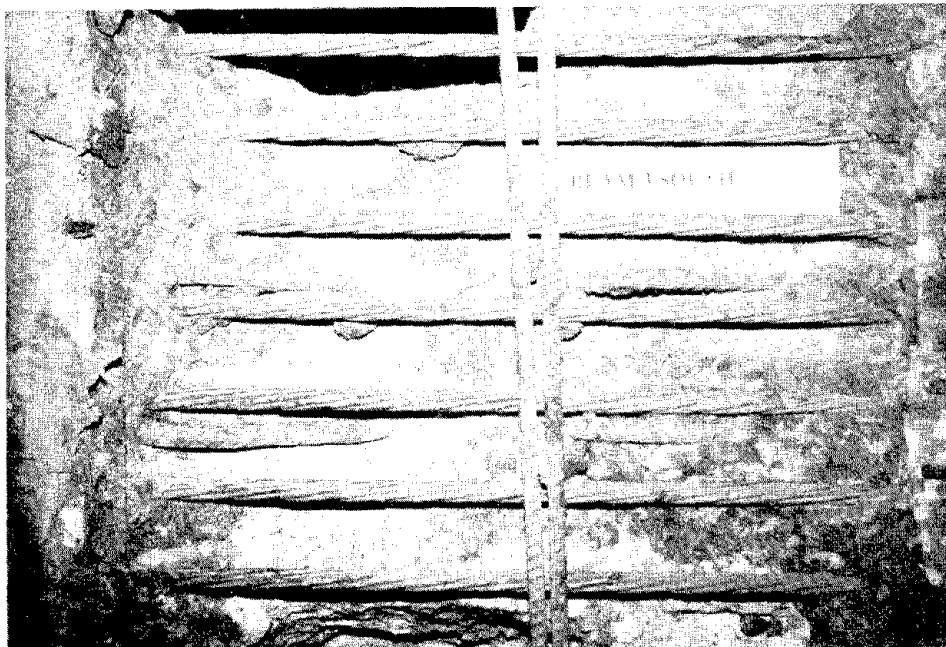
Figure 50. Appearance of uncovered tendons and reinforcing steel in south repair area, beam 3, after 100 exposure cycles.

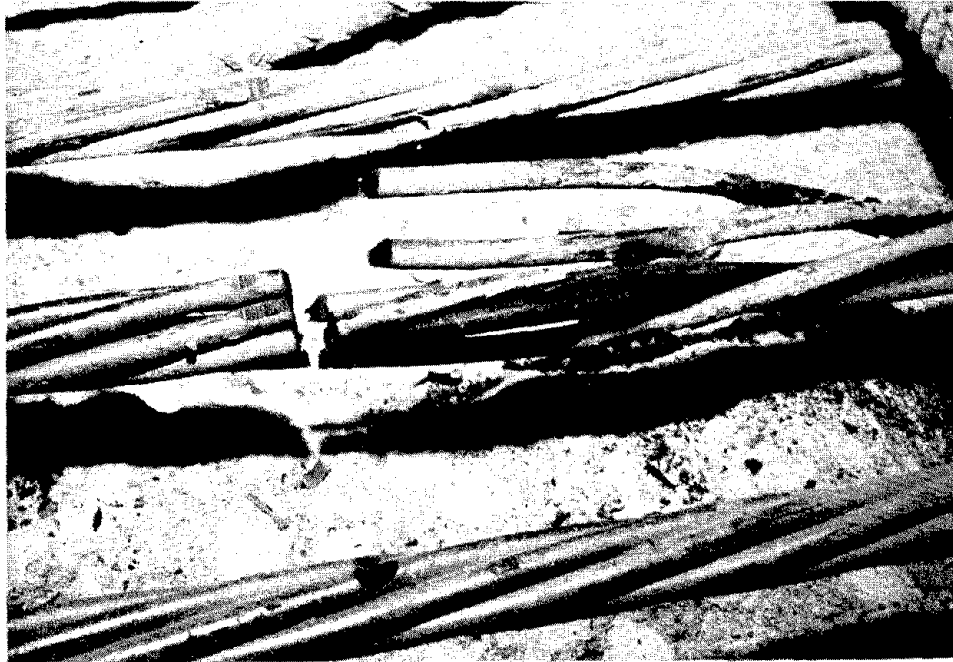
Figure 51. Appearance of interior of tendon bundle in north repair area, beam 3, after 100 exposure cycles.

While pulling back individual strands does exhibit rusting on the epoxy-coated strands (Figure 51), there is much less on the zinc-coated strands in the inhibited patch (Figure 52).

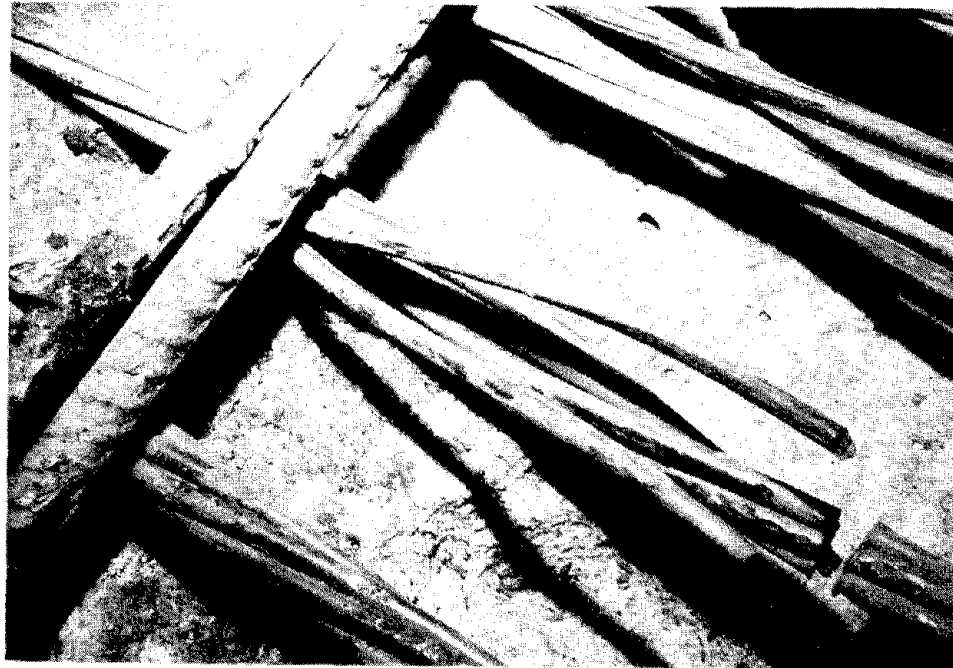
Figure 52. Appearance of interior of tendon bundle in south repair area, beam 3, after 100 exposure cycles.

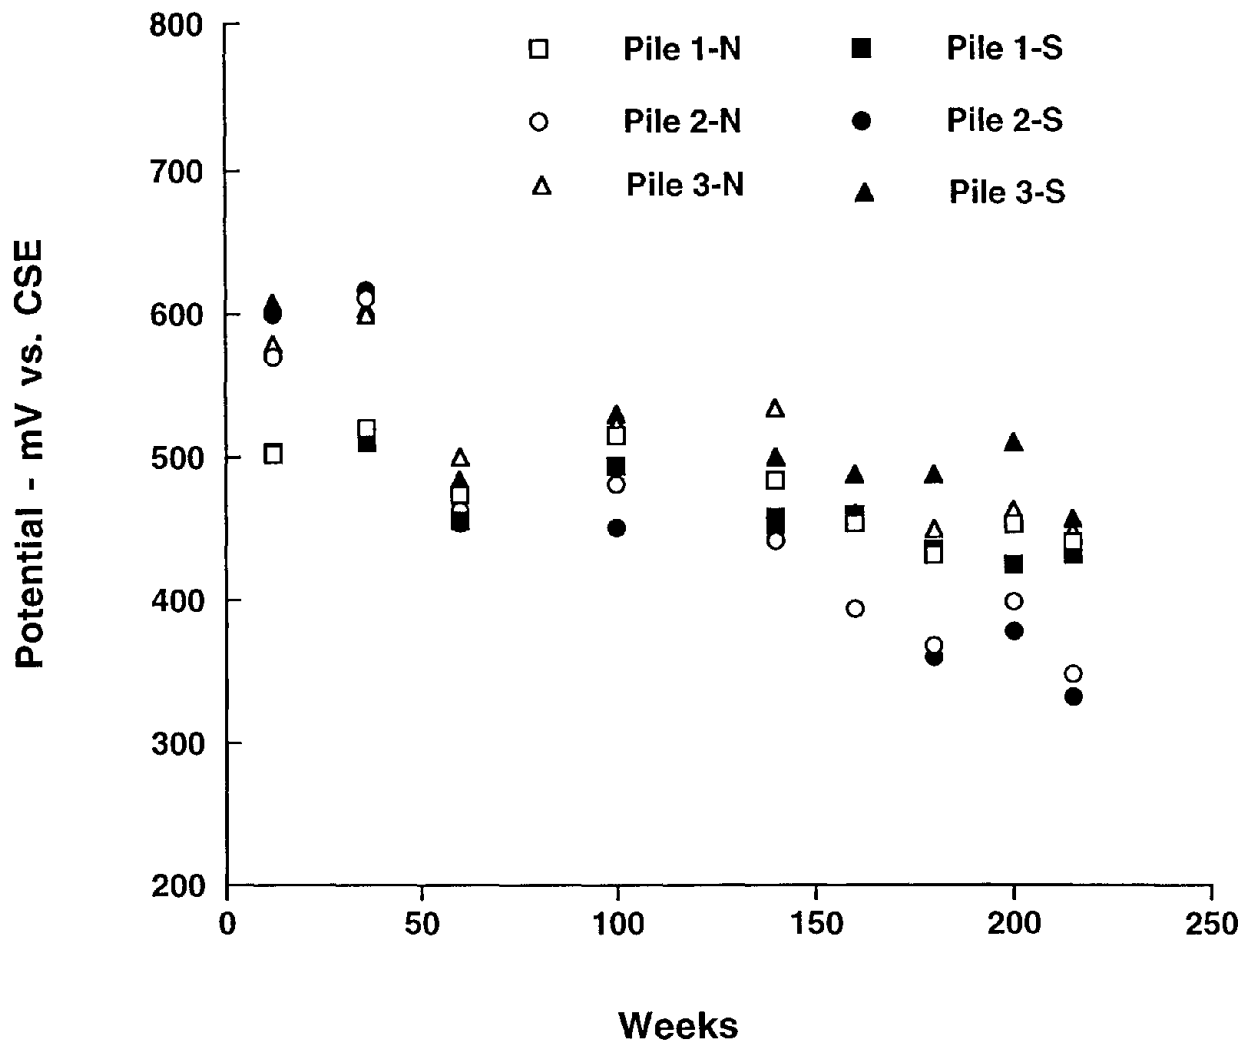
Figure 53. Average half-cell potentials in pile repair areas over 215 weeks of tidal cycling.

The trend of the potentials within the pile repair areas over the entire 215 weeks of testing is shown in Figure 53. In contrast to the beams and slabs, there are no clearly consistent differences

between the various repair areas on the pile specimens. Overall, there appears to be a progressive decrease in absolute value of potential over the course of the monitoring. As the repair areas are almost continuously saturated, this may reflect a long-term hydration of the cement, resulting in a denser microstructure, lower permeability, and higher resistivity.

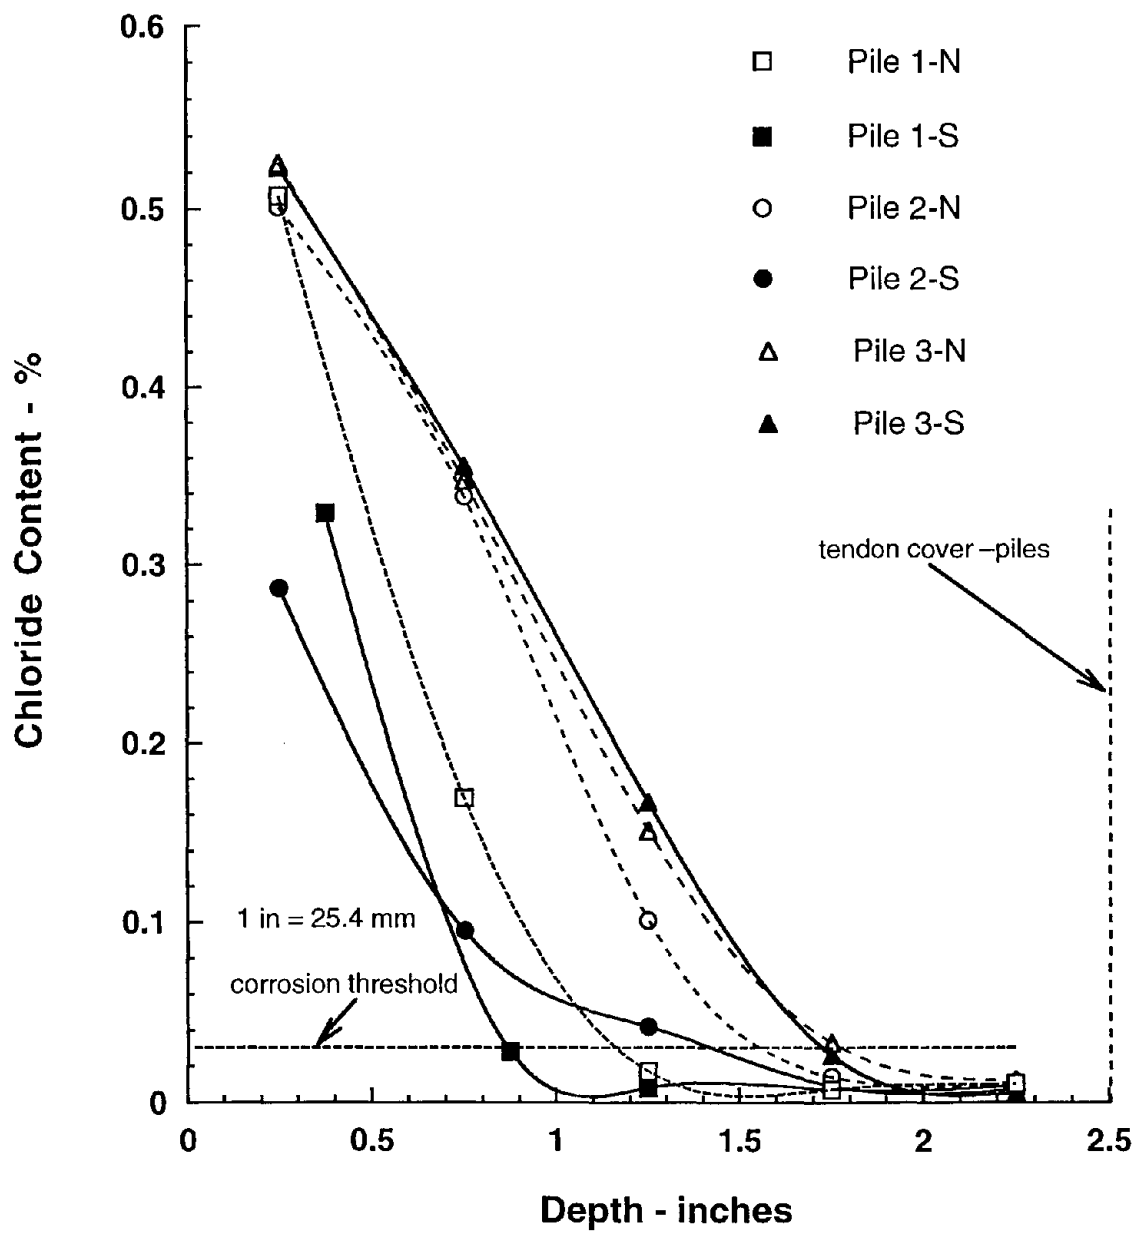
Figure 54. Chloride contents measured on pile repair specimens.

Chemical Analysis. After completion of monitoring, the piles were removed from the tidal tanks and samples were obtained from each specimen for chemical analysis. Sample locations were at the center of each repair area at opposing faces of each pile. Samples were taken at 12-mm (0.5-in) increments down to a level of 64 mm (2.5 in), and analyzed for total chloride ion. Samples taken from pile 1 were also analyzed for nitrite ion content, as the patching material for this pile was silica fume concrete with inorganic corrosion inhibitor. Results are shown in Figure 54. Significant amounts of chloride had penetrated the upper levels of the patches. The silica fume patches (1-N and 1-S) showed the least penetration, along with patch S on pile 2 (latex-modified material). However, there was essentially no chloride ion detected at the level of the prestressing strands in any of these specimens. This is predominantly due to the fact that clear cover for the piles was significantly greater than for the beam or slab specimens. Nitrite ion contents ranged from 0.11% at the first increment (likely reflecting some leaching out into the saltwater) and 0.17% at the remaining levels.
