Rehabilitation of Prestressed Concrete Bridge Components by Non-Electrical (Conventional) Methods

PUBLICATION NO. FHWA-RD-98-189

FEBRUARY 1999

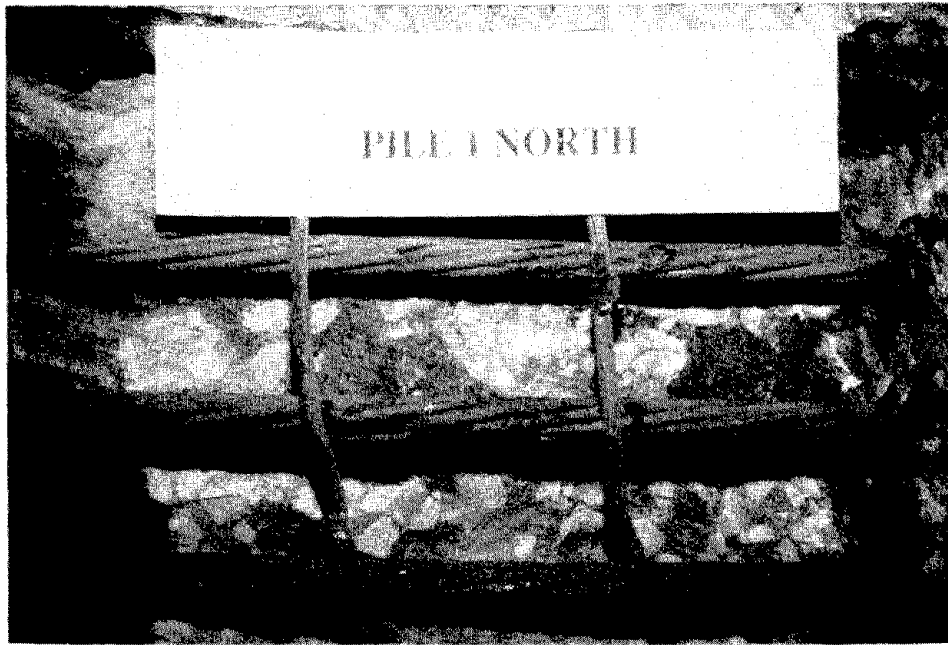
Figure 55. Appearance of uncovered tendons and reinforcing steel in north repair area, pile 1, after 215 weeks of tidal cycling.

Dissection. After all drill samples had been obtained and analyzed, the tendons and reinforcing steel in the patch areas were uncovered by air-hammer removal of the concrete cover. Photographs of steel in pile 1 (silica fume concrete patches) in the north (epoxy coating) and south (zinc-rich coating) patches are shown in Figures 55 and 56. There was some loss of coating in the epoxy-coated area, but significantly less than in the corresponding patch on the beam or slab specimens. Some rusting was noted in areas where the coating had disbonded from the tendons. In the zinc-coated areas, there was some slight loss of coating, but no noticeable corrosion on the external surfaces of the tendons. After documentation of the external appearance of the tendons, cuts were made in each tendon and the individual strands were pulled back from the bundles. Figure 57 shows some of the interior portions of the strands in the north patch. As in the slab and beam patches, rusting of the tendons in the interior of the bundle is obvious when the strands are pulled back, demonstrating again that corrosion may occur even though the coating overall appears to be sound and chlorides have apparently not penetrated through repaired areas to the steel from the external environment. When the interiors of the other two tendons in this patch were examined, less rusting was observed. The same procedure was carried out on the zinc-coated strands in the south patch. Figure 58 shows strands pulled back from the lower bundle, which had not shown any exterior corrosion. Again, rusting is noticeable on the interior of the strands. The center

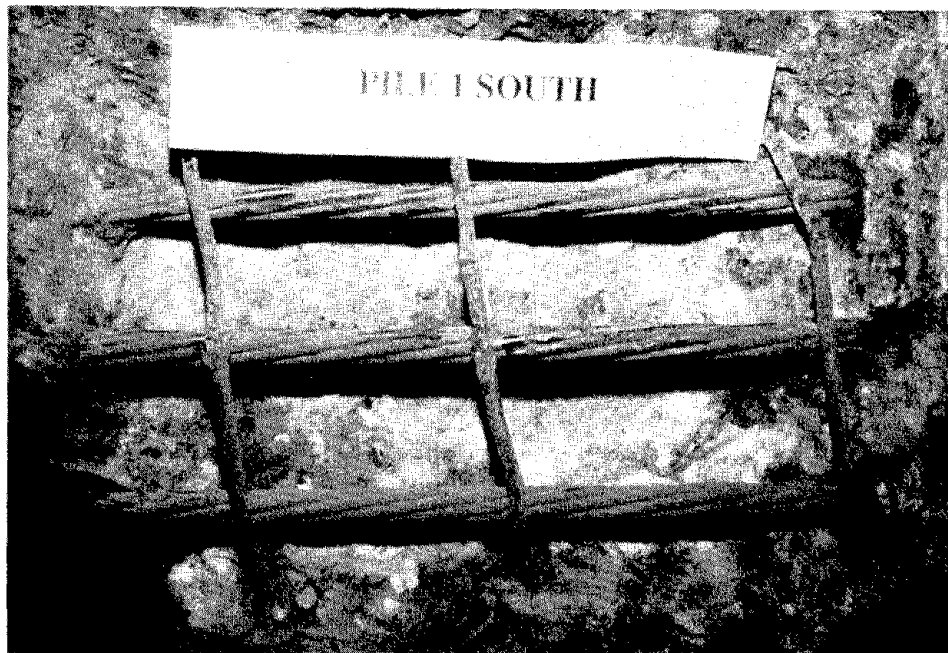
Figure 56. Appearance of uncovered tendons and reinforcing steel in south repair area, pile 1, after 215 weeks of tidal cycling.

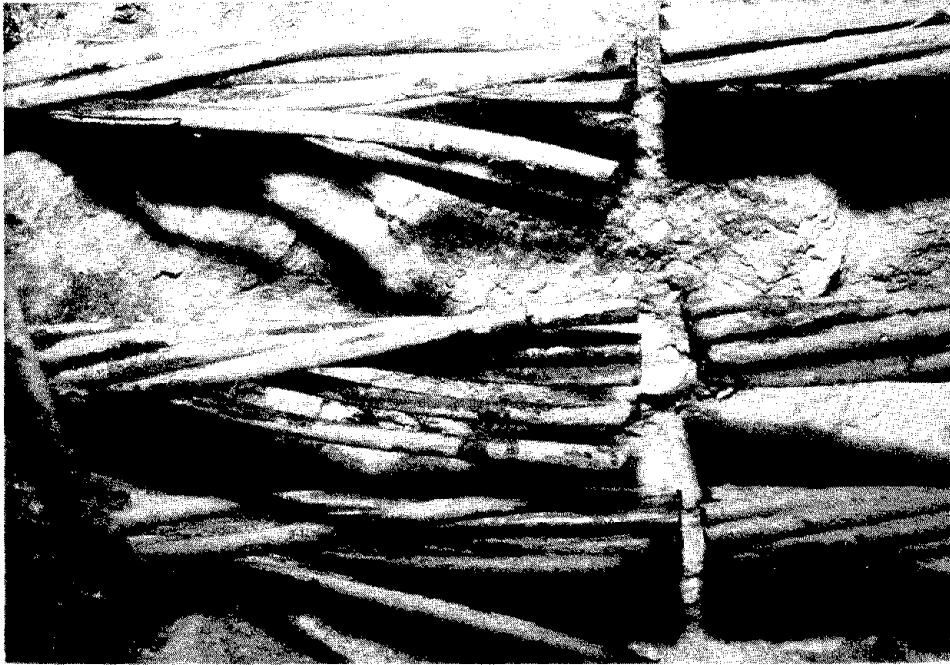
Figure 57. Appearance of interior of tendon bundle in north repair area, pile 1, after 215 weeks of tidal cycling

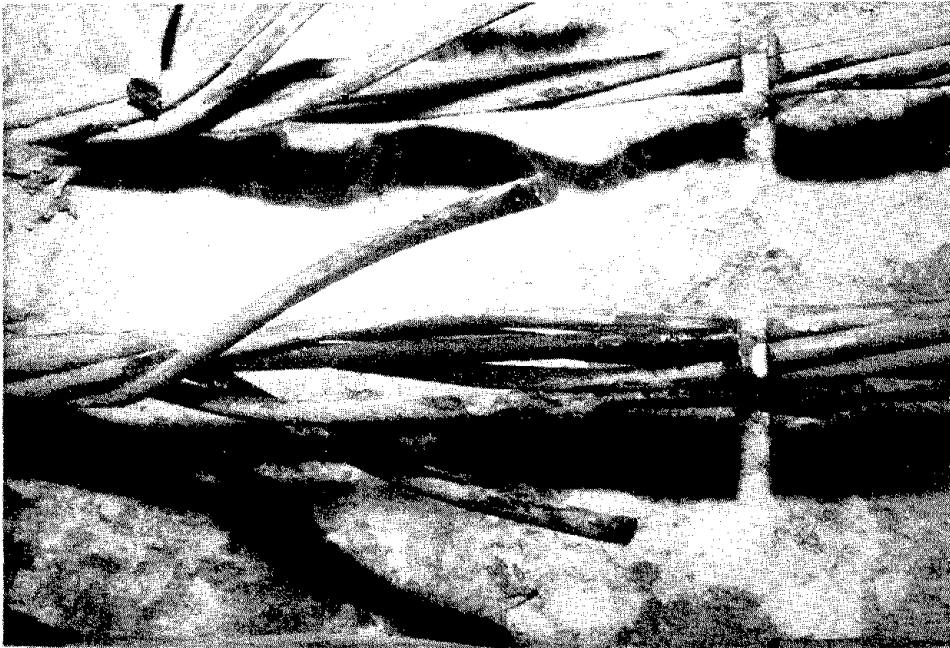
Figure 58. Appearance of interior of tendon bundle in south repair area, pile 1, after 215 weeks of tidal cycling.

tendon showed the most corrosion on the interior of the strands; less was observed on the two outer tendons.

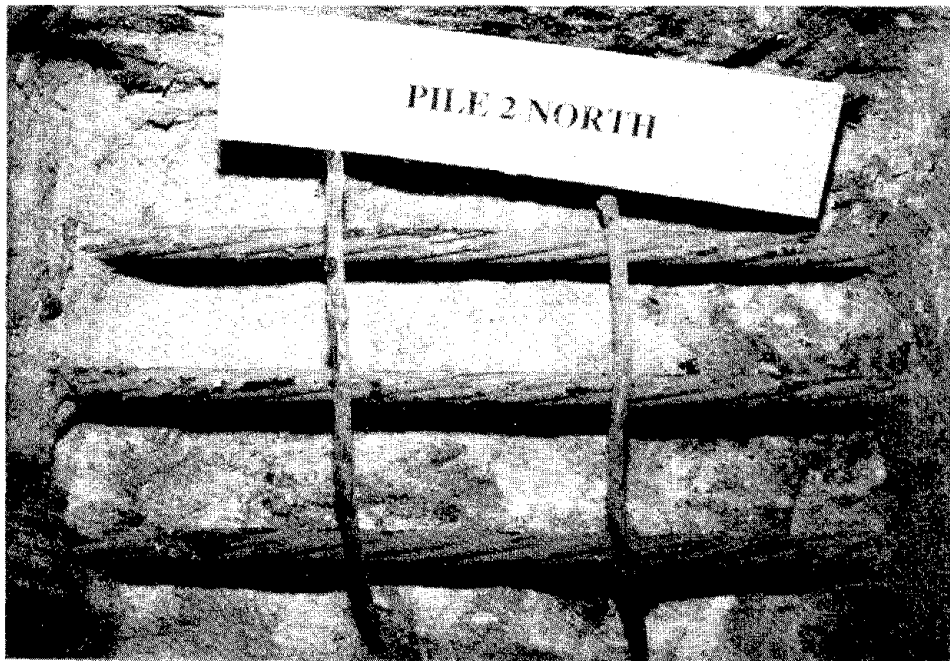
Figure 59. Appearance of uncovered tendons and reinforcing steel in north repair area, pile 2, after 215 weeks of tidal cycling.

Uncovered tendons and reinforcing steel in patches on pile 2 (latex-modified concrete patches) are shown in Figures 59 (north-patch epoxy) and 60 (south-patch zinc). On the epoxy-coated tendons, the coating failure is somewhat more extensive than in pile 1. The same is true for the zinc-coated area, where more of the zinc appears to have been lost than in the pile 1 area. Upon cutting and peel-back of the individual strands from the tendons in repair area N (epoxy), widespread corrosion of the interior of the bundles was observed (Figure 61). Corrosion of interior strands was also observed in the zinc-coated area (Figure 62).

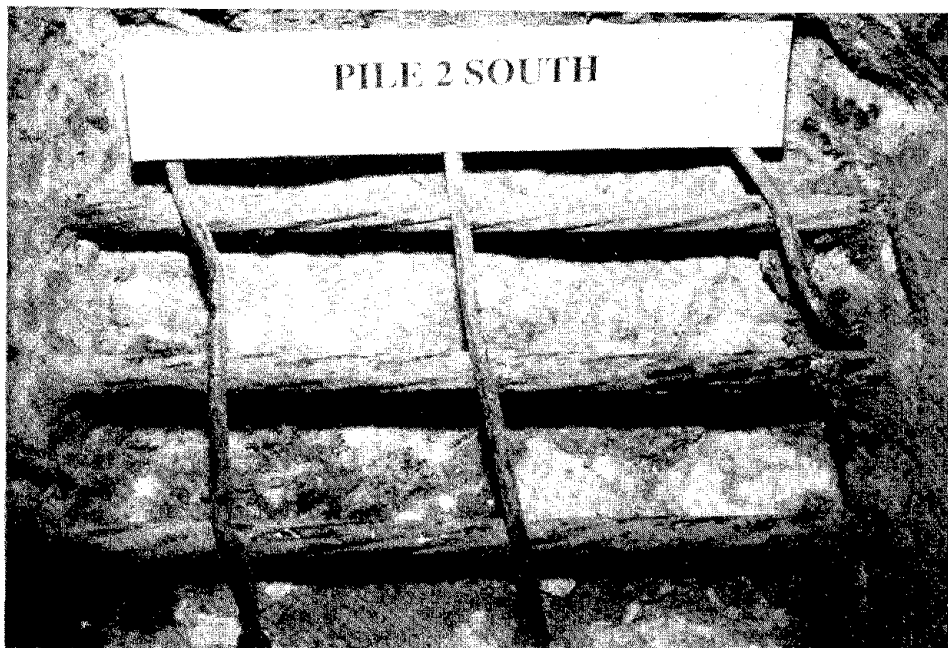
Figure 60. Appearance of uncovered tendons and reinforcing steel in south repair area, pile 2, after 215 weeks of tidal cycling.

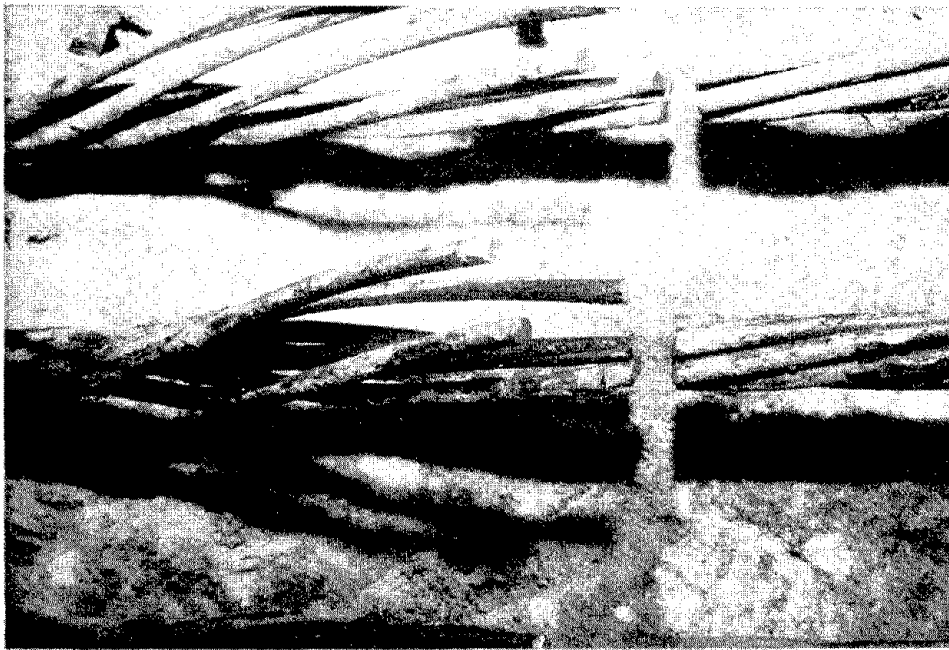
Figure 62. Appearance of interior of tendon bundle in south repair area, pile 2, after 215 weeks of tidal cycling.

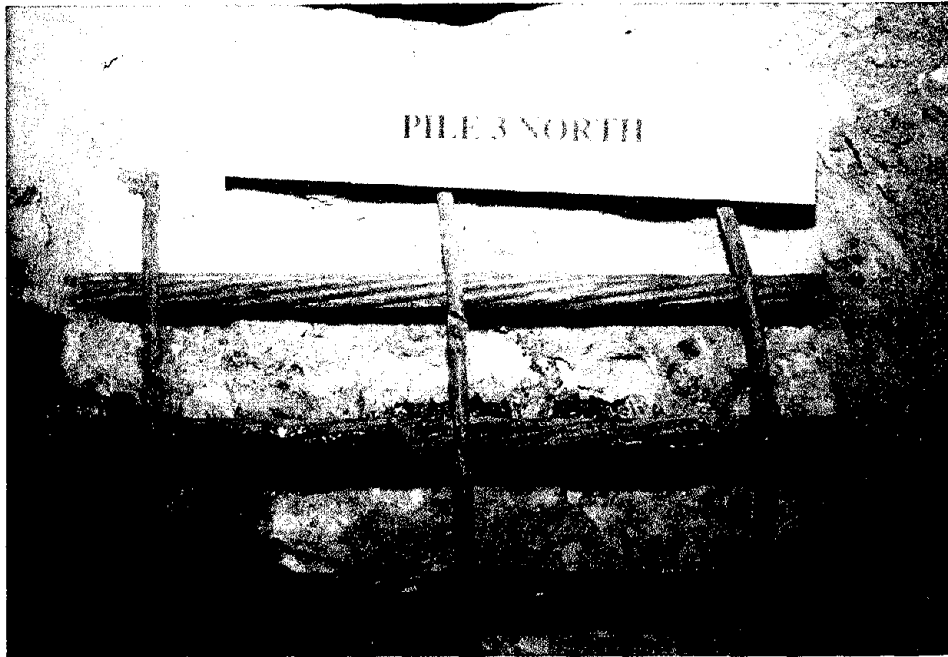
Figure 63. Appearance of uncovered tendons and reinforcing steel in north repair area, pile 3, after 215 weeks of tidal cycling.

Pile No. 3 was patched with a conventional concrete mixture. Photographs of uncovered steel are shown in Figures 63 (epoxy coating) and 64 (zinc coating). There appears to be somewhat more loss of coating and corrosion in the epoxy area for this pile as opposed to the corresponding areas on piles 1 and 2. The zinc section appears comparable to the other two piles. Figure 65 shows the interior surfaces of strands in the epoxy area after cutting and peel-back of the bundles. As for the other piles, the center strands exhibited the most interior corrosion. The corresponding zinc-coated strands are shown in Figure 66. Again, there is corrosion evident on many of the individual strands in the center bundle.

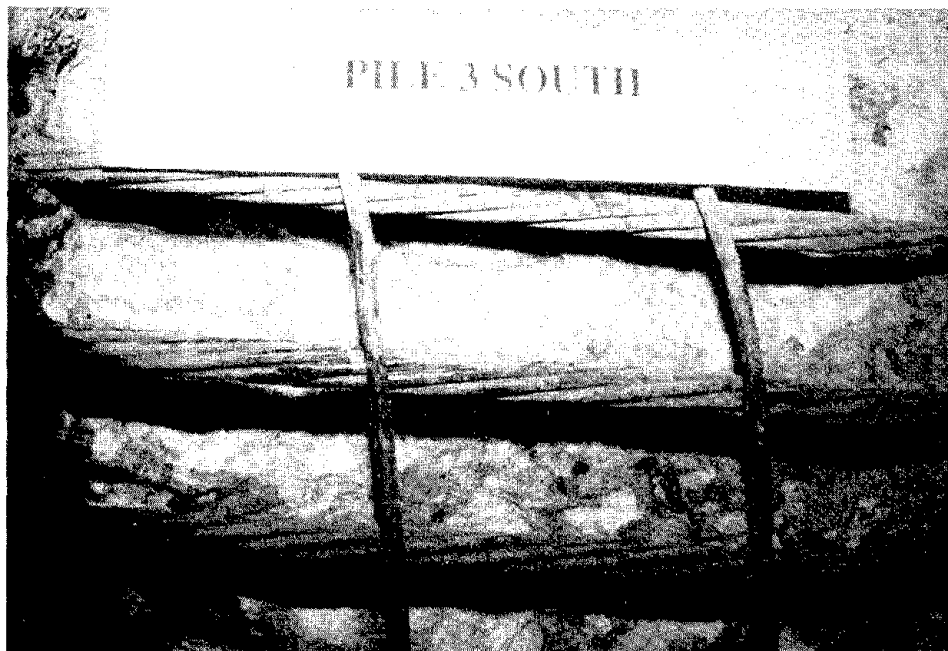
Figure 64. Appearance of uncovered tendons and reinforcing steel in south repair area, pile 3, after 215 weeks of tidal cycling.

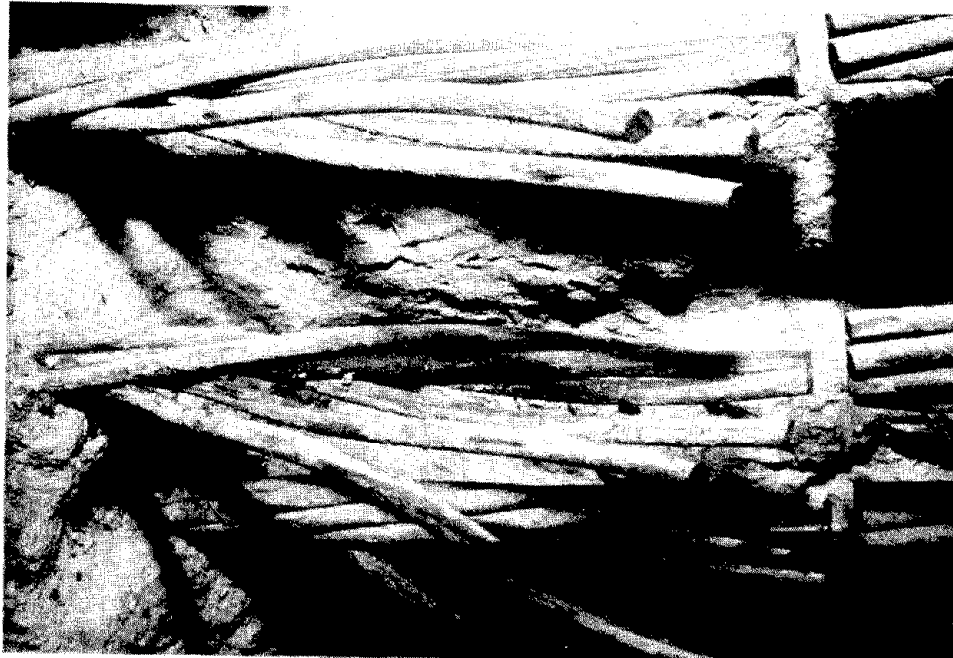
Figure 66. Appearance of interior of tendon bundle in south repair area, pile 3, after 215 weeks of tidal cycling.

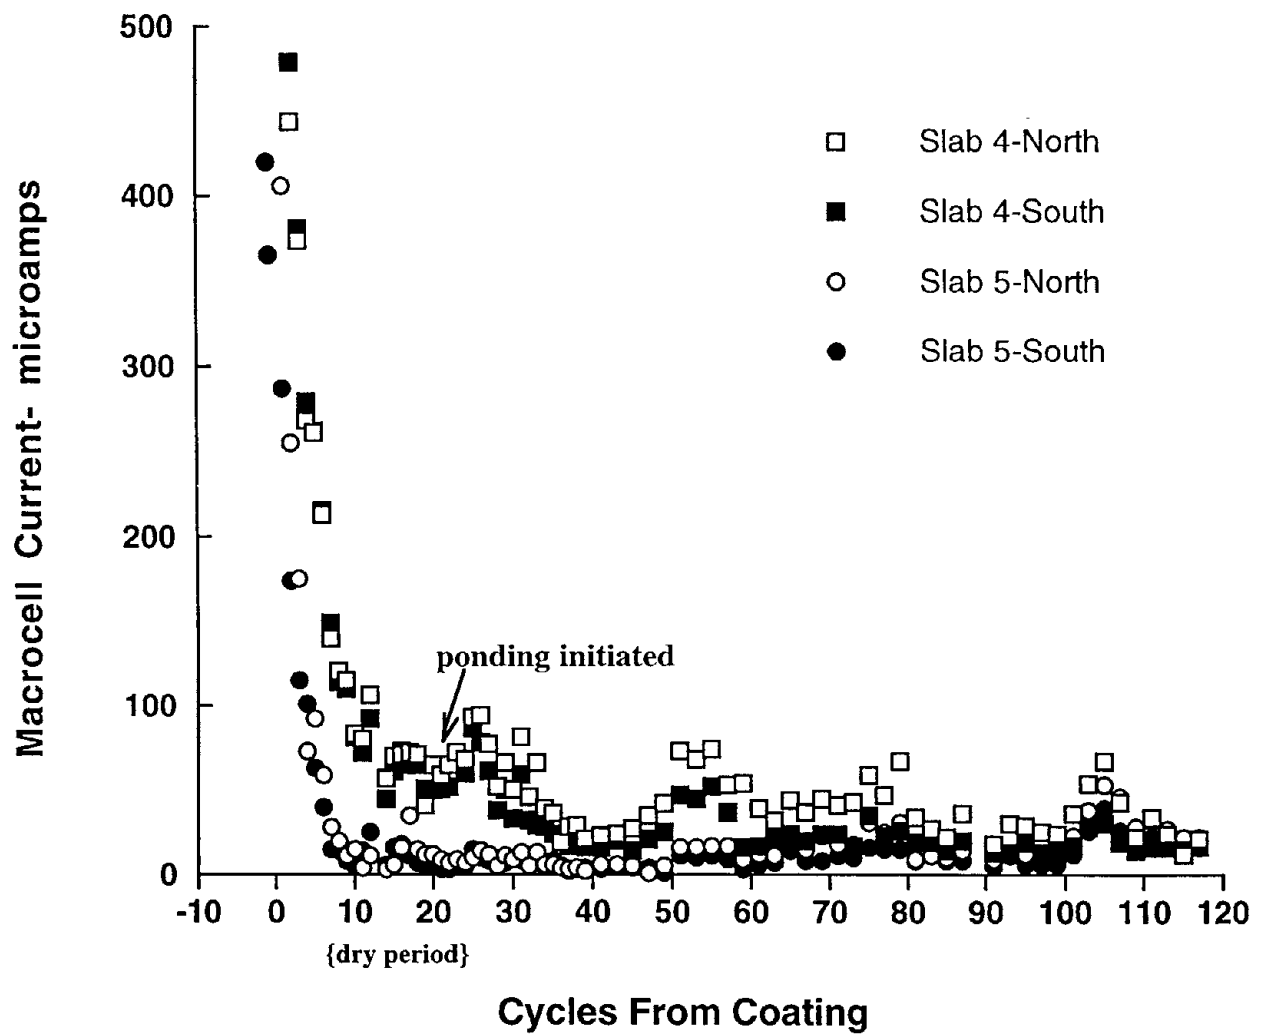
Figure 67. Macrocell currents in coated slab specimens over 118 cycles of testing.

Macrocell currents measured on sealed and coated slabs over the 118 cycles are shown in Figure 67. Initial currents for all specimens just prior to and after coating are high. The currents

continued to drop in the months after coating, and then appeared to stabilize during the "dry period" when exposure conditions were being altered. At the end of this period, ponding on the weekly cycle was initiated. At this point, slab 5 (alkyl-alkoxy silane sealer) currents were significantly less than those measured on slab 4 (two-part epoxy coating). Currents then began to follow a seasonally cyclic pattern as can be seen in Figure 67. The periods of the highest current, for instance, between cycles 22 to 32, 50 to 60, 75 to 80, and 100 to 110, correspond to the summer months when temperatures were higher and corrosion would be expected to accelerate. It is also of interest to note the time-dependence of the difference between slab 4 and slab 5 currents. Up through about 80 cycles of testing, slab 5 currents were consistently less than slab 4 currents, in both peaks and bases of the seasonal periods. After 80 cycles of testing, however, the measured currents began to be less distinct between the two slabs, and by the last winter of monitoring, the currents essentially overlapped for both slabs. Thus, it appears that slab 4 performance is stable over the period of testing, while slab 5 initially passed less current, but its performance degraded over time.

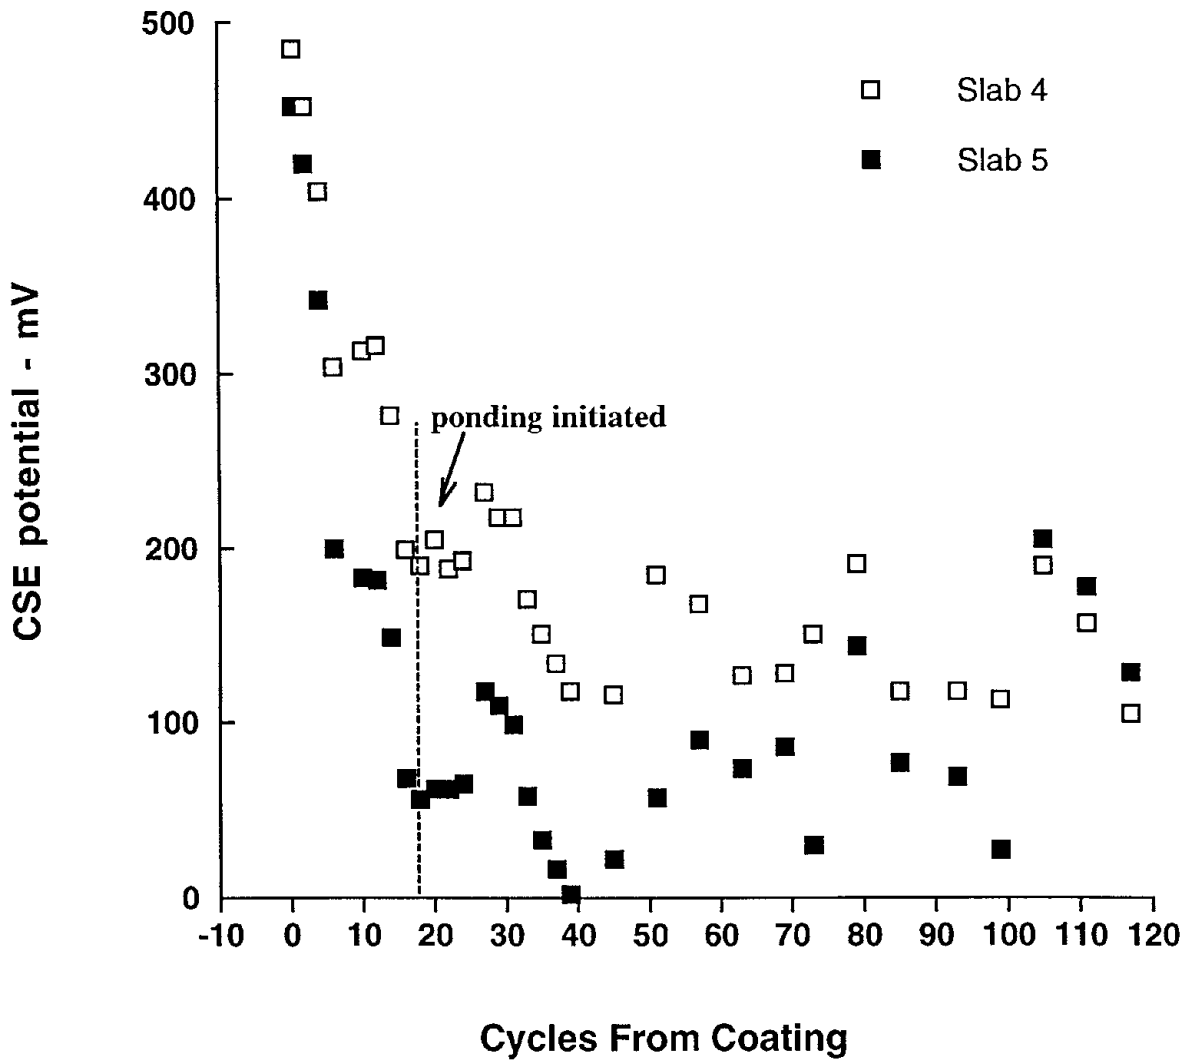
Figure 68. Half-cell potentials in coated slab specimens over 118 cycles of testing.

Half-cell potentials were measured at six positions along two of the tendons in each slab. Because the coatings (especially the two-component epoxy) create a high-resistance layer at the treated (top) surface of the slab, potentials were measured by pre-wetting the bottom surface of the slab and making the measurements from this side. As the strands were placed at the central axis of the slab, cover was essentially equivalent from either the top or bottom surfaces. It should be noted that the "bottom" surface of the slabs in the laboratory monitoring program was actually the top surface of the slabs as cast, since the slabs had been turned upside down when the salt spray was discontinued in order to be able to pond the soffits with saline solution. Results of the half-cell testing are shown in Figure 68. Results are the average of 12 readings on each slab. As for the macrocell current measurements, half-cell readings initially were high (more electro-negative), then fell after application of coatings. They also exhibited the seasonal pattern seen for the macrocell currents. Up through 100 cycles, slab 4 exhibited more electro-negative readings than slab 5. This agrees with the macrocell currents. For the last few readings, as was the case for the macrocell currents, the potentials are similar for the two slabs.

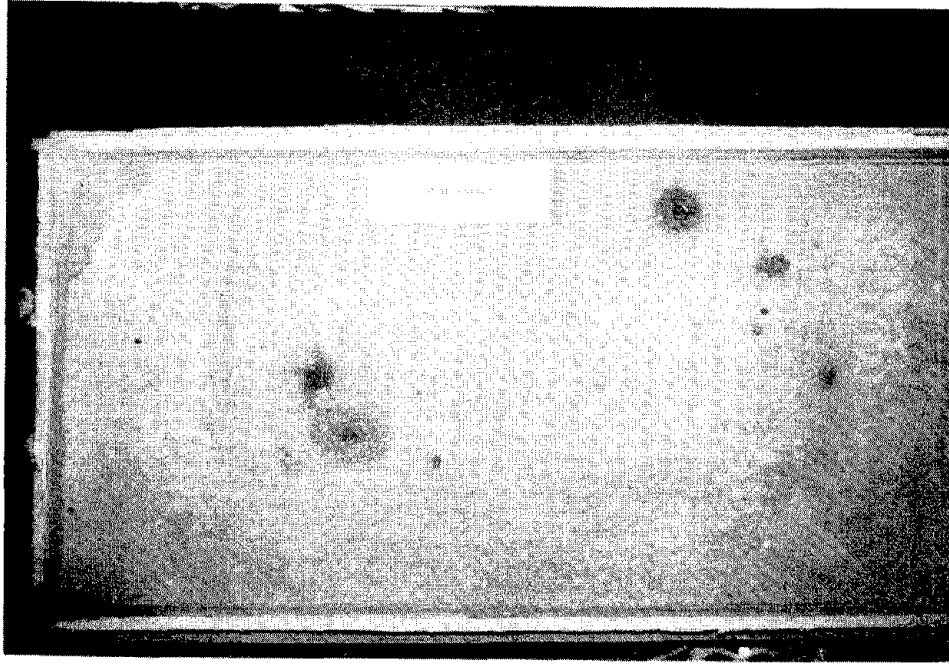
Figure 70 A. Appearance of surface of north half of slab 5 after 118 weekly salt ponding cycles.

Visual appearance of the slabs after the 118 cycles of exposure is shown in Figures 69 A and B (slab 4, north and south halves) and Figures 70 A and B (slab 5, north and south halves). The two-part epoxy coating (slab 4), though exhibiting some crazing and limited chalking, was still bonded well to the substrate and no extensive failures were noted. There was one small area of rust staining on the north half of the slab, and a larger area where the coating had blistered on the south half of the slab. The only overall defects in the coating were extensive pinholing, which had

been present since initial installation of the coating. The pinholes, however, did not appear to degrade the performance of the coating. Rust staining was somewhat more prevalent on slab 5, which had been treated with the penetrating alkyl-alkoxy silane sealer. As noted in Chapter 3, the rust stains were mostly associated with holes for plastic inserts, which had been drilled into the slabs in order to mount the mesh used in the electrical acceleration of chloride ingress. In the absence of these inserts, it is likely that little or no rust stains would have appeared on these slabs.

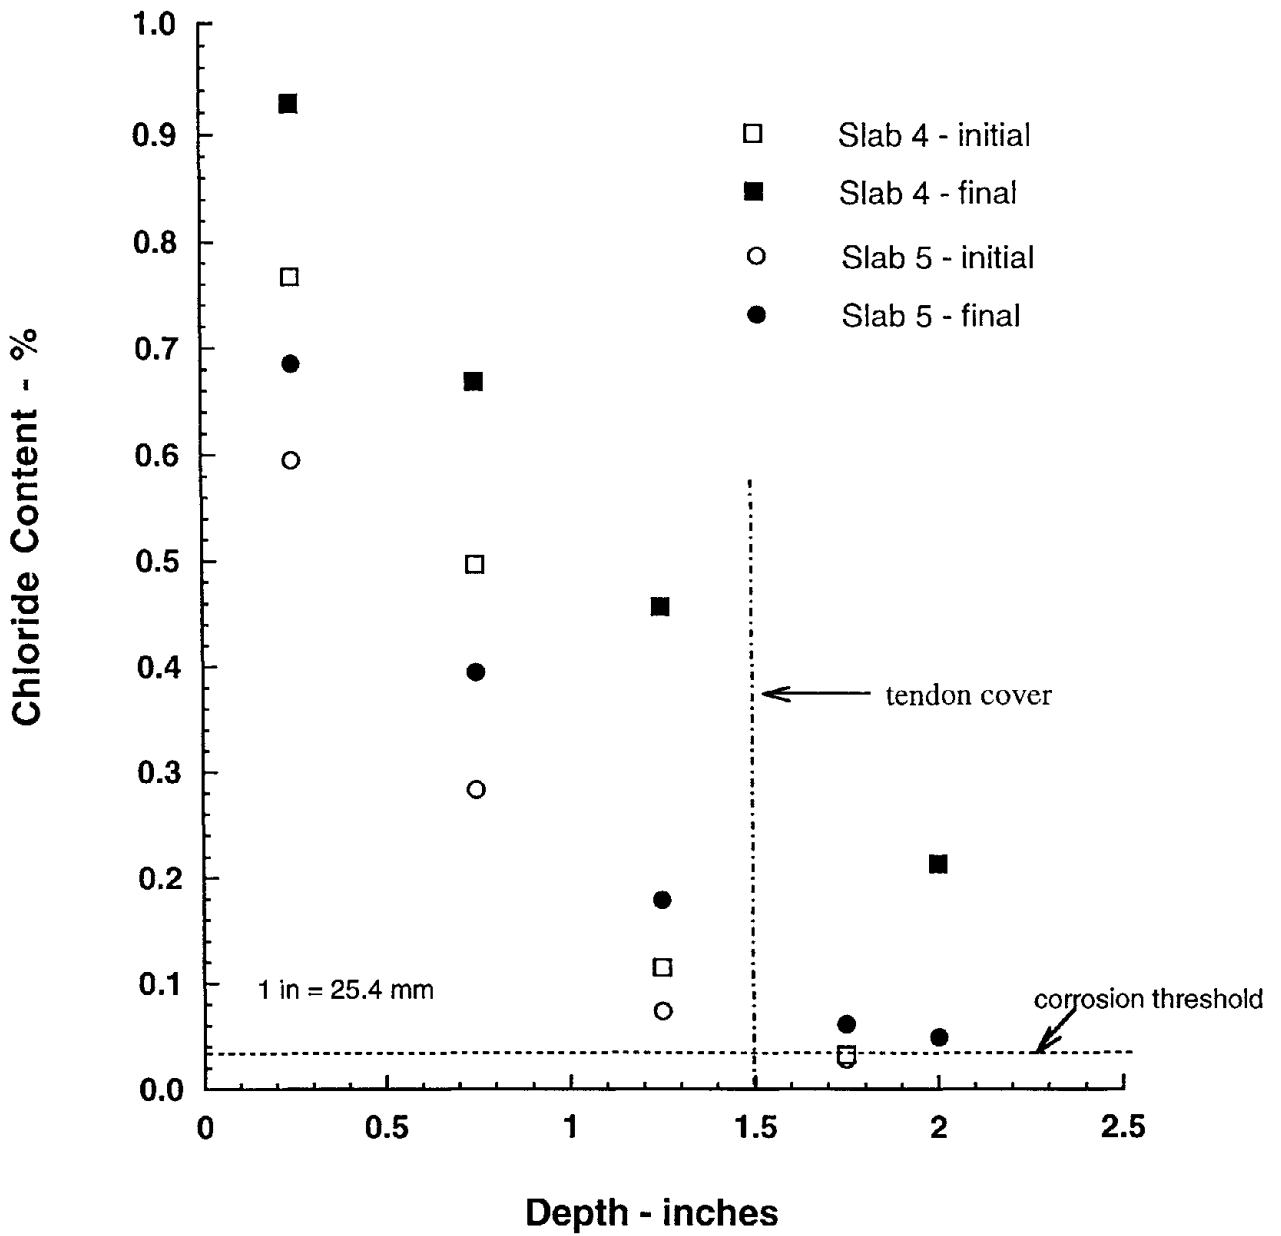
Figure 71. Chloride contents measured on slab specimens prior to and after 118 weeks of exposure.

Drill samples were obtained from two locations on each slab over a single tendon. Samples were taken at 12-mm (0.5-in) increments and chemically analyzed for total chloride ions. Results are shown in Figure 71 and are compared with chloride profiles for these same slabs taken after acceleration of chloride ingress, but prior to application of coatings. It can be seen that after 118 weekly cycles of ponding, considerably more chloride had penetrated into the slabs. Therefore, it is apparent that these coatings do not fully prevent additional chloride ions from entering the concrete. This is not surprising, as previous studies ^(9,10) have shown that "chloride screening" efficiencies of concrete sealers and coatings may vary widely.

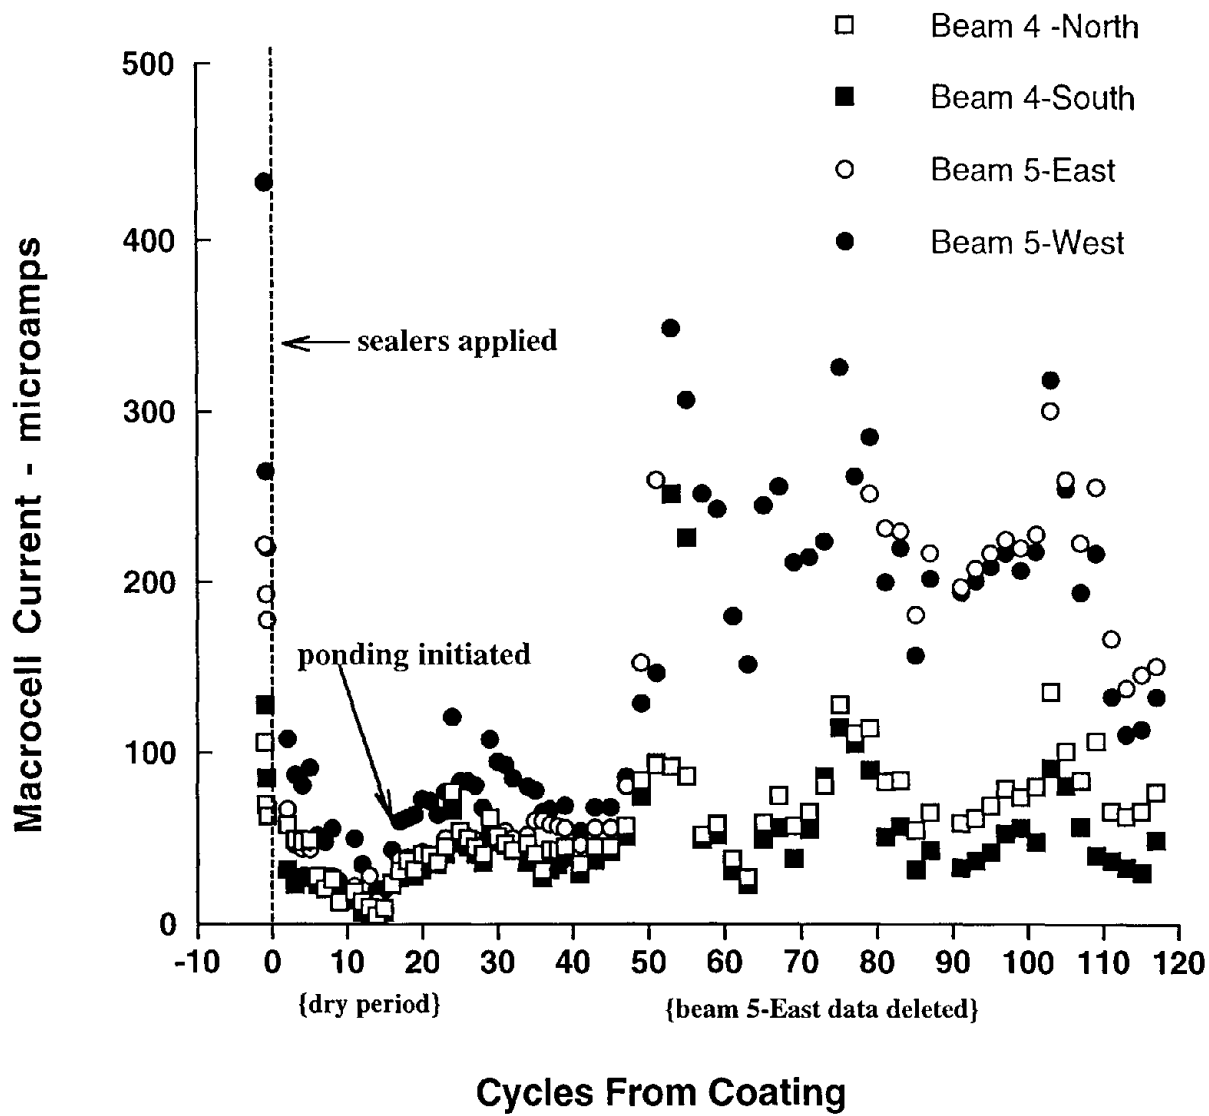
Figure 72. Macrocell currents in coated beam specimens over 118 cycles of testing.

Category B pretensioned beams received the same treatment, exposure, and monitoring as the corresponding pretensioned slabs. For the beams, macrocell currents were measured between the tendons in each beam and two electrically isolated reinforcing bars located in the lower flange of the beam as was shown in Figure 1. The trend of macrocell currents in the beam specimens is shown in Figure 72. While beam 5 (alkyltrialkoxo silane) currents initially were high, beam 4 (alkoxy siloxane/silane with topcoat of methyl methacrylate) values were significantly less at the start of exposure. Currents for both beams were similar up to about 50 cycles, at which time, beam 5 began to exhibit consistently higher currents. During peak periods, currents for beam 5 approached initial (uncoated) values. Between about 50 to 80 cycles, the data for beam 5-East have been deleted due to malfunction of the shunt resistor in this circuit during this period. The beam macrocell currents exhibit the same seasonal pattern as do the slab currents.

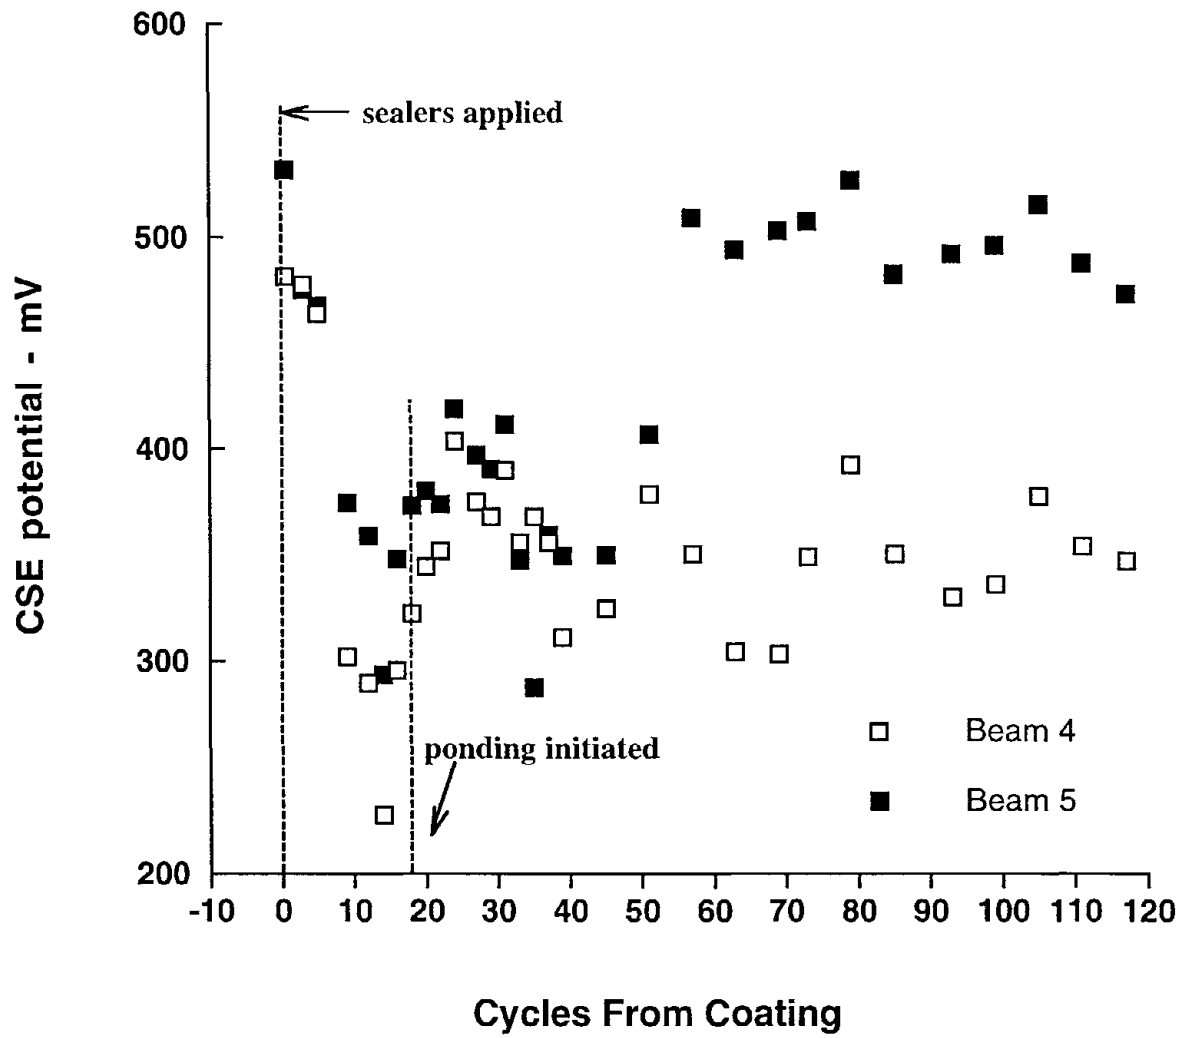
Figure 73. Half-cell potentials in coated beam specimens over 118 cycles of testing.

Half-cell potentials were measured at eight positions along both sides of the lower flange of each beam. Again, as the beams had been turned upside down to effect the ponding, this became the upper-most vertical position of the beams. In effect, potential was measured on the two outer-most tendons in the eight-tendon layer at the bottom of the beam (see Figure 1, section B, for details). Clear cover from these outer tendons to the sides of the beam was 50 mm (2 in). Results of the half-cell testing are shown in Figure 73. Results are the average of 16 readings on each beam. As

for the macrocell current measurements, half-cell readings were similar for both beams up to about 50 cycles, then they diverged. Potentials for beam 4 varied between 300 and 400 mV, whereas those for beam 5 returned to a more electro-negative potential near 500 mV. As for the macrocell currents, beam 5 potentials after 50 cycles approached those for initial (uncoated) conditions.

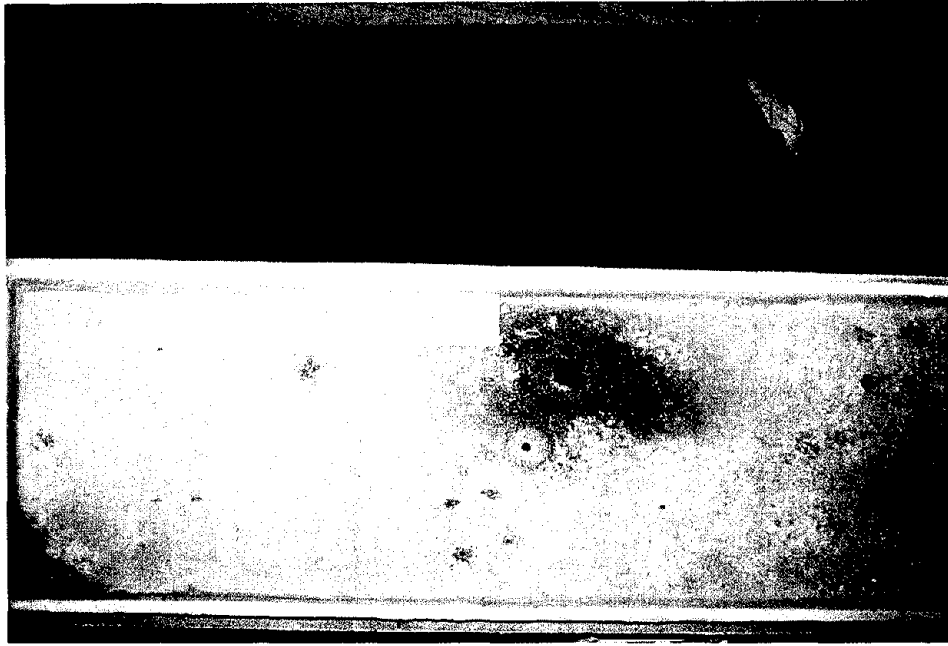
Figure 74 A. Appearance of surface of north half of beam 4 after 118 weekly salt ponding cycles.

Visual appearance of the beams after the 118 cycles of exposure is shown in Figures 74 A and B (beam 4, north and south halves) and Figures 75 A and B (beam 5, east and west halves). The considerable amounts of rust staining on the surfaces of the specimens are associated with the feet of chairs used to support the embedded steel reinforcing bars. Although plastic-coated, the coating appears to have limited utility in such a corrosive environment. When these stains are discounted, the only other distresses observable are some surface cracks filled with an efflorescence presence on the surface of beam 5.

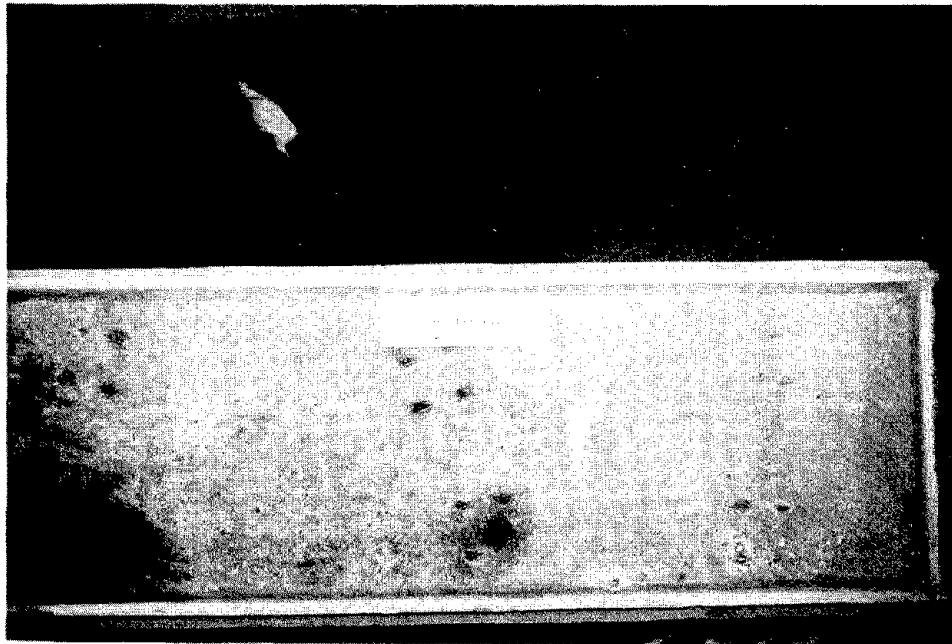
Figure 74 B. Appearance of surface of south half of beam 4 after 118 weekly salt ponding cycles.

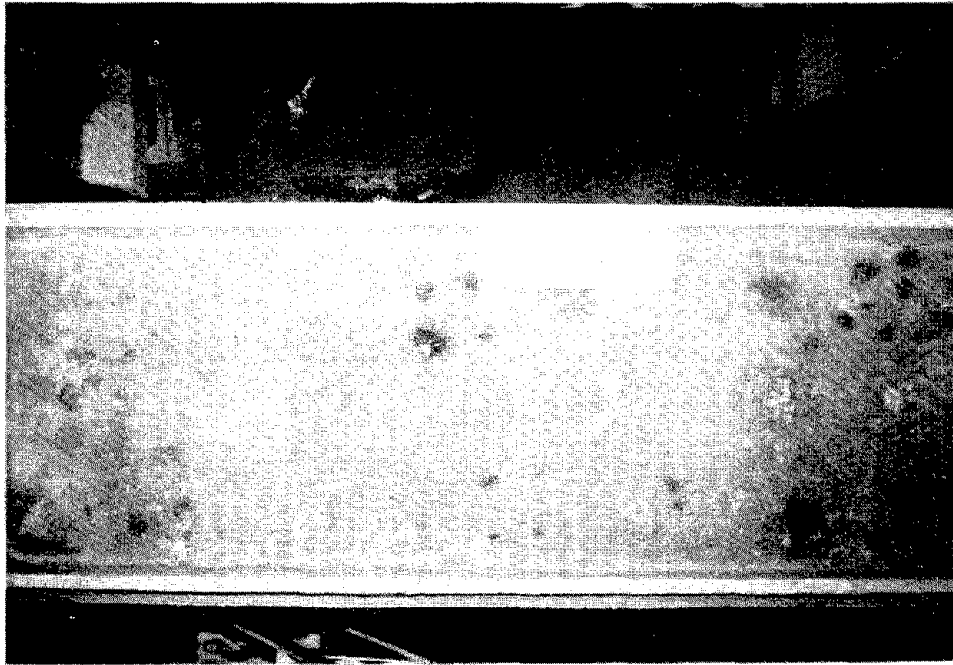
Figure 75 A. Appearance of surface of north half of beam 5 after 118 weekly salt ponding cycles.

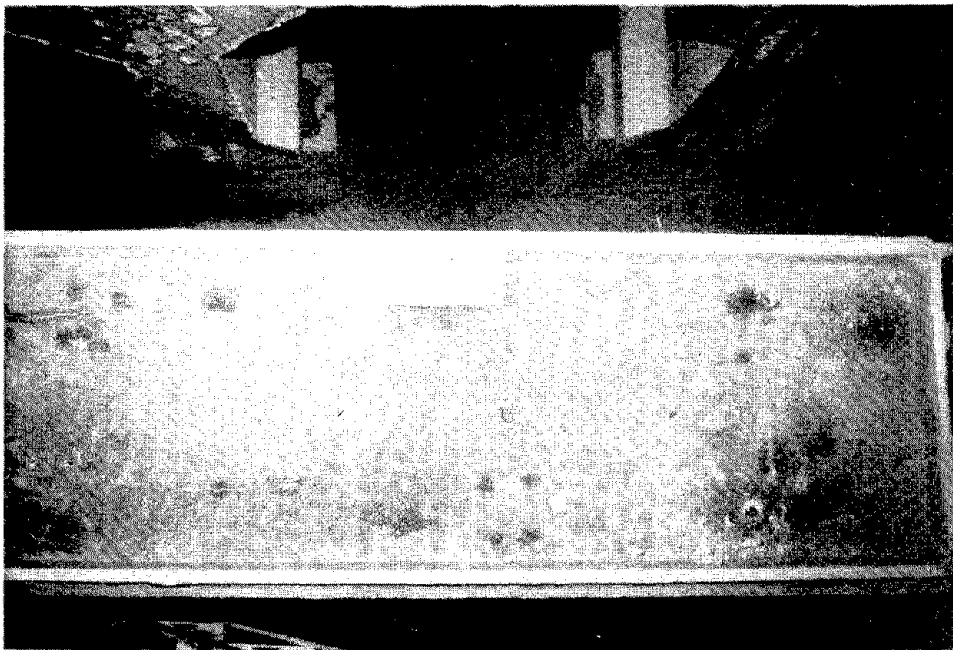
Figure 75 B. Appearance of surface of south half of beam 5 after 118 weekly salt ponding cycles.

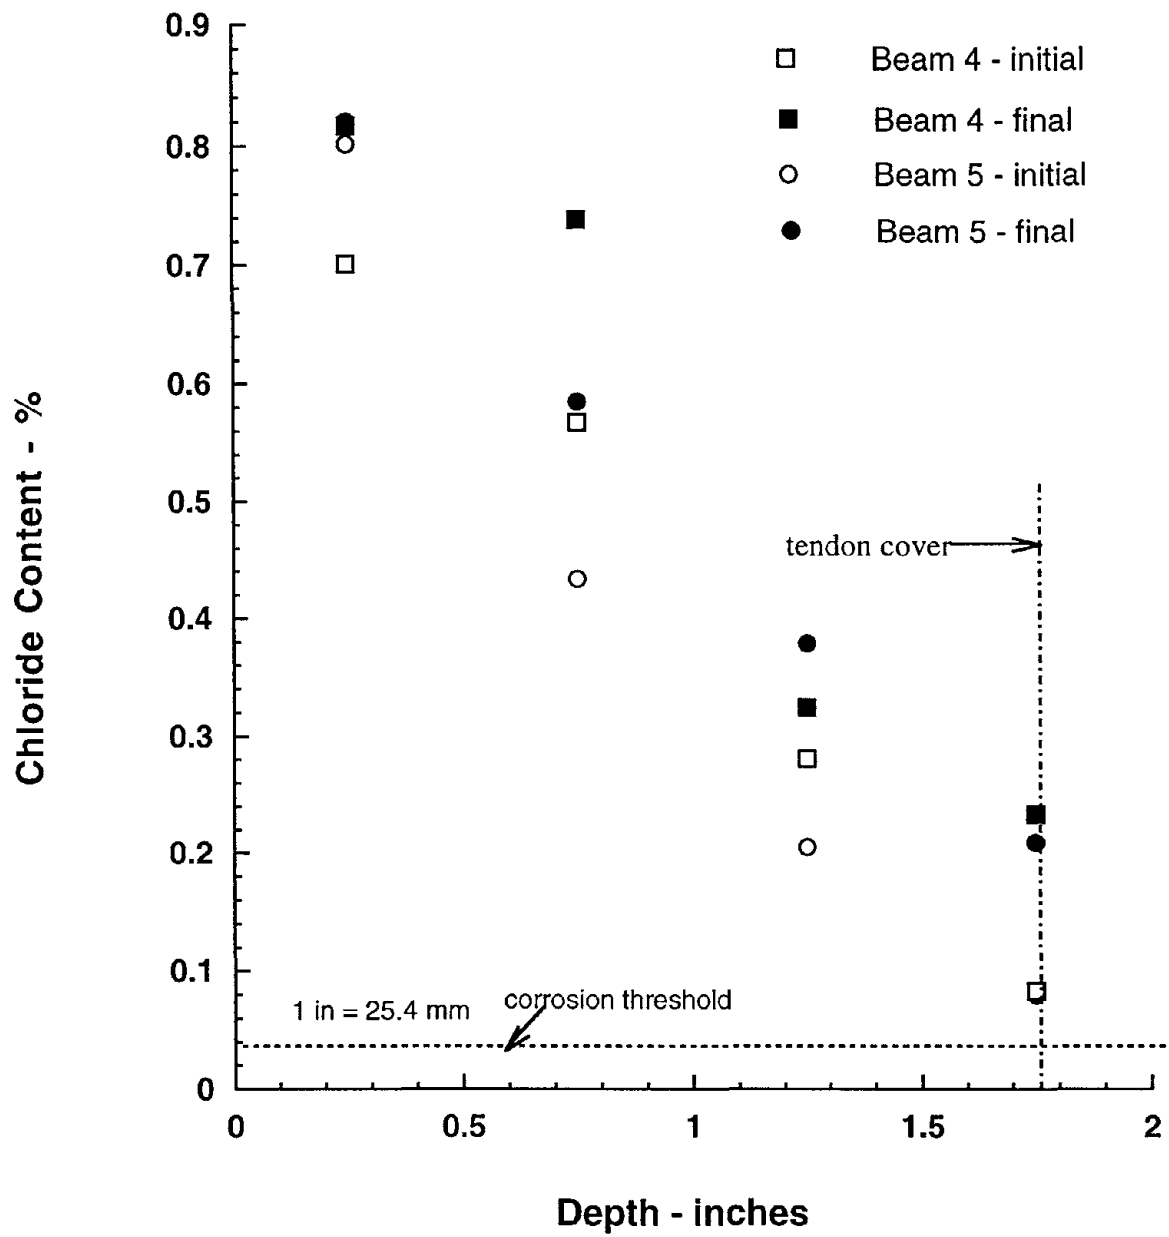
Figure 76. Chloride contents measured on beam specimens prior to and after 118 weeks of exposure.

Drill samples were obtained from two locations on each beam over a single tendon. Samples were taken at 12-mm (0.5-in) increments and chemically analyzed for total chloride ions. Results are shown in Figure 76 and are compared with chloride profiles for these same beams taken after acceleration of chloride ingress but prior to application of coatings. It can be seen that at most depths, considerably more chloride had penetrated into the slabs during the exposure period. As for the slabs, it is apparent that these coatings also did not fully prevent additional chloride ions from entering the concrete.
