Rehabilitation of Prestressed Concrete Bridge Components by Non-Electrical (Conventional) Methods

PUBLICATION NO. FHWA-RD-98-189

FEBRUARY 1999

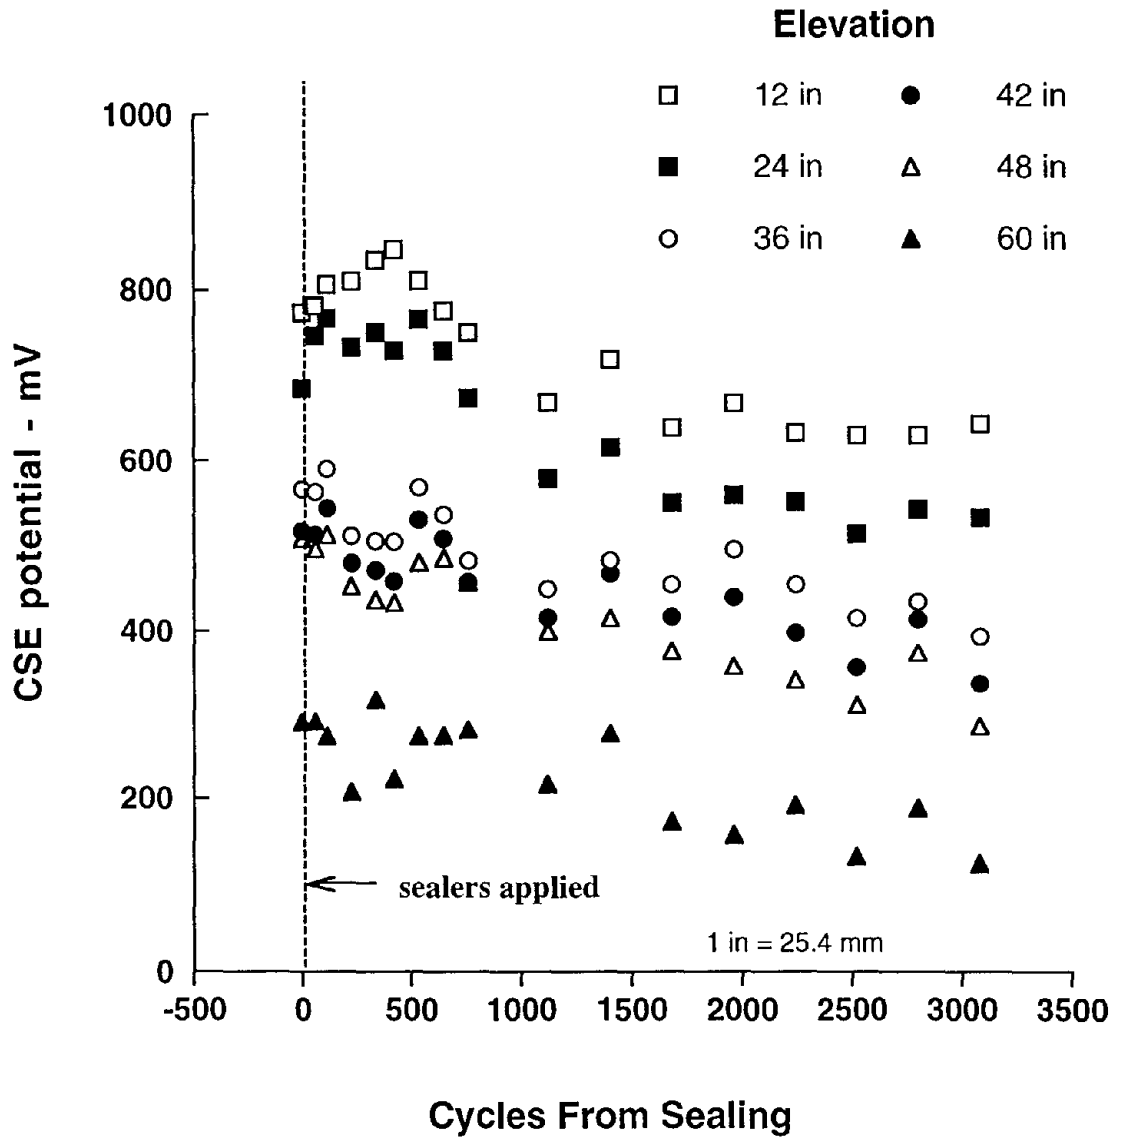
Figure 77. Half-cell potentials measured on north face of piling no. 4.

After treatment with sealers, Category B pretensioned piles were returned to the polyethylene tanks and the 24-hour tidal cycle was re-initiated. The piles remained in this cycle throughout the course of monitoring (220 weeks) for a total of 3080 tidal cycles. In contrast to the slabs and beams, no macrocell currents were measured on the pilings. This is because conditions were not uniform from bottom to top of the pilings — there being submerged, tidal, and atmospheric zones as previously described. Half-cell measurements were carried out on two opposing faces of each piling at elevations of 305, 610, 915, 1065, 1220, and 1525 mm (12, 24, 36, 42, 48, and 60 in). Measurements were made over the middle tendon on each face. These measurements were made after temporarily draining the tanks each time. Results are shown in Figures 77 through 80. On each piling, potential becomes less electro-negative as the elevation from the bottom of the tank increases. This is not unexpected, as the saturated conditions at the bottom of the tank would reduce cathodic reactions and shift the potential into a more anodic zone. In this zone, potentials at first became somewhat more electro-negative, then appeared to stabilize near -600 to -700 mV.

Within the tidal zone, extending from 710 to 1110 mm (28 to 44 in), potentials appeared to shift slightly more electro-positive with time; this is more apparent for pile 4 (alkyltrialkoxo silane) than for pile 5 (alkyl-alkoxy siloxane). Within the atmospheric zone at 1525 mm (60 in), potentials initially drop, then stabilize in the vicinity of - 200 mV.

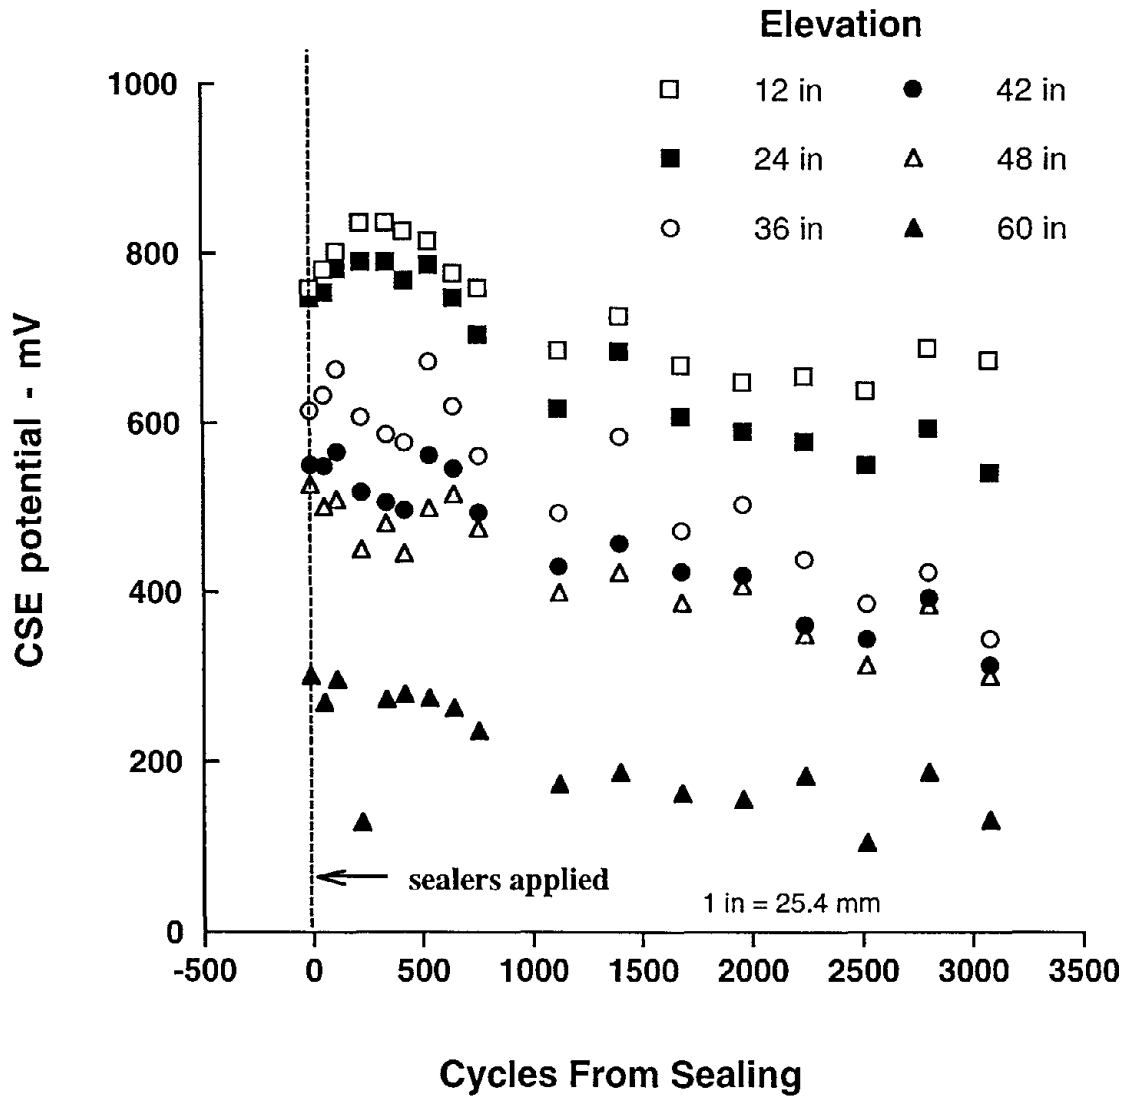
Figure 78. Half-cell potentials measured on south face of piling no. 4.

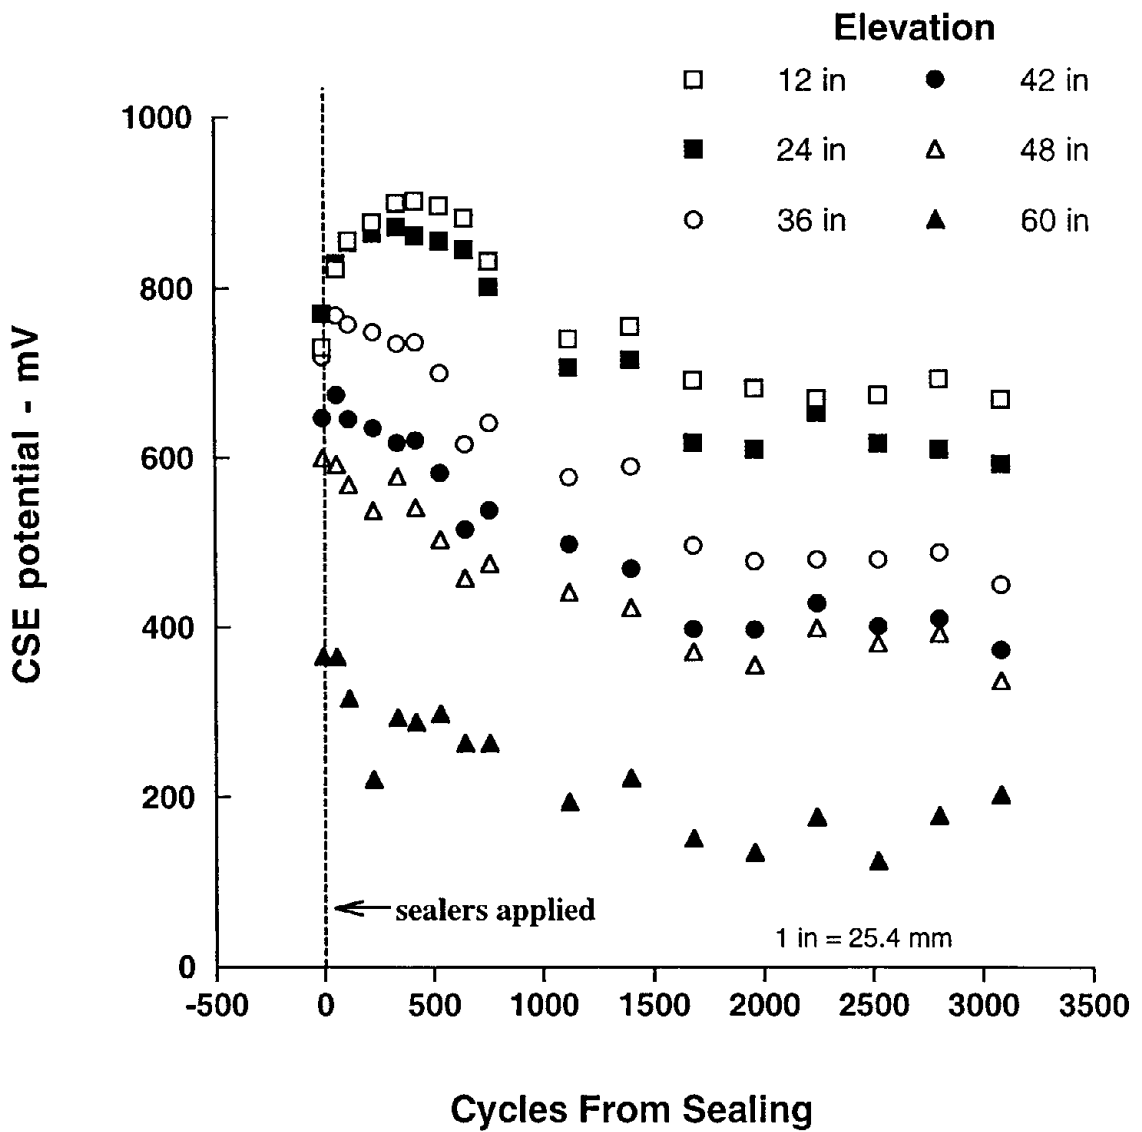
Figure 80. Half-cell potentials measured on south face of piling no. 5.

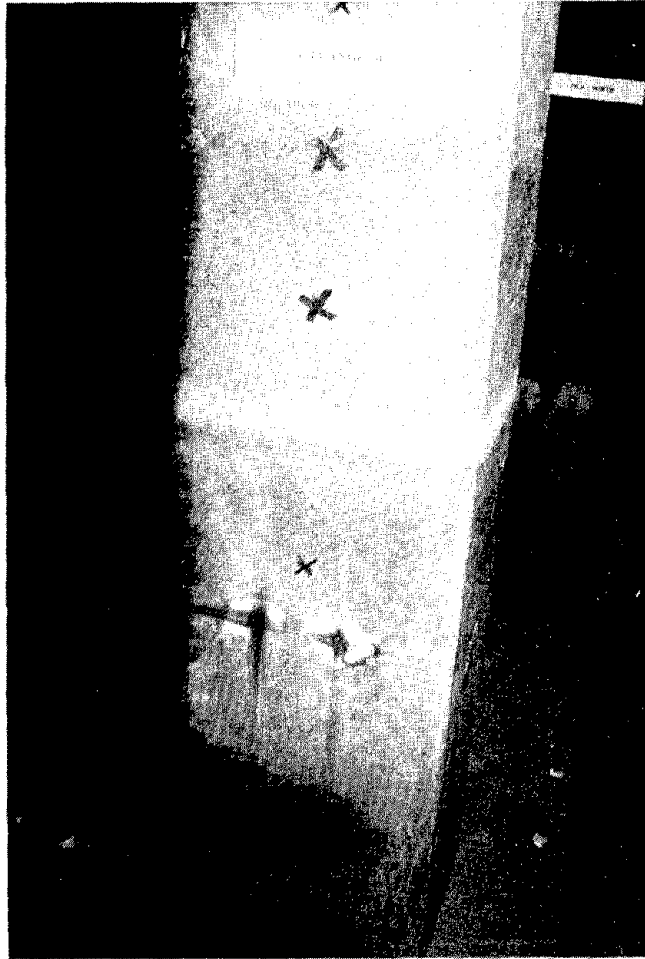
Figure 81. Appearance of surface of north face of pile 4 after 3080 tidal cycles.

Visual appearance of the surfaces of the piles after 3080 tidal cycles is shown in Figures 81 through 84. The rust staining seen on the north faces of piles 4 and 5 is associated with holes drilled for initial concrete samples and subsequently filled with epoxy. It is likely that some reinforcing steel was close to the holes, and corrosion was initiated during the course of monitoring. A crack over the middle tendon can be seen on both faces of pile 5, but the lack of rust staining indicates that this crack has not penetrated to the tendon. Again, as for the treated slabs and beams, any corrosion-induced damage appears to be associated with artifacts, and not corrosion of embedded tendons and reinforcing steel.

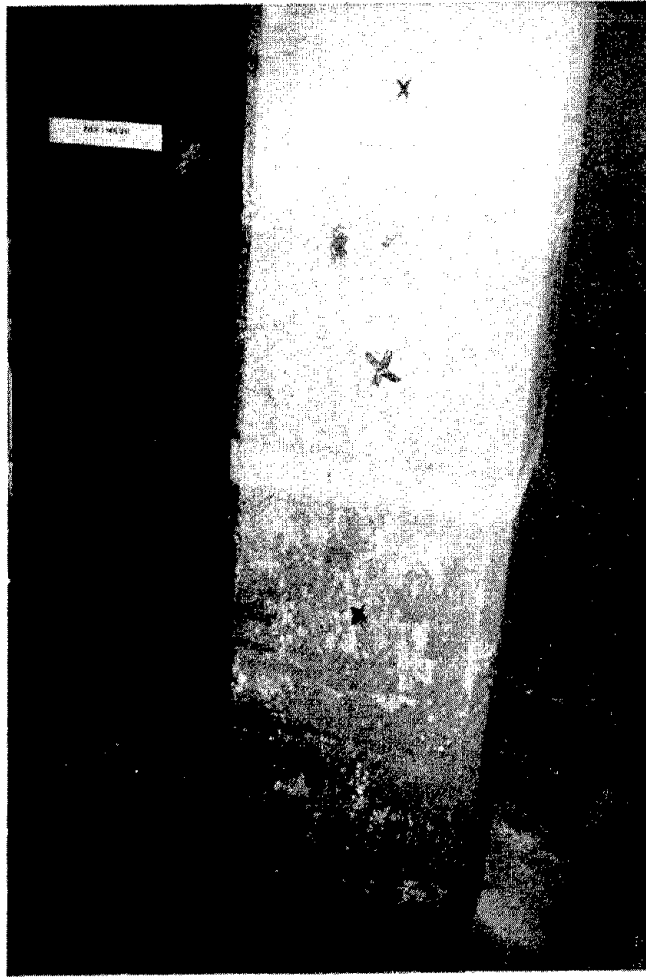
Figure 82. Appearance of surface of south face of pile 4 after 3080 tidal cycles.

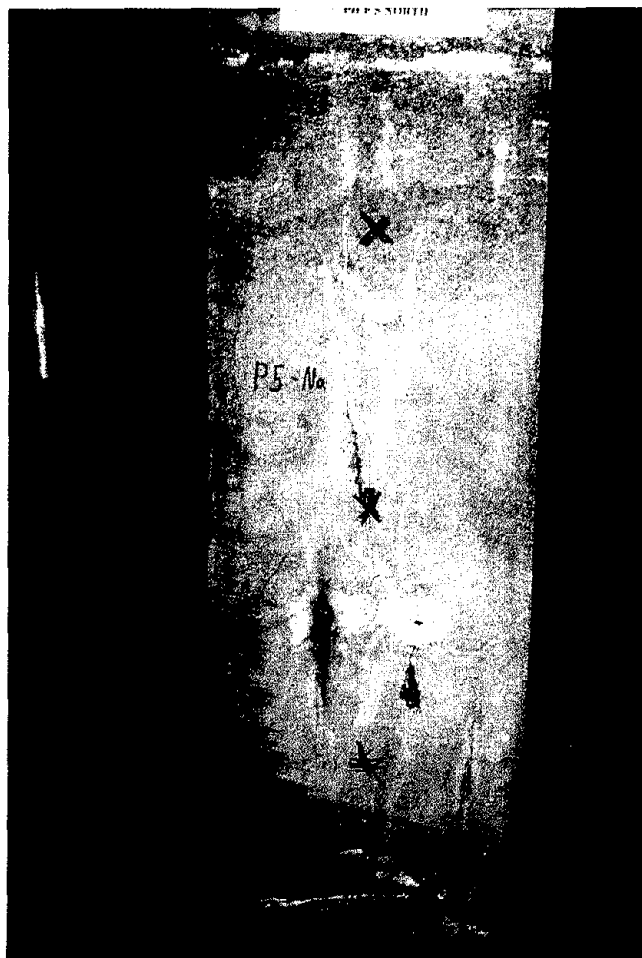
Figure 83. Appearance of surface of north face of pile 5 after 3080 tidal cycles.

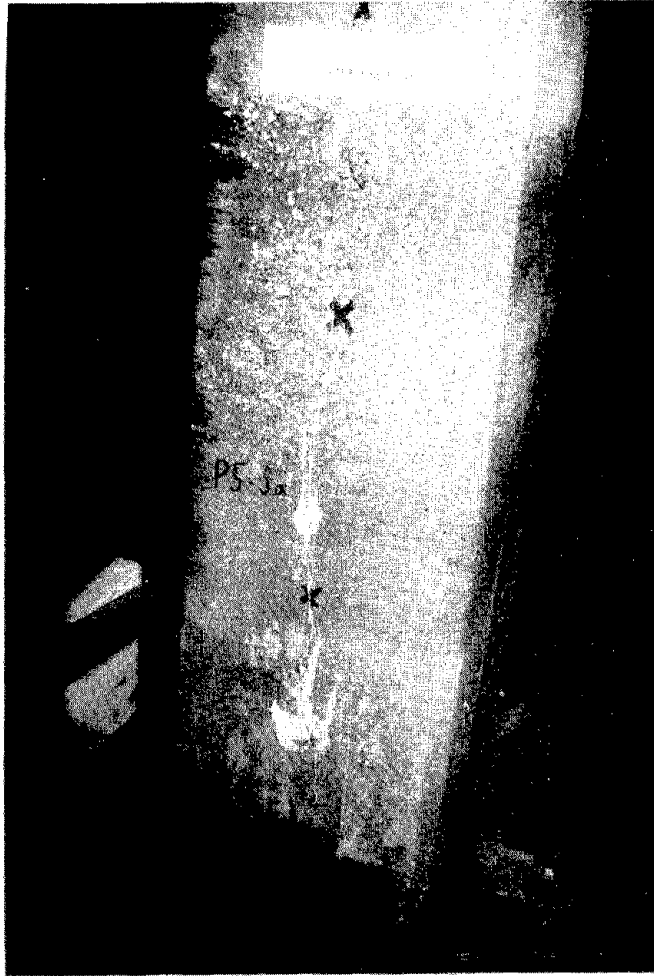
Figure 84. Appearance of surface of south face of pile 5 after 3080 tidal cycles.

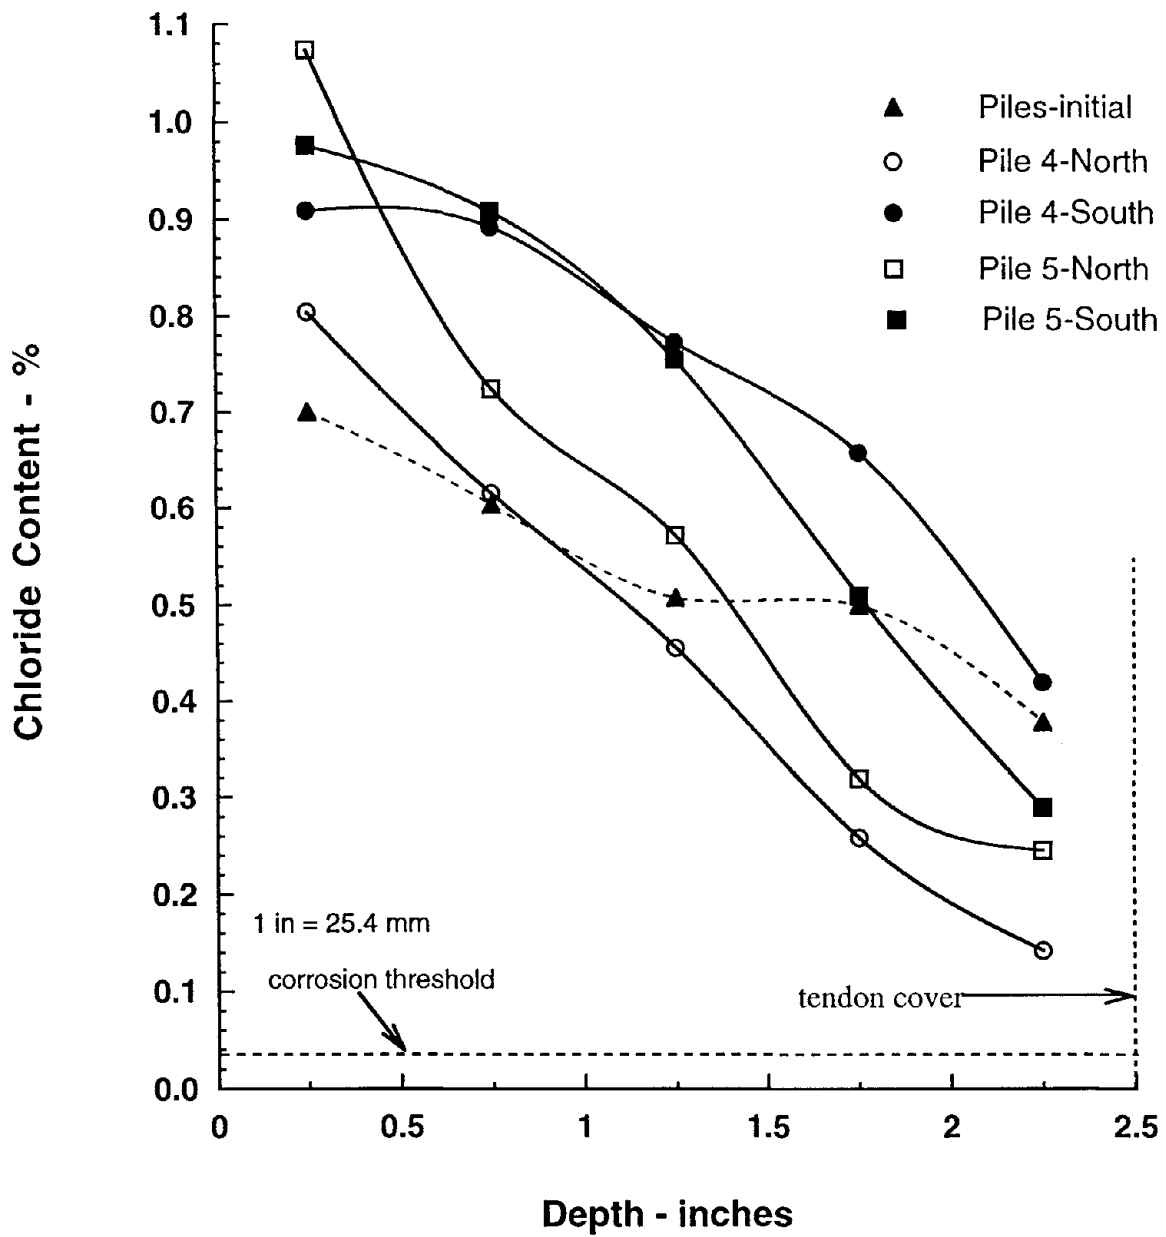
Figure 85. Chloride contents measured on pile specimens prior to and after 3080 tidal cycles.

Drill samples were obtained from one location on the face of each pile over the middle tendon. Chloride profiles are shown in Figure 85. As compared with chloride levels just prior to coating, considerably more chloride had penetrated the piles, especially at depths less than 40 mm (1.5 in). In some cases, there appears to have been a decrease in chloride constants at depths greater than 50 mm (2 in). It would be expected that if the sealer were able to screen out a certain amount of chloride, the chloride levels initially present would readjust themselves and result in a steeper profile as chloride continued to diffuse further into the center of the pile.
