AC NO: 20-59

ADVISORY CIRCULAR

MAINTENANCE INSPECTION NOTES FOR CONVAIR MODELS 240 AND
600/240D; MODELS 340/440 AND 640/340D/440D SERIES AIRCRAFT

Consolidated reprint, February 1974;
includes change 1.

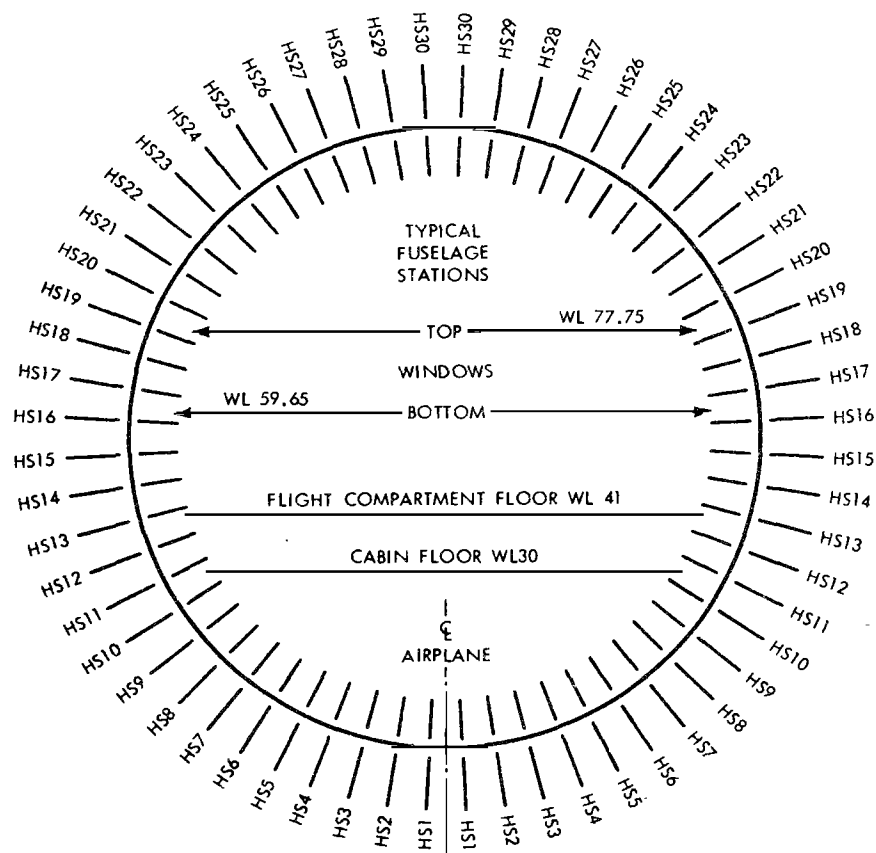
FIGURE B-5. FUSELAGE STRINGER DIAGRAM

1. HS INDICATES POINT ON LINE OF STRINGER HEEL
2. ALL STRINGERS ARE MADE FROM STANDARD ROLL-FORMED SECTIONS Y36 OR Y34, OF 24ST ALCLAD MATERIAL.
3. STRINGERS AT POSITIONS 19 L/R CABIN SECTION ARE REVERSED.
4. STRINGERS AT POSITIONS 17 L/R AND 29 L/R TAIL SECTION ARE REVERSED.
