REPORT NO. FHWA-RD-88-225
LUMINAIRE AND SIGN SUPPORTS

LUMINAIRE AND SIGN SUPPORTS
TECHNICAL VOLUME

This report presents the results, test reports and findings pertaining to the project "Luminaire and Sign Supports" conducted for the Federal Highway Administration (FHWA) by the contractor under contract no. DTFH61-87-Z-00103.

Five designs of luminaire and sign supports were impacted with 1800 lb class vehicles. The test results were evaluated to determine the safety performance of the tested luminaire and sign supports against the requirements specified by the AASHTO and NCHRP No. 230 documents. This report will be of interest to highway engineers dealing with roadside safety.

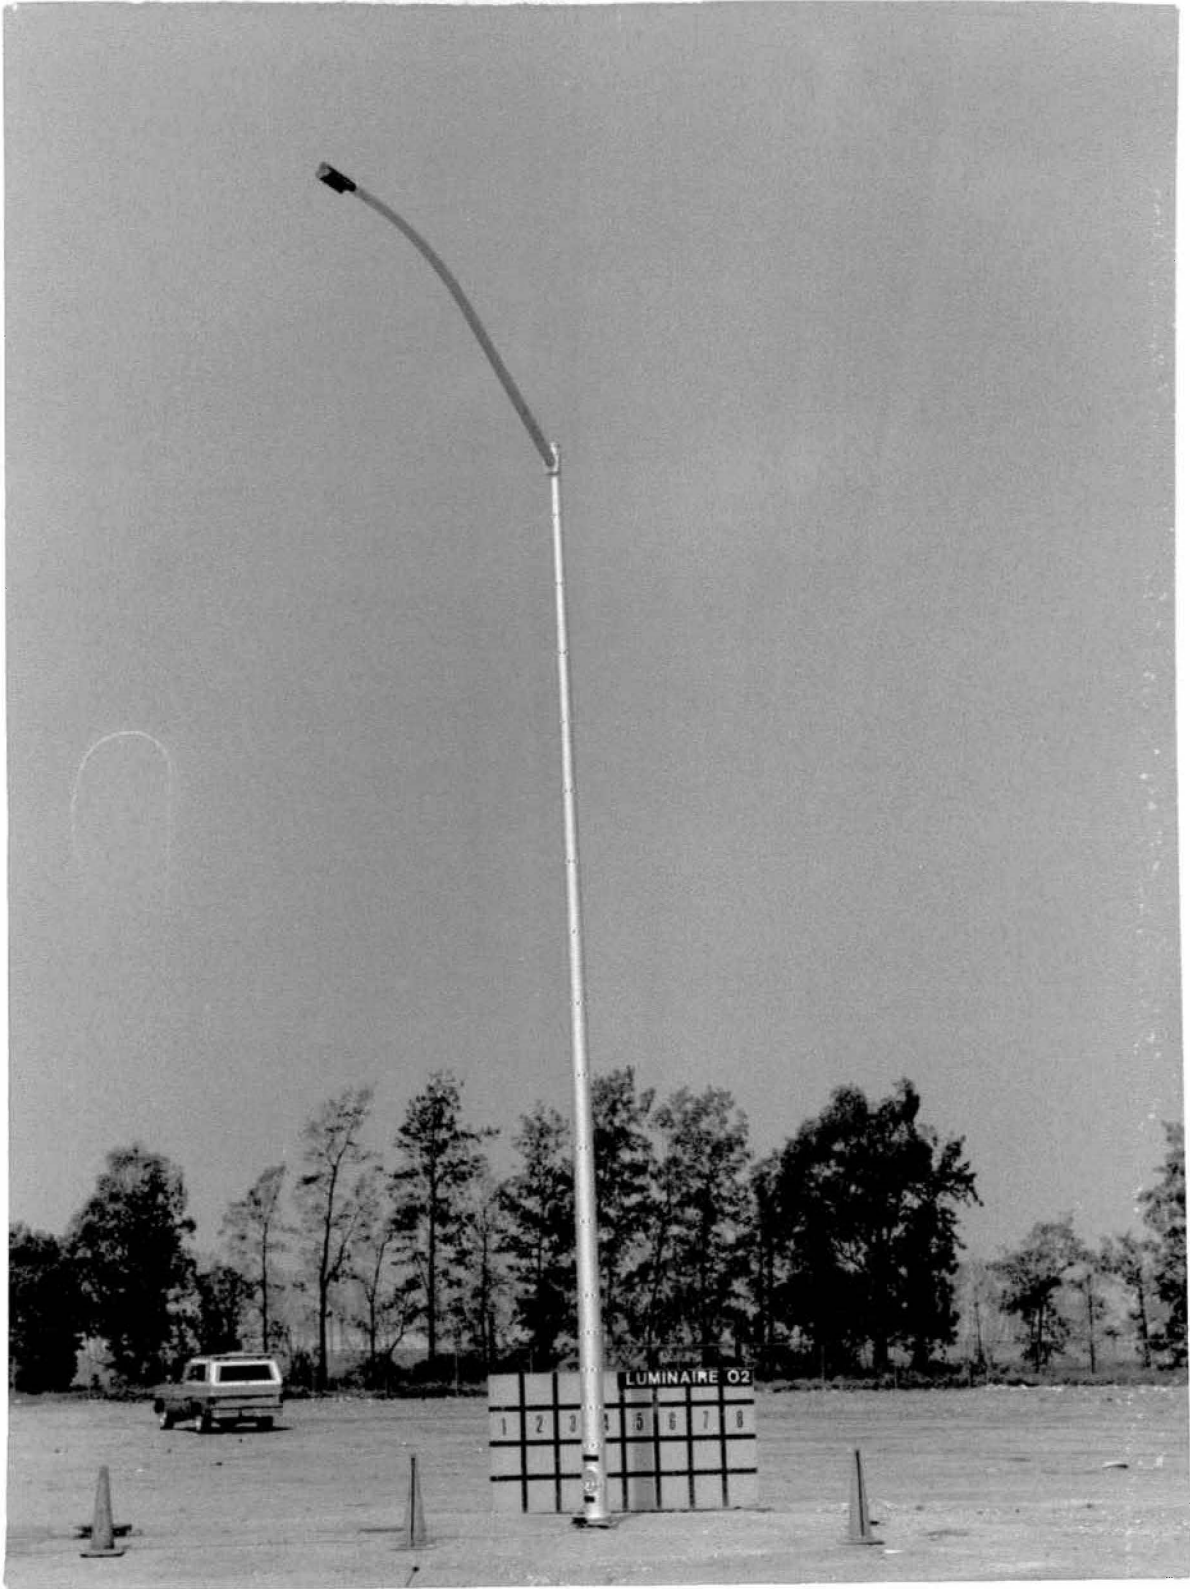
Figure 43. General test area, pretest, test no. 3.

Figures 43 through 52 show the test area, the test article and the posttest photographs of the test vehicle and the test article.

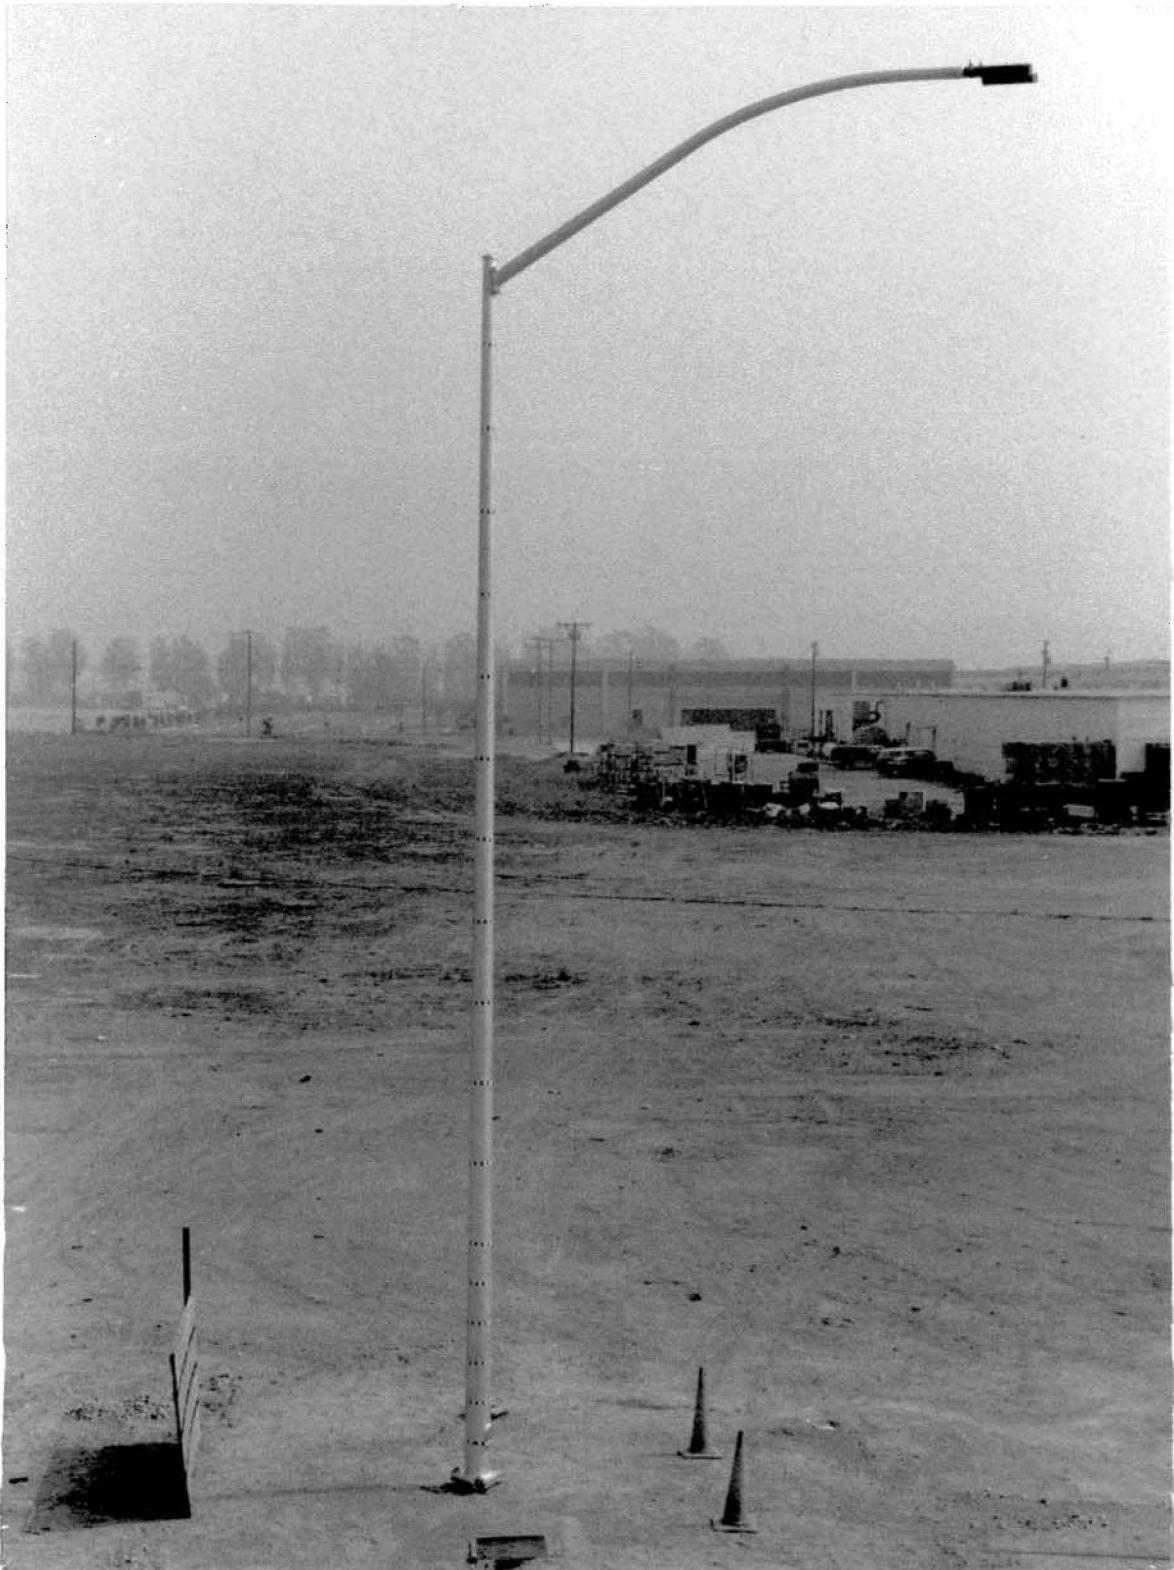
Figure 44. Test area elevated view, pretest, test no. 3.

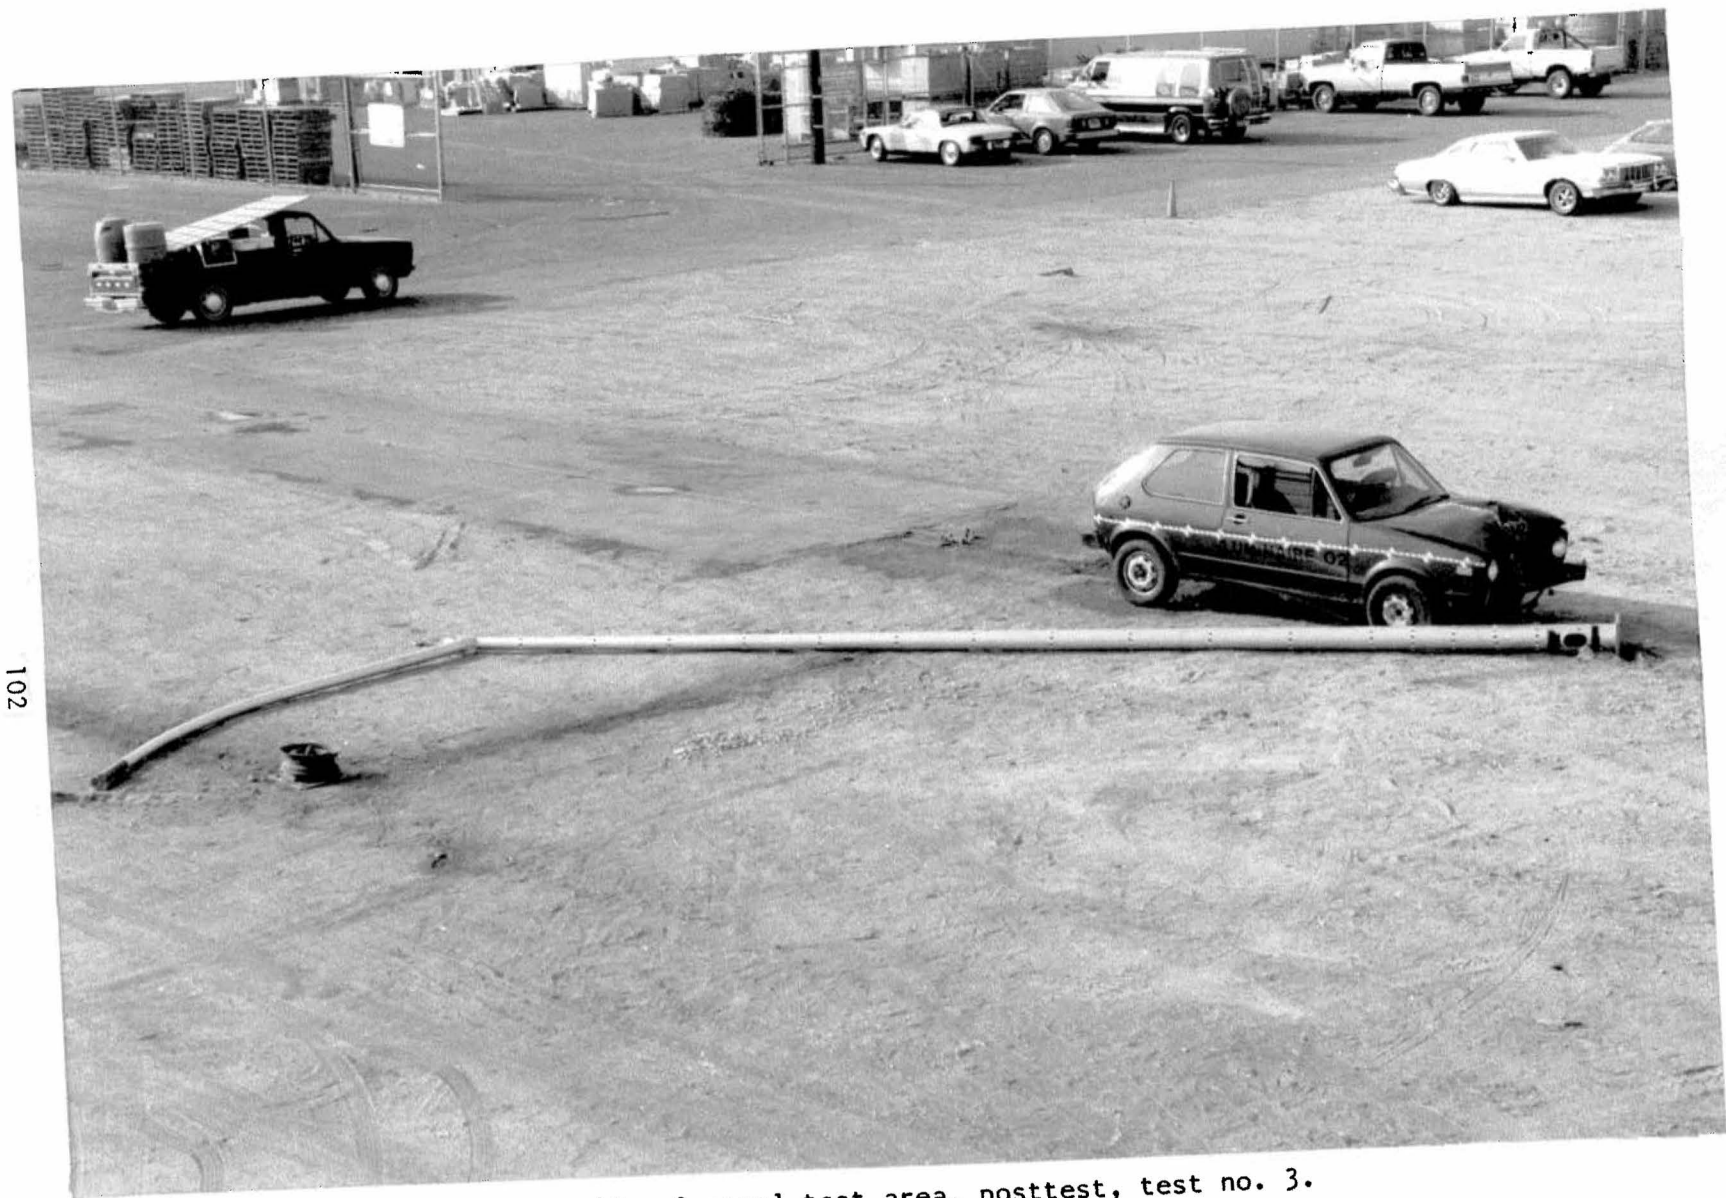
Figure 45. General test area, posttest, test no. 3.

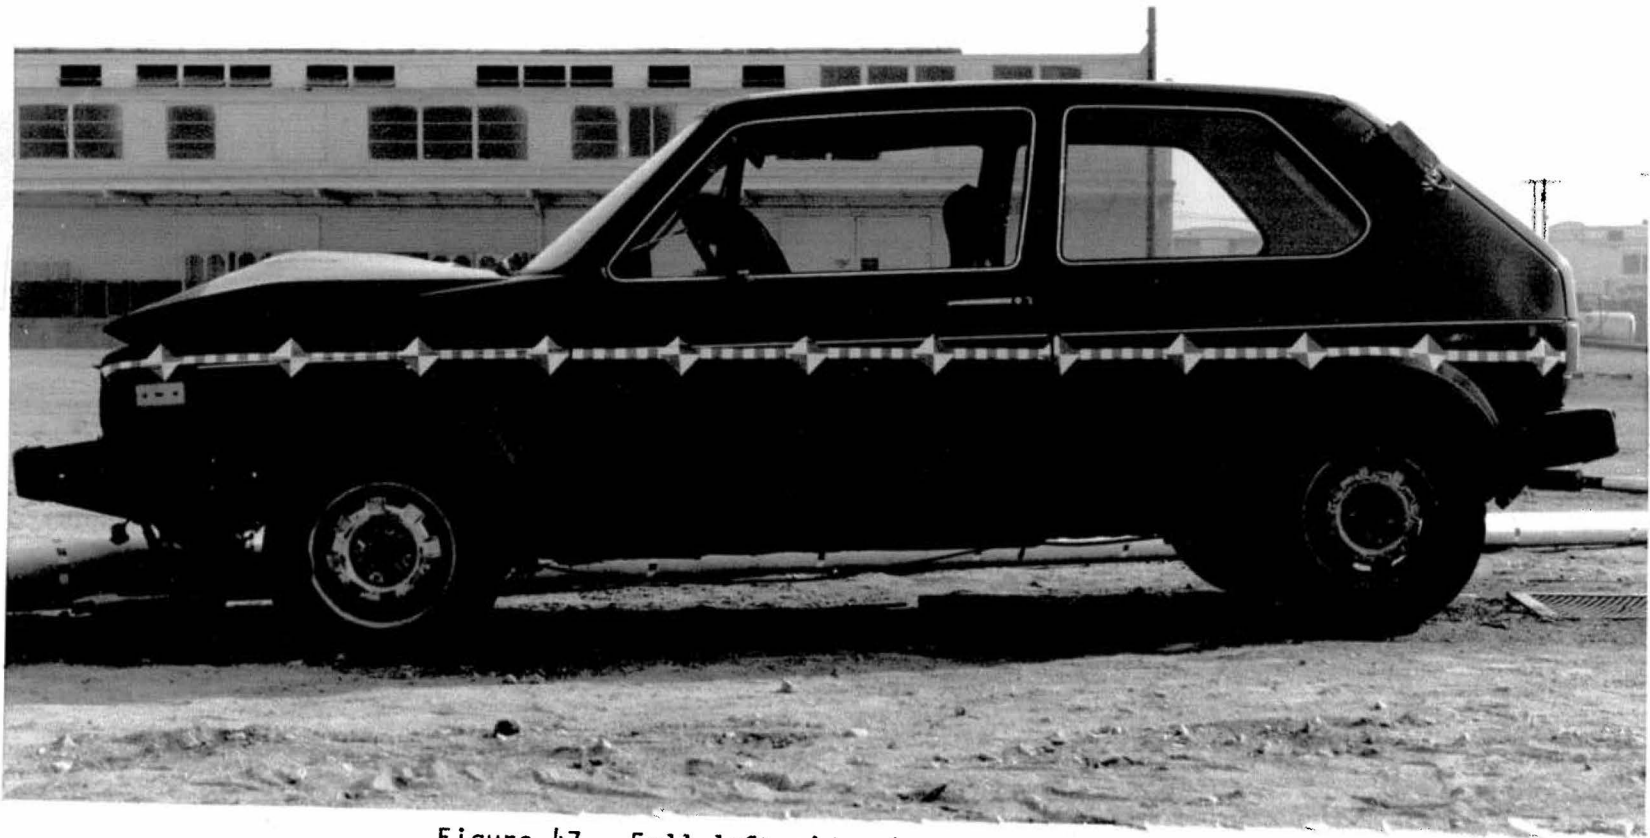
Figure 47. Full left side view, posttest, test no. 3.

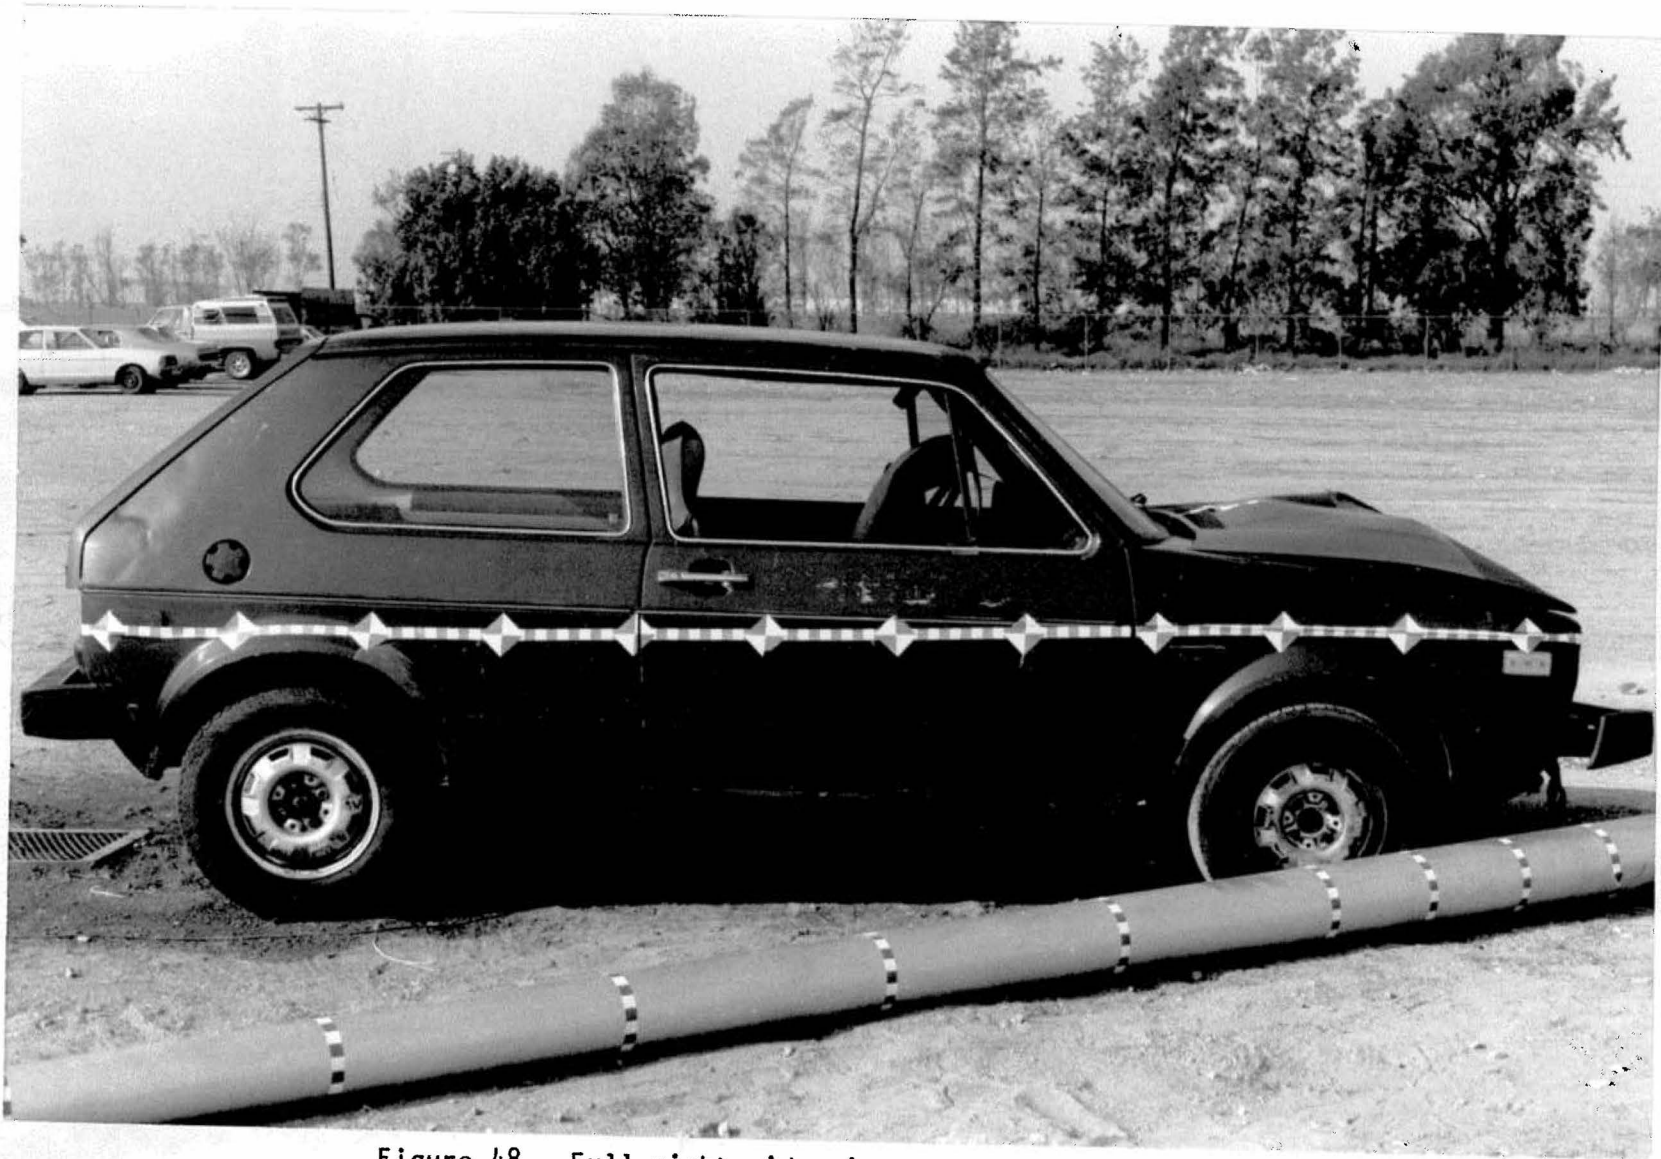
Figure 48. Full right side view, posttest, test no. 3.

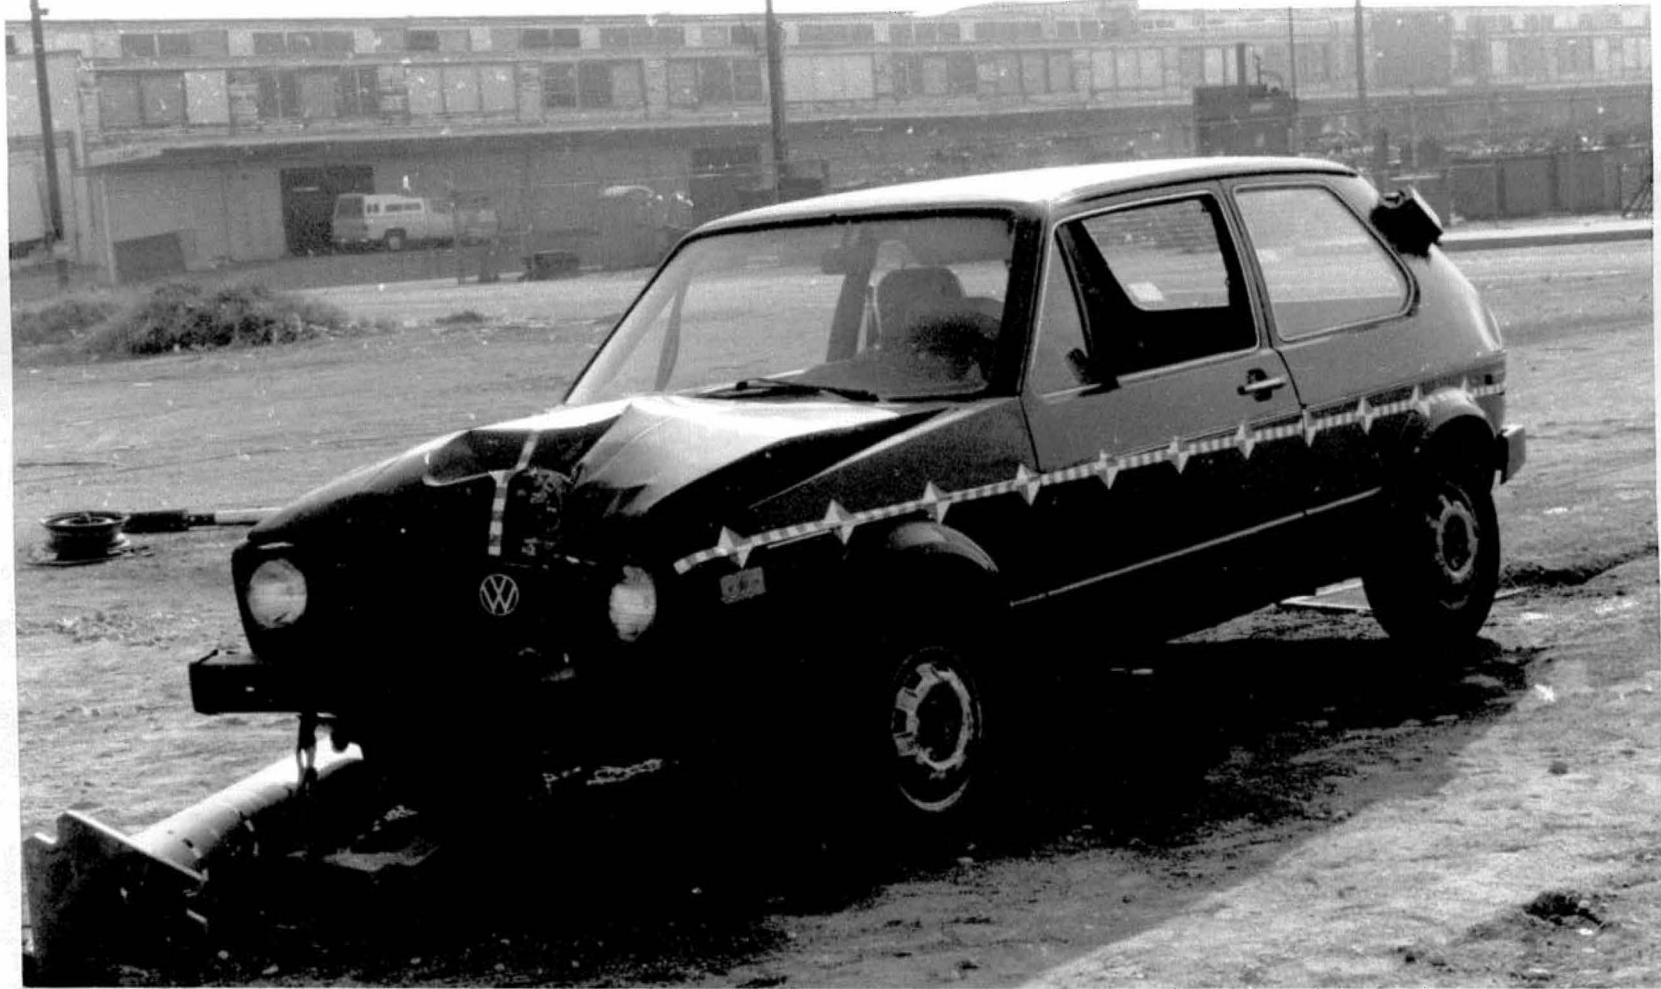
Figure 49. Left front 3/4 view, posttest, test no. 3.

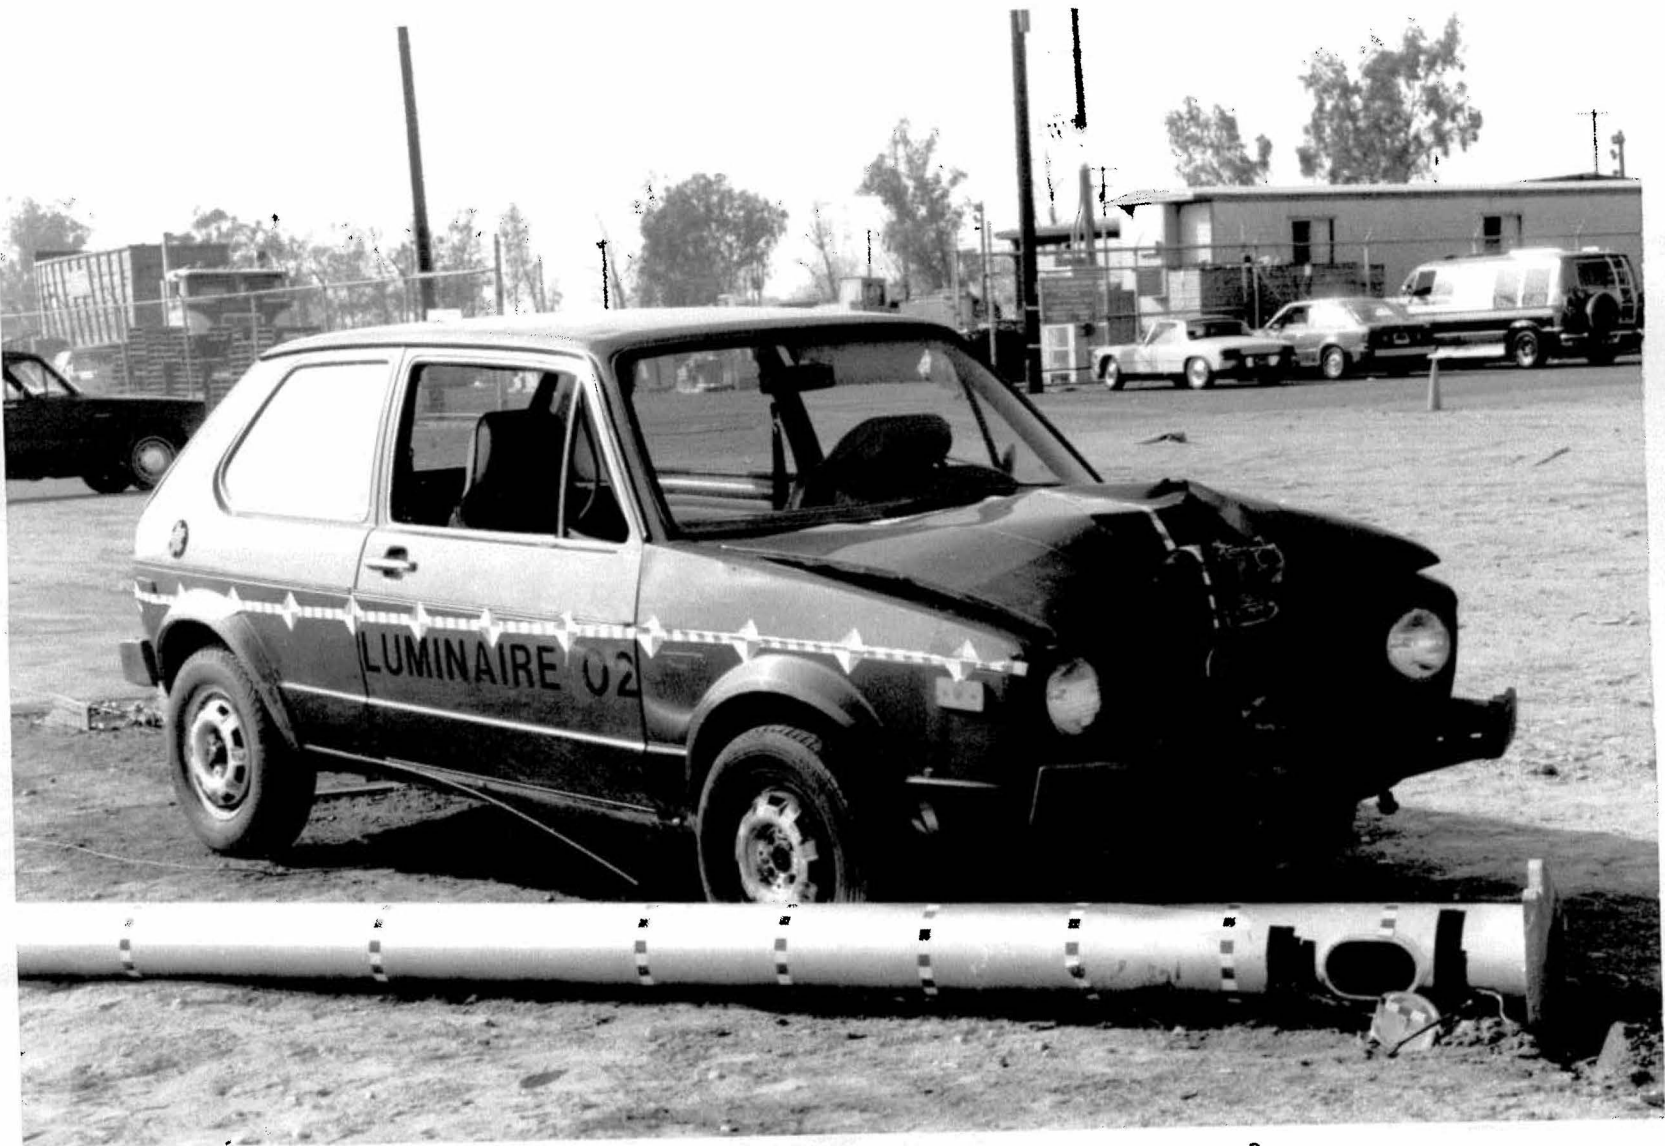
Figure 50. Right front 3/4 view, posttest, test no. 3.

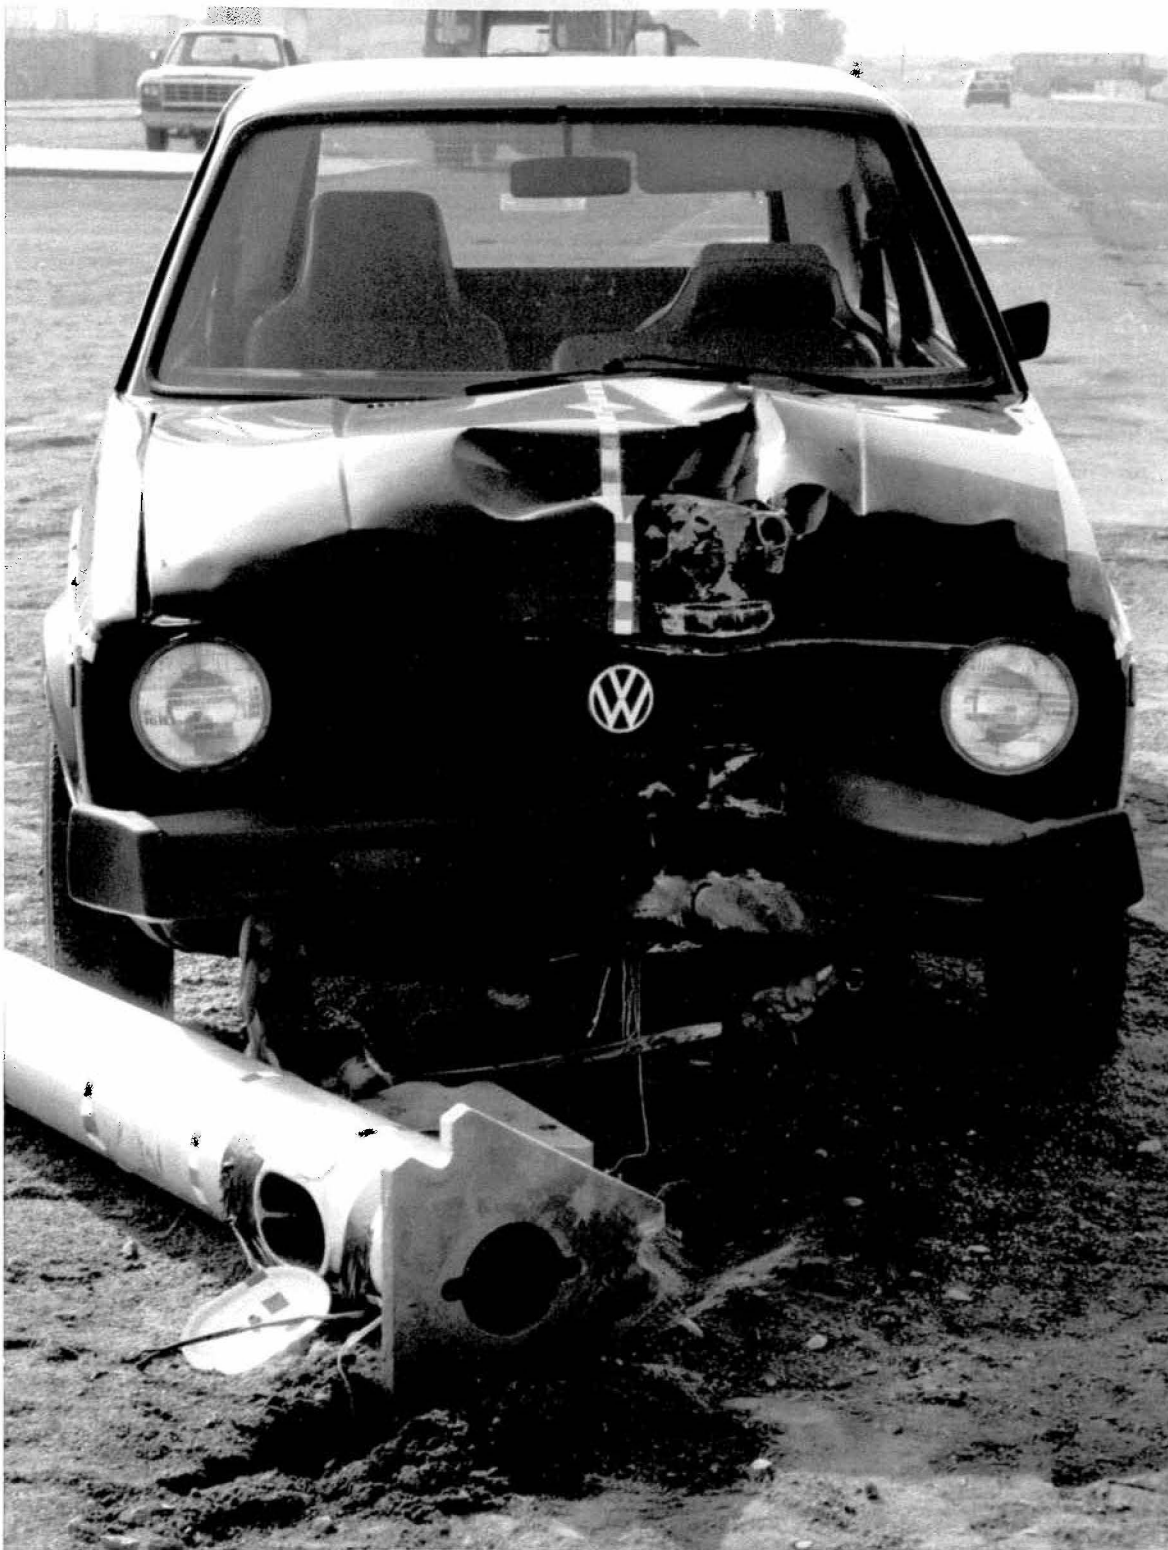
Figure 51. Front view, posttest, test no. 3.

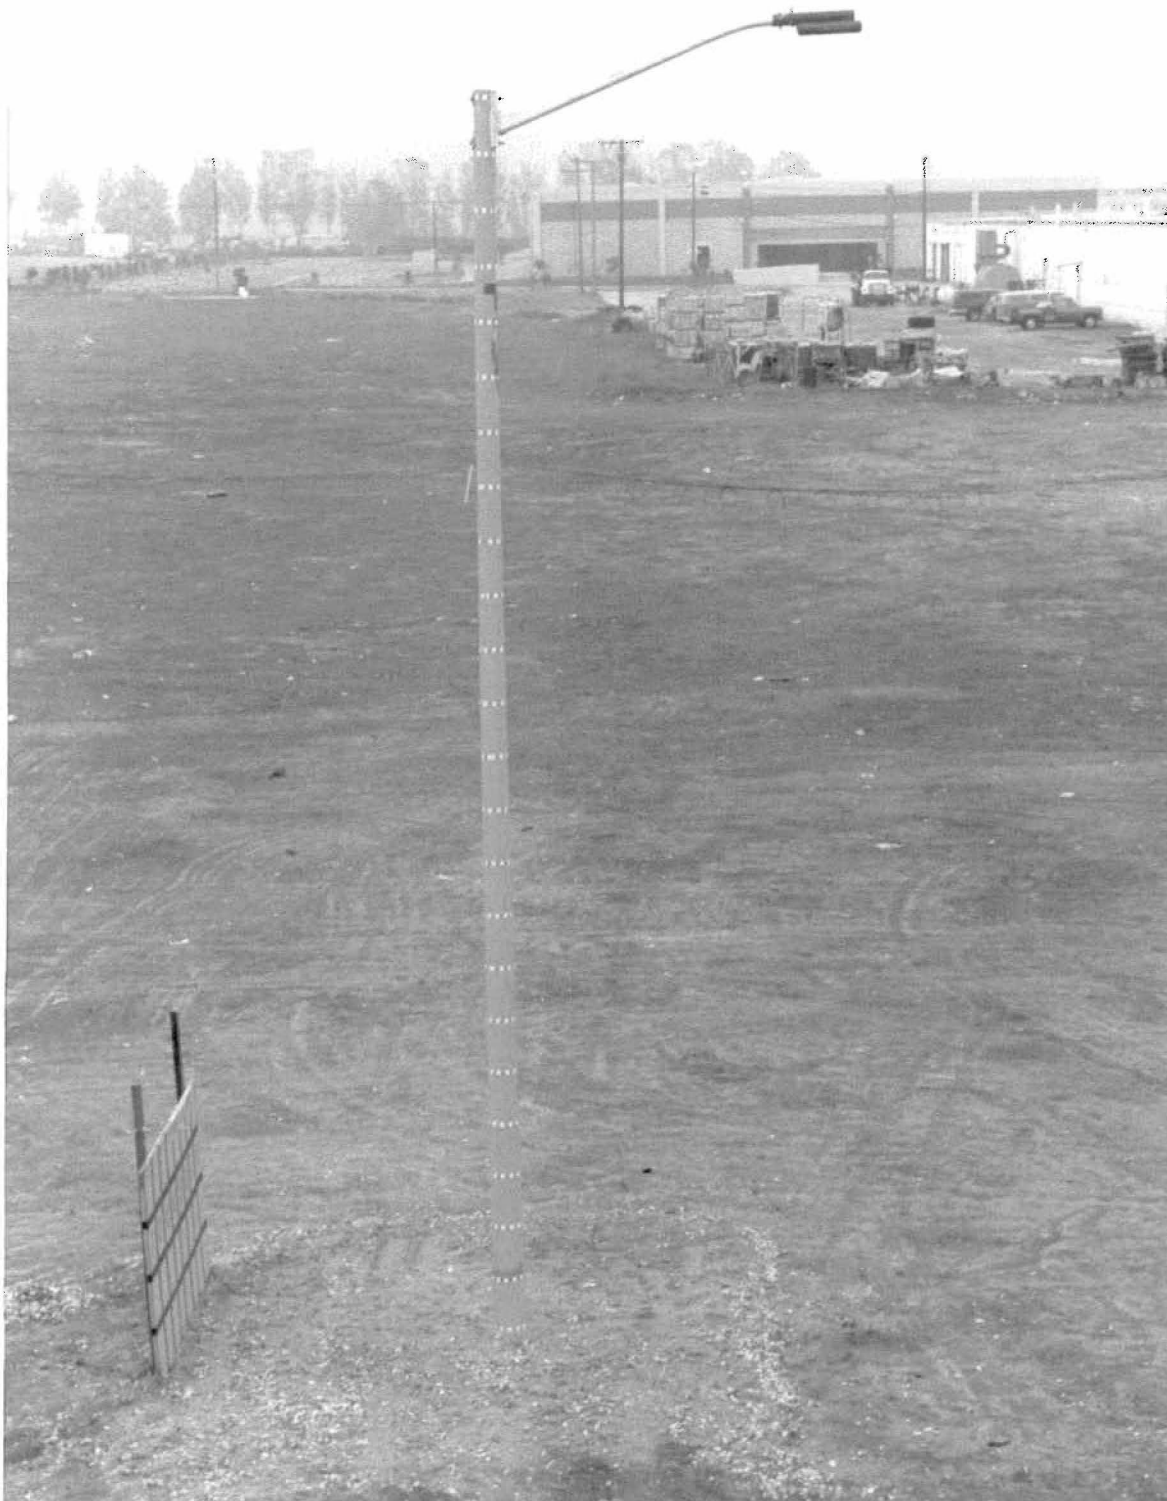
Figure 59. Test article, pretest, test no. 4.

Figures 58 through 68 show the test area, the test article and the posttest photographs of the test vehicle and the test article.

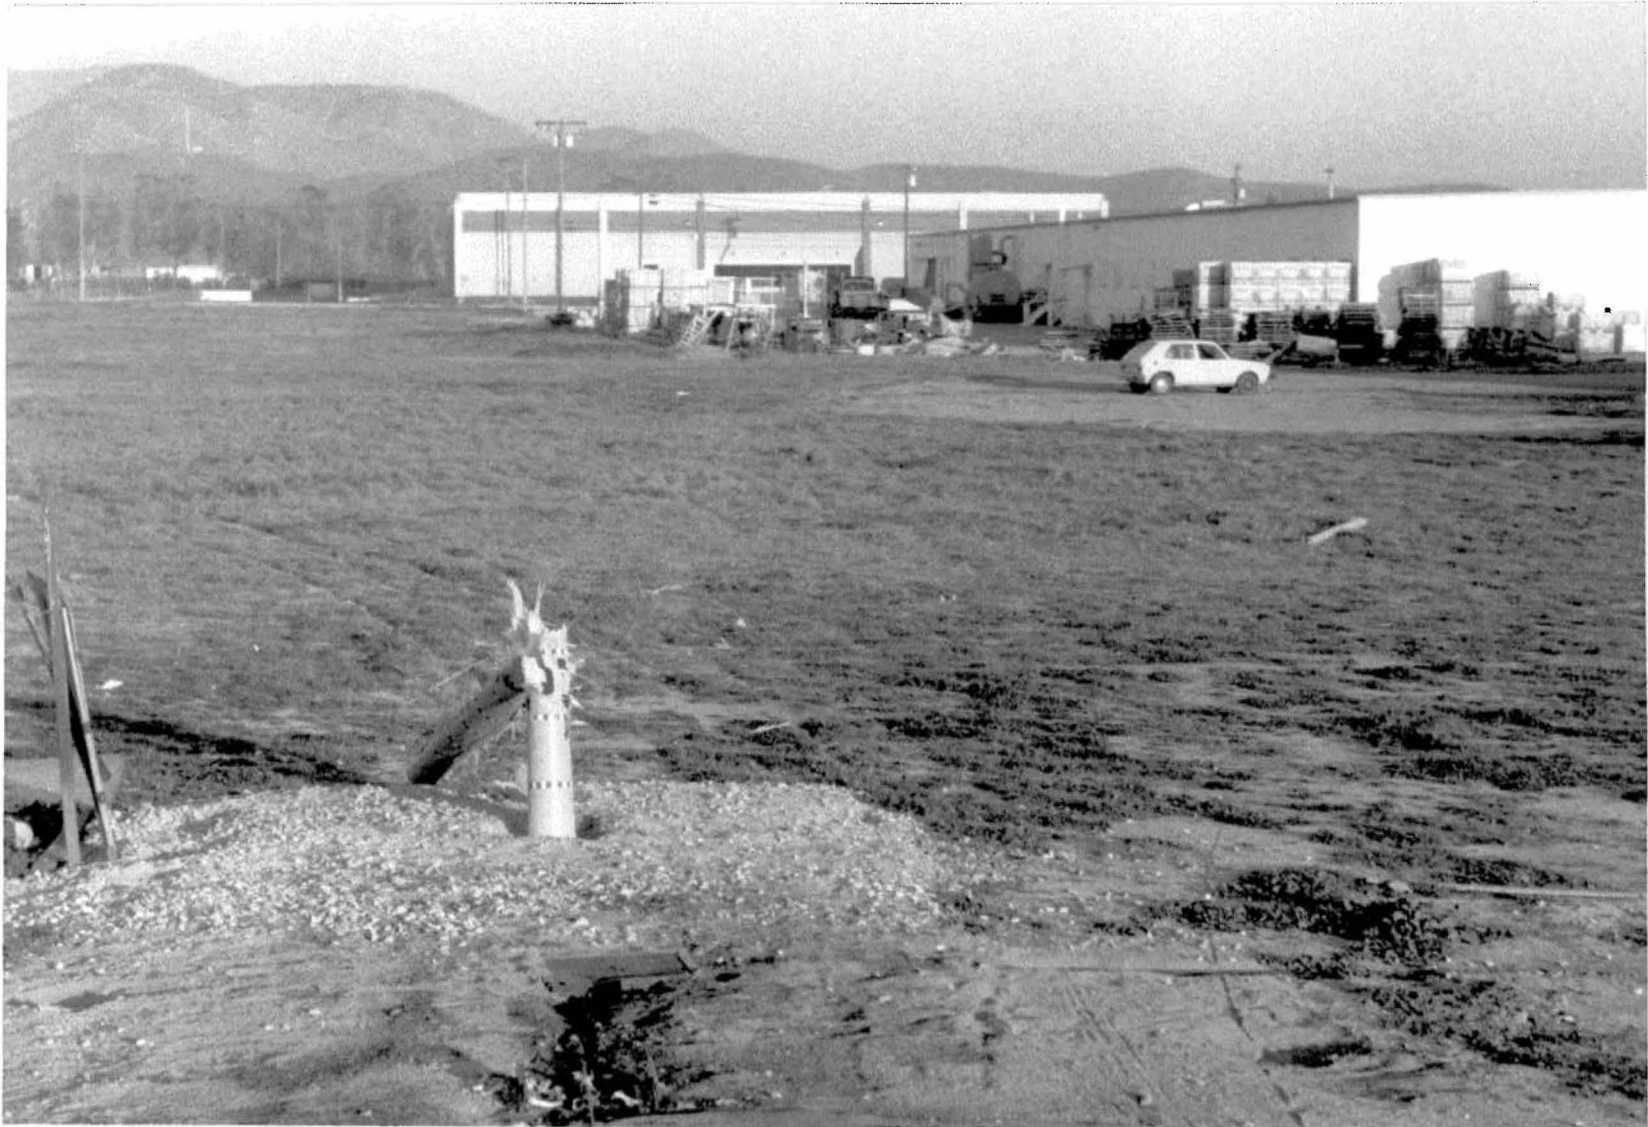
Figure 60. Test area elevated view, posttest, test no. 4.

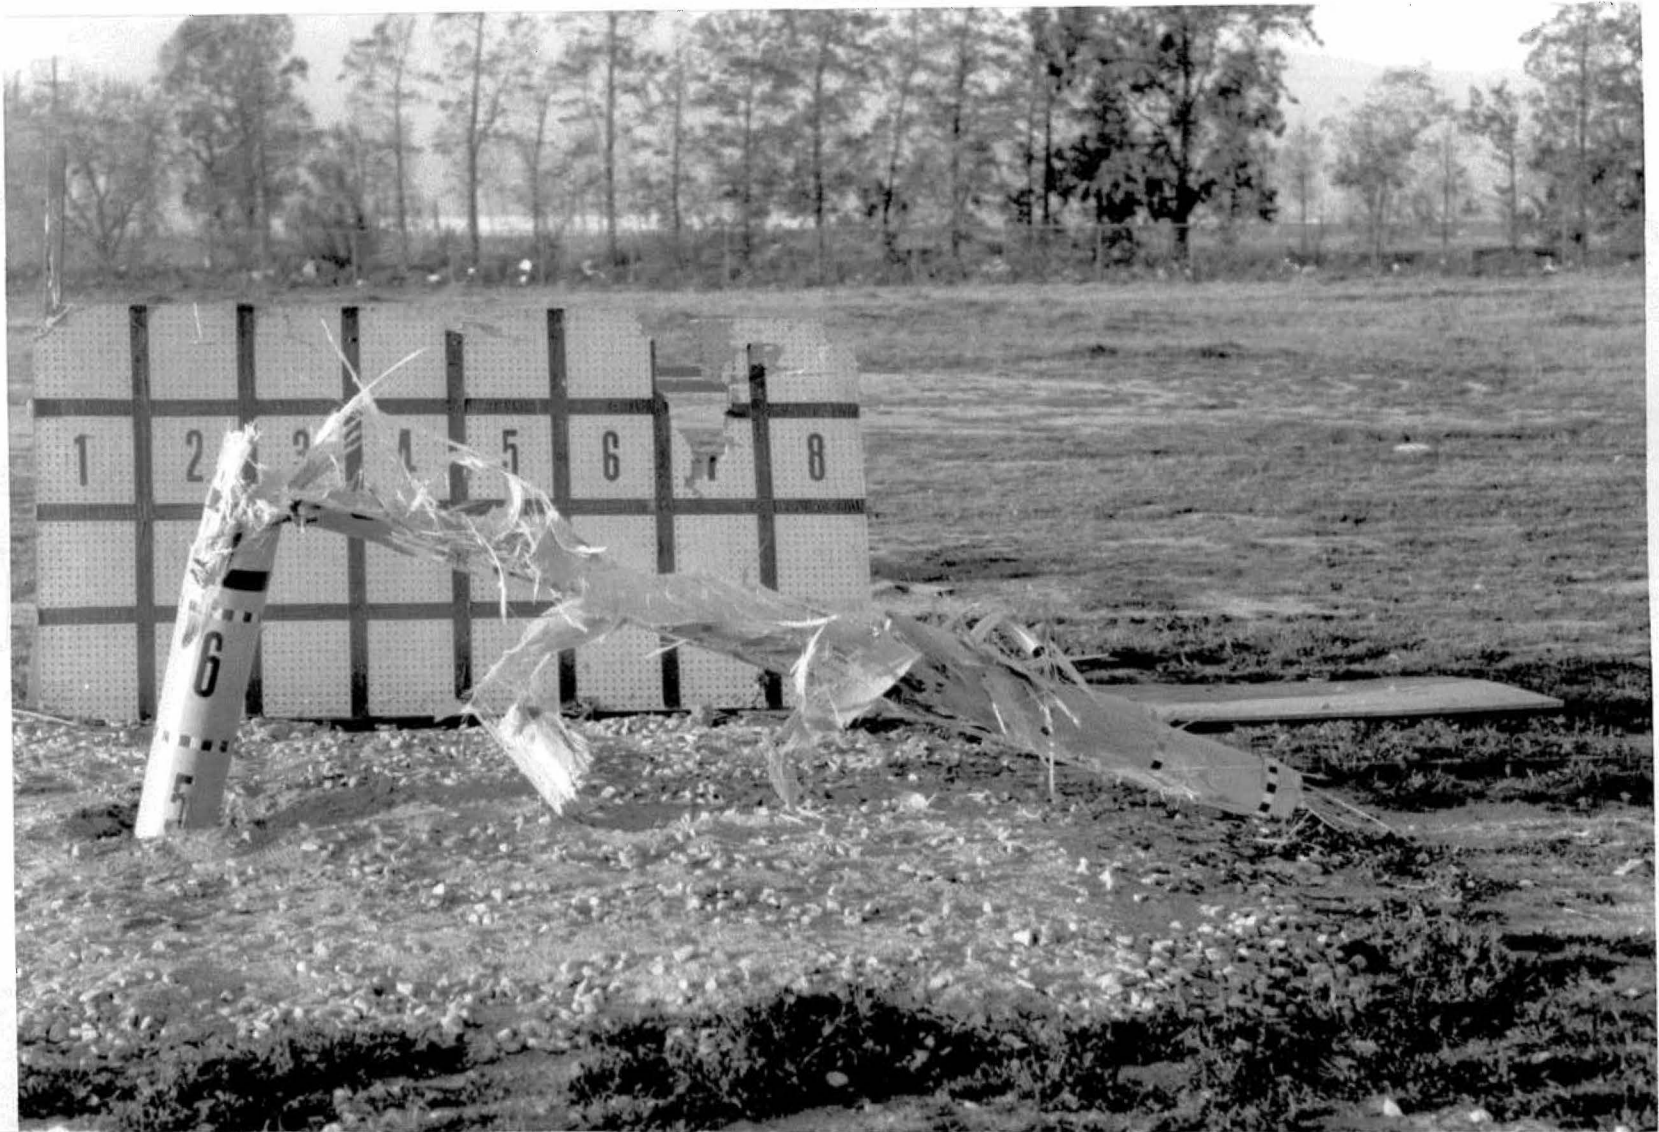
Figure 62. Closeup of pole break away, posttest, test no. 4.

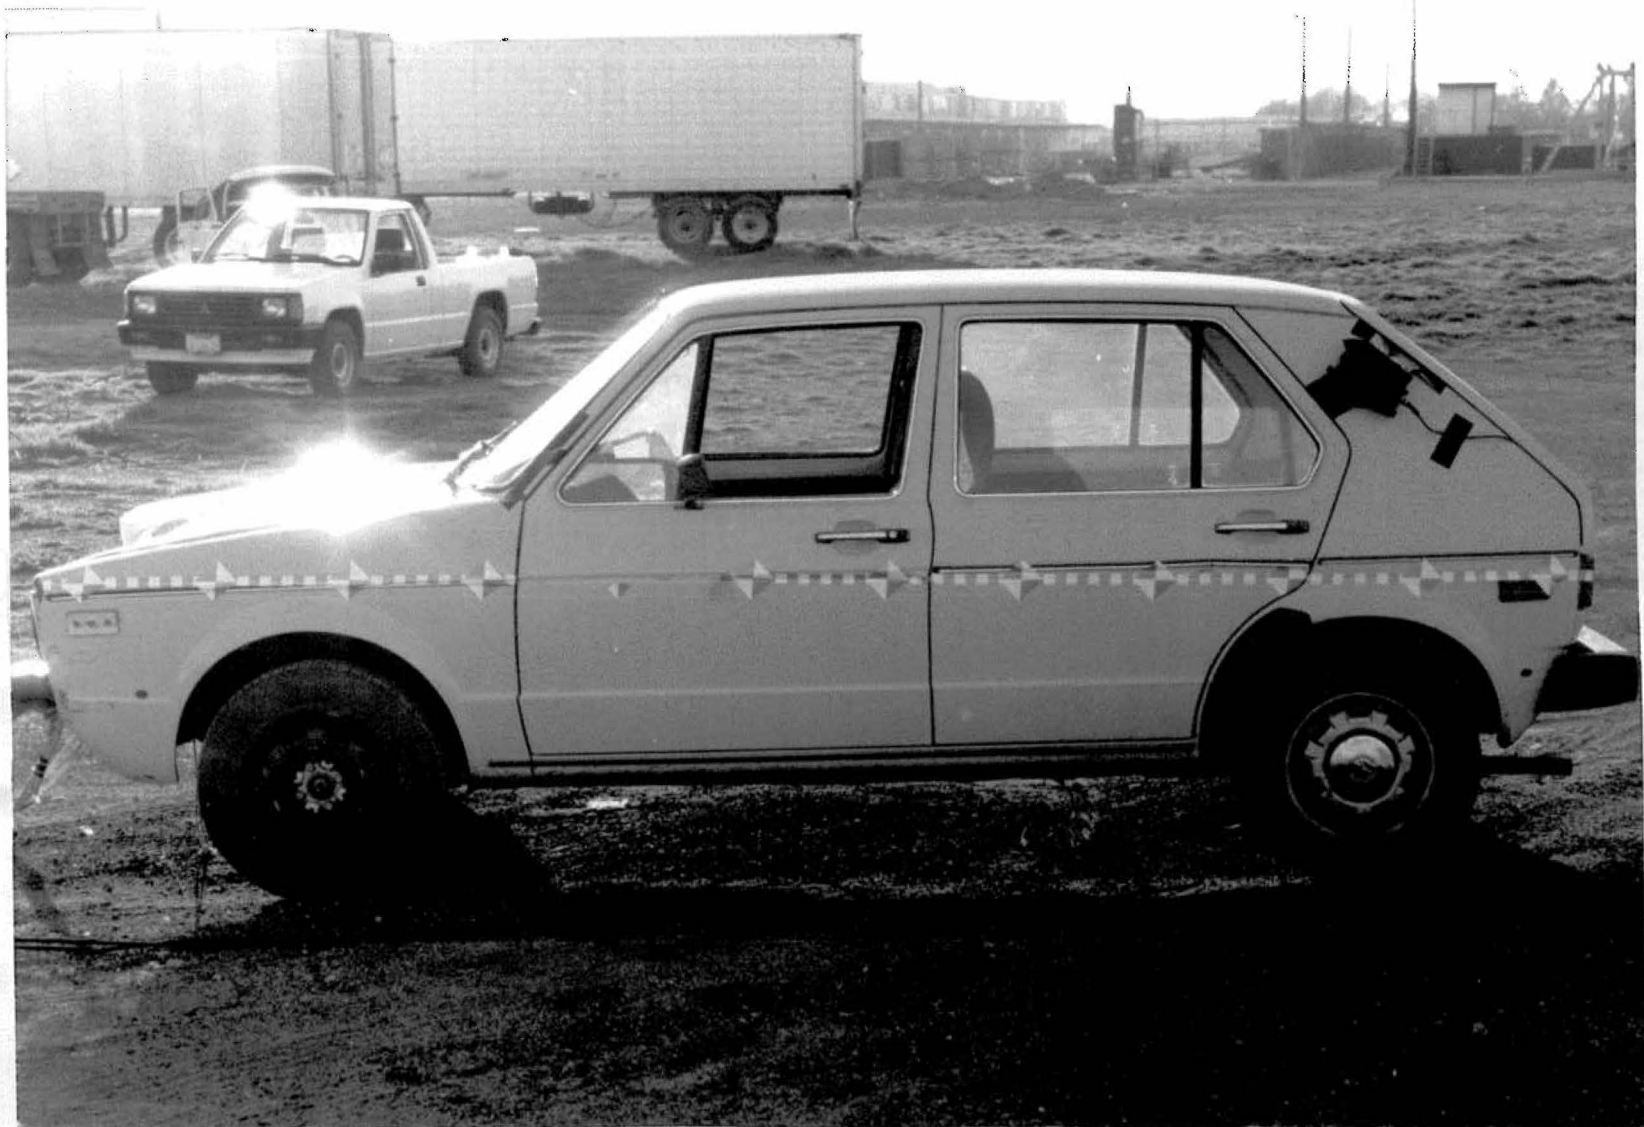
Figure 63. Full left side view, posttest, test no. 4.
