REPORT NO. FHWA-RD-88-225
LUMINAIRE AND SIGN SUPPORTS

LUMINAIRE AND SIGN SUPPORTS
TECHNICAL VOLUME

This report presents the results, test reports and findings pertaining to the project "Luminaire and Sign Supports" conducted for the Federal Highway Administration (FHWA) by the contractor under contract no. DTFH61-87-Z-00103.

Five designs of luminaire and sign supports were impacted with 1800 lb class vehicles. The test results were evaluated to determine the safety performance of the tested luminaire and sign supports against the requirements specified by the AASHTO and NCHRP No. 230 documents. This report will be of interest to highway engineers dealing with roadside safety.

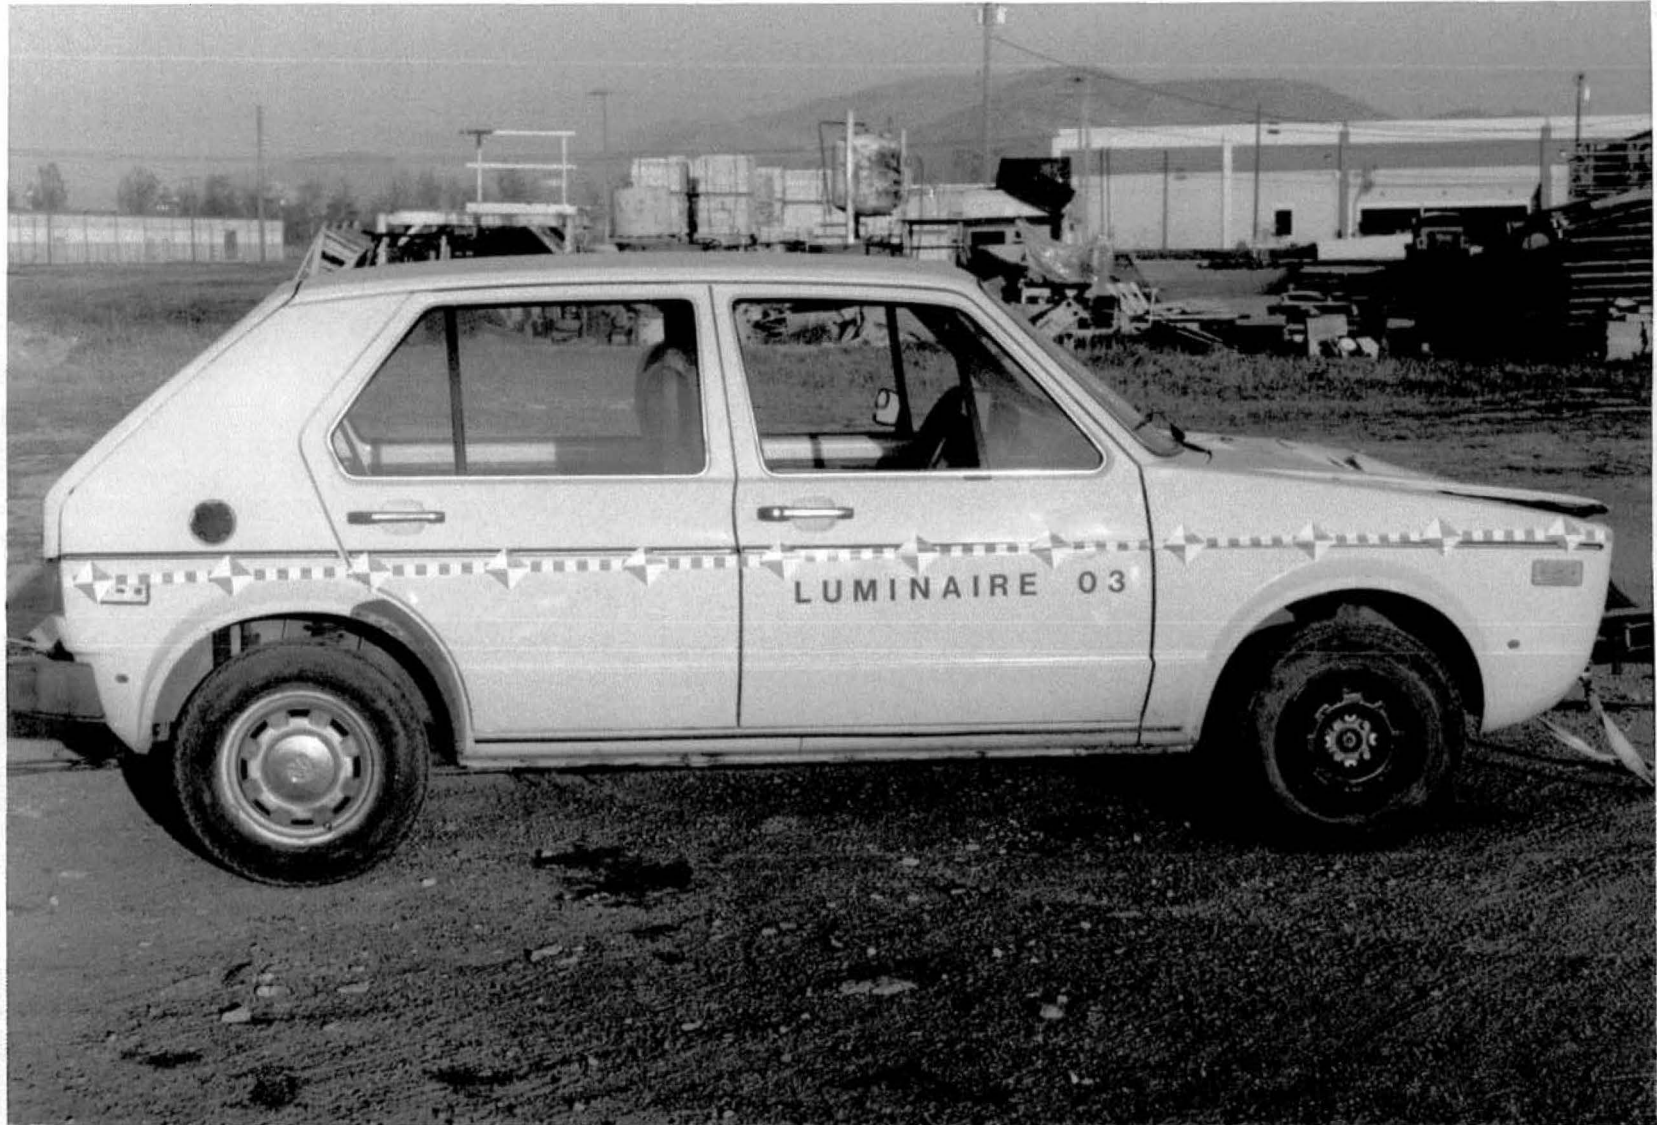
Figure 64. Full right side view, posttest, test no. 4.

Figures 58 through 68 show the test area, the test article and the posttest photographs of the test vehicle and the test article.

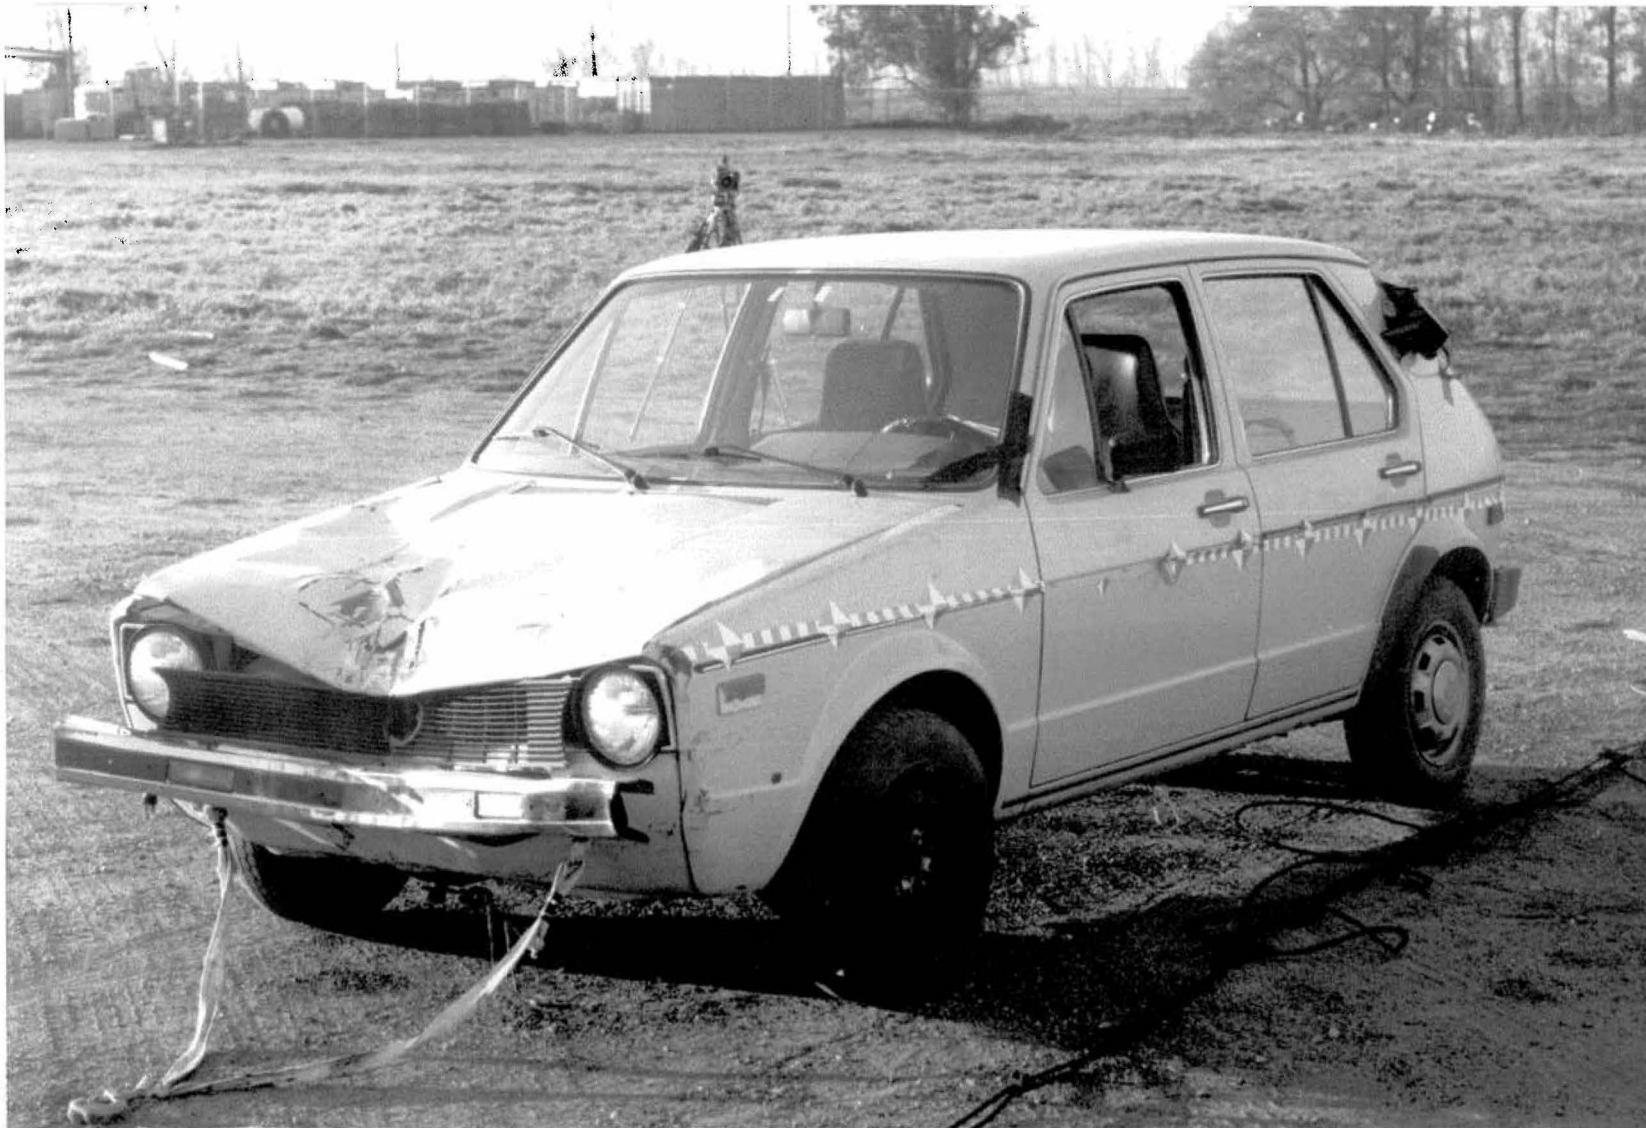
Figure 65. Left front 3/4 view, posttest, test no. 4.

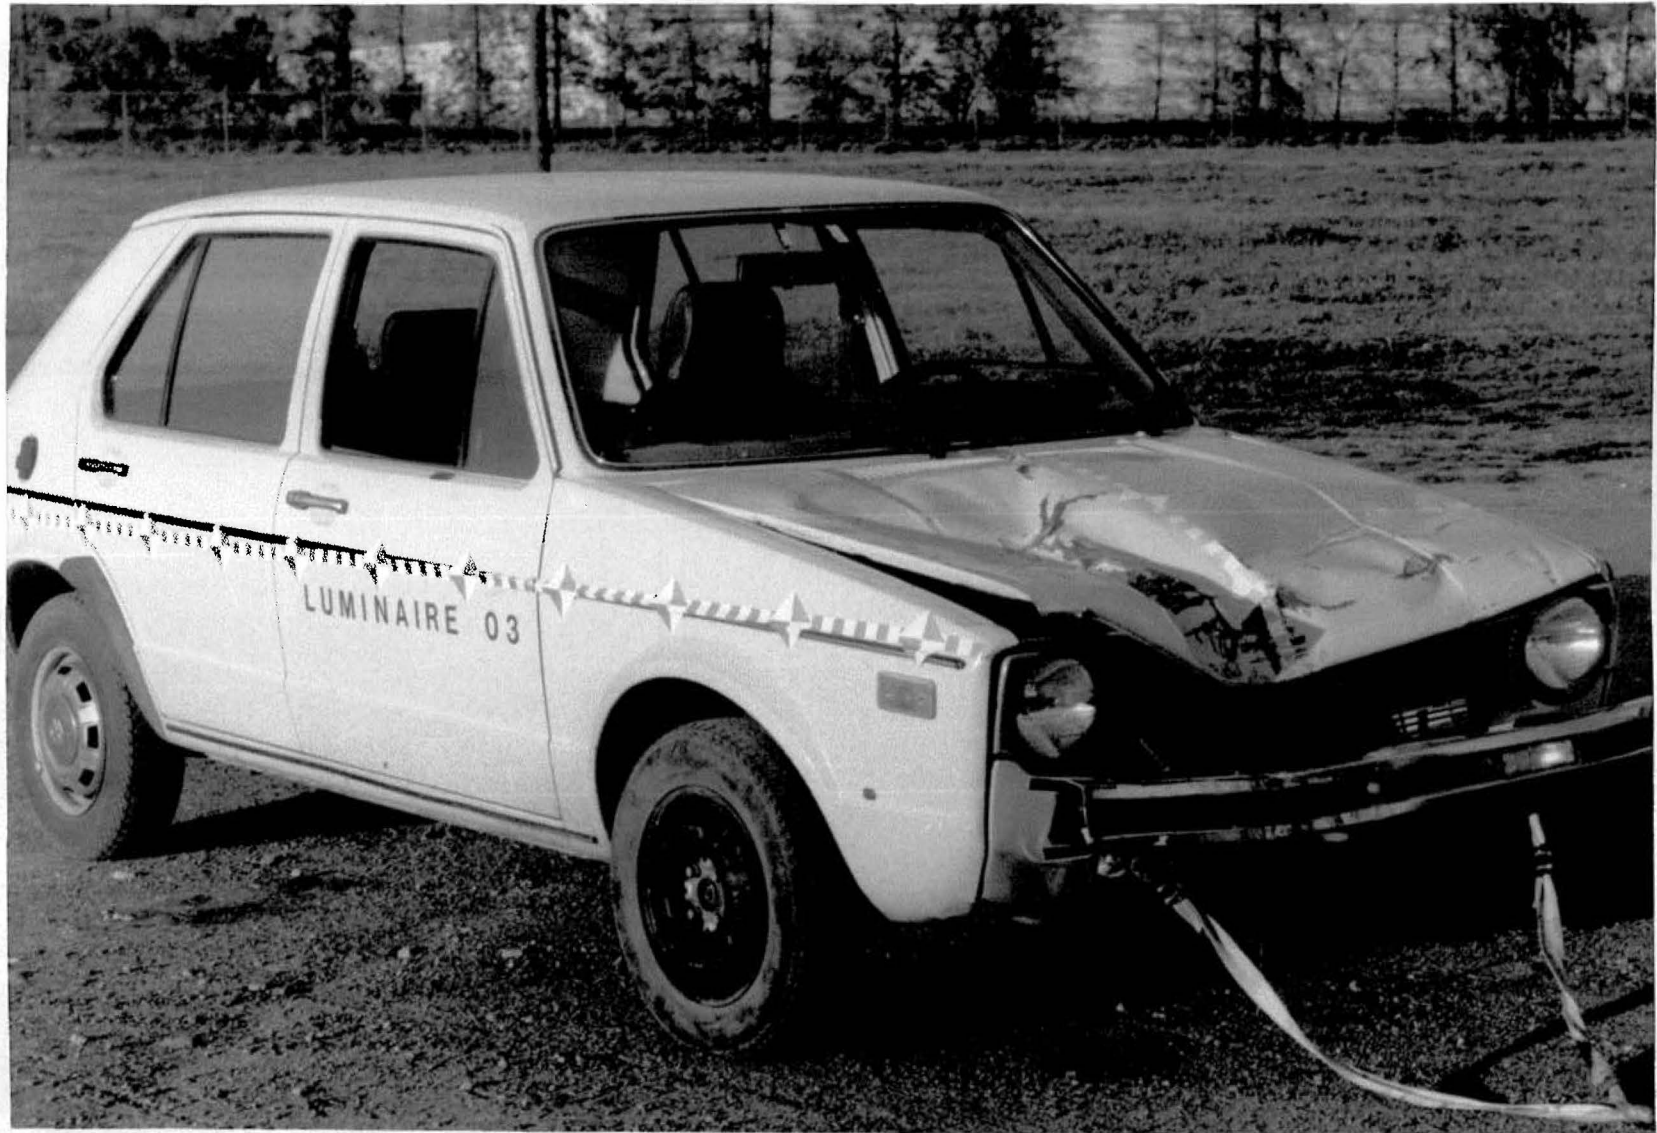
Figure 66. Right front 3/4 view, posttest, test no. 4.

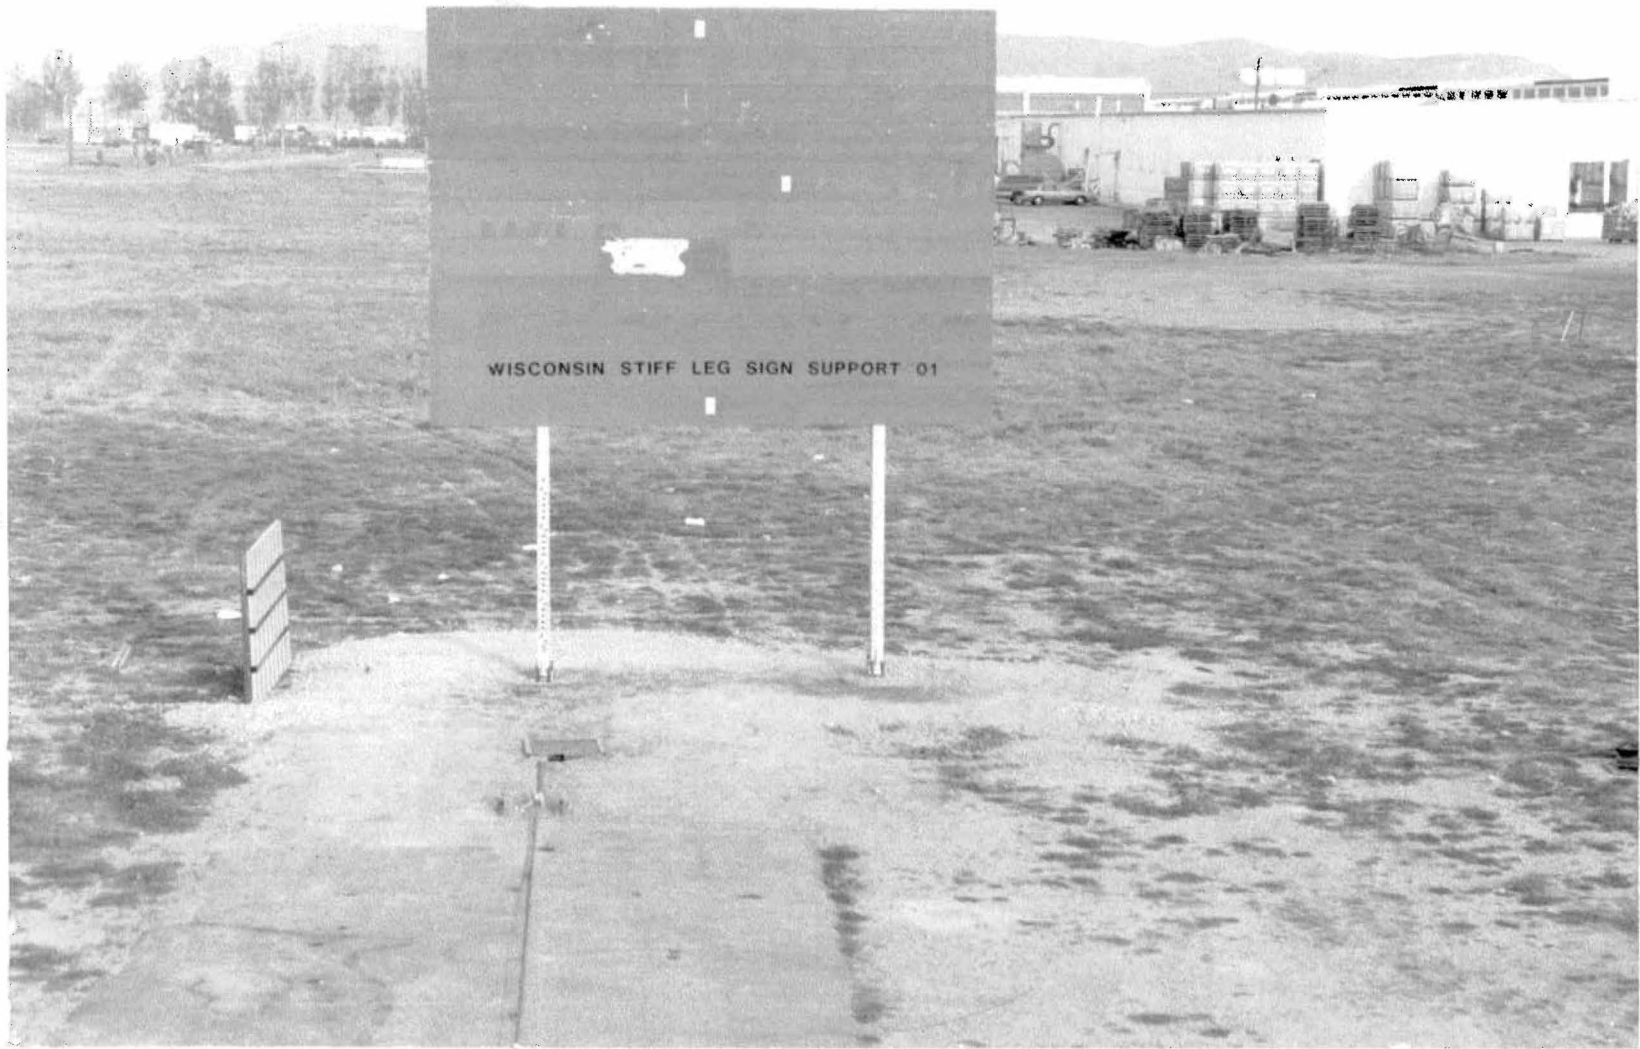
Figure 73. Test article, pretest, test no. 5.

Figures 72 through 82 show the test area, the test article and the posttest photographs of the test vehicle and the test article.

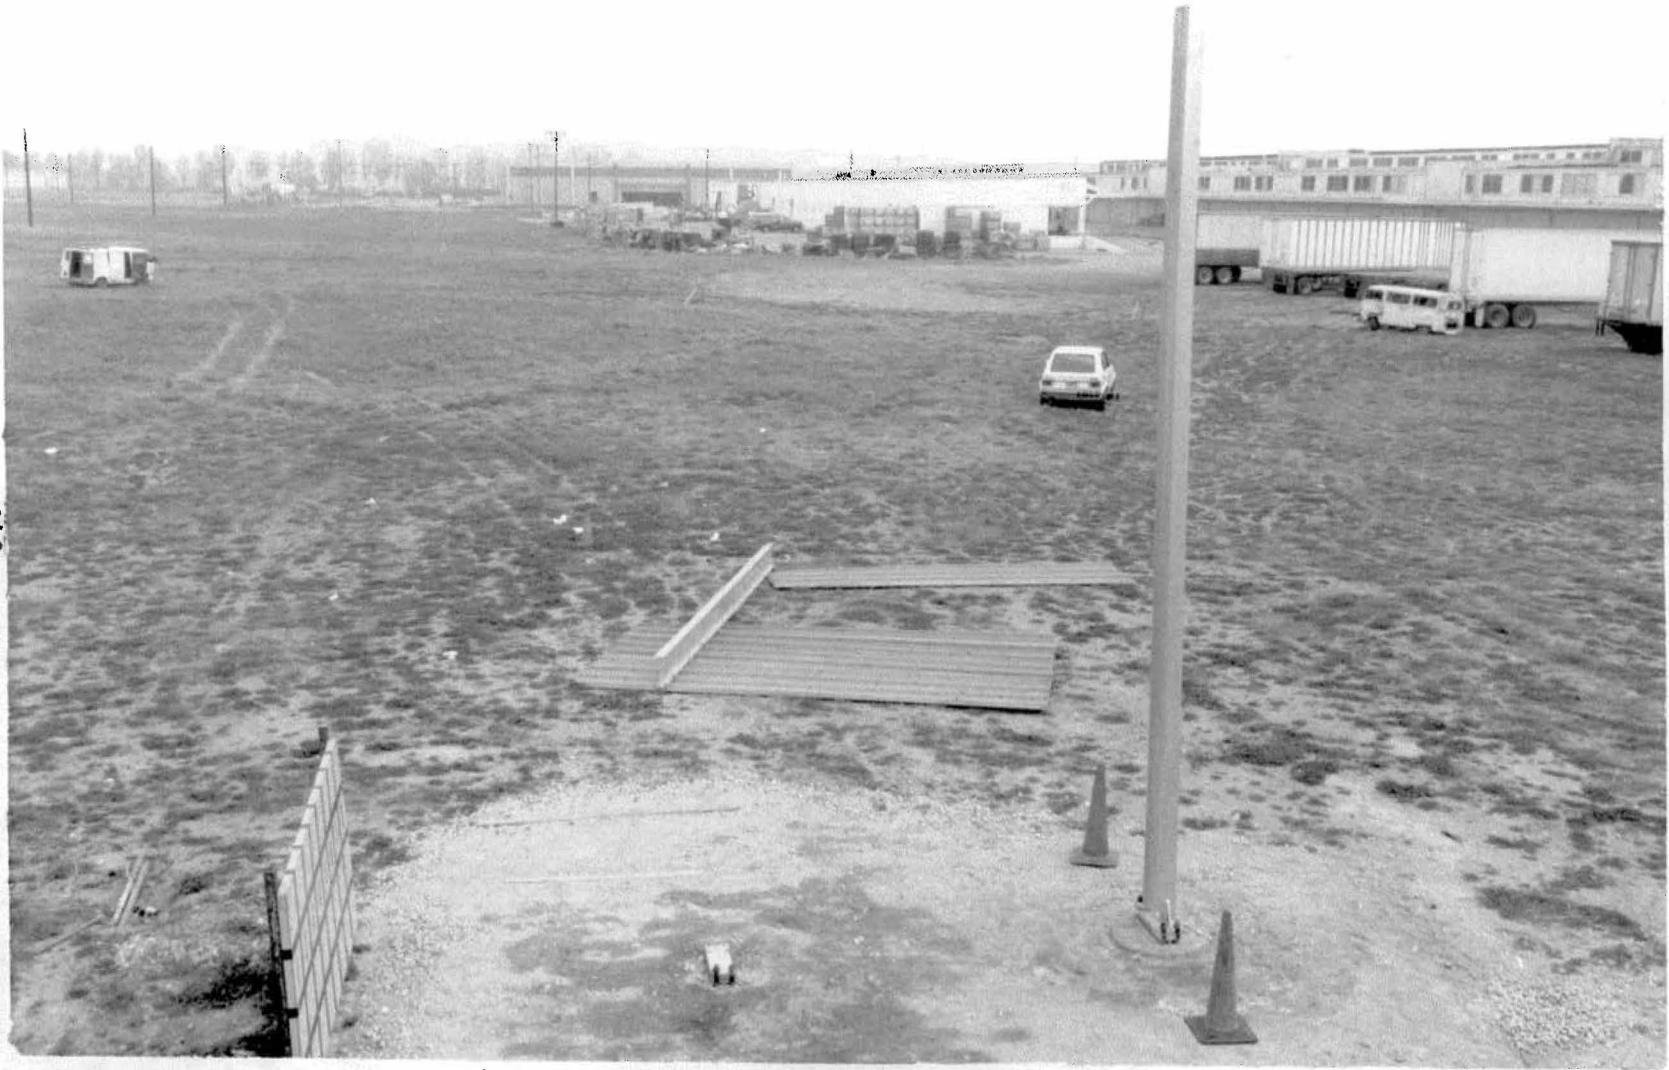
Figure 74. Test area elevated view, posttest, test no. 5.

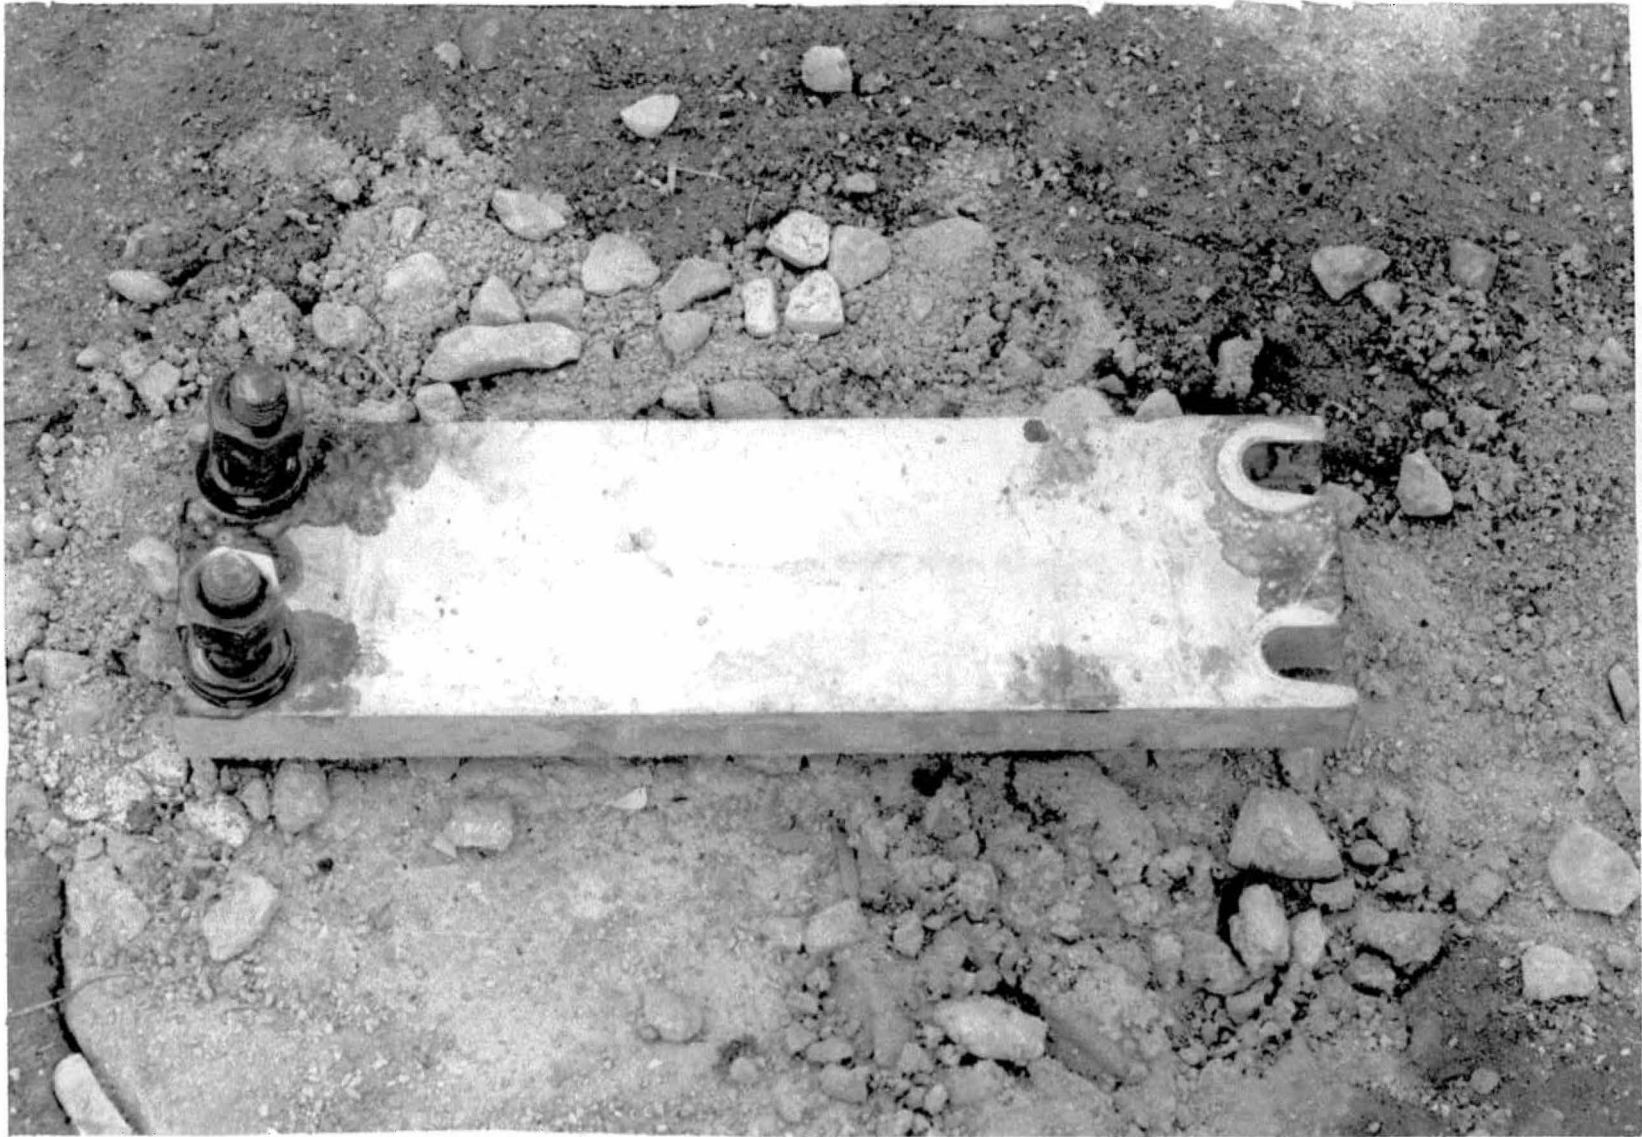
Figure 76. Test article on the ground, posttest, test no. 5.

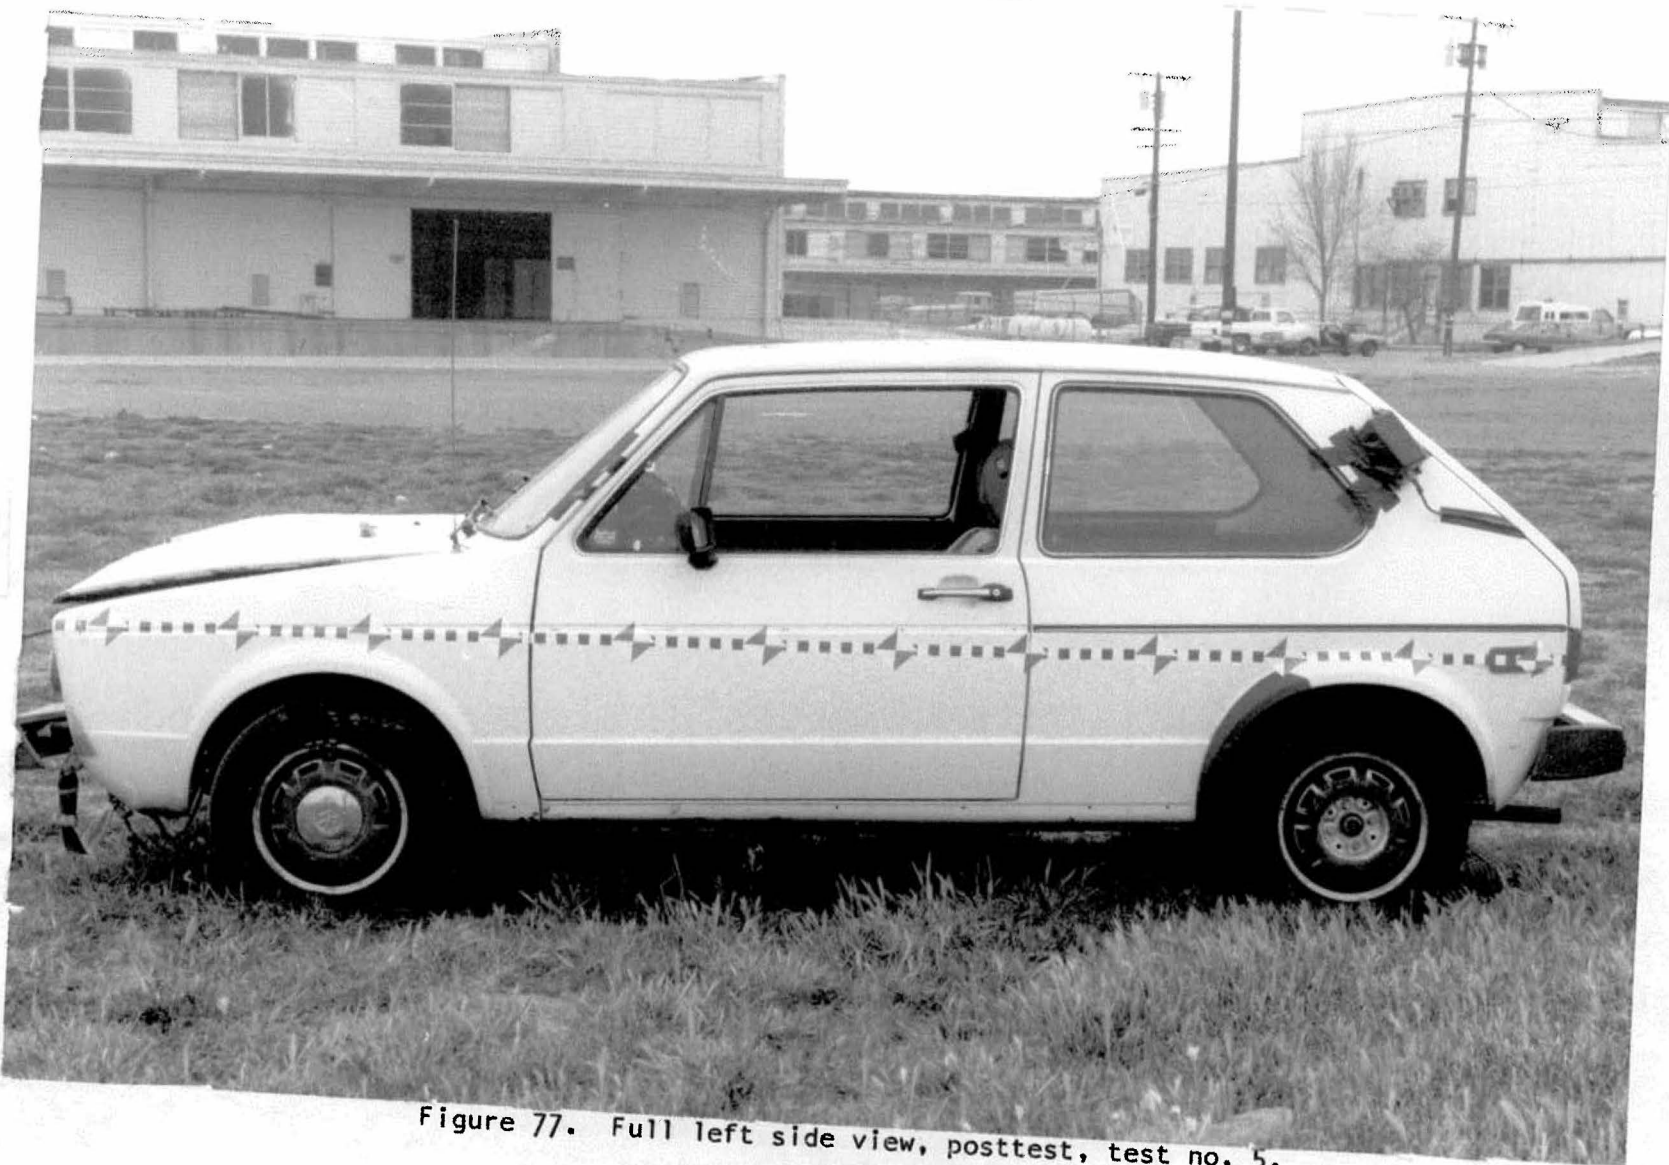
Figure 77. Full left side view, posttest, test no. 5.

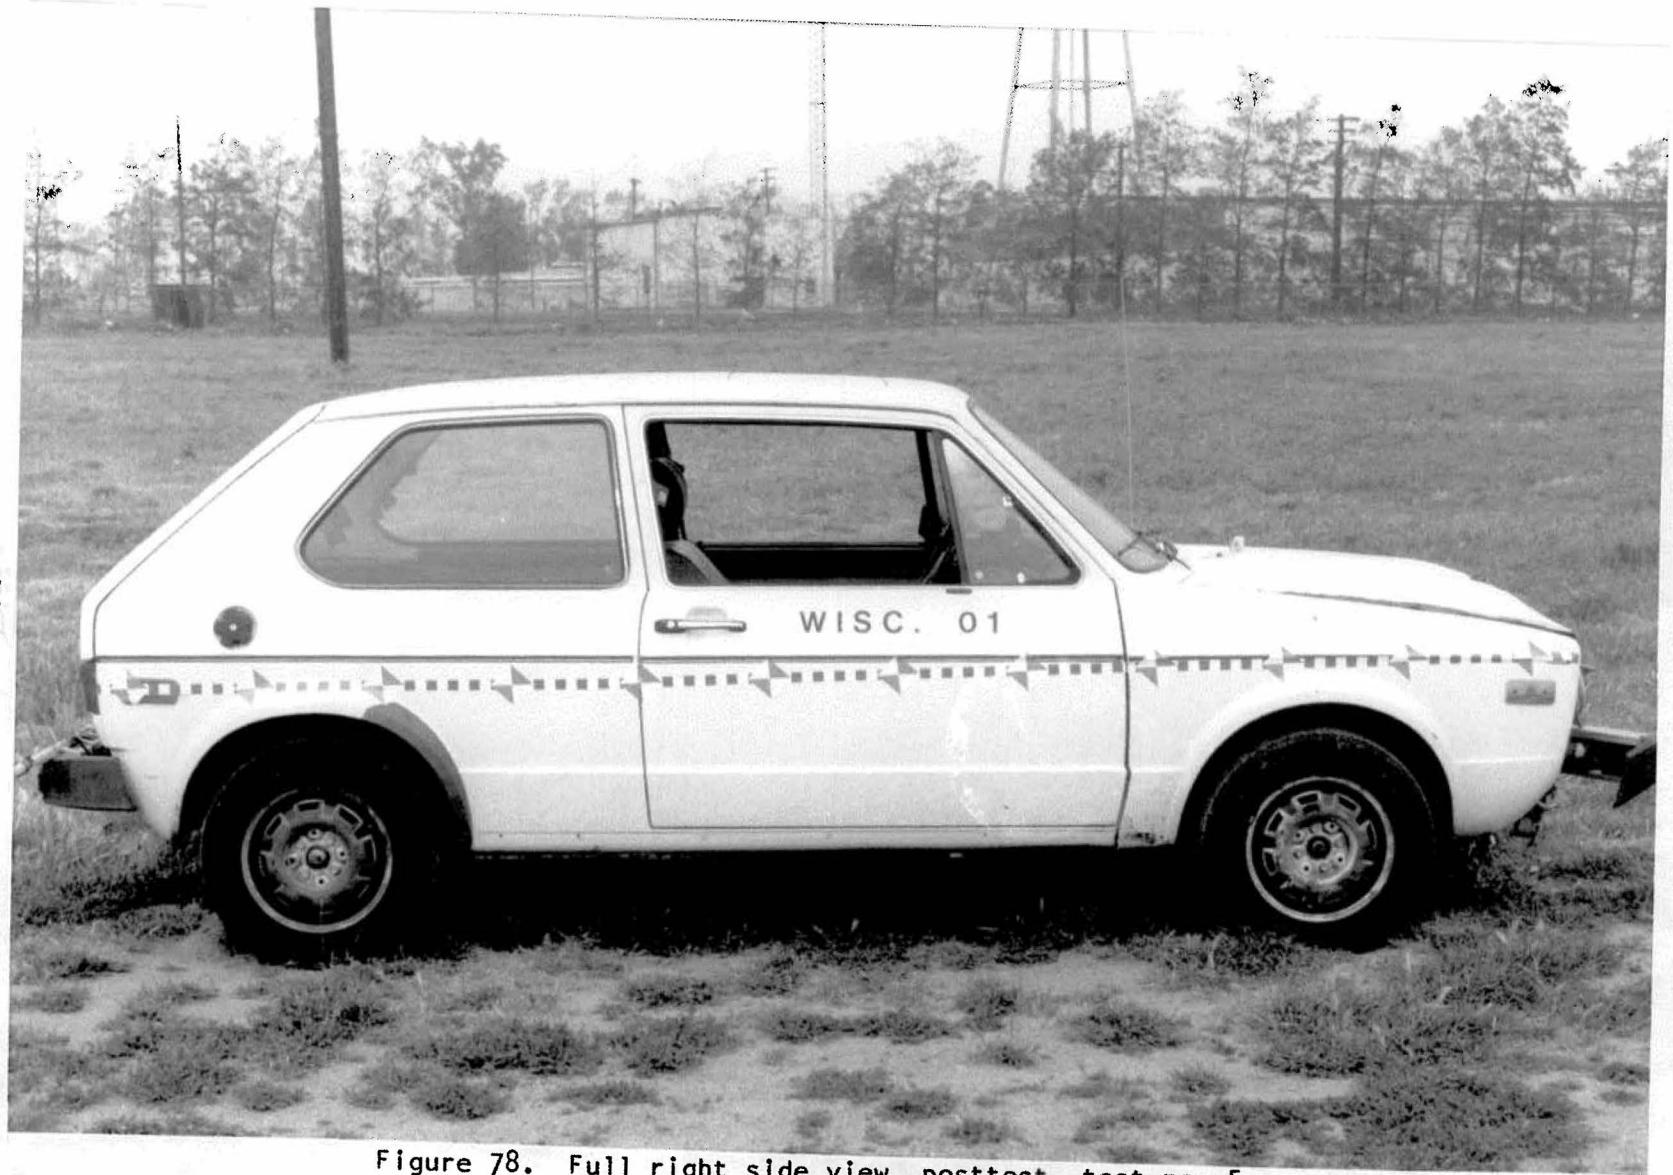
Figure 78. Full right side view, posttest, test no. 5.

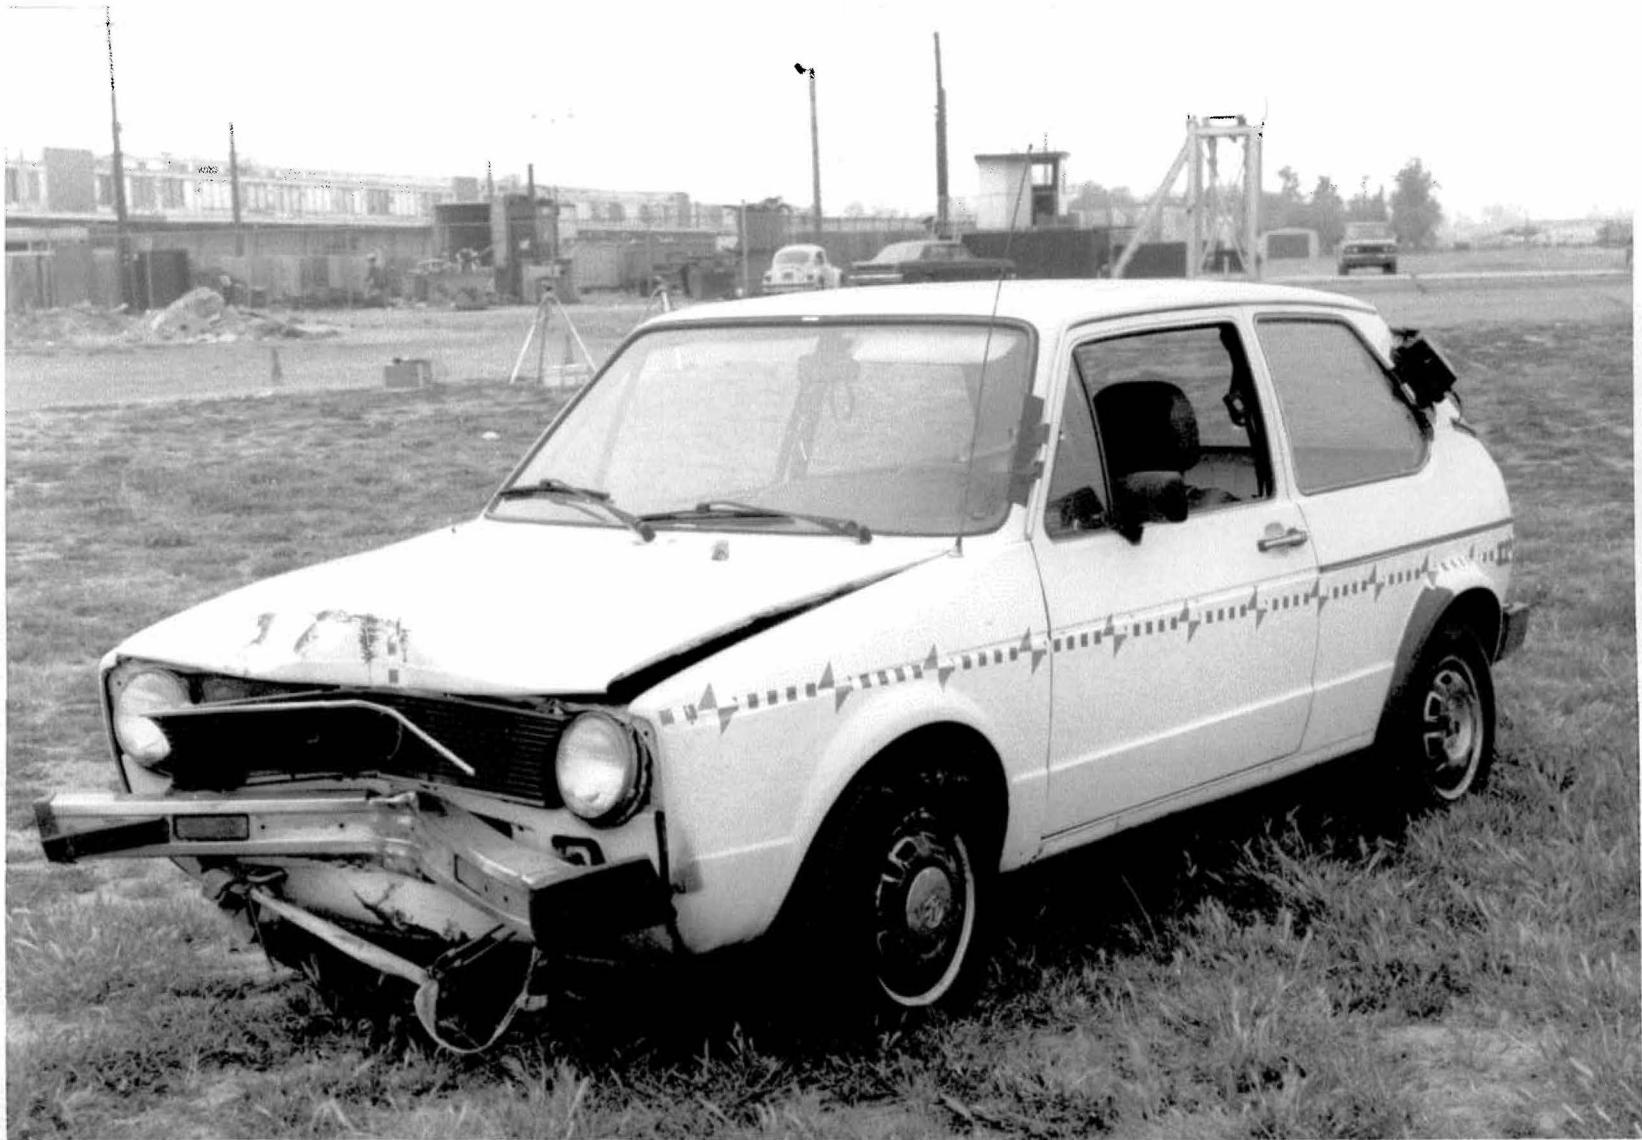
Figure 79. Left front 3/4 view, posttest, test no. 5.

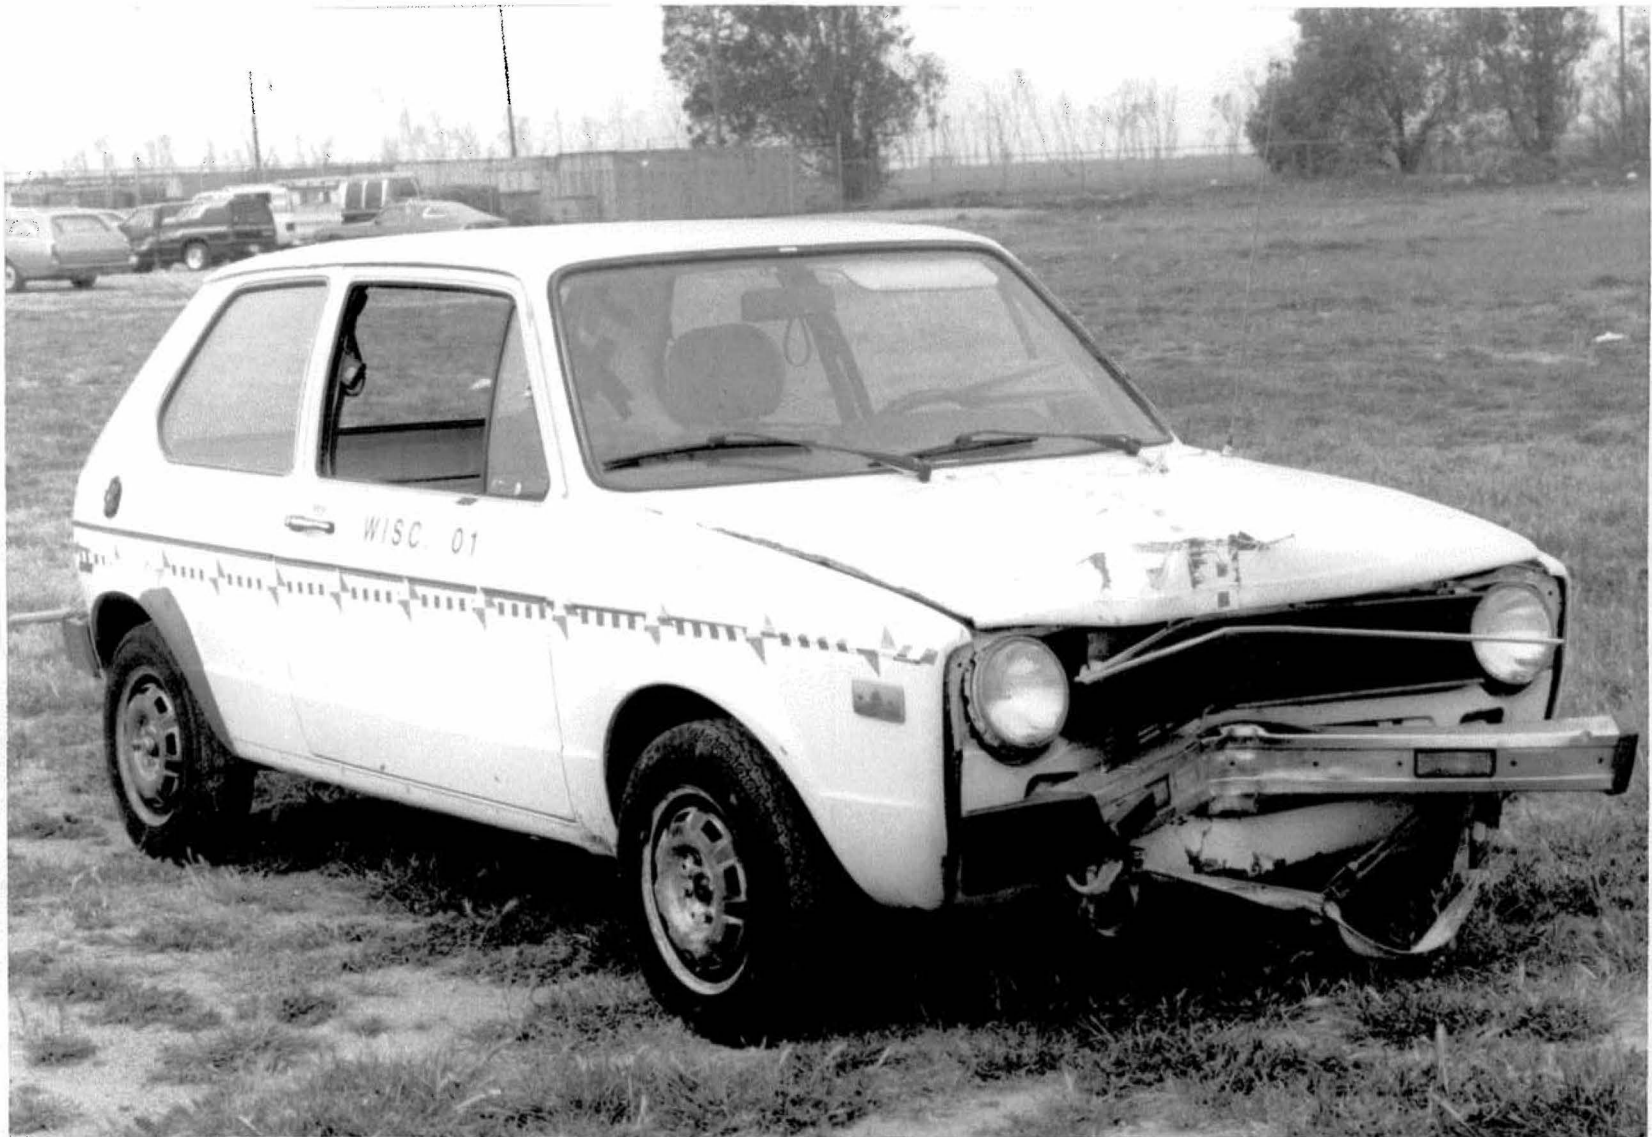
154
Figure 80. Right front 3/4 view, posttest, test no. 5.

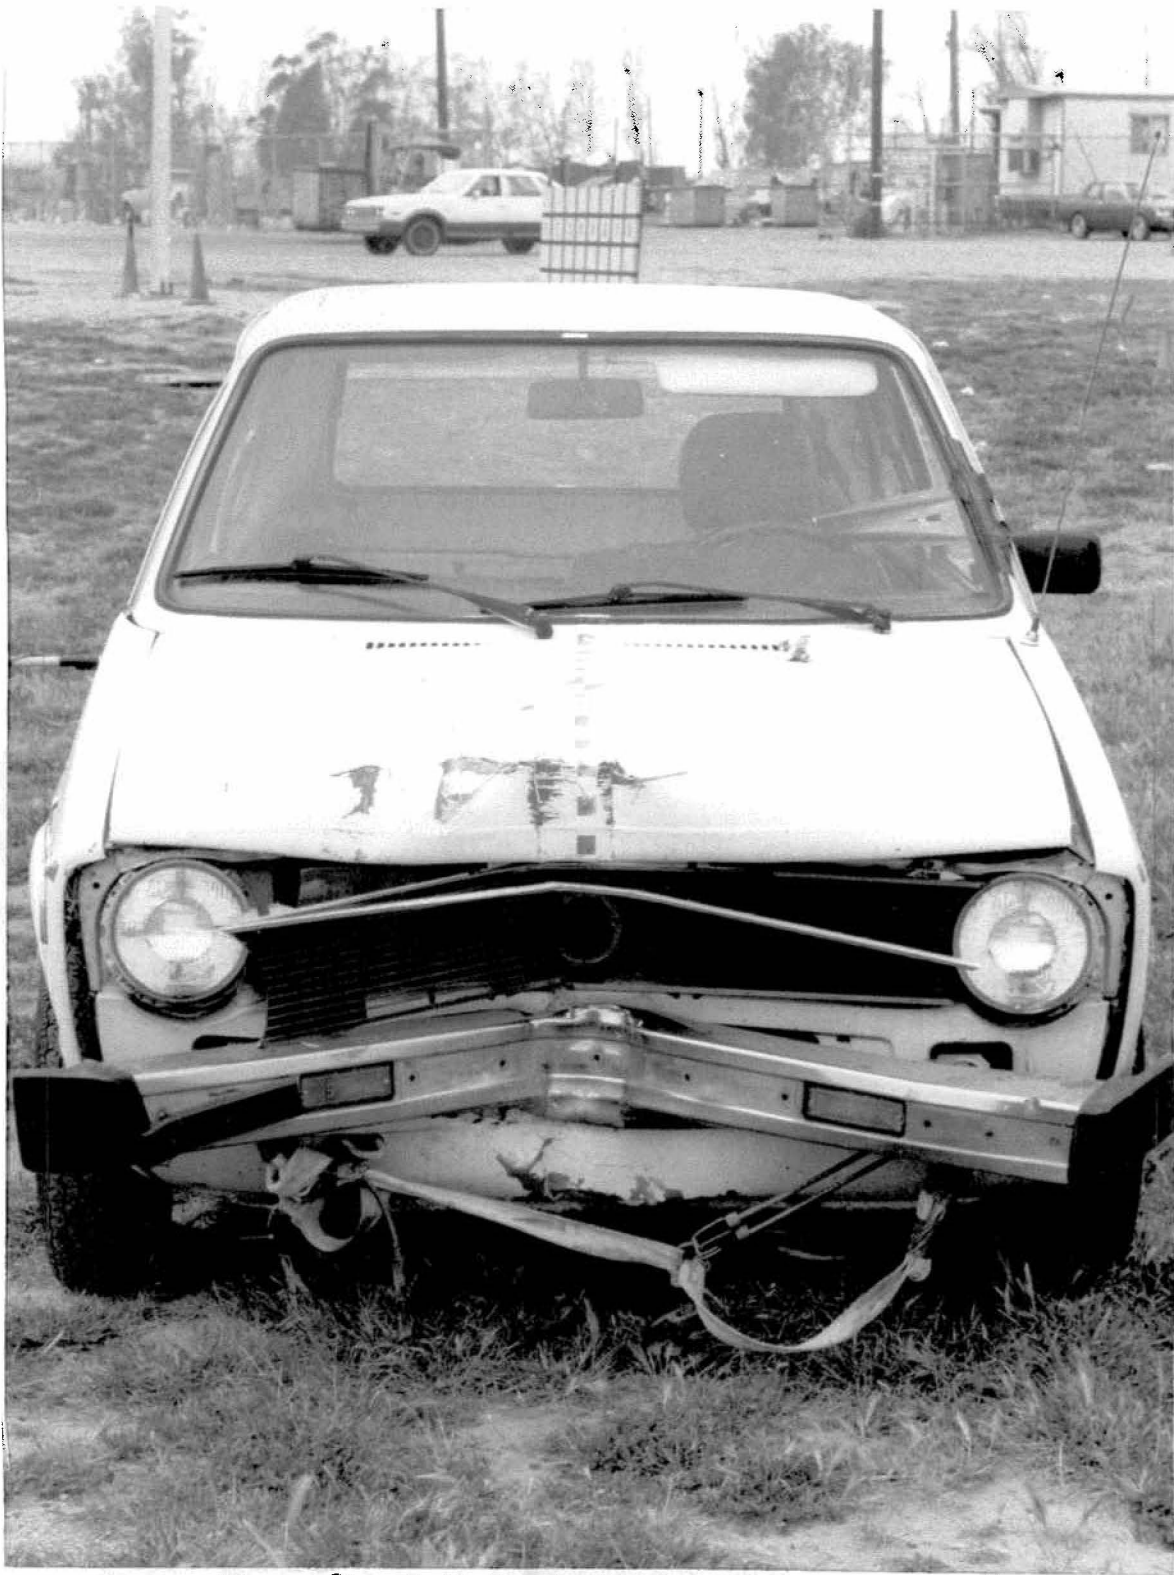
Figure 81. Full front view, posttest, test no. 5.

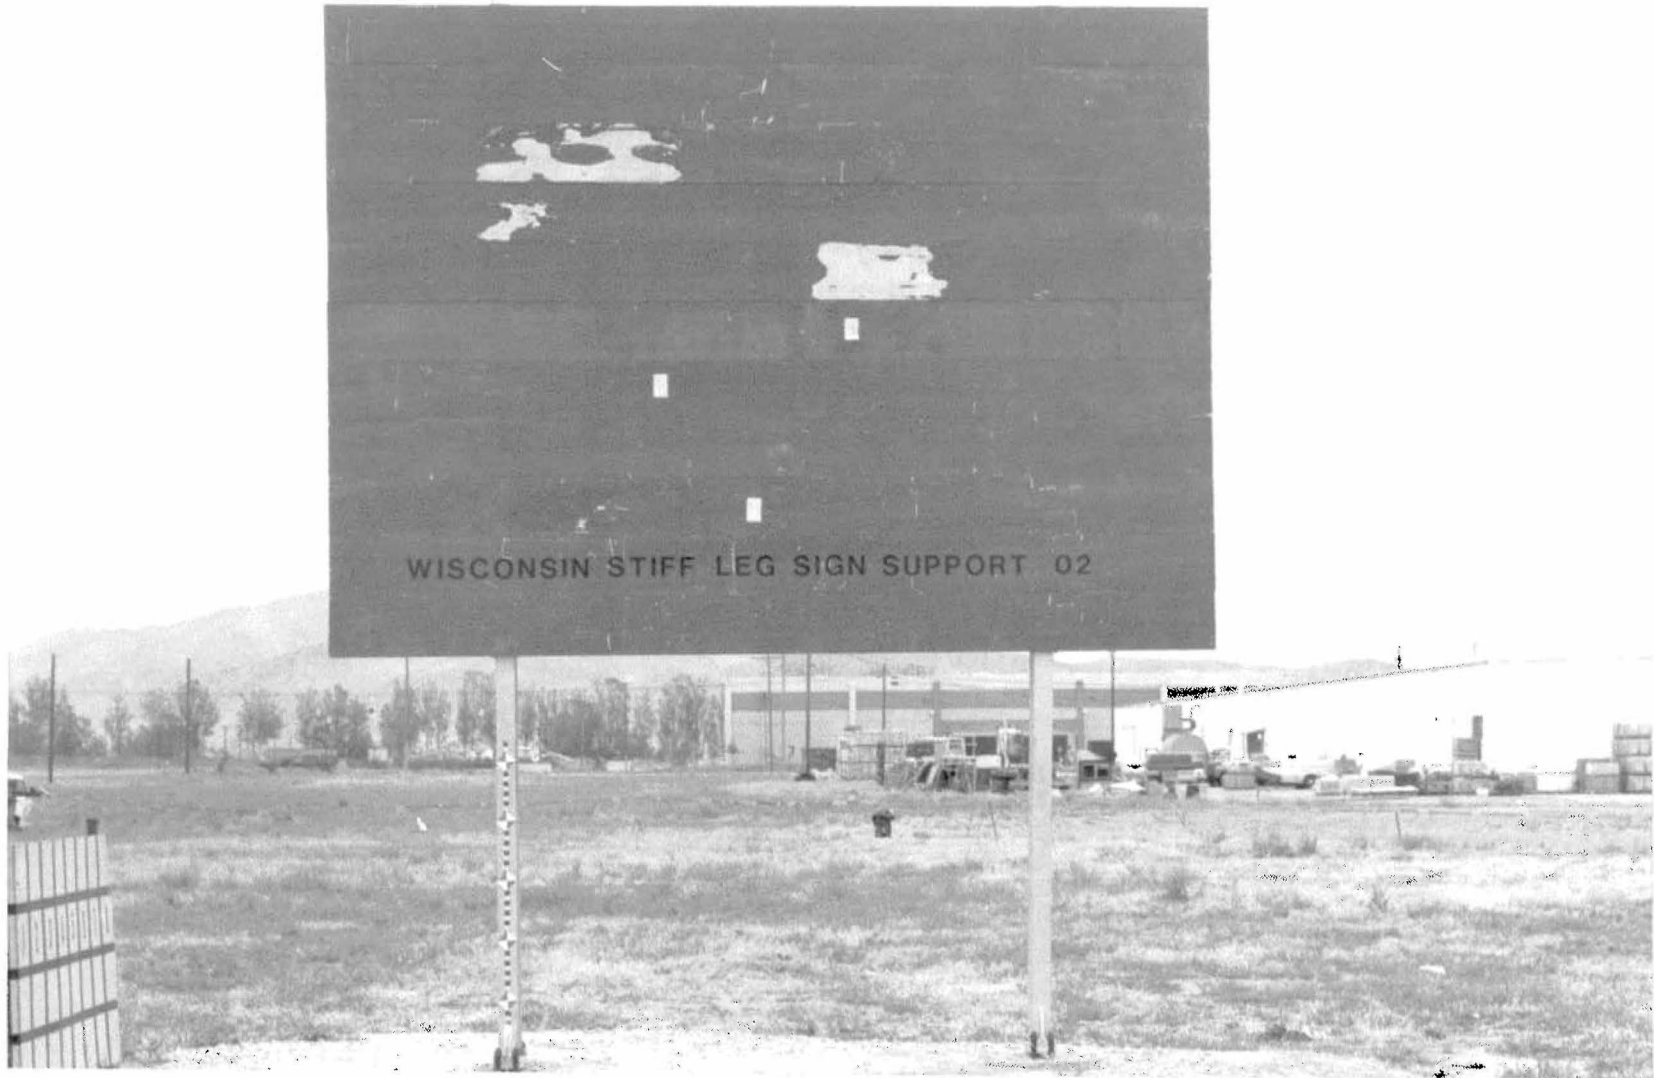
Figure 89. Test article, pretest, test no. 6.

The test article consisted of two steel stubs, each 5 1/2 ft in length; two steel supports, each 18 ft in length; and 11 sign panels, each 1 ft by 15 ft. This hardware is used to construct a Type B support with a 15-ft by 11-ft sign. The stubs were set in a 2-ft radius concrete form and then buried in S-1 strong soil so that there was stub projection of 3 in above the track level surface. The steel supports were bolted to the stubs using the manufacturer's recommended torque procedure (85 ft-lb). To obtain perpendicularity the supports were shimmed at the slip base in accordance with manufacturer's instructions. The sign boards were then clamped on to the supports one at a time to form the complete sign. Design specifications for the Wisconsin Stiff Leg Support are presented in figures 4 and 5.

Figures 88 through 97 show the test area, the test article and the posttest photographs of the test vehicle and the test article.
