REPORT NO. FHWA-RD-88-225
LUMINAIRE AND SIGN SUPPORTS

LUMINAIRE AND SIGN SUPPORTS
TECHNICAL VOLUME

This report presents the results, test reports and findings pertaining to the project "Luminaire and Sign Supports" conducted for the Federal Highway Administration (FHWA) by the contractor under contract no. DTFH61-87-Z-00103.

Five designs of luminaire and sign supports were impacted with 1800 lb class vehicles. The test results were evaluated to determine the safety performance of the tested luminaire and sign supports against the requirements specified by the AASHTO and NCHRP No. 230 documents. This report will be of interest to highway engineers dealing with roadside safety.

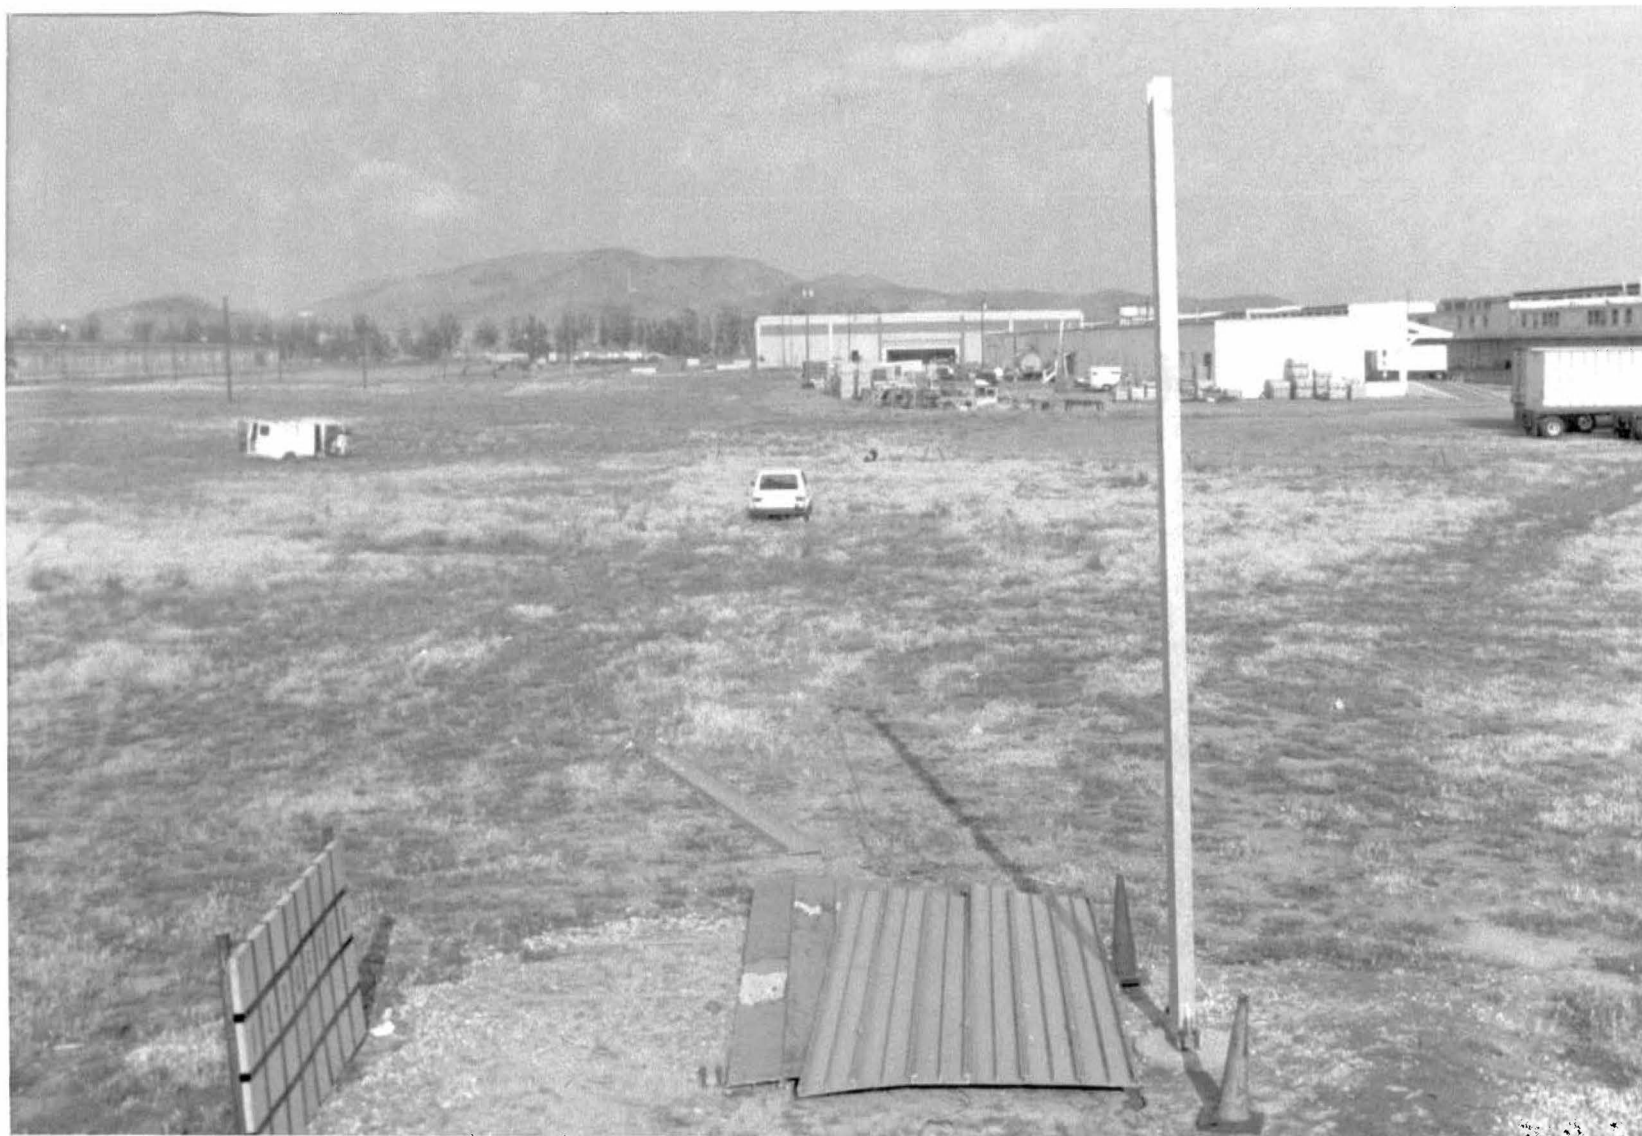
Figure 90. Test area elevated view, posttest, test no. 6.

Figures 88 through 97 show the test area, the test article and the posttest photographs of the test vehicle and the test article.

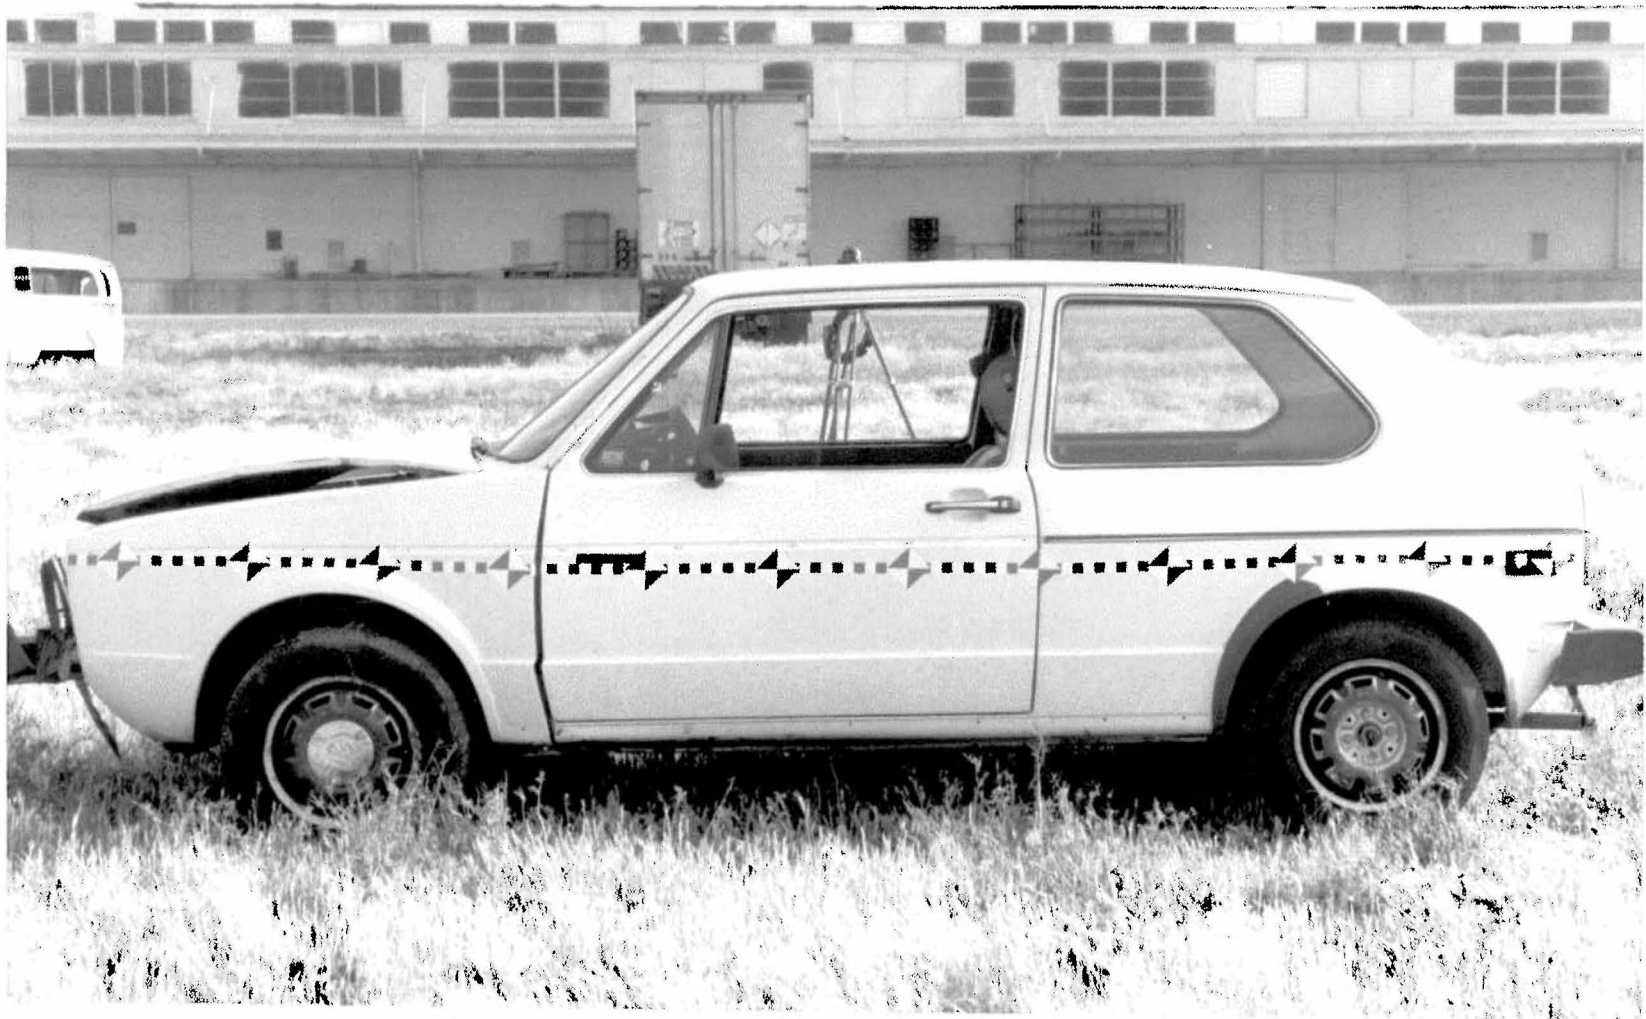
Figure 92. Full left side view, posttest, test no. 6.

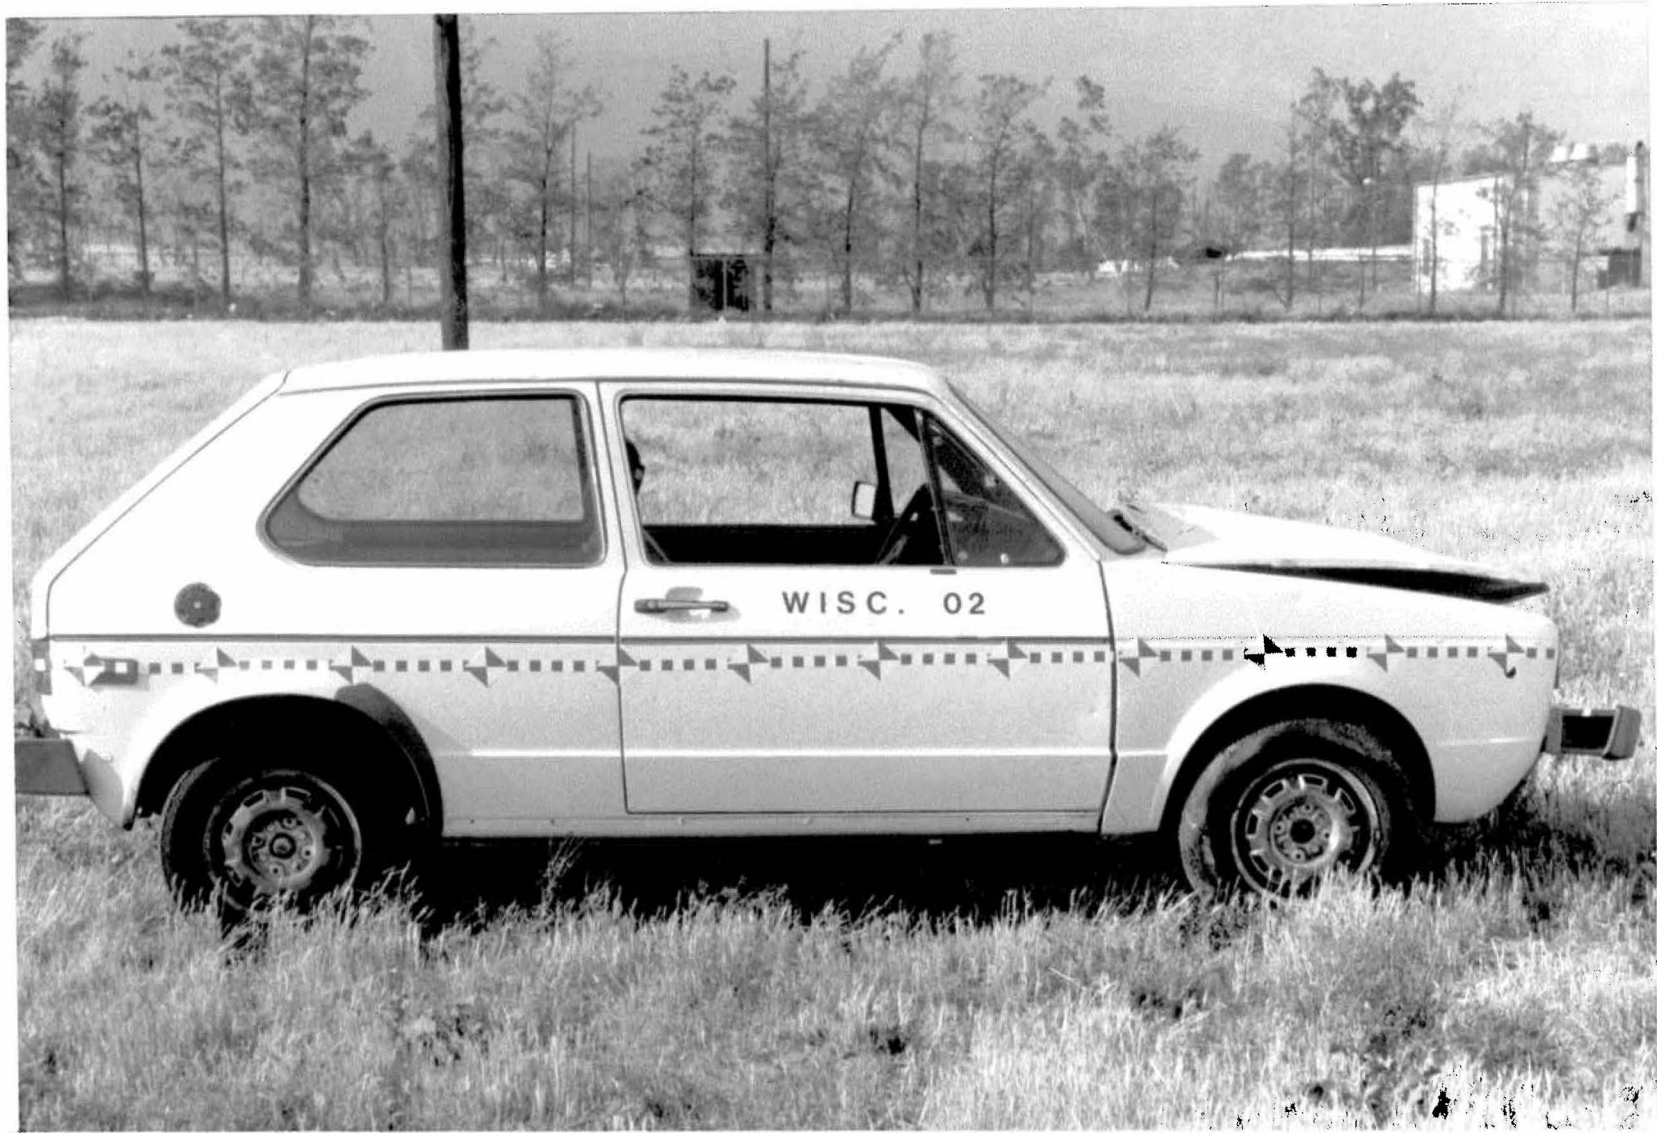
Figure 93. Full right side view, posttest, test no. 6.

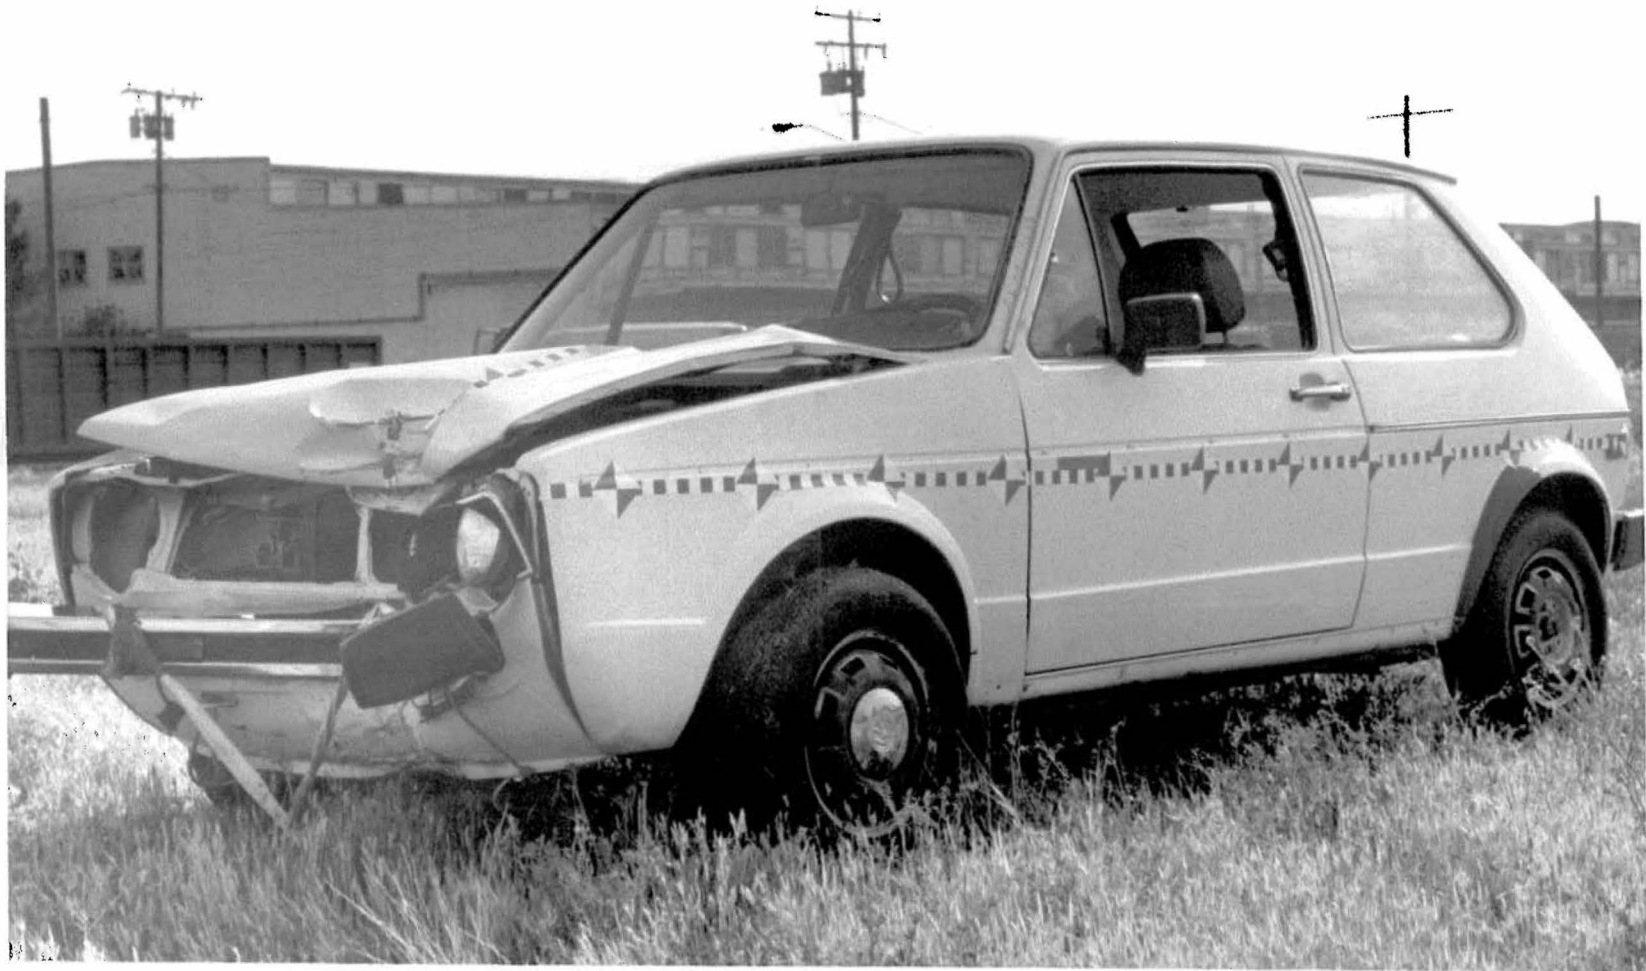
Figure 94. Left front 3/4 view, posttest, test no. 6.

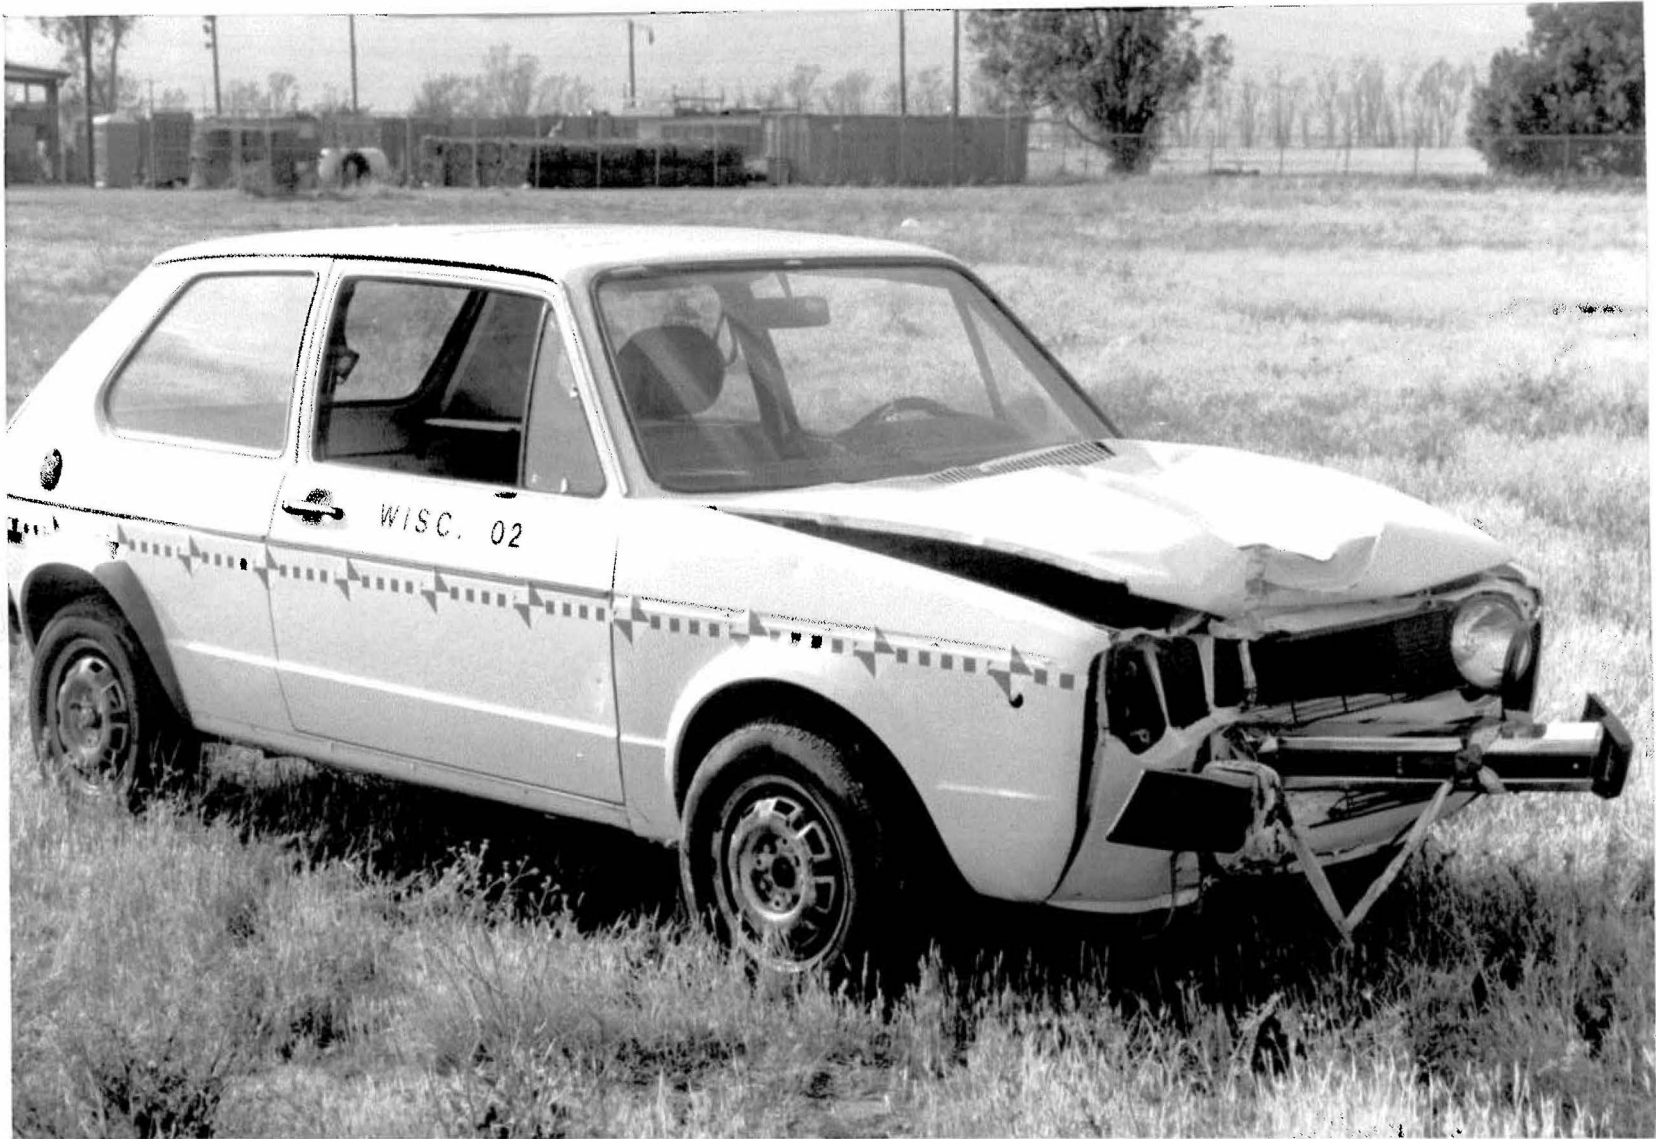
Figure 95. Right front 3/4 view, posttest, test no. 6.

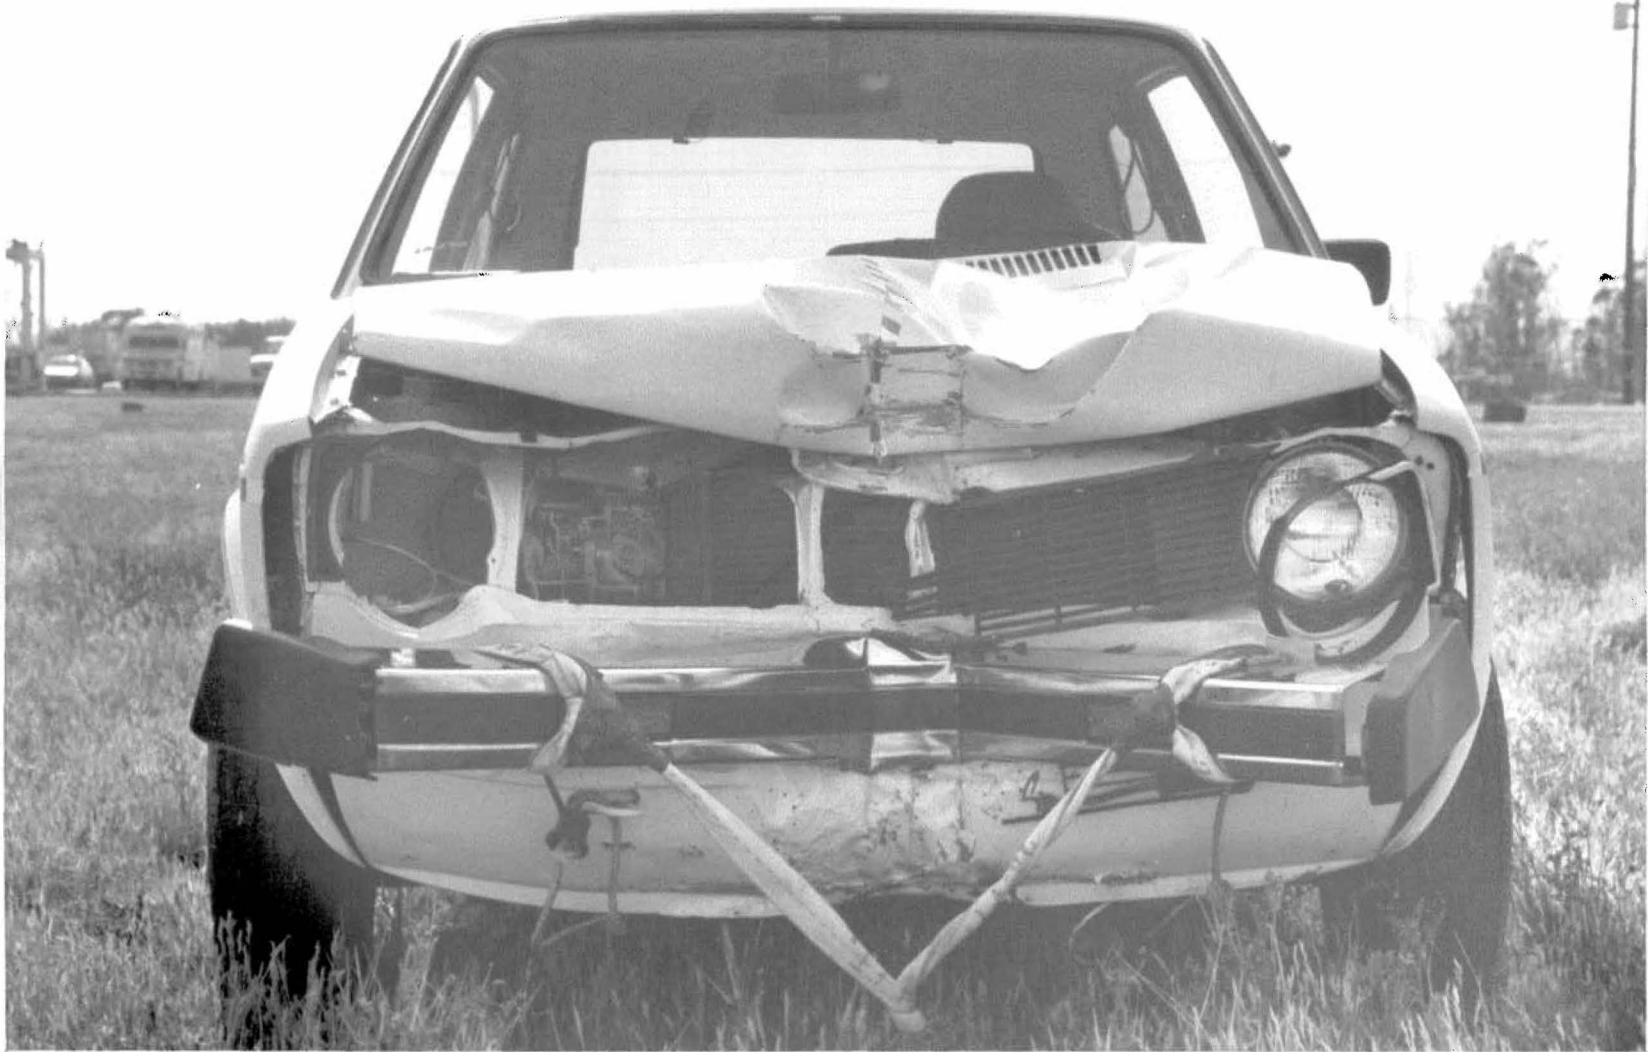
Figure 96. Full front view, posttest, test no. 6.

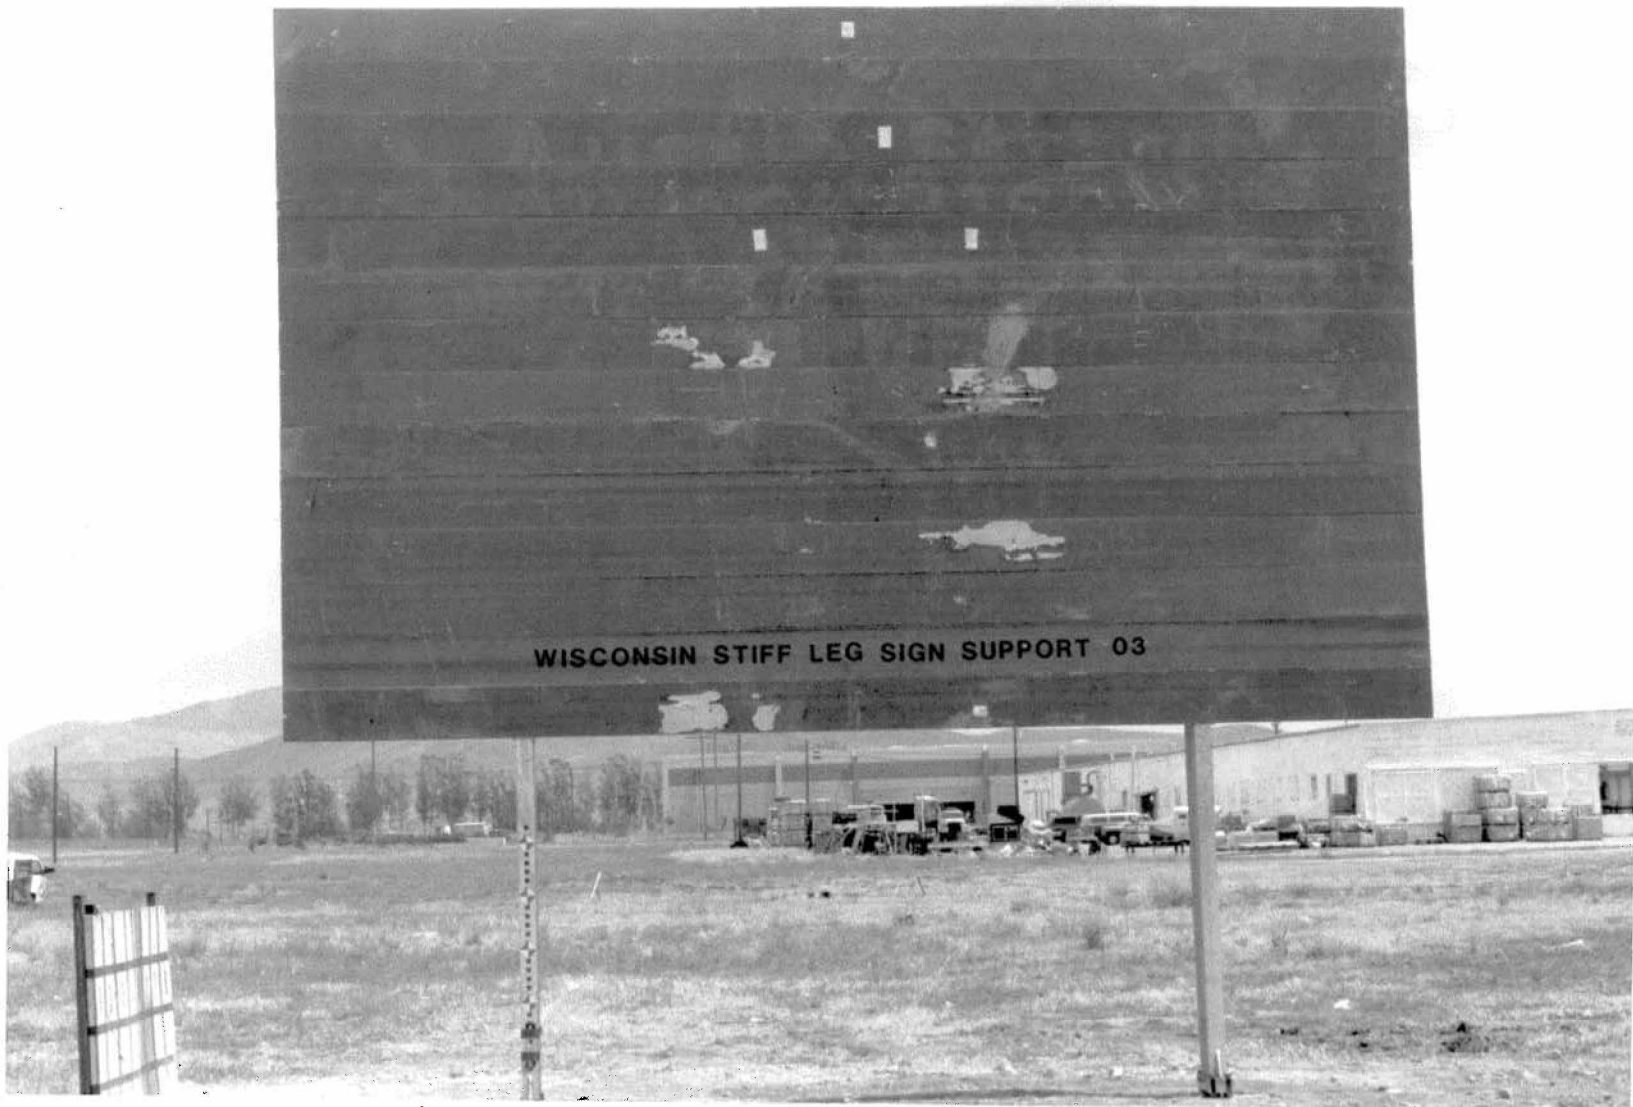
Figure 103. Test area elevated view, pretest, test no. 7.

Figures 103 through 112 show the test area, the test article and the posttest photographs of the test vehicle and the test article.

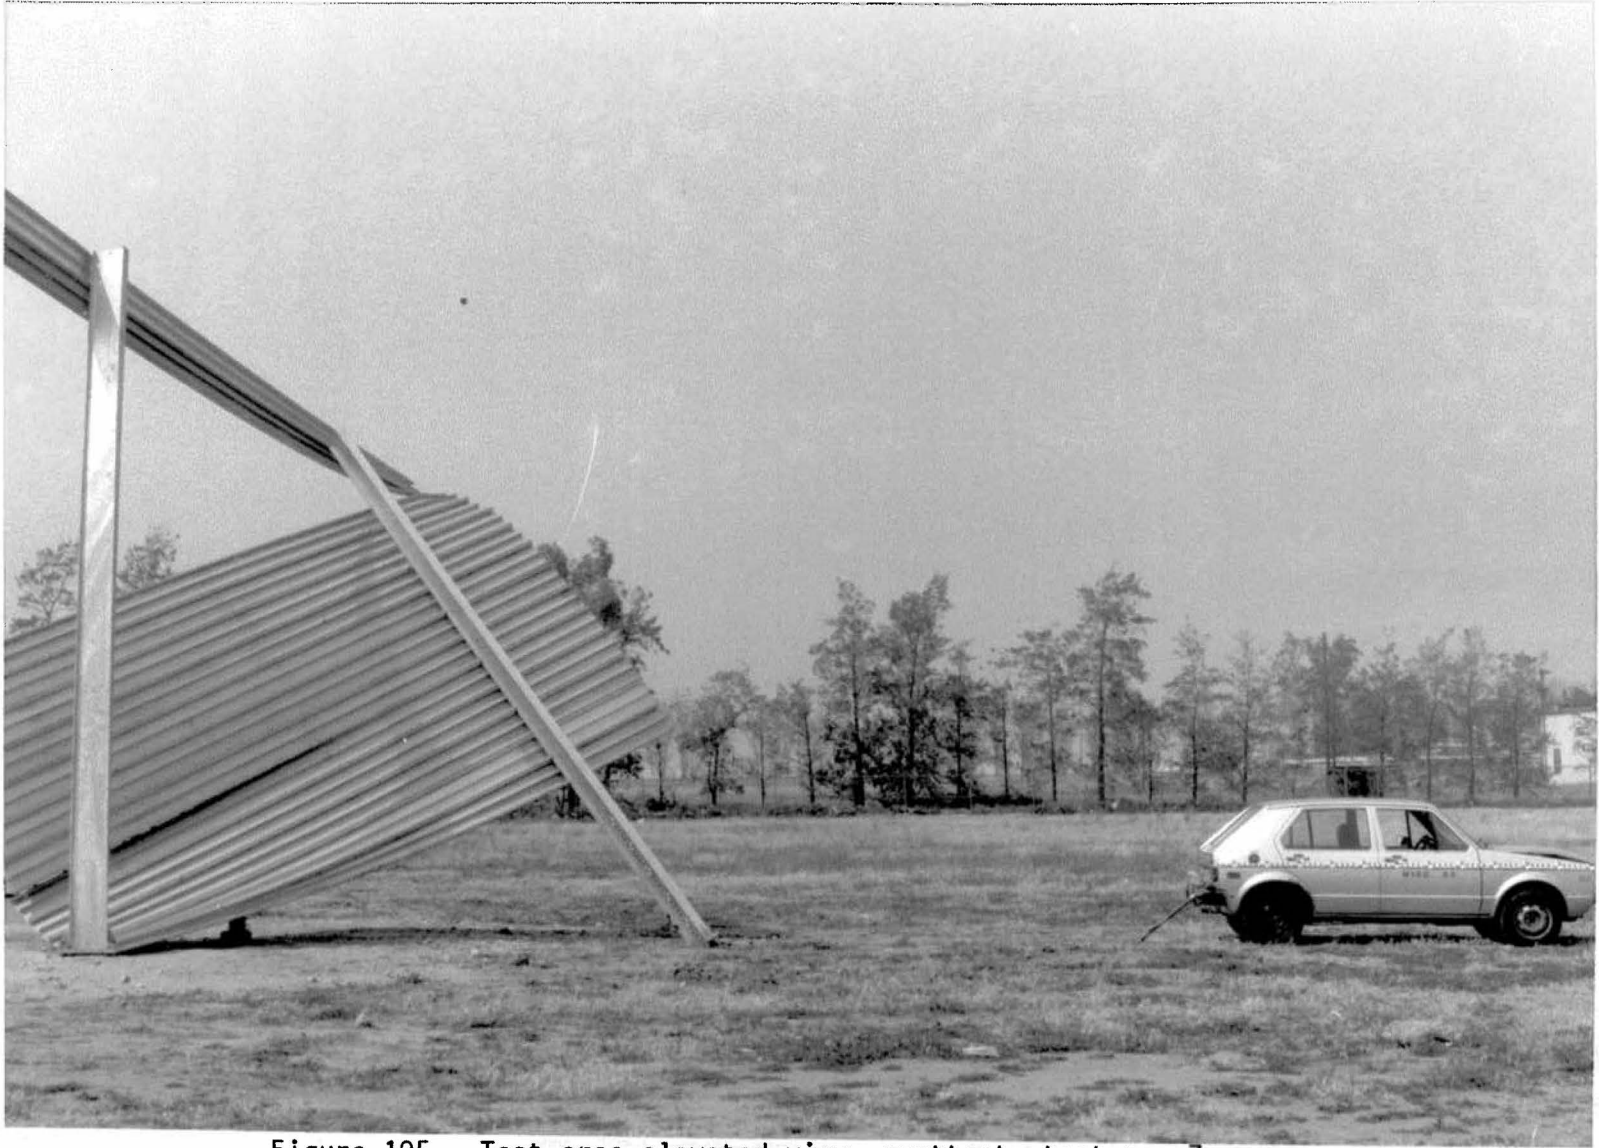
Figure 105. Test area elevated view, posttest, test no. 7.

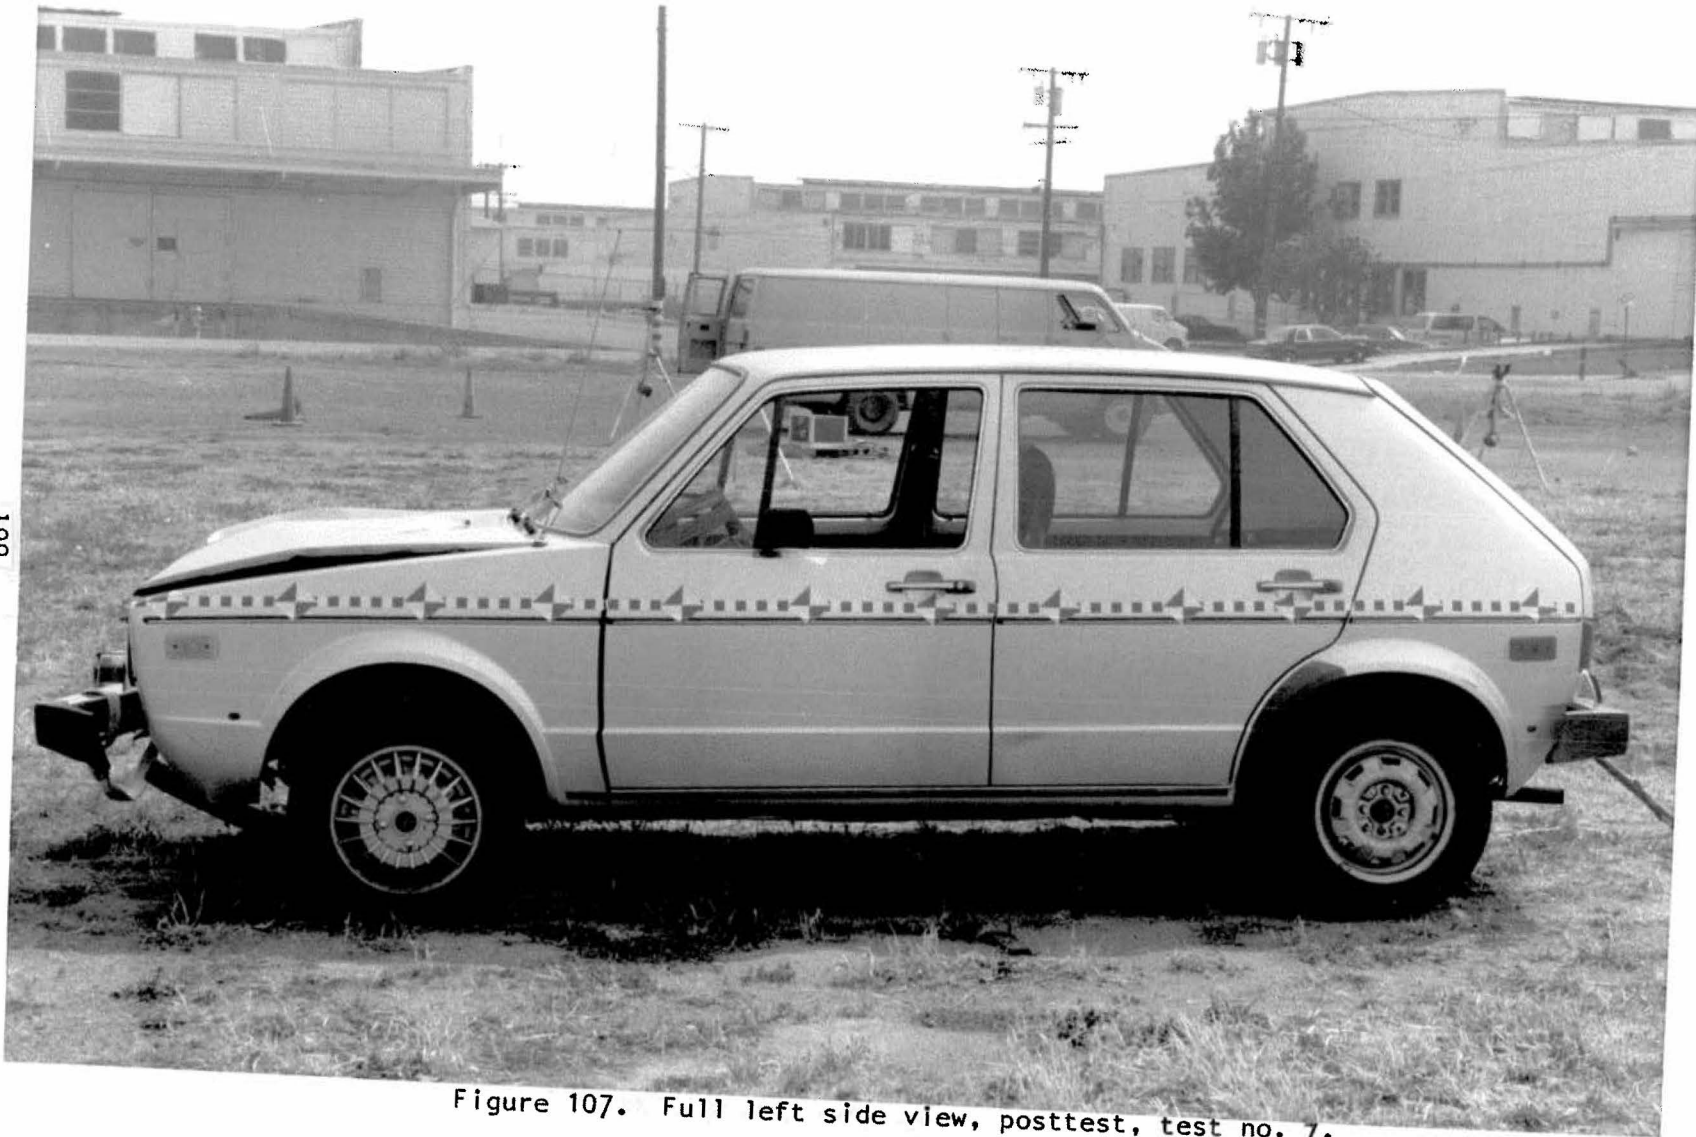
Figure 107. Full left side view, posttest, test no. 7.

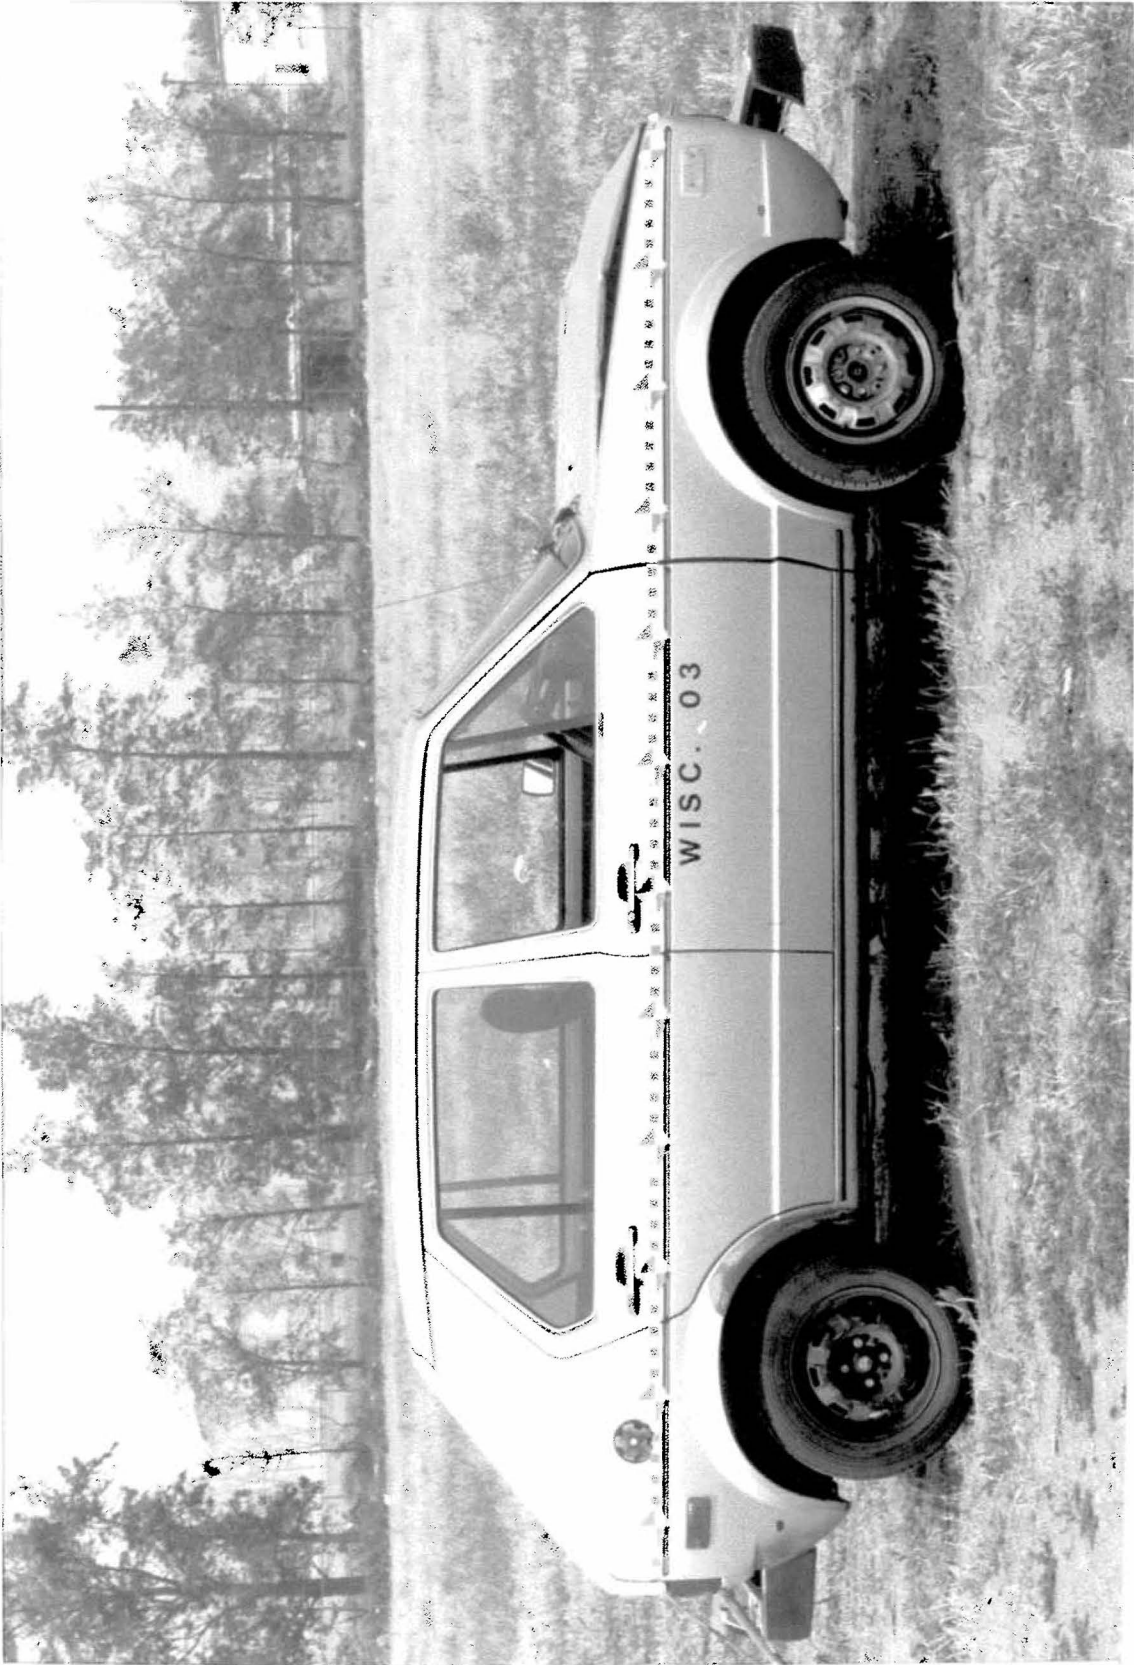
Figure 108. Full right side view, posttest, test no. 7.

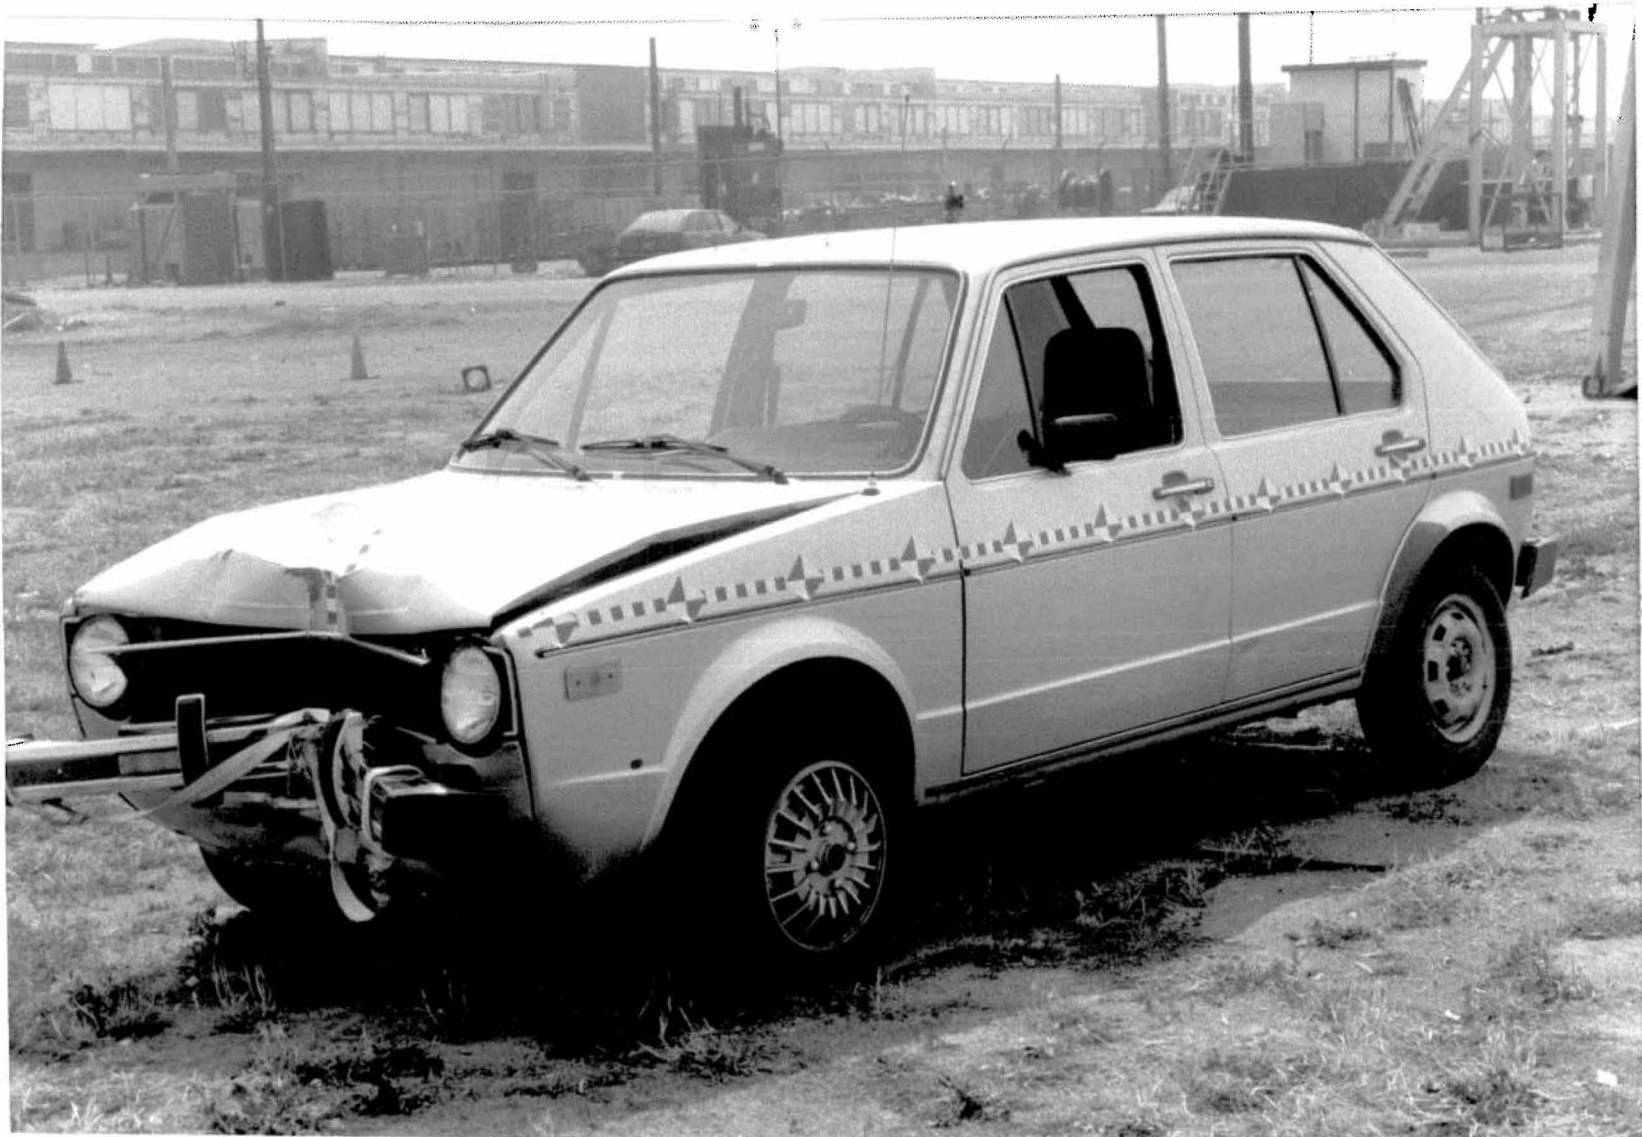
Figure 109. Left front 3/4 view, posttest, test no. 7.

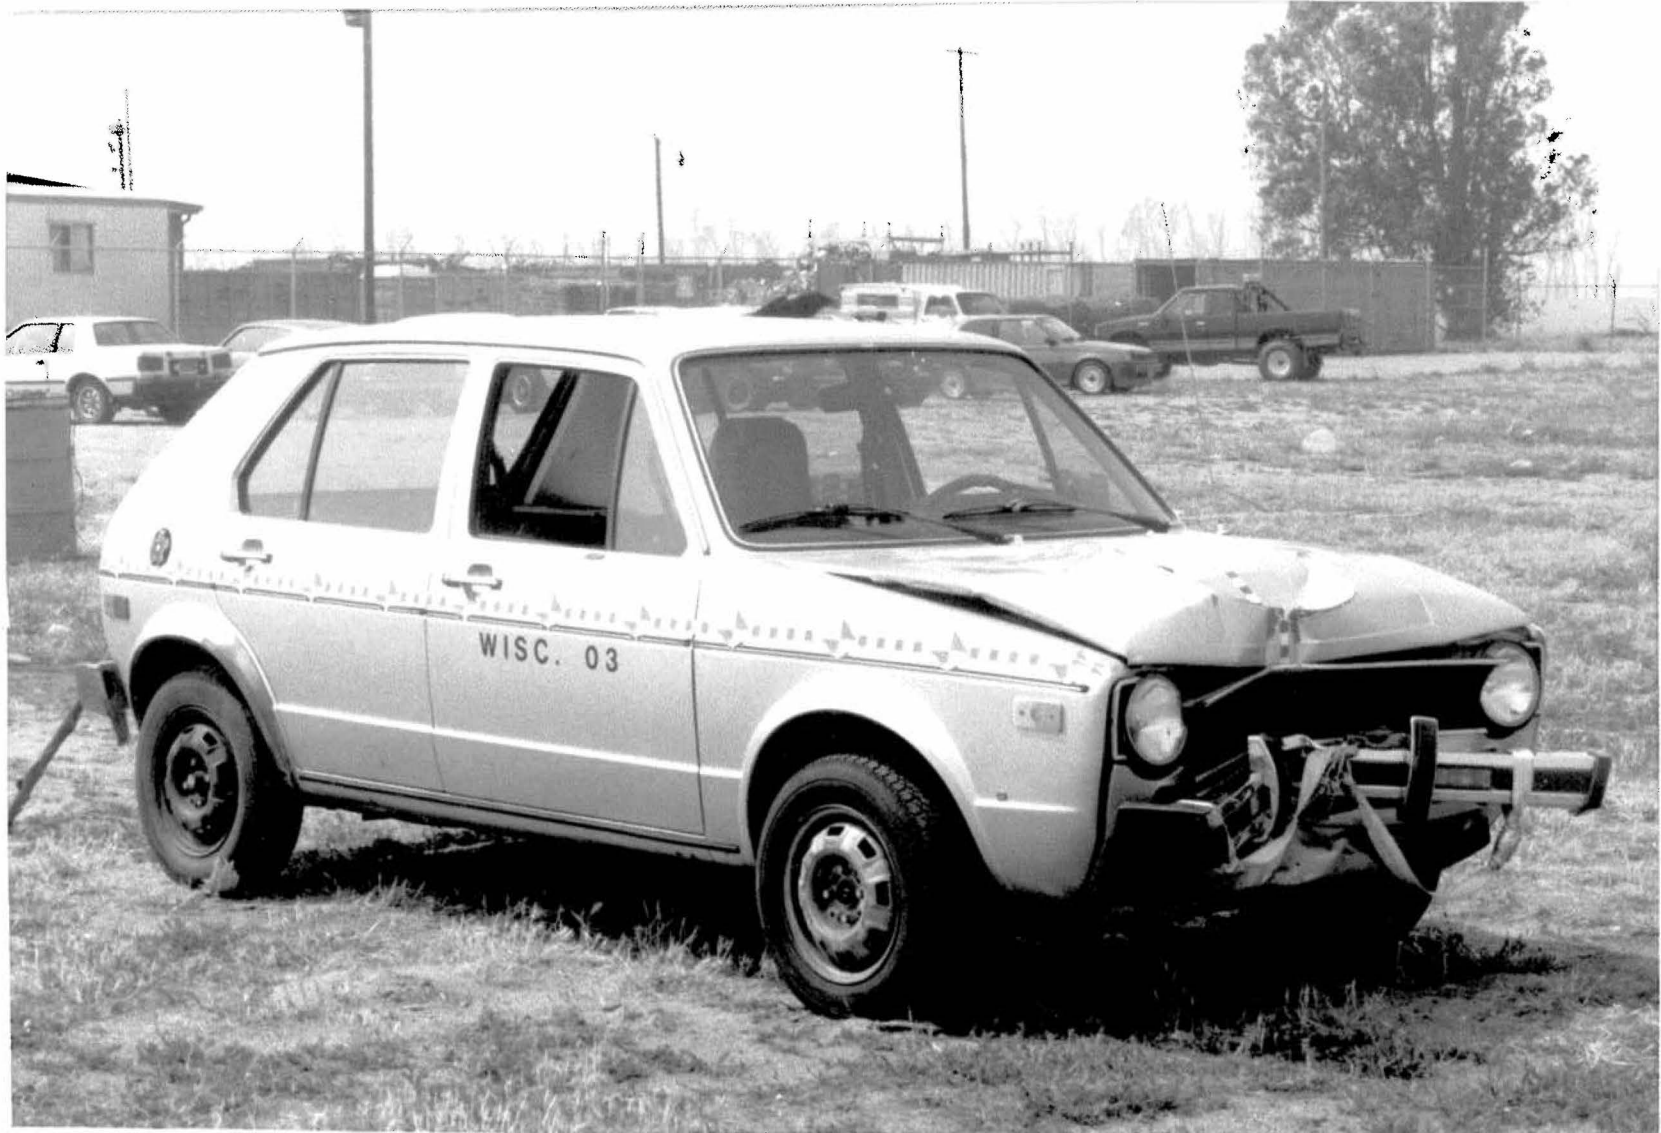
Figure 110. Right front 3/4 view, posttest, test no. 7.
