REPORT NO. FHWA-RD-88-225
LUMINAIRE AND SIGN SUPPORTS

LUMINAIRE AND SIGN SUPPORTS
TECHNICAL VOLUME

This report presents the results, test reports and findings pertaining to the project "Luminaire and Sign Supports" conducted for the Federal Highway Administration (FHWA) by the contractor under contract no. DTFH61-87-Z-00103.

Five designs of luminaire and sign supports were impacted with 1800 lb class vehicles. The test results were evaluated to determine the safety performance of the tested luminaire and sign supports against the requirements specified by the AASHTO and NCHRP No. 230 documents. This report will be of interest to highway engineers dealing with roadside safety.

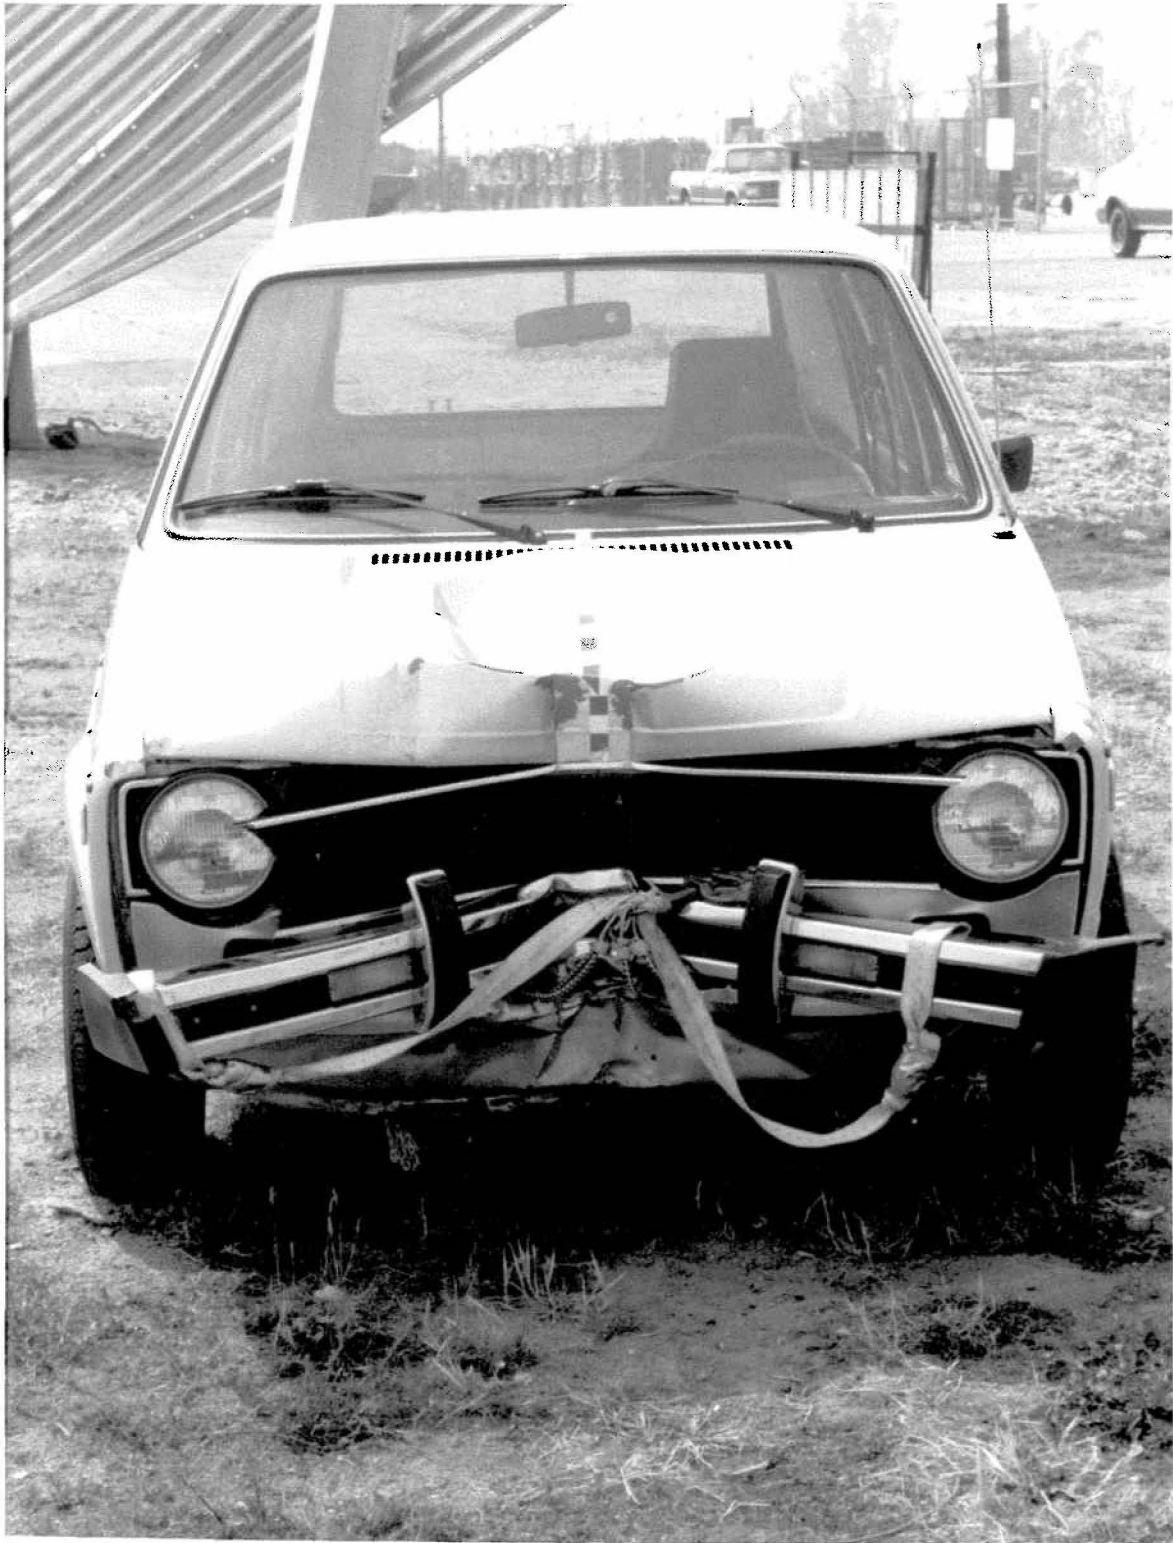
Figure 111. Full front view, posttest, test no. 7.

Figures 103 through 112 show the test area, the test article and the posttest photographs of the test vehicle and the test article.

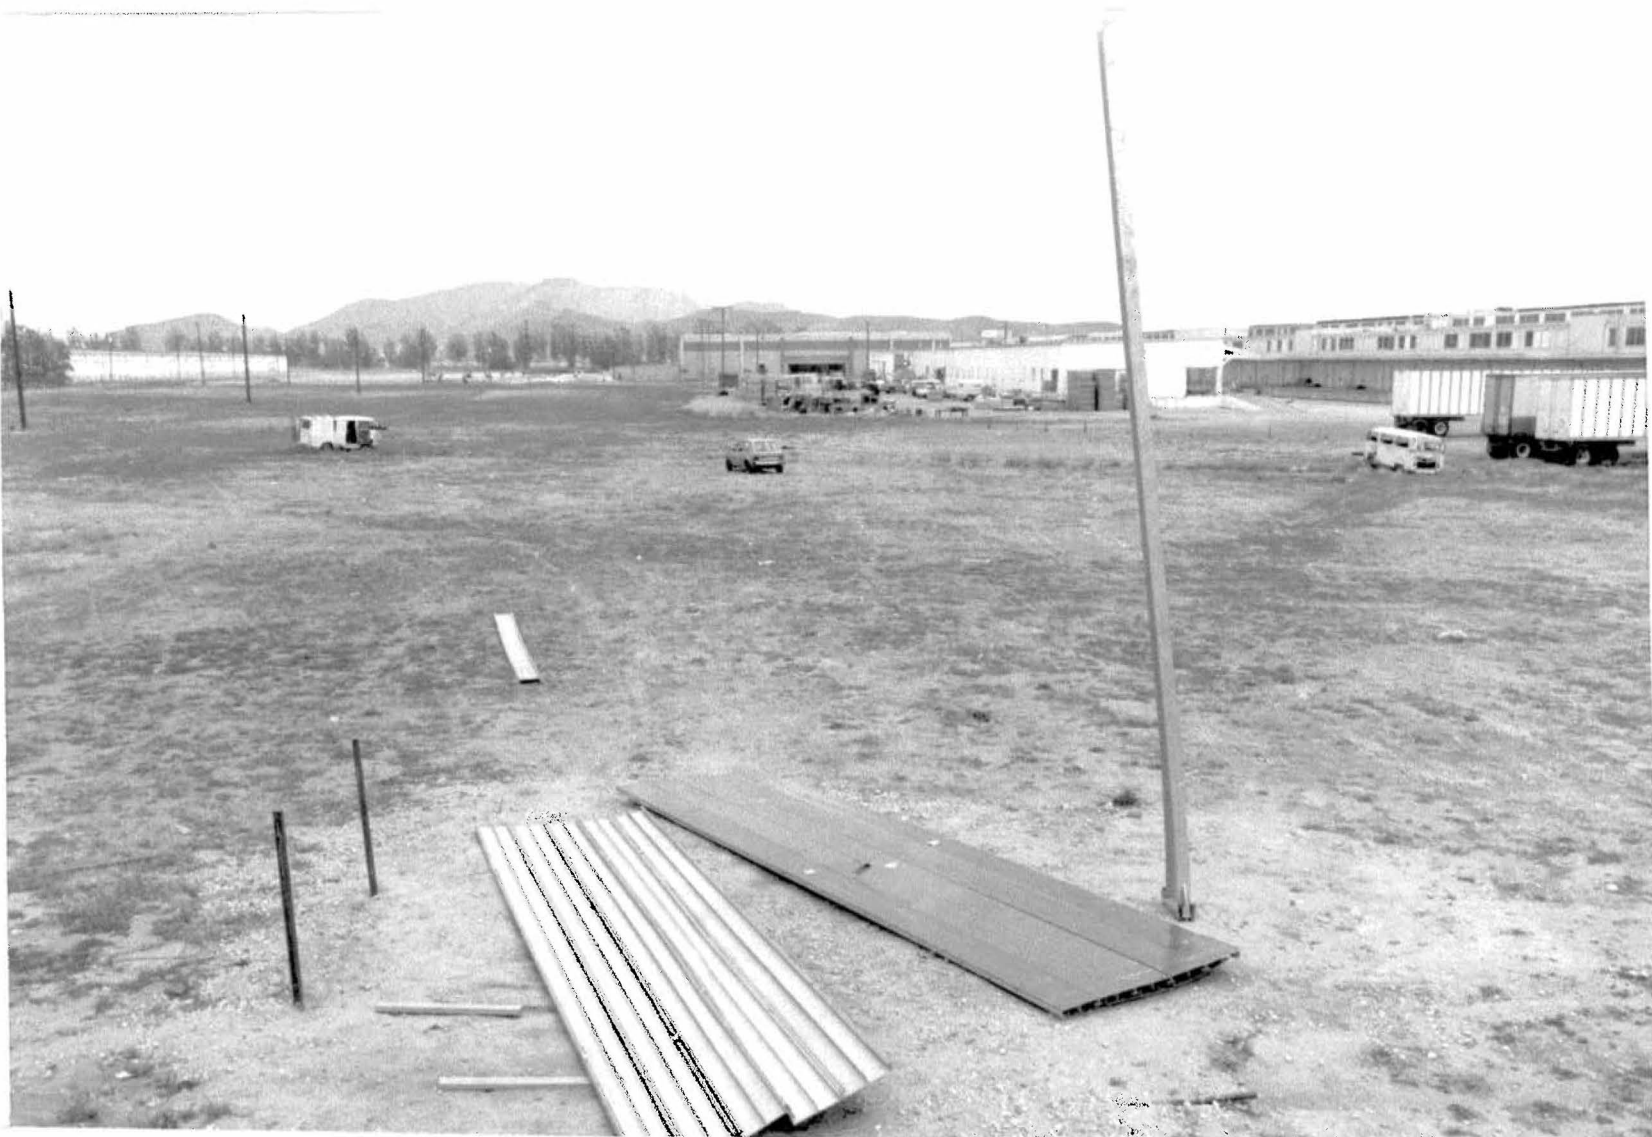
Figure 120. Test area elevated view, posttest, test no. 8.

The test article seemed to perform in the desired breakaway fashion. The impact support was knocked cleanly away from the stub and was thrown up and over the vehicle which passed easily underneath the support. The impact support landed with its base 30 ft back of the impact point and the second support stayed upright and vertical. The sign panels separated cleanly from both supports and landed approximately 2 ft back from the impact point. The sign came apart in 2 pieces, the bottom 10 panels landing on top of the upper 4 panels. The sign panels did not cause any damage to the roof of the test vehicle.

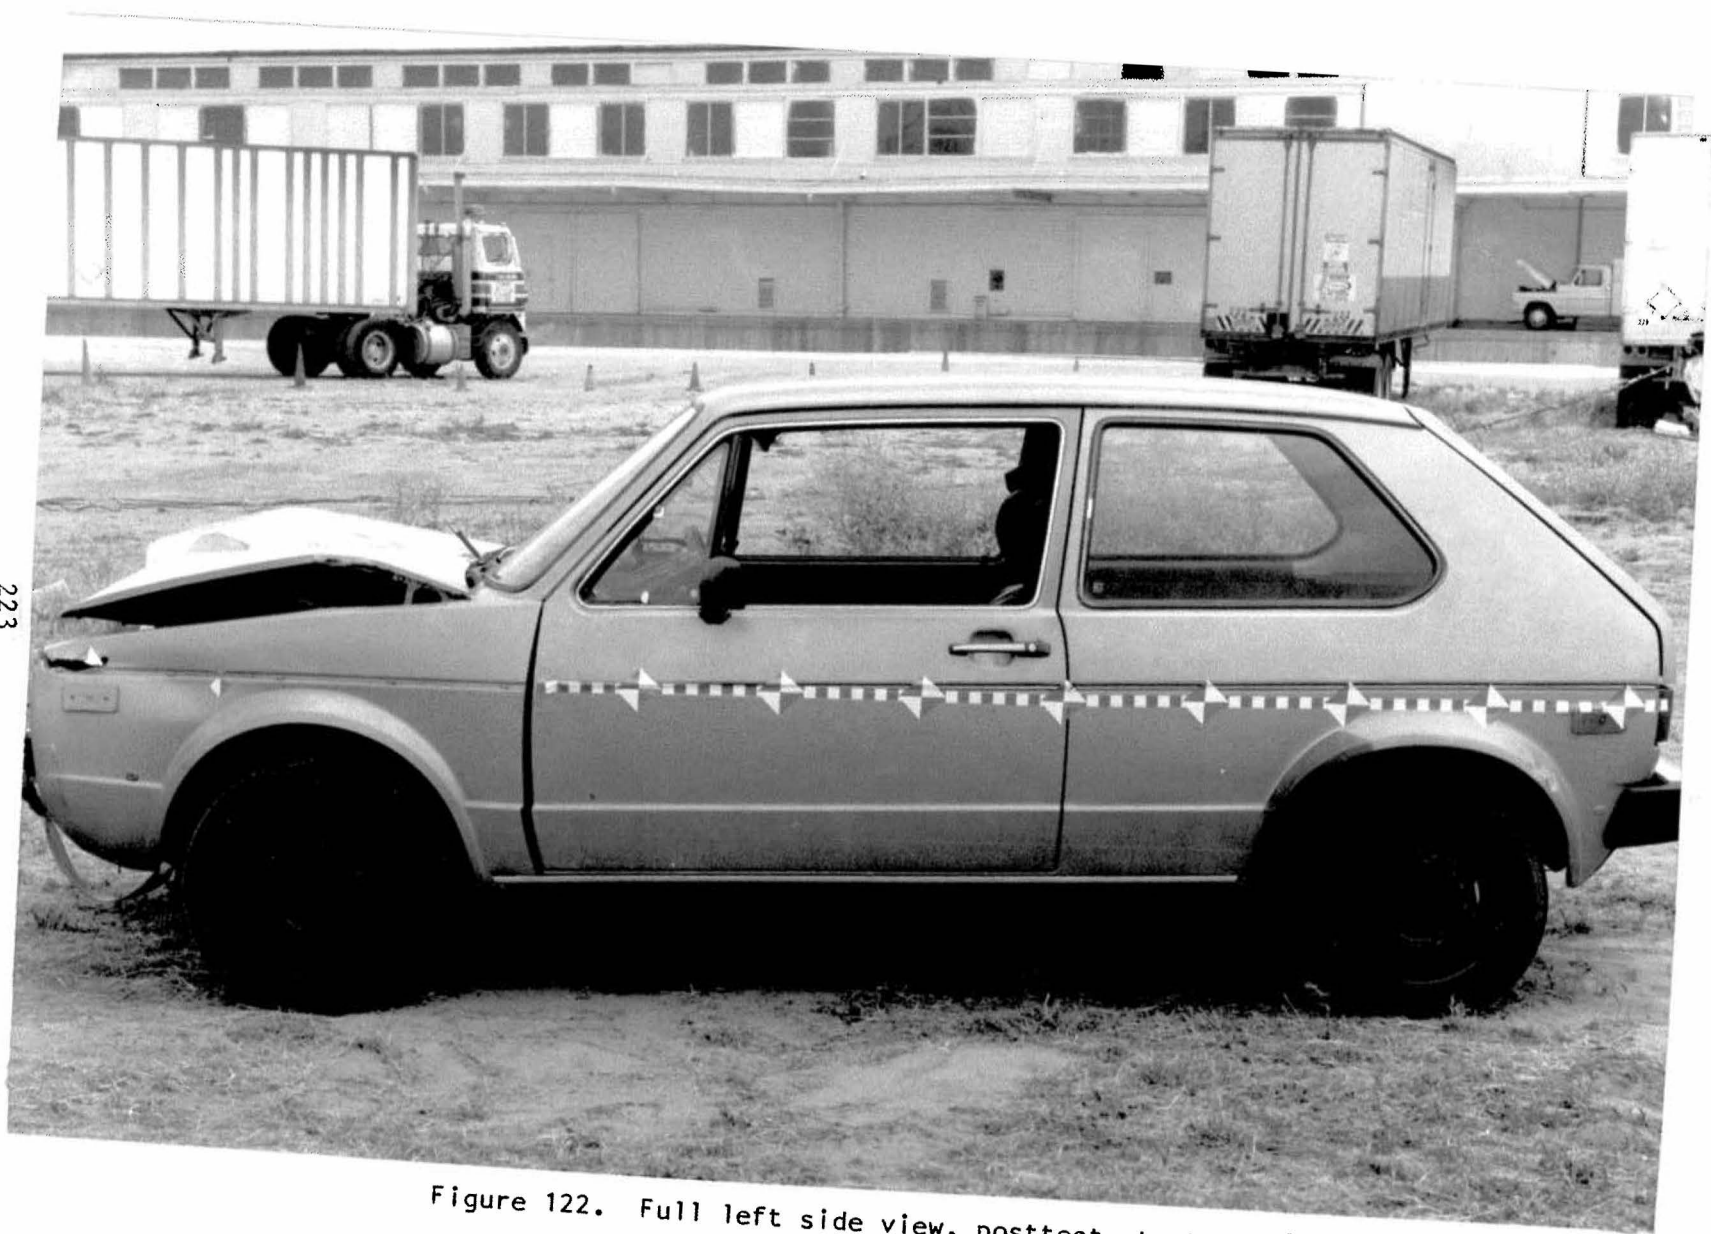
Figure 122. Full left side view, posttest, test no. 8.

The vehicle impacted the pole 5.0 in to the left of the lateral centerline. The impact velocity was 59.8 mi/h. The bumper was displaced rearward 17.25 in at the impact location. The undercarriage was also pushed in along with the bumper. The vehicle's radiator was pushed into the engine and major damage was done to the hood. The front quarter panels were bent slightly inward towards the vehicle front. No damage was done to the windshield or roof of the vehicle. The vehicle came to rest in a straight line with the initial pre-impact trajectory. Vehicle crush data are presented in table 47.

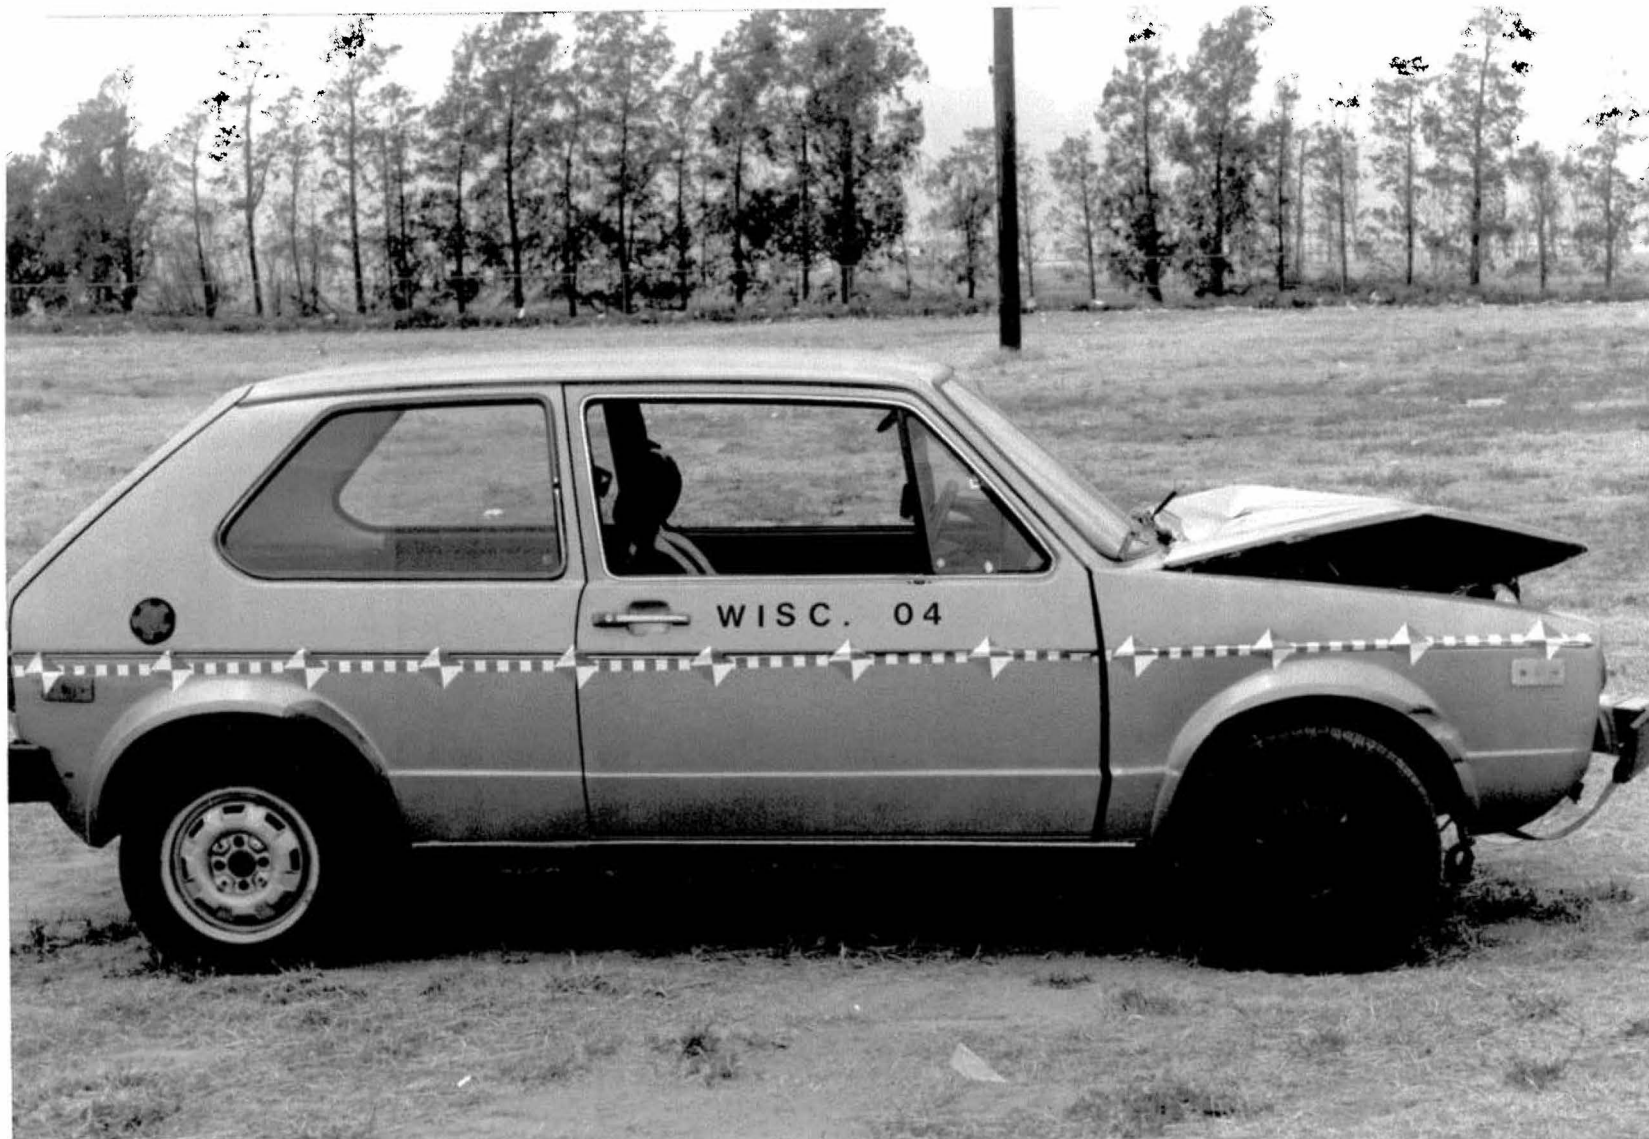
Figure 123. Full right side view, posttest, test no. 8.

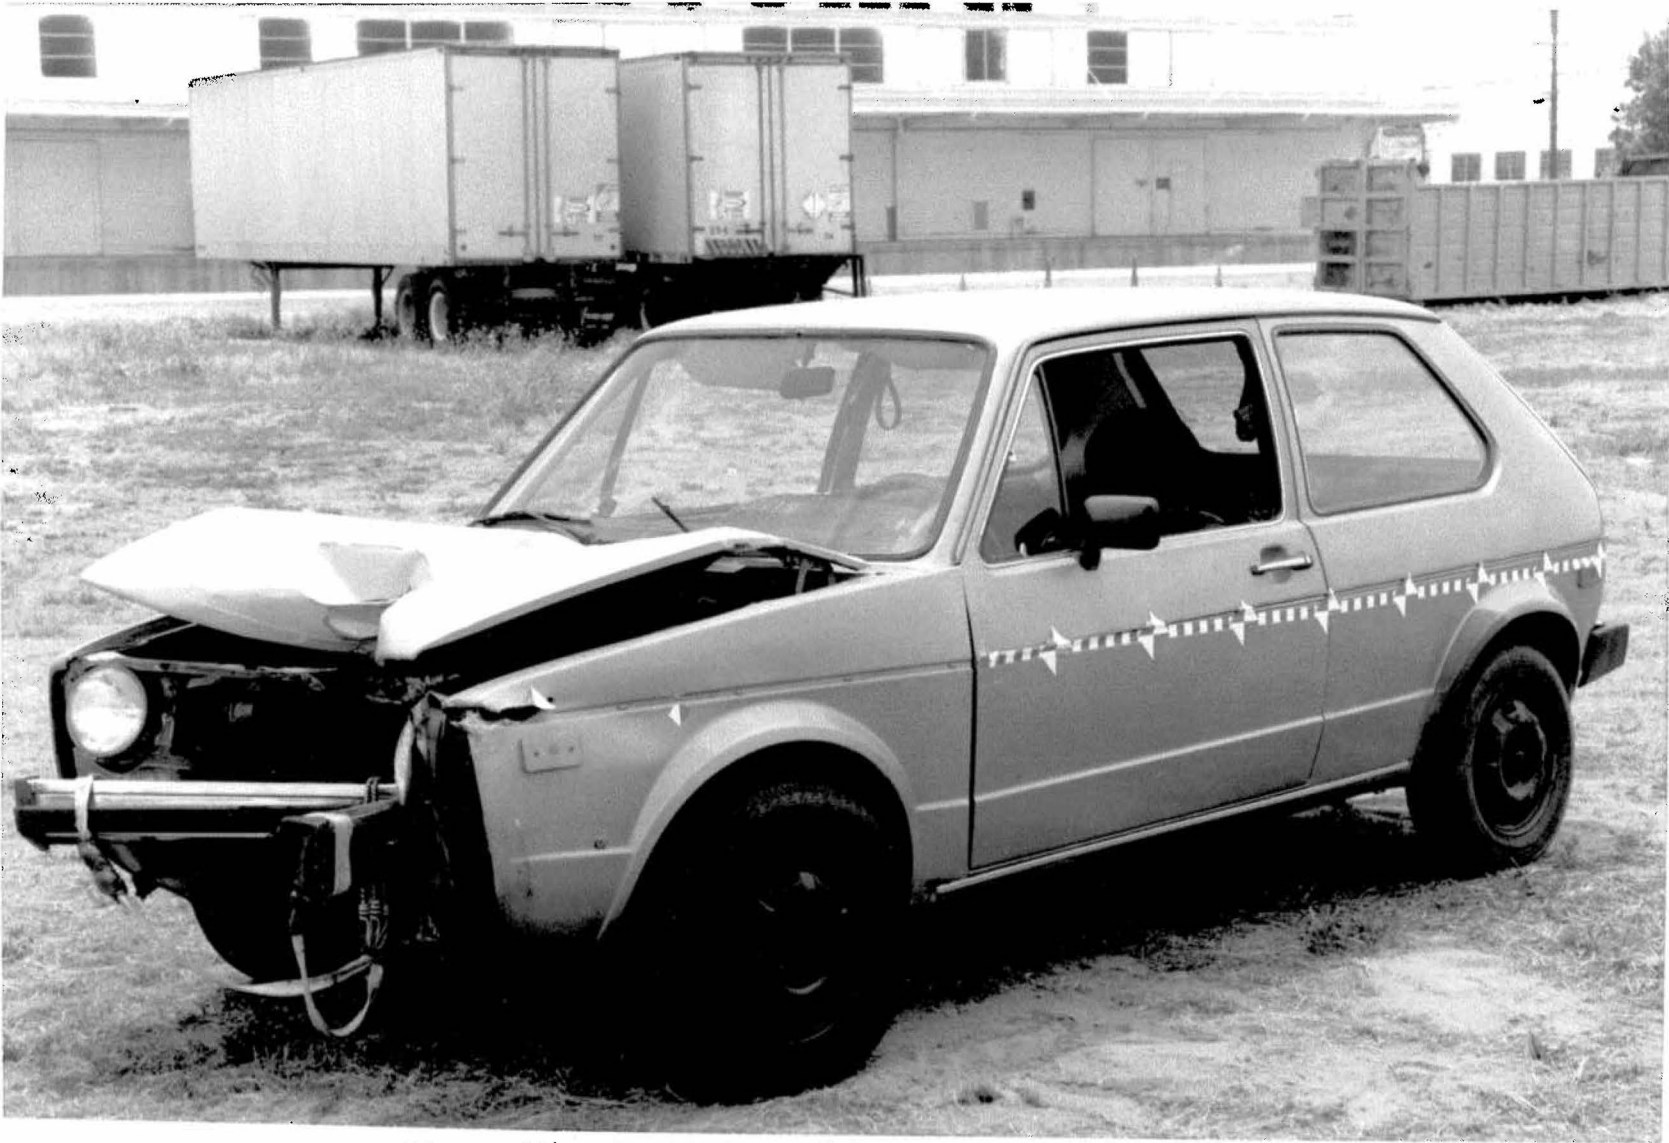
Figure 124. Left front 3/4 view, posttest, test no. 8.

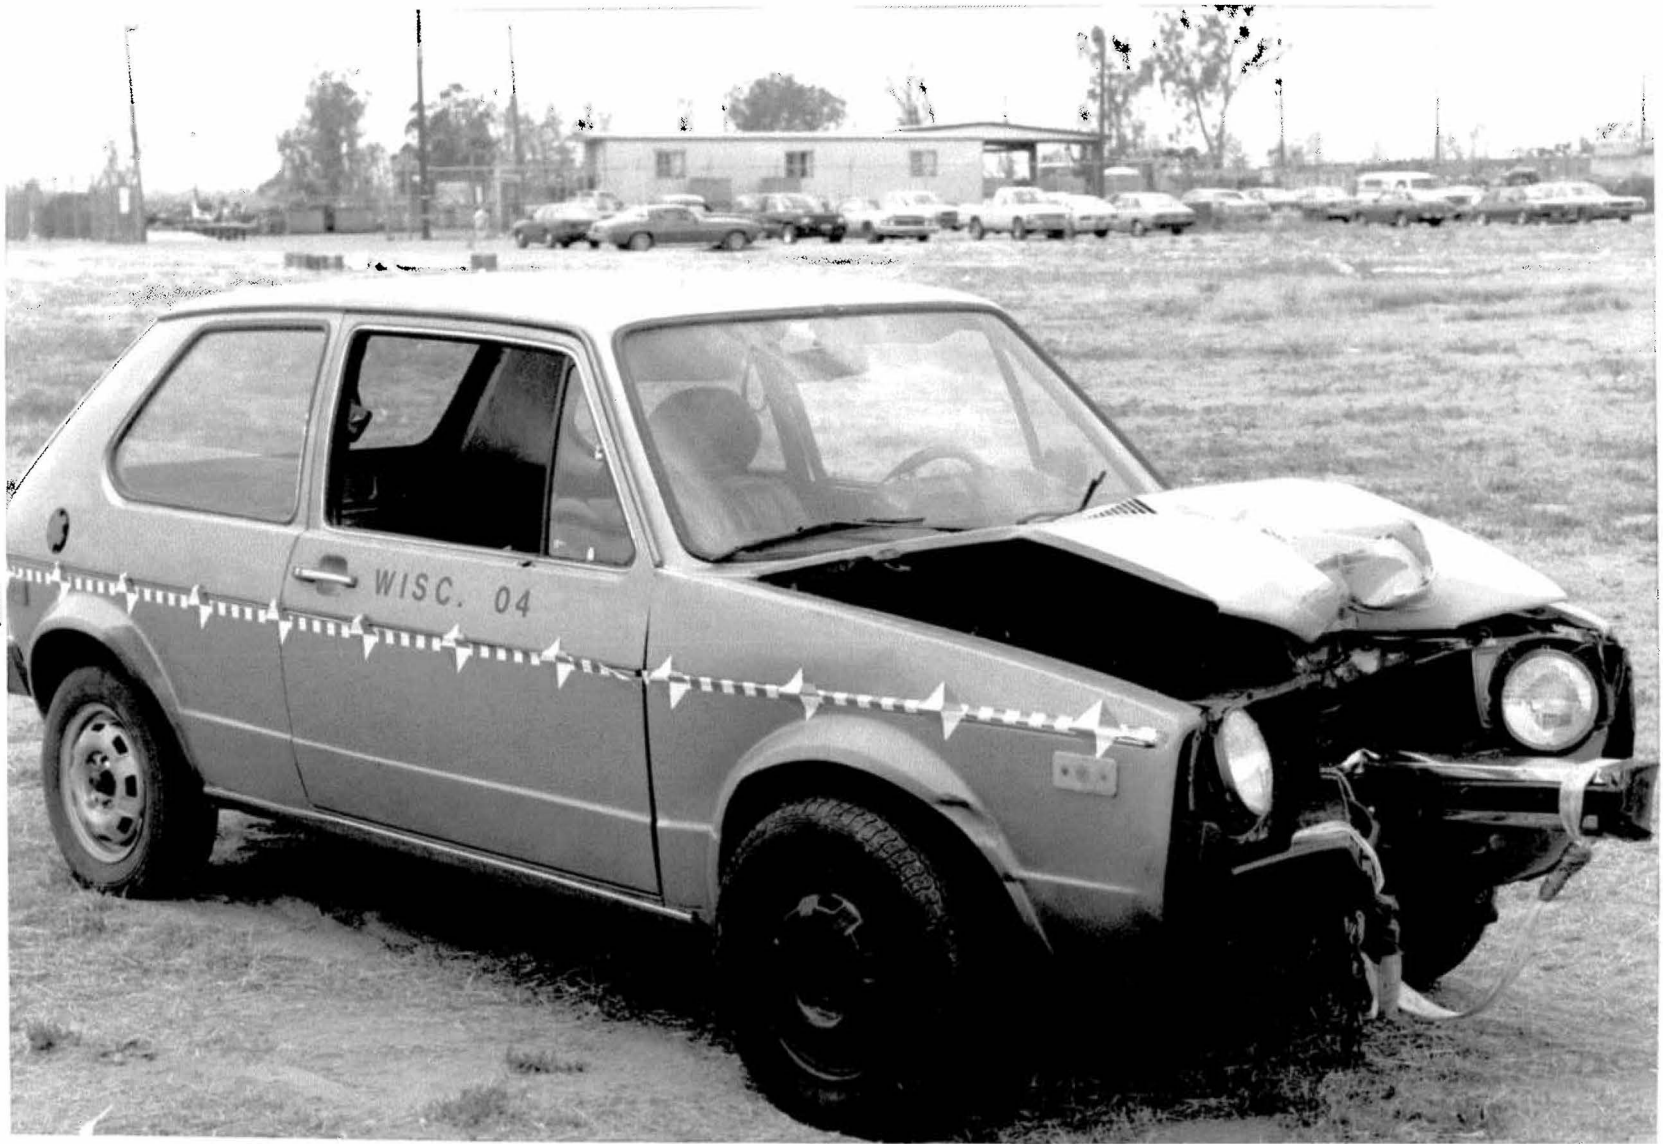
Figure 125. Right front 3/4 view, posttest, test no. 8.

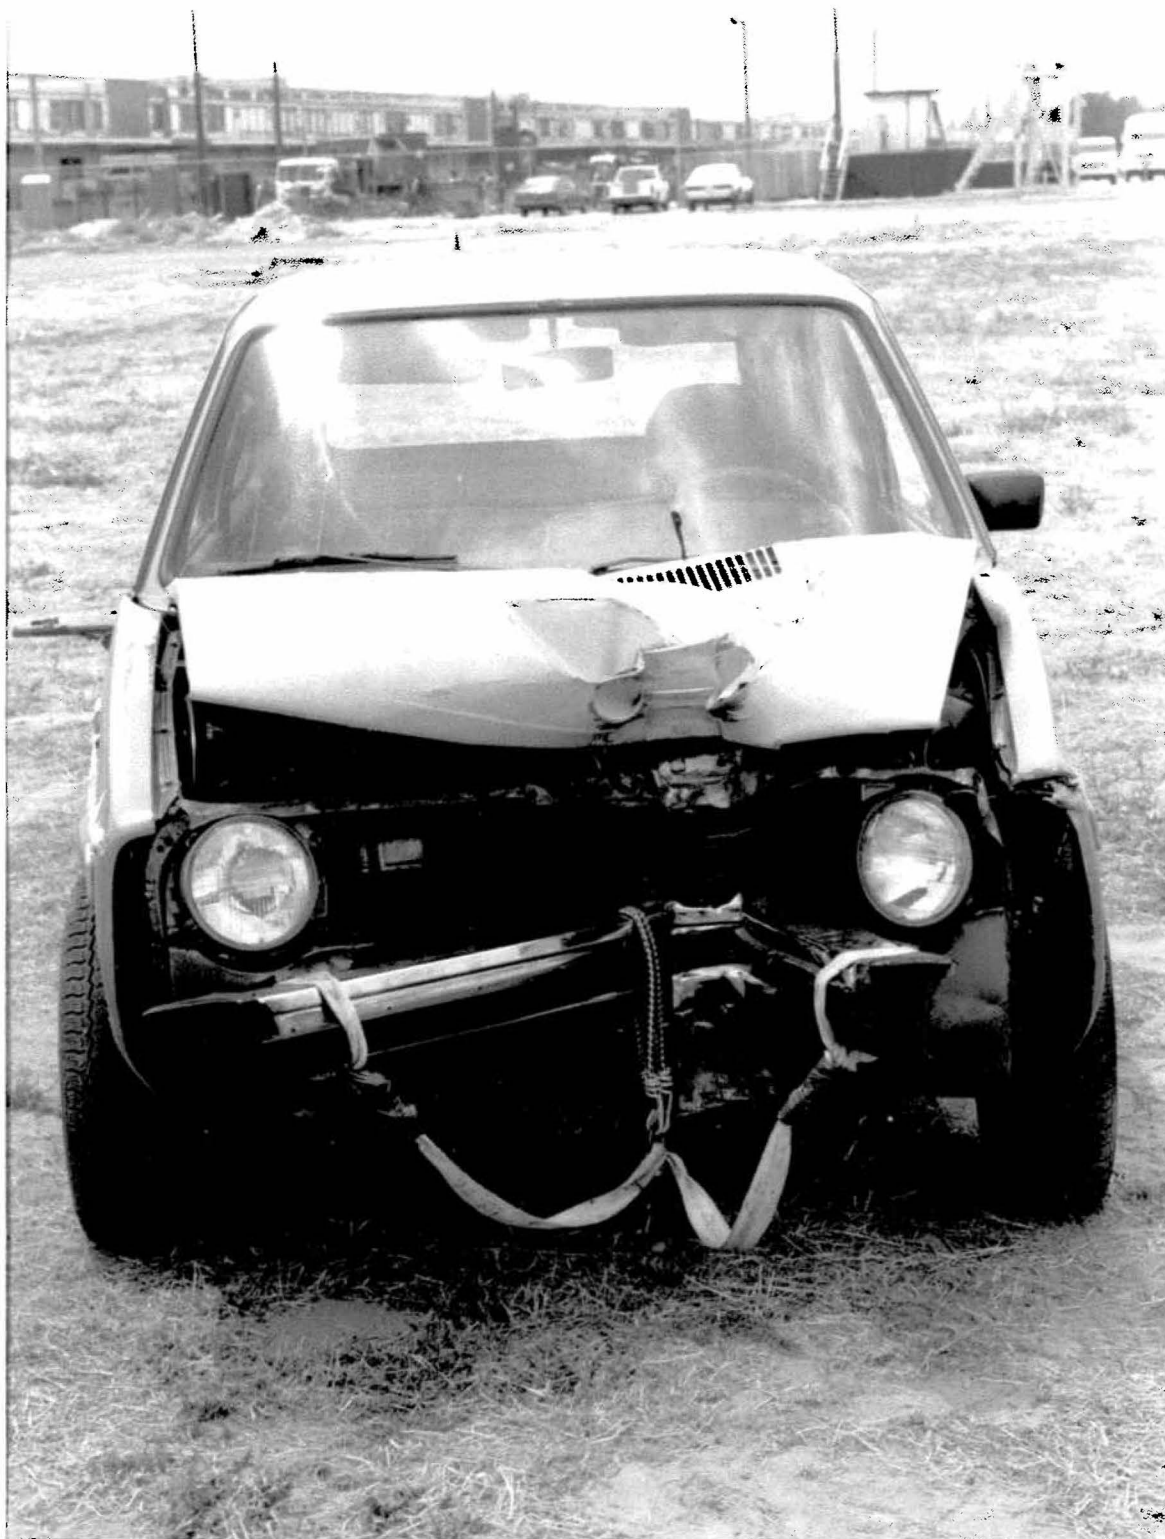
Figure 126. Full front view, posttest, test no. 8.

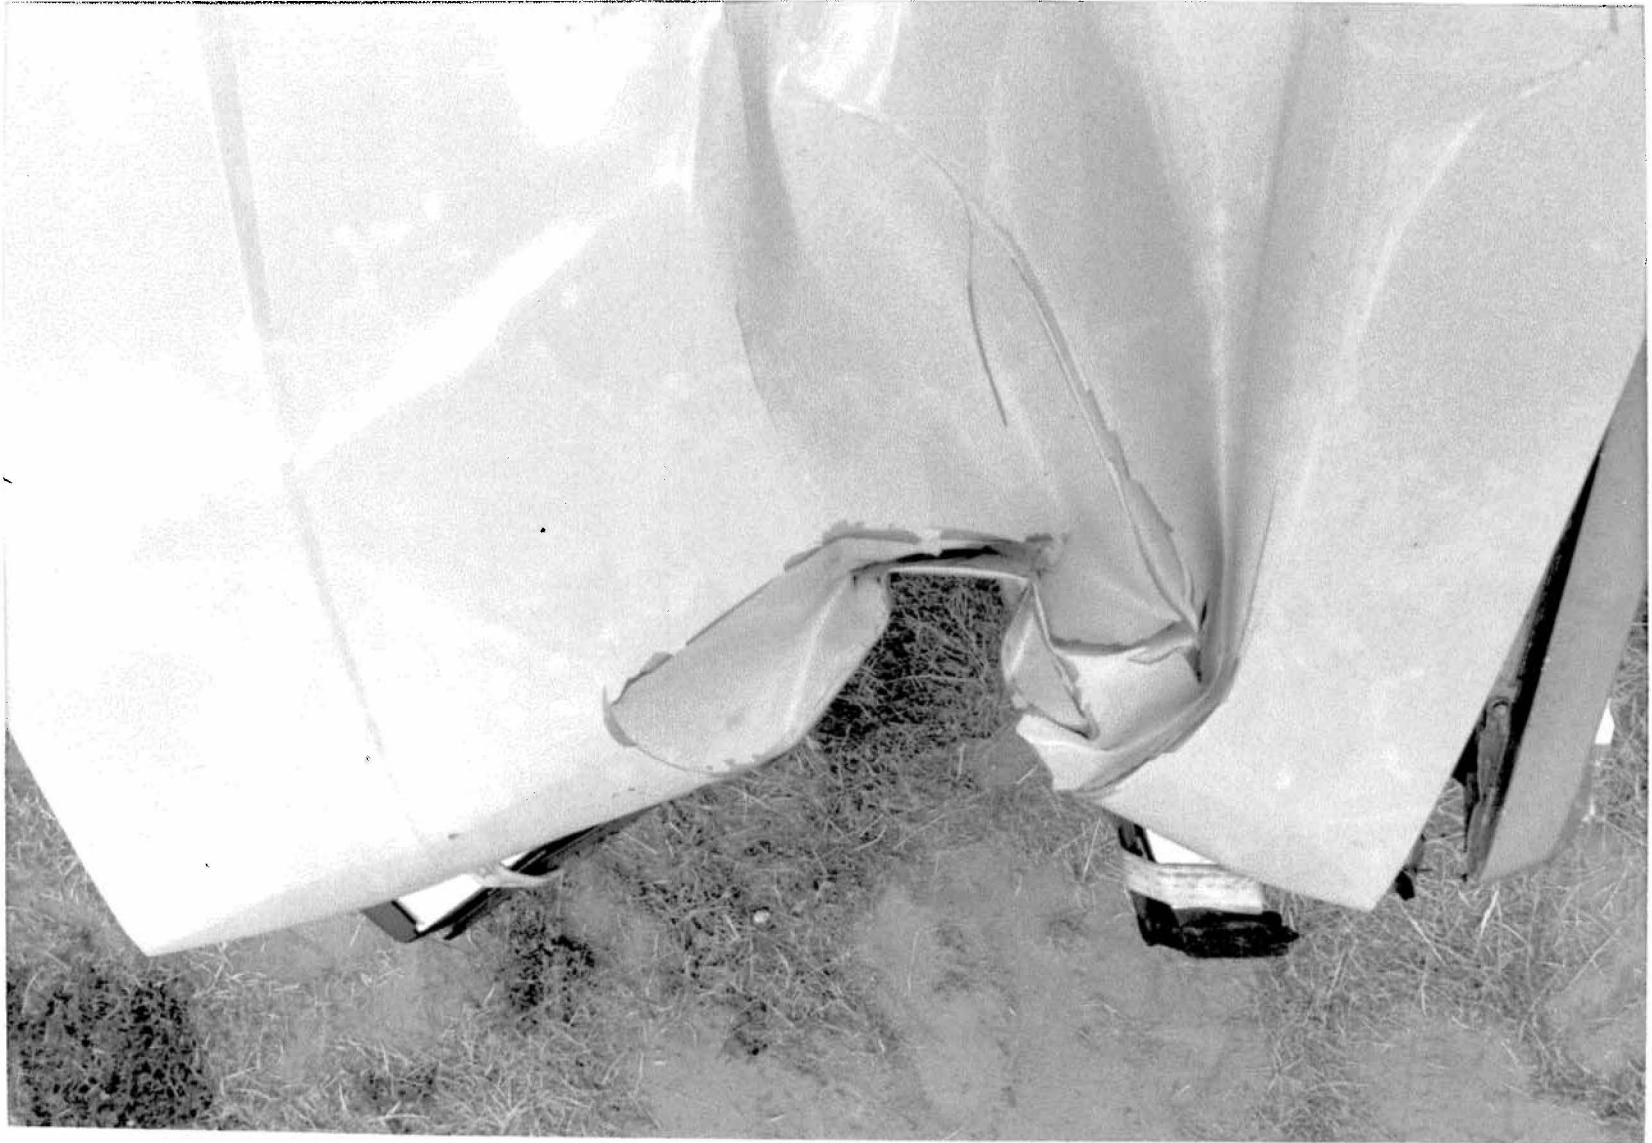
Figure 127. Impact location overhead view, posttest, test no. 8.
