U.S. Department
of Transportation

**Federal Highway
Administration**

NON-STANDARD STABILIZERS

**FHWA-FLP-92-011
Final Report**

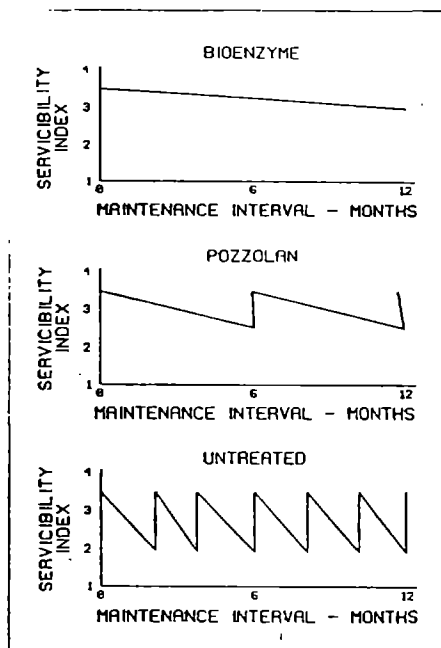
Figure 4. Treated aggregate surfaces provide for better service, with reduced maintenance frequency.

The short and long term cost benefits are of paramount importance in evaluating a stabilizer. Surface aggregate replacement is the single most costly item in maintaining aggregate surfaced roads (Figure 3). The cost of blading is less related to grader operation than to the influence of blading on surface degradation and increasing the rate of aggregate loss. To provide the long term benefit, an effective stabilizer locks the aggregate particles in place and maintains indefinitely the original compacted density achieved during construction, preventing or substantially reducing aggregate loss, and reducing or eliminating the damaging effects of frequent blading (Figure 4). In the short

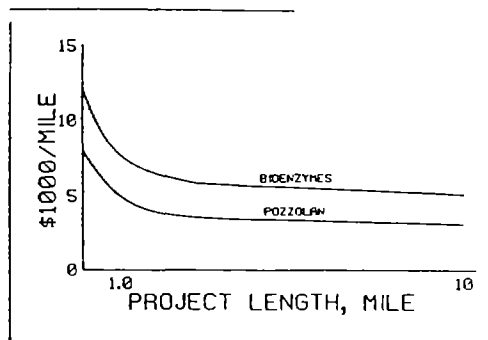
Figure 5. 1988 construction costs for aggregate surface treatment with non-standard stabilizers.

term, the cost of initial stabilization should be in the same cost range as a single aggregate replacement operation (Figure 5) to avoid unwanted increases in already strained budgets.

Attempting to water, mix and compact long sections under drying conditions will result in low densities and a poor quality surfacing. Fine grained, silty aggregates have a relatively flat Proctor curve and should always be compacted one or two percent dry of optimum to avoid excessive moisture and subsequent pumping under the roller. Excess moisture must be removed by time consuming scarifying and blading to aerate the aggregate mixture. Compaction with pneumatic or vibratory roller should be to 95 percent of Standard Proctor or better, and is followed by final shaping. Construction costs range from \$3500 to \$7000 per mile (1988 dollars), varying inversely with the project length (Fig. 5). Work production averages about 1 mile per day.

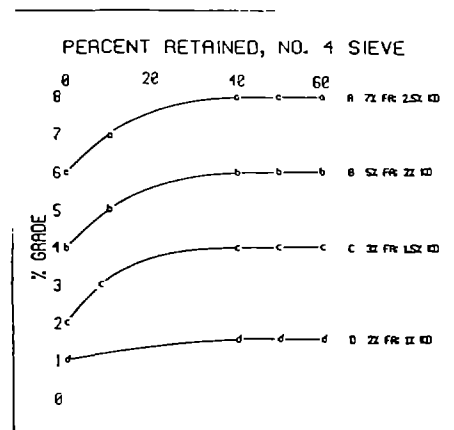
Figure 6. Estimated minimum percentages of Class "C" flyash or kiln dust required to prevent corrugations on grades.

These sections have provided particularly useful insights to the percentages of additives required to prevent corrugations on steeper grades (Figure 6).
