Design and Rehabilitation Strategies for Permeable Friction Course Pavements

Technical Report 0-7110-R1

TEXAS A&M TRANSPORTATION INSTITUTE
COLLEGE STATION, TEXAS

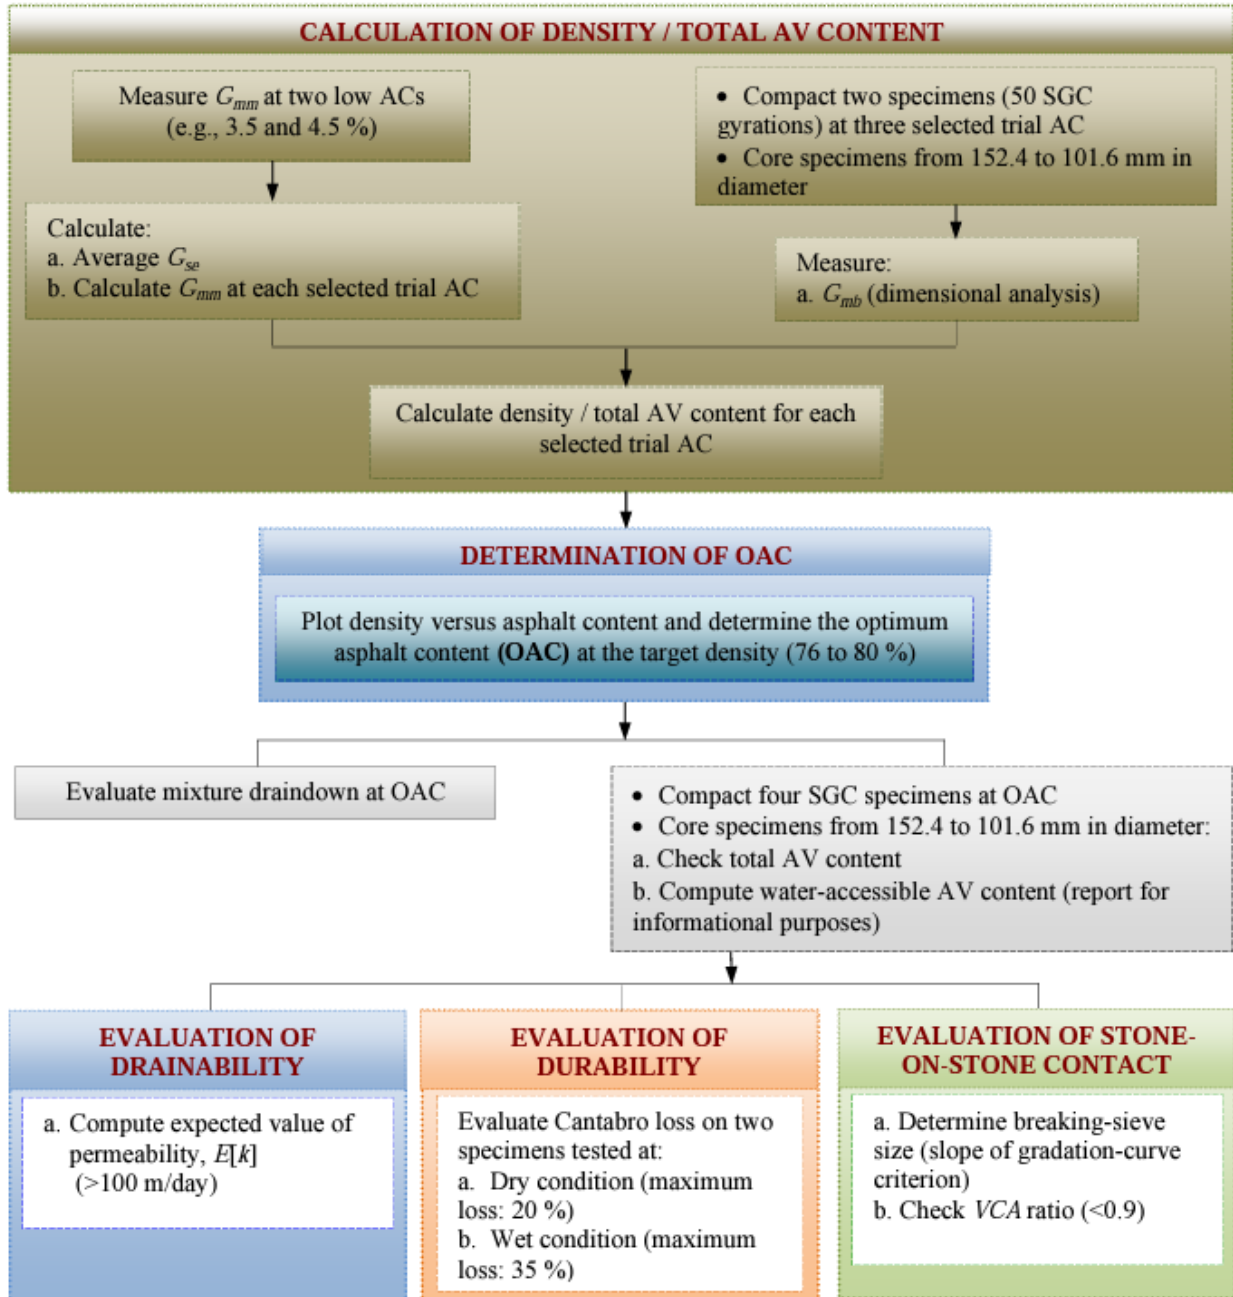
Figure 4. Recommended changes to TxDOT’s PFC mix design procedure (Alvarez 2009).

In Texas, researchers have also evaluated several aspects of PFC mix design, including volumetrics, permeability, durability, and aging (Alvarez et al. 2008). Based on results from lab experiments, researchers recommended (a) dimensional analysis to estimate the total AV content of the mix; (b) change in density specification from 78–82 percent to 76–80 percent to ensure adequate permeability; (c) field evaluation of permeability during construction; and (d) durability evaluation using the Cantabro abrasion loss and draindown tests. The proposed changes to the TxDOT PFC mix design procedure are summarized in Figure 4.

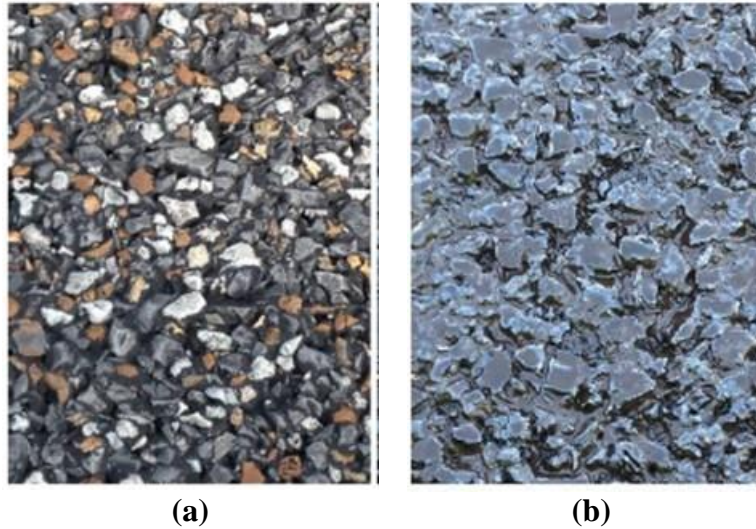
Figure 7. PFC pavement on I-40 in Tennessee: (a) before fog seal treatment, and (b) after fog seal treatment (Huang et al. 2019).

In the United States, several studies have also been conducted to explore the effectiveness of preventive maintenance strategies on PFC pavements. In Tennessee, a fog seal consisting of a light application of diluted emulsion (i.e., no aggregate) was applied on an existing PFC pavement section of I-40 that was about 3 years old (Huang et al. 2019). Figure 7 illustrates the condition of the pavement surface before and after fog seal treatment. Cores were obtained before and after treatment, and different application rates were considered. Performance was assessed via permeability, texture depth, and abrasion tests. Results indicated that the application of the fog seal reduced the PFC pavement permeability and decreased texture depth yet significantly reduced the abrasion loss (i.e., by about 50 percent compared to the untreated specimens). The reduction in texture depth after the application of the fog seal treatment was temporary since after the abrasion tests, the skid resistance was restored (Song et al. 2021).

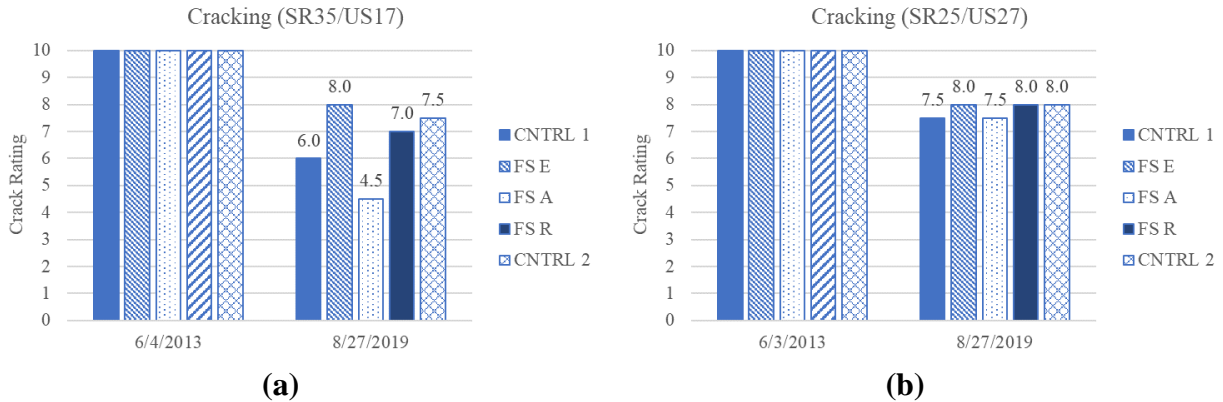
Figure 8. Cracking performance of the control and treated sections: (a) US 17, (b) US 27 (After Nazef 2020).

Performance was measured based on the condition of the pavement (cracking, rutting, and ride), friction, permeability, and binder viscosity (recovered from field cores). The results showed adequate pavement condition for all sections 6 years after treatment application, with eFog-treated sections showing the best overall cracking performance, as shown in Figure 8 (Nazef 2020). All sections had equivalent raveling performance. Researchers observed a reduced friction right after product application but acceptable values 2 weeks to 3 months after application. The permeability measured right after fog seal treatment versus 6 months after

treatment decreased for all test sections (i.e., control and treated). The eFog-treated section showed the highest drop in permeability, while Reclamite had the lowest drop and was similar to the control section. The viscosity of the extracted binder from field cores was less for the treated sections compared to the control section, which proved the rejuvenation ability of the products.

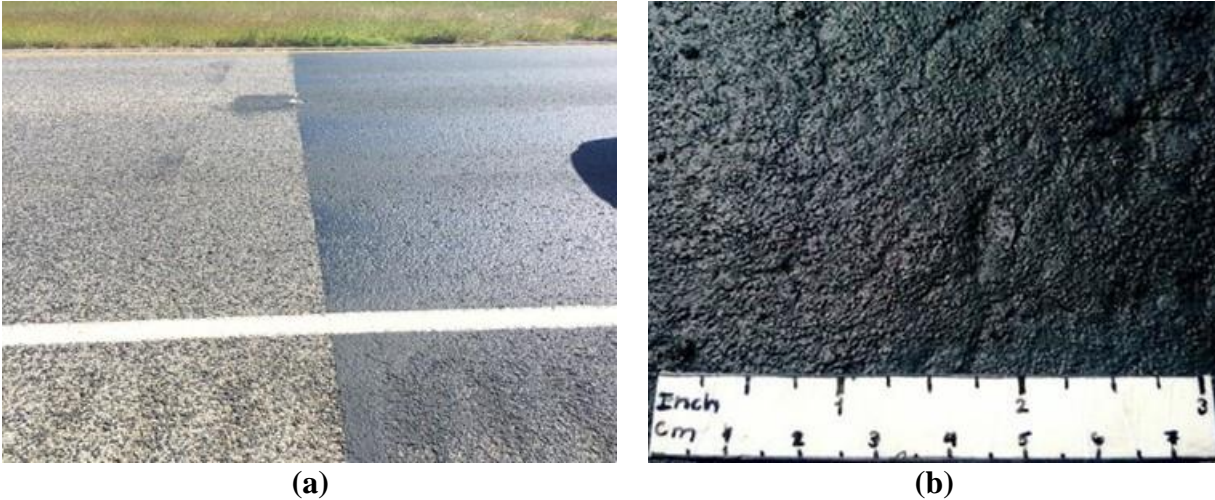
Figure 9. IH 35 in the San Antonio District: (a) beginning of Onyx product application, and (b) surface of the pavement after Onyx application (Scullion et al. 2020).

The San Antonio District also constructed a 1-mi test section in the southbound lanes of IH 35 in June of 2017. This portion of IH 35 is surfaced with an older PFC, which is about at the end of its life and is beginning to exhibit significant raveling. Therefore, the district wanted to see if a product marketed under the name Onyx could hold up the raveling and extend the life of the PFC pavement. Onyx is the tradename for Special Specification (SS) 3028 Frictional Asphalt Surface Preservation Treatment, which is a spray-applied, emulsified binder that also contains an exceptionally fine aggregate or grit to aid in friction. The old PFC surface and the beginning of the Onyx application along with a close-up of the Onyx treatment are shown in Figure 9. Skid measurements taken on the Onyx surfacing and on the existing PFC at either end of the Onyx section are shown in Figure 10. These results are concerning because the skid numbers seem to have dropped by about 10 points and did not recover even after almost 1 year.

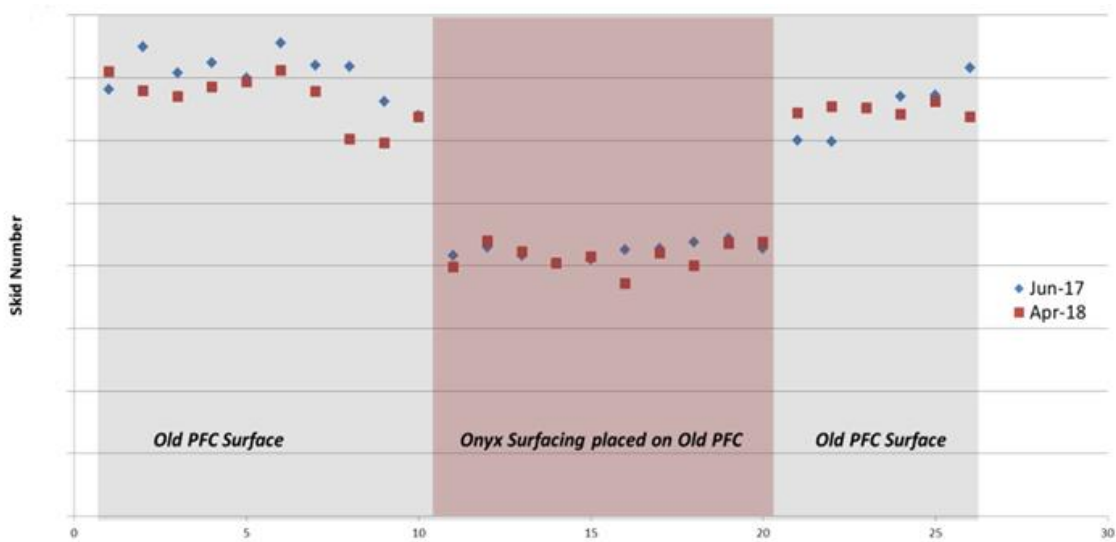
Figure 10. Skid data on IH 35 in the San Antonio District showing the existing PFC pavement and the Onyx test section results (Scullion et al. 2020).

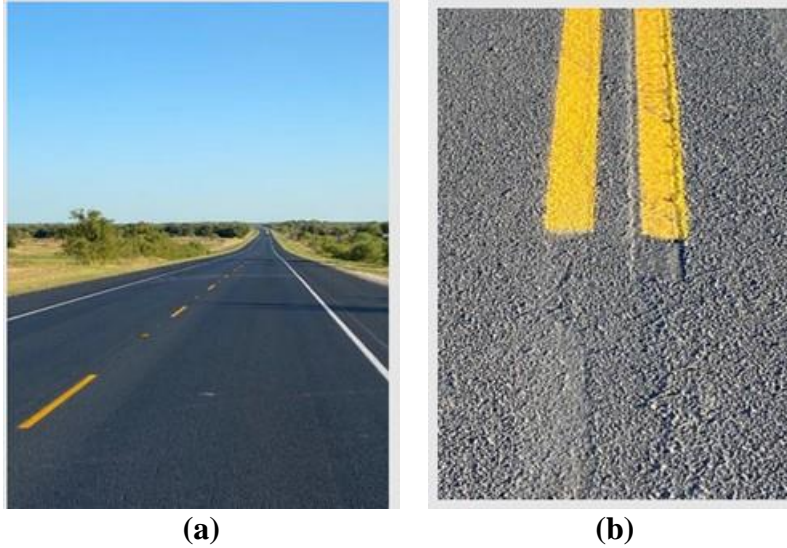
Figure 11. Spray-applied frictional asphalt surface treatment (SS 3028, Onyx) on US 183 in Stephens County: (a) general view of the test section, and (b) detailed view of the pavement surface.

In 2020, the Brownwood District applied a frictional asphalt surface preservation treatment (Onyx, SS 3028) to a PFC pavement on US 183 south of Breckenridge (Figure 11). It would have been difficult to mill off this PFC mix since it was originally placed on a flexible base covered with a surface treatment. The skid results were good, with no noticeable loss in friction observed.

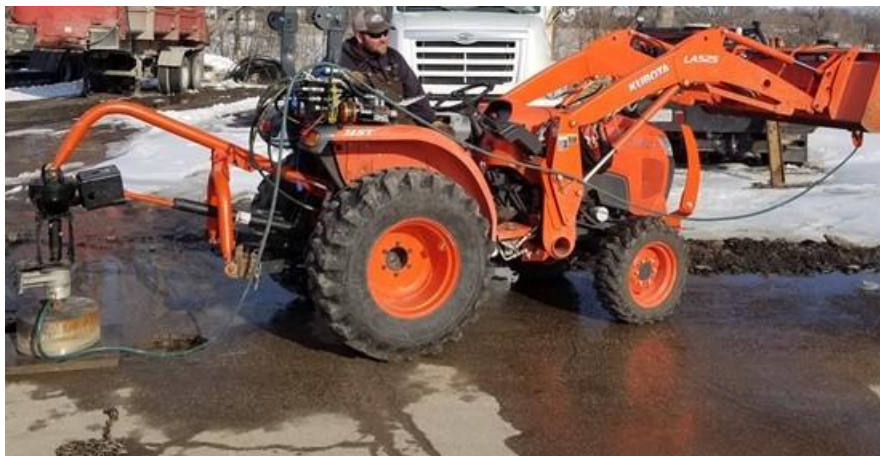
Figure 12. Equipment used to obtain 16-inch diameter cores from the PFC pavement.

To achieve this acceptable skid performance, the application quantity was optimized. The district worked with the contractor, who obtained 16-inch diameter cores using the equipment shown in Figure 12 and then applied different quantities of Onyx. The cores were then trafficked using a three-wheel polisher (Figure 13a). After 16,000 passes, the friction was measured using a dynamic friction tester (DFT) (Figure 13b), and the texture was measured using a circular track meter (Figure 13c). These two metrics provided a correlation to the skid number obtained with the locked wheel skid trailer. Based on the results of the laboratory testing, 0.12 gal/yd² was selected as the application quantity.

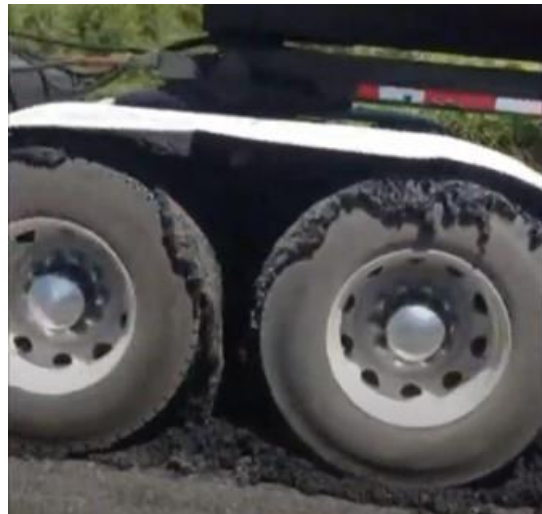
Figure 14. PFC pavement surfaced with AR seal coat tracking on vehicle tires immediately after construction.

In 2017, the Houston District attempted to place an AR seal coat on top of an existing PFC pavement on SH 146. Rain had occurred a couple of days prior to the seal coat, trapping water in portions of the PFC. The result was disastrous, with 40 cars and trucks stalled for 5 hours after the AR seal tracked on the tires. An example of an affected truck is shown in Figure 14.

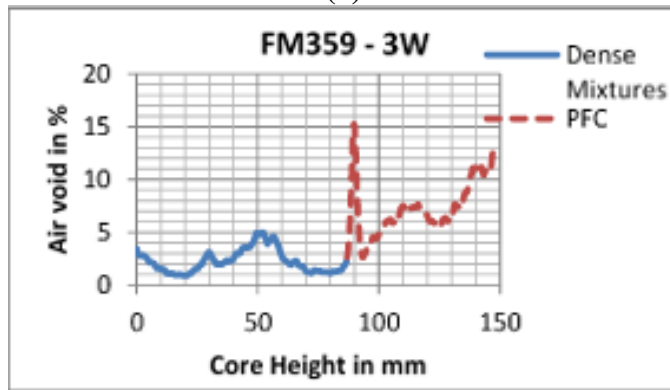
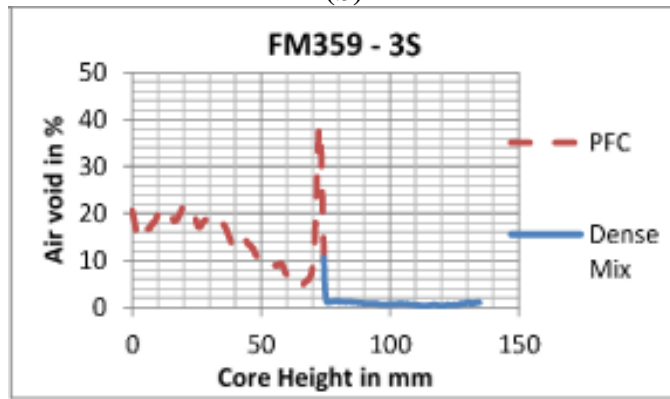
Figure 16. Air void distribution estimates obtained from X-ray computed tomography images of cores from the PFC Pavement on US 359: (a) outer lane 1W, (b) inner lane 3W, and (c) Shoulder 3S (Scullion et al. 2020).

Figure 15 shows images of the computed tomography scans and Figure 16 the estimated AV for the cores extracted from US 359. The results indicate that the estimated AV was higher at the top half-inch of the PFC and reduced toward the center, where the AV detected was below 10 percent (the typical AV of a new PFC pavement is about 20 percent). The reduction was more prominent on the inner lane (3W) than the outer lane (1W) and shoulders (3S). A similar trend was noted during the field flow test. There is a spike in the middle of the AV plot, which represents the joint between the pavement bottom dense layer and the PFC mix. At that point, there was no effect on water flow initiating from the surface.

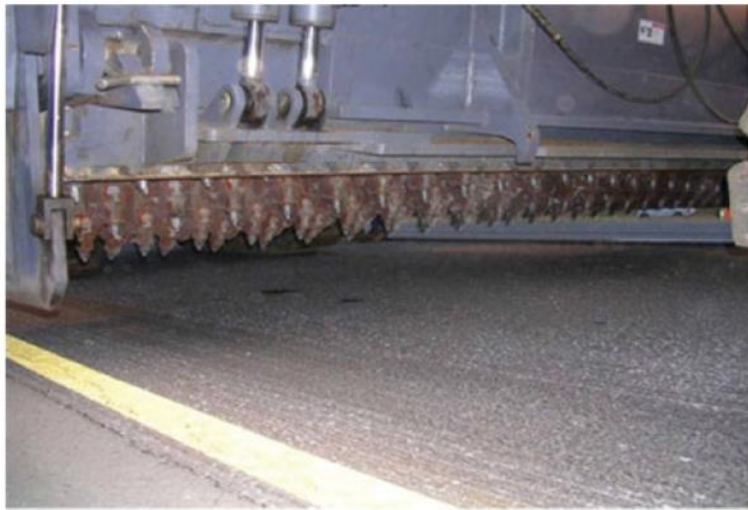
Figure 18. Micromilling equipment teeth (Jared and Hines 2014).

Micromilling employs equipment with more teeth that are spaced more closely, which produces a more uniform, smoother, and finer surface texture. Micromilling equipment is shown in Figure 18. To successfully apply this procedure, stringent surface texture and smoothness requirements were established by GDOT, including less than $\frac{1}{16}$ -inch difference between ridges and valleys, and a target smoothness index of 825–900 mm/km. A new PFC or porous European mix can be placed directly on top of the micromilled surface, which also represents cost savings. Often, variable-depth micromilling is required to completely remove the existing surface layer. Figure 19 shows an example of a micromilled surface with variable depth.

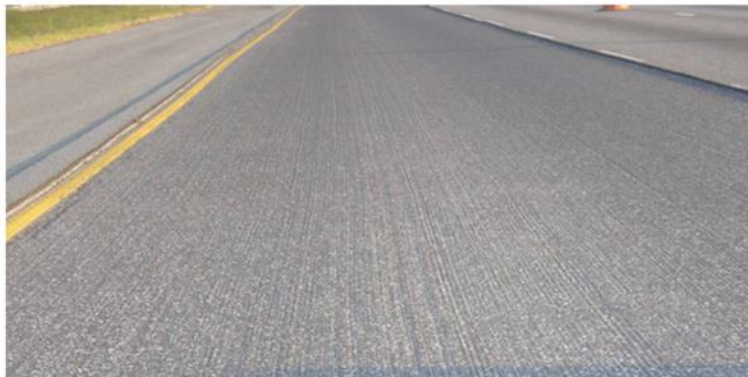
Figure 19. Variable-depth micromilled surface in Georgia (Jared and Hines 2014).

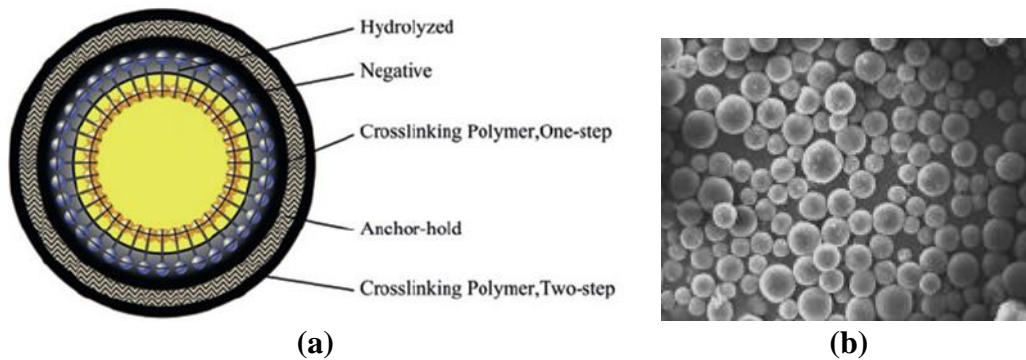
Figure 20. Rejuvenator encapsulation: (a) schematic of the structure of a microcapsule (Su and Schlangen 2012), and (b) microcapsule morphology captured by scanning electron microscope (Su et al. 2013).

Other rehabilitation strategies labeled self-healing, including rejuvenator encapsulation, induction heating, and microwave heating, have been explored by researchers in Ireland as an option to refurbish PFC mixes that can achieve a longer service life (Tabokovic et al. 2019). Rejuvenator encapsulation consists of adding microcapsules with rejuvenators during PFC mix production; when cracking distress commences in the pavement, the capsules will open, releasing the rejuvenator and restoring the binder properties. The structure of a microcapsule and microcapsule morphology are shown in Figure 20.

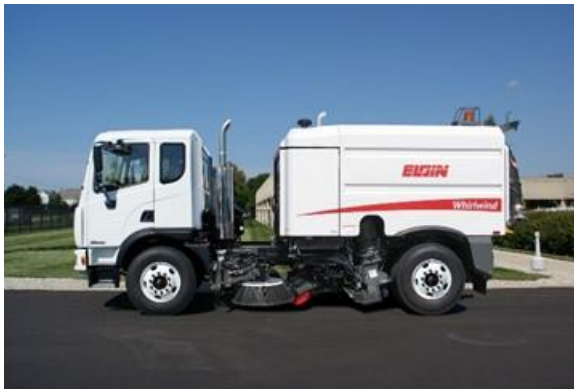
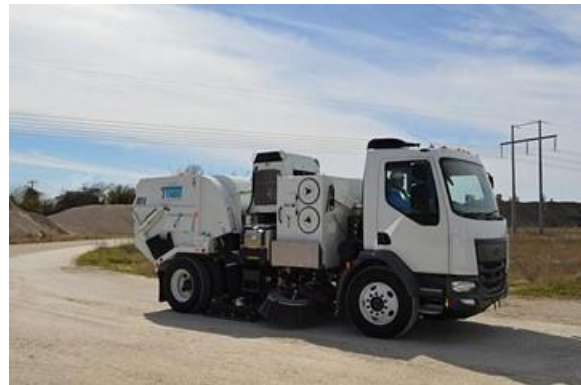
Figure 23. Commercially available sweeper trucks: (a) Elgin Whirlwind (Joe Johnson Equipment 2021), and (b) Tymco-DST 6 (Tymco 2021).

In Canada, researchers studied the effect of small-scale and full-scale sweepers in restoring the permeability of permeable pavements (i.e., porous asphalt, pervious concrete, and permeable interlocking concrete). The researchers selected eight locations that were at least 3 years old and had been subjected to winter maintenance activities including sand and deicers (Drake and Bradford 2013). Infiltration tests following a modified ASTM D3385 standard test procedure were conducted before and after sweeping for the small-scale treatment sites, and ASTM C1701 standard test method was followed for the full-scale treatment sites. The small-scale treatment consisted of (a) pressure washing followed by 24-hour drying, (b) sweeping with a push broom, or (c) vacuuming with a wet/dry Mastervac (i.e., high or low suction with air flow). Full-sized treatment was conducted with two commercially available sweeper trucks (i.e., Elgin Whirlwind and Tymco-DST 6) like the ones shown in Figure 23.

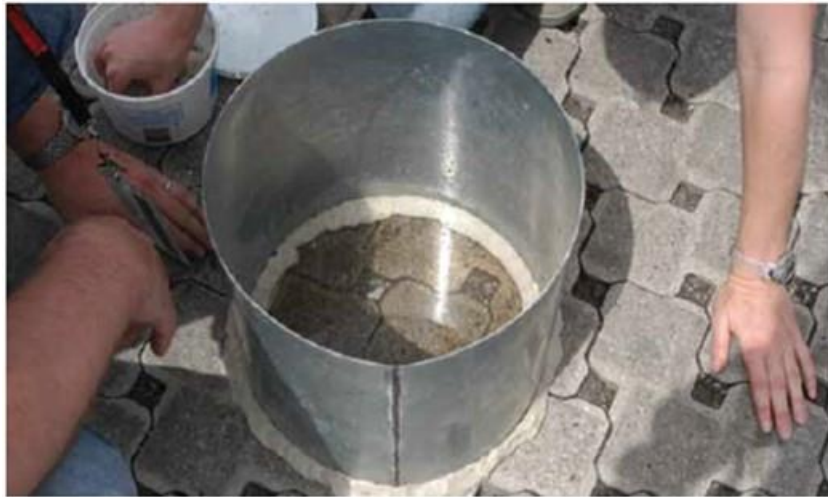
Figure 24. Single-ring infiltrometer used to measure water infiltration rate on permeable pavements (Kinter 2010).

In a joint study between Sweden and the United States, different small-scale and full-scale maintenance techniques aimed at restoring permeability in permeable pavements were evaluated. Two sites located on residential streets paved with porous asphalt that were 21 and 28 years old at the time of maintenance and had not received prior treatment to restore functionality were used in the study (Winston et al. 2016). During winter seasons, these pavements had been subjected to various applications of sand mixed with salt or fine gravel and had very minimal drainability. These two porous asphalt sites were treated with vacuuming using an industrial handheld wet/dry vacuum device (i.e., Dustcontrol DC 50-W), pressure washing with Nilfisk ALTO Poseidon 2-22 XT, a combination of vacuuming followed by pressure washing, and milling. Surface infiltration rate per ASTM C1781 was measured before and after maintenance using equipment like that shown in Figure 24.

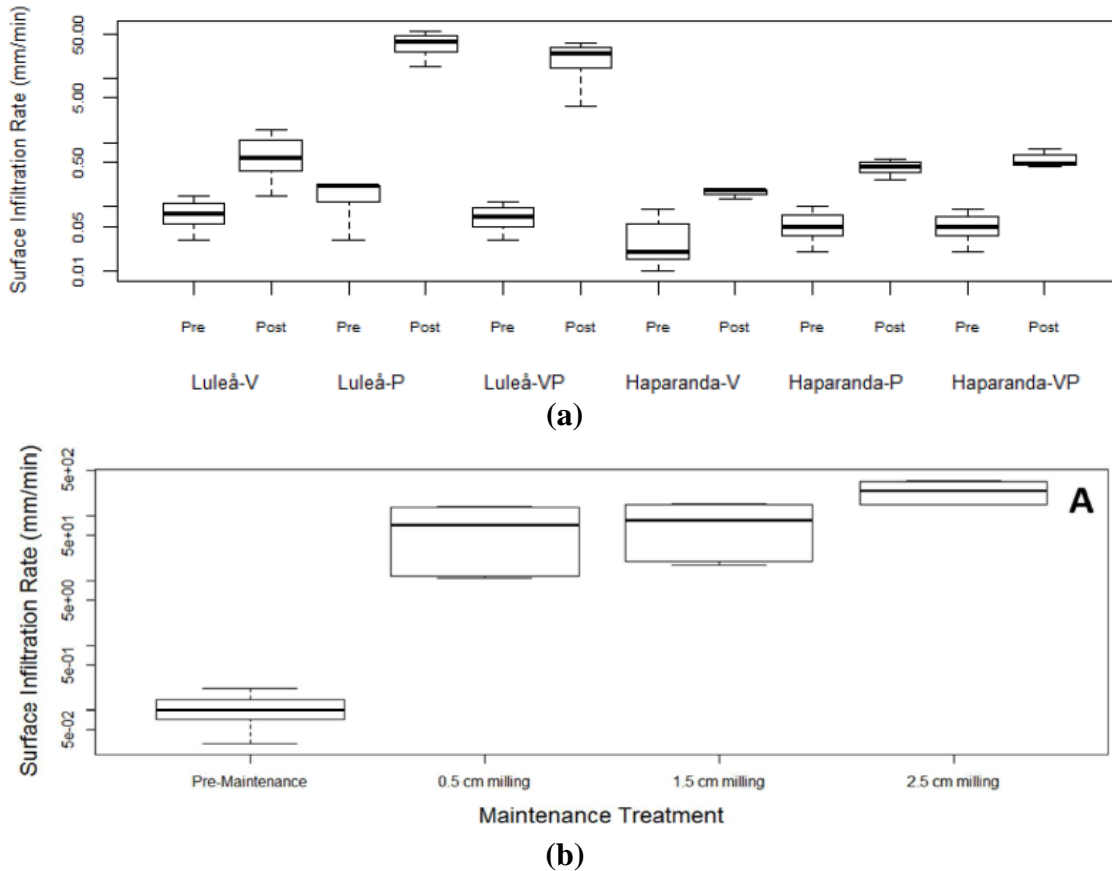
Figure 25. Effects of maintenance strategies on surface infiltration rate at test sites in Sweden: (a) pre- and post-treatment with vacuuming (V), pressure washing (P), and vacuuming plus pressure washing (VP); and (b) milling at various depths (Winston et al. 2016).

Although vacuuming restored the surface infiltration rate, the most effective methods were those involving pressure washing, especially the one that combined pressure washing with vacuuming, as shown in Figure 25a. In one of the two sites, milling at various depths (0.2 inch, 0.6 inch, and 1.0 inch) was tested to verify if this technique would be more effective in removing the sediment accumulated near the surface of the pavement. A 1-inch milling depth produced the best surface infiltration rate, as shown in Figure 25b, as well as an infiltration rate value twice as large as the vacuuming plus pressure washing option.

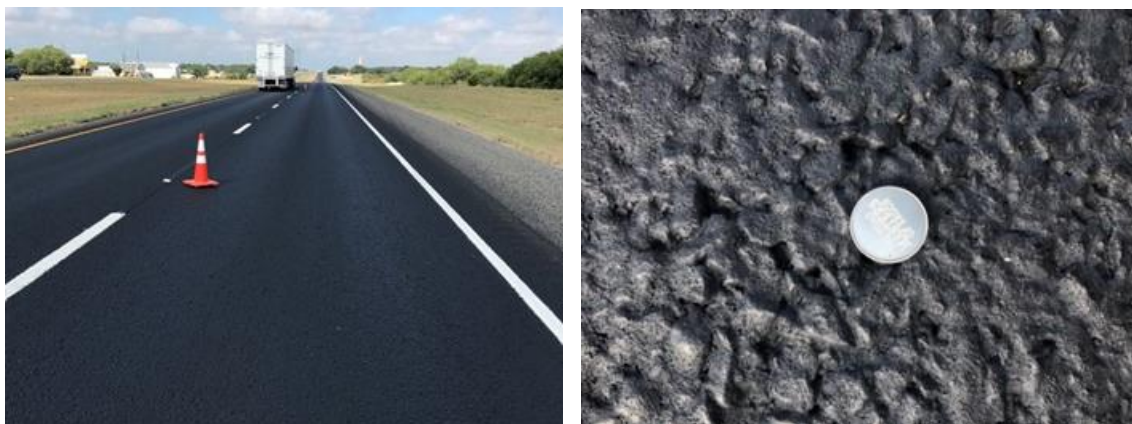
Figure 26. IH 35 PFC surfaced with Onyx.

The San Antonio District constructed a 1-mi test section in the southbound lanes of IH 35 in June of 2017. This portion of IH 35 was surfaced with an older PFC that was about at the end of its life and beginning to exhibit significant raveling, and the district wanted to see if Onyx could retard the raveling and extend the life of the PFC. Figure 26 shows the treatment soon after application.

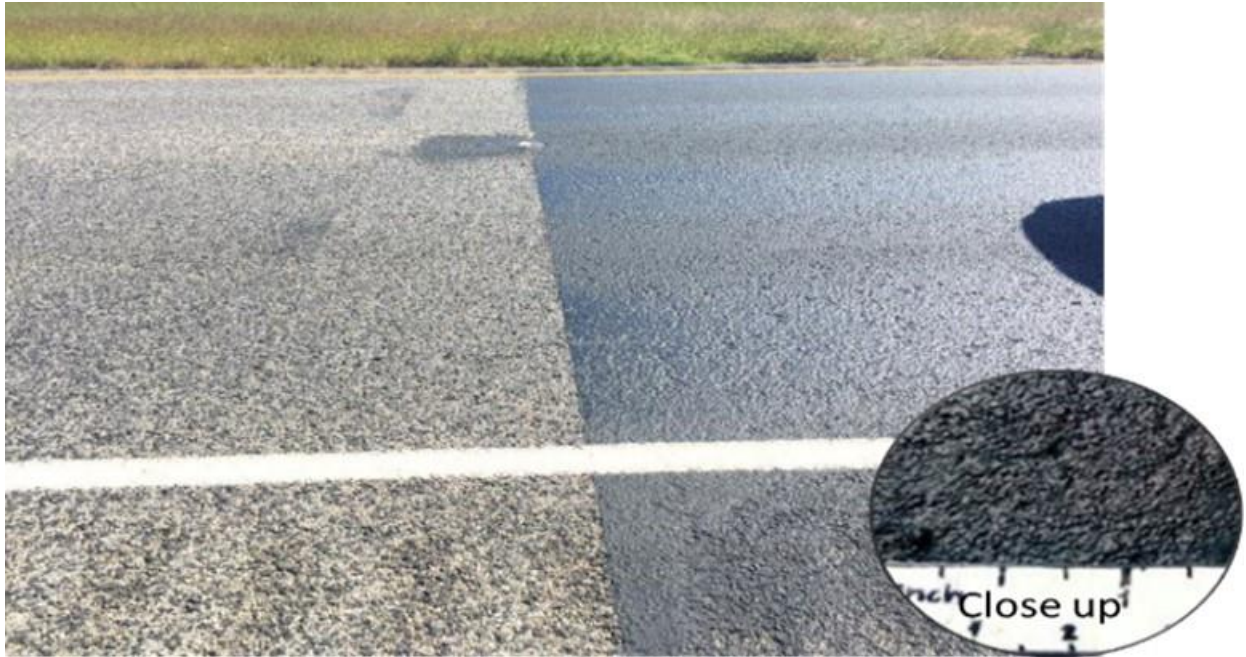
Figure 27. IH 35 existing PFC and beginning of Onyx application.

The old PFC surface along with the beginning of the Onyx application can be seen in Figure 27. Skid measurements taken on the Onyx surface and on the existing PFC at either end of the Onyx section are shown in Figure 28. These data are concerning because the skid numbers seem to have dropped by about 10 points. Some improvements in skid were noted in the last set of measurements from April 2019, but all measurements were observed to increase, and it was concluded that this increase was attributed to either (a) the slurry wearing off (Figure 29); or (b) the continuation of the raveling (Figure 30), which was visually apparent. Figure 29 and Figure 30 show the pavement surface condition 3 years after placement of the Onyx.

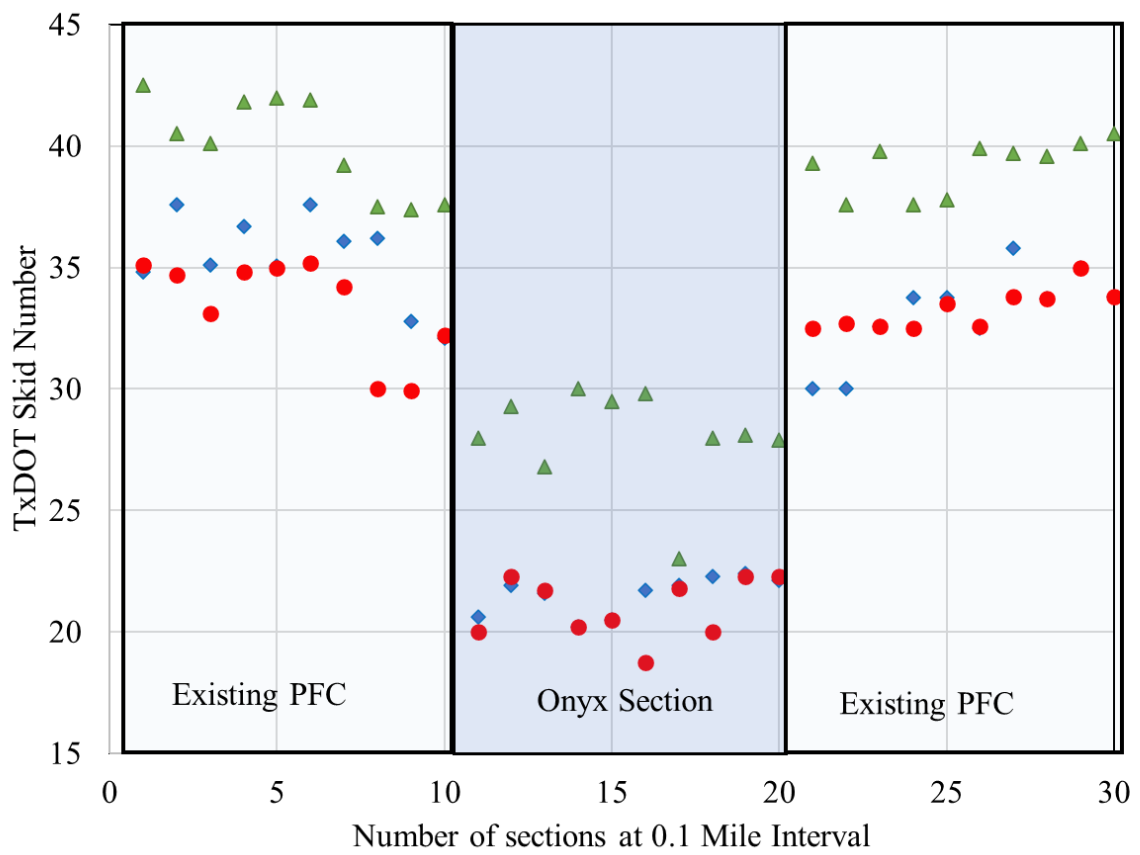
Figure 28. Skid data on IH 35 existing PFC and Onyx test section.

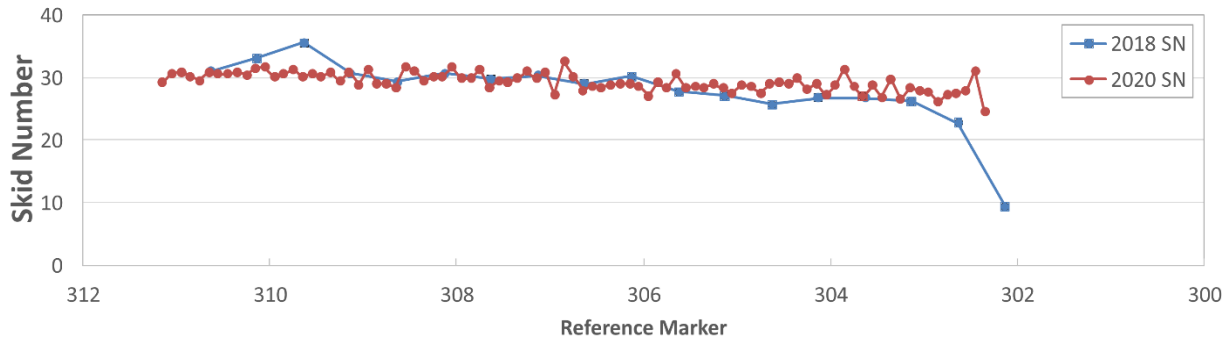
Figure 31. Skid before Onyx application (2018) compared to skid after Onyx application (2020).

In 2020, the Brownwood District applied a frictional asphalt surface preservation treatment (Onyx, SS 3028) to a PFC on US 183 south of Breckenridge. Project information is shown in Table 11. It would have been difficult to mill this PFC off since it was originally placed on a flexible base covered with a surface treatment. The results were good in terms of friction, as shown in Figure 31. No noticeable loss in friction was observed.

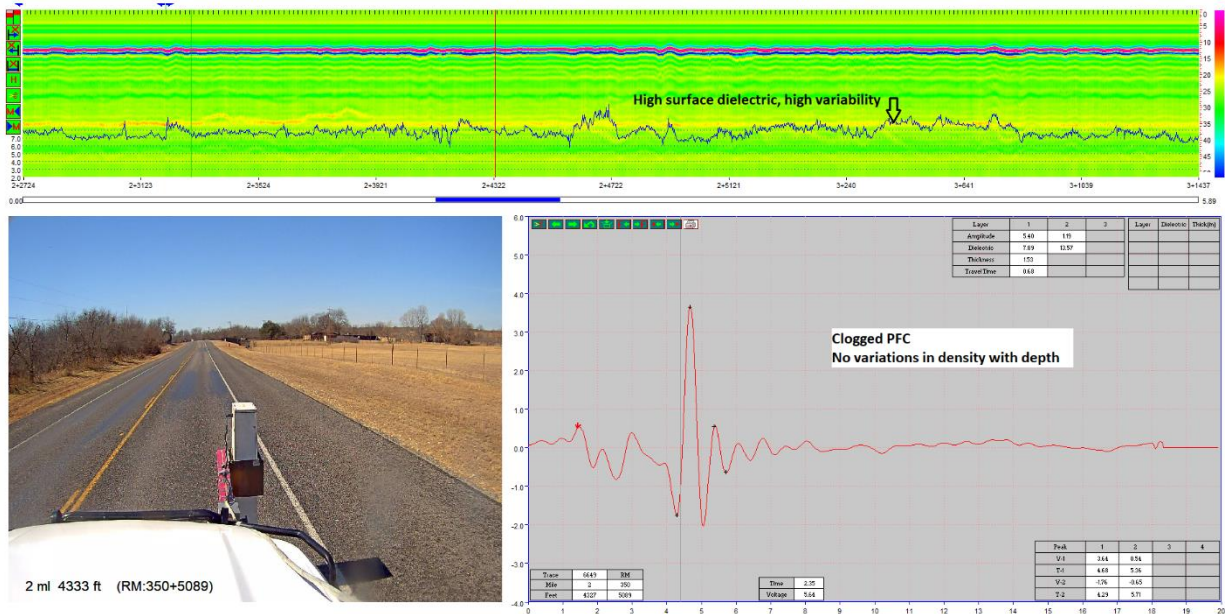
Figure 36. GPR evaluation of SH 36 indicating PFC is clogged.

A GPR survey was conducted in February of 2022, and examples of the GPR survey are shown in Figure 36 and Figure 37. Based on the GPR, most of the project seems to be clogged (not draining) since there is no variation in density with depth, as shown in Figure 36 and schematically depicted in Figure 38. This finding indicates that the pavement was no longer functioning as a PFC at the time of seal coating. However, in some areas (as shown in Figure 37), there appears to be a portion of low density at the bottom of the PFC, meaning that the PFC is clogged in the top portion but open in the bottom portion (as illustrated in the schematic of Figure 39). While this could be an area to potentially hold water, there do not appear to be any surface distresses causing concern.

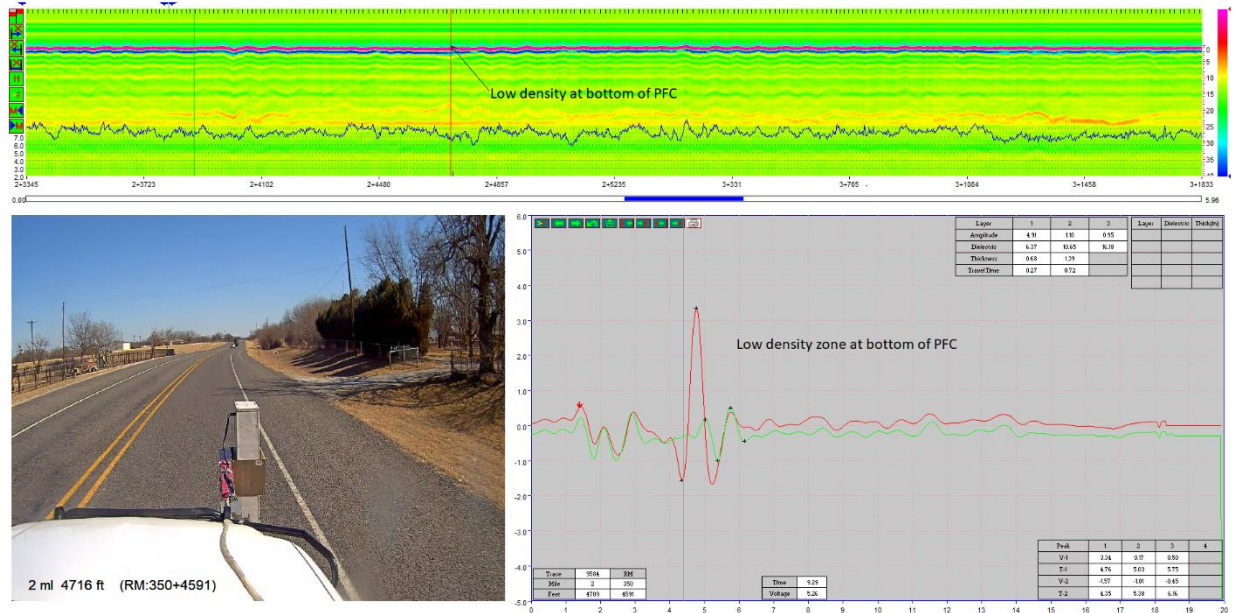
Figure 37. GPR evaluation of SH 36 showing isolated areas of low density at the bottom of the PFC layer.

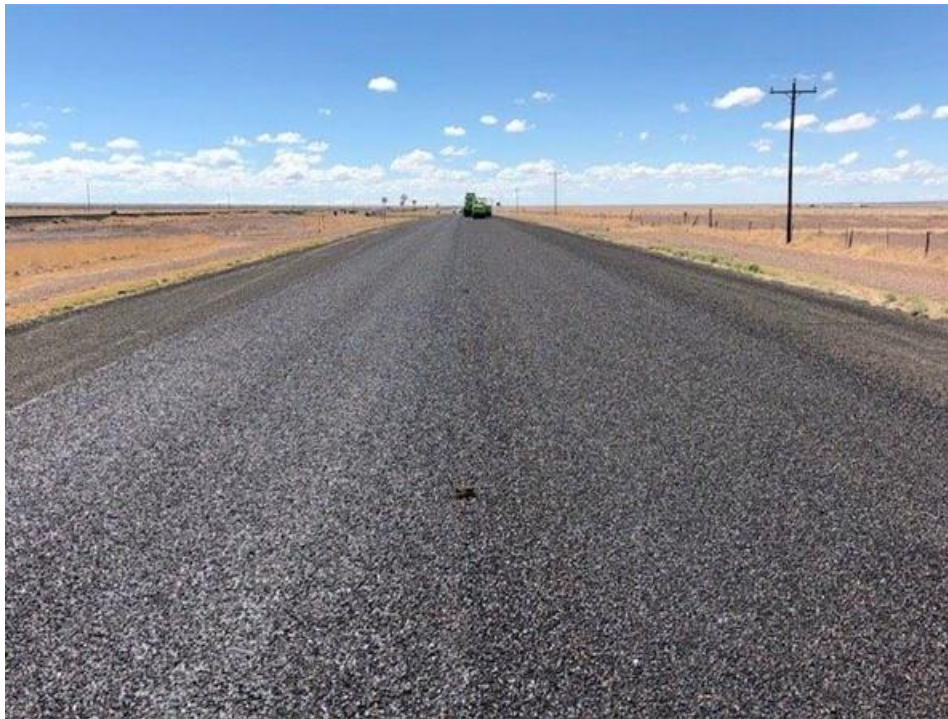
Figure 40. Seal coat construction on US 90 in El Paso District.

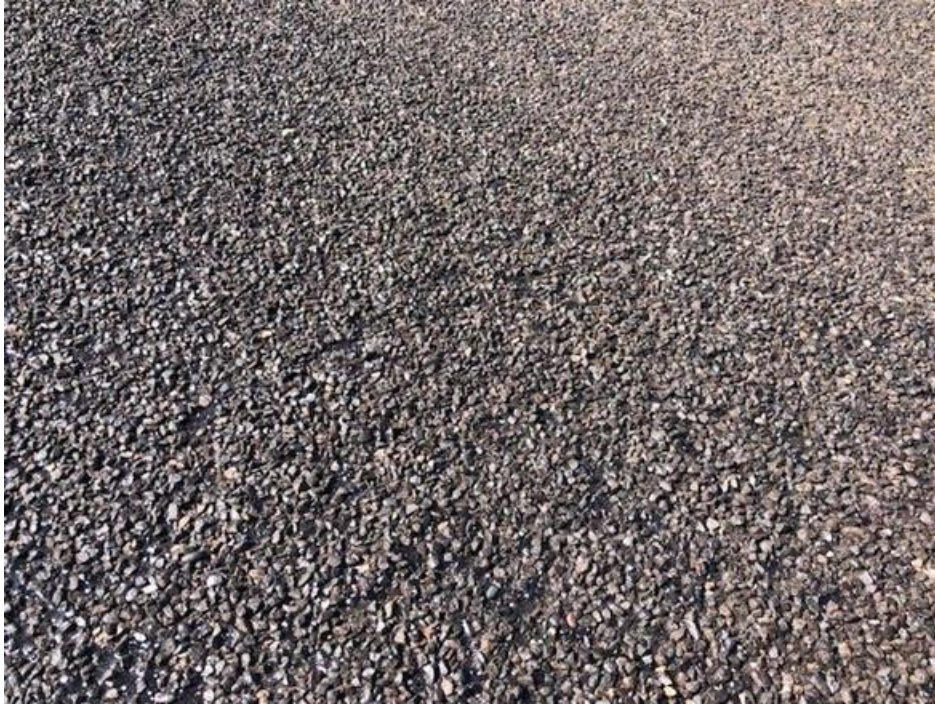
Figure 41. Seal coat at time of construction on US 90 in El Paso District.

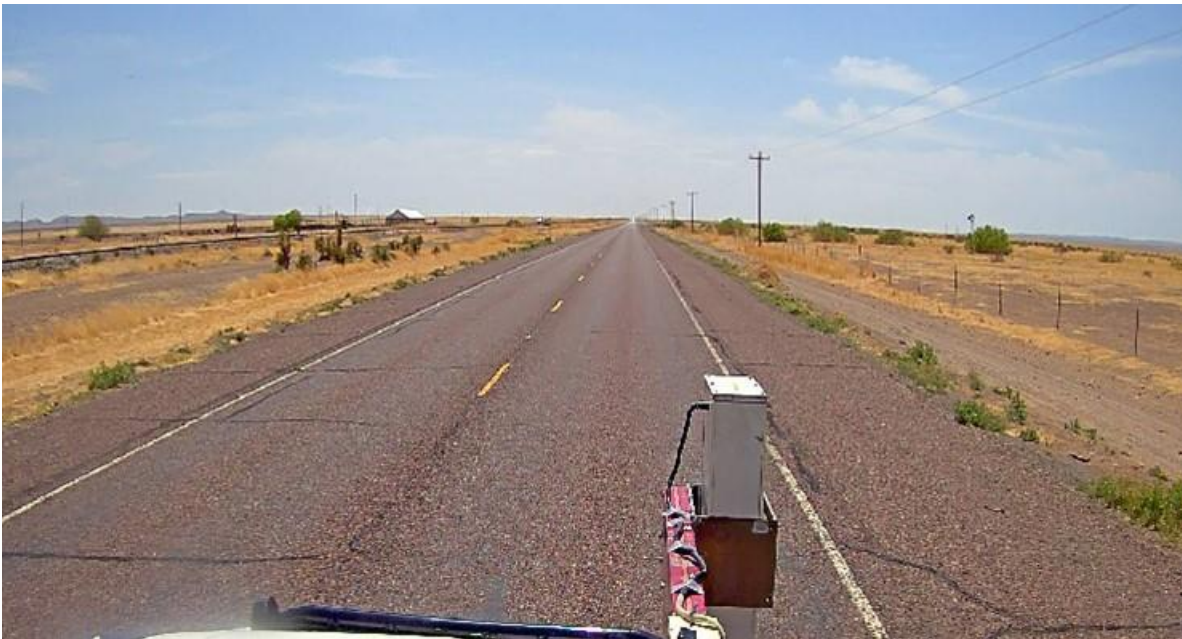
Figure 42. Current condition of US 90 at western end of project near Presidio County Line (April 2022).

In 2018, the El Paso District seal coated about 27 mi of US 90 from the Jeff Davis/Presidio County Line, east to the Marfa city limits. The project information is shown in Table 13. A 500-ft-long FM roadway with the same PFC was tied into the project and was sealed first to make sure that it worked. Construction photos are shown in Figure 40 and Figure 41. The seal coat is currently exhibiting some cracking that was present in the underlying surface prior to the placement of the PFC. There is also some flushing of the wheel paths in portions of the project (Figure 42).

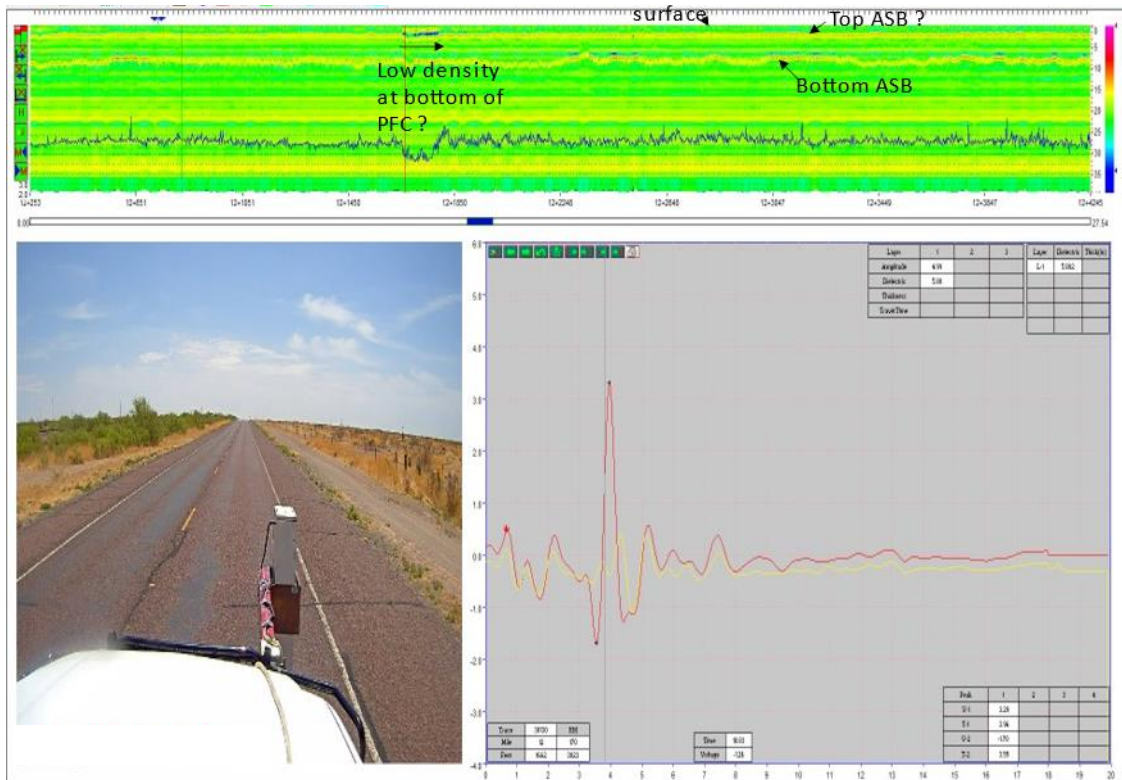
Figure 43. GPR evaluation of US 90 in El Paso District.

GPR imagery is shown in Figure 43. Most of the PFC appears to be clogged since there is no variation in density with depth. However, as on SH 36, there are some isolated areas where the PFC exhibits low density at the bottom of the layer, but there do not appear to be any performance problems associated with the low-density areas.

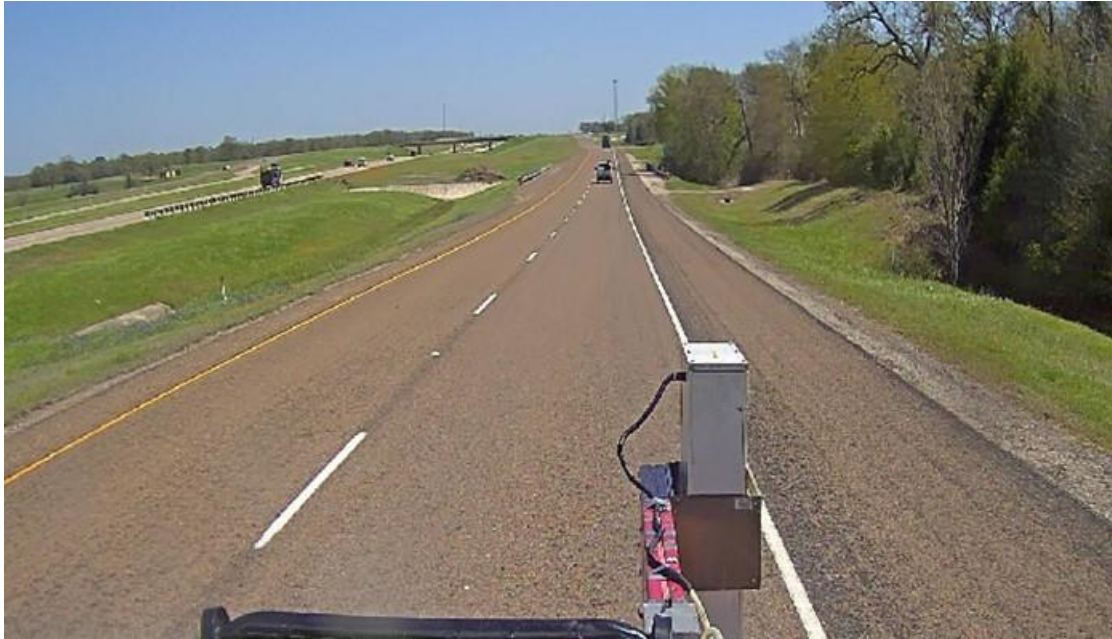
Figure 44. Current condition of SH 6 FR (April 2022).

The current condition of the roadway is particularly good and can be seen in Figure 44. The GPR indicates there are quite a few defects deeper into the pavement but none near the surface. There are no indications of any problems or that the PFC may be holding moisture (Figure 45) except in an area at the bottom of a hill (Figure 46), as indicated by the elevated surface dielectric. However, there are no visual surface indicators that this area has caused any performance problems.

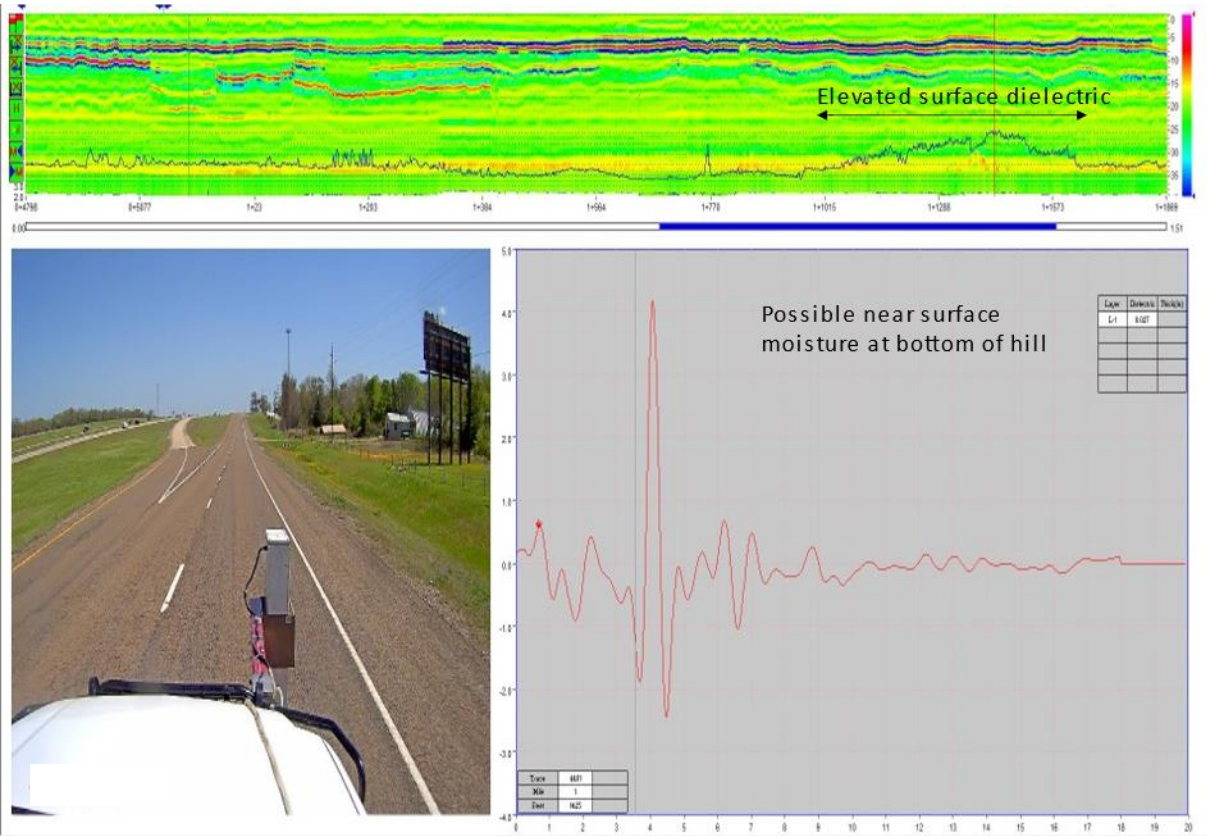
Figure 46. GPR evaluation of SH 6 showing possible moisture.

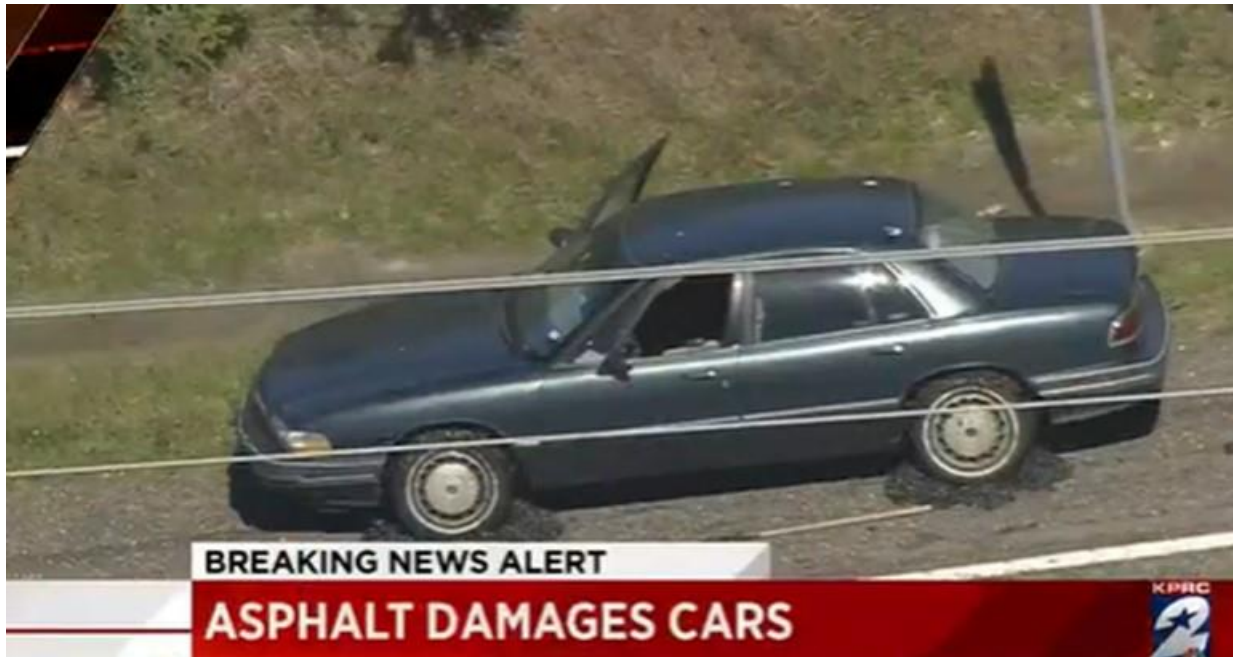
Figure 47. Seal coat stuck to vehicle tires (from TV news report).

In March of 2017, Texas A&M Transportation Institute (TTI) researchers became aware of the Houston District placing an AR seal coat (intended to be an interlayer) over a PFC on SH 146. Project information is shown in Table 15. This seal coat failed dramatically by not sticking to the surface and peeling up on vehicle tires on the day of placement, as shown in Figure 47 through Figure 49.

This was not part of any ongoing research, and no documentation was collected at the time. Based on discussions with the contractor, there had been a recent rainstorm, and it was believed that there may have been moisture trapped in the PFC at the time of the seal coat. AR seal coats are placed at elevated temperatures, and the contractor believed this created steam in the PFC layer, causing the debonding.
