Design and Rehabilitation Strategies for Permeable Friction Course Pavements

Technical Report 0-7110-R1

TEXAS A&M TRANSPORTATION INSTITUTE
COLLEGE STATION, TEXAS

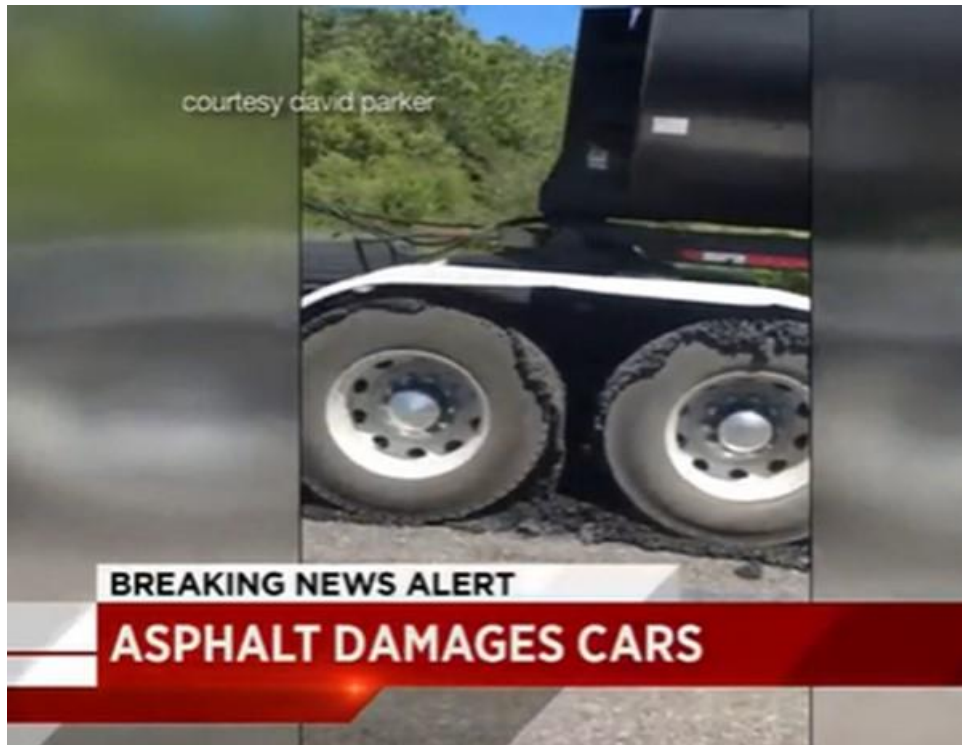
Figure 48. Seal coat stuck to truck tires (from TV news report).

In March of 2017, Texas A&M Transportation Institute (TTI) researchers became aware of the Houston District placing an AR seal coat (intended to be an interlayer) over a PFC on SH 146. Project information is shown in Table 15. This seal coat failed dramatically by not sticking to the surface and peeling up on vehicle tires on the day of placement, as shown in Figure 47 through Figure 49.

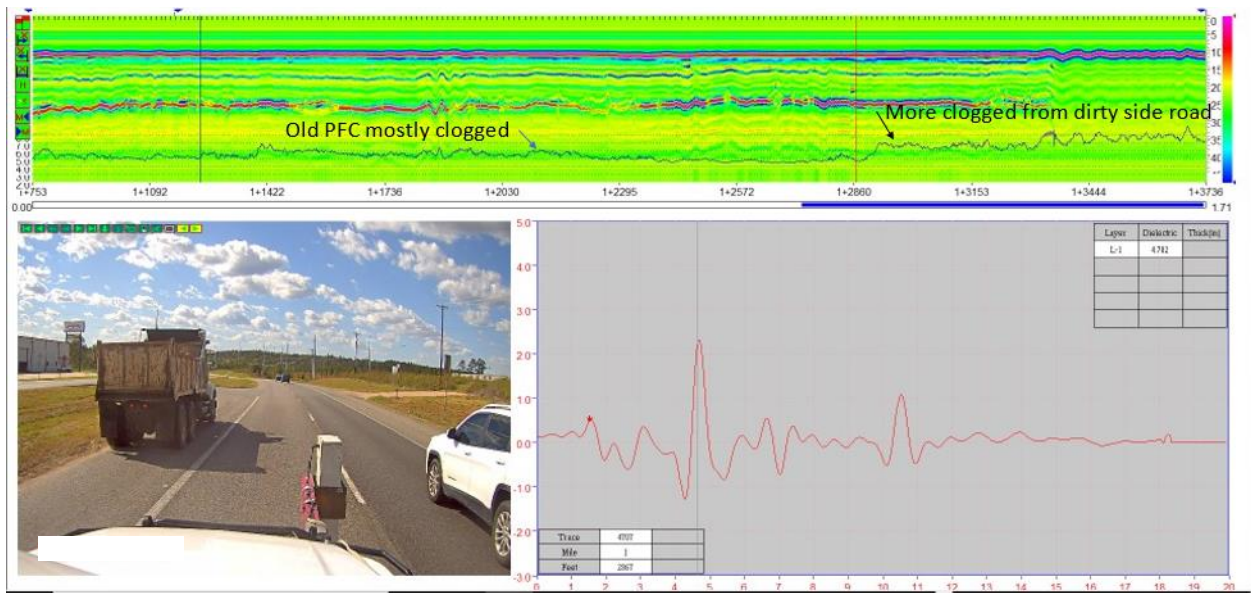
Figure 53. GPR data for left lane of US 69.

The Superpave mix was placed across the full width of the test section. GPR data for the left lane, right lane, and shoulder are shown in Figure 53 through Figure 55. When a PFC becomes clogged and is no longer draining, the GPR dielectric is higher and is more like a dense-graded HMA. Most of this older PFC tended to have a higher dielectric, indicating that it was clogged. The newer PFC inlaid patch (Figure 54) was draining a little better, but because the shoulder was also clogged, there was nowhere for the water to drain off, which created a bathtub effect within the patched area.

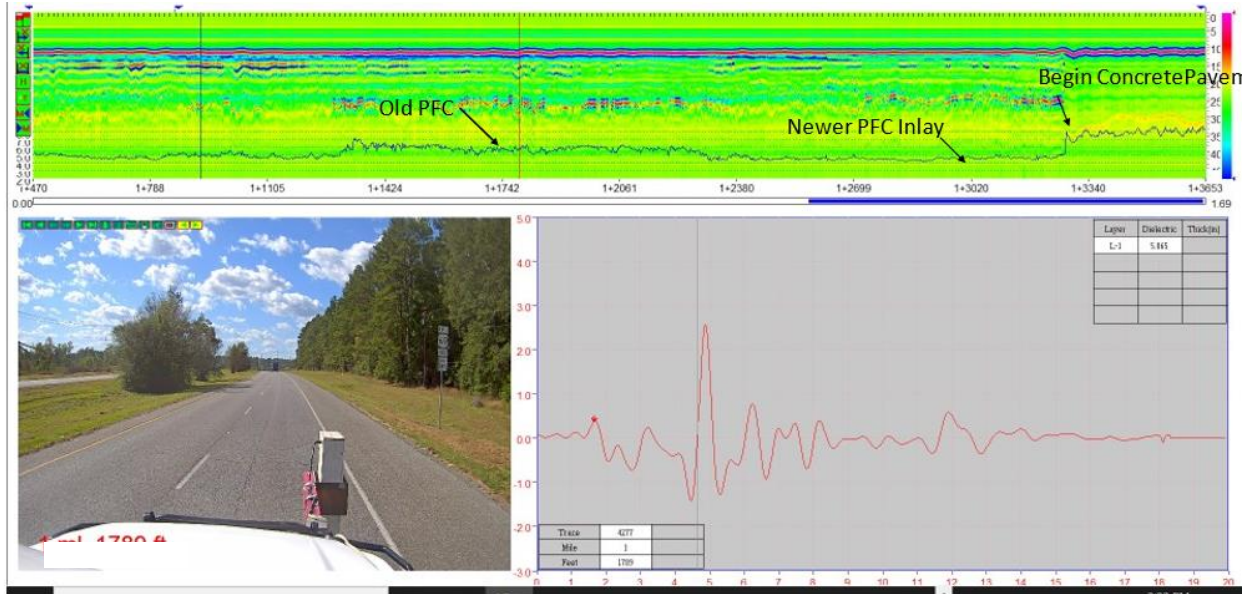
Figure 54. GPR data for right lane of US 69.

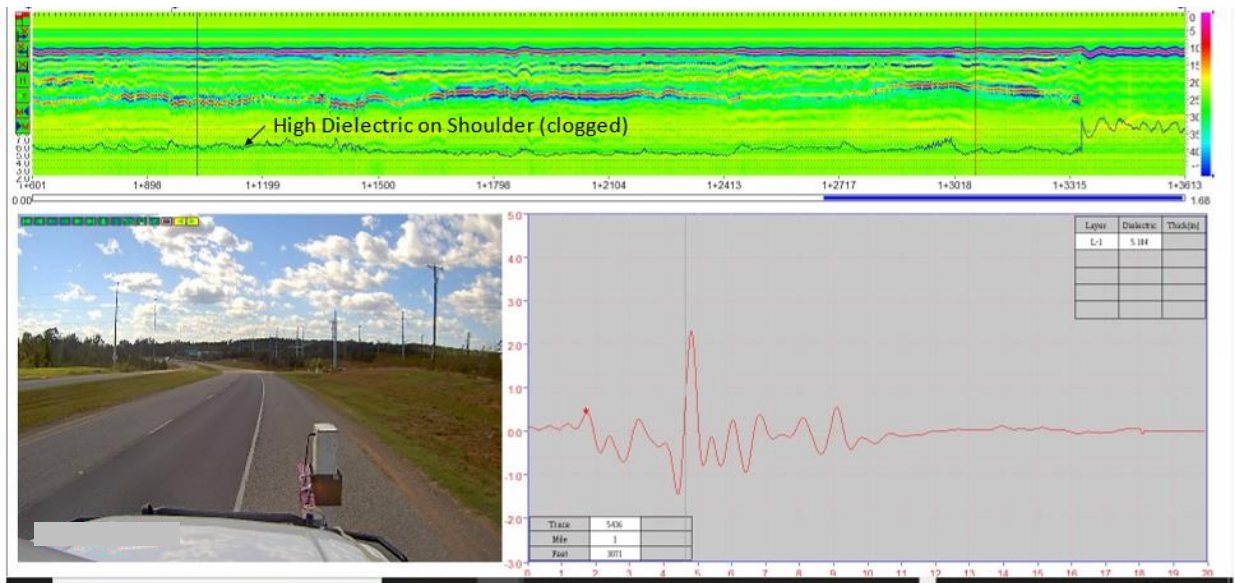
Figure 55. GPR data for shoulder of US 69.

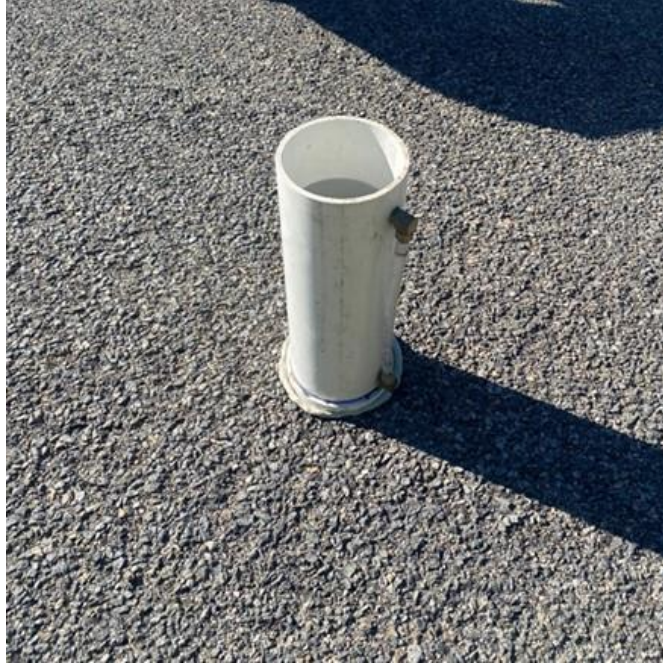
Figure 56. No water flowing in old PFC.

To verify these findings, the Lufkin District provided traffic control for the researchers to conduct field water flow tests and to take cores of the PFC pavement. The older PFC was not draining. At 180 seconds, as shown in the photo in Figure 56, if there was still no water flowing, the test was discontinued. The newer inlaid PFC patch performed better in terms of drainability, and these field tests confirmed the GPR data. A schematic of the test section layout and locations of field water flow tests along with results is shown in Figure 57.

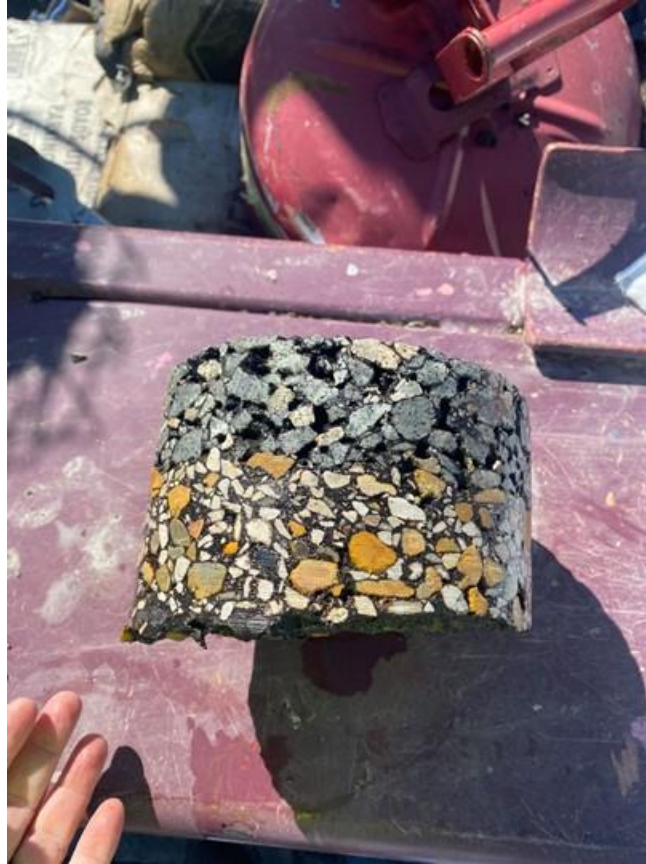
Figure 58. Core from US 69 showing PFC bonded to underlying HMA.

Cores were also taken of the old PFC and the PFC inlaid patch. The PFCs were well bonded to the underlying HMA layer (Figure 58). The PFCs did not ravel or disintegrate from the coring operation.

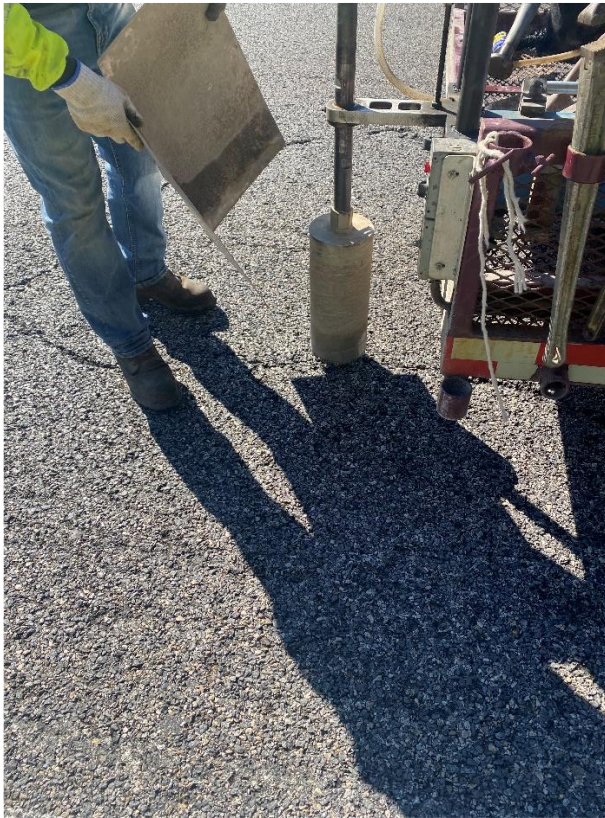
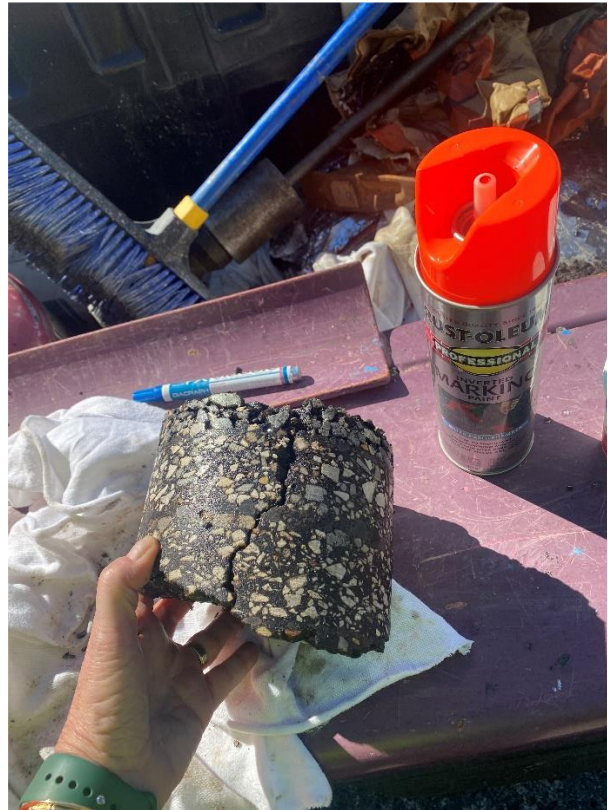
A core was also taken over one of the cracked areas of the PFC to determine if the crack was coming from underneath or if it originated in the PFC. Figure 59 shows that the crack originated in a lower layer; however, when it reflected through to the PFC, there tended to be raveling around the crack edges, making the crack more open.

Figure 59. Coring on US 69: (a) coring rig, and (b) core acquired over cracked area of the pavement.

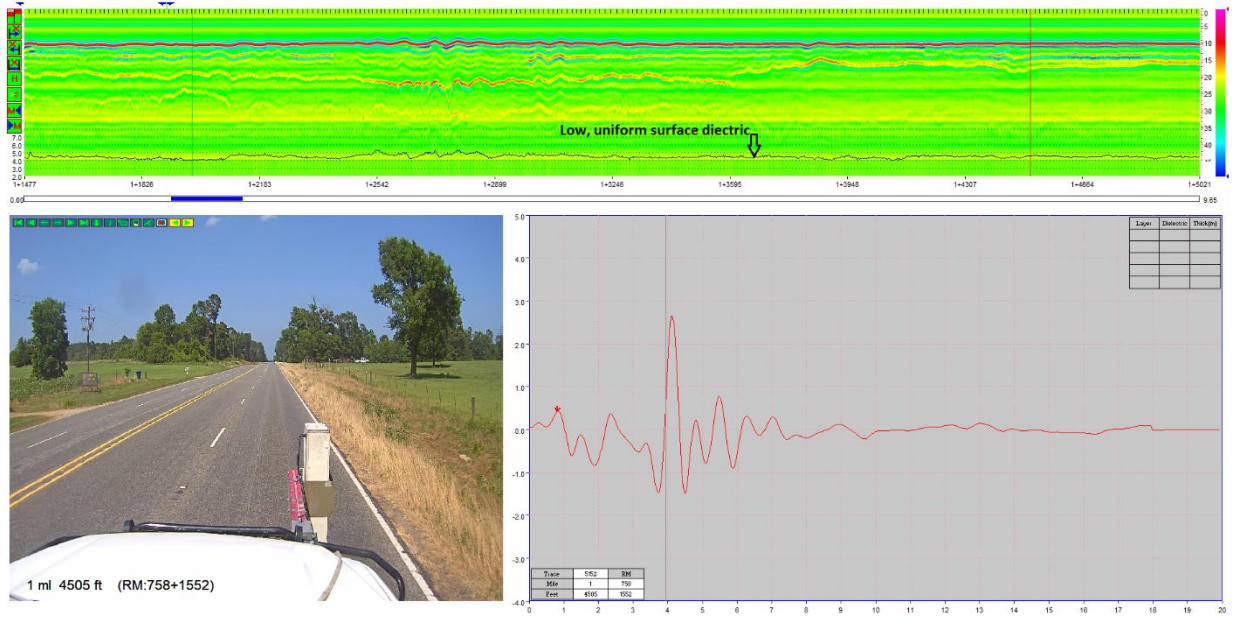
The location of this PFC was on SH 7 from SH 96 to Mt. Herman. This PFC was performing well but was exhibiting some minor transverse and longitudinal cracking. There was no indication of significant raveling. GPR data are presented in Figure 60 and Figure 61. Based on the low and uniform dielectric shown in these figures, the PFC appeared to be draining.

Figure 60. SH 7 PFC eastbound outside lane.

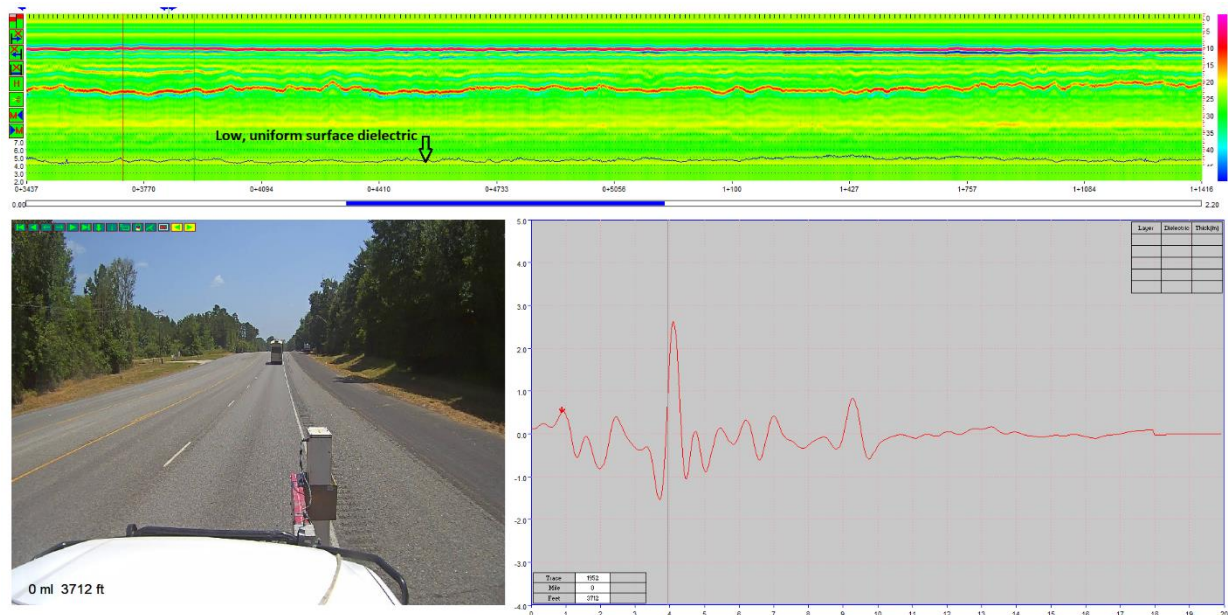
This PFC was located on US 59 north, beginning at the cloverleaf intersection of SH 84 and US 59 and going north to the county line about 4 mi. This PFC also had a low, consistent dielectric around 5, indicating that it was still draining, as shown in Figure 64.

Figure 64. GPR data on US 59 near Tenaha (northbound outside lane).

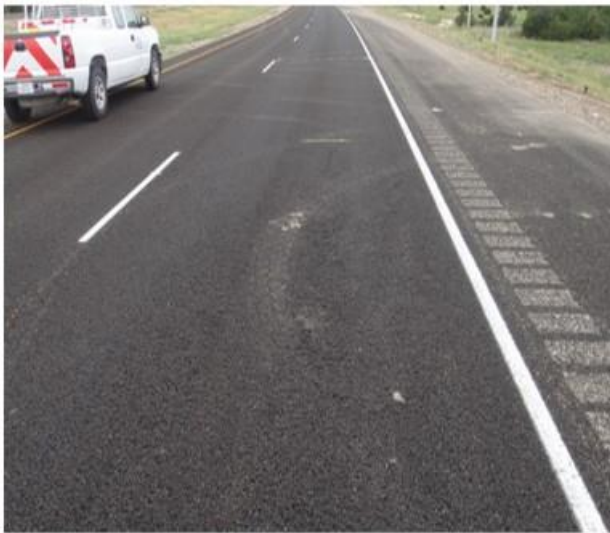
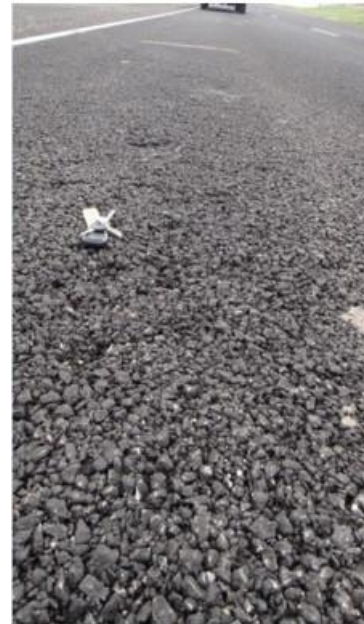
In 2014, the Austin District constructed a PFC on SH 195 (new construction) near Florence. Prior to opening to traffic, the PFC started to exhibit potential signs of raveling. Even turning a pickup truck tire on the mix caused raveling. Also, the mix looked very aged and oxidized (see Figure 65 and Figure 66). The exact cause of the excess wear was not determined, but this construction occurred when recycled oil engine bottoms were first being identified in asphalt, along with their negative effects on HMA.

Figure 65. SH 195 PFC in 2014: (a) overview of the signs of pavement distress before opening to traffic, and (b) closeup view of the oxidation and raveling distress.

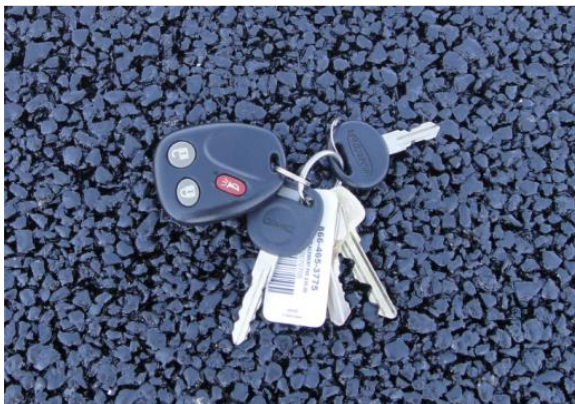
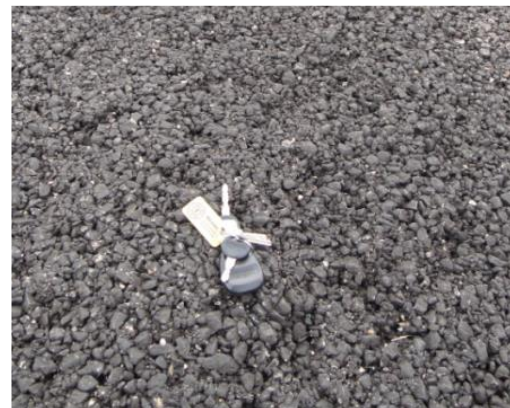
Figure 66. Comparison of typical new PFC to the SH 195 PFC mix: (a) typical new PFC; (b) SH 195 new PFC.

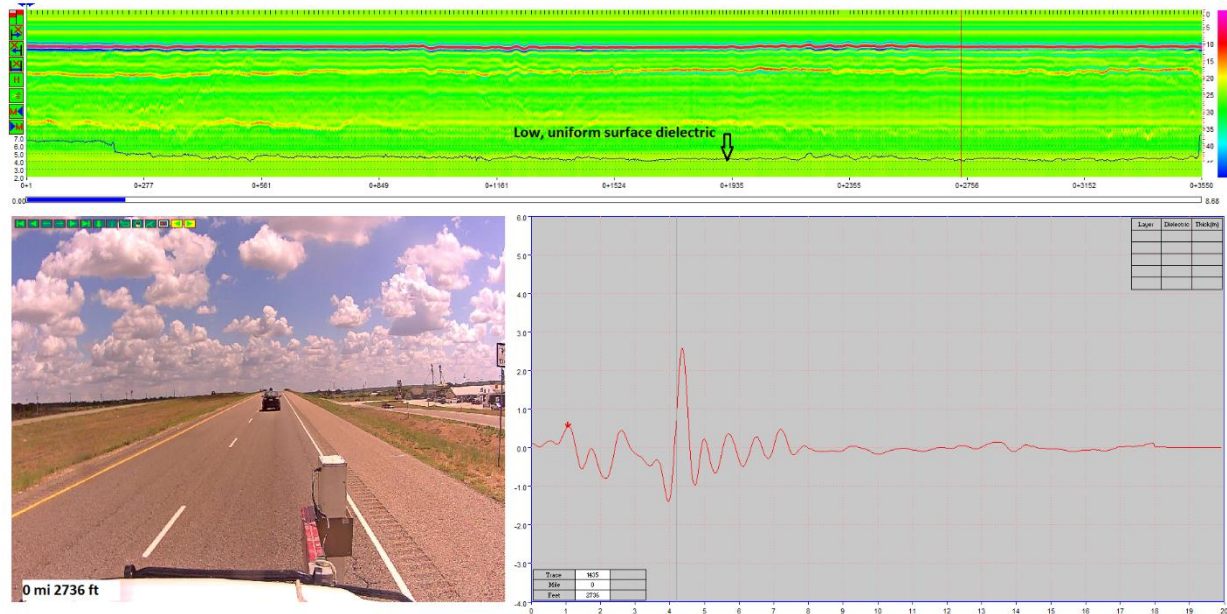
TTI collected GPR and HD video in August 2022 (8 years later), as shown in Figure 67. While the PFC is showing some signs of raveling and some cracking, it has performed remarkably well given initial concerns.

Figure 67. GPR data for SH 195 collected in August 2022.

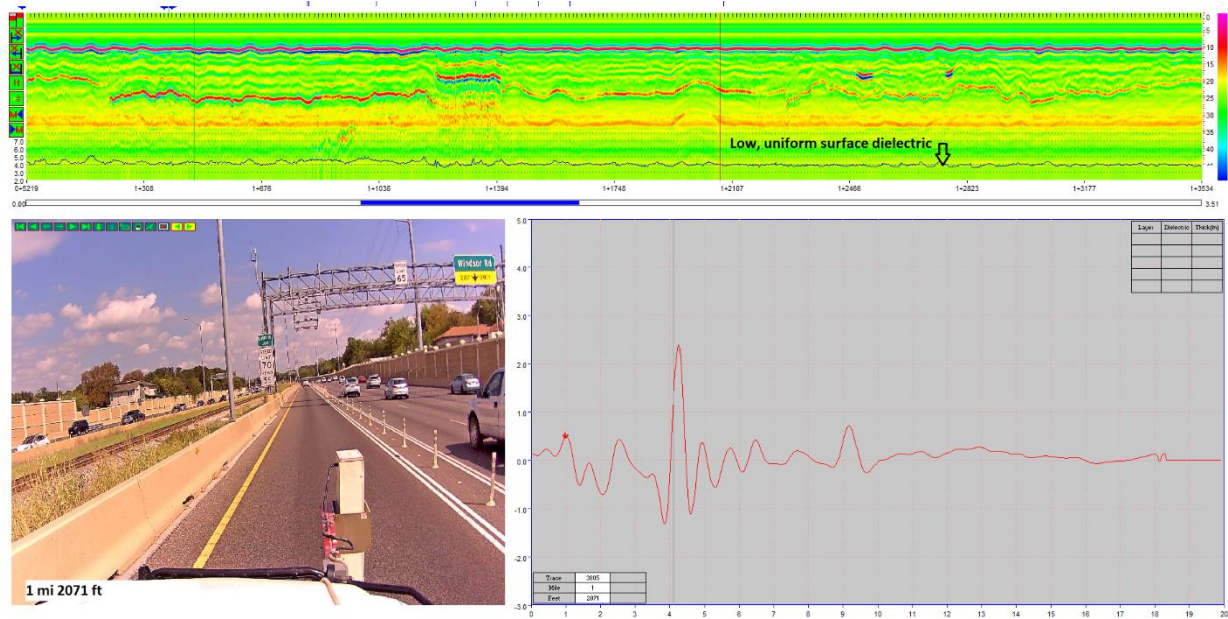
Testing before and after fog seal included skid, GPR, and water flow. The research team also collected GPR data on the test section in October 2022 prior to placement of the fog seal. Some of these data are shown in Figure 68. The video shows the surface to be in good condition, and the surface dielectric is low and consistent, indicating good drainability.

Figure 68. GPR data on MoPac.

As discussed in Chapter 5, TTI collected GPR data on the test section in October 2022 prior to placement of the fog seal. As shown in Figure 68, the surface at that time was in good condition, and the surface dielectric was low and consistent, indicating good drainability.

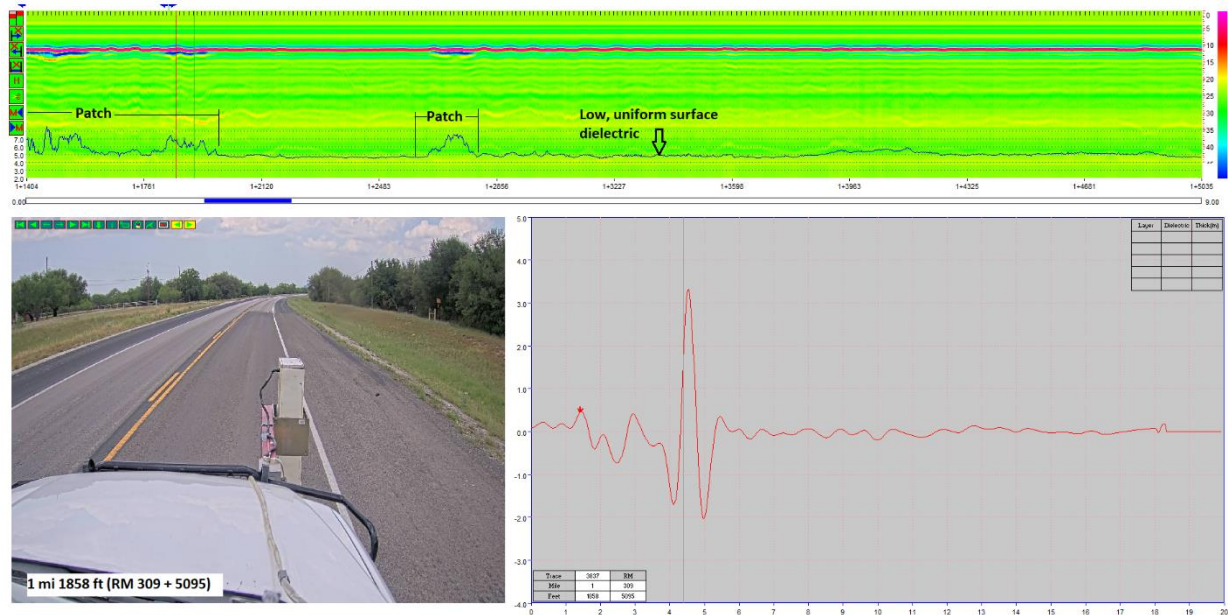
In 2012, the Brownwood District placed a fine PFC on US 183 south of Breckenridge. This section of roadway had a surface treatment exhibiting some flushing, which is why a PFC was selected as the overlay. In 2020, the district applied a frictional asphalt surface preservation treatment (Onyx, SS 3028) to this PFC to extend its life (Figure 69 and Figure 70). After a couple of years in service, the Onyx surface was almost completely worn off.

Figure 69. GPR data on US 183 south of Breckenridge.

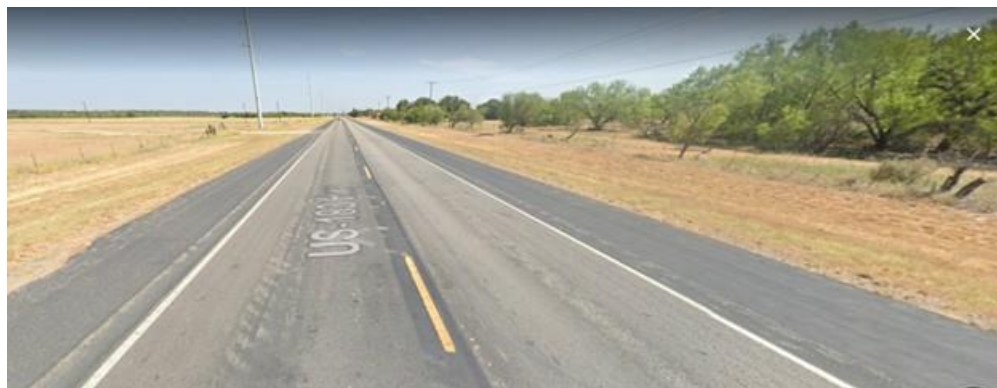
Figure 70. Condition of US 183 PFC from July 2022, Google Maps.

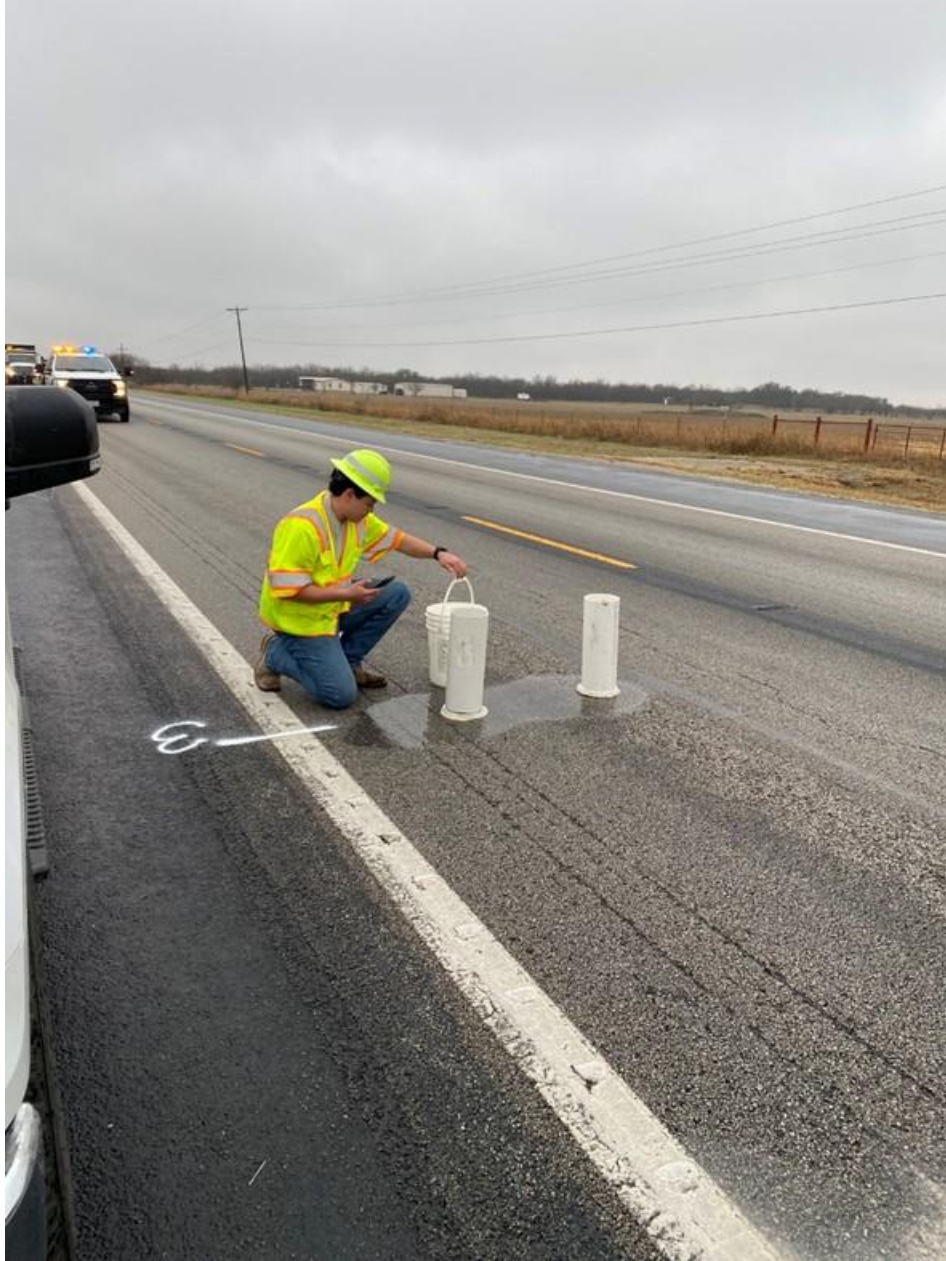
In March of 2023, TTI researchers conducted field testing on this section of roadway. Five locations were selected for water flow testing and for coring. Water flow tests were conducted in the outside wheel path and between the wheel paths, as shown in Figure 71. For the most part, the PFC was clogged, but there were a few locations where the PFC could be taking in water. The results of the water flow tests are shown in Figure 72.

Figure 71. Water flow testing.

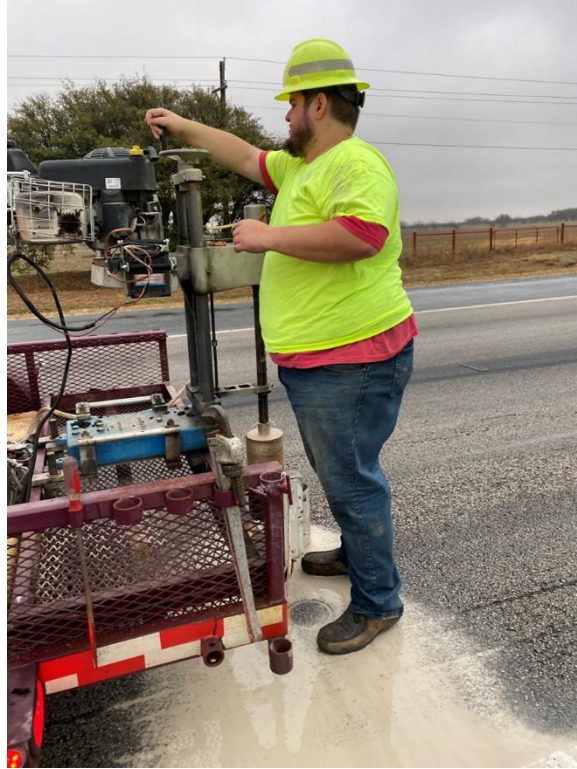
Cores were also taken at each of these five locations and brought back to TTI's laboratory for further evaluation. The coring operation is shown in Figure 73. A close-up of the core is shown in Figure 74. The cross section of the pavement consists of a flex base with a seal coat and then the fine PFC on top of the seal coat. The fine PFC is very thin (less than 1 inch thick).

Figure 73. Coring of fine PFC.

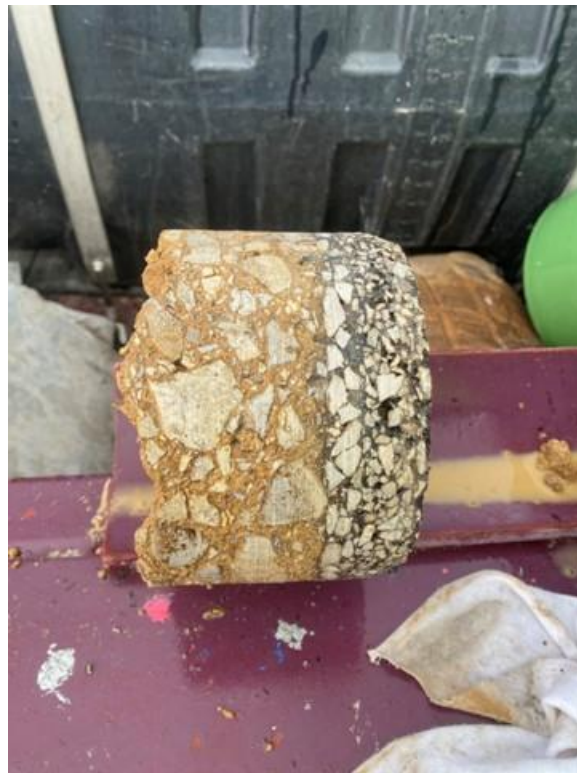
Figure 74. Close-up of US 183 PFC core.

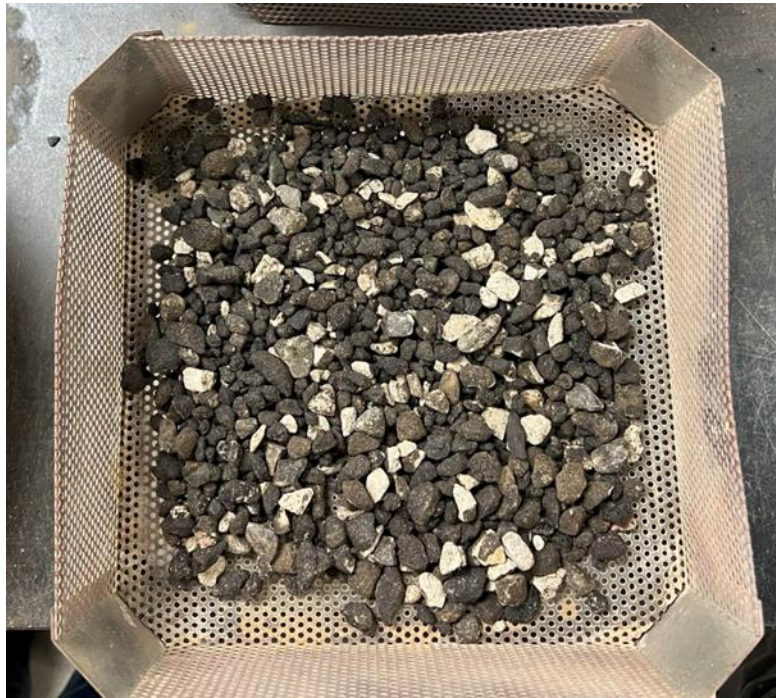
virgin binder content to accommodate the RAP while keeping the target gradation and OBC the same as the virgin mix design. Three replicate RAP samples were subjected to the ignition oven, and the resulting average RAP binder content was 3.39 percent. Therefore, the virgin binder content in the PFC mix was reduced from 6.2 percent to 5.86 percent to account for the binder contribution from the RAP. One of the samples of RAP after being subjected to the ignition oven is shown in Figure 76. Next, the material was washed and sieved to obtain the RAP gradation. The adjusted mix design with RAP is also shown in Appendix A.

Figure 76. RAP sample after the ignition oven.

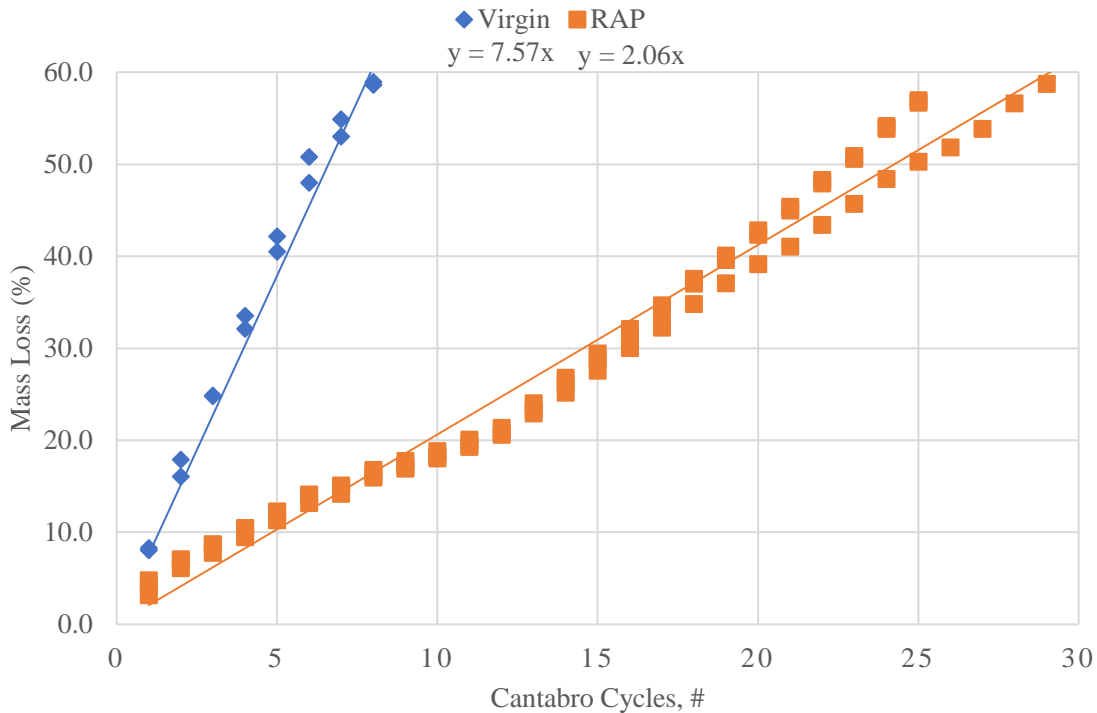
The effect of RAP on durability is illustrated in Figure 77. Each curve represents the average of two or three specimens. The average percent AV of the virgin specimens measured via dimensional analysis was 21.7 percent, while the average percent AV of the RAP specimens was 22.0 percent, which makes them comparable. Trendlines are added to each dataset with a forced intercept (0,0) to assess the degree of degradation for each PFC mix type. This is useful because

if only one Cantabro cycle were used, as prescribed in the current standard test method Tex-245-F, both virgin and RAP mixes would show acceptable mass loss with values below 10 percent (maximum Cantabro loss for PFC specimens per current TxDOT specifications, Item 342, is 20 percent). However, when looking at the trend with multiple Cantabro cycles, it is apparent that the degradation of the virgin mix is more accelerated than that of the PFC mix, reaching 60 percent mass loss in about eight Cantabro cycles, while the RAP mix takes about 29 cycles to reach that same mass loss value. This result is likely because the RAP mixes are stiffer and less prone to abrasion.

Figure 77. Cantabro loss degradation curves for virgin and RAP specimens.

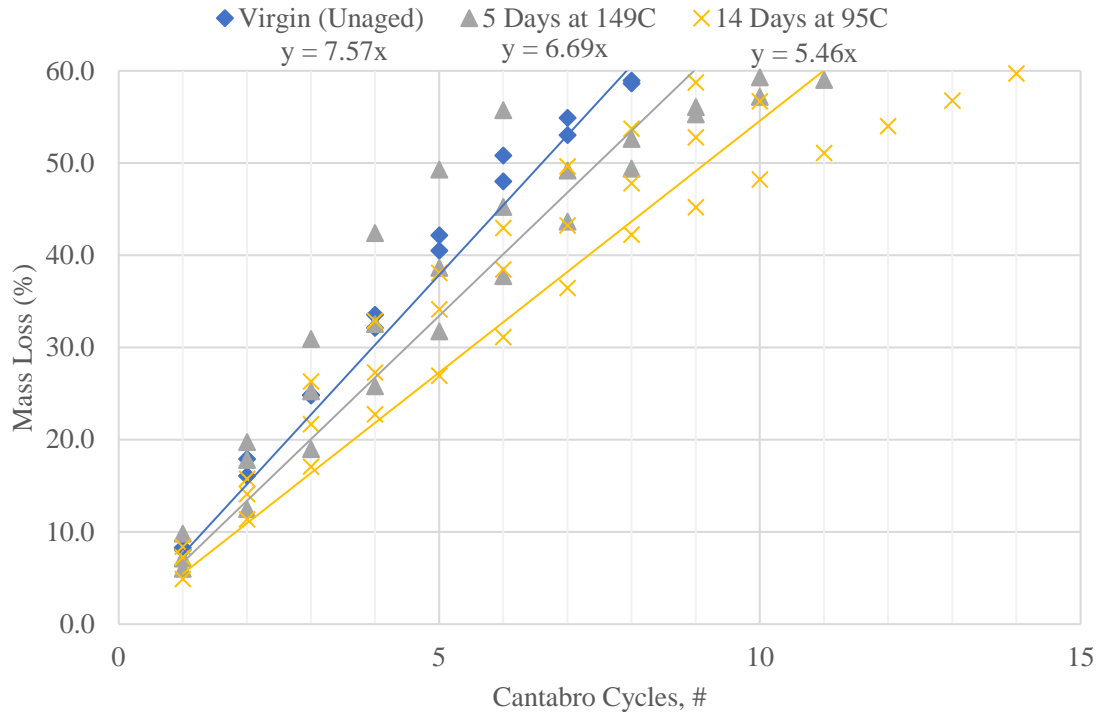
The effect of aging at durability is shown in Figure 78. The average AV of each set of specimens was 21.7 percent for unaged (virgin), 22.4 percent for aged for 5 days at 149°C, and 22.5 percent for aged for 14 days at 95°C. Two aging protocols were selected: a shorter protocol at a higher temperature and a longer protocol at a more moderate temperature. It is apparent that aging did not have a significant impact on the Cantabro loss degradation curve; the mix stiffened with aging, which slowed the rate of mass loss, but the effect was not as significant as what was observed when 10 percent RAP was added to the mix (Figure 77). The difference in slope was about 1.0 between unaged and 5 days aging at 149°C and between 5 days aging at 149°C and 14 days aging at 95°C, which corresponded to 8, 9, and 11 Cantabro cycles to reach 60 percent mass loss for the virgin, 5 days aging at 149°C, and 14 days aging at 95°C, respectively.

Figure 78. Cantabro loss degradation curves for unaged and aged specimens.

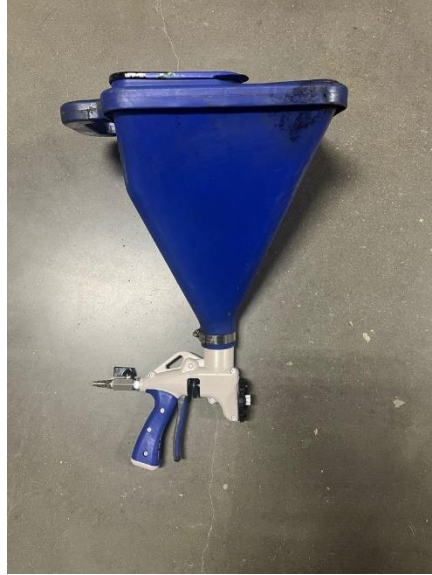
As previously mentioned, two types of rejuvenators, CMS and CSS-1H, were applied to the Cantabro specimens with RAP and the ones that were prepared with aged loose plant mix. The application rate was 0.10 gal/yd² for both rejuvenators. The rejuvenators were applied using a Sharpshooter 2.1 drywall hopper gun sprayer like the one shown in Figure 79. To determine the approximate amount of rejuvenator to be applied by the sprayer, a wooden sheet was used. It was weighed without any rejuvenator on it, resulting in a weight of 279.1 grams. Once eight passes of the rejuvenator were applied, the weight on the sheet was 356.2 grams. The approximate amount of material that the device applied in each pass was determined using Equation 2.

Figure 79. Sharpshooter drywall hopper by Marshalltown.

Four slabs with dimensions of 12.6 inches long \times 10.2 inches wide were prepared to evaluate the effect of two types of rejuvenators and two application rates on the surface friction of PFC mixes. The slabs were prepared with an average 1-inch thickness and target AV content of 20 percent. Molding of the slabs was done using the asphalt roller compactor. Once they were cast, the four slabs underwent polishing and friction tests to obtain a stable or plateau friction value. A plateau in initial friction was reached after approximately 500 cycles in the three-wheel polisher. At that point, the rejuvenators were applied to the surface of each of the slabs. The selected rates for each rejuvenator were 0.1 and 0.14 gal/yd². The rejuvenators were applied to the surface of the slab using a Sharpshooter 2.1 drywall hopper gun sprayer (see Figure 79).

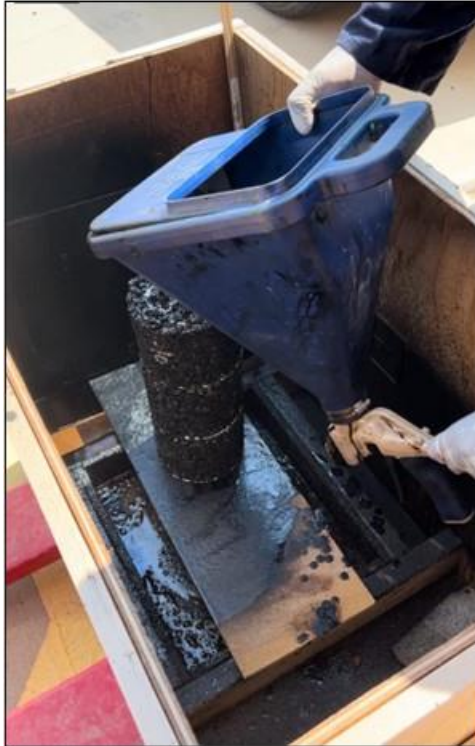
To spray the material over a larger area, three specimens were stacked on top of each other. The area to be treated was calculated using Equation 3 and considering that the dimensions of each specimen were 6-inch diameter by 4.6-inch height. Note that the area was divided by two because half of the whole longitudinal area was exposed per each pass, as shown in Figure 80:

Figure 80. Cantabro specimens stacked rejuvenator application.

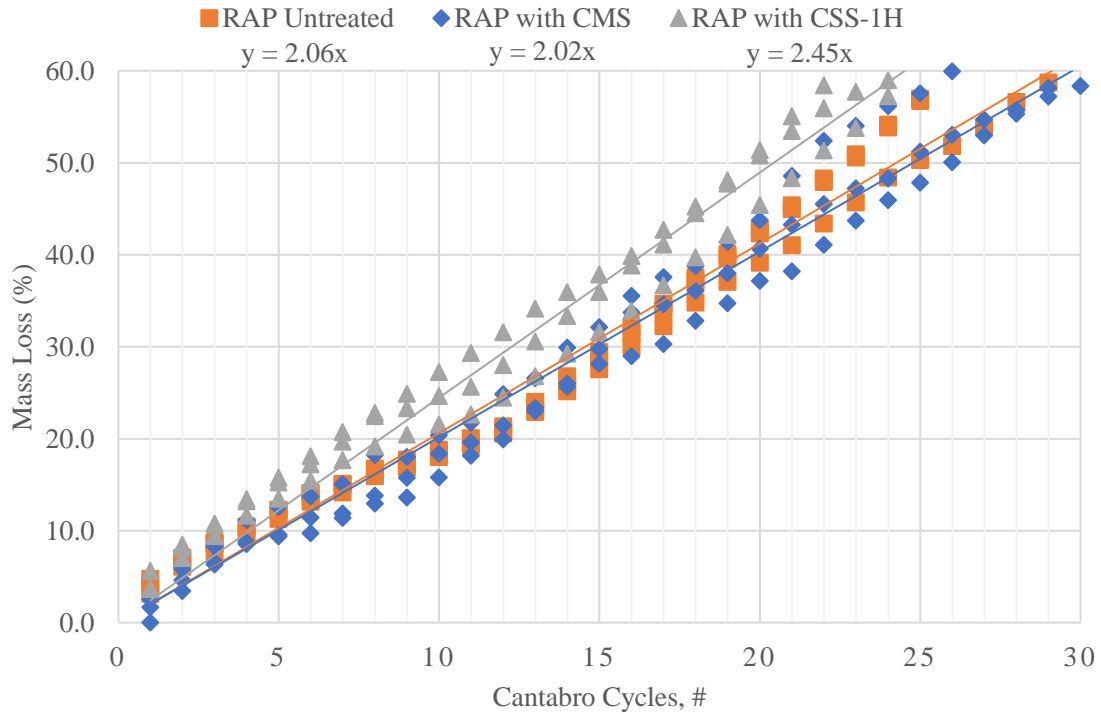
The effect of the rejuvenator on RAP is shown in Figure 81. Each dataset represents the results of three replicate specimens. The average AV of each set of specimens was 22.0 percent for RAP untreated, 23.6 percent for RAP with CMS, and 22.1 percent for RAP with CSS-1H. The results show minimal effect from the rejuvenator on the RAP specimens, with slopes of 2.06 for untreated RAP, 2.02 for RAP with CMS, and 2.45 for RAP with CSS-1H.

Figure 81. Cantabro loss degradation curves for untreated and treated RAP specimens.

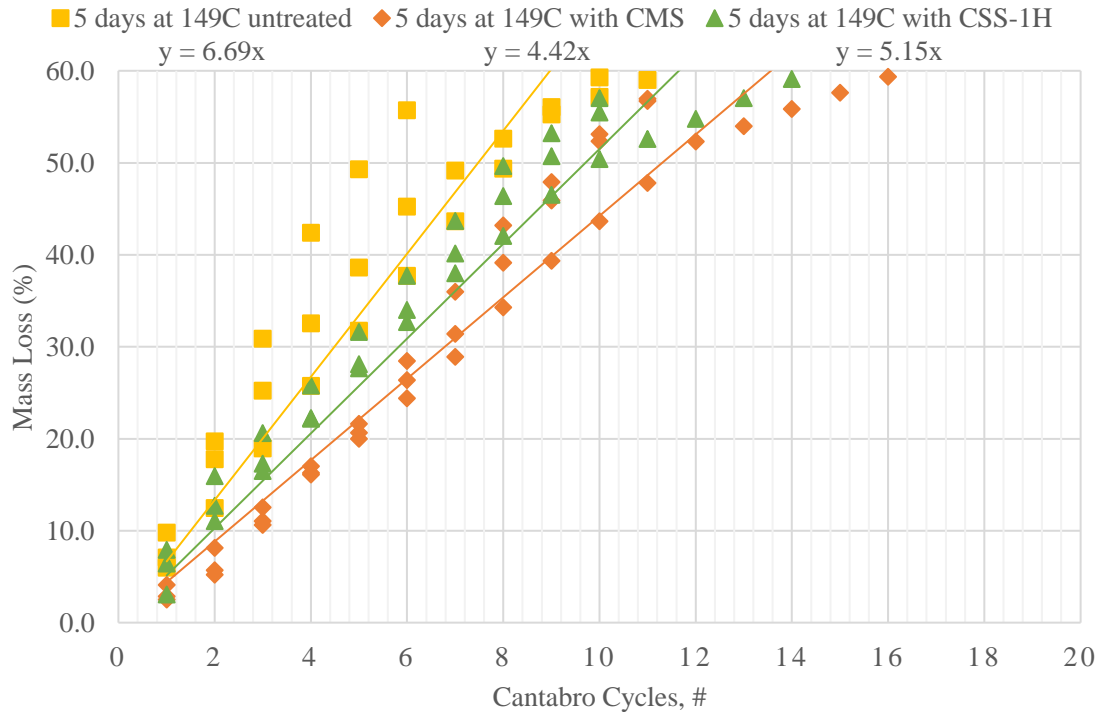
The effect of the rejuvenators on specimens aged for 5 days at 149°C is shown in Figure 82. The average AV of each set of specimens was 22.4 percent for untreated specimens, 23.9 percent for specimens treated with CMS, and 23.6 percent for specimens treated with CSS-1H. In this case, the rejuvenators did seem to have a positive effect on the aged specimens, reducing the rate of mass loss from a slope of 6.69 for the untreated specimens to 5.15 for the specimens treated with CSS-1H, and to 4.42 for the specimens treated with CMS. These values translated to 9 cycles to reach 60 percent mass loss for the untreated aged specimens, about 12 cycles to reach 60 percent mass loss for the aged specimens treated with CSS-1H, and about 14 cycles to reach 60 percent mass loss for the aged specimens treated with CMS.

Figure 82. Cantabro loss degradation curves for the untreated and treated specimens aged for 5 days at 149°C.

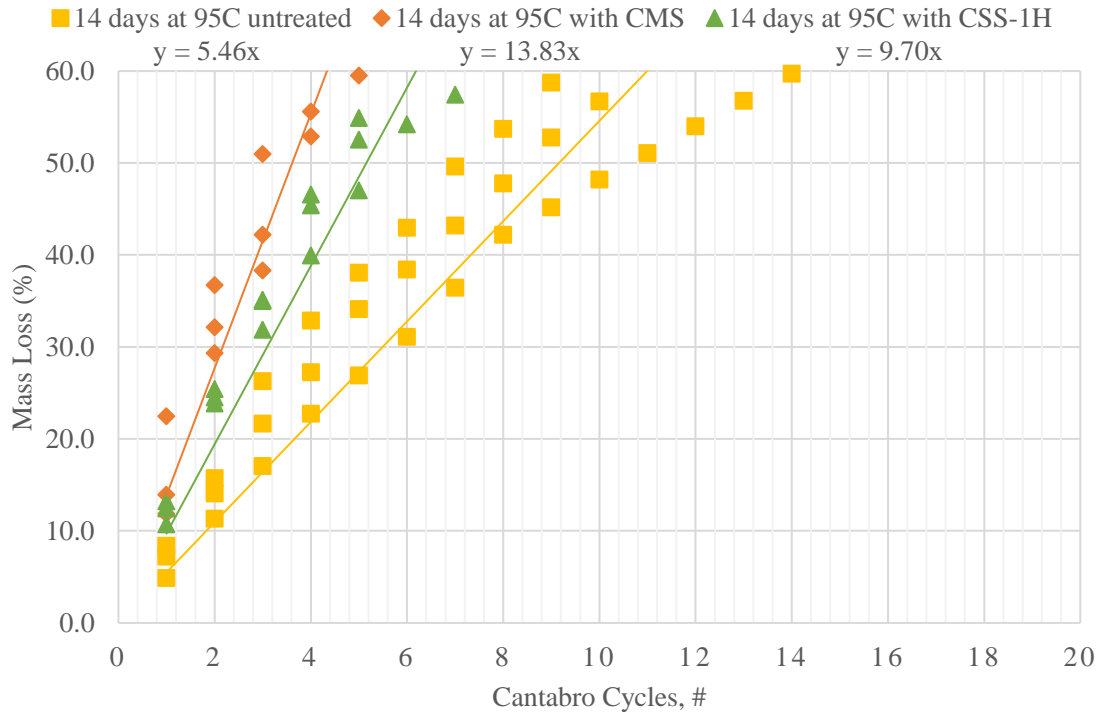
Last, the effect of the rejuvenators on specimens aged for 14 days at 95°C is shown in Figure 83. The average AV of each set of specimens was 23.9 percent for untreated specimens, 23.5 percent for specimens treated with CMS, and 22.3 percent for specimens treated with CSS-1H. In this instance, the application of the rejuvenators had the opposite effect as the one observed for the specimens aged 5 days at 149°C. For both rejuvenators, the rate of mass loss increased from a slope of 5.46 in the case of the untreated aged specimens to a slope of 9.7 for the specimens treated with CSS-1H, and to 13.83 for the specimens treated with CMS. The initial mass loss (i.e., after one Cantabro cycle) was 12.1 percent for specimens treated with CSS-1H and 16.1 percent for specimens treated with CMS, which is a higher mass loss compared to other types of specimens tested with Cantabro. This behavior is contrary to expectation, and further investigation of the potential causes would be needed before determining the reason behind these trends.

Figure 83. Cantabro loss degradation curves for the untreated and treated specimens aged for 14 days at 95°C.

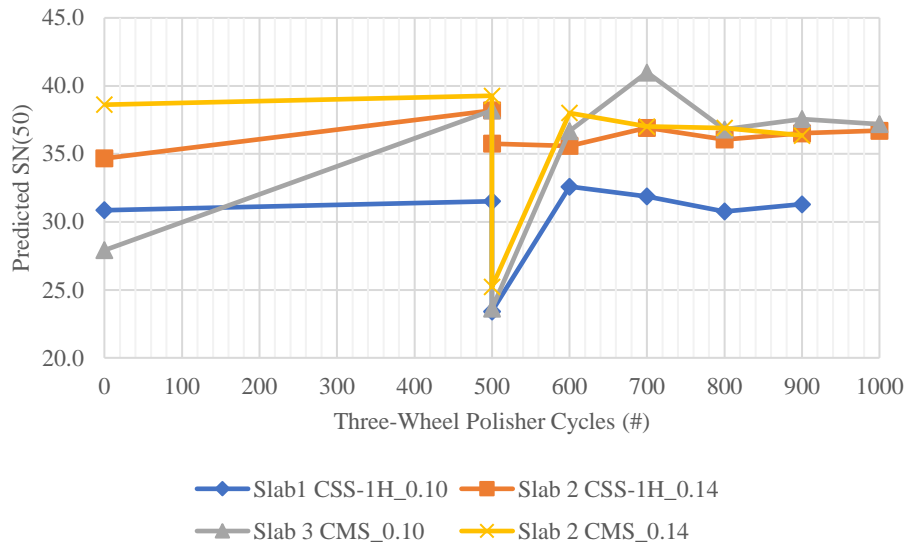
Figure 85. Skid number for different rejuvenators and application rates.

The results can be observed in Figure 85.

Regarding skid resistance, the research team analyzed SN(50) considering variations in rejuvenator type and application rate. The skid numbers calculated through friction testing were compared to understand the influence of material and application rate on skid resistance. The following observations were made based on Figure 85.

Similarly, among the slabs treated with CMS, Slab 2 treated with an application rate of 0.14 gal/yd² had a slightly higher average SN(50) of approximately 37.19 compared to Slab 3 treated with an application rate of 0.1 gal/yd², which had an average SN(50) of approximately 35.12. However, the difference was not as pronounced as what was observed for CSS-1H. This result suggests that while an increase in application rate may positively impact skid resistance, its effect might be less pronounced for rejuvenator type CMS.

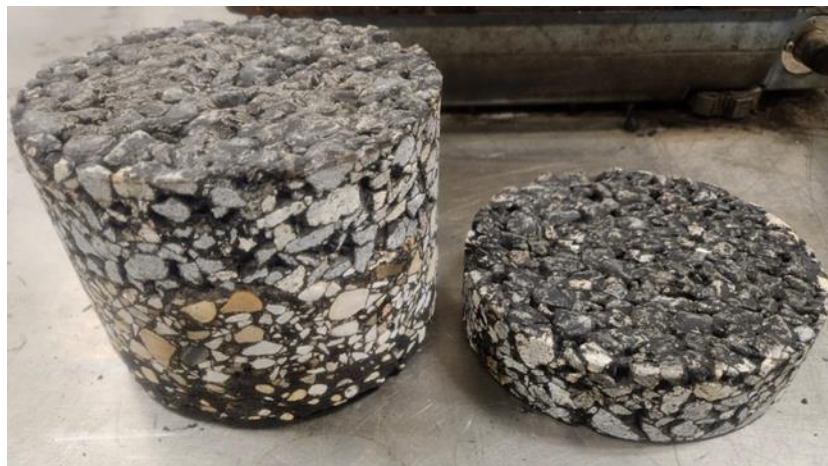
Figure 86. Lufkin core before and after saw cut.

The research team performed a permeability test on 6-inch cores collected from US 69 in Lufkin (Figure 51). The cores had a PFC layer on top of a dense-graded HMA. The research interest was to determine the permeability of the PFC surface layer; therefore, the cores' dense-graded part was removed by a saw cut. The remaining PFC layer, about 1.5 inches thick (Figure 86), was used for measuring water permeability via the Florida method, FM 5-565. The research team tested two PFC cores from Lufkin US 69 obtained from the newer PFC inlay (Figure 57). Cores obtained from the older PFC were too thin and could not be tested.

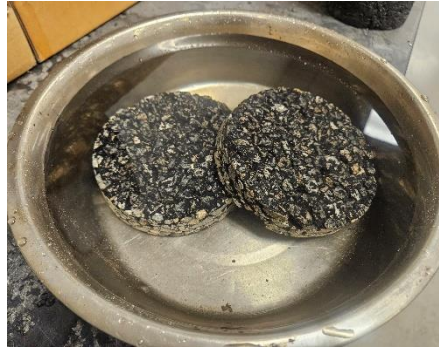
Figure 87. Lufkin cores being saturated under water.

According to FM 5-565, before the cores are subjected to the permeability test, they must be fully saturated. The cores were placed under water for over 3 hours to attain complete saturation conditions (Figure 87). Another way of achieving saturation is by subjecting the samples to 15 minutes of vacuum saturation.
