Design and Rehabilitation Strategies for Permeable Friction Course Pavements

Technical Report 0-7110-R1

TEXAS A&M TRANSPORTATION INSTITUTE
COLLEGE STATION, TEXAS

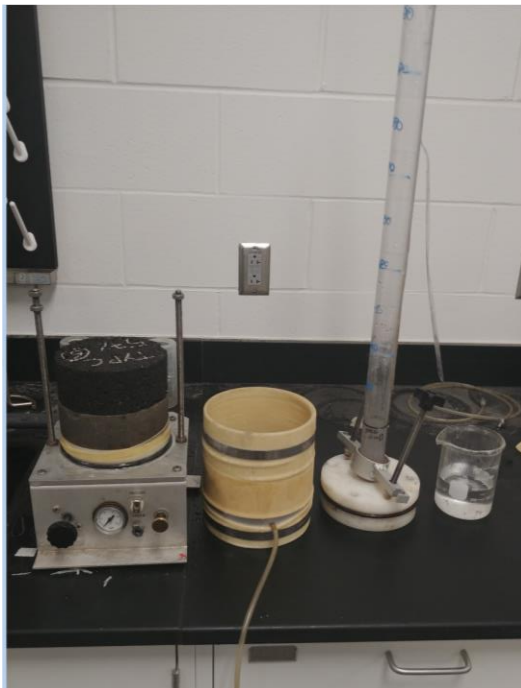
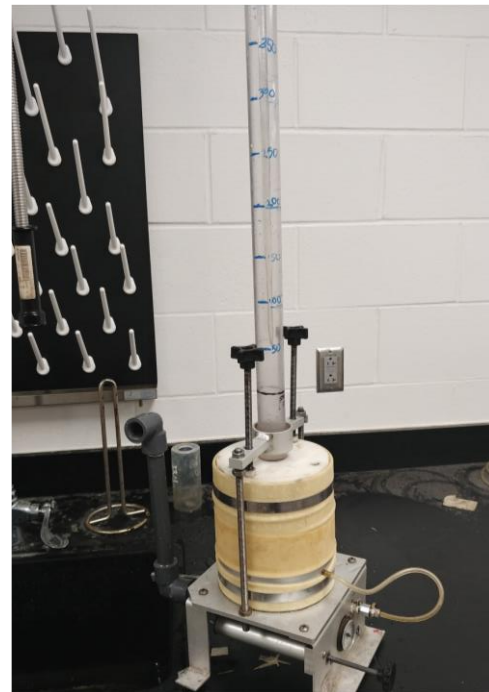
Figure 88. Florida permeameter: (a) specimen setup on top of porous stone and equipment parts, and (b) equipment assembly during testing.

After soaking, the cores were placed on a porous pedestal plate at the base of the permeameter (Figure 88). A housing sealing tube and a graduated cylinder were assembled to cover the pedestal and the test cores according to the FM 5-565 protocol (Figure 88). Then water was added to the upper mark of the graduated cylinder (500 ml mark). Before releasing the water (through the bottom orifice), the operator checked for leaks or water loss due to under saturation. The water was then released, and the time taken to drop from the 500 ml mark to the 0 ml mark was recorded.

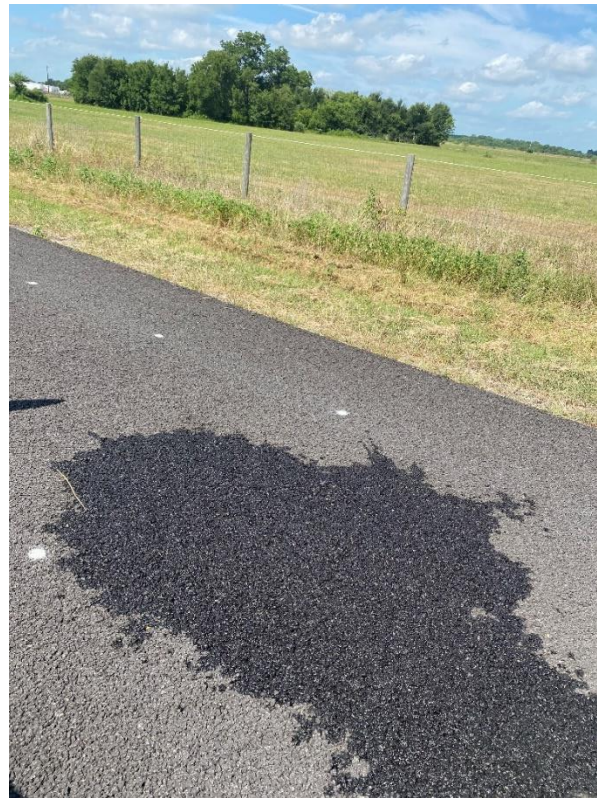
Figure 92. Water poured onto the PFC surface.

Researchers conducted field testing to determine if this was an effective test to measure the presence of moisture in a PFC. Testing was performed on a very dry PFC and at an air temperature of 95°F. The pavement surface was at TTI’s RELLIS Campus and is one of the surfaces used to calibrate profilometers. A 5-gal bucket of water was poured onto the pavement surface (Figure 92). The PFC was draining very well, and all the water penetrated the PFC within 5 seconds. The surface was then allowed to dry, which took about 10 minutes. Two types of moisture barriers were then duct-taped to the surface: a plastic sheet and roofing paper (Figure 93).

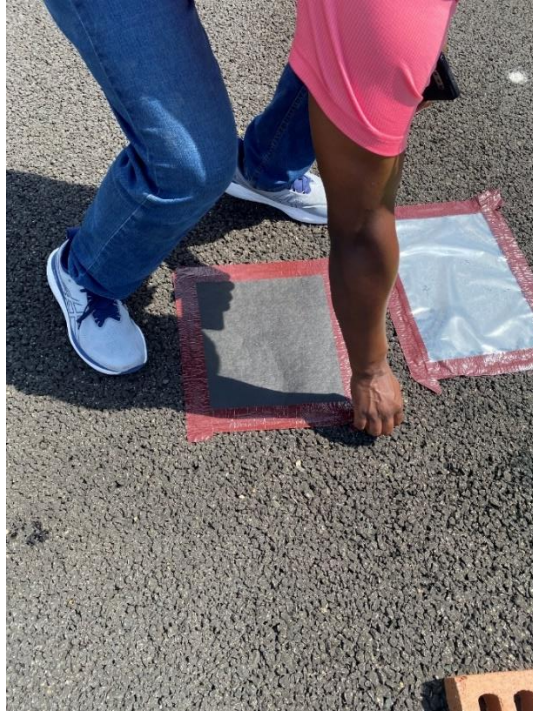
Figure 93. Roofing paper (left) and plastic sheeting (right) taped to the PFC surface.

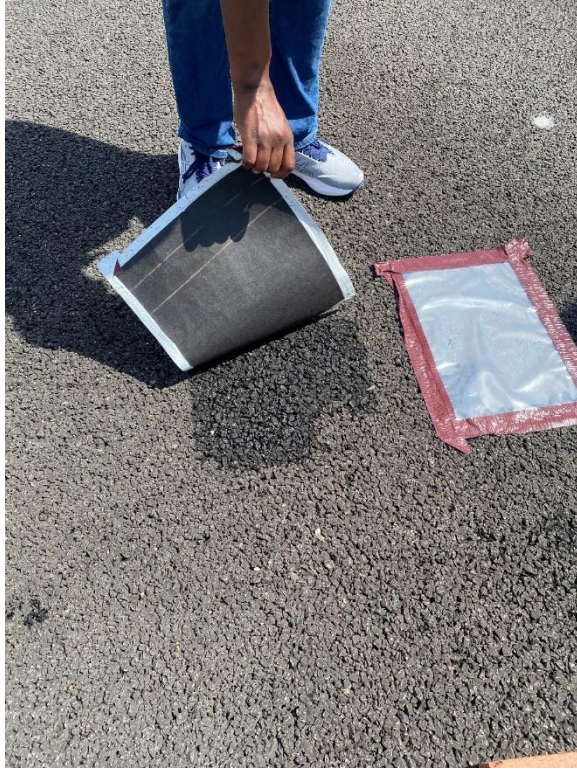
Figure 95. Moisture condensation on the underside of the roofing paper.

Within 5 minutes, moisture became visible on the underside of the plastic sheet, as shown in Figure 94. Some condensation was also observed under the roofing paper (Figure 95); however, it was much easier to see the condensation through the plastic as it began to appear. After 10 minutes, a significant amount of moisture was visible on the underside of the plastic, as shown in Figure 96, after it was removed from the pavement surface.

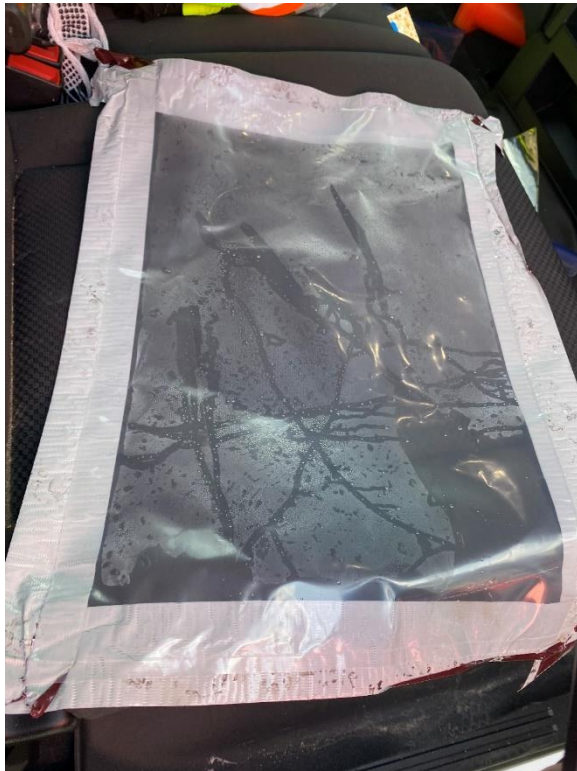
Figure 96. Plastic sheeting after removal from pavement surface after 10 minutes.

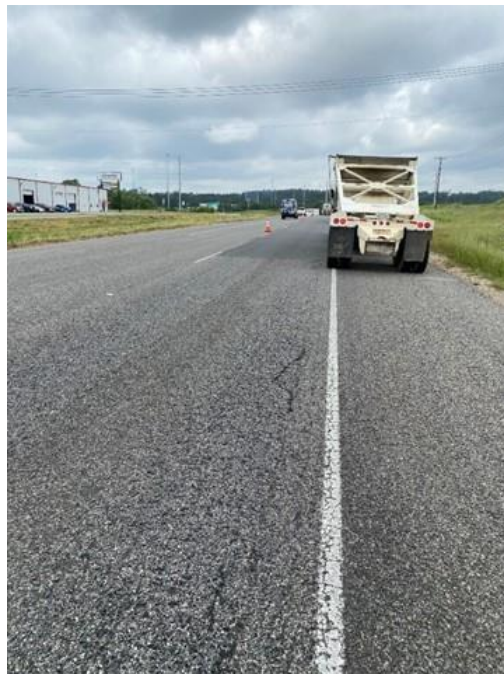
Figure 97. Newer PFC inlaid patch in the travel lane.

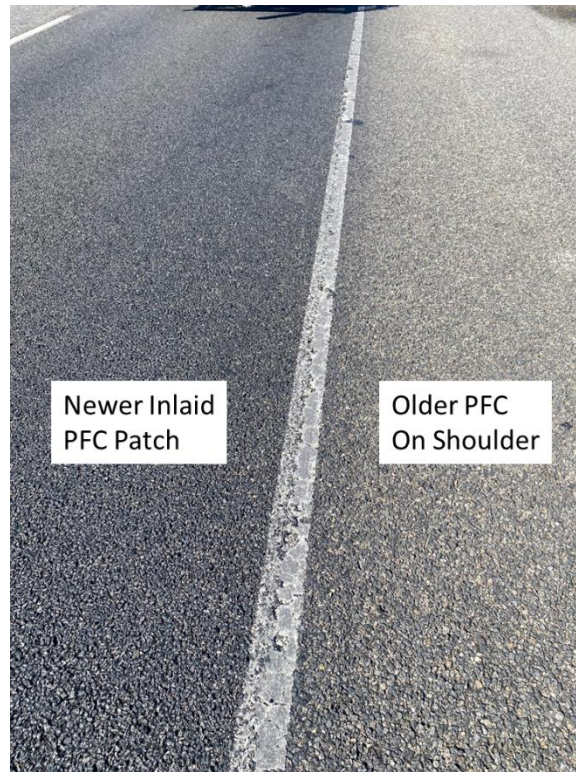
Figure 98. Close-up of newer PFC patch next to older PFC in shoulder.

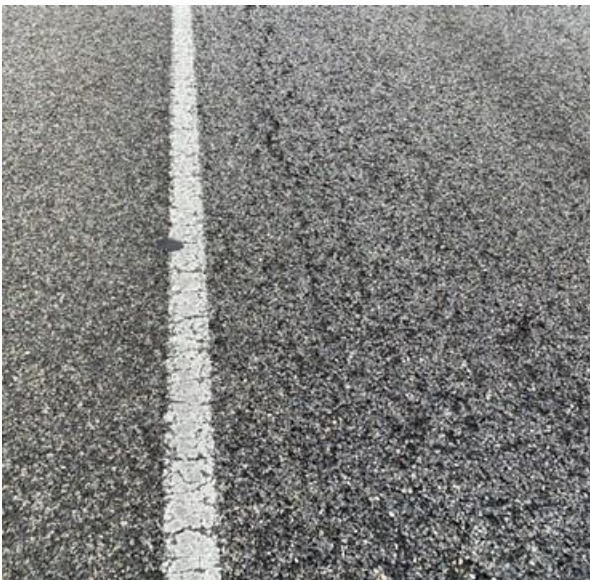
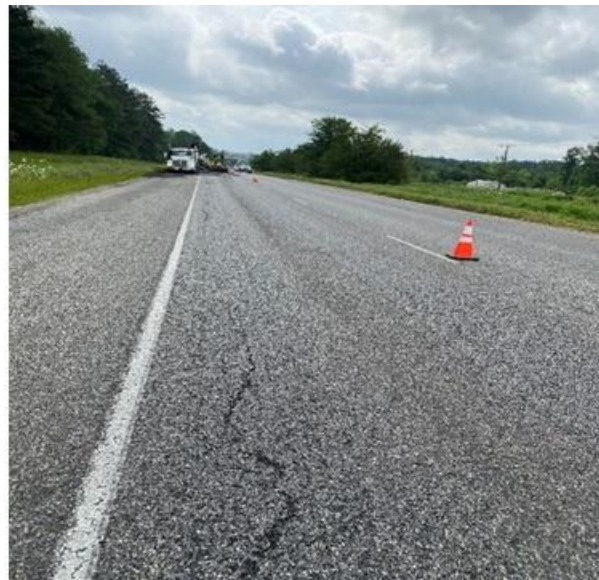
Figure 99. Typical distress shown in test section area of the old PFC: (a) raveling, and (b) cracking.

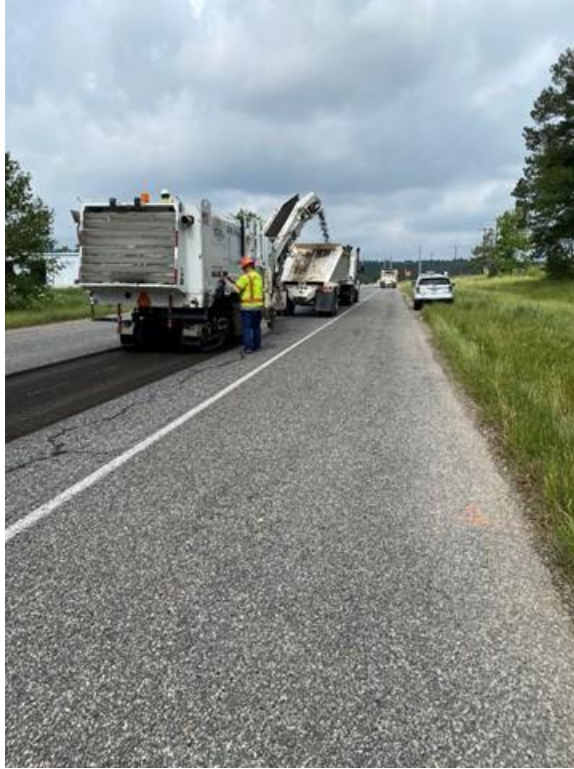
Figure 100. Milling the old surface to provide smooth transition to new overlay.

Since the test section consisted of a 2-inch overlay on an existing surface, construction began with milling the old surface at each end of the section to provide a transition to and from the new overlay (Figure 100). A non-tracking tack coat was then applied at a rate of 0.08 gal/yd² (Figure 101). Material was placed in windrows on the pavement surface ((Figure 102a) and picked up with a material transfer vehicle (Figure 102b) and moved into the laydown machine (Figure 103a). A steel-wheel roller was used to compact the mix using three vibratory passes and one static pass (Figure 103b).

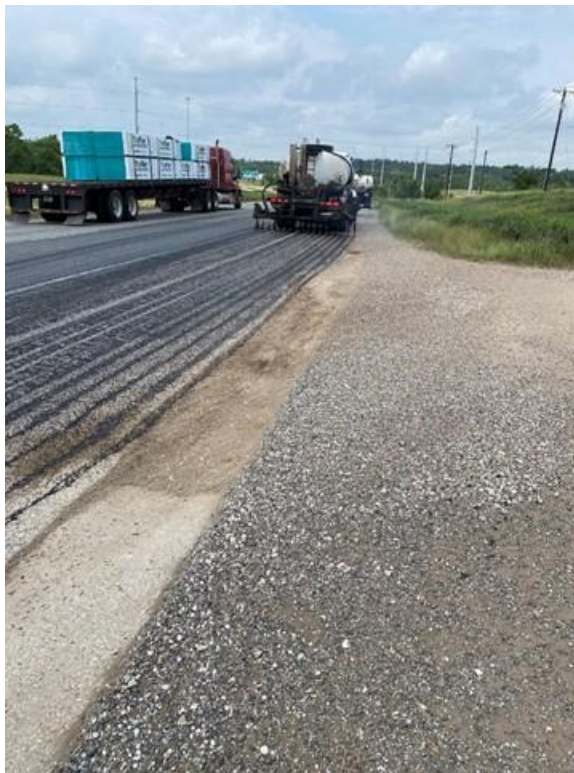
Figure 101. Non-tracking tack coat applied first to travel lane and then shoulder.

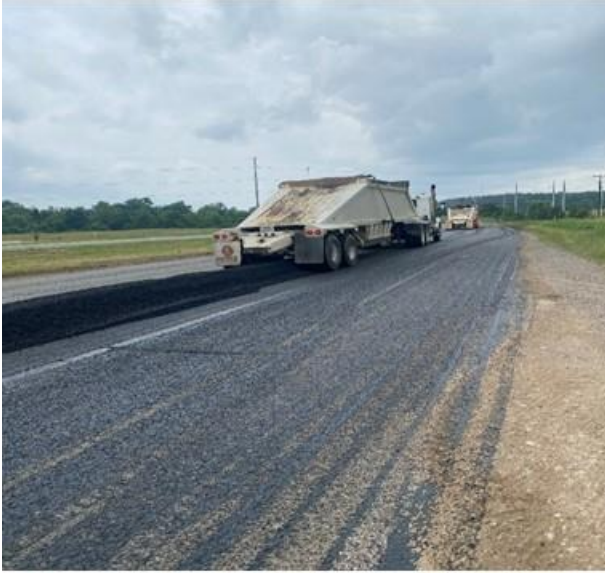
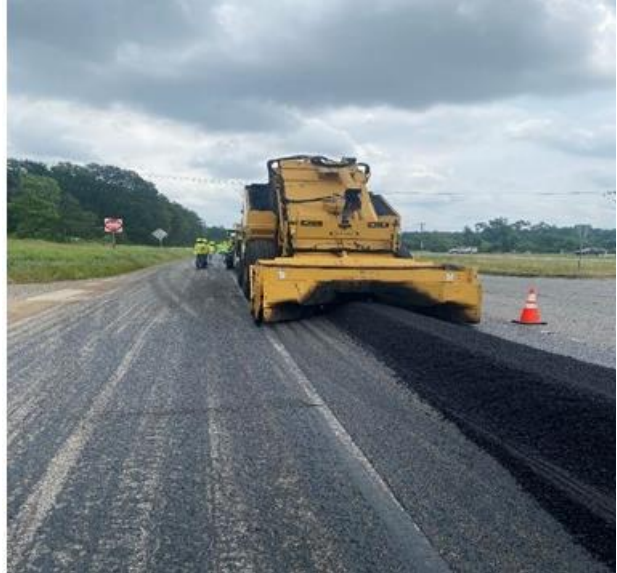
Figure 102. Superpave mix laydown: (a) windrows placing mix on the pavement surface, and (b) material transfer vehicle picking up the mix to move it to the laydown machine.

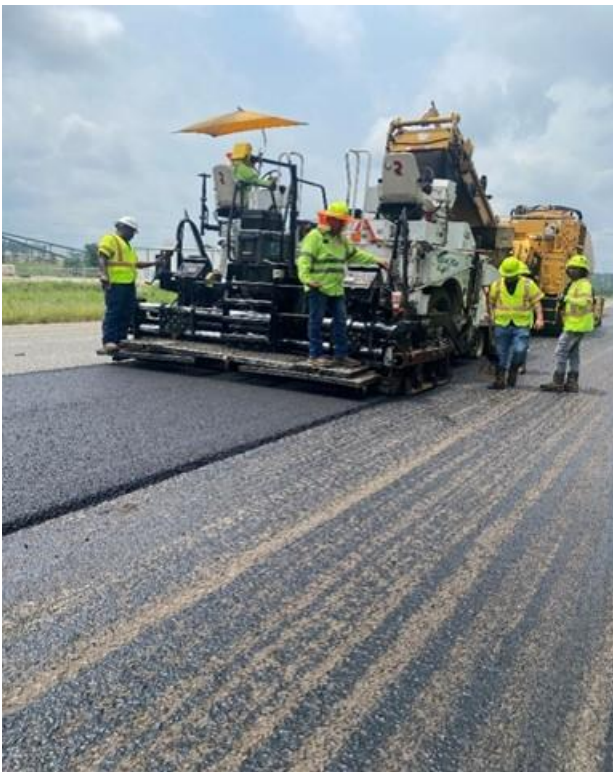
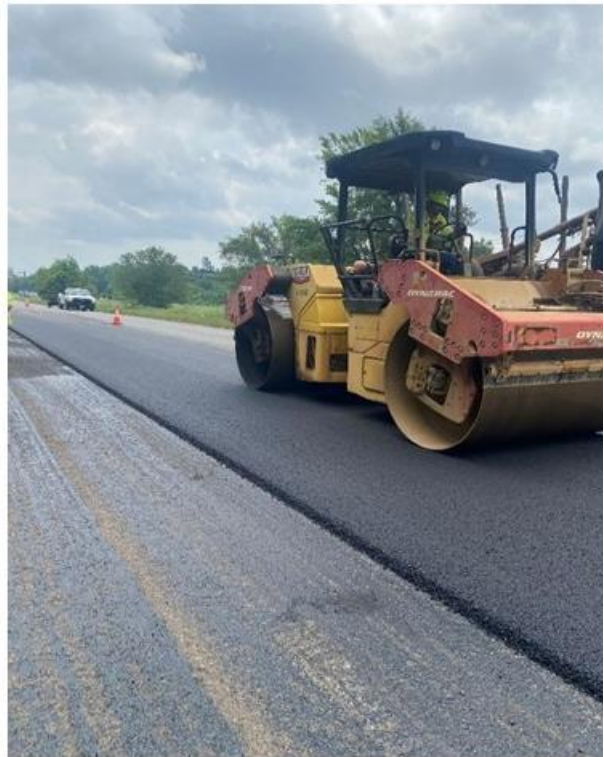
Figure 103. Paving and compaction of Superpave mix over PFC: (a) laydown machine, and (b) steel-wheel roller.

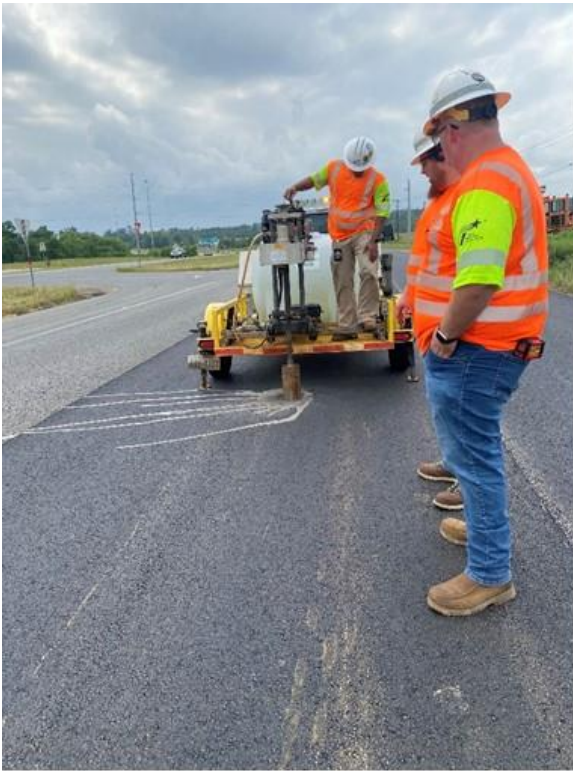
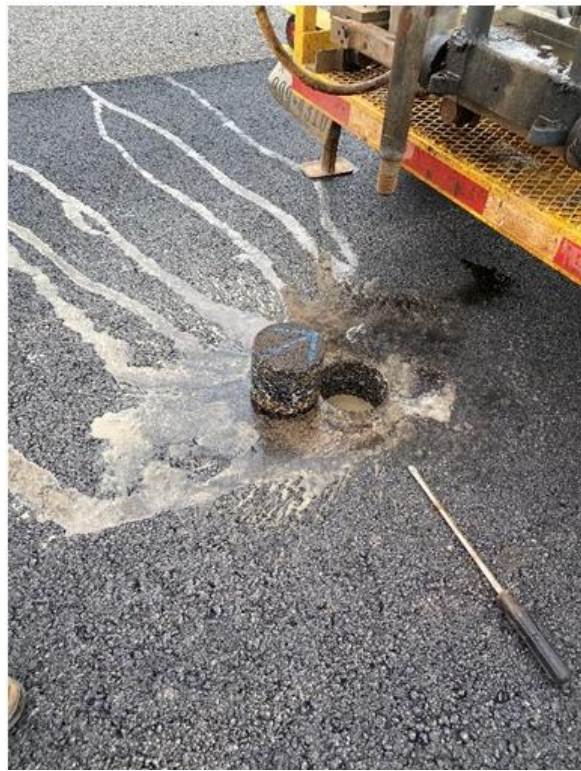
Figure 105. Coring operation over bulged pavement area: (a) coring rig, and (b) cores taken showing the new overlay bonded to the old PFC.

behaving as if it were tender or unbonded and was moving laterally, causing the edges to crack (Figure 104). The roller operator immediately ceased all rolling, paving was halted, and the district lab was called out to take cores to check the bond. Cores were taken immediately over the bulged areas (Figure 105). The cores came out intact, and the bond was secure. Later, the district lab measured the shear strength of the bond (Table 21), and the bond strengths of the two cores were 21.8 and 11.9 psi. While this may not be a great bond, nonetheless there was a bond of the new surface to the old, so the bond did not appear to be the culprit for the problems seen in the field. A photo of the core after shear testing is shown in Figure 106. After this occurred, the tack rate was also increased to 0.1 gal/yd² for the rest of the test section construction.

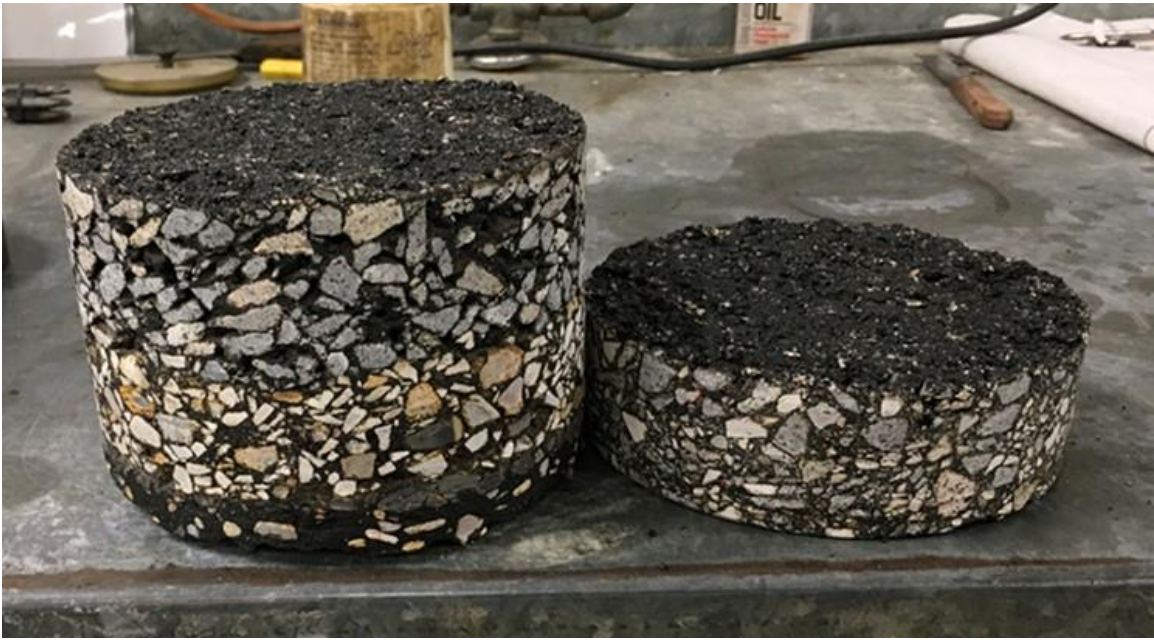
Figure 106. Photo of core after shear test.

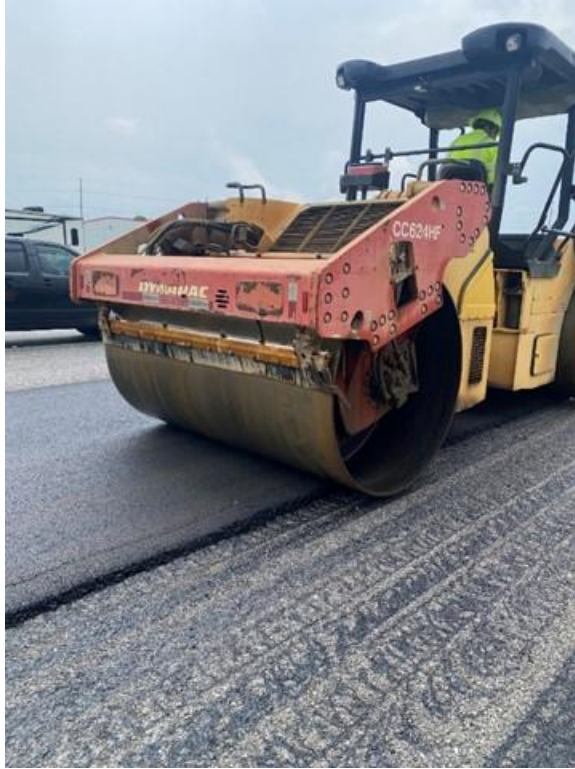
Figure 107. Additional static rolling on the problem areas after mat cooled down.

After coring, and after the mat had cooled significantly, a few more static passes of the roller were made in the problem areas, which smoothed the mat (Figure 107). There was still a slight visible crack on each edge of the mat (Figure 108).

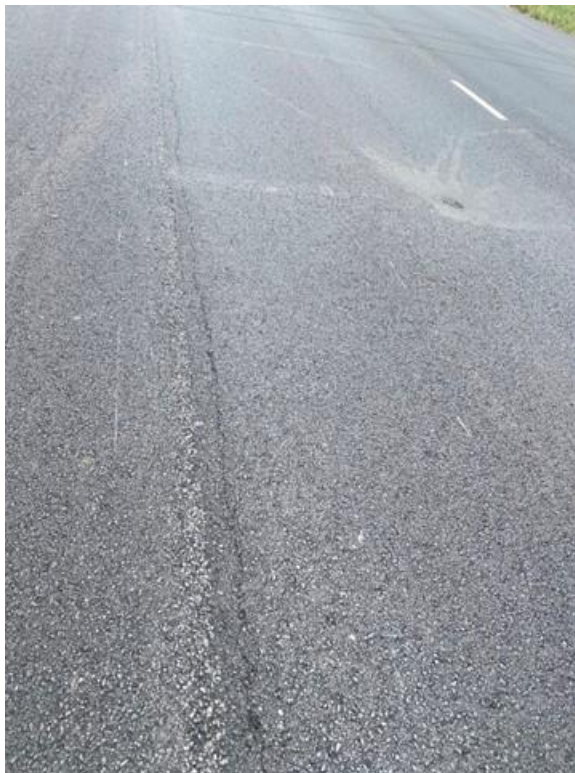
Figure 108. After 1 week of traffic.

Figure 108 shows the overlay 1 week after traffic, and a crack was visible but did not appear to have gotten any worse. A GPR test was also performed about a week later, and based on the radar (Figure 109), there did not appear to be any moisture trapped in the underlying PFC (Figure 110).

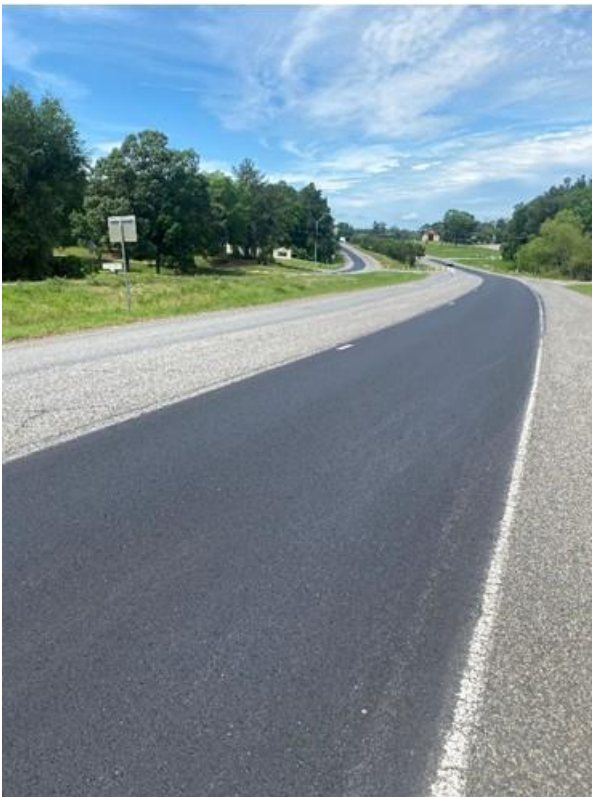
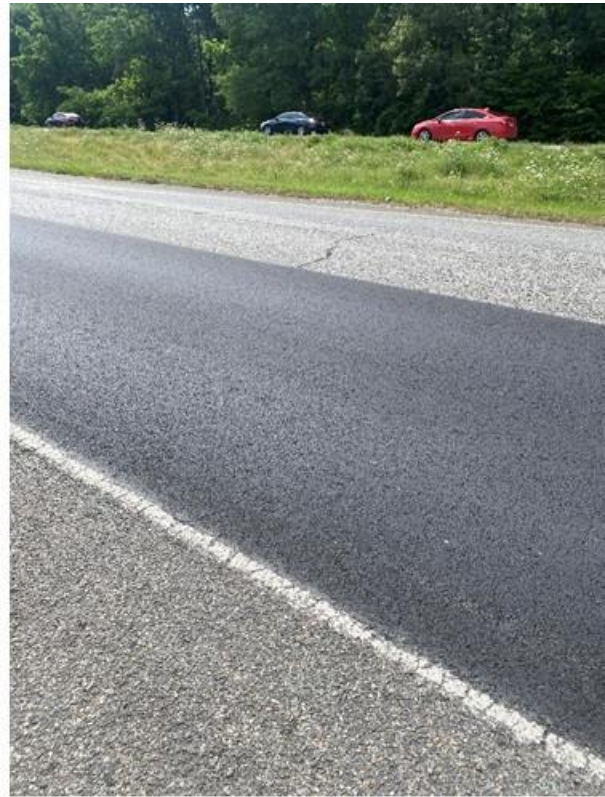
Figure 110. Other portions of the greater contract where old PFCs were milled and inlaid with Superpave C: (a) general view, (b) closeup view.

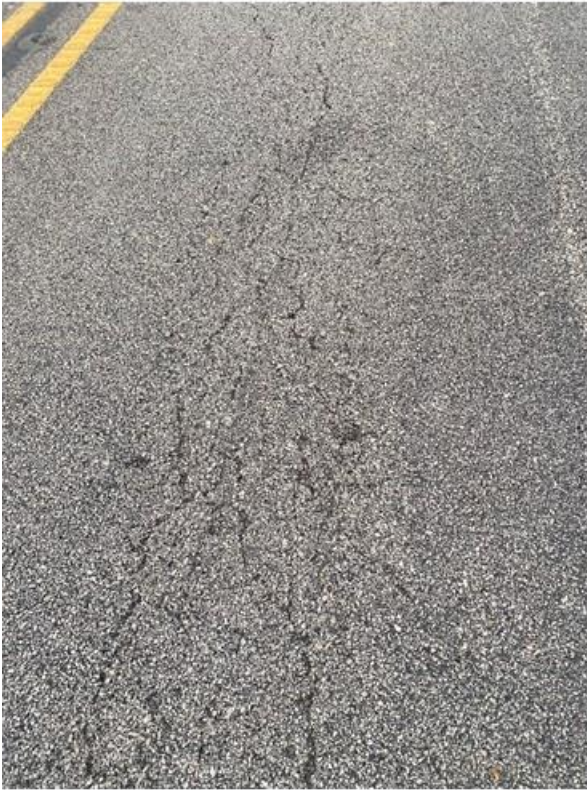
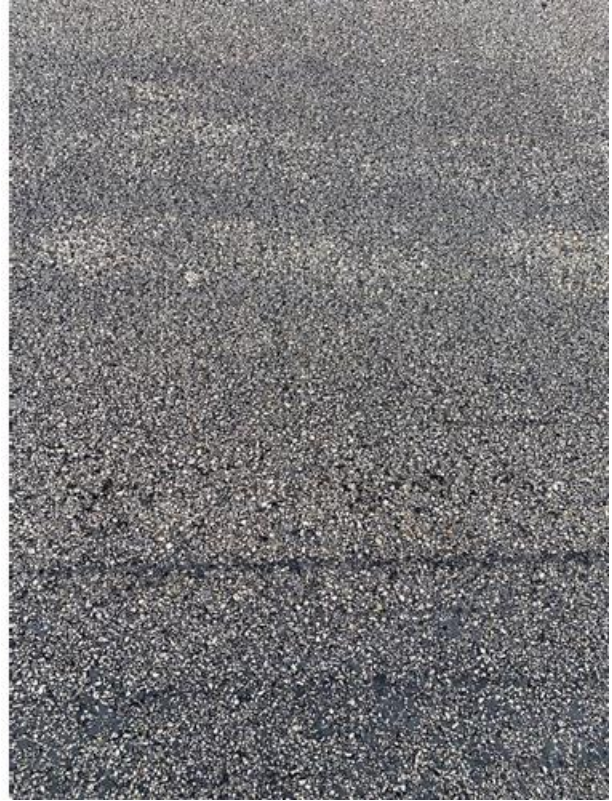
Figure 112. Pavement distress observed in the PFC surface: (a) cracking, and (b) slight raveling.

The existing surface condition is shown in Figure 111 and Figure 112. The PFC looks very dry, with some moderate cracking and minor raveling. Maintenance crews had placed some cold-mix level-up patches at several locations throughout the project, as shown in Figure 113. Photographs of the construction process are documented in Figure 114.

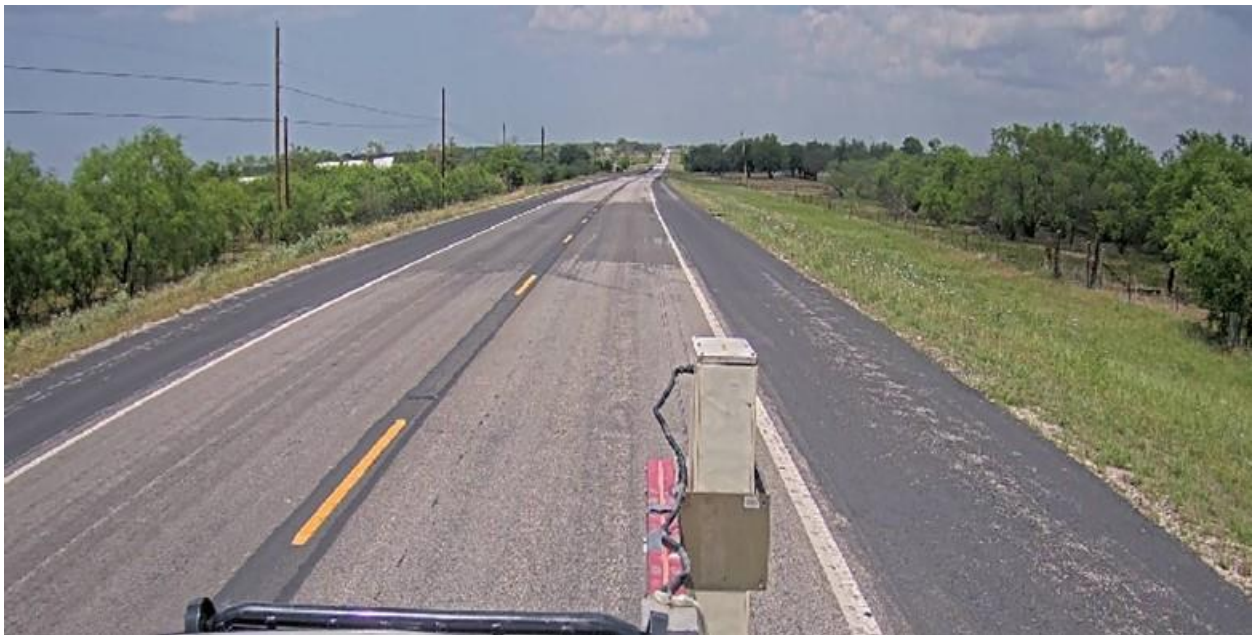
Figure 113. Several level-up cold-mix patches located throughout the project.

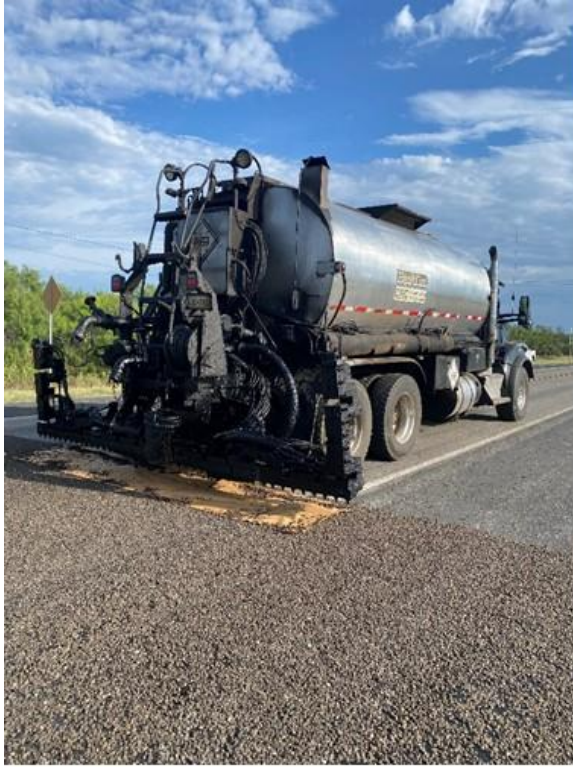
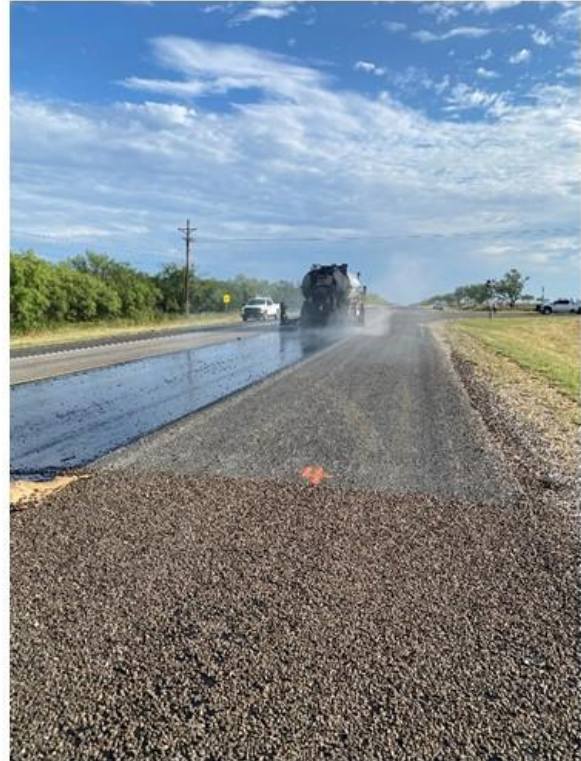
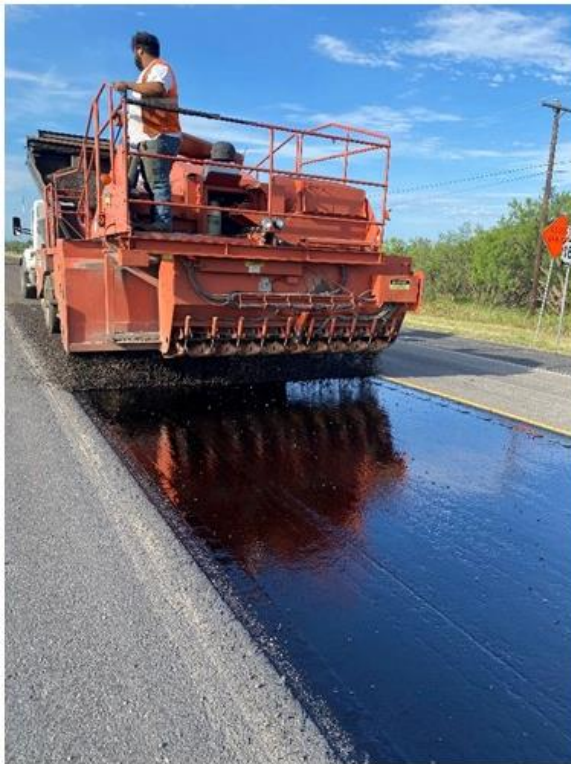
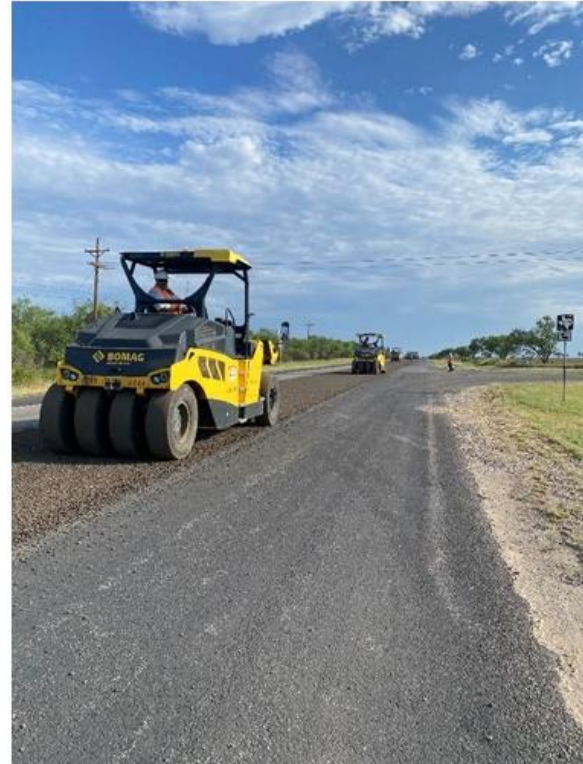
Figure 114. Construction of Grade 3 seal coat over PFC: (a) asphalt distributor truck, (b) asphalt application, (c) aggregate application, (d) rolling.

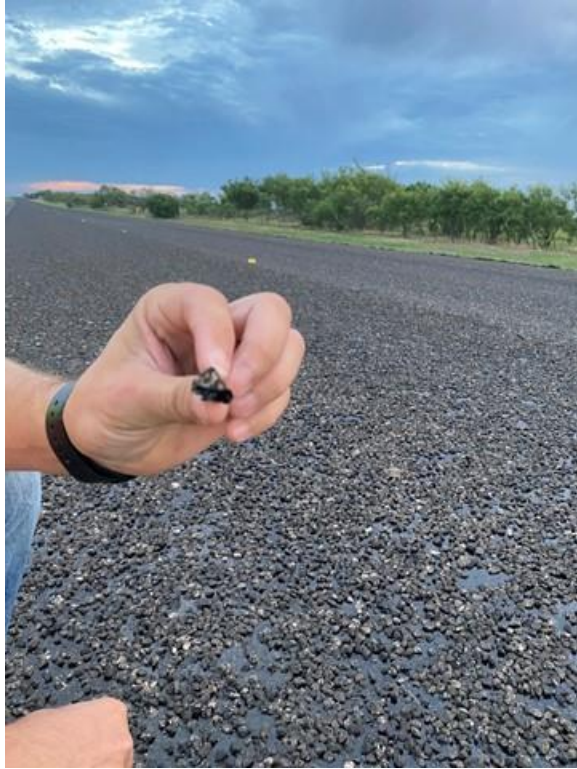
Figure 115. Initial embedment after rolling.

Initial asphalt application rates were selected at 0.45 gal/yd² for the main lanes and 0.48 for the shoulder. While these rates were thought to be high compared to what the district was shooting on other roadways for this contract, it still did not seem to be quite enough. Initial embedment depth after rolling is shown in Figure 115. It looks to be about 25 percent. Asphalt rate was eventually increased for the main lanes to 0.5 gal/yd². The district seal coat specialist who was setting the rates did not think that asphalt was soaking into the PFC; he believed that the surface was very aged and hard and there was zero penetration of the aggregate into the old surface after rolling. The aggregate application rate started out at 125 yd²/yd³ but was increased to 120 yd²/yd³ (Figure 116).

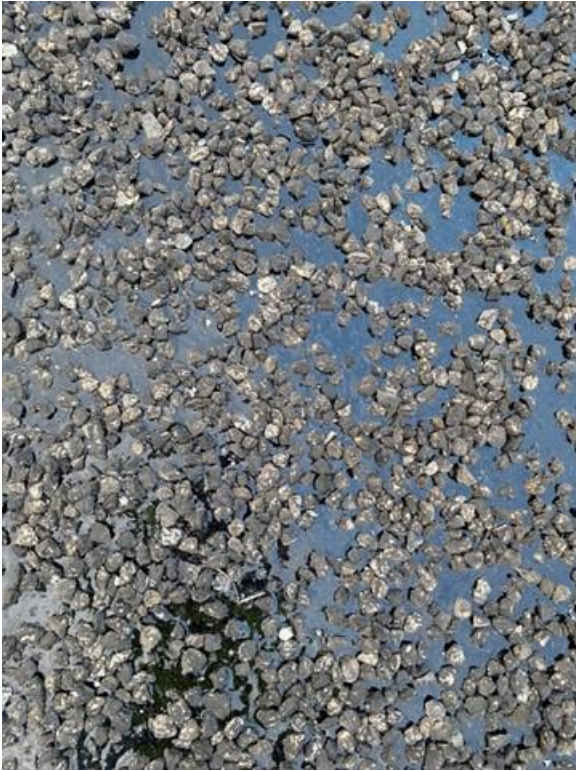
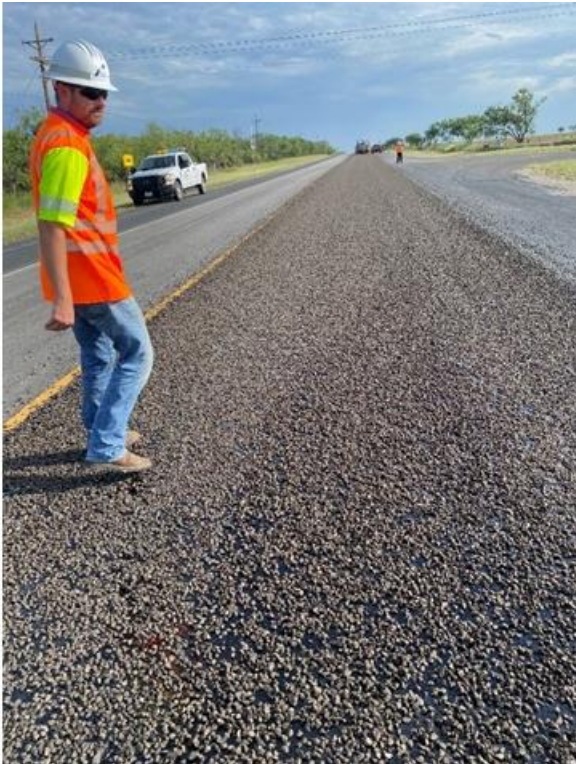
Figure 116. Aggregate application rates: (a) initial, and (b) final.

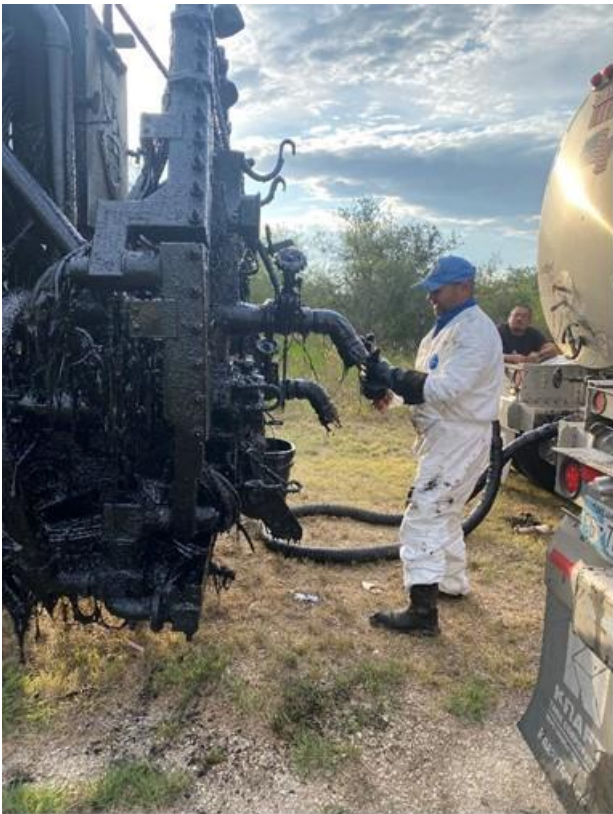
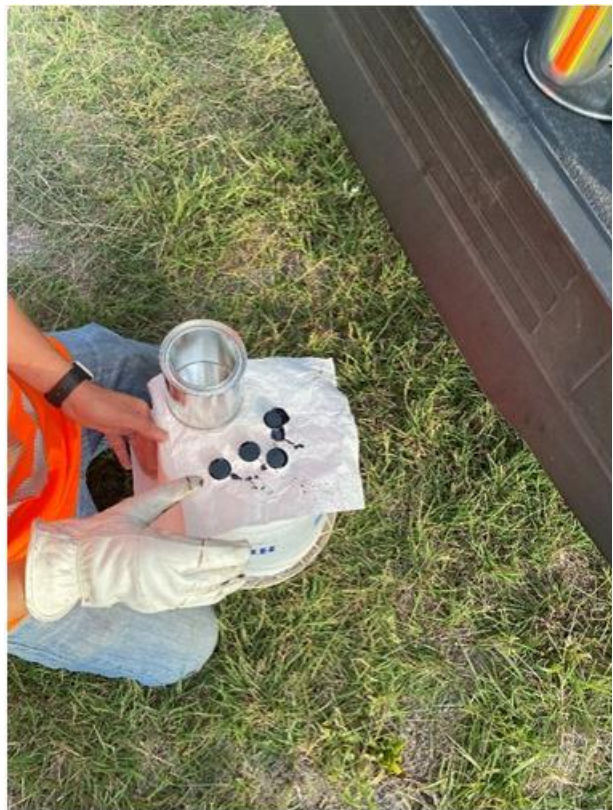
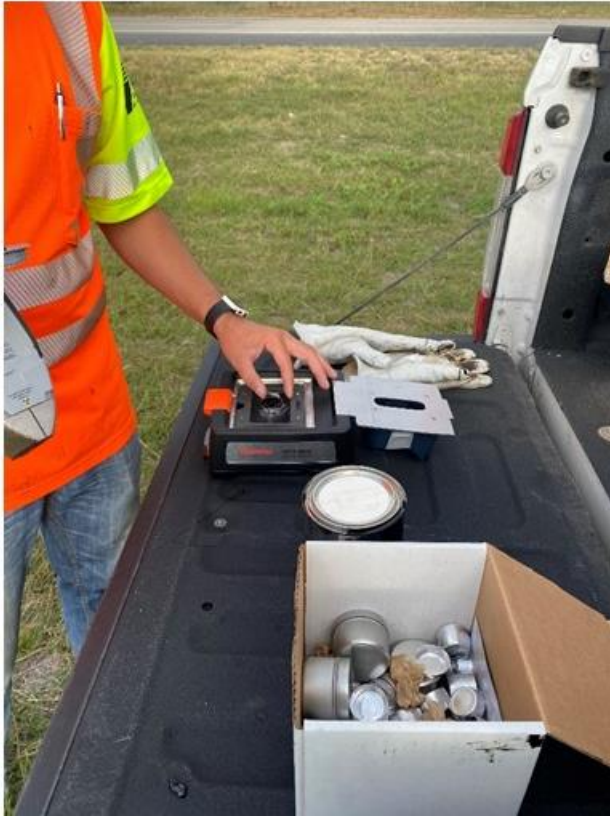
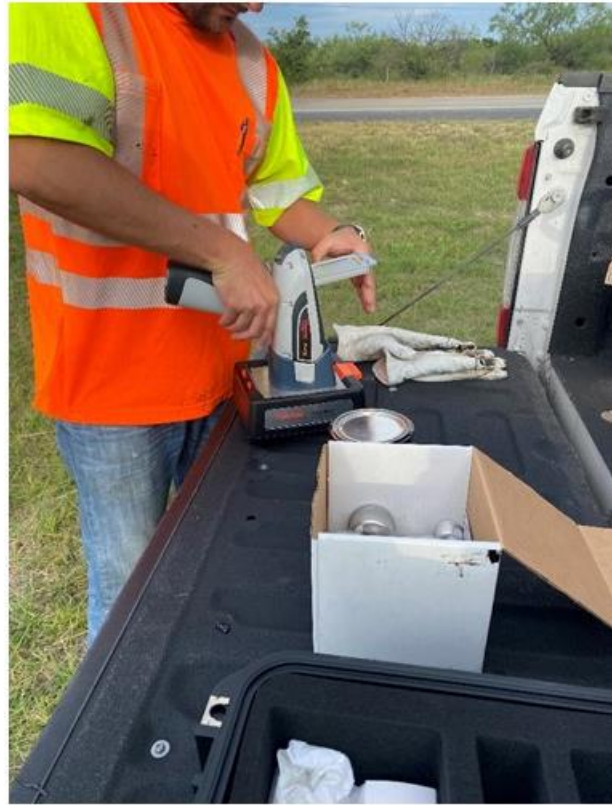
Figure 117. Field XRF testing to verify tire rubber content in AC-20-5TR: (a) sampling from the distributor truck, (b) preparing the test specimens, (c) inserting the test specimens in the equipment, and (d) acquiring the XRF measurement.

Some districts have recently had problems with AC-20-5TR in that the tire rubber content has been variable, in some cases as low as 2 percent rather than the required 5 percent. The Brownwood District was experimenting with a handheld XRF to measure the tire rubber content in the asphalt binder. The Brownwood District seal coat specialist took samples throughout the construction of the district-wide seal coat contract and performed the XRF test in the field (Figure 117 and Figure 118). He reported that this supplier was consistently providing a product with 5 percent tire rubber, as required.

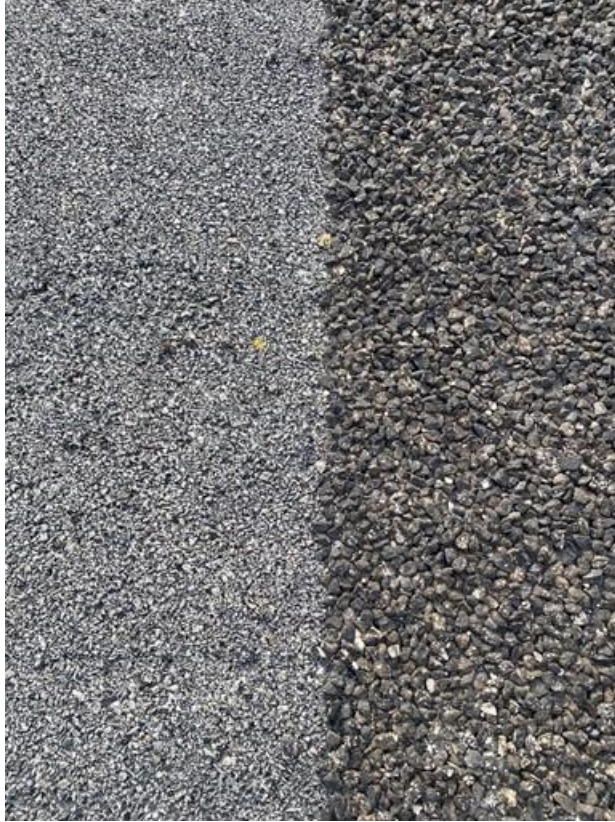
Figure 119. Close-up of seal coat next to PFC surface.

The seal coat surface compared to the old PFC is shown in Figure 119 and Figure 120. Thus far, this test section has been successful. At the time of this report, it had seen about 3 weeks of traffic and extremely hot temperatures and had performed well. All current indications are that this PFC may remain in place indefinitely for future resurfacings.

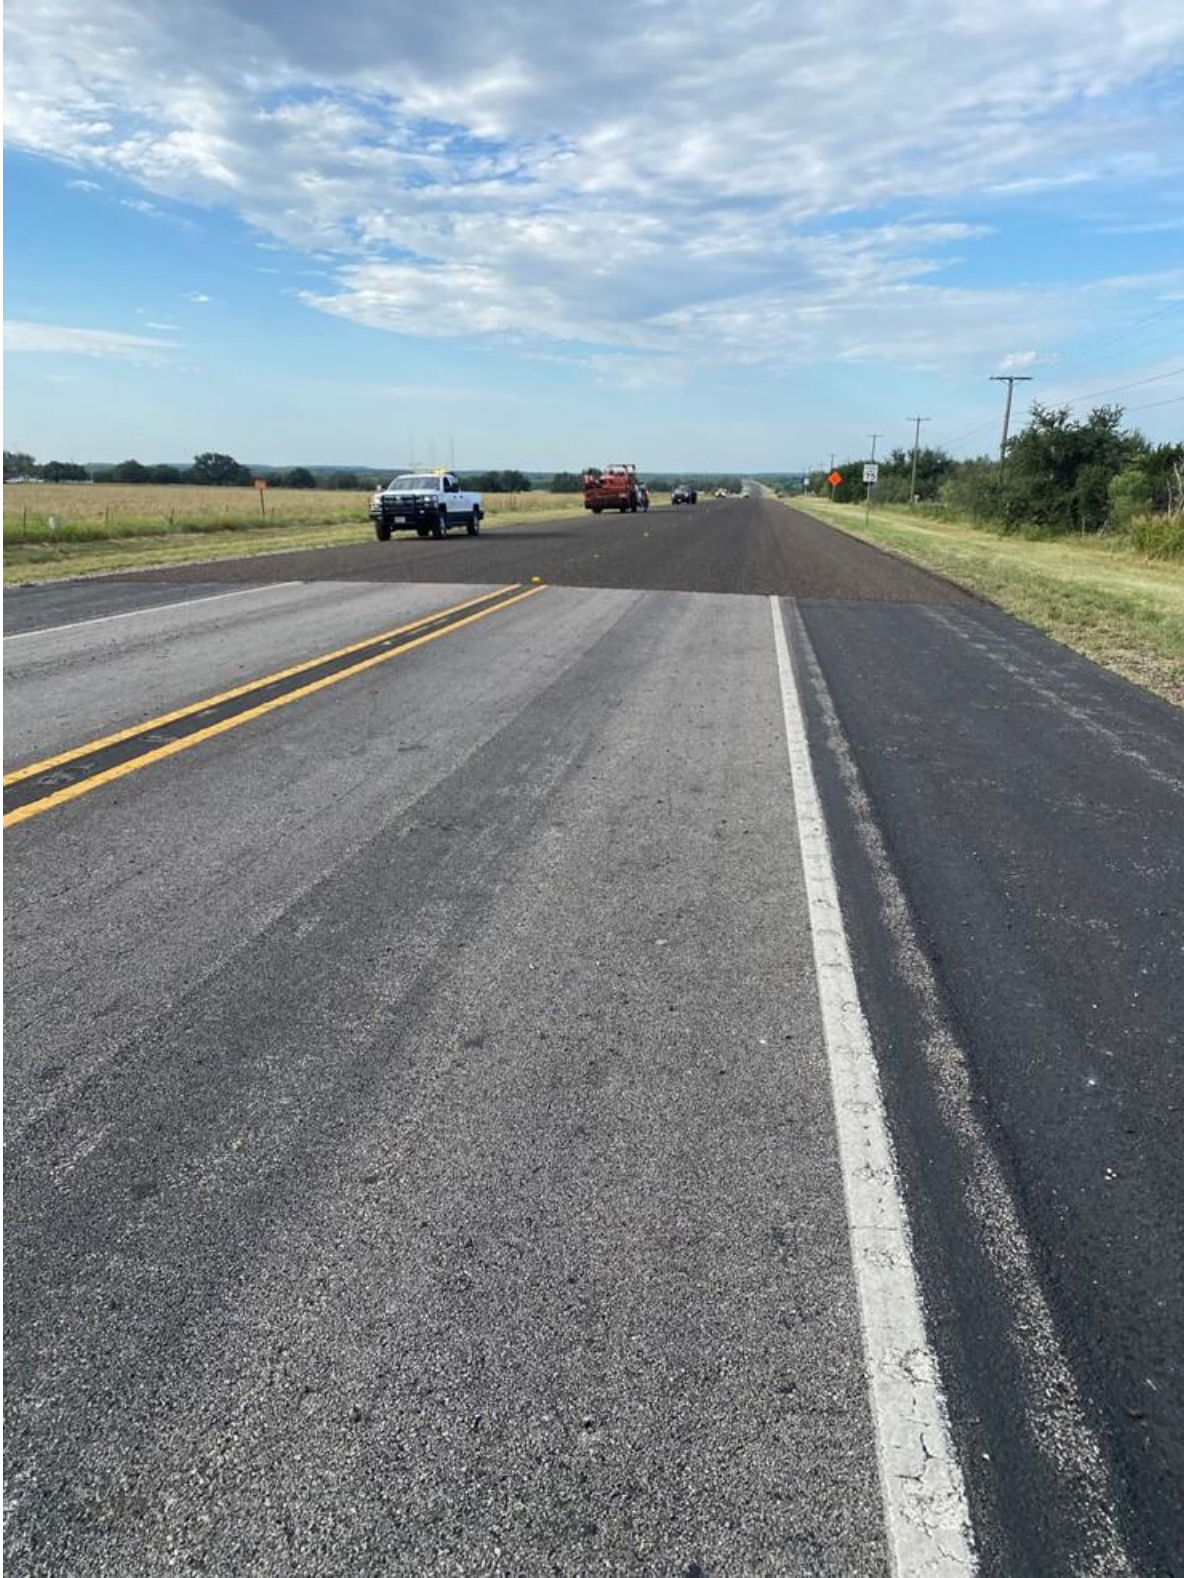
Figure 120. View of seal coat and PFC surface.

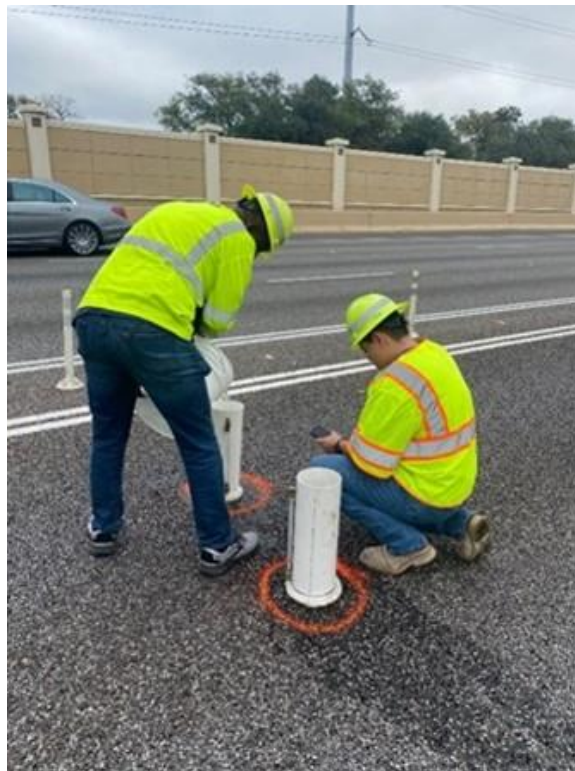
Figure 121. Water flow testing on MoPac.

TTI performed water flow tests before and after placement of the fog seal (Figure 121). Seven stations were evaluated, and at each station, water flow in the right wheel path and between the wheel paths was tested. These results are shown in Figure 122 and Figure 123. The fog seal reduced the water flow in the right wheel path an average of almost 5 seconds and reduced the water flow between the wheel paths by an average of 3 seconds.

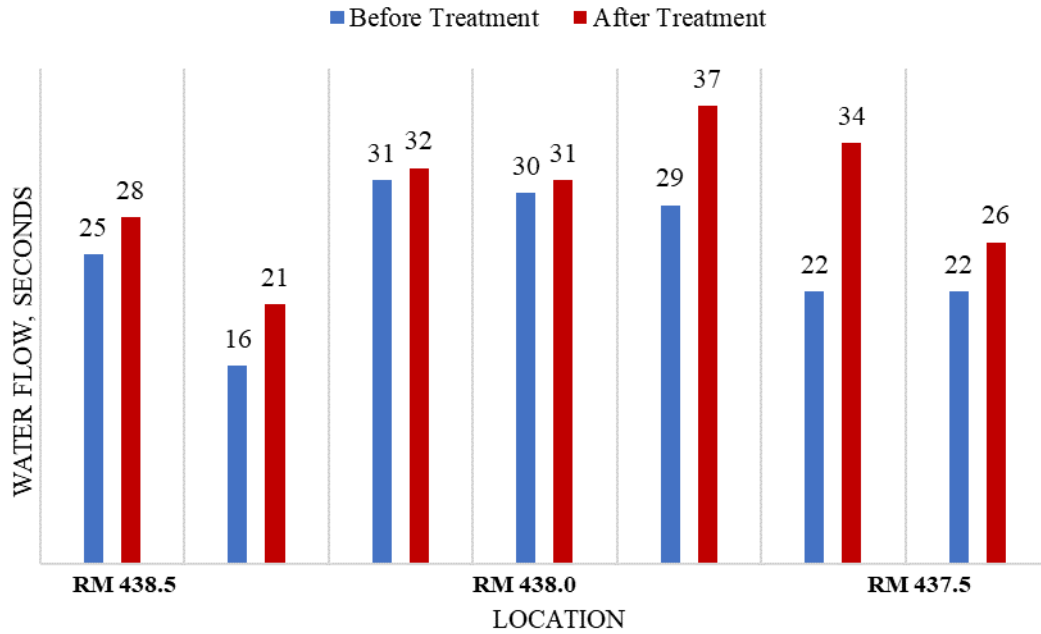
Figure 122. Water flow results before and after treatment for right wheel path: average before 25.0 seconds, average after 29.8 seconds.
