Design and Rehabilitation Strategies for Permeable Friction Course Pavements

Technical Report 0-7110-R1

TEXAS A&M TRANSPORTATION INSTITUTE
COLLEGE STATION, TEXAS

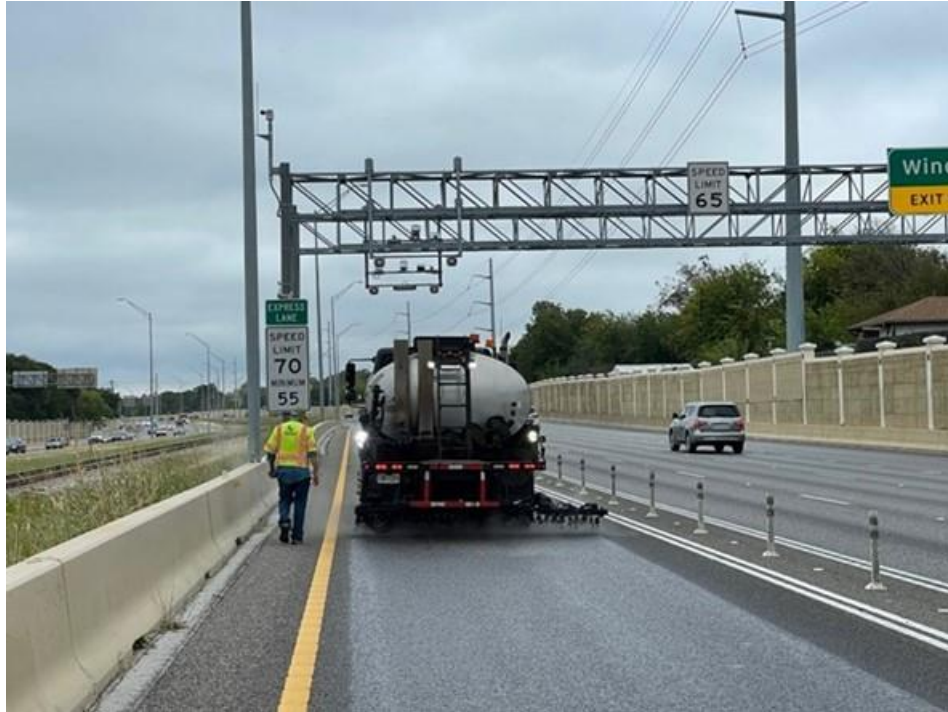
Figure 124. Construction of fog seal on MoPac.

On November 9, 2022, the 1-mi rejuvenating fog seal was placed on MoPac (Figure 124). TxDOT was on site to observe and collect skid data, CTRMA coordinated events and traffic control, and TTI personnel were on site to do water flow testing and document construction. Ergon donated the product for the test section. The product was applied at a rate of 0.14 gal/yd², which provided a relatively thick, sticky film of asphalt on the surface (Figure 125). The test section was opened to traffic approximately 1.5 hours after placement.

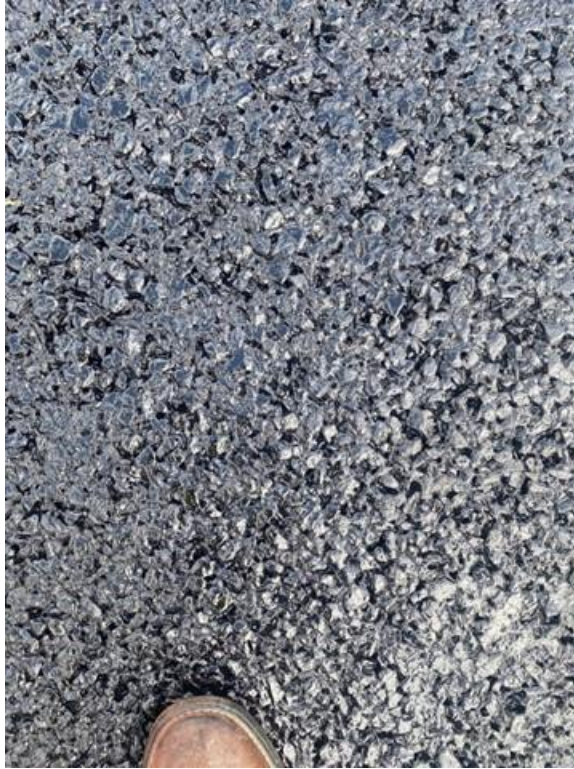
Figure 125. Close-up of fog seal application on PFC.

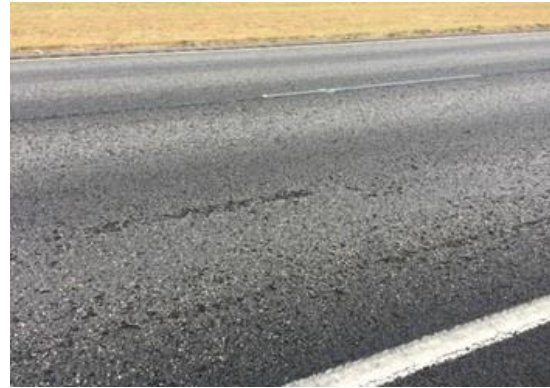
Figure 1. Raveling distress in aged PFC.

When PFC pavements begin to reach the end of their serviceable life, the most common distress is raveling, as shown in Figure 1. Cracking is also sometimes observed to reflect from lower layers. When cracking occurs in a PFC, the edges of the cracks begin to ravel as well, causing the cracks to appear quite wide (Figure 2).

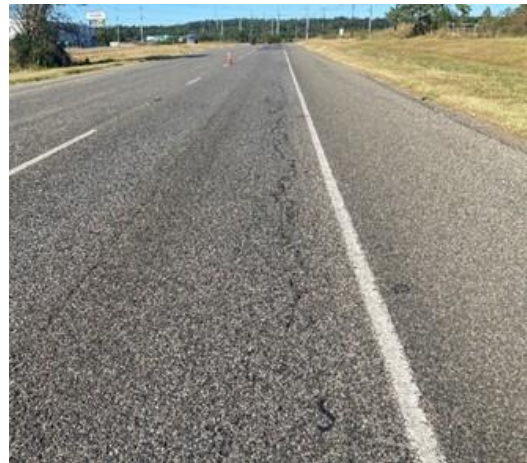
Figure 2. Cracking distress in aged PFC.

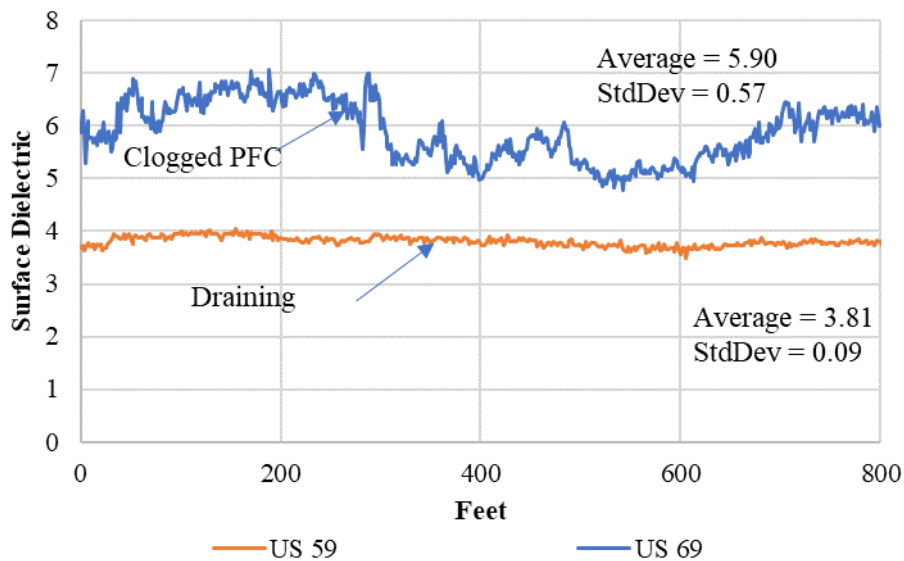
Figure 3. GPR surface dielectric when it is low and uniform it indicates the PFC pavement is still open and draining and when it is high and nonuniform indicates the PFC pavement is clogged and not draining.

A PFC mix that still has open air voids and is draining will typically have a uniform and low surface dielectric. An example of the surface dielectric of this type of mix is shown in Figure 3. The dielectric trace shown for the draining PFC in Figure 3 is very uniform and has a value of less than 5. A PFC that is clogged and not draining will have a nonuniform and higher dielectric, which resembles a surface dielectric more typically seen with dense-graded mixes like the one shown for the clogged PFC in Figure 3.

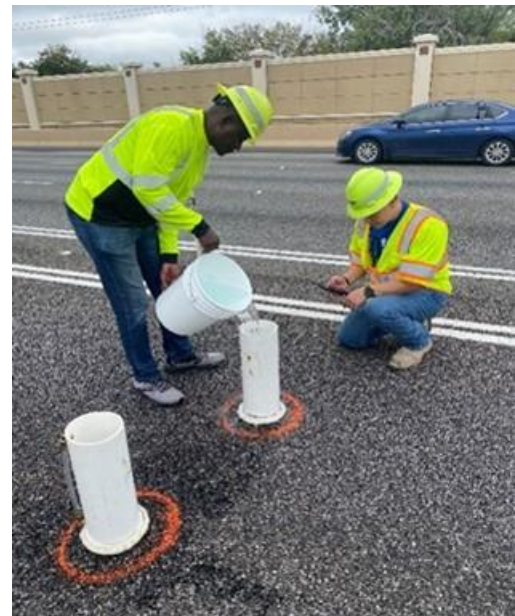
Figure 4. Water flow testing.

Figure 4 shows the water flow test being conducted in the field. A cylindrical permeameter is used along with plumber’s putty to create a watertight seal. The permeameter is filled with water, and the time that it takes the water to travel from the top marking on the pipette to the bottom marking on the pipette is recorded.

For new PFC mixtures to be considered permeable, immediately after construction they are expected to have water flow time less than 20 seconds. For a TOM to be considered impermeable, it is expected to have a water flow value greater than 120 seconds. Thus, if an old PFC has a water flow greater than 120 seconds, it could be considered clogged.

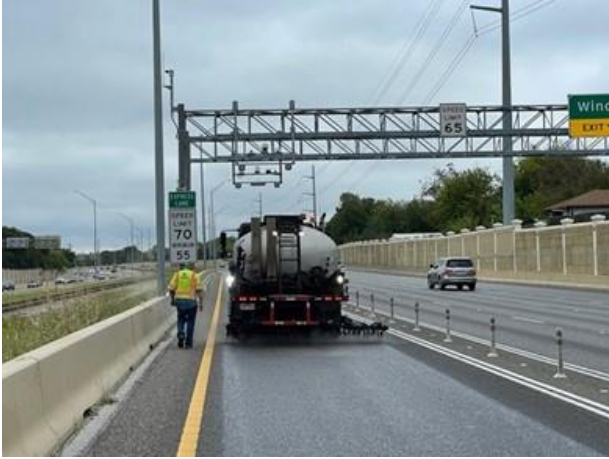
Figure 5. Rejuvenating fog seal application on PFC.

- Fog seal the surface with either conventional fog seal or rejuvenating fog seal to prevent or prolong raveling and extend service life. Figure 5 shows a rejuvenating fog seal being placed on PFC on MoPac in Austin.
- Overlay the PFC with a new PFC.

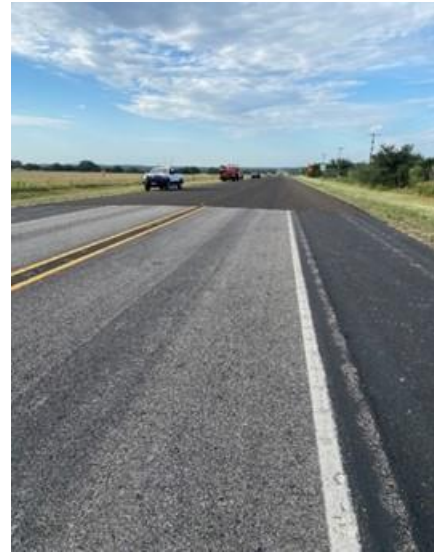
Figure 6. Seal coat application on PFC.

While placing a seal coat or hot-mix overlay on a PFC is somewhat controversial, several districts have done so successfully (Figure 6). The Brownwood, Bryan, and El Paso Districts have placed a seal coat on a PFC. The Lufkin District has overlayed a PFC with a Superpave C mix as part of a research test section (Figure 7). The critical aspect of sealing or overlaying a PFC is to do an adequate field evaluation to determine whether or not it is still draining. If it is clogged and not draining, it behaves similarly to a dense-graded mix.

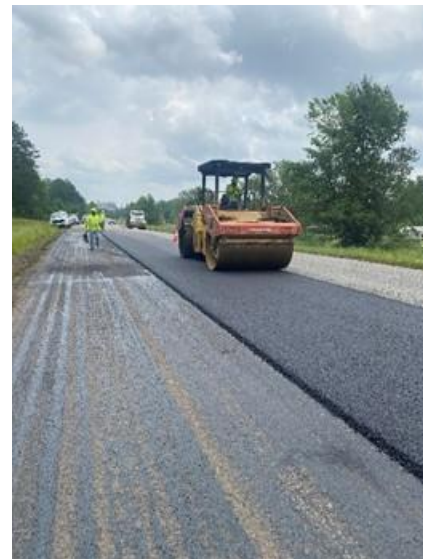
Figure 7. Hot-mix application on PFC.

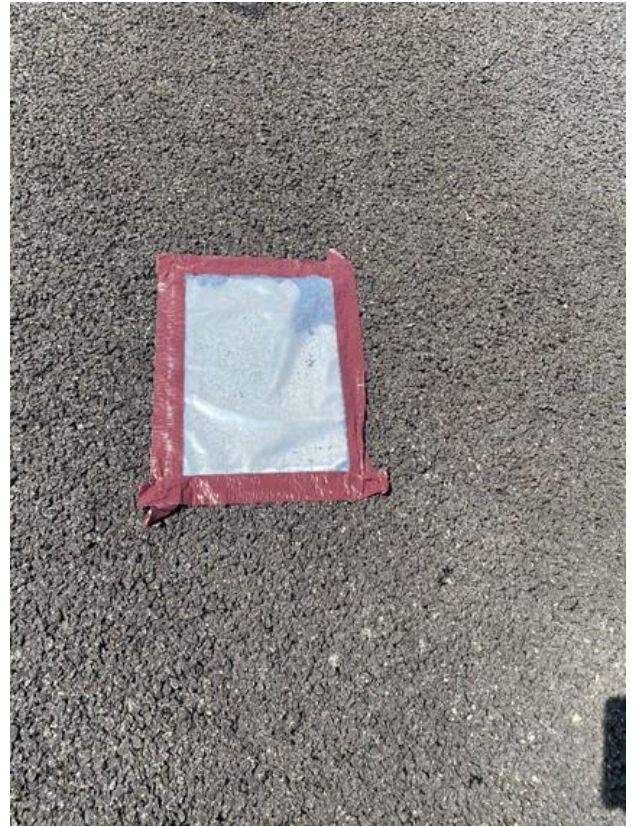
Figure 10. Moisture test on PFC pavement surface.

Apply the material to pavement that is completely dry. Pavement will be considered dry if, on a sunny day after 15 minutes, no condensation occurs on the underside of a 1-sq. ft transparent plastic that has been placed on the pavement and weighted on the edges.

Figure 10 shows a transparent plastic sheet duct-taped to a PFC pavement surface. Researchers poured water into the pavement surface and waited for the surface to dry before taping the plastic to the PFC. Within a few short minutes, moisture appeared on the underside of the plastic sheet.
