Report No. UT-24.14

EVALUATION OF METHODS FOR UDOT BRINE TANK CONDITION ASSESSMENT

Utah Department of Transportation
Research & Innovation Division

**Final Report
January 2024**

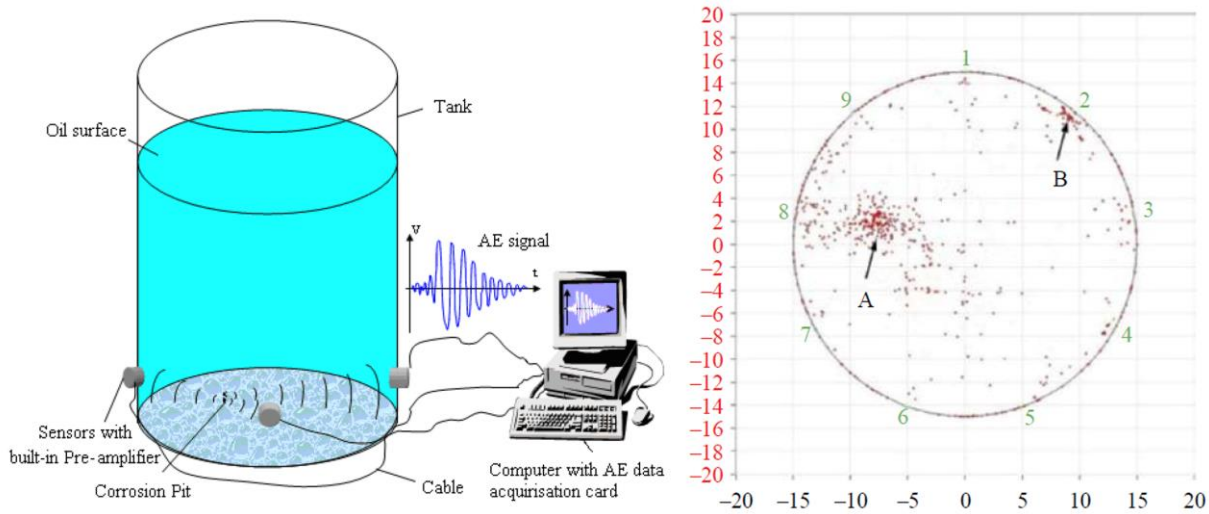
Figure 2-3 The principle of AE monitoring for above-ground storage tanks (left) and AE localization of the corrosion at the tank floor (right). (Lin et al., 2010)

To address such challenges, Lin et al. (2010) deployed guard sensors to shield inside-tank noise signals during AE monitoring, which facilitated extracting characteristics of AE signals from tank-bottom corrosion areas. Such an advancement enabled the localization and classification of corrosion events occurring on the tank bottom. Data-driven models have also been studied for AE monitoring. Murakami et al. (2007) investigated both the bulk wave and guided wave for corrosion damage localization on the tank bottom. They developed a neural

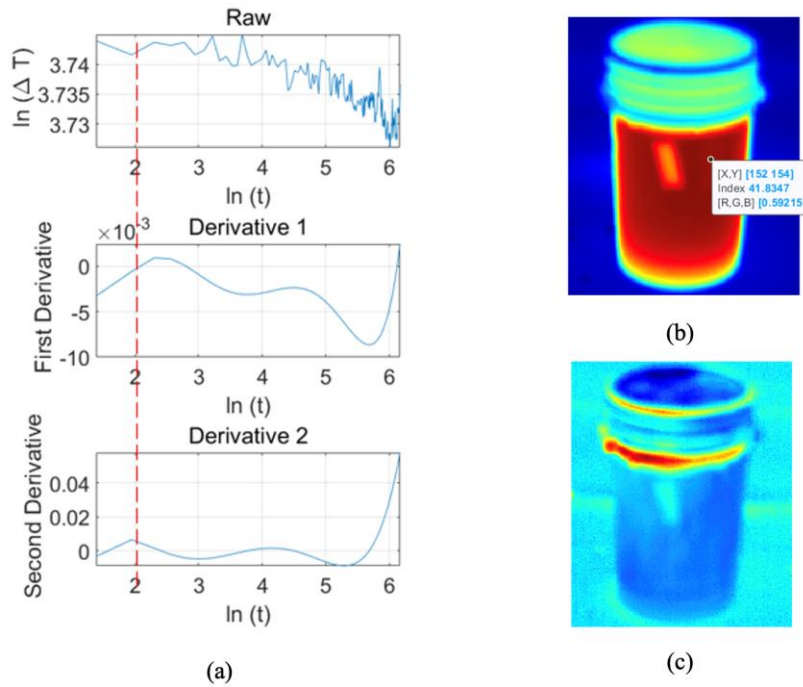
Figure 3-4 TSR result: (a) temperature evolution, first derivative and second derivative at duct tape with pixel location (152, 154), (b) thermal raw image at time $\ln(2)$ s, (c) second derivative image at time $\ln(2)$ s.

To enhance the performance of using thermal images for defect detection, the thermographic signal reconstruction (TSR) technique was implemented for defect enhancement. In TSR, the logarithmic temperature response of each pixel is fit to a first-order polynomial. Then, derivatives of the logarithmic signal, calculated with respect to logarithmic time, were constructed for amplifying defect deviation from the normal temperature. Figure 3-4(a) shows the time evolution of the first and second derivative of the double-sided-taped area with a pixel location of (152, 154). The amplitude peaks at $\ln(2)$ s in the second derivative, which generally indicates changes in the heat diffusion process. The corresponding thermal image is shown in Figure 3-4(b). While the double-sided-taped area was highlighted, the duct-taped location in the second derivative image was not retrieved as expected. The reason can be attributed to the fact that the TRS signal processing may only be suitable for pulse, step thermal excitation, and not for continuous thermal excitation.

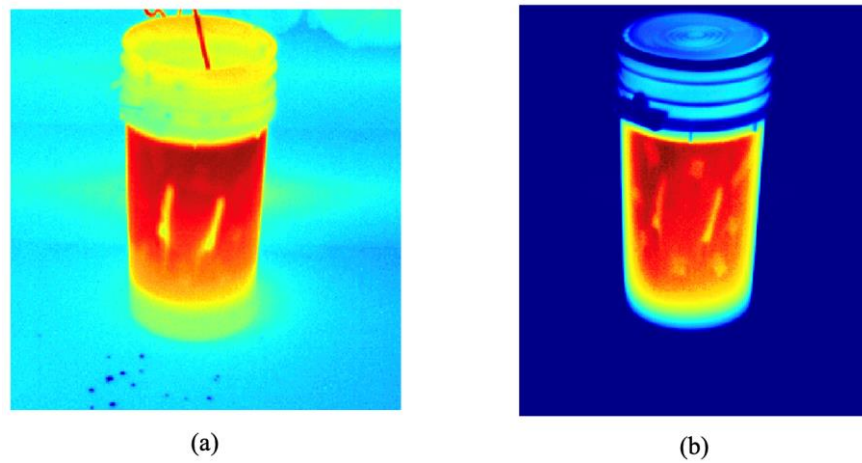
Figure 3-5 Thermal raw image of foam sample: (a) heating-up cycle, (b) cooling-down cycle.

Figure 3-5 shows the results using foam as the defect. From both the heating and cooling cycle, the raw thermal image can clearly show the contour of the foam and duct tape.

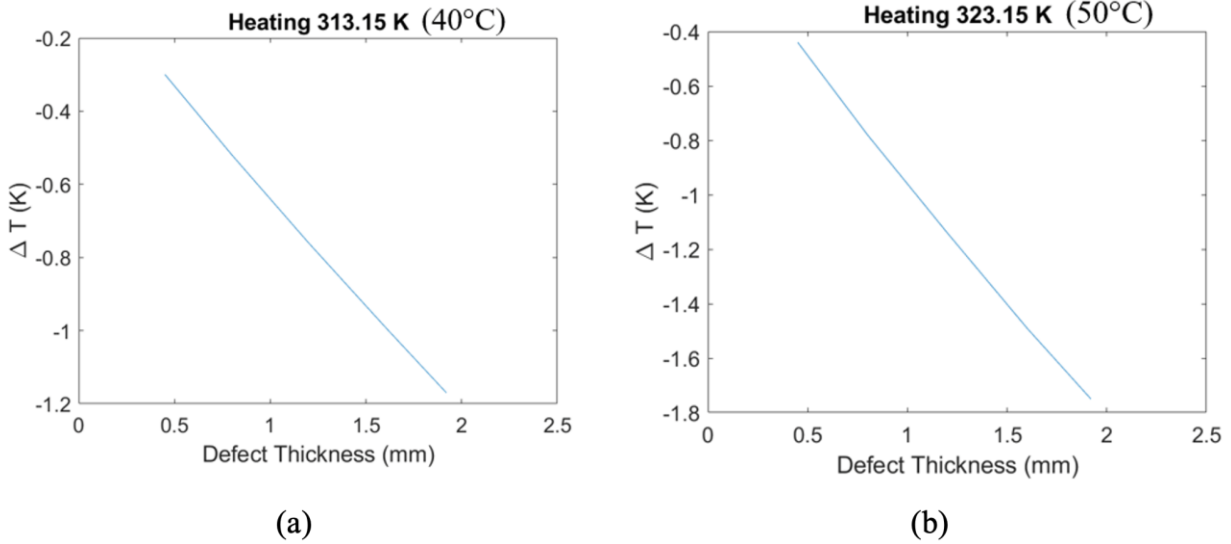
Figure 3-7 The effect of defect thickness on temperature contrast with (a) 40°C water and (b) 50°C water.

A parametric study for defect thickness effect was conducted within the range 0.5 mm to 2 mm. Temperature contrast (abs ΔT) increases with the defect thickness as shown in Figure 3-7(a) and (b), which demonstrates that the thicker defect can obstruct more flow of heat. Temperature measured at the defect location is lower than the nominal surface. Simulation results agree well with the lab test observation. The more the thickness change, the larger

temperature contrasts that we can observe. Furthermore, the higher the temperature of container water, the defect would cause higher temperature contrast at the outside of the bucket wall.

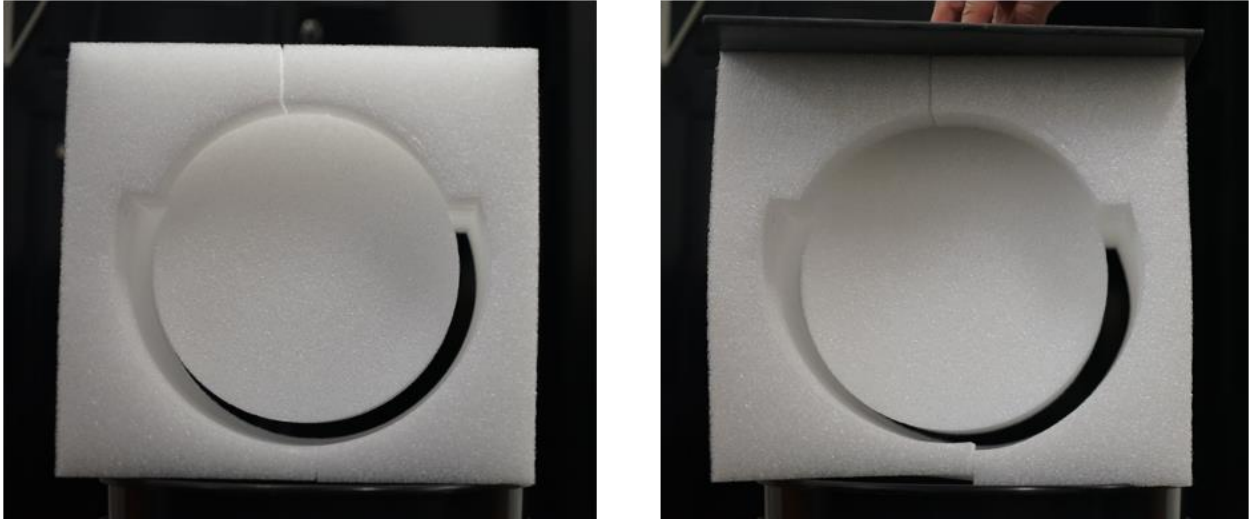
Figure 3-8 The image captured using a Sony optical camera of (a) an undeformed foam cube and (b) a deformed foam cube.

In order to remotely measure the deflection of a tank wall, we developed image processing techniques on a surrogate sample and evaluated its feasibility. We used an optical camera to capture images of a foam cube at its undeformed and deformed states, as shown in Figure 3-8.

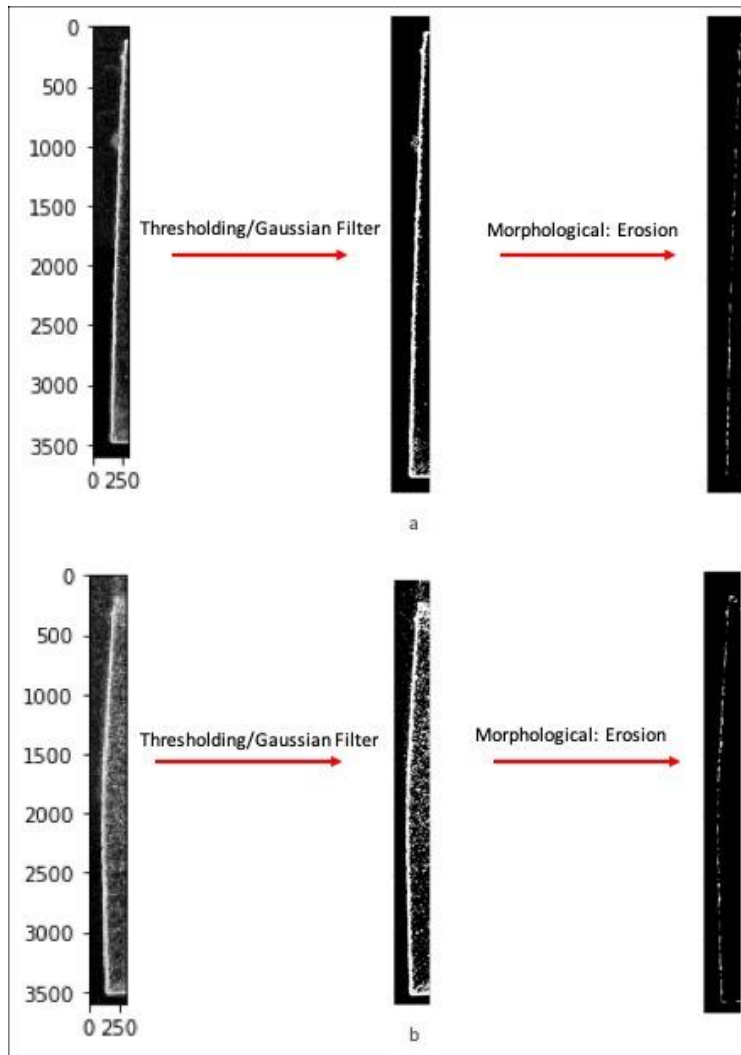
Figure 3-10 Image processing to obtain a clear edge of (a) an undeformed foam cube, and (b) a deformed foam cube.

Furthermore, in order to evaluate the displacement of the edge on the left side of the foam sample after loading, the center of the white pixels was computed for each row of the image, as shown in Figure 3-10.

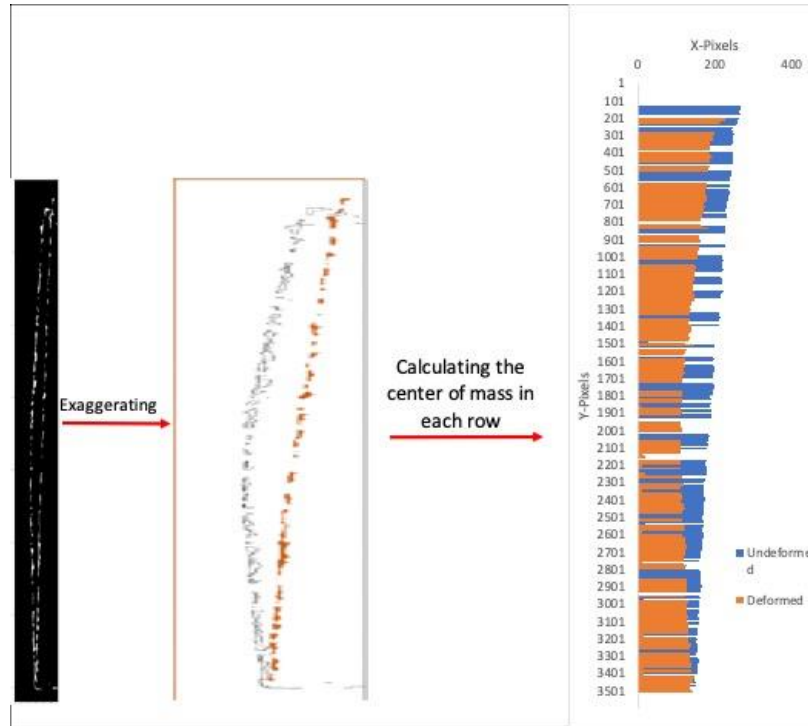
Figure 3-11 Steps to obtain the maximum displacement of the left side of deformed foam in pixels.

The primary objective of this study was to monitor wall tank deformations using nondestructive evaluation techniques. The deflection of the surrogate sample was determined using an optical camera with the edge detection image processing technique. The precision of the optical camera for measuring small deformations was evaluated by computing the deformation of the prototype sample using Sobel edge detection. Figure 3-11 demonstrates steps to determine the maximum displacement of the left edge of the deformed foam sample, which measures 95 pixels.

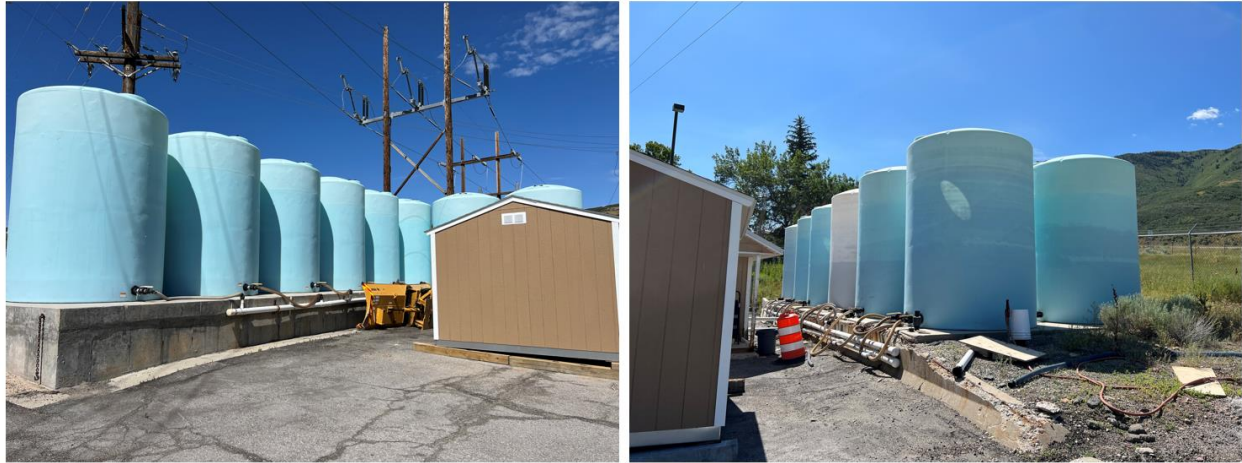
Figure 4-2 Two groups of UDOT brine tanks at the Parley Springs Maintenance Shed.

The team conducted data collection at the UDOT Parley Springs Maintenance Shed from August 4th to September 1st, 2022, for which a Google Maps view is shown in Figure 4-1. There are two groups of brine tanks without any reported leakages, as shown in Figure 4-2. During the period when inspection was favorable (summer months), the brine tanks were filled with stormwater. A long-term monitoring system was developed and deployed at the maintenance shed close to the tanks. Considering the cost and limitations, the designed system was positioned toward one group of tanks in the first two weeks and then positioned toward the other group of tanks in the second two weeks.

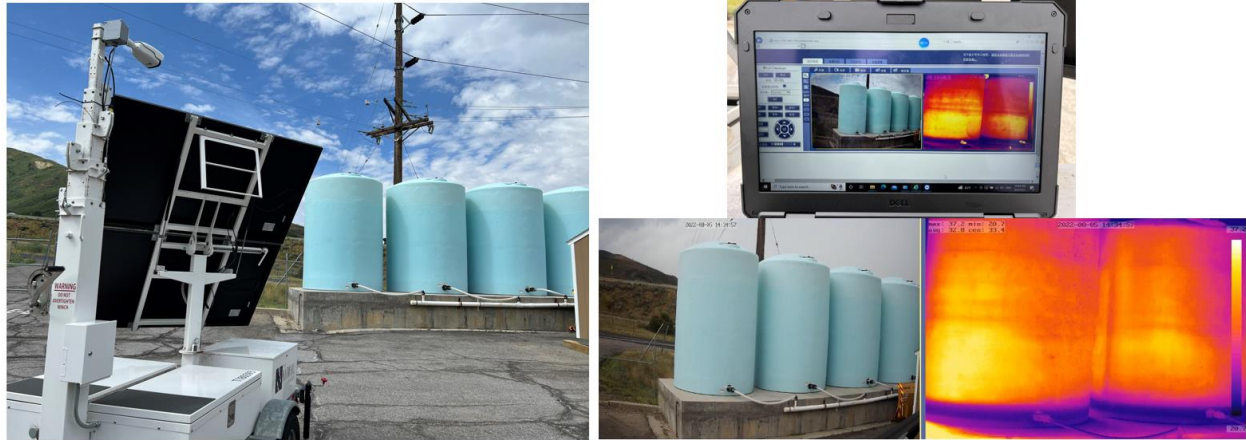
Figure 4-4 Dual-spectrum camera mounted on the portable trailer (left) and typical data collected at the UDOT Parley Springs Maintenance Shed.

1080 with a wider FOV compared to its infrared imager. This network camera simultaneously streams optical and thermal images with an interval of 1/25s, which are directly transferred and stored in a rugged laptop. The dual-spectrum camera was attached to an extendable pole on the trailer via a customized fixture, which was lifted to approximately 10 ft (~3 m). The portable trailer continuously powered the data collection system with sets of batteries and solar panels, as shown in Figure 4-3. The recorded optical and thermal images were regularly saved and transferred for further processing, as shown in Figure 4-4. The aim of this field test is to understand the temperature range of brine tanks in the Parley Springs site and evaluate the feasibility of wall thinning and deflection detection based on our field observations.

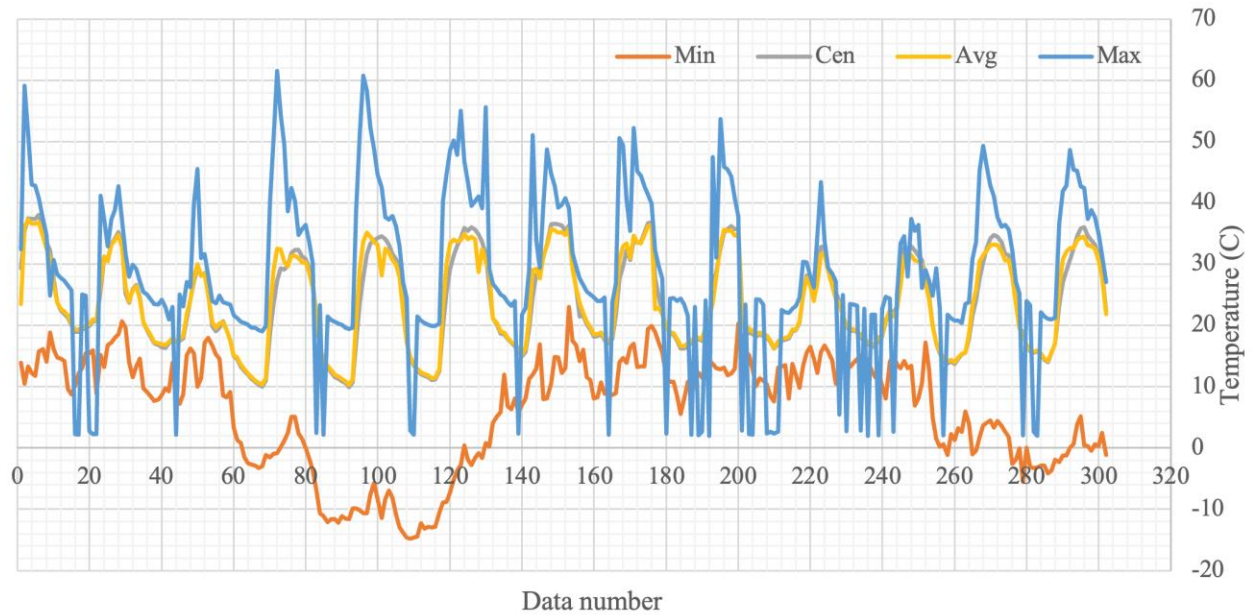
Figure 4-5 The minimum, average, and maximum temperature, and the temperature of the center of the image over time.

To determine the minimum, maximum, and average temperatures of the UDOT brine tanks, we used OCR to convert symbols in the images to specific numbers. The OCR method was applied in MATLAB, where we preprocessed the images by filtering and thresholding them before using the OCR function to extract the temperature values. We trained the computer with existing number symbols; then, the OCR function was applied to the original thermal image to extract temperature numbers. The OCR approach was used to convert symbols in the images to specific numbers for the extraction of the minimum, maximum, and average temperature of the water tank and the temperature of the center of the water tank. Figure 4-5 demonstrates the minimum, average, and maximum temperature, and temperature of the center of the image over 14 days with 2-hour intervals. It is notable that some minimum temperature values are below freezing point, which is mainly caused by passing vehicles on the highway in the background. Considering the temperature readings at the center of the field of view and the maximum temperatures, it will suffice to support wall-thickness change detection using the developed algorithm. No significant temperature variations were observed.

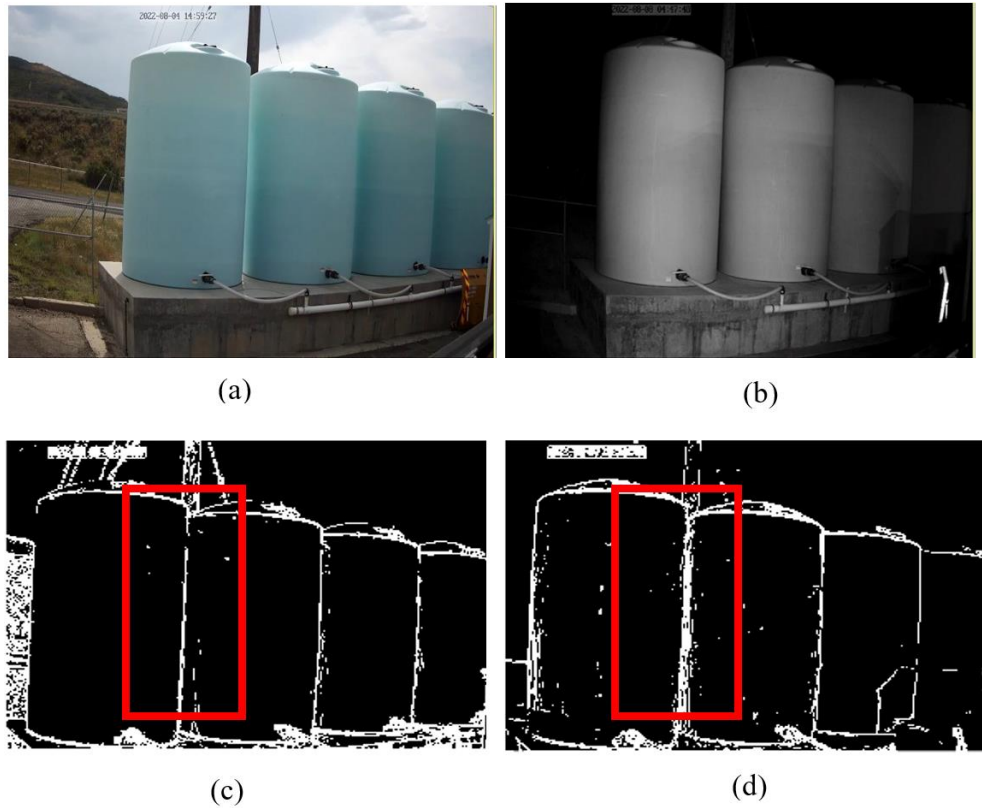
Figure 4-7 (a) Image of the water tank with center temperature of 38.1°C, (b) image of the water tank with center temperature of 9.9°C, (c) edge detection by the Sobel operator on with center temperature of 38.1°C, and (d) edge detection by the Sobel operator on with center temperature of 9.9°C

Once we determined the accuracy of the optical camera in finding deformation in the prototype, we applied the same technique to the UDOT brine tank with high contrast in temperature, where we expect to see large deflection due to the thermal effects. We used the optical camera to capture images of the water tank and applied the same image processing techniques as with the prototype to detect the deflection of the water tank. The deformation of the water tank was determined by following a procedure similar to that used for the surrogate sample, which involved measuring the displacement of the edges. The edge detection results are shown in Figure 4-7.

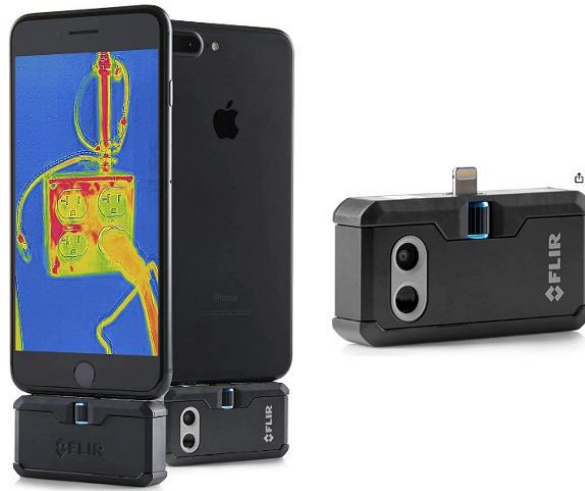
Figure A-1 FLIR ONE Pro camera attached to an iPhone for data collection.

It is recommended to perform inspection using a low-cost thermal camera every year during July or August, and keep documentation at times when there will be sufficient heat diffusion through the natural heating-cooling cycles. It is also recommended to perform the inspection using low-cost thermal cameras within the time windows of 10 a.m. to 12 p.m. and from 3 to 6 p.m., when the tank surface temperature ascends to or descends from the peak temperature of the day. Cloudy/windy/rainy days shall be avoided for taking measurements. The
