Test Report No. 469940-03, 469942-01, and 469943-01

**DEVELOP A RETROFIT DESIGN FOR GUARD FENCE SYSTEM TO
ENHANCE MOTORCYCLE SAFETY
COOPERATIVE RESEARCH PROGRAM**

Texas Department of Transportation
<https://tti.tamu.edu/documents/0-6994-R1.pdf>

TEXAS A&M TRANSPORTATION INSTITUTE PROVING GROUND

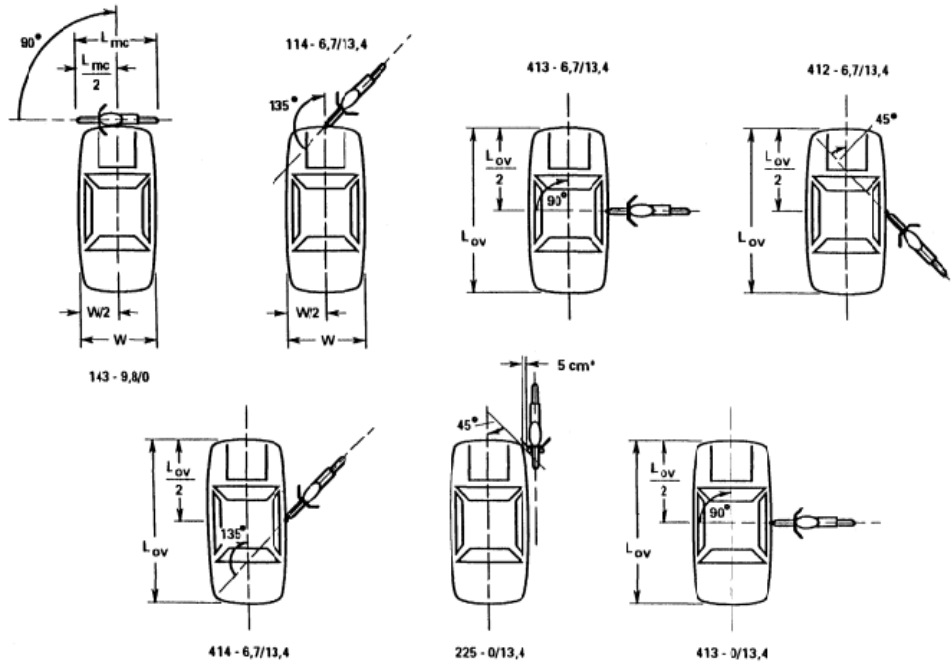
Figure 2.2. ISO 13232-2 Impact Configurations (12).

Figure 2.2 illustrates the seven impact configurations specified by ISO 13232-2 to determine severity of motorcycle (MC) impact against an opposing vehicle (OV). Table 2.1 gives the details of the seven configurations.

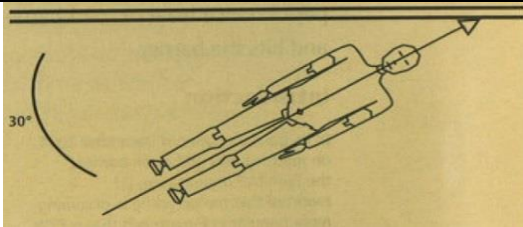
<p>Test 1. Dummy aligned w/ launch path</p>

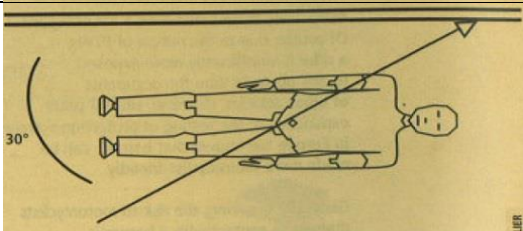
<p>Test 2. Dummy parallel to the test item</p>

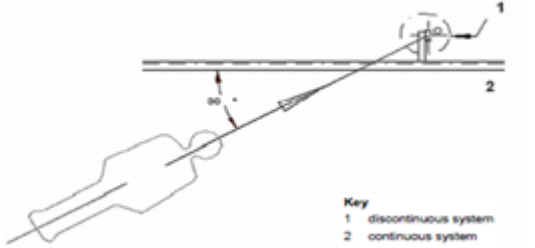
<p>Test 1. Launch Configuration 1: Post-Centered Impact</p>

<p>Key 1 discontinuous system 2 continuous system</p>
<p>Test 2. Launch Configuration 2: Post-Offset Impact</p>

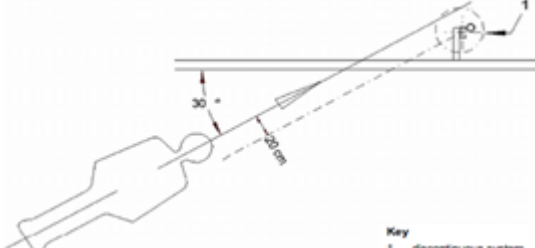
<p>Key 1 discontinuous system</p>
<p>Test 3. Launch Configuration 3: Midspan Impact</p>

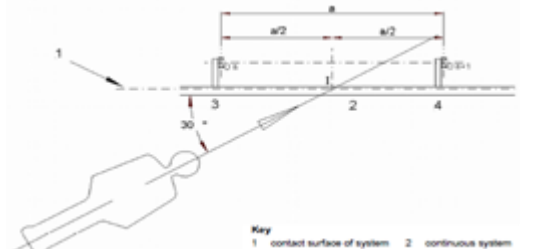
<p>Key 1 contact surface of system 2 continuous system 3 post-n 4 post-n+1</p>

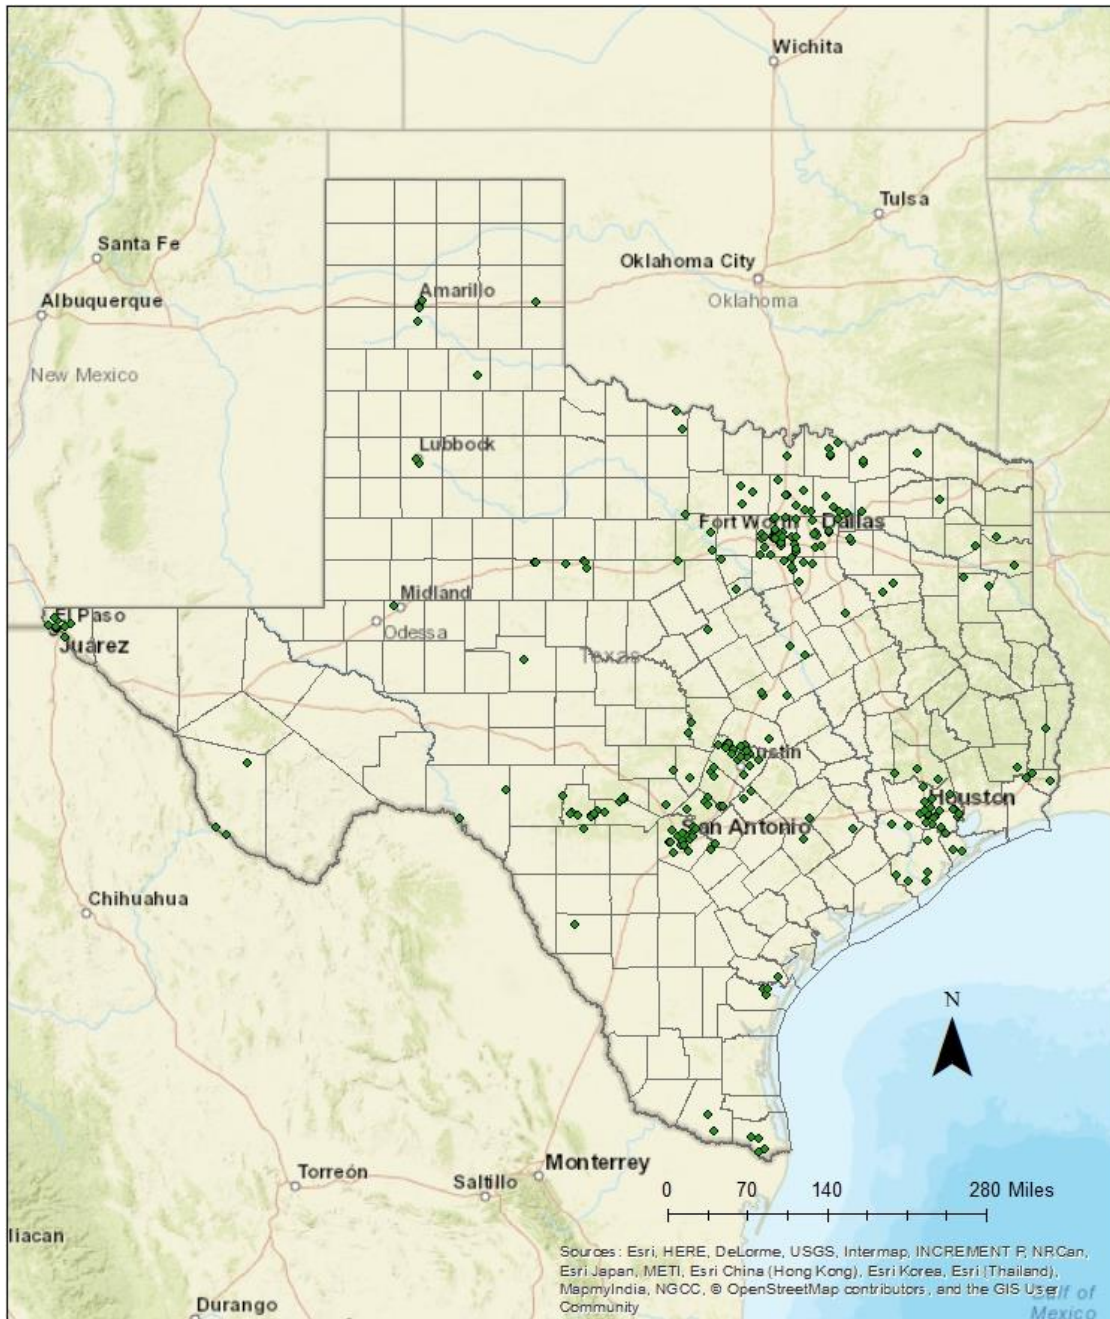
Figure 3.3. Map of Fatal and Suspected Serious Injury Motorcycle Crashes Involving Guardrail Contact, 2010–2017.

Figure 3.3 shows that fatal and suspected serious injury SMV motorcycle crashes involving guardrails occurred in 77 of the 254 Texas counties between 2010 and 2017.

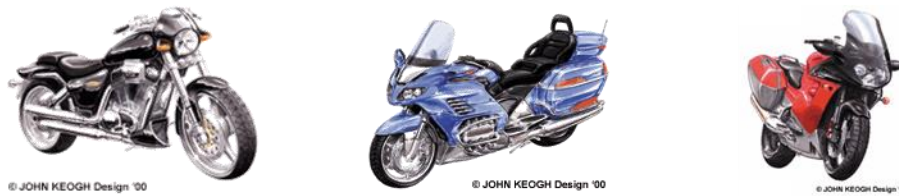
Figure 3.4. Examples of Cruiser, Touring, and Sport-Touring Motorcycles.

The data obtained from the VIN decoding gave more details about the motorcycles involved. Using the returned information on the vehicle body class, researchers obtained a better understanding of the type of motorcycles involved in the crashes. Combining the body class categories of custom, touring, and cruiser, researchers found that 57 percent of the riders were on a motorcycle that would be considered a cruiser body style. Figure 3.4 shows the different types.

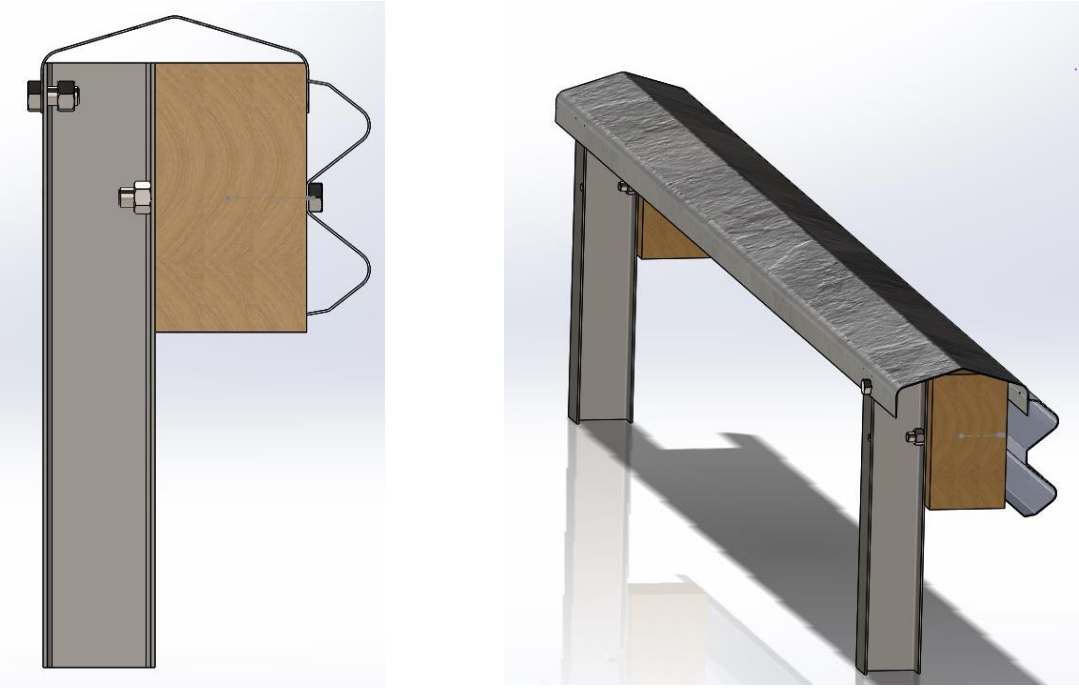
Figure 4.1. Option 1 Conceptual Drawing for Bent Plate Top Protection.

Figure 4.1 shows a bent plate top protection attached to a standard MGS. Option 1 consists of a plate bent to form a smooth vertex on top, gently sloping down and outward from the vertex and bent down at the ends to provide some vertical distance for attachment to the steel post. The top protection bent plate can be provided with the same material and thickness as that of the W-beam rail. Table 4.1 lists the advantages and disadvantages of Option 1.

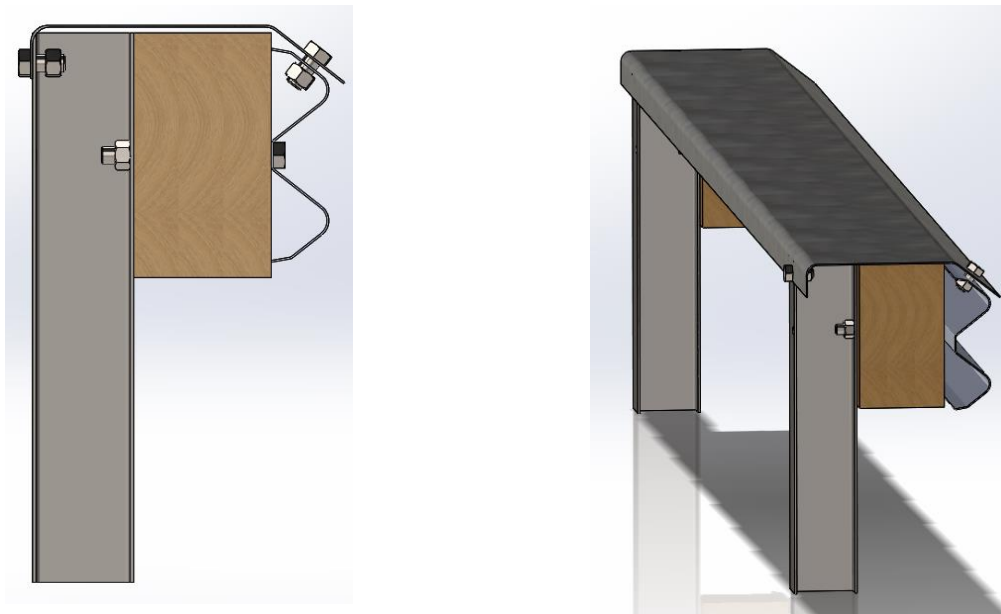
Figure 4.2. Option 2 Conceptual Drawing for Flat Plate Top Protection.

Figure 4.2 shows a flat plate top protection attached to a standard steel-post MGS with 8-inch blockouts. Option 2 consists of a flat plate bent vertically at one end and sloped at the other end to accommodate attachment to the existing W-beam rail. Attachment is provided by a bolted connection at suitable intervals. Bent radius can be determined based on the required smoothness on top with reasonable dimensions. Top protection can be provided with the same material and thickness as that of a W-beam rail. Thickness can be reduced to a certain extent to provide adequate flexibility for

better rider protection during an impact event. Table 4.2 lists the advantages and disadvantages of Option 2.

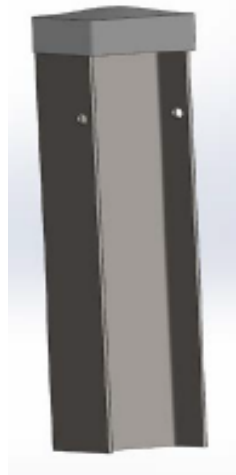
Figure 4.3. Option 3 Conceptual Drawing for Top Protection Cap for MGS Steel Posts.

Figure 4.3 shows a top protection cap for discrete posts of the standard MGS. Option 3 consists of a cap attached to the top of the steel post. Attachment is relatively easy and does not require a bolted connection. Top protection can be provided with a suitable thickness and appropriate dimensions that allow flexibility for implementation. Table 4.3 lists the advantages and disadvantages of Option 3.

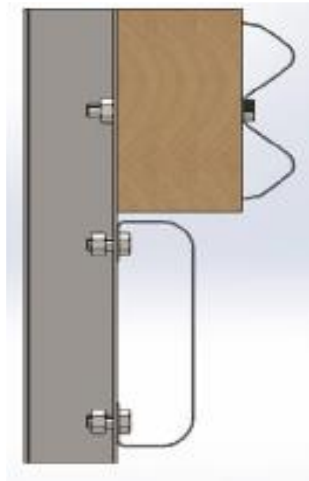
Figure 4.4. Option A Conceptual Drawing for Flat Plate for Bottom Protection.

Figure 4.4 shows a flat bottom protection for a steel-post MGS. Option A consists of a round-cornered flat bottom plate attached to the posts with two bolts (at the top and bottom of the plate). The plate is spaced at a suitable distance from the post to allow adequate deformation when a motorcyclist impacts while sliding. The plate is smoothly bent at the ends to provide sufficient length for bolting. The thickness and material of the bottom plate can be the same as those of the standard MGS top rail. However, thickness can be investigated through computer simulations to provide flexibility to dissipate adequate energy after motorcyclist impact to lower injury risk. The distance

between the flat bottom rail and the existing W-beam rail should be minimized to prevent any chance for motorcyclist limbs entangling between the rail and bottom protection. Table 4.4 lists the advantages and disadvantages of Option A.

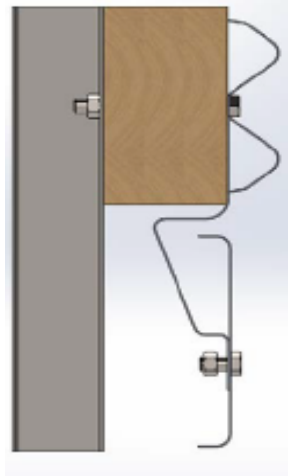
Figure 4.5. Option B Conceptual Drawing for Flat Plate Attached to Connection Plates.

Figure 4.5 shows a flat plate bottom protection for a steel-post MGS. Option B consists of a continuous rubrail attached to the upper W-beam rail and blockout through discrete connection plates. The plates are inserted between the top rail and the blockout through a single bolt connection. The rubrail could be inclined at an angle. The thickness and material of the plates and rubrail can be the same as those of a standard W-beam. However, thickness can be reduced based on computer simulations to provide

flexibility and energy dissipation during motorcyclist impact. The distance between the flat bottom rail and the existing W-beam rail should be minimized to reduce the chance for motorcyclist limbs entangling between the rail and bottom protection. Table 4.5 lists the advantages and disadvantages of Option B.

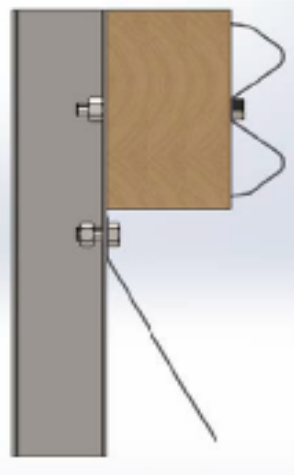
Figure 4.6. Option C Conceptual Drawing for Inclined Plate Attached to Posts.

Figure 4.6 shows the inclined plate for bottom protection for a steel-post MGS. Option C consists of a continuous plate attached to the front of the posts of the MGS and then bent to form an incline at the bottom to accommodate a sliding rider during an impact event. The thickness and material of the plate can be the same as those of the standard MGS top rail. However, thickness can be reduced based on computer simulations to provide flexibility and therefore energy dissipation during motorcyclist impact. The bottom end of the plate should be at a suitable height from the ground to prevent accumulation of debris at the bottom. The advantages and disadvantages for this option are similar to Option A (Table 4.4).

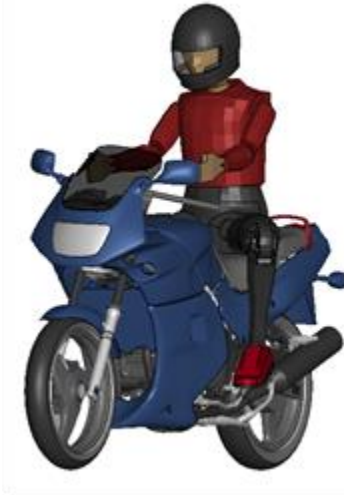
Figure 5.1. Motorcycle and ATD FE Model.

An FE model of the selected design was developed, and LS-DYNA was used to perform impact simulations. The design was evaluated according to *MASH TL-3* and according to upright and sliding motorcyclist impact configurations. Figure 5.1 shows the motorcycle and Hybrid III 50th percentile ATD model. The ATD FAST Hybrid III 50th percentile model was developed by LSTC. The simulation results were used to evaluate whether any design modifications were required to the developed design system to increase the likelihood of meeting the project objectives before proceeding with full-scale crash testing.

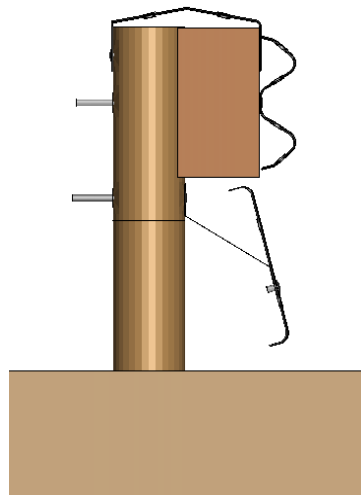
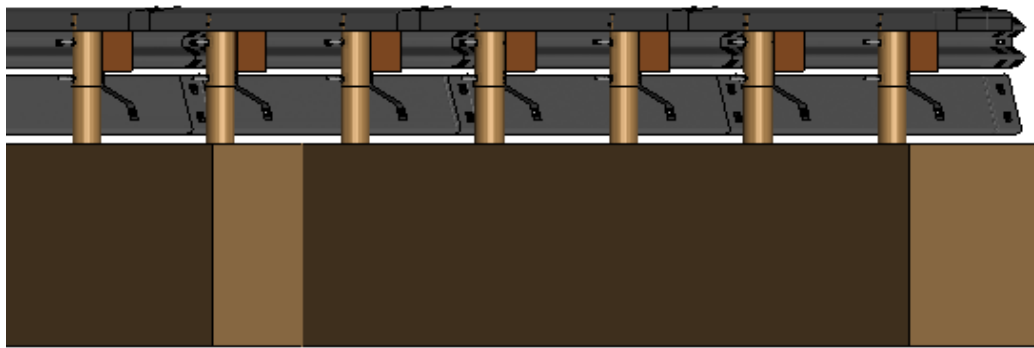
Figure 5.2. FE Model of Retrofit Guardrail System.

Figure 5.2 shows the model that was developed to retrofit the existing guardrail system to address errant motorcyclists' safety. This model included the top rail and rubrail design options.

(a) Side View

(b) Perspective Rear

(c) Perspective Front

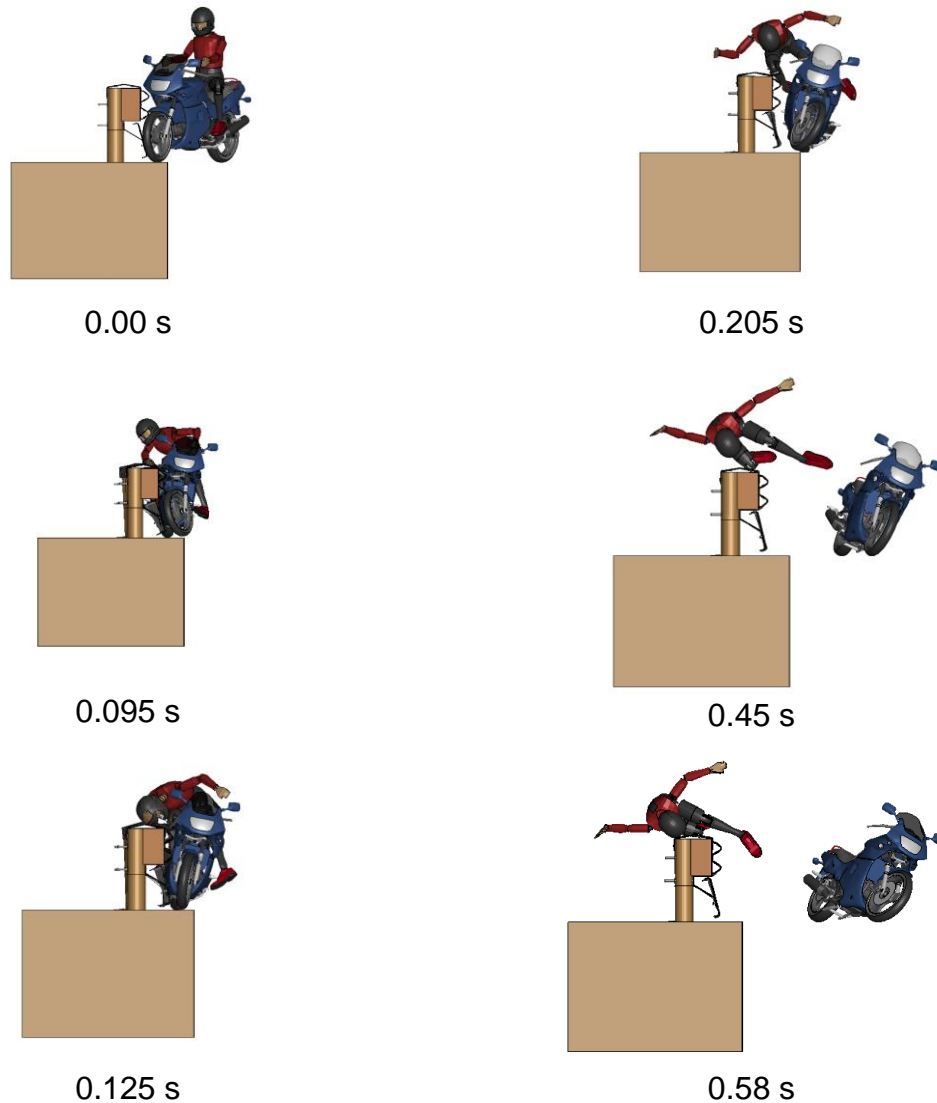
Figure 5.3. Sequential Images of Upright Motorcyclist Impact with Barrier.

The developed retrofitted computer model was used to perform simulations with a motorcycle and ATD computer model. The purpose of this simulation was to verify the general behavior of the guardrail retrofitted system during a motorcycle-rider impact event, as well as to understand the ATD interaction with the barrier during impact. The

impact conditions were determined by referring to literature of previous sliding motorcycle crash tests. The impact angle of the motorcycle with rider was 30 degrees, and the impact velocity was 37 mi/h. Figure 5.3 shows sequential images of the simulation.

During initial impact with the guardrail, the ATD began ejecting from the motorcycle and sliding across the top of the system. The ATD eventually traversed to the field side of the system. No significant snagging of any ATD limbs with the guardrail system was observed. Thus, the system appeared adequate in minimizing ATD interaction with discrete elements of the guardrail system.

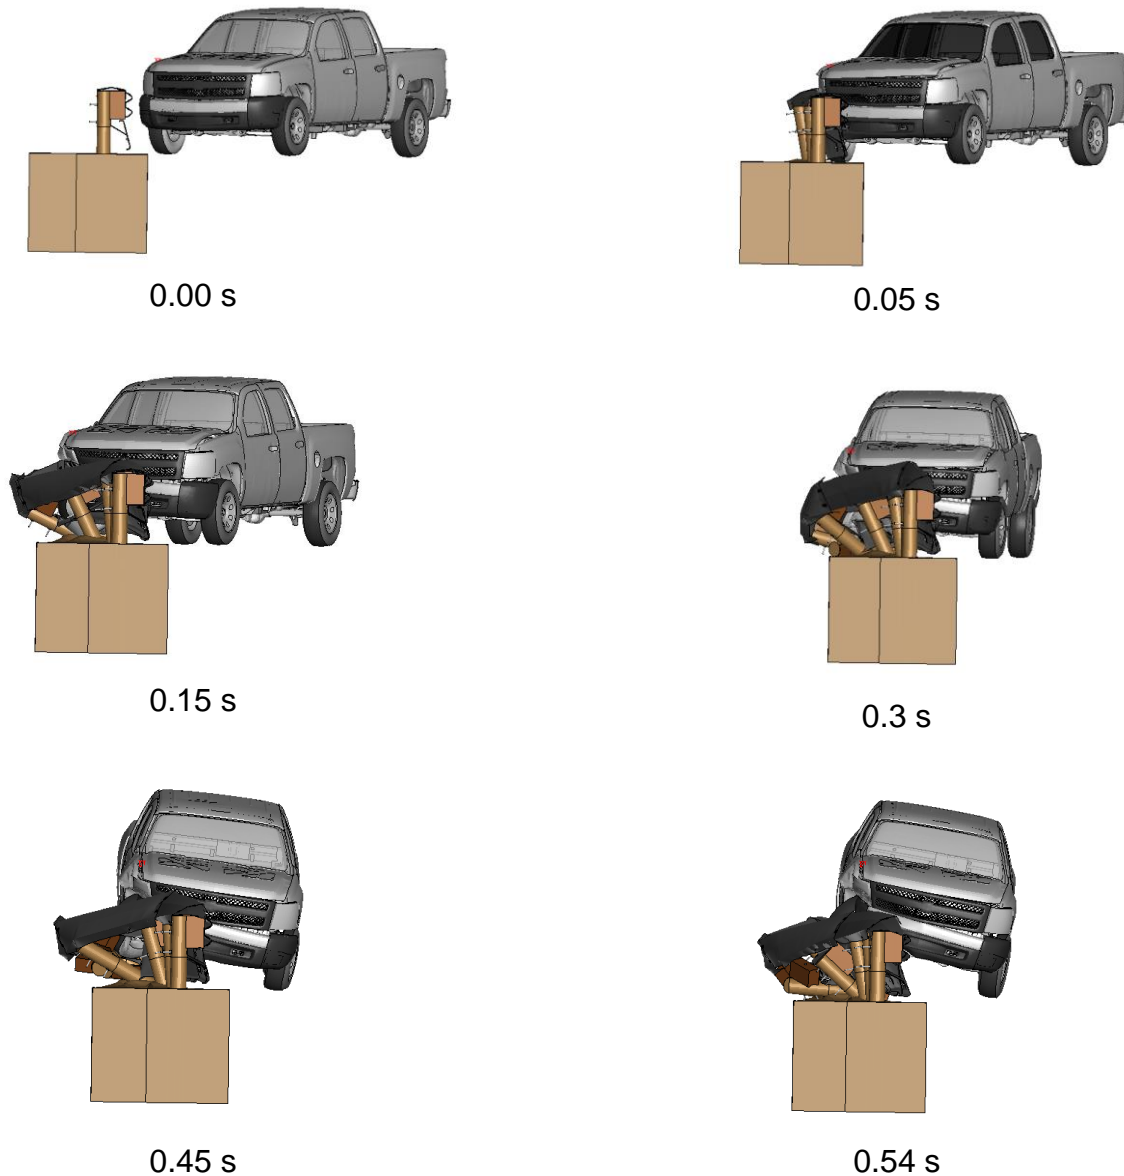
Figure 5.4. Sequential Images of *MASH* Test 3-11 Impact with Barrier.

The pickup truck was successfully contained and redirected during impact with the guardrail system. The vehicle remained stable throughout the event, and the occupant risk values were below the *MASH* limit. During the impact event, however, it was noted that the pickup truck pushed down on the rubrail element and seemed to keep riding on top of it. Although it appeared that riding on top of the rubrail did not

A pickup truck FE model was used to impact the retrofit guardrail system according to *MASH* Test 3-11. The impact speed was 62 mi/h, and the impact angle was 25 degrees. Figure 5.4 shows sequential images of the simulation impact.

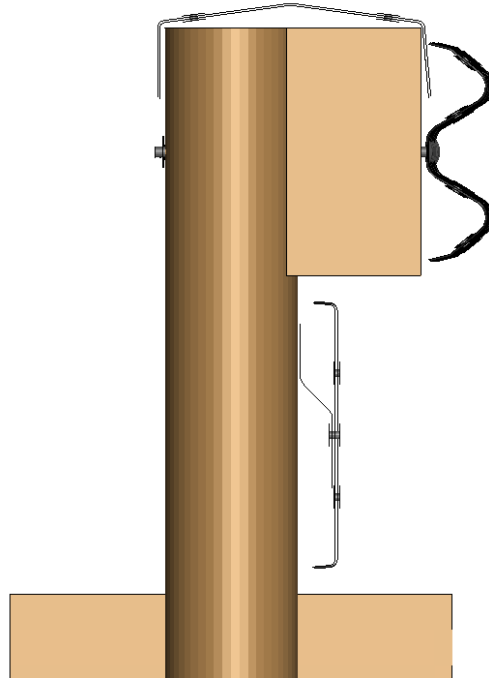
Figure 5.5. FE Model of Modified Retrofit Guardrail System.

A modification was made to the system to attach the rubrail with minimal offset from the wood posts to reduce some of the noted pickup truck interaction with the rubrail. Figure 5.5 shows a cross-section view of the modified system.

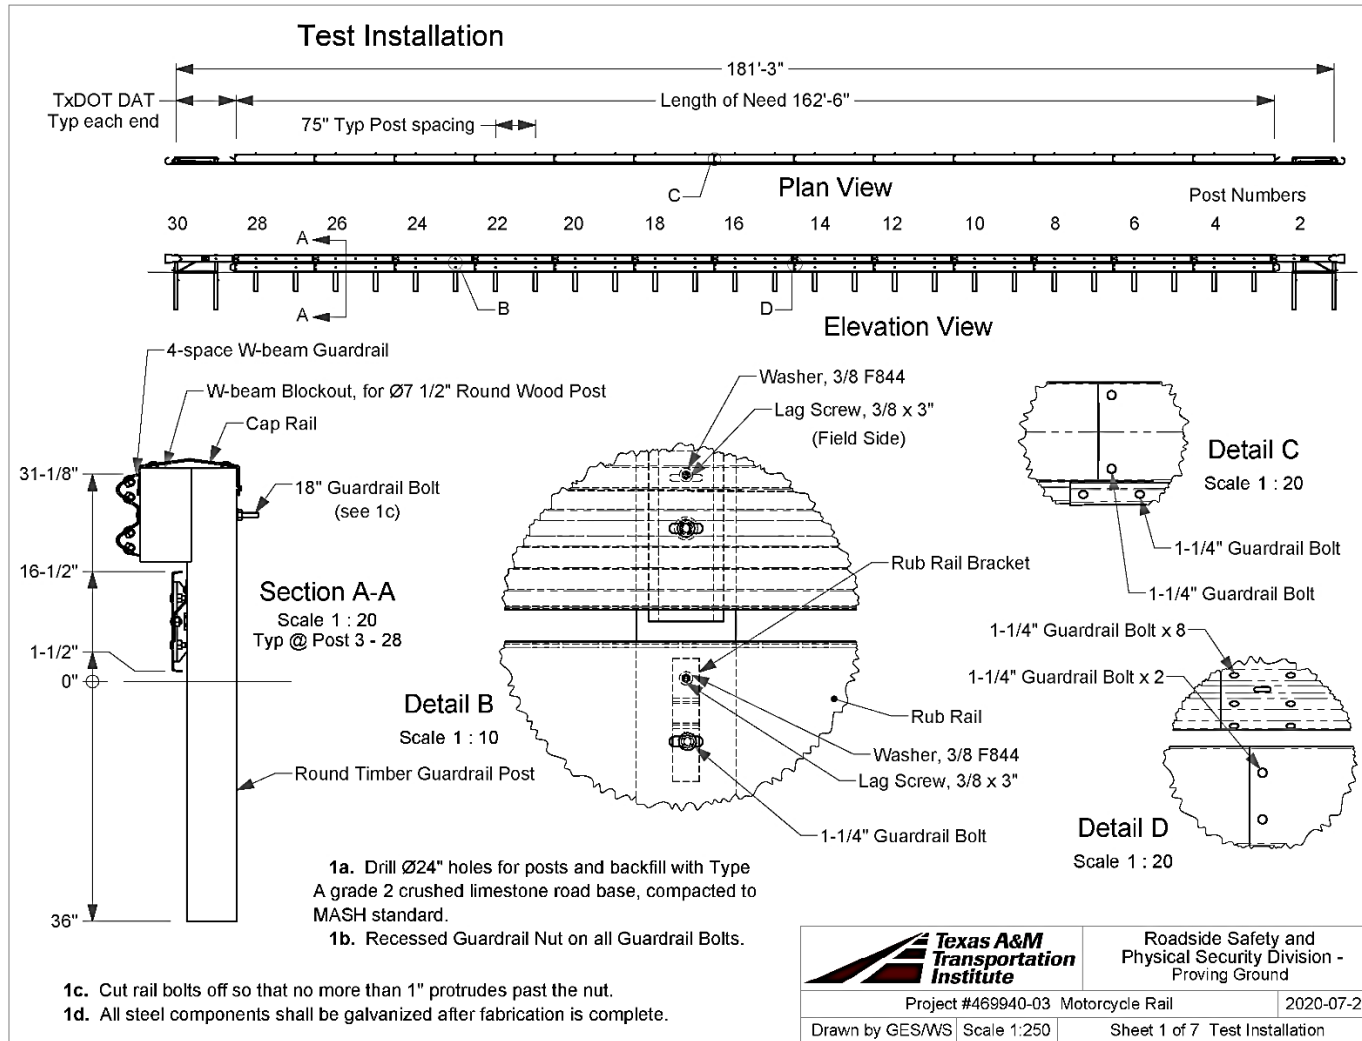
Figure 6.1. Details of Enhanced Motorcycle Guard Fence System for Crash Tests 469940-03-1, 469940-03-2, 469940-03-3, and 469940-03-4A.

Figure 6.1 presents the overall information on the enhanced motorcycle guard fence system installed for the 469940 tests, and Figure 6.2 through Figure 6.7 provide photographs of the installation. Figure 6.8 presents the overall information on the enhanced motorcycle guard fence system installed for the 469942 test, and Figure 6.9 and Figure 6.10 provide photographs of the installation. Figure 6.11 presents the overall information on the enhanced motorcycle guard fence system installed for the 469943 tests, and Figure 6.12 and Figure 6.13 provide photographs of the installation.

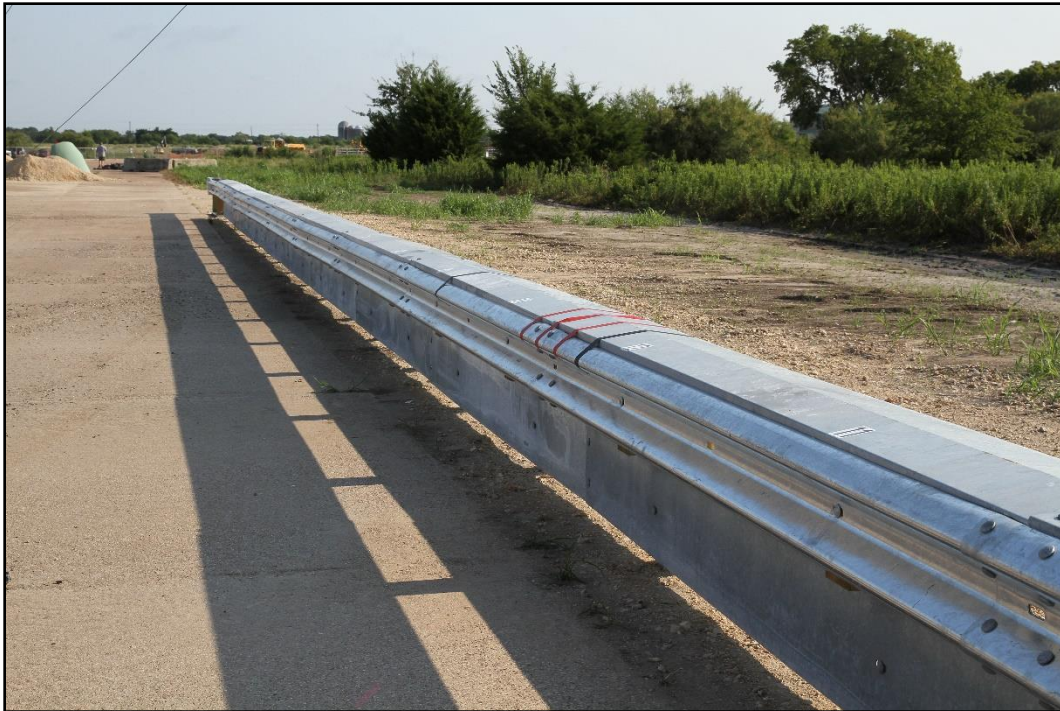
Figure 6.2. Enhanced Motorcycle Guard Fence System prior to Testing for 469940-03-1, 469940-03-2, 469940-03-3, and 469940-03-4A.

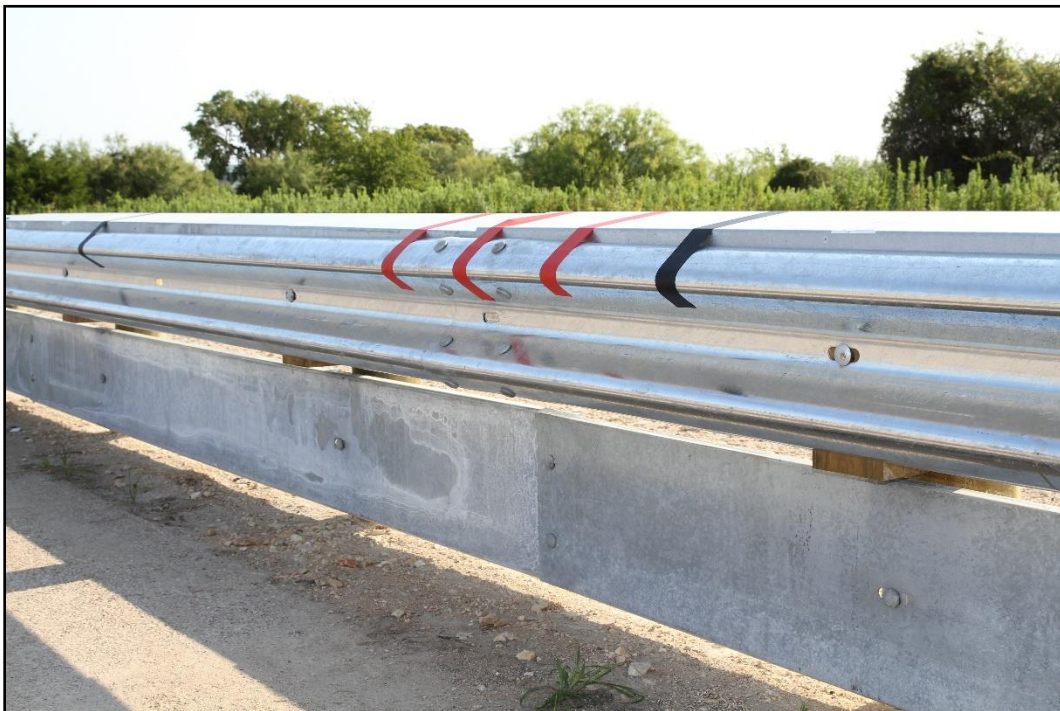
Figure 6.3. Enhanced Motorcycle Guard Fence System Rail Detail prior to Testing for 469940-03-1, 469940-03-2, 469940-03-3, and 469940-03-4A.

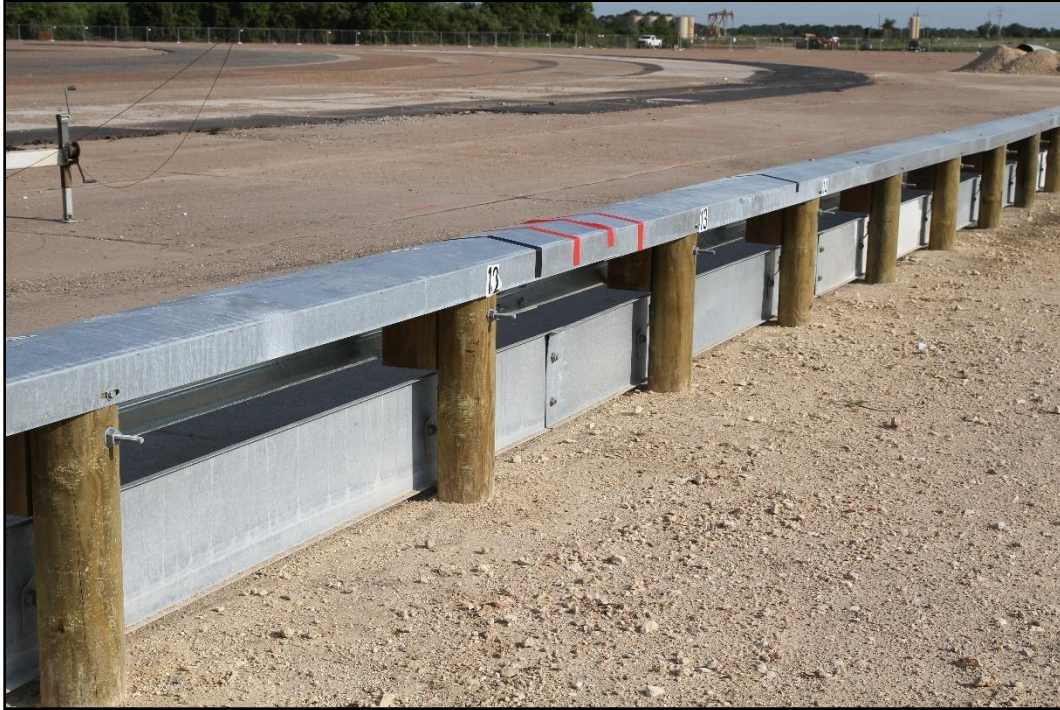
Figure 6.4. Field-Side View of the Enhanced Motorcycle Guard Fence System prior to Testing for 469940-03-1, 469940-03-2, 469940-03-3, and 469940-03-4A.

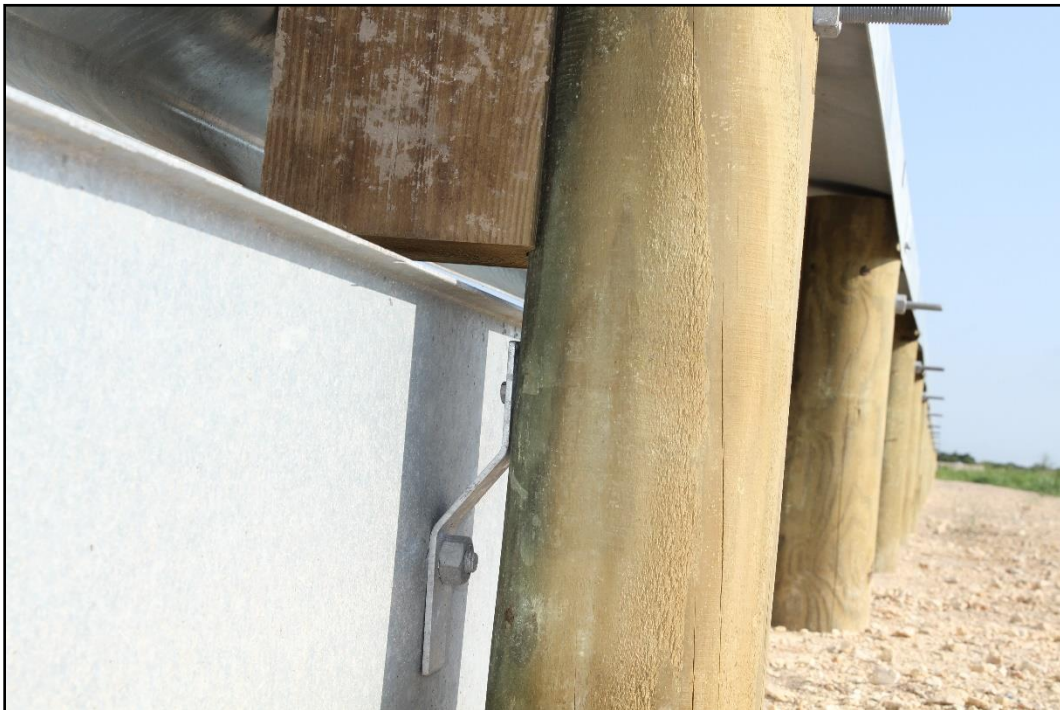
Figure 6.5. Enhanced Motorcycle Guard Fence System Rubrail Bracket Detail prior to Testing for 469940-03-1, 469940-03-2, 469940-03-3, and 469940-03-4A.

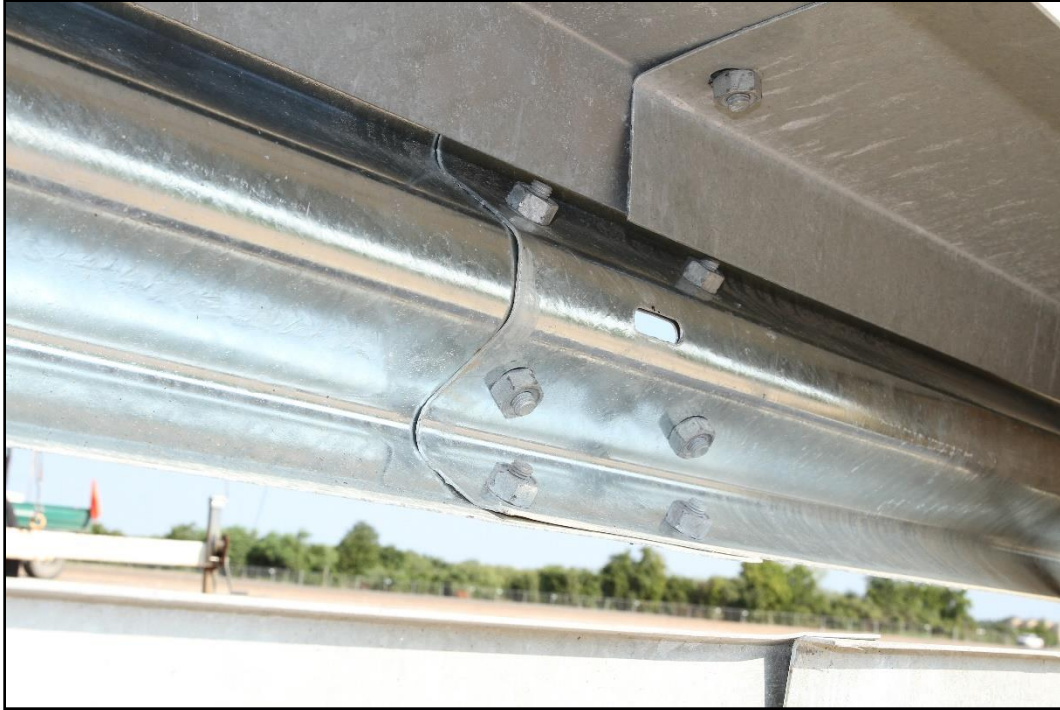
Figure 6.6. Enhanced Motorcycle Guard Fence System W-Beam Hardware Detail prior to Testing for 469940-03-1, 469940-03-2, 469940-03-3, and 469940-03-4A.

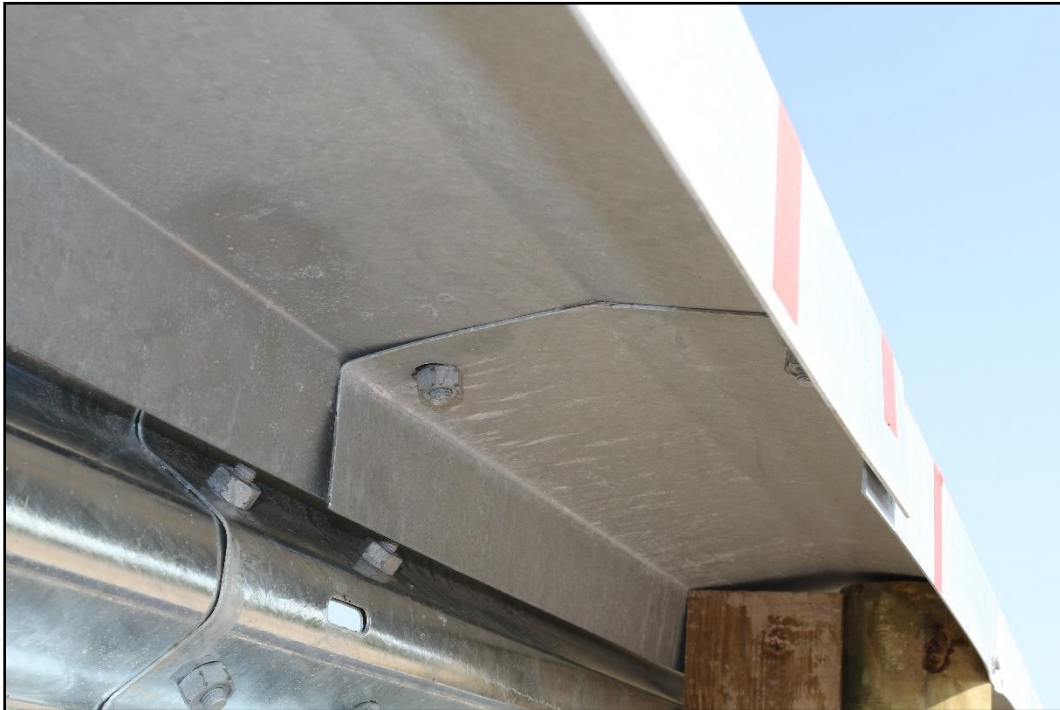
Figure 6.7. Enhanced Motorcycle Guard Fence System Cap Rail Hardware Detail prior to Testing for 469940-03-1, 469940-03-2, 469940-03-3, and 469940-03-4A.

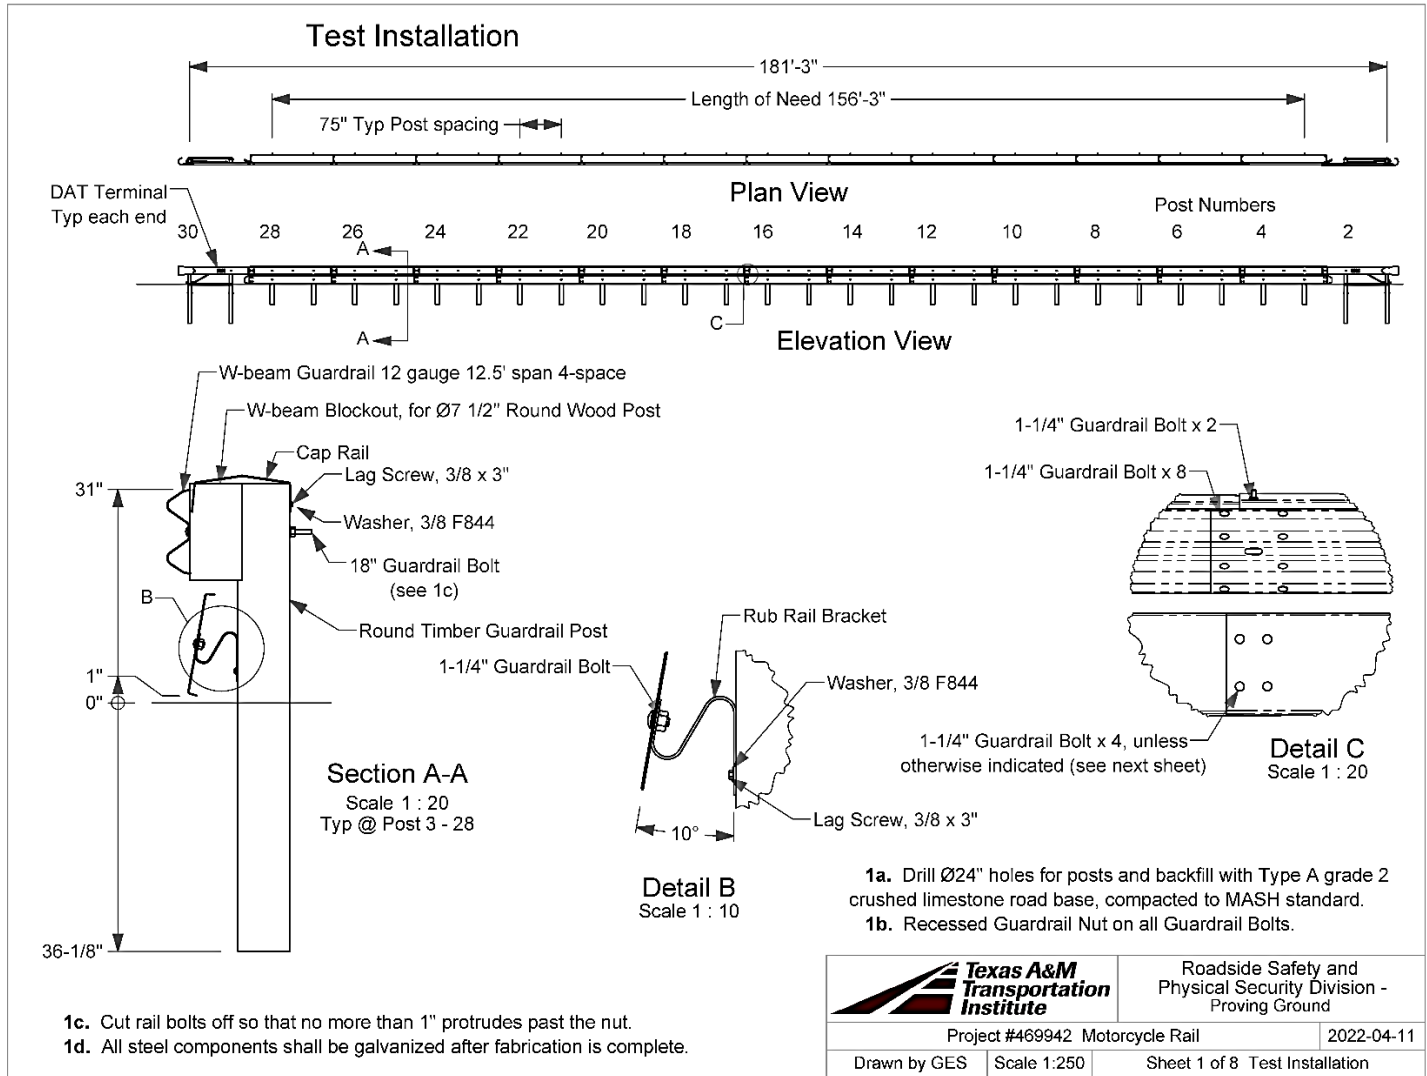
Figure 6.8. Details of Enhanced Motorcycle Guard Fence System for Crash Test 469942-01-1.

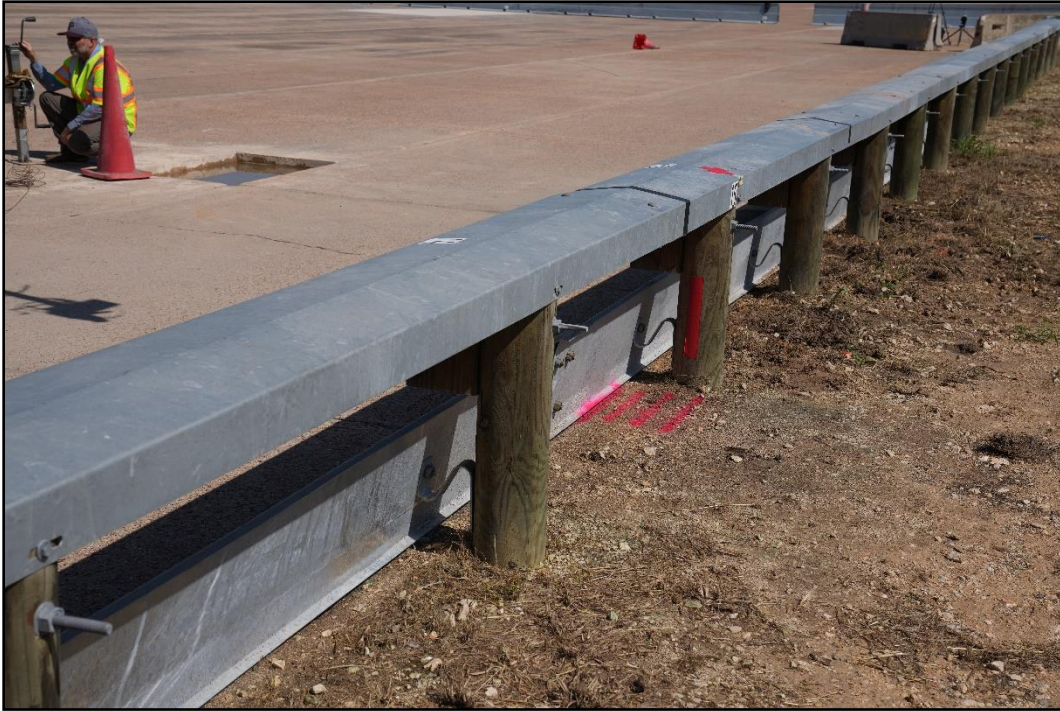
Figure 6.9. Field-Side View of the Enhanced Motorcycle Guard Fence System prior to Testing for 469942-01-1.

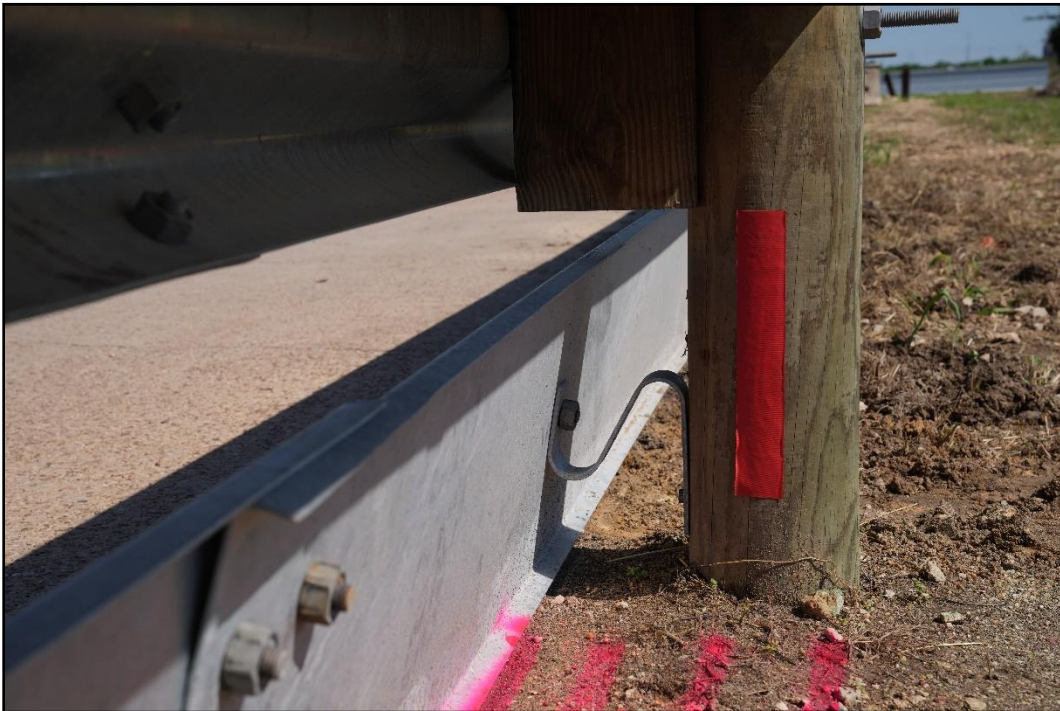
Figure 6.10. Enhanced Motorcycle Guard Fence System Rubrail Bracket Detail prior to Testing for 469942-01-1.

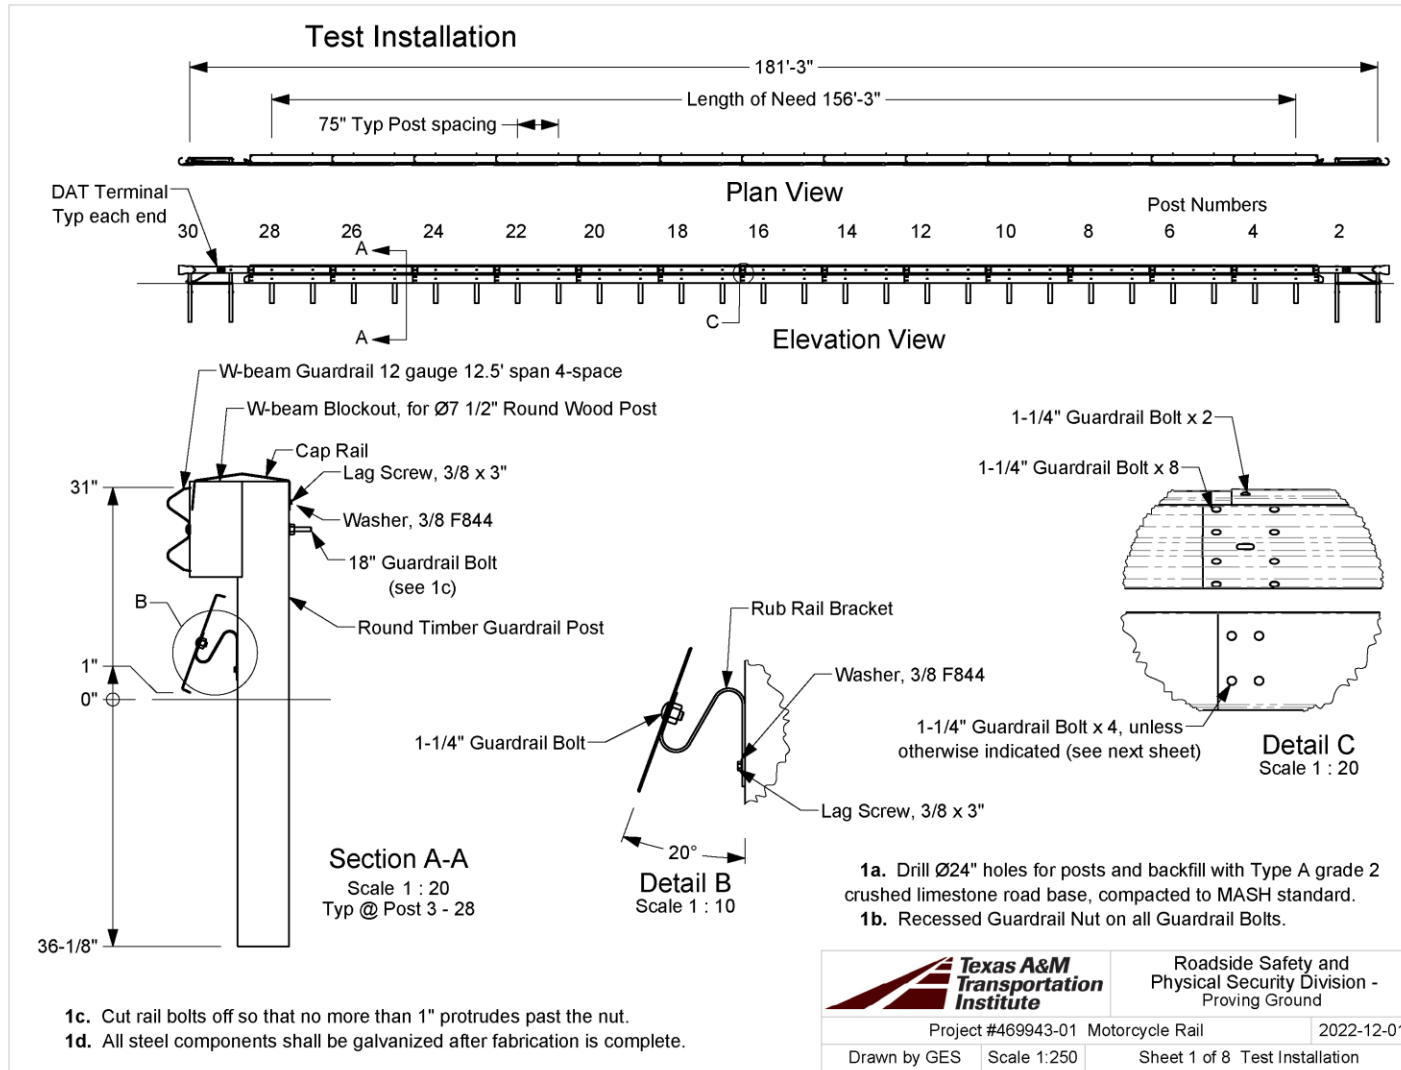
Figure 6.11. Details of Enhanced Motorcycle Guard Fence System for Crash Tests 469943-01-1A, 469943-01-2, 469943-01-3, and 469943-01-4.

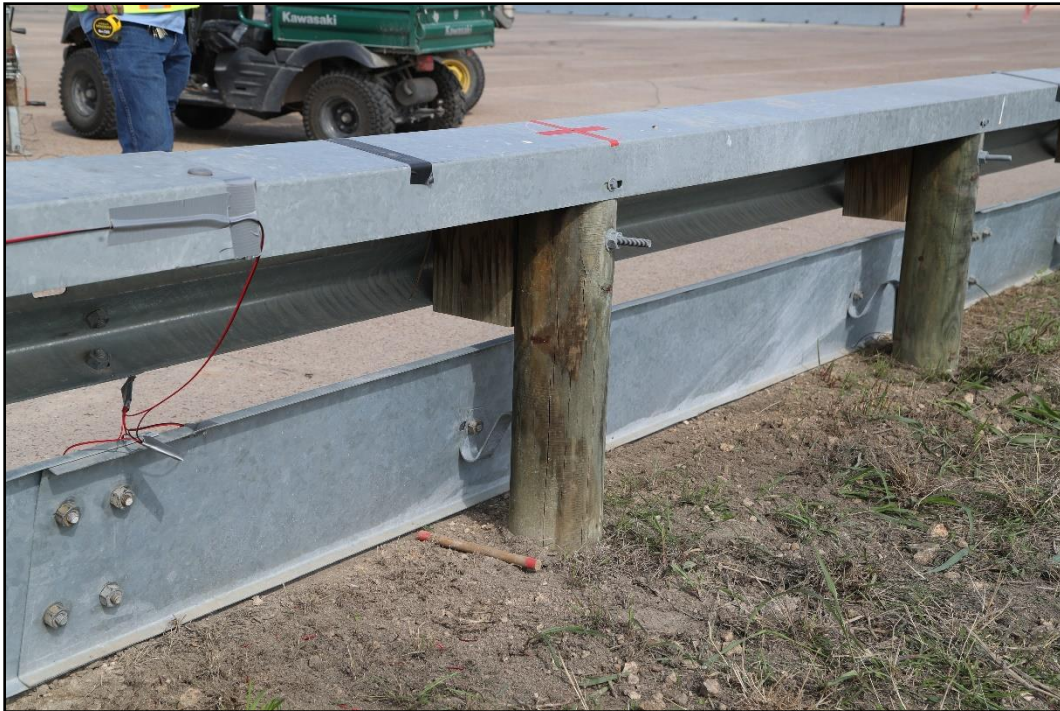
Figure 6.12. Field-Side View of the Enhanced Motorcycle Guard Fence System prior to Testing for 469943-01-1A, 469943-01-2, 469943-01-3, and 469943-01-4.
