Test Report No. 469940-03, 469942-01, and 469943-01

**DEVELOP A RETROFIT DESIGN FOR GUARD FENCE SYSTEM TO
ENHANCE MOTORCYCLE SAFETY
COOPERATIVE RESEARCH PROGRAM**

Texas Department of Transportation
<https://tti.tamu.edu/documents/0-6994-R1.pdf>

TEXAS A&M TRANSPORTATION INSTITUTE PROVING GROUND

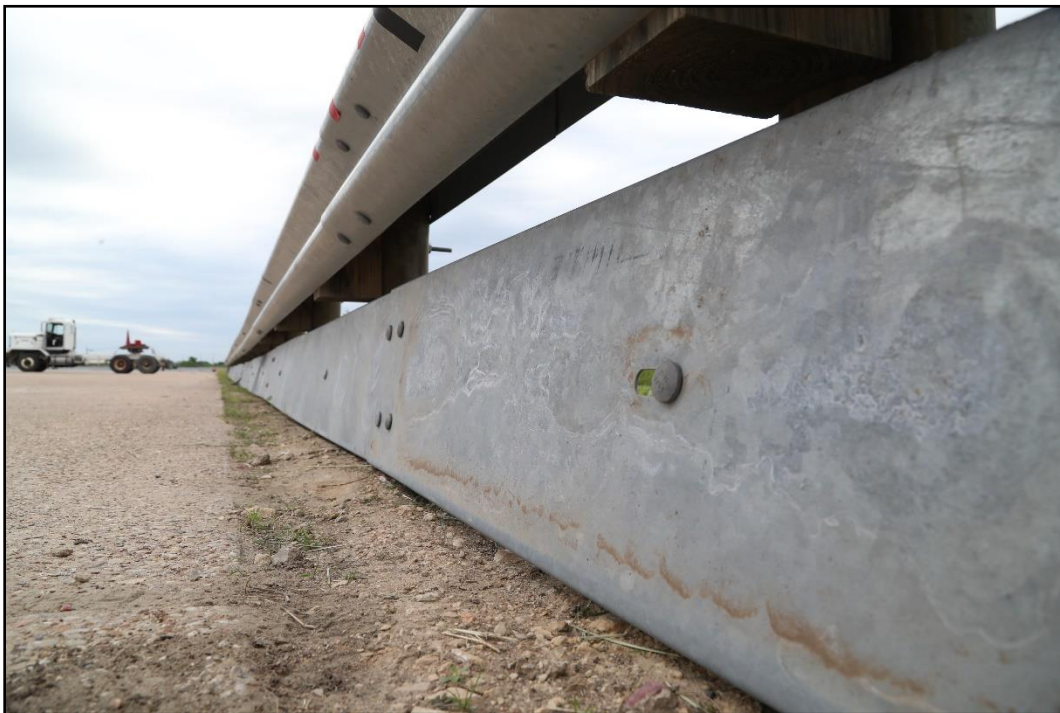
Figure 6.13. Enhanced Motorcycle Guard Fence System Rubrail Detail prior to Testing for 469943-01-1A, 469943-01-2, 469943-01-3, and 469943-01-4.

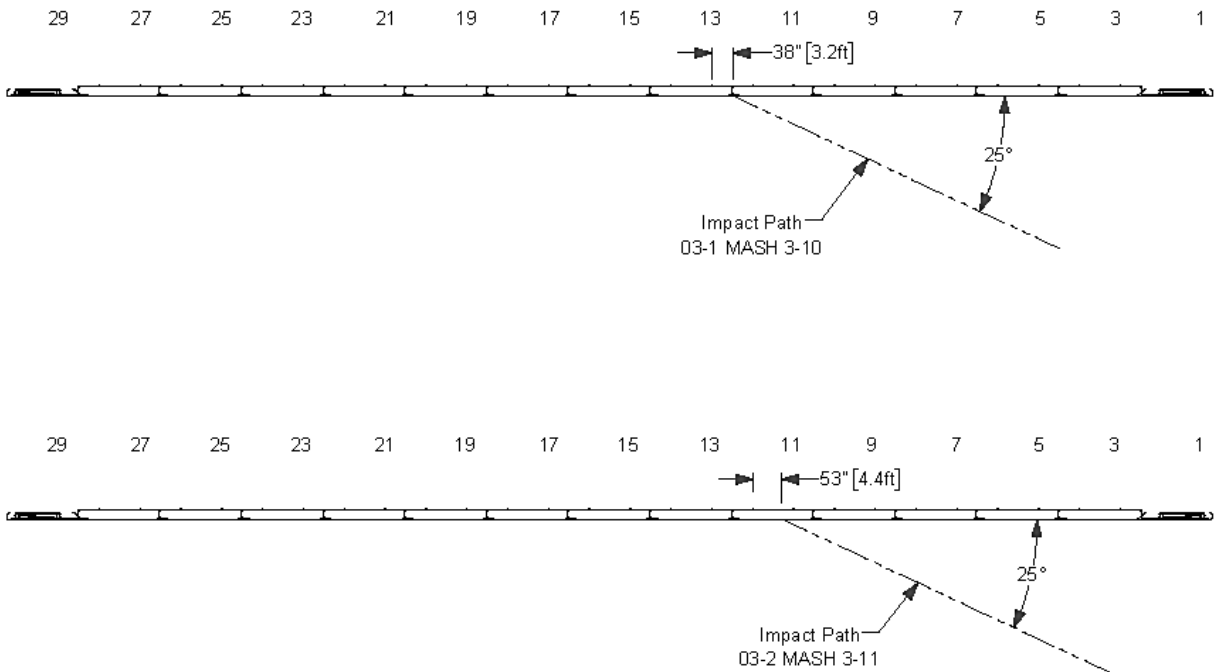
Figure 7.1. Target CIP for 469940-03-1 and 469940-03-2 Crash Tests on Enhanced Motorcycle Guard Fence System.

Table 7.1 shows the test conditions and evaluation criteria for the crash tests conducted on the enhanced motorcycle guard fence system. The target critical impact points (CIPs) for Tests 469940-03-1, 469940-03-2, 469943-01-3, and 469943-01-4 were determined using the information provided in *MASH* Section 2.2.1 and Section 2.3.2. The test condition for Test 469940-03-3 was for research purposes and was not based on any standard or specification. Test conditions for Tests 469940-03-4A, 469942-01-1, 469943-01-1A, and 469943-01-2 were based on criteria from EN 1317-8. Figure 7.1 through Figure 7.6 show the target CIPs for the various tests conducted on the enhanced motorcycle guard fence system.

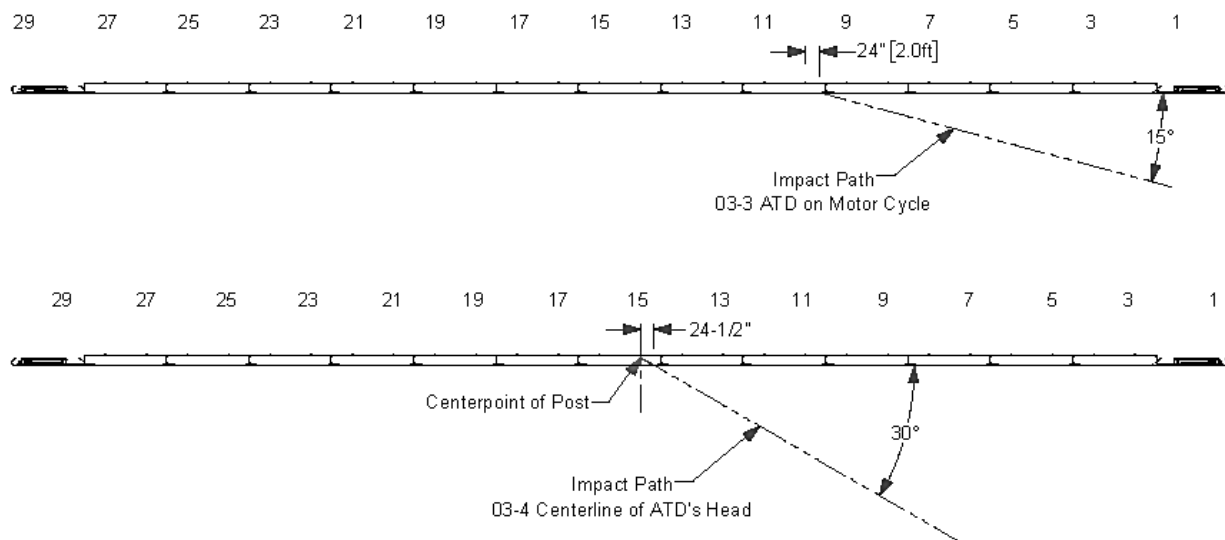
Figure 7.2. Target CIP for 469940-03-3 and 469940-03-4A Crash Tests on Enhanced Motorcycle Guard Fence System.

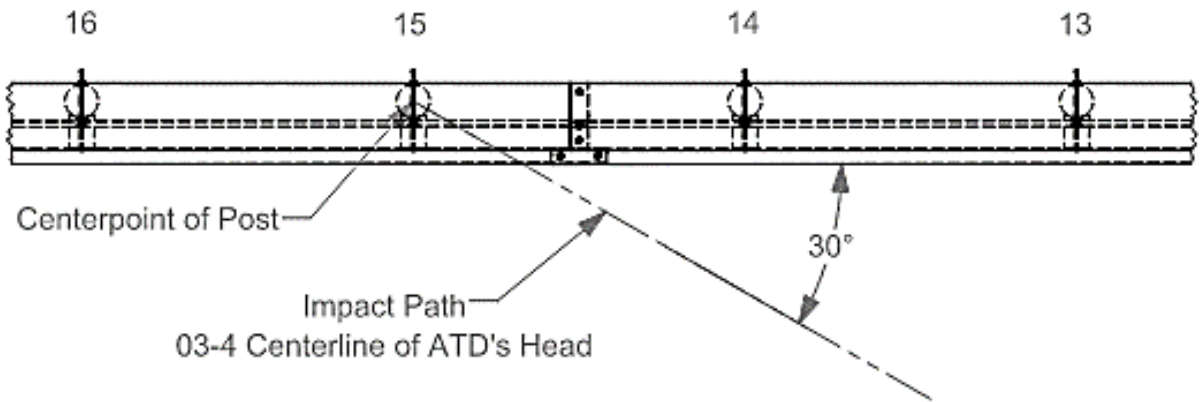
Figure 7.3. Target CIP for 469942-01-1 Crash Test on Enhanced Motorcycle Guard Fence System.

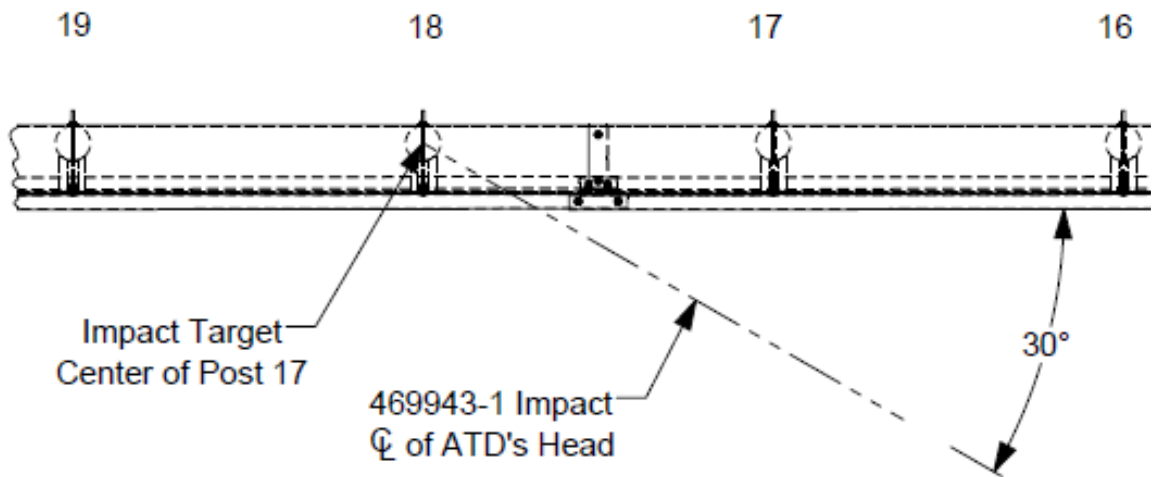
Figure 7.4. Target CIP for 469943-01-1A Crash Test on Enhanced Motorcycle Guard Fence System.

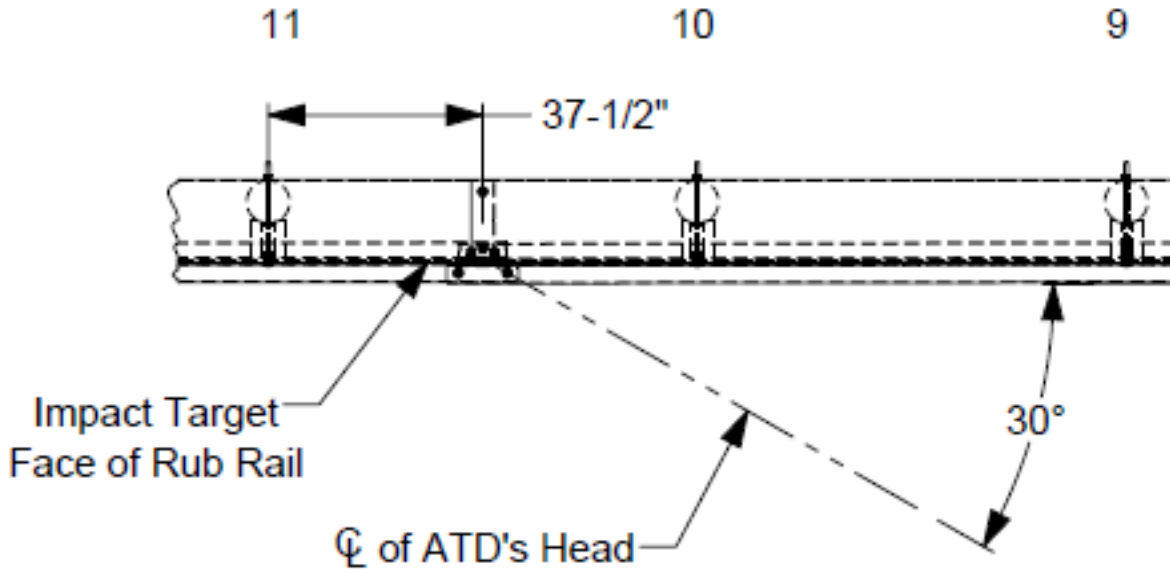
Figure 7.5. Target CIP for 469943-01-2 Crash Test on Enhanced Motorcycle Guard Fence System.

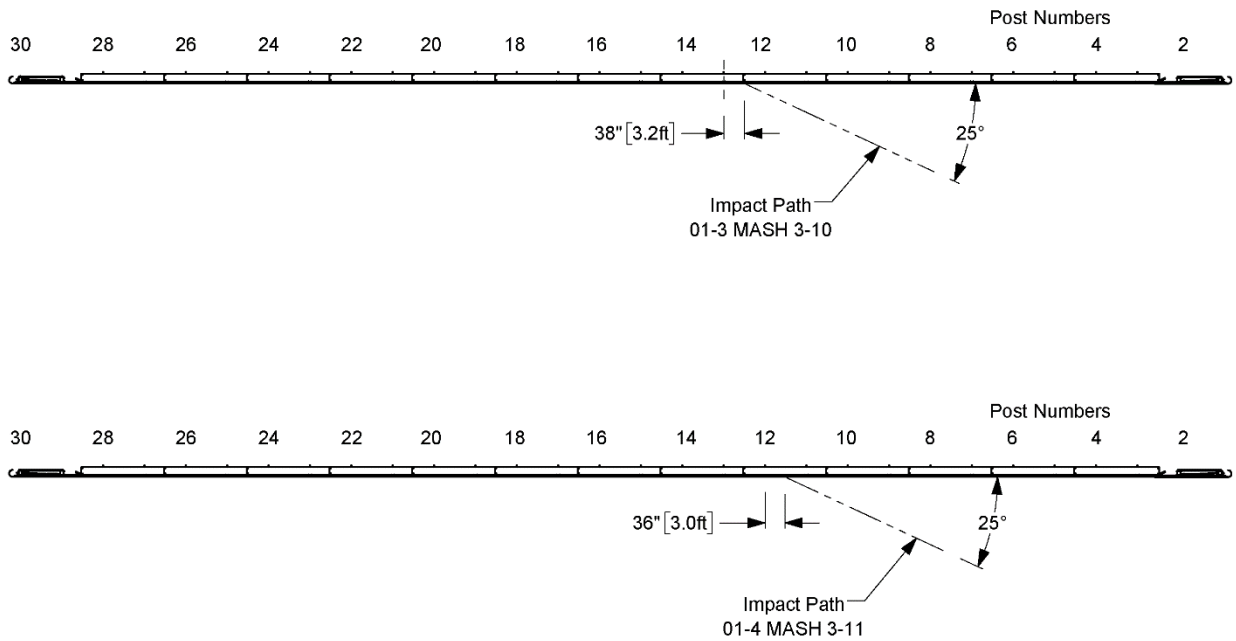
Figure 7.6. Target CIP for 469943-01-3 and 469943-01-4 Crash Tests on Enhanced Motorcycle Guard Fence System.

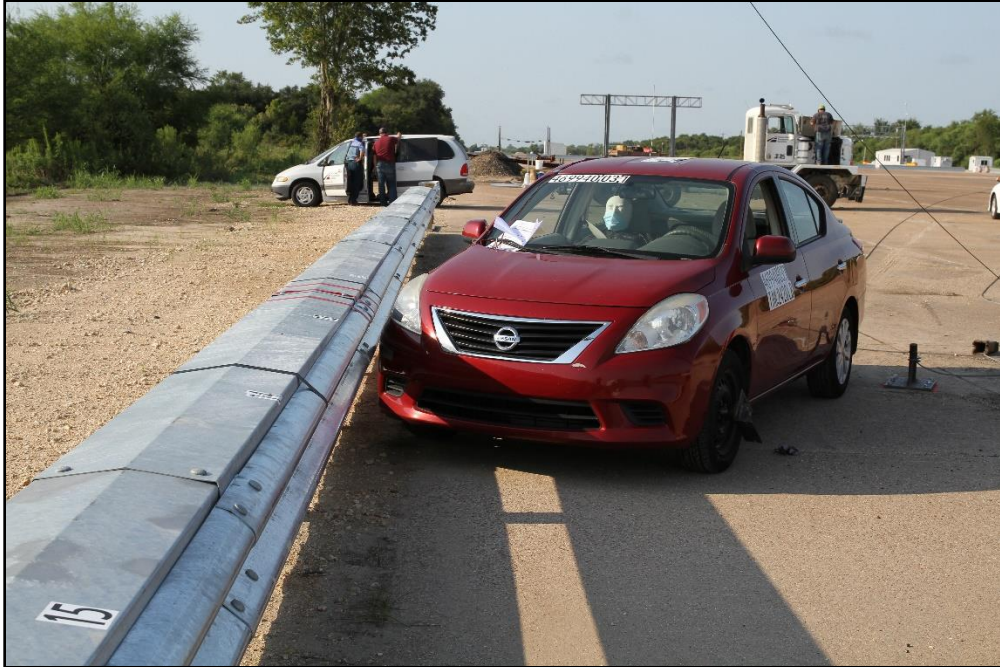
Figure 9.1. Enhanced Motorcycle Guard Fence System/Test Vehicle Geometrics for Test 469940-03-1.

See Table 9.1 for the *MASH* impact conditions and Table 9.2 for the exit parameters for Test 469940-03-1. Figure 9.1 and Figure 9.2 depict the target impact setup.

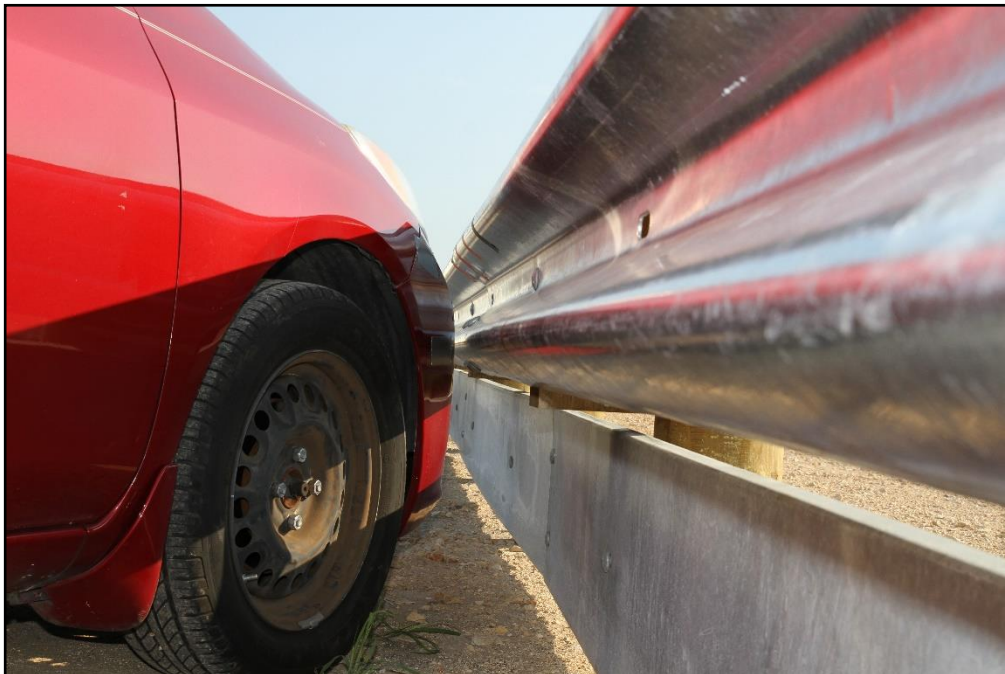
Figure 9.2. Enhanced Motorcycle Guard Fence System/Test Vehicle Impact Location for Test 469940-03-1.

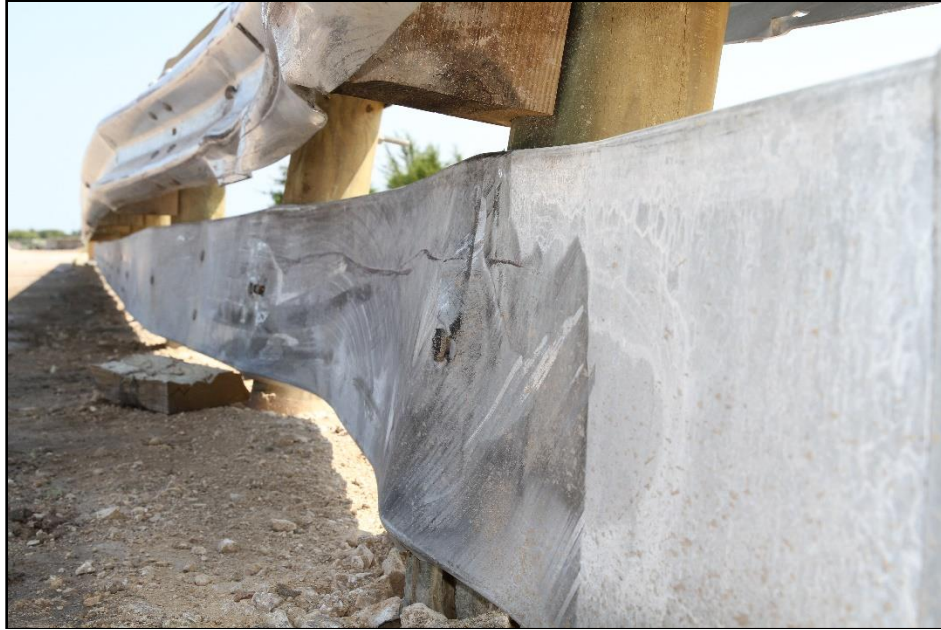
Figure 9.6. Enhanced Motorcycle Guard Fence System at the Rubrail at Impact after Test 469940-03-1.

There was no movement at the end terminals. Post 13 was cracked at grade, the blockout was missing from post 14, and the lower channel was detached from post 14. Table 9.6 details the soil gap and post lean information.

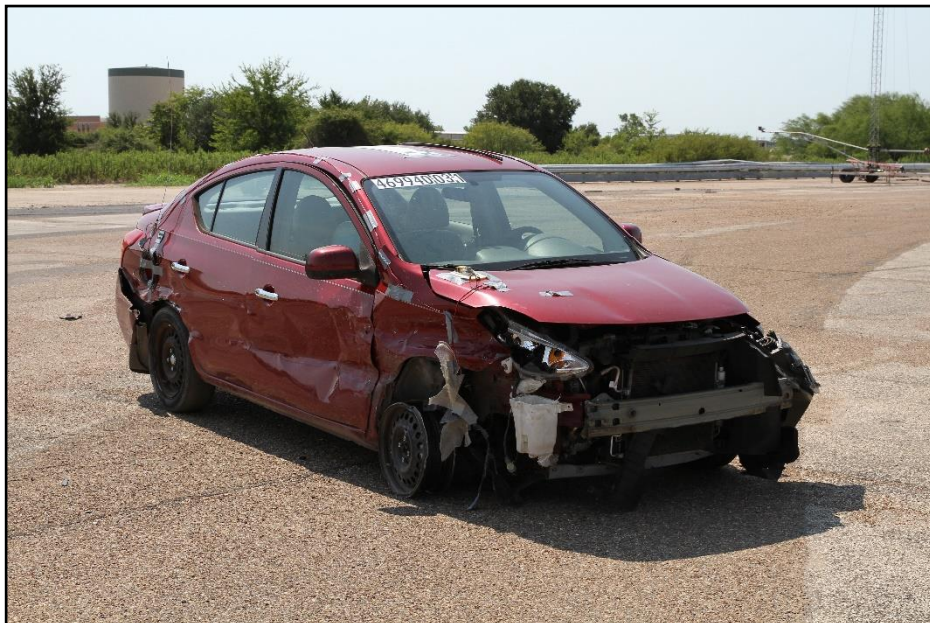
Figure 9.7. Impact Side of Test Vehicle after Test 469940-03-1.

Figure 9.7 and Figure 9.8 show the damage sustained by the vehicle. Figure 9.9 and Figure 9.10 show the interior of the test vehicle. Table 9.8 and Table 9.9 provide details on the occupant compartment deformation and exterior vehicle damage. Figures C.2 and C.3 in Appendix C.1 provide exterior crush and occupant compartment measurements.

Side Windows	Side windows remained intact
Maximum Exterior Deformation	8 inches in the right plane at the right front corner at bumper height
VDS	01RFQ2
CDC	01FREW1
Fuel Tank Damage	None
Description of Damage to Vehicle:	The front bumper, hood, grill, right front fender and headlight, radiator support, right front strut and tower, right front control arm, right front tire and rim, right front door, right rear door, and right rear fender and bumper were damaged. The right front door had a 2-inch gap at the top.

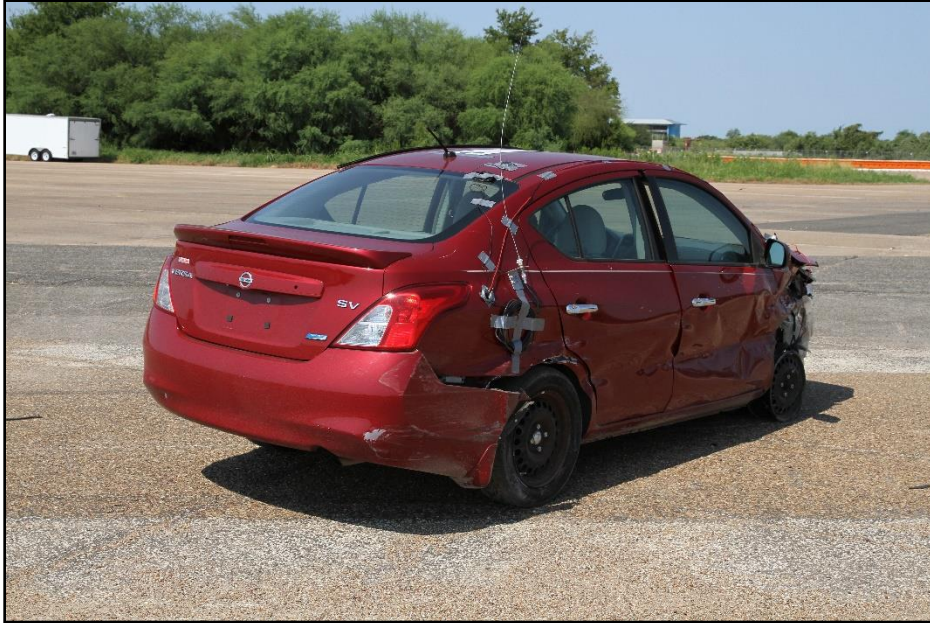
Figure 9.8. Rear Impact Side of Test Vehicle after Test 469940-03-1.

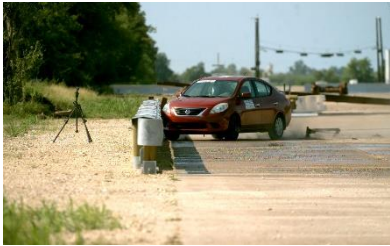
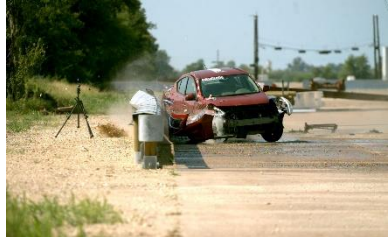
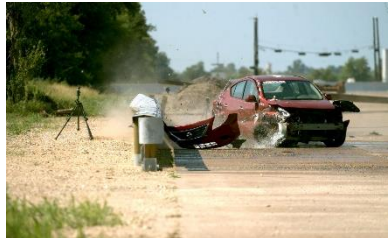
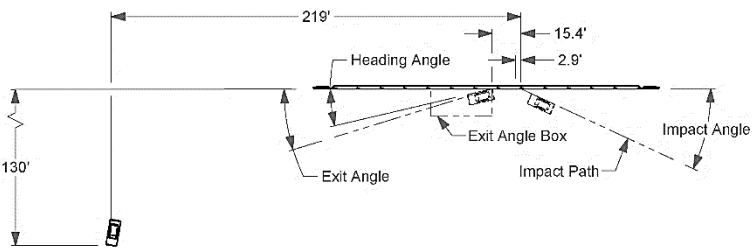
<p style="text-align: center;">0.000 s</p>	Test Agency	Texas A&M Transportation Institute (TTI)					
	Test Standard/Test No.	MASH 2016, Test 3-10					
	TTI Project No.	469940-03-1					
	Test Date	2020-08-05

<p style="text-align: center;">0.200 s</p>	TEST ARTICLE						
	Type	Longitudinal Barrier					
	Name	Enhanced Motorcycle Guard Fence System					
	Length	181 ft 3 inches

<p style="text-align: center;">0.400 s</p>	Key Materials	Round timber posts, cap rail, W-beam guardrail, rubrail					
	Soil Type and Condition	Type A Grade 2 crushed limestone					
	TEST VEHICLE						
	Type/Designation	1100C

<p style="text-align: center;">0.600 s</p>	Year, Make and Model	2014 Nissan Versa					
	Inertial Weight (lb)	2440					
	Dummy (lb)	165					
	Gross Static (lb)	2605					
IMPACT CONDITIONS							
Impact Speed (mi/h)	63.1						
Impact Angle (deg)	25.1						
Impact Location	35.2 inches upstream from the centerline of post 13

Impact Severity (kip-ft)	58.4						
EXIT CONDITIONS							
Exit Speed (mi/h)	43.4						
Trajectory/Heading Angle (deg)	17.0/13.2						
Exit Box Criteria	Vehicle crossed exit box 29 ft downstream						
Stopping Distance	219 ft downstream 130 ft to the traffic side						
TEST ARTICLE DEFLECTIONS							
Dynamic (inches)	19.5						
Permanent (inches)	10.5						
Working Width/Height (inches)	37.25/36.8						
VEHICLE DAMAGE							
VDS	01RFQ2						
CDC	01FREW1						
Max. Ext. Deformation (inches)	8						
Max Occupant Compartment Deformation	None						
OCCUPANT RISK VALUES							
Long. OIV (ft/s)	19.2	Long. Ridedown (g)	8	Max 50-ms Long. (g)	-7.4	Max Roll (deg)	8.1
Lat. OIV (ft/s)	21.7	Lat. Ridedown (g)	9.9	Max 50-ms Lat. (g)	-8.8	Max Pitch (deg)	3.3
THIV (m/s)	9.5	ASI	1.16	Max 50-ms Vert. (g)	2.4	Max Yaw (deg)	62.1

Figure 9.11. Summary of Results for MASH Test 3-10 on Enhanced Motorcycle Guard Fence System.

Figure 9.11 summarizes the results of *MASH* Test 469940-03-1.

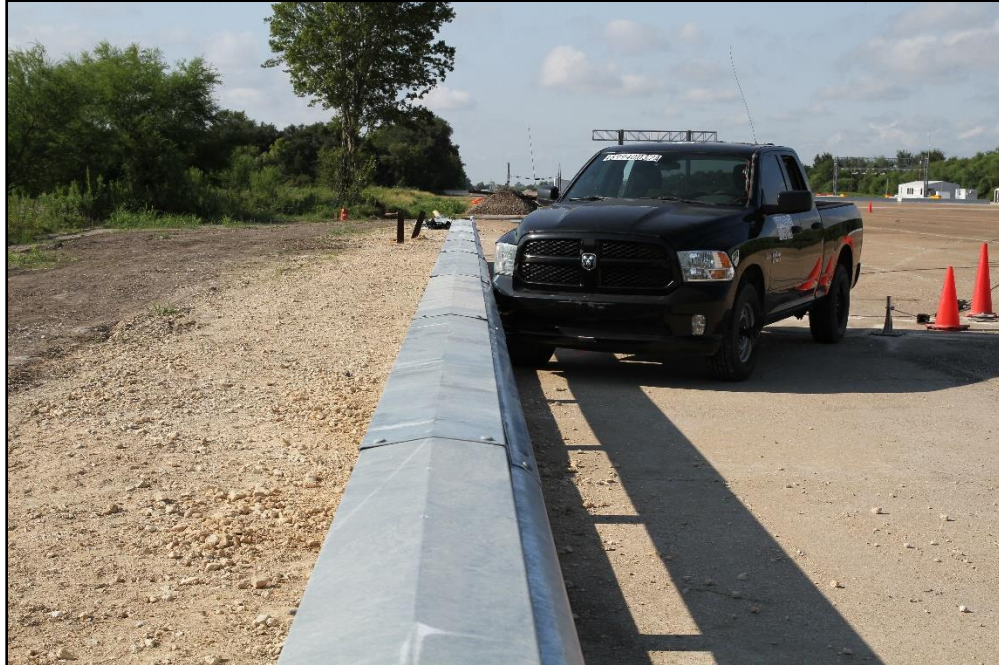
Figure 10.1. Enhanced Motorcycle Guard Fence System/Test Vehicle Geometrics for Test 469940-03-2.

See Table 10.1 for the *MASH* impact conditions and Table 10.2 for the exit parameters for Test 469940-03-2. Figure 10.1 and Figure 10.2 depict the target impact setup.

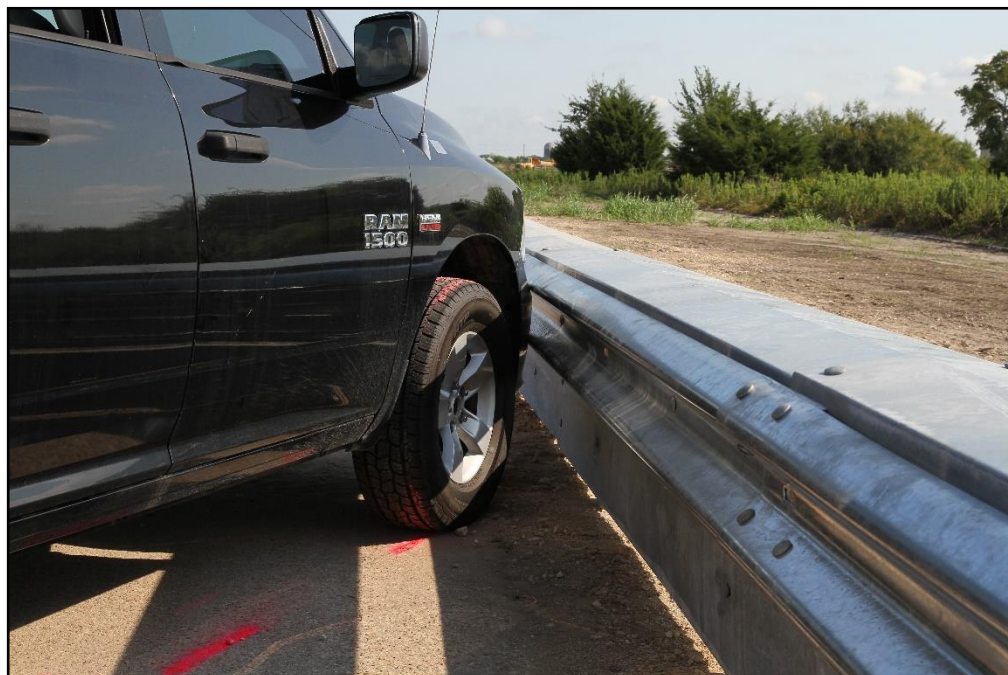
Figure 10.2. Enhanced Motorcycle Guard Fence System/Test Vehicle Impact Location for Test 469940-03-2.

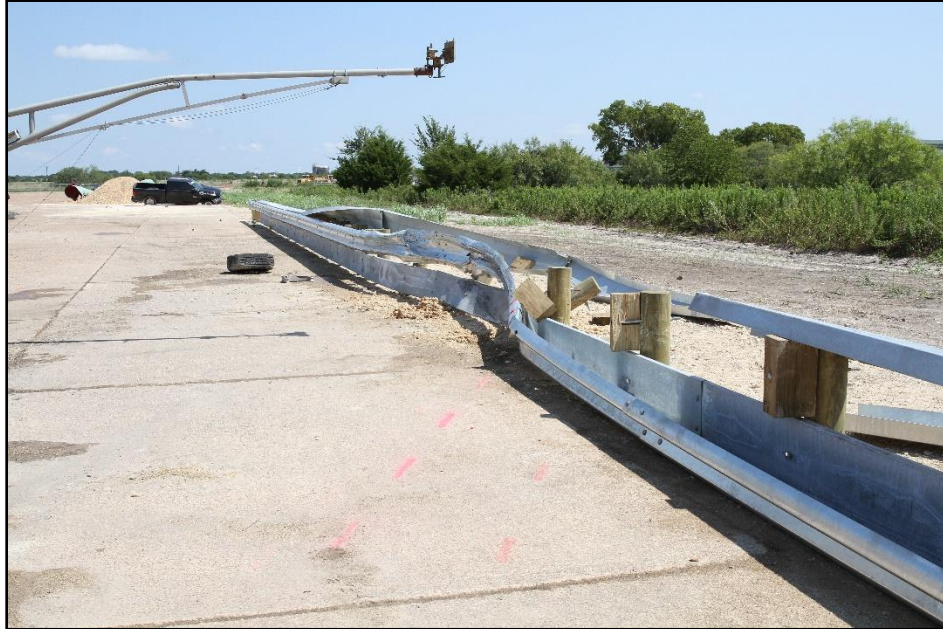
Figure 10.5. Enhanced Motorcycle Guard Fence System at Impact Location on the Traffic Side after Test 469940-03-2.

Table 10.6 describes the deflection and working width of the enhanced motorcycle guard fence system. Figure 10.5 and Figure 10.6 show the damage to the enhanced motorcycle guard fence system.

Test Parameter	Measured
Permanent Deflection/Location	27.3 inches toward field side, 2.5 ft upstream from the centerline of post 14
Dynamic Deflection	32.4 inches toward field side at the midspan between posts 13 and 14
Working Width ^a and Height	113.8 inches, at a height of 1.0 inch, at the top rail at the midspan of posts 12 and 13

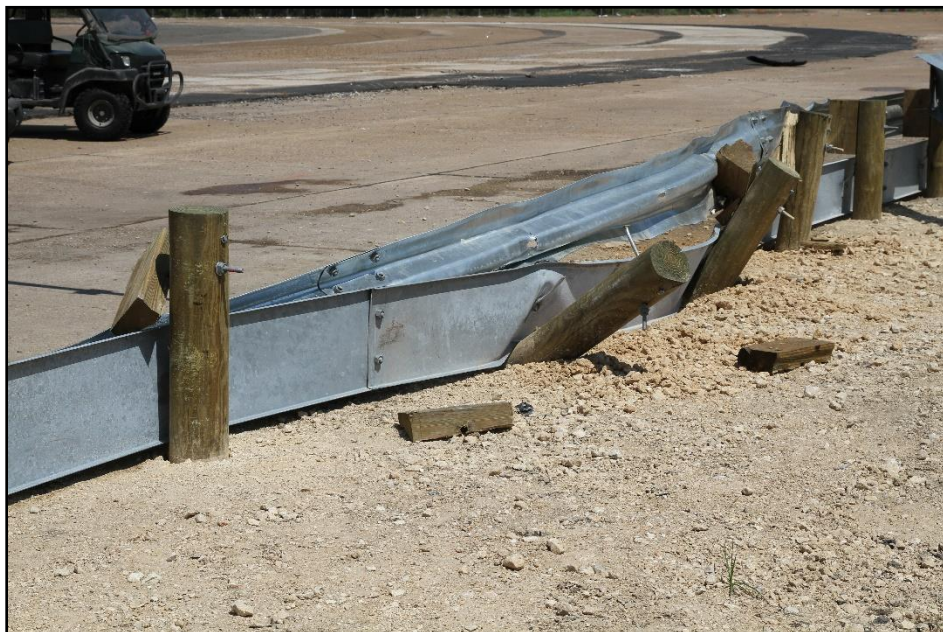
Figure 10.6. Enhanced Motorcycle Guard Fence System at Impact Location on the Field Side after Test 469940-03-2.

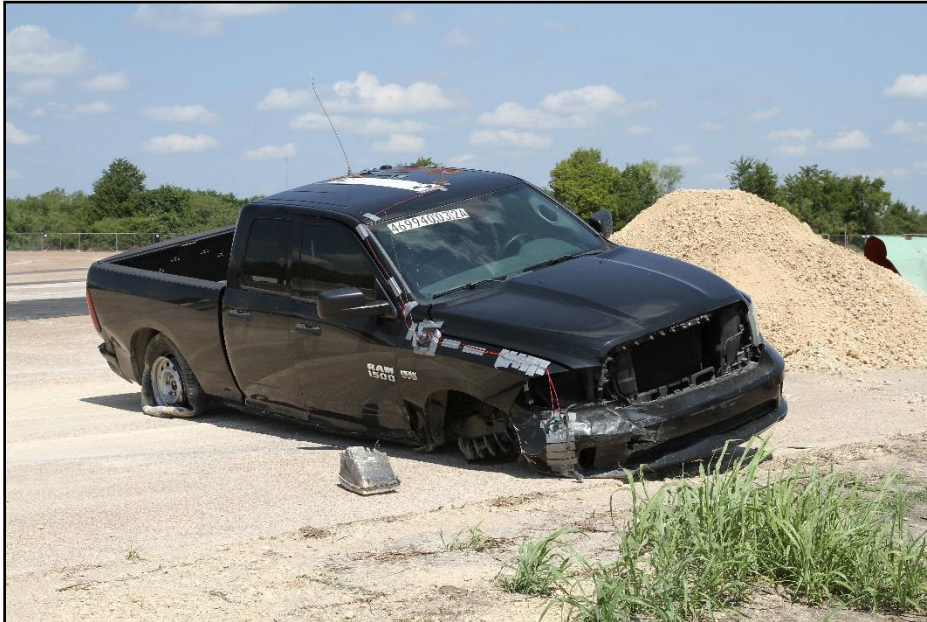
Figure 10.7. Impact Side of Test Vehicle after Test 469940-03-2.

Figure 10.7 and Figure 10.8 show the damage sustained by the vehicle. Figure 10.9 and Figure 10.10 show the interior of the test vehicle. Table 10.7 and Table 10.8 provide details on the occupant compartment deformation and exterior vehicle damage. Figures D.2 and D.3 in Appendix D.1 provide exterior crush and occupant compartment measurements.

Side Windows	The side windows remained intact
Maximum Exterior Deformation	8 inches in the front and side plane at the right front corner at bumper height
VDS	01RFQ3
CDC	01FREW2
Fuel Tank Damage	None
Description of Damage to Vehicle:	The front bumper, hood, grill, right headlight, right front fender, right front upper and lower control arms, right front tire and rim, right front door, right rear door, right rear fender, right rear tire and rim, and rear bumper were damaged. The right front door had a 1.5-inch gap at the top.

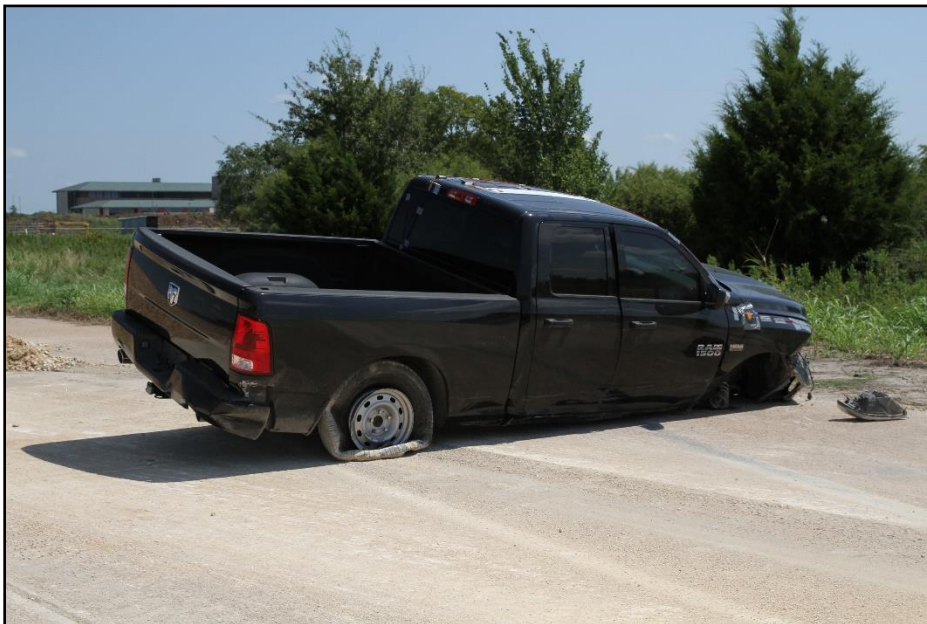
Figure 10.8. Rear Impact Side of Test Vehicle after Test 469940-03-2.

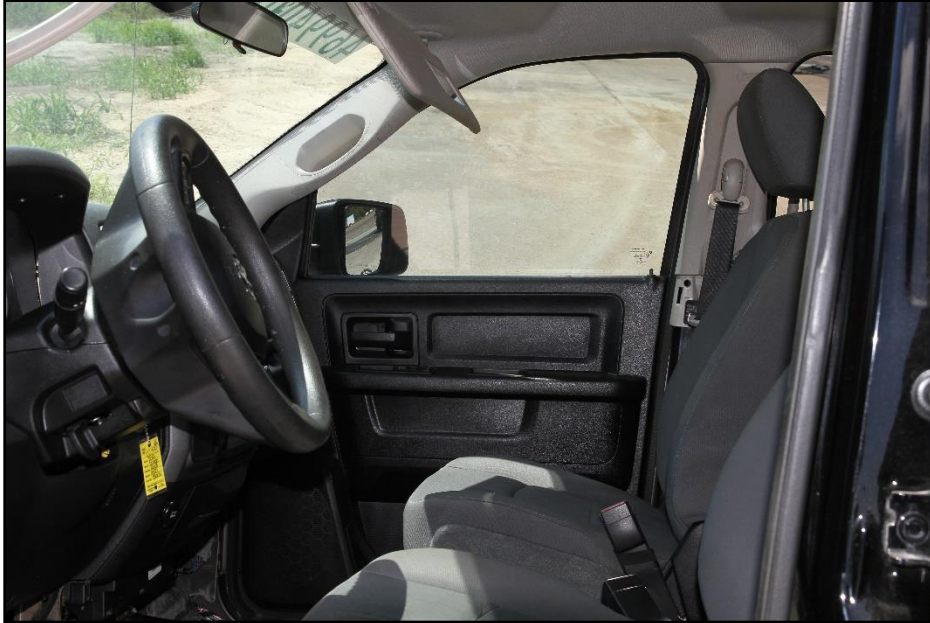
Figure 10.9. Overall Interior of Test Vehicle after Test 469940-03-2.

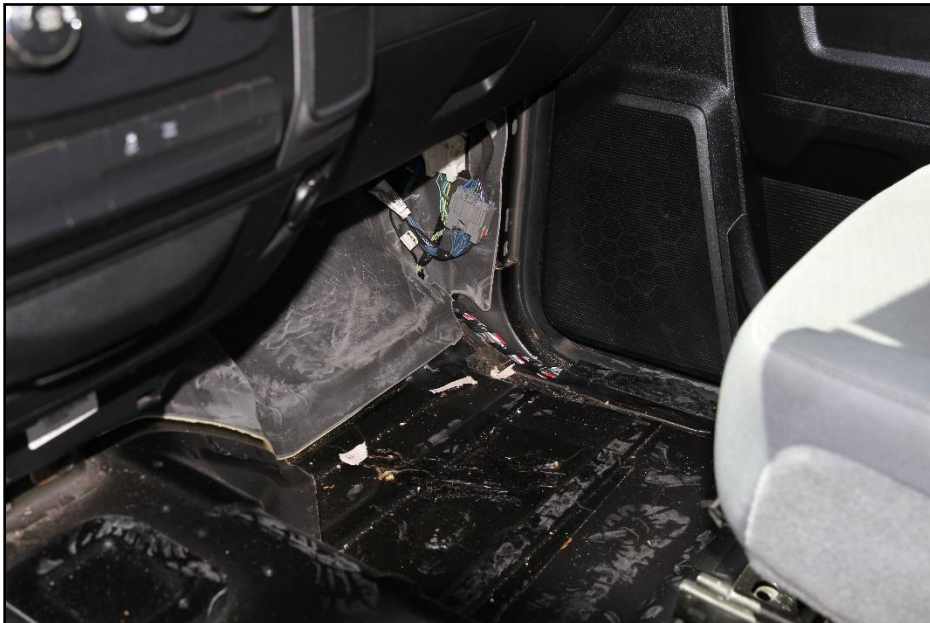
Figure 10.10. Interior of Test Vehicle on Impact Side after Test 469940-03-2.

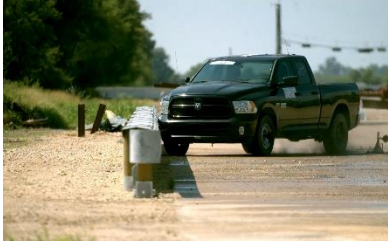
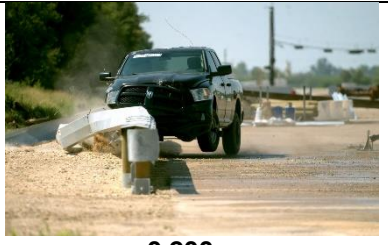
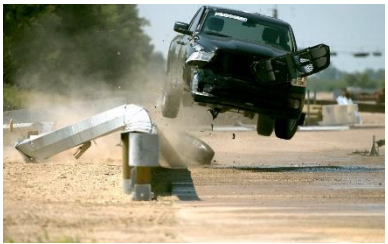
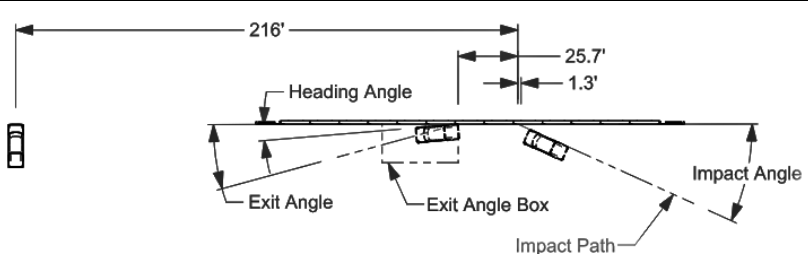
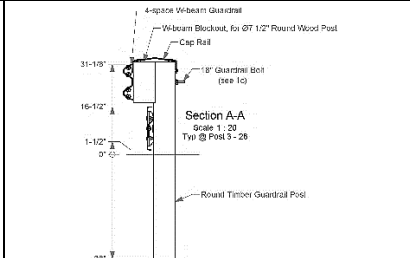
<p style="text-align: center;">0.000 s</p>	Test Agency	Texas A&M Transportation Institute (TTI)							
	Test Standard/Test No.	MASH 2016, Test 3-11							
	TTI Project No.	469940-03-2							
	Test Date	2020-08-07							
TEST ARTICLE									
		Type	Longitudinal Barrier						
		Name	Enhanced Motorcycle Guard Fence System						
		Length	181 ft 3 inches						
		Key Materials	Round timber posts, cap rail, W-beam guardrail, rubrail						
		Soil Type and Condition	Type A Grade 2 crushed limestone

<p style="text-align: center;">0.200 s</p>	TEST VEHICLE								
			Type/Designation	2270P					
			Year, Make and Model	2014 RAM 1500					
			Inertial Weight (lb)	5026					
			Dummy (lb)	N/A					
		Gross Static (lb)	5026						
IMPACT CONDITIONS									
		Impact Speed (mi/h)	63.4						
		Impact Angle (deg)	24.4						
		Impact Location	16.1 inches downstream from the centerline of post 12						
		Impact Severity (kip-ft)	115.3

<p style="text-align: center;">0.400 s</p>	EXIT CONDITIONS								
			Exit Speed (mi/h)	42.1					
			Trajectory/Heading Angle (deg)	15.2/4.7					
			Exit Box Criteria	Vehicle crossed exit box 59 ft downstream from loss of contact					
			Stopping Distance	216 ft downstream In line with the installation

<p style="text-align: center;">0.600 s</p>	TEST ARTICLE DEFLECTIONS								
			Dynamic (inches)	32.4					
			Permanent (inches)	27.25					
			Working Width/Height (inches)	113.8/1.0					
	VEHICLE DAMAGE								
		VDS	01RFQ3						
		CDC	01FREW2						
		Max. Ext. Deformation (inches)	8						
		Max Occupant Compartment Deformation	2.0 inches in the right foot well						
OCCUPANT RISK VALUES									
Long. OIV (ft/s)	18.2	Long. Ridedown (g)	9.7	Max 50-ms Long. (g)	-6.1	Max Roll (deg)	27.3		
Lat. OIV (ft/s)	14.4	Lat. Ridedown (g)	10	Max 50-ms Lat. (g)	-6.4	Max Pitch (deg)	25.3		
THIV (m/s)	8	ASI	0.82	Max 50-ms Vert. (g)	-4.8	Max Yaw (deg)	32.7

Figure 10.11. Summary of Results for MASH Test 3-11 on Enhanced Motorcycle Guard Fence System.

Figure 10.11 summarizes the results of *MASH* Test 469940-03-2.

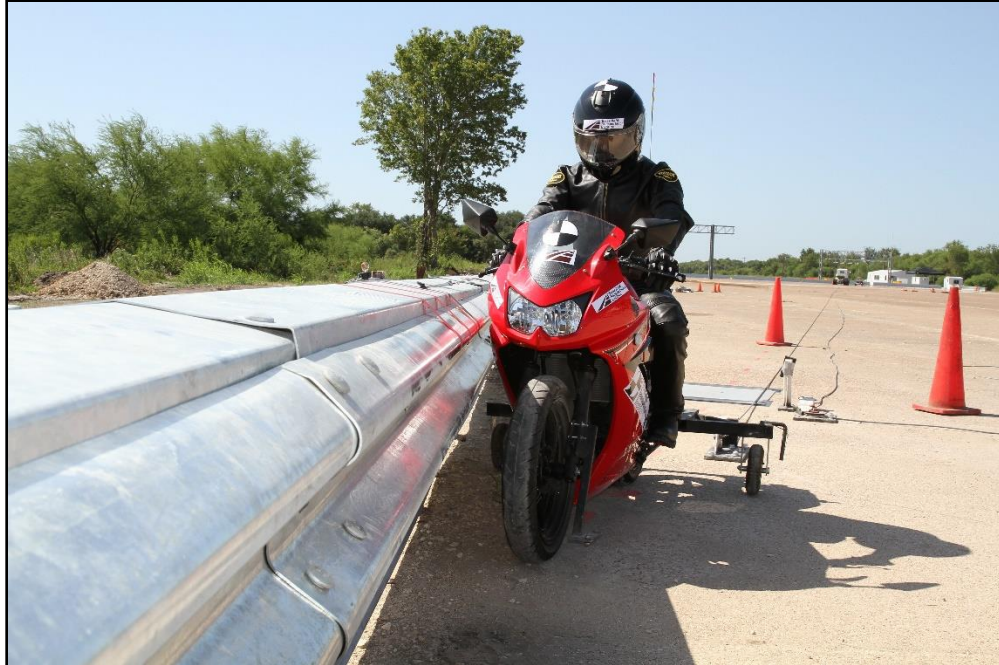
Figure 11.1. Enhanced Motorcycle Guard Fence System/Test Vehicle Geometrics for Test 469940-03-3.

See Table 11.1 for the impact conditions and Table 11.2 for the exit parameters for Test 469940-03-3. Figure 11.1 and Figure 11.2 depict the target impact setup.

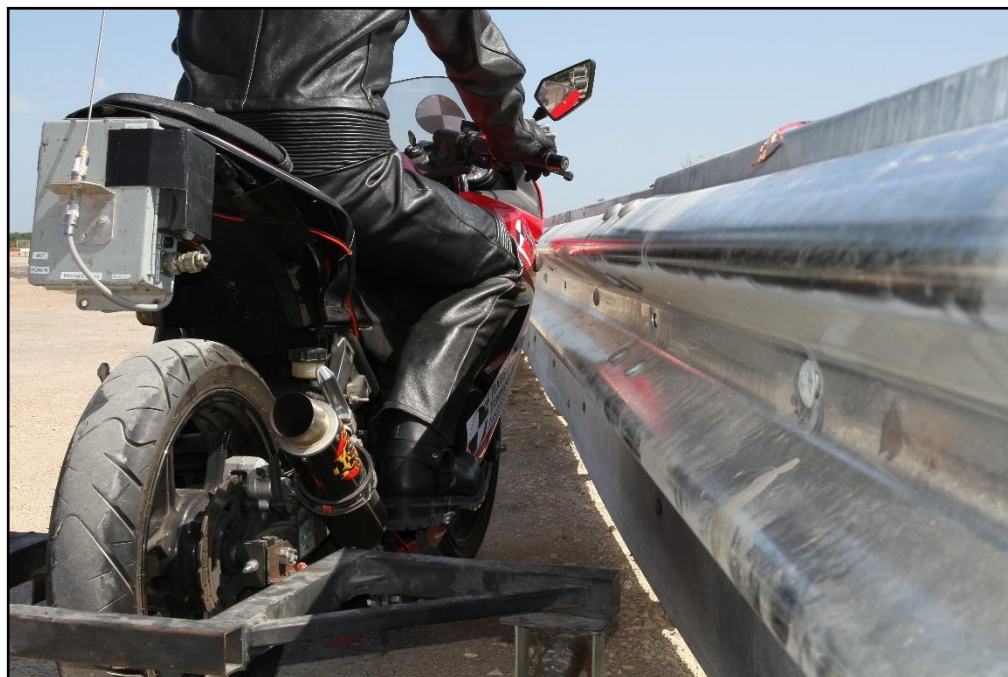
Figure 11.2. Enhanced Motorcycle Guard Fence System/Test Vehicle Impact Location for Test 469940-03-3.

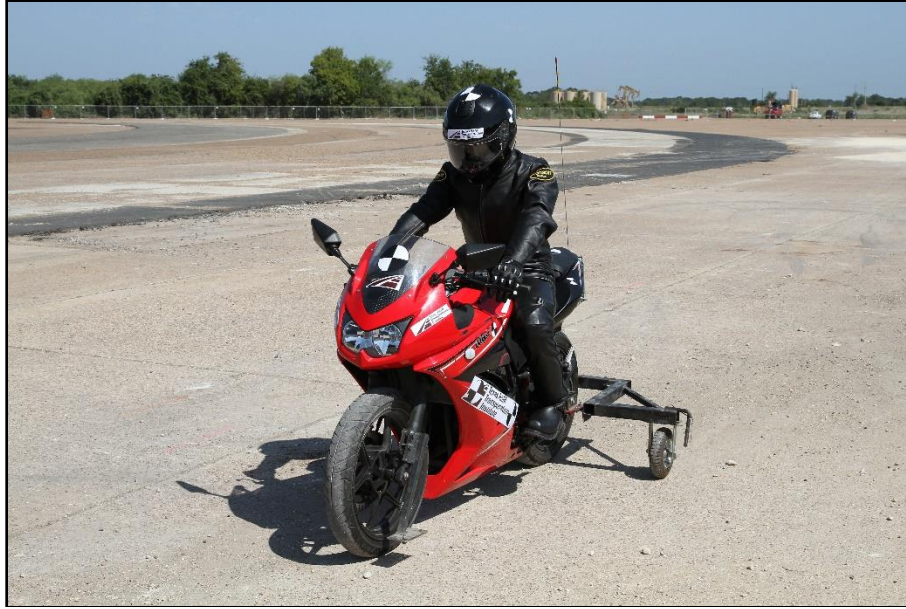
Figure 11.4. Opposite Impact Side of Test Vehicle before Test 469940-03-3.

Figure 11.3 and Figure 11.4 show the 2012 Kawasaki 250 Ninja used for the crash test. Table 11.4 shows the vehicle measurements. Figure E.1 in Appendix E.1 gives additional dimensions and information on the vehicle.

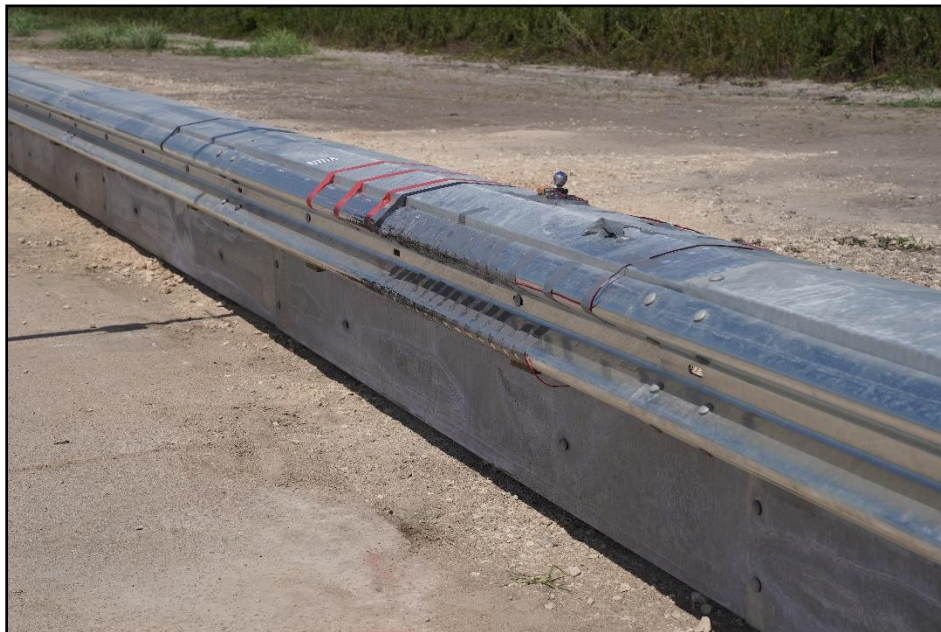
Figure 11.5. Isometric View of the Enhanced Motorcycle Guard Fence System at Impact Location after Test 469940-03-3.

There was some scuffing on the rail at impact. Table 11.6 describes the deflection and working width of the enhanced motorcycle guard fence system. Figure 11.5 and Figure 11.6 show the damage to the enhanced motorcycle guard fence system.

Test Parameter	Measured
Permanent Deflection/Location	None
Dynamic Deflection	0.28 inches toward field side
Working Width ^a and Height	18.5 inches, at a height of 31.1 inches, at the field side of the top of the post.

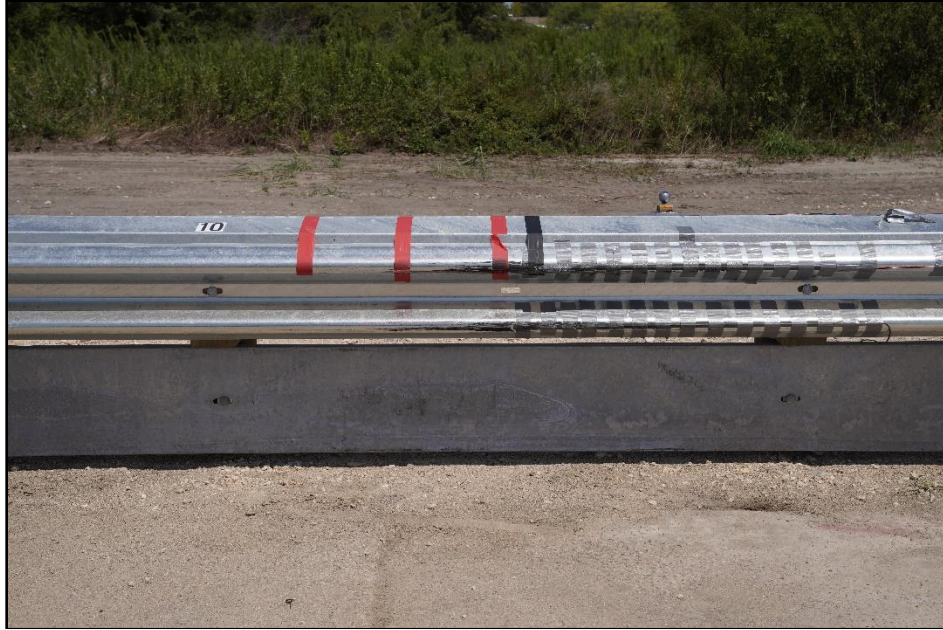
Figure 11.6. Elevation View of the Enhanced Motorcycle Guard Fence System at Impact Location after Test 469940-03-3.

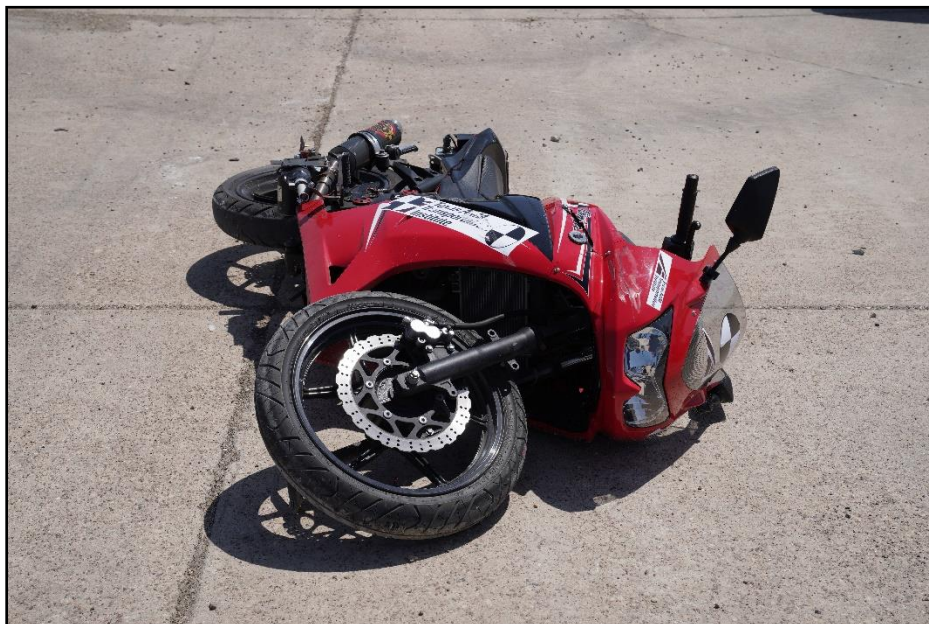
Figure 11.7. Impact Side of Test Vehicle after Test 469940-03-3.

The front fairing, right and left side fairings, and right turn signal were damaged. No damage to the fuel tank was observed.

Figure 11.7, Figure 11.8, and Figure 11.9 show the damage sustained by the vehicle.

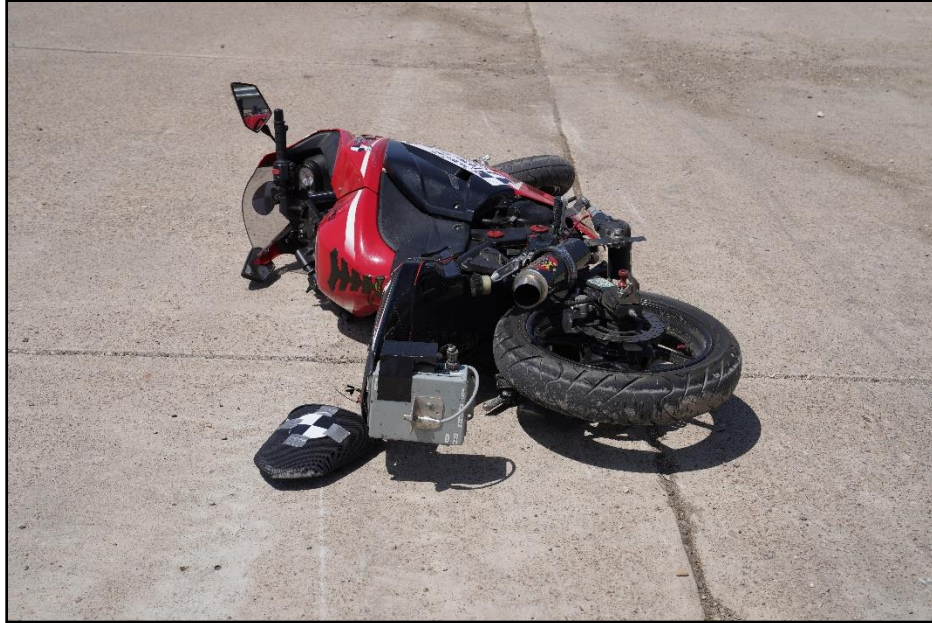
Figure 11.8. Rear Impact Side of Test Vehicle after Test 469940-03-3.

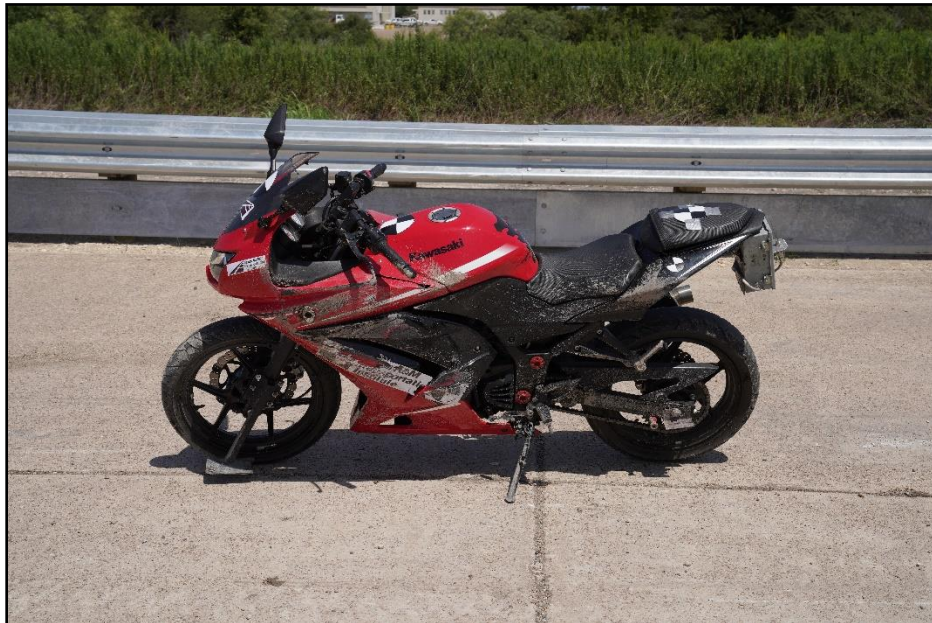
Figure 11.9. Opposite Impact Side of Test Vehicle after Test 469940-03-3.

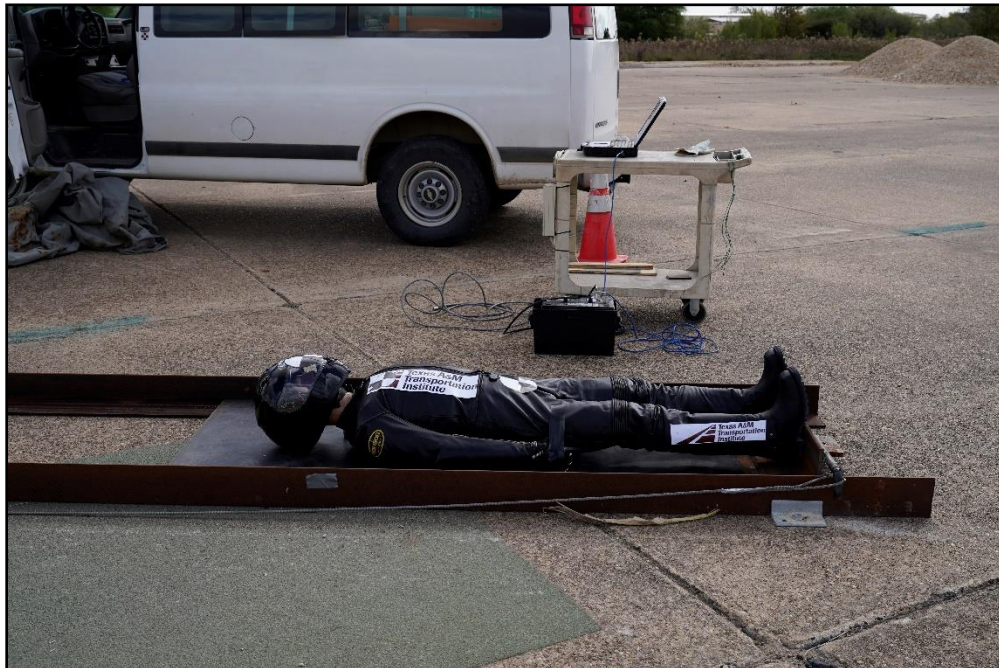
Figure 12.1. Right Side of the ATD prior to Test 469940-03-4A.

See Table 12.1 for the impact conditions and Table 12.2 for the exit parameters for Test 469940-03-4A. Figure 12.1 and Figure 12.2 show the ATD prior to impact.
