Test Report No. 469940-03, 469942-01, and 469943-01

**DEVELOP A RETROFIT DESIGN FOR GUARD FENCE SYSTEM TO
ENHANCE MOTORCYCLE SAFETY
COOPERATIVE RESEARCH PROGRAM**

Texas Department of Transportation
<https://tti.tamu.edu/documents/0-6994-R1.pdf>

TEXAS A&M TRANSPORTATION INSTITUTE PROVING GROUND

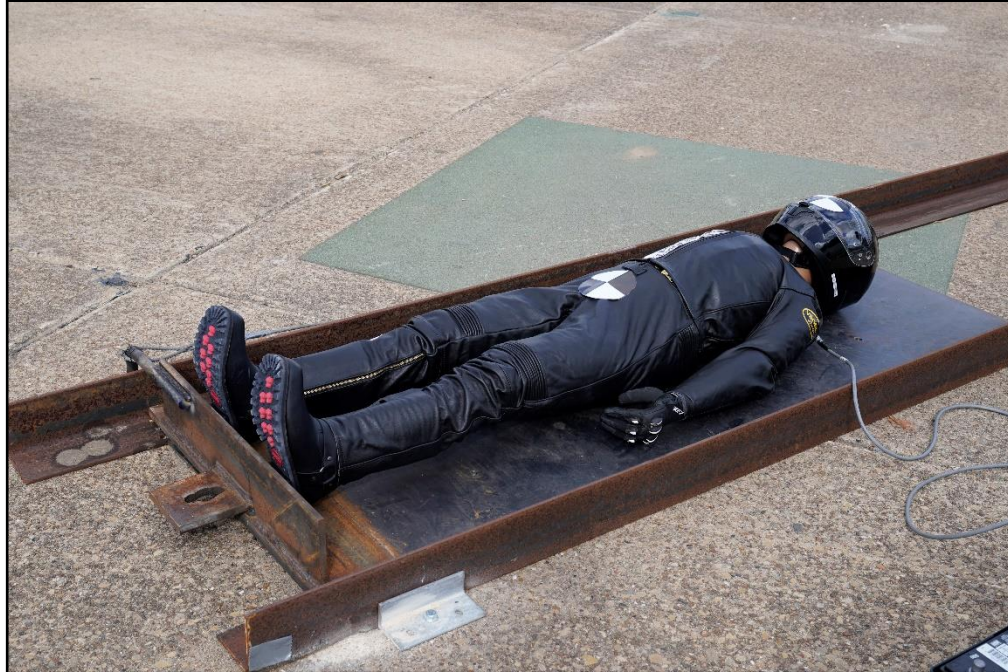
Figure 12.2. Left Side of the ATD prior to Test 469940-03-4A.

See Table 12.1 for the impact conditions and Table 12.2 for the exit parameters for Test 469940-03-4A. Figure 12.1 and Figure 12.2 show the ATD prior to impact.

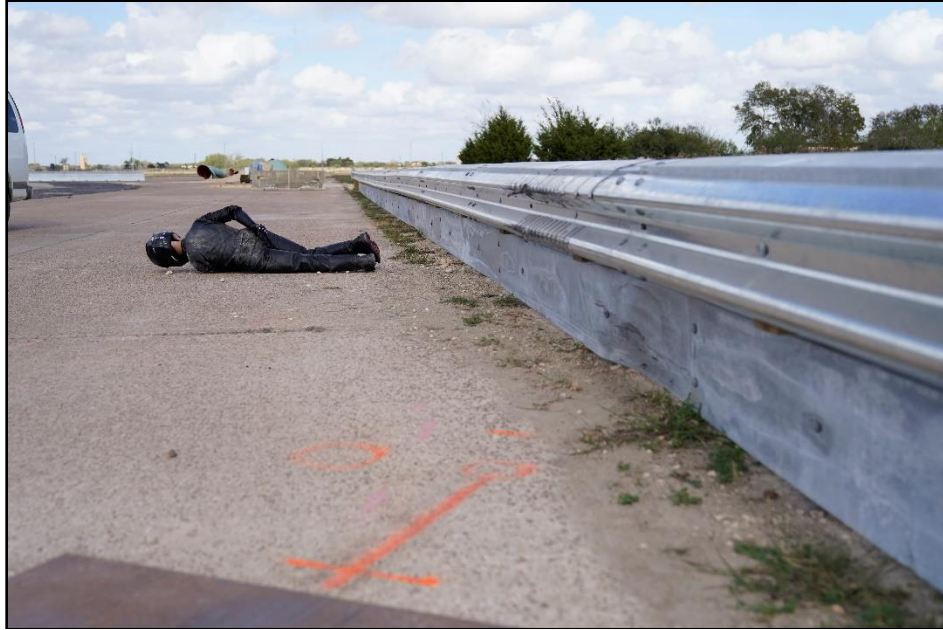
Figure 12.3. Enhanced Motorcycle Guard Fence System at Impact Location on the Traffic Side after Test 469940-03-4A.

The rubrail was deformed and scuffed at impact. Table 12.5 describes the deflection and working width of the enhanced motorcycle guard fence system. Figure 12.3 and Figure 12.4 show the damage to the enhanced motorcycle guard fence system.

Test Parameter	Measured
Permanent Deflection/Location	2.4 inches toward field side, 13 inches upstream from the centerline of post 9
Dynamic Deflection	4 inches toward field side, 13 inches upstream from the centerline of post 9
Working Width ^a and Height	18.6 inches, at a height of 31.1 inches, at the guardrail bolt on the field side of post 9

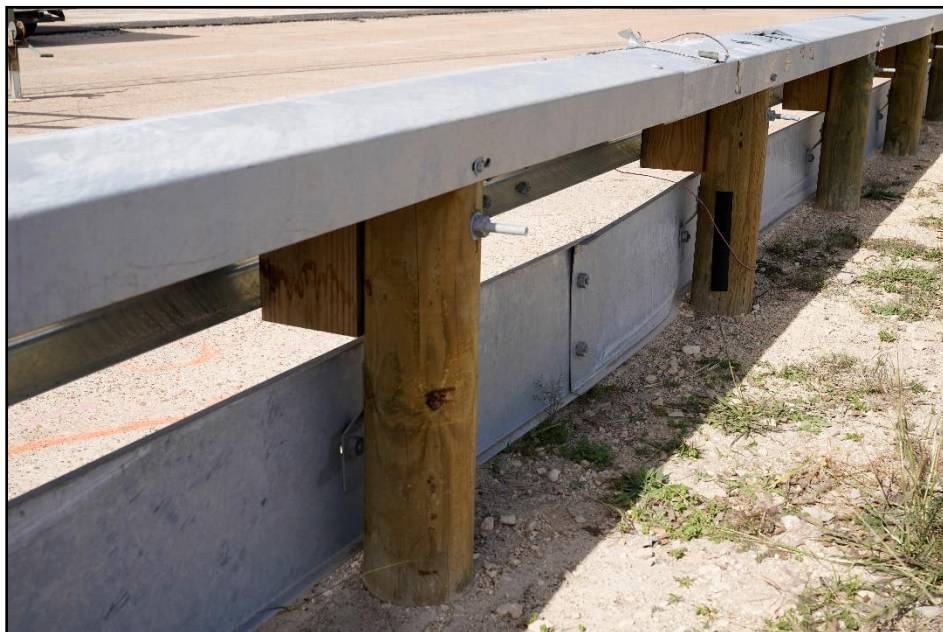
Figure 12.4. Enhanced Motorcycle Guard Fence System at Impact Location on the Field Side after Test 469940-03-4A.

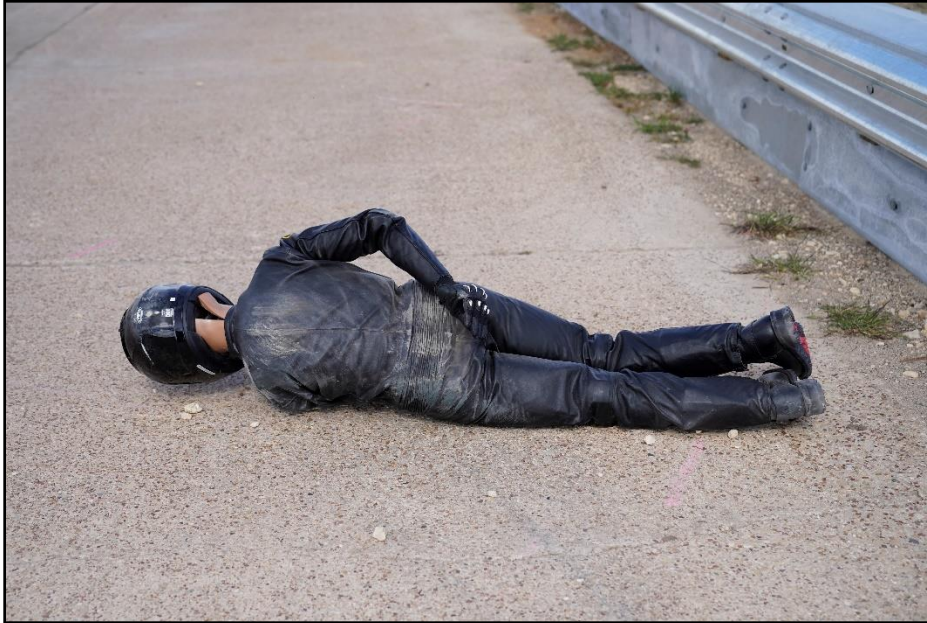
Figure 12.5. Backside of the ATD after Test 469940-03-4A.

Figure 12.5 and Figure 12.6 show the overall damage sustained by the ATD. Figure 12.7 and Figure 12.8 show the helmet and neck damage sustained by the ATD. Table 12.6 provides details on the calculated injury criteria for the head and neck of the ATD.

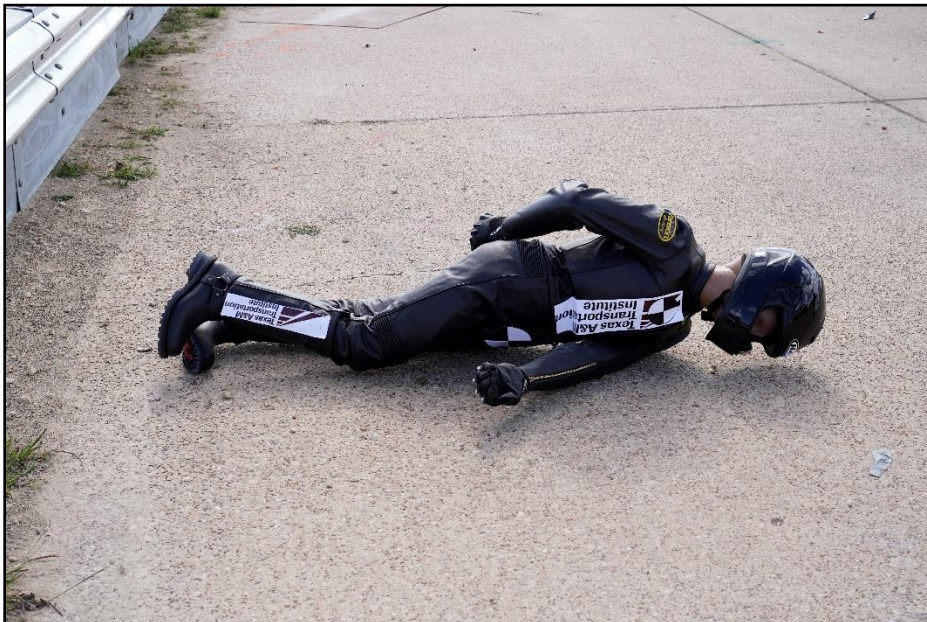
Figure 12.6. Front of the ATD after Test 469940-03-4A.

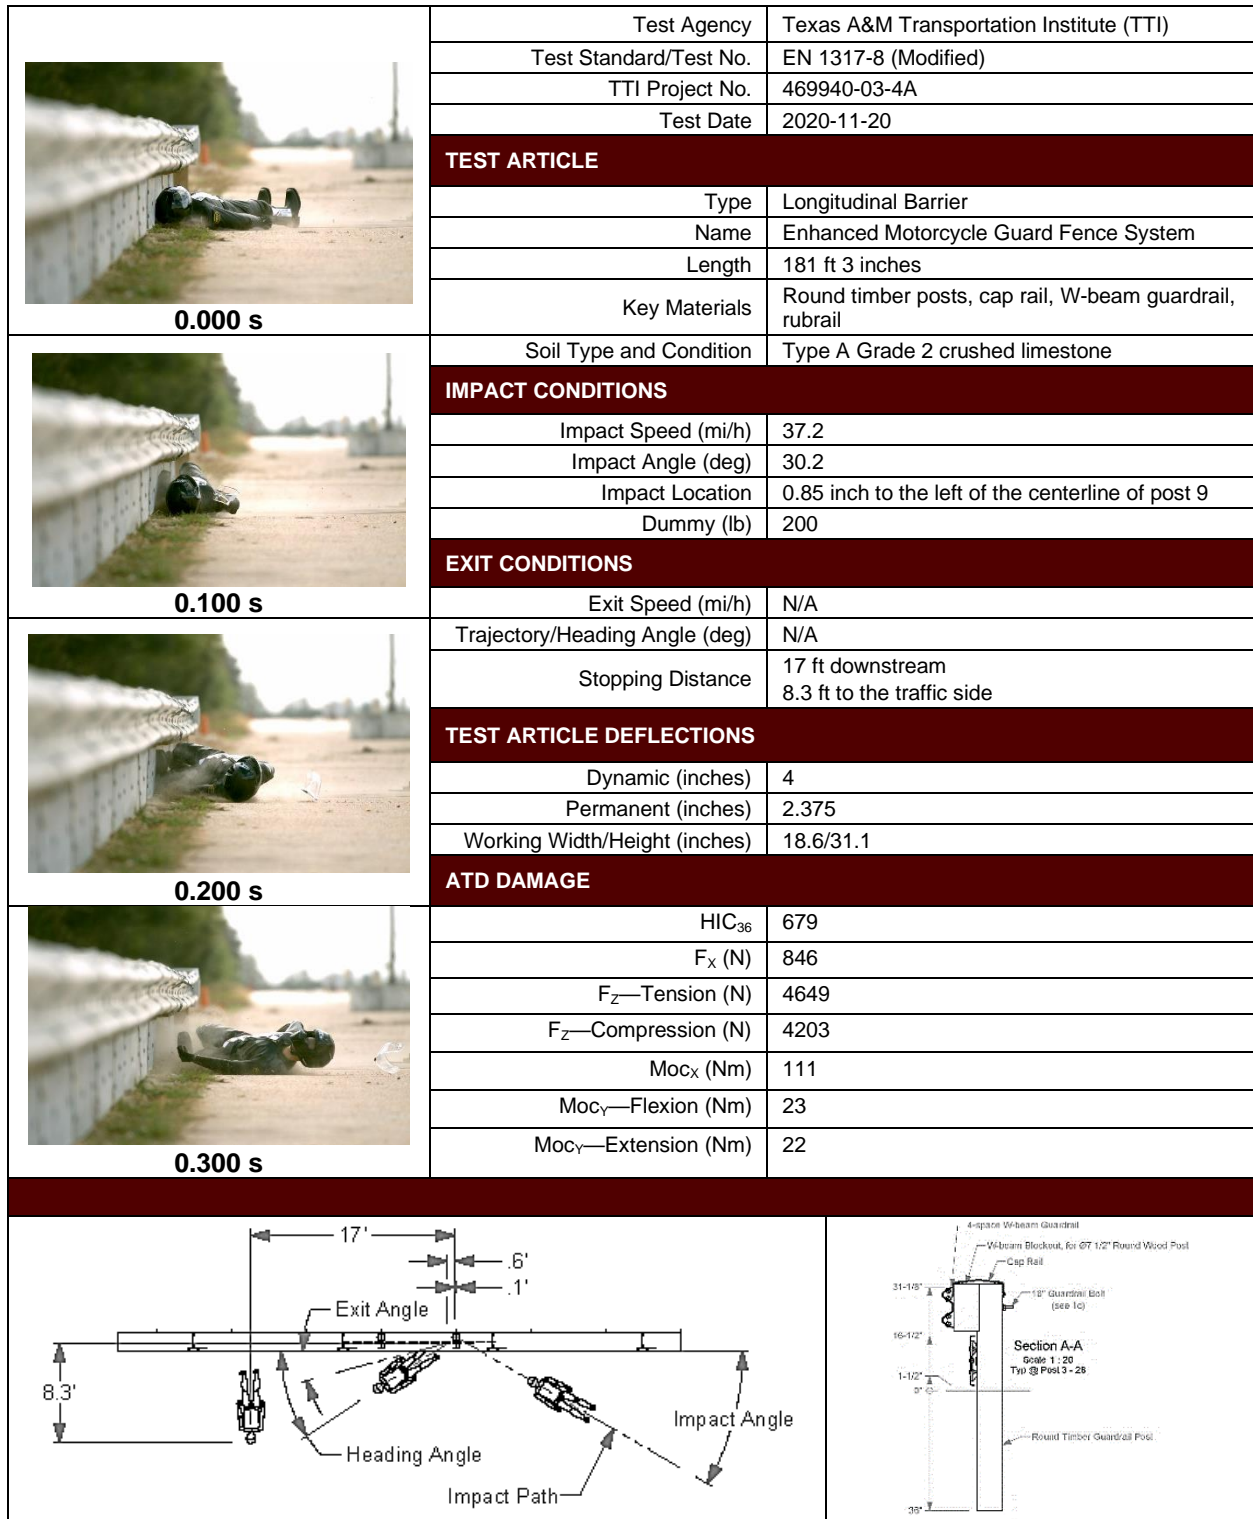
Figure 12.9. Summary of Results for Modified EN 1317-8 Test on Enhanced Motorcycle Guard Fence System.

Figure 12.9 summarizes the results of Test 469940-03-4A.

The enhanced motorcycle guard fence system successfully redirected the ATD during impact. There was no snagging of the ATD limbs with the wood posts or other elements of the longitudinal barrier. The ATD neck axial tension and compression forces measured during the impact did exceed the EN 1317-8 limits. Modifications were investigated, as described in Chapter 13, to potentially reduce the injury criteria for the sliding ATD impact.

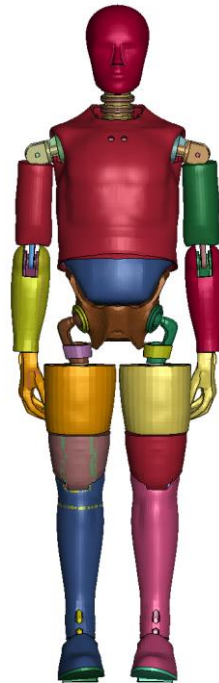
Finite element models of various new design options were developed, and LS-DYNA was used to perform impact simulations with inclusion of the developed models, available Hybrid III 50th percentile ATD (dummy) model (Figure 13.1), and available rider helmet model. To allow for a sliding position of the dummy, the seated pelvis was removed from the model and the legs were straightened. The developed model was calibrated by comparing results of the developed FE barrier system model against available full-scale crash test data. Once the FE model was calibrated, the same model was used to apply the proposed design retrofit changes and conduct predictive simulations.

Figure 13.1. ATD Finite Element Model.

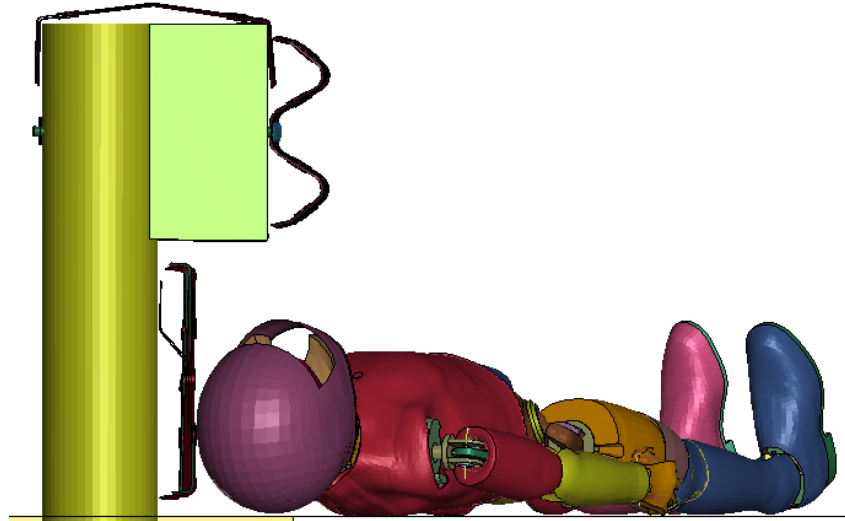
Previous testing was conducted with a sliding motorcyclist into a guardrail system with a vertical rubrail attachment (Chapter 12). To validate the dummy and helmet FE models, a computer simulation was conducted with impact conditions that replicated the full-scale crash test. Figure 13.2 shows the dummy model at impact with the system.

Figure 13.2. Computer Simulation of Sliding Dummy Impact.

The overall behavior of the dummy model was similar to the crash test. A quantitative comparison was conducted by comparing the injury criteria values from the full-scale crash test and the computer simulation. Table 13.1 shows the injury criteria values.

Some of the injury criteria values were comparable. The neck shear force and neck axial force were higher in the simulation than in the crash test. Also, the Mx and My moments were higher in the simulation than in the crash test. The dummy and helmet models used in the validation simulation were used in the design evaluation simulations discussed in the next section. Researchers noted that the models may overpredict certain injury criteria values.

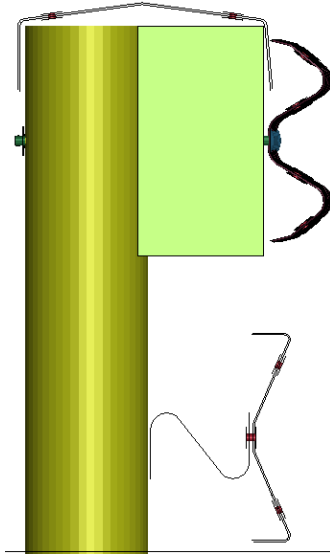
A modified version of the vertical channel rubrail that had a V-shape profile with attachment to an S-shape bracket was developed. Figure 13.3 shows a cross-section view of the rubrail shape.

Figure 13.3. V-Shape Rubrail Design Option.

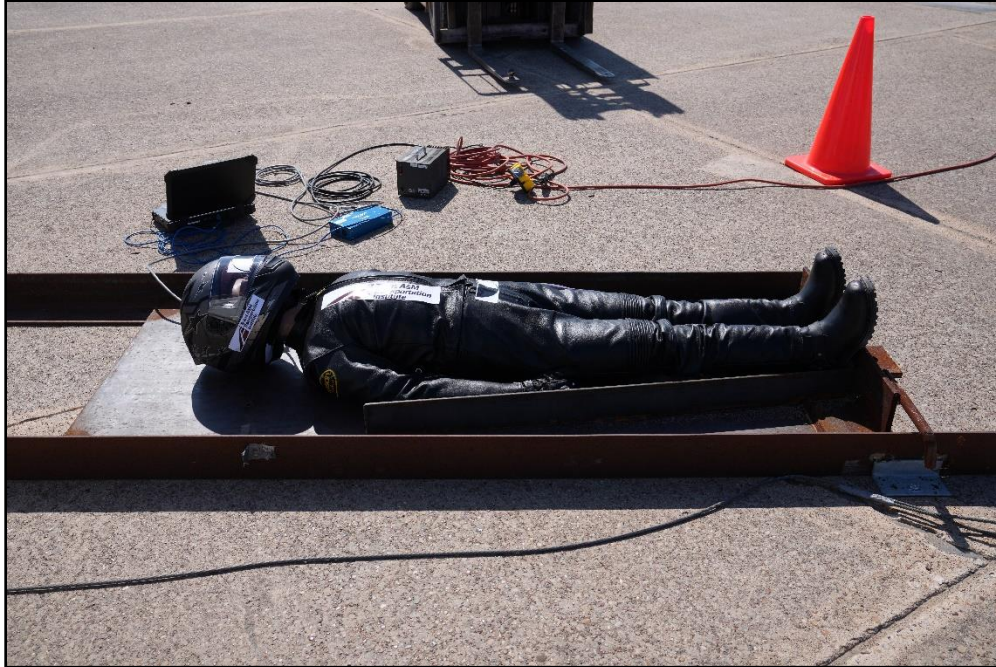
Figure 14.1. Side View of the ATD on the Sled Delivery System Prior to Test 469942-01-1.

See Table 14.1 for the impact conditions and Table 14.2 for the exit parameters for Test 469942-01-1. Figure 14.1 and Figure 14.2 depict the ATD prior to testing.

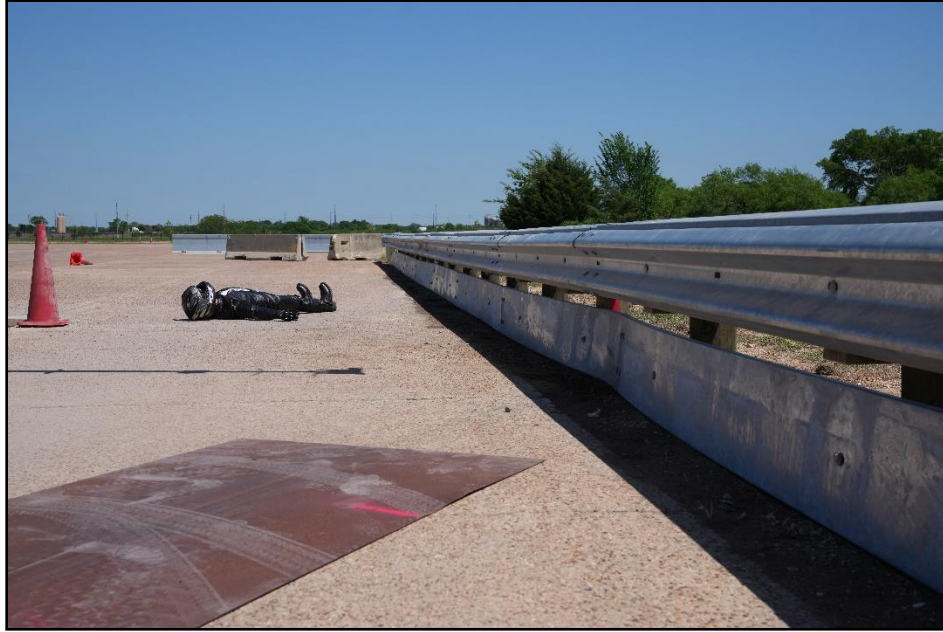
Figure 14.3. Enhanced Motorcycle Guard Fence System at Impact Location after Test 469942-01-1.

The rubrail was deformed and scuffed at impact, and there were also scuffs on the W-beam at impact. Table 14.5 describes the deflection and working width of the enhanced motorcycle guard fence system. Figure 14.3 and Figure 14.4 show the damage to the enhanced motorcycle guard fence system.

Test Parameter	Measured
Permanent Deflection/Location	5.5 inches toward field side, 15 inches upstream from the centerline of post 15
Dynamic Deflection	9.3 inches toward field side, 15 inches upstream from the centerline of post 15
Working Width ^a and Height	19.5 inches, at a height of 30.0 inches, at the guardrail bolt on the field side of post 15

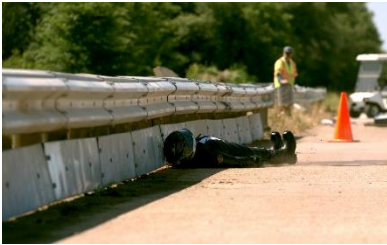
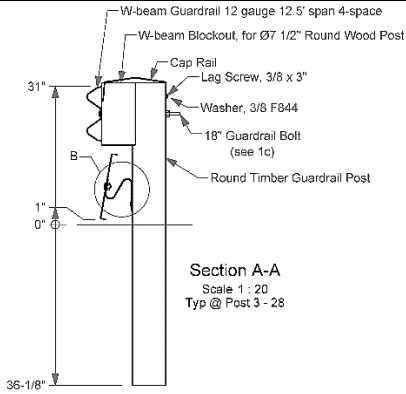
Figure 14.9. Summary of Results for Modified EN 1317-8 Test on Enhanced Motorcycle Guard Fence System.

<p style="text-align: center;">0.000 s</p>	Test Agency	Texas A&M Transportation Institute (TTI)
	Test Standard/Test No.	EN 1317-8 (Modified)
	TTI Project No.	469942-01-1
	Test Date	2022-04-27
TEST ARTICLE		
	Type	Longitudinal Barrier
	Name	Enhanced Motorcycle Guard Fence System
	Length	181 ft 3 inches
	Key Materials	Round timber posts, cap rail, W-beam guardrail, rubrail
	Soil Type and Condition	Type A Grade 2 crushed limestone

<p style="text-align: center;">0.100 s</p>	IMPACT CONDITIONS	
	Impact Speed (mi/h)	41.4
	Impact Angle (deg)	29.7
	Impact Location	Centerline of the ATD's head aligned with the center of post 15
	Dummy (lb)	200

<p style="text-align: center;">0.300 s</p>	ATD DAMAGE	
	HIC ₃₆	344
	F _x (N)	568
	F _z —Tension (N)	1993
	F _z —Compression (N)	4709
	Moc _x (Nm)	72
	Moc _y —Flexion (Nm)	29
	Moc _y —Extension (Nm)	32

<p style="text-align: center;">Section A-A Scale 1 : 20 Typ @ Post 3 - 28</p>

Figure 14.9 summarizes the results of Test 469942-01-1.

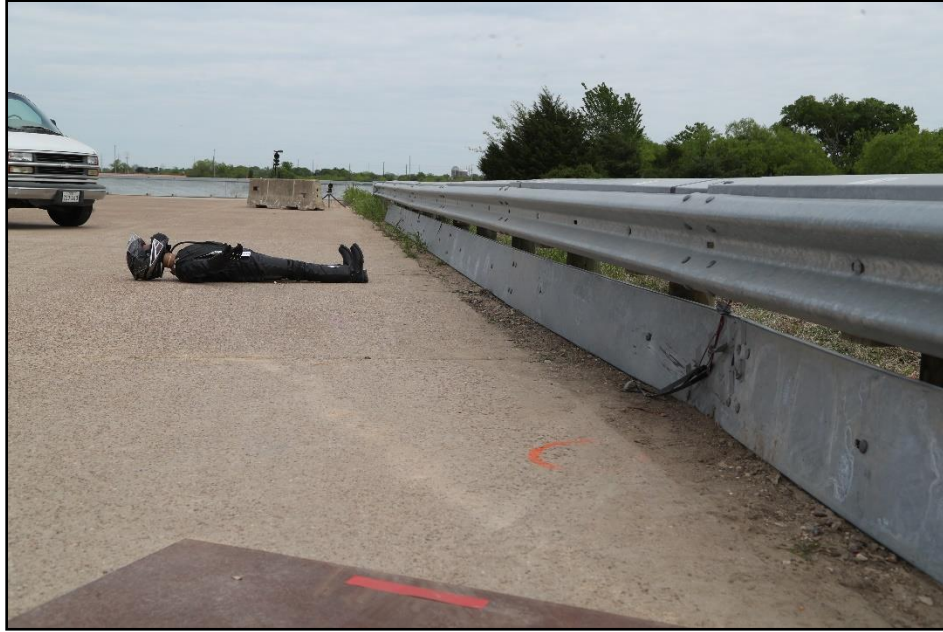
Figure 16.3. Enhanced Motorcycle Guard Fence System at Impact Location after Test 469943-01-1A.

The rubrail was deformed and scuffed at impact. Table 16.5 describes the deflection and working width of the enhanced motorcycle guard fence system. Figure 16.3 and Figure 16.4 show the damage to the enhanced motorcycle guard fence system.

Test Parameter	Measured
Permanent Deflection/Location	5.3 inches toward field side, 20 inches upstream from the centerline of post 19
Dynamic Deflection	8.3 inches toward field side, 20 inches upstream from the centerline of post 19
Working Width ^a and Height	17.3 inches, at a height of 31 inches, at the guardrail bolt on the field side of post 15

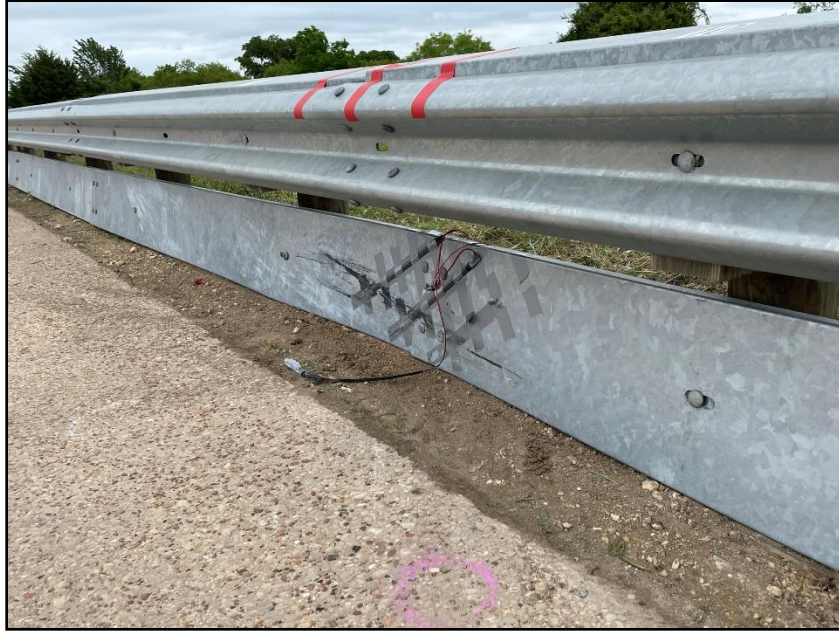
Figure 17.3. Traffic Side of the Enhanced Motorcycle Guard Fence System at Impact Location after Test 469943-01-2.

There was some scuffing on the rubrail at impact, and the rail was deformed. Table 17.5 describes the deflection and working width of the enhanced motorcycle guard fence system. Figure 17.3 and Figure 17.4 show the damage to the enhanced motorcycle guard fence system.

Test Parameter	Measured
Permanent Deflection/Location	4.5 inches toward field side, 4 inches downstream from the center of the joint
Dynamic Deflection	8.5 inches toward field side, 4 inches downstream from the center of the joint
Working Width ^a and Height	17.3 inches, at a height of 31 inches, at the guardrail bolt on the field side of post 15

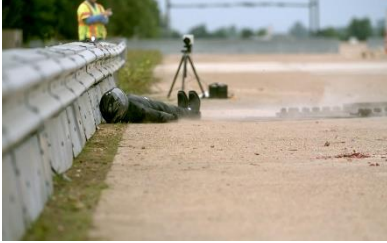
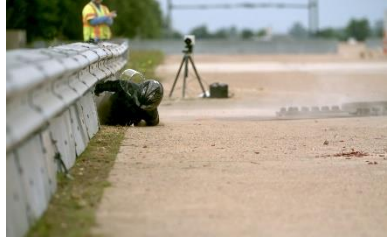
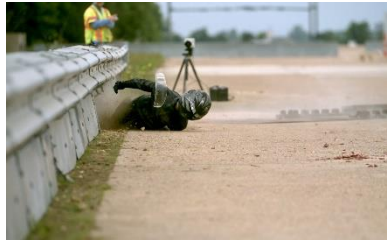
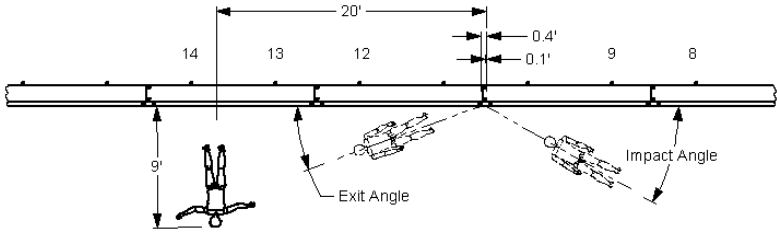
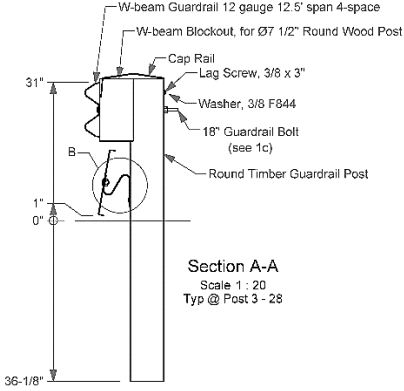
Figure 17.9. Summary of Results for Modified EN 1317-8 Test on Enhanced Motorcycle Guard Fence System.

<p style="text-align: center;">0.000 s</p>	Test Agency	Texas A&M Transportation Institute (TTI)
	Test Standard/Test No.	EN 1317-8 (Modified)
	TTI Project No.	469943-01-2
	Test Date	2023-04-14
Test ARTICLE		
	Type	Longitudinal Barrier
	Name	Enhanced Motorcycle Guard Fence System
	Length	181 ft 3 inches
	Key Materials	Round timber posts, cap rail, W-beam guardrail, rubrail
	Soil Type and Condition	Type A Grade 2 crushed limestone

<p style="text-align: center;">0.100 s</p>	IMPACT CONDITIONS	
	Impact Speed (mi/h)	37.9
	Impact Angle (deg)	29.7
	Impact Location	1.1 inches upstream from the center of the joint in the rubrail
	Dummy (lb)	200

<p style="text-align: center;">0.200 s</p>	EXIT CONDITIONS	
	Exit Speed (mi/h)	N/A
	Trajectory/Heading Angle (deg)	N/A
	Stopping Distance	20 ft downstream 9 ft to the traffic side

<p style="text-align: center;">0.300 s</p>	Test ARTICLE DEFLECTIONS	
	Dynamic (inches)	8.5

Permanent (inches)	4.5
	Working Width/Height (inches)	17.25/31
ATD DAMAGE		
	HIC ₃₆	420
	F _x (N)	430
	F _z —Tension (N)	2236
	F _z —Compression (N)	4003
	Moc _x (Nm)	74
	Moc _y —Flexion (Nm)	18
	Moc _y —Extension (Nm)	24

<p style="text-align: center;">Section A-A Scale 1 : 20 Typ @ Post 3 - 28</p>

Figure 17.9 summarizes the results of Test 469943-01-2.

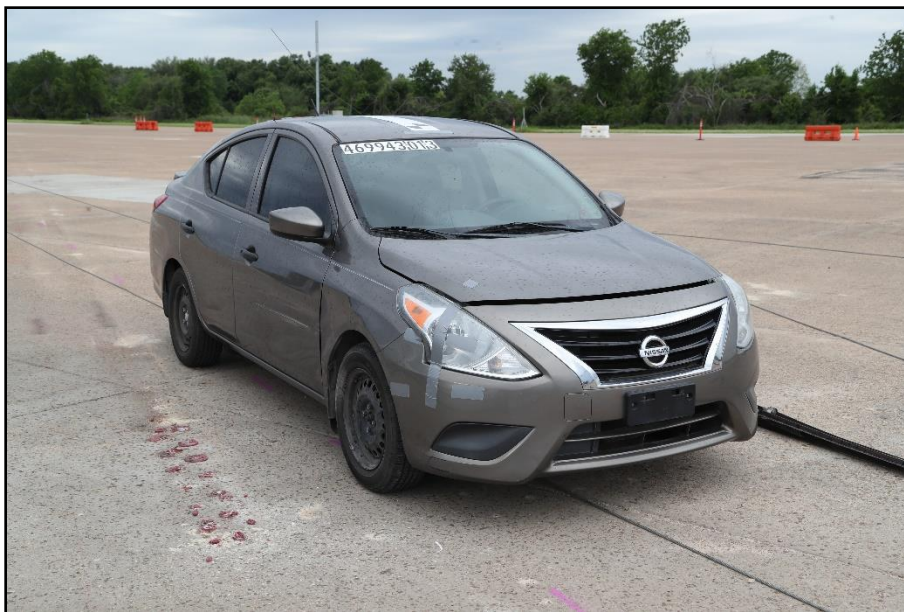
Figure 18.3. Impact Side of Test Vehicle before Test 469943-01-3.

Figure 18.3 and Figure 18.4 show the 2017 Nissan Versa used for the crash test. Table 18.4 shows the vehicle measurements. Figure J.1 in Appendix J.1 gives additional dimensions and information on the vehicle.

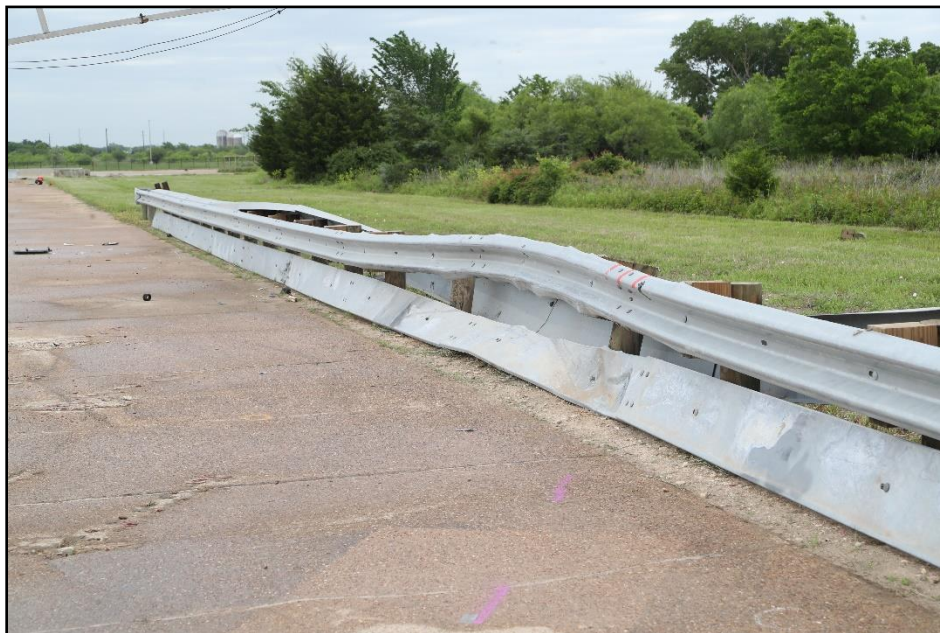
Figure 18.5. Traffic-Side View of the Enhanced Motorcycle Guard Fence System at Impact Location after Test 469943-01-3.

Table 18.7 describes the deflection and working width of the enhanced motorcycle guard fence system. Figure 18.5 and Figure 18.6 show the damage to the enhanced motorcycle guard fence system.

Test Parameter	Measured
Permanent Deflection/Location	15.4 inches toward field side at post 14
Dynamic Deflection	22.8 inches toward field side at the main rail 1 ft downstream of post 14
Working Width ^a and Height	51.9 inches, at a height of 39.4 inches, at the top rail cover joint between posts 14 and 15

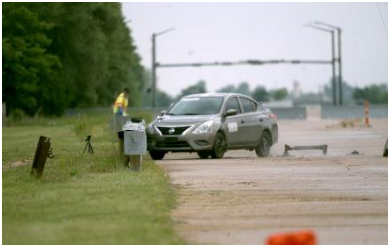
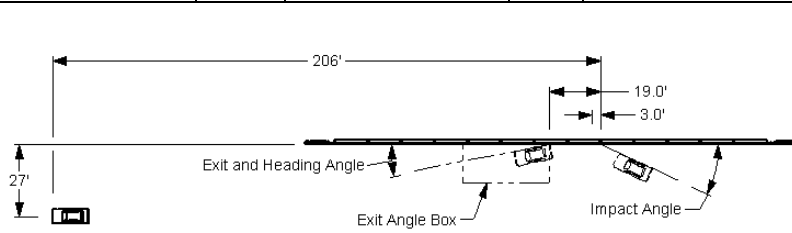
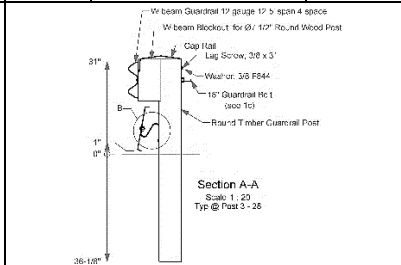
Figure 18.11. Summary of Results for MASH Test 3-10 on Enhanced Motorcycle Guard Fence System.

<p>0.000 s</p>	Test Agency	Texas A&M Transportation Institute (TTI)					
	Test Standard/Test No.	MASH 2016, Test 3-10					
	TTI Project No.	469943-01-3					
	Test Date	2023-04-18

<p>0.200 s</p>	TEST ARTICLE						
	Type	Longitudinal Barrier					
	Name	Enhanced Motorcycle Guard Fence System					
	Length	181 ft 3 inches					
  <p>0.400 s</p>	Key Materials	Round timber posts, cap rail, W-beam guardrail, rubrail					
	Soil Type and Condition	Type A Grade 2 crushed limestone					
	TEST VEHICLE						
	Type/Designation	1100C					
  <p>0.600 s</p>	Year, Make and Model	2017 Nissan Versa					
	Inertial Weight (lb)	2434					
	Dummy (lb)	165					
	Gross Static (lb)	2599					
IMPACT CONDITIONS							
Impact Speed (mi/h)	62.2						
Impact Angle (deg)	24.7						
Impact Location	36.4 inches upstream from the centerline of post 13						
Impact Severity (kip-ft)	55.0						
EXIT CONDITIONS							
Exit Speed (mi/h)	41.4

Trajectory/Heading Angle (deg)	11.6/11.2						
Exit Box Criteria	Vehicle crossed the exit box 31 ft downstream from loss of contact						
Stopping Distance	206 ft downstream 27 ft to the traffic side						
TEST ARTICLE DEFLECTIONS							
Dynamic (inches)	22.8						
Permanent (inches)	15.4						
Working Width/Height (inches)	51.9/39.4						
VEHICLE DAMAGE							
VDS	01RFQ2						
CDC	01FREW1						
Max. Ext. Deformation (inches)	8						
Max Occupant Compartment Deformation	1 inch in the right foot well and in the front side panel						
OCCUPANT RISK VALUES							
Long. OIV (ft/s)	14.5	Long. Ridedown (g)	10.6	Max 50-ms Long. (g)	-7.1	Max Roll (deg)	17.8
Lat. OIV (ft/s)	18.8	Lat. Ridedown (g)	10.1	Max 50-ms Lat. (g)	-9.3	Max Pitch (deg)	5.4
THIV (m/s)	7.2	ASI	1.24	Max 50-ms Vert. (g)	-2.7	Max Yaw (deg)	49.2

Figure 18.11 summarizes the results of *MASH* Test 469943-01-3.

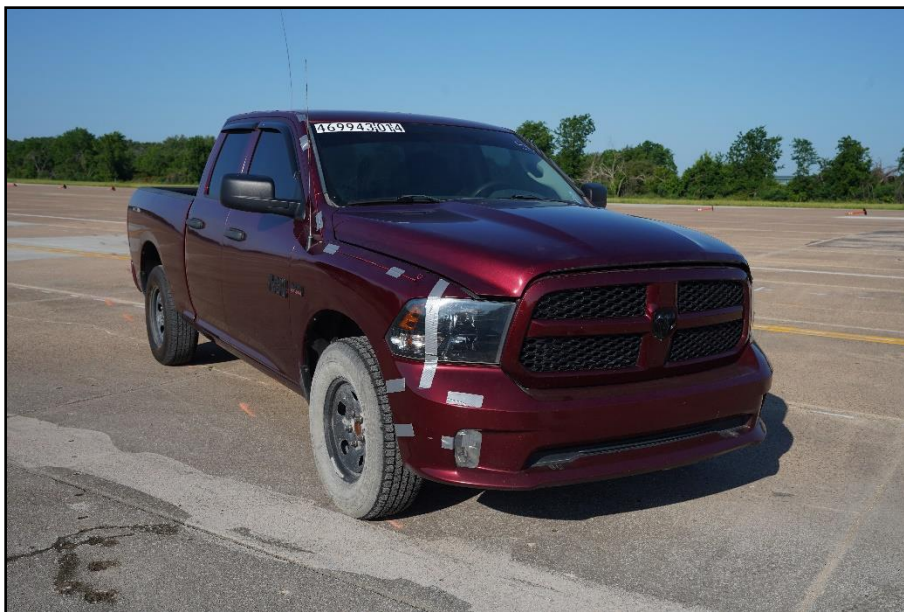
Figure 19.3. Impact Side of Test Vehicle before Test 469943-01-4.

Figure 19.3 and Figure 19.4 show the 2017 RAM 1500 used for the crash test. Table 19.4 shows the vehicle measurements. Figure K.1 in Appendix K.1 gives additional dimensions and information on the vehicle.

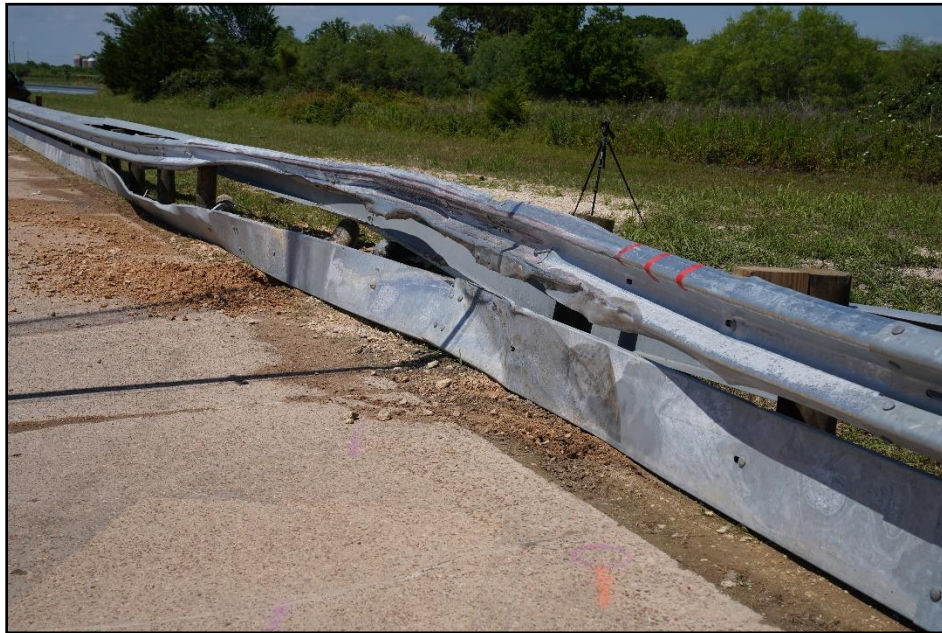
Figure 19.5. Traffic-Side View of the Enhanced Motorcycle Guard Fence System at Impact Location after Test 469943-01-4.

Table 19.7 describes the deflection and working width of the enhanced motorcycle guard fence system. Figure 19.5 and Figure 19.6 show the damage to the enhanced motorcycle guard fence system.

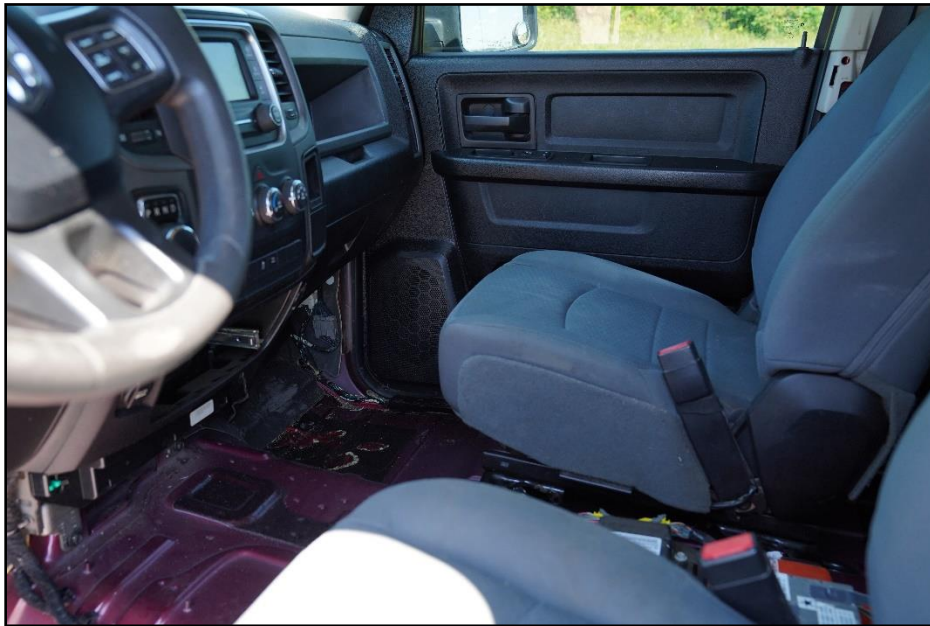
Figure 19.9. Overall Interior of Test Vehicle after Test 469943-01-4.

Figure 19.7 and Figure 19.8 show the damage sustained by the vehicle. Figure 19.9 and Figure 19.10 show the interior of the test vehicle. Table 19.8 and Table 19.9 provide details on the occupant compartment deformation and exterior vehicle damage. Figures K.2 and K.3 in Appendix K.1 provide exterior crush and occupant compartment measurements.

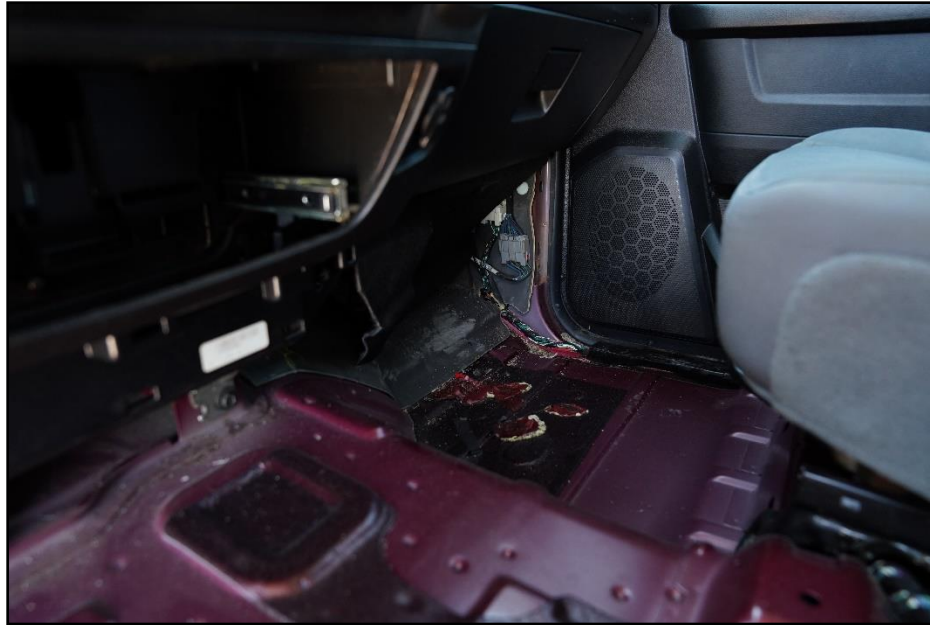
Figure 19.10. Interior of Test Vehicle on Impact Side after Test 469943-01-4.

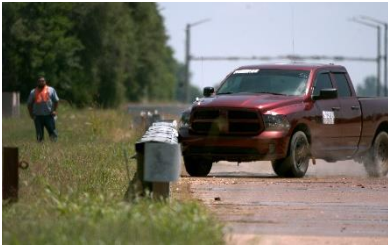
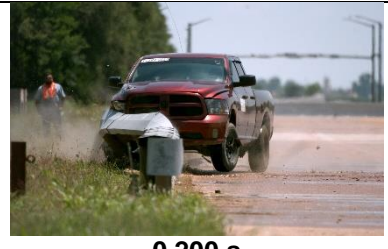
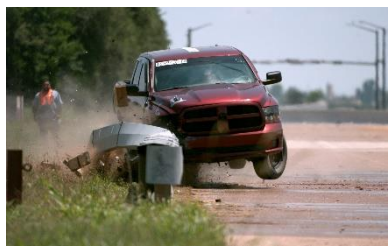
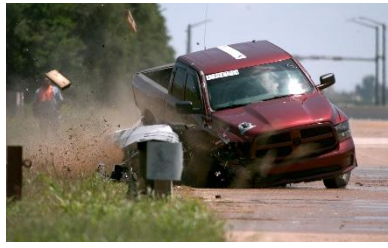
<p style="text-align: center;">0.000 s</p>	Test Agency	Texas A&M Transportation Institute (TTI)					
	Test Standard/Test No.	MASH 2016, Test 3-11					
	TTI Project No.	469943-01-4					
	Test Date	2023-05-18

<p style="text-align: center;">0.200 s</p>	Test ARTICLE						
	Type	Longitudinal Barrier					
	Name	Enhanced Motorcycle Guard Fence System					
	Length	181 ft 3 inches

<p style="text-align: center;">0.400 s</p>	Key Materials	Round timber posts, cap rail, W-beam guardrail, rubrail					
	Soil Type and Condition	Type A Grade 2 crushed limestone					
	Test VEHICLE						
	Type/Designation	2270P

<p style="text-align: center;">0.600 s</p>	Year, Make and Model	2017 RAM 1500					
	Inertial Weight (lb)	5032					
	Dummy (lb)	N/A					
	Gross Static (lb)	5032					
IMPACT CONDITIONS							
Impact Speed (mi/h)	65.0						
Impact Angle (deg)	24.7						
Impact Location	13 ³ / ₁₆ inches upstream of centerline of post 12

Impact Severity (kip-ft)	124.1						
EXIT CONDITIONS							
Exit Speed (mi/h)	Not measurable. Exit was out of camera frame.						
Trajectory/Heading Angle (deg)	Not measurable. Exit was out of camera frame.						
Exit Box Criteria	Vehicle did not cross the exit box						
Stopping Distance	171 ft downstream 6 ft to the field side						
Test ARTICLE DEFLECTIONS							
Dynamic (inches)	41.4						
Permanent (inches)	32						
Working Width/Height (inches)	57.3/34.0						
VEHICLE DAMAGE							
VDS	01RFQ3						
CDC	01FREW2						
Max. Ext. Deformation (inches)	10						
Max Occupant Compartment Deformation	No occupant compartment deformation						
OCCUPANT RISK VALUES							
Long. OIV (ft/s)	14.7	Long. Ridedown (g)	8.7	Max 50-ms Long. (g)	-5.1	Max Roll (deg)	13.9
Lat. OIV (ft/s)	15	Lat. Ridedown (g)	8.6	Max 50-ms Lat. (g)	-6.2	Max Pitch (deg)	9.4
THIV (m/s)	5.9	ASI	0.76	Max 50-ms Vert. (g)	3	Max Yaw (deg)	40.5

Figure 19.11. Summary of Results for MASH Test 3-11 on Enhanced Motorcycle Guard Fence System.

Figure 19.11 summarizes the results of *MASH* Test 469943-01-4.

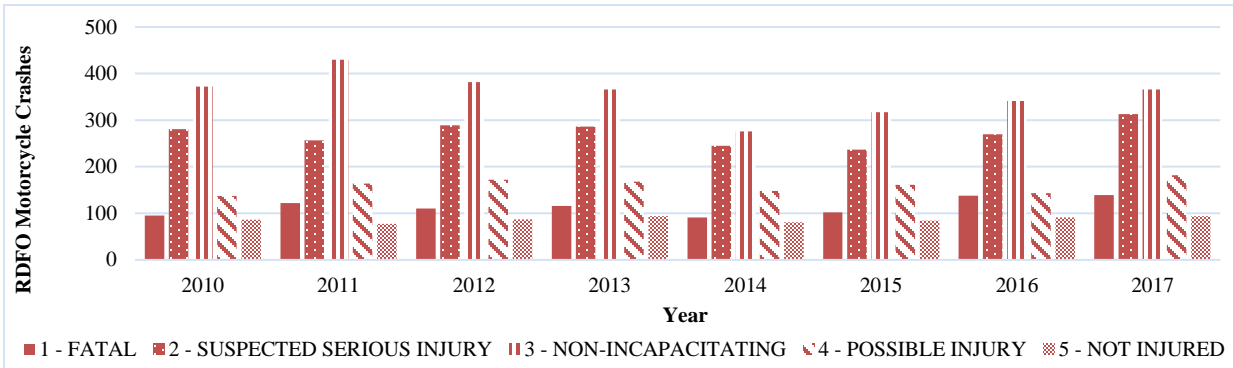
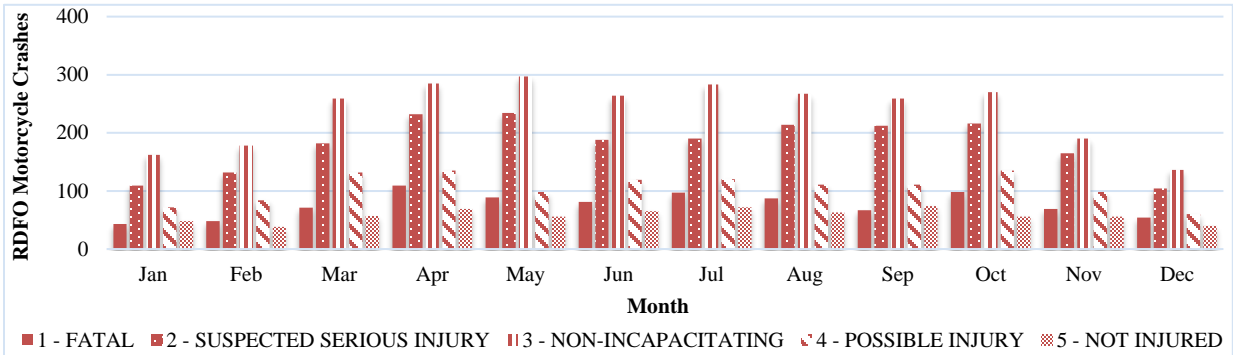
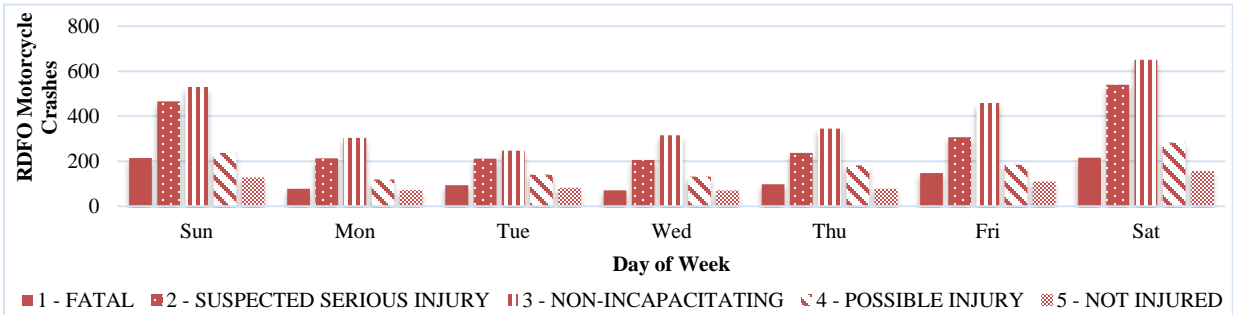
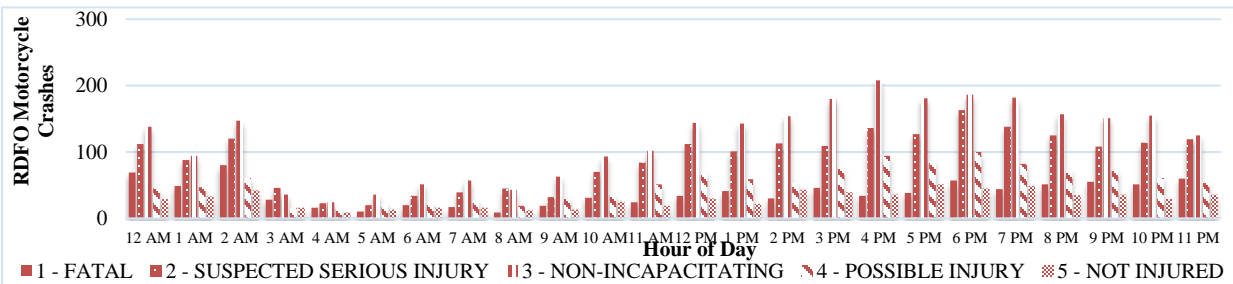
Figure 20.1. Temporal Distribution of RDFS Motorcycle Crashes.

Figure 20.1 depicts the temporal features of RDFO motorcycle crashes that resulted in a fatality or injury (FI, or KABC). As the figure shows, FI crashes, particularly fatal and suspected serious injury RDFO motorcycle crashes, have been increasing in past years (Figure 20.1[a]). The crashes from 2010 to 2017 occurred mainly during summer months (Figure 20.1[b]) and on the weekends (Figure 20.1[c]), indicating high recreational activity. The RDFO FI motorcycle crashes also tended to occur during peak hours (Figure 20.1[d]). However, unlike the vehicle crashes, the crash frequency and severity of RDFO motorcycle crashes remained high until 2:00 a.m.

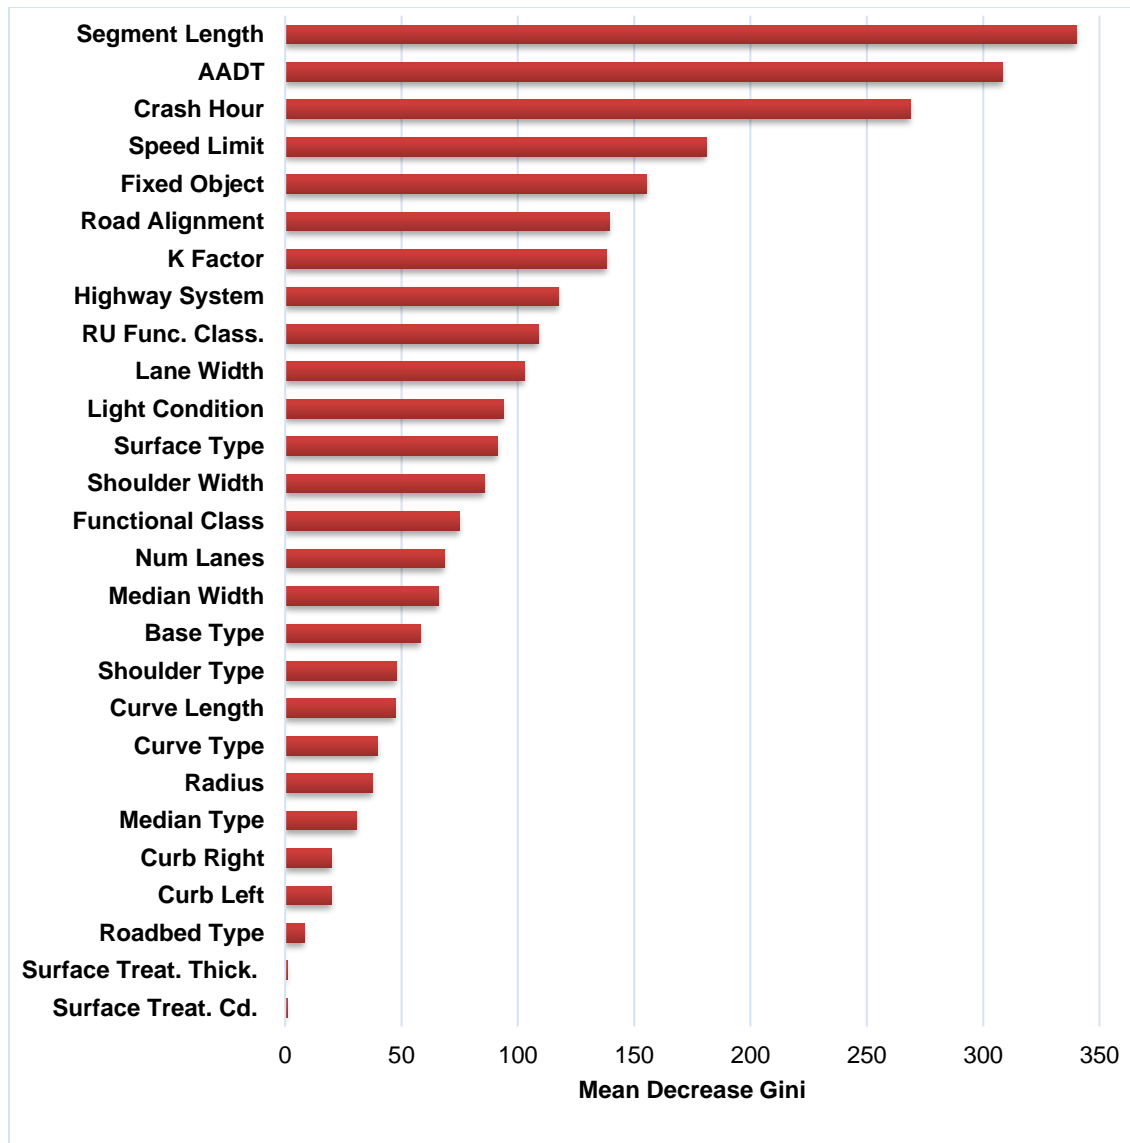
Figure 20.2. Important Variables Associated with Motorcycle Crash Severity.

To assess how external roadway and roadside factors affect the crash severity of motorcycle crashes, the researchers used random forests. Figure 20.2 shows the importance of the crash-contributing variables in determining the severity outcome of a crash. As the figure illustrates, the most important variables associated with the RDFO motorcycle crash severity are segment length, AADT, crash hour, speed limit, fixed object, road alignment, K-factor, highway system, rural-urban (RU) classification, lane width, lighting conditions, surface type, and shoulder width. The variables of segment length and AADT are related to exposure, while all the others are related to risk.

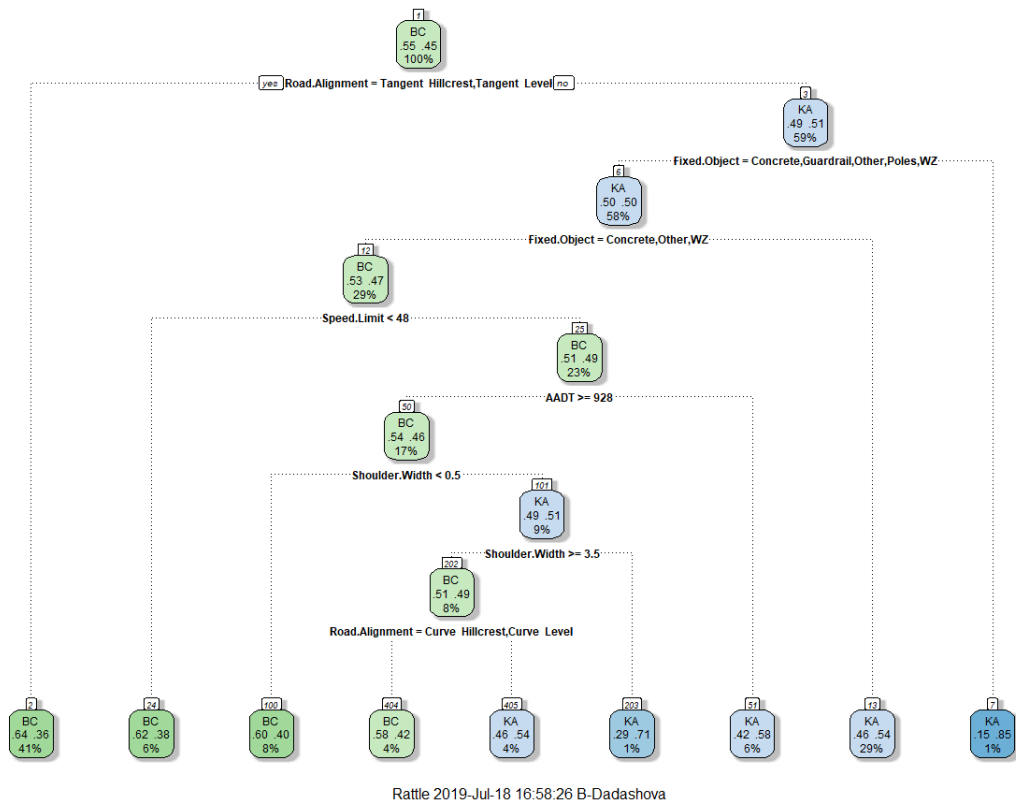
Figure 20.3. Decision Tree for Identifying Risk Factor Groups.

The researchers then used the most important crash-contributing factors identified from random forests and multinomial logit models to create risk factor groups (RFGs) to determine the list of potential sites for improvement. RFG, in this context, refers to the group of roadway and roadside design elements, as well as operational factors that are associated with high-severity (KA) and low-severity (BC) motorcycle crashes. Because temporal factors such as crash hour or daylight conditions cannot be altered by engineering decisions, these variables were not considered for creating the RFGs. Researchers used 80 percent of the observations to train the decision tree and 20 percent to test it. Results of the decision tree are shown in Figure 20.3.

This decision tree has nine nodes, or RFGs. The first RFG is created by the first split of the tree: roadway alignment. This node, or RFG, indicates that when a motorcycle crash occurs on a tangent hillcrest and level road, the probability of a crash resulting in a KA and BC injury is 36 and 64 percent, respectively, indicating that the severity of this RFG is relatively low. The second split is caused by the fixed object type. This split shows that if a motorcyclist hits a bridge and barrier on a curve (level, grade, and hillcrest) and tangent with the grade, the crash has an 85 percent probability of resulting in a fatality or serious injury. This combination of roadway (i.e., alignment) and roadside (i.e., fixed object type) factors creates RFG #9, which is a high-risk roadway segment group. If the motorcyclist hits a guardrail and pole on a segment with a similar roadway alignment, the crash has a 54 percent probability of resulting in a KA crash (RFG #8). On the other hand, if a motorcyclist hits a concrete, work zone, or other roadside structure, the severity of the crash will depend on a combination of roadway (shoulder width), roadside, and operational (posted speed limit [PSL] and AADT) elements. For example, hitting a concrete barrier or work zone element on the roadway with less than a 48 mi/h (e.g., 45 mi/h) PSL would result in a less severe crash (RFG #2). Note that 48 mi/h is a cutoff or threshold value determined by the decision tree. If the PSL is more than this threshold, AADT is more than 928, and shoulder width is less than 3.5 ft (and more than 0.5), a crash could result in a KA crash with a 71 percent probability (RFG #6).

Overall, the risk groups can be classified into three groups: high risk (RFG #6 and #9), moderate risk (RFG #5, #7, and #8), and low risk (RFG #1, #2, #3, and #4). Table 20.6 depicts the list of RFGs together with the risk level and the roadway, roadside, and operational characteristics of each risk group. According to these results, bridge and building structures on horizontal and vertical curves may present a very high risk for motorcyclist safety. Although curve and tangent grades were found to be associated with more severe crashes, the RFG indicates that not all the segments with these roadway alignment characteristics are high risk; for example, hitting a concrete or work zone device on a horizontal curve with less than a 48 mi/h PSL will have a 38 percent probability of resulting in a fatality or suspected serious injury. The probability starts increasing for the roadways where the PSL is higher than this threshold.
