Test Report No. 469940-03, 469942-01, and 469943-01

**DEVELOP A RETROFIT DESIGN FOR GUARD FENCE SYSTEM TO
ENHANCE MOTORCYCLE SAFETY
COOPERATIVE RESEARCH PROGRAM**

Texas Department of Transportation
<https://tti.tamu.edu/documents/0-6994-R1.pdf>

TEXAS A&M TRANSPORTATION INSTITUTE PROVING GROUND

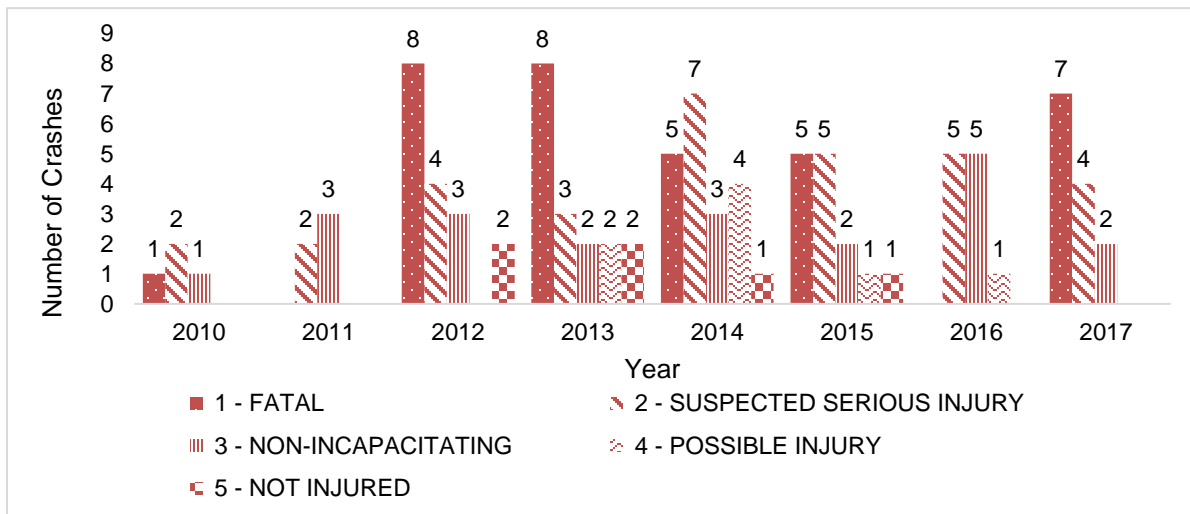
Figure 20.4. Number of Severe Crashes at High-Risk Sites.

Figure 20.4 shows the number of crashes per crash severity and year at high-risk sites. As shown, the number of fatal and injury crashes at the high-risk sites was higher than the possible and non-injury crashes. Thus, these sites have the potential for safety improvement and were the candidate sites for installing the retrofit guardrails. Figure 20.5 shows the low- to high-risk locations where the RDFO motorcycle crashes occurred.

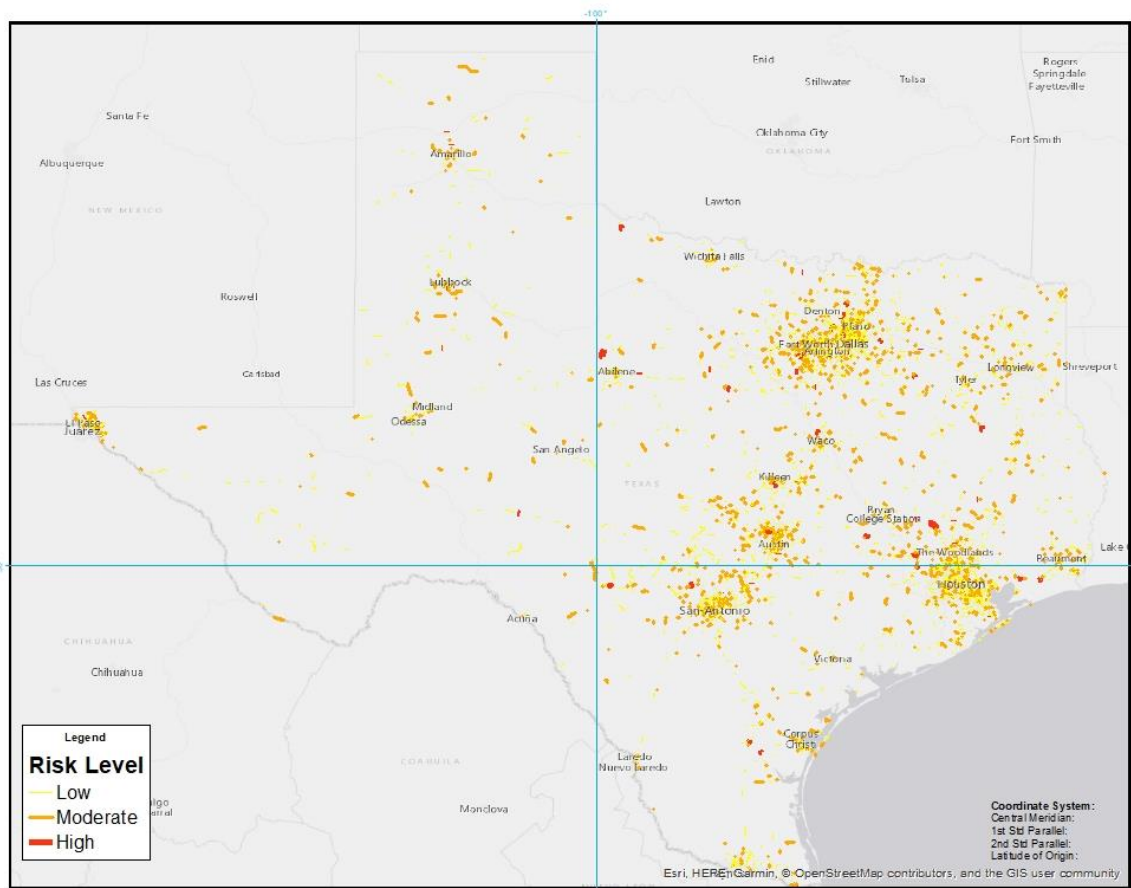
Figure 20.5. Low- to High-Risk Sites.

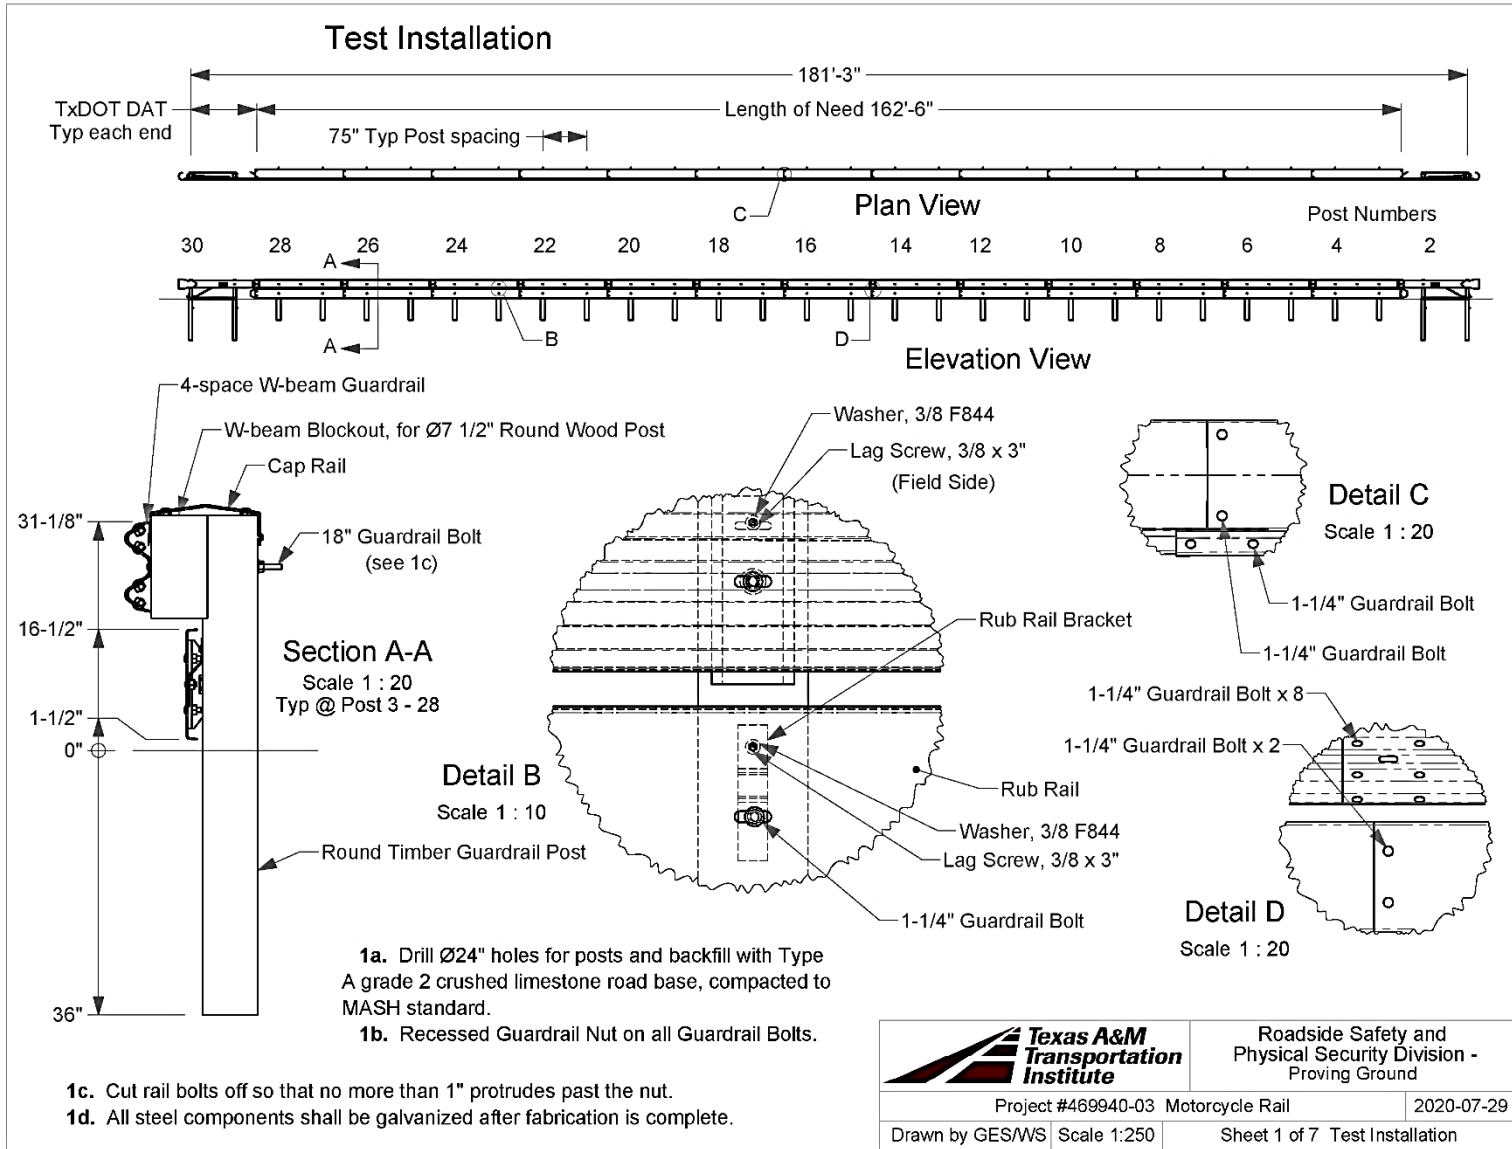
Rub Rail Anchor Details

2a. Rub Rail Anchor Cap is placed on field side of Rub Rail in this location. It will be on the traffic side on the upstream end of the installation to minimize snagging.

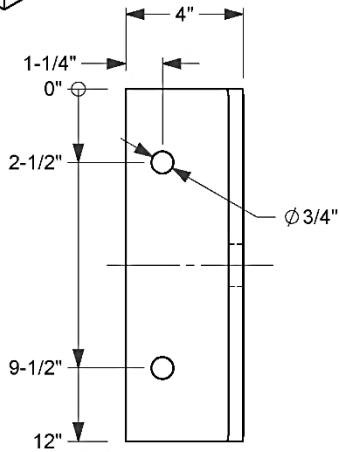
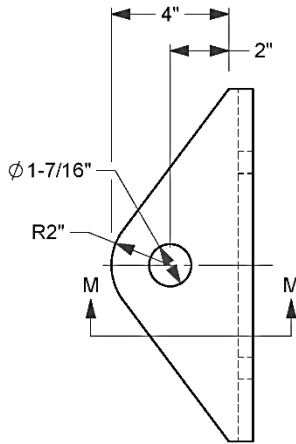
Rub Rail Anchor Bracket
 Plate, 12" x 1/2" x 8"
 ASTM A572 Grade 50

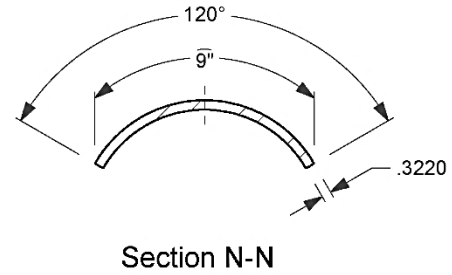
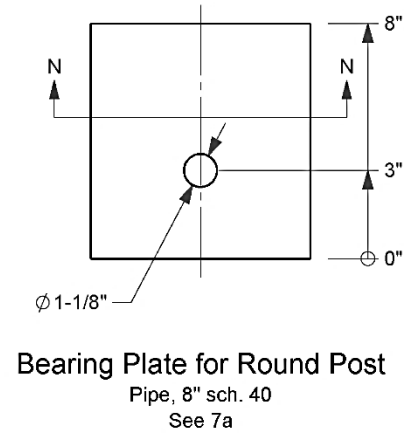
Bearing Plate for Round Post
 Pipe, 8" sch. 40
 See 7a

7a. Bearing Plate for Round Post may be fabricated from schedule 40 pipe, as indicated, or 3/8" plate at contractor's discretion. Contractor shall specify which option was used for the installation and provide material certs.

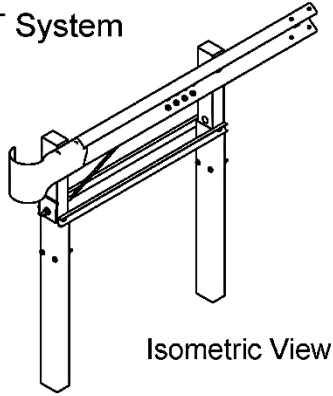
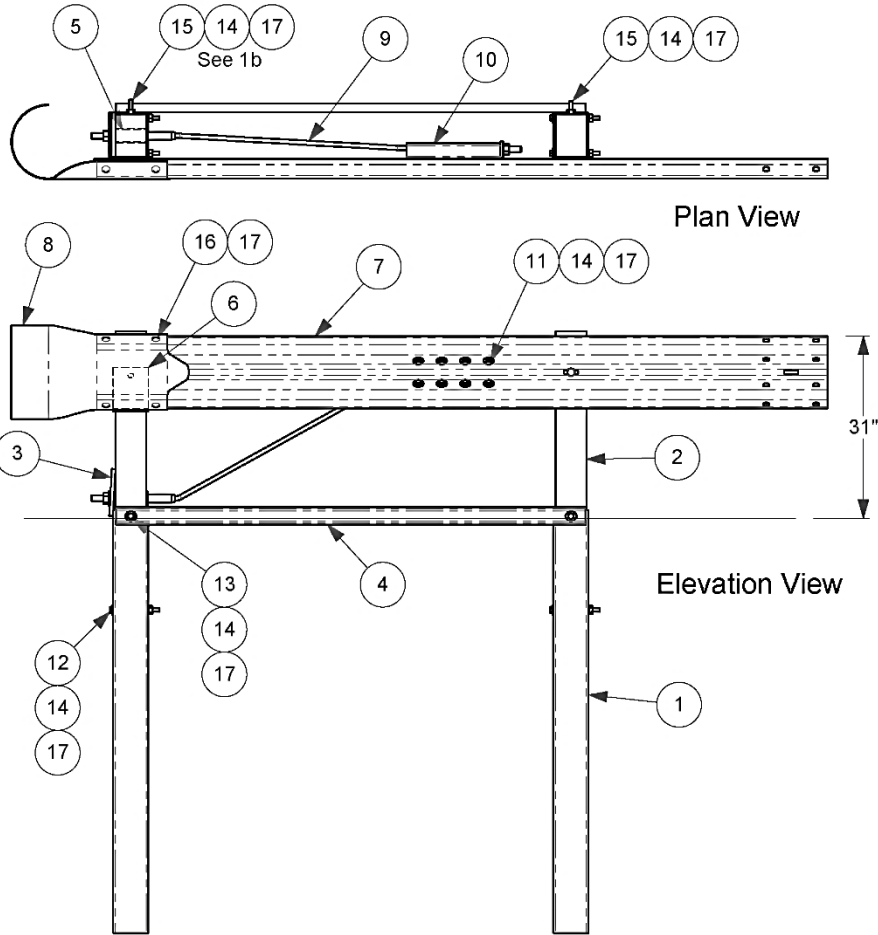
DAT System

1a. All bolts are ASTM A307.
1b. Hardware secures Shelf Angle Bracket to Post. Rail is supported by Shelf Angle Bracket and does not attach directly to Post.

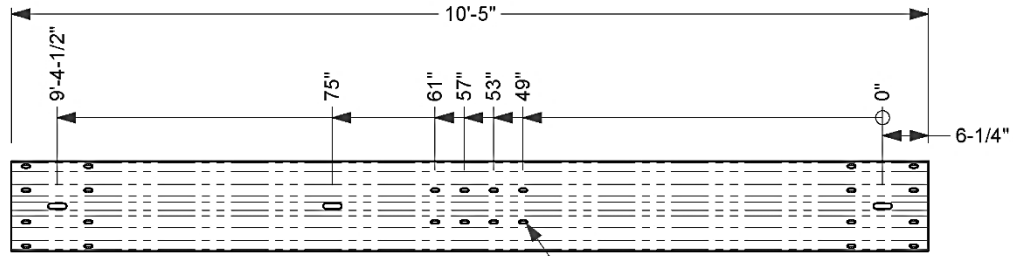
DAT Terminal Rail

Scale 1:20 - See 4-space W-beam Guardrail drawing for cross-section and other dimensions.

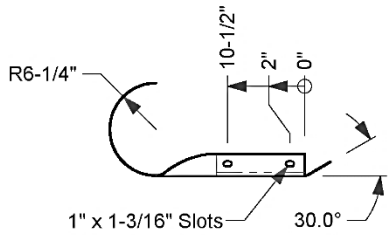
W-beam End Section

12 gauge steel - Scale 1:20

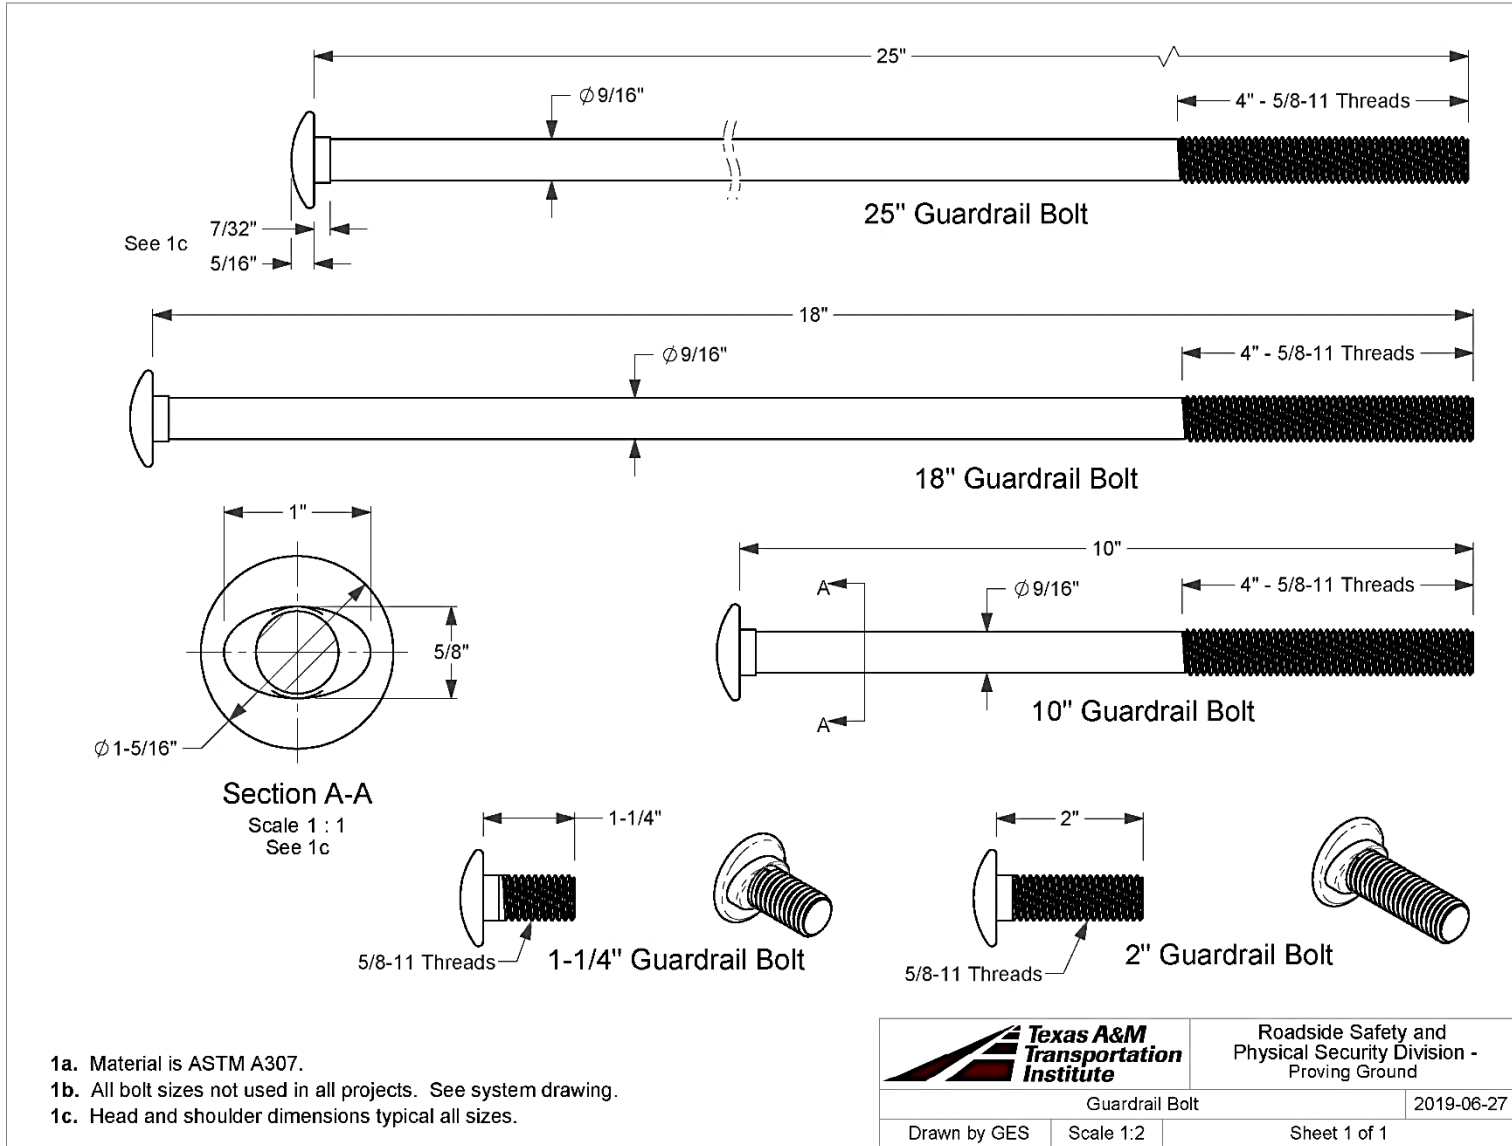
- 1a. Material is ASTM A307.
- 1b. All bolt sizes not used in all projects. See system drawing.
- 1c. Head and shoulder dimensions typical all sizes.

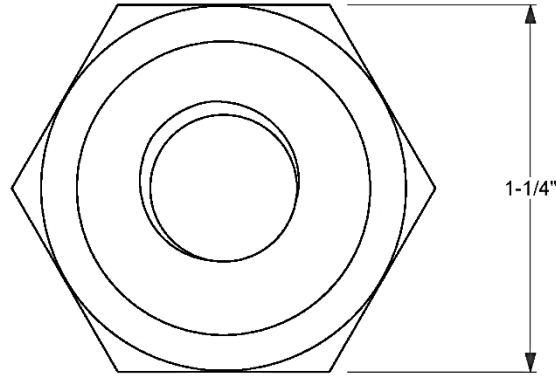
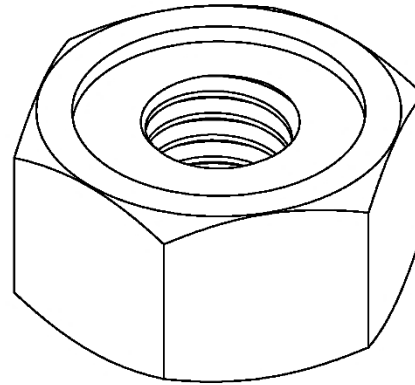
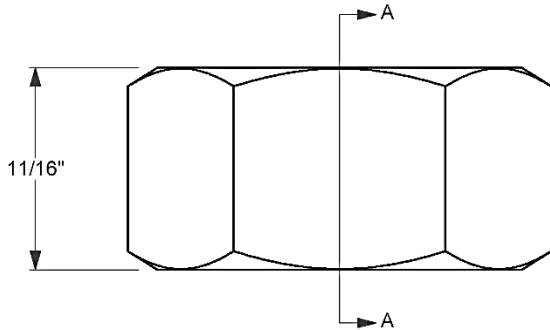
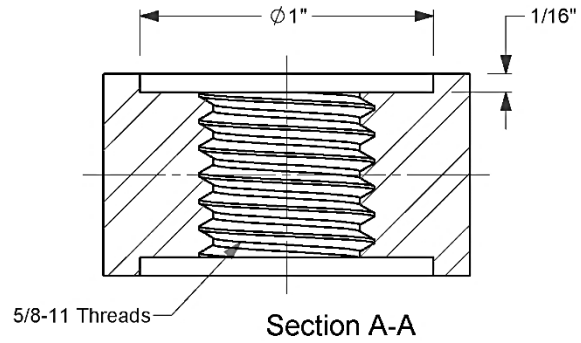
1a. Material is ASTM A 563 Grade A.

Roadside Safety and Physical Security Division - Proving Ground
Recessed Guardrail Nut		2019-06-27
Drawn by GES	Scale 2:1	Sheet 1 of 1

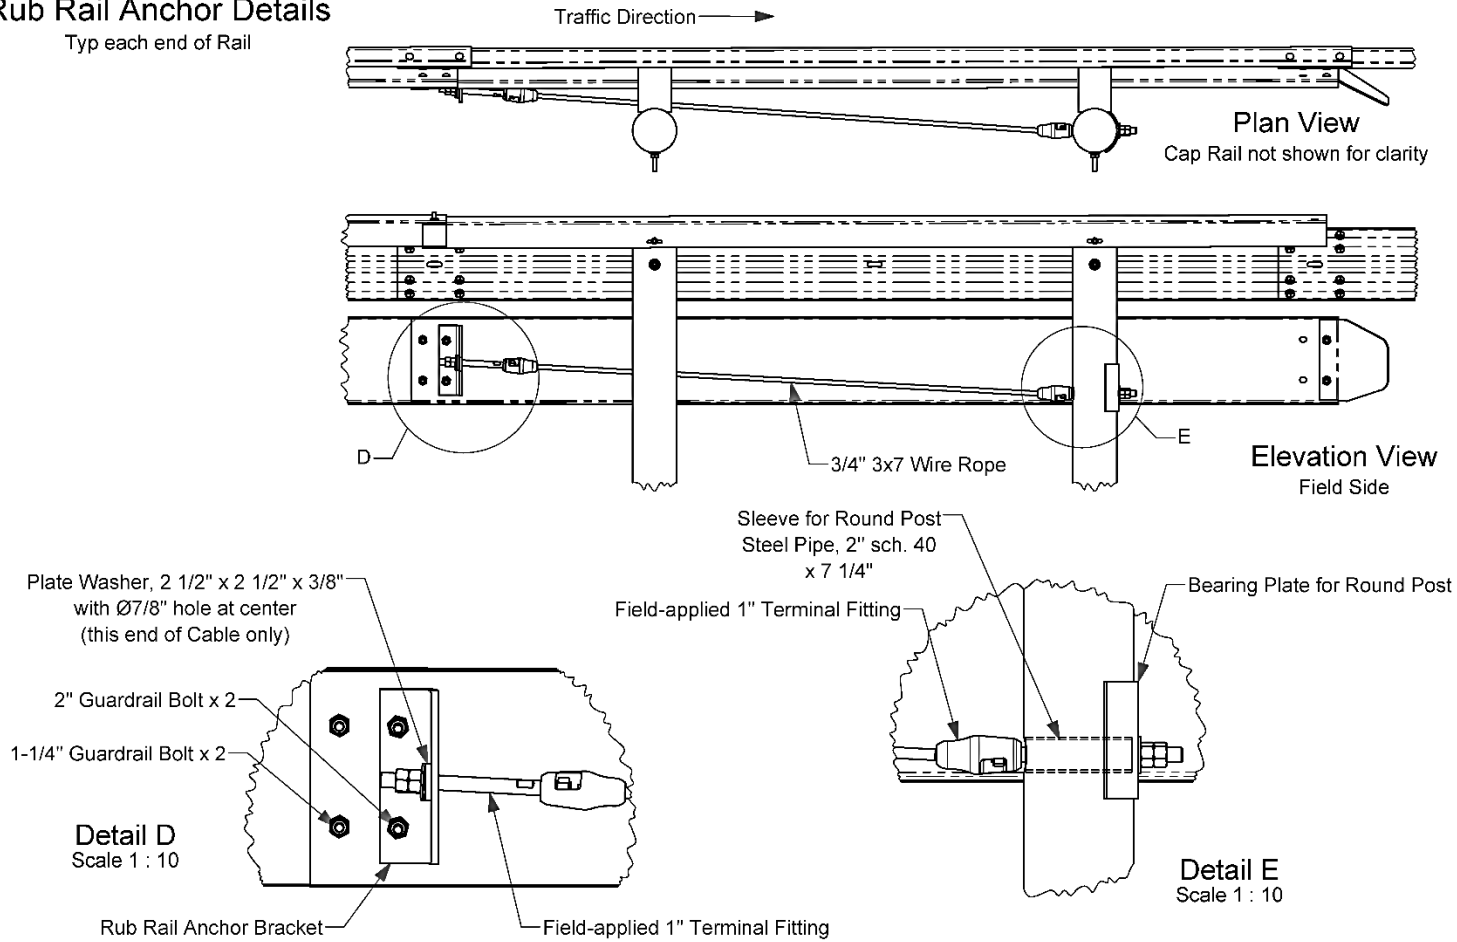
Roadside Safety and Physical Security Division - Proving Ground
Project #469942 Motorcycle Rail		2022-04-11
Drawn by GES	Scale 1:25	Sheet 2 of 8 Rub Rail Anchor Details

Rub Rail Anchor Details

Typ each end of Rail

2a. Rub Rail Anchor Cap is placed on field side of Rub Rail in this location. It will be on the traffic side on the upstream end of the installation to minimize snagging.

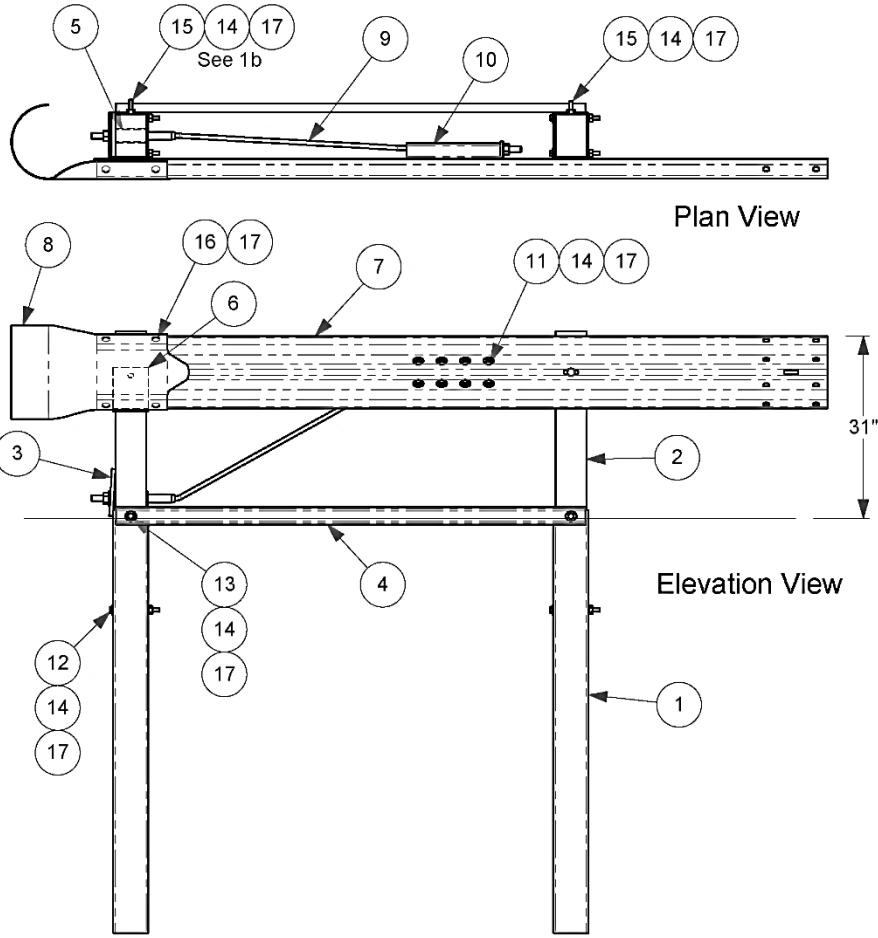
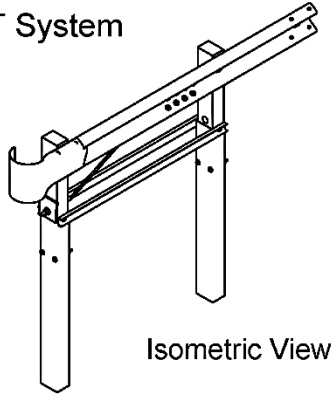
Roadside Safety and Physical Security Division - Proving Ground	
	DAT (Downstream Anchor Terminal) 2019-07-26	
Drawn by GES	Scale 1:25	Sheet 1 of 3

DAT System

#	Part Name	Qty.
1	Foundation Tube	2
2	Terminal Timber Post	2
3	BCT Bearing Plate	1
4	DAT Strut	2
5	BCT Post Sleeve	1
6	Shelf Angle Bracket	1
7	DAT Terminal Rail	1
8	W-beam End Section	1
9	Anchor Cable Assembly	1
10	Guardrail Anchor Bracket	1
11	Bolt, 5/8 x 2" hex	8
12	Bolt, 5/8 x 8" hex	4
13	Bolt, 5/8 x 10" hex	2
14	Washer, 5/8 F844	16
15	10" Guardrail Bolt	2
16	1-1/4" Guardrail Bolt	4
17	Recessed Guardrail Nut	20

1a. All bolts are ASTM A307.
1b. Hardware secures Shelf Angle Bracket to Post. Rail is supported by Shelf Angle Bracket and does not attach directly to Post.

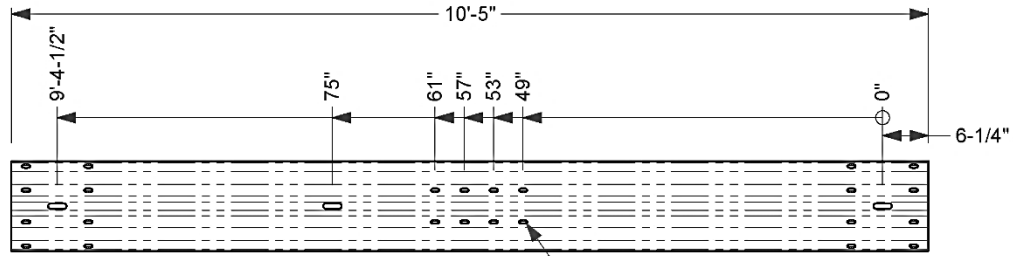
DAT Terminal Rail

Scale 1:20 - See 4-space W-beam Guardrail drawing for cross-section and other dimensions.

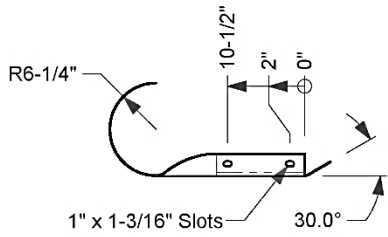
W-beam End Section

12 gauge steel - Scale 1:20

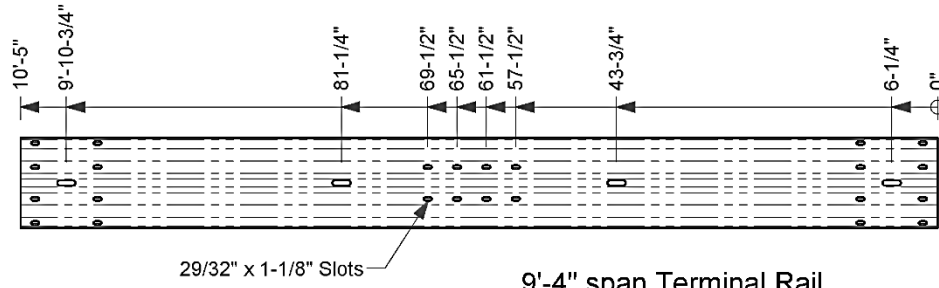
9'-4" span Terminal Rail

29/32" x 1-1/8" Slots

Scale 1:20 - See 4-space W-beam Guardrail drawing for cross-section and other dimensions.

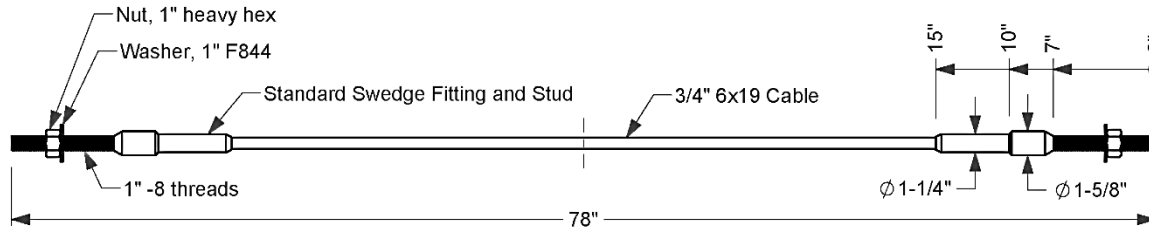
Anchor Cable Assembly

Roadside Safety and Physical Security Division - Proving Ground
Project # Terminal		2021-06-01
Drawn by GES	Scale 1:5	Sheet 6 of 6 Assorted Parts B

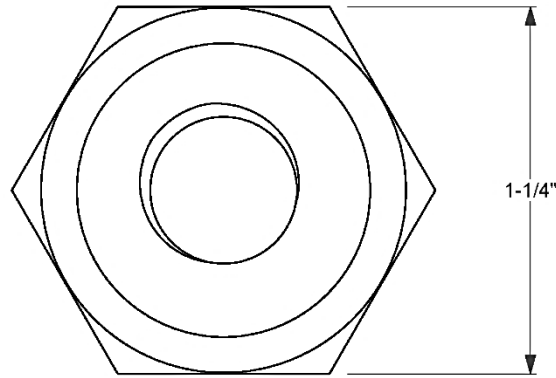
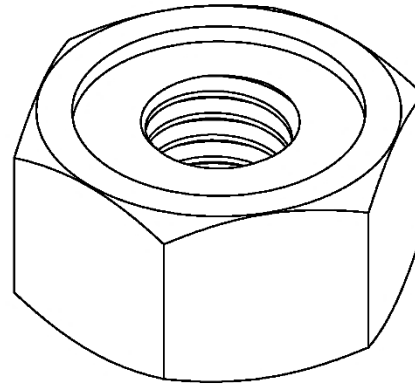
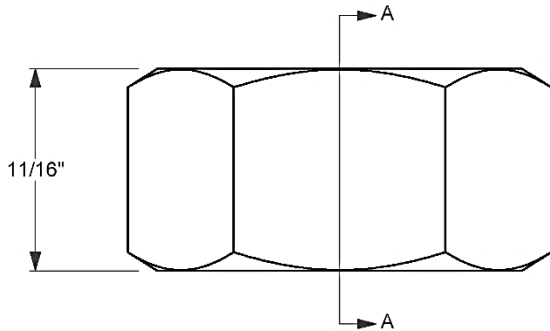
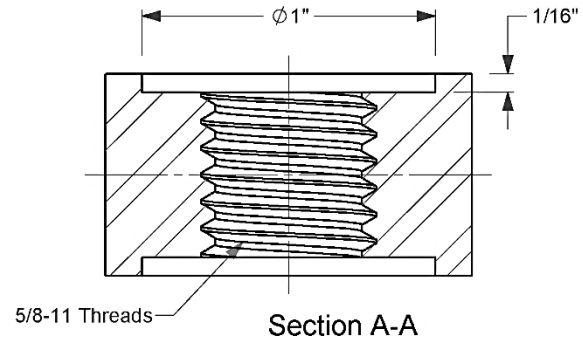
1a. Material is ASTM A 563 Grade A.

Roadside Safety and Physical Security Division - Proving Ground
Recessed Guardrail Nut		2019-06-27
Drawn by GES	Scale 2:1	Sheet 1 of 1

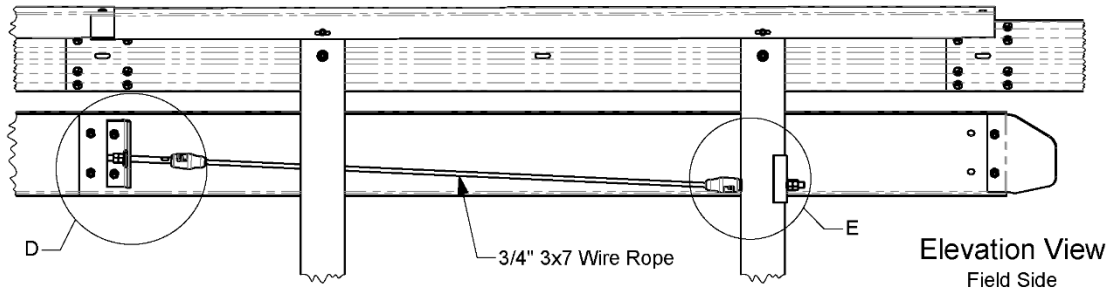
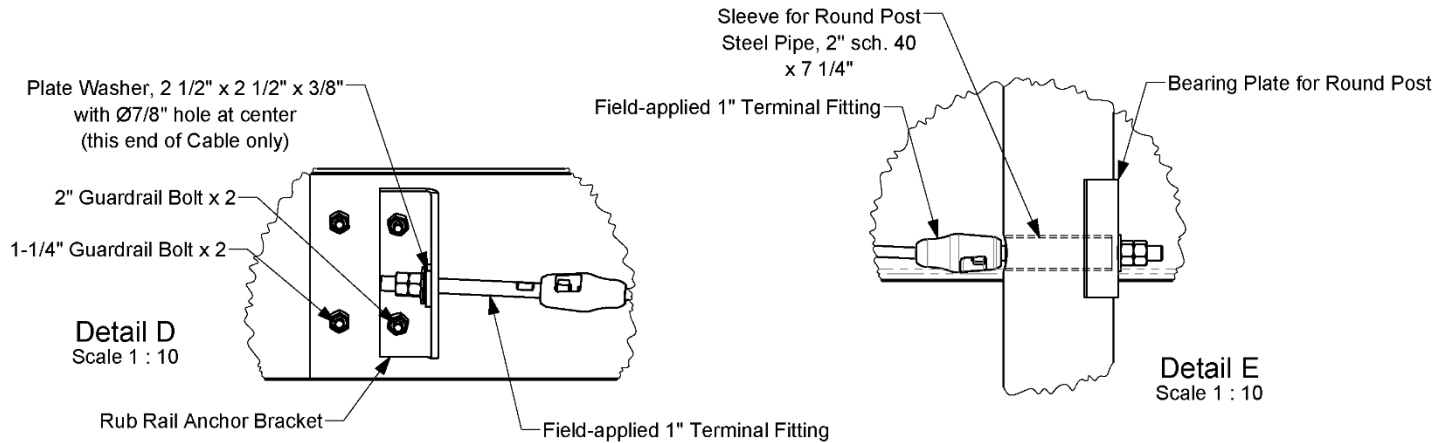
Project #469943-01 Motorcycle Rail		2022-12-01
Drawn by GES	Scale 1:25	Sheet 2 of 8 Rub Rail Anchor Details

Rub Rail Anchor Details

Typ each end of Rail

Traffic Direction →

2a. Rub Rail Anchor Cap is placed on field side of Rub Rail in this location. It will be on the traffic side on the upstream end of the installation to minimize snagging.

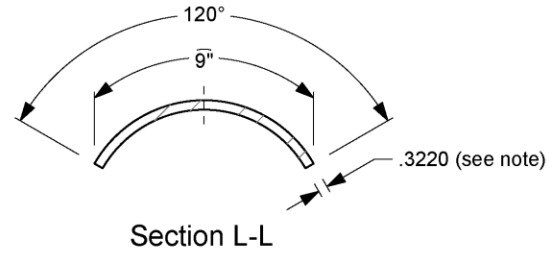
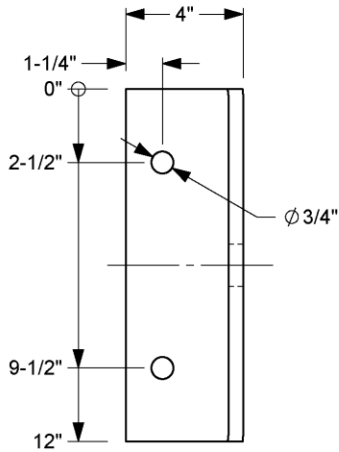
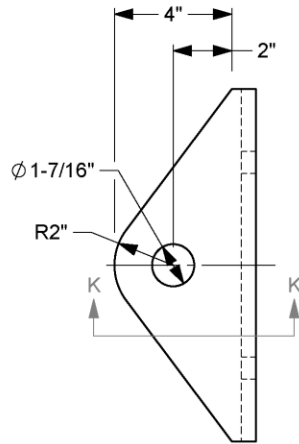
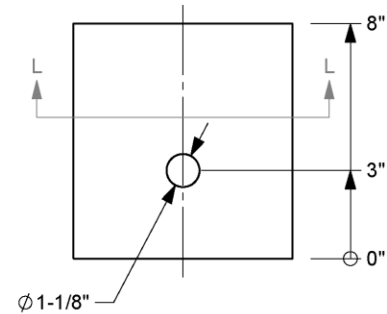
Roadside Safety and Physical Security Division - Proving Ground	
Project #469943-01 Motorcycle Rail		2022-12-01	
Drawn by GES	Scale 1:5	Sheet 7 of 8 Anchor Bracket and Bearing Plate

Bearing Plate for Round Post
Pipe, 8" sch. 40
See 7a

Rub Rail Anchor Bracket
Plate, 12" x 1/2" x 8"
ASTM A572 Grade 50

7a. Bearing Plate for Round Post may be fabricated from schedule 40 pipe, as indicated, or 3/8" plate at contractor's discretion. Contractor shall specify which option was used for the installation and provide material certs.

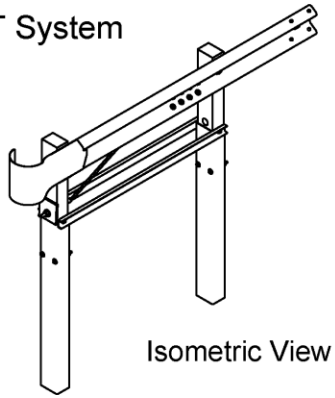
DAT System

#	Part Name	Qty.
1	72" Foundation Tube	2
2	Tube Post	2
3	BCT Bearing Plate	1
4	DAT Strut	2
5	BCT Post Sleeve	1
6	Shelf Angle Bracket	1
7	9'-4" span Terminal Rail	1
8	W-beam End Section	1
9	Anchor Cable Assembly	1
10	Guardrail Anchor Bracket	1
11	Bolt, 5/8 x 2" hex	8
12	Bolt, 5/8 x 8" hex	4
13	Bolt, 5/8 x 10" hex	2
14	Washer, 5/8 F844	16
15	10" Guardrail Bolt	2
16	1-1/4" Guardrail Bolt	4
17	Recessed Guardrail Nut	20

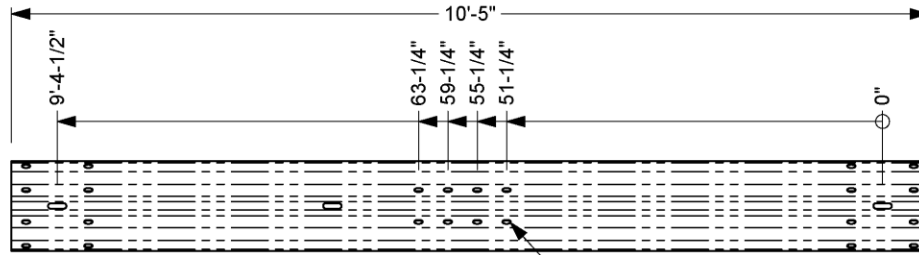
9'-4" span Terminal Rail
Scale 1:20 - See 4-space W-beam
Guardrail drawing for cross-section
and other dimensions.

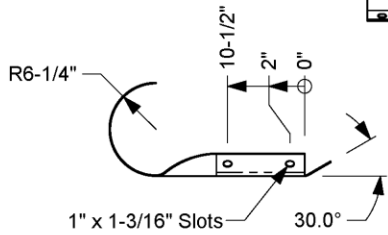
W-beam End Section
12 gauge steel - Scale 1:20

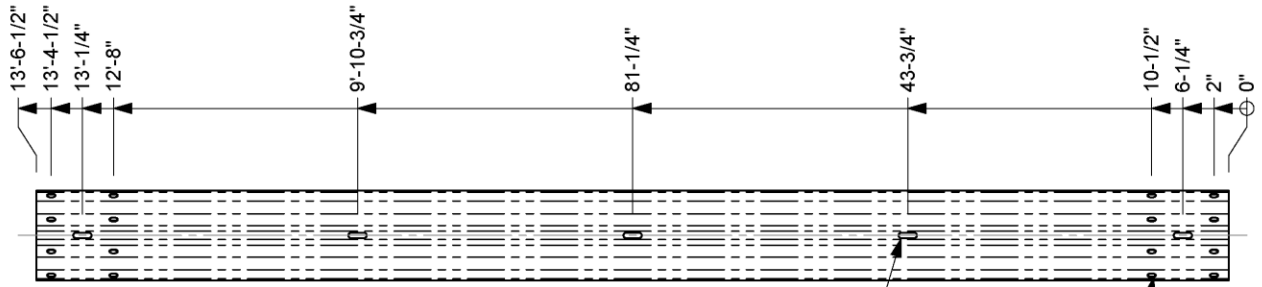
Elevation View

3/4" x 2-1/2" Slot
Typ x 5
See 1b

29/32" x 1-1/8" Slot
Typ x 8 each end

1a. Manufacture per AASHTO M180 specifications.
 1b. 4-space Guardrail is shown. Slots typical x 3 for 2-space W-beam spaced at 75", and typical x 9 for 8-space W-beam spaced at 18-3/4". Slots are typical x 4 at 37-1/2" for 9'-4-1/2" span W-beam.

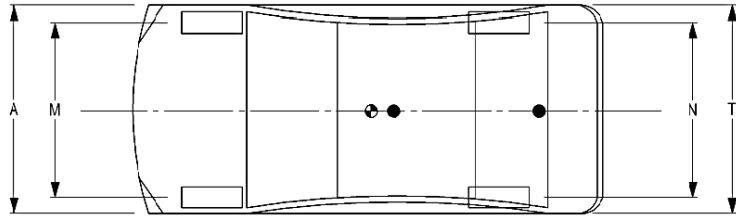
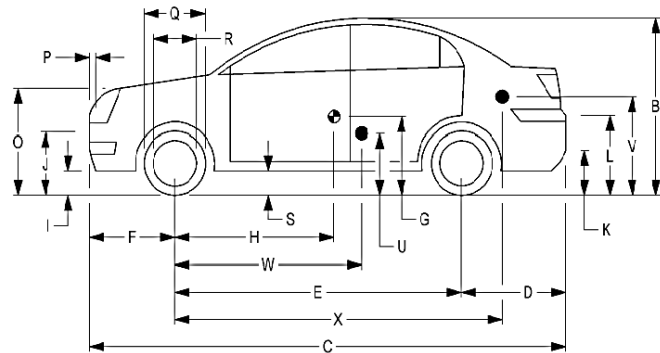
Geometry: inches

A <u>66.70</u>	F <u>32.50</u>	K <u>12.50</u>	P <u>4.50</u>	U <u>15.50</u>
B <u>59.60</u>	G _____	L <u>26.00</u>	Q <u>24.00</u>	V <u>21.25</u>
C <u>175.40</u>	H <u>40.20</u>	M <u>58.30</u>	R <u>16.25</u>	W <u>40.20</u>
D <u>40.50</u>	I <u>7.00</u>	N <u>58.50</u>	S <u>7.50</u>	X <u>79.75</u>
E <u>102.40</u>	J <u>22.25</u>	O <u>30.50</u>	T <u>64.50</u>	
Wheel Center Ht Front <u>11.50</u>	Wheel Center Ht Rear <u>11.50</u>	W-H <u>0.00</u>

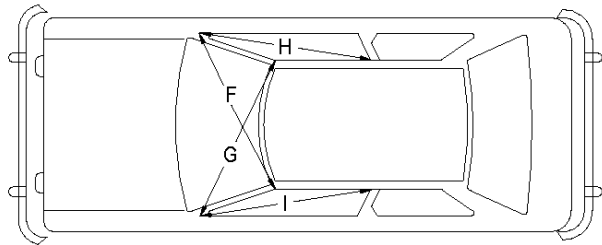
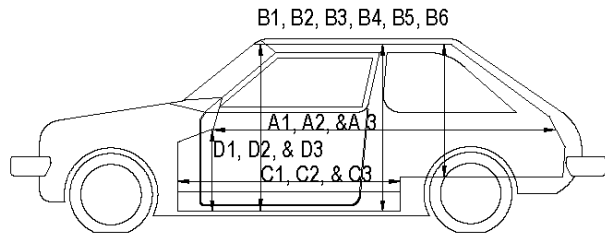
OCCUPANT COMPARTMENT DEFORMATION MEASUREMENT

Before	After (inches)	Differ.
A1	75.00	75.00	0.00
A2	74.00	74.00	0.00
A3	74.00	74.00	0.00
B1	43.00	43.00	0.00
B2	37.00	37.00	0.00
B3	43.00	43.00	0.00
B4	46.50	46.50	0.00
B5	42.50	42.50	0.00
B6	46.50	46.50	0.00
C1	26.00	26.00	0.00
C2	0.00	0.00	0.00
C3	26.00	26.00	0.00
D1	12.50	12.50	0.00
D2	0.00	0.00	0.00
D3	10.00	10.00	0.00
E1	45.00	45.00	0.00
E2	48.75	48.75	0.00
F	47.50	47.50	0.00
G	47.50	47.50	0.00
H	39.00	39.00	0.00
I	39.00	39.00	0.00
J*	48.50	48.50	0.00

Figure C.3. Occupant Compartment Measurements for Test 469940-03-1.

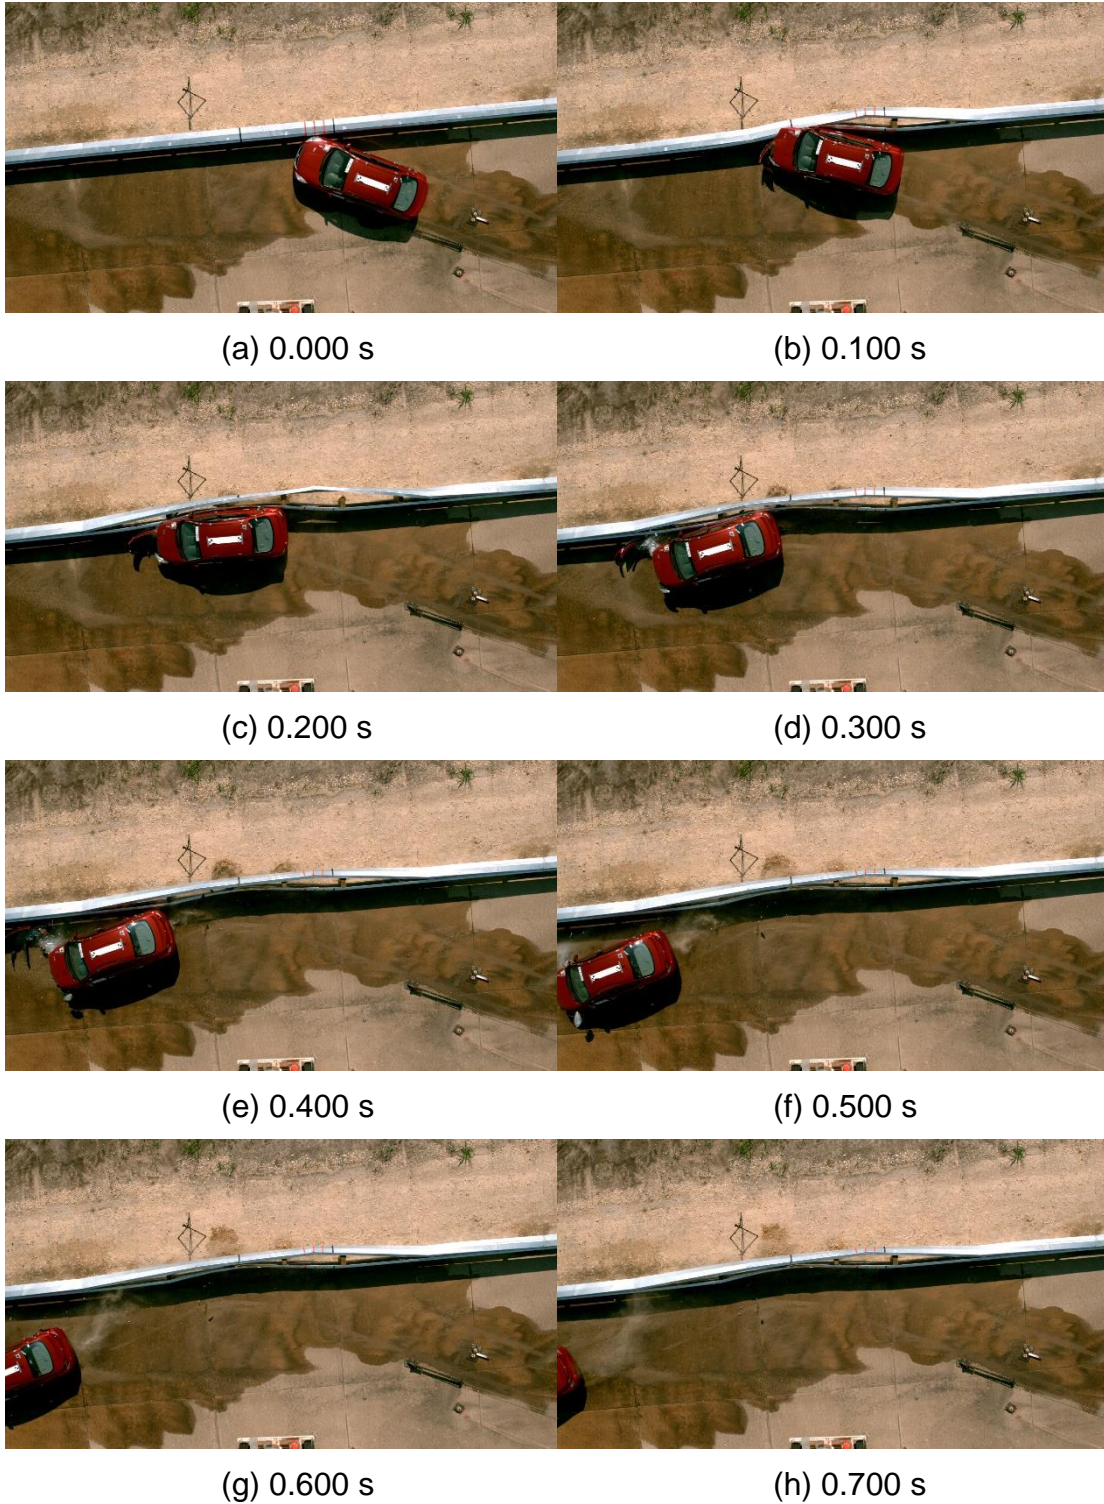
Figure C.4. Sequential Photographs for Test 469940-03-1 (Overhead Views).

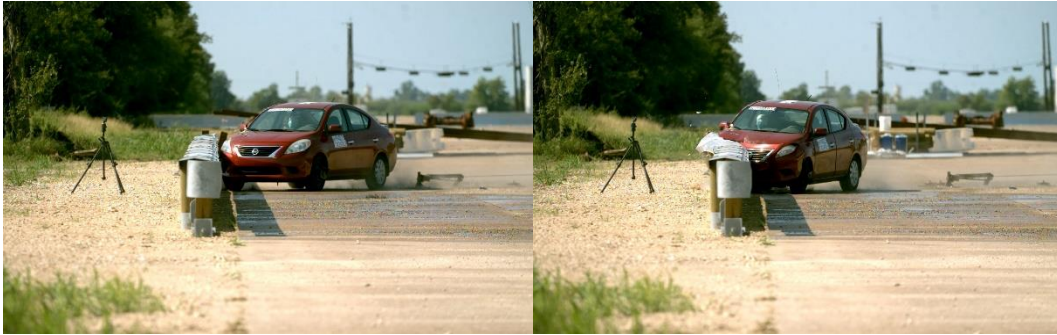
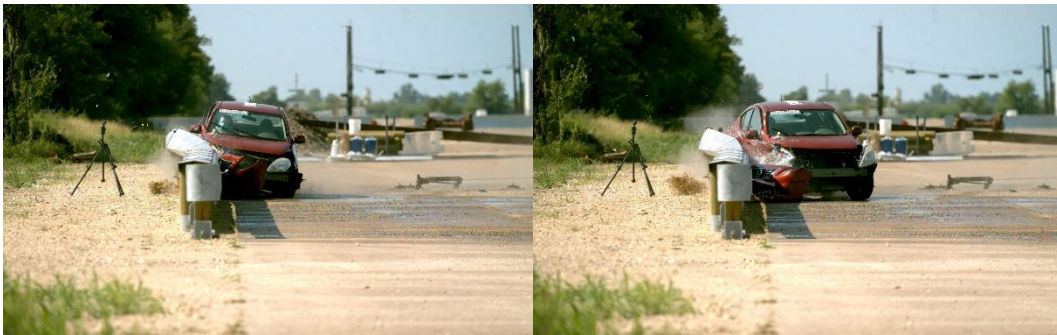
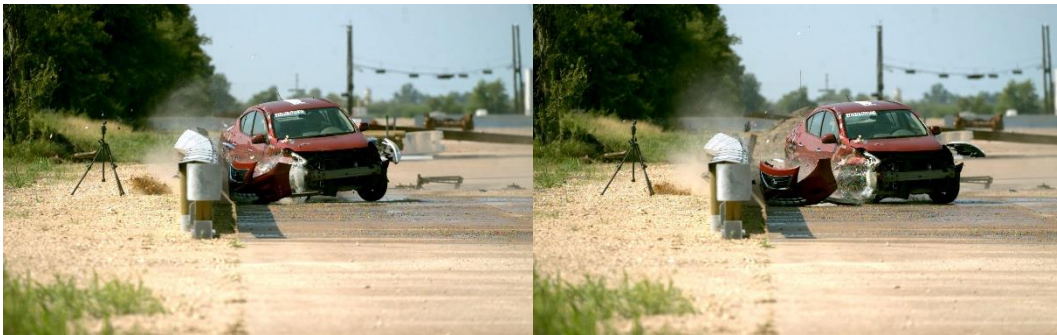
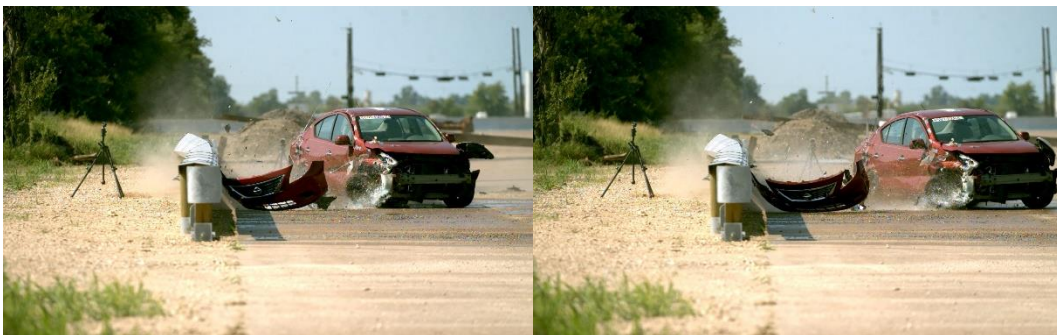
Figure C.5. Sequential Photographs for Test 469940-03-1 (Frontal Views).

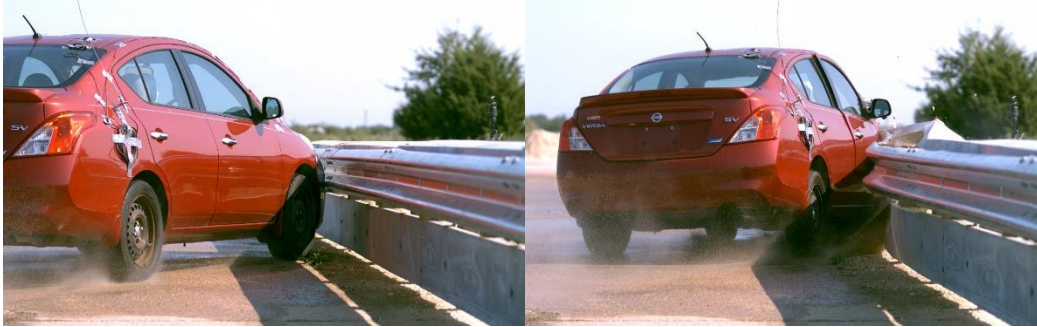
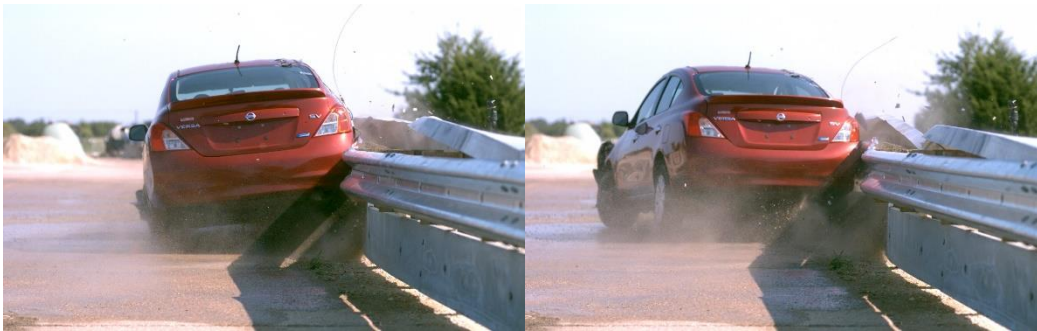
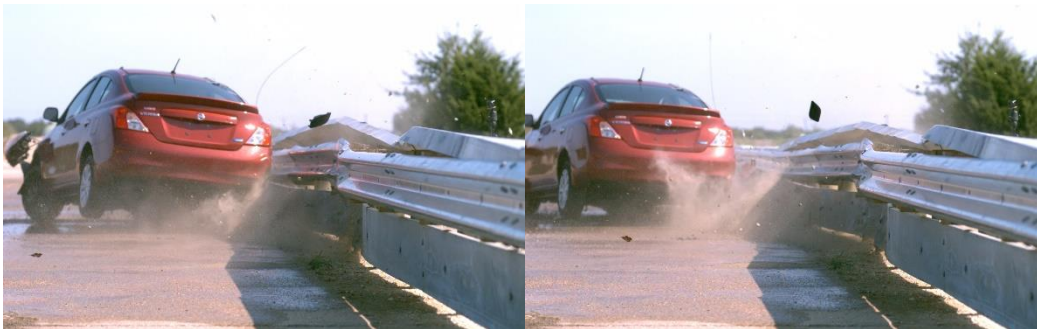
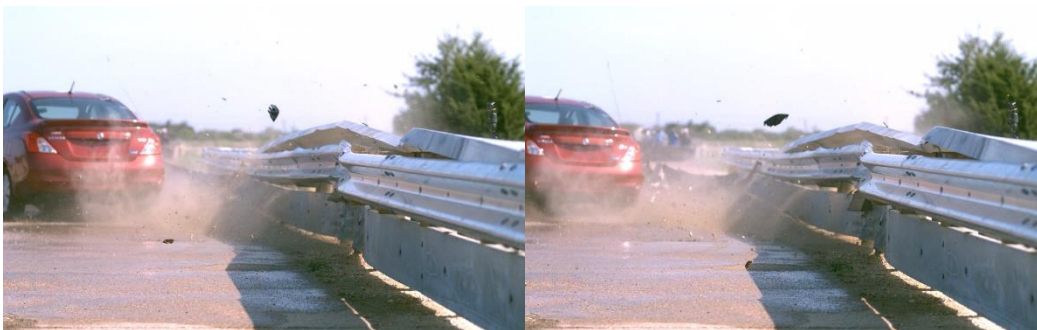
Figure C.6. Sequential Photographs for Test 469940-03-1 (Rear Views).

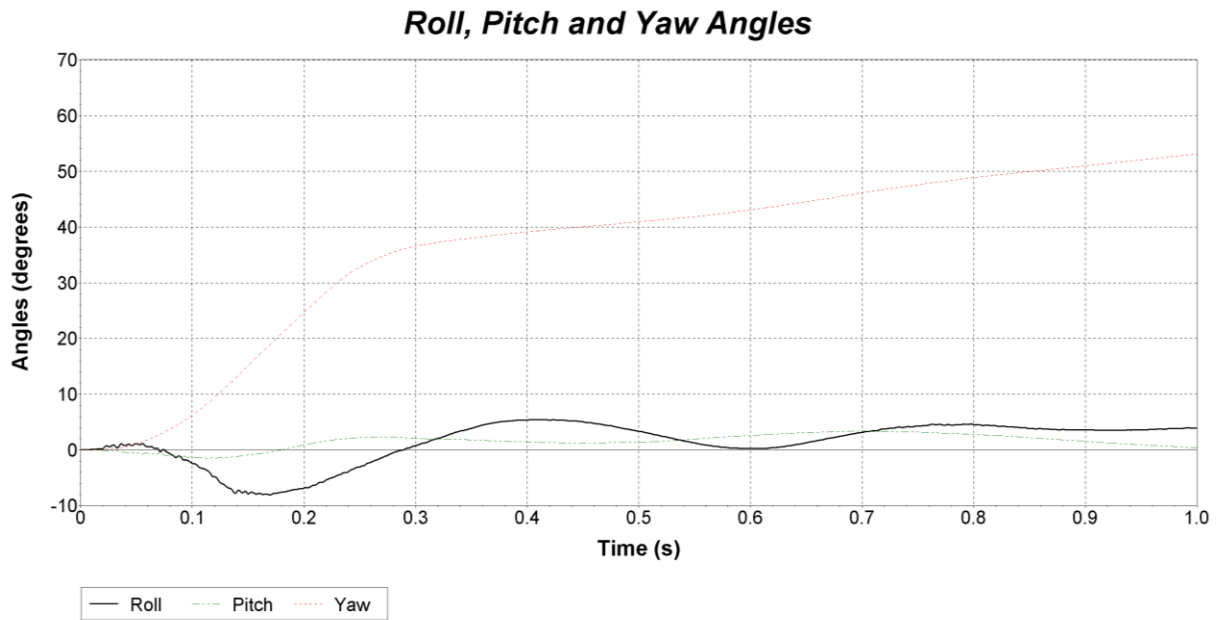
Axes are vehicle-fixed.
Sequence for determining orientation:

1. Yaw.
2. Pitch.
3. Roll.

Figure C.7. Vehicle Angular Displacements for Test 469940-03-1.

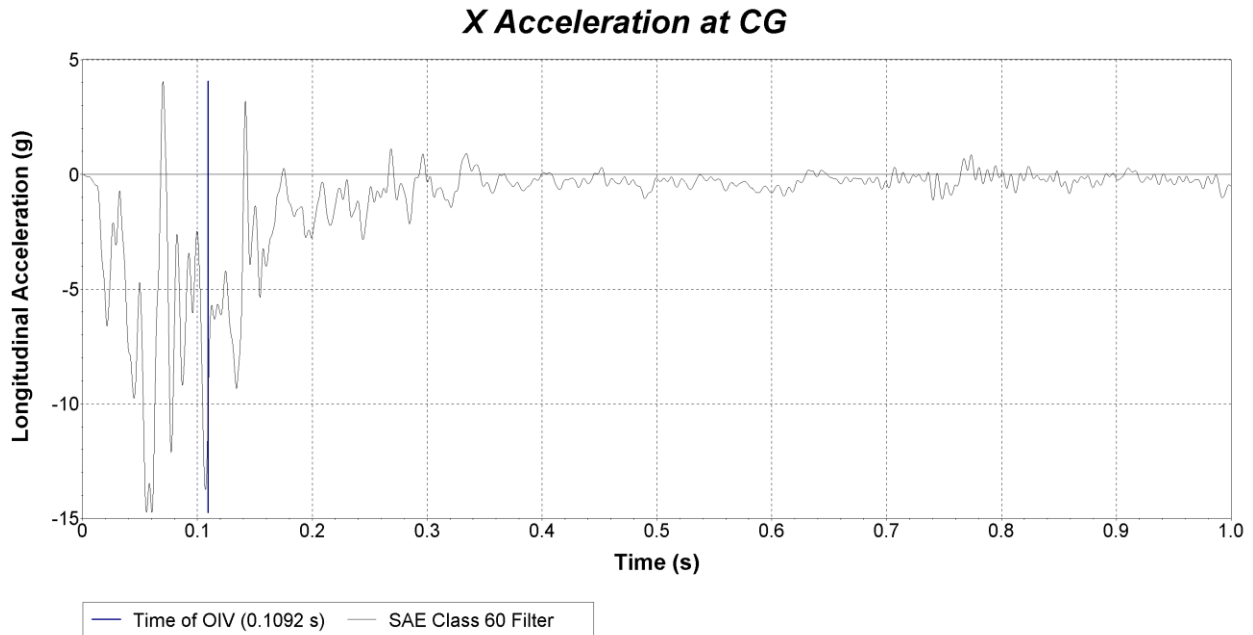
Figure C.8. Vehicle Longitudinal Accelerometer Trace for Test 469940-03-1 (Accelerometer Located at Center of Gravity).
