Test Report No. 469940-03, 469942-01, and 469943-01

**DEVELOP A RETROFIT DESIGN FOR GUARD FENCE SYSTEM TO
ENHANCE MOTORCYCLE SAFETY
COOPERATIVE RESEARCH PROGRAM**

Texas Department of Transportation
<https://tti.tamu.edu/documents/0-6994-R1.pdf>

TEXAS A&M TRANSPORTATION INSTITUTE PROVING GROUND

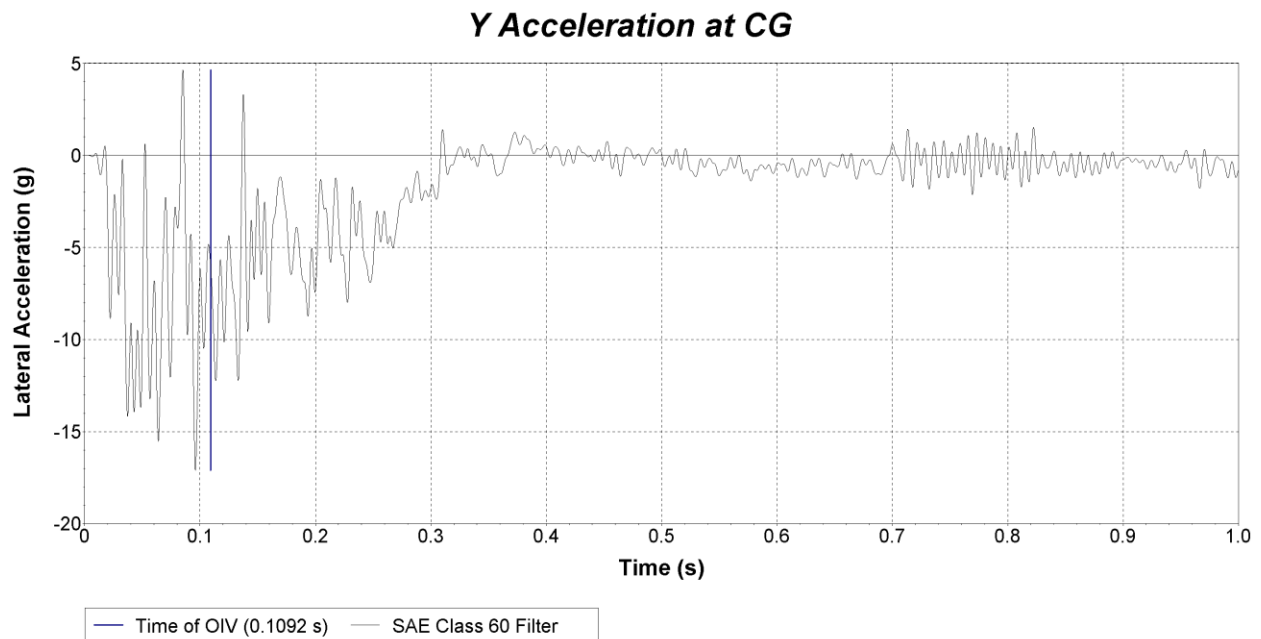
Figure C.9. Vehicle Lateral Accelerometer Trace for Test 469940-03-1 (Accelerometer Located at Center of Gravity).

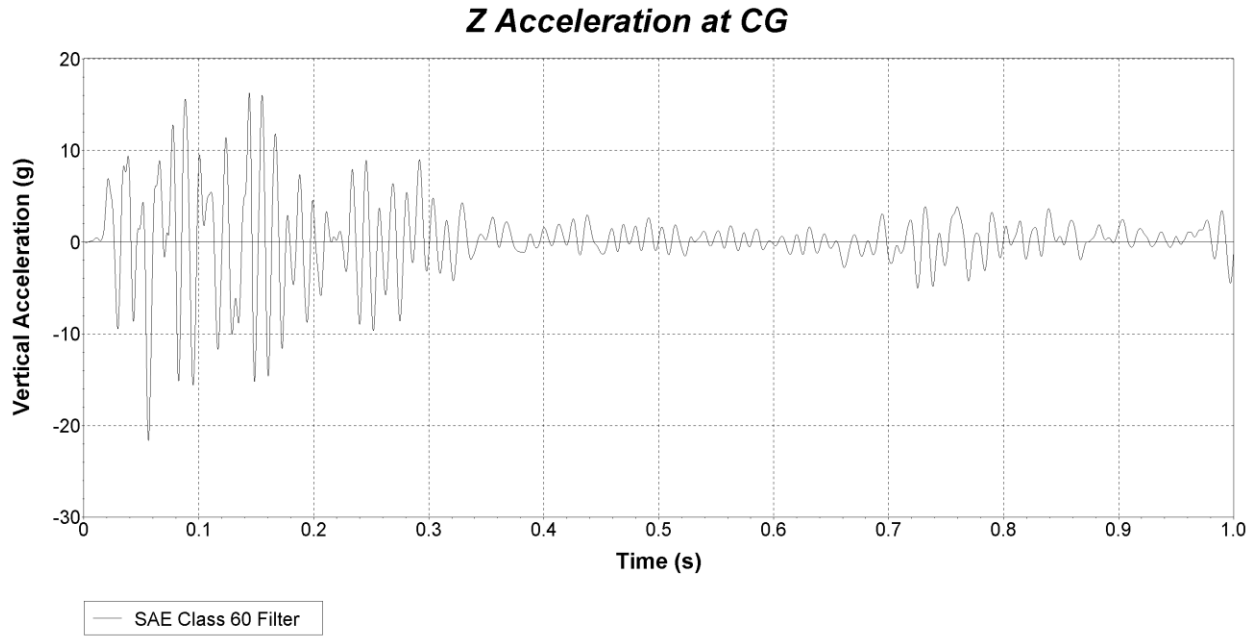
Figure C.10. Vehicle Vertical Accelerometer Trace for Test 469940-03-1 (Accelerometer Located at Center of Gravity).

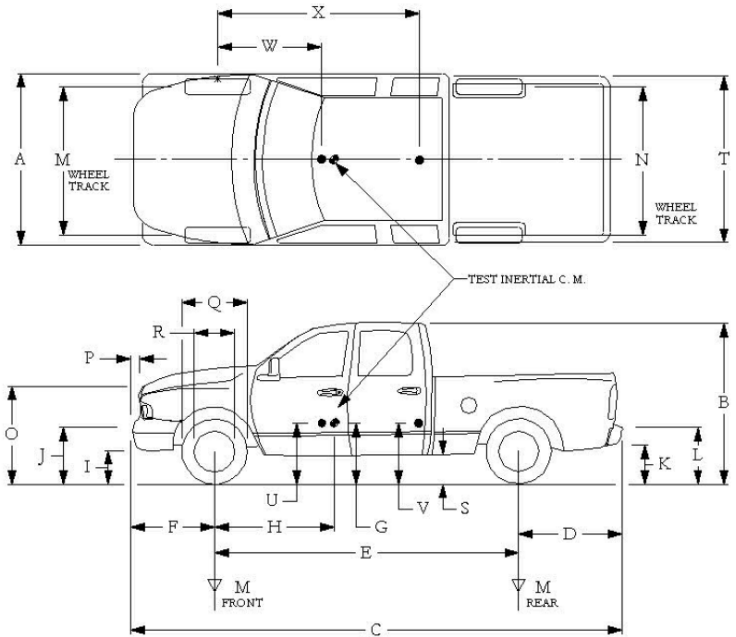
Geometry: inches

A	78.50	F	40.00	K	20.00	P	3.00	U	26.75
B	74.00	G	28.80	L	30.00	Q	30.50	V	30.25
C	227.50	H	61.36	M	68.50	R	18.00	W	61.30
D	44.00	I	11.75	N	68.00	S	13.00	X	79.00
E	140.50	J	27.00	O	46.00	T	77.00		
Wheel Center Height Front		14.75	Wheel Well Clearance (Front)		6.00	Bottom Frame Height - Front		12.50	
Wheel Center Height Rear		14.75	Wheel Well Clearance (Rear)		9.25	Bottom Frame Height - Rear		22.50

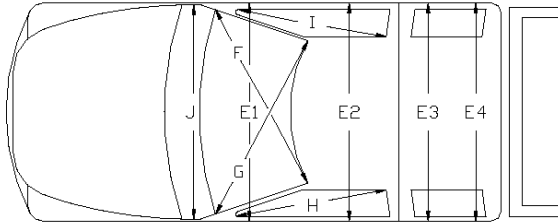
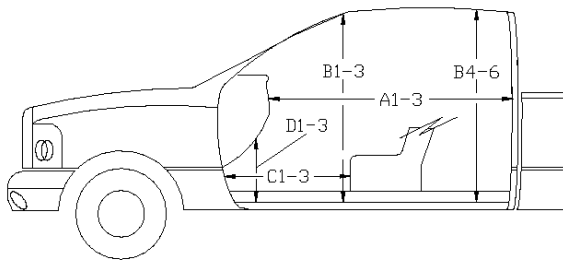
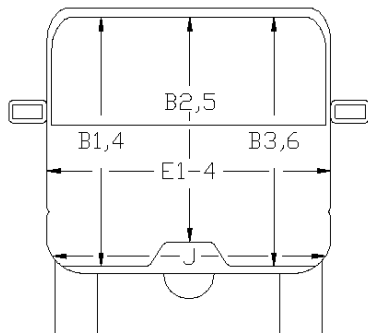
**OCCUPANT COMPARTMENT
DEFORMATION MEASUREMENT**

Before	After (inches)	Differ.
A1	65.00	65.00	0.00
A2	63.00	63.00	0.00
A3	65.50	65.50	0.00
B1	45.00	45.00	0.00
B2	38.00	38.00	0.00
B3	45.00	45.00	0.00
B4	39.50	39.50	0.00
B5	43.00	43.00	0.00
B6	39.50	39.50	0.00
C1	26.00	26.00	0.00
C2	0.00	0.00	0.00
C3	26.00	24.00	-2.00
D1	11.00	11.00	0.00
D2	0.00	0.00	0.00
D3	11.50	11.50	0.00
E1	58.50	58.50	0.00
E2	63.50	64.5	1.00
E3	63.50	63.50	0.00
E4	63.50	63.50	0.00
F	59.00	59.00	0.00
G	59.00	59.00	0.00
H	37.50	37.50	0.00
I	37.50	37.50	0.00
J*	25.00	25.00	0.00

*Lateral area across the cab from driver's side kickpanel to passenger's side kickpanel.

Figure D.3. Occupant Compartment Measurements for Test 469940-03-2.

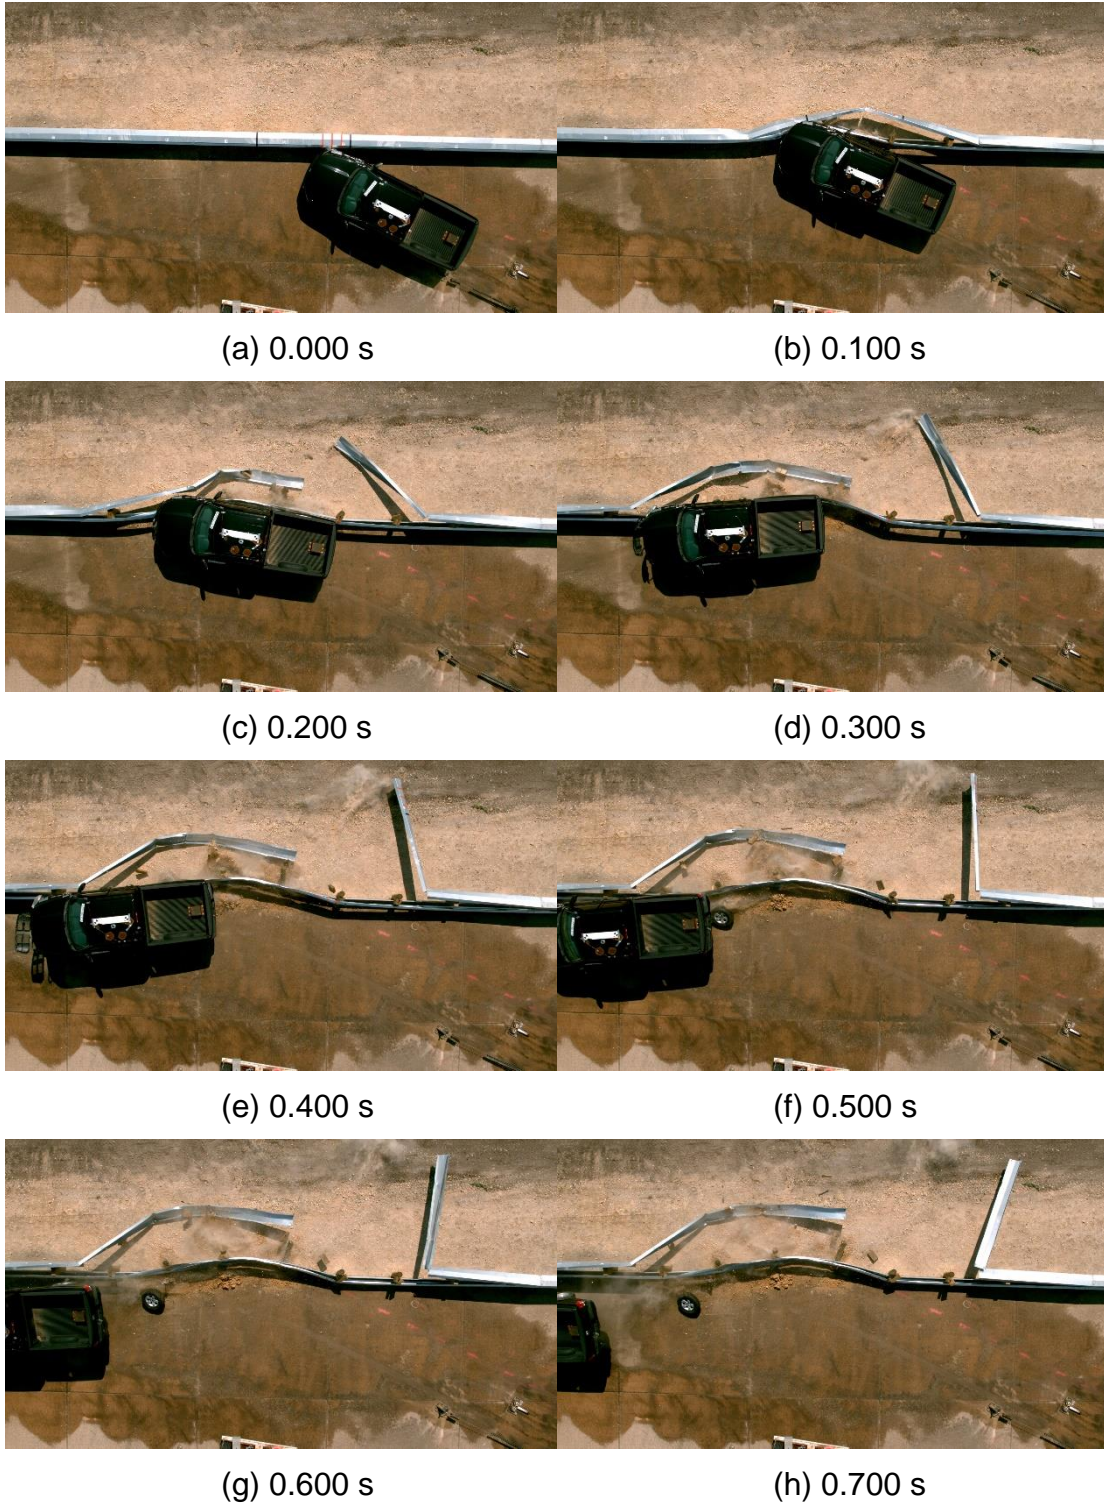
Figure D.4. Sequential Photographs for Test 469940-03-2 (Overhead Views).

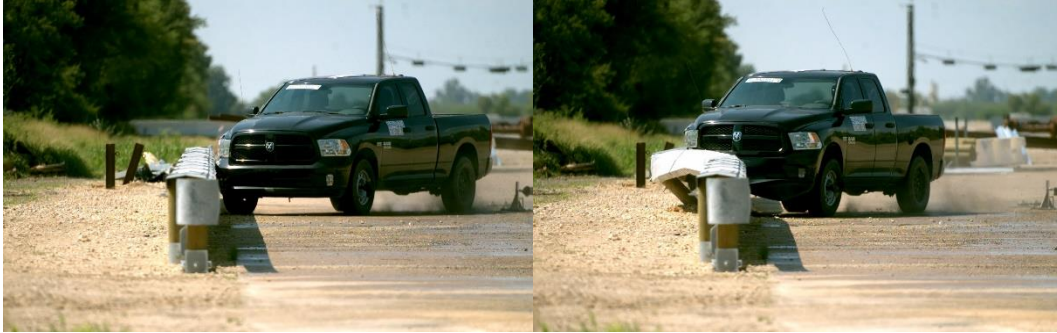
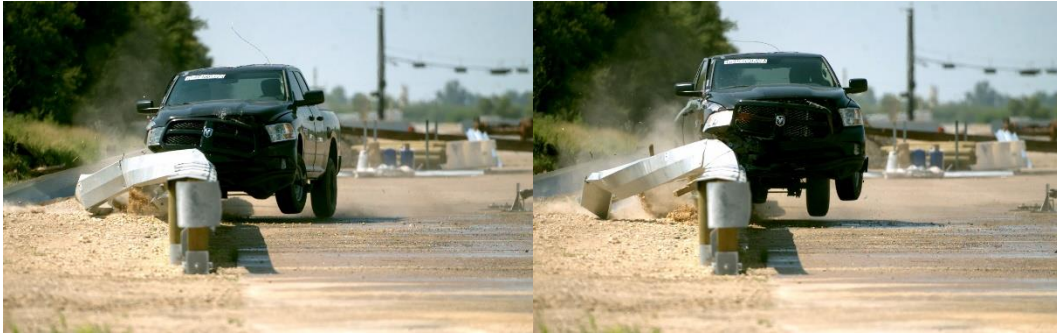
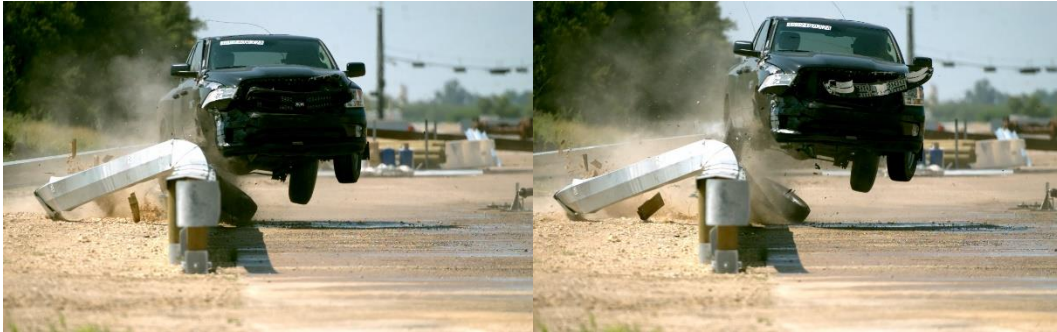
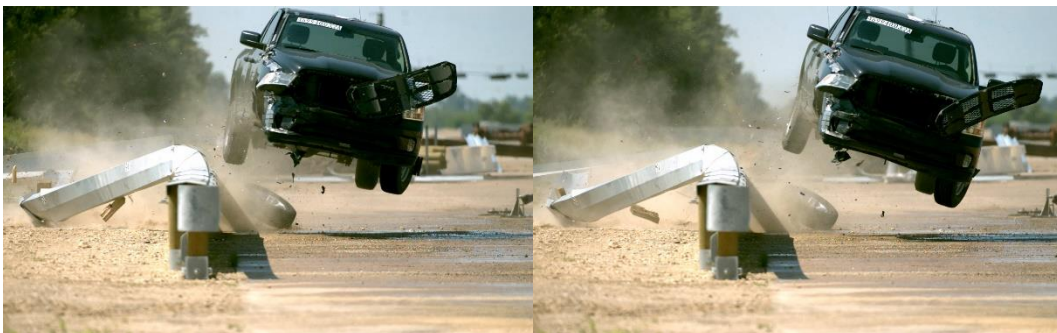
Figure D.5. Sequential Photographs for Test 469940-03-2 (Frontal Views).

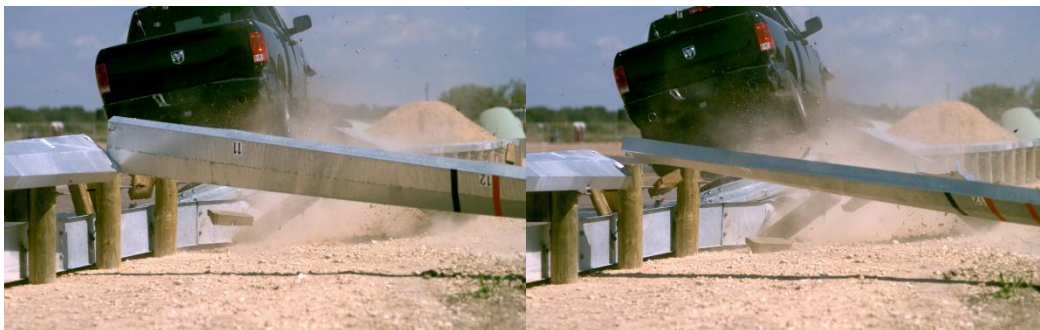
Figure D.6. Sequential Photographs for Test 469940-03-2 (Rear Views).

(g) 0.600 s

(h) 0.700 s

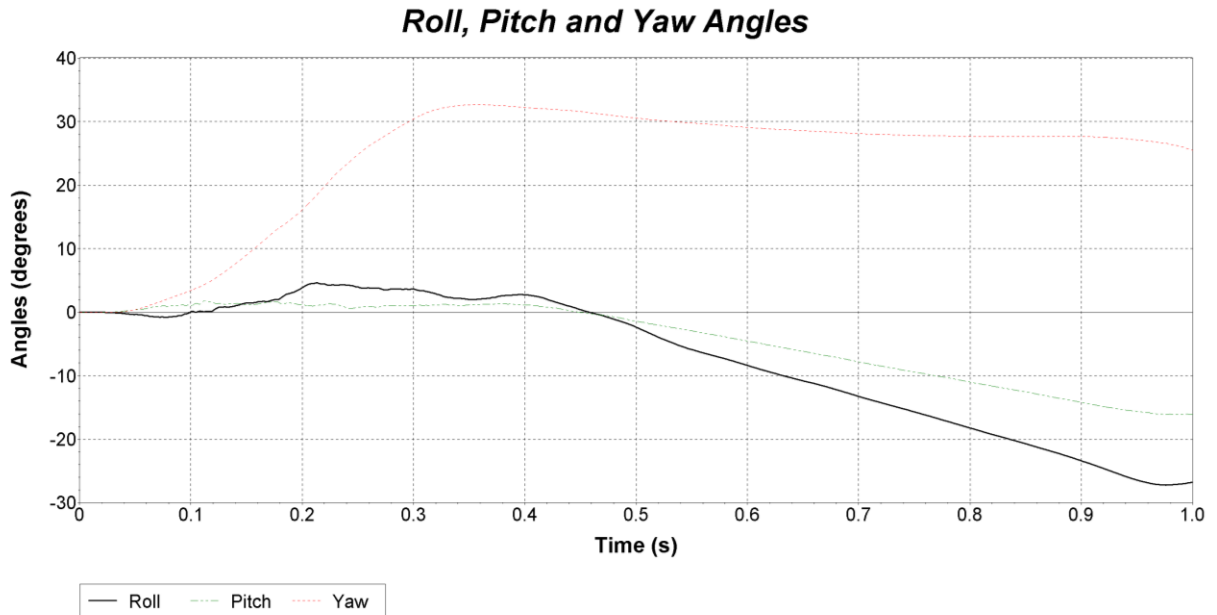
Figure D.7. Vehicle Angular Displacements for Test 469940-03-2.

Axes are vehicle-fixed.
Sequence for determining orientation:

4. Yaw.
5. Pitch.
6. Roll.

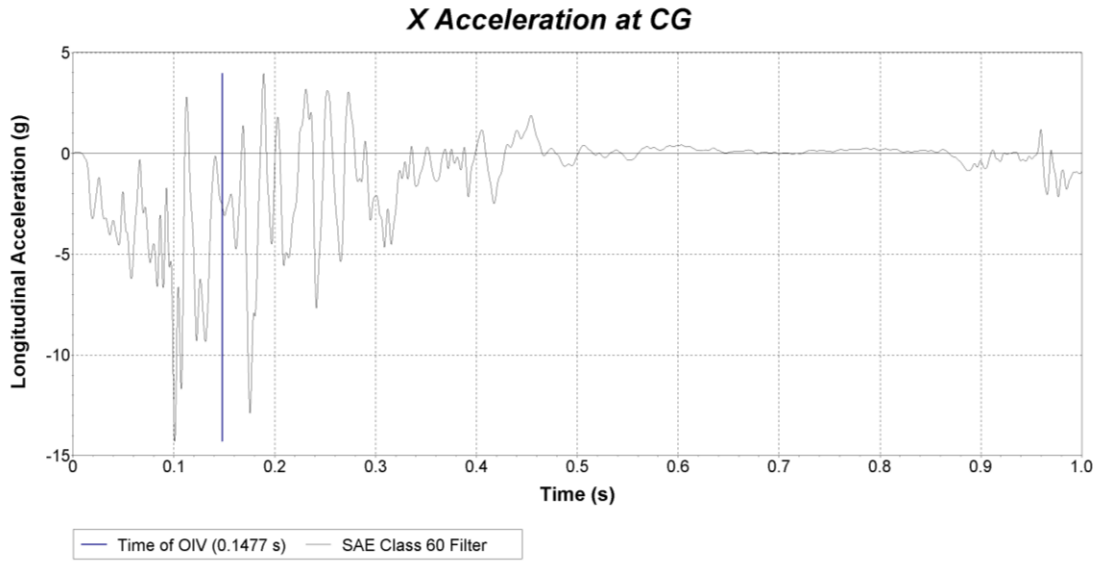
Figure D.8. Vehicle Longitudinal Accelerometer Trace for Test 469940-03-2 (Accelerometer Located at Center of Gravity).

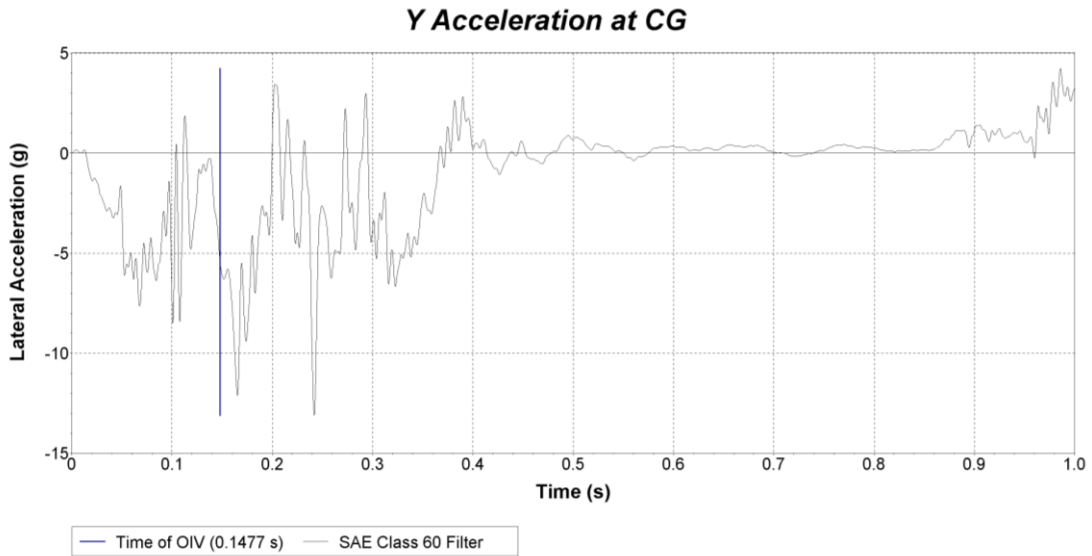
Figure D.9. Vehicle Lateral Accelerometer Trace for Test 469940-03-2 (Accelerometer Located at Center of Gravity).

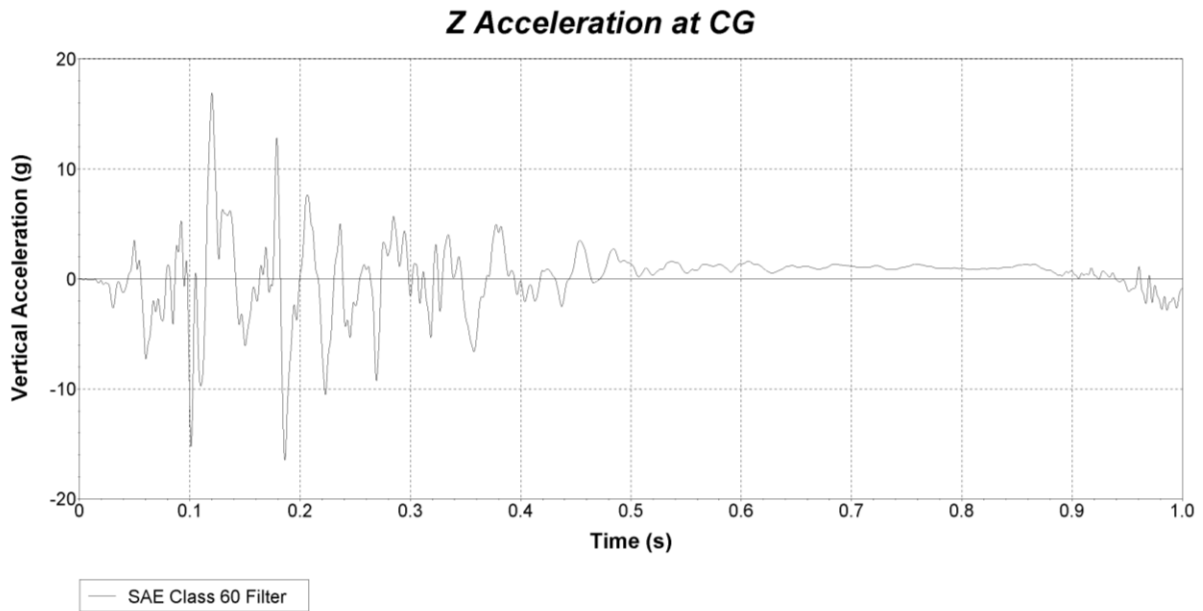
Figure D.10. Vehicle Vertical Accelerometer Trace for Test 469940-03-2 (Accelerometer Located at Center of Gravity).

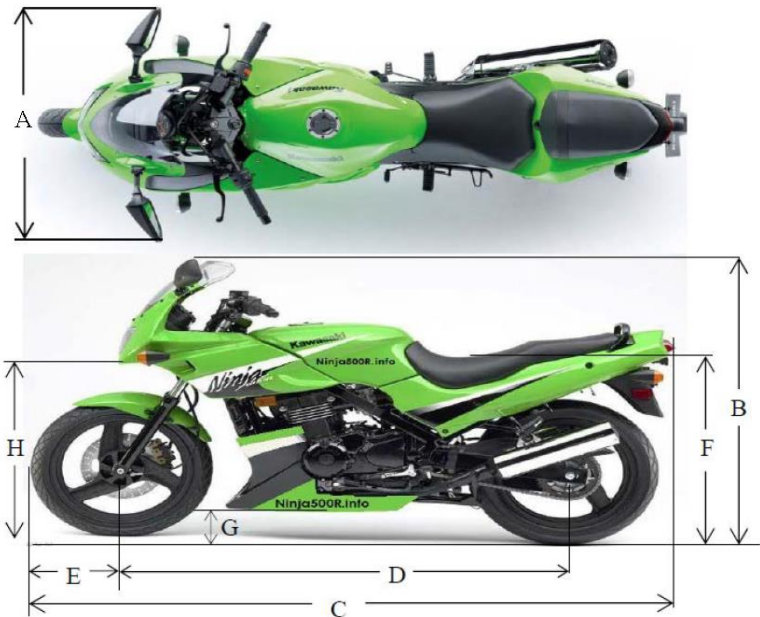
Figure E.1. Vehicle Properties for Test 469940-03-3.

Geometry: inches

A	<u>30</u>	C	<u>78.5</u>	E	<u>12.5</u>	G	<u>5</u>
B	<u>45.8</u>		<u>55</u>	F	<u>30.5</u>	H	<u>26.5</u>
Wheel Center Height Front	<u>11.3</u>	Wheel Well Clearance (Front)	<u>1.5</u>	Bottom Frame Height - Front	<u>8</u>		
Wheel Center Height Rear	<u>11.8</u>	Wheel Well Clearance (Rear)	<u>6.75</u>	Bottom Frame Height - Rear	<u>9</u>

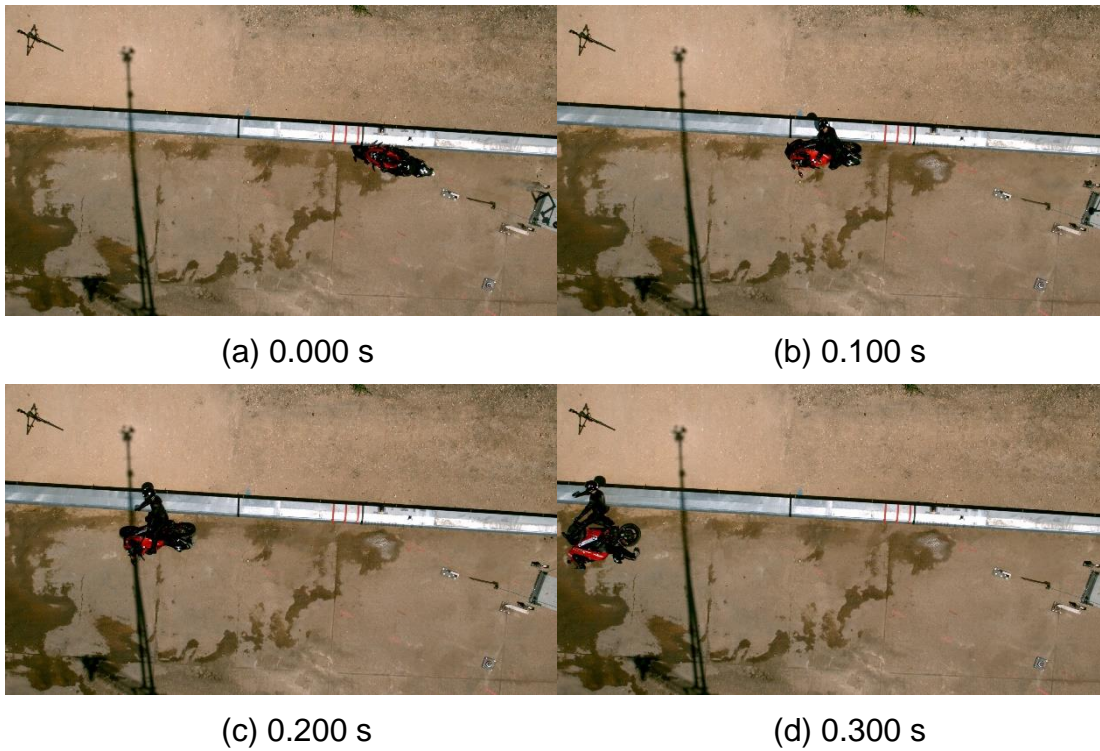
Figure E.2. Sequential Photographs for Test 469940-03-3 (Overhead Views).

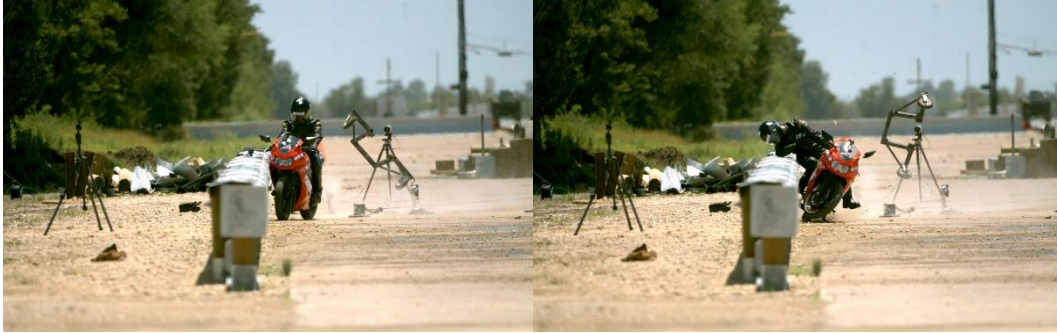
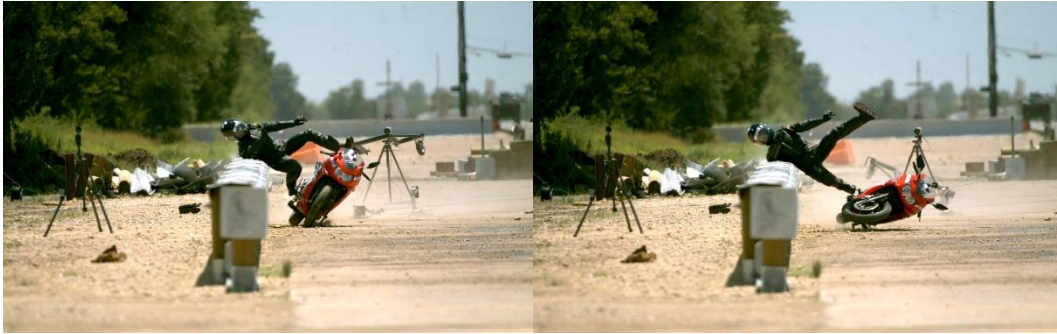
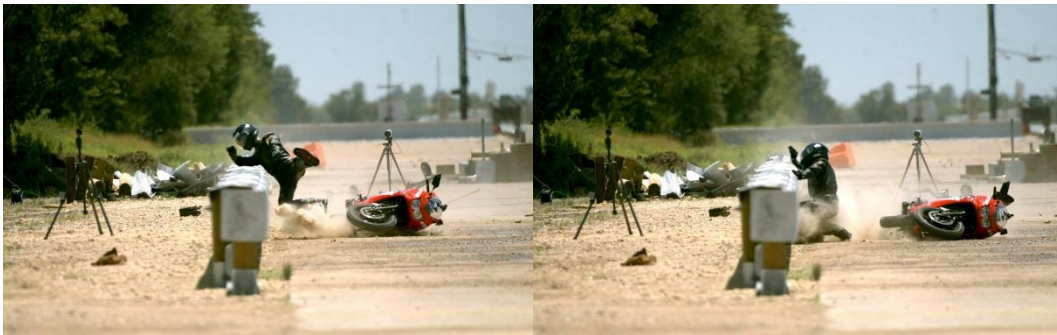
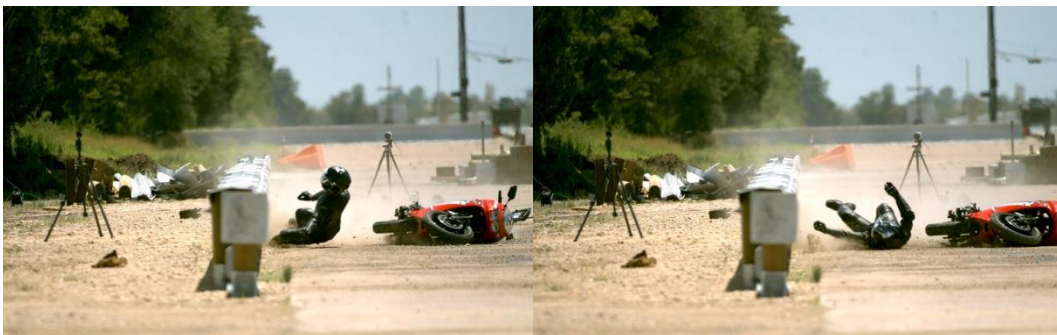
Figure E.3. Sequential Photographs for Test 469940-03-3 (Frontal Views).

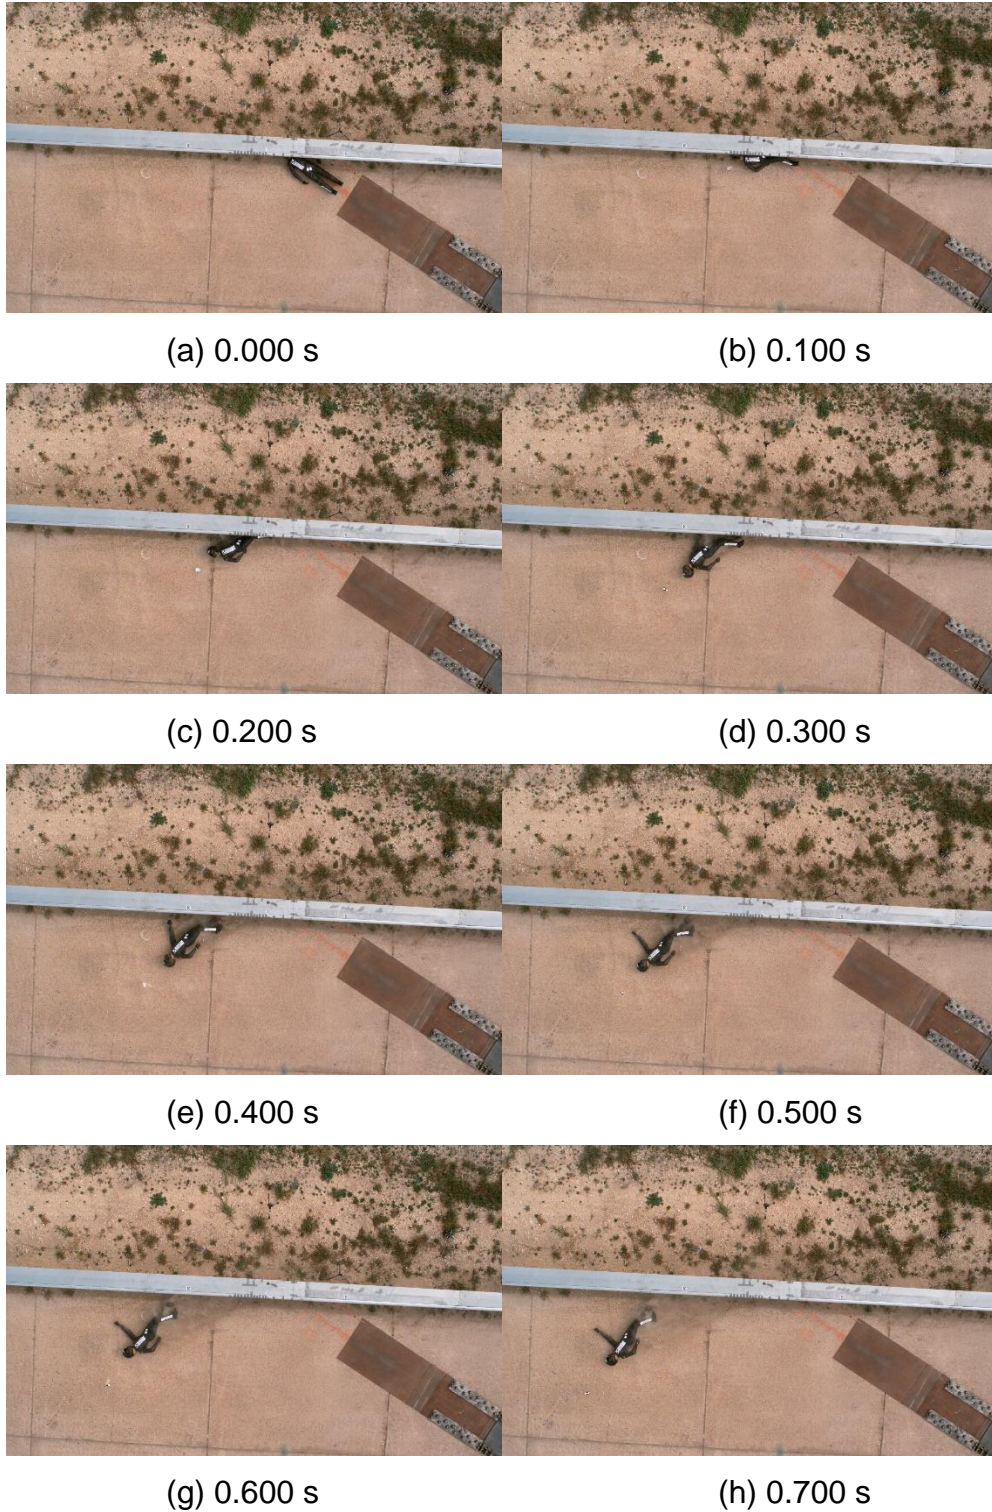
Figure F.1. Sequential Photographs for Test 469940-03-4A (Overhead Views).

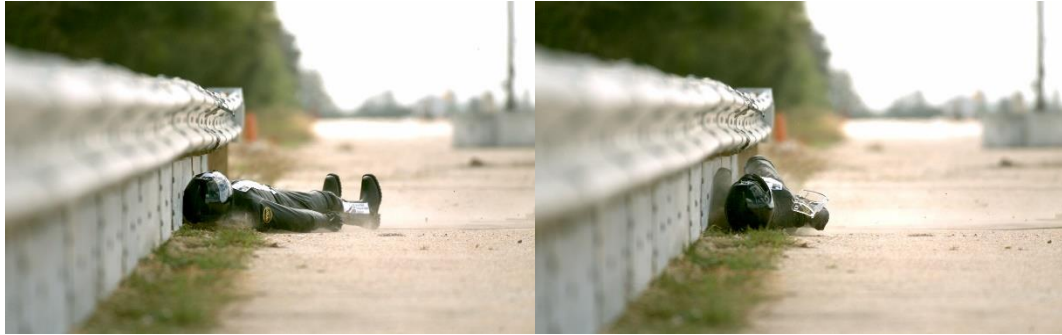
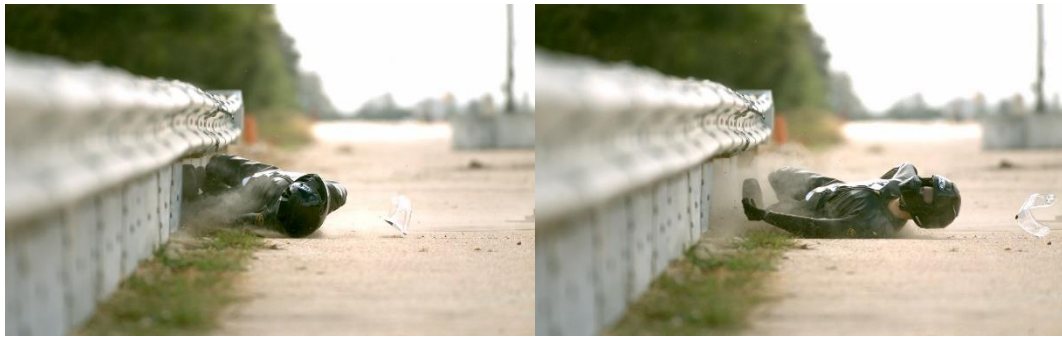
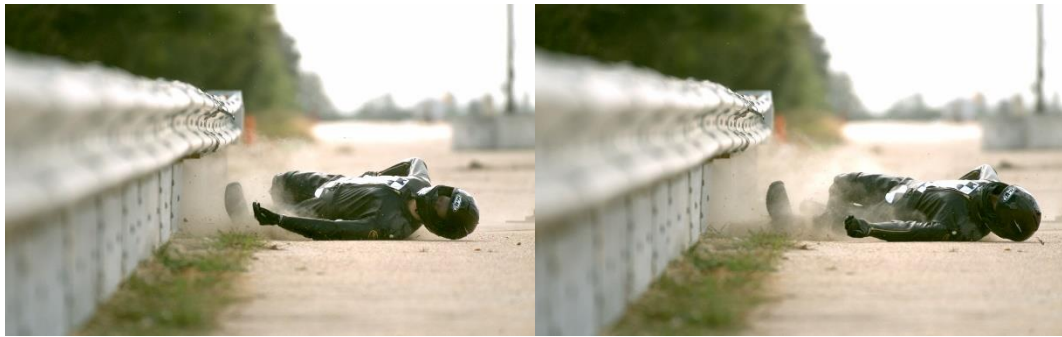
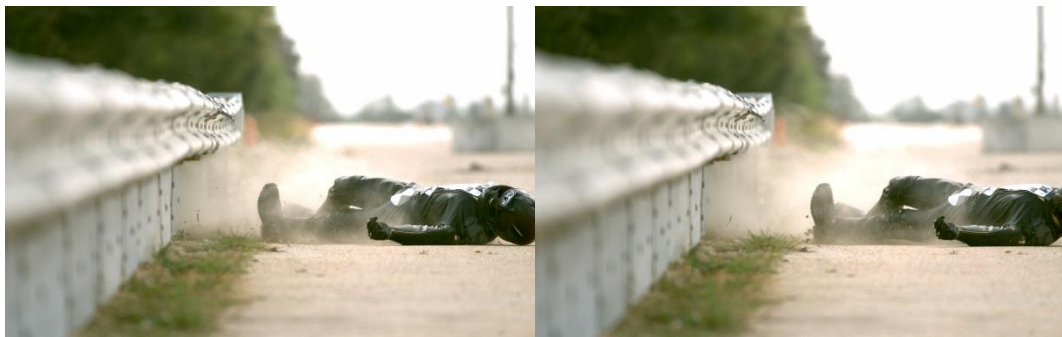
Figure F.2. Sequential Photographs for Test 469940-03-4A (Frontal Views).

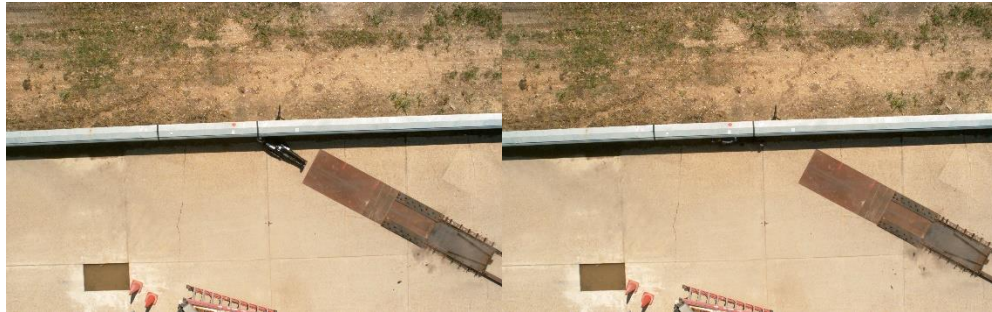
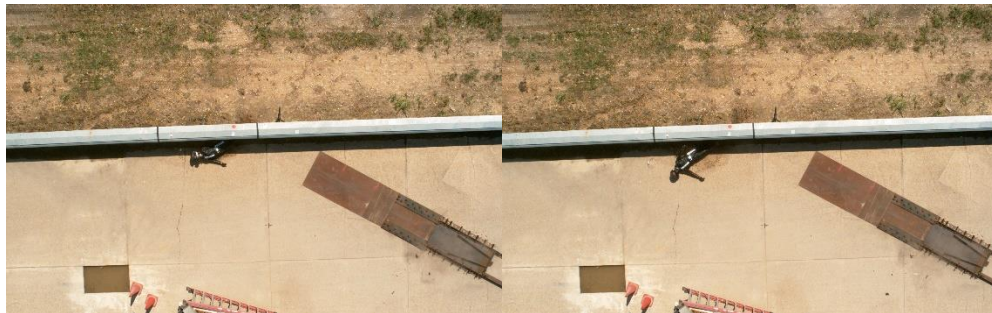
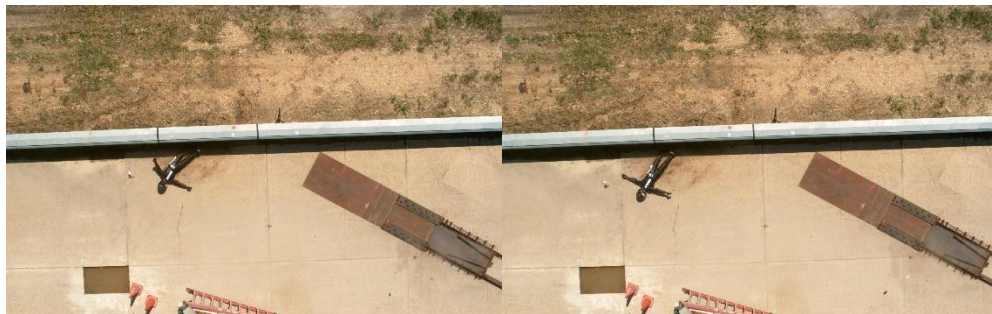
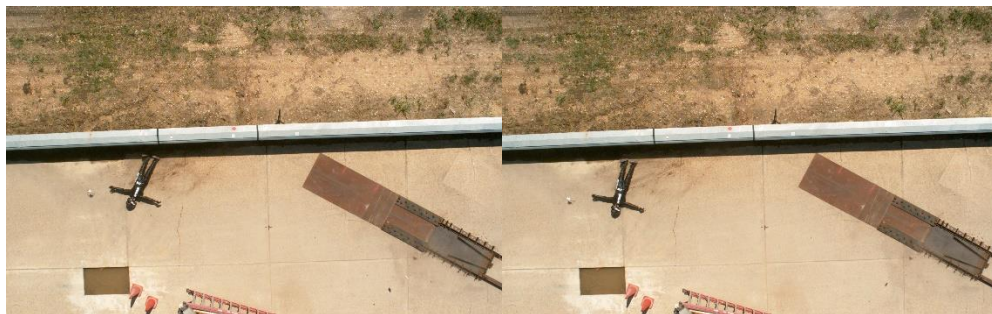
Figure G.1. Sequential Photographs for Test 469942-01-1 (Overhead Views).

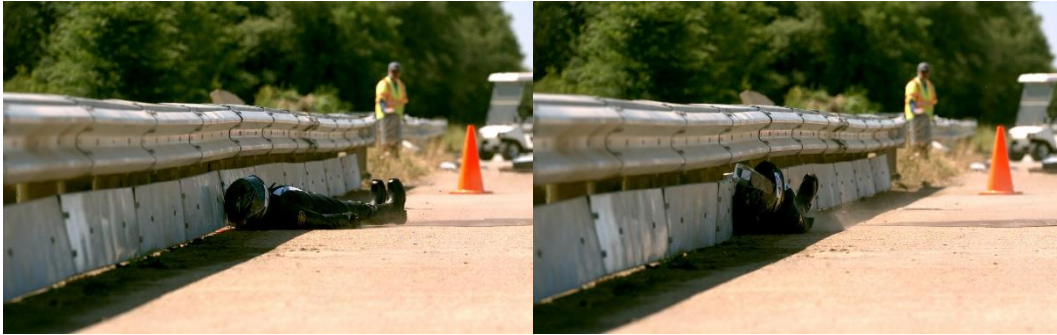
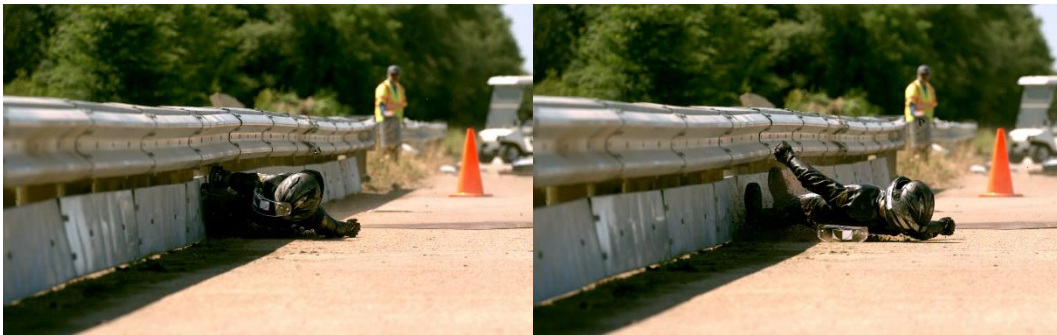
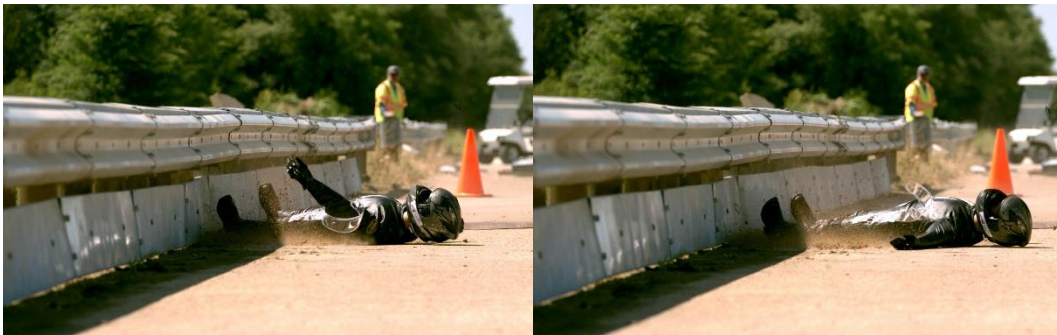
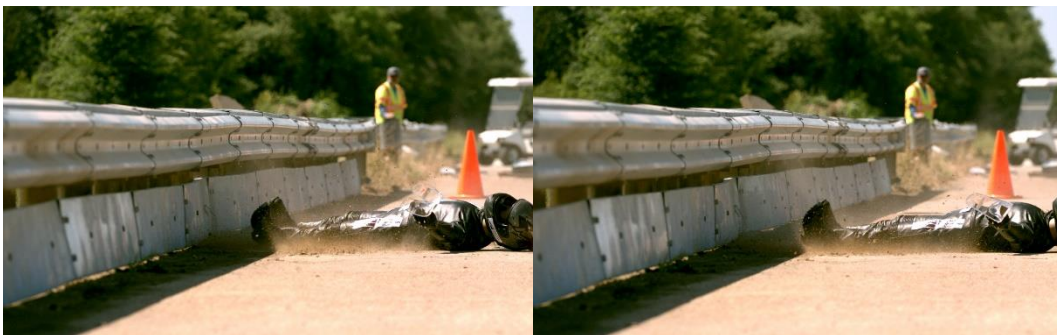
Figure G.2. Sequential Photographs for Test 469942-01-1 (Frontal Views).

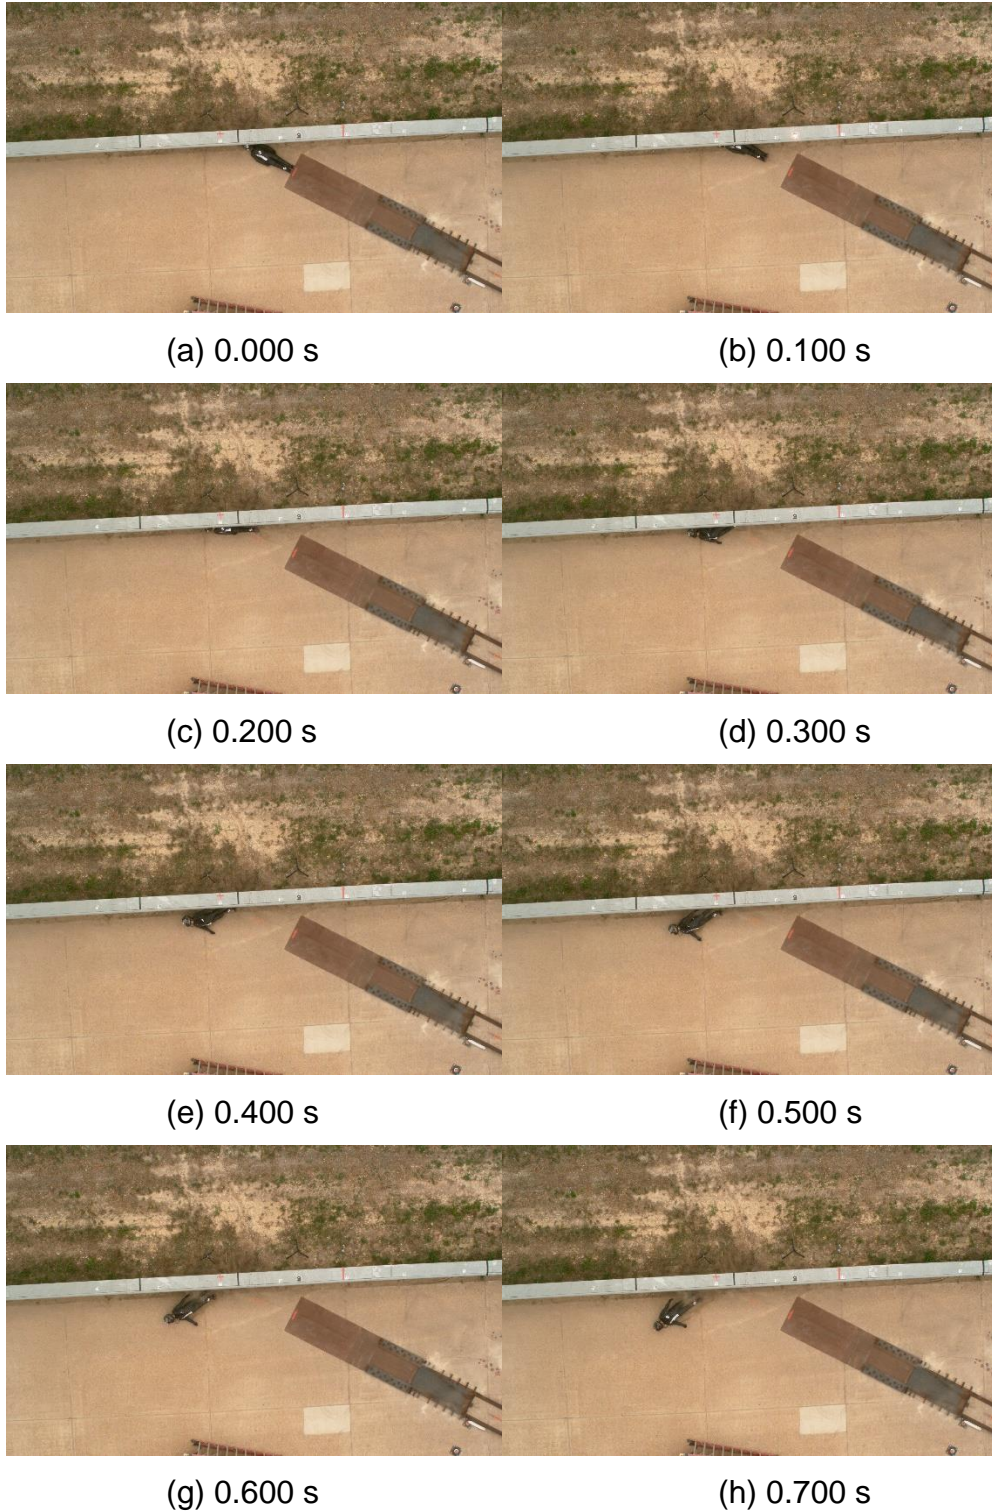
Figure H.1. Sequential Photographs for Test 469943-01-1A (Overhead Views).

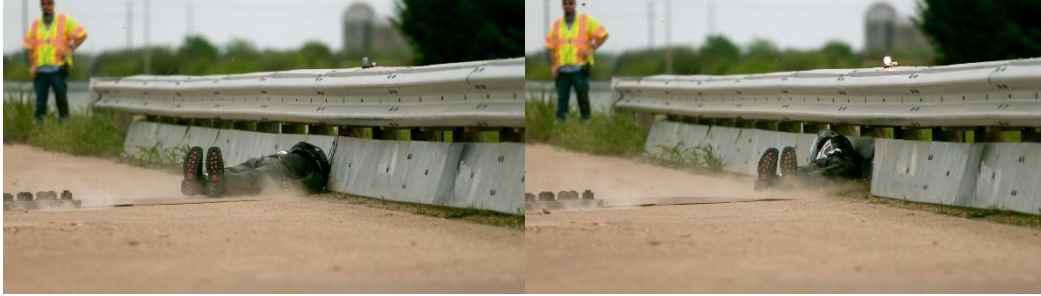
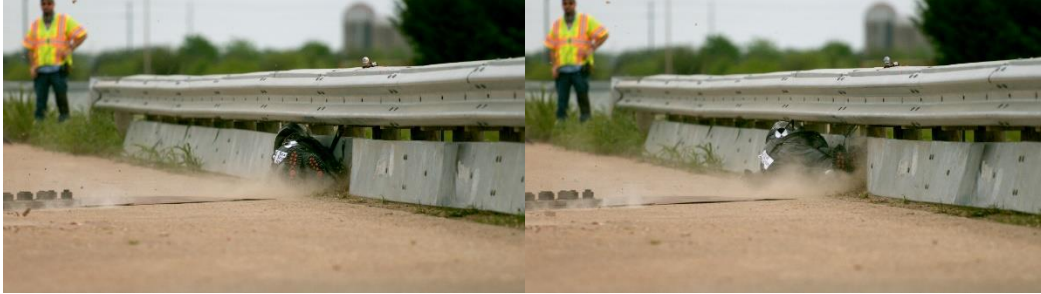
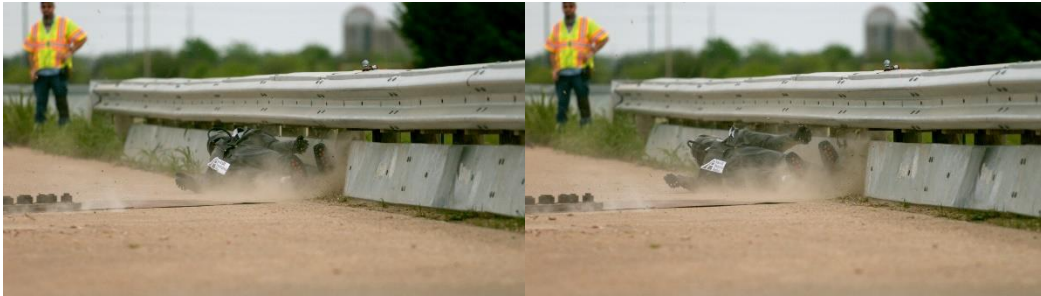
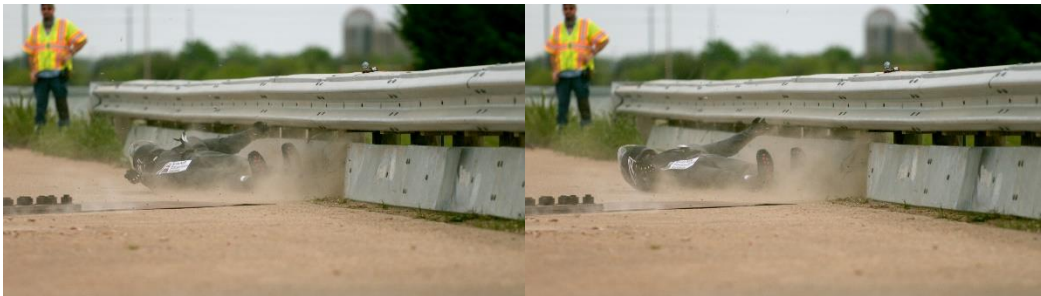
Figure H.2. Sequential Photographs for Test 469943-01-1A (Frontal Views).

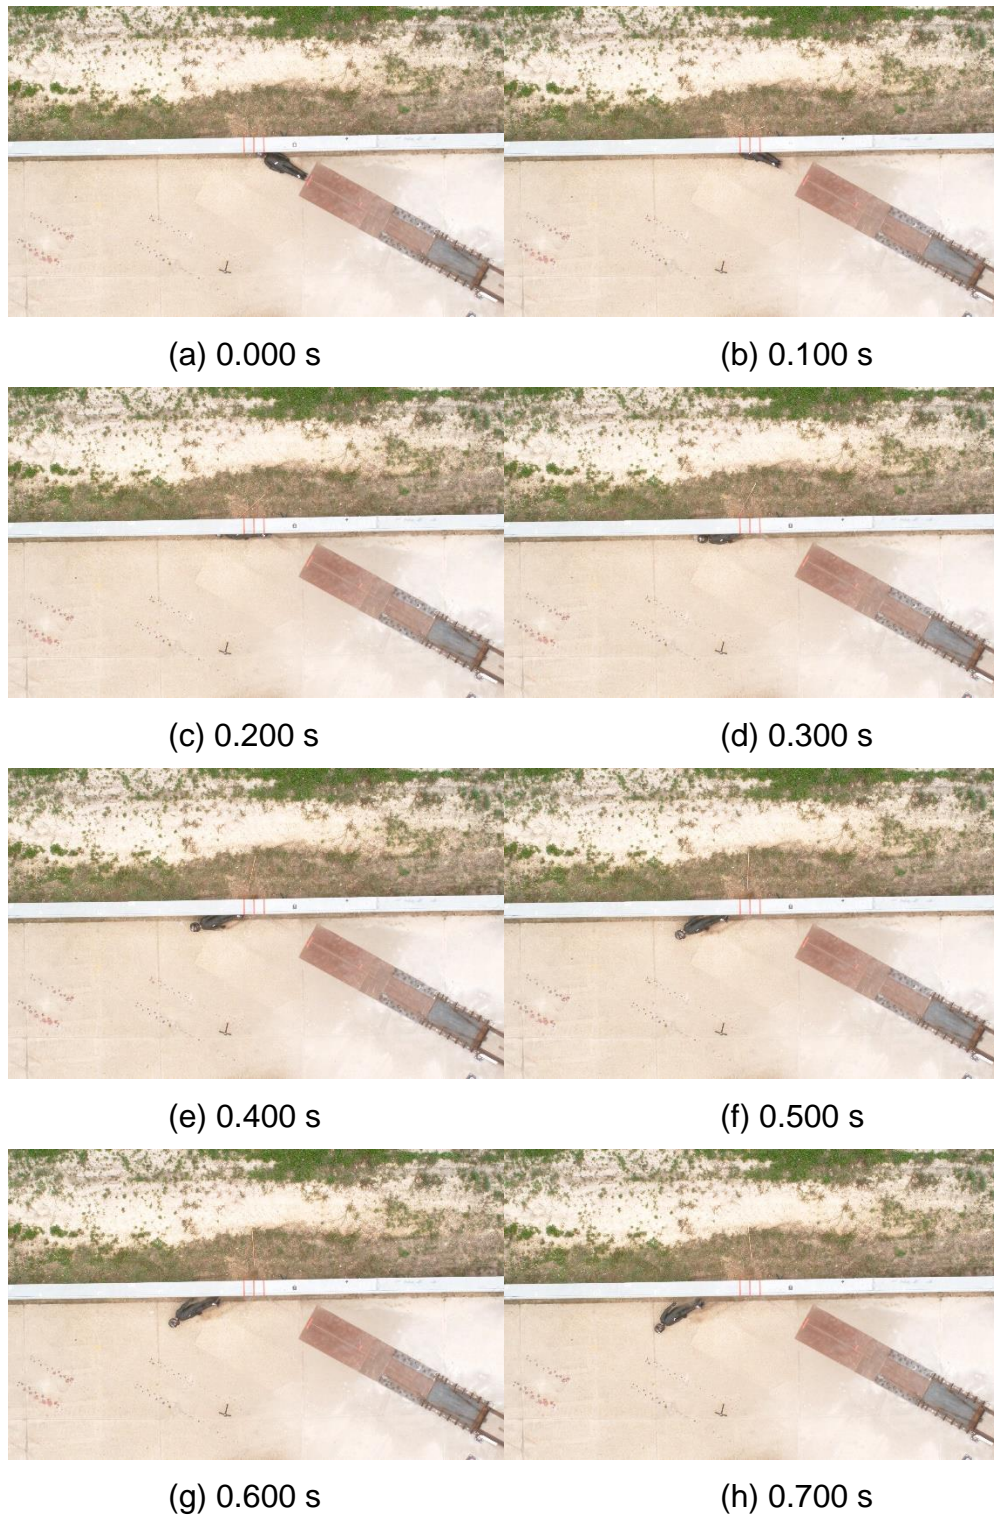
Figure I.1. Sequential Photographs for Test 469943-01-2 (Overhead Views).
