Test Report No. 469940-03, 469942-01, and 469943-01

**DEVELOP A RETROFIT DESIGN FOR GUARD FENCE SYSTEM TO
ENHANCE MOTORCYCLE SAFETY
COOPERATIVE RESEARCH PROGRAM**

Texas Department of Transportation
<https://tti.tamu.edu/documents/0-6994-R1.pdf>

TEXAS A&M TRANSPORTATION INSTITUTE PROVING GROUND

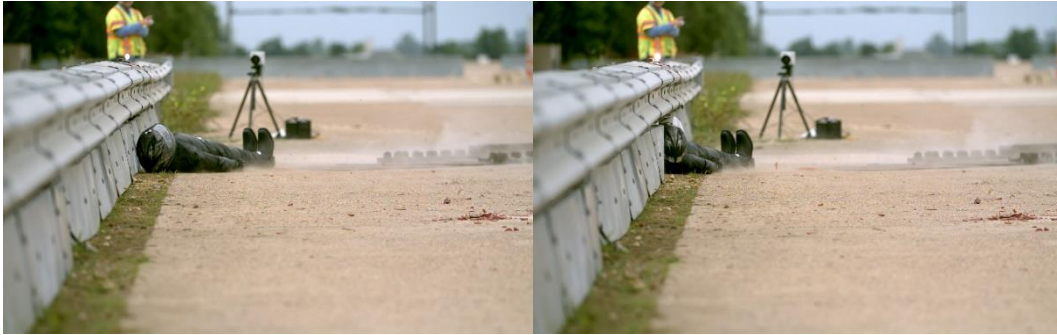
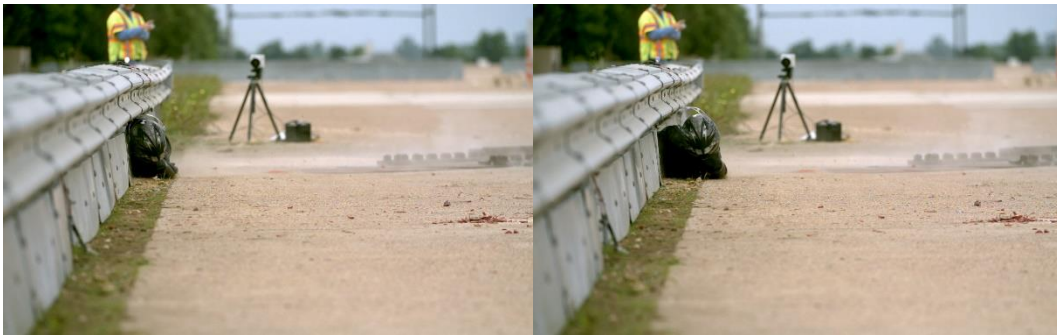
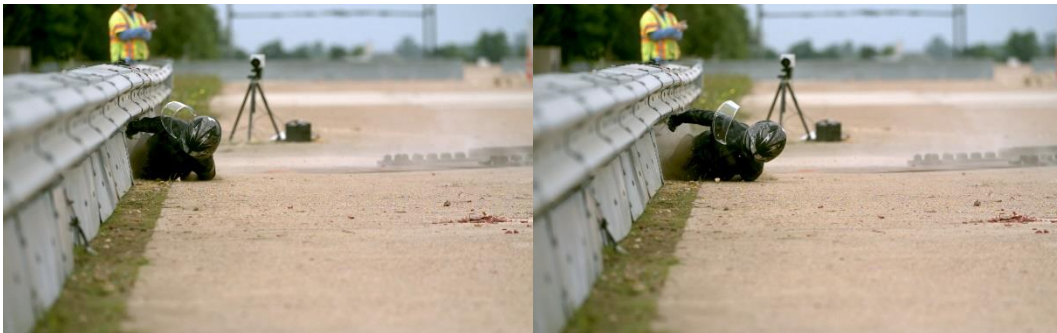
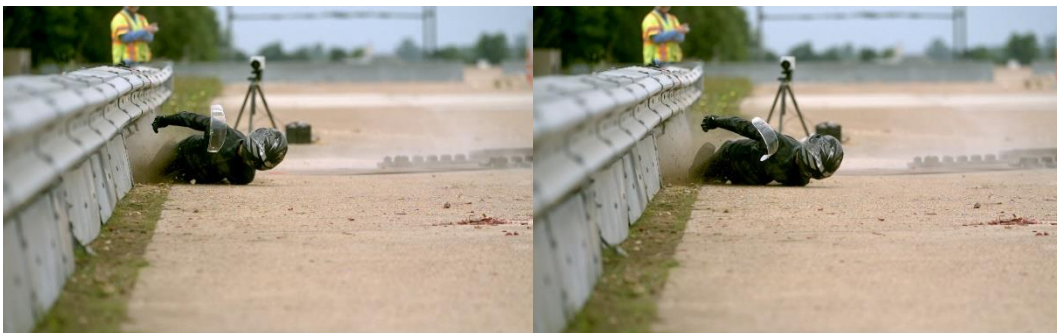
Figure I.2. Sequential Photographs for Test 469943-01-2 (Frontal Views).

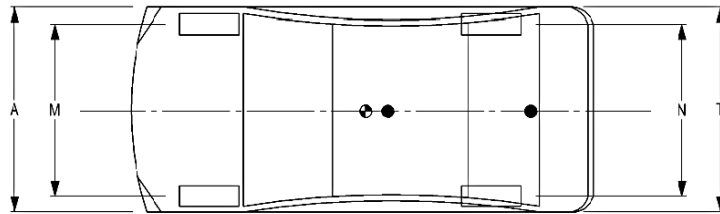
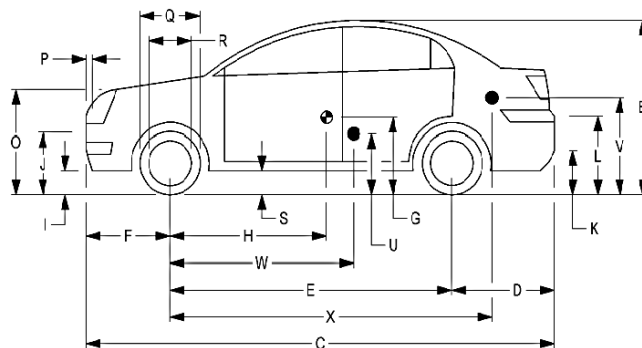
Geometry: inches

A <u>66.70</u>	F <u>32.50</u>	K <u>12.50</u>	P <u>4.50</u>	U <u>15.50</u>
B <u>59.60</u>	G <u>0.00</u>	L <u>26.00</u>	Q <u>24.00</u>	V <u>21.25</u>
C <u>175.40</u>	H <u>41.22</u>	M <u>58.30</u>	R <u>16.25</u>	W <u>41.25</u>
D <u>40.50</u>	I <u>7.00</u>	N <u>58.50</u>	S <u>7.50</u>	X <u>79.75</u>
E <u>102.40</u>	J <u>22.50</u>	O <u>30.50</u>	T <u>64.50</u>	
Wheel Center Ht Front <u>11.50</u>	Wheel Center Ht Rear <u>11.50</u>	W-H <u>0.03</u>

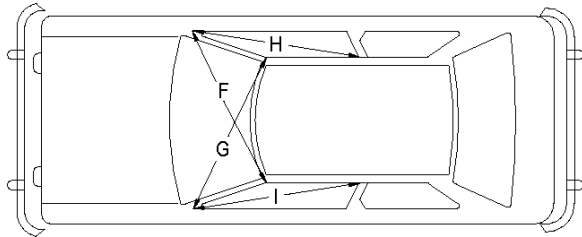
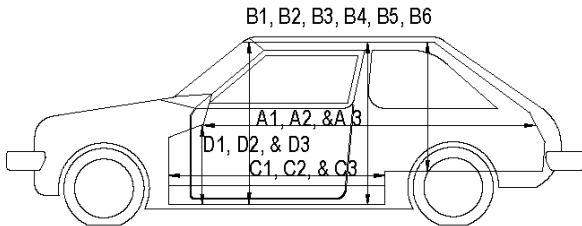
OCCUPANT COMPARTMENT DEFORMATION MEASUREMENT

Before	After (inches)	Differ.
A1	67.50	67.50	0.00
A2	67.25	67.25	0.00
A3	67.75	67.75	0.00
B1	40.50	40.50	0.00
B2	39.00	39.00	0.00
B3	40.50	40.50	0.00
B4	36.25	36.25	0.00
B5	36.00	36.00	0.00
B6	36.25	36.25	0.00
C1	26.00	26.00	0.00
C2	0.00	0.00	0.00
C3	26.00	25.00	-1.00
D1	9.50	9.50	0.00
D2	0.00	0.00	0.00
D3	9.50	9.50	0.00
E1	51.50	51.50	0.00
E2	51.00	51.00	0.00
F	51.00	51.00	0.00
G	51.00	51.00	0.00
H	37.50	37.50	0.00
I	37.50	37.50	0.00
J*	51.00	50.00	-1.00

Figure J.3. Occupant Compartment Measurements for Test 469943-01-3.

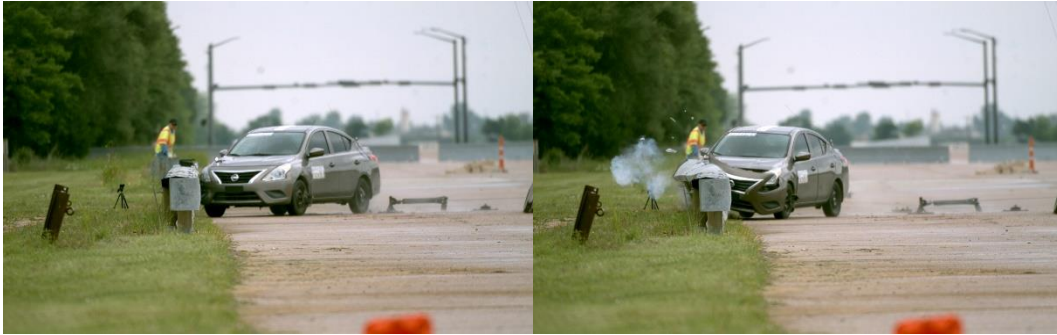
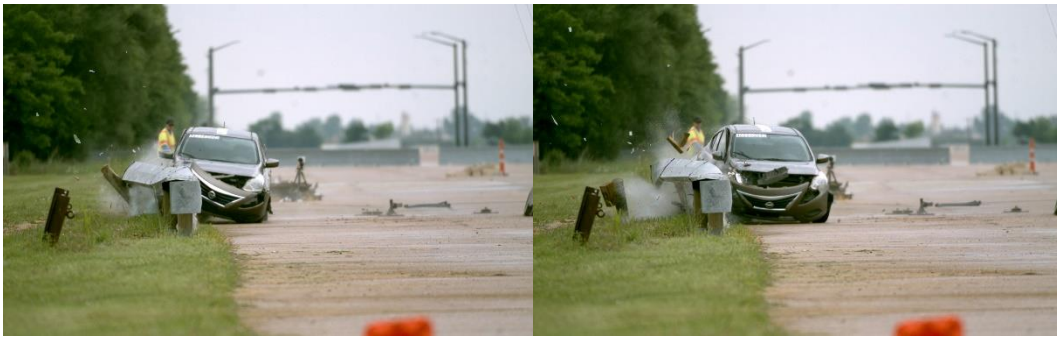
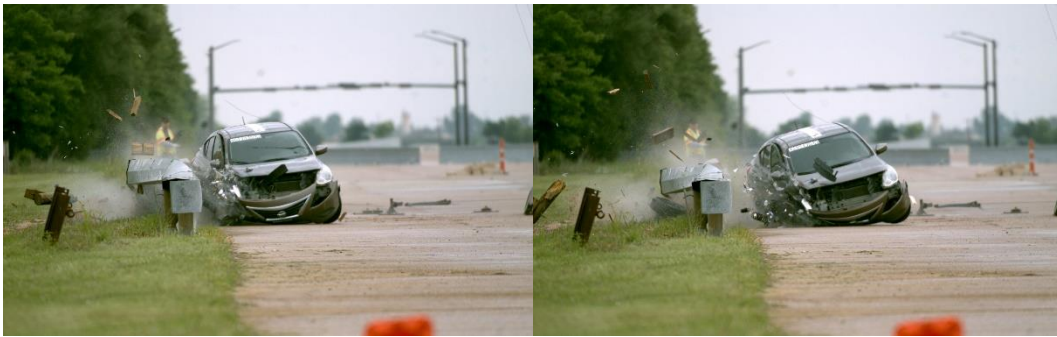
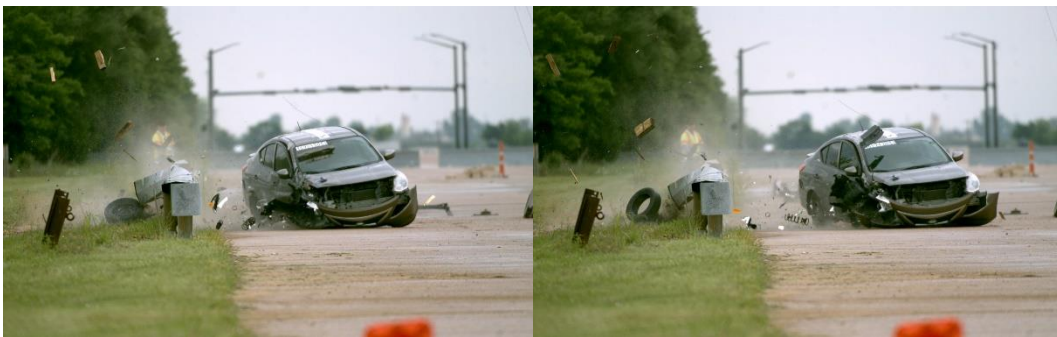
Figure J.5. Sequential Photographs for Test 469943-01-3 (Frontal Views).

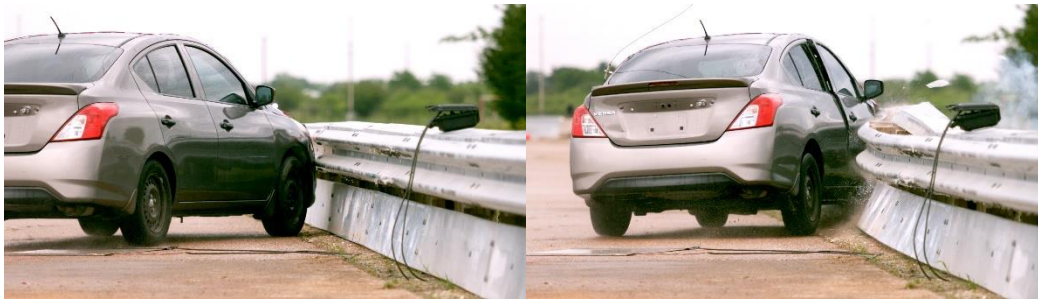
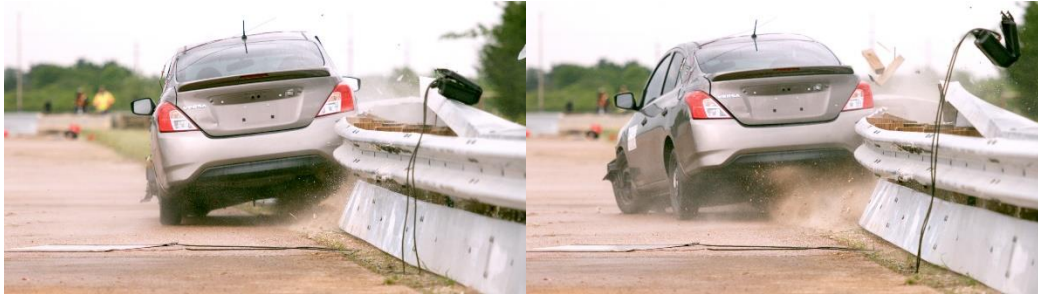
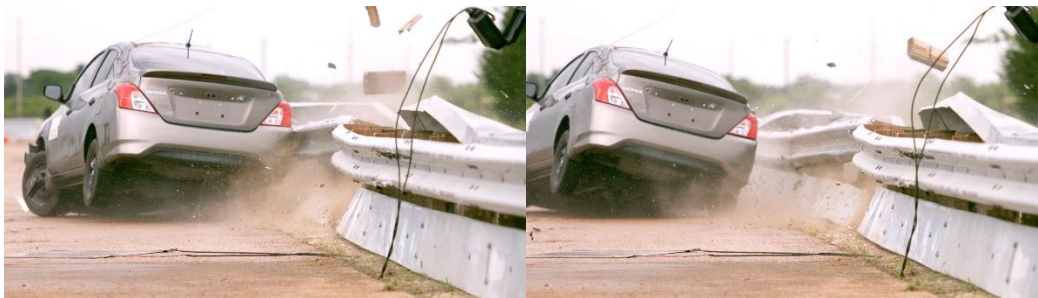
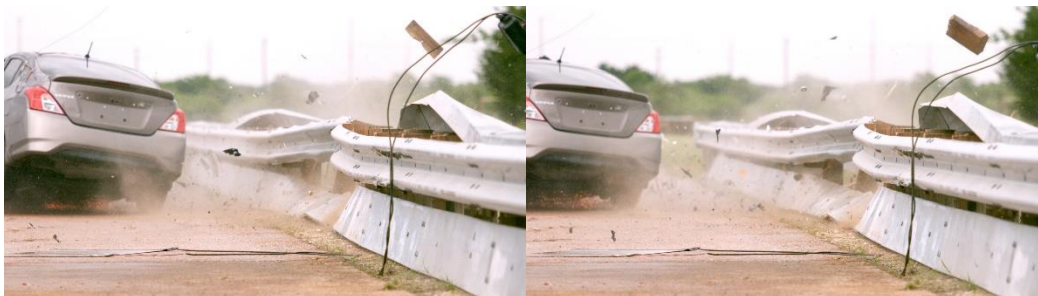
Figure J.6. Sequential Photographs for Test 469943-01-3 (Rear Views).

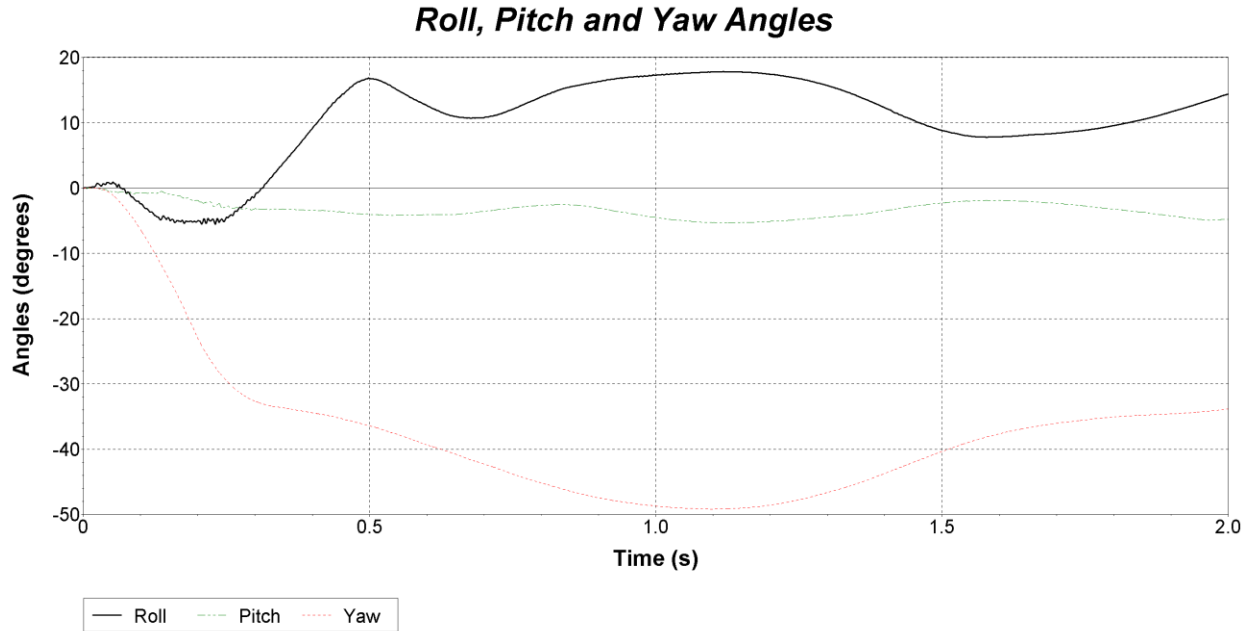
Axes are vehicle-fixed.
Sequence for determining orientation:

7. Yaw.
8. Pitch.
9. Roll.

Figure J.7. Vehicle Angular Displacements for Test 469943-01-3.

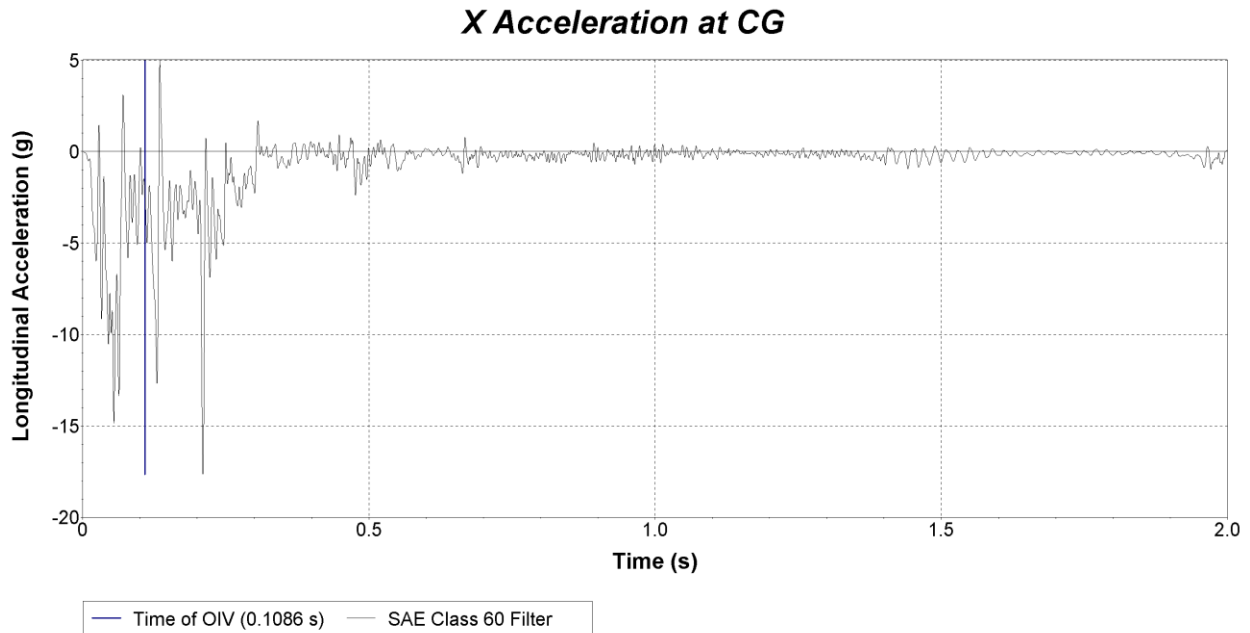
Figure J.8. Vehicle Longitudinal Accelerometer Trace for Test 469943-01-3 (Accelerometer Located at Center of Gravity).

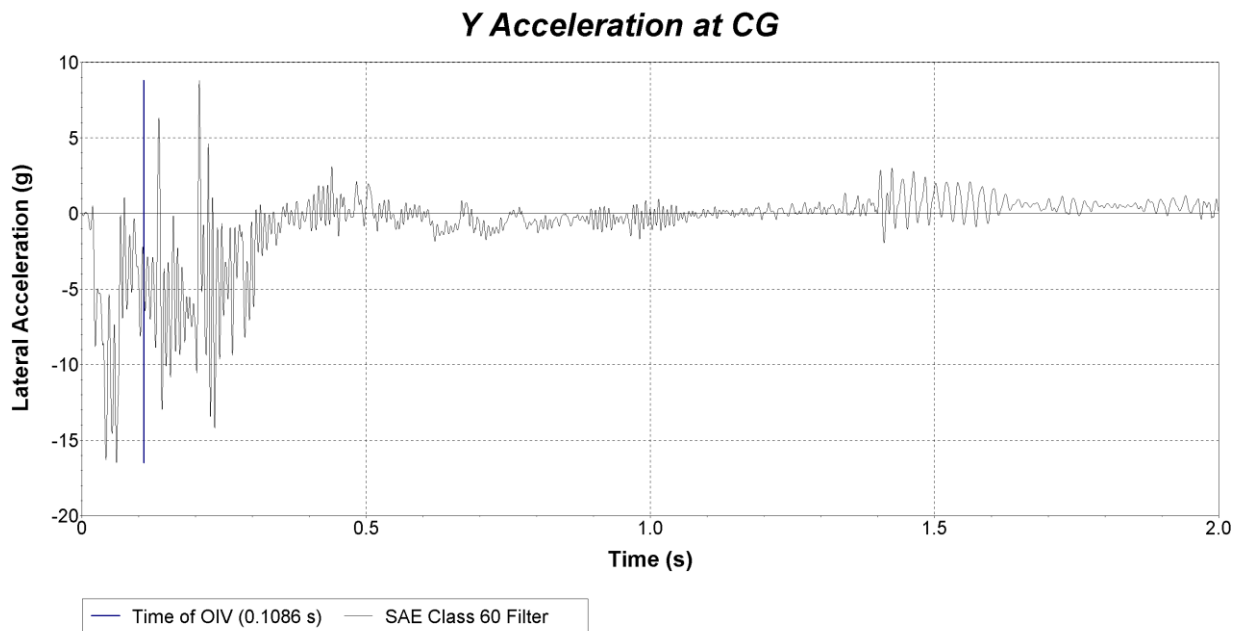
Figure J.9. Vehicle Lateral Accelerometer Trace for Test 469943-01-3 (Accelerometer Located at Center of Gravity).

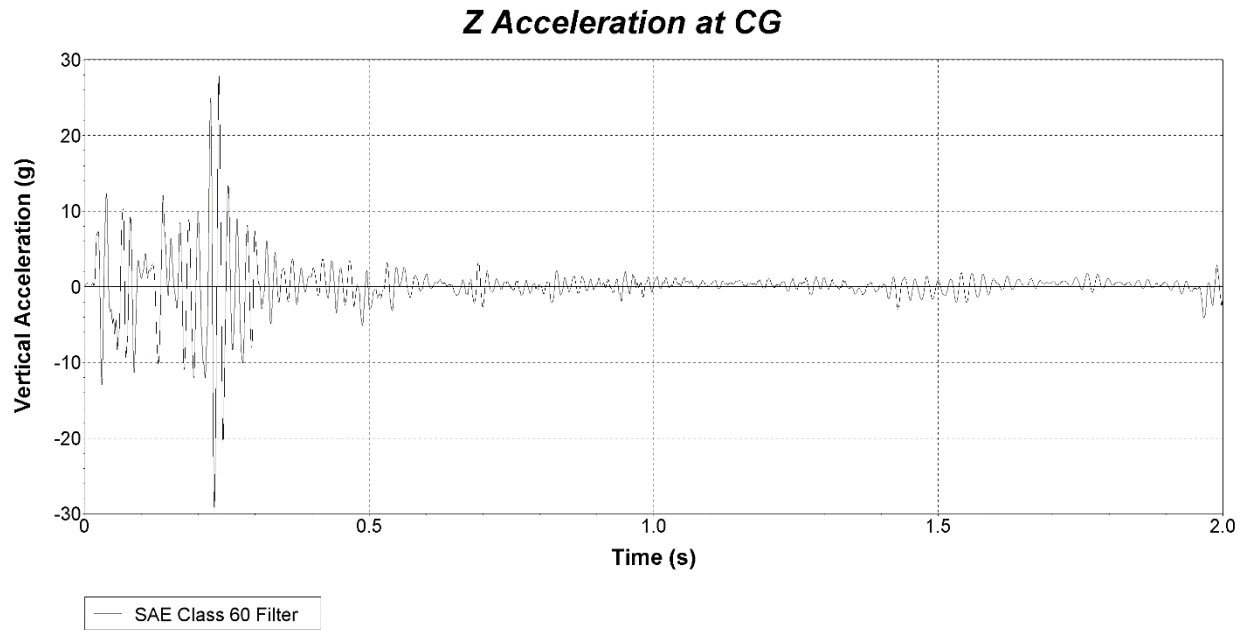
**Figure J.10. Vehicle Vertical Accelerometer Trace for Test 469943-01-3
(Accelerometer Located at Center of Gravity).**

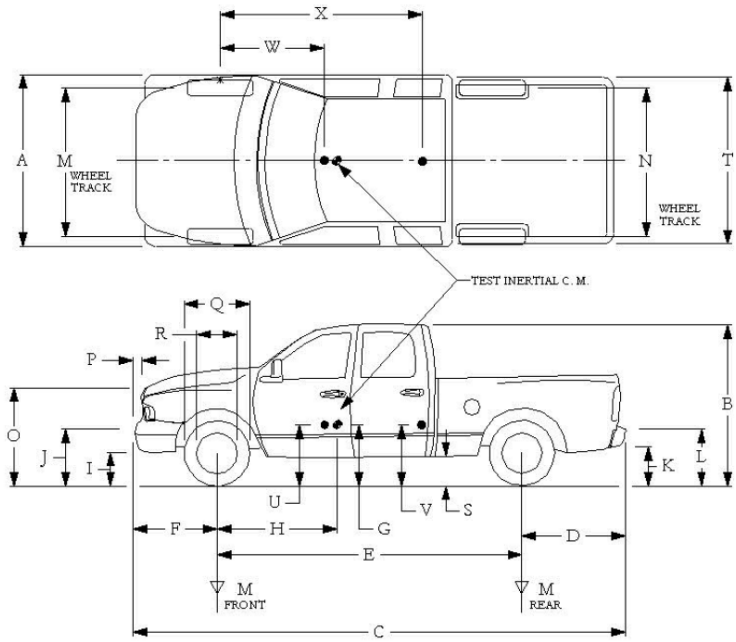
Geometry: inches

A	78.50	F	40.00	K	20.00	P	3.00	U	26.75
B	74.00	G	28.62	L	30.00	Q	30.50	V	30.25
C	227.50	H	61.06	M	68.50	R	18.00	W	61.50
D	44.00	I	11.75	N	68.00	S	13.00	X	79.00
E	140.50	J	27.00	O	46.00	T	77.00		
Wheel Center Height Front		14.75	Wheel Well Clearance (Front)		6.00	Bottom Frame Height - Front		12.50	
Wheel Center Height Rear		14.75	Wheel Well Clearance (Rear)		9.25	Bottom Frame Height - Rear		22.50

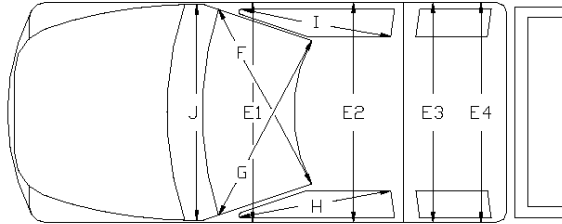
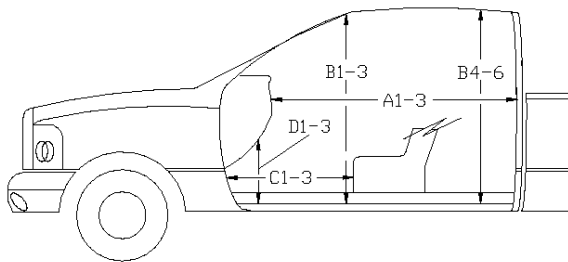
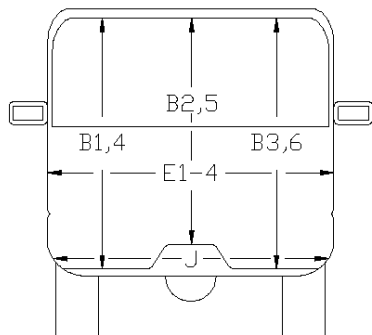
OCCUPANT COMPARTMENT DEFORMATION MEASUREMENT

*Lateral area across the cab from driver's side kickpanel to passenger's side kickpanel.

Before	After (inches)	Differ.
A1	65.00	65.00	0.00
A2	63.00	63.00	0.00
A3	65.50	65.50	0.00
B1	45.00	45.00	0.00
B2	38.00	38.00	0.00
B3	45.00	45.00	0.00
B4	39.50	39.50	0.00
B5	43.00	43.00	0.00
B6	39.50	39.50	0.00
C1	26.00	26.00	0.00
C2	0.00	0.00	0.00
C3	26.00	26.00	0.00
D1	11.00	11.00	0.00
D2	0.00	0.00	0.00
D3	11.50	11.50	0.00
E1	58.50	58.50	0.00
E2	63.50	63.50	0.00
E3	63.50	63.50	0.00
E4	63.50	63.50	0.00
F	59.00	59.00	0.00
G	59.00	59.00	0.00
H	37.50	37.50	0.00
I	37.50	37.50	0.00
J*	25.00	25.00	0.00

Figure K.3. Occupant Compartment Measurements for Test 469943-01-4.

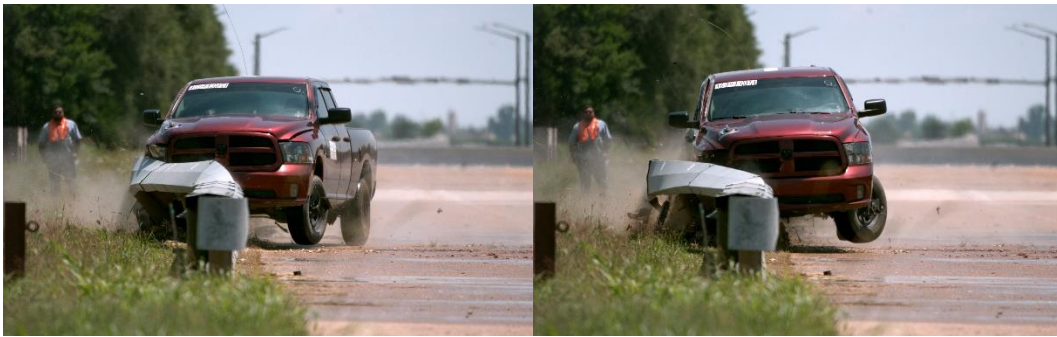
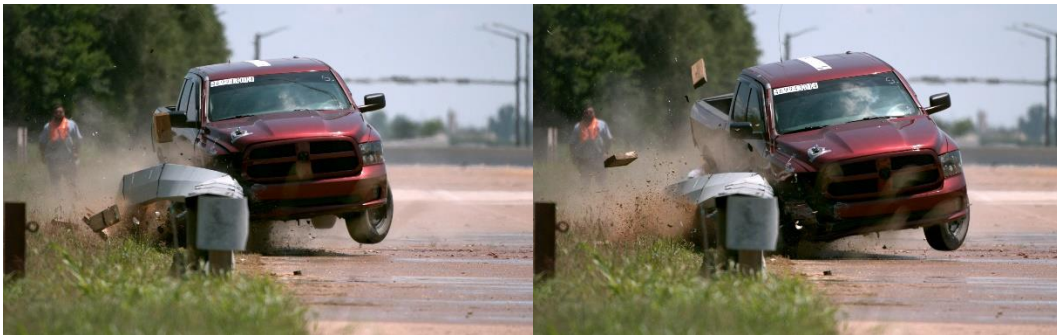
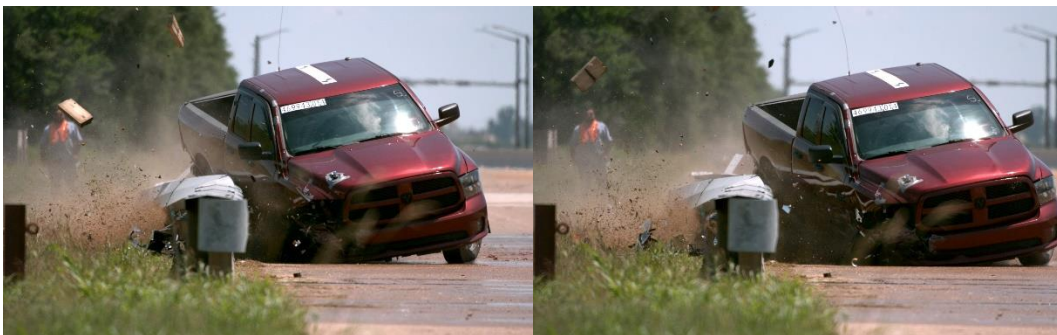
Figure K.5. Sequential Photographs for Test 469943-01-4 (Frontal Views).

(a) 0.000 s

(b) 0.100 s

(c) 0.200 s

(d) 0.300 s

(e) 0.400 s

(f) 0.500 s

(g) 0.600 s

(h) 0.700 s

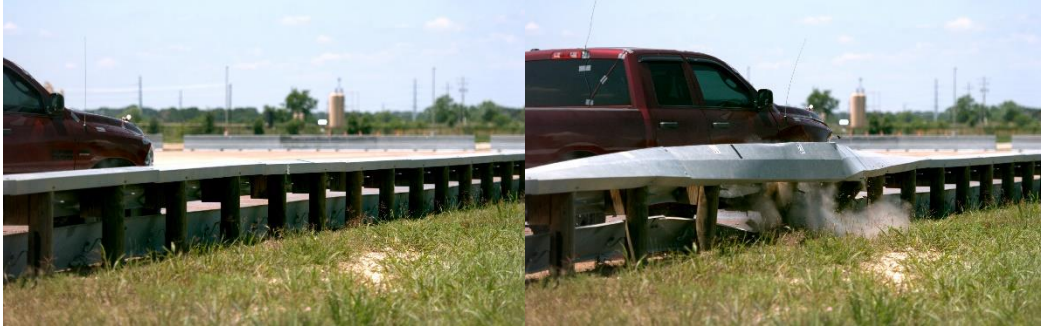
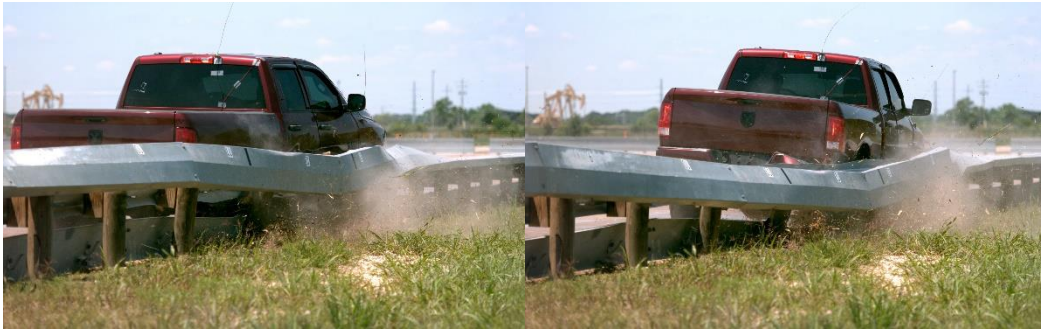
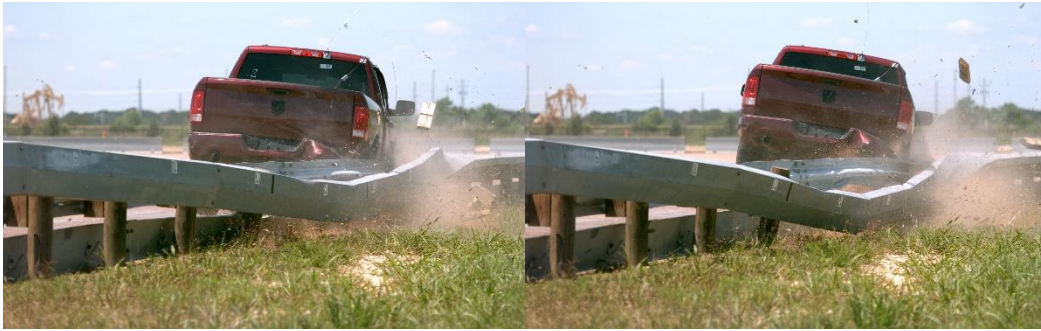
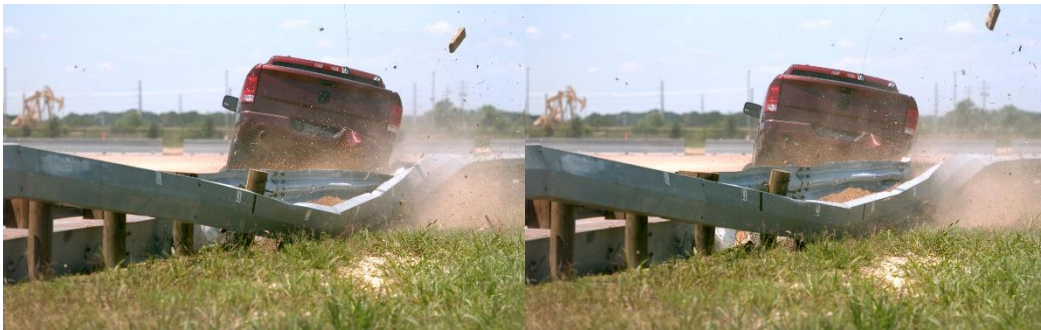
Figure K.6. Sequential Photographs for Test 469943-01-4 (Rear Views).

(a) 0.000 s

(b) 0.100 s

(c) 0.200 s

(d) 0.300 s

(e) 0.400 s

(f) 0.500 s

(g) 0.600 s

(h) 0.700 s

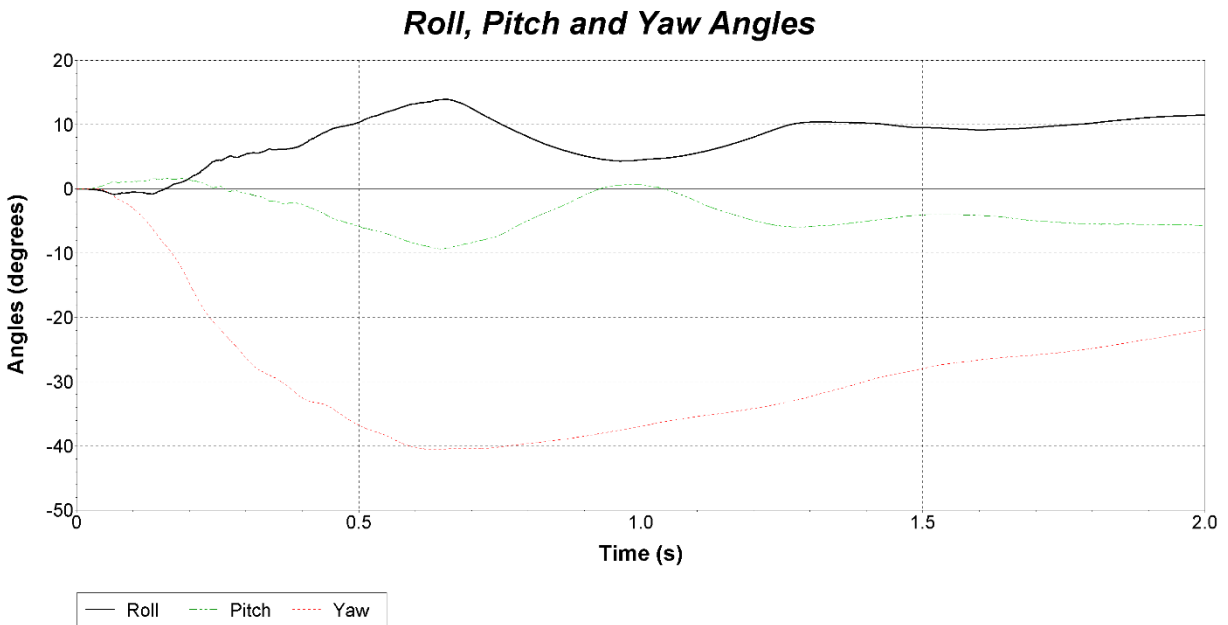
Figure K.7. Vehicle Angular Displacements for Test 469943-01-4.

Axes are vehicle-fixed.
Sequence for determining orientation:

10. Yaw.
11. Pitch.
12. Roll.
