# FX2-Division: Shared Bicycle and Pedestrian Platform Evaluation

Final Report

August 2024

Transportation Research and Education Center (TREC)

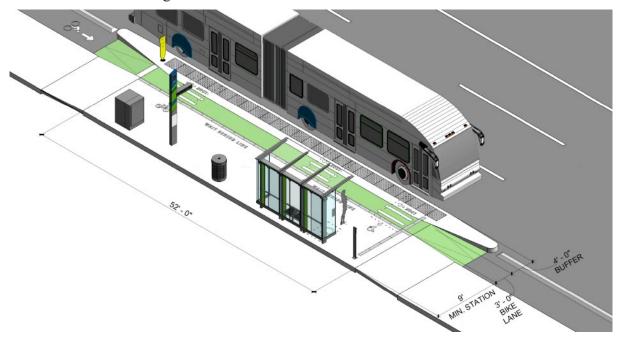
The design seeks to mitigate bicyclists moving out into traffic on the SE Division Street corridor; however, it also depends upon users understanding how to navigate the shared space, included where to wait for the bus, how to board and alight, and when and where bicyclists should yield to allows riders to access the buses. Figure 1 shows the standard FX2 platform design. The standard design includes a 4 feet boarding/alighting zone with a white truncated dome. There is a 3' green bike lane with crosswalk markings which are aligned with the FX2 door openings. There is a 6" strip of tactile walking surface indicators (TWSI) to mark the border of the bike lane and waiting area. Also included in the design is a transit rider waiting area with amenities and a shelter. When no bus is at the platform, transit riders are intended to wait behind a marked line of tactile guide strips, and bicyclists are free to pass through the platform area. When a bus arrives, bicyclists are intended to stop at a stop bar prior to passing through the platform area, and bus riders are to board and alight.

Figure 1 TriMet schematic of standard FX2 platform design (Source: TriMet)

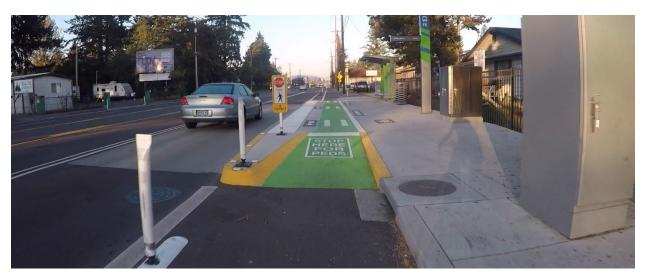
Figure 2 Bicyclist perspective of standard FX2 platform

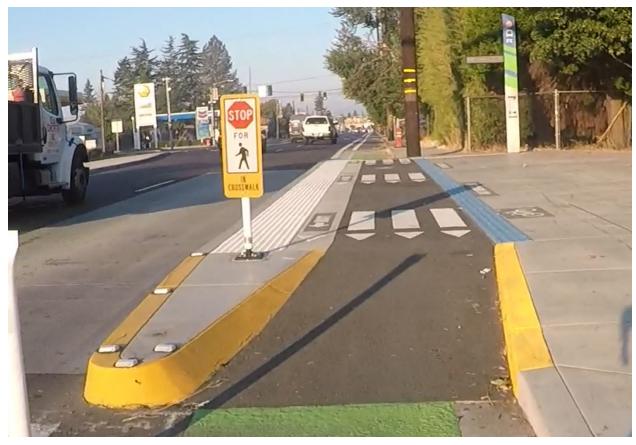
Variations to the standard design were implemented at FX2 platforms located on ODOT property adjacent to I-205 and the MAX Green Line due to site constraints and variations in ODOT and PBOT guidelines and requirements. Figure 3 shows the transit stop at SE 93<sup>rd</sup> Ave. The following differences were observed compared to the standard design. At these locations:

- The bicyclist stop bar and "Stop here for peds" markings were absent.
- There is a 4' wide black bike lane, rather than 3' wide green bike lane present with the standard design.
- There is a 12" blue strip of TWSIs, rather than 6" white strip and a larger / deeper waiting area.
- On the approach to the platform, there is a "Bike Lane Ends" sign, and on the far side of the platform there is a "Bike Lane" sign to imply the resumption of the bike lane. Note that these signs were added after the photo in Figure 3 was taken.

Figure 3 FX2 westbound platform at SE 93rd Avenue, incorporating design variations

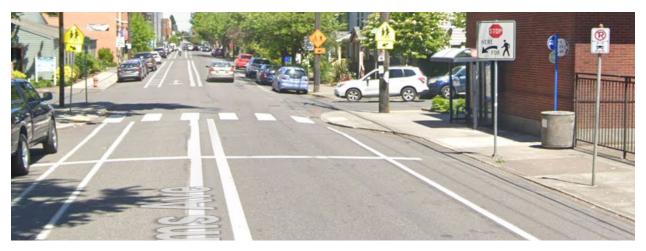
Complications may arise if bicyclists need to be routed from the right side of the street over to the left side of the street. An example of this approach is North Williams Street in Portland, OR (Figure 4).

Figure 4 Left-side bike lane with right side bus stop, North Williams Street in Portland, OR (Source: Google Street View)

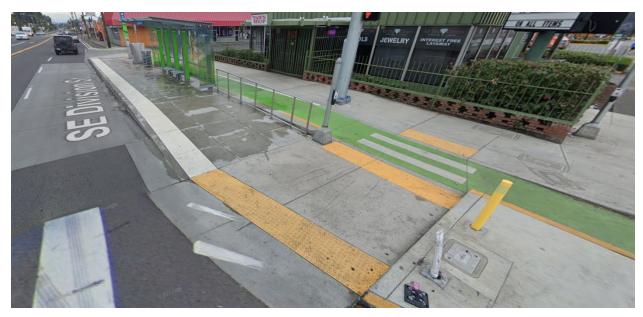
Figure 5 Floating transit island on SE Division and  $122^{nd}$  Avenue in Portland, OR (Source: Google Street View)

Examples of permanent floating bus transit islands include those on SE Division in Portland (Figure 5) and on Roosevelt Way NE in Seattle (Figure 6). Examples of modular floating bus islands include SE Hawthorne in Portland (Figure 7) 108<sup>th</sup> Ave NE in Bellevue, WA (Figure 8)

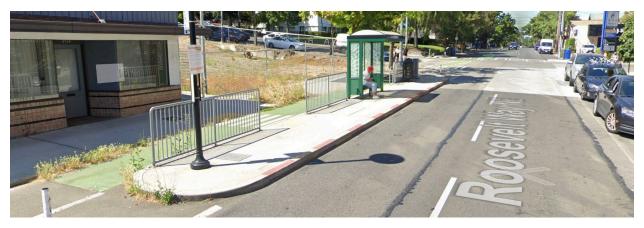
Figure 6 Floating transit island on Roosevelt Way NE in Seattle, WA (Source: Google Street View)

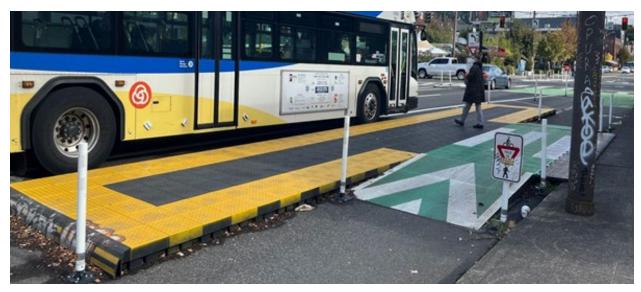
Figure 7 SE Hawthorne Blvd at 12th Avenue in Portland, OR (Photo: Kyuri Kim)

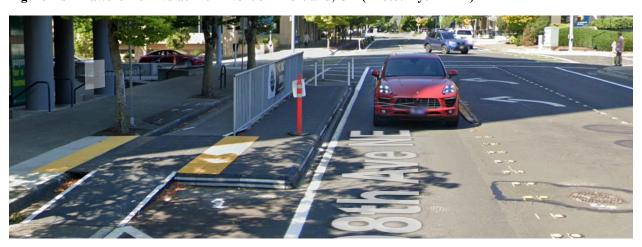
Figure 8 108th Avenue NE in Bellevue, WA (Source: Google Street View)

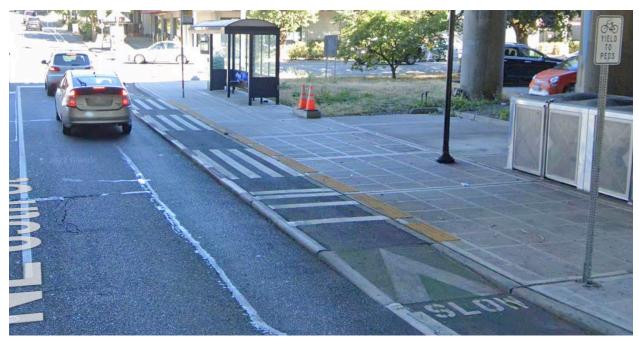
Figure 11 Cycle track bus stop with no additional boarding area. Seattle, NE 65<sup>th</sup> Avenue (Source: Google Street View)

Examples of this type of stop are included below, including a stop on NE 65<sup>th</sup> Street in Seattle (Figure 9), and a stop on Sherbourne Street in Toronto, Ontario (Figure 10). These two designs do not feature an additional boarding zone on the street side of the bike lane. Another version of this design from West 4<sup>th</sup> Street in Charlotte, NC (Figure 11) contains a narrow, marked boarding area.

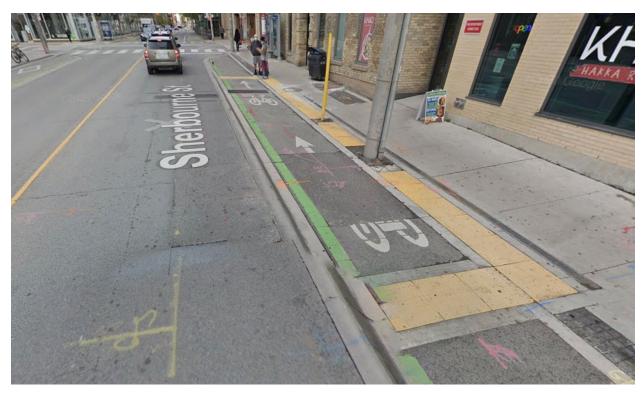
Figure 12 Cycle track bus stop with no additional boarding area. Toronto, ON, Sherbourne Street (Source: Google Street View)

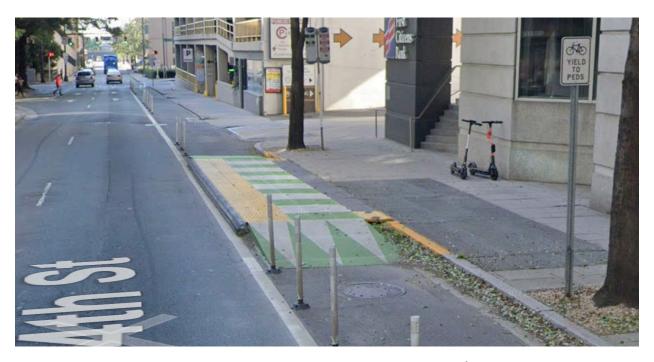
Figure 13 Shared transit stop with marked boarding area. Charlotte, NC, W. 4<sup>th</sup> Street (Source: Google Street View)
