# Performance and Improvement of Texas Poor Boy Continuous Bridge Deck Details: Final Report

Technical Report 0-7013-R1

TEXAS A&M TRANSPORTATION INSTITUTE  
COLLEGE STATION, TEXAS

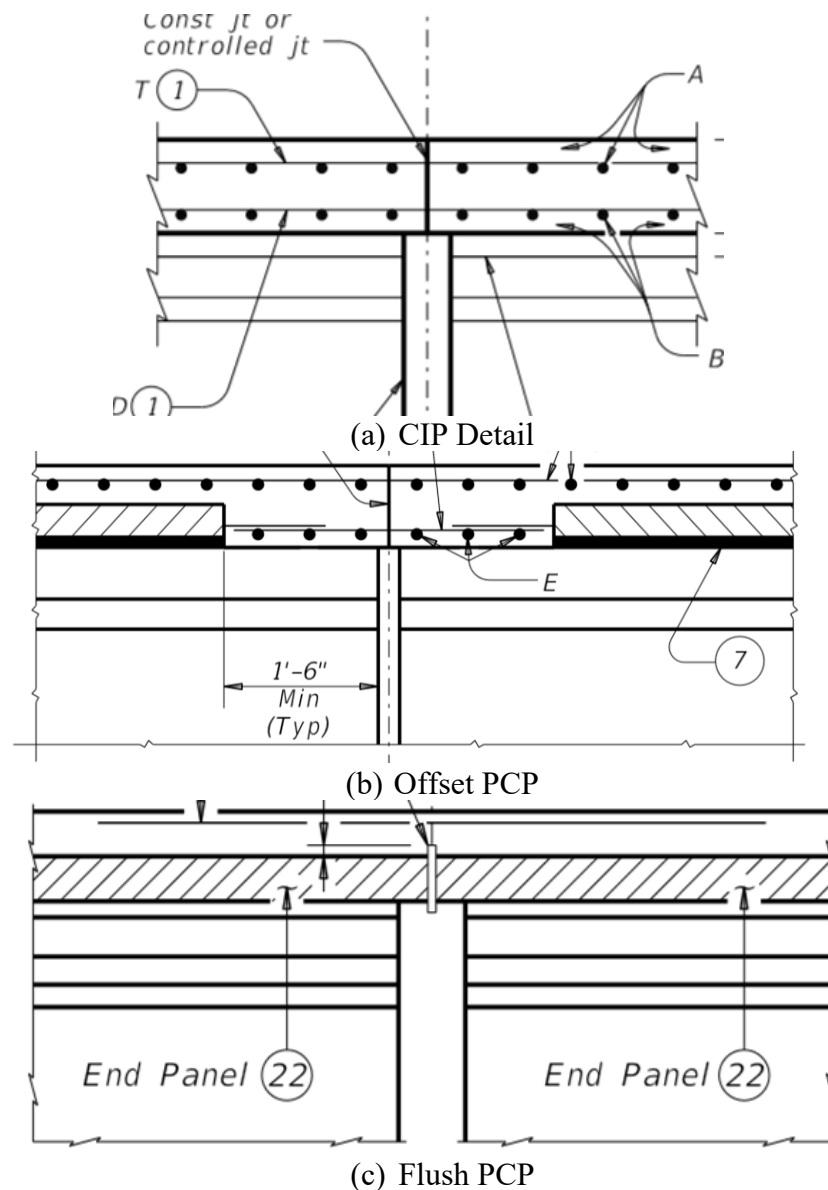
TxDOT has utilized bonded link slabs for approximately four decades. These are commonly referred to as “poor boy” continuous deck details, or poor boy joints (PBJs), because the reinforcement for the link slab region is the same as that used in the remainder of the deck. Figure 1.1 shows the different types of continuous deck details used by TxDOT at the time of this report. Figure 1.1(a) shows the cast-in-place (CIP) details, consisting of #4 reinforcement at a spacing of 9 in. While not shown in the drawing, a  $\frac{3}{4}$ -in. chamfer is provided transverse on the bottom of the deck to encourage cracking at the center of the joint.

The majority of new decks in Texas bridges utilize partial-depth precast panels (PCPs) in which the bottom reinforcement is provided by the precast panels and only the top layer of reinforcement is needed in the CIP portion of the deck. Historically, the detailing of the PBJ in partial-depth panels has been to terminate the panels at least 1.5 ft prior to the ends of the girders and to have either a full-depth CIP region or permanent metal deck forms (PMDFs); in this report, such detail is referred to as an offset panel detail. Figure 1.1(b) shows the detail when the full-depth CIP region is used with the offset panel detail. Top reinforcement is simply the top reinforcement in the detail continued through the link slab. Bottom reinforcement is provided spliced with dowel bars extending from the precast panel. More recently, another detailing option, shown in Figure 1.1(c), has been introduced to the TxDOT standards, in which panels are continued the full length of the girders, with panels over the two ends meeting over the gap between the girder ends, and with a  $\frac{3}{4}$ -in. timber board separating the panels (board is terminated at the exterior edge of the fascia girders to allow full-depth CIP overhang). The top of the board is chamfered to produce a similar effect to the control location where cracks form. In the flush panel detail, the critical section at the center of the link slab is the depth of only the top CIP portion of the full deck (4.5 in.). Since the slab is thinner here, additional 5-ft long #4 bars are provided between each deck longitudinal bar, effectively providing #4 @ 4.5” instead of #4 @ 9” as in the other deck designs. The current standards for offset and flush panel details include the use of an intentional crack former above the chamfer/notch. This top surface crack former has not always been used, allowing cracks to occur naturally in some decks.

**Figure 1.1. TxDOT poor boy joint continuous deck details (TxDOT bridge standards).**

Detailing considerations include panel details, use of crack formers, and detailing at girder ends. In current TxDOT standard details, offset and flush panel options are available (see Figure 1.1). The differences in performance of these should be considered when evaluating the expected performance of the details. For flush panels, this includes the detail as designed and the observed field conditions in bridges monitored and documented in Chapter 6. An additional option of a continuous panel is also explored. The objective of the continuous panel is to provide continuity of the bottom portion of the deck and thus eliminate a potential plane of weakness at the panel gap in the flush panel option. The continuous panel would also provide prestressed concrete in the bottom, which may contribute to avoiding full-depth cracking of link slab designs. A disadvantage of the continuous panel relative to offset panel designs is the need to coordinate the correct panel length prior to construction. However, this is no different than that needed for flush panels.

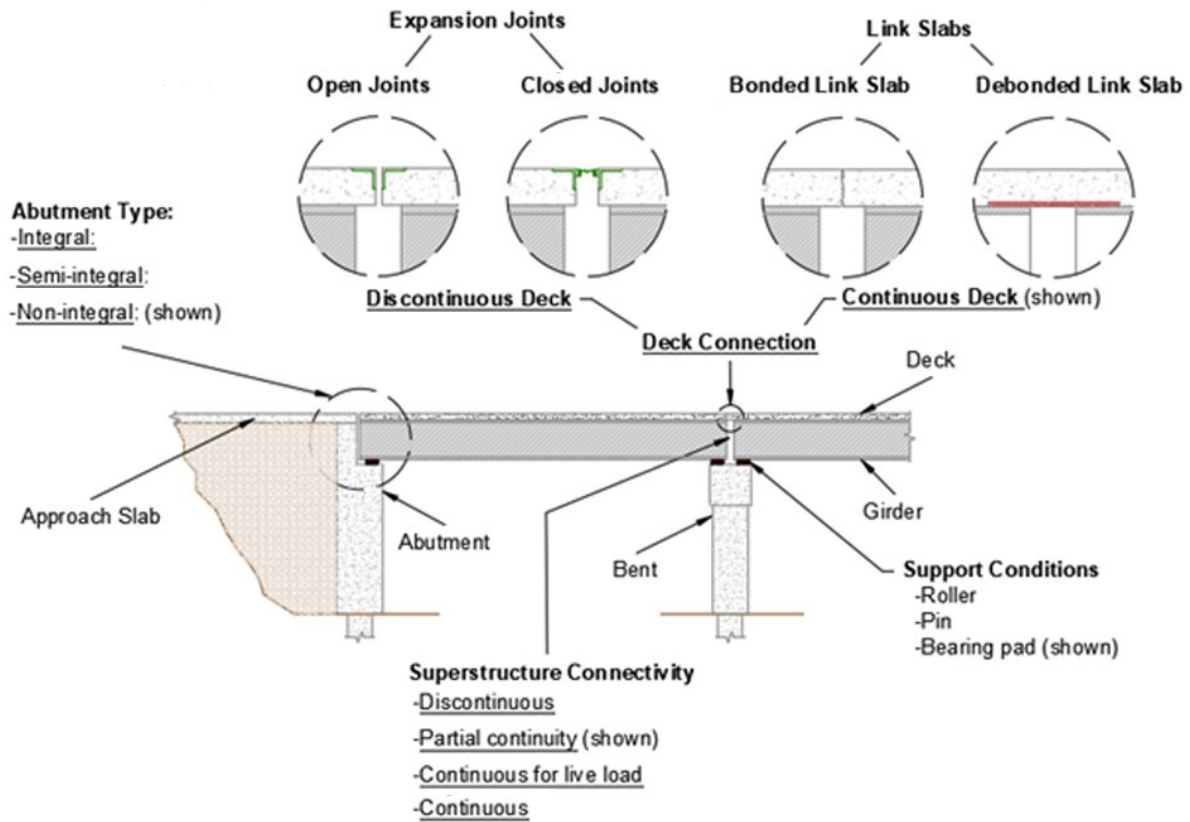
Figure 2.1. Nomenclature diagram for bridge components.

The design for bridge deck deformations, forces, and performance should not only consider the deck and connection but also the rest of the superstructure and substructure. Similarities in the terminology used in the literature to describe bridge, deck, and joint characteristics make clarifying these terms an important step in examination of the literature. To support this, Figure 2.1 and Figure 2.2 provide an overview of the bridge characteristics.

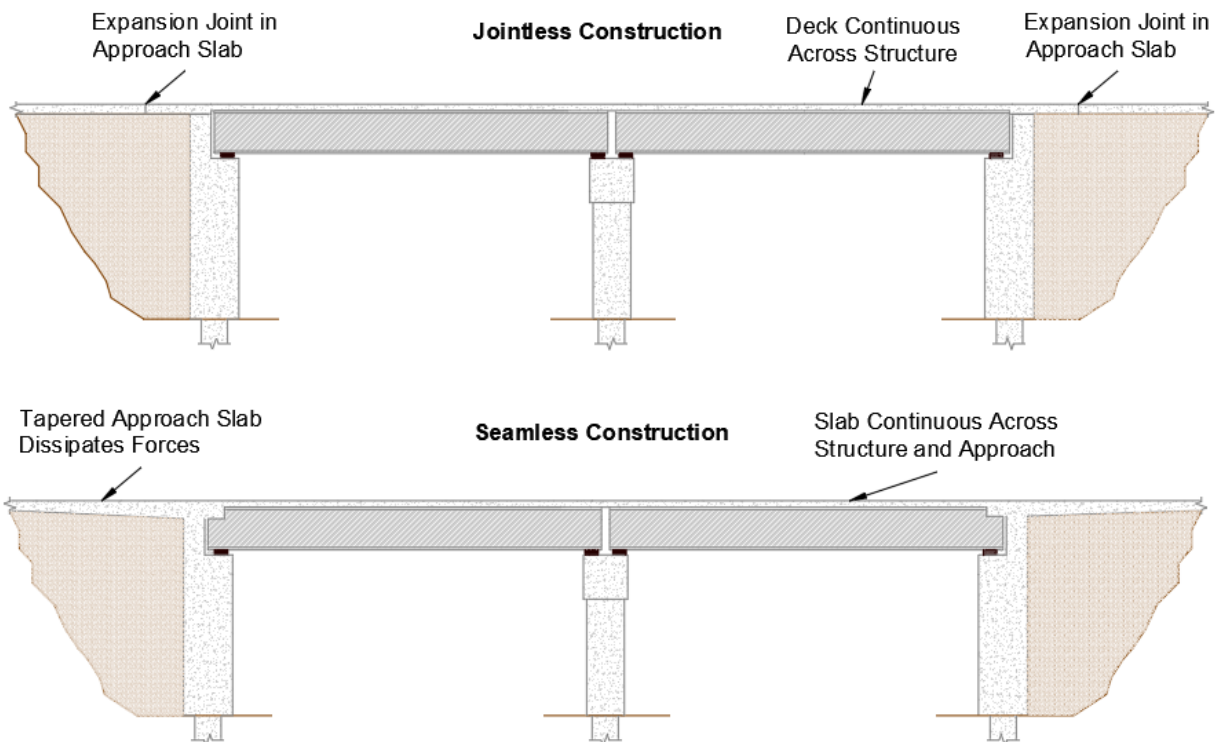
Figure 2.2. Bridge system nomenclature diagram.

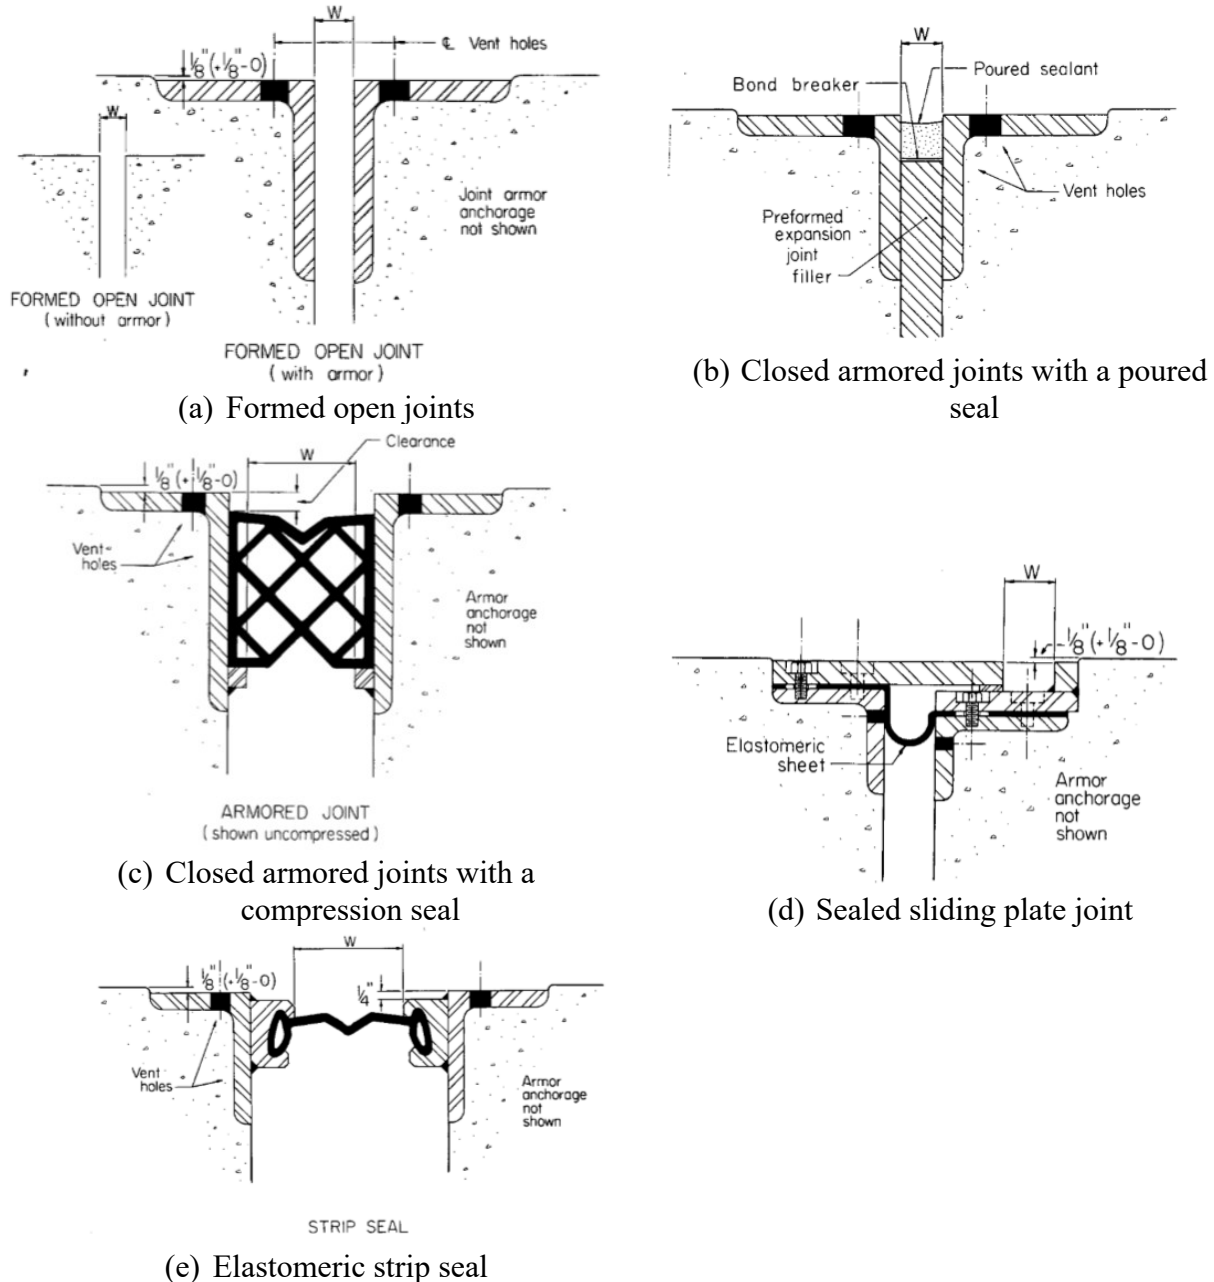
Joints may be broadly categorized as either open or closed. Open joints include formed joints (see Figure 2.3) and finger-plate joints that allow water and debris to pass through. Closed joints include various types of seals (see Figure 2.3[b–c]) and sliding plates. Poured seals are limited to small deflections. They may include additional elements such as backer rods, bond-breaking material between the sealant and joint filler, or angled steel to reinforce the top edges. Compression seals, which consist of cellular elastomeric structures, may incorporate larger displacements. Cellular seals are a similar concept made of foams. Sliding plate joints (see Figure 2.3[d]) are typically used for displacements up to 4 in. While simple to construct and harder than elastomeric options, they will allow water to permeate if not sealed and are vulnerable to damage from vertical deflections. Prefabricated elastomeric seals may be sheet or strip style (see Figure 2.3[e]), incorporating deflections up to around 4 in. or more complex plank seals for large deflections up to 13 in. While the performance of deck joints is an area of concern for bridge engineers, the deck itself must also be durable, especially when it comes to controlling cracking that leads to corrosion.

**Figure 2.3. Examples of joints in discontinuous decks, reprinted from Burke Jr. (1989).**

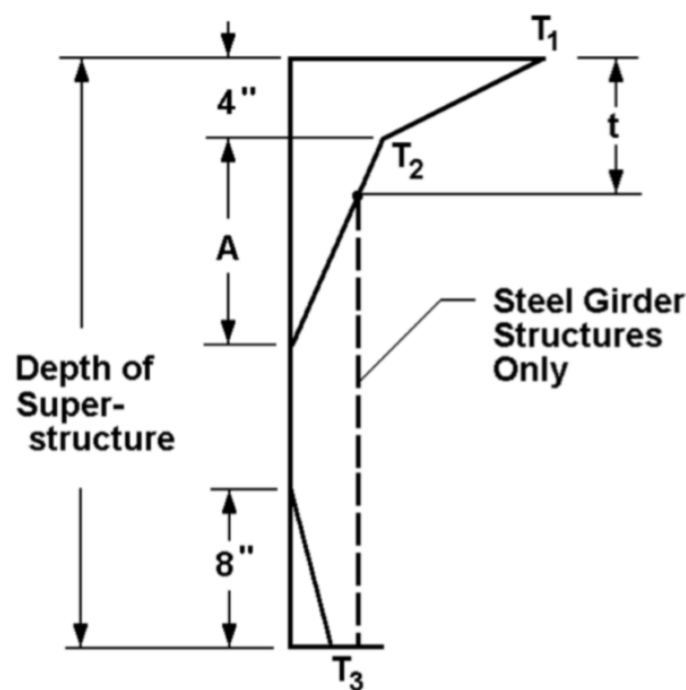
Regarding temperature gradient, positive temperature gradient values are chosen with a map and table. Negative gradient values are found similarly and then modified based on deck surface material. These temperatures are applied to a standard thermal gradient (AASHTO Figure 3.12.3-2, shown in Figure 2.4), with dimensions defined by superstructure depth. AASHTO Section 4.6.6 specifies that axial deformation, bending deformation, and associated stresses should be calculated using this temperature gradient. AASHTO Equations C4.6.6.-1 through C4.6.6.-7 may be used to find axial deformation, axial strain, curvature, bending and axial end forces, and internal stresses.

**Figure 2.4. Girder temperature gradient, reprinted from AASHTO (2017).**

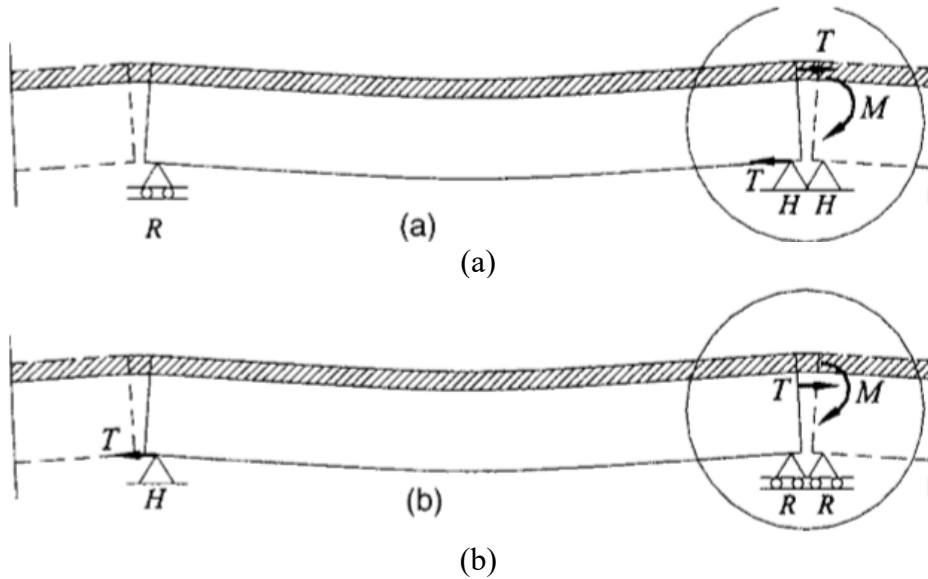
difficulty in modeling partially continuous bridges arises because of the lack of rotational compatibility across a support at the link slab caused by tensile elongation in the link slab. The rotational behavior also changes with support conditions (see Figure 2.5) because roller supports necessitate the elongation of the girders in tension, while the use of pinned supports causes a reaction at the support to counter the tension in the link slab. The elongation of the girders with roller conditions means a reduced tensile force in the link slab and the prevention of a couple moment between the support and slab (see Figure 2.6). The most common way to capture such behavior in modeling is through the use of finite element methods.

**Figure 2.5. (a) Hinge supports causing a couple moment and tension in the link slab, and (b) roller supports preventing the formation of a couple moment, reducing the tension in the link slab; reprinted from Okeil and ElSafty (2005).**

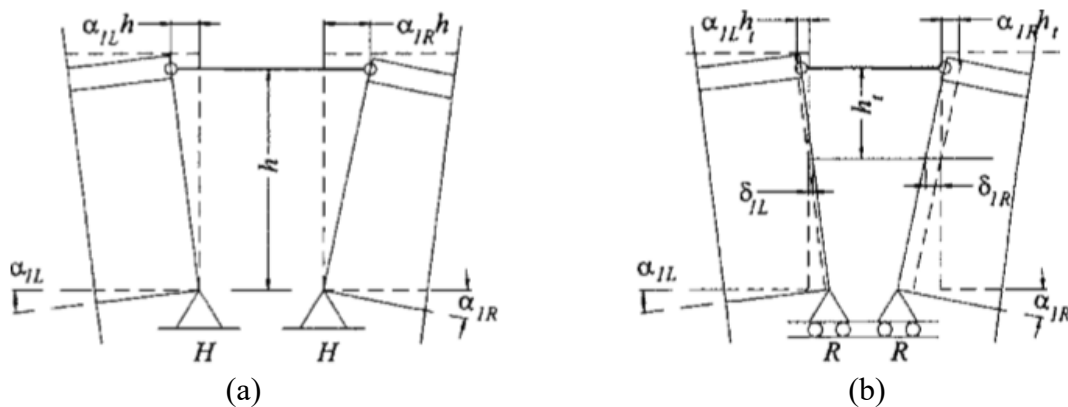
**Figure 2.6. Deformation of the link slab system with (a) pin supports and (b) roller supports; reprinted from Okeil and ElSafty (2005).**

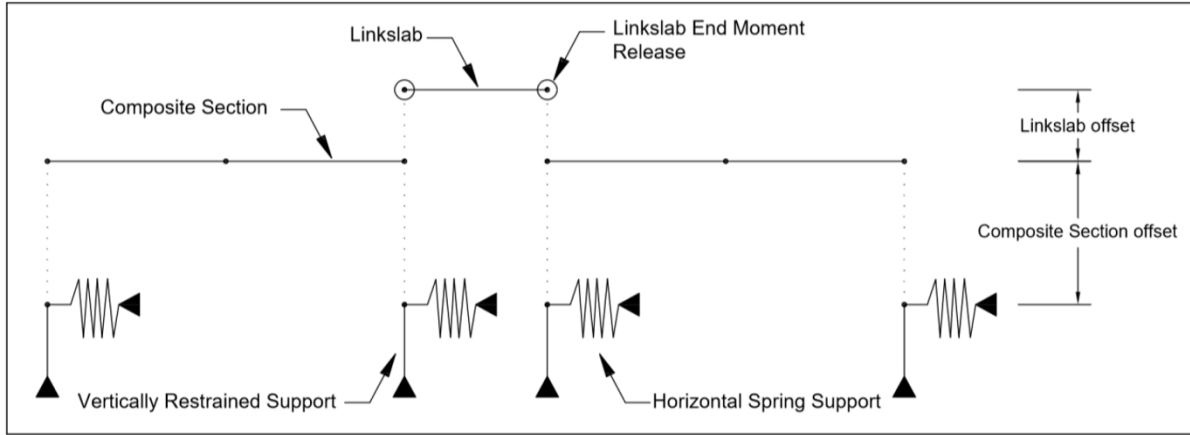
Researchers analyzed 648 line models to incorporate the various parameters, with 324 of those models including link slabs. The line models included five elements for a two-span structure and eight elements for a three-span structure (see Figure 2.7). Notably, the ends of the link slab element were released for moments. Thus, the link slab was only considered to undergo axial force demands. Researchers theorized that the offset of the link slab from the centroid of the section would cause the link slab to contribute an axial force to the system, while the link slab's low moment stiffness would preclude significant development of flexure in the member.

**Figure 2.7. Finite element model, reprinted from Canales and Okeil (2019).**

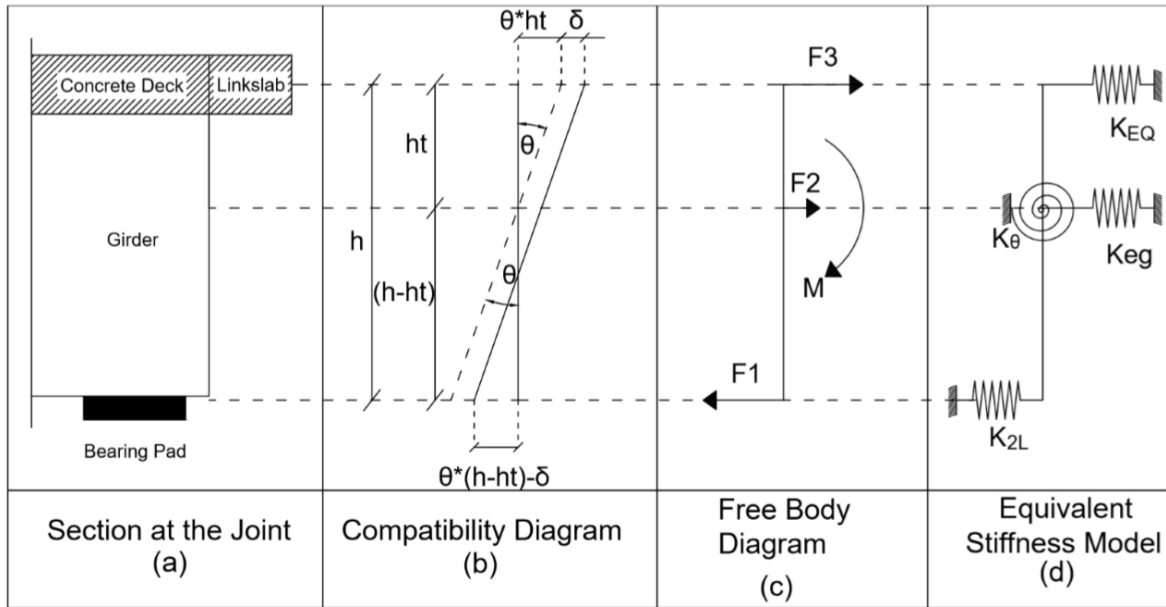
To analyze the parameters, an equivalent stiffness for the structure was defined in terms of each structure parameter (see Figure 2.8). Similarly, an equivalent support stiffness was defined in terms of the support and temperature parameters.  $F_1$  is defined as the force at the support,  $F_2$  as the force at the centroid,  $F_3$  as the link slab force,  $\theta$  as the girder end rotation, and  $\delta$  as the girder deformation from axial forces. Using the diagram shown in Figure 2.8, it was possible to solve for the girder end rotation in terms of the stiffness and dimensional parameters. By rearranging terms and substituting, the equivalent stiffness of the whole system,  $K_{EQ}$ , is also found. This parameter is used to simply compare the various cases. The model was validated using STAAD software.

**Figure 2.8. Parameter calculation for equivalent stiffness model, reprinted from Canales and Okeil (2019).**

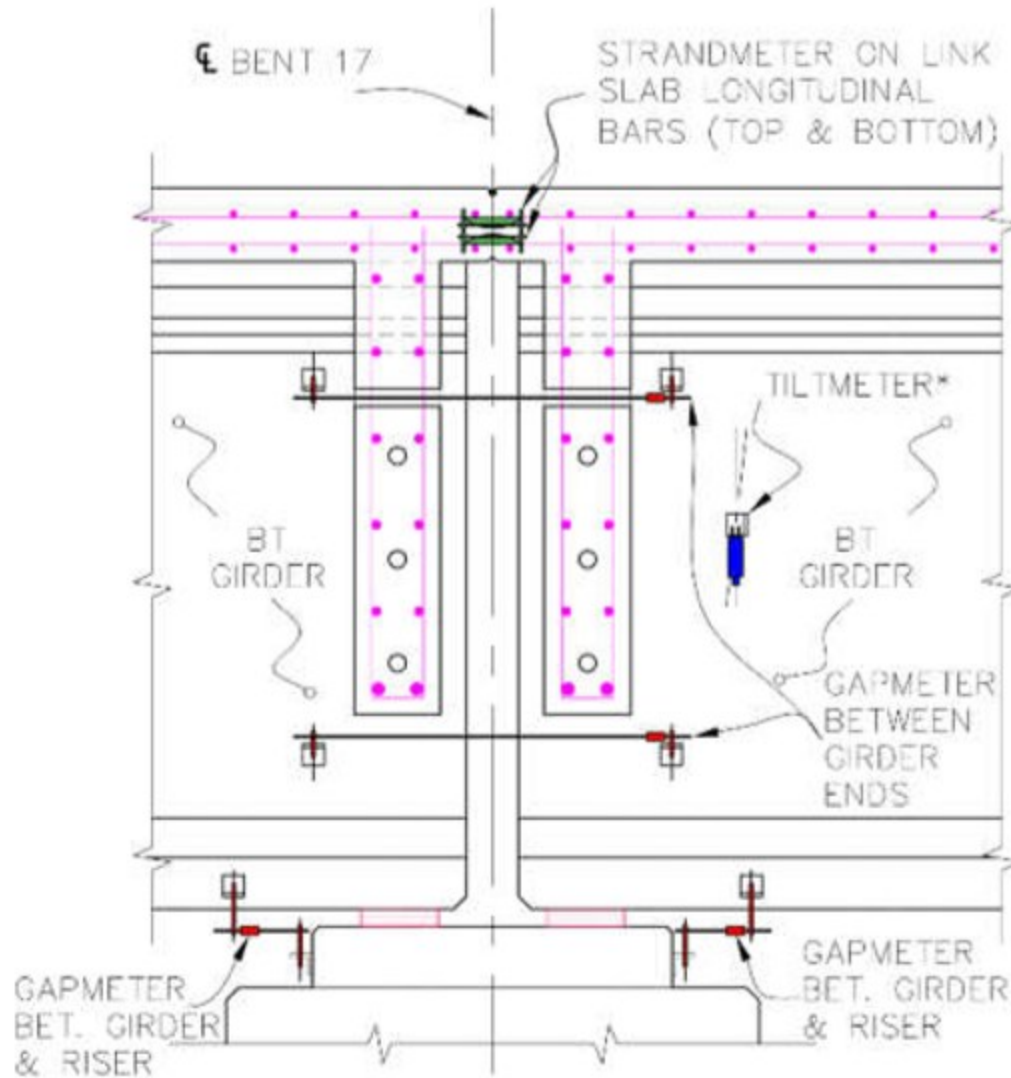
Canales Jr. (2019) performed field monitoring of a new 20-span girder bridge with link slabs spanning the Ouachita River in Harrisonburg, Louisiana. One four-span 540-ft segment, three two-span 270-ft segments, and one 135-ft span were all instrumented. In the link slabs, additional No. 6 longitudinal bars were placed in the top and bottom mats at 7-in. spacing. Silicone-sealed crack-control grooves were tested in some link slabs. Internal vibrating wire sensors were placed to record reinforcement forces, and external vibrating wire sensors were placed to record girder end displacements, girder end rotation, and temperature (see Figure 2.9).

**Figure 2.9. Field monitoring instrumentation setup, reprinted from Canales Jr. (2019).**

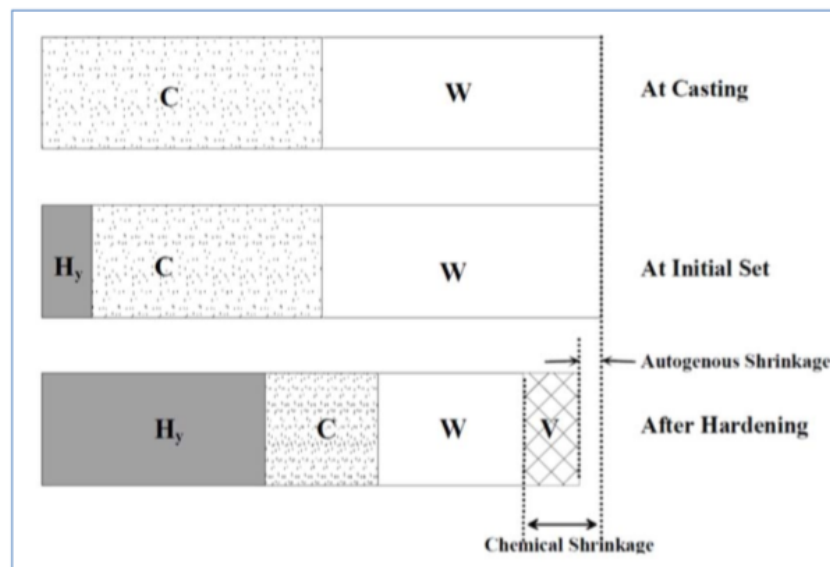
low water-to-cementitious materials ratio. Chemical shrinkage is caused by air filling pores as the supply of water in the mixture is depleted, leading to a contracting force of surface tension within the pores. Aggregate, which is subject to compressive forces by this cement contraction, helps prevent shrinkage of the system depending on the stiffness and volume fraction of the aggregate. Autogenous shrinkage, which is related to chemical shrinkage, is defined in terms of the apparent volume change of the system (the total volume of solids, liquid, and air), while total chemical shrinkage is defined in terms of absolute volume change (the volume of the system discounting air). Figure 2.10 shows a representation of chemical changes and shrinkage during the concrete curing process. An analytical model of autogenous shrinkage by Hedlund (2000) was used for the ConcreteWorks software.

**Figure 2.10. Chemical changes and shrinkage during the concrete curing process, reprinted from Holt (2001).**

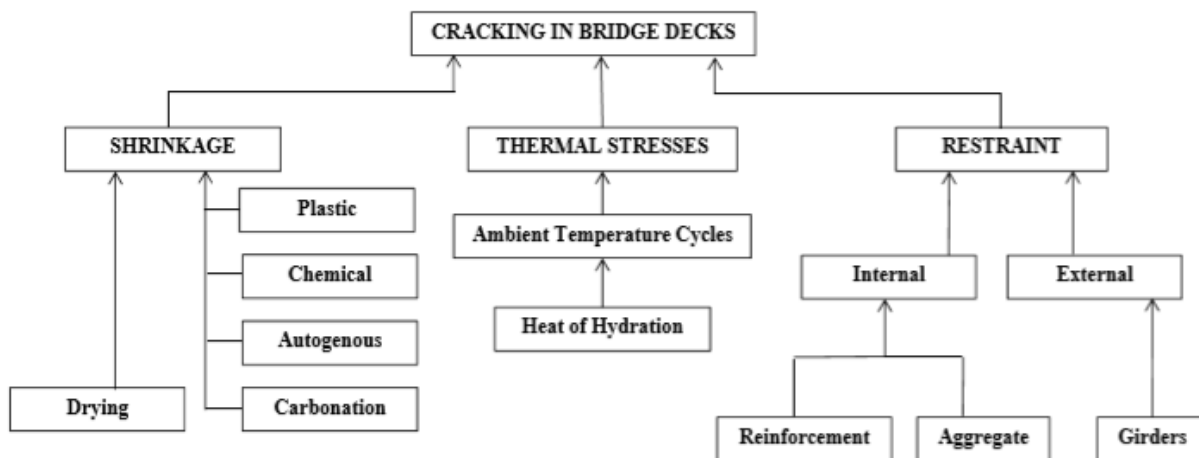
The other dimension of the concrete cracking issue pertains to the concrete's strength development and restraint conditions that allow the deck to resist tensile stress. A primary factor in determining strength is a low water-to-cementitious materials ratio, which corresponds to higher early and long-term strength development. Cement type and fineness have an important influence. Aggregate strength is less of a factor for normal concrete mixtures, but it becomes an important factor for high-strength concrete. The texture, size, and shape of aggregate do have a major effect on concrete tensile capacity. It is important to be mindful of trade-offs in concrete design. For instance, rough aggregate leads to increased tensile strength but also decreased workability. If water is added to restore workability, the advantage of rough aggregate is negated by strength loss. Figure 2.11 shows a diagram of sources of bridge deck cracking.

**Figure 2.11. Bridge deck cracking sources, reprinted from Pesek et al. (2013).**

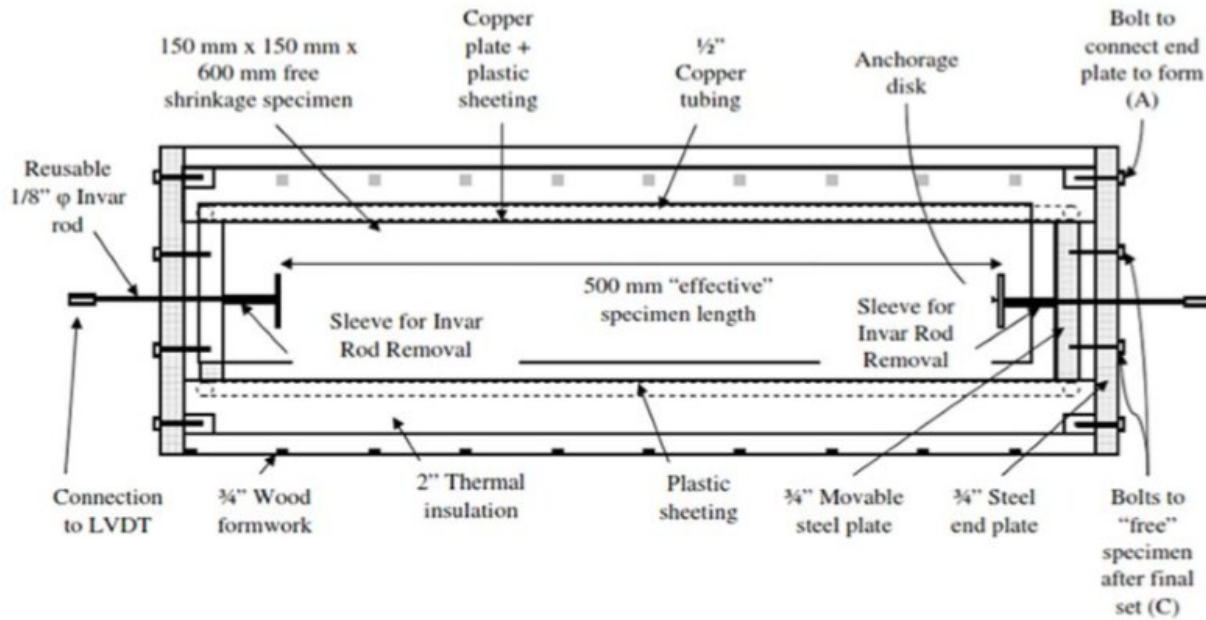
Pesek et al. (2013) conducted a test program to investigate the early-age cracking behavior of materials commonly used to fabricate TxDOT bridge decks. These constituents included cements, fly ash, blast furnace slag, coarse and fine aggregate, and water reducing and shrinkage reducing admixtures. Materials were used to generate numerous mix designs that were cast into cylinders and prisms for strength, elasticity, and shrinkage testing. Frames were constructed to evaluate restrained cracking behavior and unrestrained shrinkage (see Figure 2.12).

**Figure 2.12. Diagram of shrinkage test setup, reprinted from Pesek et al. (2013).**

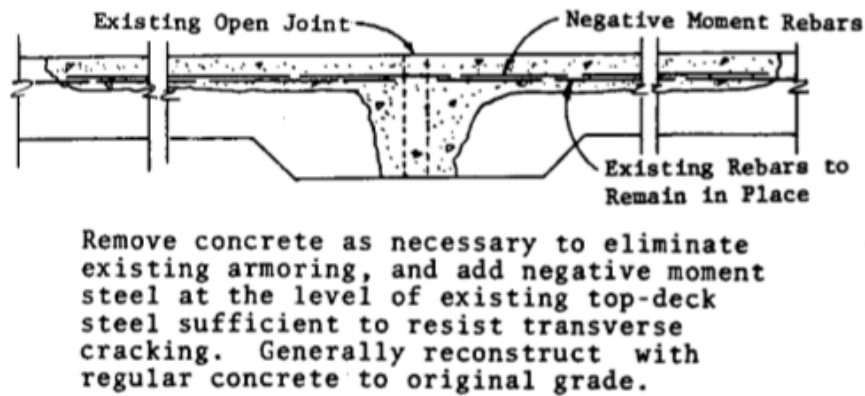
Burke Jr. (1989) noted that in the 1980s, TxDOT was conducting retrofits of intermediate slab expansion joints with continuous decks (see Figure 2.13). This fully bonded design was different from link slab designs in states such as Utah, which incorporated a polyethylene layer over the beam ends to prevent bonding of the concrete to the top surface of the beam ends. Additionally, the poor boy joint differed from designs in Wisconsin and Ohio, which included concrete cast between the beam ends to make the slab and beams composite.

**Figure 2.13. 1980s TxDOT expansion joint retrofit to continuous deck, reprinted from Burke Jr. (1989).**

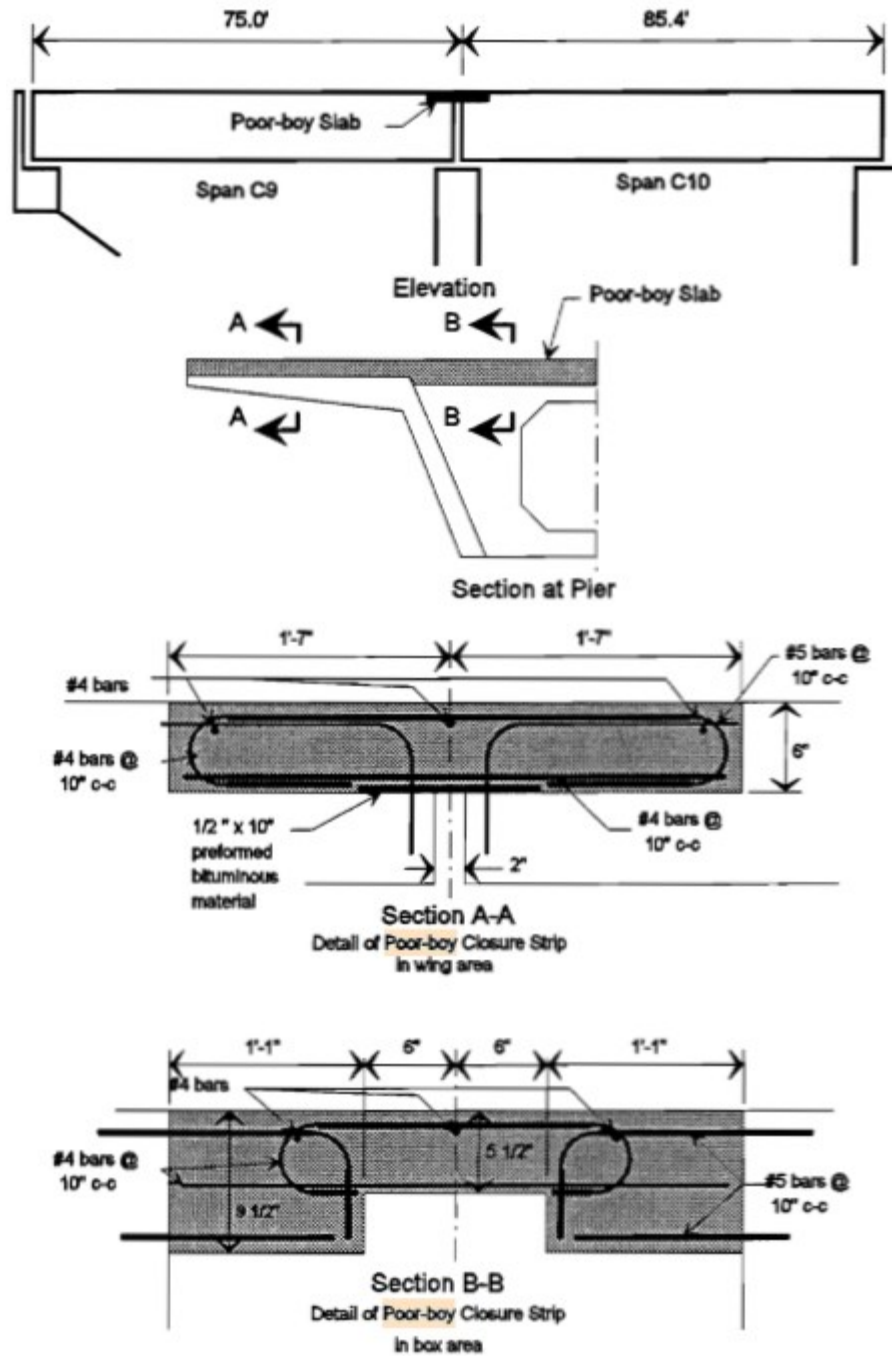
Roberts et al. (1993) conducted a field study of the San Antonio “Y” project, which included one highway span joined with poor boy connectivity. The spans consisted of segmental post-tensioned box girders. One two-span segment was left as simply supported over the bent with poor boy continuity in the deck (see Figure 2.14). Such a detail was novel for TxDOT segmental box girder structures. The spans were 75 and 85 ft long and were not connected with continuous tendons. The primary unknowns were whether the joint would cause partially continuous behavior.

Figure 2.14. Poor boy continuous slab details, reprinted from Roberts et al. (1993).

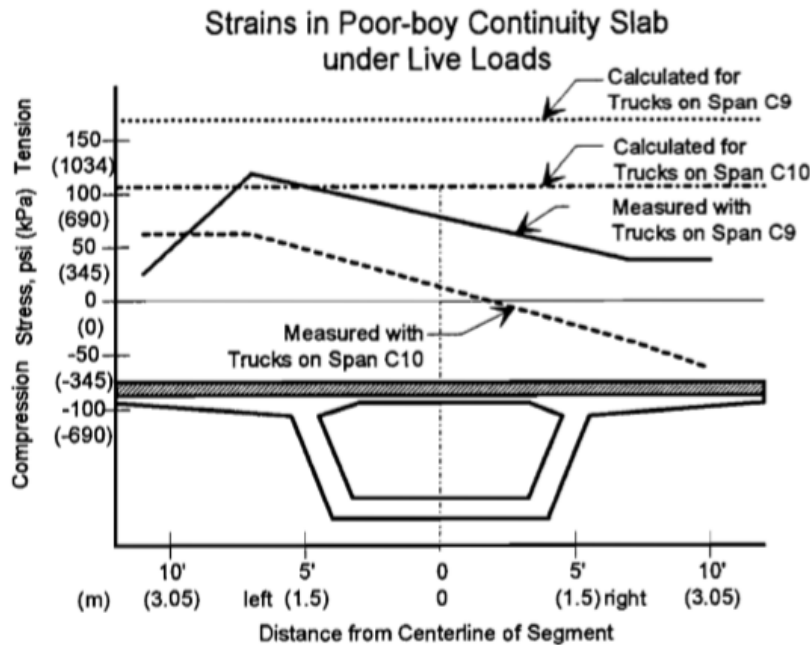
The poor boy span was instrumented with grid crack monitors that were read periodically, as well as strain gages to determine deck forces. Data were gathered with a live load truck test (see Figure 2.15). Results showed continuity over the closure slab due to a couple moment between the slab and girder bearing pads (see Figure 2.16). The use of thicker bearing pads with a lower shear modulus to allow less constrained deformation was suggested to reduce this continuity. Even so, cracking of the slab under live load was not observed.

Figure 2.15. Link slab stresses, reprinted from Roberts et al. (1993).

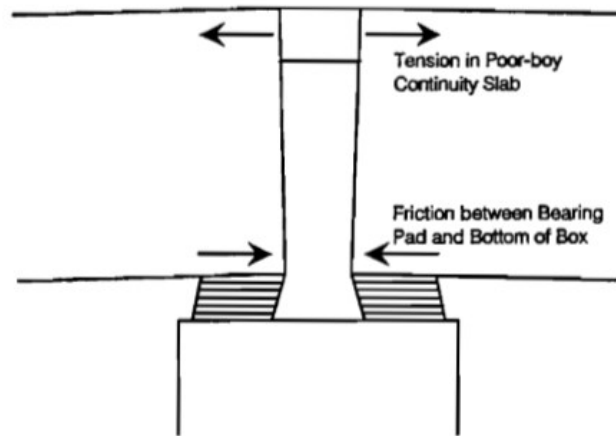
Figure 2.16. Couple moment causing link slab tension, reprinted from Roberts et al. (1993).

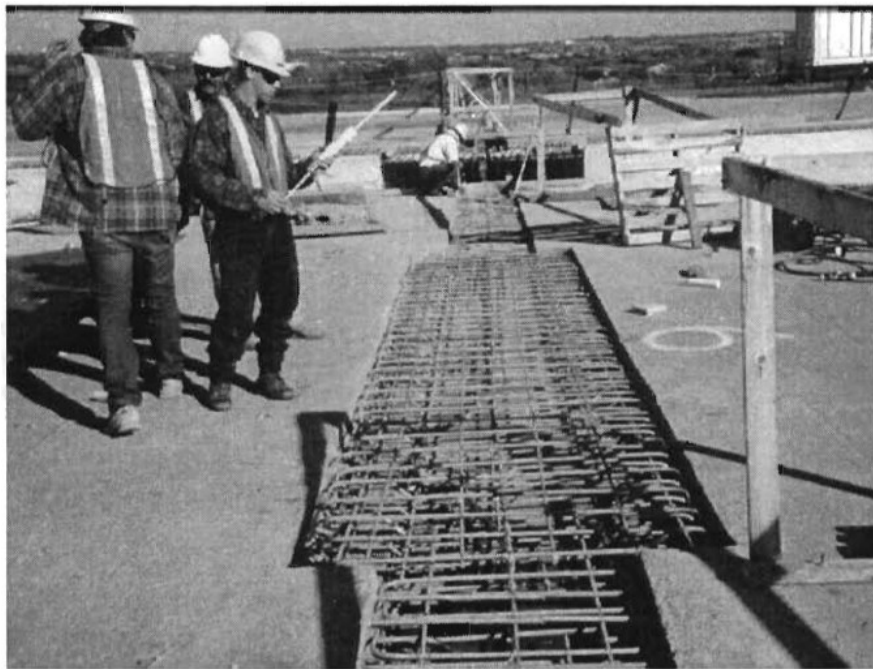
**Figure 2.17. Poor boy continuous joint pour, reprinted from Davis et al. (1999).**

construction and service. Because of complications with designing and constructing the spans as continuous, especially due to difficulty with post-tensioning continuity between spans, much of the structure was designed with simply supported spans. The deck between simple spans was made continuous with poor boy continuity for two to three spans by casting closure decks between the flanges of the box girders (see Figure 2.17). These joint slabs were designed to carry vehicle loads without transferring significant moment between girders. A poor boy continuous slab detail was chosen to reduce the number of expansion joints and because TxDOT has found that “the durability and ride quality of these slabs has proven to be excellent when properly detailed.”

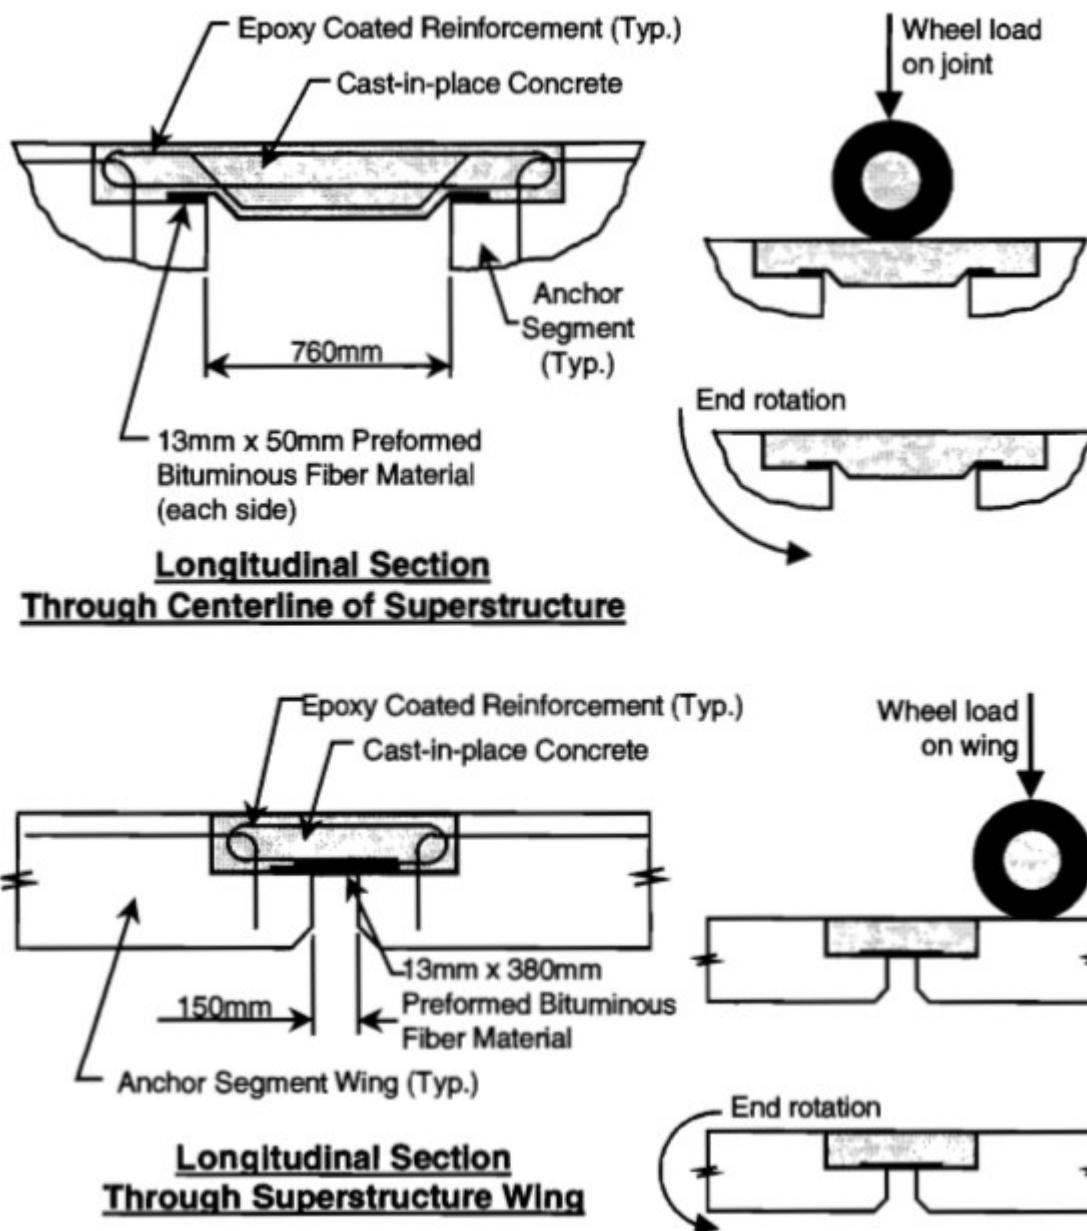
Figure 2.18. Link slab sections, reprinted from Davis et al. (1999).

In addition to wheel loading, the joint slab was designed to withstand tensile, compressive, and bending forces caused by temperature changes. Another load effect that TxDOT engineers wished to avoid was a moment couple caused by tension in the deck and compression at the bearing supports. Bituminous pads were placed across the gap between members at the wings of the section to decrease the bending stiffness of the slab. To ensure that the girders would be able to displace longitudinally from load carried through the poor boy slab detail, low-stiffness elastomeric bearing pads that respond to the longitudinal stress by deforming in shear were installed (see Figure 2.18).

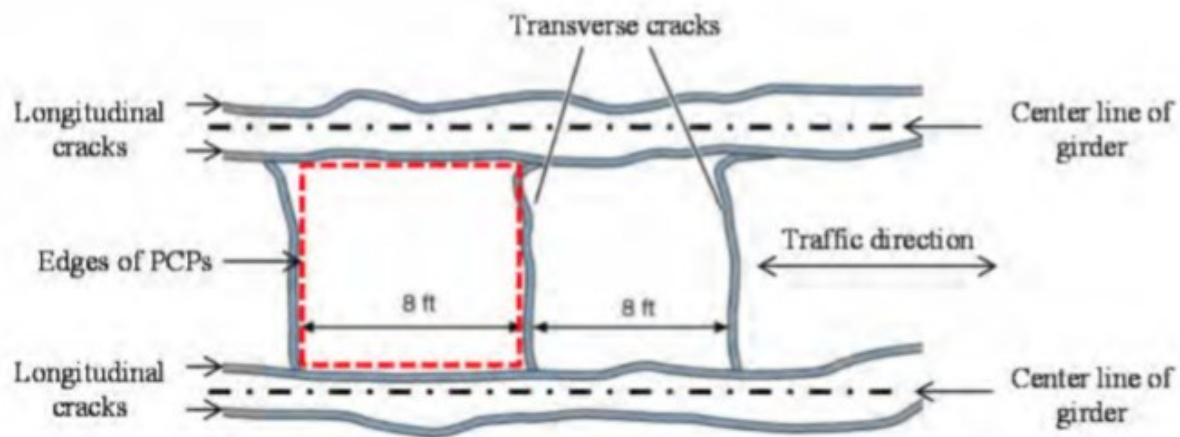
**Figure 2.20. Crack pattern for CIP-PCP bridge deck, reprinted from Folliard et al. (2003).**

The current Texas poor boy detail retains much of the simplicity of older designs. The deck is not debonded from the girders, and no closure pour is provided between the beam ends. With the widespread use of PCPs in Texas bridge construction, researchers have investigated the behavior of such systems in the region of the poor boy joint. Bayrak et al. (2013) investigated the optimization of reinforcement and cracking behavior of bridge decks composed of PCPs and CIP concrete, including those with poor boy continuity. The goals of the project included determining whether a reduced amount of top-mat reinforcement in the CIP slabs was acceptable and managing cracking in the PCPs in order to reduce the cost of damaged materials. Joints between panels and interfaces between PCPs and CIP concrete over supports are vulnerable to cracking due to shrinkage and creep (see Figure 2.20).

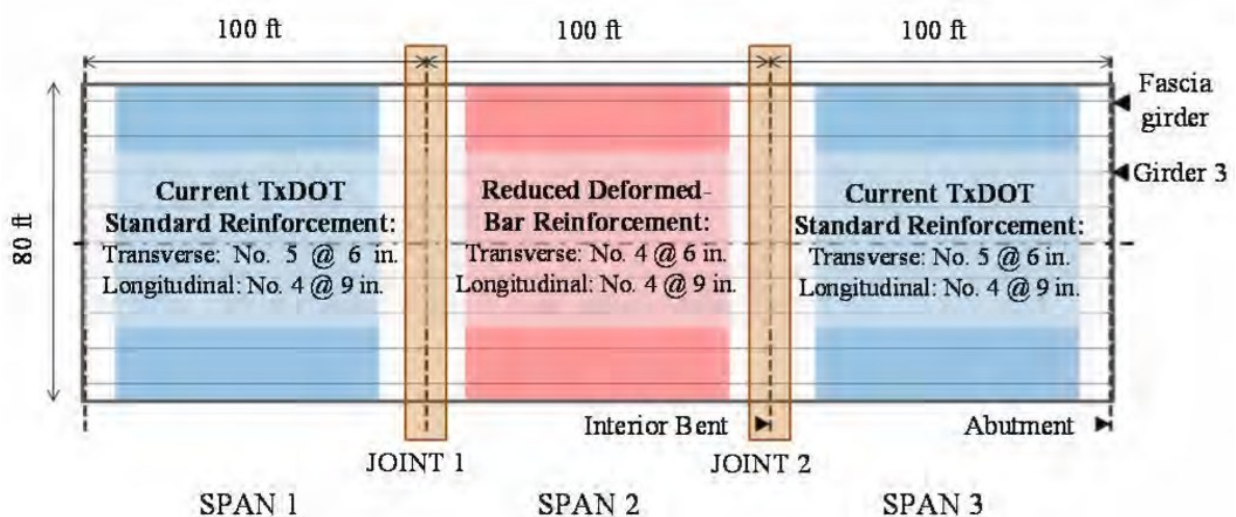
**Figure 2.21. Deck reinforcement scheme on Wharton-Weems Overpass, reprinted from Bayrak et al. (2013).**

Researchers instrumented poor boy details with gages during construction of two bridge structures with 8-in. deep decks in order to record crack widths. The first structure was the newly constructed Wharton-Weems Overpass, a three-span bridge at the crossing of Choate Road and Shoreacres Boulevard in Houston, Texas. Two exterior spans included standard TxDOT reinforcement, while the third span was designed with reduced transverse reinforcement, #4 bars at 6 in. One of the two poor boy details contained standard reinforcement, while the other contained the reduced reinforcement (see Figure 2.21).

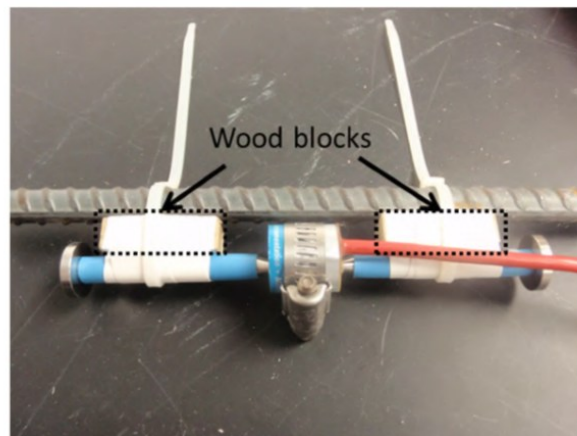
**Figure 2.22. Vibrating wire strain gage installation on rebar, reprinted from Bayrak et al. (2013).**

The top-mat reinforcement was instrumented with 16 vibrating wire (VW) strain gages (see Figure 2.22 and Figure 2.23). The gages transmitted data every 30 minutes. The deck was cast in nine hours using concrete with a compressive strength of 4000 psi. Crack formers, known as zip strips, were placed at the poor boy details (see Figure 2.24).

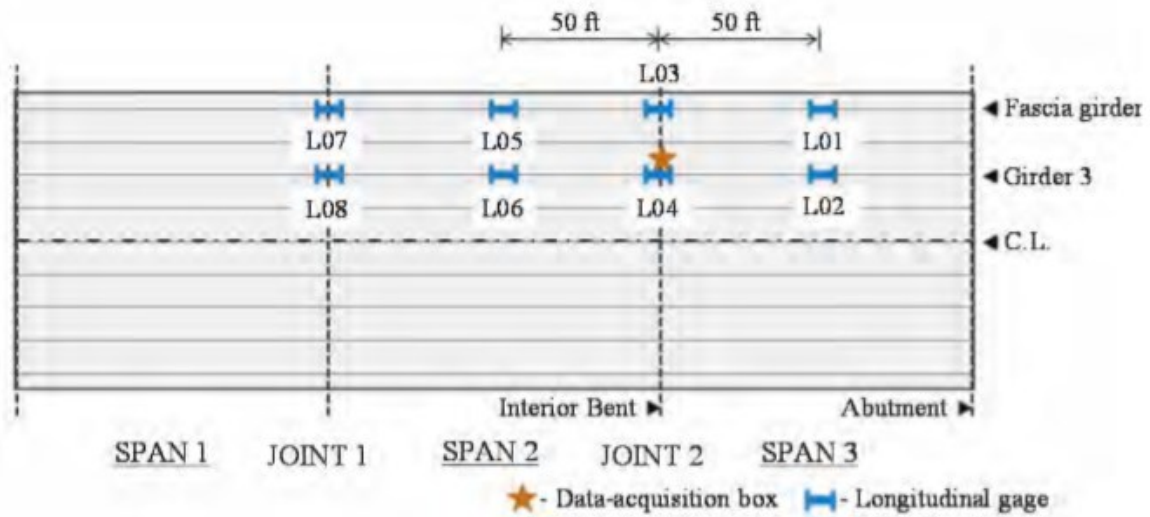
Figure 2.23. Longitudinal bar VW gage layout for the Wharton-Weems Overpass, reprinted from Bayrak et al. (2013).

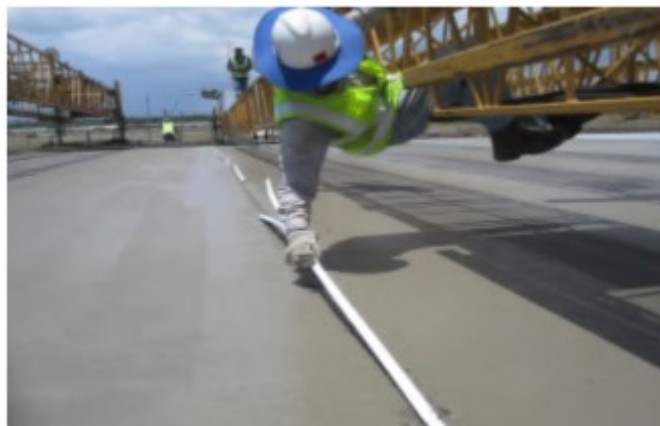
Figure 2.24. Installation of zip strip crack former, reprinted from Bayrak et al. (2013).

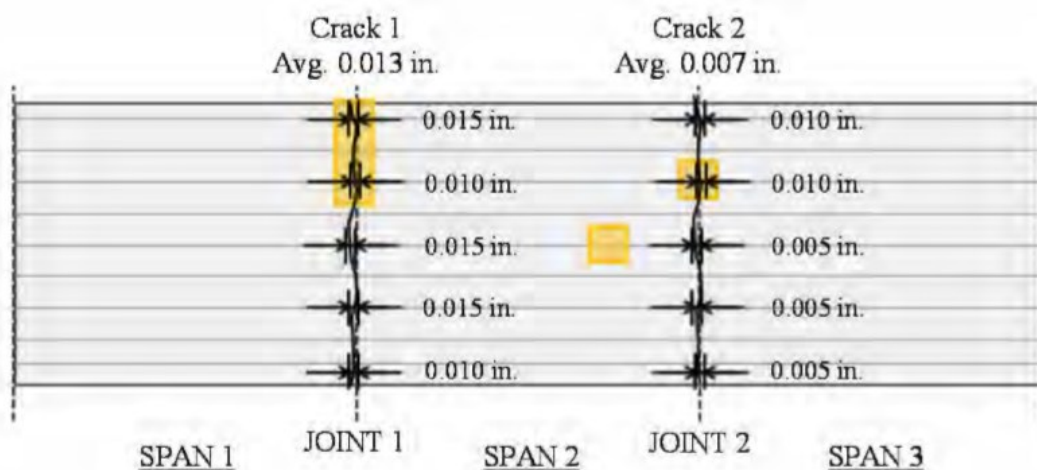
Figure 2.25. Crack widths found in the first inspection of the Wharton-Weems Overpass, reprinted from Bayrak et al. (2013).

Prior to the application of traffic loads, crack widths were measured two times—once prior to the installation of roadway barriers and once after barrier installation. The transverse cracks at the poor boy slab details in the first inspection measured, on average, 0.013 in. and 0.007 in. wide. These measurements were taken across the entire slab width (see Figure 2.25). The second inspection only considered the half-width of the span that had been instrumented (see Figure 2.26). The average crack width over both bents was found to be 0.010 in. Other transverse cracks were also recorded at PCP joints. The cracking behavior harmonized with a theoretical cracking prediction that used the VW strain gage data to estimate concrete stress. The inspections included applying water on the concrete surface, which reveals cracks after the surface water evaporates.
