# Performance and Improvement of Texas Poor Boy Continuous Bridge Deck Details: Final Report

Technical Report 0-7013-R1

TEXAS A&M TRANSPORTATION INSTITUTE  
COLLEGE STATION, TEXAS

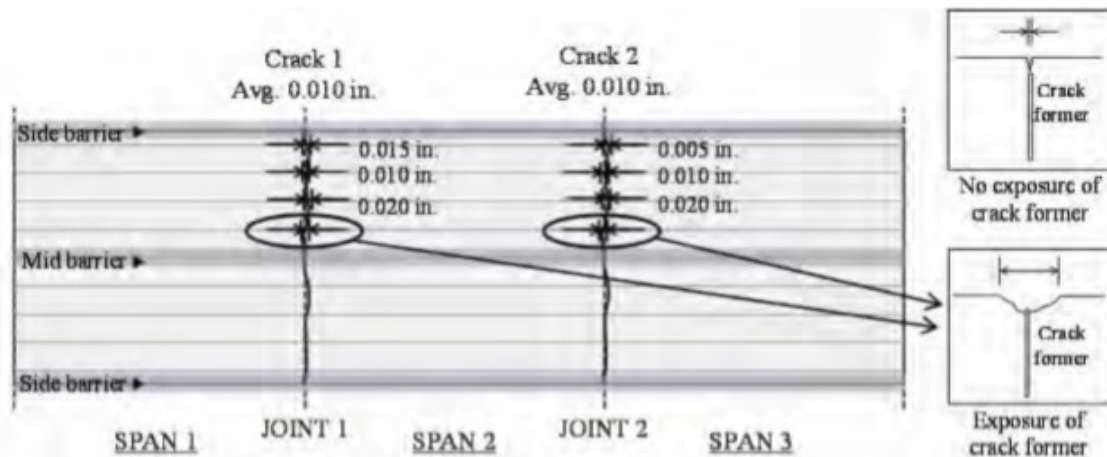
**Figure 2.26. Crack widths found in the second inspection of the Wharton-Weems Overpass, reprinted from Bayrak et al. (2013).**

Prior to the application of traffic loads, crack widths were measured two times—once prior to the installation of roadway barriers and once after barrier installation. The transverse cracks at the poor boy slab details in the first inspection measured, on average, 0.013 in. and 0.007 in. wide. These measurements were taken across the entire slab width (see Figure 2.25). The second inspection only considered the half-width of the span that had been instrumented (see Figure 2.26). The average crack width over both bents was found to be 0.010 in. Other transverse cracks were also recorded at PCP joints. The cracking behavior harmonized with a theoretical cracking prediction that used the VW strain gage data to estimate concrete stress. The inspections included applying water on the concrete surface, which reveals cracks after the surface water evaporates.

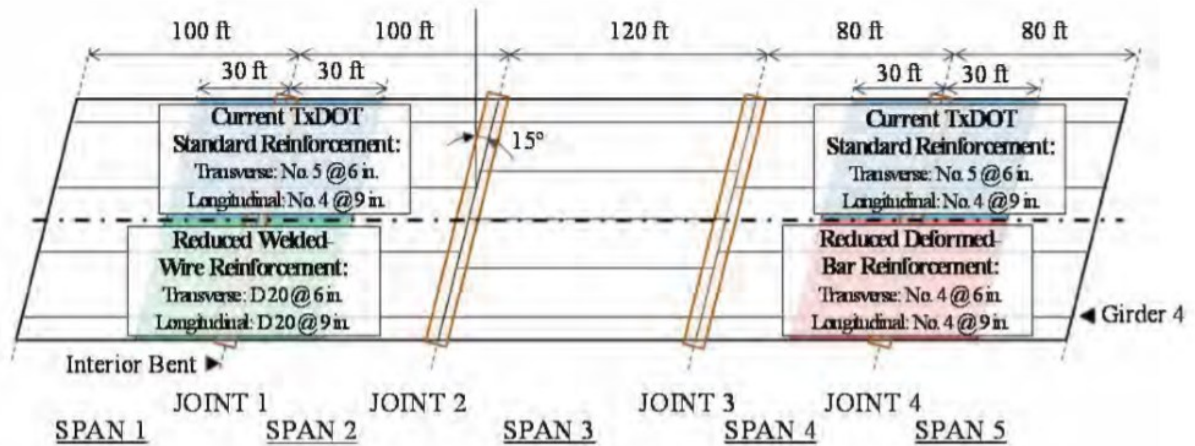
Figure 2.27. Deck reinforcement scheme on Lampasas River Bridge, reprinted from Bayrak et al. (2013).

The second bridge structure was the Lampasas River Bridge on the south frontage road of IH 35 near Belton, Texas. The structure has five spans with varying span lengths and numbers of girders. Like the Wharton-Weems Overpass, the structure utilizes prestressed concrete girders and a PCP with CIP topping deck. The poor boy details connecting Spans 1 to 2 and 4 to 5 were instrumented. Reinforcement included the standard and reduced rebar variations used in the Wharton-Weems Overpass and an additional region with welded-wire reinforcement (see Figure 2.27 and Figure 2.28). The structure was also instrumented with VW strain gages as before (see Figure 2.29). The average crack width at 75 days after pouring of the slab in Joint 4, the location of a poor boy detail, was 0.008 in. Long-term crack development followed a similar pattern to that of the Wharton-Weems Overpass.

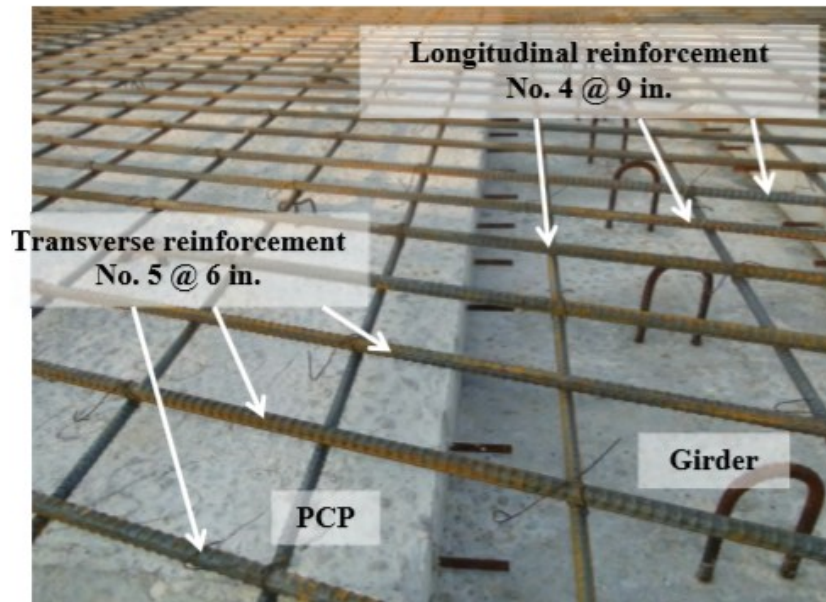
Figure 2.28. Deck reinforcement placement on Lampasas River Bridge, reprinted from Bayrak et al. (2013).

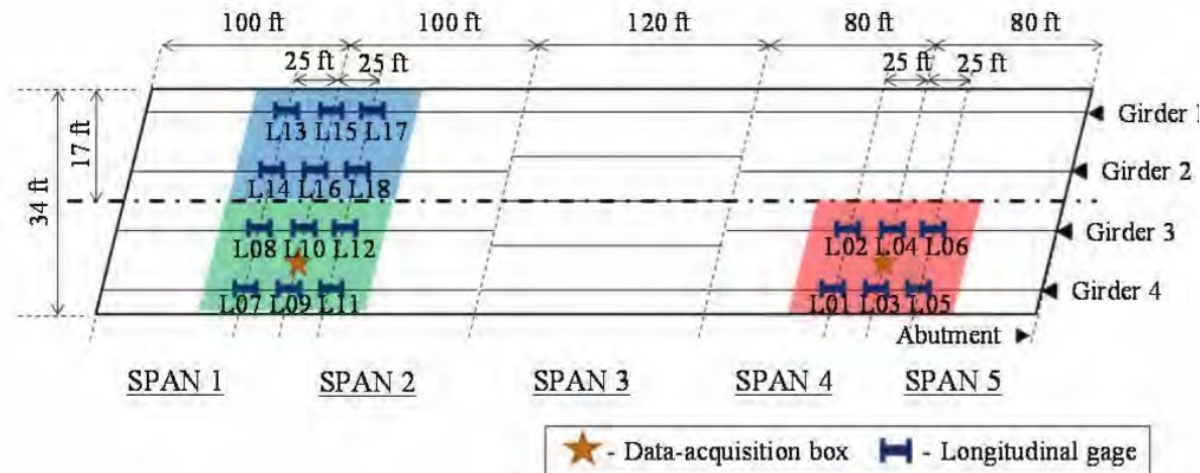
**Figure 2.29. Longitudinal bar VW gage layout for the Lampasas River Bridge, reprinted from Bayrak et al. (2013).**

Results of the cracking study determined that standard longitudinal reinforcement successfully kept crack widths low over the supports but that the reinforcement nearly reached its yield strain. Therefore, the longitudinal reinforcement should not be reduced in the poor boy details. However, the stress in transverse reinforcement remained well below yield despite the reduced bar area of the alternative reinforcement pattern, indicating that a reduction in transverse reinforcement was appropriate. Researchers concluded that using the reduced rebar layout could reduce material costs by 25 percent, while the welded-wire reinforcement layout could reduce material cost by 5 percent with additional savings in labor.

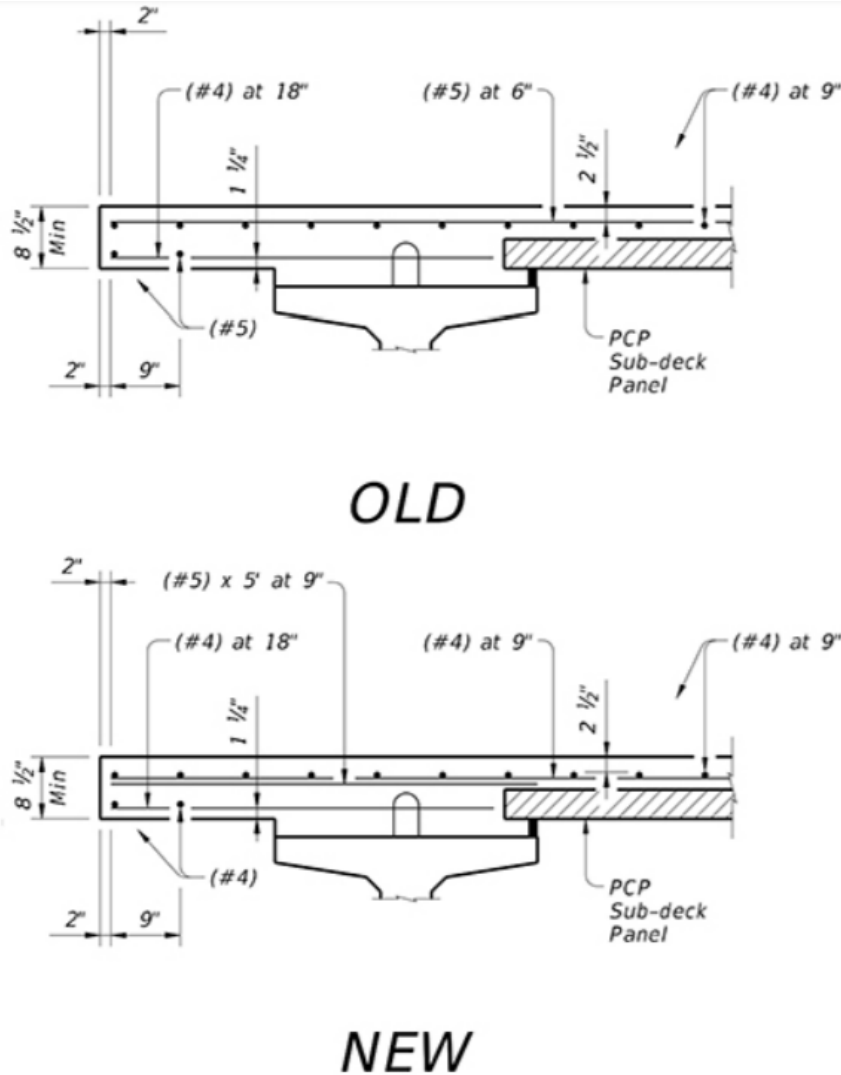
**Figure 2.30. Old and new deck reinforcement detail with precast panels, reprinted from Holt and Smith (2014).**

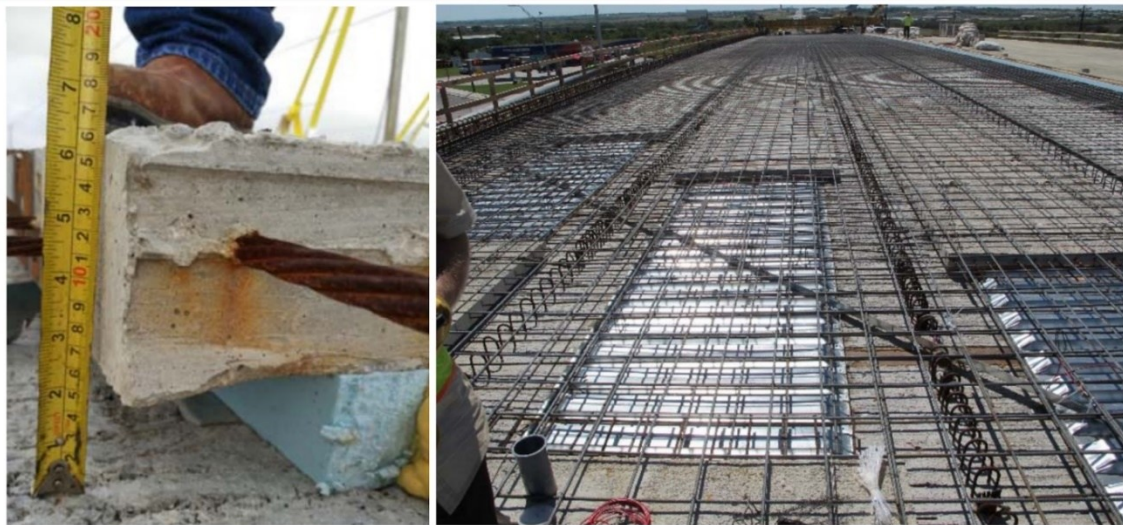
**Figure 2.31. Precast panel size and placement, reprinted from Munsterman (2017).**

PCPs are reinforced with prestressing strands in the bridge's transverse direction and with mild steel parallel to traffic. They are placed on the girders with an amendable foam bedding strip in between, typically filling gaps of around 0.5 in. to 4 in., which ensures an even placement on the structure (see Figure 2.31). PMDFs are often used in places on the structure not covered by PCPs, such as near the supports in skewed bridges. In the past, a fully CIP deck over plywood forms was another option used near expansion joints. Current details allow PCPs to be placed

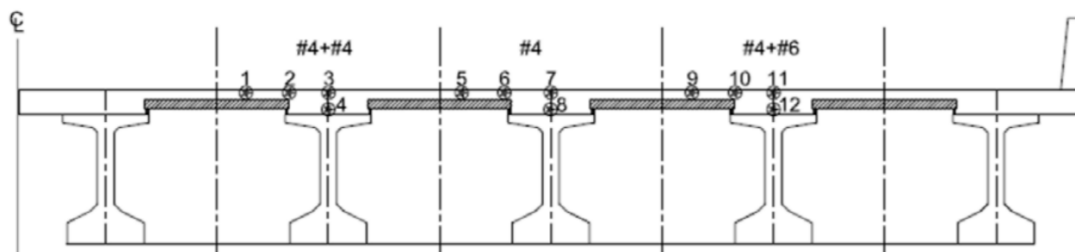
**Figure 2.32. Gage placement diagram, reprinted from Munsterman (2017).**

TxDOT deck reinforcement, consisting of #4 bars at 9 in. in both the longitudinal and transverse directions, was instrumented over a bent to provide a comparison to alternate reinforcement details. Two alternative reinforcement schemes were installed by tying additional bars to the standard reinforcement. The length of added bars was calculated using development length of a #6 bar. Gages were placed on top-mat reinforcement over the bent with an additional gage placed over the girder in order to define the deck's strain profile, as shown in Figure 2.32. The VW gages were attached to bars with zip ties, with additional instruments attached to the gage with clamps (see Figure 2.33).

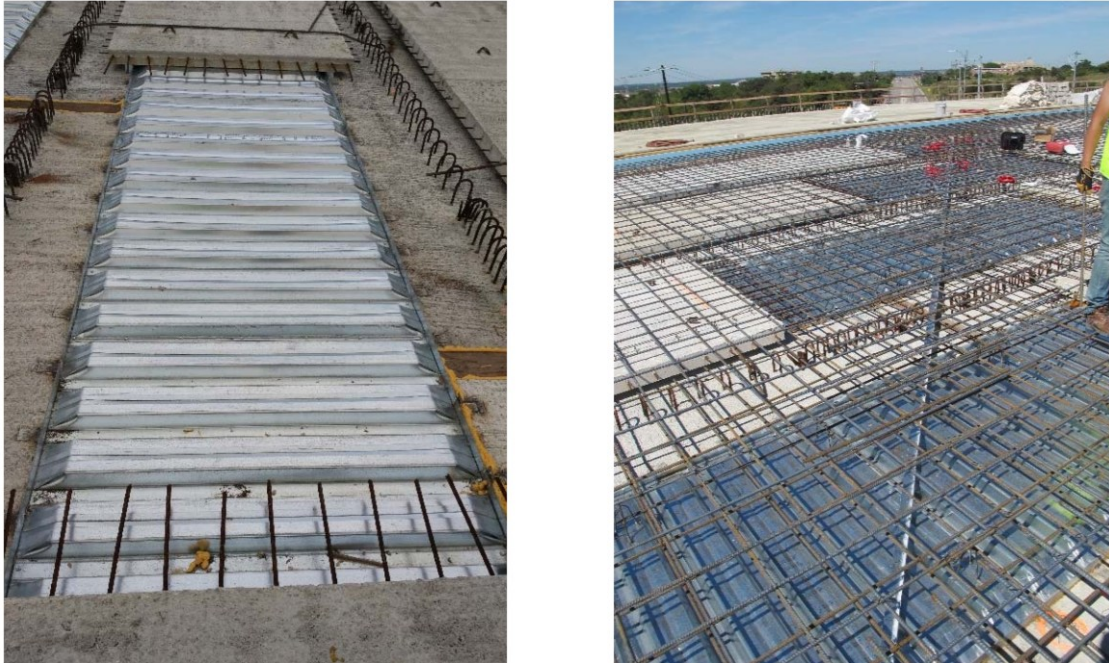
**Figure 2.34. PMDF construction due to skew at supports, reprinted from Munsterman (2017).**

The first bridge, located in San Marcos, Texas, on SH 123, was a three-span structure. Three interior girders on one bent on the east span of the bridge were instrumented. The bridge was heavily skewed, leading to the use of PMDF over the bents where PCPs were not continuous (see Figure 2.34).

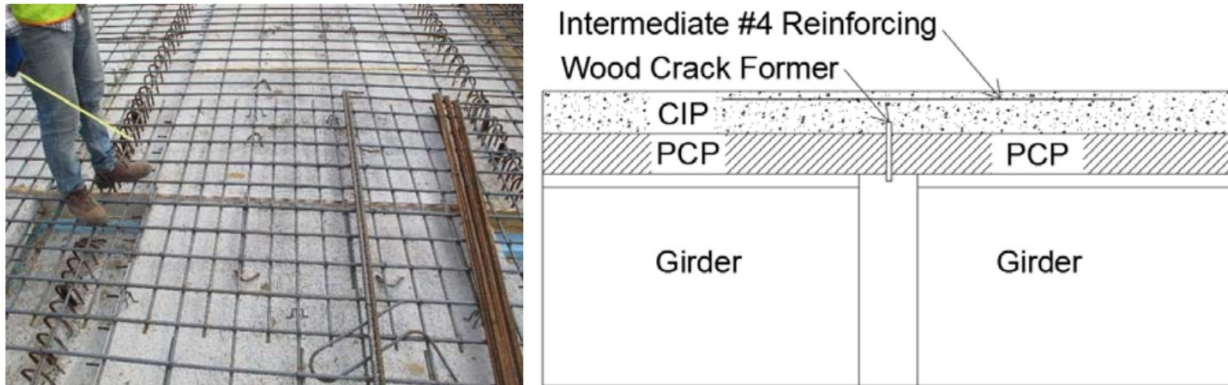
**Figure 2.35. Added reinforcement over supports and crack-forming detail, reprinted from Munsterman (2017).**

A second structure, in Bastrop, Texas, consisted of a highway entrance ramp onto SH 71 with four girder lines and five total spans. The top-mat deck reinforcement consisted of #4 bars at 6 in. in the transverse direction above #4 bars at 9 in. in the longitudinal direction. The span chosen for instrumentation included a thicker, fully CIP deck section over one exterior girder. The difference in construction was considered negligible, and the three interior girders with a PCP formed deck were instrumented. The deck included standard steel reinforcement at one girder line, with 5-ft lengths of #4 bars included in the longitudinal direction, spaced at 4.5 in. in the gaps between existing bars at the second girder line. The gap reinforcement was added in the third girder line, along with #4 longitudinal bars attached to the standard reinforcing bars (see Figure 2.35).

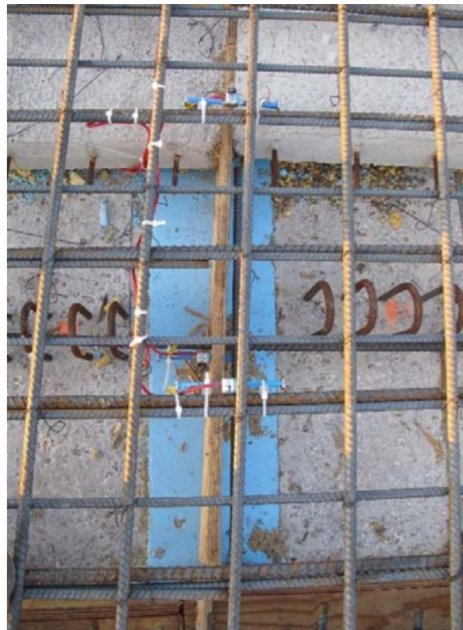
**Figure 2.36. Construction of crack-forming wood detail, reprinted from Munsterman (2017).**

The crack-forming mechanism in this structure consisted of a  $\frac{3}{4}$ -in. wooden board, affixed in the gap between abutting PCPs over the bent (see Figure 2.36). Gages were installed above the crack former. The deck was cast and live load tests were conducted in a similar manner to the structure in San Marcos.

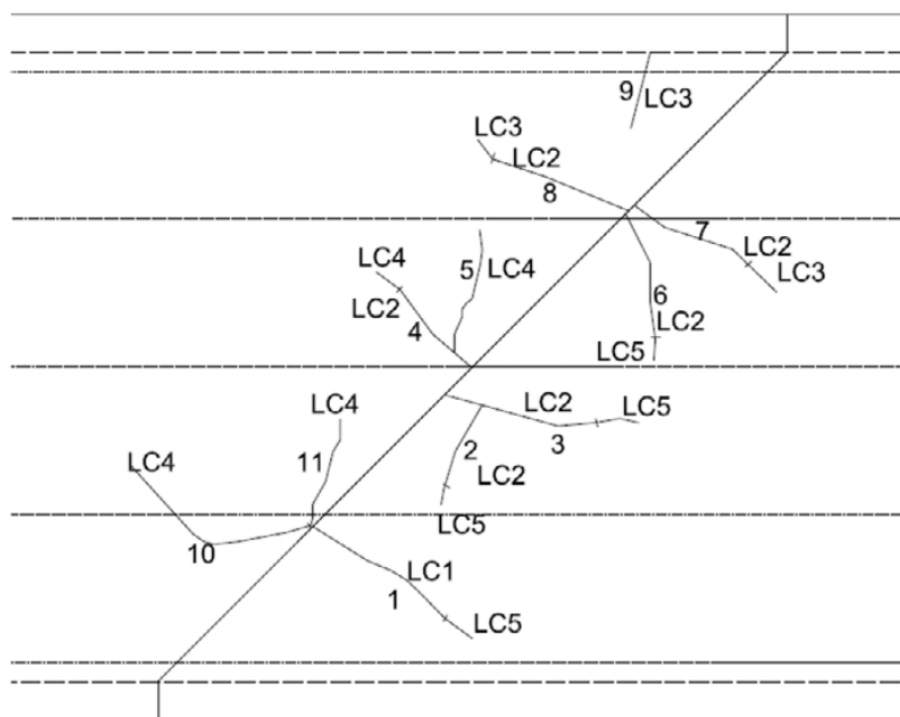
During live load testing, initial cracking was found to propagate from the location of zip strips in the poor boy joint (see Figure 2.37). The researchers theorized that the high skew of the bridge triggered such a cracking pattern. Crack widths were small enough that attempts to determine their size with a crack gage were unsuccessful, and the cracks closed after the trucks left the structure. Live load tests showed that increasing steel area led to a decrease in strain at the gage locations, with the addition of the #4 and #6 bars leading to 18.6 percent and 50.3 percent reductions, respectively. Compression strains were recorded in the lower gages, demonstrating flexural forces in the poor boy slab.

**Figure 2.37. Crack propagation from crack former, reprinted from Munsterman (2017).**

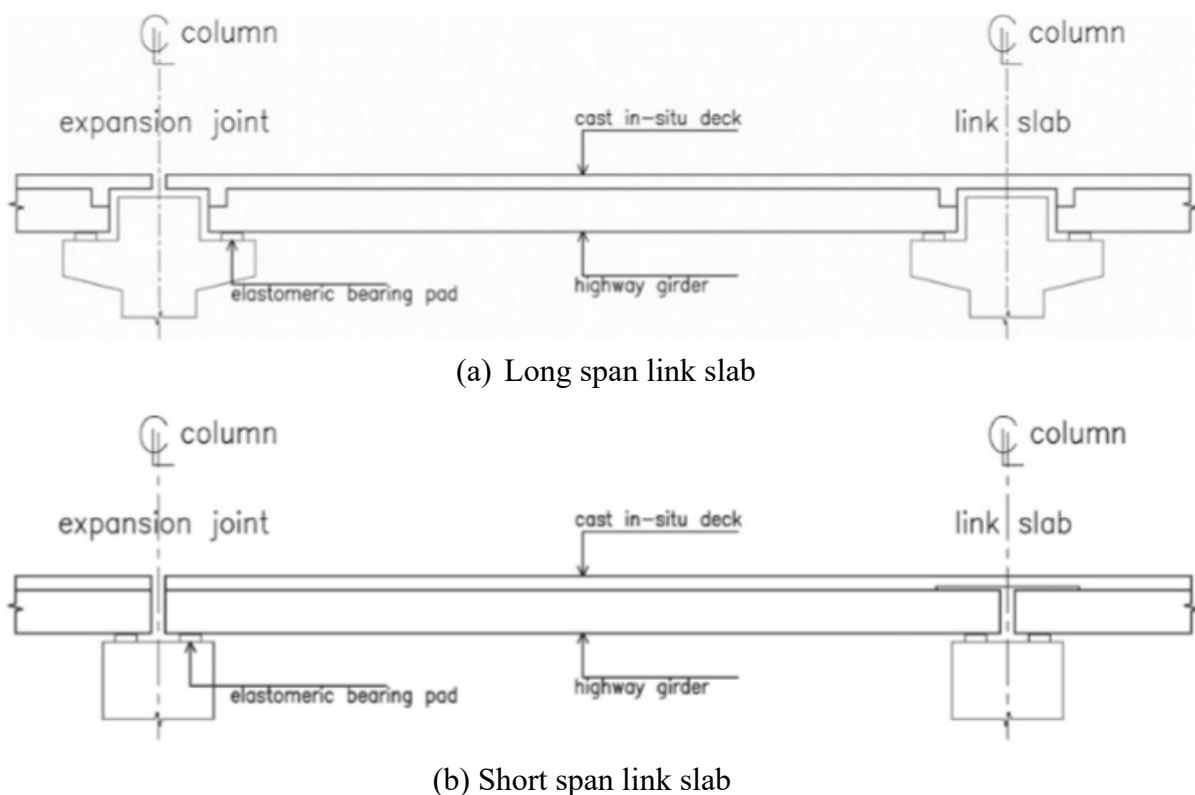
Charuchaimontri et al. (2008) used finite element models to investigate the effect of different lap reinforcement details within link slabs, with the results verified by three full-scale tests of link slabs. The researchers categorized their link slabs as either long span or short span (see Figure 2.38). While long-span link slabs have enough length to facilitate low flexural stiffness without debonding, short-span link slabs are often debonded from girders to reduce flexural stiffness. Researchers aimed to develop a model for long-span link slabs that takes the nonlinear behavior due to distributed cracking into account, rather than using elastic beam theory and considering a cracked section at midspan. An effective moment of inertia, cracking behavior, and failure mode were predicted. Researchers analyzed long-span link slabs for axial deformations, translation and rotation of the ends of the link slab, and direct loading. Three full-scale, long-span link slab specimens were tested to evaluate the performance of three corresponding reinforcement details under midspan loading (see Figure 2.39).

**Figure 2.38. Short- and long-span link slabs, reprinted from Charuchaimontri et al. (2008).**

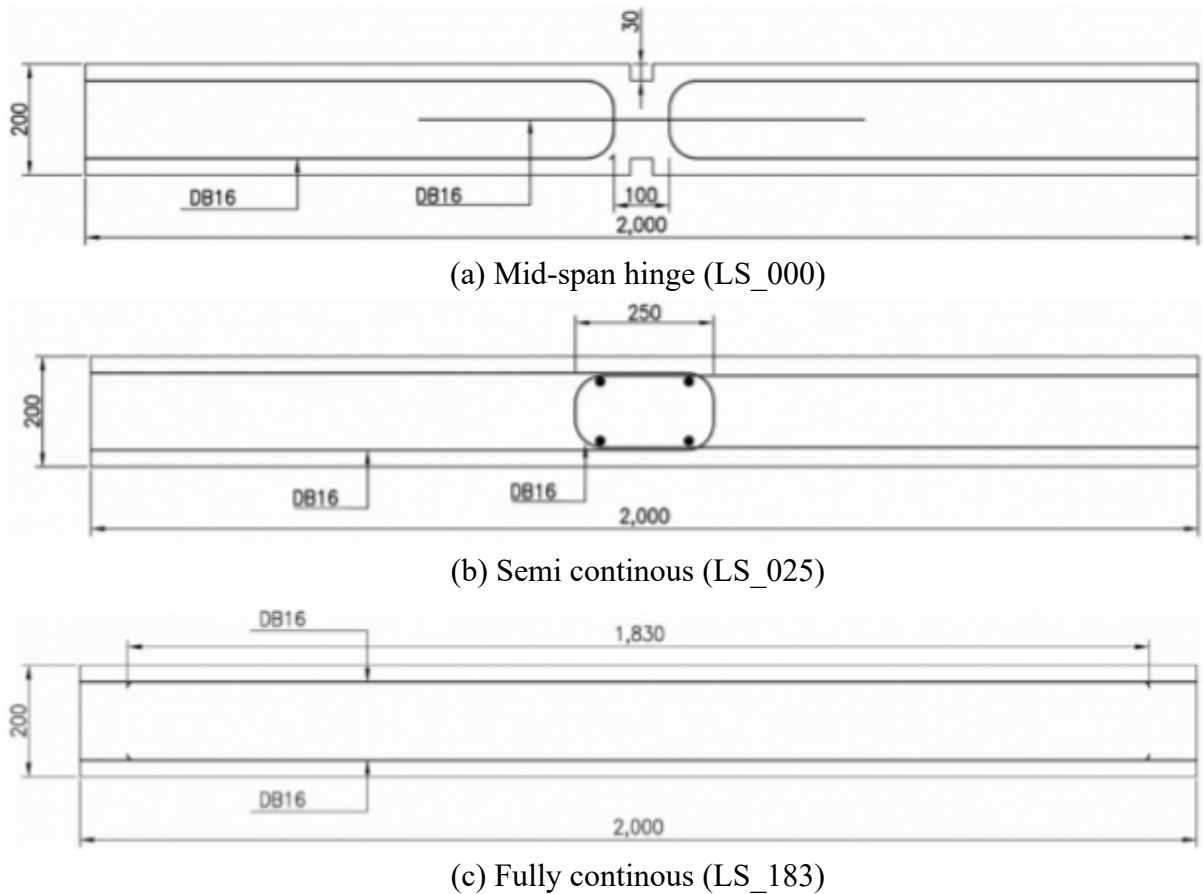
**Figure 2.39. Tested reinforcement details, reprinted from Charuchaimontri et al. (2008).**

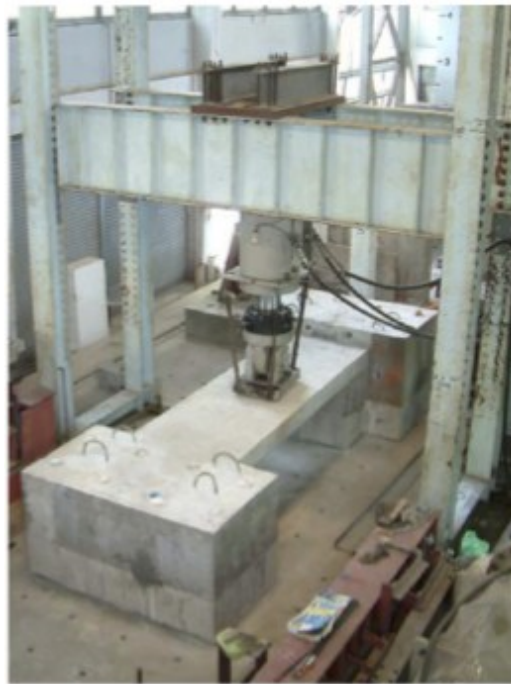
The midspan case was physically modeled and tested to confirm the FEA results. Three specimens (Figure 2.40), 200 mm (7.87 in.) thick by 2,000 mm (78.74 in.) long by 1,000 mm (39.37 in.) wide, were loaded by an actuator and steel loading plate that simulated an AASHTO wheel load. The slab was instrumented, top and bottom, with strain gages, while LVDTs were added to gather out-of-plane displacement. After repeated loading to service levels, followed by

**Figure 2.40. Test setup, reprinted from Charuchaimontri et al. (2008).**

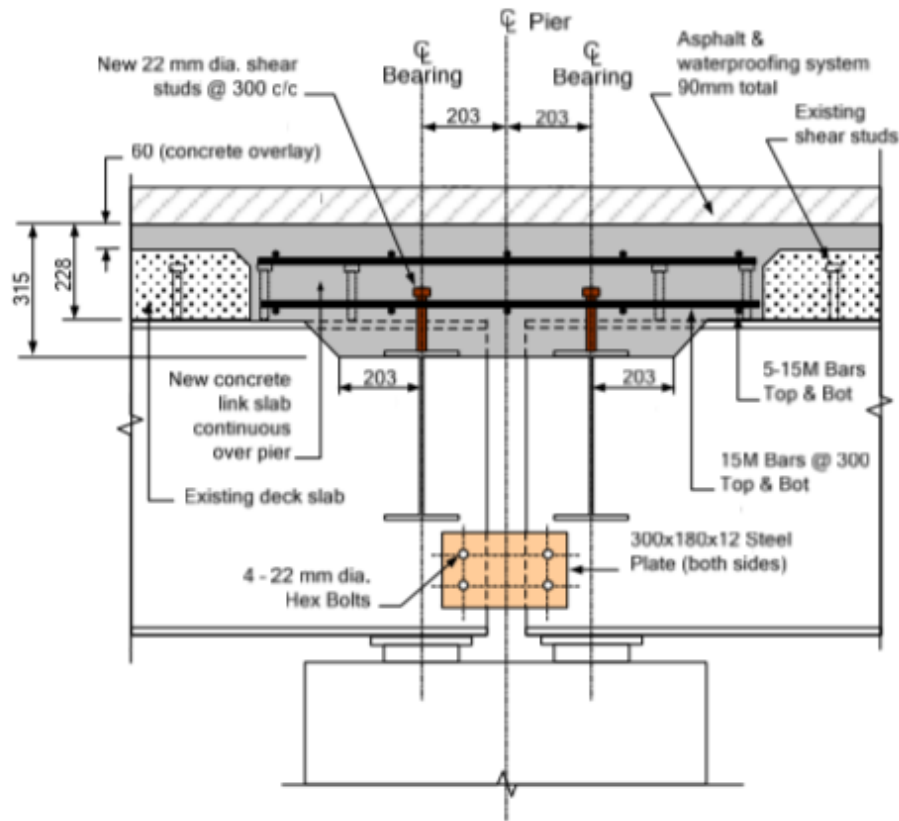
Lam et al. (2008) detailed the efforts of the Ministry of Transportation of Ontario (MTO) to retrofit simply supported, multi-span bridges with joints by the addition of link slabs to form a continuous deck over simply supported girders. The Trent Canal Bridge is a four-span structure that was rehabilitated in 1995 with 1.2-m (3.9-ft) wide haunched link slabs (see Figure 2.41). The haunched deck was 315 mm (12.4 in.) deep, beneath a topping pout 60 mm (2.36 in.) thick. The link slab was reinforced top and bottom with steel layers and connected to diaphragms with shear studs. After 13 years, the structure was in good condition, showing no issues.

**Figure 2.41. Trent Canal Bridge link slab detail, reprinted from Lam et al. (2008).**

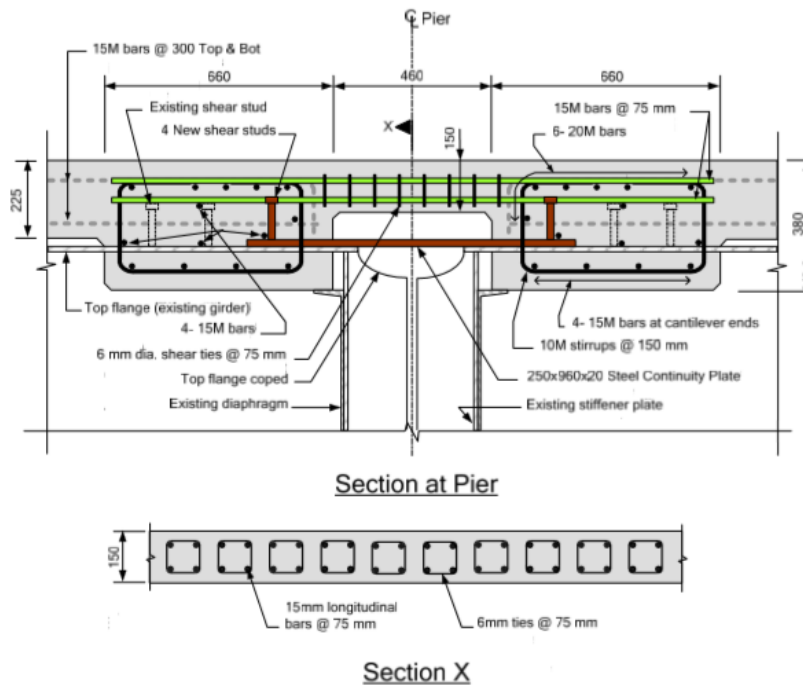
A flexible link slab design was implemented in 1987 on a bridge on the Gardiner Expressway (see Figure 2.42). The system consisted of a slender slab bridging between beam haunches, which were poured above the beam end diaphragms. The beams were not made continuous. This design became popular on multiple other bridges. The goal of the thick-thin design was to restrict flexure and corresponding cracking in the slender link slab. The top flanges of the connecting beams were also coped at their end regions to facilitate rotation. The link slab was covered with a rubber coating to prevent chemical infiltration. It was reinforced with mats top and bottom of 15M bars, spaced longitudinal at 75 mm (2.95 in.) and transversely at 150 mm (5.9 in.), and 6-mm (0.24-in) diameter shear ties were added at 75-mm (2.95-in.) spacing.

**Figure 2.42. HwY 401 Underpass link slab detail, reprinted from Lam et al. (2008).**

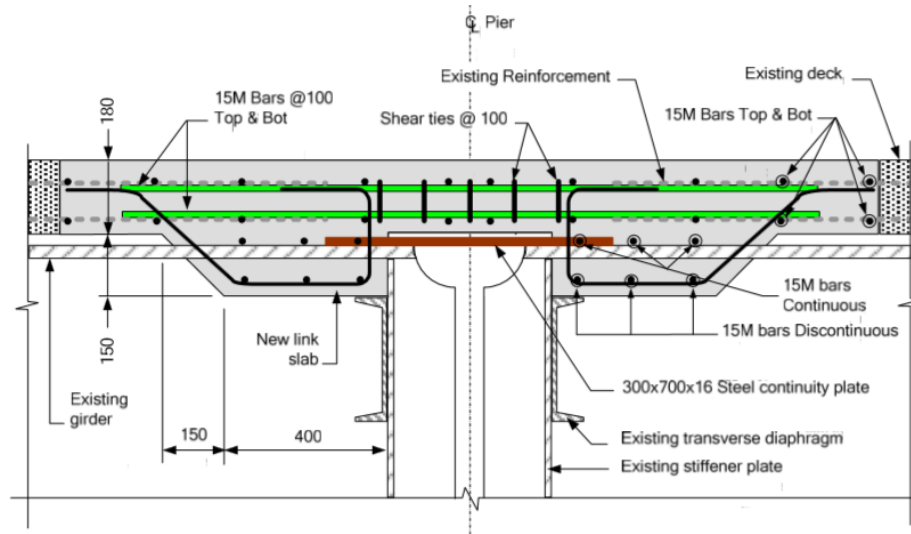
These design suggestions were applied to the Dixon Road Overpass, another four-span bridge with 12 steel girders spaced at 2.1 m (6.9 ft). Link slabs with the suggested dimensions and reinforcement, with the addition of shear reinforcement, were added as part of a widening project (see Figure 2.43). Upon later inspection, the link slabs were performing well, but water infiltration was still an issue at the barriers.

**Figure 2.43. Dixon Road Overpass link slab detail, reprinted from Lam et al. (2008).**

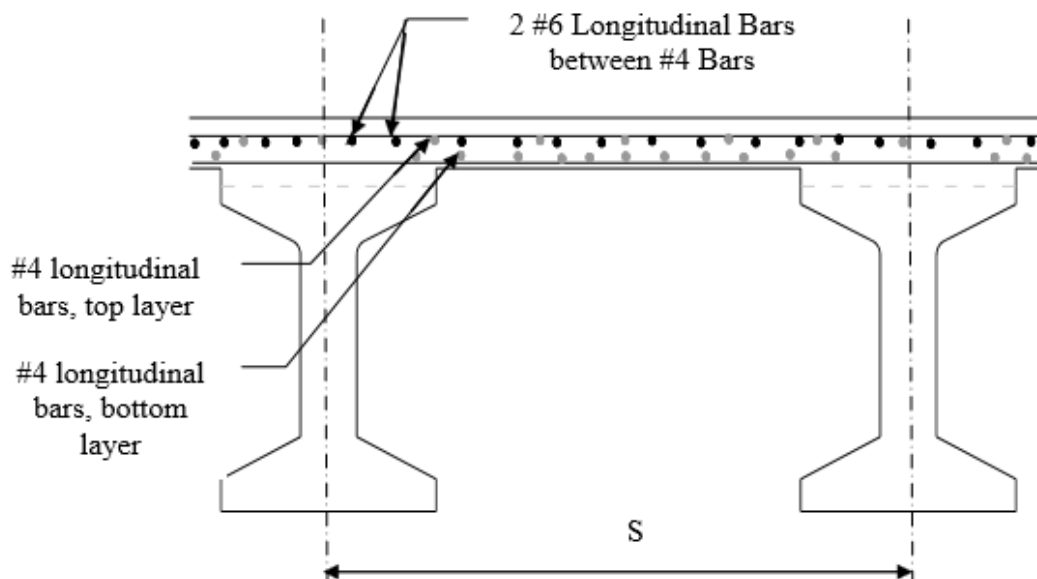
Snedeker et al. (2011) performed an evaluation of the bonded continuous deck detail used by the Georgia Department of Transportation (GDOT). At the time, the detail used a construction joint in the center of the link slab, with the normal deck reinforcement terminated on either side of the joint and additional #6 bars placed continuously across the joint between the normal reinforcement (see Figure 2.44). The surface of the slab at the construction joint features a filleted groove, sealed to prevent moisture infiltration (see Figure 2.45).

**Figure 2.44. Reinforcement placement at continuous deck detail, reprinted from Snedeker et al. (2011).**

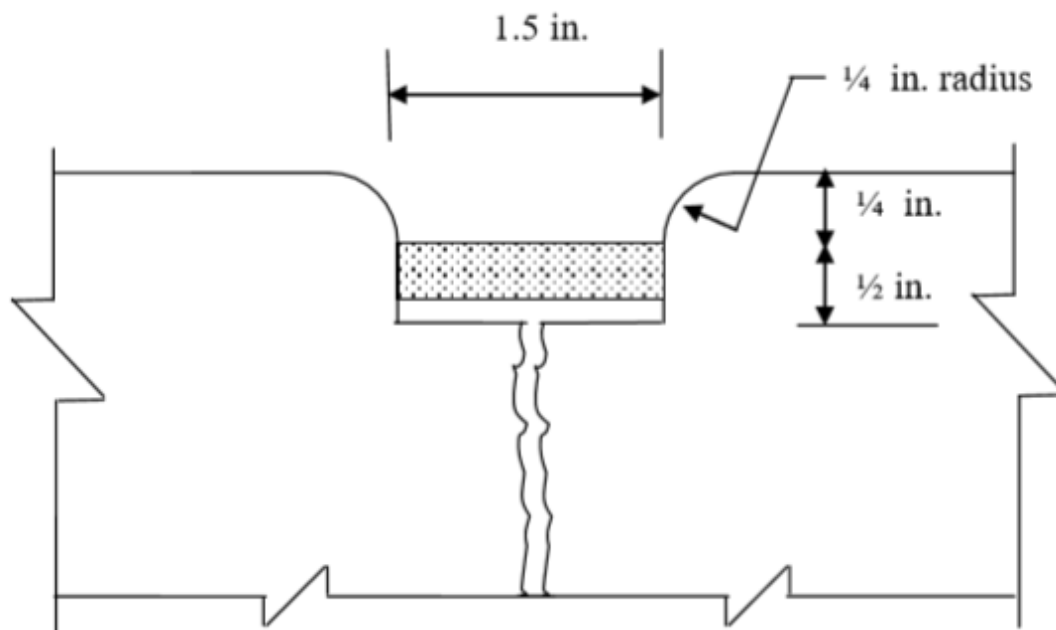
**Figure 2.45. Surface detail at construction joint, reprinted from Snedeker et al. (2011).**

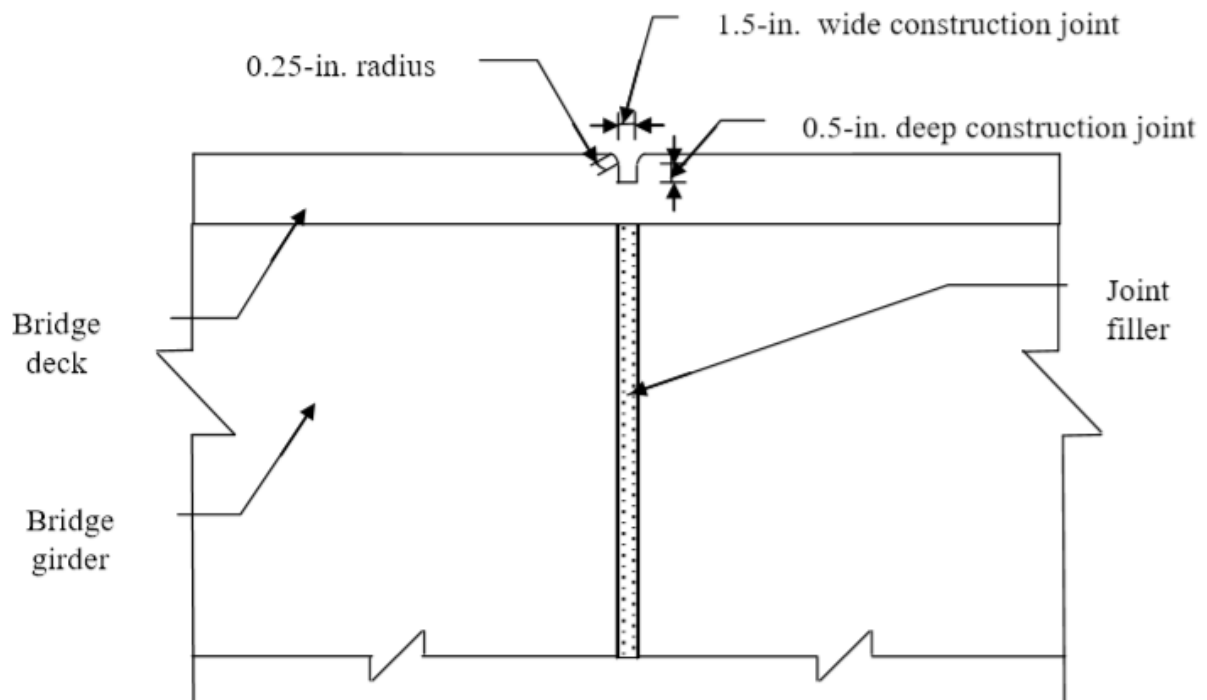
Saw cutting or otherwise forming the crack-control joint after pouring the deck allows for a much faster continuous concrete pour. A saw-cut control joint is not included in specifications since the joint must be cut in a specific time frame between concrete set and the onset of shrinkage cracking. The construction joint is required to have 0.25-in. radius fillet edges to prevent spalling. The detail, including the nonstructural joint filler placed between the girder ends, is shown in Figure 2.46.

**Figure 2.46. Construction joint and girder joint filler, reprinted from Snedeker et al. (2011).**

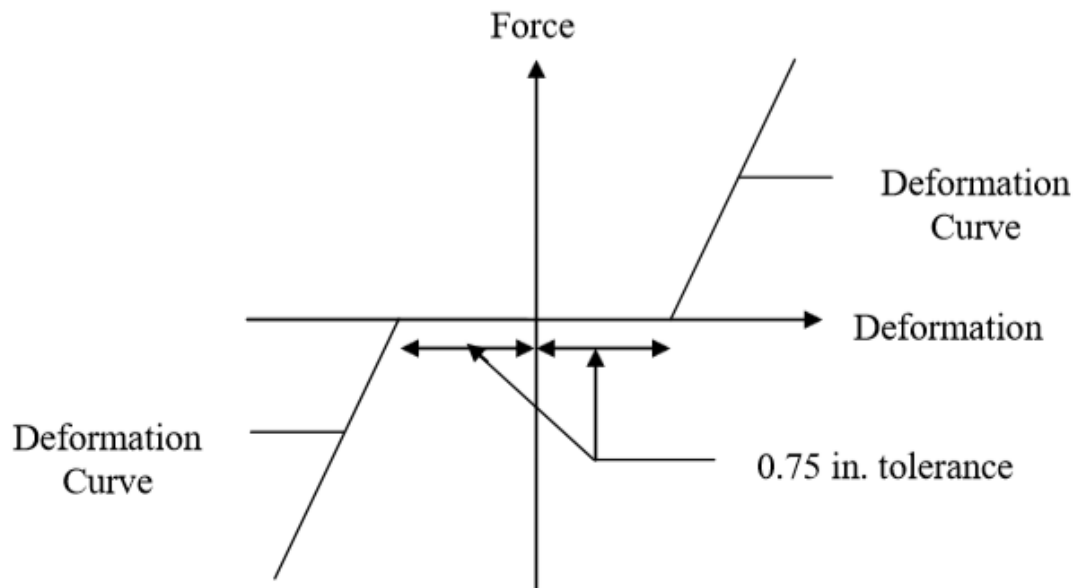
**Figure 2.47. Bearing pad force-deformation behavior, reprinted from Snedeker et al. (2011).**

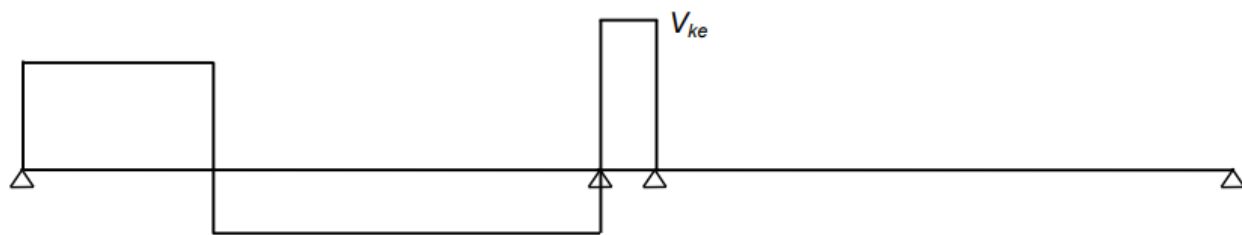
Shear force diagram due to a concentrated load  $P$  applied at distance  $X_F$   
(also representative of the case where the uniform load  $w$  is applied in one span)

**Figure 2.49. Shear force, reprinted from Gergess (2019).**

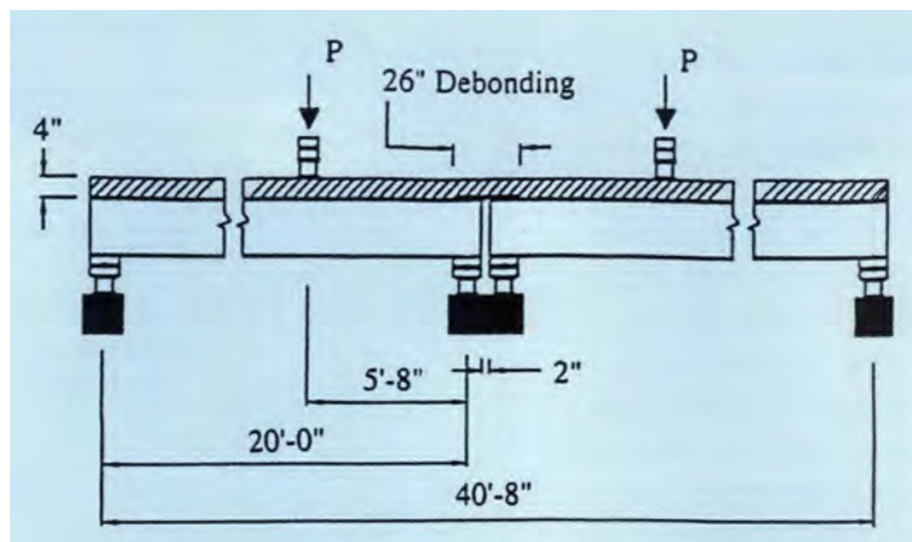
One specimen with concrete girders and another with steel girders were fabricated. Both specimens used two 20.5-ft spans beneath a 4-in. thick composite deck reinforced with three #6 epoxy-coated reinforcing bars oriented longitudinally. Including the gap between spans, the total length of the link slab was 26 in. Figure 2.50 shows the layout of these specimens, including the region of slab debonded from the girders for a length of 5 percent of the girder span on each side of the support.

**Figure 2.50. Elevation view of specimens, reprinted from Caner and Zia (1998).**

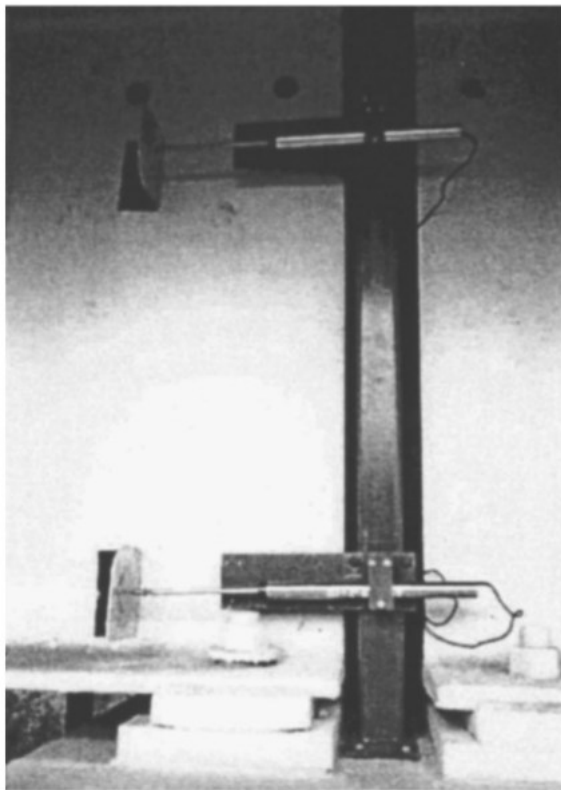
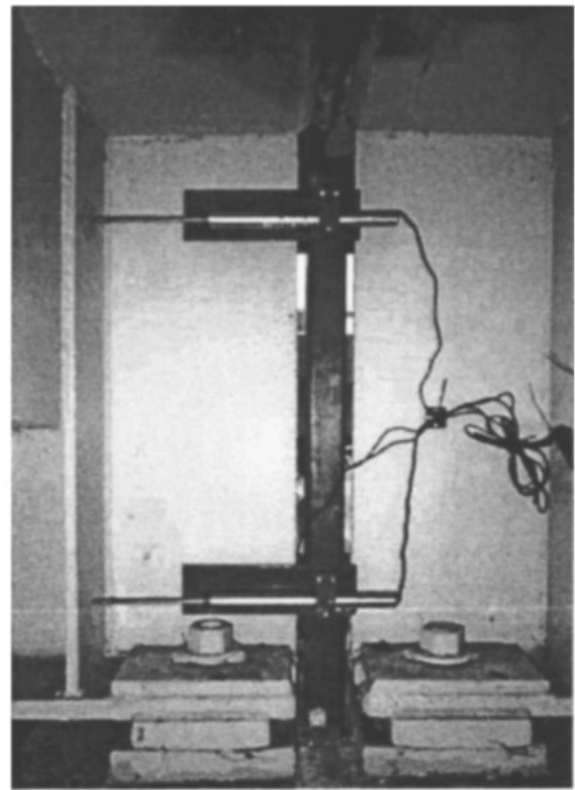
**Exterior stand on girder line 5**

**Interior stand on girder line 4**

**Figure 2.51. LVDT placement at girder ends, reprinted from Wing and Kowalsky (2005).**

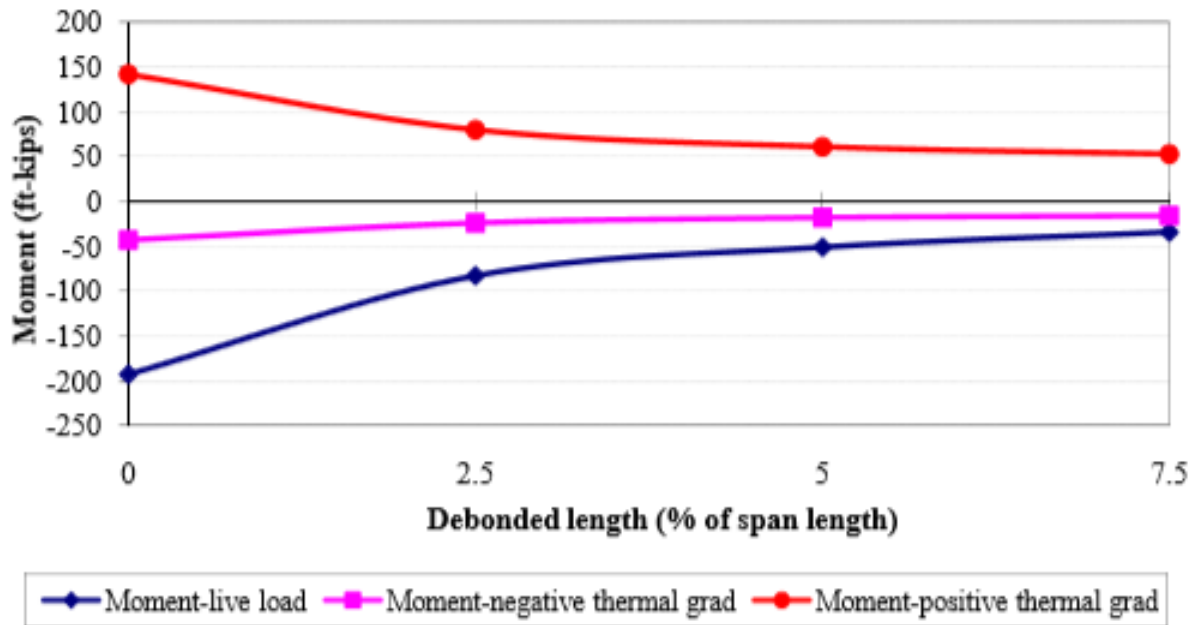
Debonding a length of the link slab effectively reduced link slab moment but led to only a limited reduction after about 5 percent span length debonding (see Figure 2.52). Increased girder depth caused additional axial force in the link slab. Increased girder stiffness, however, reduced the force and moment in the link slab as girder end rotations decreased.

**Figure 2.52. Moment demand for different debonded lengths, reprinted from Aktan et al. (2008).**

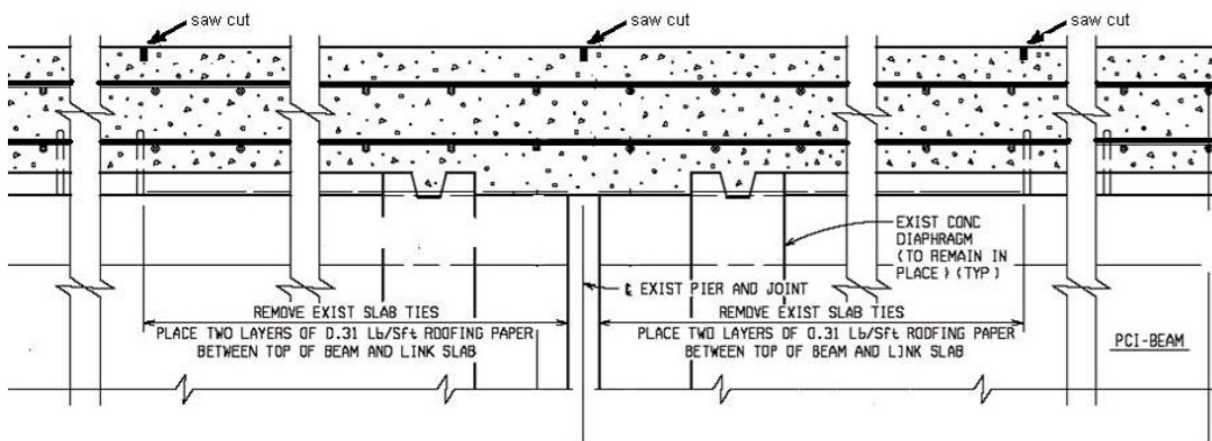
**Figure 2.53. Debonded link slab design, reprinted from Aktan et al. (2008).**

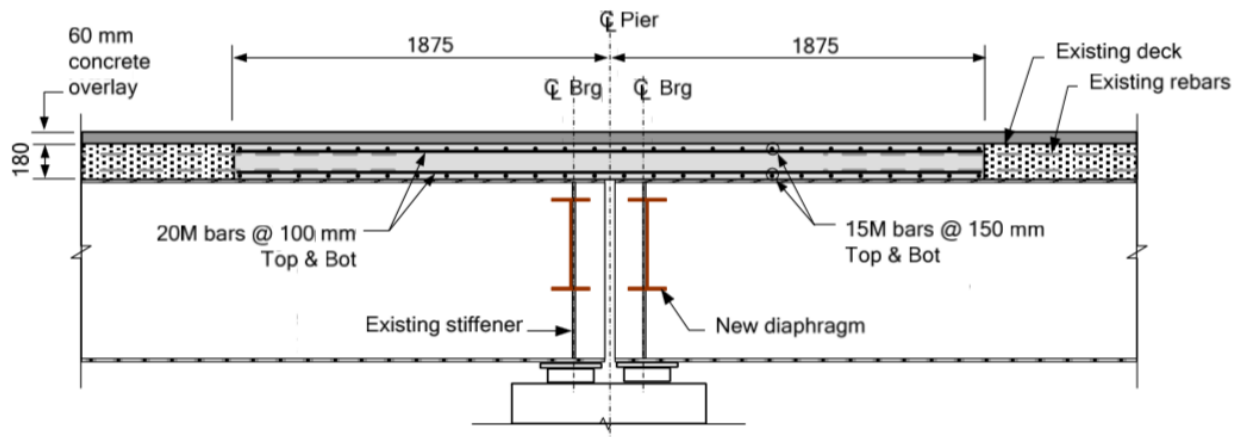
Lam et al. (2008) described the use of a debonded link slab concept in Ontario for situations where a bonded link slab was impractical due to serviceability conditions or bridge geometry. This concept was applied at the Orford Road Underpass, a four-span bridge using steel I-girders and conventional abutments (see Figure 2.54). The slab was retrofitted in 2006 with a 180 mm (7.1 in.) thick debonded link slab, reinforced with 20M longitudinal bars at 100 mm (3.94 in.) and 15M bars in the transverse direction at 150 mm (5.91 in.), in both the top and bottom mat. Bars were spliced into existing bars with straight laps. Rubber membrane reinforcement was laid over the link slab for water protection in anticipation of cracking. To control cracking, a saw cut was provided in both the slab and topping layer (see Figure 2.55). The structure was later inspected and found to be performing well, outside of hairline cracks in sidewalks above the link slabs. Providing a control joint in the sidewalk was suggested as a solution.

**Figure 2.54. Orford Road Underpass link slab detail, reprinted from Lam et al. (2008).**

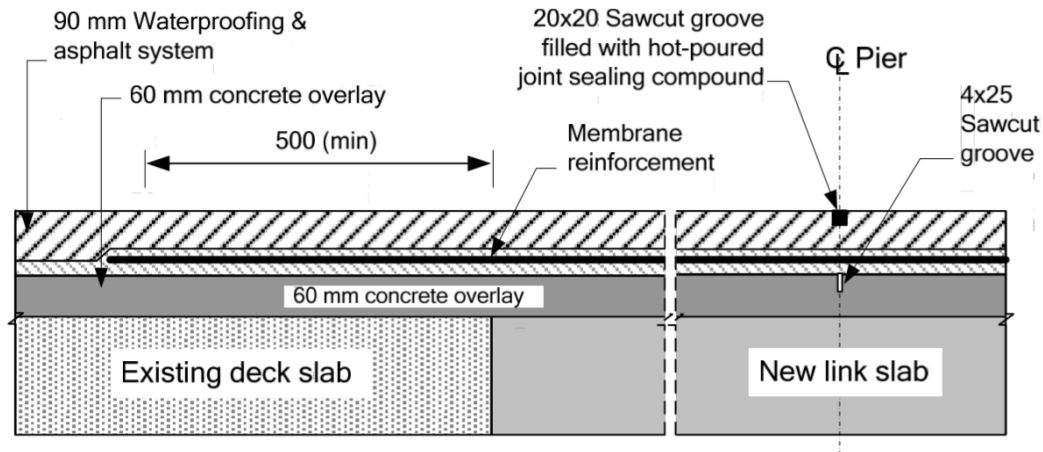
**Figure 2.55. Water protection and crack-control details, reprinted from Lam et al. (2008).**

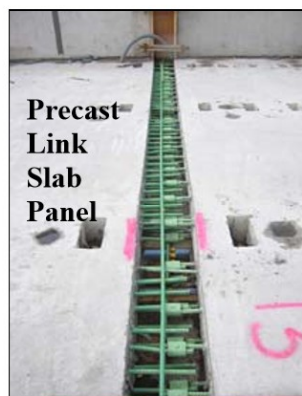
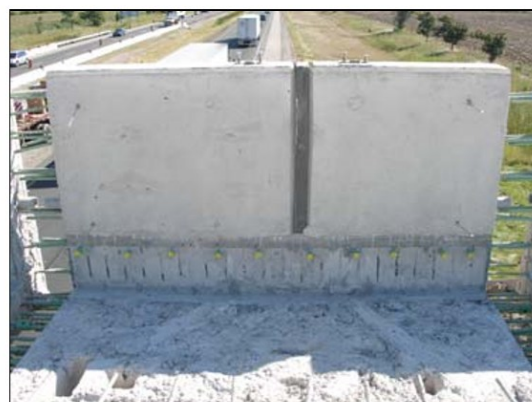
(a) Reinforced continuity provided by mechanical couplers

(b) Prefabricated link slab panel showing expansion joint in parapet well

**Figure 2.56. Prefabricated link slab construction, reprinted from Lam et al. (2008).**

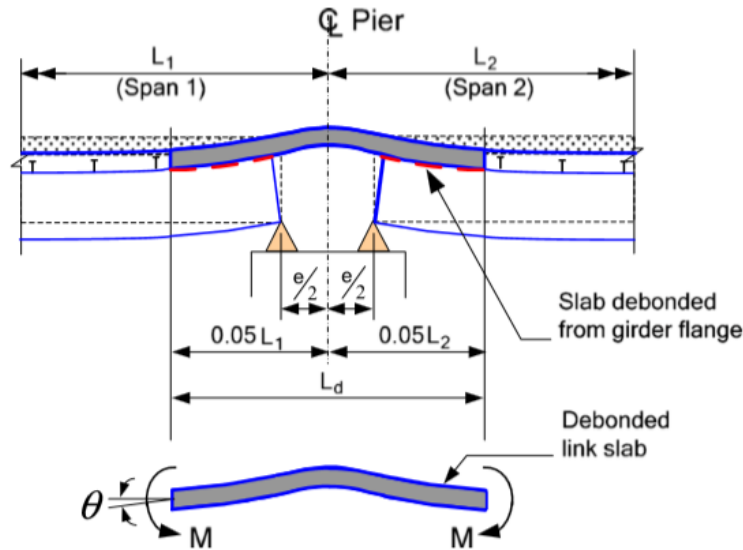
**Fig. 1.** DLS system

**Figure 2.57.** DLS system, reprinted from Au et al. (2013).

MTO conducted 1/3-scale experimental tests and field examinations of debonded link slab (DLS) systems in order to evaluate their utility in the rehabilitation of deteriorated expansion joints in multiple-span, simply supported bridges (Au et al. 2013). DLS systems replace expansion joints by linking the existing deck slab on either side of the support with a section of continuous slab debonded from the supporting girder (see Figure 2.57). The debonded slab section can cope with the girder end rotations across the simple support.
