# Performance and Improvement of Texas Poor Boy Continuous Bridge Deck Details: Final Report

Technical Report 0-7013-R1

TEXAS A&M TRANSPORTATION INSTITUTE  
COLLEGE STATION, TEXAS

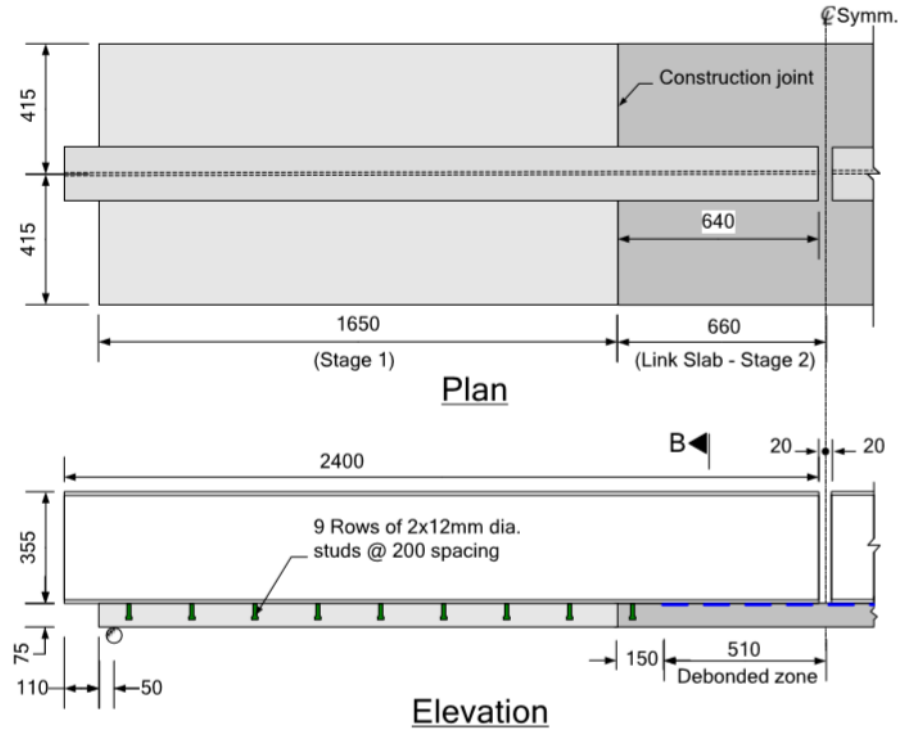
**Figure 2.58. Diagram of test specimen, reprinted from Au et al. (2013).**

The goals of the test program were to evaluate the performance of the link slab under repeated traffic loading and serviceability limits, and to determine whether the debonding dimension of 5 percent of the span was reasonable. The  $\frac{1}{3}$ -scale specimens consisted of two steel girders connected to a strip of CIP slab and joined by a DLS (see Figure 2.58). One specimen approximated the 5 percent span requirement, and the second specimen approximated a 3 percent span length condition. The specimens were instrumented to record deflection and rebar strain. They were loaded cyclically in order to plot their response after increasing numbers of load cycles, up to 4 million.

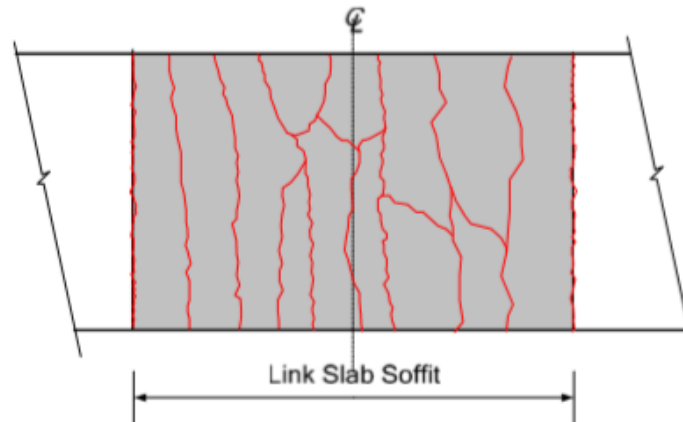
**Figure 2.59. Slab crack pattern, reprinted from Au et al. (2013).**

The cracking in the 5 percent specimen consisted of hairline cracks in a fairly regular pattern (see Figure 2.59). There was minimal change in specimen stiffness with an increasing number of load cycles. Deflections were underestimated by the theoretical model.

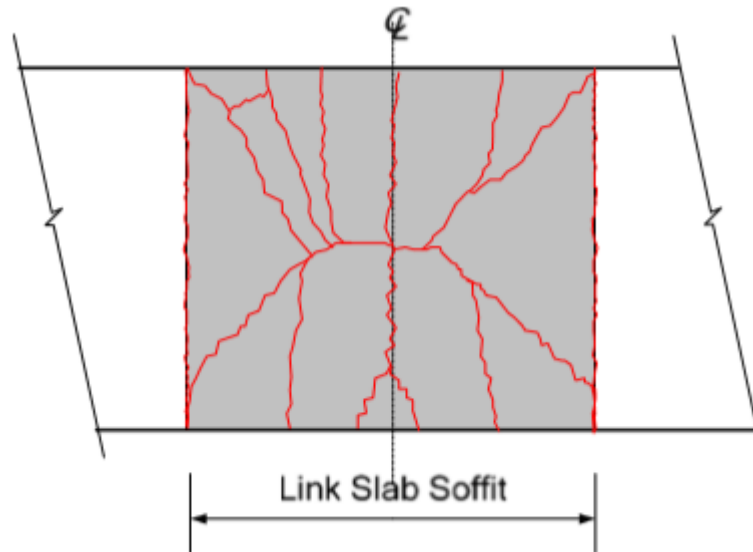
**Figure 2.60. Slab crack pattern, reprinted from Au et al. (2013).**

The 3 percent model displayed inelastic behavior prior to repeated load cycles. The cracks in the link slab were slightly larger. Since the debonded length of the slab was reduced, the link slab was not able to deform adequately to avoid the application of focused load by the deformed ends of the girders on the center of the slab. Thus, the crack pattern shows evidence of punching behavior, with cracks emanating from the location of load application (see Figure 2.60). Therefore, the feasibility of reducing the 5 percent requirement was not confirmed without further investigation.

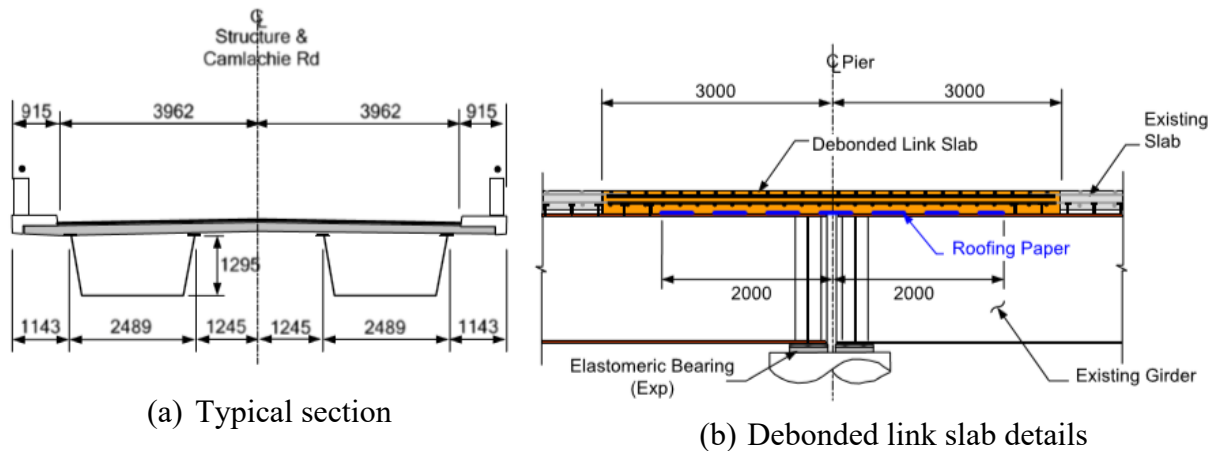
**Figure 2.61. Bridge details, reprinted from Au et al. (2013).**

An in-service bridge in Ontario was load tested before and after rehabilitation with DLSs to observe its deformation behavior and compare the results to those calculated with analytical models. The bridge consists of two simply supported spans of CIP slab over steel box girders (see Figure 2.61). The rehabilitation project included removing expansion joints at the abutments and bent in favor of integral abutments and a DLS. The structure was instrumented with 44 strain gages over the slab, girder, and on some of the reinforcement within the link slab. Ten LVDTs and two inclinometers measured the bridge's vertical deflection and end rotation, respectively. Trucks were positioned on the span to create maximum structural responses.

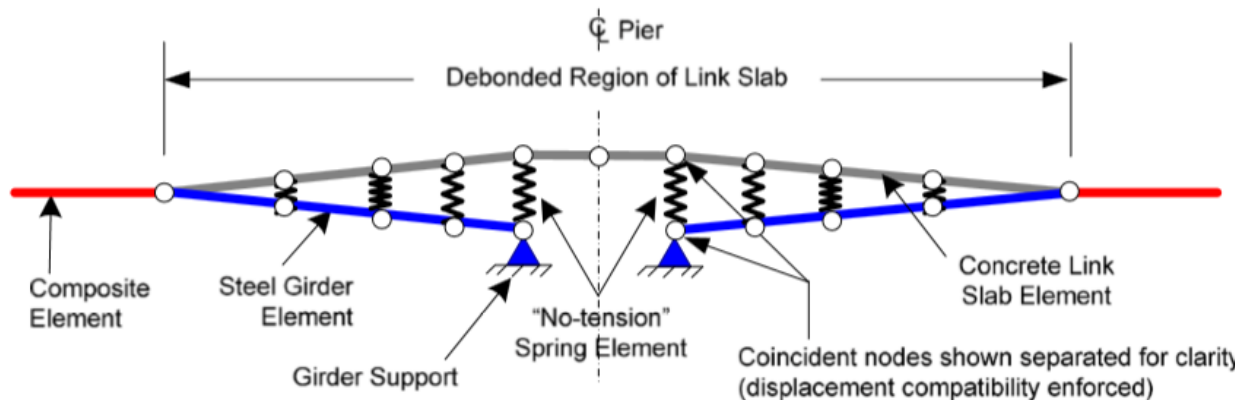
**Figure 2.62. Spring model of link slab, reprinted from Au et al. (2013).**

The results were compared to the output of an S-FRAME 7.02 model, which utilized tensionless, rigid spring elements to simulate the debonded connection (see Figure 2.62). Axial loads were not considered, but this effect was considered negligible based on prior findings. The link slab model included an estimate of cracking in the negative moment region based on a reduced moment of inertia. This reduced section was calculated iteratively for each load step based on the value of the applied moment. After the strains in the rebar were calculated from the moment, crack width was estimated based on the strain listed in the Canadian Highway Bridge Design Code provisions.

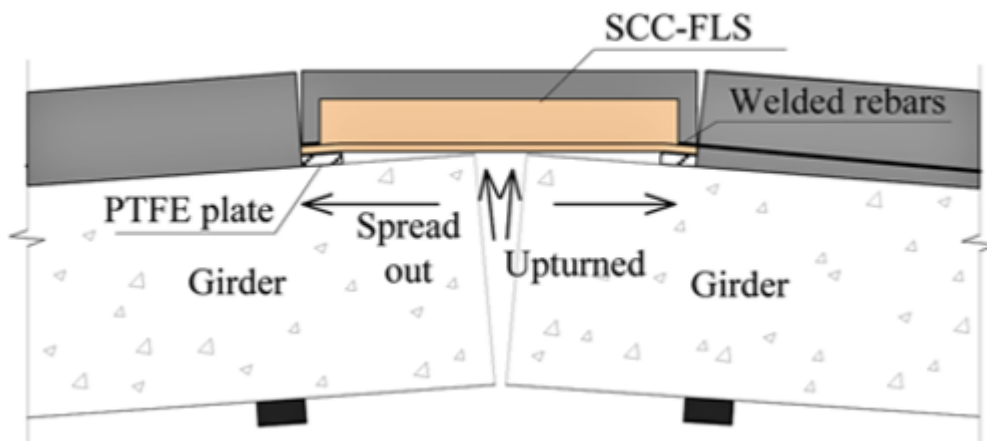
**Figure 2.63. Composite link slab design, reprinted from Wang et al. (2019).**

developed a design for a composite link slab with reinforced concrete atop steel sections. The steel section includes a void above the girder ends, such that they are able to rotate without contacting the link slab above. The steel section is able to translate atop polytetrafluoroethylene (PTFE) plate supports, and reinforcing bars are welded to the steel, leaving an intentional gap in the concrete at the ends of the link slab (see Figure 2.63).

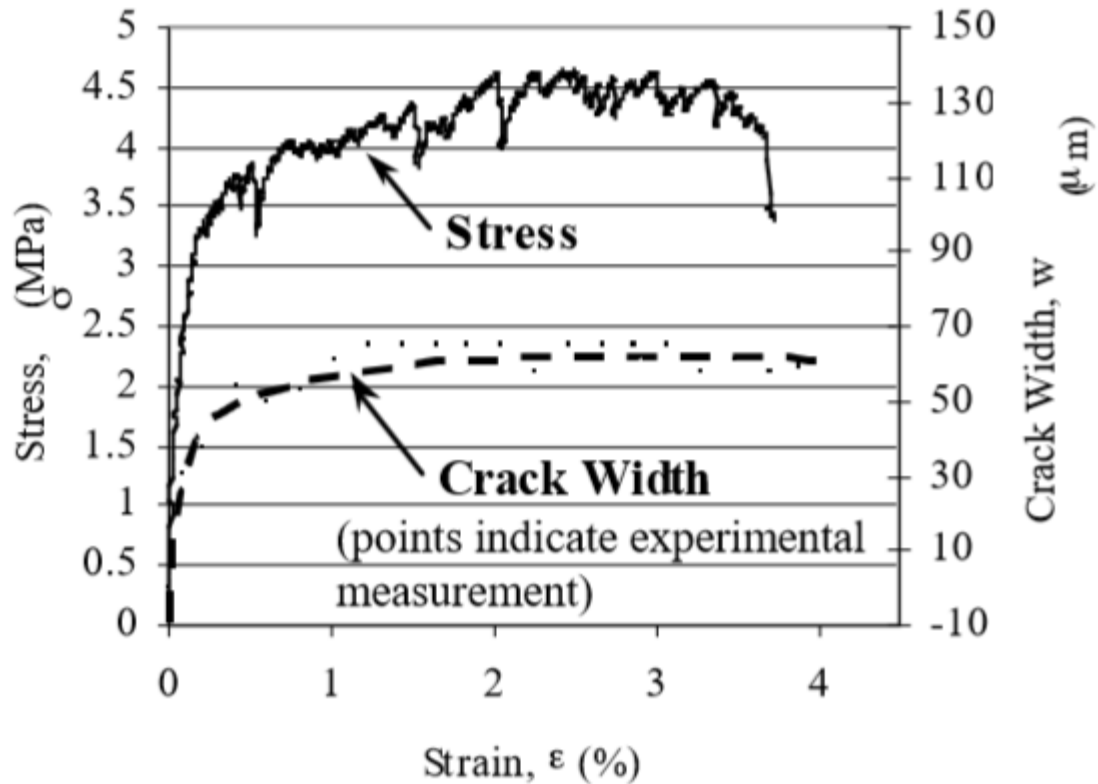
**Figure 2.64. ECC stress-strain plot and corresponding crack width, reprinted from Lepech and Li (2005).**

Engineered cementitious composites (ECCs) are fiber-reinforced materials with microstructures tailored to induce strain-hardening behavior after initial cracking, in contrast to conventional concrete materials, which also have a tensile strain capacity 500–600 times lower than ECCs (see Figure 2.64). Additional benefits of ECCs include superior toughness, shear ductility, and damage resistance (Keoleian et al. 2005).

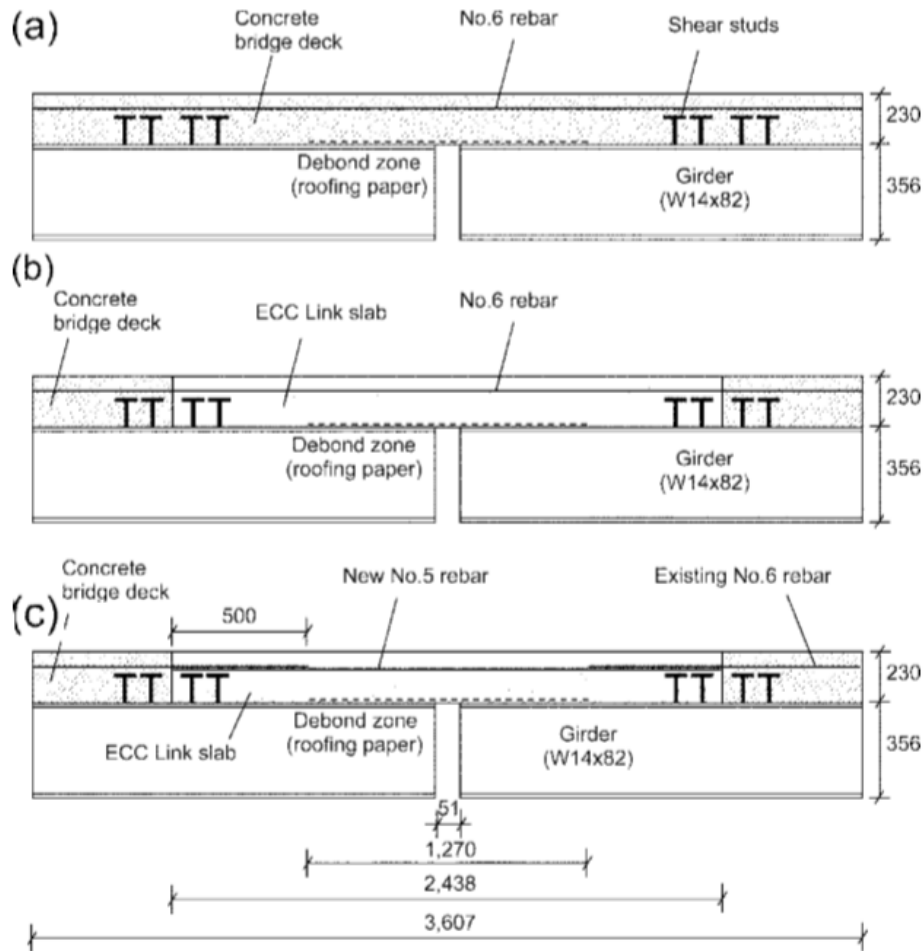
**Figure 2.65. Diagrams of the three link slab specimens, dimensions in mm (1 in. = 25.4), reprinted from Kim et al. (2004).**

The tensile capacity of ECC materials makes them an attractive option in link slab designs since cracks in the deck that would allow the intrusion of deleterious substances may be minimized. Kim et al. (2004) utilized ECCs in the design of a link slab to enhance the durability of the system. By adding only 2 percent volume fraction of steel fibers, ECC materials can offer 370 times the tensile strain capacity of everyday concretes. The researchers formulated an ECC mix design and poured three full-scale link slab specimens, one with standard concrete and two with ECC (see Figure 2.65).

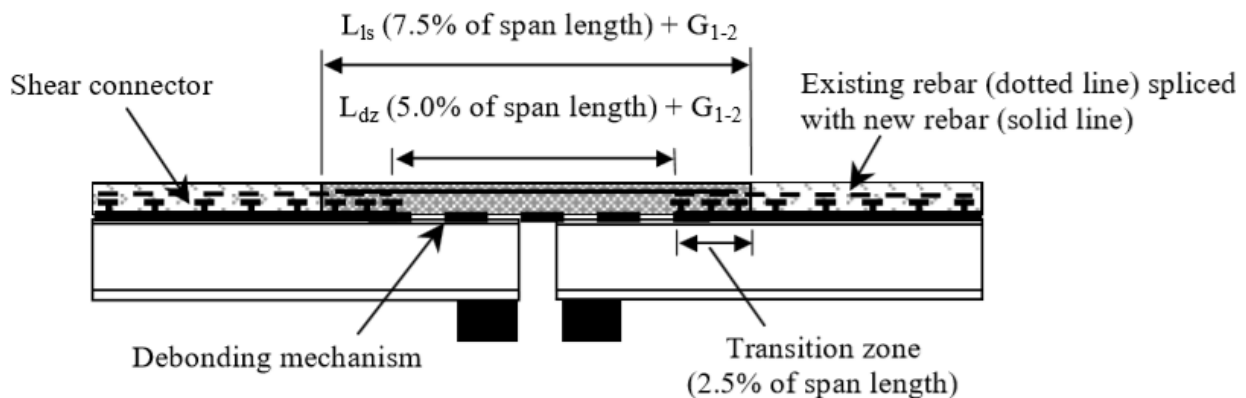
**Figure 2.66. Debonded ECC link slab diagram.**

Lepech and Li (2005) described the use of debonded ECCs in link slabs in Michigan (see Figure 2.66). Using ECCs makes possible a reduction of reinforcing steel that would be used for crack control, which reduces the stiffness of the link slab. While normal concrete link slab designs were found to deteriorate quickly due to poor placement of steel and construction issues,

The link slab's transition from an ECC to normal concrete was designed with 50 percent more shear stud reinforcement than the deck slab to account for the high-shear stresses near the interface. The design of the link slab followed standard methods, using the rotation of the girder ends to calculate the moment in the link slab. The steel reinforcement was then chosen based on a working stress design and assuming elastic-perfectly-plastic behavior of the ECC. After selecting reinforcement, the link slab was checked to ensure that maximum material strains were not exceeded due to live load, temperature, or shrinkage.

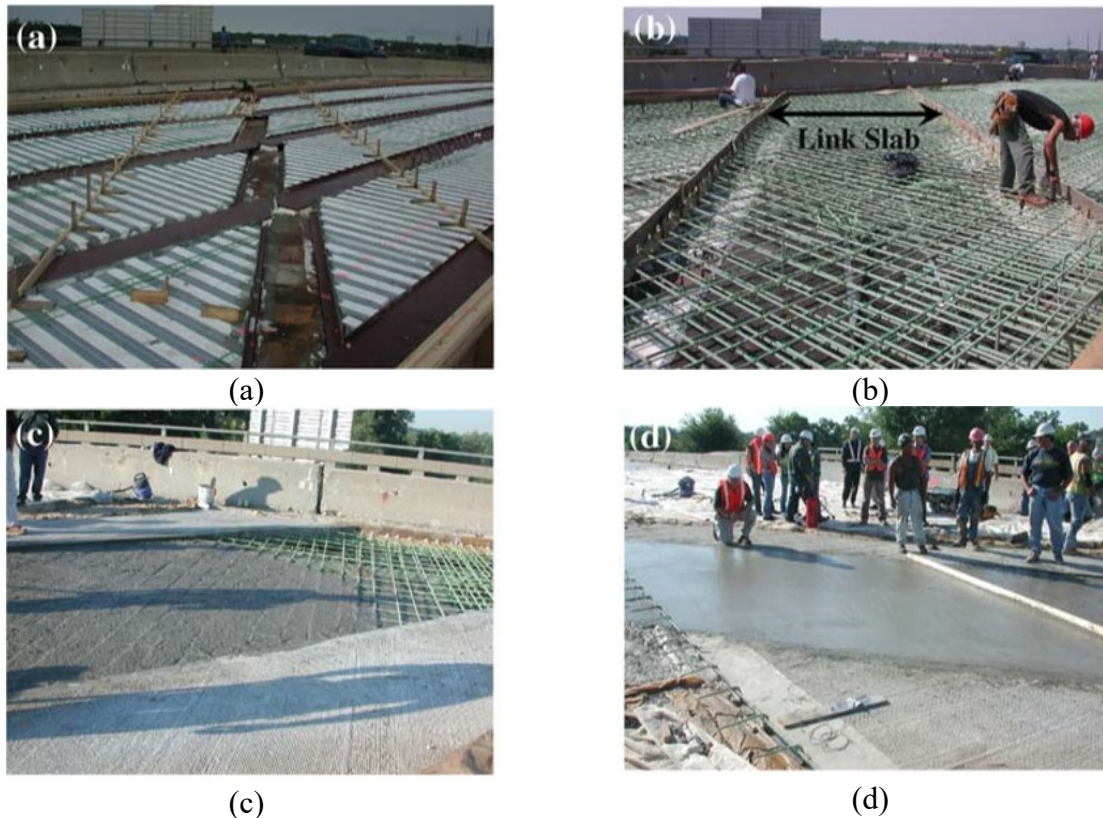
**Figure 2.67. Construction of the ECC link slab, showing the (a) girder ends beneath, (b) placement of reinforcement, (c) ECC pour, and (d) ECC finishing; reprinted from Lepech and Li (2009).**

These designs were put into practice on a demonstration bridge (see Figure 2.67) (Lepech and Li 2009). Since the structure was designed according to AASHTO standards, the link slab included almost three times the calculated necessary reinforcing steel. After the deck cured, the link slab was proof tested with live load. Recorded girder end rotations were similar to values found with a finite element model. Strain measurements at the link slab surface also were similar to values calculated using end rotations and were well below the tensile capacity of the ECC. Two years after construction, the detail was still performing well.

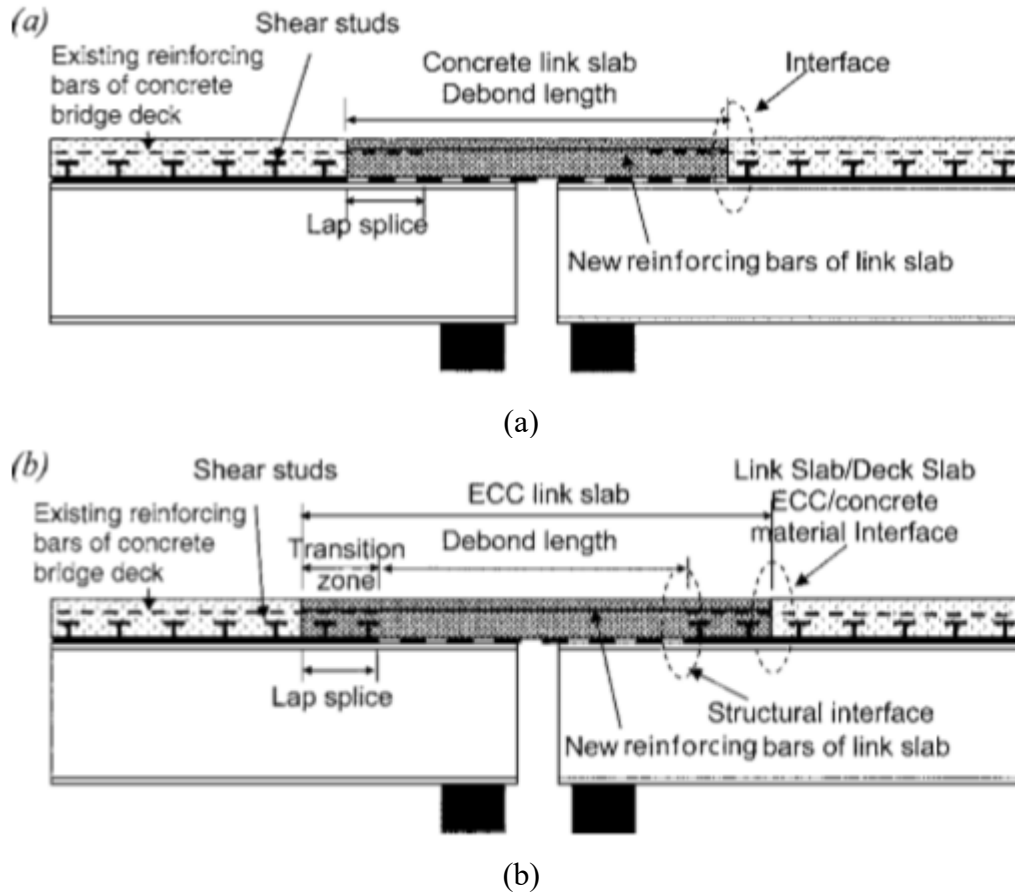
**Figure 2.68. Link slab design for (a) normal concrete and (b) ECC with a reinforced transition zone to protect the discontinuity between materials; reprinted from Qian et al. (2009).**

Qian et al. (2009) developed designs for the transition regions of ECC link slabs where the ECC materials terminate and the normal concrete deck begins. This abrupt transition between materials generates stress concentrations and is vulnerable to cracking. The researchers proposed using shear studs and splicing reinforcing bars within the ECC transition zone (see Figure 2.68). Both elements encourage shear transfer between the different cementitious materials.

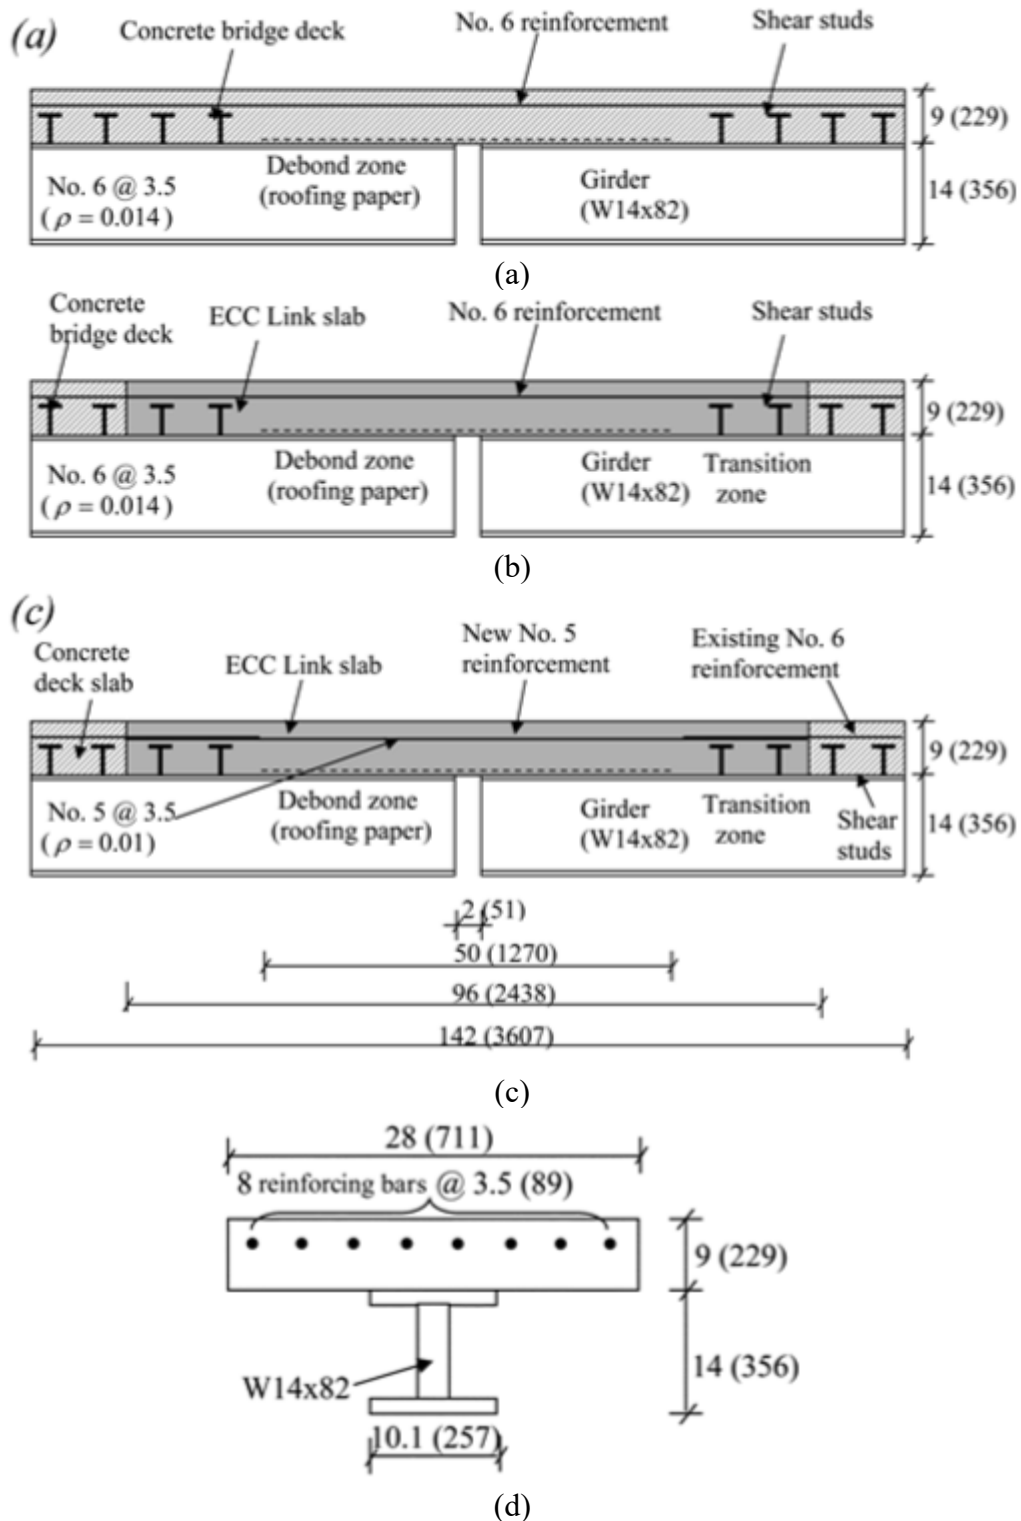
Figure 2.69. The three experimental link slab specimens (a, b, c) and a section view of the specimens (d), reprinted from Qian et al. (2009).

Experimental testing was conducted using three full-scale link slab units (see Figure 2.69). The specimens were built to represent (a) new construction with conventional materials, (b) new construction using ECC in the link slab, and (c) a retrofit using an ECC link slab. The slabs were subjected to 100,000 load cycles. The ECC link slabs successfully prevented cracking in the transition zones. Microcracking was limited to the debonded zones of the ECC slabs, while much wider cracks were generated in the normal concrete link slab.

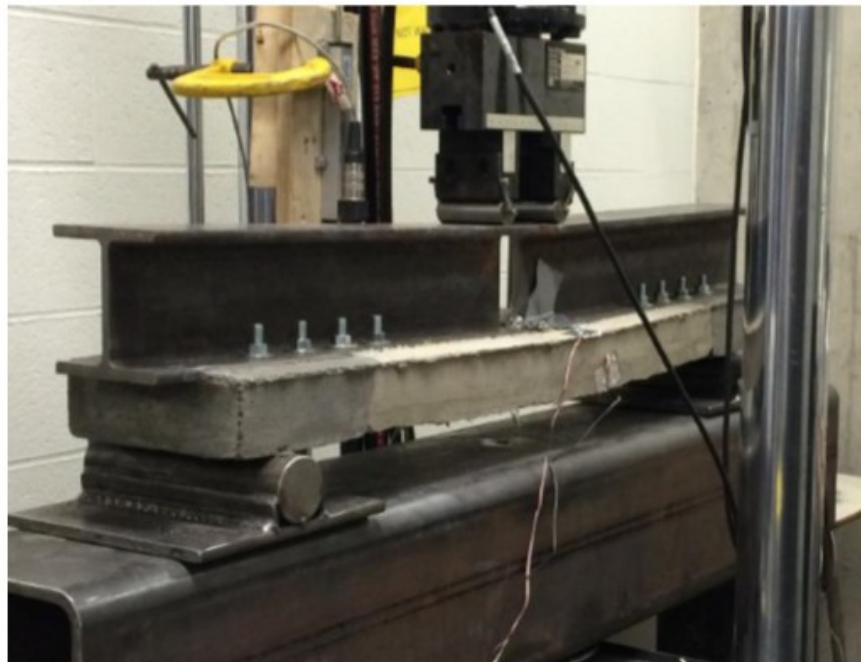
**Figure 2.70. ECC link slab specimen under load test, reprinted from Samani (2015).**

Samani (2015) considered fatigue loading on debonded ECC link slabs with an experimental test program. Three ECC mixtures and one self-consolidating concrete (SCC) mixture were fatigue tested in  $\frac{1}{4}$ -scale link slabs (see Figure 2.70). Seven ECC mixtures and two SCC mixtures were tested statically.

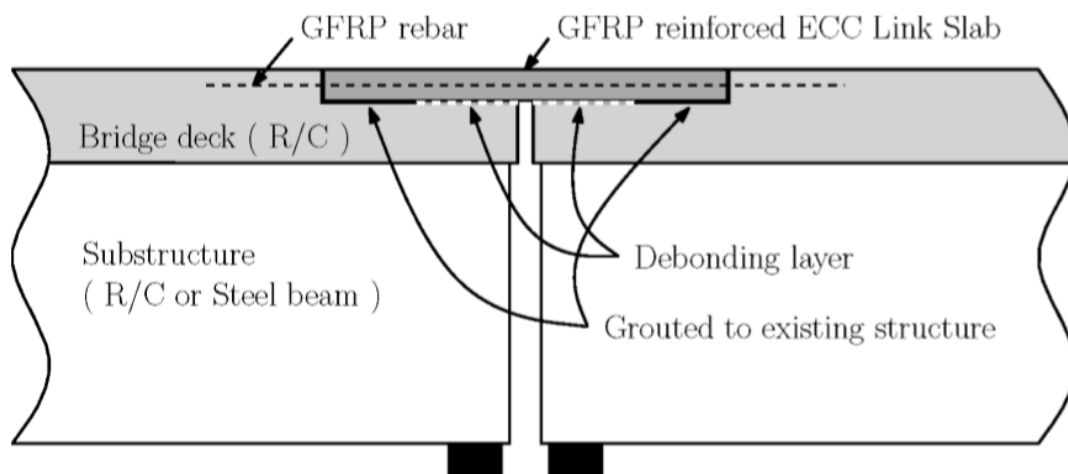
**Figure 2.71. Prefabricated ECC link slab concept with GFRP reinforcement, reprinted from Lárusson et al. (2013).**

Lárusson et al. (2013) used ECC and glass fiber-reinforced polymer (GFRP) reinforcement to design a flexible, debonded link slab with advantageous cracking behavior. The link slab concept consists of a thin, prefabricated ECC panel, which is grouted on its ends to the surrounding bridge deck and debonded for the rest of its length (see Figure 2.71). Prefabrication of the link slab makes manufacturing and curing possible in a controlled environment while also accelerating construction. Reinforcement protruding from the ends of the link slab into the deck provided the connection that would typically be achieved with shear studs. The added reinforcement at the ends of the prefabricated link slab also stiffened and strengthened the connected ends, which helped to control the location of deformation. The use of GFRP, which has much lower tensile stiffness than reinforcing steel, allows the prefabricated section to be fully anchored to the surrounding deck concrete without using an excessive number of bars.

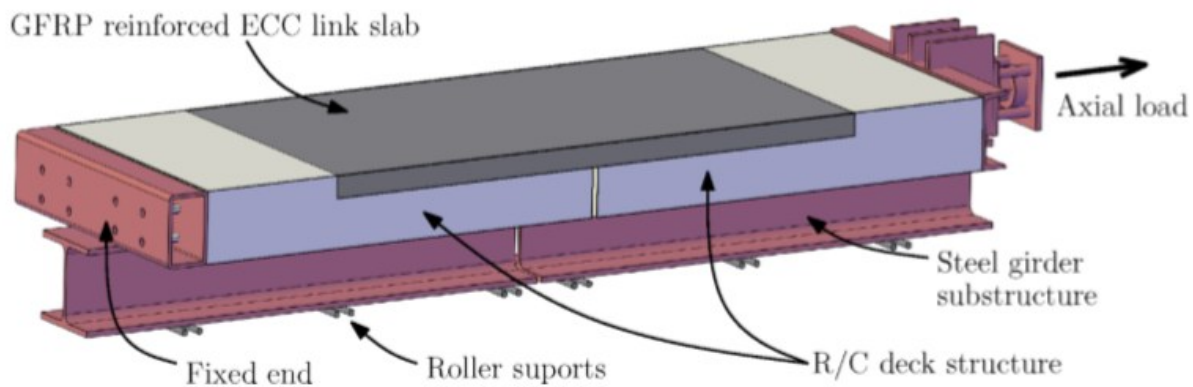
**Figure 2.72. ECC link slab specimen characteristics, reprinted from Lárusson et al. (2013).**

Four test specimens were constructed with a prefabricated section attached to reinforcement prior to the main concrete pour (see Figure 2.72). The specimens were subjected to both static and cyclic axial loading only since bending tests were out of the scope of the project. The specimens achieved satisfactory strength and cracking behavior.

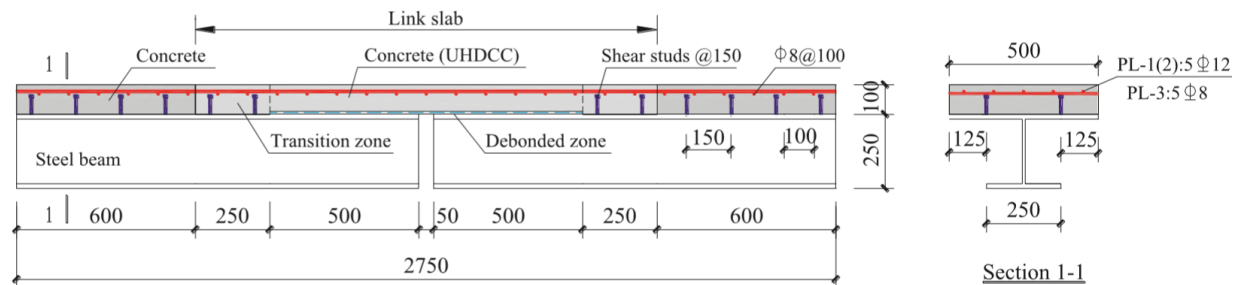
**Figure 2.73. UHDC link slab design, reprinted from Hou et al. (2018).**

Hou et al. (2018) used ultra-high ductility cementitious composites (UHDCCs) in link slab design, studying their performance under fatigue loading. UHDCCs use polyethylene fiber to achieve a tensile strain capacity between 6 percent and 12 percent, and tensile strengths up to 20 MPa (2.9 ksi). Researchers produced a UHDC mix and fabricated three steel-reinforced link slab specimens—two with UHDC and one with normal concrete (see Figure 2.73).

The UHDC link slabs exhibited decreased flexural stiffness and triple the fatigue life of the normal concrete specimen. Enhanced fatigue performance was related to the cracking and strain-hardening behavior of the UHDC. Since the cracks in UHDCs are much smaller and more widespread, steel rebar bridging the cracks are subjected to smaller strain fluctuations in each load cycle. The strain-hardening behavior causes the UHDC to assume higher bending loads with deformation, again reducing the magnitude of strain fluctuation in the reinforcing bars.

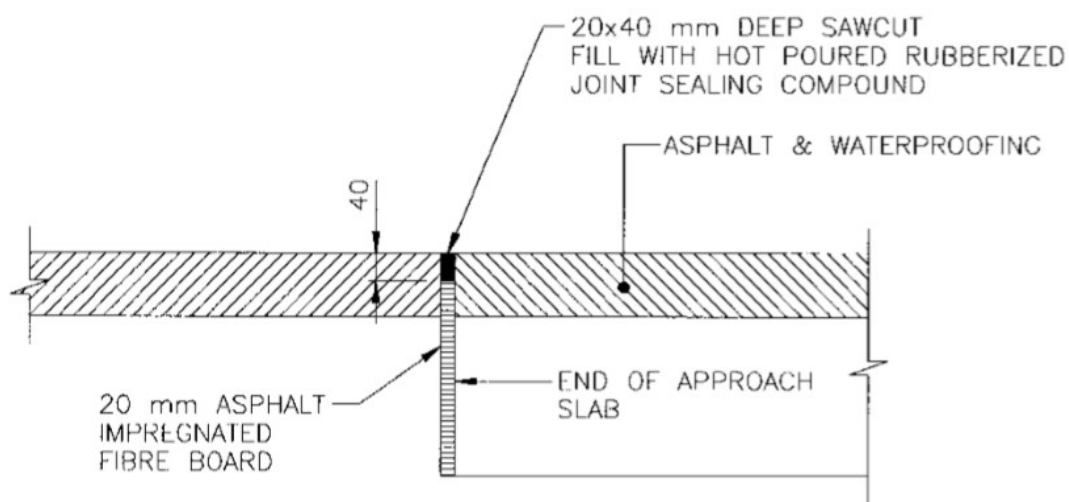
**Figure 2.74. Approach slab expansion joint detail, reprinted from Husain and Bagnariol (2000).**

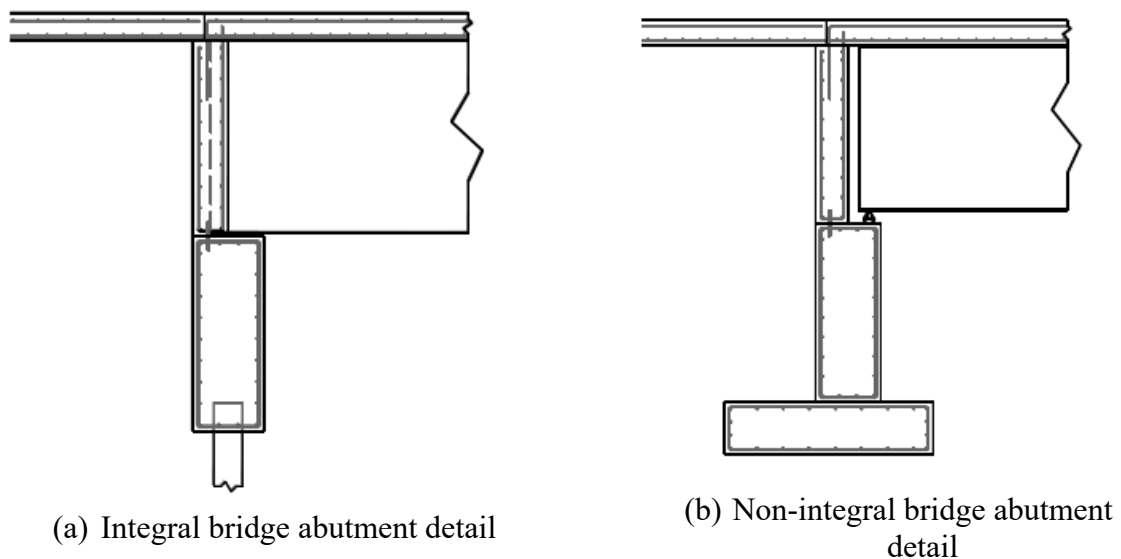
**Figure 2.75. Abutment details: (a) integral and (b) non-integral; reprinted from Stringer and Burgueño (2012).**

Stringer and Burgueño (2012) investigated the issue of deck cracking in jointless bridges. Such structures may be classified by the level of connection at their abutments. Integral bridges have the abutment and girder cast together, while non-integral bridges have only the continuous deck connecting into the abutment (see Figure 2.75).

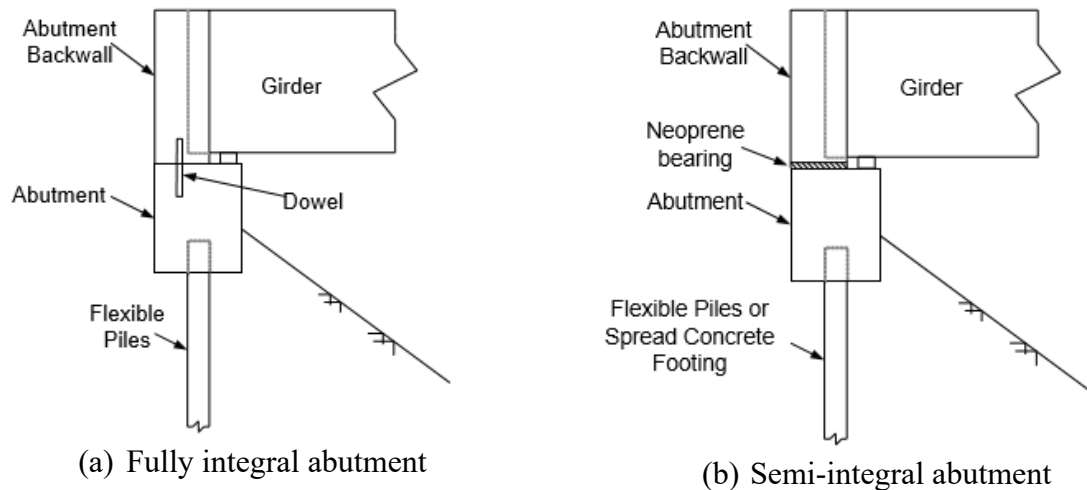
**Figure 2.76. Abutment types in integral bridges, reprinted from Stringer and Burgueño (2012).**

Furthermore, integral bridges may be subdivided into those with fully integral abutments that transfer both moment and shear to the foundation and those with semi-integral abutments that only transfer shear force to the pile or footing (see Figure 2.76). H-piles are typically used, oriented in their weak axis to facilitate some movement at the abutment. Typically, concrete girder bridges designed with jointless decks are between 150 ft and 800 ft in total length.

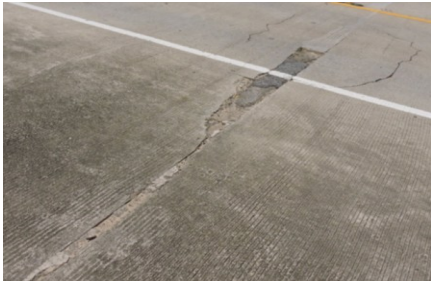
(a) Cracking and spalling on top of deck

(b) Cracking on bottom of overhang

(c) Girder end damage

**Figure 3.7. Example of damage reducing the PBJ-R.**

To meet the desired goals of this study, a unique poor boy joint rating (PBJ-R) was created for each bridge. The PBJ-R is on a scale of 1–4, with 4 being the highest and indicating no reported damage. For each bridge, a rating of 4 was initially assumed, with the score then reduced by 1 for each reported instance of cracking, spalling, rust, or delamination in the deck or for damage at the end of the girders. Examples are shown in Figure 3.7.

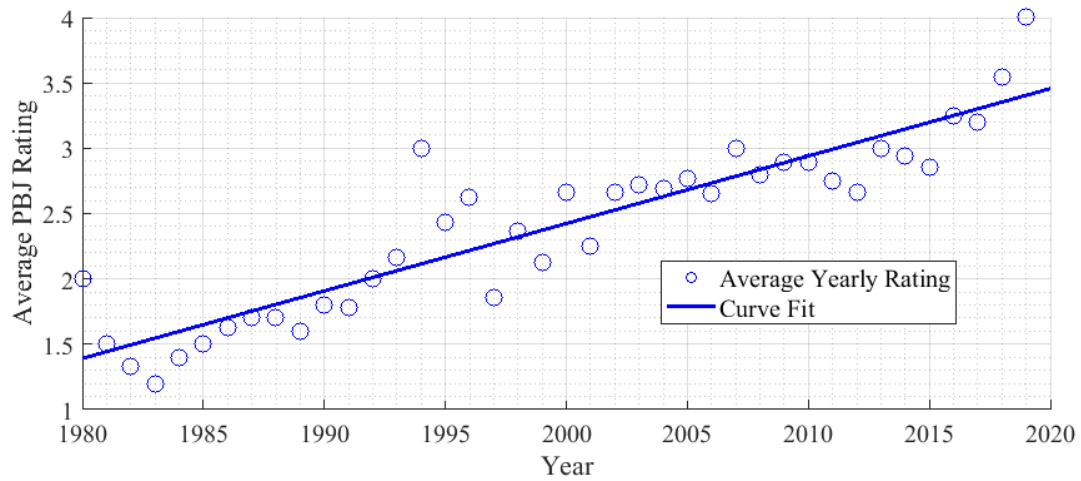
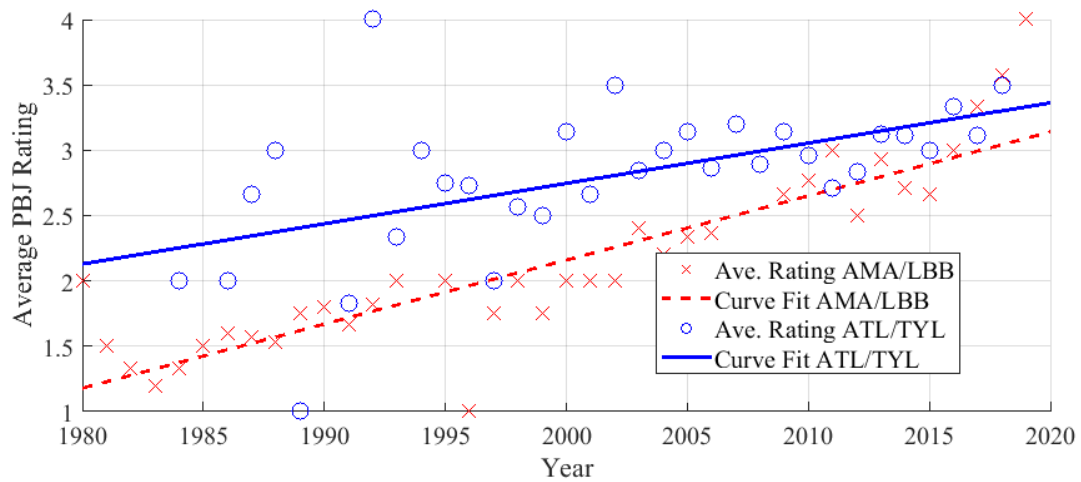
**Figure 3.8. Linear fit of the PBJ-AAR for (a) the entire database and (b) split by region.**

An initial linear fit for the PBJ-AAR using the average PBJ ratings for all bridges in the database is shown in Figure 3.8(a). However, subdividing the rating by region, shown in Figure 3.8(b), reveals that there is a significant difference in average PBJ ratings between the north region (Amarillo and Lubbock Districts) and the east region (Atlanta and Tyler Districts).

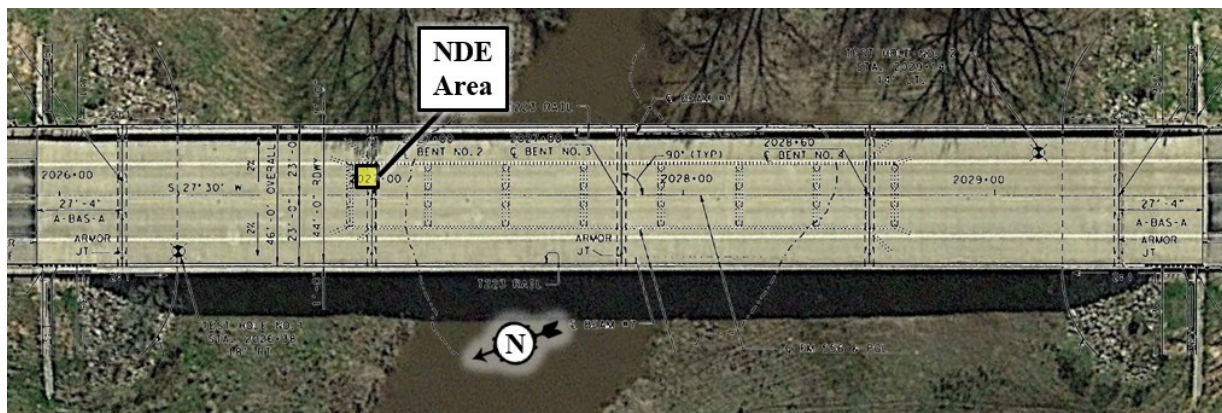
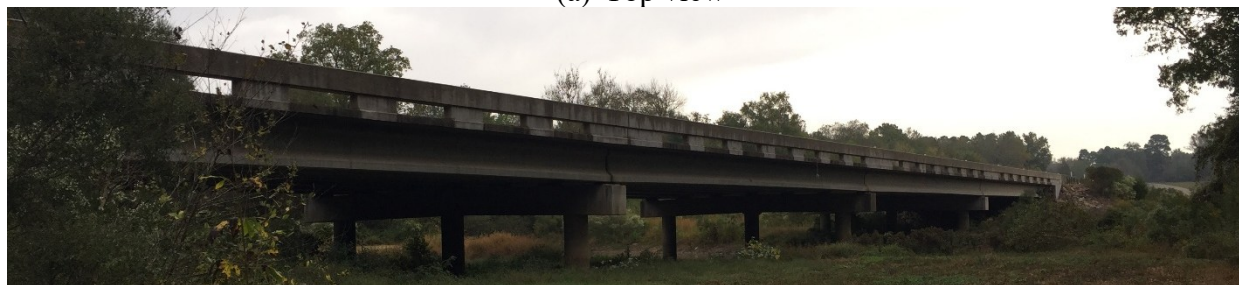
(a) Top view

(b) Elevation view

**Figure 4.2. Site conditions at Bridge ATL1 (FM 556 over Lilly Creek).**

Bridge ATL1, shown in Figure 4.2, was built in 2012; it carries FM 556 over Lilly Creek in Camp County, Texas. The 46-ft wide bridge has seven Type C prestressed concrete I-girders spaced at 6.667 ft with 3-ft overhangs. The bridge carries two 12-ft wide traffic lanes, with 10-ft wide shoulders on both sides.

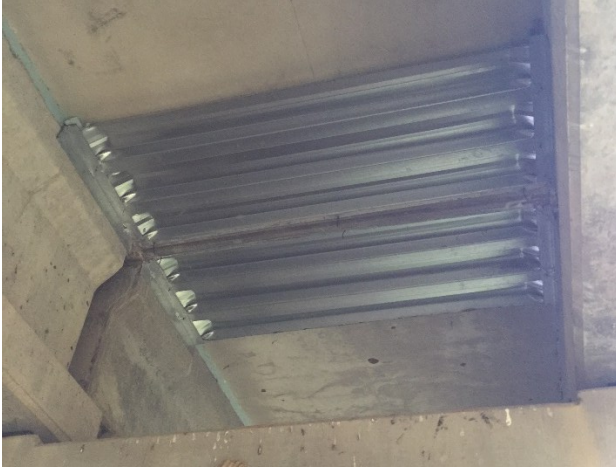
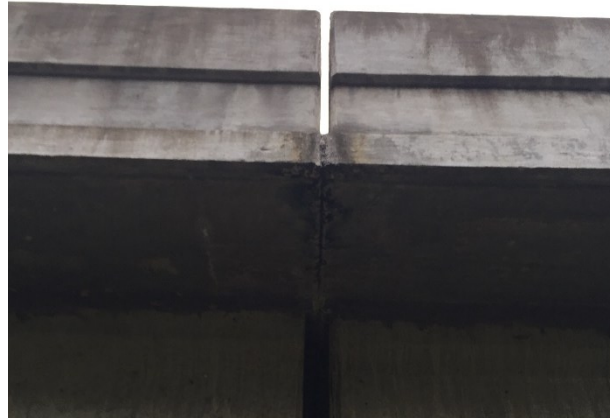
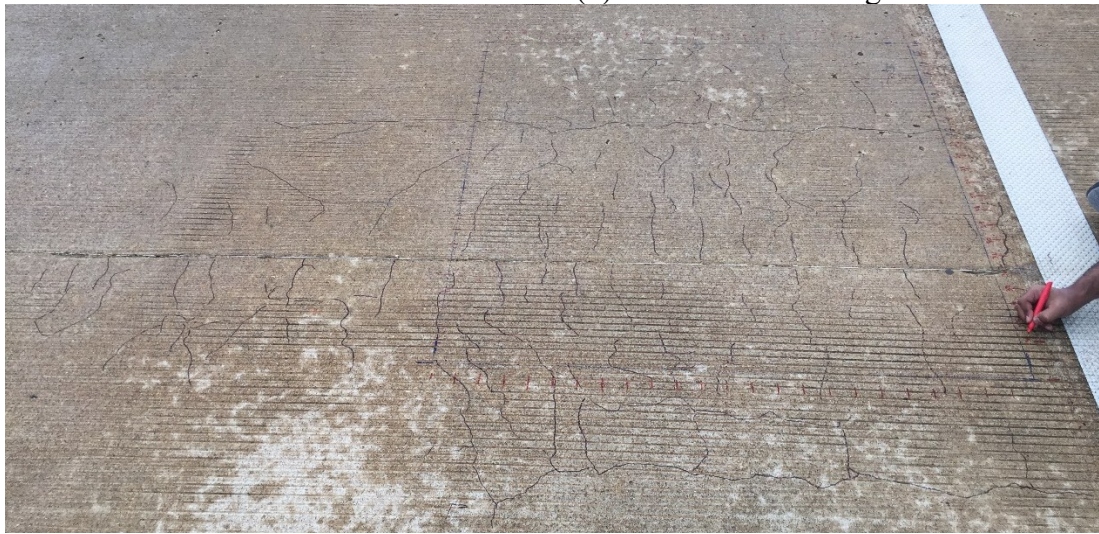
(a) PMDF at Bent 4

(b) Bottom of overhang at Bent 4

(c) Marked cracks in the NDE region at Bent 2

**Figure 4.3. Link slab condition for Bridge ATL1 (FM 556 over Lilly Creek).**

Visual inspection of the bridge confirmed the inspection report damage of minor spalling at the construction joint. The conditions of the continuous deck regions at Bent 2 and Bent 4 were similar. Figure 4.3 shows the condition of the link slab region at Bent 4 from below the deck and the top of the deck at Bent 2. The PMDF was in good condition, with no indication of rust or other damage. In the overhang, some minor spalling was observed at the PBJ crack, but no cracking was noted. Visual observations on the top side of the deck indicated that zip strips were used to form the main PBJ crack. The zip strip was still intact, but some minor spalling was observed at several locations along the length. Figure 4.3(c) shows the marked cracks in the NDE region. Secondary PBJ cracks were present at approximately the end of the portion of the deck where PMDFs were used. The secondary PBJ cracks were 0.014–0.016 in. wide in the NDE region. Hairline cracks were present in the link slab region and in the main deck, and they were primarily longitudinal, with an occasional transverse crack.

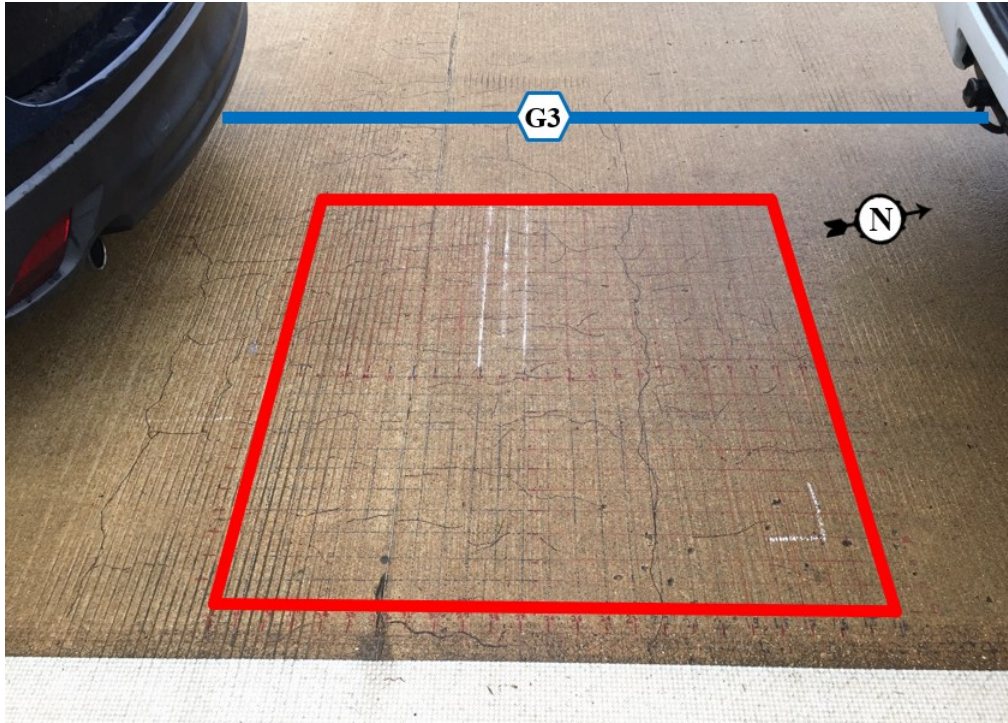
Figure 4.4. NDE region at Bent 2 for Bridge ATL1 (FM 556 over Lilly Creek).

The NDE region was a 4-ft by 4-ft region at Bent 2, shown in Figure 4.4, located at the edge of the northbound lane and between Girders (G) 2 and 3. The region was off center relative to the main PBJ crack to capture the reinforcement at the main crack and one secondary crack, plus an extension beyond the secondary crack. At the time of the evaluation, rain had resulted in the deck being wet at the time of the GPR and UST data collection.

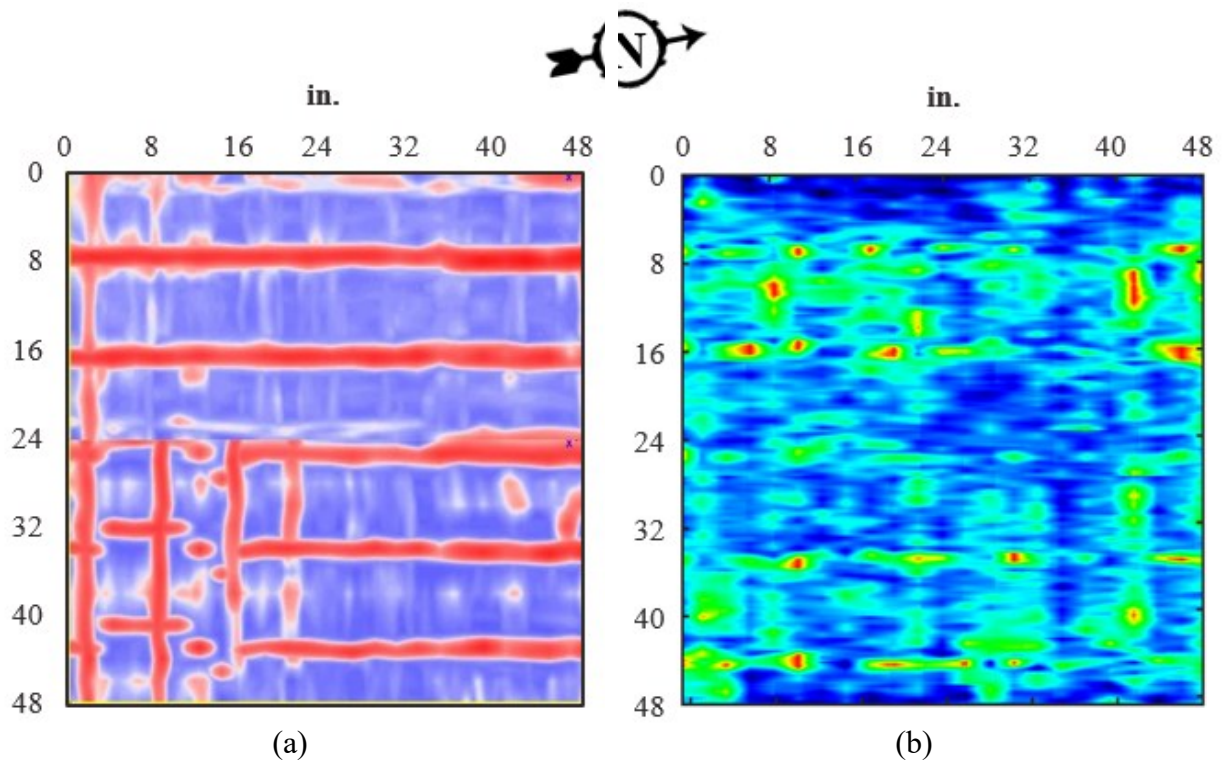
Figure 4.5. ATL1 results for (a) GPR and (b) UST of top longitudinal reinforcement at depth 2.73 in.

Figure 4.5 through Figure 4.9 show 2D views of GPR and UST scans at various depths. Figure 4.5 confirms longitudinal reinforcement spacing at 9 in., while Figure 4.6 and Figure 4.7 confirm transverse reinforcement spacing of 6 in., as specified in the as-built drawings. Transverse reinforcement is shown in two views for clarity; evaluation of 3D images reveals the transverse reinforcement to be at the same depth throughout the link slab region.

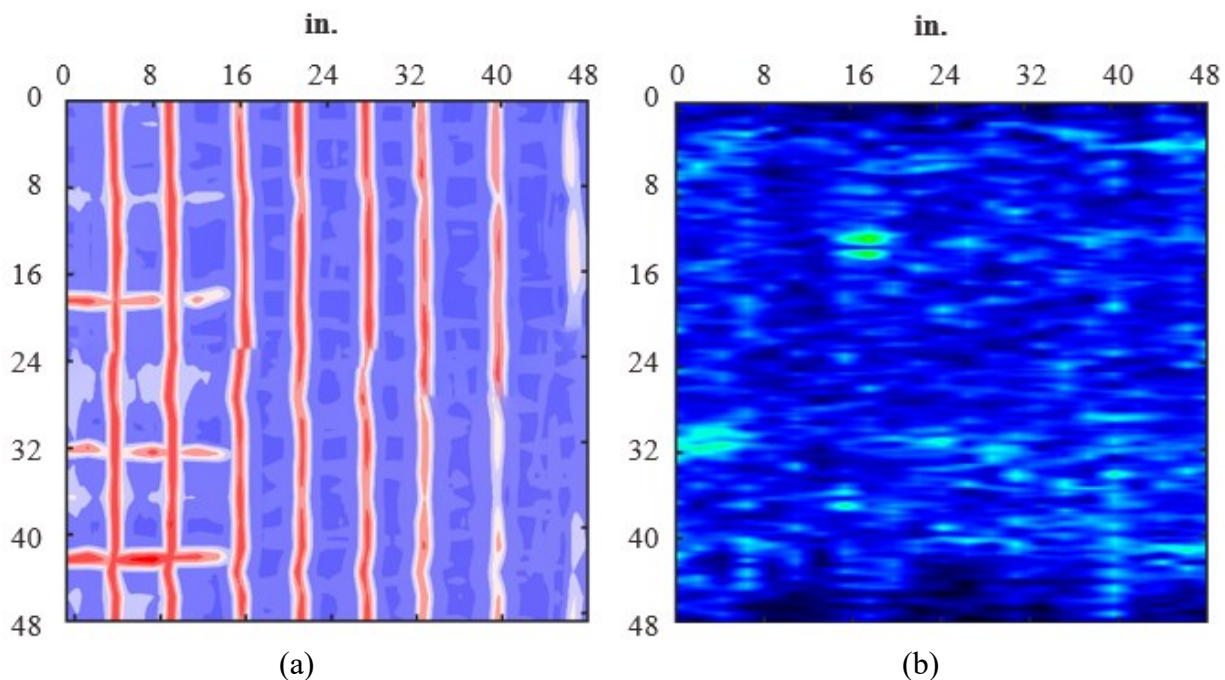
**Figure 4.6. ATL1 results for (a) GPR and (b) UST of top longitudinal reinforcement at depth 1.48 in.**
