# Performance and Improvement of Texas Poor Boy Continuous Bridge Deck Details: Final Report

Technical Report 0-7013-R1

TEXAS A&M TRANSPORTATION INSTITUTE  
COLLEGE STATION, TEXAS

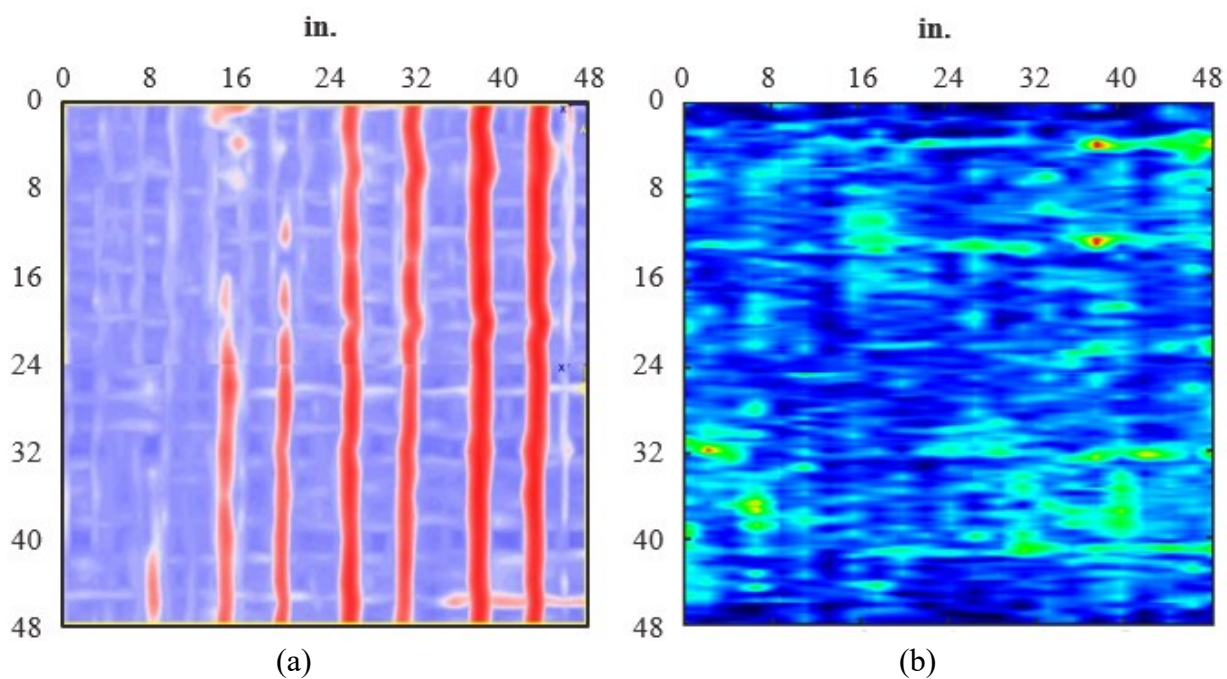
**Figure 4.7. ATL1 results for (a) GPR and (b) UST of top transverse reinforcement at depth 2.23 in.**

Figure 4.5 through Figure 4.9 show 2D views of GPR and UST scans at various depths. Figure 4.5 confirms longitudinal reinforcement spacing at 9 in., while Figure 4.6 and Figure 4.7 confirm transverse reinforcement spacing of 6 in., as specified in the as-built drawings. Transverse reinforcement is shown in two views for clarity; evaluation of 3D images reveals the transverse reinforcement to be at the same depth throughout the link slab region.

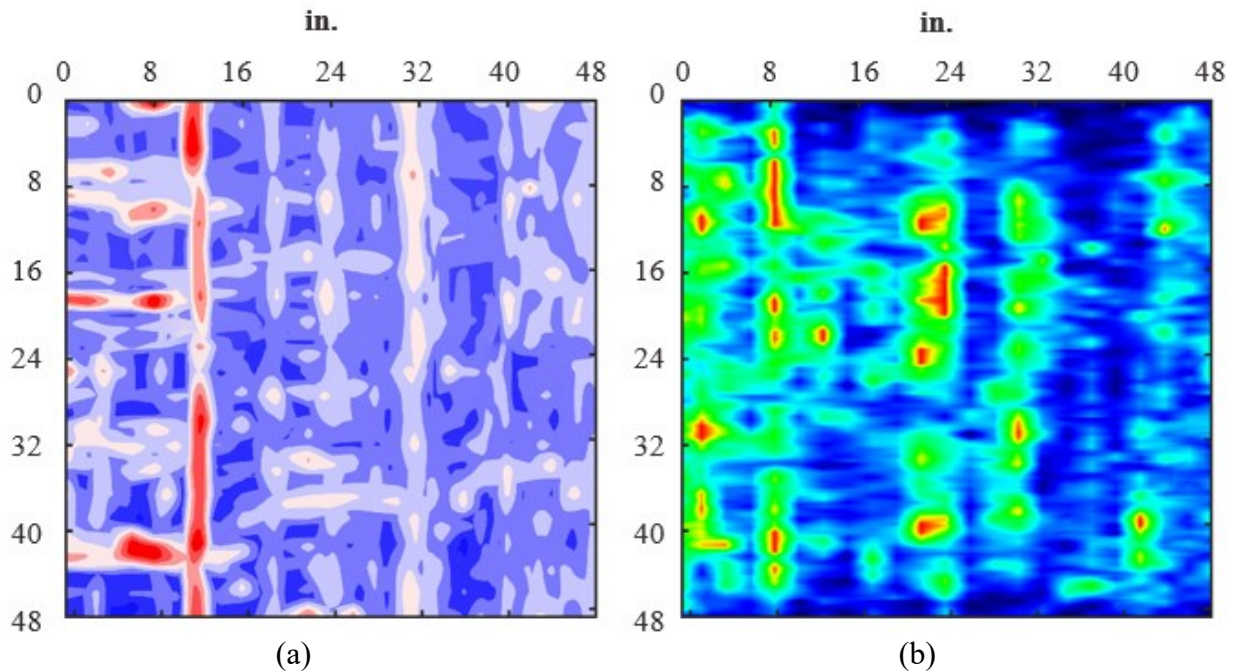
**Figure 4.8. ATL1 results for (a) GPR and (b) UST of bottom reinforcement at depth 7.48 in.**

Figure 4.8 does not show clear images of the bottom reinforcement due to the presence of PMDFs, which obscure the GPR and UST signals. Still, longitudinal reinforcement at 9 in. can be made out from the GPR images of Figure 4.8(a) and Figure 4.9(a). The UST image in Figure 4.9(b) clearly shows the ribs of the PMDF laid out vertically in the figure, especially with the strong signal from zero to 10 in. horizontally in the image.

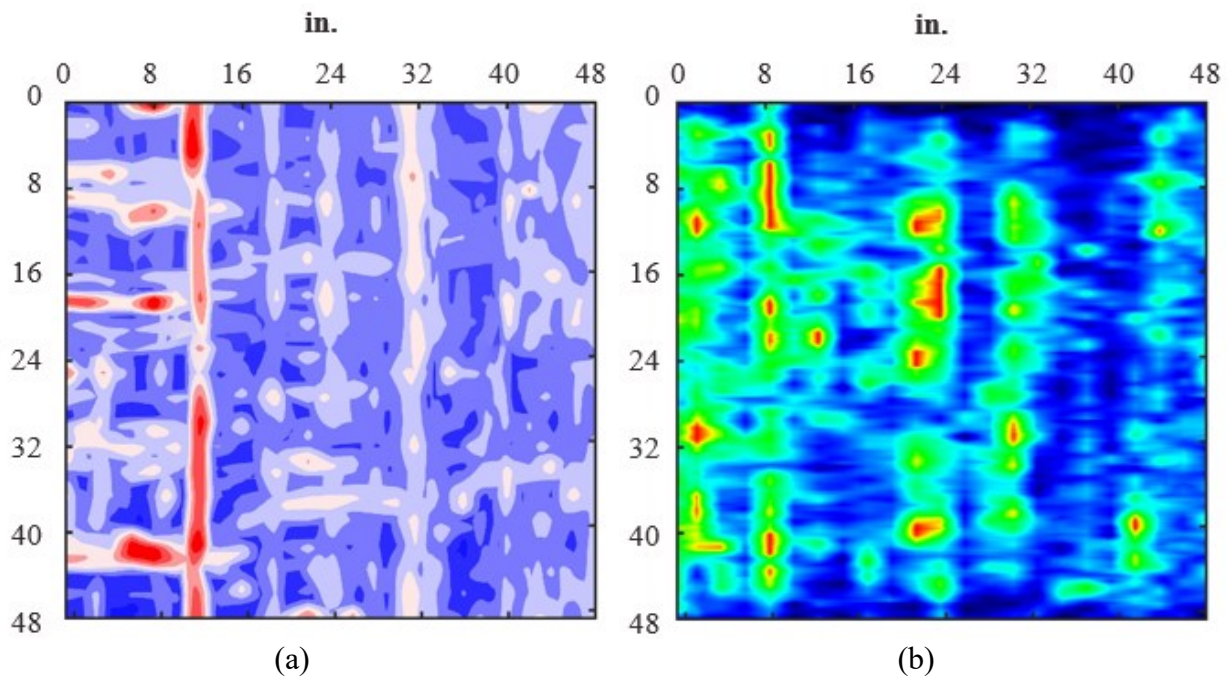
**Figure 4.9. ATL1 results for (a) GPR and (b) UST of PMDF at depth 8.5 in.**

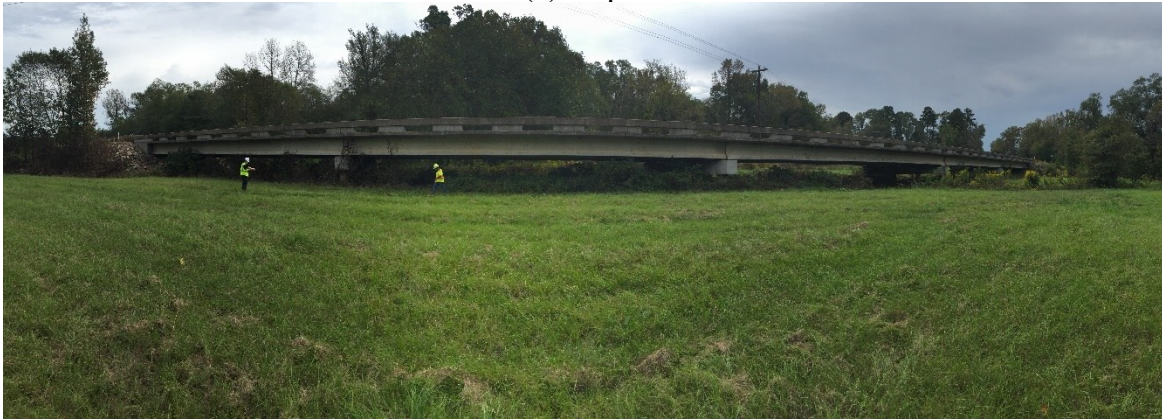
(b) Elevation view

**Figure 4.10. Site conditions at Bridge ATL2 (FM 250 over Black Cypress Creek).**

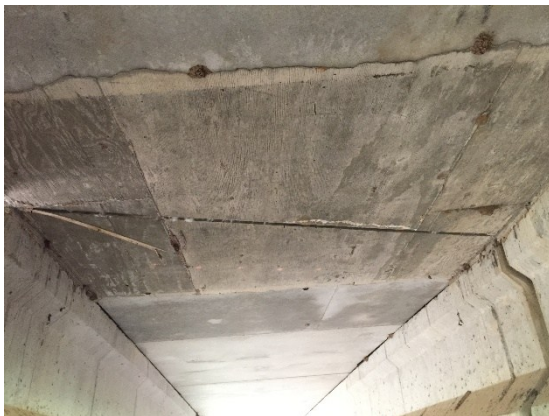
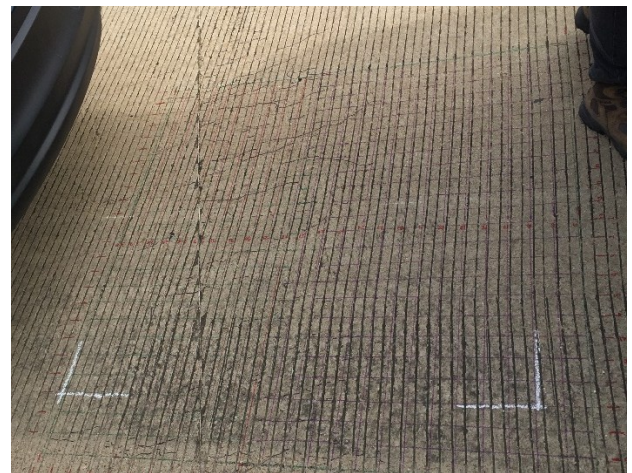
(a) CIP at continuous deck detail

(b) Cracks in NDE region

**Figure 4.11. Typical link slab condition for Bridge ATL2 (FM 250 over Black Cypress Creek).**

Visual inspection of the bridge confirmed the inspection report damage. The condition of all continuous deck regions was similar. Figure 4.11 shows representative conditions of the link slab regions. Visual observations on the top side indicated that zip strips were used to form the main PBJ crack. The zip strip was still intact, but some minor spalling was observed at several locations along the length. There were no distinct secondary PBJ cracks. Aside from the main PBJ crack, random cracks were present. The maximum cracks were 0.008 in. near the exterior side of the girder, but most cracks were 0.007 in. or less.

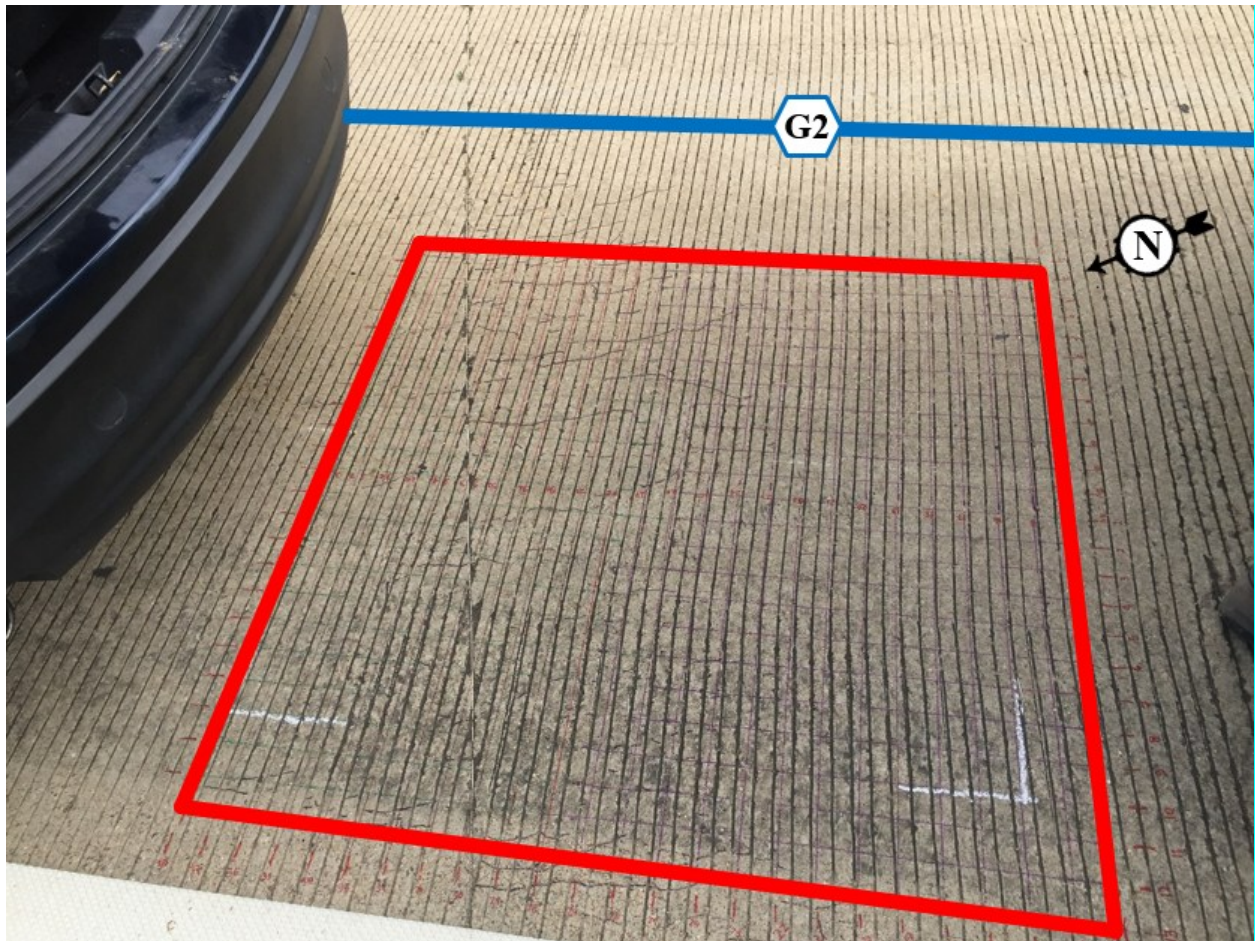
**Figure 4.12. NDE region at Bent 3 for Bridge ATL2 (FM 250 over Black Cypress Creek).**

The NDE region was a 4-ft by 4-ft region at Bent 4 (in Unit 2), shown in Figure 4.12, located at the edge of the southbound lane and between G1 and G2 and was oriented parallel to the girder lines. The region was off center relative to the main PBJ crack to capture the reinforcement at the main PBJ crack and also extend beyond the CIP region. Figure 4.13 and Figure 4.14 confirm the spacing of longitudinal and transverse reinforcement in the as-built drawings as 9 in. and 6 in., respectively. Figure 4.15 and Figure 4.16 confirm the reinforcement spacing for the bottom reinforcement. No evidence of voids or delaminations was discovered using IR images.

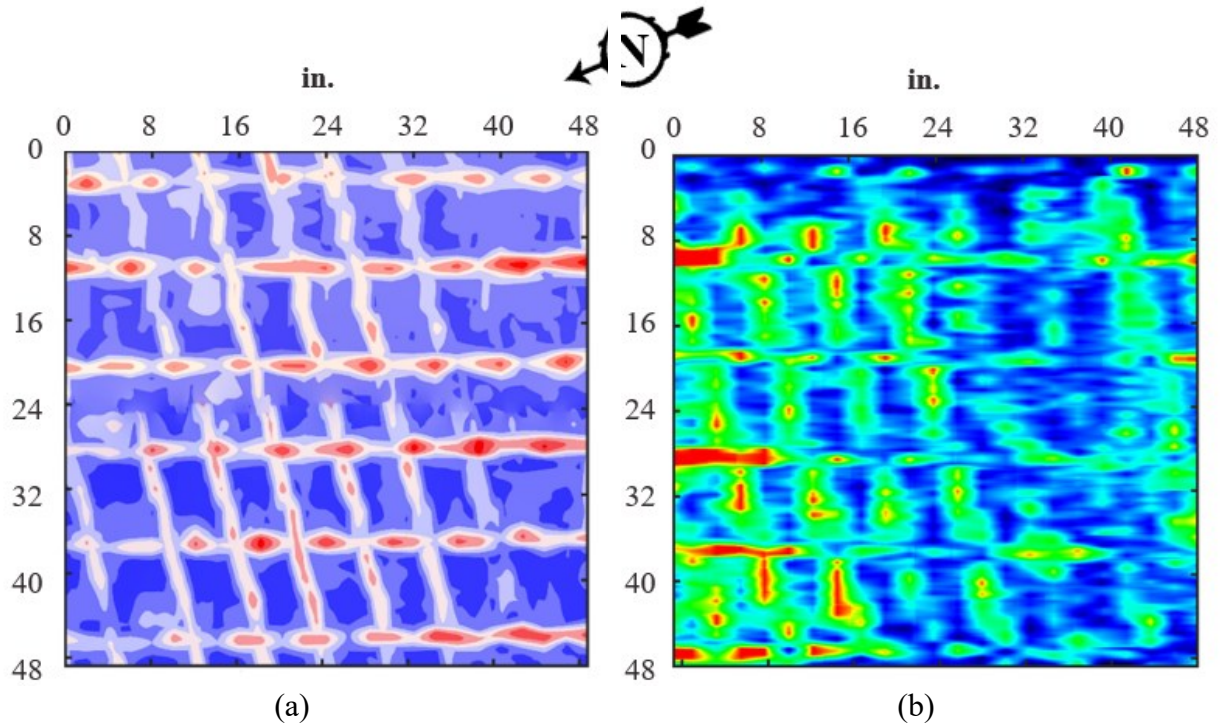
**Figure 4.13. ATL2 results for (a) GPR and (b) UST of top longitudinal reinforcement at depth 3.73 in.**

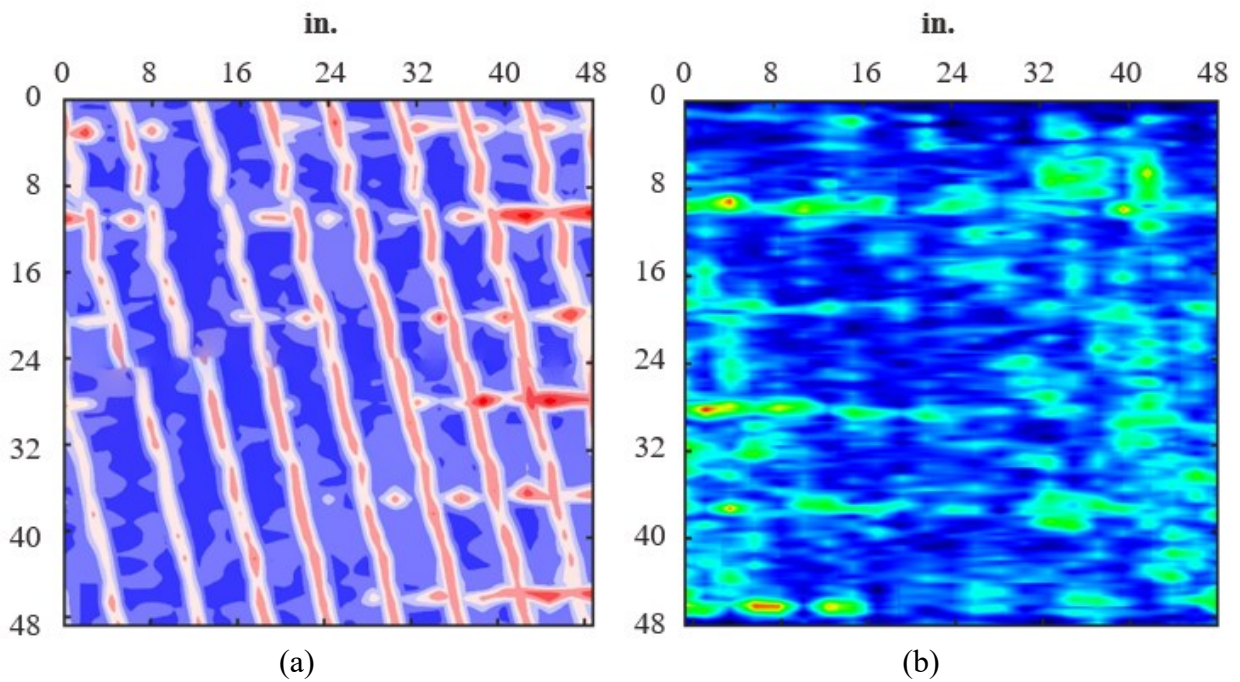
**Figure 4.14. ATL2 results for (a) GPR and (b) UST of top transverse reinforcement at depth 2.98 in.**

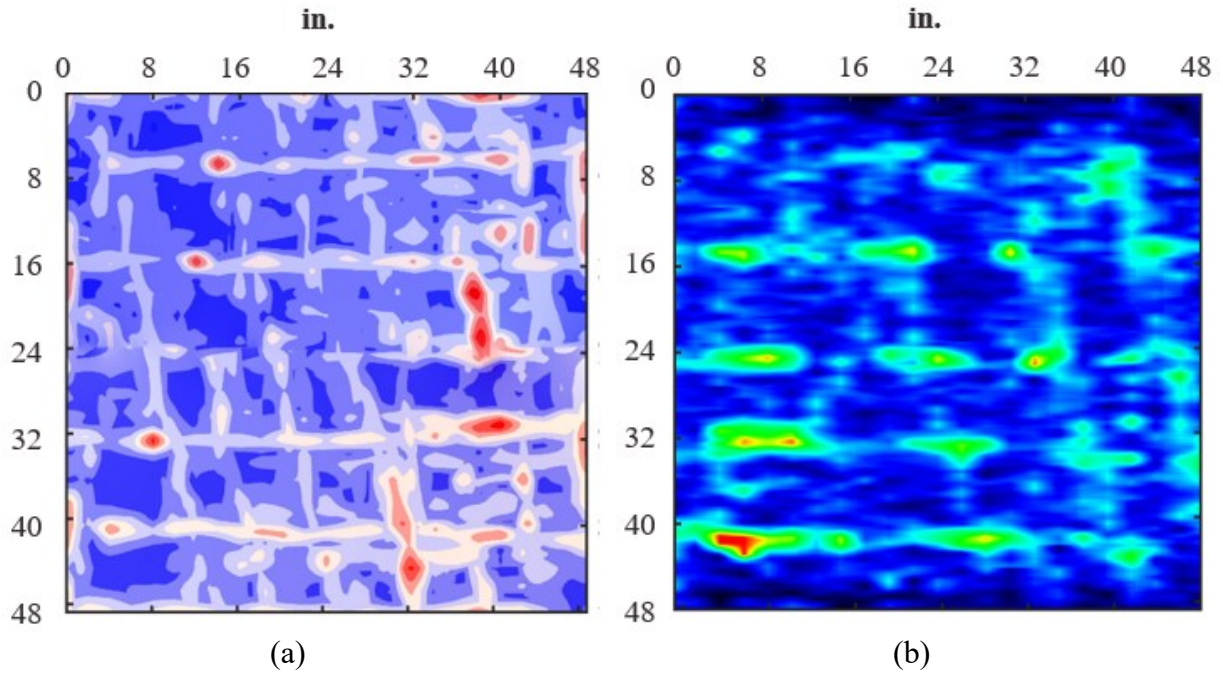
**Figure 4.15. ATL2 results for (a) GPR and (b) UST of bottom longitudinal reinforcement at depth 7.23 in.**

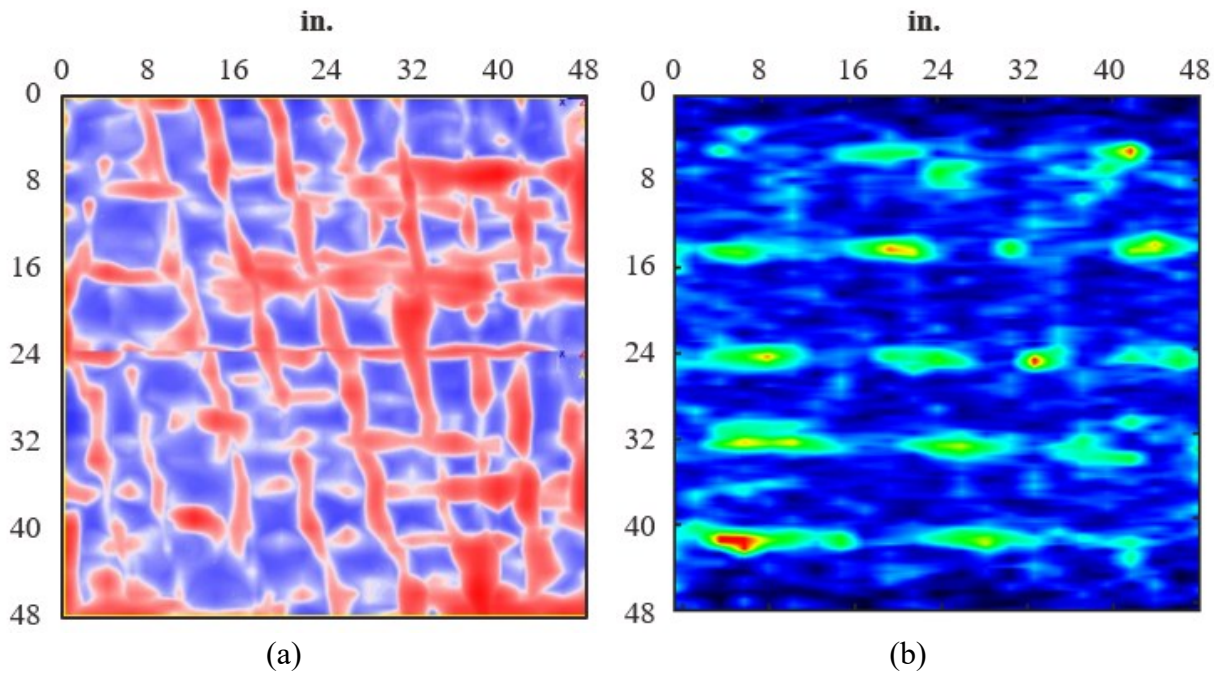
**Figure 4.16. ATL2 results for (a) GPR and (b) UST of bottom transverse reinforcement at depth 6.73 in.**

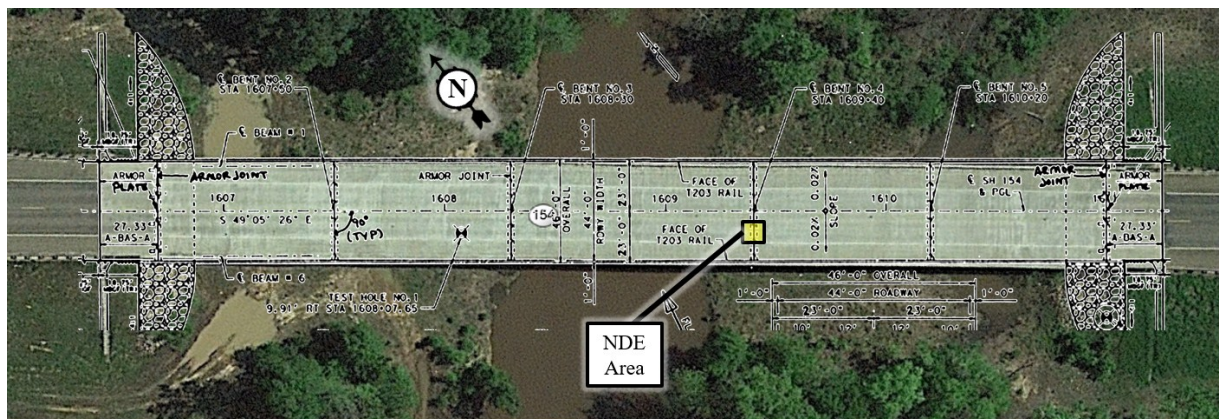
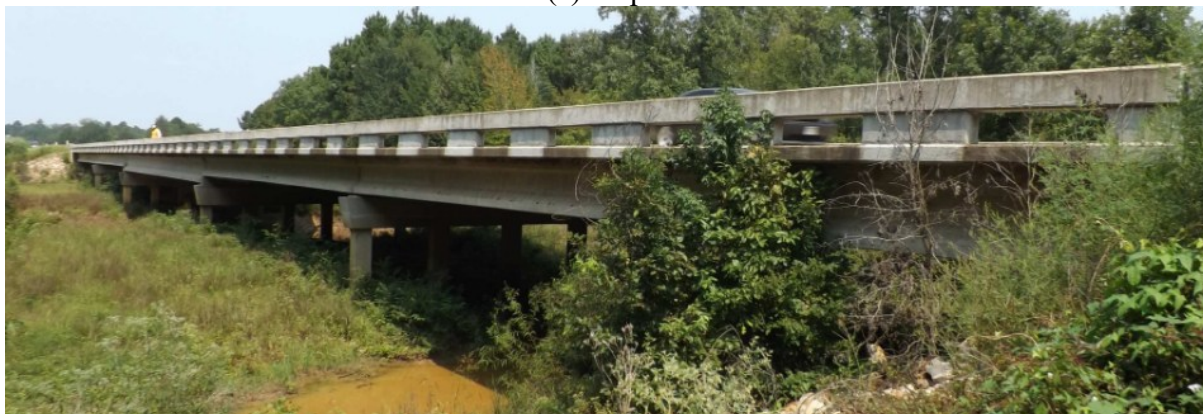
(a) Top view

(b) Elevation view

**Figure 4.17. Site conditions at Bridge ATL3 (FM 154 over Little Cypress Bayou).**

Bridge ATL3, shown in Figure 4.17, was built in 2010 and carries FM 154 over Little Cypress Bayou near Harleton, Texas. The 46-ft wide bridge has two lanes on six prestressed concrete I-girders spaced at 8 ft with 3-ft overhangs. Type C girders are used for four of five spans, with Type IV girders at the middle span.

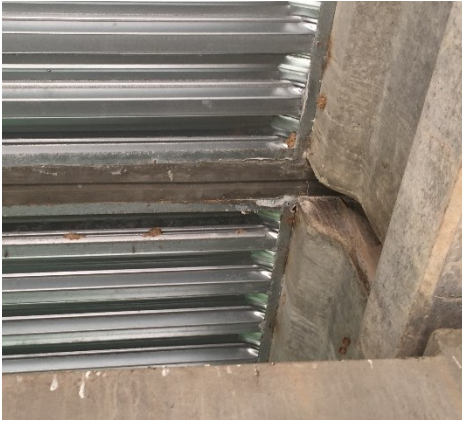
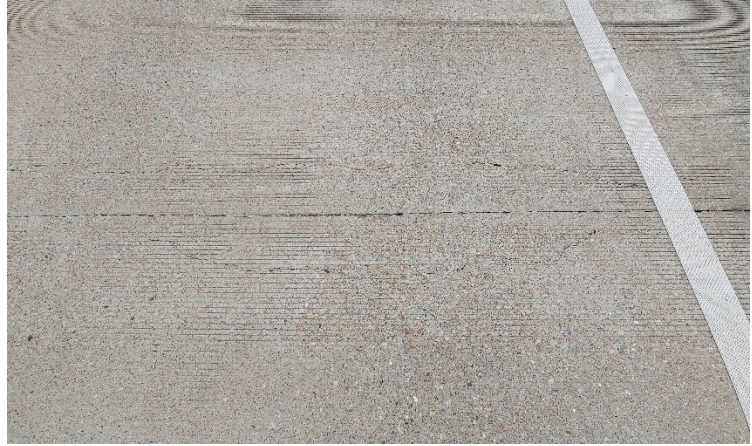
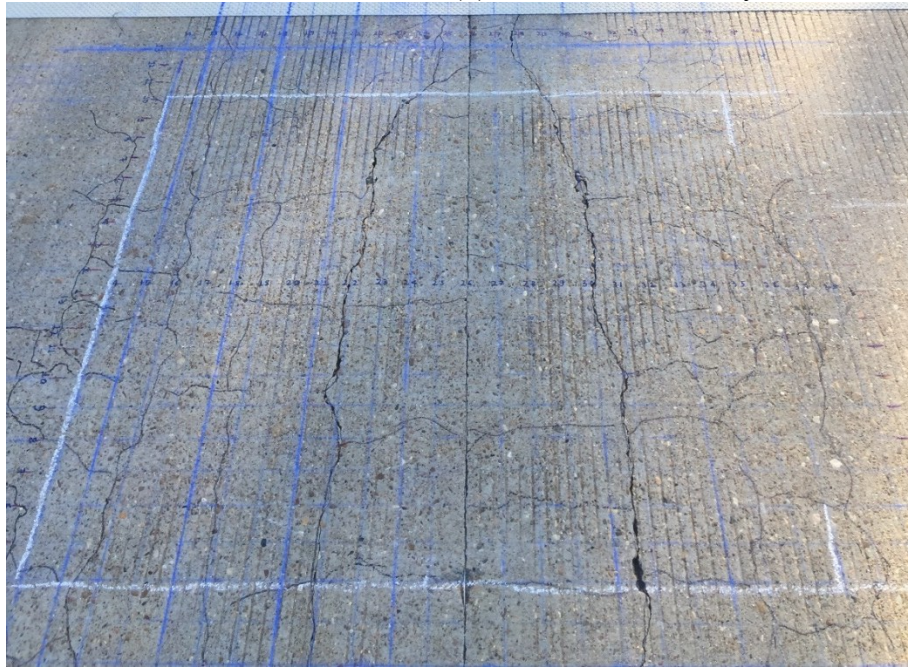
(a) PMDF at continuous deck

(b) Main and secondary PBJ cracks

(c) Cracks in NDE region

**Figure 4.18. Typical link slab condition for Bridge ATL3 (FM 154 over Little Cypress Bayou).**

Visual inspection of the bridge confirmed the damage indicated in the inspection reports, with all PBJ regions having similar damage characteristics. Figure 4.18 shows the condition of the PMDF below the continuous deck and the pattern of cracking on the top of the deck. Efflorescence was observed at the ends of the girders, and small gaps in the PMDF were present below the location of the main PBJ crack. Otherwise, the PMDF was in good condition with no indication of rust.

Figure 4.18(b) shows the main and secondary PBJ cracks typical of all continuous deck joints. The main PBJ crack was formed with a zip strip that was still located in the deck. There was moderate spalling along the main crack, larger than observed in the other bridges inspected in the Atlanta District. The location of the secondary cracks relative to the main PBJ crack varied, occurring as close as 5 in. at the girders or as far as 11 in. between the girders. The width of the secondary cracks varied from 0.020–0.025 in. and was smallest over the girders. Similar crack patterns were observed in the overhang, but the widths were 0.014–0.016 in. Figure 4.18(c) shows the marked cracks in the NDE region. In addition to the main and secondary PBJ cracks, cracking was consistent with the rest of the deck, with most of the cracks being longitudinal cracks and measuring as hairline cracks.

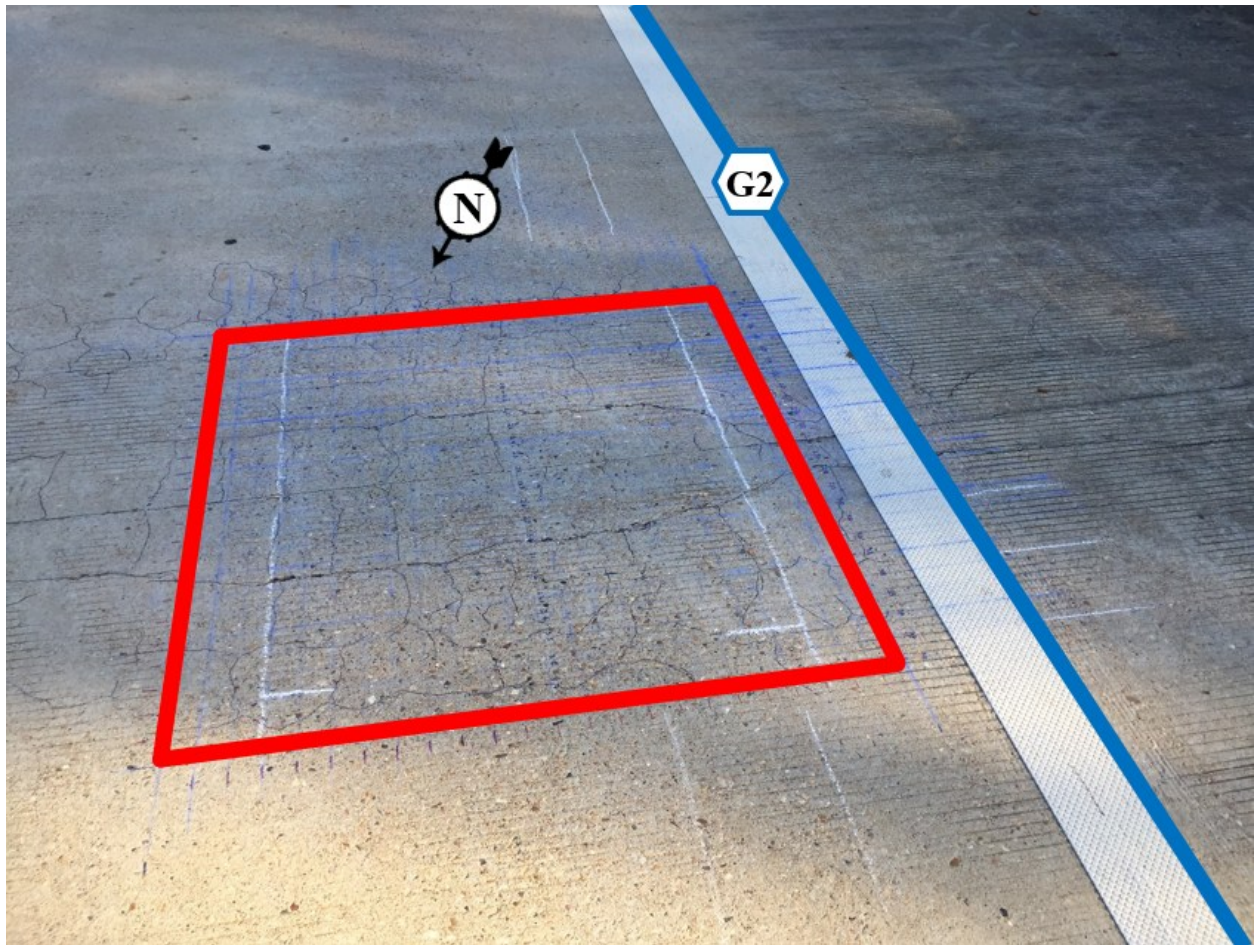
**Figure 4.19. NDE region at Bent 3 for Bridge A3 (FM 154 over Little Cypress Bayou).**

The NDE region was a 4-ft by 4-ft region at Bent 3, shown in Figure 4.19, located in the east/southbound lane. The region was centered on the main PBJ crack and captured both secondary cracks, plus an extension beyond the secondary cracks.

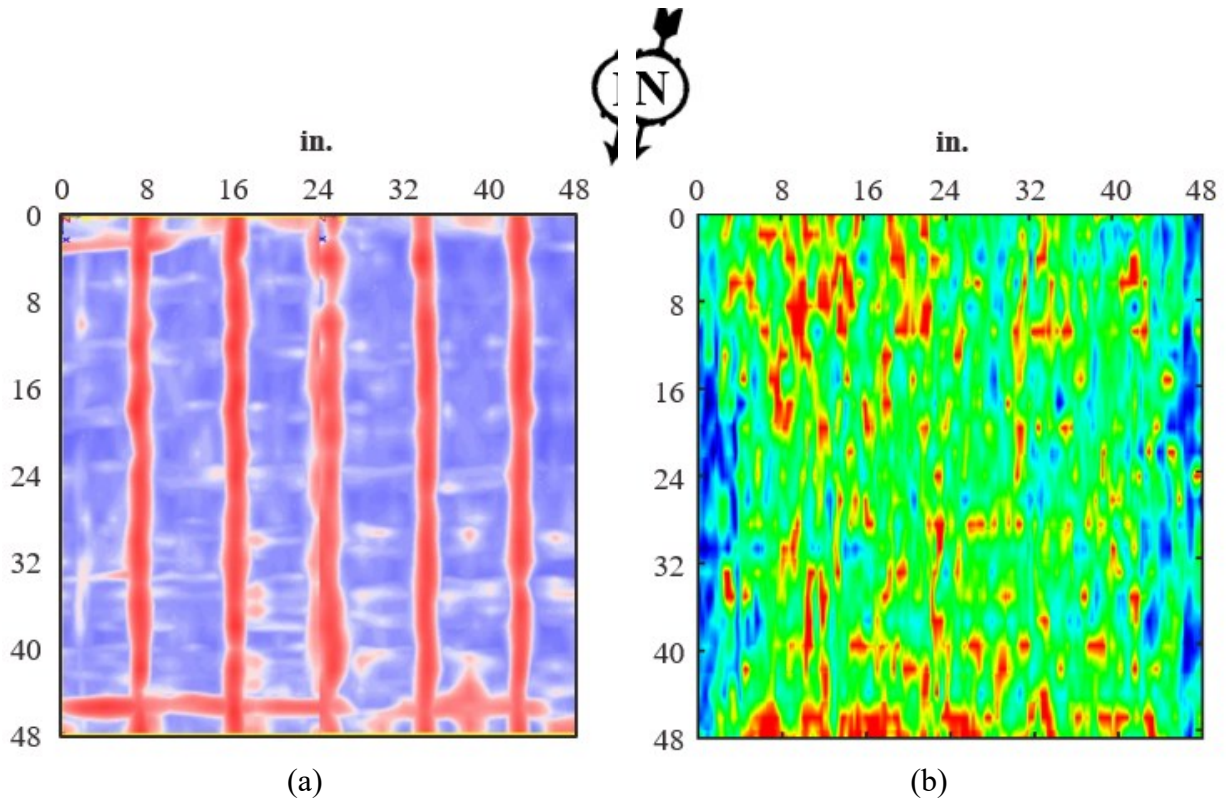
**Figure 4.20. ATL3 results for (a) GPR and (b) UST of top longitudinal reinforcement at depth 2.72 in.**

Figure 4.20 and Figure 4.21 confirm the spacing of top longitudinal and transverse reinforcement in the as-built drawings as 9 in. and 6 in., respectively. Figure 4.22 and Figure 4.23 confirm the reinforcement spacing for the bottom reinforcement, but it is less distinct due to interference from the PMDF, which is identifiable in Figure 4.24(b). Using the IR camera, differences in heat at the PBJ over the girders and between the girders are visible. However, no evidence of voids or delaminations was discovered using IR images.

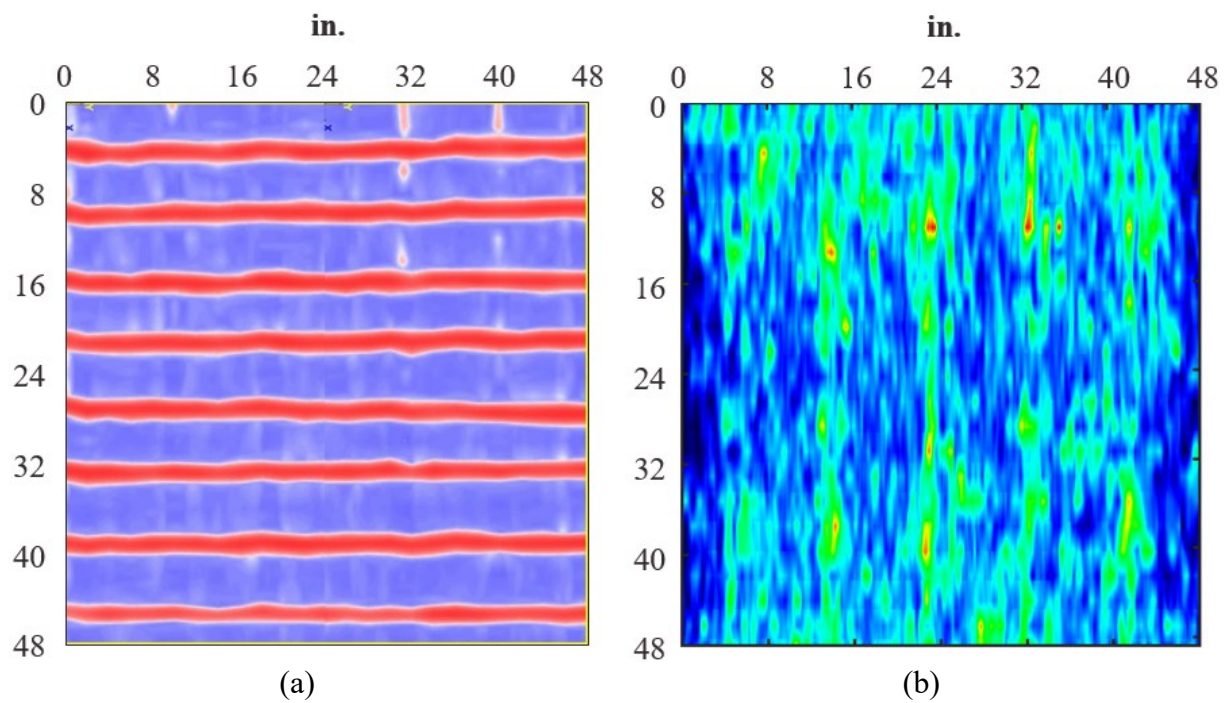
**Figure 4.21. ATL3 results for (a) GPR and (b) UST of top transverse reinforcement at depth 1.98 in.**

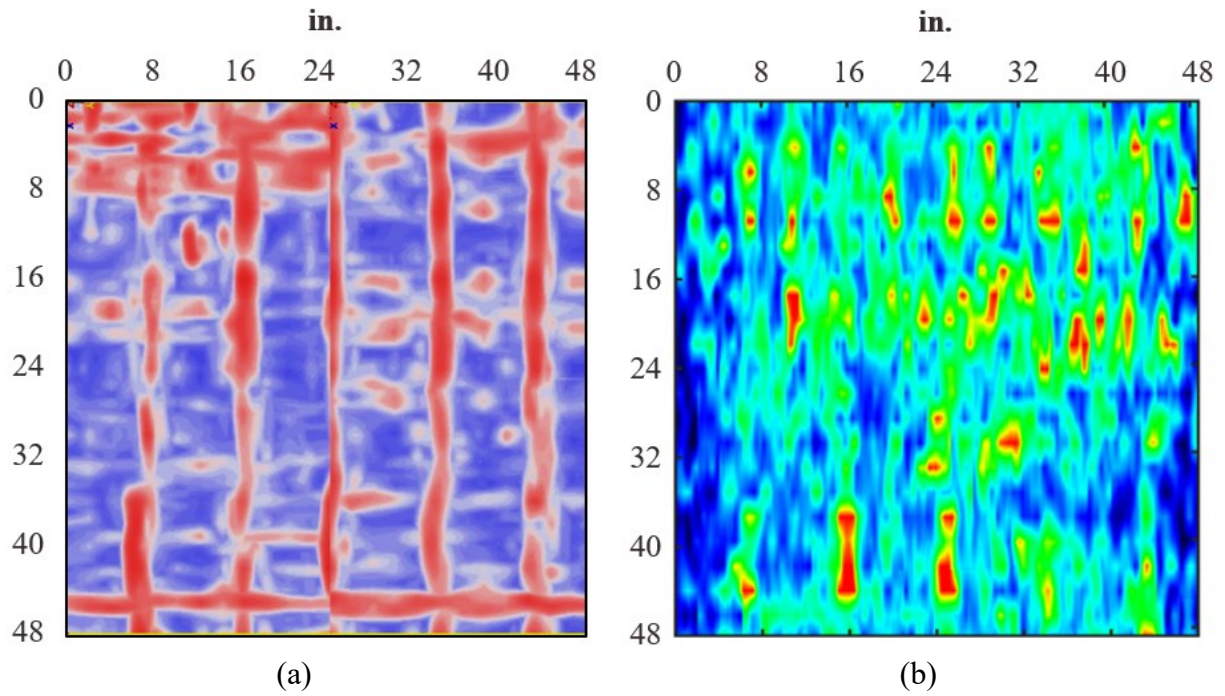
**Figure 4.22. ATL3 results for (a) GPR and (b) UST of bottom longitudinal reinforcement at depth 5.98 in.**

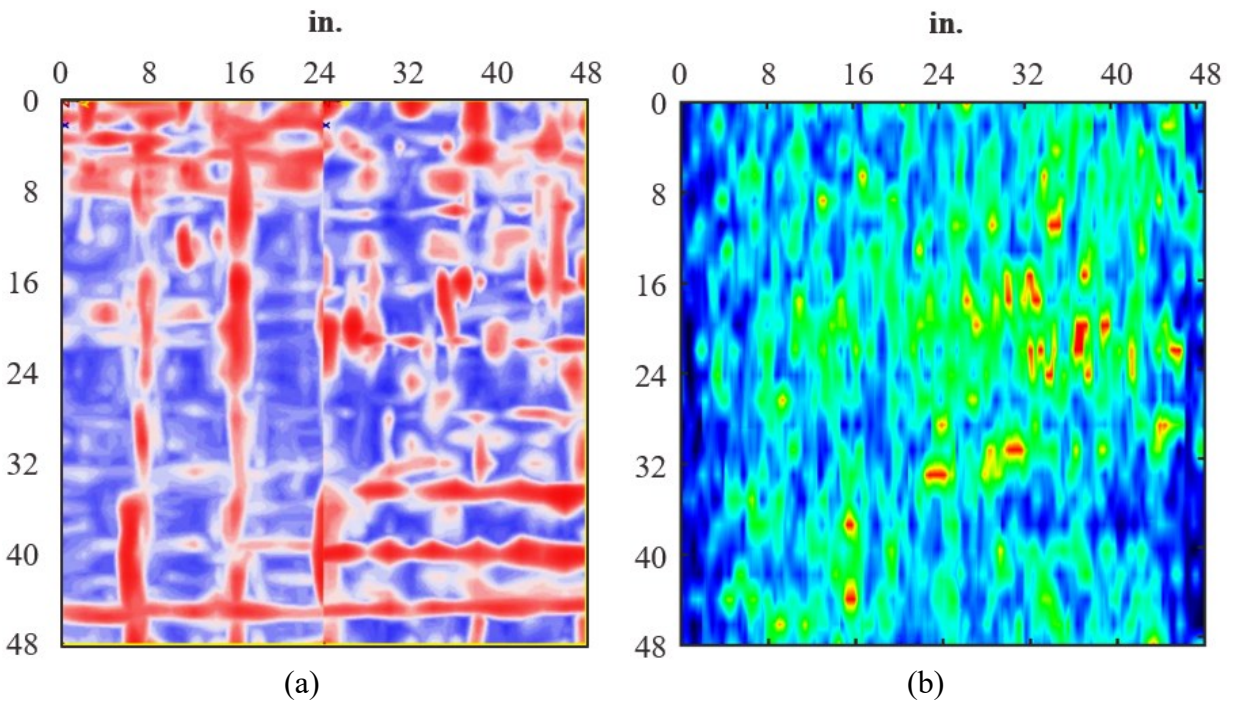
**Figure 4.23. ATL3 results for (a) GPR and (b) UST of bottom transverse reinforcement at depth 5.48 in.**

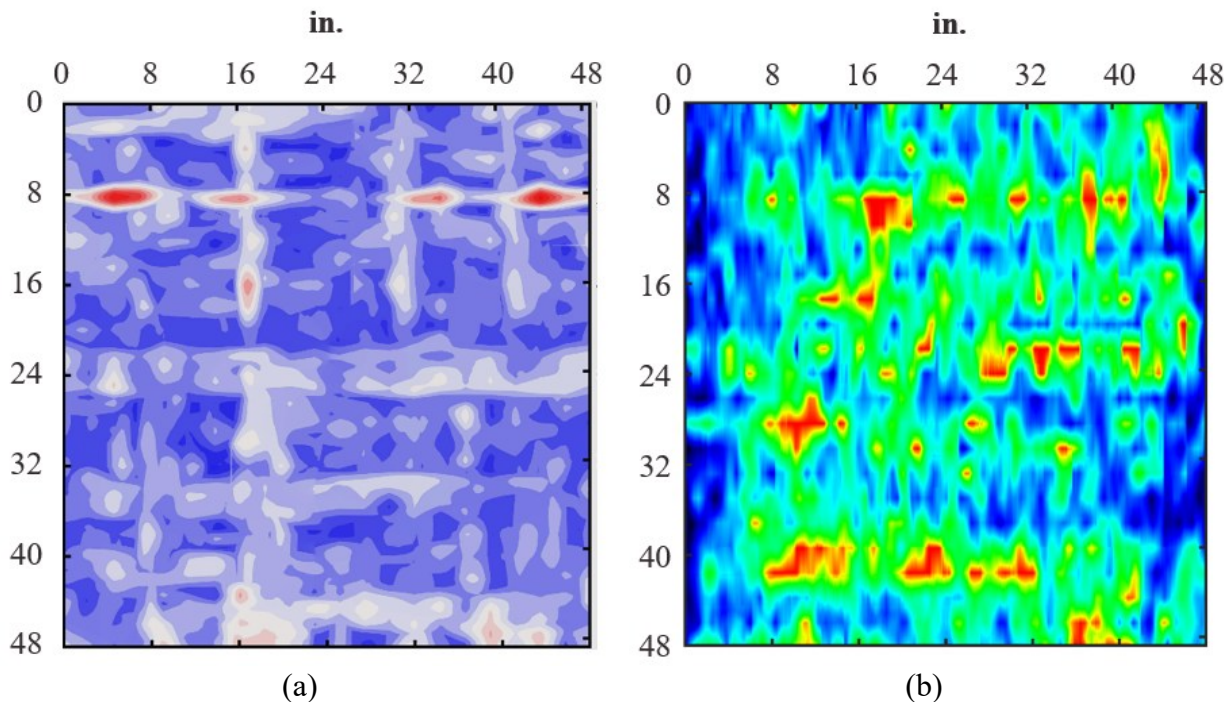
**Figure 4.24. ATL3 results for (a) GPR and (b) UST of the PMDF at depth 8.5 in.**

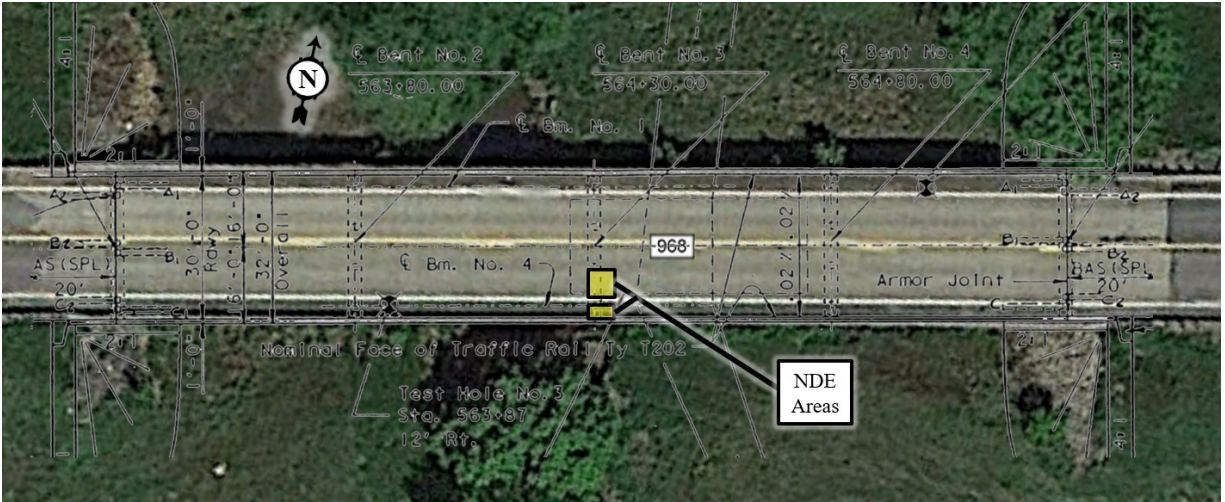
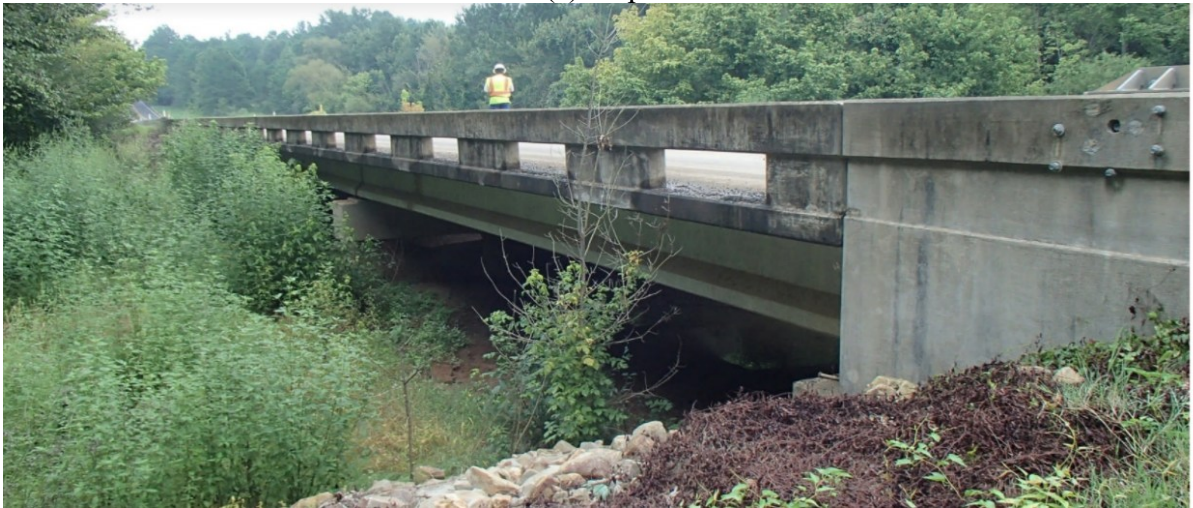
(a) Top view

(b) Side view

**Figure 4.25. Site conditions at Bridge ATL4 (FM 968 over Clarks Creek).**

Bridge ATL4, shown in Figure 4.25, was built in 1996 and carries FM 968 over Clarks Creek near Longview, Texas. The 32-ft wide bridge has two lanes on four Type B prestressed concrete I-girders spaced at 8 ft 8 in. with 3-ft overhangs.

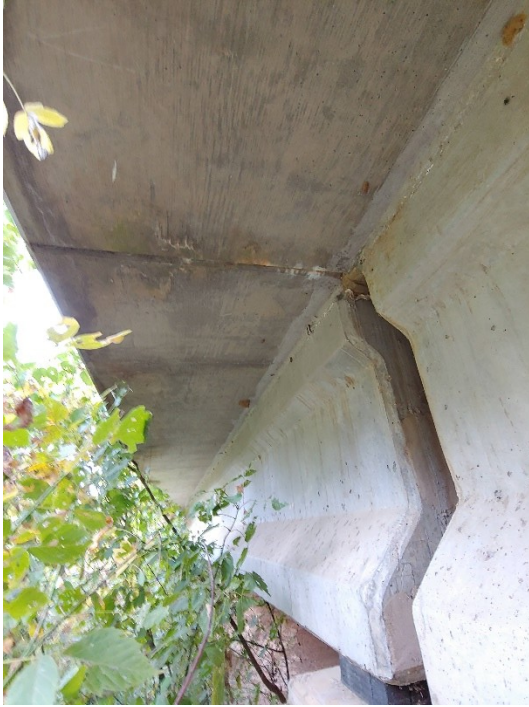
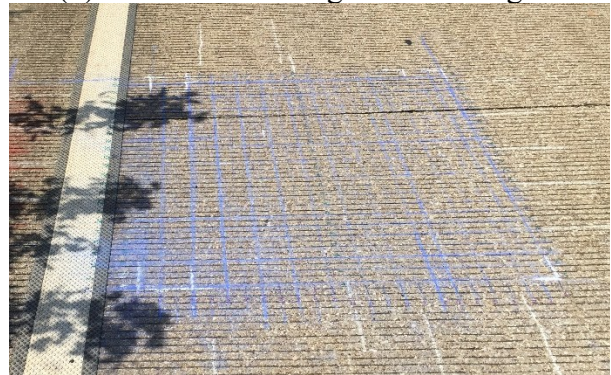
(a) Bottom of overhang

(b) Bottom of CIP region between girders

(c) Main PBJ crack

(d) Main NDE region

**Figure 4.26. Typical link slab condition for Bridge ATL4 (FM 968 over Clarks Creek).**

Visual inspection indicated that the condition of the three continuous deck regions was similar, and while the PBJs were overall in great condition, there was some very minor damage not indicated in the inspection report. Minor efflorescence was observed on the overhang shown in Figure 4.26(a). Between the girders, link slabs were in excellent condition, without any visible cracks or other damage, as shown in Figure 4.26(b). Visual observations on the top side indicated that some longitudinal cracks were present in the NDE region. The cracks were mostly hairline and measured 0.007 in. at the most. Zip strips were used to form the main PBJ crack. The extent of cracking and spalling along the main PBJ crack was much less than observed in other bridges evaluated. Figure 4.26(d) shows the marked cracks in the NDE region. Secondary PBJ cracks formed at approximately the end of the portion of the deck where PMDFs were used. The secondary PBJ cracks were 0.014–0.016 in. wide in the NDE region. Hairline cracks were present in the link slab region and in the main deck, and they were primarily longitudinal, with an occasional transverse crack.

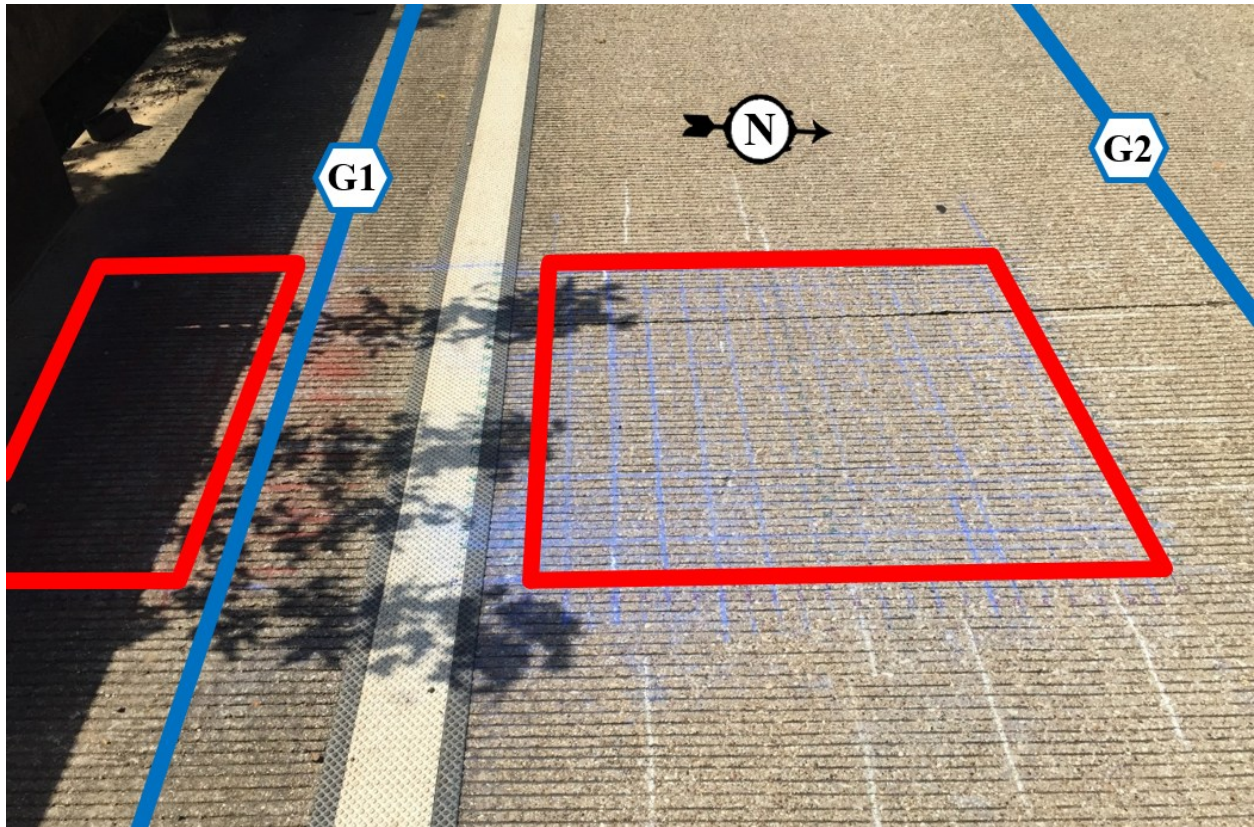
Figure 4.27. NDE region at Bent 3 for Bridge ATL4 (FM 968 over Clarks Creek).

The NDE regions are shown in Figure 4.27. The main NDE region was a 4-ft by 4-ft region at Bent 2, located in the northbound lane and between G1 and G2. The region was off center relative to the main PBJ crack to capture the reinforcement at the main crack plus an extension beyond the CIP region.

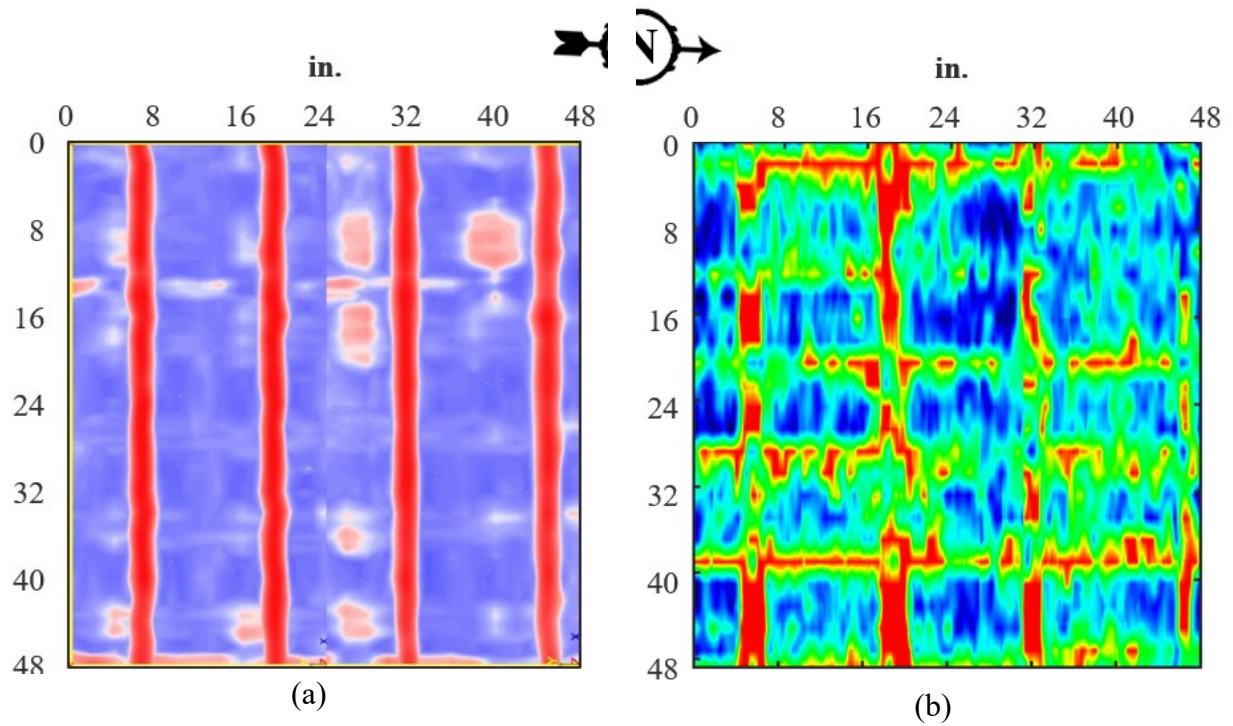
Figure 4.28. ATL4 results for (a) GPR and (b) UST of top longitudinal reinforcement between the girders at depth 4.95 in.

Figure 4.28 confirms the spacing of the top longitudinal reinforcement in the as-built drawings as 12 in. Figure 4.29, however, only shows transverse bars at 9.5 in. Transverse bent bars at 9.5-in. spacing were not found in GPR or UST images. Figure 4.30 and Figure 4.31 show that the reinforcement is deeper in the slab by approximately 1 in. at the PBJ than in the rest of the deck. A thickened CIP slab and a different depth of reinforcement at the PBJ are not specified in drawings or details. The spacing of the bottom longitudinal steel, seen in Figure 4.31(a), is approximately 7 in., which is a reasonable value given that bottom longitudinal steel is not shown on drawings as being placed over the girder lines and is instead clustered between the girder lines.
