# Performance and Improvement of Texas Poor Boy Continuous Bridge Deck Details: Final Report

Technical Report 0-7013-R1

TEXAS A&M TRANSPORTATION INSTITUTE  
COLLEGE STATION, TEXAS

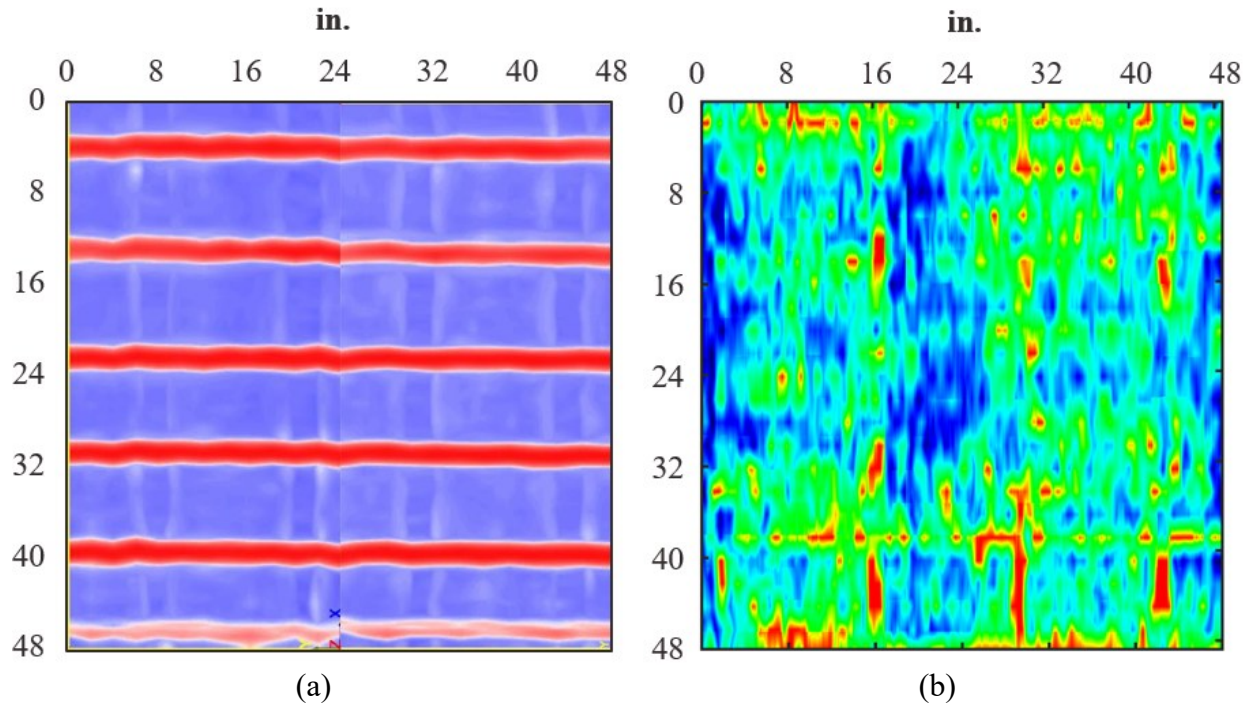
**Figure 4.29. ATL4 results for (a) GPR and (b) UST of top transverse reinforcement between the girders at depth 3.95 in.**

Figure 4.28 confirms the spacing of the top longitudinal reinforcement in the as-built drawings as 12 in. Figure 4.29, however, only shows transverse bars at 9.5 in. Transverse bent bars at 9.5-in. spacing were not found in GPR or UST images. Figure 4.30 and Figure 4.31 show that the reinforcement is deeper in the slab by approximately 1 in. at the PBJ than in the rest of the deck. A thickened CIP slab and a different depth of reinforcement at the PBJ are not specified in drawings or details. The spacing of the bottom longitudinal steel, seen in Figure 4.31(a), is approximately 7 in., which is a reasonable value given that bottom longitudinal steel is not shown on drawings as being placed over the girder lines and is instead clustered between the girder lines.

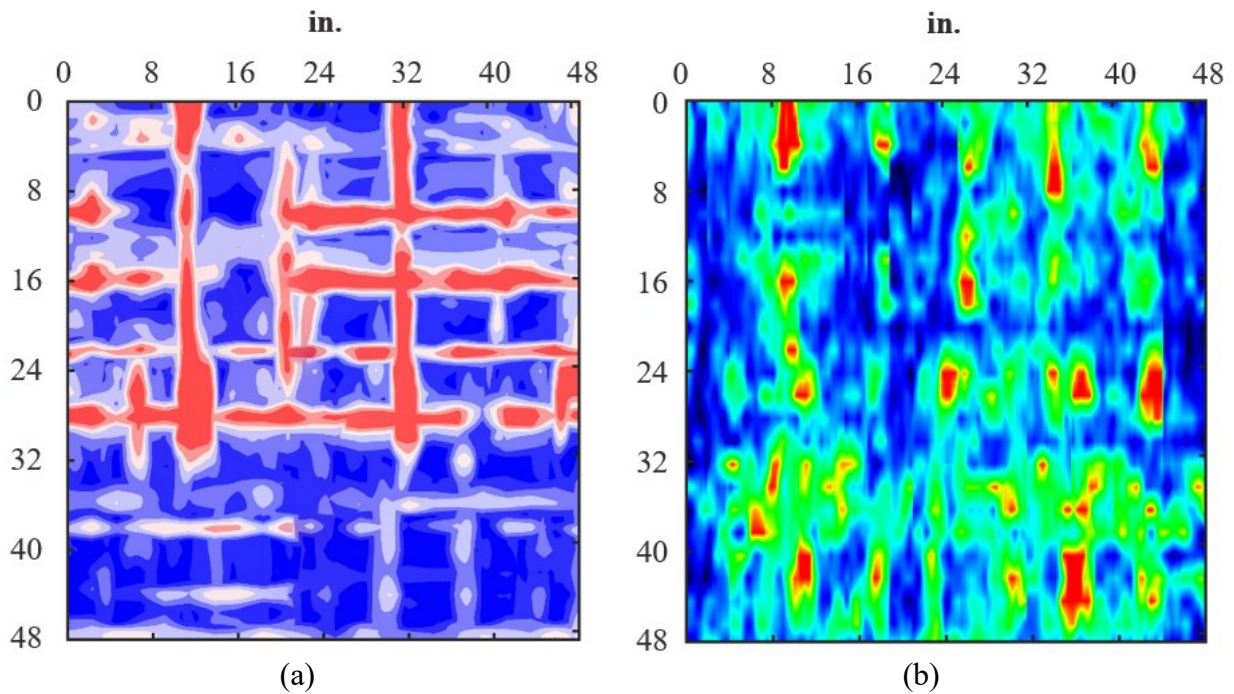
**Figure 4.30. ATL4 results for (a) GPR and (b) UST of bottom reinforcement between the girders at depth 8.48 in.**

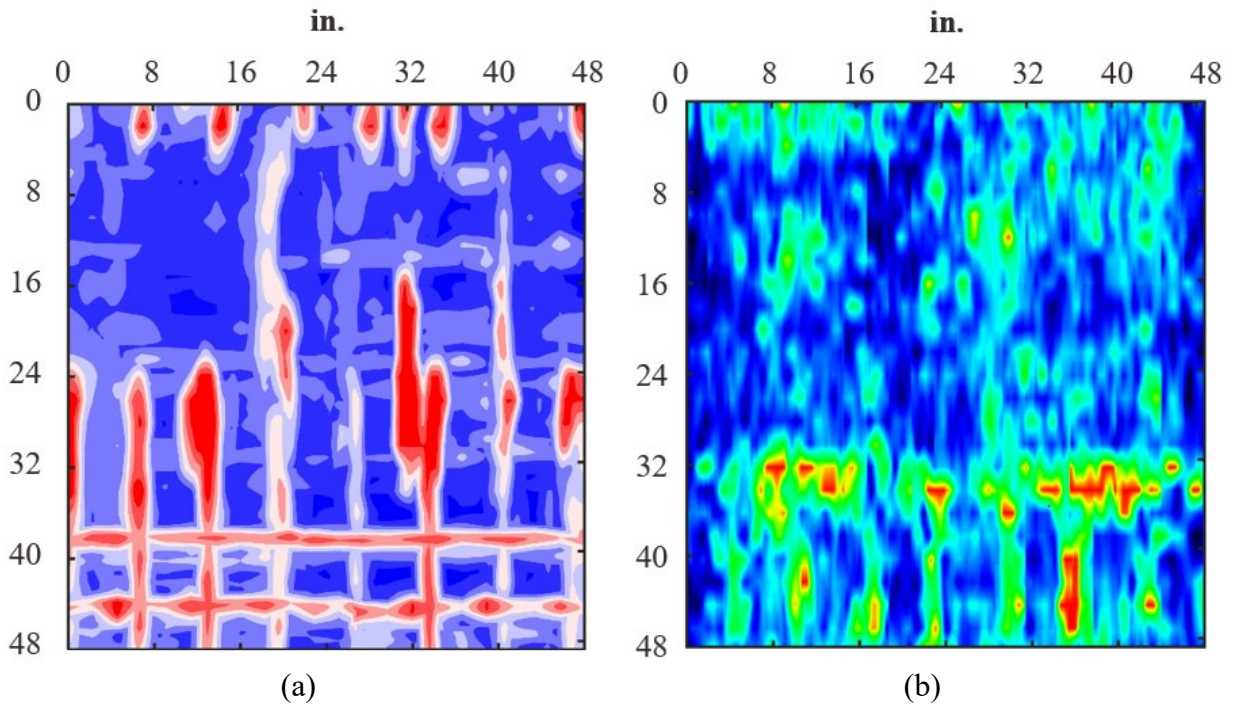
**Figure 4.31. ATL4 results for (a) GPR and (b) UST of bottom reinforcement between the girders at depth 7.48 in.**

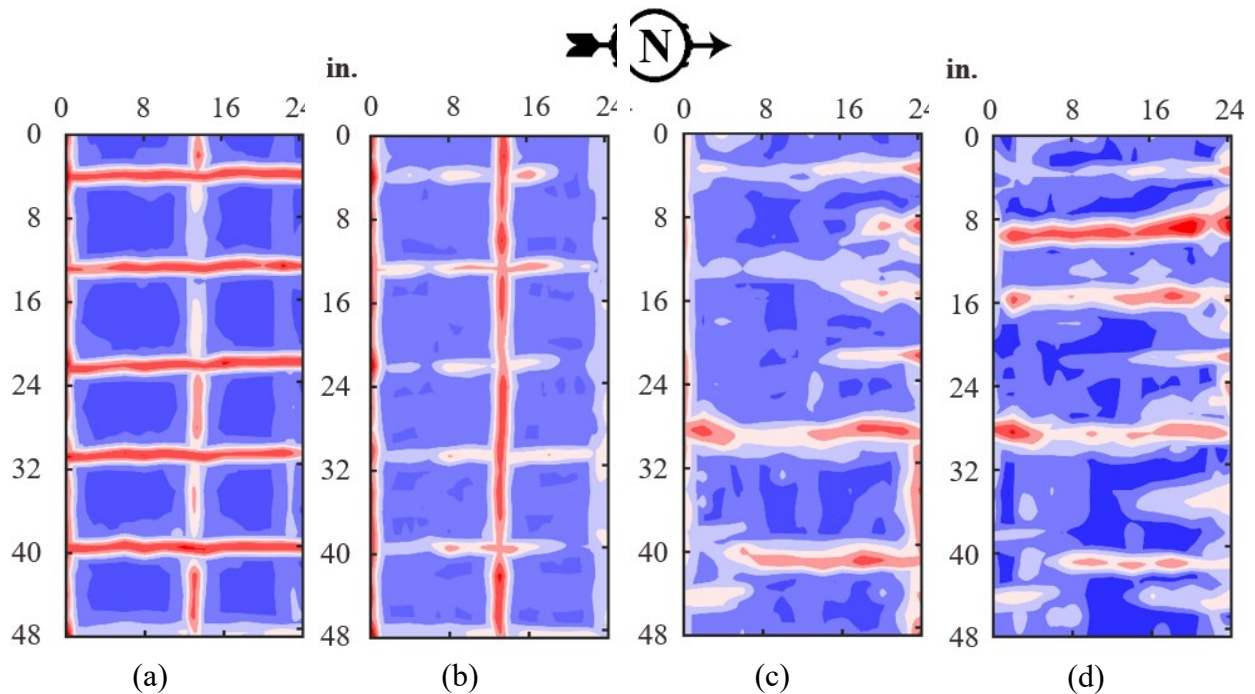
**Figure 4.32. ATL4 GPR results in the overhang for (a) top transverse reinforcement at depth 4.23 in., (b) top longitudinal reinforcement at depth 4.98 in., (c) bottom reinforcement at 8.23 in., and (d) bottom reinforcement at 8.73 in.**

Figure 4.32 shows GPR images of the reinforcement placement in the overhang NDE region. Figure 4.32(a) and (b) show similar top-layer reinforcement spacing as in the primary NDE region between the girders. Figure 4.32(c) and (d), however, are less conclusive for the bottom reinforcement but still show that bottom transverse reinforcement appears to be placed deeper in the PBJ region. No evidence of voids or delaminations was discovered using IR images.

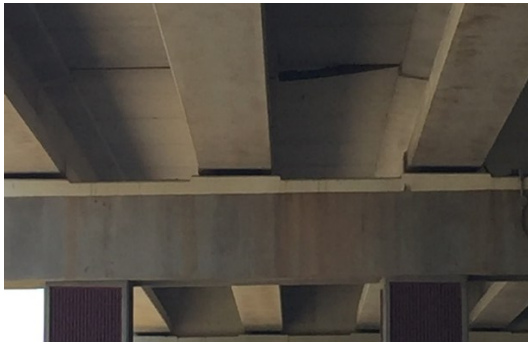
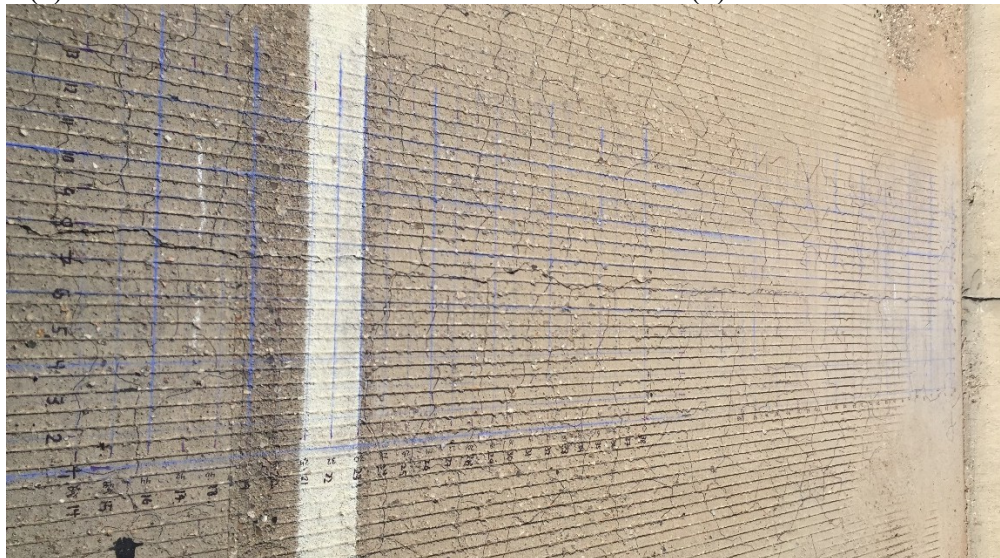
(a) CIP deck between northbound and southbound lanes

(b) Cracking and efflorescence in overhang

(c) Panels at interior bent

(d) Main PBJ crack

(e) Marked cracks in NDE regions

**Figure 4.34. Typical link slab condition for Bridge LUB1 (SB Loop 289 over Slide Rd./4th St.).**

Bridge LUB1, shown in Figure 4.33, was built in 2010 and carries the southbound lanes of Loop 289 over Slide Rd./4th St. in Lubbock, Texas. The 58-ft 6-in. wide bridge has three lanes on eight Tx46 prestressed concrete I-girders spaced at 7.5 ft with 3-ft overhangs; a center barrier is shared with the adjacent bridge carrying northbound lanes, and a CIP region of deck connects the two bridges (Figure 4.34a).

Visual inspection of the bridge confirmed the inspection report damage, and the condition of all continuous deck regions was similar. Figure 4.34 shows representative conditions of the link slab regions. Visual observations below the deck indicated confirmed cracking and efflorescence in the CIP overhangs. While the PCPs were in excellent condition, the gap between flush panels had some material hanging loss, and water stains were clearly present on the bent caps. On the top of the deck, the extensive cracking was confirmed. The main PBJ crack formed naturally (no zip strip). Between girders, the maximum width was 0.030 in. In the overhang, the maximum width was 0.025 in. Minor spalling was present in several locations along the main PBJ crack. Aside from the main PBJ crack, extensive cracks were present in the link slab region and the overall deck. Most cracks were no larger than 0.008 in., but one longitudinal crack was measured as 0.012 in. and several other longitudinal cracks as 0.010 in. While there were no distinct secondary PBJ cracks spanning the width of the bridge, NDE Area #3 contained a large transverse crack located 35.625 in. from the main PBJ crack with a width of 0.016–0.025 in.

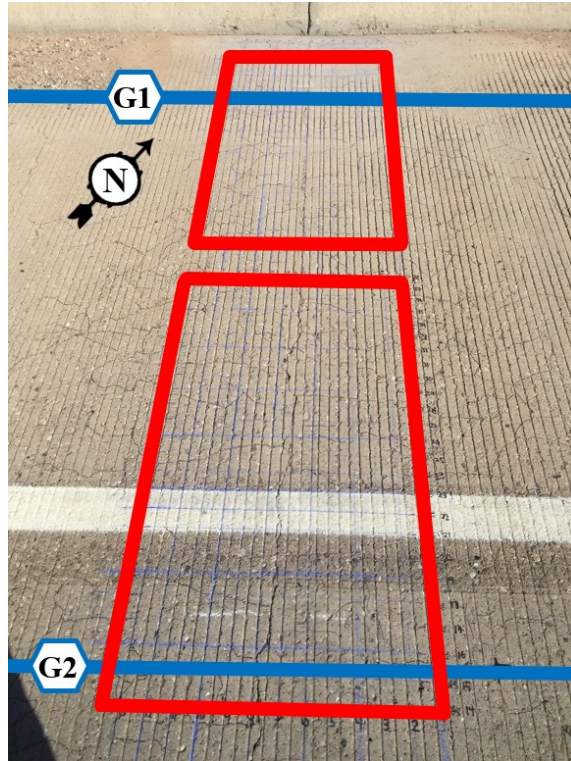
**Figure 4.35. Primary NDE regions (Region 1 and 2) at Bent 3 for Bridge LUB1 (SB Loop 289 over Slide Rd./4th St.).**

Three NDE regions were investigated, all in the outside lane/overhang over Bent 3. Region 1 is a 2-ft by 4-ft region centered on the main PBJ crack over G2 and between G2 and G1 (42-in. mark is centered over G2). Region 2 is another 2-ft by 4-ft region centered over the main PBJ crack

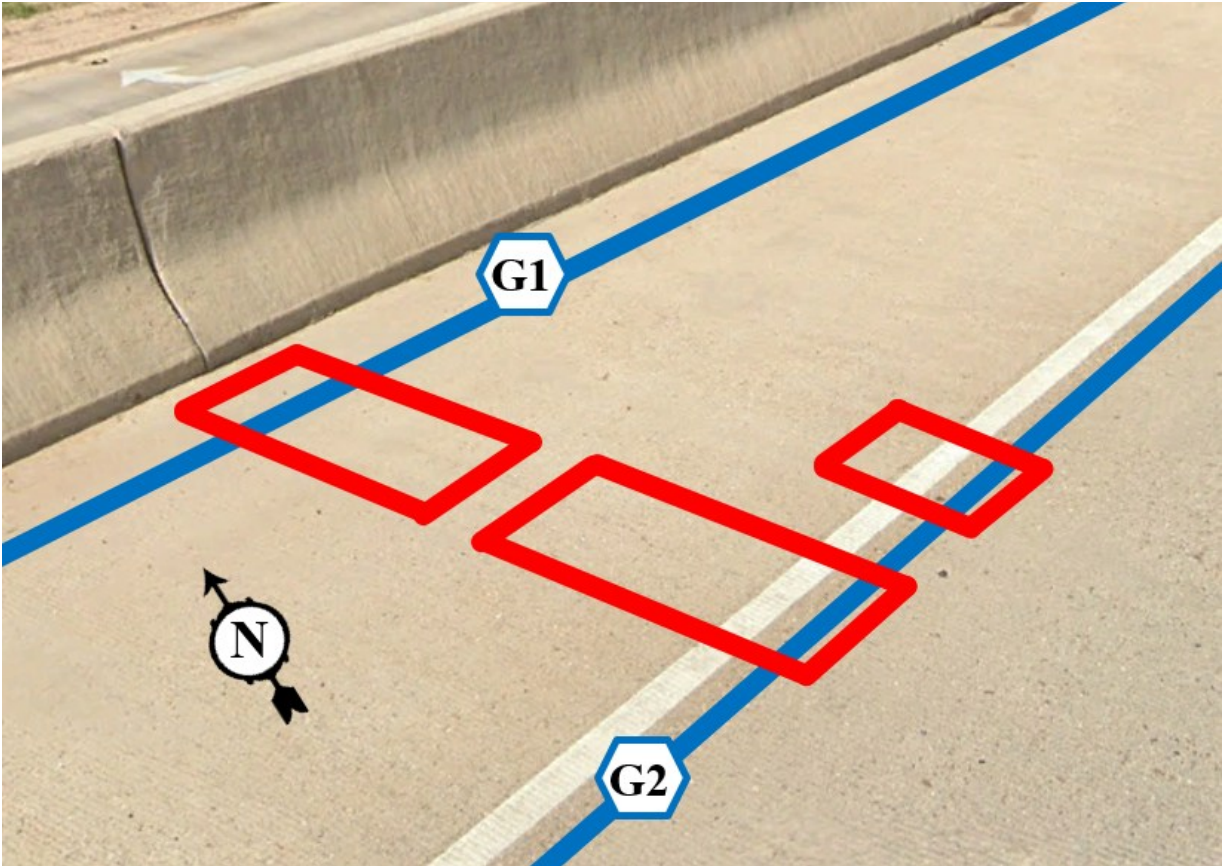
**Figure 4.36. Primary NDE regions (1 and 2) at Bent 3 for Bridge LUB1 (SB Loop 289 over Slide Rd./4th St.) with the smaller secondary NDE region (Region 3) east of the primary regions adjacent to G2.**

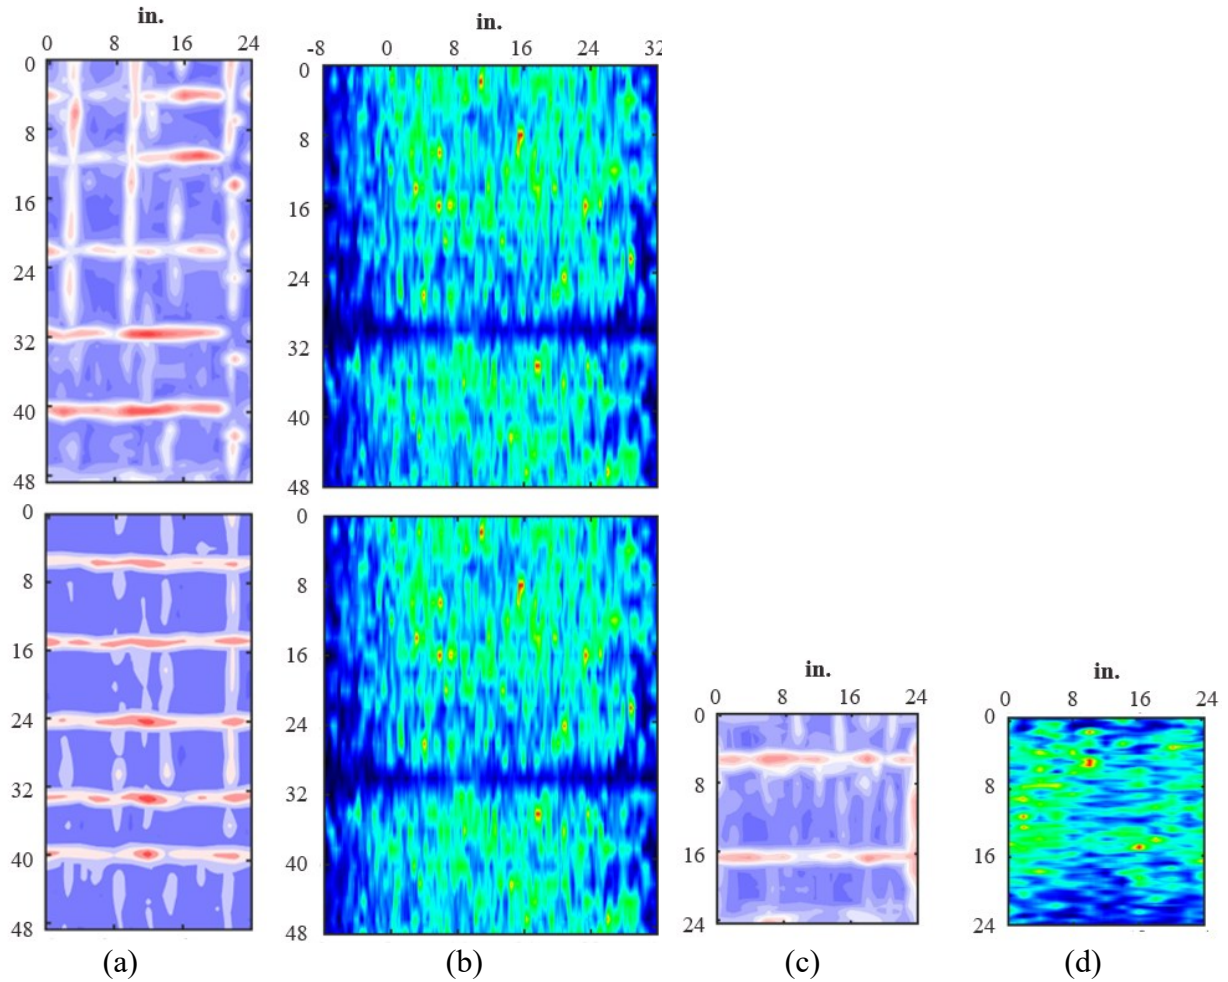
**Figure 4.37. LUB1 results for top longitudinal reinforcement at depth 3.73 in. for (a) GPR in NDE Regions 1 and 2, (b) UST in Regions 1 and 2, (c) GPR in Region 3, and (d) UST in Region 3.**

Figure 4.37 and Figure 4.38 confirm the spacing of the top longitudinal and transverse reinforcement in the as-built drawings as 9 in. and 6 in., respectively. Additionally, the dark horizontal areas in Figure 4.37(b), Figure 4.38(b), and Figure 4.39(b) at approximately 32 in. on the vertical axis appear to show a reflection caused by the edge of the girders. Figure 4.39 confirms that bottom longitudinal reinforcement is clustered between the girder lines, while bars are not placed directly over the girders, which is consistent with the design drawings. No evidence of voids or delaminations was discovered using IR images.

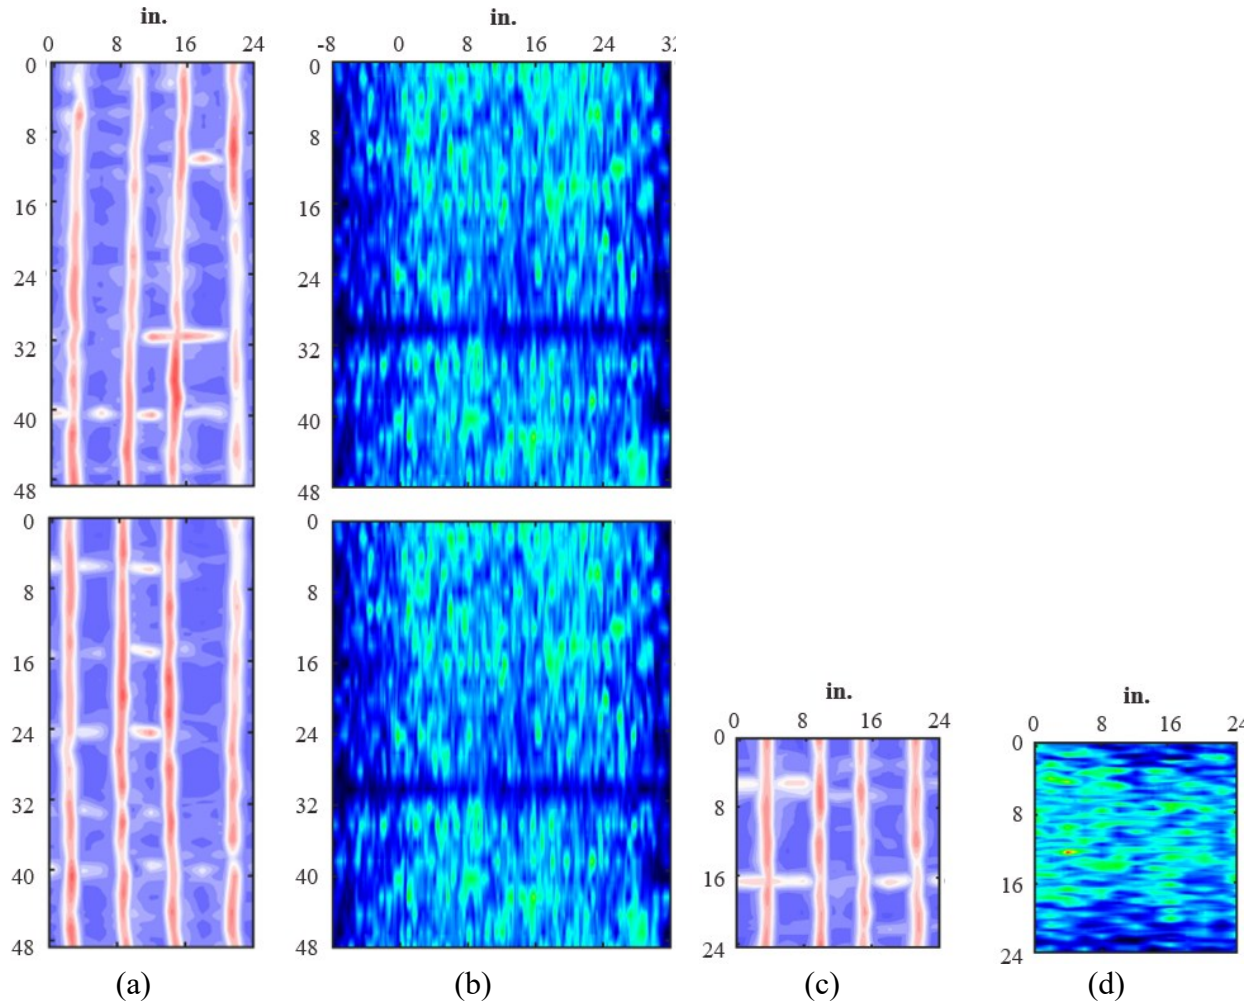
**Figure 4.38. LUB1 results for top transverse reinforcement at depth 2.73 in. for (a) GPR in NDE Regions 1 and 2, (b) UST in Regions 1 and 2, (c) GPR in Region 3, and (d) UST in Region 3.**

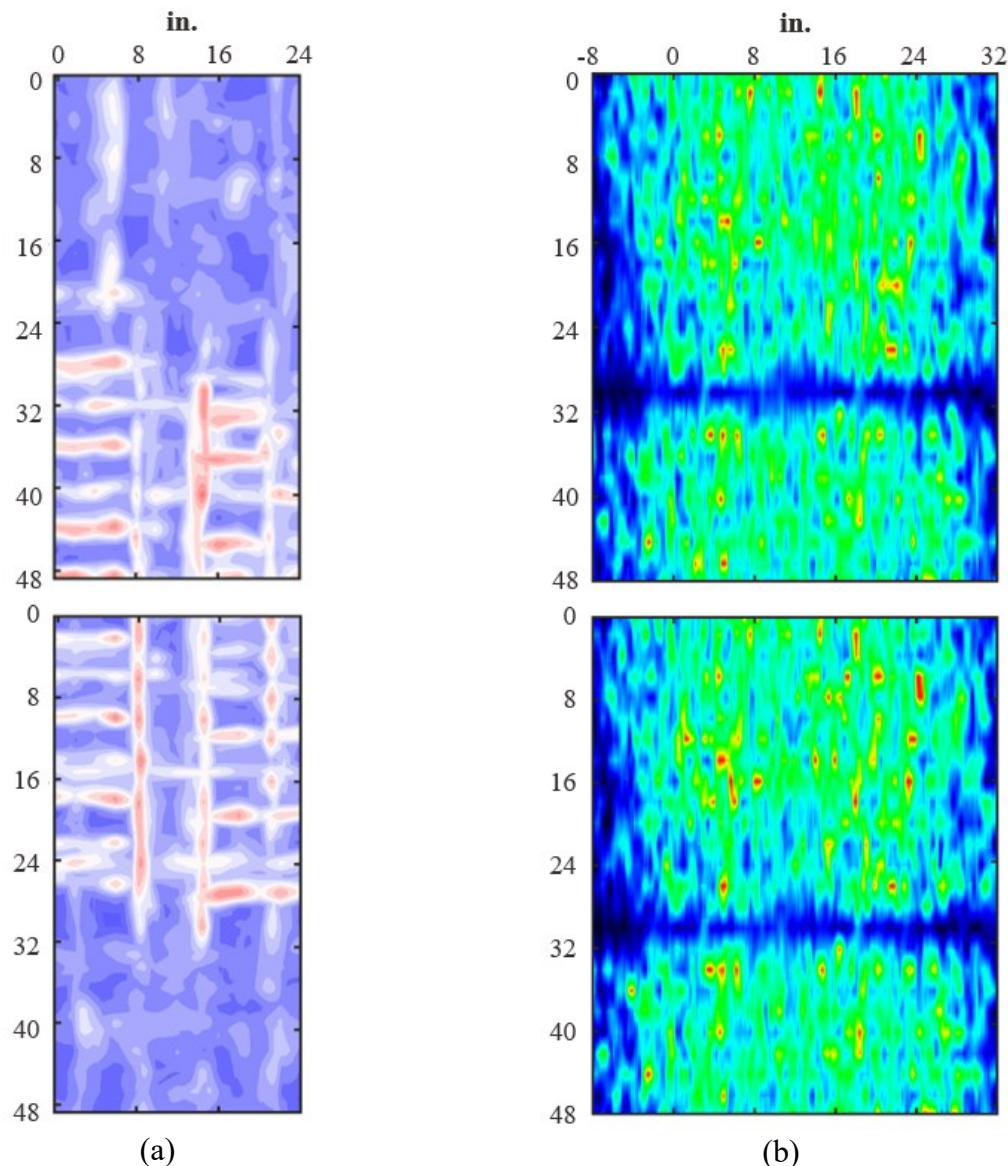
**Figure 4.39. LUB1 results for bottom reinforcement at depth 6.98 in. for (a) GPR in NDE Regions 1 and 2, and (b) UST in Regions 1 and 2.**

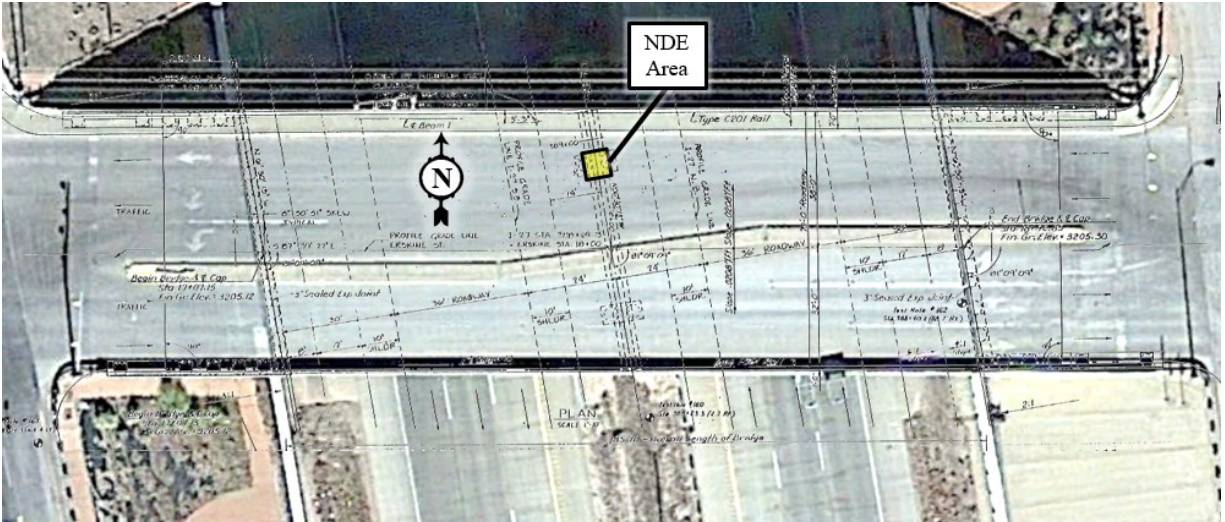
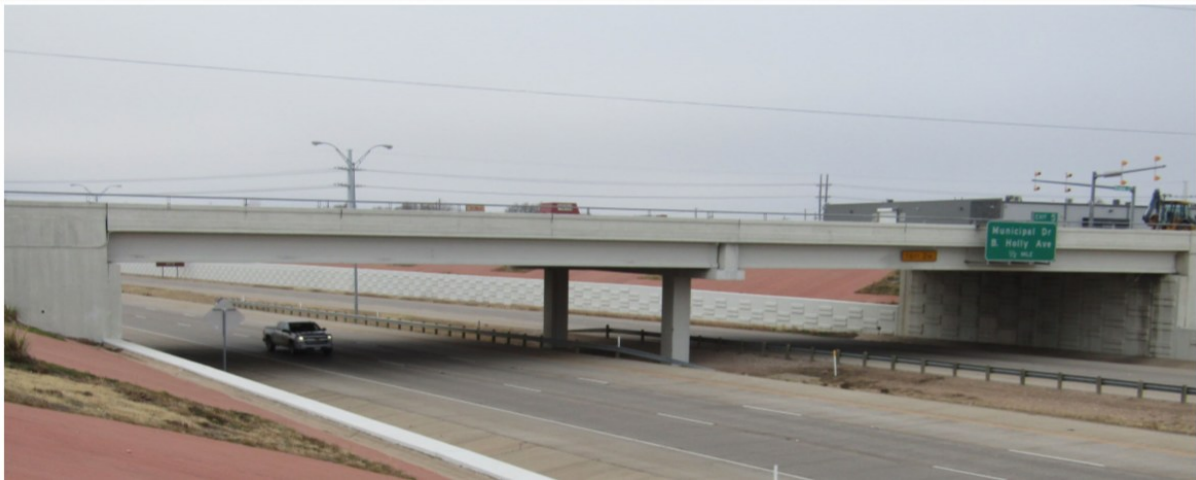
(a) Top view

(b) Elevation view

**Figure 4.40. Site conditions at Bridge LUB2 (Erskine St. over I-27).**

Bridge LUB2, shown in Figure 4.40, was built in 1990 and carries Erskine St. over I-27 in Lubbock, Texas. The 72-ft wide bridge has five lanes (two continuous each direction with a split turn lane) on 10 Type 54 prestressed concrete I-girders spaced at 7.333 ft with 3-ft overhangs. A 7-ft wide, 1-ft 2.5-in. thick (beyond the thickness of the deck) sidewalk is located on the westbound side of the bridge. The bridge is 185.7 ft long and is made up of two 92.85-ft simple spans forming one continuous deck unit with poor boy continuous deck regions providing deck continuity over interior supports. The interior bent is an inverted-T bent cap with a stem width of 2.5 ft. Expansion joints separate the unit from the abutment.

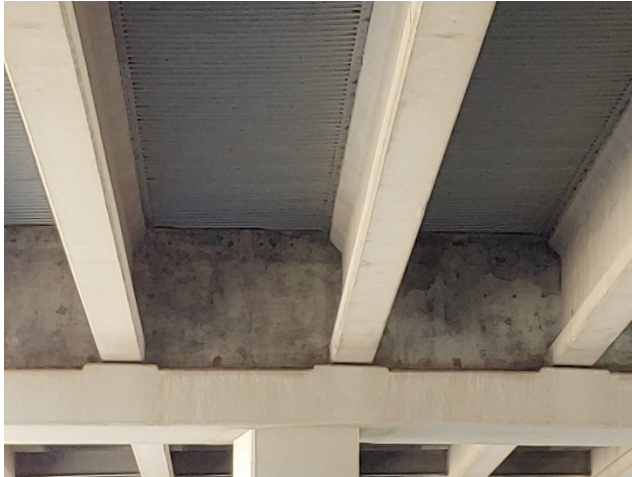
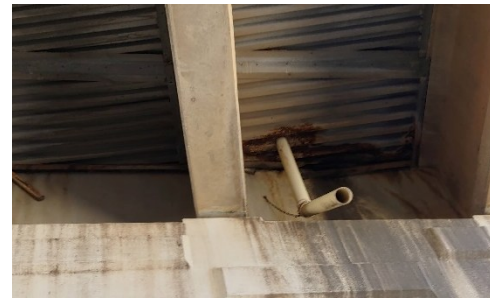
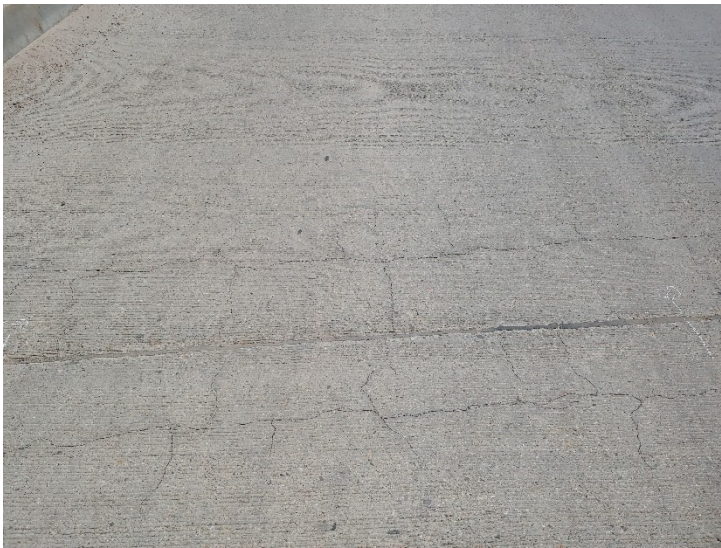
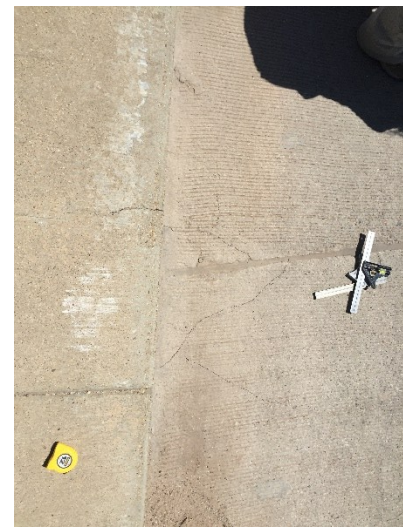
(a) Inverted-T bent cap and PMDF between girders

(b) Rusting PMDF on eastbound side

(c) Marked cracks in NDE area

(d) Marked cracks adjacent to sidewalk

**Figure 4.41. Typical link slab condition for Bridge LUB2 (Erskine St. over I-27).**

Access below the bridge for visual inspection was limited; however, photographs taken from the shoulder of I-27 show spalling at the tops of the stems (Figure 4.41a). The bridge was sloped down toward the eastbound lane. At the time of visual inspection, water had pooled against the rail over the bent. Visual inspection below the bridge revealed dusting of the PMDF around and adjacent to a drainpipe (Figure 4.41[b]). Figure 4.41(c) shows the cracking at the top of the deck. Significant spalling was present along the main PBJ crack. The main PBJ had been formed at the time of construction (wider than a zip strip) and was not measured. The secondary PBJs were 2 ft 6 in. apart, aligning with the edges of the inverted-T bent cap stem and measured 0.03 in. wide in a couple of locations within the NDE region but were mostly 0.01–0.014 in. wide. Other transverse cracks in the NDE region were no more than 0.006 in., and longitudinal cracks did not exceed 0.012 in. wide. Adjacent to the sidewalk, diagonal cracks formed as shown in Figure 4.41(d).

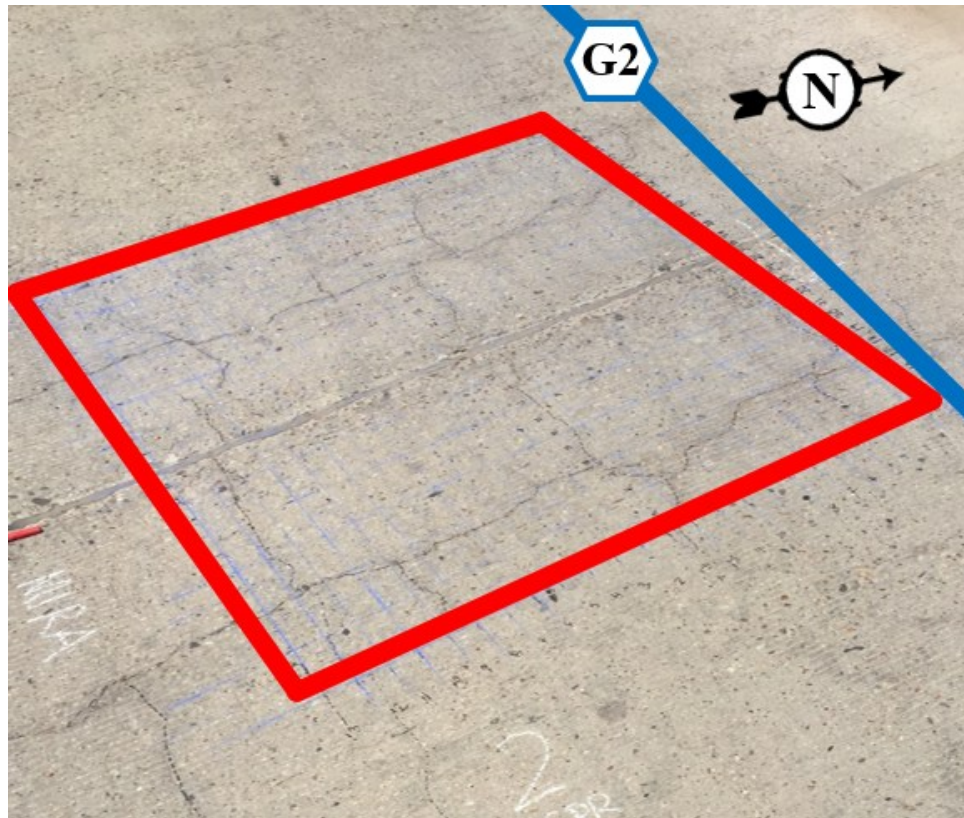
Figure 4.42. NDE region at Bent 2 for Bridge L2 (Erskine St. over I-27).

One 4-ft by 4-ft NDE region was investigated in the westbound lane between G2 and G3. The NDE area consisted of two adjacent 2-ft by 4-ft grids centered on the main PBJ crack and oriented perpendicular to the control joint. GPR was conducted in the full area. UST was conducted in a reduced area. Figure 4.42 shows the NDE region.

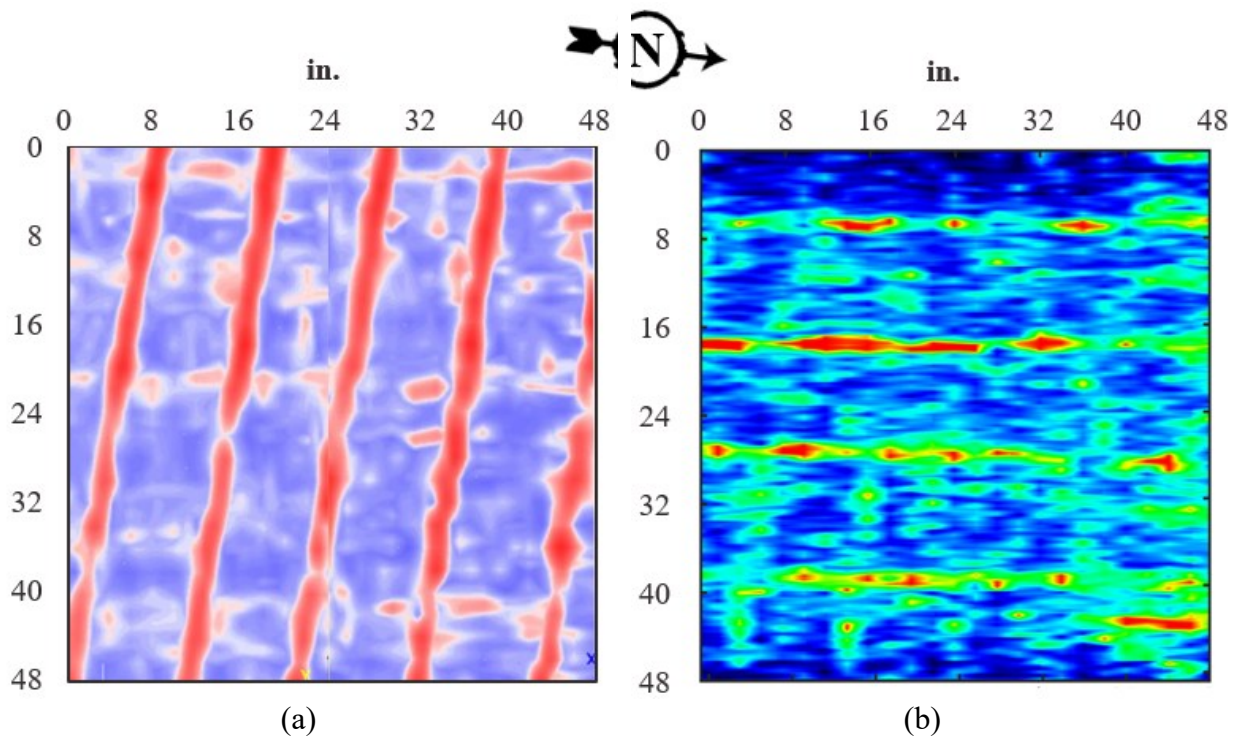
Figure 4.43. LUB2 results for (a) GPR and (b) UST of top longitudinal reinforcement at depth 3.48 in.

Figure 4.43 and Figure 4.44 confirm the specified top reinforcement spacing. The top end of the bent transverse bars can be seen on the right side of the GPR and UST images in Figure 4.44, spaced between the straight transverse bars. The bottom end of the same bent transverse bars can be seen on the left of the GPR image in Figure 4.45(a). The ribs of the PMDF are visible in the UST image in Figure 4.46(b). No evidence of voids or delaminations was not found on the deck.

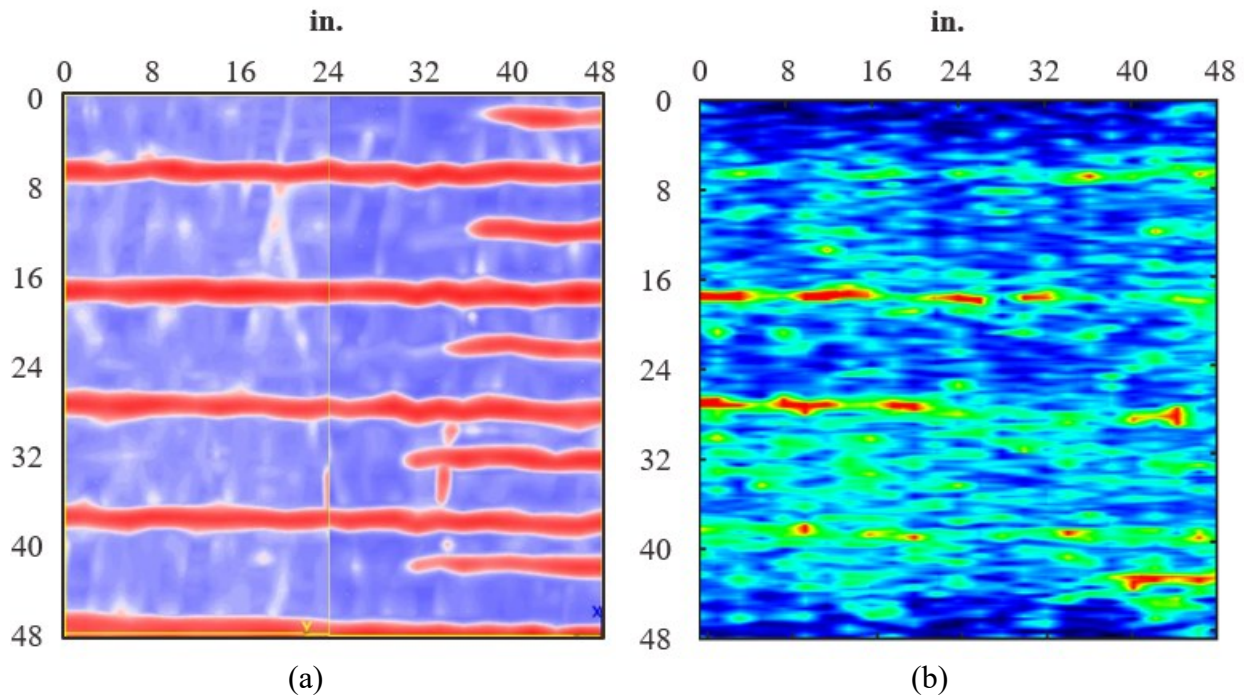
**Figure 4.44. LUB2 results for (a) GPR and (b) UST of top transverse reinforcement at depth 2.73 in.**

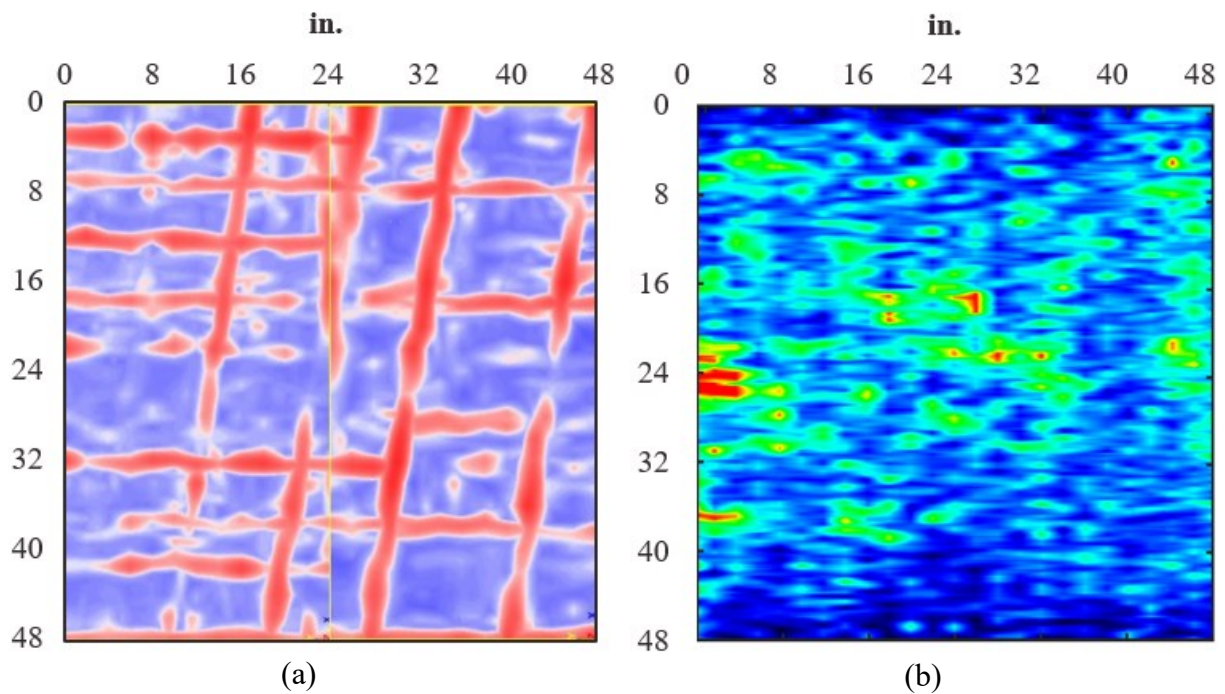
**Figure 4.45. LUB2 results for (a) GPR and (b) UST of bottom reinforcement at depth 5.73 in.**

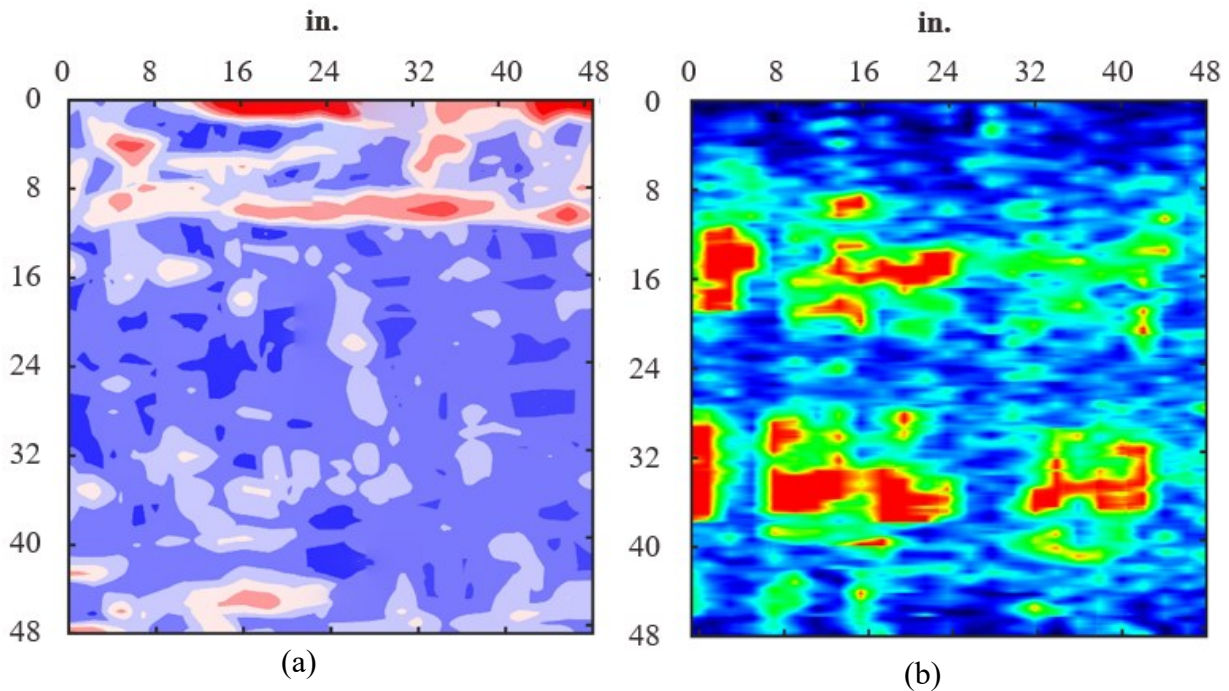
**Figure 4.46. LUB2 results for (a) GPR and (b) UST of PMDF at depth 8.5 in.**

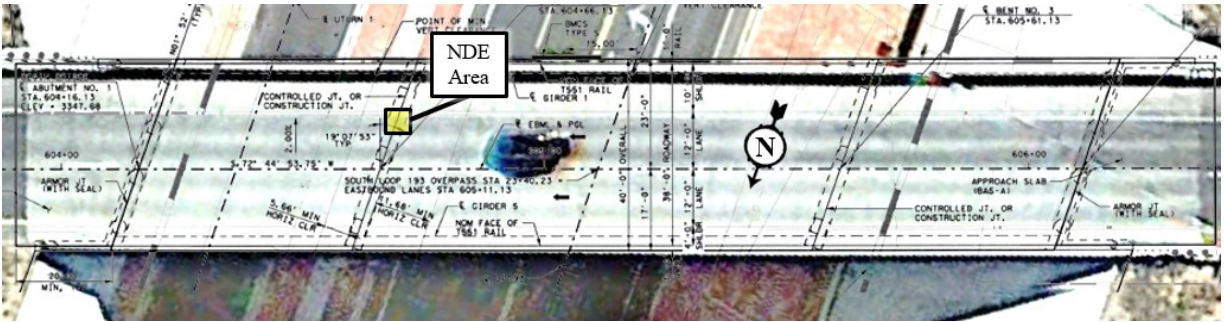
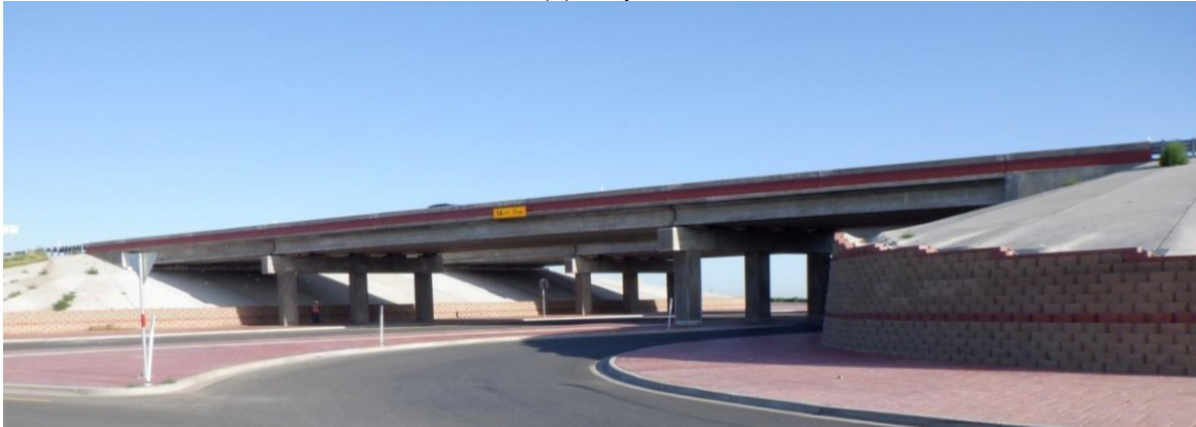
(a) Top view

(b) Elevation view

**Figure 4.47. Site conditions at Bridge LUB3 (US 62 over Research Blvd.).**

Bridge LUB3, shown in Figure 4.47, was constructed in 2017 and carries eastbound US 62 over Research Blvd. in Wolfforth, Texas. The 40-ft wide bridge has two lanes with a 10-ft exterior shoulder on five Tx40 prestressed concrete I-girders spaced at 8.5 ft with 3-ft overhangs.

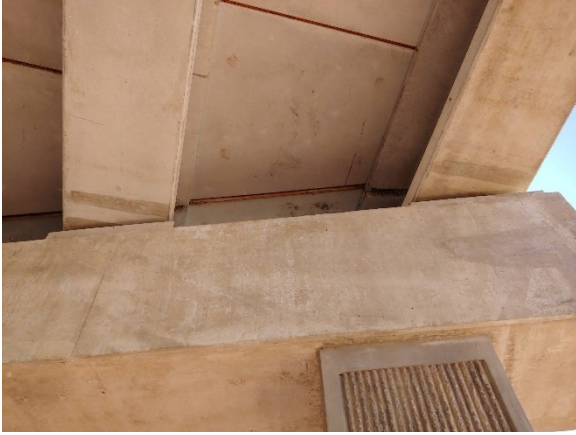
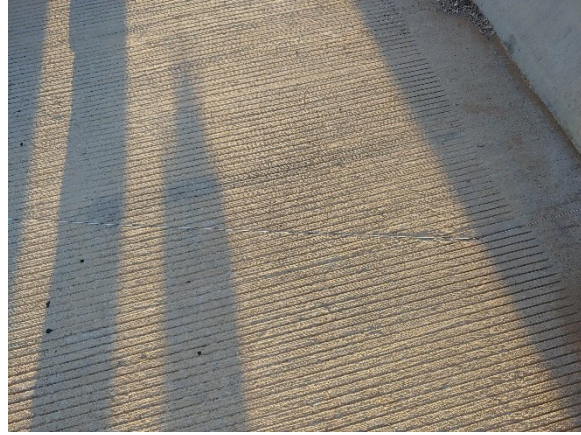
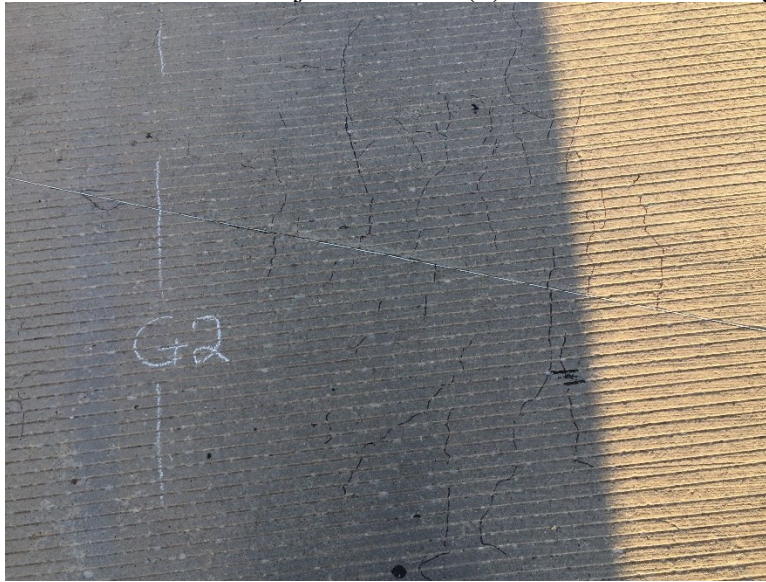
(a) Flush panels at continuous deck joint

(b) Continuous deck region in shoulder

(c) Marked cracks in NDE region

**Figure 4.48. Typical link slab condition for Bridge LUB3 (US 62 over Research Blvd.).**

Visual inspection of the bridge confirmed the excellent condition. Some hairline cracks were present in the deck, consisting mainly of longitudinal cracks. Figure 4.48(c) shows the marked cracks in the NDE region. No spalling was observed along the main PBJ crack in the NDE region. The main PBJ crack measured 0.025 in. wide. Visual inspection from the ground beneath the bridge did not indicate any cracking or efflorescence in the overhang, and the panels and girder ends were all in excellent condition except for filler material between some panels hanging loose below the main PBJ crack.

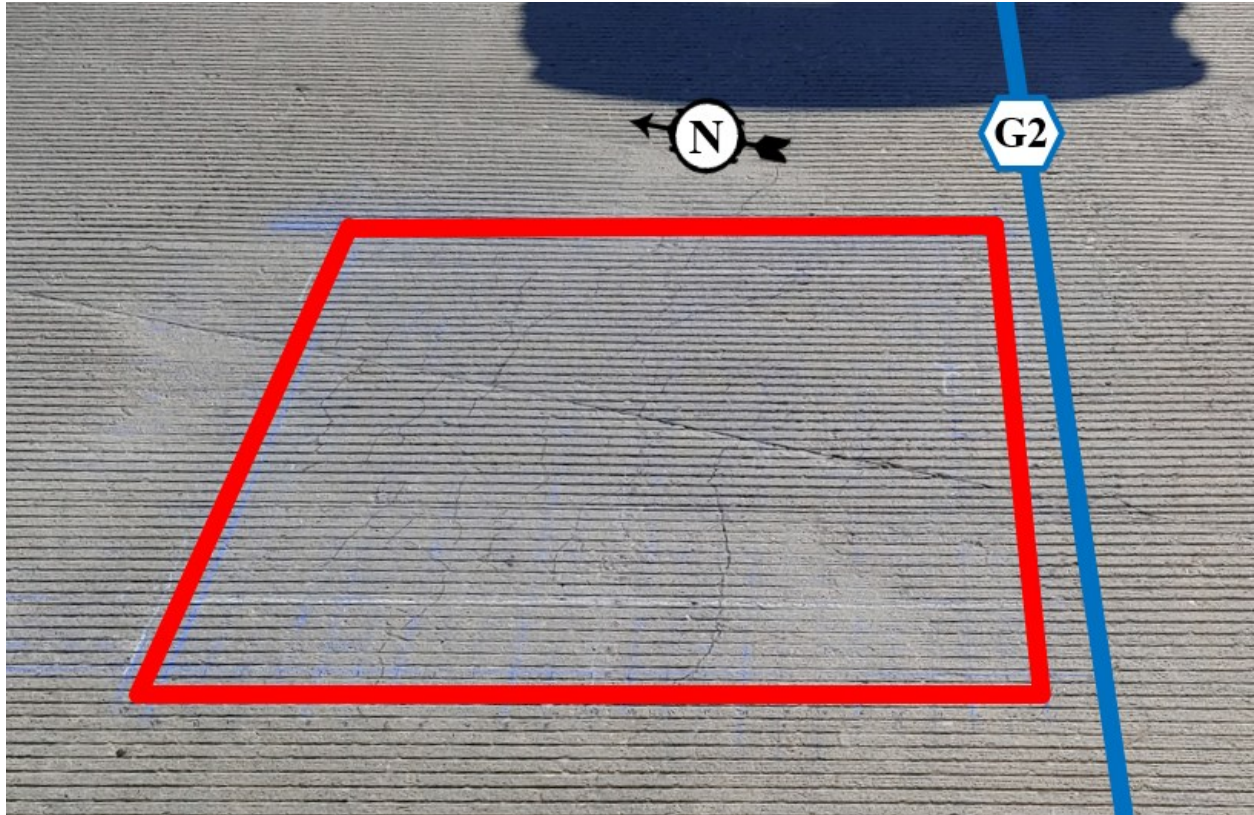
Figure 4.49. NDE region at Bent 2 for Bridge LUB3 (US 62 over Research Blvd.).

Evaluation of LUB3 was done in a single NDE area at Bent 2 between G2 and G3, adjacent to G2 (Figure 4.49). The area consisted of two 2-ft by 4-ft grids, oriented with the 4-ft dimension parallel to the flow of traffic, with the main PBJ crack centered in the region.

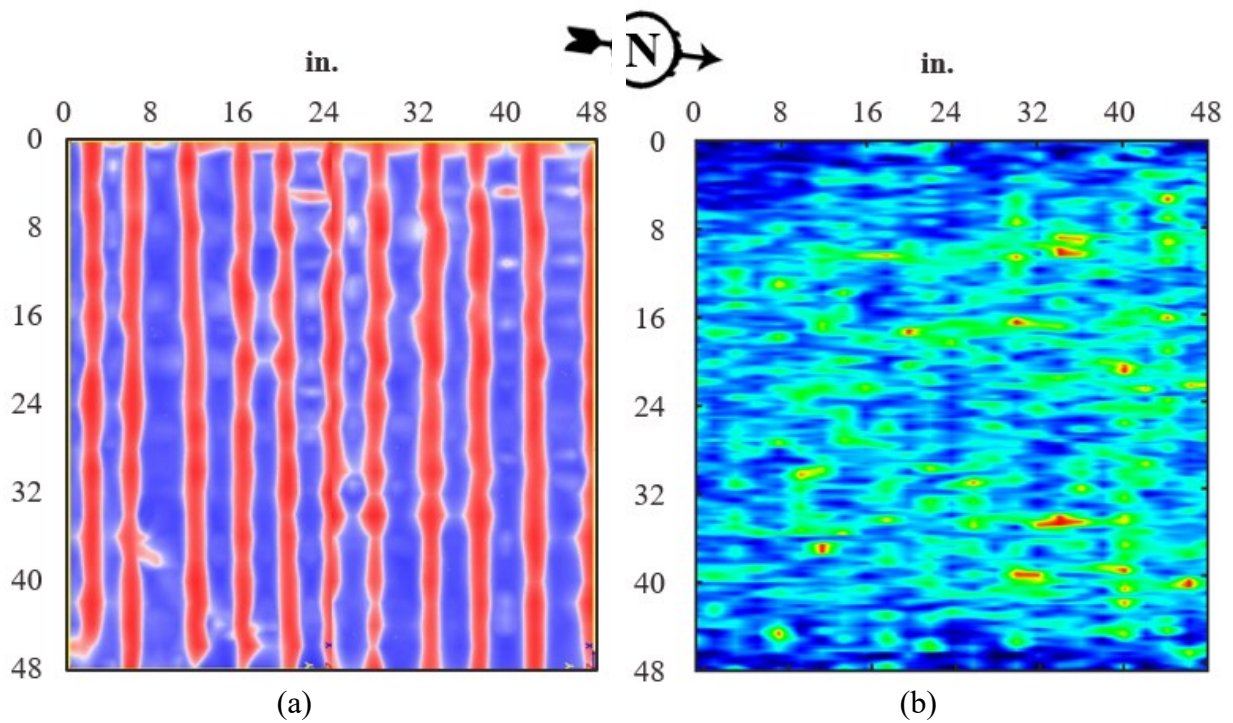
Figure 4.50. LUB3 results for (a) GPR and (b) UST of top longitudinal reinforcement at depth 4.73 in.

Figure 4.50 appears to show that the top longitudinal reinforcement was doubled in the PBJ region since the bars are spaced at approximately 4.5 in. Figure 4.51 confirms that the top transverse bars are spaced according to the design drawings. The diagonal gap between the PCPs can be faintly seen in Figure 4.52, crossing the image at approximately 16 in. on the left to 32 in. on the right on the vertical axis. Figure 4.49 shows the diagonal PBJ crack and longitudinal cracks extending from the PBJ. No evidence of voids or delaminations was found in the IR images.
