# Performance and Improvement of Texas Poor Boy Continuous Bridge Deck Details: Final Report

Technical Report 0-7013-R1

TEXAS A&M TRANSPORTATION INSTITUTE  
COLLEGE STATION, TEXAS

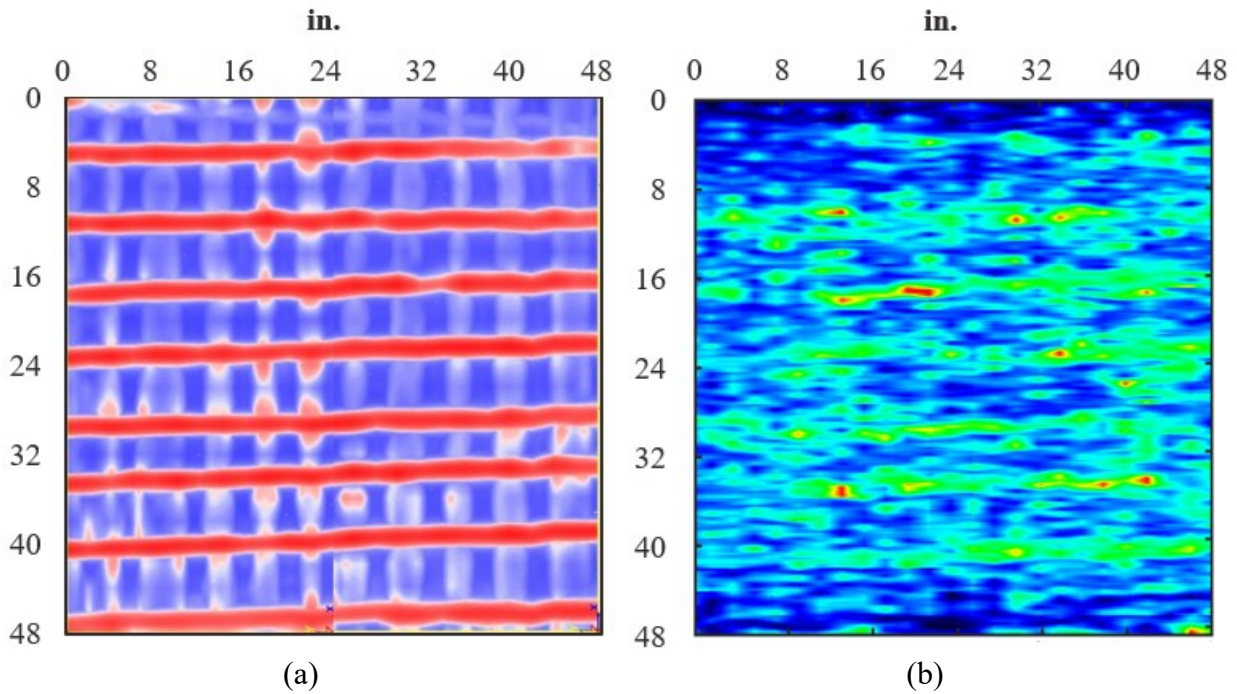
**Figure 4.51. LUB3 results for (a) GPR and (b) UST of top transverse reinforcement at depth 3.73 in.**

Figure 4.50 appears to show that the top longitudinal reinforcement was doubled in the PBJ region since the bars are spaced at approximately 4.5 in. Figure 4.51 confirms that the top transverse bars are spaced according to the design drawings. The diagonal gap between the PCPs can be faintly seen in Figure 4.52, crossing the image at approximately 16 in. on the left to 32 in. on the right on the vertical axis. Figure 4.49 shows the diagonal PBJ crack and longitudinal cracks extending from the PBJ. No evidence of voids or delaminations was found in the IR images.

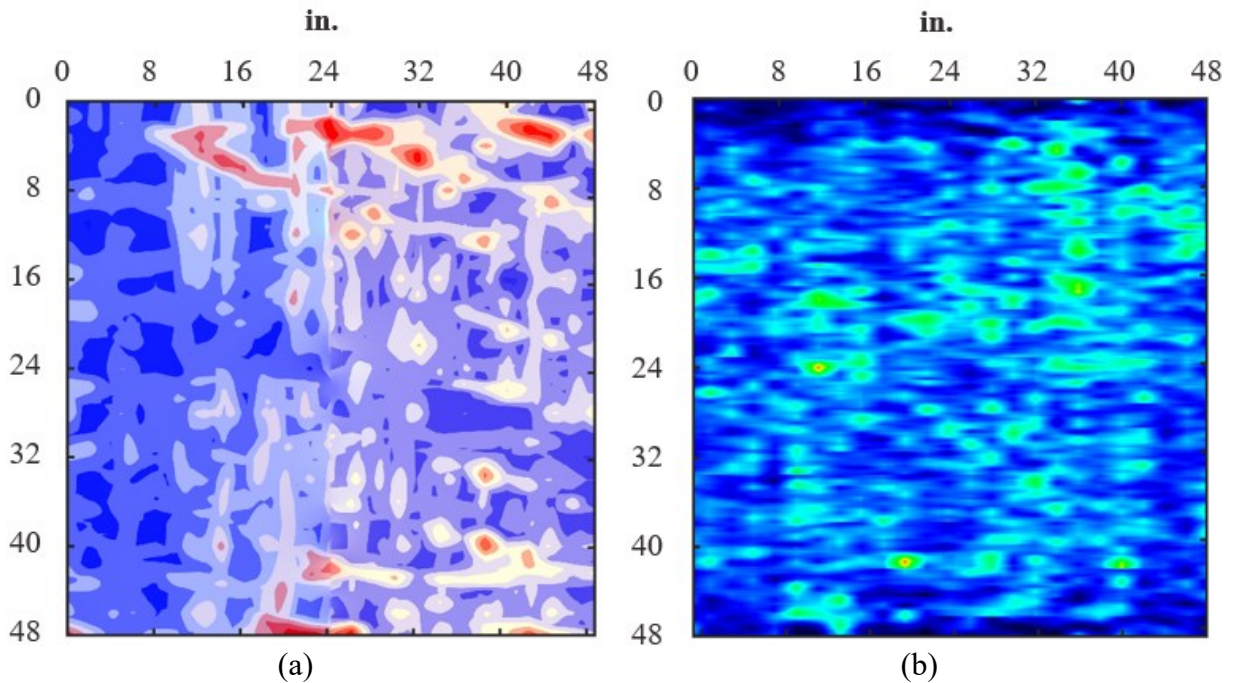
**Figure 4.52. LUB3 results for (a) GPR and (b) UST of the PCP end gap at depth 8.5 in.**

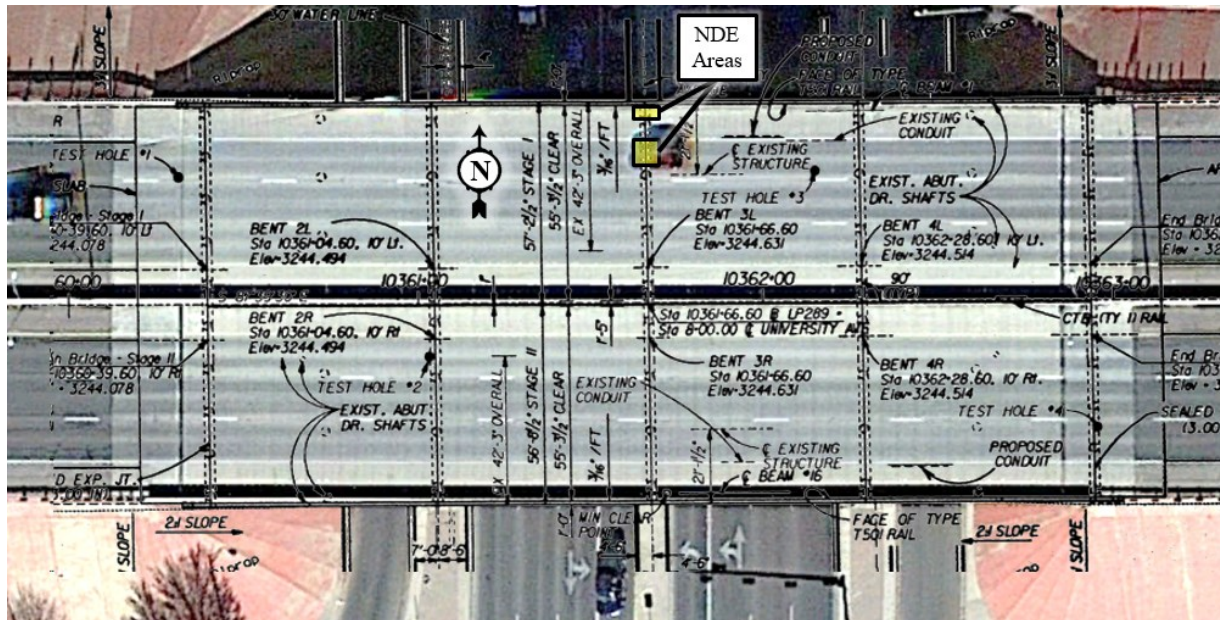
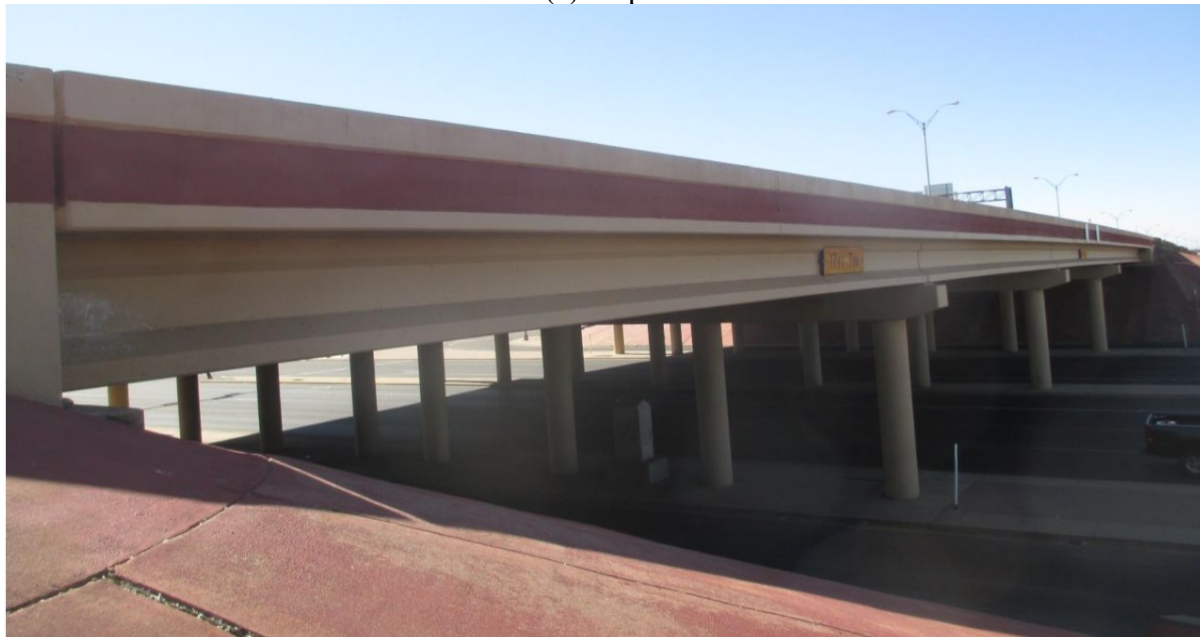
(a) Top view

(b) Elevation view

**Figure 4.53. Site conditions at Bridge LUB4 (WB Loop 289 over University Ave.).**

Bridge LUB4, shown in Figure 4.53, was built in 1992 and carries WB Loop 289 over University Ave. in Lubbock, Texas. The 57-ft 2-in. wide bridge has three lanes on eight Type C prestressed

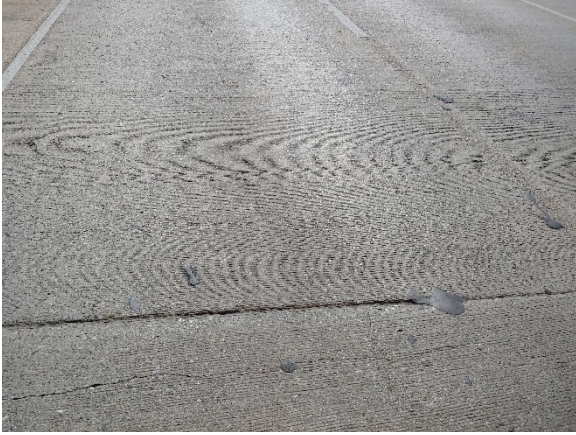
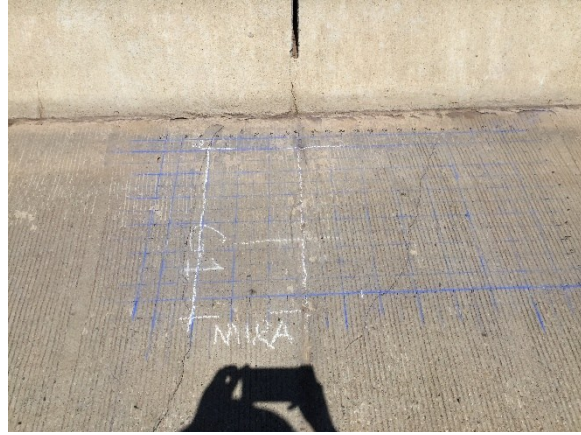
(a) CIP at continuous deck detail

(b) Marked cracks in overhang

**Figure 4.54. Typical link slab condition for Bridge LUB4 (WB Loop 289 over University Ave.).**

Visual inspection of the bridge confirmed the inspection report damage on the top of the deck; visual inspection below the bridge was not possible. The condition of all three continuous deck regions was similar. Figure 4.54 shows representative conditions of the link slab regions. The main PBJ crack had been formed as a construction joint, with the material no longer present. Considerable spalling was present along the main PBJ crack. Where measurable, the main crack was as wide at 0.030 in. Secondary PBJ cracks formed approximately 18 in. on either side of the main PBJ crack, measuring as wide as 0.025 in. in the NDE region. Outside the main NDE region, the secondary PBJ cracks were diagonal and joined with the main PBJ crack over the girder. Other cracks in the main NDE region measured no more than 0.01 in. except for one longitudinal crack outside the east secondary PBJ crack. Diagonal cracks were also present in the overhang, as shown in Figure 4.54(b).

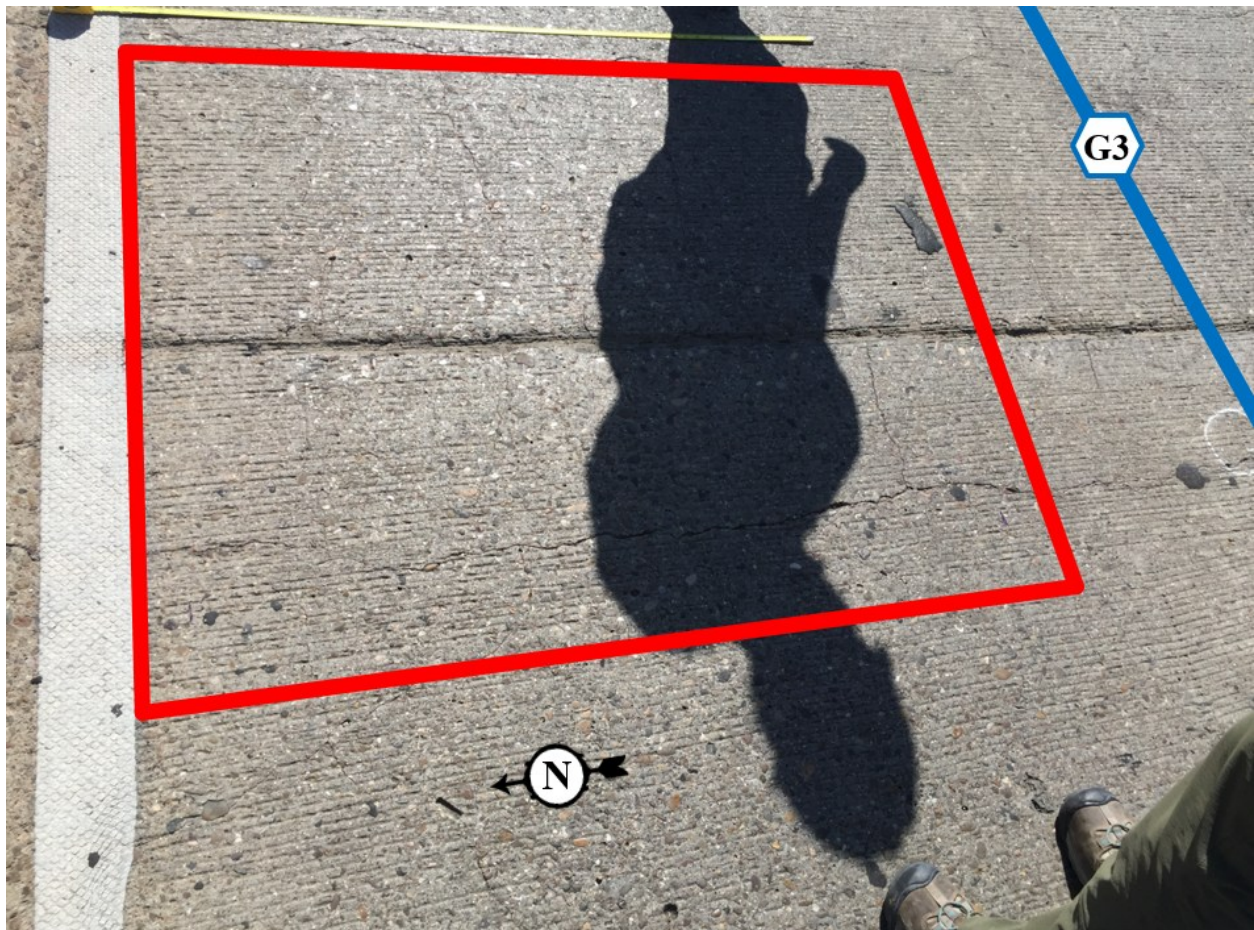
**Figure 4.55. Primary NDE region at Bent 3 between G2 and G3 at Bridge LUB4 (WB Loop 289 over University Ave.).**

Three NDE regions were investigated at Bent 3, shown in Figure 4.55, Figure 4.56, and Figure 4.57. The 4-ft by 4-ft primary region, shown in Figure 4.55, was located between G2 and G3 and was made up of two 2-ft by 4-ft grids centered on the main PBJ crack, with the 4-ft dimension parallel to the girders. Both GPR and UST were conducted in this region. Region 2, shown in Figure 4.56, was a 2-ft by 4-ft region centered on the main PBJ crack in the overhang. GPR was conducted in this region. Region 3, shown in Figure 4.57, is a smaller section of Region 2 and was used for conducting UST.

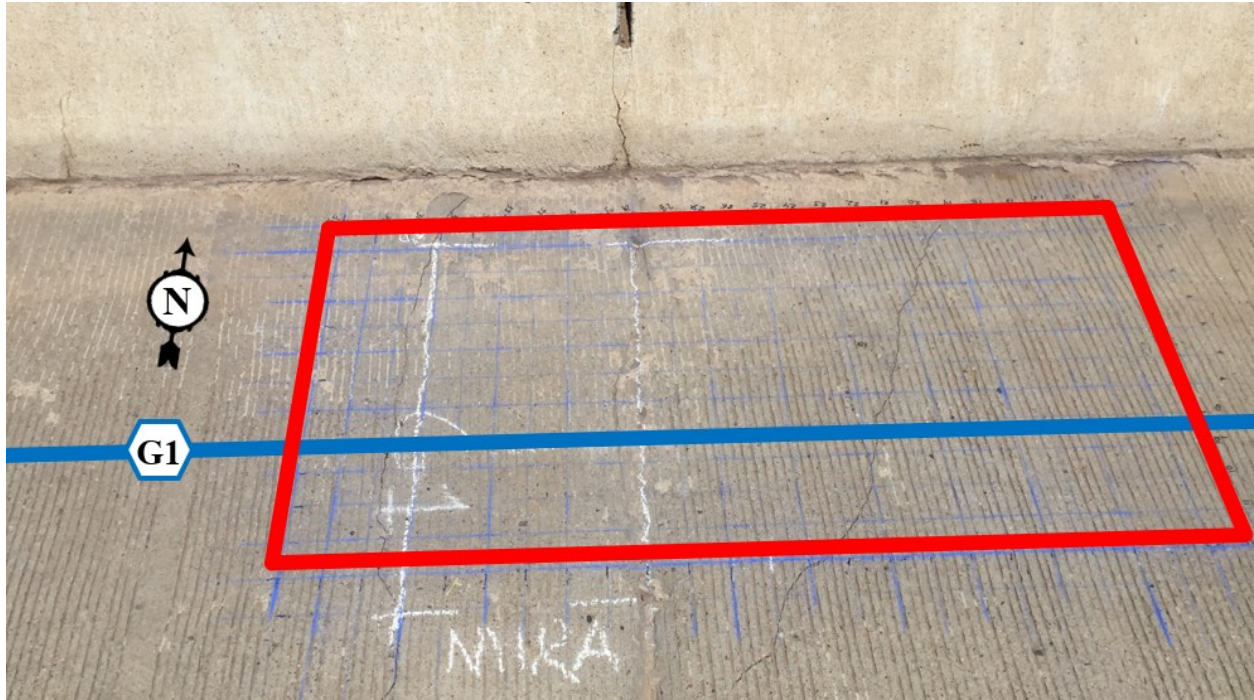
**Figure 4.56. Secondary NDE region for GPR at Bent 3 in the overhang at Bridge LUB4 (WB Loop 289 over University Ave.).**

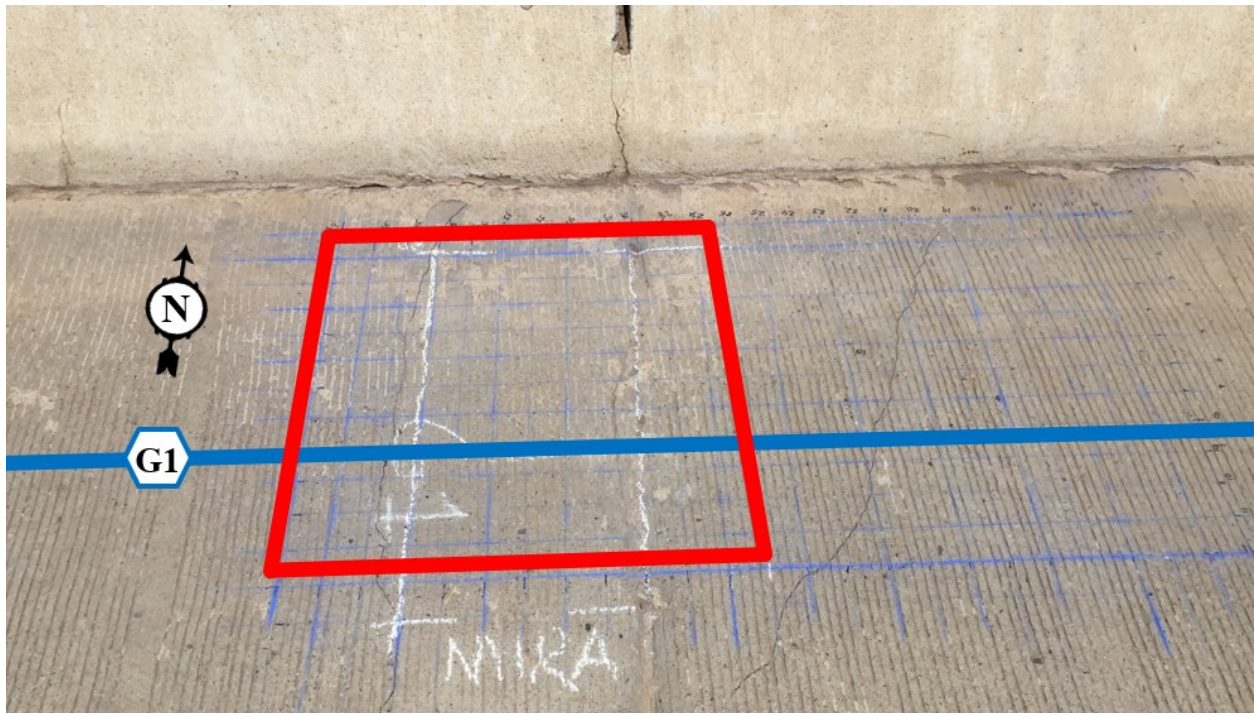
**Figure 4.57. Secondary NDE region for UST at Bent 3 in the overhang at Bridge LUB4 (WB Loop 289 over University Ave.).**

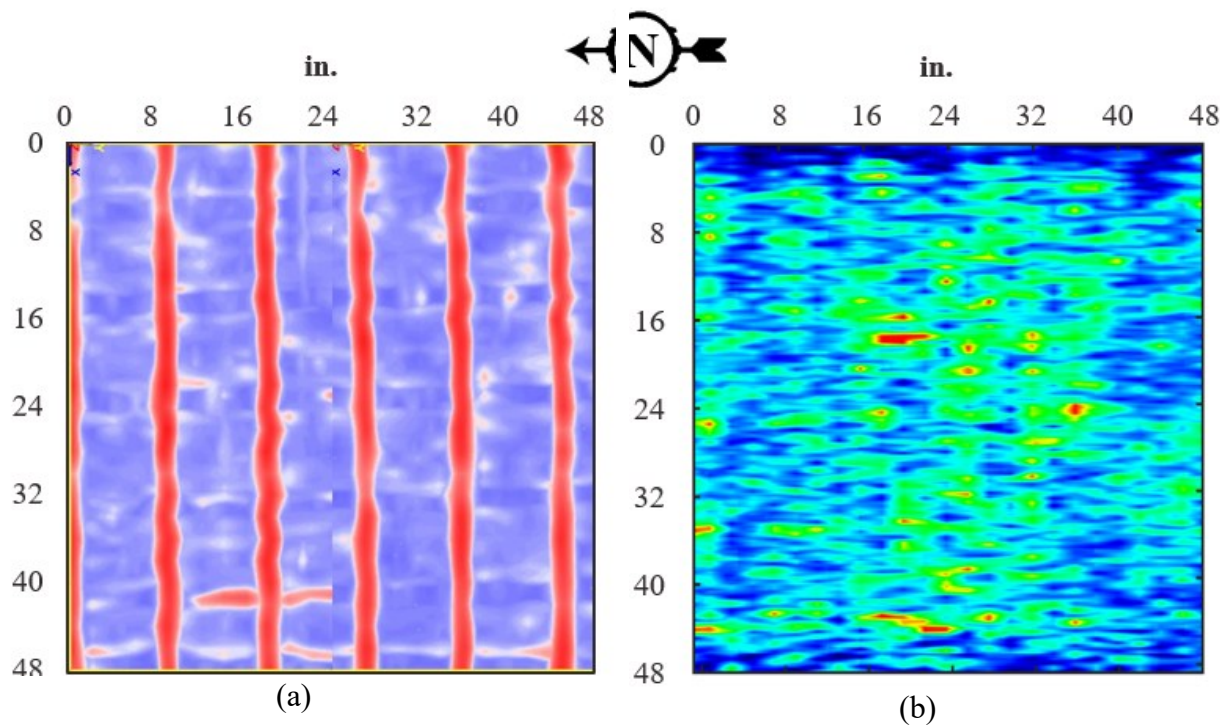
**Figure 4.58. LUB4 results for the primary NDE area for (a) GPR and (b) UST of top longitudinal reinforcement at depth 2.73 in.**

Figure 4.58, Figure 4.59, and Figure 4.60 show that the top and bottom longitudinal and transverse reinforcement appears to be spaced according to the design drawings. Figure 4.61 shows the PMDF at the bottom of the link slab. The longitudinal reinforcement spacing is consistent in the overhang, shown in Figure 4.62 and Figure 4.64. However, Figure 4.63 shows

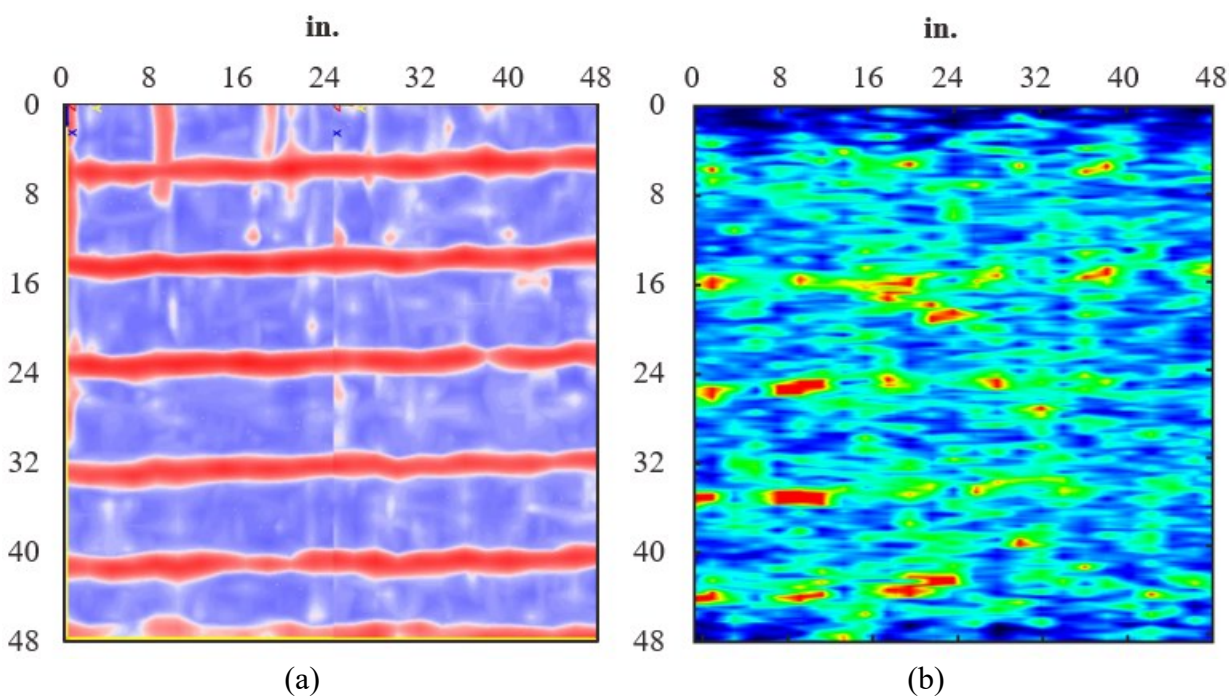
**Figure 4.59. LUB4 results for the primary NDE area for (a) GPR and (b) UST of top transverse reinforcement at depth 3.5 in.**

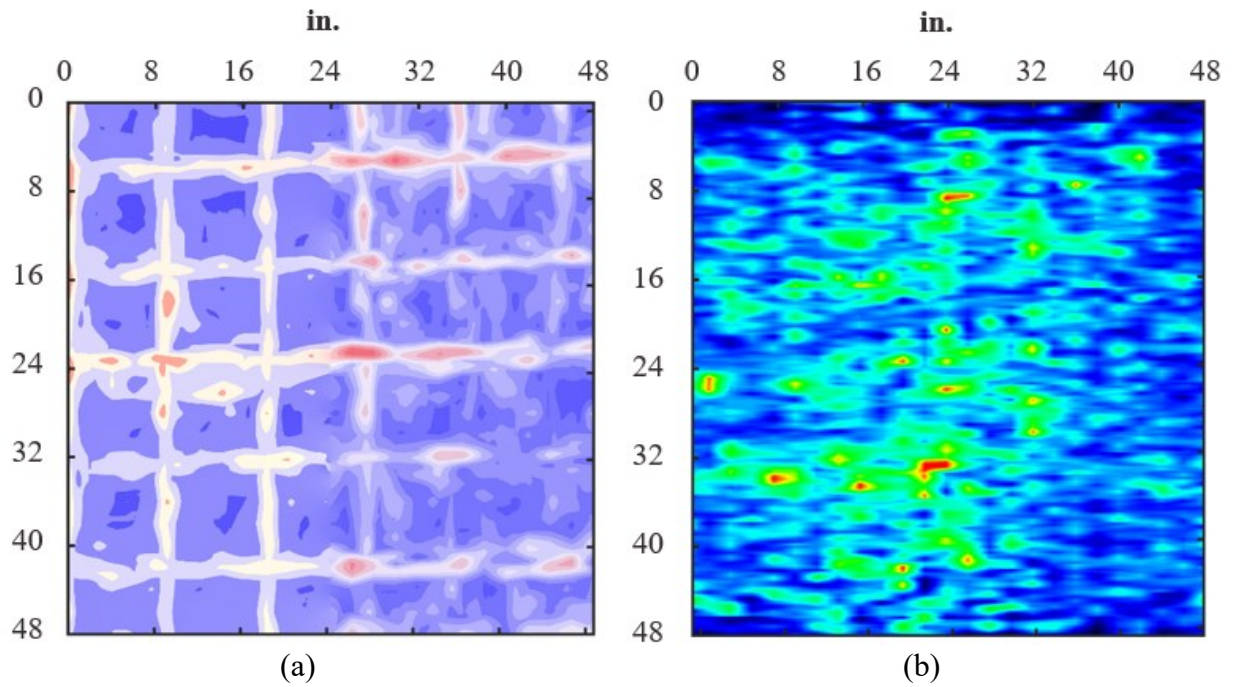
**Figure 4.60. LUB4 results for the primary NDE area for (a) GPR and (b) UST of bottom reinforcement at depth 6.5 in.**

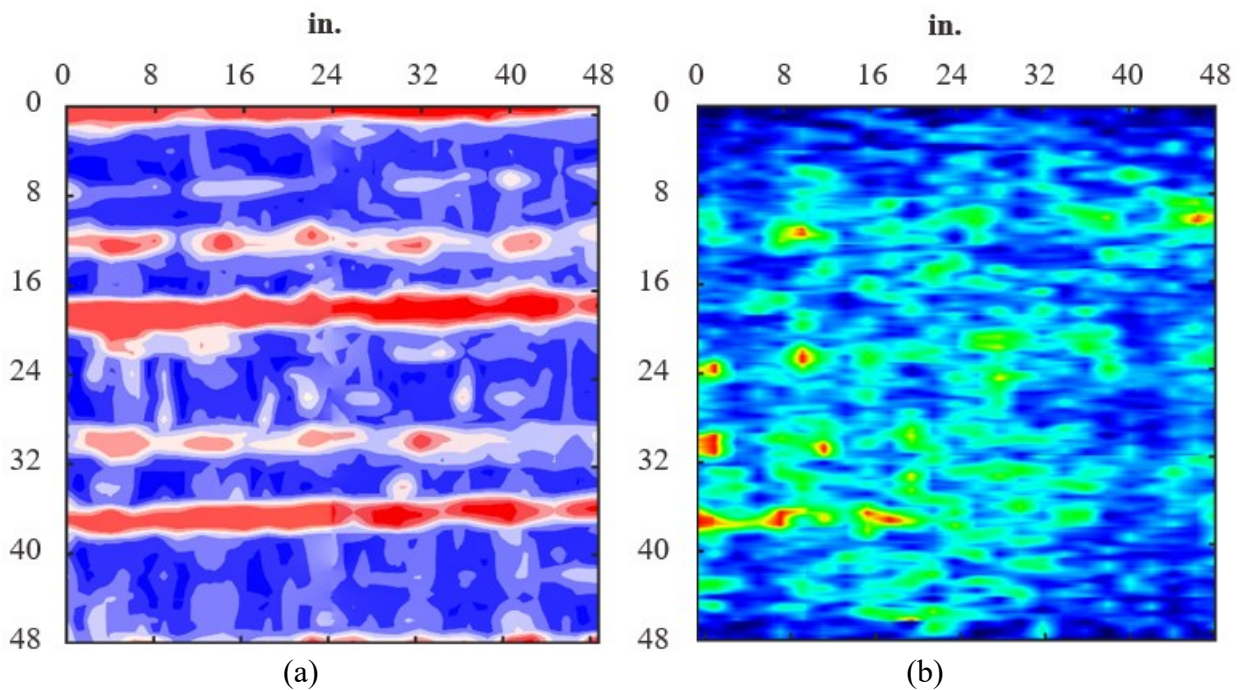
**Figure 4.61. LUB4 results for the primary NDE area for (a) GPR and (b) UST of PMDF at depth 8.5 in.**

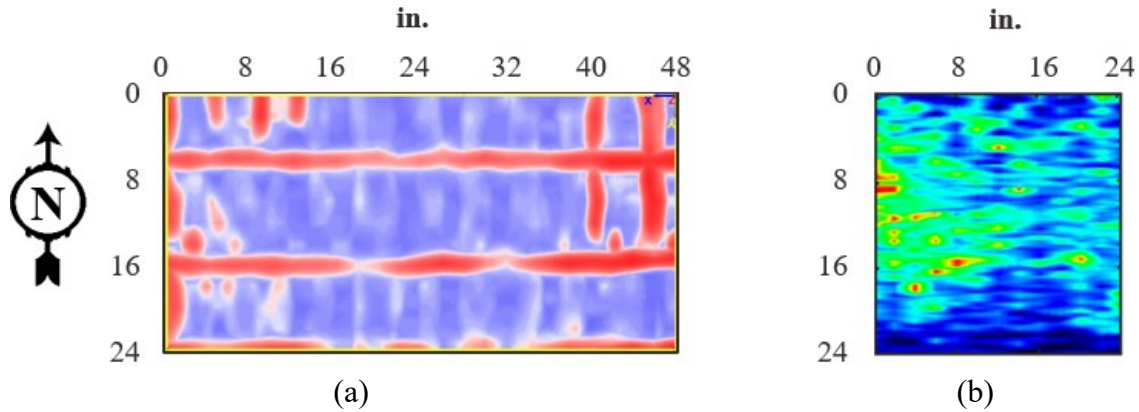
**Figure 4.62. LUB4 results for the secondary NDE area for (a) GPR and (b) UST of the top longitudinal reinforcement in the overhang at depth 2.73 in.**

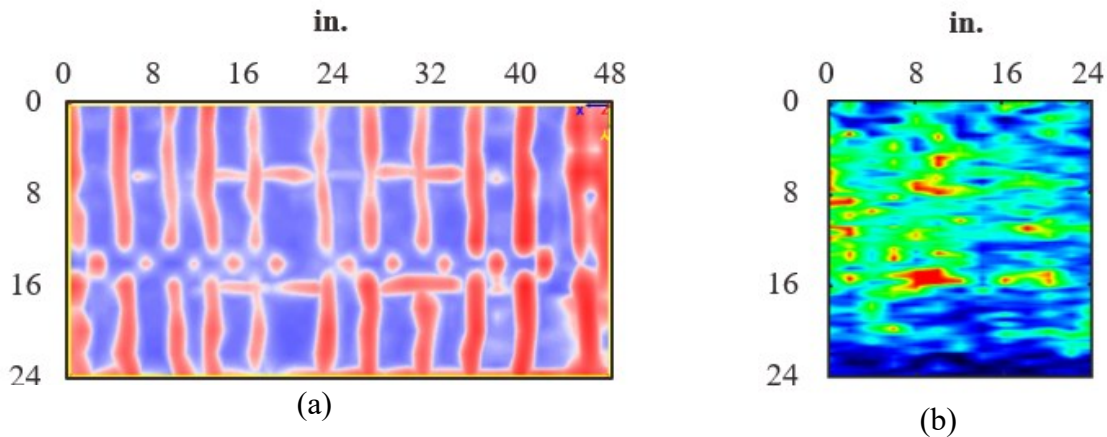
**Figure 4.63. LUB4 results for the secondary NDE area for (a) GPR and (b) UST of the top transverse reinforcement in the overhang at depth 3.48 in.**

doubled transverse bars in the overhang, which is consistent with design drawings. The single rib of PMDF visible in Figure 4.65 indicates that the PMDF section directly below the PBJ is at a slightly different depth. No evidence of delaminations or voids was found in the IR images.

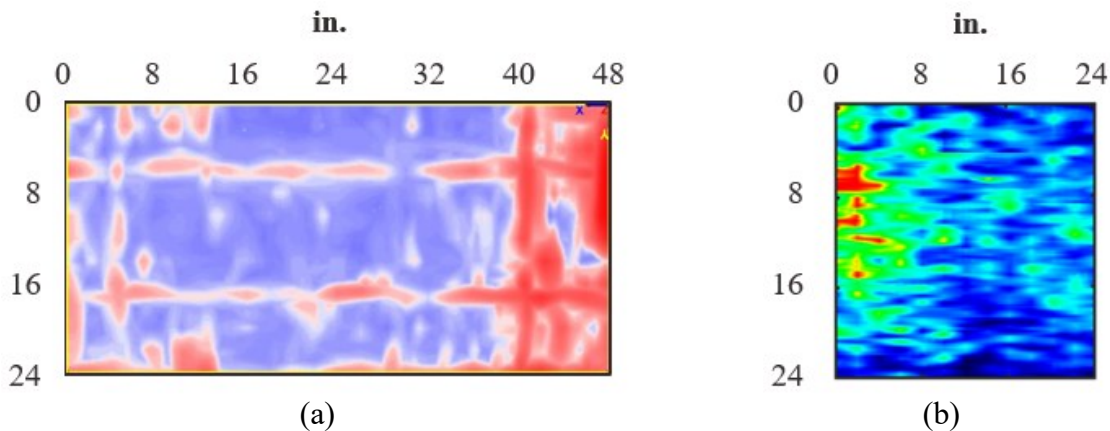
**Figure 4.64. LUB4 results for the secondary NDE area for (a) GPR and (b) UST of the bottom reinforcement in the overhang at depth 5.98 in.**

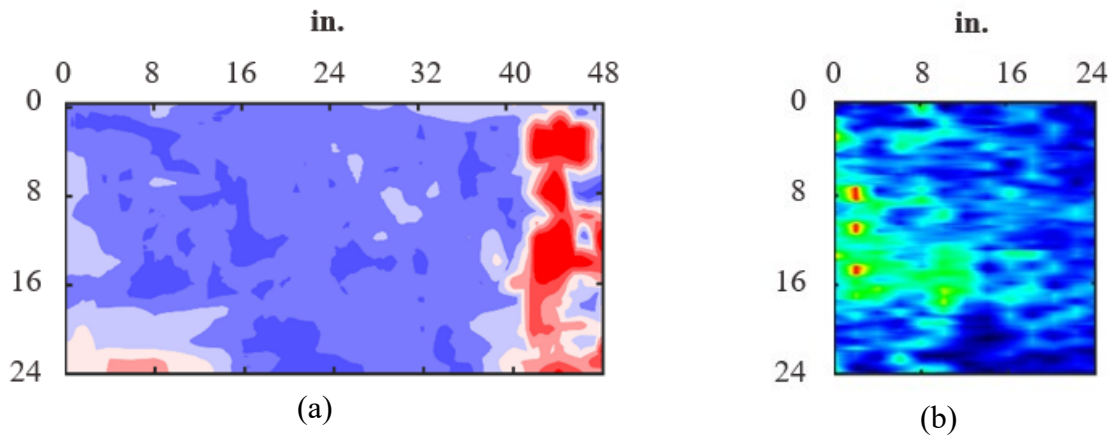
**Figure 4.65. LUB4 results for the secondary NDE area for (a) GPR and (b) UST of the PMDF in the overhang at depth 8.5 in.**

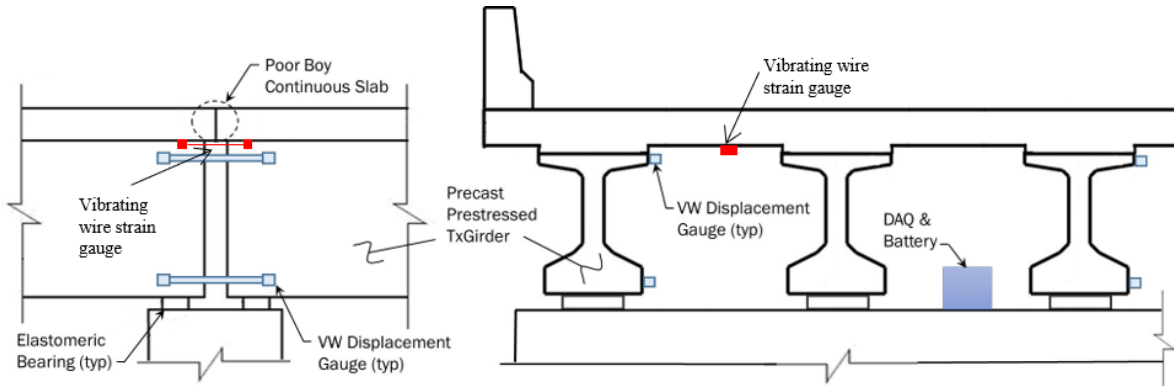
**Figure 5.2. General layout of instrumentation at girder ends.**

Figure 5.2 shows the general configuration of instrumentation for the bridges. Figure 5.3 shows an example of instruments attached in the field. Vibrating wire strain gages, indicated by diamonds on the instrumentation plans, were placed on the bottom of the deck spanning the location (or presumed location) of the main PBJ crack. Pairs of VW displacement gages, indicated by triangles on the instrumentation plans, were located at the top and bottom of the girders to capture the relative displacement between the girders ends at the bents, or the girder end relative to the abutment. Each sensor included a thermistor to measure temperatures. The pairs of displacement gages were used to calculate the relative rotation. Generally, these pairs were provided at the PBJs (referred to as PBJ pairs), but on some bridges were also provided at SEJs (referred to as SEJ pairs) to provide a comparison between the response at the two joint types. Where pairs were installed at PBJs, 1-in. stroke length gages were used; 4-in. stroke length gages were used at SEJs. At the abutments, 4-in. stroke gages were located on the bottom flange to capture the full change in length of the girders under thermal loads.

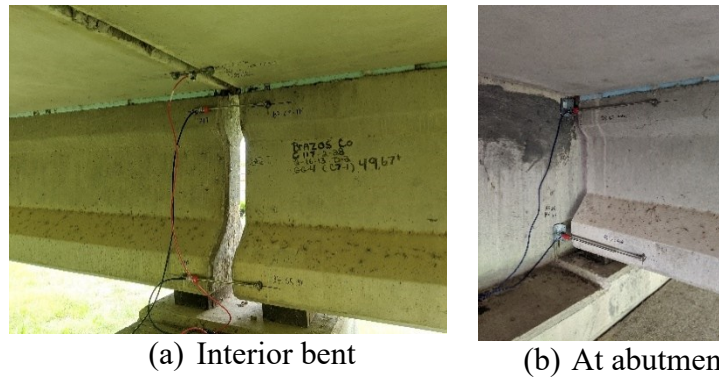
**Figure 5.3. Example of gage attachment (shown installed on Bridge BRY3).**

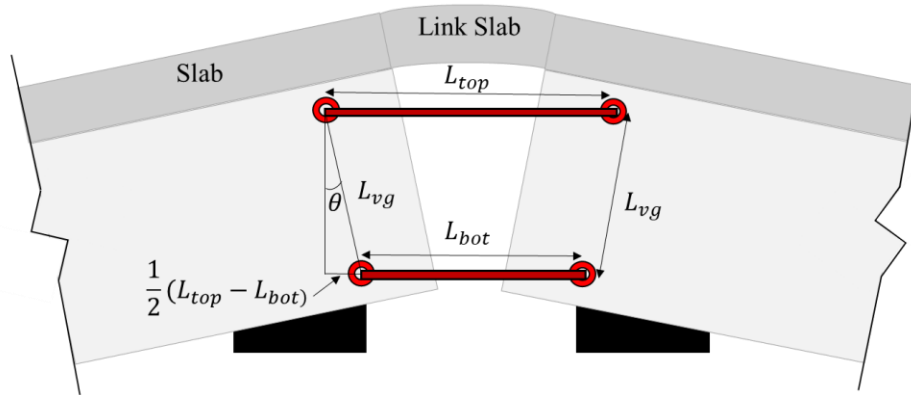
**Figure 5.4. Variables used for the calculation of girder end rotations from displacement gages.**

The data from the displacement gages were used to calculate the rotation at the ends of the girders. Figure 5.4 shows the notation used for the calculations.

where  $L_{top}$  is the length of the top gage,  $L_{bot}$  is the length of the bottom gage, and  $L_{vg}$  is the vertical distance between gage ends.

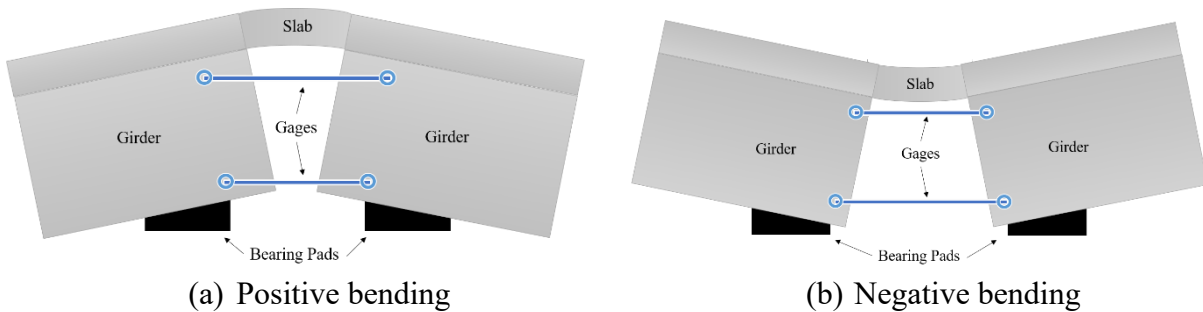
**Figure 5.5. Sign convention for rotations.**

The rotation presented is for a single girder end, with the assumption made that the total rotation between two girders is split evenly between the connected girders. Figure 5.5 shows the sign convention used. Positive angles are based on positive bending in the girders and are associated with a concave down configuration of the link slab. Negative angles are based on positive bending in the girders and are associated with a concave up configuration of the link slab.

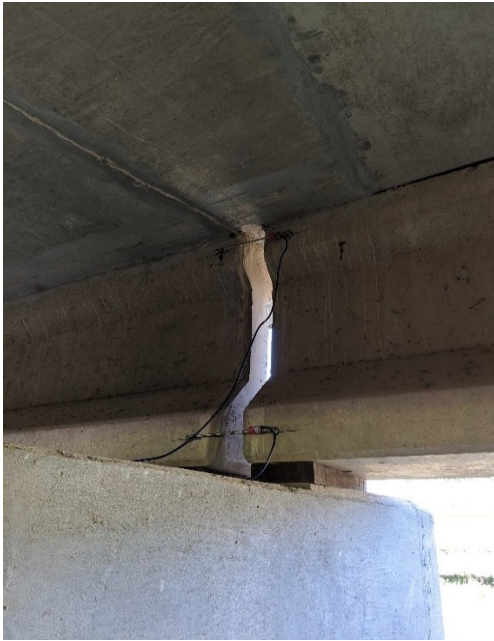
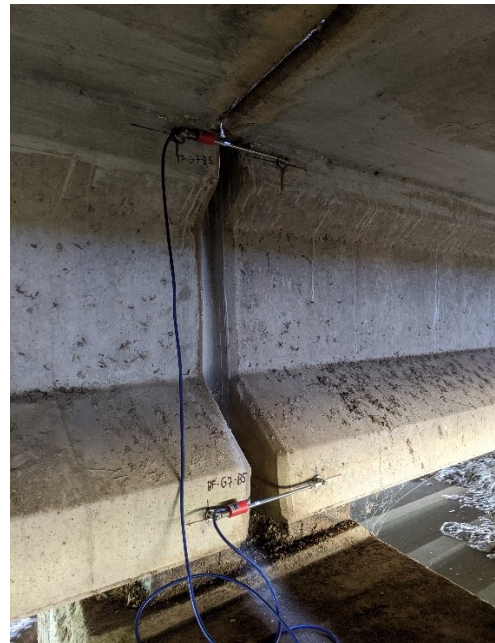
(a) Elevation view of bridge

(b) View beneath bridge

(c) Close-up at PBJ

(d) Close-up at SEJ

**Figure 5.6. Overview of Bridge BRY1 (SH 6 over Peach Creek).**

Bridge BRY1, shown in Figure 5.6, was built in 1996 and carries SH 6 over Peach Creek near Millican, Texas. The 94-ft wide bridge has four lanes with a median on 14 Type C prestressed concrete I-girders at 6.769-ft spacing with 3-ft overhangs. The bridge has a constant skew of

The bridge is 425 ft long and is made up of five simple spans forming three continuous deck units. Unit 1 and Unit 3 are single 85-ft spans. Unit 2 has three equal 85-ft spans. The deck is 7.25 in. thick, made up of 4-in. PCPs with a 3.25-in. thick CIP top. At PBJ joints, the link slab is fully CIP and is thicker than the adjacent deck. The thickened slab appeared to be implementation of the SEJ thickened slab detail at the PBJ. Overhangs are fully CIP.

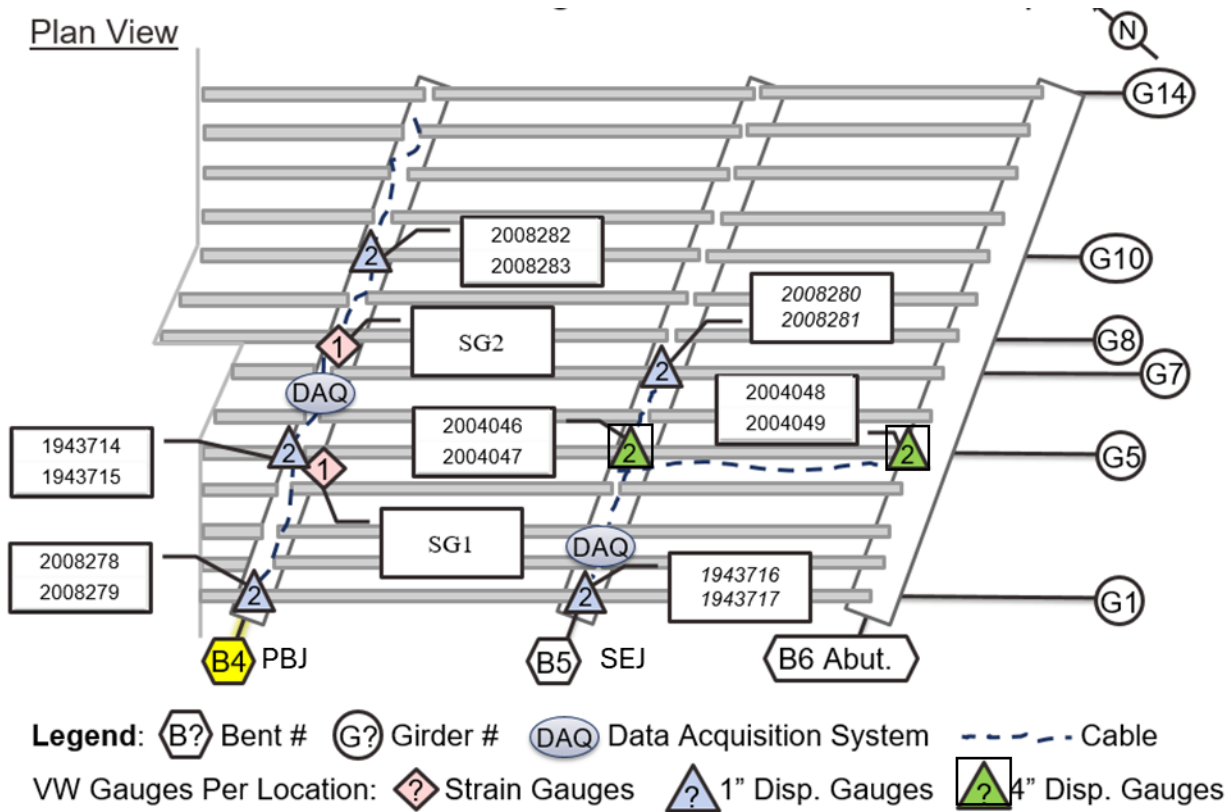
**Figure 5.7. Instrumentation plan for Bridge BRY1 (SH 6 over Peach Creek).**

Figure 5.7 shows the instrumentation plan for Bridge BRY1. The primary location of monitoring was at the continuous deck over Bent (B) 4. PBJ pairs of gages were installed at the top and bottom flange of girder lines G1 (west exterior), G5 (under southbound lanes), and G10 (under northbound lanes). Strain gages were placed on the bottom of the deck on the exterior side of G5 and G8. SEJ pairs of gages were installed on the top and bottom flanges of girder lines G1, G5, and G7 at B5 and G5 at the south abutment (B6 Abut.). Instrumentation was installed on June 8, 2020, and remained in place until June 15, 2020.

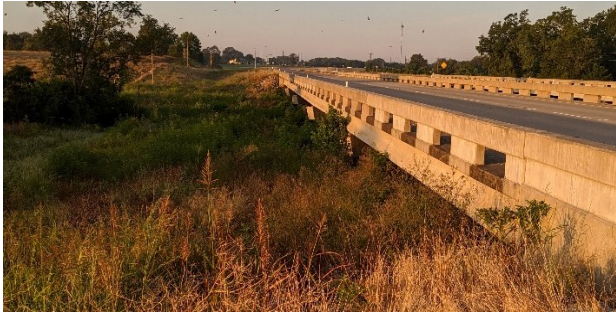
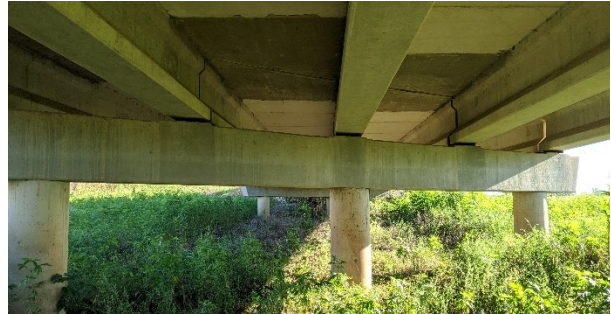
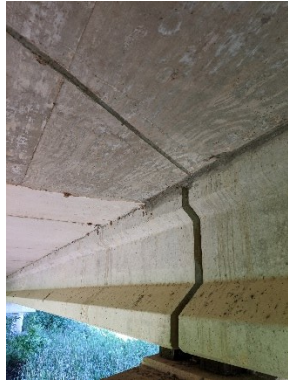
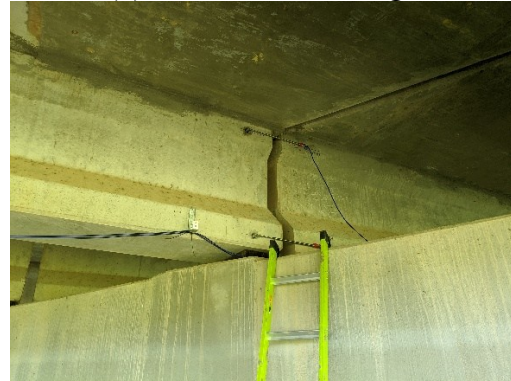
(a) Elevation view of bridge

(b) View beneath bridge

(c) Close-up at PBJ

(d) Close-up at SEJ

**Figure 5.8. Overview of Bridge BRY2 (FM 60 over Old River).**

Bridge BRY2, shown in Figure 5.8, was built in 2010 and carries eastbound FM 60 over Old River near Snook, Texas. The 40-ft wide bridge has two lanes on five Type C prestressed concrete I-girders spaced at 8 ft 6 in. with 3-ft 0-in. overhangs. The bridge has a constant skew of 30 degrees.

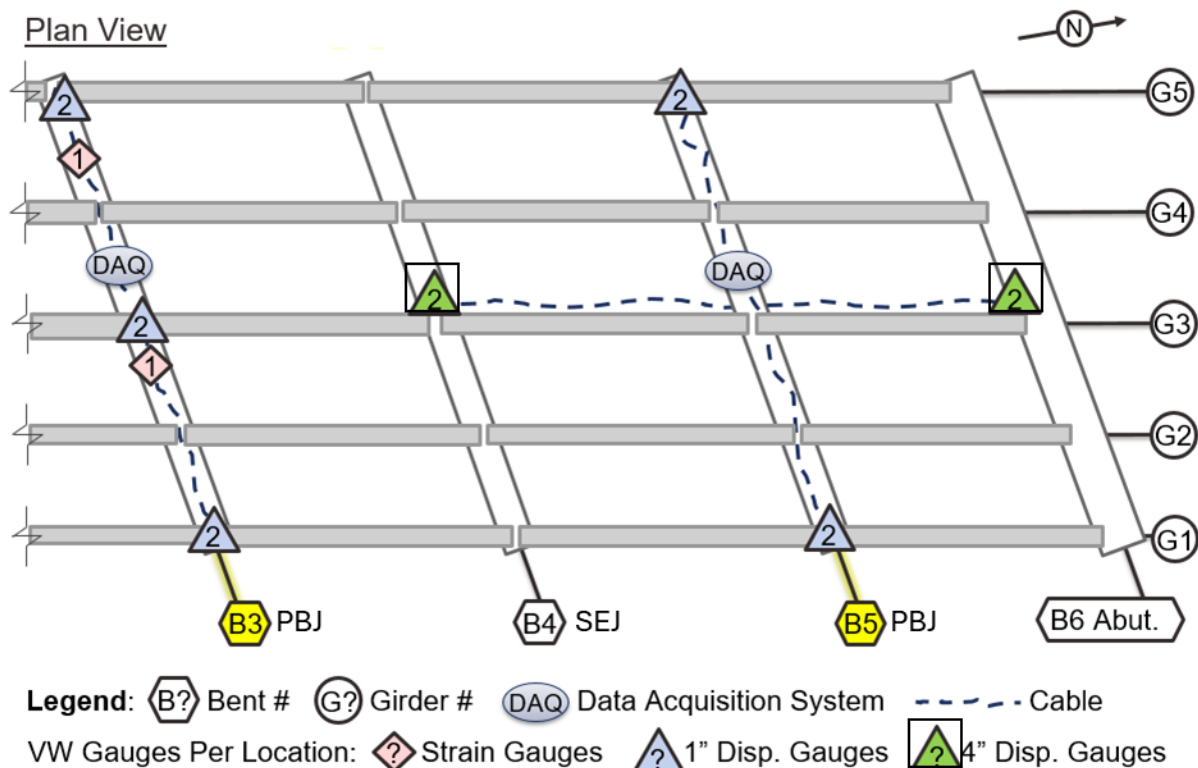
**Figure 5.9. Instrumentation plan for Bridge BRY2 (FM 60 over Old River).**

Figure 5.9 shows the instrumentation plan for Bridge BRY2. The primary location of monitoring is at the continuous deck over B3 (part of the three-span Unit 1). PBJ pairs of gages were installed at the top and bottom flange of both outer girder lines (G1 and G5) and the center girder line (G3). Strain gages were placed on the bottom of the deck between G2–G3 and G4–G5. The

outer girder lines were also instrumented with PBJ pairs of gages at B5 (part of the two-span Unit 2). SEJ pairs of gages were installed at the top and bottom flange of the center girder line (G3) at B4 and the north abutment (B6 Abut.). Instrumentation was installed on June 18, 2020, and remained in place until June 25, 2020.

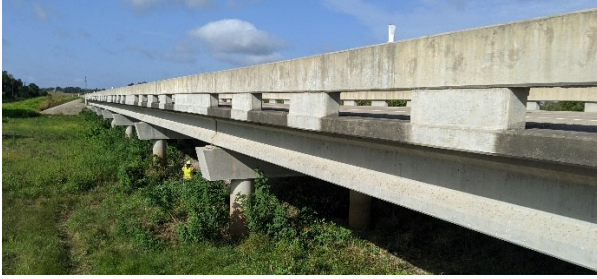
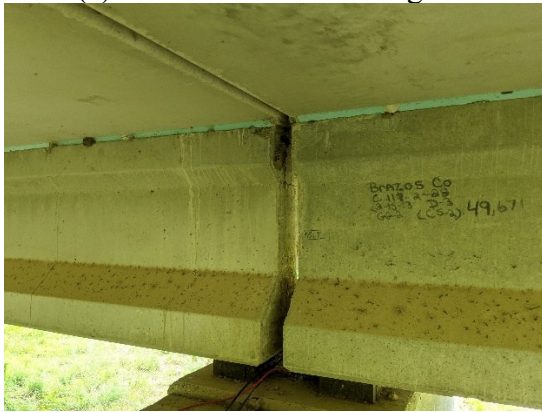
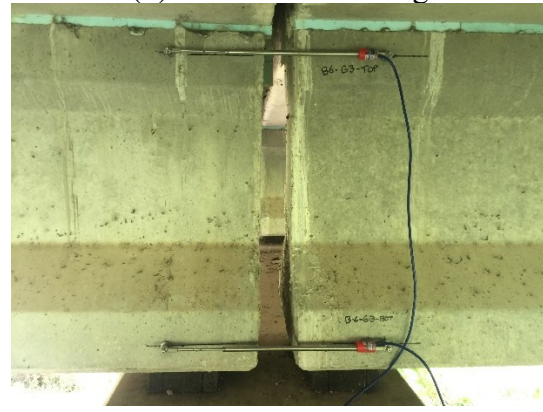
(a) Elevation view of bridge

(b) View beneath bridge

(c) Close-up at PBJ

(d) Close-up at SEJ

**Figure 5.10. Overview of Bridge BRY3 (SH 21/US 190 over Old Cedar Creek).**

Bridge BRY3, shown in Figure 5.10, was built in 2013 and carries eastbound SH 21 over Old Cedar Creek near Kurten, Texas. The 40-ft wide bridge has two lanes on five Type B prestressed concrete I-girders spaced at 8 ft 6 in. with 3-ft 0-in. overhangs.

The bridge is 350 ft long and is made up of seven simple spans forming three continuous deck units. Unit 1 is two equal 50-ft spans, Unit 2 is three equal 50-ft spans, and Unit 3 is two equal 50-ft spans. The deck is 8 in. thick, made up of 4-in. thick PCPs with a 4-in. CIP top. At PBJ joints, flush PCPs are used. As-built drawings do not provide the details used; it is assumed that the top deck reinforcement in the link slab is the same as that in the decks.

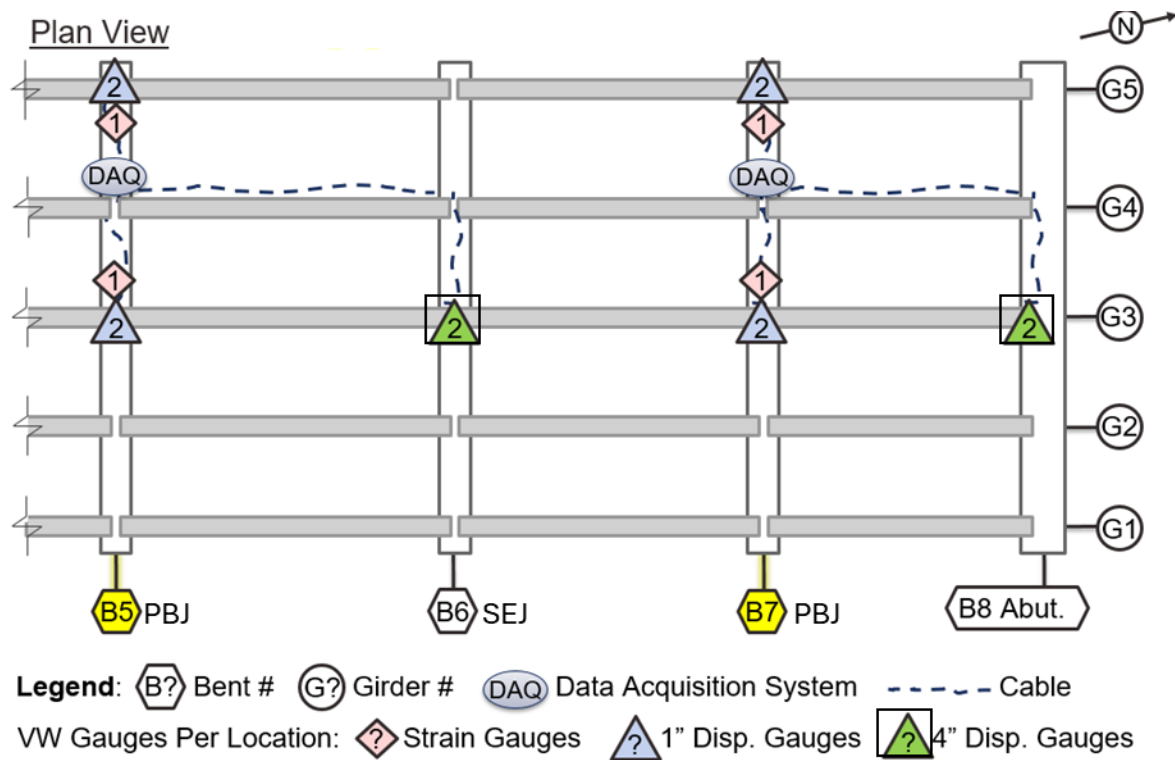
**Figure 5.11. Instrumentation plan for Bridge BRY3 (SH 21/US 190 over Old Cedar Creek).**

Figure 5.11 shows the instrumentation plan for Bridge BRY3. The primary locations of monitoring were at the continuous deck over B5 and B7 (part of the three-span Unit 2 and the two-span Unit 3). Instrumentation was identical at these bents, with PBJ pairs of gages installed at the top and bottom flange of girder lines G3 (center) and G5 (east exterior). Strain gages were located at the bottom of the deck adjacent to the interior side of G5 and the east side of G3. SEJ pairs of gages were installed at the top and bottom flange of the center girder line (G3) at B6 (between Unit 2 and Unit 3) and abutment at the north end of Unit 3 (B8 Abut.). Instrumentation was installed on July 21, 2020, and remained in place until July 30, 2020.

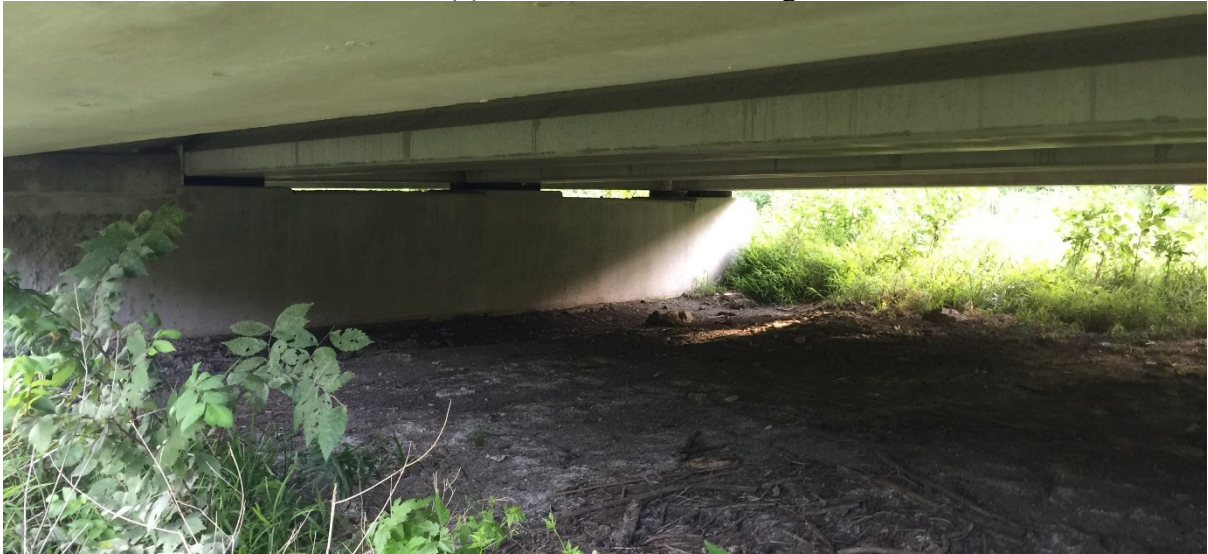
(a) Elevation view of bridge

(b) View beneath bridge

**Figure 5.12. Overview of Bridge BRY4 (FM 3090 at Spring/Holland Relief).**

Bridge BRY4, shown in Figure 5.12, was built in 2017 and carries FM 3090 over a relief area for Spring Creek and Holland Creek near Navasota, Texas. The 34-ft wide bridge has two lanes on four Tx28 prestressed concrete I-girders at 9-ft 4-in. spacing with 3-ft 0-in. overhangs.

The bridge is 195 ft long and is made up of three 65-ft long simple spans forming one continuous deck unit. The deck is 8 in. thick, made up of 4-in. thick PCPs with a 4-in. CIP top. At PBJs, fully CIP link slabs are used; while the as-builts do not include the details used, from the age of the bridge, it is assumed that details similar to those in Bridge BRY2 were used. PBJ top reinforcement is assumed the same as the adjacent deck. Bottom reinforcement is assumed to be #5 @ 6 in. in the transverse direction and #5 @ 9 in. in the longitudinal direction.
