# Performance and Improvement of Texas Poor Boy Continuous Bridge Deck Details: Final Report

Technical Report 0-7013-R1

TEXAS A&M TRANSPORTATION INSTITUTE  
COLLEGE STATION, TEXAS

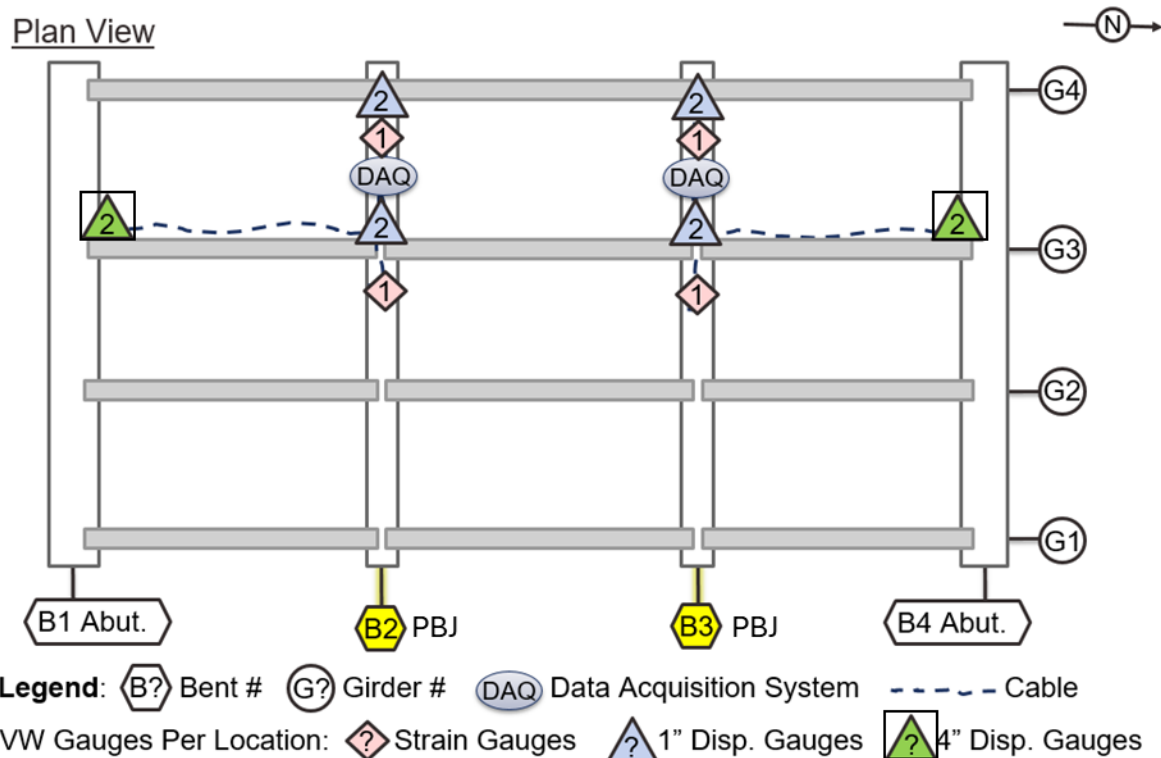
**Figure 5.13. Instrumentation plan for Bridge BRY4 (FM 3090 at Spring/Holland Relief).**

Figure 5.13 shows the instrumentation plan for Bridge BRY4. With the bridge being only three spans and having no skew, instrumentation was installed at all bents and abutments. PBJ pairs of gages were installed on the top and bottom flanges of girder lines G3 (interior) and G4 (east exterior). SEJ pairs of gages were installed at the abutments (B1 Abut. and B4 Abut.) on girder line G3. At both interior bents, strain gages were installed on the interior side of girder lines G3 and G4. Instrumentation was installed on September 10, 2020, and remained in place until September 18, 2020.

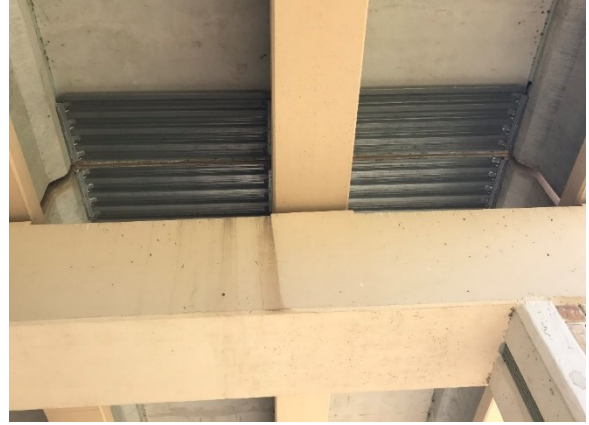
(a) Elevation view of bridge

(b) Close-up at PBJ

**Figure 5.14. Overview of Bridge BRY5 (SH 6 over Nantucket Dr.).**

Bridge BRY5, shown in Figure 5.14, was built in 2006 and carries SH 6 over Nantucket Dr. near College Station, Texas. The 94-ft wide bridge has four lanes on 11 Type IV prestressed concrete I-girders at 8.8-ft spacing with 3-ft overhangs.

The bridge is 795 ft long and is made up of eight simple spans forming three continuous deck units. Unit 1 is one 115-ft span and two 105-ft spans, Unit 2 is three equal 105-ft spans, and Unit 3 consists of a 90-ft span and a 65-ft span. The deck is 8 in. thick made up of 4-in. thick PCPs with a 4-in. thick CIP top. At PBJ joints, the link slab region is full-depth CIP on PMDF. PBJ top reinforcement is assumed to be the same as the adjacent deck. Bottom reinforcement is assumed be #5 @ 6 in. in the transverse direction and #5 @ 9 in. in the longitudinal direction.

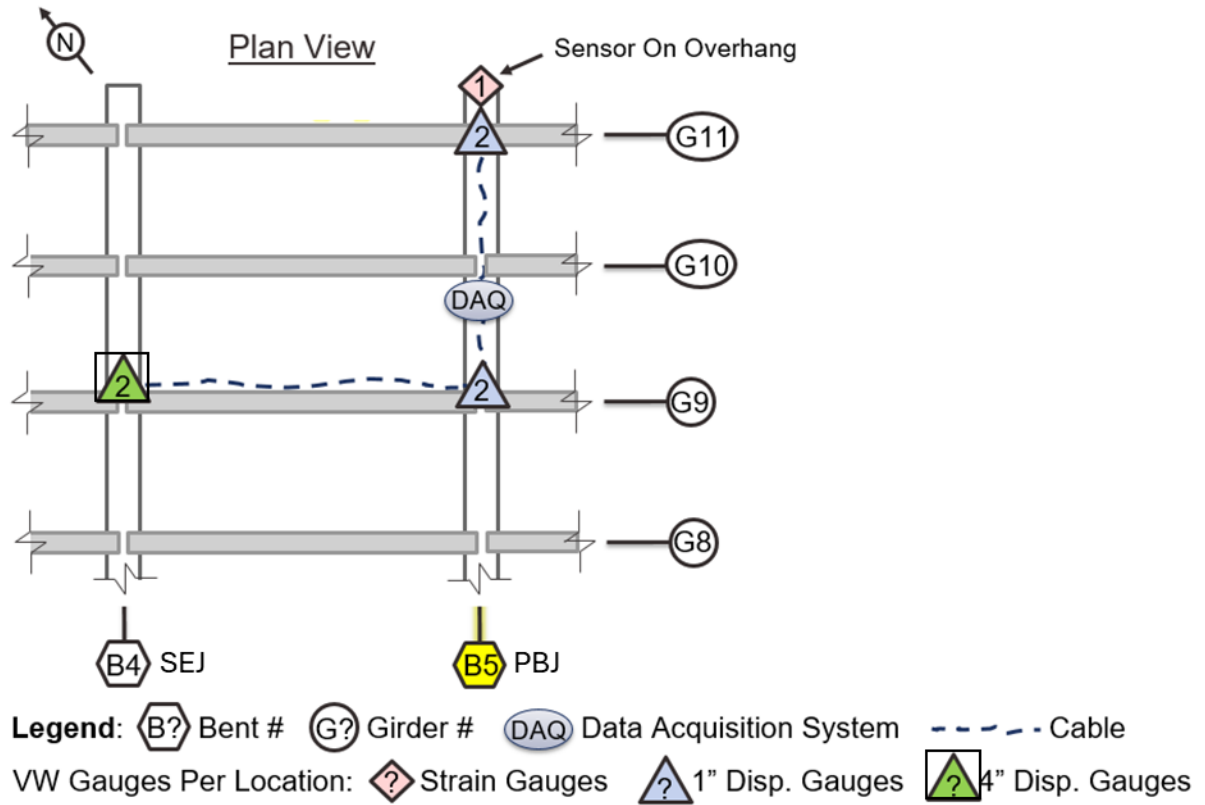
**Figure 5.15. Instrumentation plan for Bridge BRY5 (SH 6 over Nantucket Dr.).**

Figure 5.15 shows the instrumentation plan for Bridge BRY5. Monitoring was limited relative to the other bridges since the primary objective was to capture deformations in a bridge with PMDF detail. The primary location of monitoring was at the continuous deck over B5 (part of the three-span Unit 2). PBJ pairs of gages were installed at the top and bottom flange of an outer girder line (G11) and an interior girder line (G9). Strain gages were placed on the bottom of the deck in the overhang because this was the only location where it was practical to attach the gage since between girders had PMDF. An SEJ pair of gages was installed at the top and bottom flange of interior girder line (G9) at B4.

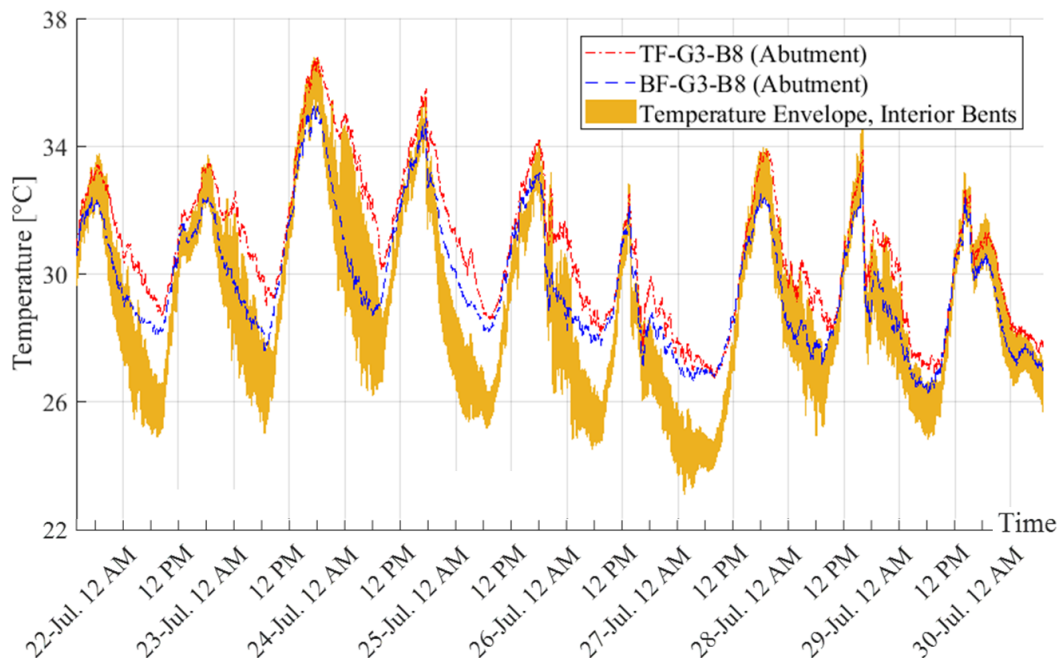
**Figure 5.16. Temperature envelope for BRY3.**

Each gage on a bridge provided a temperature reading, with measured values varying at locations throughout an individual bridge. When examining the data holistically, researchers observed a noticeable difference in temperatures at the interior bents and those at the abutments. Figure 5.16 provides an example of the temperatures collected for the BRY3 bridge. The yellow area provides an envelope of temperatures at the interior bents. The blue and red lines provide the temperatures measured at the abutments. The higher temperatures at the abutment are a result of the abutment backwall retaining heat and resulting in slower drops in temperature in the evening and morning, compared to that of the interior bents. Temperatures are highest in the evening and lowest in the morning hours.

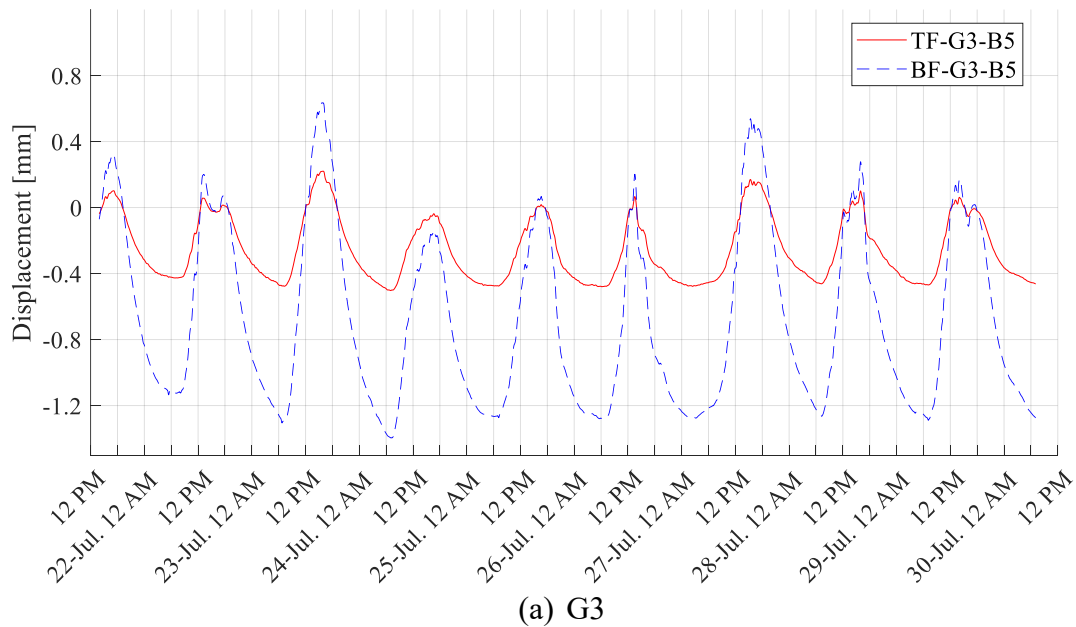
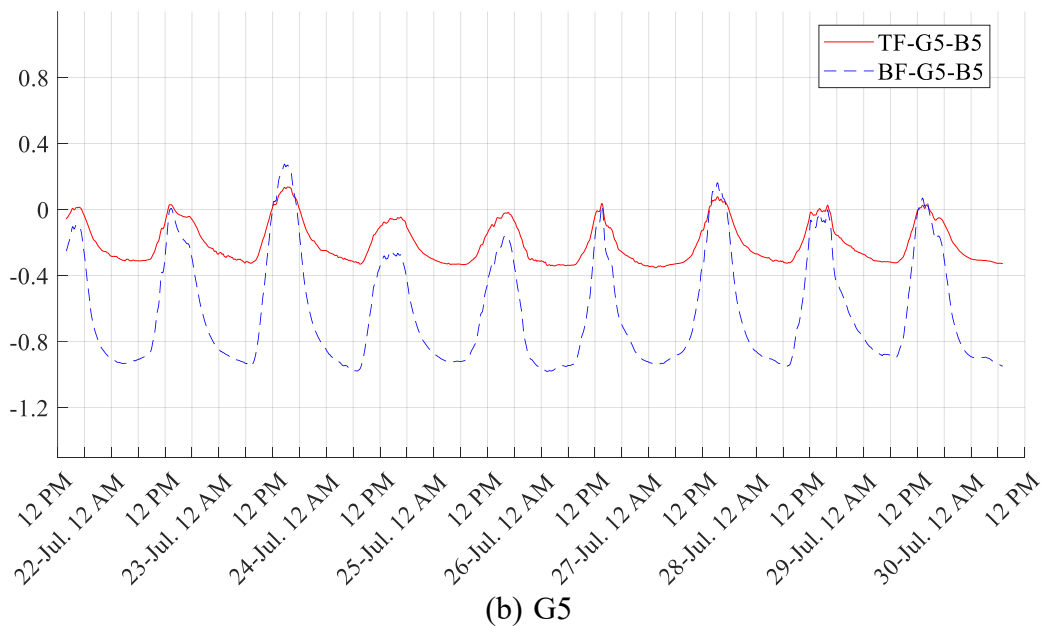
**Figure 5.17. Thermal deformations of gages in BRY3 at PBJs at B5.**

Deformation histories for gages on BRY3 are provided in Figure 5.17 and Figure 5.18 at PBJ locations and Figure 5.19 for SEJ locations. Figure 5.20 shows the strain history for strain gages located on either side of G3.

A comparison of the deformations at the PBJ and SEJ indicates a difference in the general trends of deformation in the top and bottom gages. At the PBJ locations, displacements of the top gages (those starting with TF and shown as a solid red line) are smaller than those of the bottom gages (those starting with BF and shown as a dashed blue line). For SEJ, the displacements are larger at the top flanges. This fundamental difference in the response is an indication that the center of rotation is different between the two locations. At SEJs, the center of rotation is located within the height of the girder. For PBJs, the continuity provided by the deck shifts the center of rotation higher toward or within the slab.

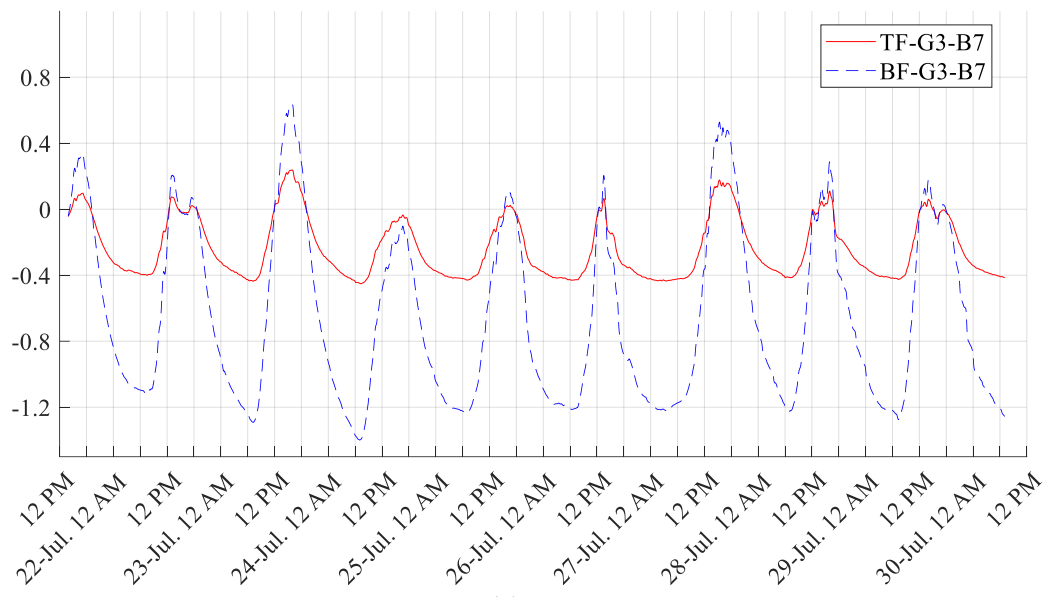
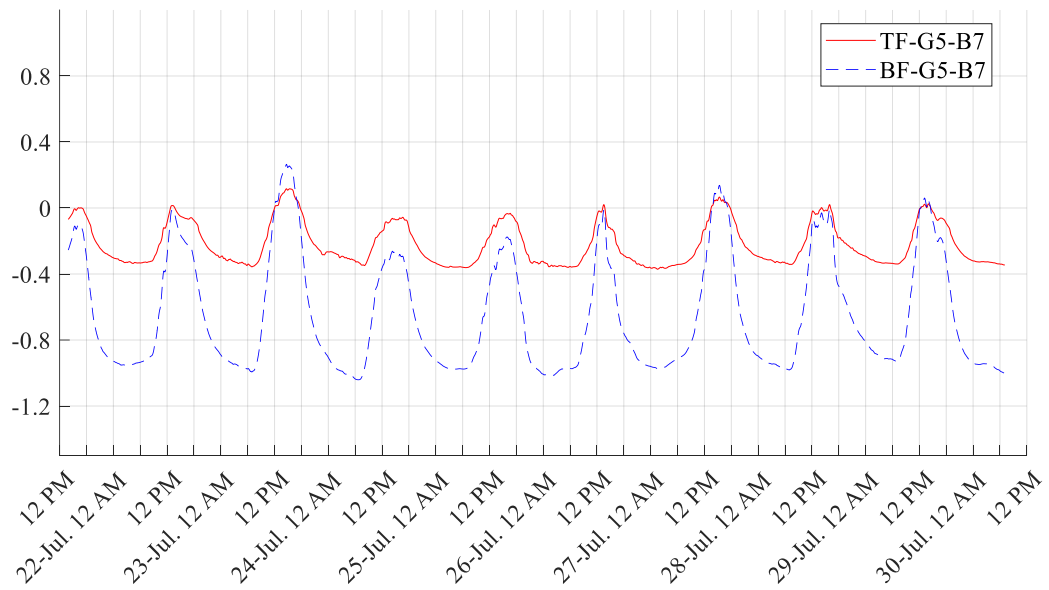
(a) G3

(b) G5

**Figure 5.18. Thermal deformations of gages in BRY3 at PBJs at B7.**

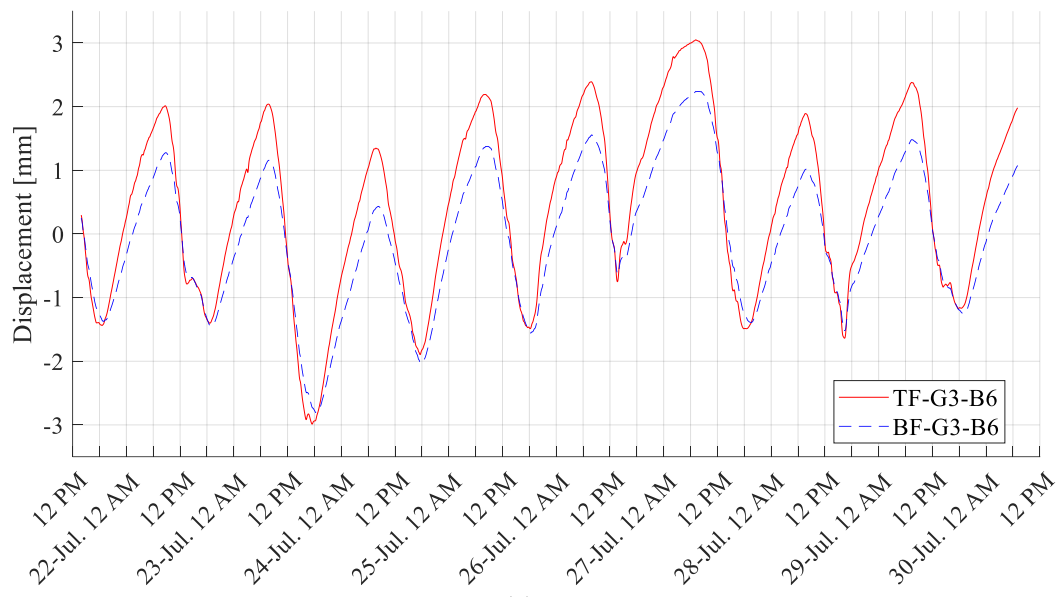
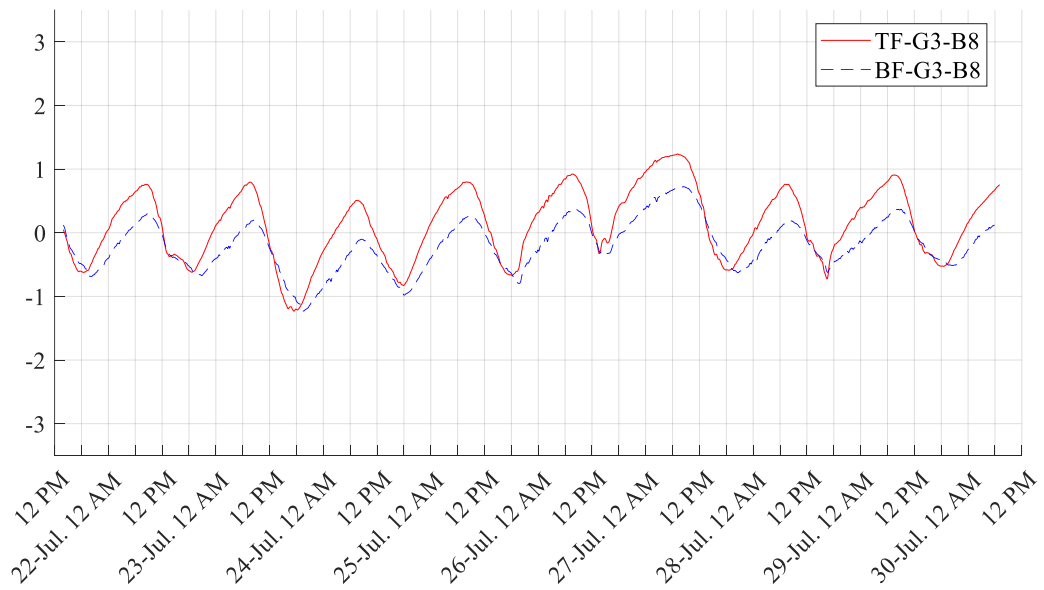
(a) B6

(b) B8

**Figure 5.19. Thermal deformations of gages in BRY3 at SEJs along G3.**

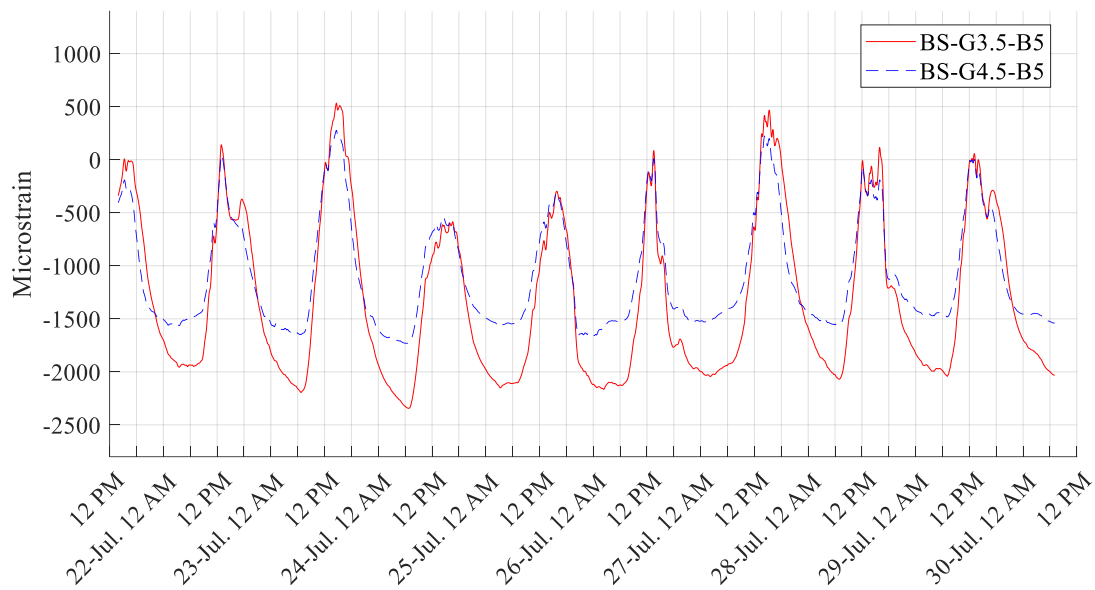
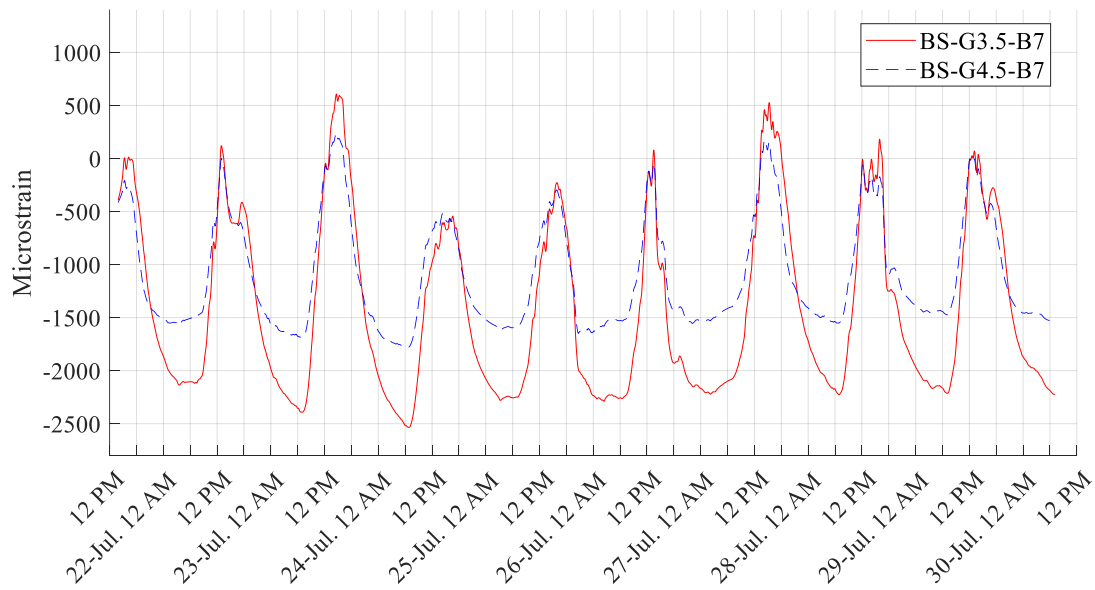
(a) B5

(b) B7

**Figure 5.20. Thermal strains for BRY3 on either side of G3.**

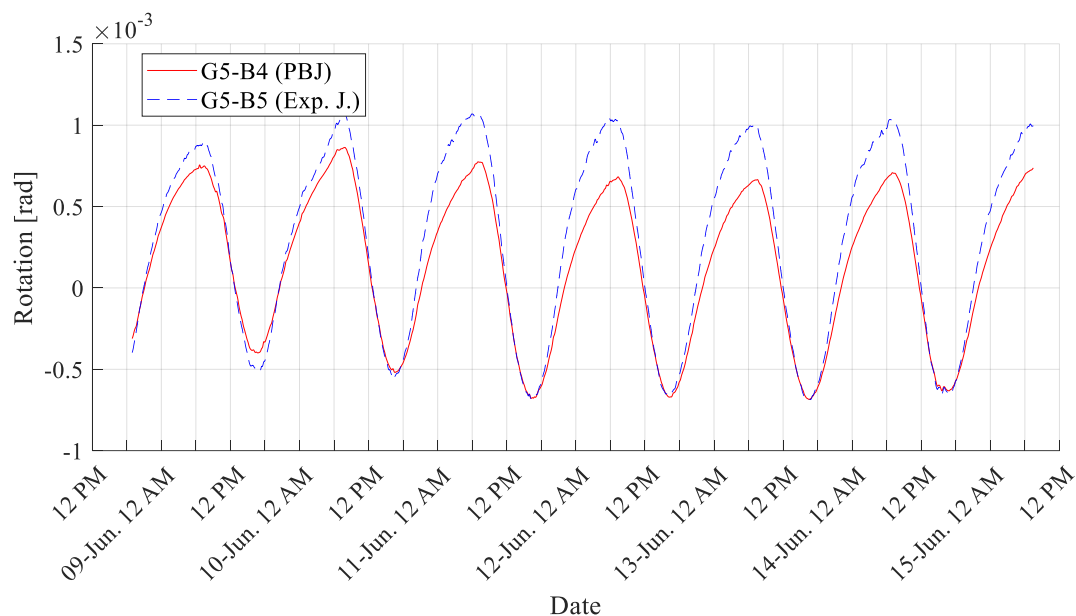
**Figure 5.21. Example of thermal rotation time history, shown for BRY1.**

The deformations at each location were used to calculate the rotation using Equation 5.1. An example of rotations is shown in Figure 5.21 for BRY1. The rotation history cycles between peak negative values in the evening (when temperatures are highest) and positive values in the morning (when temperatures the lowest). The selected histories shown are for G5-B4 (PBJ) and G5-B5 (SEJ). Since both are along the same girder line, the comparison allows for a comparison of the influence of the slab continuity on the rotation. Under positive bending, the rotation varies

by as much as 35 percent, illustrating the considerable impact of the slab continuity on the rotation demand used for design. For negative bending, the difference is much smaller.

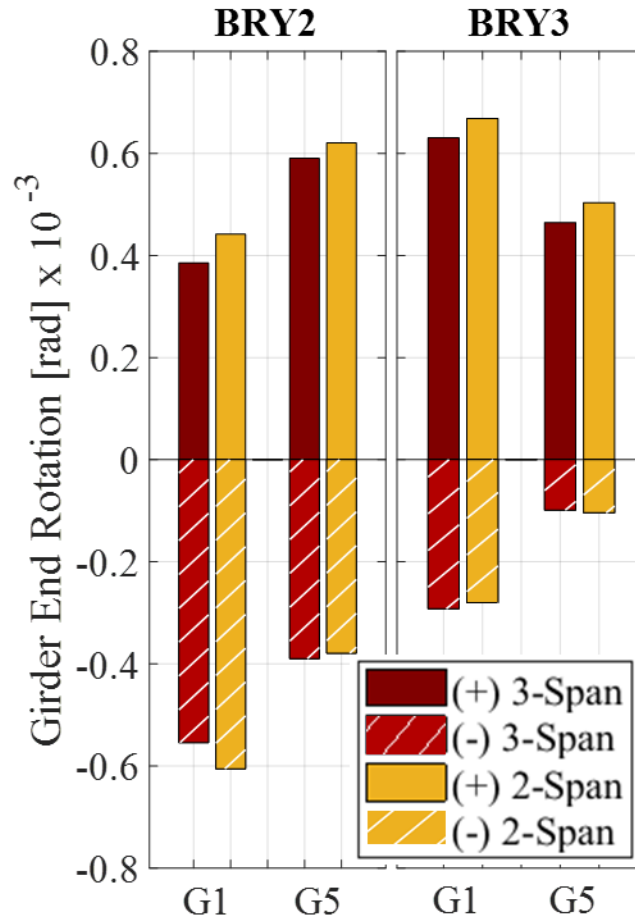
**Figure 5.23. Thermal rotations for BRY2 and BRY3, with bars indicating number of continuous spans in a unit (red bars indicate three-span units and yellow bars indicate two-span units).**

For BRY3, the center girder line (G3) provided rotations at both PBJ and SEJs, with the girders having slightly larger magnitude rotations at the interior SEJs. The smallest magnitude rotations are at the abutment SEJs. The exterior girder line was instrumented only at the PBJs, with both bents having similar rotations throughout the monitoring period. BRY3 provides another opportunity for comparison of two- and three-span units, with the relevant data included in Figure 5.22. As with BRY2, there is larger positive rotation in the two-span units. The negative rotation is similar or slightly smaller when negative bending is considered. This finding is slightly different than for BRY2, but it may be due in part to the inclusion of interior girder data and the fact that BRY3 is not skewed while BRY2 is skewed.

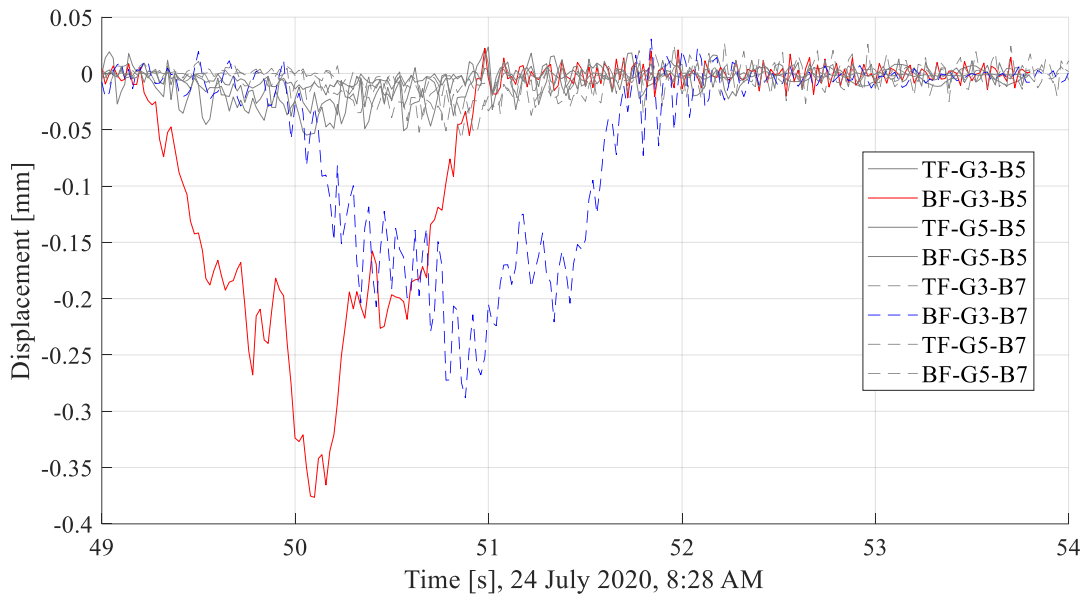
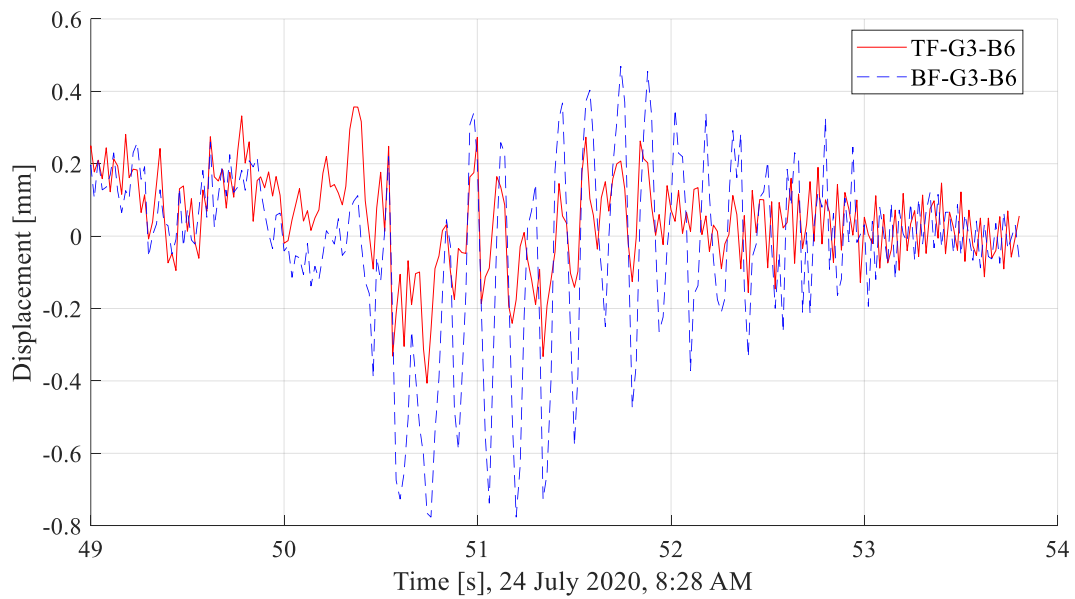
(a) Displacements at PBJ closest to truck event

(b) Displacements at SEJ closest to expansion joint

**Figure 5.24. Displacement data for sample live load event for truck on BRY3 above G3.**

An example of data from a live load event is shown in Figure 5.24 and Figure 5.25. Figure 5.24(a) and (b) show the displacements of gages at the PBJ and SEJs, respectively. At the PBJs, the data from all gages are shown. The gages on the bottom and top flanges of the location nearest the truck are shown by solid red and dashed blue lines, respectively. The other gages are not distinguishable as individual lines and are shown only to demonstrate that the magnitude is significantly smaller at those locations since the truck is not near to those locations at the time of the data collection. Figure 5.25 shows the strain data, with the two gages closest to the event highlighted.

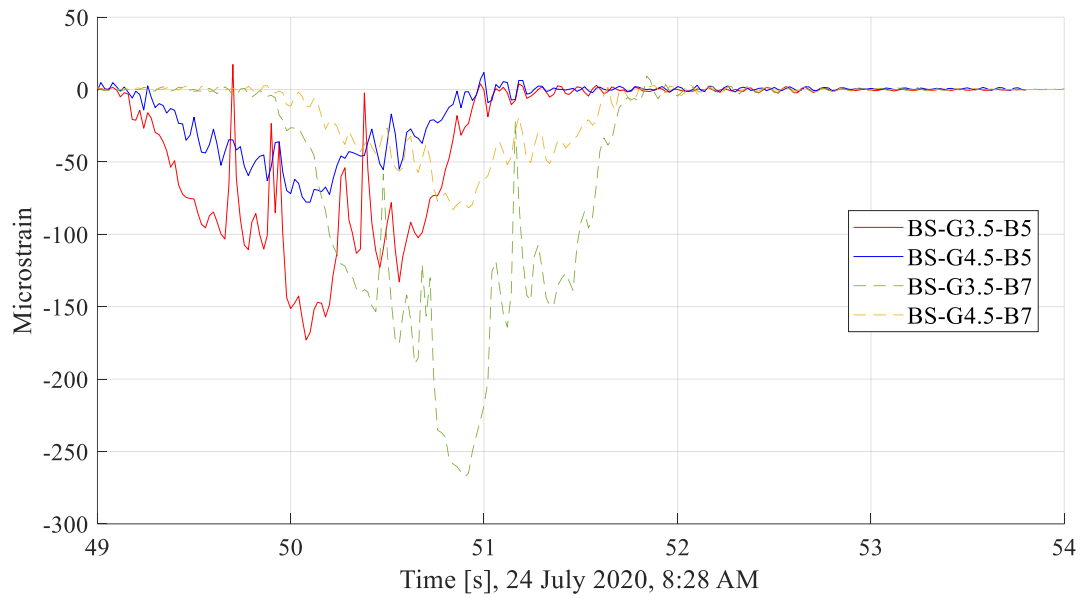
**Figure 5.25. Strain data for sample live load event for truck on BRY3 above G3.**

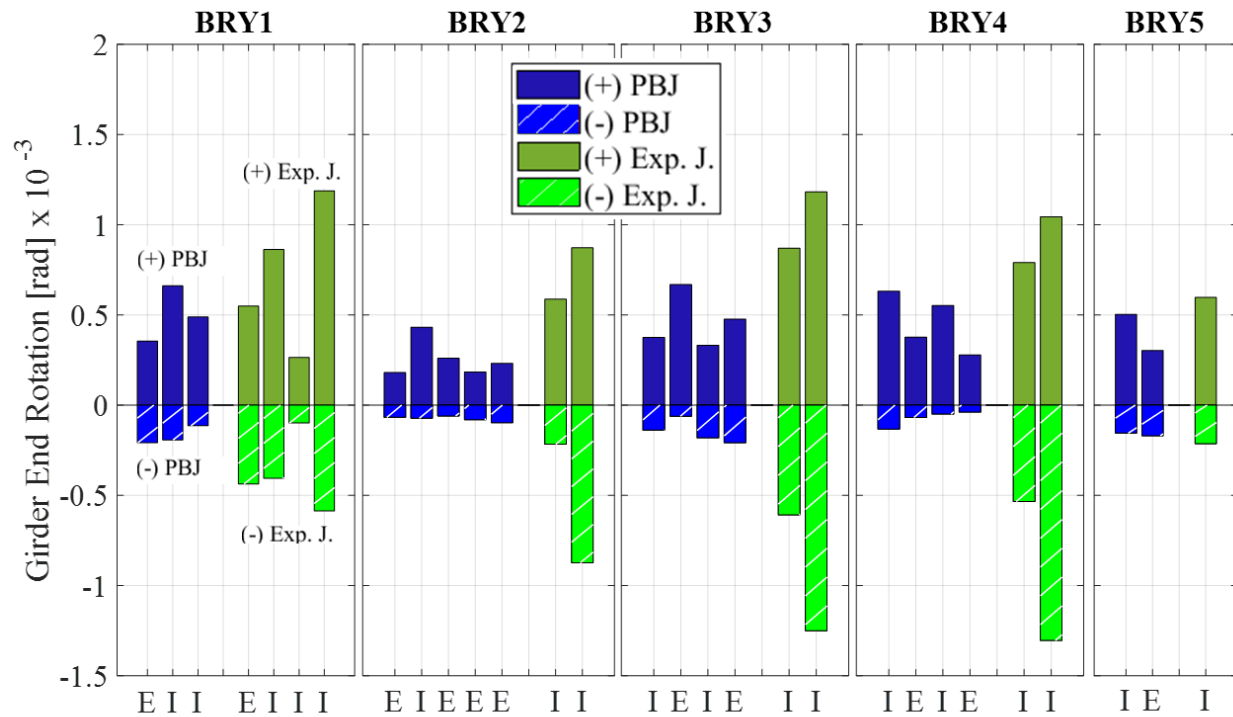
**Figure 5.26. Maximum positive and negative live load rotations.**

While the trends in the thermal response were similar between all bridges, there is a greater range of responses in live load. A driving factor of this is the dynamic nature of the load. For BRY3, the truck event is positioned well relative to the instrumentation and thus provides very clear results. This is not the case for all bridges, where the instrumented locations may not directly correspond to the live load events triggered. Thus, the response for individual bridges is presented as the maximum magnitudes of the rotations in Figure 5.26. Each bar represents an individual monitoring location, with blue bars showing PBJ rotations and green bars showing SEJ rotations. Positive values are shown as solid, and negative values are shown as hatched. Below each bar, the transverse location is indicated, with E indicating an exterior girder and I indicating an interior girder. Both positive and negative rotations are calculated. The positive

Overall, the relative observations for each bridge are similar to those made for thermal. For all bridges, PBJ rotations are smaller than the SEJ rotations. A comparison of interior and exterior locations shows that the interior rotations are larger magnitudes than the thermal demands.

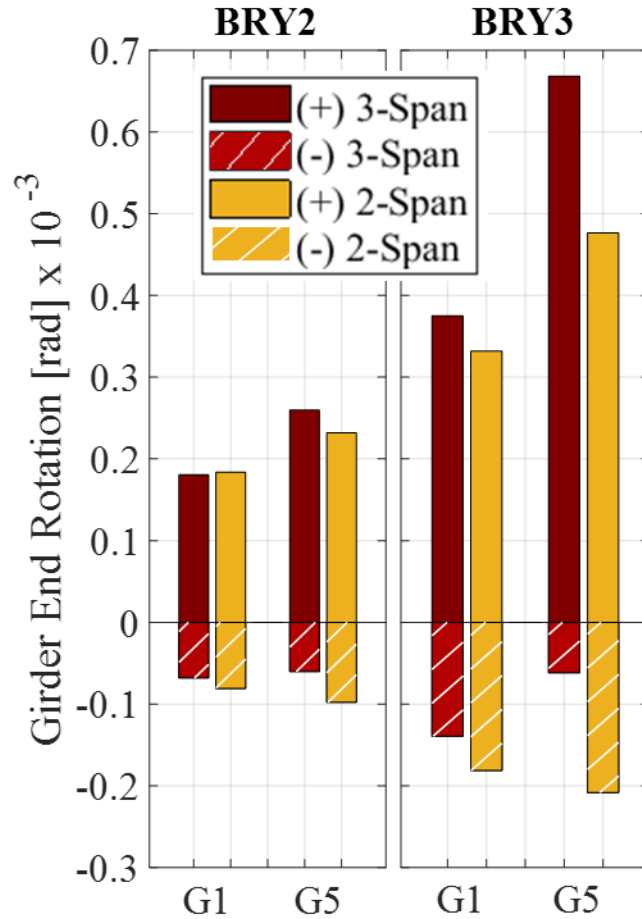
**Figure 5.27. Thermal rotations for BRY2 and BRY3, with bars indicating number of continuous spans in a unit.**

Figure 5.27 shows the live load rotations for two- and three-span units in BRY2 and BRY3. Presentation of the data is the same as that for the thermal loads shown in Figure 5.23. Rotations are generally larger for three-span units under positive bending and larger for two-span bridges under negative bending.

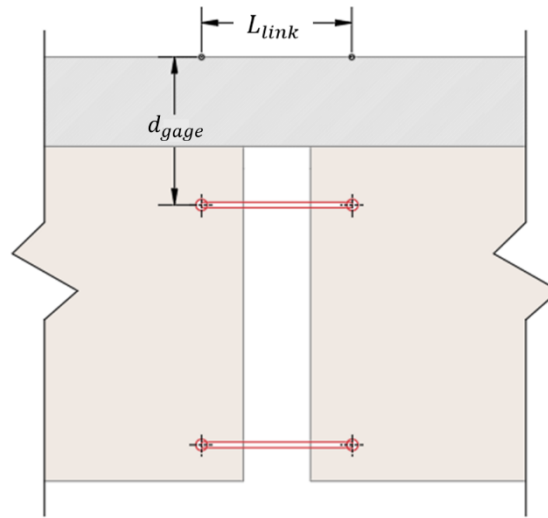
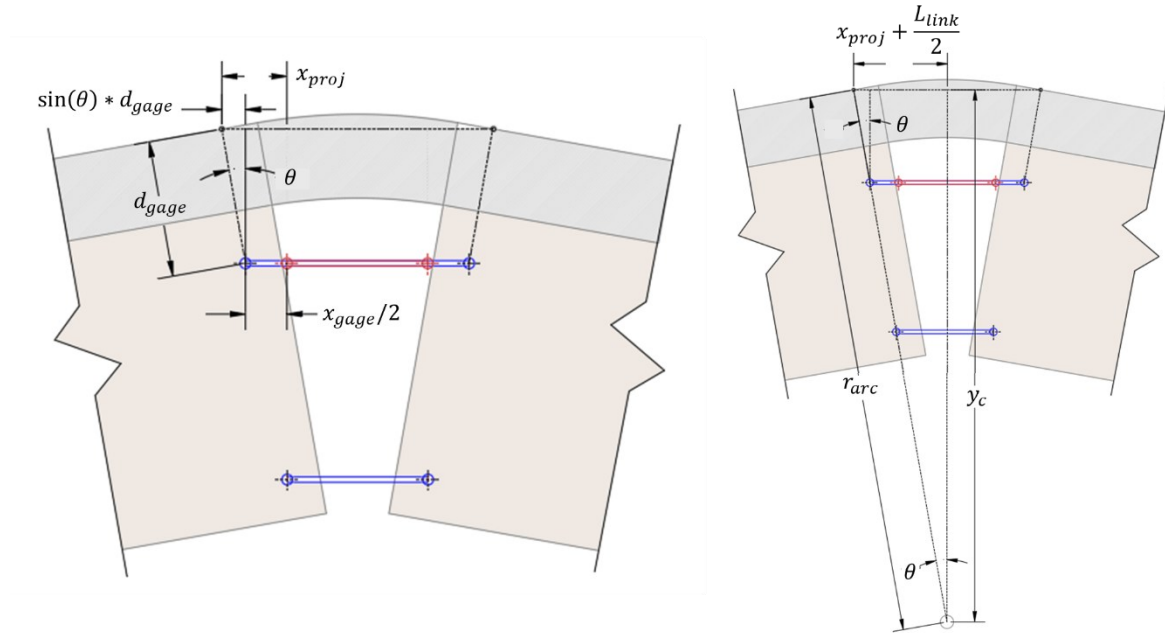
(a) Undeformed configuration

(b) Deformed configuration

**Figure 5.28. Variables and deformed shape of link slab used for calculating deck strains from measured displacements at the ends of girders.**

Figure 5.28 provides an overview of the variables describing the deformed and undeformed configuration of the link slabs. The undeformed configuration is shown in Figure 5.28(a).  $L_{link}$  is the effective link slab length and does not necessarily align with the location of the ends of the gages. The distance between the top displacement gage and the point of interest for calculation of the strain is  $d_{gage}$ . This is shown as the top of the slab but can be the bottom of the slab, which is used for comparison to the measured data.

Figure 5.28(b) shows the deformed configuration of the link slab. The measured displacement of the top gage is  $x_{gage}$ . The projected elongation at the location of the desired strain,  $x_{proj}$ , is calculated as:

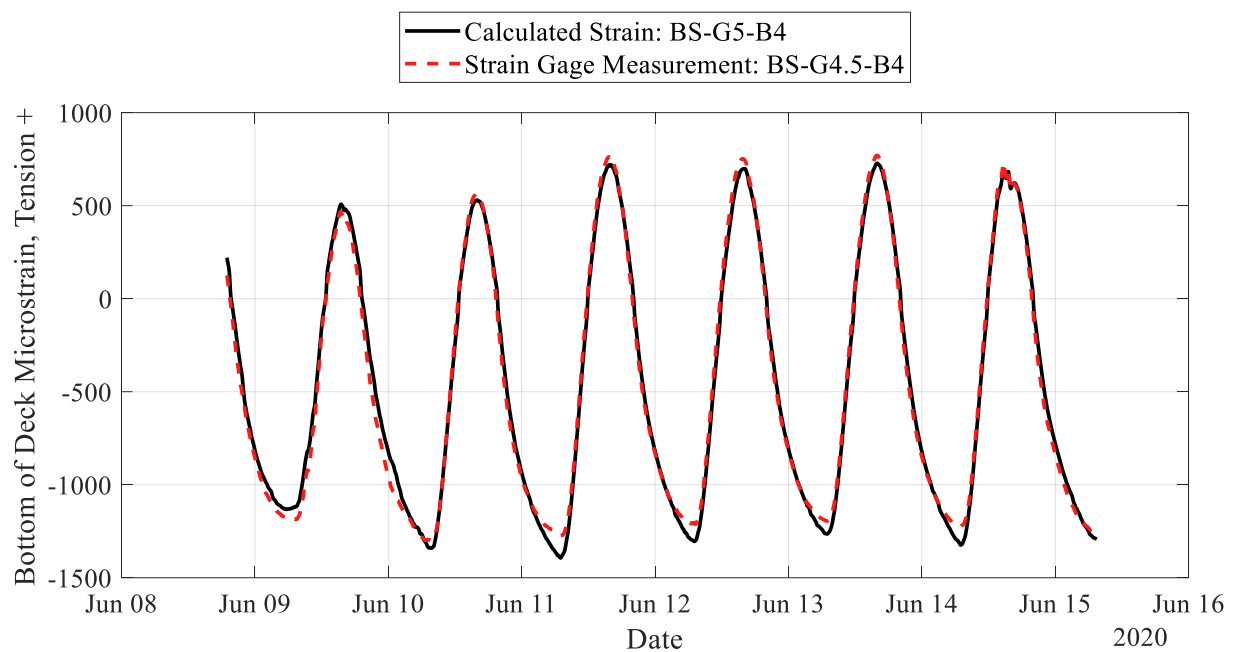
From gage displacements and girder rotation, the strains in the deck can be estimated and compared to the measured strain. The measured strains were located slightly off from the girder edges, but it was assumed that the strains were similar to those immediately over the girder line. By estimating strains for a range of possible effective link slab lengths in 0.5-in. increments, the effective length could be identified as the length that minimizes the difference between the measured and estimated strains. An example of the estimated and measured strains is shown for BRY1 in Figure 5.29.

**Figure 5.29. Comparison of measured and estimated strains for BRY1.**

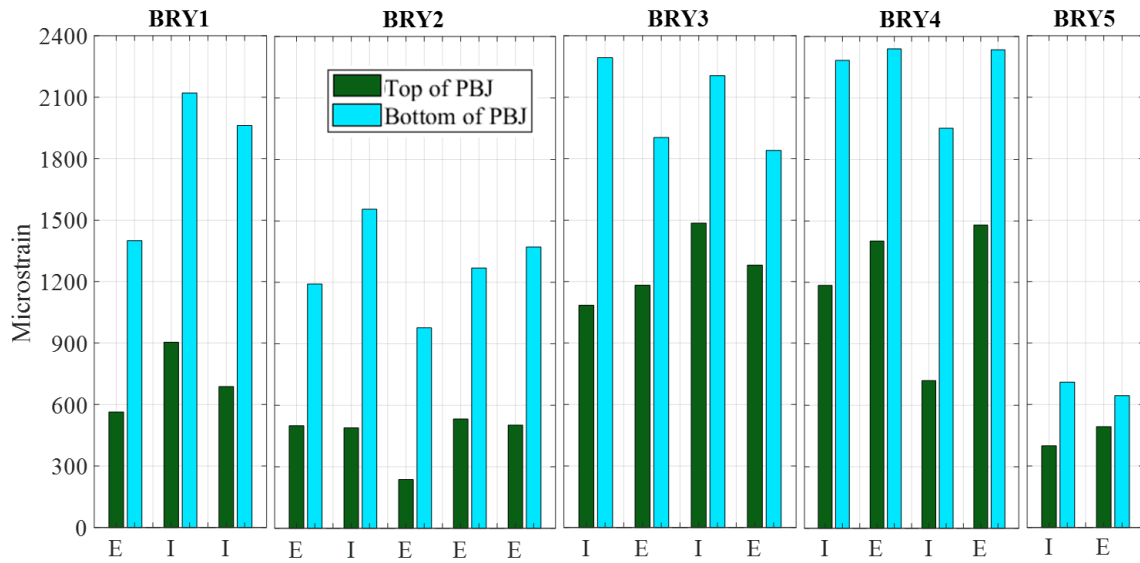
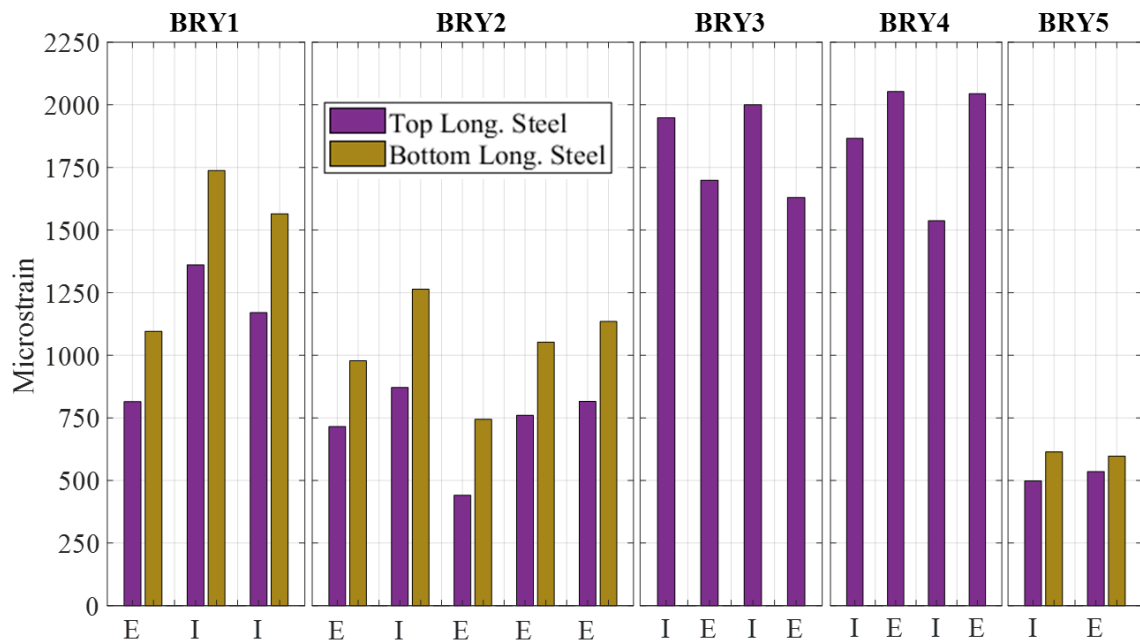
For thermal strains, it was not possible to establish the true point of zero strain; thus, the range of strains is presented in Figure 5.30. Figure 5.30(a) shows the strain range at the top (green) and bottom (cyan) of the deck. Figure 5.30(b) shows the strain range in the longitudinal reinforcement bars. For the flush panel bridges (BRY3 and BRY4), only top steel is shown because there is no bottom reinforcement at the center of the link slab. Thermal strains are larger at the bottom of the deck for both steel and concrete. While the strain range exceeds the anticipated yield strain of the longitudinal reinforcement, it is not expected that yielding is occurring since the range of strain is expected to be split between positive and negative strains.

(a) Concrete strains

(b) Longitudinal rebar strain

**Figure 5.30. Thermal strain range estimated at each PBJ for each bridge (E = exterior girders and I = interior girders).**

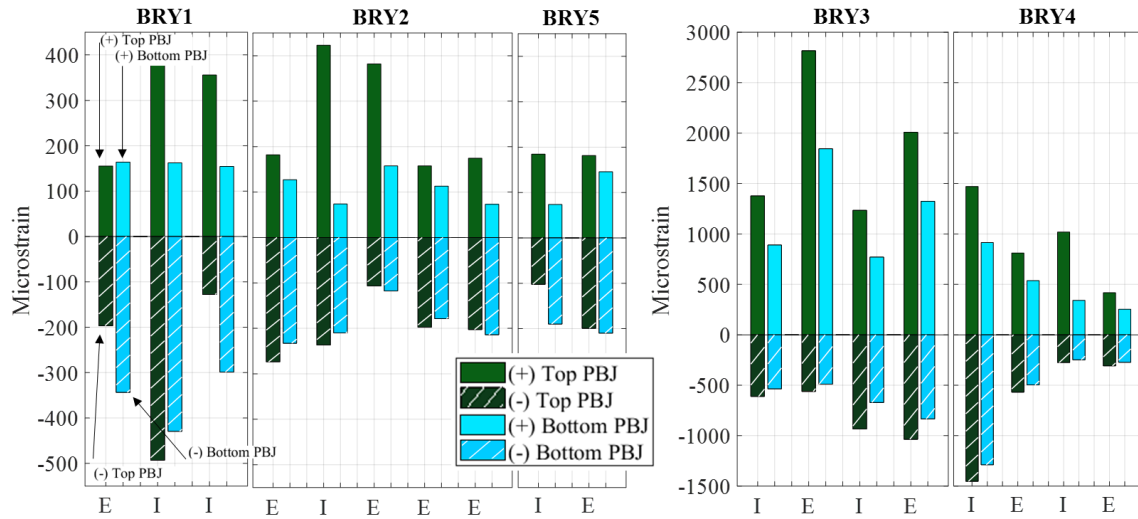
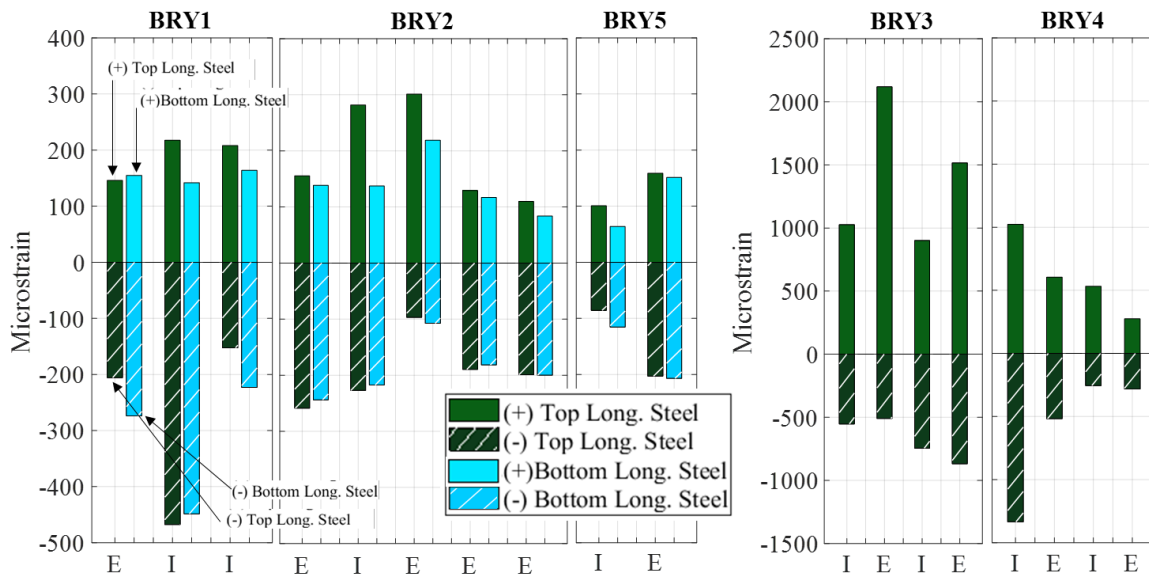
Live load strains are shown in Figure 5.31. Bridges are grouped as non-flush panels (BRY1, BRY2, and BRY5) and flush panels (BRY3 and BRY4). The strains for individual events are considered and include both positive and negative strains. Note that this is the strain due to the live load event, not the total strain. The strains are larger magnitude in the flush panel bridges, indicating concentration of deformation where the panels meet.

(a) Concrete strains

(b) Longitudinal rebar strain

**Figure 5.31. Thermal strain range estimated at each PBJ for each bridge (E = exterior girders and I = interior girders).**

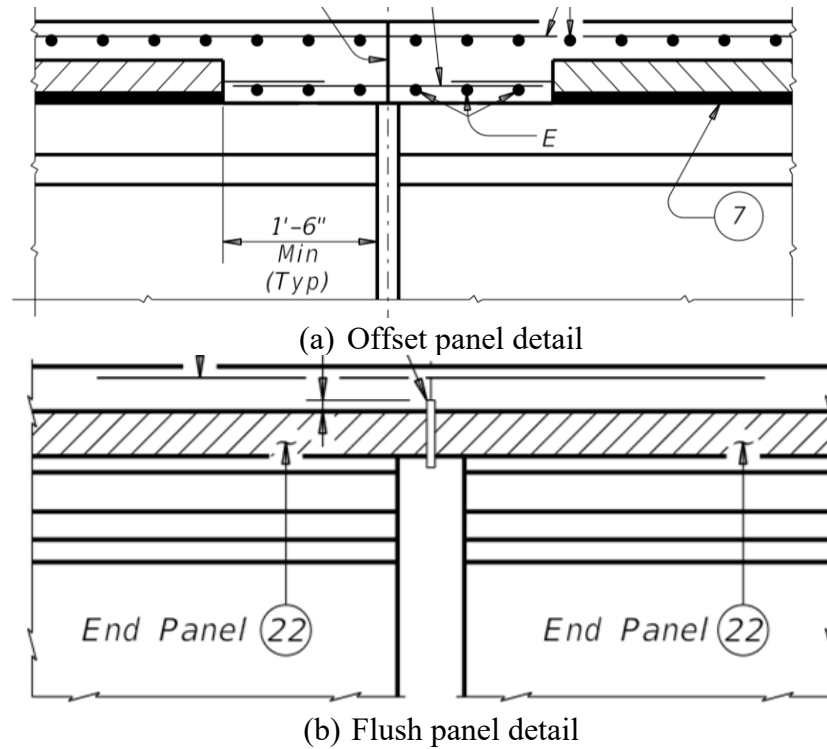
TxDOT standards offers two options for continuous deck detailing when partial-depth PCPs are used: offset panels and flush panels (see Figure 6.1).

When offset panels are used (Figure 6.1[a]), the panels end a minimum of 1 ft 6 in. from the end of the girders, with the deck full-depth CIP between the ends of the panel. The top reinforcement is the same as that in the remainder of the deck, while bottom reinforcement is provided spliced with dowel bars extending from the panels. Per the standard details, the intent of the detail is that the deck in the link slab region be the same thickness as the deck elsewhere. This is notably different than for a thickened deck at the ends of girders where expansion joints are used. At bridges with offset panel detailing visited as part of this project, researchers observed a slight thickening of the slab where there were continuous decks. Although measurement of the thickness increase was not possible, it appeared to be similar to the increase in thickness at expansion joint locations. While such a deviation will have limited impact on the stiffness and strength of the deck, it is worth considering in making recommendations for future changes to standard details.

**Figure 6.1. TxDOT PBJ detailing with partial-depth PCPs.**

The current flush panel detail (Figure 6.1[a]) utilizes a  $\frac{3}{4}$ -in. redwood board, chamfered at the top to act as a crack former, between the panels from either span of the girder line. During field visits for BRY3 and BRY4, flush panel details were observed to have been constructed differently than in the current standards, utilizing bedding strip foam for the gap between the panels (Figure 6.2). It is not clear what the design drawings or approved change orders were for these bridges, only that the constructed detail is different than the current standard.

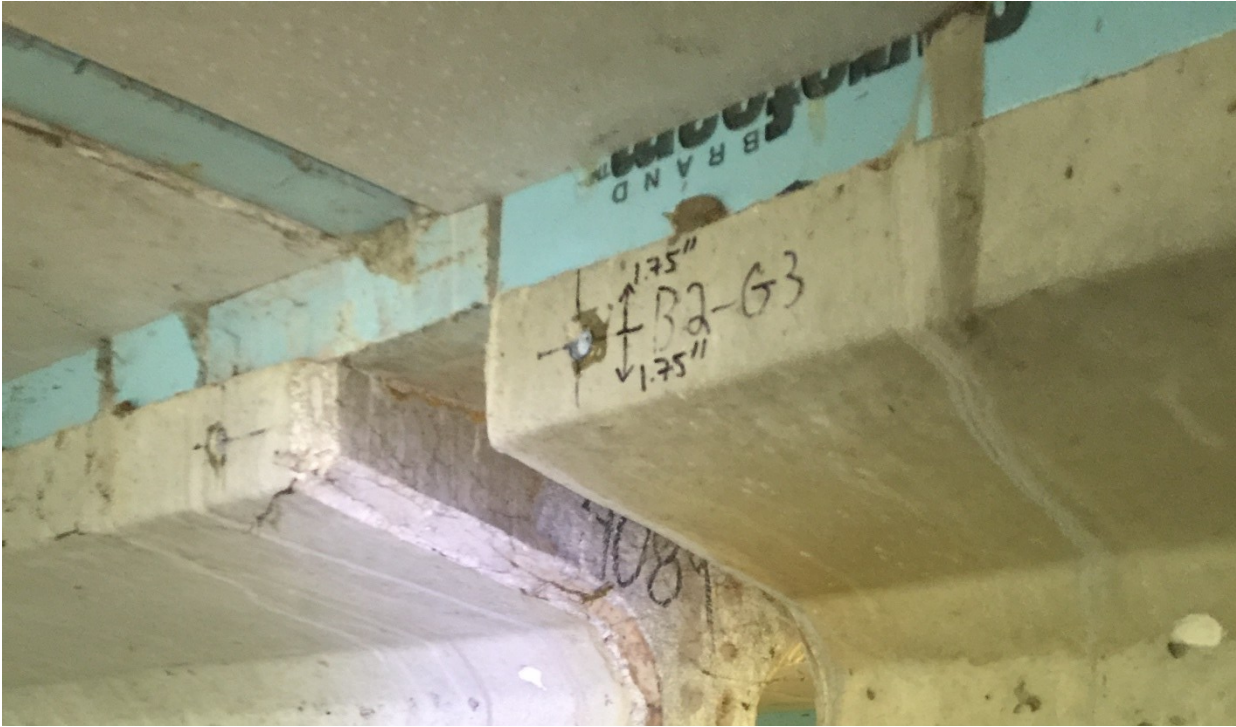
**Figure 6.2. Observed flush panel detail for BRY4.**
