# Performance and Improvement of Texas Poor Boy Continuous Bridge Deck Details: Final Report

Technical Report 0-7013-R1

TEXAS A&M TRANSPORTATION INSTITUTE  
COLLEGE STATION, TEXAS

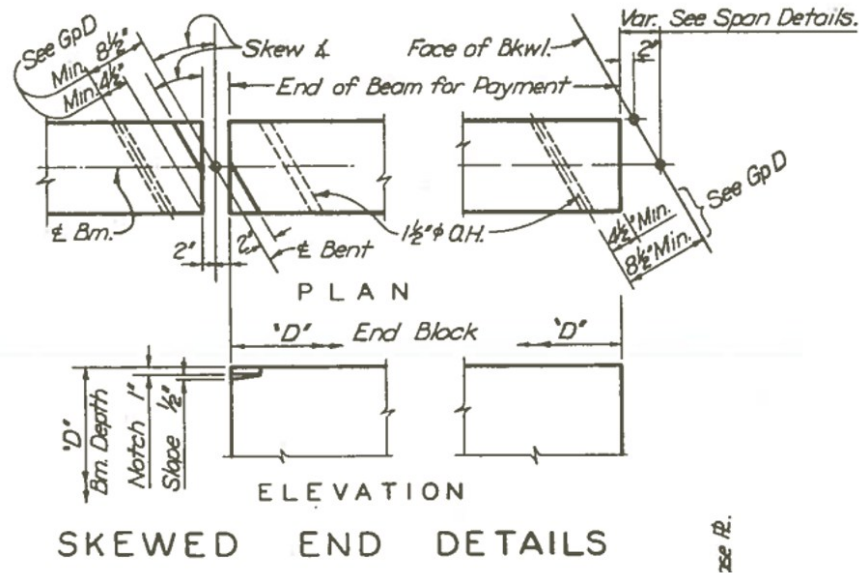
To prevent the girder and bridge deck from interfering with one another as the bridge deforms under load, there are two main detail types: a skewed girder end detail and a foam insert detail. The skewed girder end detail consists of a girder end face design that is trimmed to match the support skew. The foam insert detail uses typical squared girder end faces but includes a strip of polystyrene foam over the protruding corner of the girder to prevent concrete-to-concrete contact with the deck. In 1959, TxDOT's prestressed concrete beams GPC1 standard detail (see Figure 6.3) included a skewed end detail with a 1-in. deep notch cut into the girder end.

**Figure 6.3. Prestressed concrete beams GPC1 standard detail of 1959.**

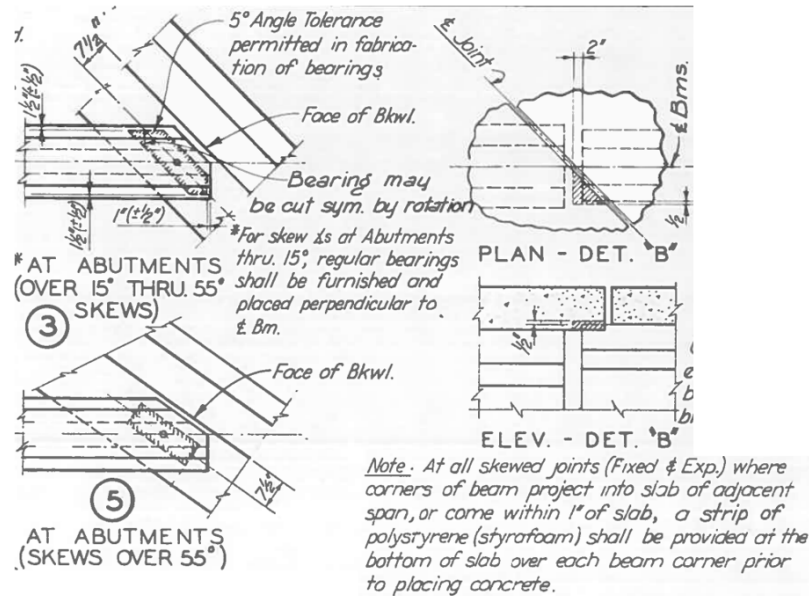
In 1968, both types of end details were present (see Figure 6.4). Rather than using a partial-depth notch in the girder end, the end face was skewed for the whole depth of the girder. The foam insert detail appeared for the first time, mandating a minimum of  $\frac{1}{2}$  in. of clearance.

Figure 6.4. Prestressed concrete beam span details, AASHTO Type IV standard detail of 1968.

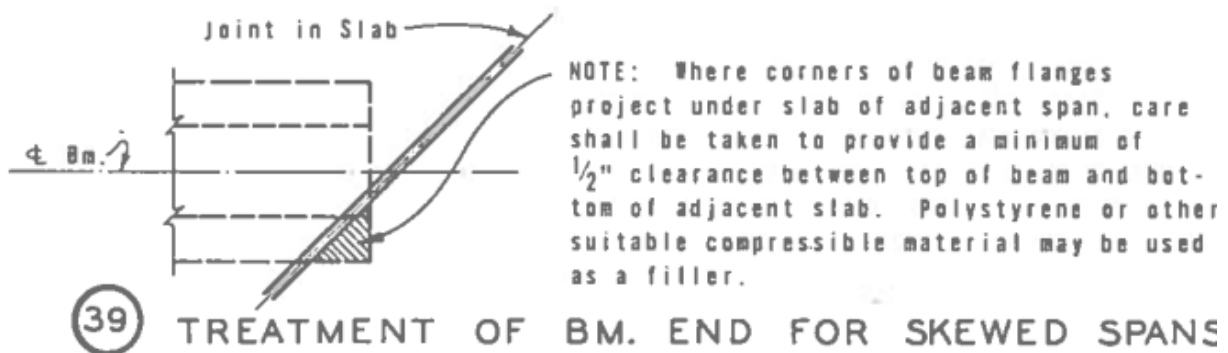
The prestressed concrete beam span details of 1971 (see Figure 6.5) continued the use of the foam insert. In 1998, the foam insert detail changed slightly to mandate 3 in. of foam extension past the edge of the girder, as shown in Figure 6.6.

Figure 6.5. Prestressed concrete beam span details of 1971.

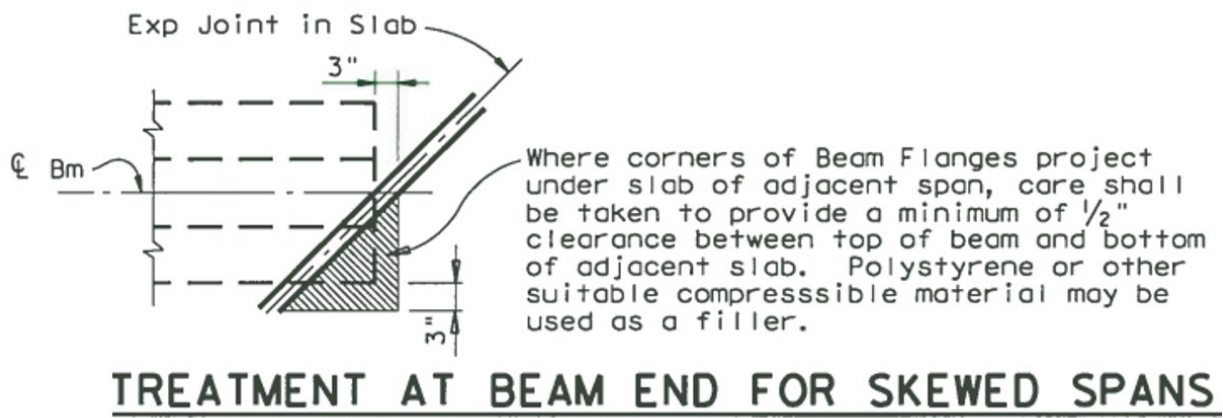
Figure 6.6. Miscellaneous slab details of 1998.

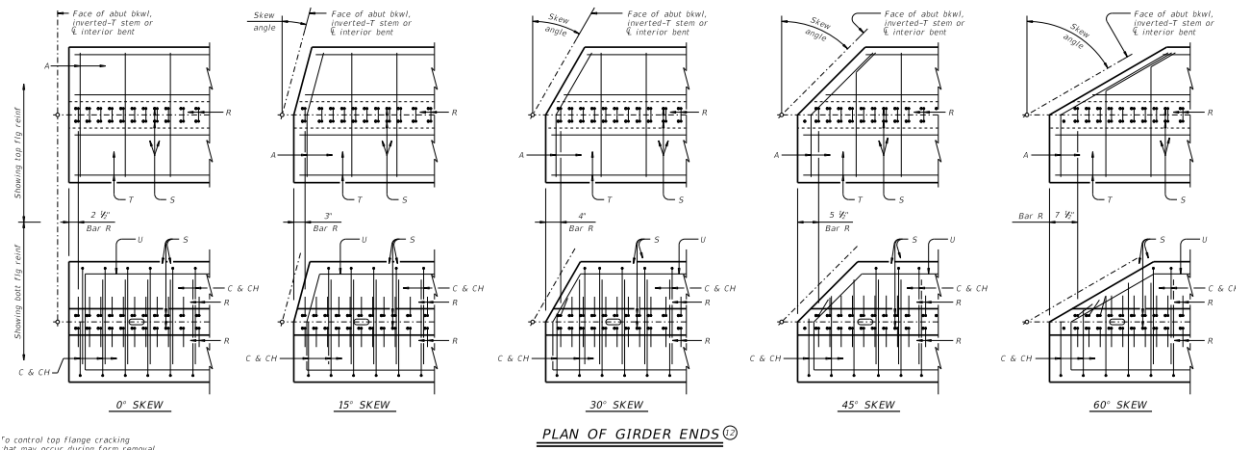
The current iteration of the two girder end detail options at skewed supports includes direction on reinforcement placement (Figure 6.7) and bearing pad placement (Figure 6.8) for the skewed end detail. The current foam insert detail, shown in Figure 6.9, is similar to the detail from 1998.

**Figure 6.7. Current standard details for skewed ends from prestressed concrete I-girder details sheet.**

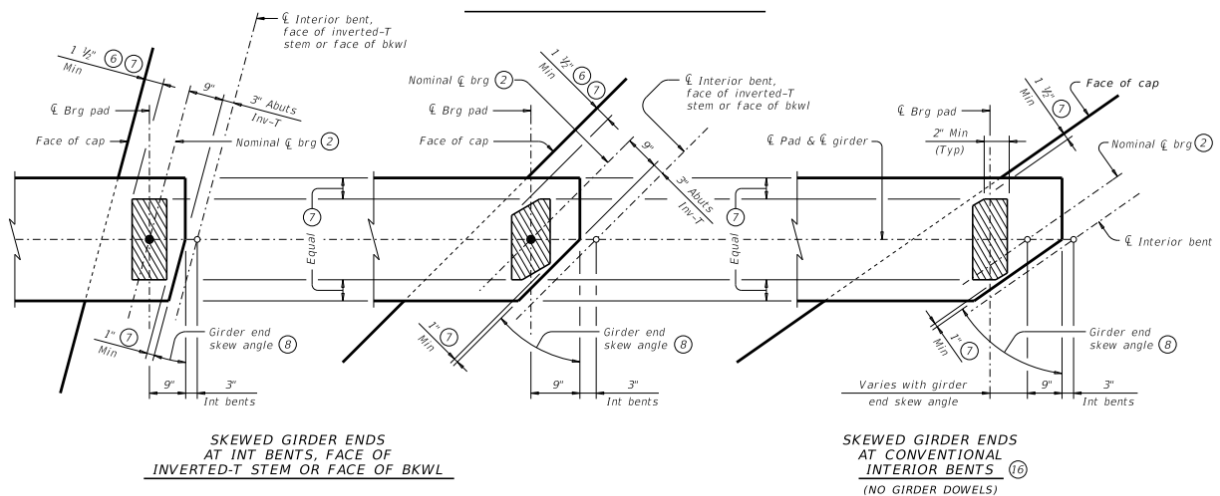
**Figure 6.8. Current standard details for skewed ends from elastomeric bearings and girder end details sheet.**

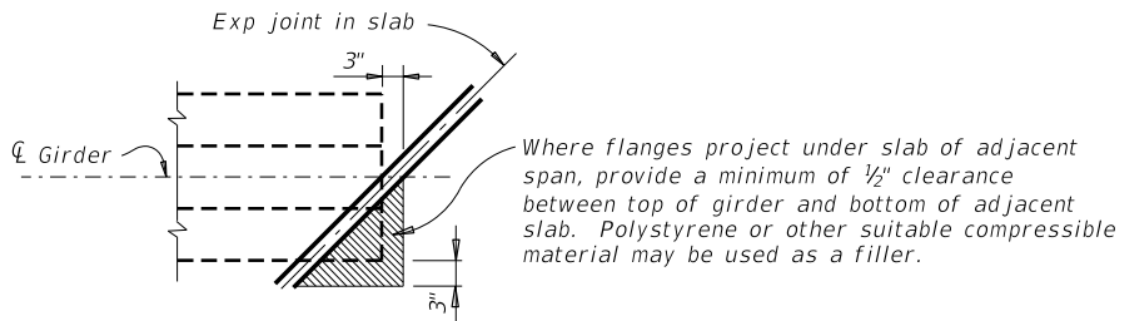
**Figure 6.9. Foam insert detail from current miscellaneous slab details sheet.**

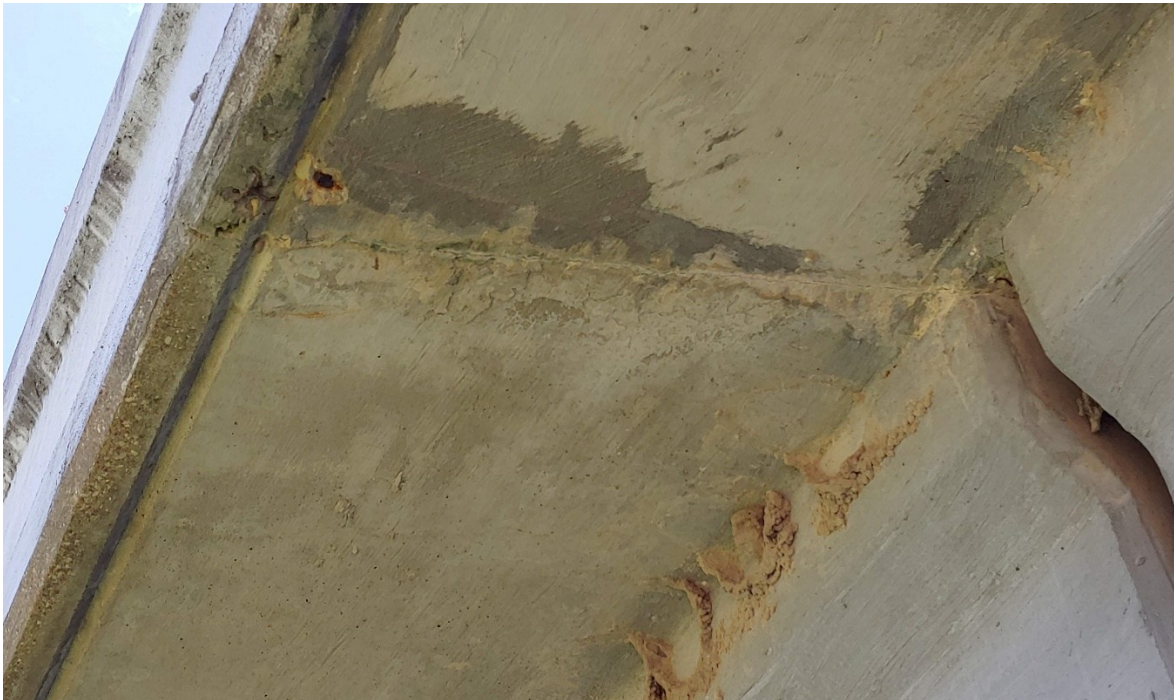
**Figure 6.12. Cracking in the deck above the girder ends at skewed supports on Peach Creek Bridge.**

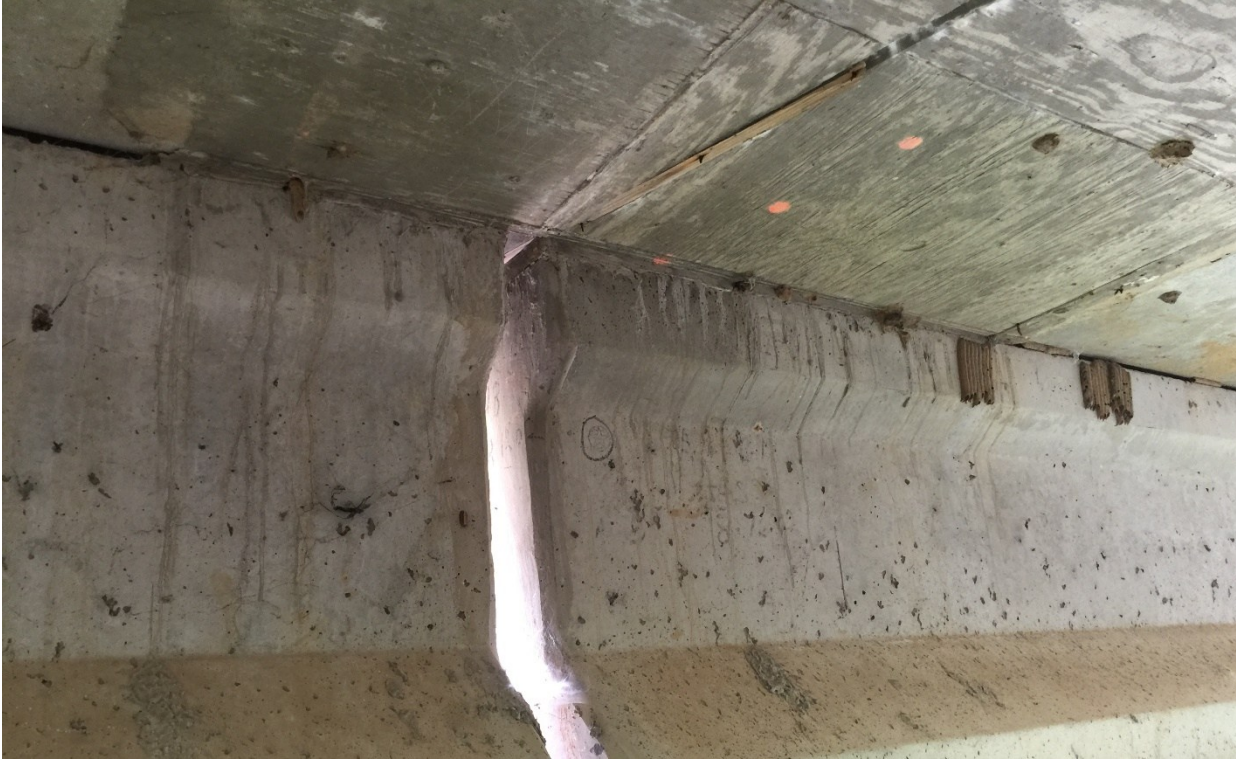
Despite the availability of two standard detail options, there is evidence that contractors have not provided either detail at some bridges. For instance, at Old River Bridge (Bridge ID 17-026-0648-03-020), neither skewed girder ends nor a visible foam insert was used to prevent the girder ends from contacting the slab of the adjacent span, as shown in Figure 6.10. The skew at all bents of Old River Bridge is 30 degrees. Figure 6.11 shows possible damage from contact between the slab and protruding girder at an expansion joint. At Peach Creek Bridge (Bridge ID 17-021-0050-02-135), no skewed girder or foam insert detail is visible, despite the deck crack between spans running beneath the edge of the girder end (see Figure 6.12). Peach Creek Bridge has supports with 15-degree skew. At Bridge 2.2 in the Atlanta District (Bridge ID 19-034-00946-01-013), which has a 15-degree skew, no skewed girder or foam insert detail is visible at the girder ends (see Figure 6.13).

**Figure 6.13. Atlanta District bridge without a foam insert or skewed girder end detail.**

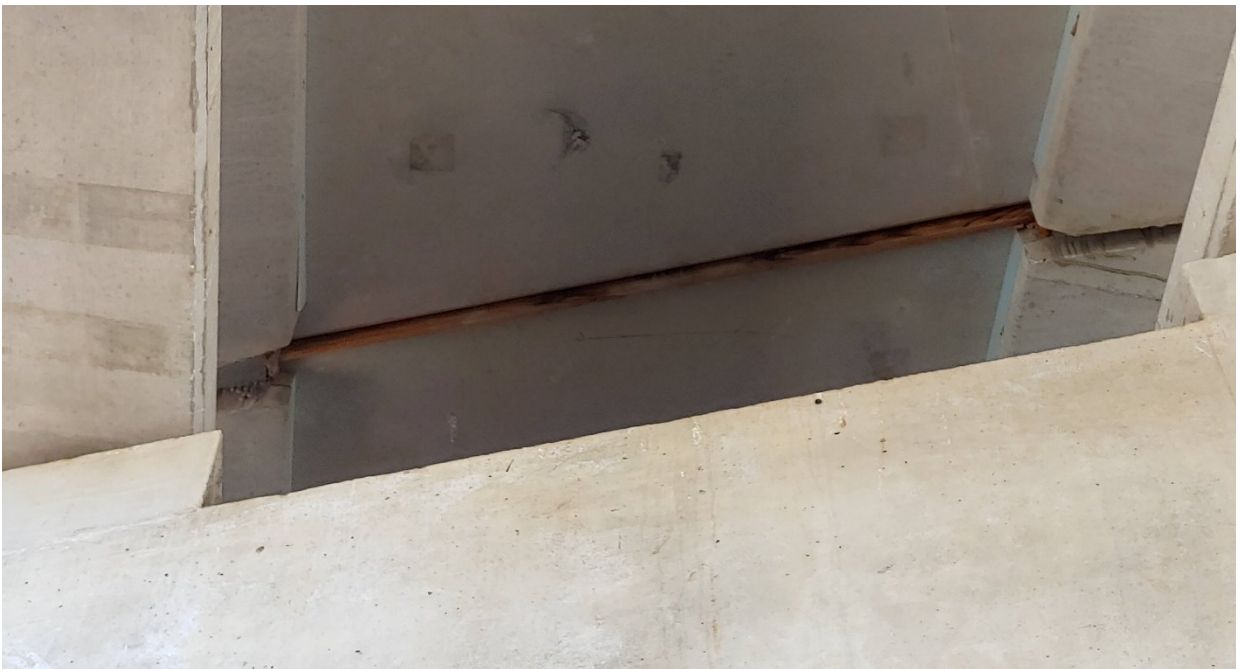
An as-built example of a skewed girder end detail is shown in Figure 6.14 on a bridge in the Lubbock District on Highway 62 (Bridge ID 5-152-00380-01-236). This bridge has a 19-degree skew. Of the four skewed bridges with visible details that the project team assessed as part of Task 3, only one had a visible skewed end detail. The application of these details appears to be inconsistent.

**Figure 6.14. Lubbock District bridge with skewed girder end details.**

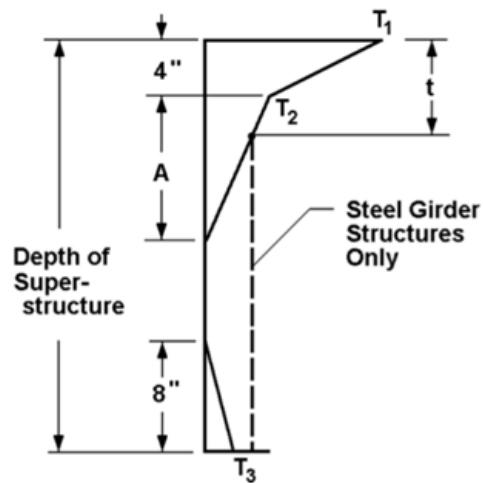
The effect of temperature gradient is accounted for using Section 3.12.3 of the AASHTO specifications. The profile of AASHTO's temperature gradient is shown in Figure 7.1. To simplify rotation calculations, this nonlinear gradient was simplified as a linear gradient with endpoints T1 at the top of the superstructure and T3 equal to zero at the bottom of the superstructure. For positive bending in the girders, a negative gradient is used, which applies a factor of  $-0.30$  to the AASHTO specified values. For each prototype bridge, rotations due to thermal loading were found by integrating the temperature gradient. Values are shown as absolute values in Figure 7.2. Positive thermal values are for positive thermal gradients and correspond to negative girder bending. Negative thermal values are for negative thermal gradients and correspond to positive girder bending. The magnitudes of thermal rotations are typically larger than live load rotations, except for very flexible bridges, in which the live load values exceed the negative thermal loading values.

**Figure 7.1. Temperature gradient from AASHTO LRFD specification.**

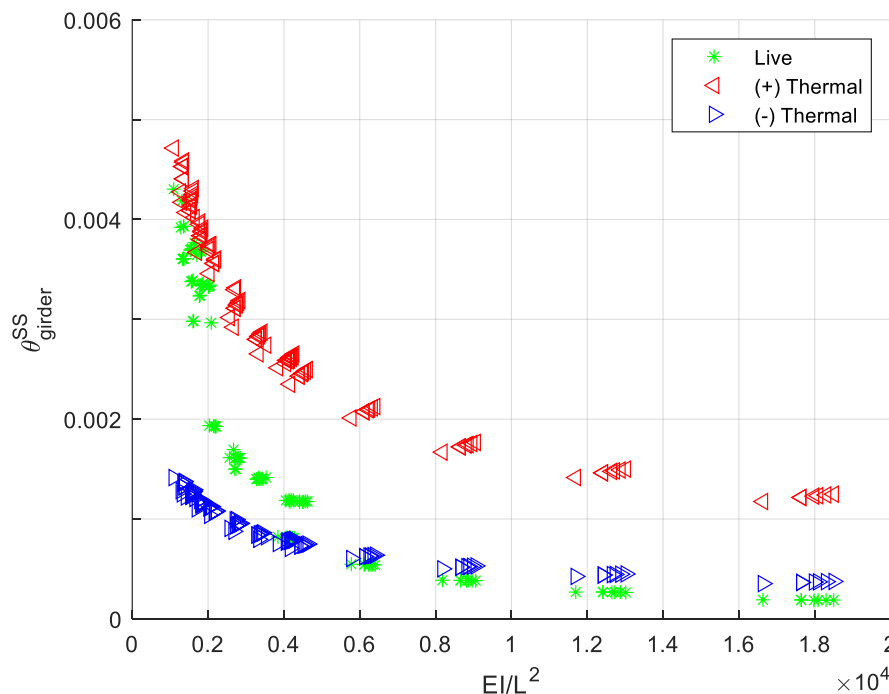
**Figure 7.2. Girder end rotations for live and thermal loading.**

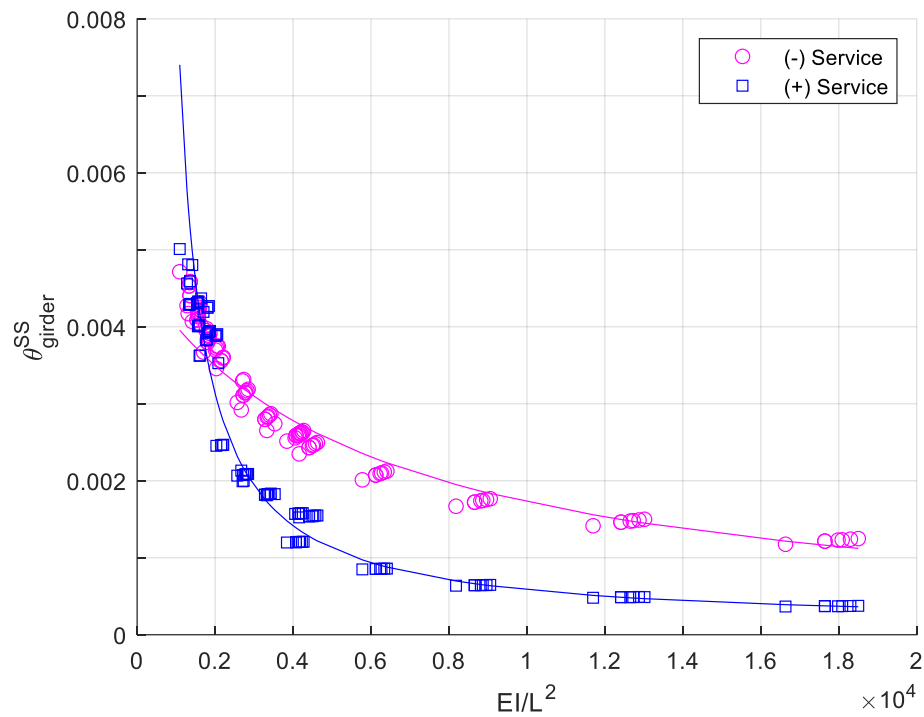
The rotations from live plus impact and thermal demands were combined using the AASHTO LRFD Service I load combination. In accordance with the AASHTO specifications, service combinations use the maximum of (a) thermal and (b) one-half thermal plus live. Figure 7.3 shows the positive and negative bending service combinations. Negative bending values are typically larger. However, this is a different load scenario than what is tested in the lab tests. Strength combinations use live only with a factor of 1.75 (thermal is not included in strength combinations); therefore, only positive bending is relevant. Figure 7.4 compares the service and strength combinations for positive girder bending. Appendix A provides tables containing rotation values used for the suite of standard bridges considered here.

**Figure 7.3. Girder end rotations for service load combinations.**

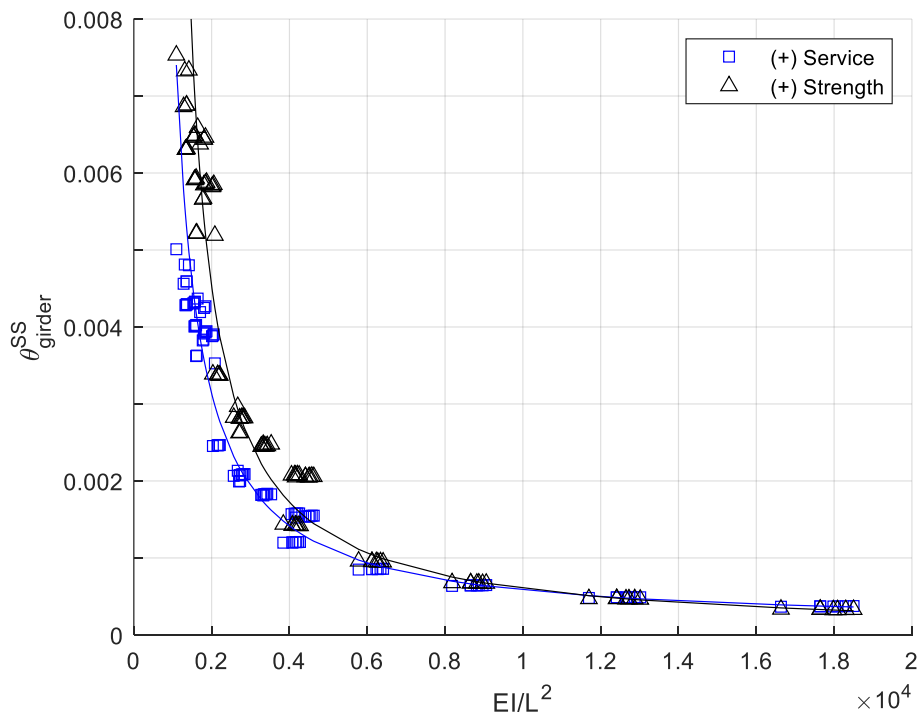
**Figure 7.4. Girder end rotations for design of TxDOT standard I-girder bridges (only positive bending shown).**

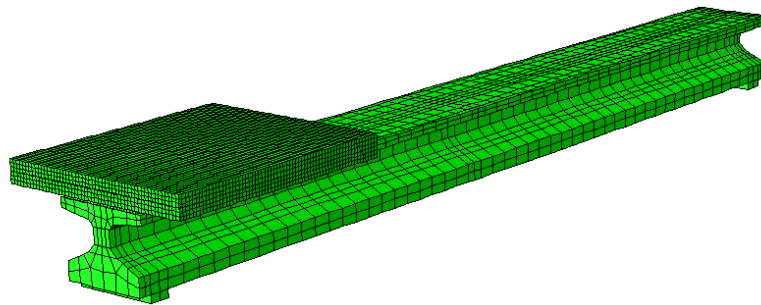
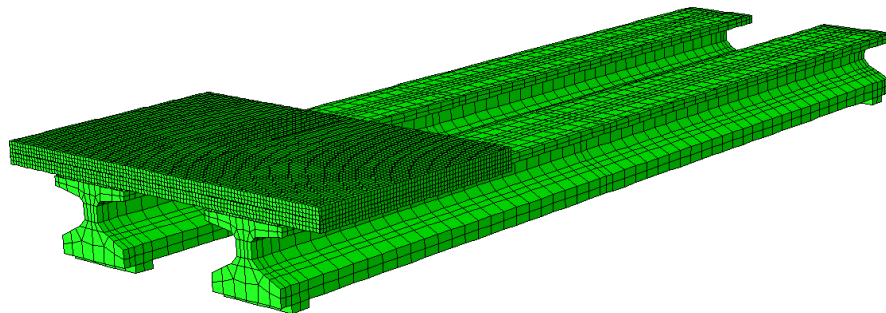
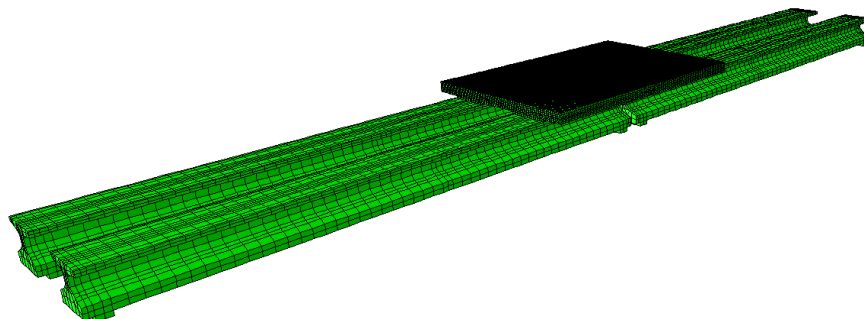
To maintain computing efficiency, multiple girder lines and girder parts were reduced to a single girder and slab section for some models. As shown in Figure 8.1, using a symmetrical single-girder model allowed for mirroring of the model along lines of symmetry. Thus, a single-girder model with symmetrical constraints across two directions of the slab could be used to obtain more efficient results. Both concrete faces and the ends of continuous reinforcement were marked as symmetrical using boundary conditions in the analysis, creating continuity along mirrored faces. The single-girder line model was used to study a variety of link slab cases. While material properties were simplified for the concrete girders, the deck and deck reinforcement used the nonlinear material models described in Section 8.2.1.

(a) Single girder modeled

(b) Mirrored longitudinally

(c) Mirrored longitudinally and transversely

**Figure 8.1. Mirroring of symmetric models.**

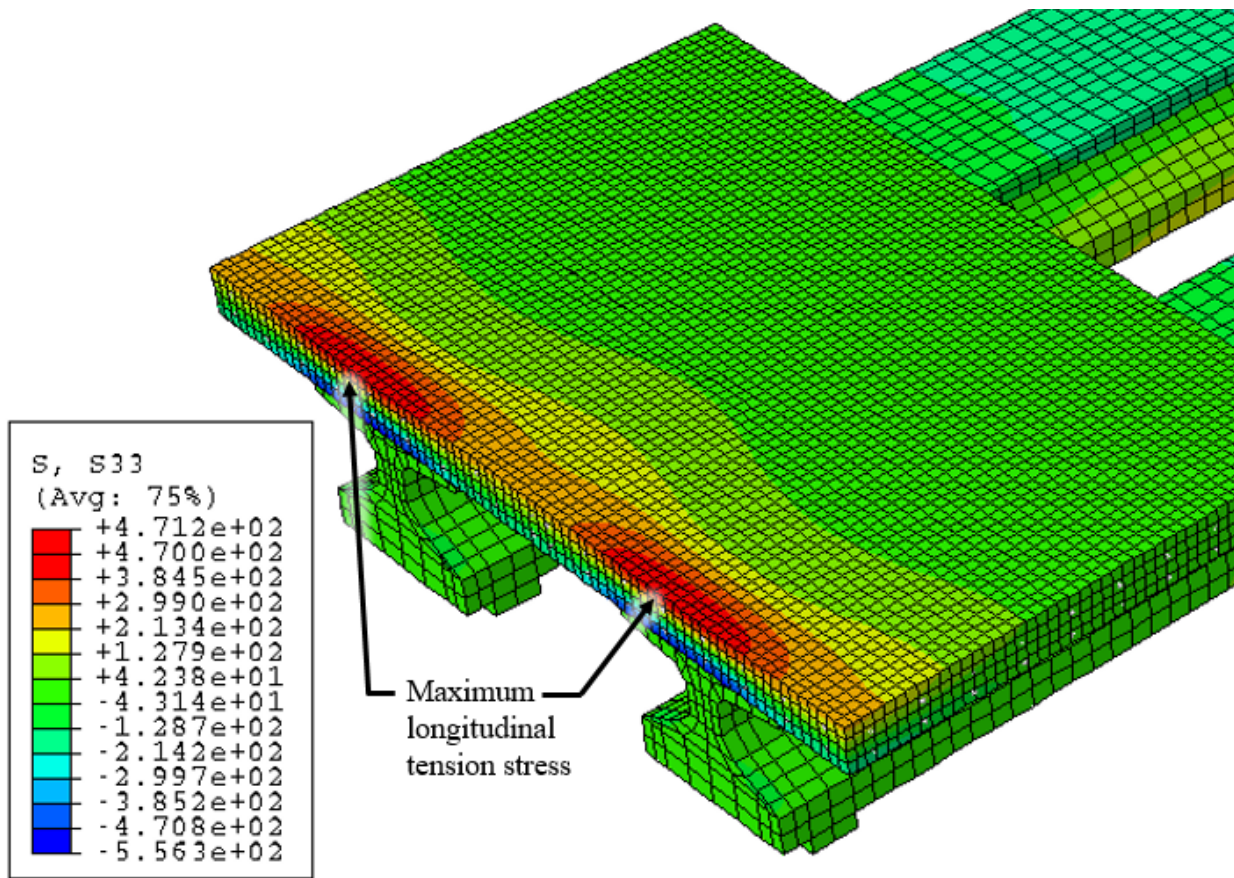
An important effect demonstrated using this mirroring technique was the hourglass behavior in stress distribution caused by shear lag. As shown in Figure 8.2, an hourglass shape formed when

viewing a color gradient of longitudinal stresses in the deck, with stress concentrated over the girder ends and fading between the girders.

**Figure 8.2. Shear lag effect shown by longitudinal stress distribution with hourglass shape over the girder ends.**

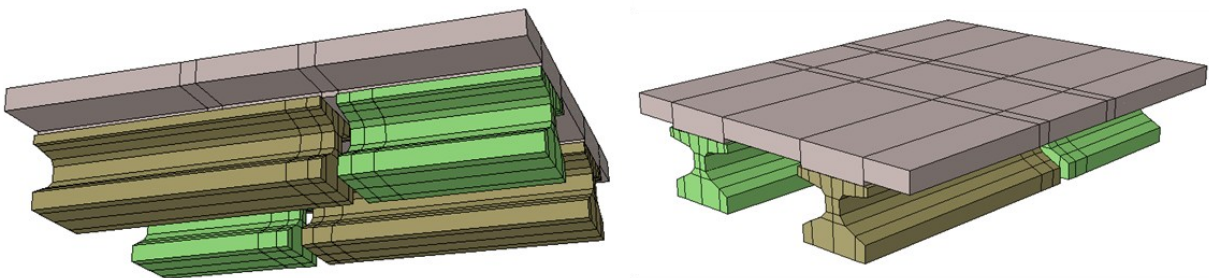
**Figure 8.3. Dual-girder model for skewed girder configuration without clipped girders.**

The dual-girder line model was used when a more in-depth investigation of differences at each girder line is needed, including (a) modeling of experimental test setups where different detailing is used in each overhang, (b) investigation of a bridge with more than two girder lines (using mirroring with two girders allows for consideration of a four-girder bridge), (c) modeling of asymmetrical loading conditions, and (d) investigation of skewed designs. A skewed support model, shown in Figure 8.3, had two girder lines with girder ends offset to model skew effects in the slab. The model was loaded by displacing the girder ends rather than by applying a load to the model.

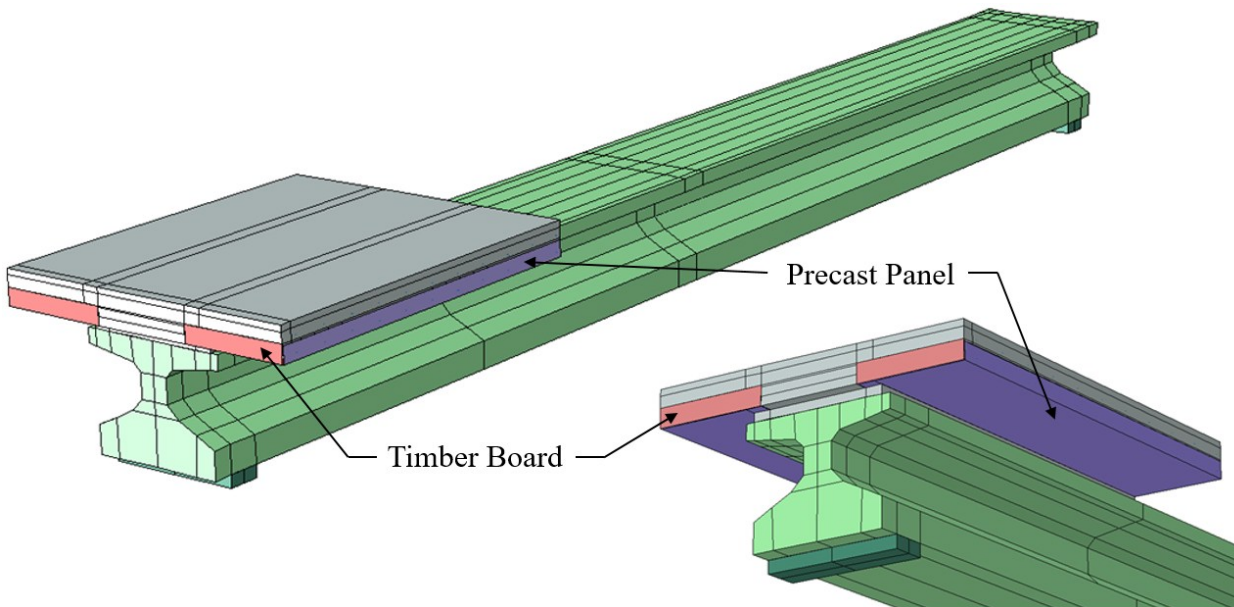
A single-girder line flush precast panel model is shown in Figure 8.4. Half-sections of precast panel form the bottom of the PBJ crack with a timber board separating the panels. The top face of the CIP slab has an extra dividing line that can be used to create a crack-forming gap at the PBJ, similar to the gap that would be provided by a zip strip during construction.

**Figure 8.4. Flush panel model with timber board.**

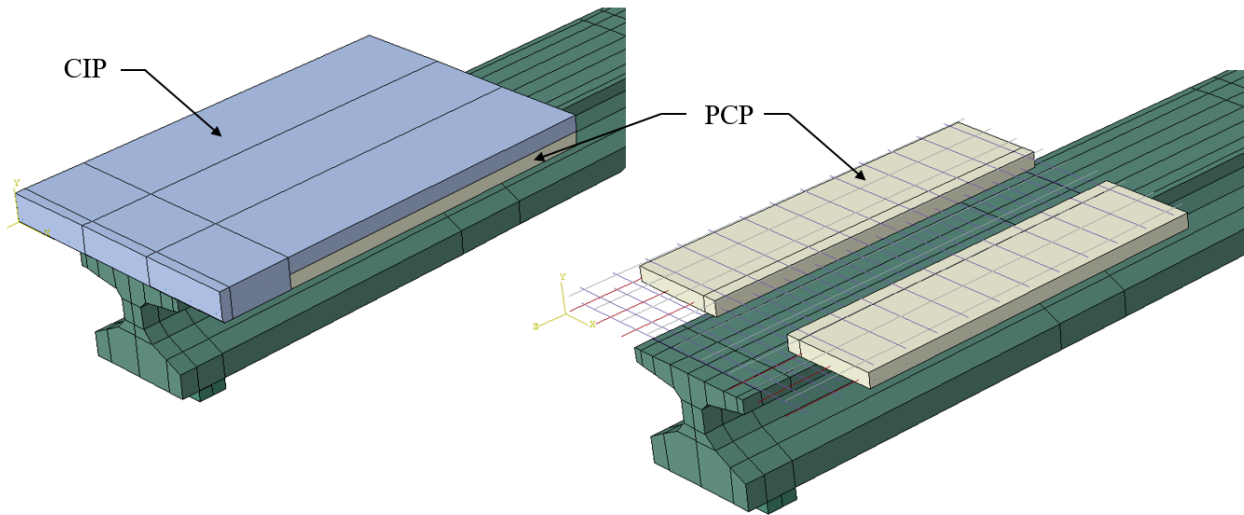
A single-girder line offset precast panel model is shown in Figure 8.5. This model also uses half-panels on each side of the girder, but the panels terminate 18 in. from the girder end (21 in. from the center of the PBJ). Models with and without a notch in the bottom of deck at the PBJ were considered.

**Figure 8.5. Single-girder offset precast panel model, showing the CIP topping slab (left) and without the CIP concrete, revealing the offset PCPs and reinforcement beneath (right).**

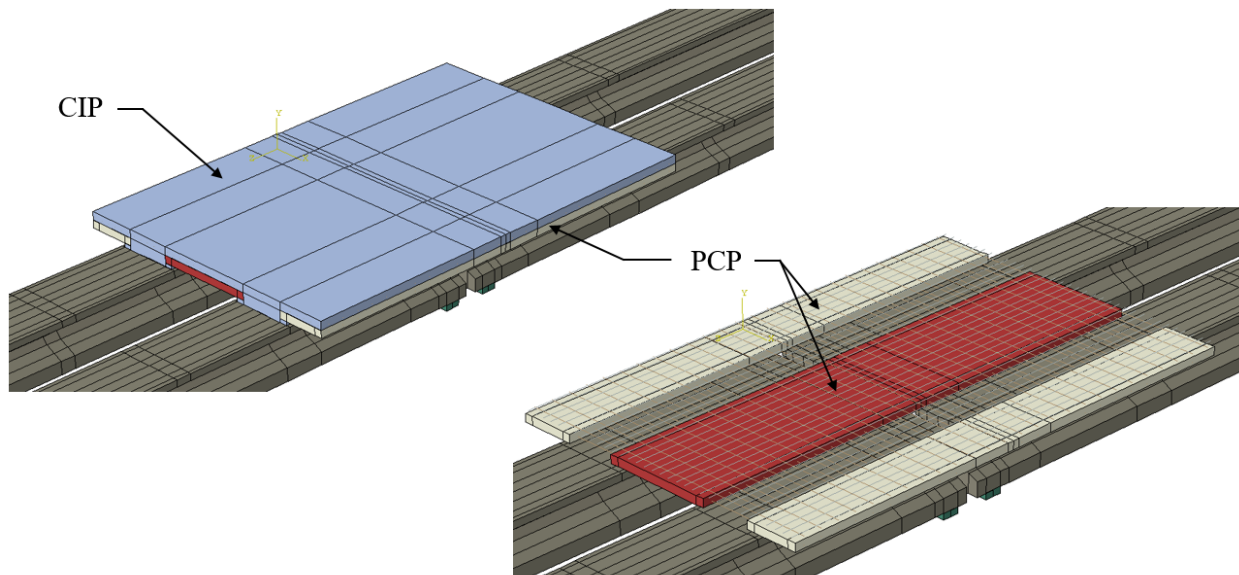
A double-girder line model with continuous PCPs is shown in Figure 8.6. Continuous panels span across the girder ends. A full-width panel sits between the girder lines, while half-width panels rest on the exterior side of each girder. The continuous panel model includes no crack-forming notch or strip since a main intention of the continuous panel design is the reduction of crack severity.

**Figure 8.6. Double-girder continuous precast panel model, showing the CIP topping slab (left) and without the CIP concrete, revealing the continuous PCPs and reinforcement beneath (right).**

The continuous panel model, shown in Figure 8.6, utilizes PCPs that span across the girder end gap and the PBJ. Each continuous panel model was developed with equal loading in the four girder spans. This setup has the potential to simplify PBJ construction by eliminating the need for the additional formwork associated with offset panel details. Furthermore, the continuous panel eliminates the weak plane at the PBJ associated with the flush panel details that promote cracking.

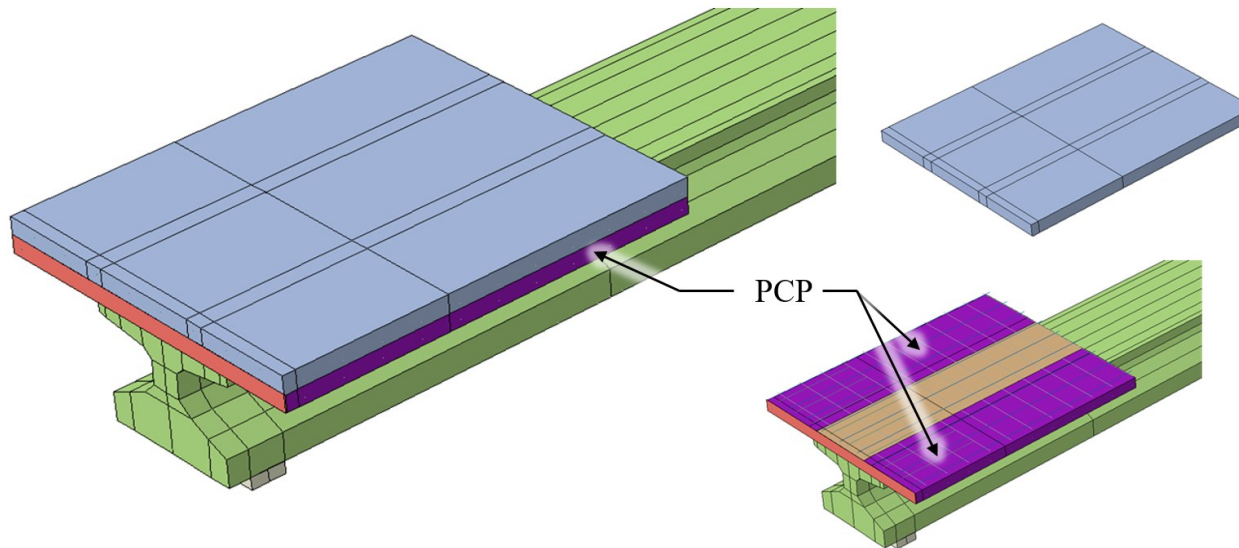
length, reducing bending curvature and delaying or eliminating cracking. A partial-depth debonded model, shown in Figure 8.7, has the upper section of slab debonded from the lower slab and PCPs at the level of the PCP top face. Figure 8.8 shows a full-depth debonded model, where a section of slab is debonded at the girder face.

**Figure 8.7. Partial-depth debonded model used with flush panel configuration.**

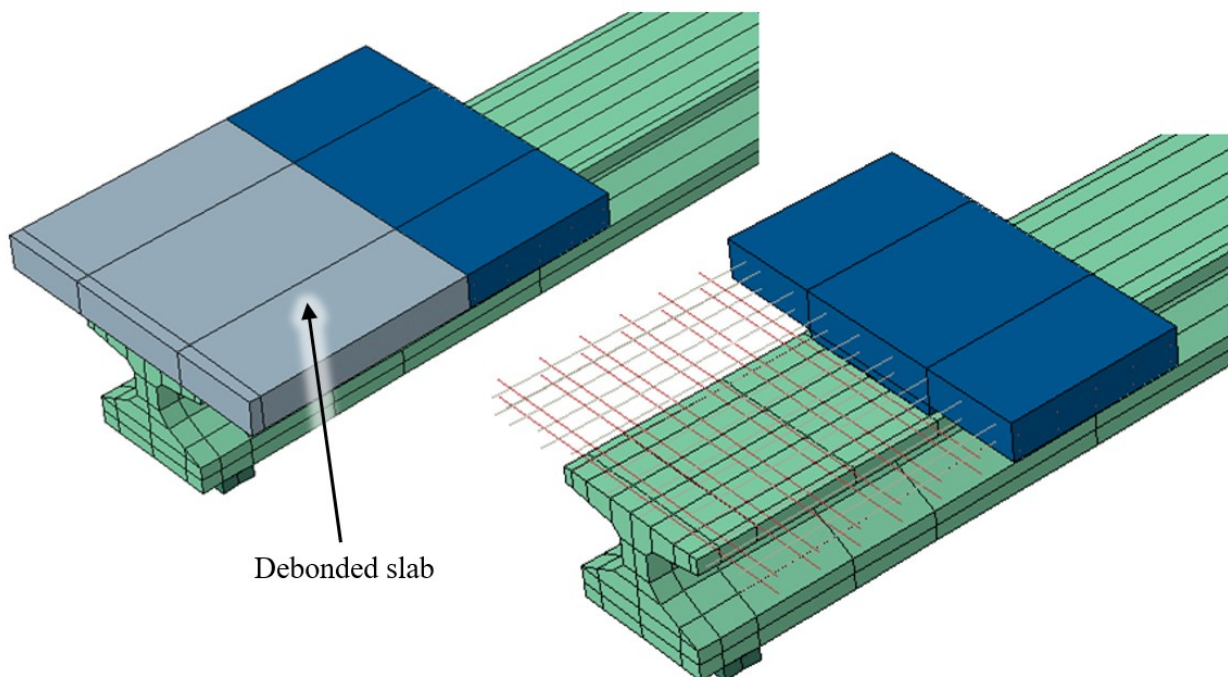
**Figure 8.8. Full-depth debonded model.**

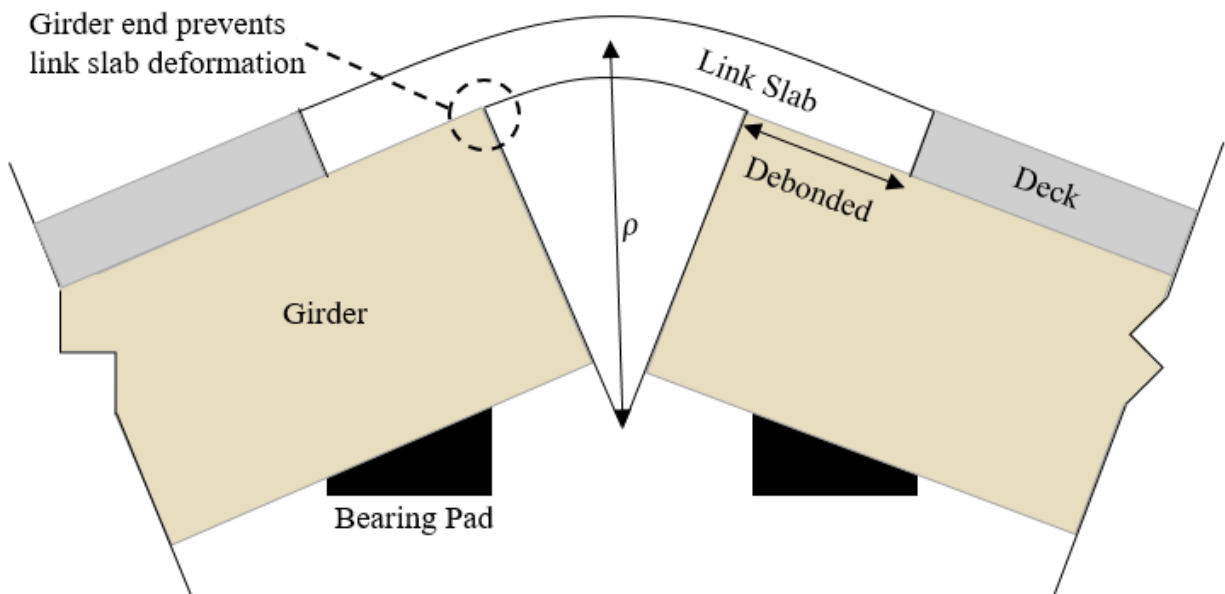
the disconnected segments. This is because the upward deflection of the girder ends under positive bending interferes with the slab above, as shown in Figure 8.9.

**Figure 8.9. DLS diagram showing the girder ends interfering with intended link slab deformation, causing a short radius of curvature,  $\rho$ , for the link slab.**

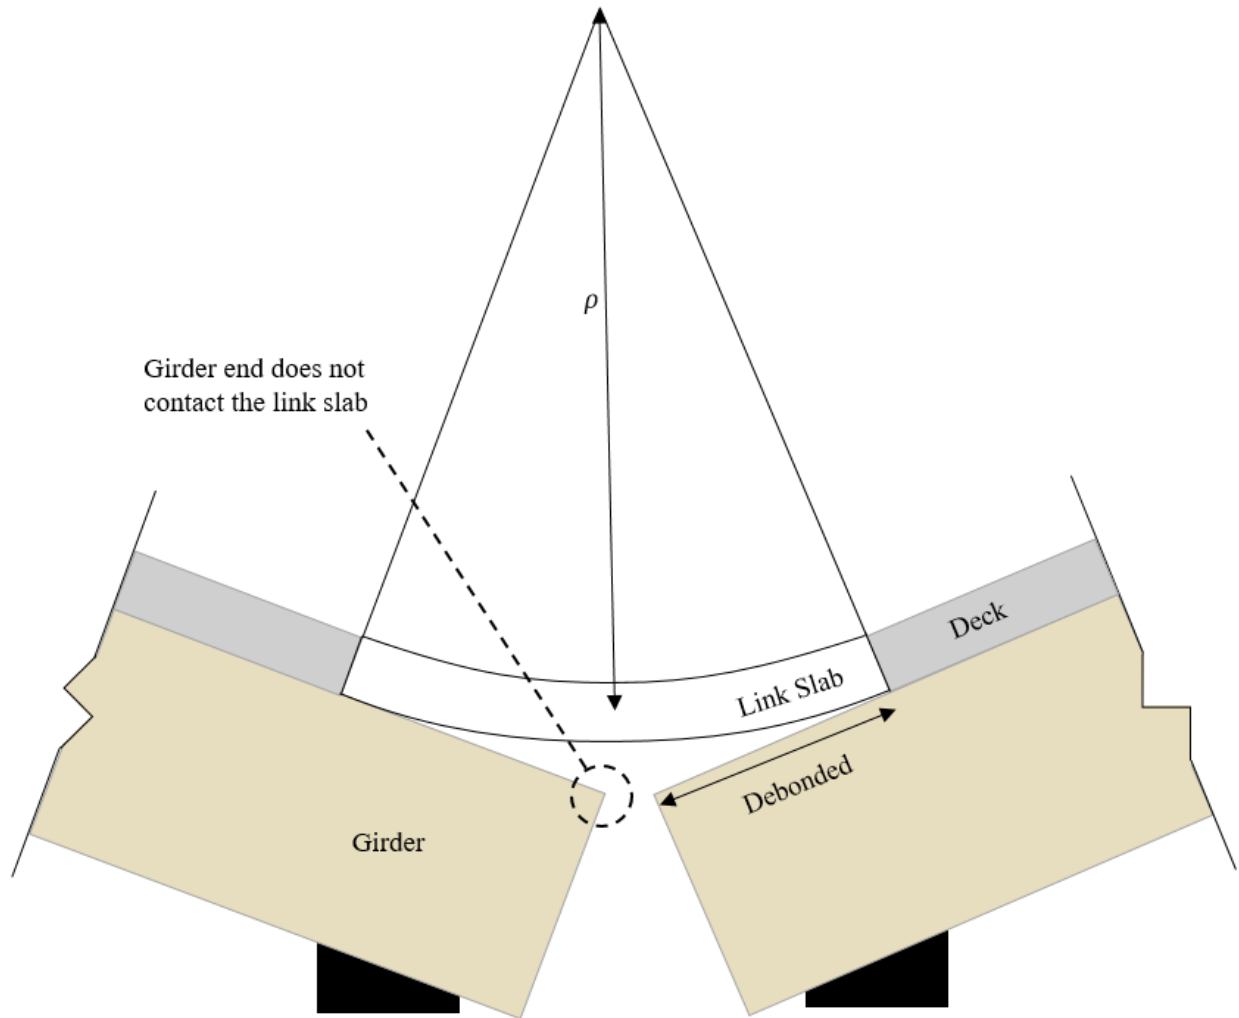
where  $E$  is elastic modulus and  $I$  is the moment of inertia. For negative bending in the girders, such as the deformation caused by thermal gradient, a gap is naturally formed between the debonded faces. Simply detaching the link slab from the girder ends allows the link slab to deform freely and produce a larger radius of curvature associated with debonding, as shown in Figure 8.10.

**Figure 8.10. DLS diagram showing that the girder ends do not interfere with link slab deformation under negative bending, causing a longer radius of curvature,  $\rho$ , for the link slab.**

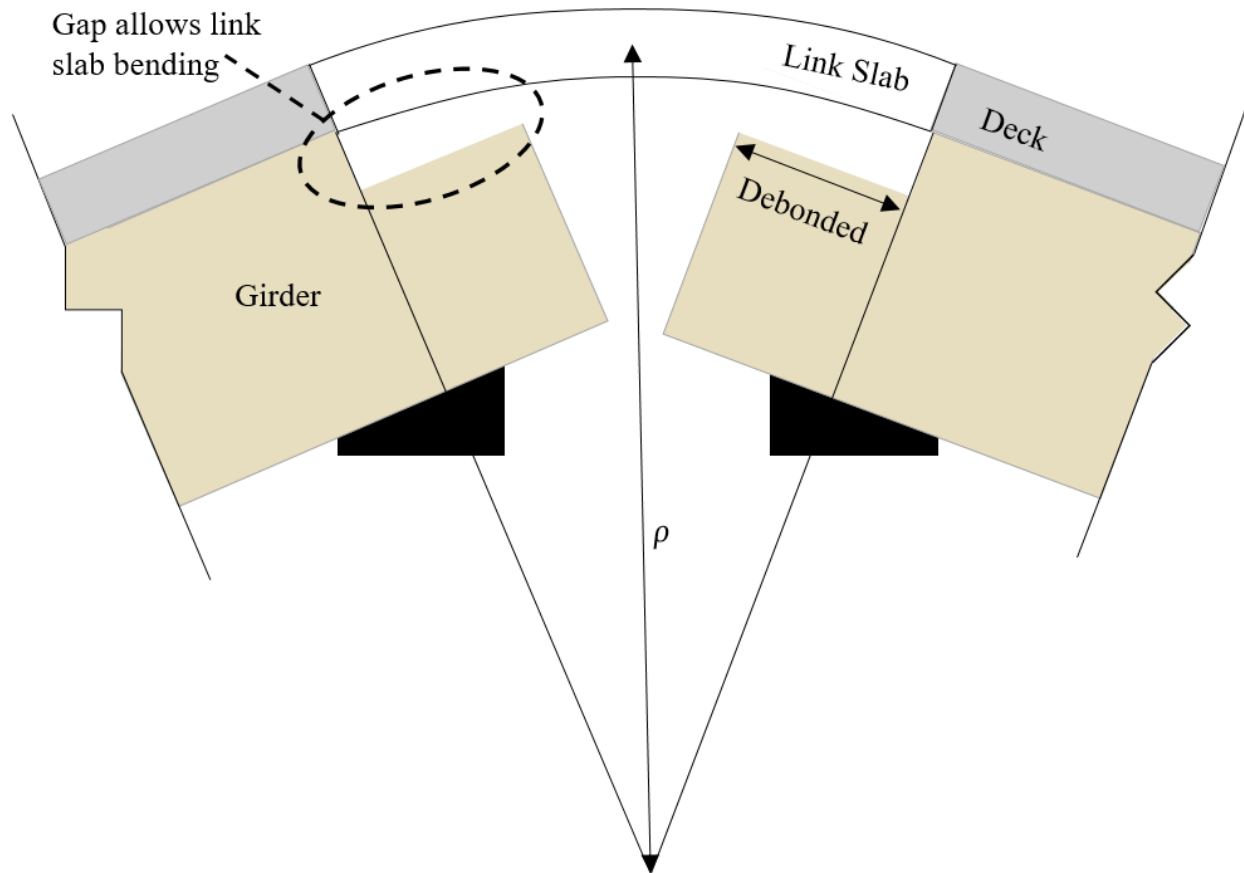
Providing a vertical gap between the two debonded faces allows the link slab to deform as intended. The radius of curvature of the link slab is increased, reducing bending stress in the deck, as shown in Figure 8.11. Early finite element models were built without vertical gaps in the debonded region, leading to small improvements in cracking performance. Later models that included a debonded gap of 0.5 in. or larger showed much larger improvements in link slab cracking performance. Measuring the girder end vertical deflection on multiple models showed that a 0.5-in. gap would be sufficient to prevent the girder ends from contacting the bottom of the link slab at high rotations.

**Figure 8.11. DLS diagram showing that the girder ends do not interfere with link slab deformation when a gap is provided along the debonded length, causing a longer radius of curvature,  $\rho$ , for the link slab.**

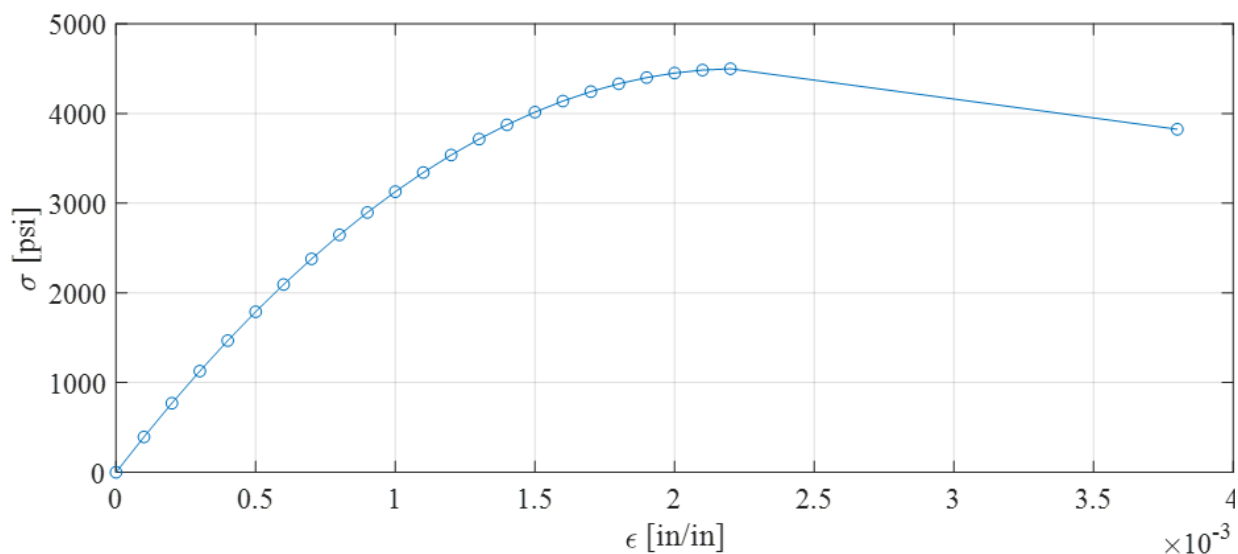
**Figure 8.12. Hognestad concrete model for ultimate compressive strength of 4500 psi.**

Nonlinear concrete compressive models that were considered include the Hognestad model (shown in Figure 8.12) and the unconfined Kent-Park model (shown in Figure 8.13); presented results use the Kent-Park model. Both models utilize a parabolic rise in stress to ultimate strength, with linear post-peak behavior. While both models provided reasonable results and have been used in literature for concrete deck slabs (Al-Rousan et al. 2020; Chaudhari and Chakrabarti 2012), the unconfined Kent-Park model was chosen as the primary compressive concrete material model.

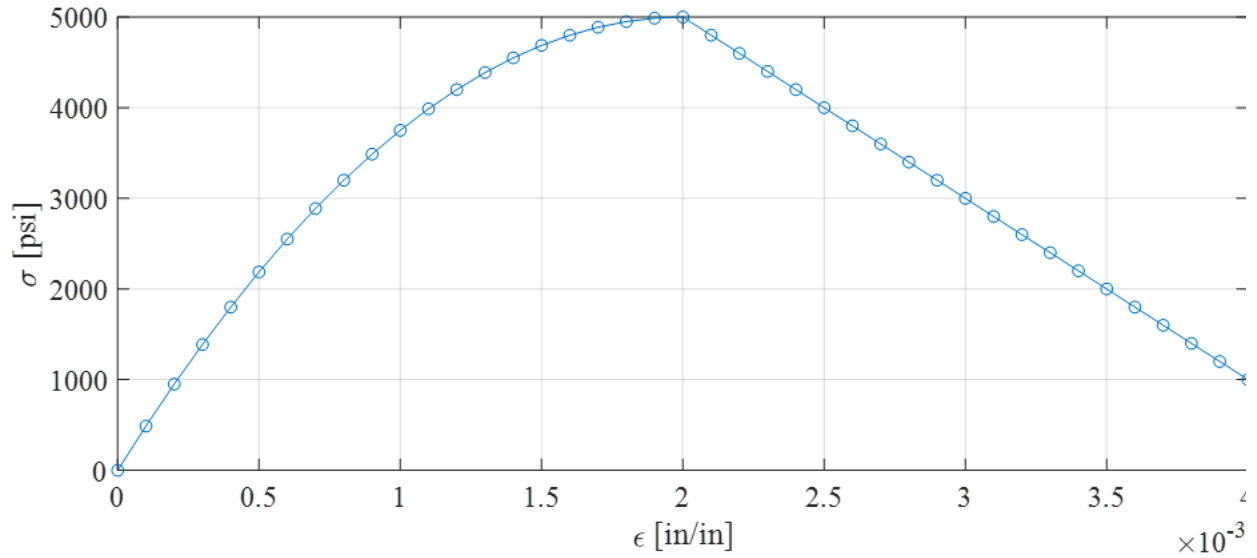
**Figure 8.13. Unconfined Kent-Park concrete model for ultimate compressive strength of 5000 psi.**
