# Performance and Improvement of Texas Poor Boy Continuous Bridge Deck Details: Final Report

Technical Report 0-7013-R1

TEXAS A&M TRANSPORTATION INSTITUTE  
COLLEGE STATION, TEXAS

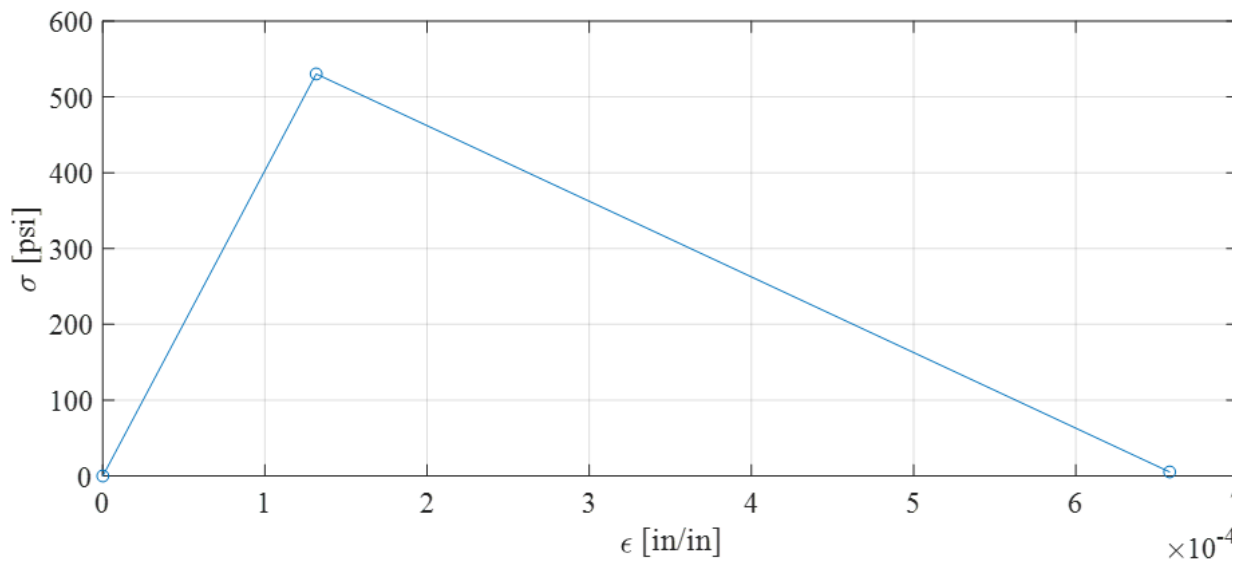
**Figure 8.14. Bilinear tension model for concrete.**

To model tensile behavior of concrete, the simple bilinear model shown in Figure 8.14 was chosen based on experience with convergence issues and suggestions for use with the concrete damaged plasticity model in ABAQUS. This bilinear example is for 5000 psi concrete and defines constant slope of stress before and after rupture. For steel reinforcement, a bilinear elastic-perfectly-plastic model was chosen for typical Grade 60 reinforcing bars.

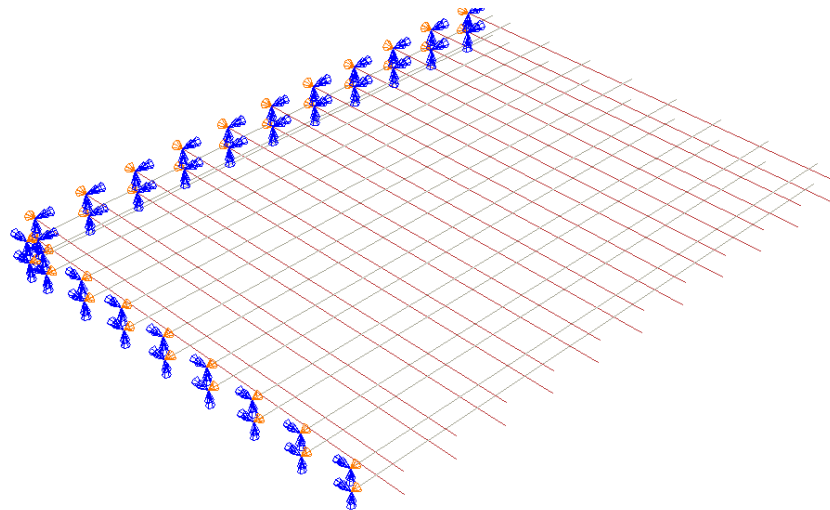
**Figure 8.15. Rebar cage showing the mirrored end constraints on the reinforcement in two directions.**

between the embedded elements (steel) and the host material (concrete). Longitudinal and transverse reinforcement layers for the slab, shown in Figure 8.15, were modeled with symmetric boundary conditions in two directions to simulate continuous reinforcement.

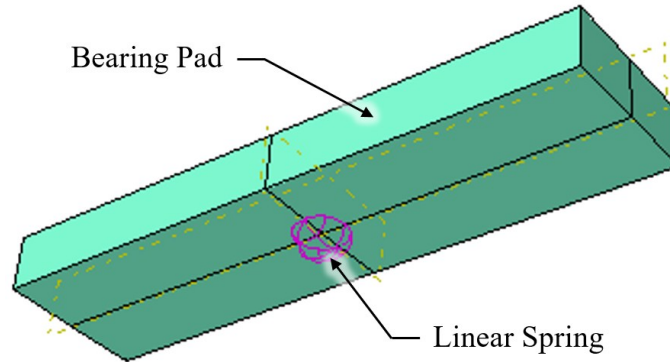
**Figure 8.16. Bearing pad spring location.**

Bearing pad behavior was modeled using linear springs in three directions. Spring stiffness was estimated based on values from Terzioglu (2015) and Wassef et al. (2003) for typical elastomeric bearing pads (see Table 8.2). The location of all three springs was centered on the bottom of a stiff bearing pad part, shown with a spring element in Figure 8.16. The bearing pad part, shown attached to the bottom of the girder in Figure 8.17, was connected to the girder's bottom face with a tie constraint. This allowed girder ends to rotate on their supports with minimal resistance, but to deflect horizontally with resistance typical of the shear force provided by an elastomeric bearing pad. Using a bearing pad part instead of attaching the spring directly to the girder face prevents the formation of unrealistic stress concentrations at the girder ends.

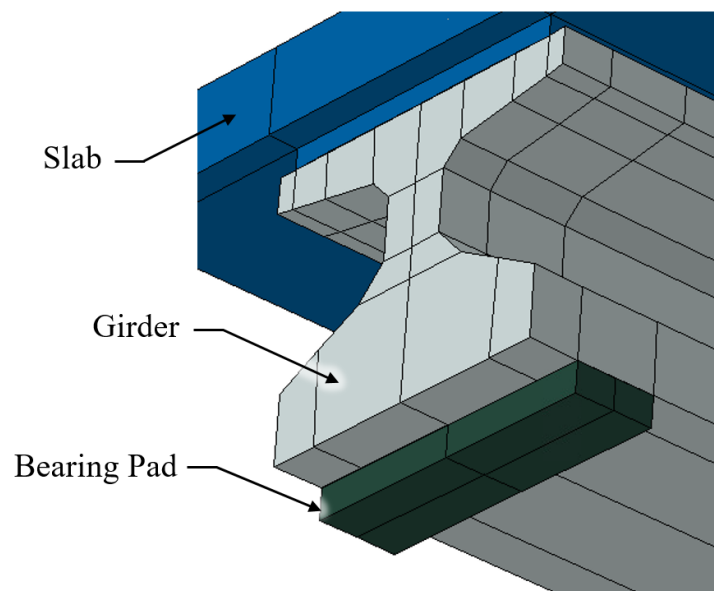
**Figure 8.17. Bearing pad location at girder end.**

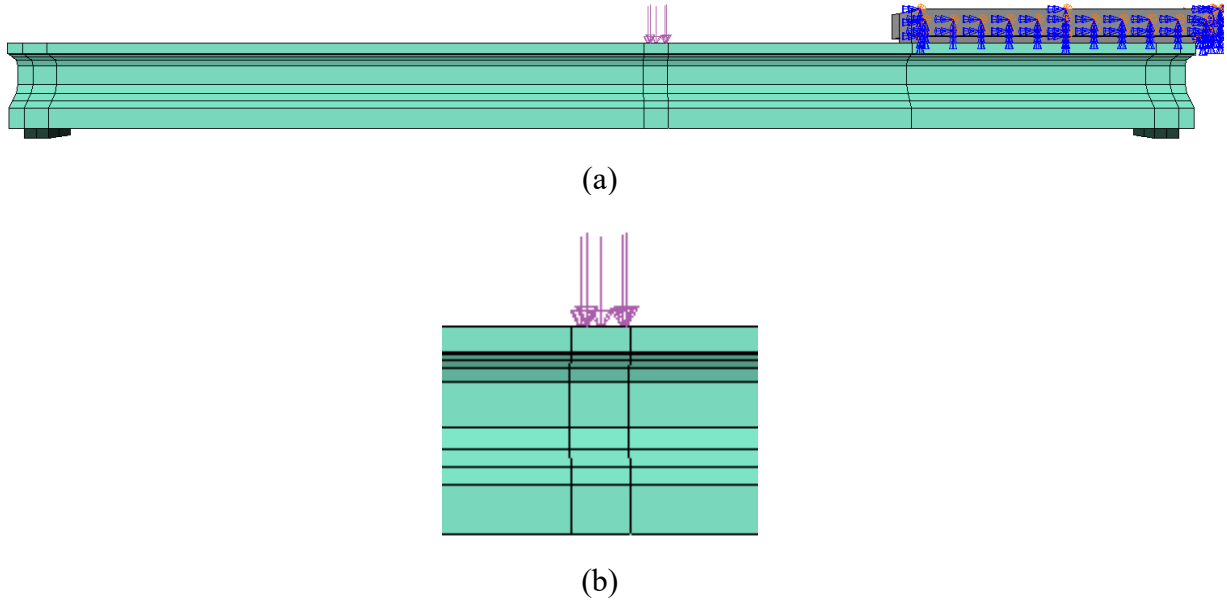
**Figure 8.18. Loading on top girder face.**

Loading of the model was designed to simulate the loading conditions of the experimental test setup, as shown in Figure 8.18. A pressure load (b) was applied to the top girder face near midspan (a), far from the slab section in order to avoid localized effects due to loading. For single-girder models, the symmetrical boundary conditions meant that each mirrored span has an equivalent pressure load applied. Models with multiple girder lines required increased computing time but allowed for asymmetrical loading conditions. The vertical load on the girder face caused

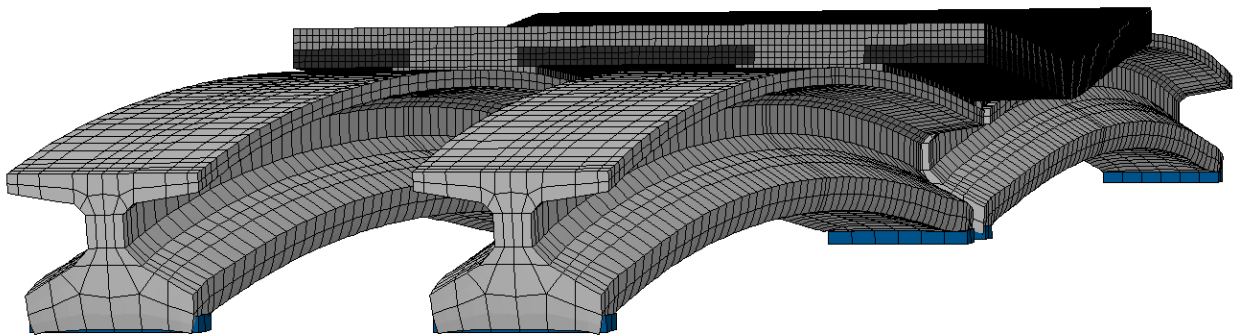
**Figure 8.19. Negative bending due to thermal gradient with deformation exaggerated to show girder curvature.**

In order to investigate the effects of thermal gradient and negative bending of the girders, temperature loading was applied in some models. A preliminary analysis step was used to designate initial temperature conditions of the girders. During the loading step, the temperature of the bottom face of the girder was decreased, producing negative girder end rotations (see Figure 8.19) and tensile forces in the bottom of the link slab. Uniform temperature loading was also used to investigate deck shrinkage effects.

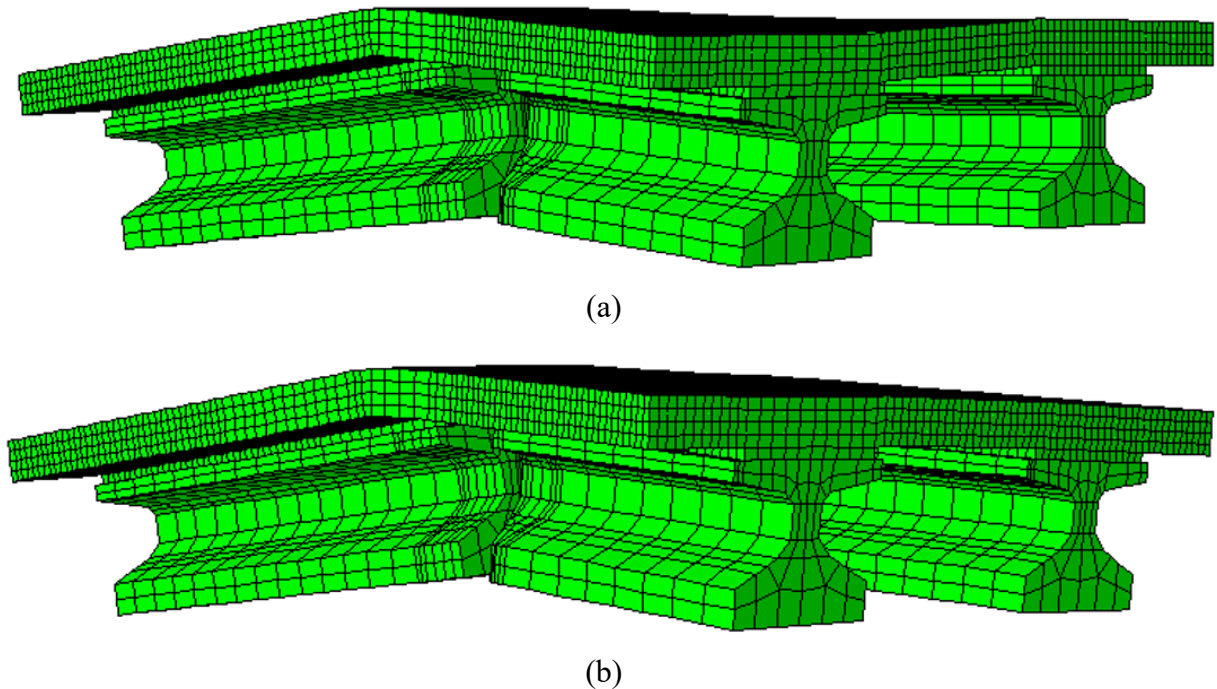
**Figure 8.20. Deformation of girder stub model, at 20 times scale, showing deformation of (a) one girder line and (b) both girder lines.**

Since midspan loading is not possible for girder stub models, the exterior girder ends were displaced using rotation boundary conditions for each girder line. This displacement loading (see Figure 8.20) rotates both exterior ends of one girder by 0.005 rad (a), and then rotates the second girder line in the same way (b) while the first girder line is held in its rotated state. Thus, stresses in the deck can be seen propagating from over one girder line to the next.

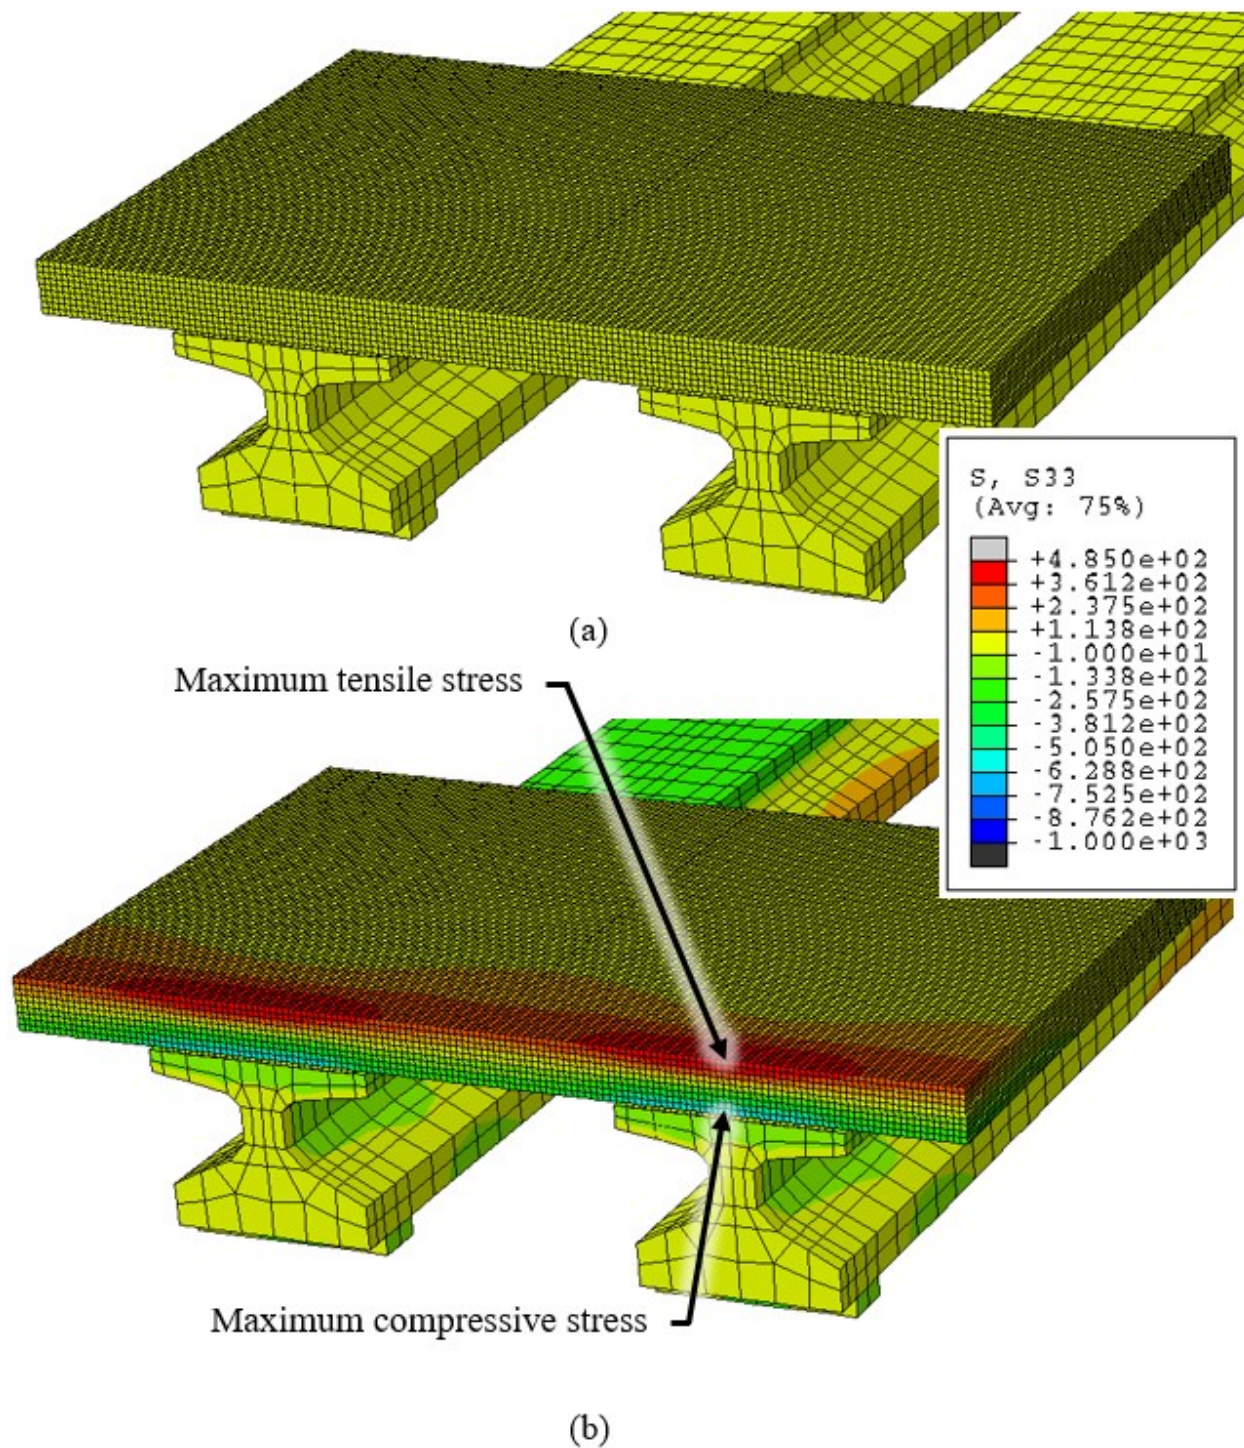
**Figure 8.21. Longitudinal stresses in CIP deck concrete (psi), showing (a) the unloaded condition and (b) the formation of a force couple in the deck, concentrated over the girders.**

The most basic model developed in ABAQUS was a fully CIP deck, bonded completely to the girder below, with typical reinforcement. This model, which may be used to compare results of other model iterations, is shown in Figure 8.21 and Figure 8.22. Bonding is accomplished using tie constraints that model zero separation between the disparate surfaces. The effect of initial loading, shown in Figure 8.21(b), demonstrates the buildup of longitudinal tensile stresses in the top of the deck concentrated over the girder. In Figure 8.22(a), cracking initiates over the girders at the center of the link slab as the bottom of the slab is in compression. In Figure 8.22(b), the section is fully cracked, and some regions of compressive stress develop in the deck away from the girder ends. As the slab cracks to around half-depth, the neutral axis of the section falls closer to the bottom of the slab. Compressive forces in the bottom of the slab are still concentrated over the girders. Significant tensile forces in the slab are limited to about the first 6 in. of link slab length, corresponding to high stress in the reinforcement that is also limited to the area in the immediate vicinity of the PBJ crack.

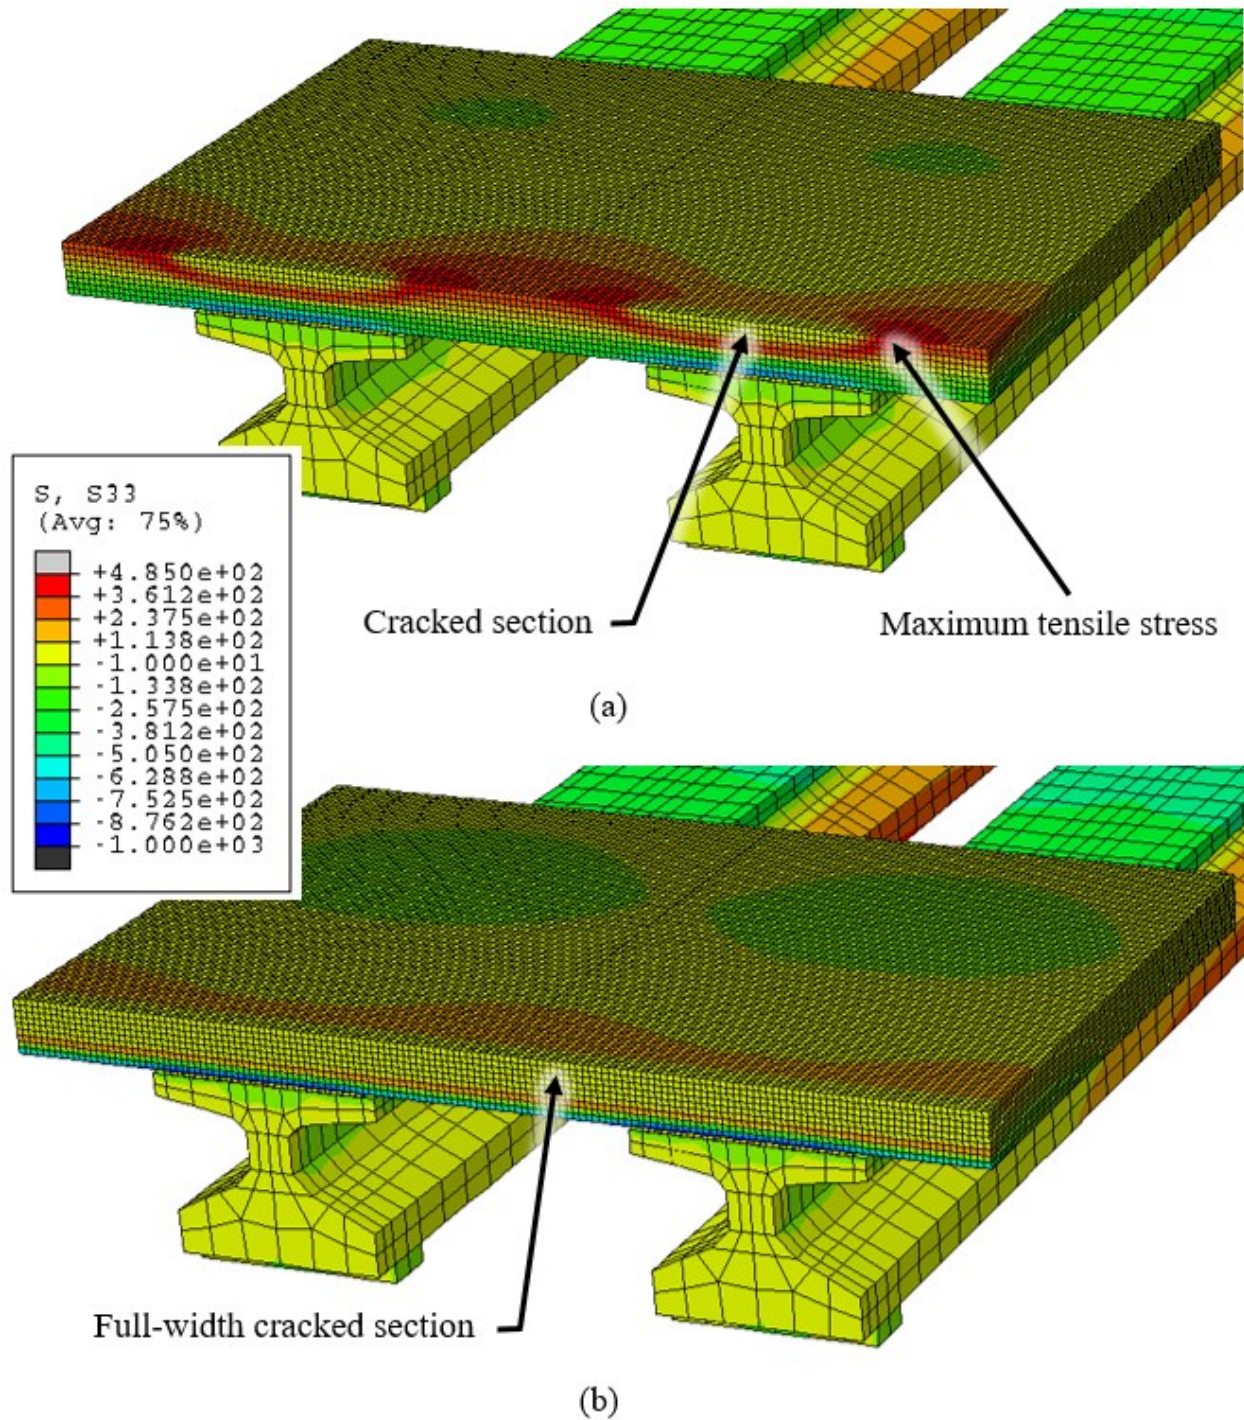
**Figure 8.22. Longitudinal stresses in CIP deck concrete (psi), showing (a) initial crack propagation over the girders, which (b) continues until the entire deck width is cracked.**

Figure 8.23 shows reinforcement stresses corresponding to the partial cracking in the slab over the girder in Figure 8.22(a). Figure 8.23(a) shows the transverse reinforcement at the PBJ developing mild tensile stresses between the girders and in the overhang, as well as mild compressive stresses over the girders. Figure 8.23(b) shows the top longitudinal reinforcement

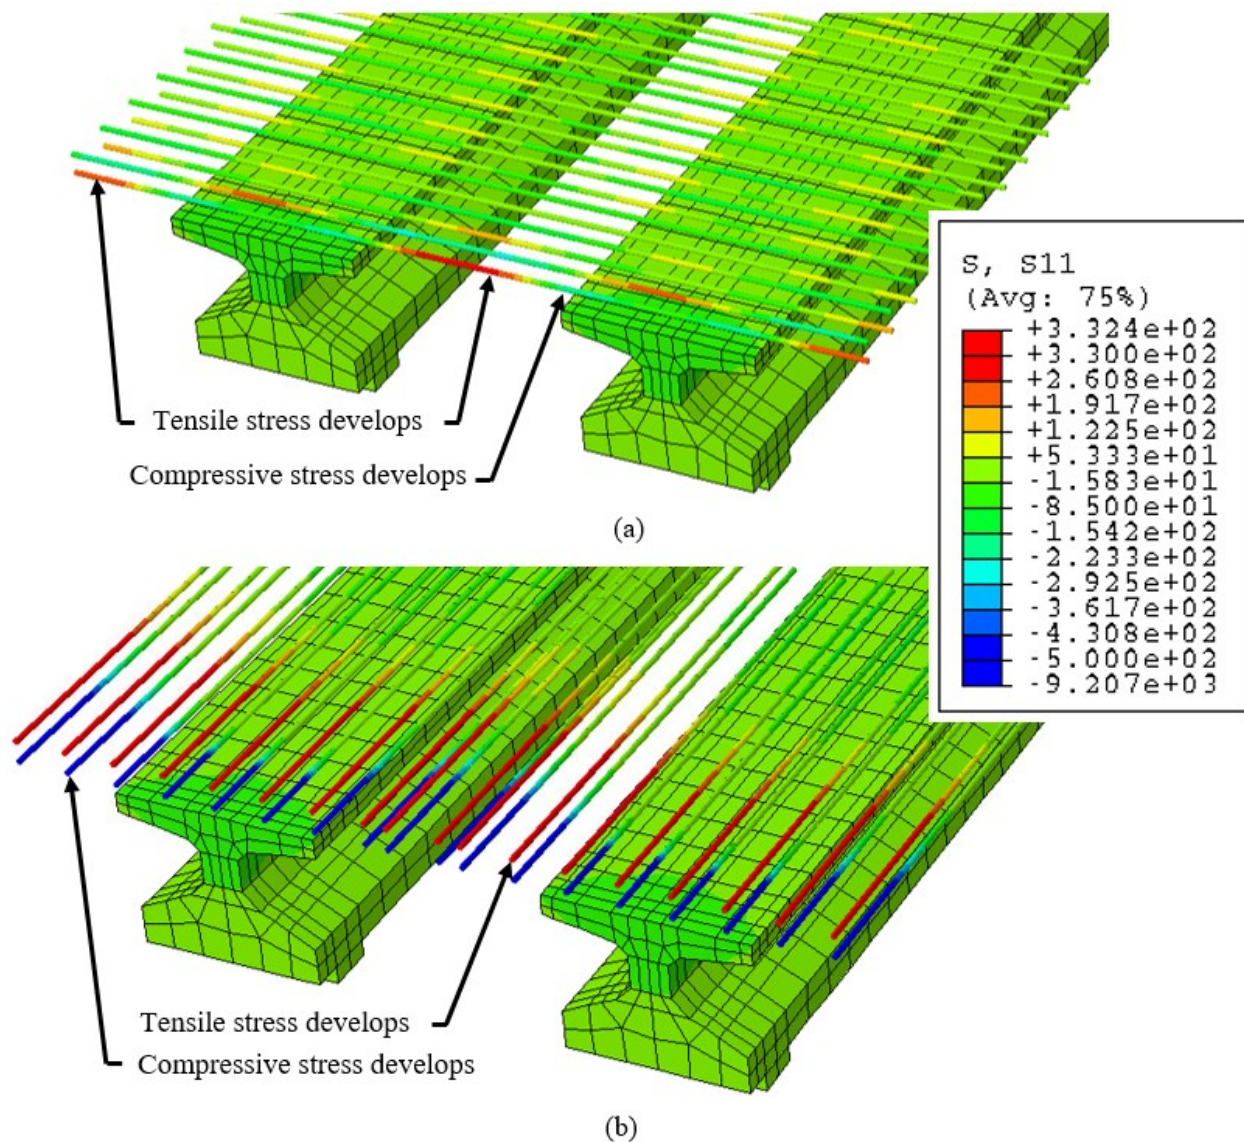
**Figure 8.23. Longitudinal stresses in reinforcement (psi) for (a) transverse bars and (b) longitudinal bars at the onset of cracking.**

developing mild tensile stresses (around 330 psi), while the bottom longitudinal reinforcement develops higher compressive stresses (around 9200 psi). In Figure 8.24, steel stresses are shown for cracking across the entire width of the section, as shown in Figure 8.22(b). Figure 8.24(a) shows similar stresses in the transverse reinforcement as in the initial cracking phase. Figure 8.24(b) shows the top layer of steel developing larger tensile stresses close to the PBJ as the concrete no longer resists the rotation of the link slab across the crack. The stress drops in the bottom longitudinal steel.

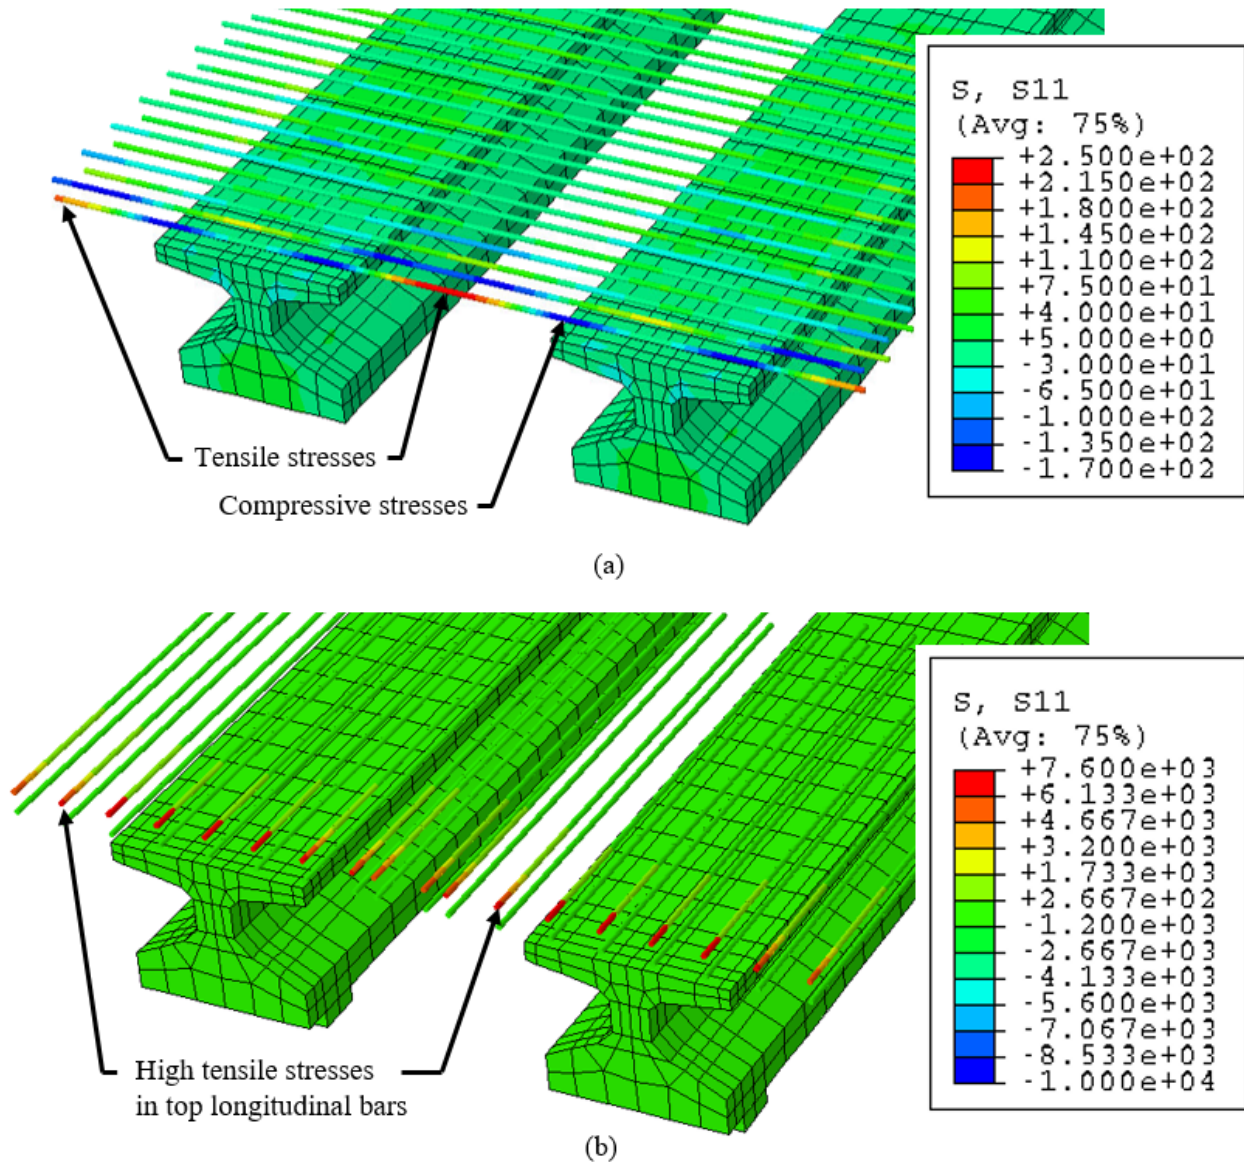
**Figure 8.24. Longitudinal stresses (psi) in the reinforcement when the deck is cracked across the width of the section for (a) transverse bars and (b) longitudinal bars.**

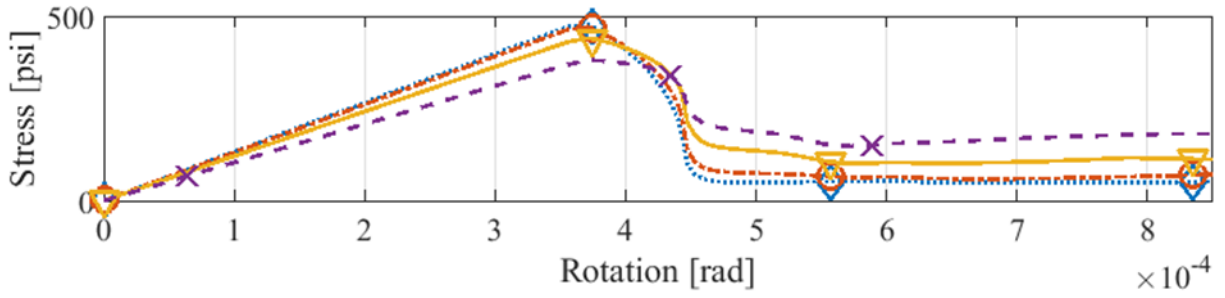
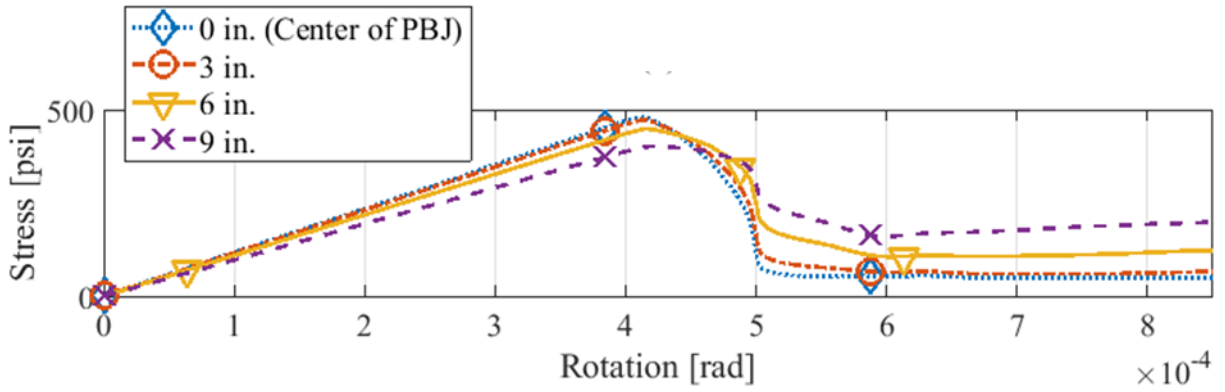
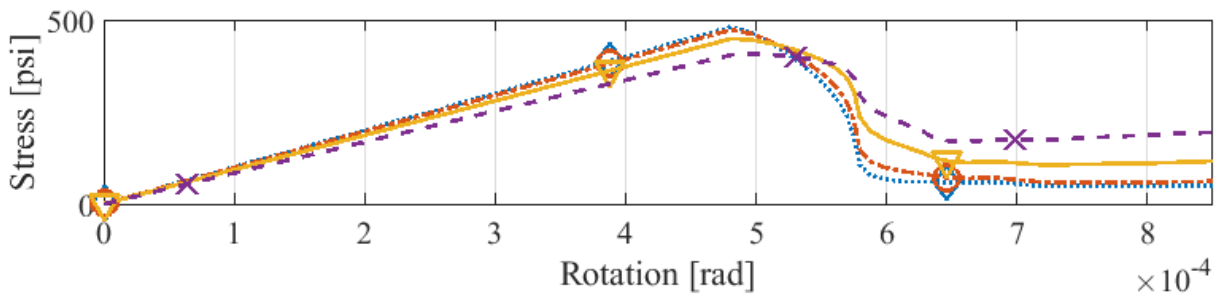
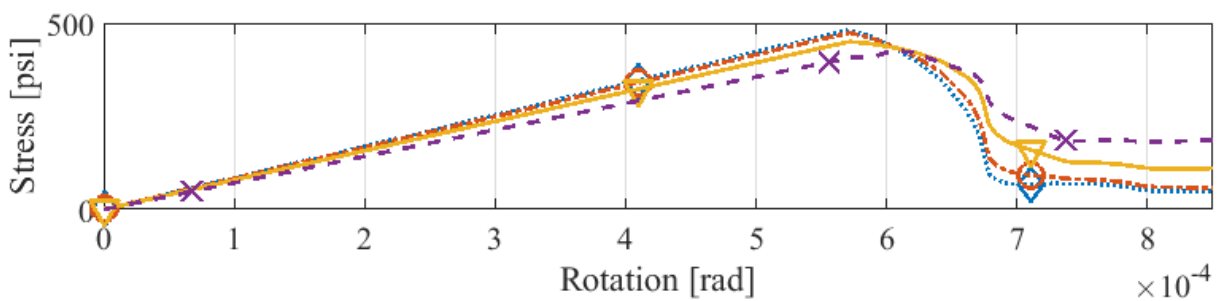
**Figure 8.25. Effect of debonded length on longitudinal concrete stresses, showing (a) a fully bonded slab, as well as a slab debonded at the girder-slab interface for (b) 16 in., (c) 35 in., and (d) 54 in.**

Longitudinal concrete stresses at different longitudinal distances from the center of the PBJ are shown for each level of debonding in Figure 8.25. Stress was recorded over the girder at distances of 0 in. (the center of the PBJ), 3 in., 6 in., and 9 in. longitudinally from the center of the PBJ. Stresses increase until cracking with stress highest at the center of the PBJ. Post-cracking behavior shows minimal remaining stress in the concrete at the center and 3 in. from the PBJ. Increasing debonded length delays the onset of cracking.

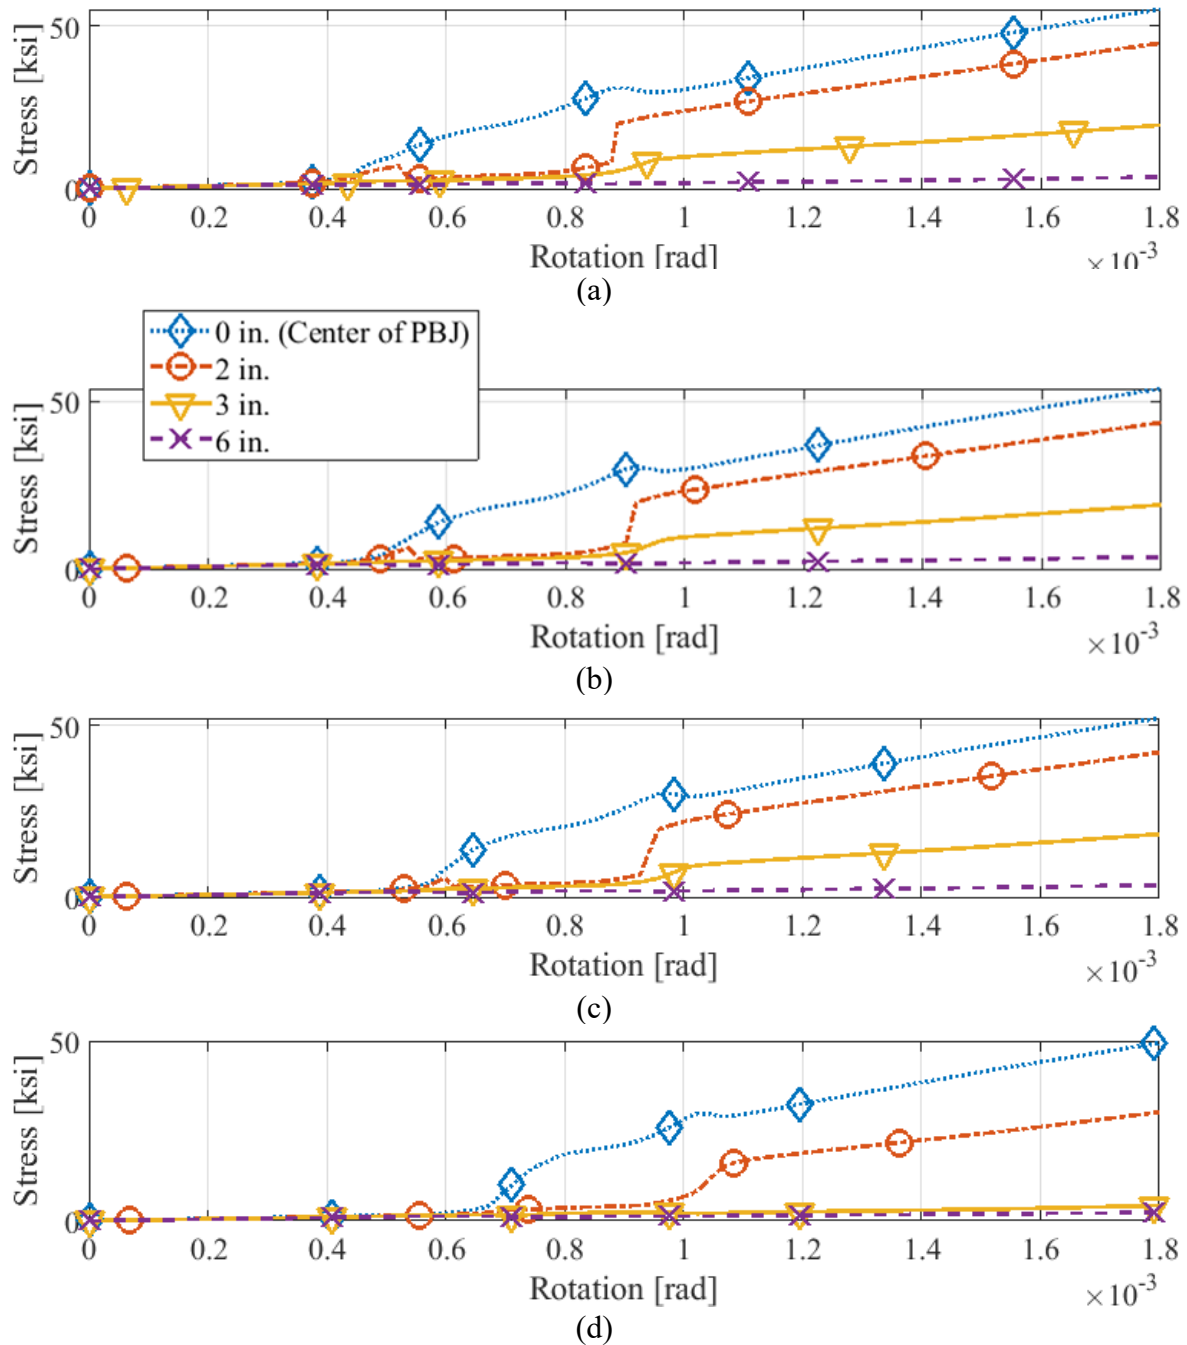
**Figure 8.26. Effect of debonded length on top longitudinal reinforcing steel stresses, showing (a) a fully bonded slab, as well as a slab debonded at the girder-slab interface for (b) 16 in., (c) 35 in., and (d) 54 in.**

Figure 8.26 shows the effect of debonding on the top longitudinal steel stresses within the section at the same distances from the PBJ. Stresses in the steel decrease dramatically within a few inches of the poor boy crack. The steel is barely engaged before cracking, but stresses near the PBJ increase toward the yield strength of the bars after cracking. Debonding delays when the bars are engaged until higher girder end rotations, as shown in Figure 8.27.

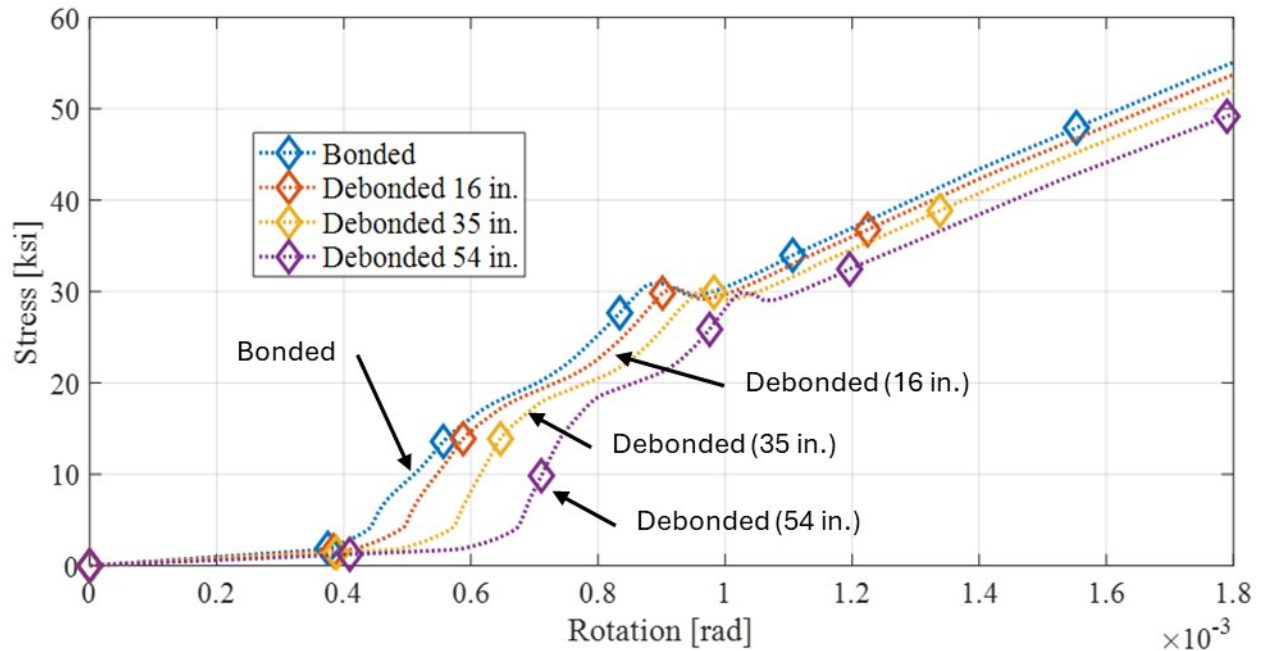
**Figure 8.27. Comparison of top longitudinal steel stresses at different lengths of debonded slab, showing that debonding delays steel stress and crack formation.**

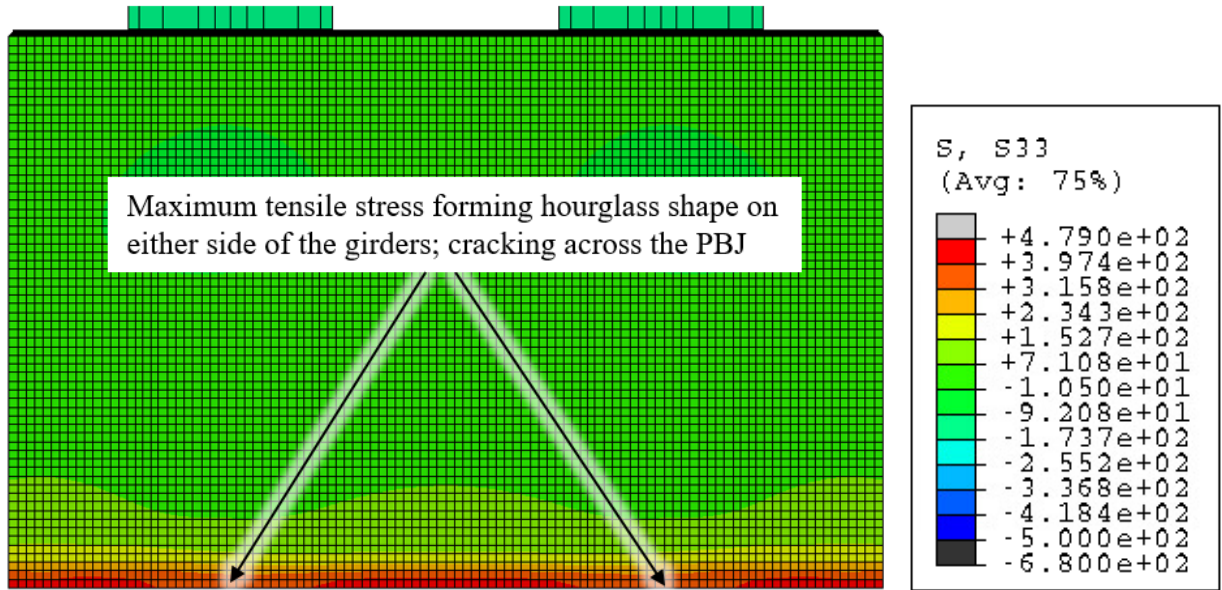
**Figure 8.28. Initial cracking of the PBJ with the use of a control joint detail for a flush PCP model.**

Selected results of a flush PCP model demonstrate stress and cracking patterns in the deck at rotations of approximately 0.005 rad. In Figure 8.28, the use of a crack-former detail including a timber board causes high longitudinal tensile stresses at the PBJ almost immediately after loading commences. The elements at the PBJ location reach their cracking stress, while the hourglass stress shape is noticeable, developing on both sides of the girder lines. Since the center of the PBJ is still the weakest point in the slab with the highest bending curvature, cracking still initiates at the center of the PBJ regardless of the use of a crack-former detail. Cracking is limited to this weak section at the center of the PBJ, even at higher rotations.

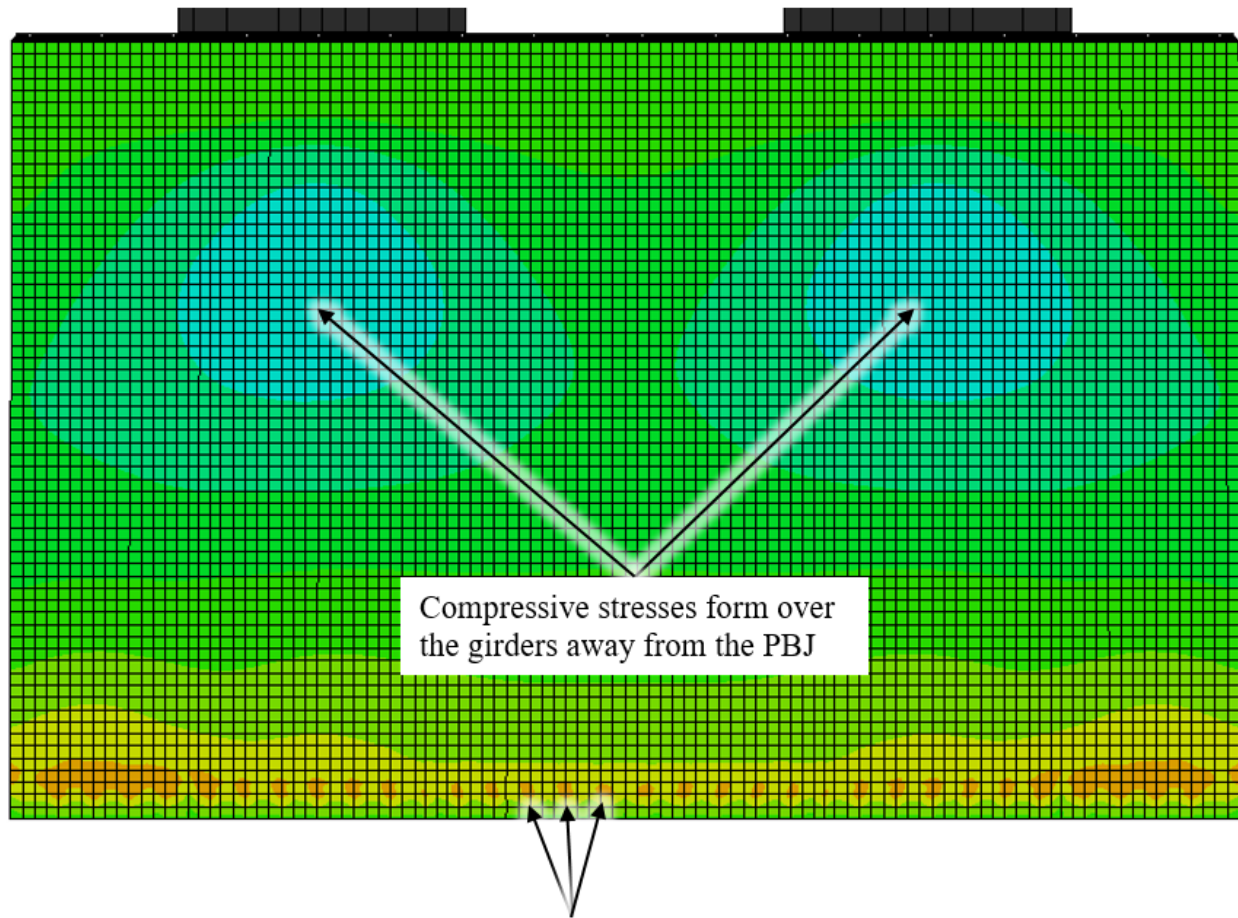
Longitudinal stresses form above each longitudinal rebar

**Figure 8.29. Longitudinal stresses form near the PBJ at the locations of longitudinal reinforcing bars, while compressive forces form away from the PBJ over the girder lines.**

At higher rotations, with the PBJ long since cracked, longitudinal tensile stresses form over the reinforcement embedded within the slab, as shown in Figure 8.29. Furthermore, compressive stresses form farther back in the slab over the girders. The tensile stress within the top longitudinal steel, shown in Figure 8.30, reveals that the bulk of the tensile stress in the steel is constrained to the first 4 in. of bar length on each side of the joint. Cracking reaches the full depth of the CIP concrete over the timber board.

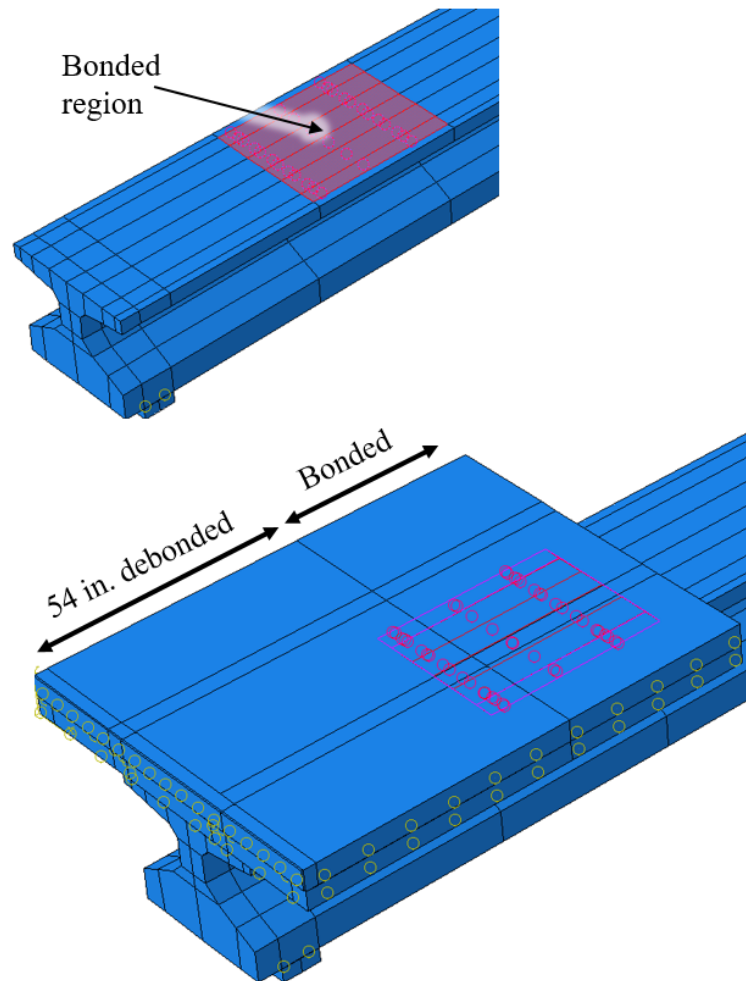
**Figure 8.31. Flush precast panel model debonded from the top face of the girder for a length of 54 in.**

The full-depth debonded flush precast panel model shown in Figure 8.31 has a debonded length of 54 in. along the top face of the girder. This model did not include a vertical gap between the top of the girder and the bottom of the slab. Figure 8.32 shows the stress pattern for the deck, where cracking occurs at the center of the PBJ above the panel end gap. The weak plane in the deck caused by the panel end gap leads to a crack at low rotations above this feature despite debonding.

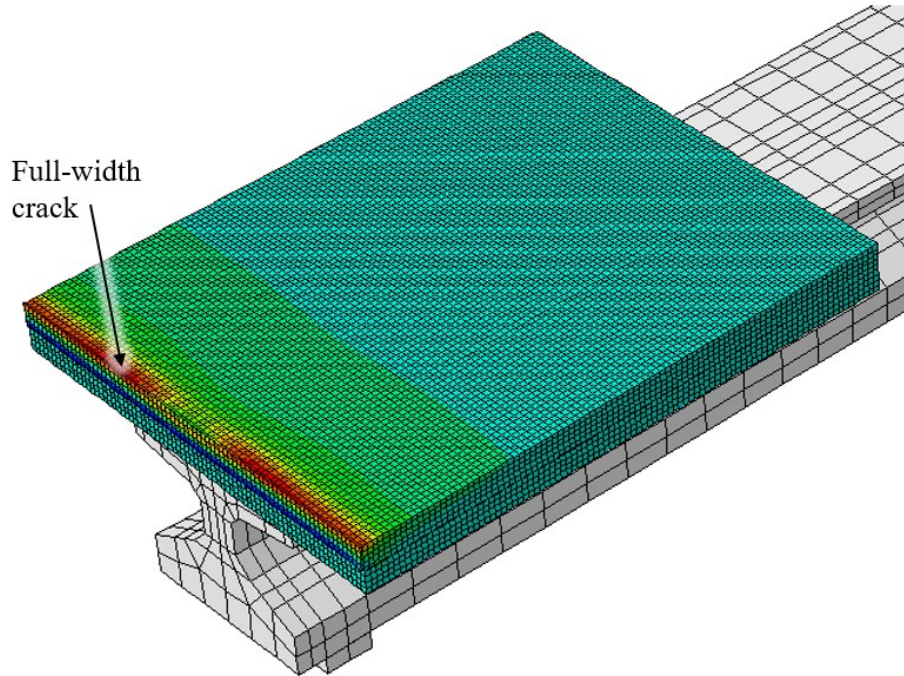
**Figure 8.32. Debonded flush precast panel model with cracks across the full width of the deck above the panel gap.**

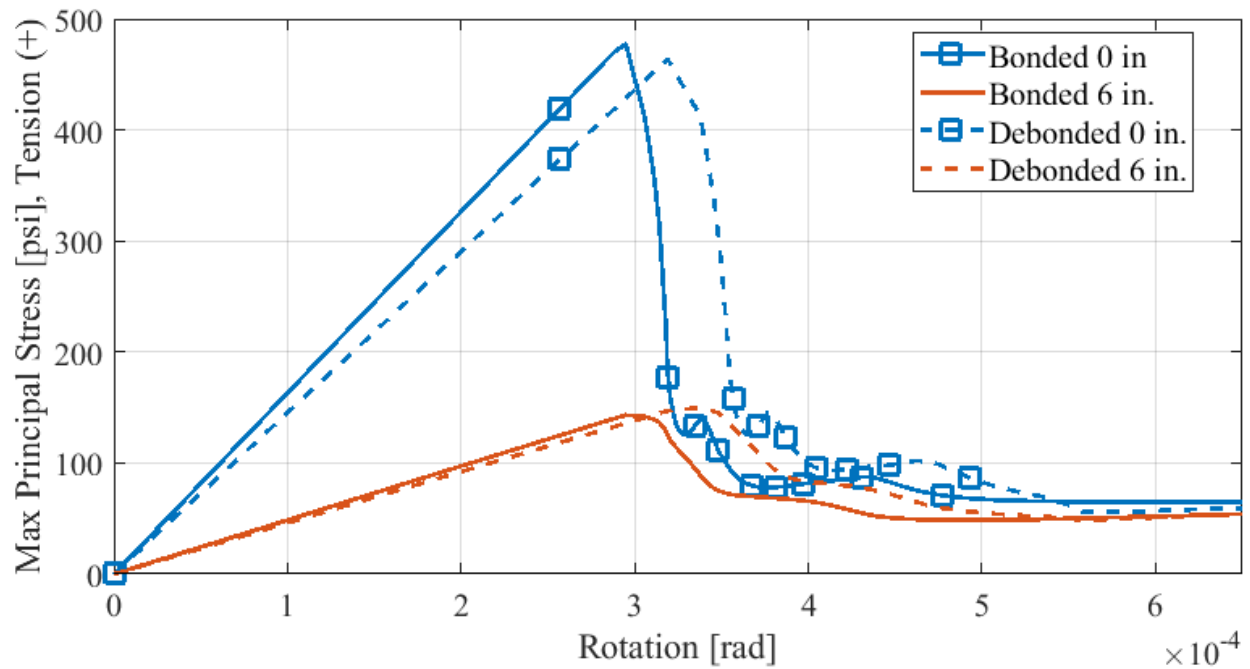
**Figure 8.33. Bonded and 54-in. debonded flush precast panel model concrete stresses at the center of the PBJ (0 in.) and at 6 in. away longitudinally from the PBJ.**

Figure 8.33 shows the principal stress in the concrete at the center of the PBJ and 6 in. longitudinally from the center for the bonded and debonded flush PCP models. The 6-in. curves show that concrete stresses dissipate quickly away from the center of the PBJ. The 0-in. curves show that this debonded detail delays cracking by a small amount—approximately 0.00003 rad. Figure 8.34 shows the longitudinal stress in top longitudinal steel at the center of the PBJ and 6 in. from the center, also for both the bonded and debonded flush PCP models. Prior to cracking, the top longitudinal steel is in compression. Due to the reduced section height at the PBJ because of the PCP gap, the tension zone in the concrete does not reach the steel

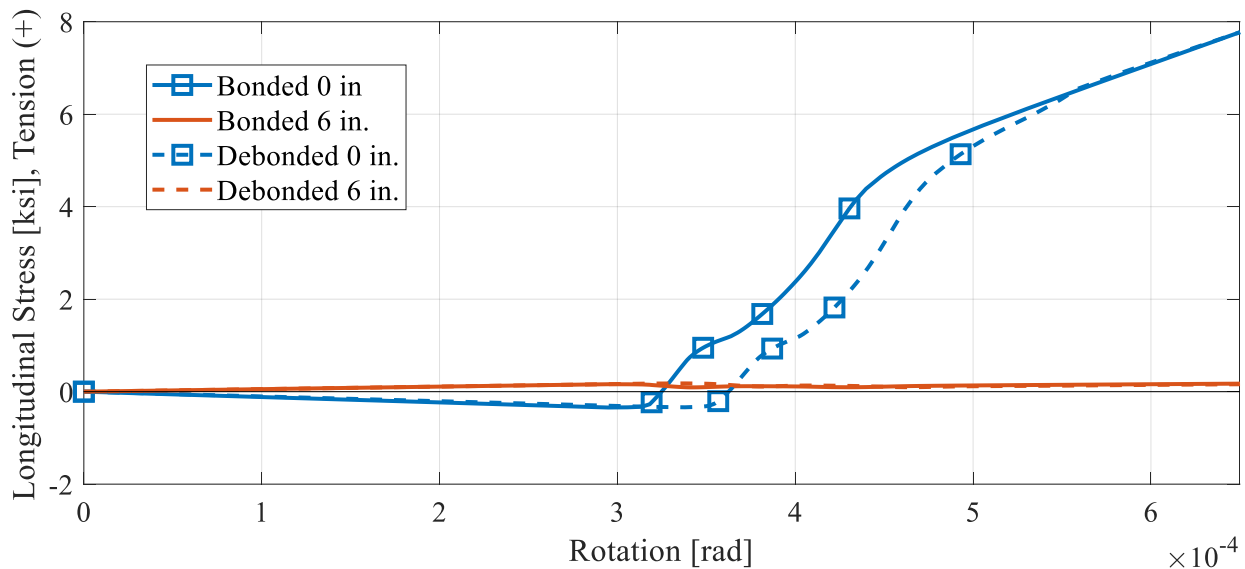
**Figure 8.34. Bonded and debonded flush precast panel model steel stresses at the center of the PBJ (0 in.) and at 6 in. away longitudinally from the PBJ.**
