# Performance and Improvement of Texas Poor Boy Continuous Bridge Deck Details: Final Report

Technical Report 0-7013-R1

TEXAS A&M TRANSPORTATION INSTITUTE  
COLLEGE STATION, TEXAS

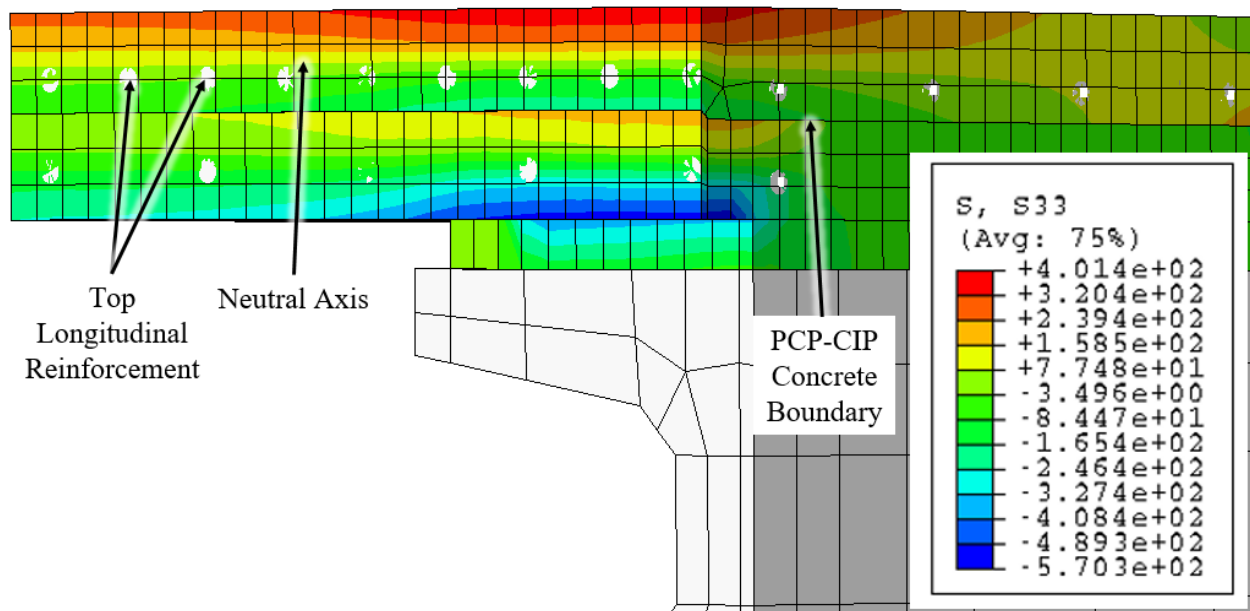
**Figure 8.35. Cross-section of the slab for the partial-depth debonded model showing that the top longitudinal steel reinforcement is below the tension zone in the concrete prior to cracking.**

Debonding the slab at the level of the PCP top face resulted in a continuous slab with no reinforcement in the tension zone at the PBJ before cracking under current designs, as shown in Figure 8.35 and Figure 8.36. Thus, a second model with alternative reinforcement was considered. The standard flush PCP detail included additional 5-ft lengths of longitudinal rebar, centered at the PBJ and placed between the continuous longitudinal bars. Raising these bars by 1 in. in the slab allowed for placement of reinforcement in the tension zone of the DLS while sacrificing concrete cover.

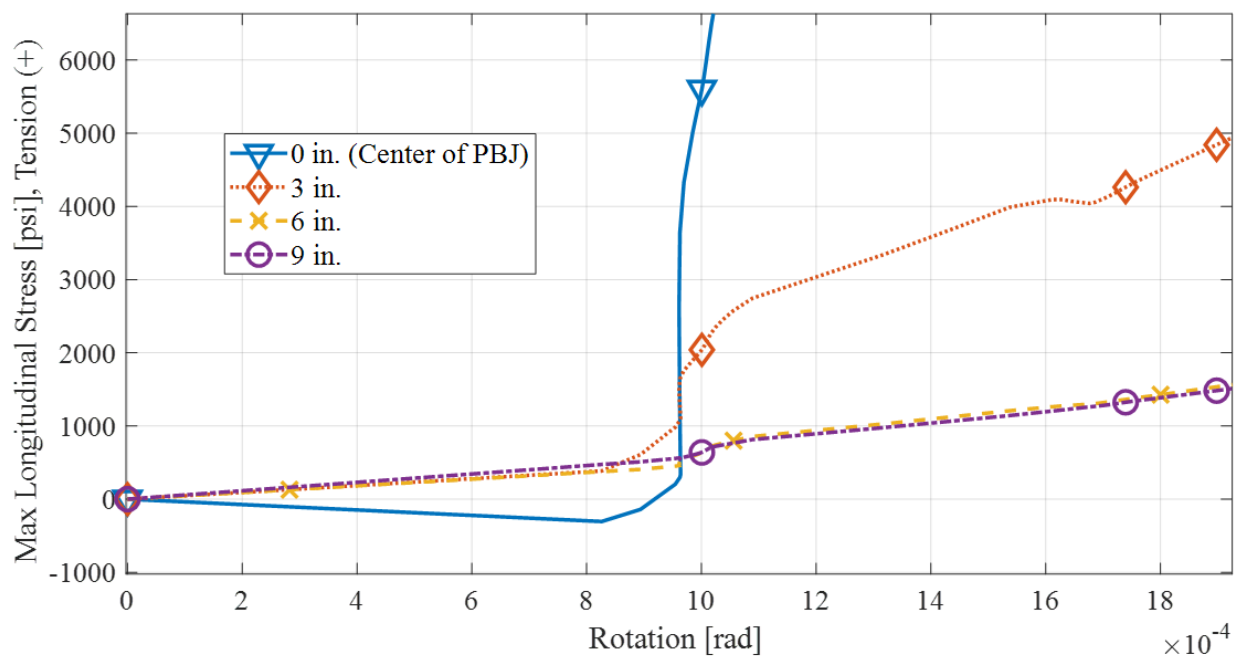
**Figure 8.36. Top longitudinal steel stresses for the partial-depth debonded model showing that the bars at the center of the PBJ develop compressive stress prior to cracking.**

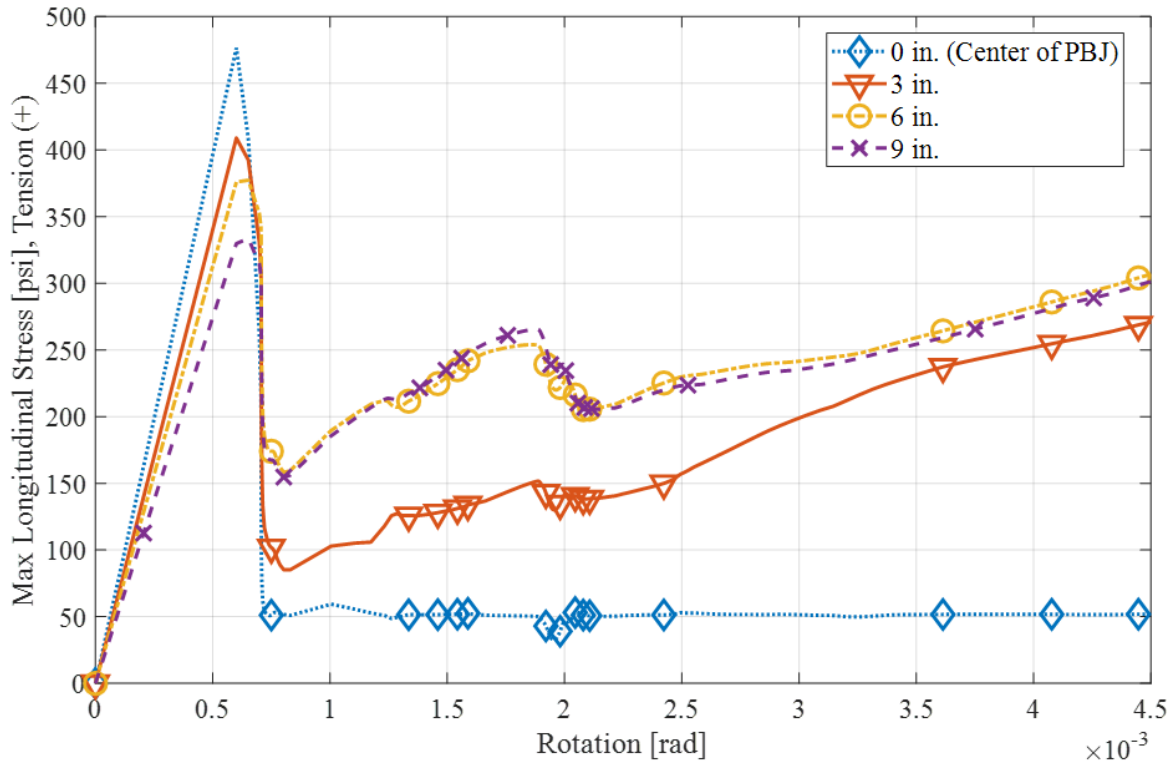
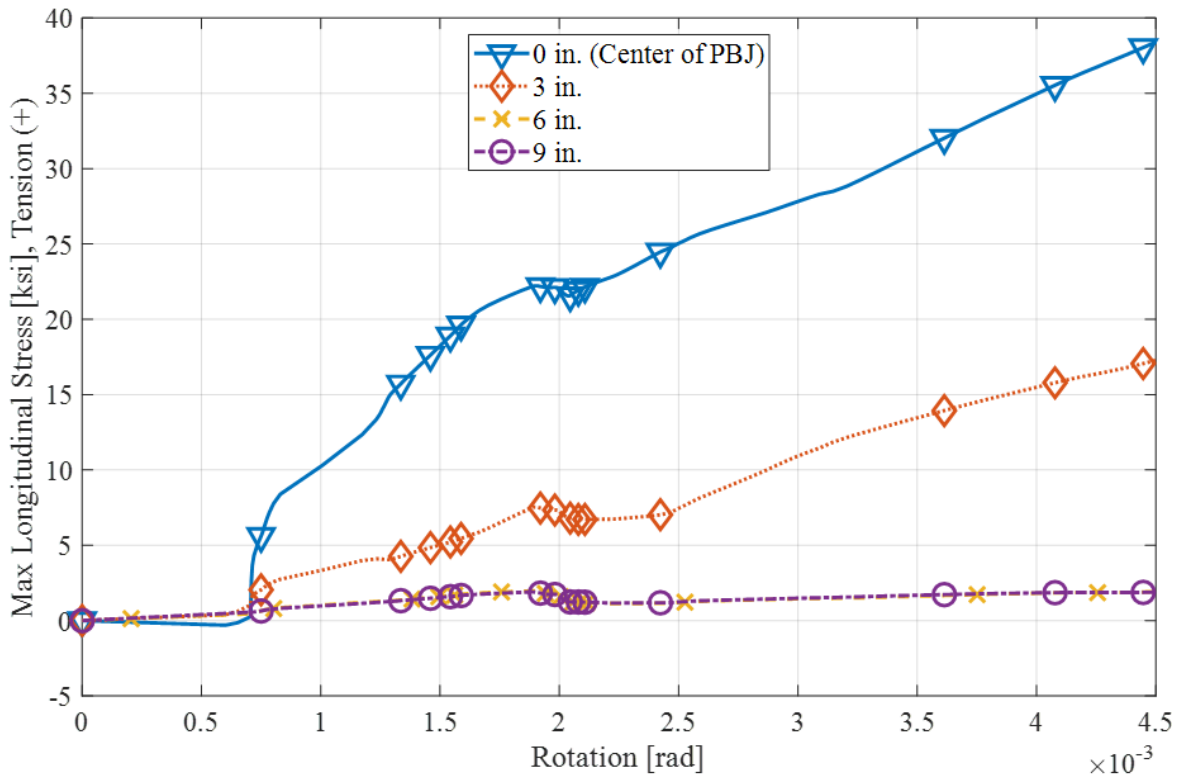
(a) Concrete stress, top of slab

(b) Rebar stress (5 ft supplemental bars)

**Figure 8.37. (a) Strains in the concrete and (b) supplemental top longitudinal bars for the 35-in. partial-depth DLS.**

Results for the partial-depth debonded flush panel model and partial-depth debonded flush panel model with raised reinforcement are shown in Figure 8.37 and Figure 8.38, respectively. Concrete and steel stresses are presented at the center of the PBJ (0 in.) and at 3 in., 6 in., and 9 in. from the center.

The results of these two models show that there is minimal difference in concrete stress at the PBJ with the alternative reinforcement. The standard longitudinal reinforcement goes briefly into compression prior to cracking of the section. The raised longitudinal reinforcement, however, bears tensile forces throughout loading, before and after cracking.

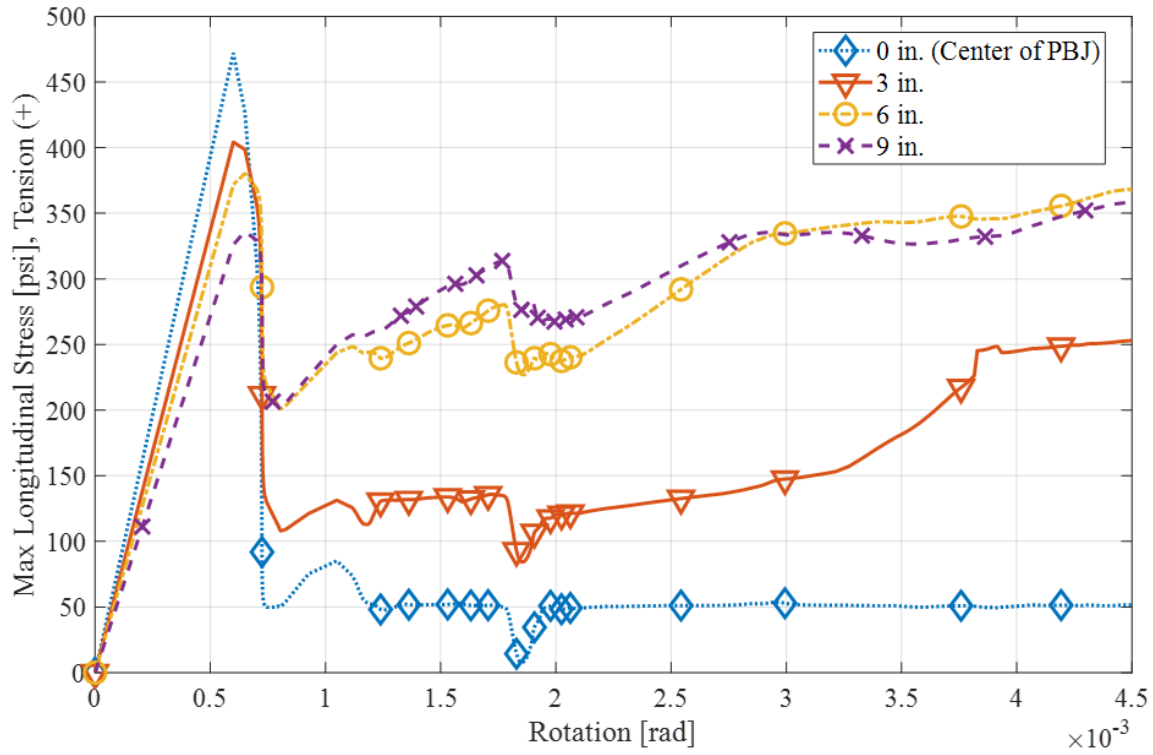
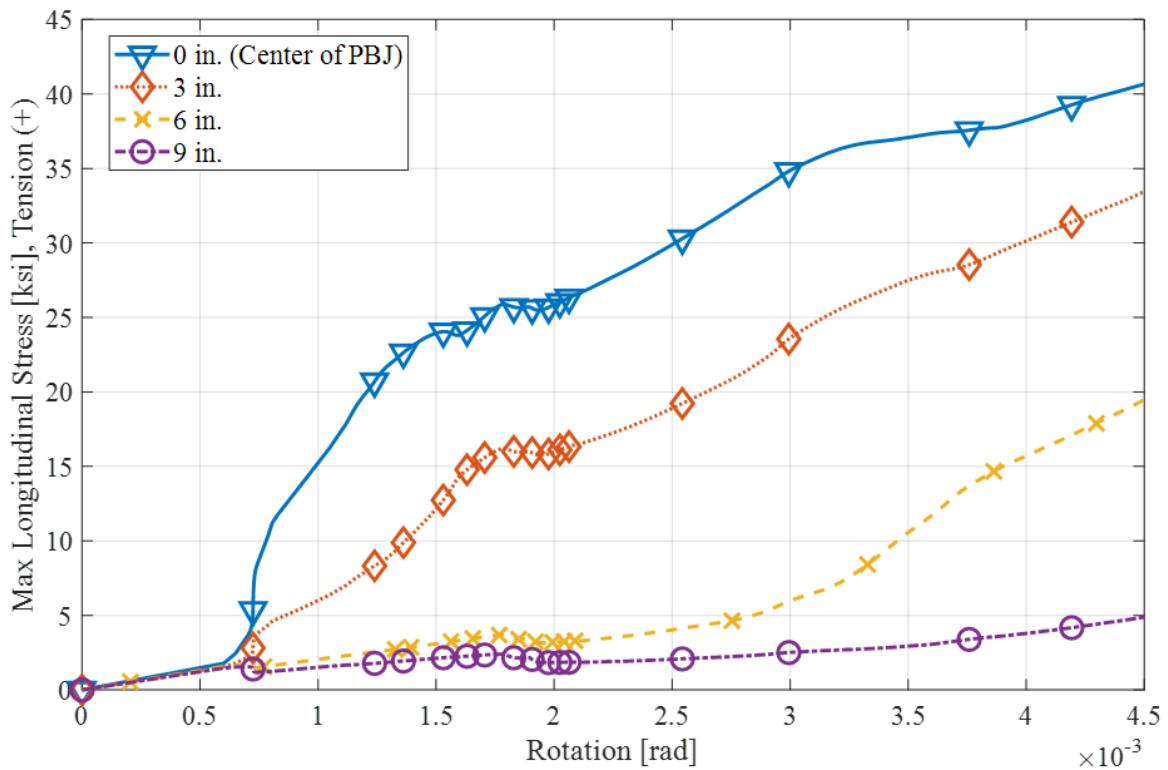
**Figure 8.38. (a) Strains in the concrete and (b) raised supplemental longitudinal bars for the 35-in. partial-depth DLS with elevated reinforcement.**

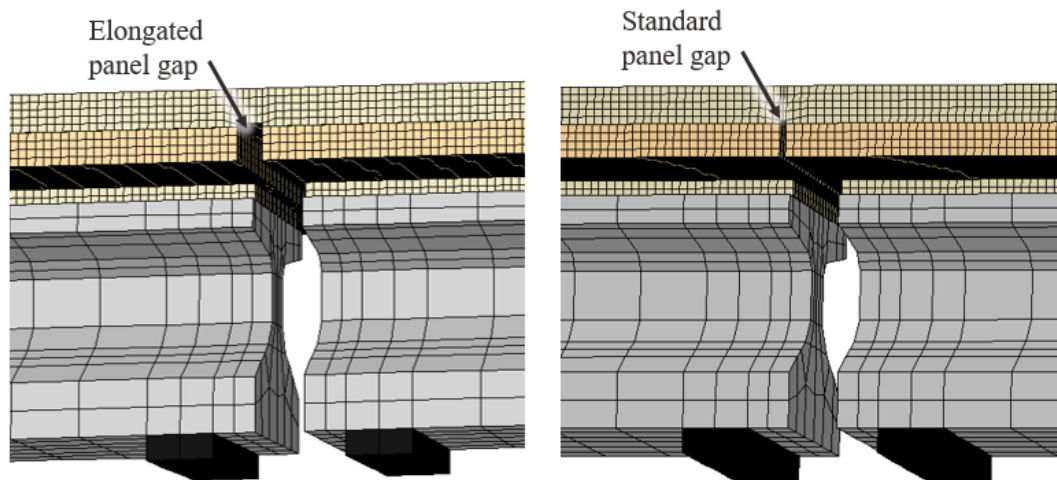
**Figure 8.39. Flush precast panel models with a standard 0.75-in. end gap width (right) and an elongated 3-in. end gap width (left).**

Because the panel end gap creates a weak plane in the deck where cracking originates, a model that lengthens the panel gap to distribute cracking over a wider section of deck was considered. Figure 8.39 shows the difference in end gap between the standard 0.75-in. detail and an elongated 3-in. end gap detail. The deck still cracks over the center of the PBJ for both details. However, Figure 8.40 shows that the 3-in. detail performs better, with delayed cracking behavior and more distributed concrete stresses. While elongating a thinner slab section over the girder ends may lead to concerns with regards to design considerations such as punching shear, a longer end gap improves the general behavior of the link slab.

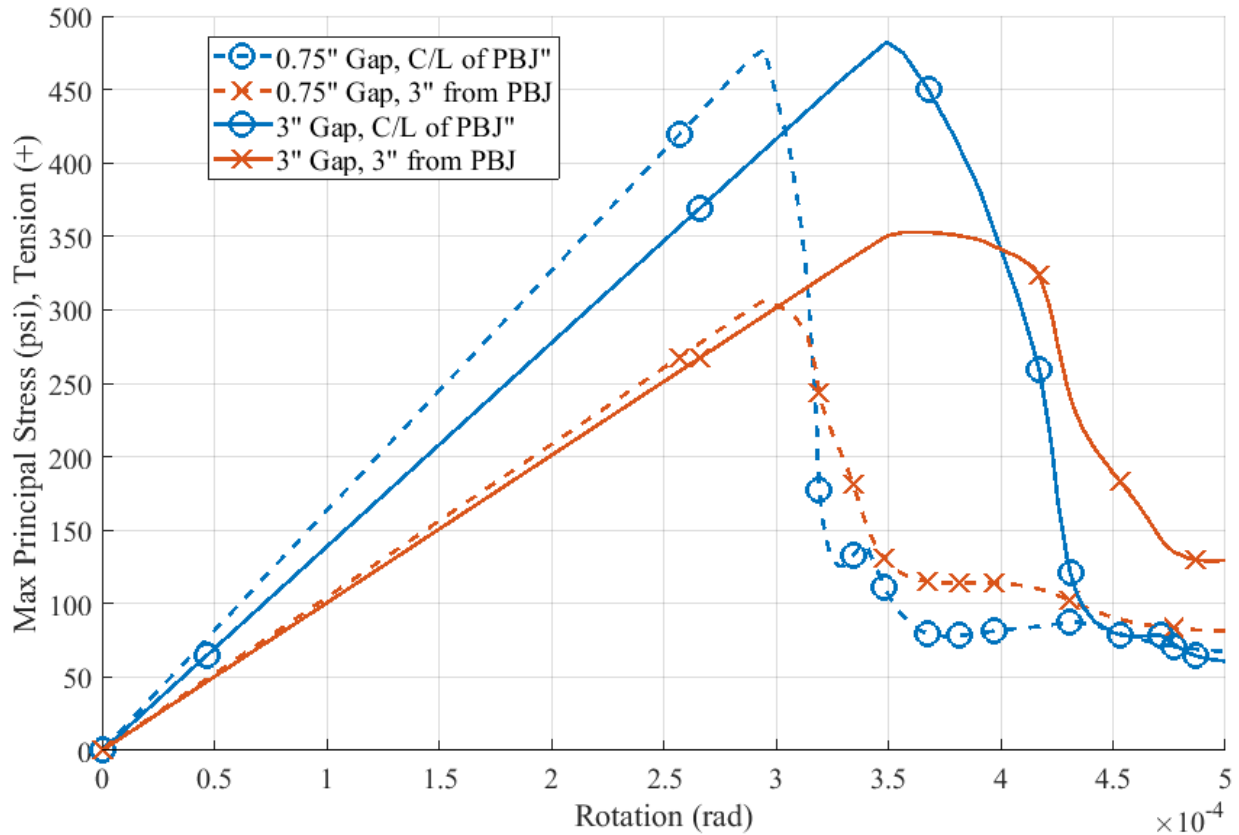
**Figure 8.40. Concrete principal stress for flush precast panel models, comparing details of the standard 0.75-in. end gap with a longer 3-in. end gap.**

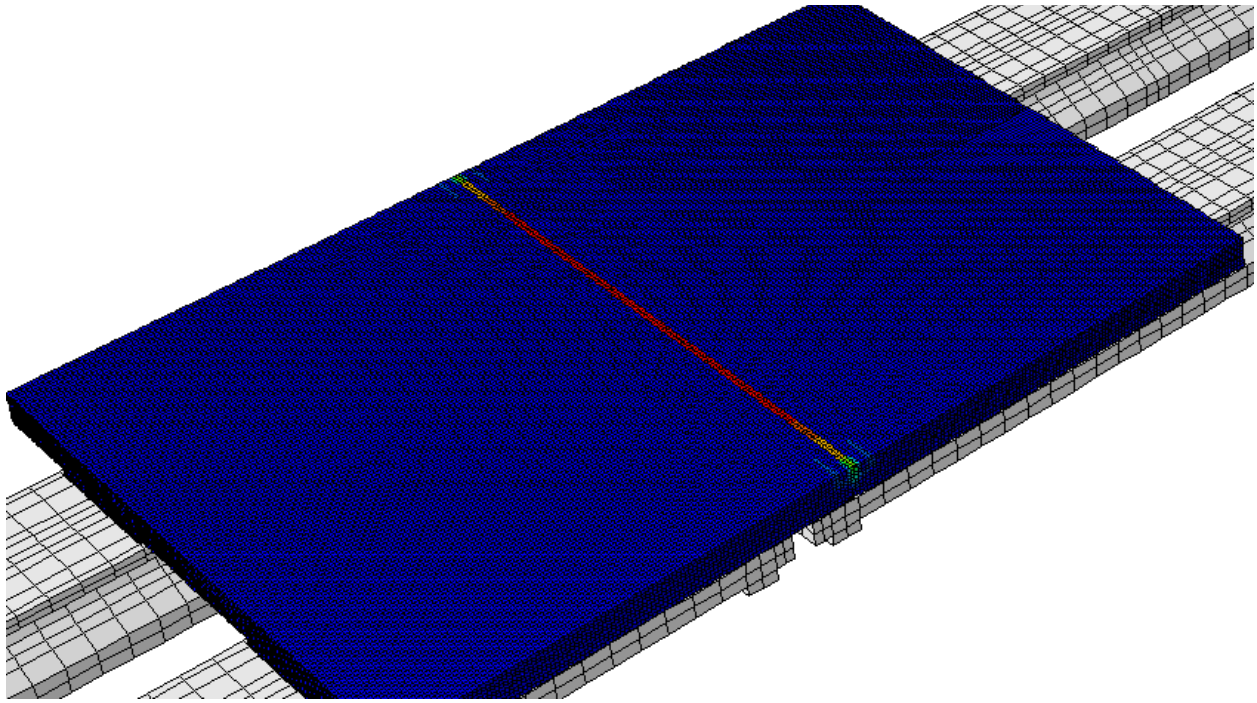
**Figure 8.41. Cracking pattern for single-girder offset panel model, mirrored to show four girder lines and secondary cracking in the overhangs.**

A single-girder bonded offset panel model, utilizing mirroring to simulate a four-girder model, was used as a baseline for subsequent models (see Figure 8.41). Its cracking pattern was reminiscent of the bonded flush panel model under similar rotations (0.005 rad). The presence of a notch in the bottom of the deck created a weak section at the center of the PBJ, which focused cracking across the deck. However, secondary cracks were noticeable in the overhangs.

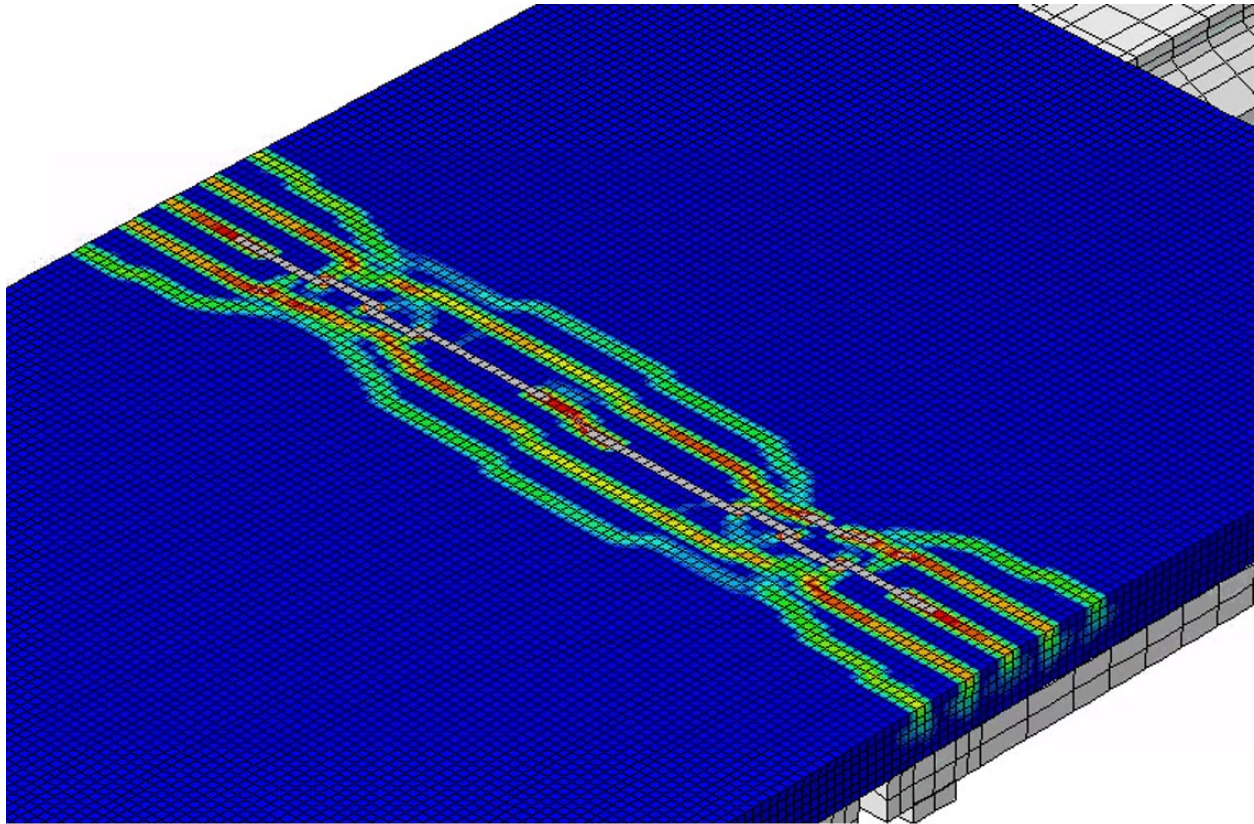
**Figure 8.42. Cracking pattern for a bonded offset precast panel model, without a transverse notch in the bottom of the deck and with double the amount of top longitudinal reinforcement at the PBJ.**

A four-girder bonded offset panel model was also developed as a baseline for subsequent models. This model was subjected to much higher rotations (up to 0.012 rad) under symmetric loading. In order to promote a more dispersed cracking pattern, the bottom notch in the PBJ was removed and the top longitudinal reinforcement was doubled over the PBJ. This model's cracking pattern, shown in Figure 8.42, is more distributed than flush panel cracking patterns. Cracking initiated transversely above the center of the link slab, and secondary cracks formed on either side as the girder ends continued to rotate. Still, while secondary and tertiary cracks formed at over double the rotation of the single-line model, the crack at the center of the PBJ still formed first and remained large. A more detailed analysis of the development of cracking and stresses is presented in Section 8.5.2 as a basis for comparing to debonded models.

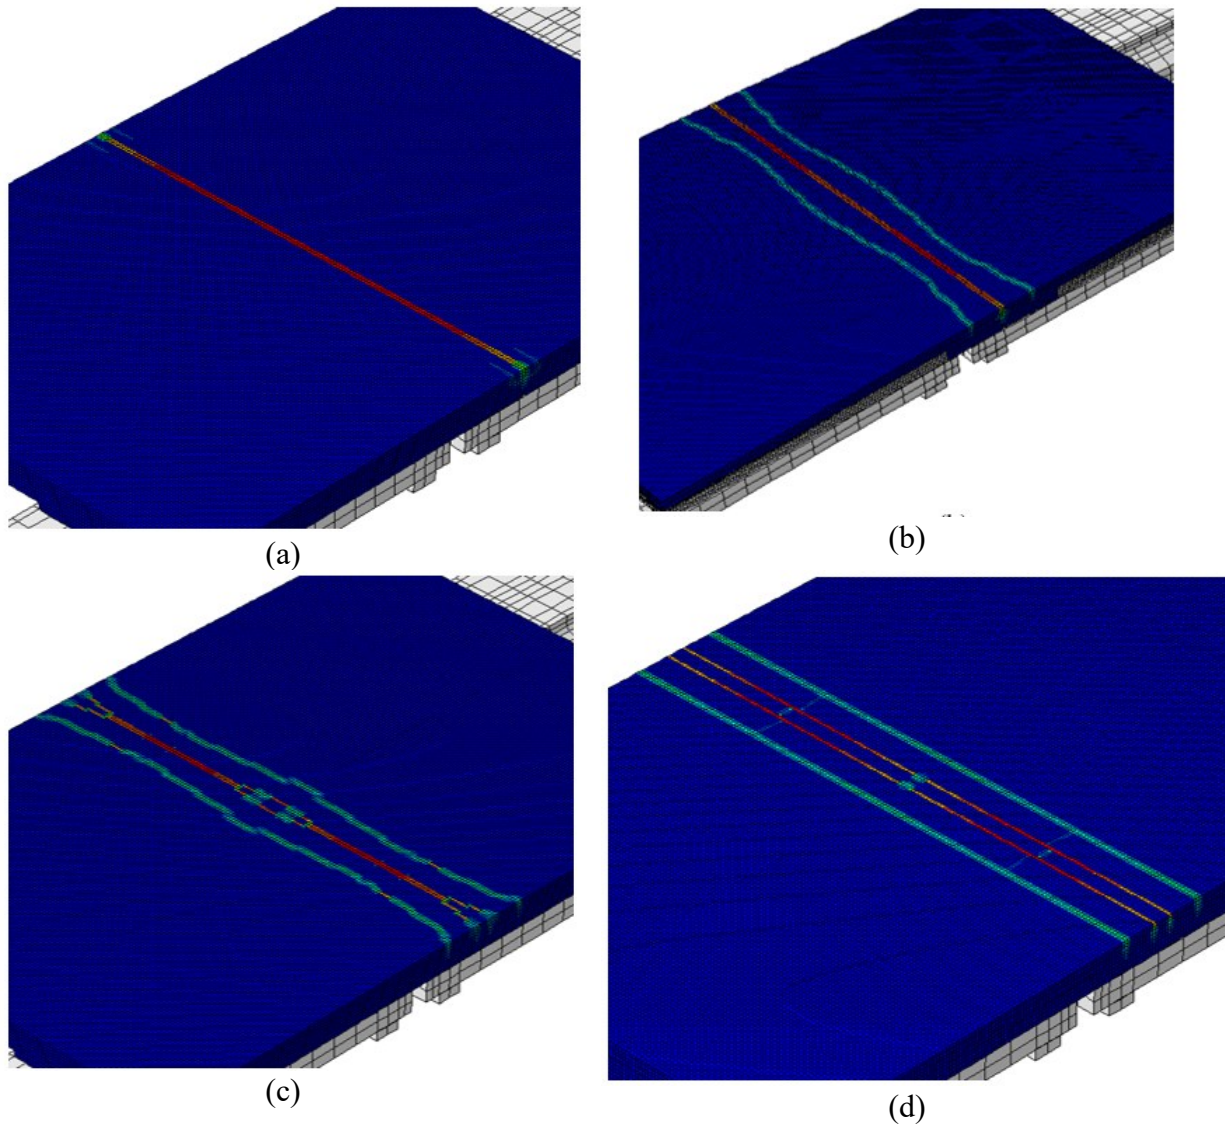
**Figure 8.43. Crack patterns for different offset precast panel models: (a) bonded, (b) debonded, (c) debonded without a bottom notch, and (d) debonded without a bottom notch and with additional top longitudinal rebar.**

Various offset panel debonded details were examined. First, a bonded model, shown in Figure 8.43(a), was compared with the three debonded details in Figure 8.43(b–d). Figure 8.43 (b) is debonded for a length of 54 in. Figure 8.43 (c) is also debonded 54 in. but does not include the standard crack-forming notch detail at the bottom of the PBJ. Figure 8.43 (d) is also debonded 54 in. without a bottom notch but has doubled top longitudinal rebar. All four models were loaded to girder end rotations of approximately 0.005 rad.

The cracking pattern in Figure 8.43(a) shows a large crack focused to a singular location, the center of the PBJ. The existence of the notch in the bottom of the slab consolidates cracking. Figure 8.43 shows that debonding causes a longer link slab length, allowing secondary cracks to form. Figure 8.43 (c) shows that the same debonded model without a notch in the bottom of the link slab at the center of the PBJ allows the central crack to split off into branched main cracks between the girders and in the deck edges. Finally, Figure 8.43 (d) shows that doubled top longitudinal rebar allows for further distribution of cracking, leading to four distinct transverse cracks.

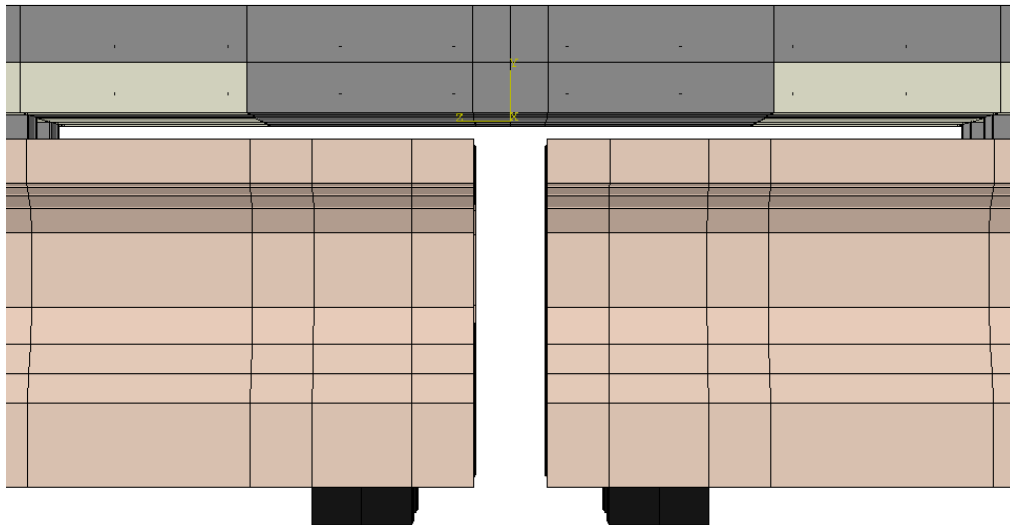
**Figure 8.44. Debonded offset panel model with the girder haunch removed, creating a 2-in. vertical gap between the girder and the bottom of the slab.**

The vertical gap between the debonded concrete faces was found to be a key factor in the effectiveness of debonded details. Four dual-girder models were developed to investigate debonding length effects and the effectiveness of a vertical gap over the debonded length. One debonded model with the girder haunch removed was compared to the bonded detail and two debonded details with different debonded lengths. Figure 8.44 shows the debonded model with the girder haunch removed, creating a vertical gap of 2 in. in the debonded region. Figure 8.45 shows a comparison of the concrete stresses at first cracking for these four models. While increasing debonded lengths caused a small delay in the onset of cracking, including a vertical gap over the debonded length yielded large improvements to cracking behavior. Figure 8.46 shows the plastic principal strains for the same models. The magnitude of these plastic strains

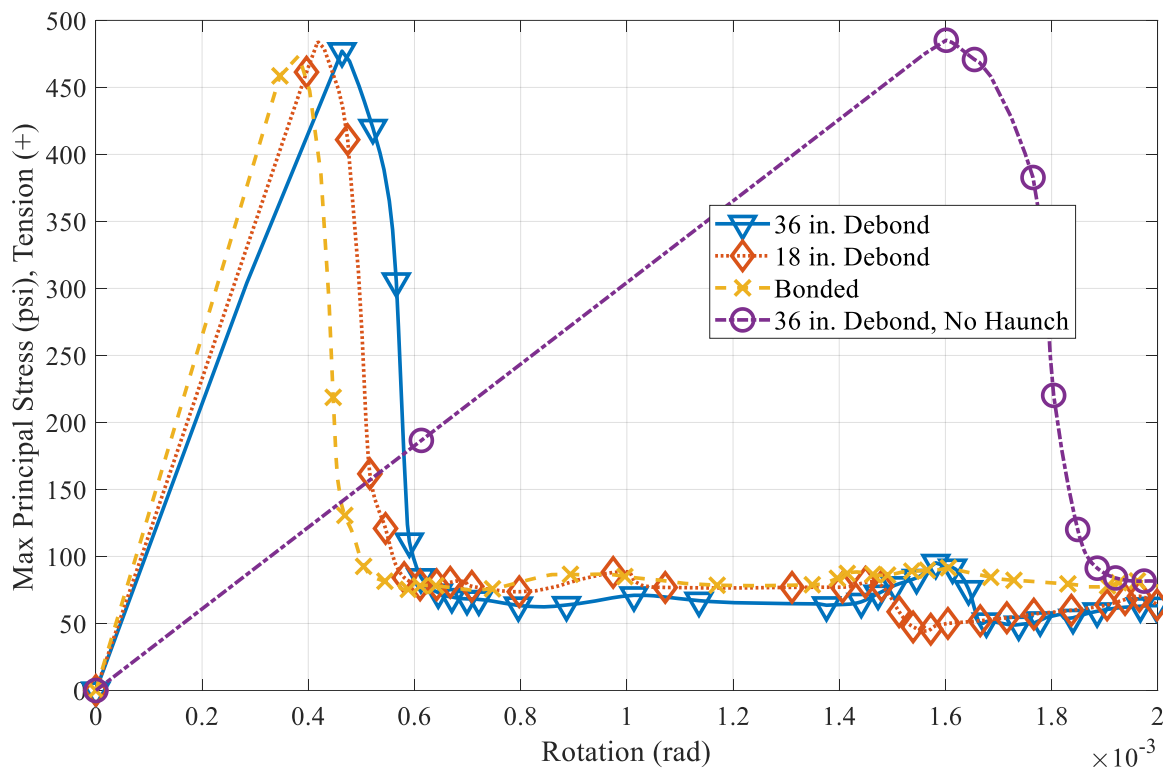
**Figure 8.45. Maximum principal stress for various offset precast panel models at the location of first cracking.**

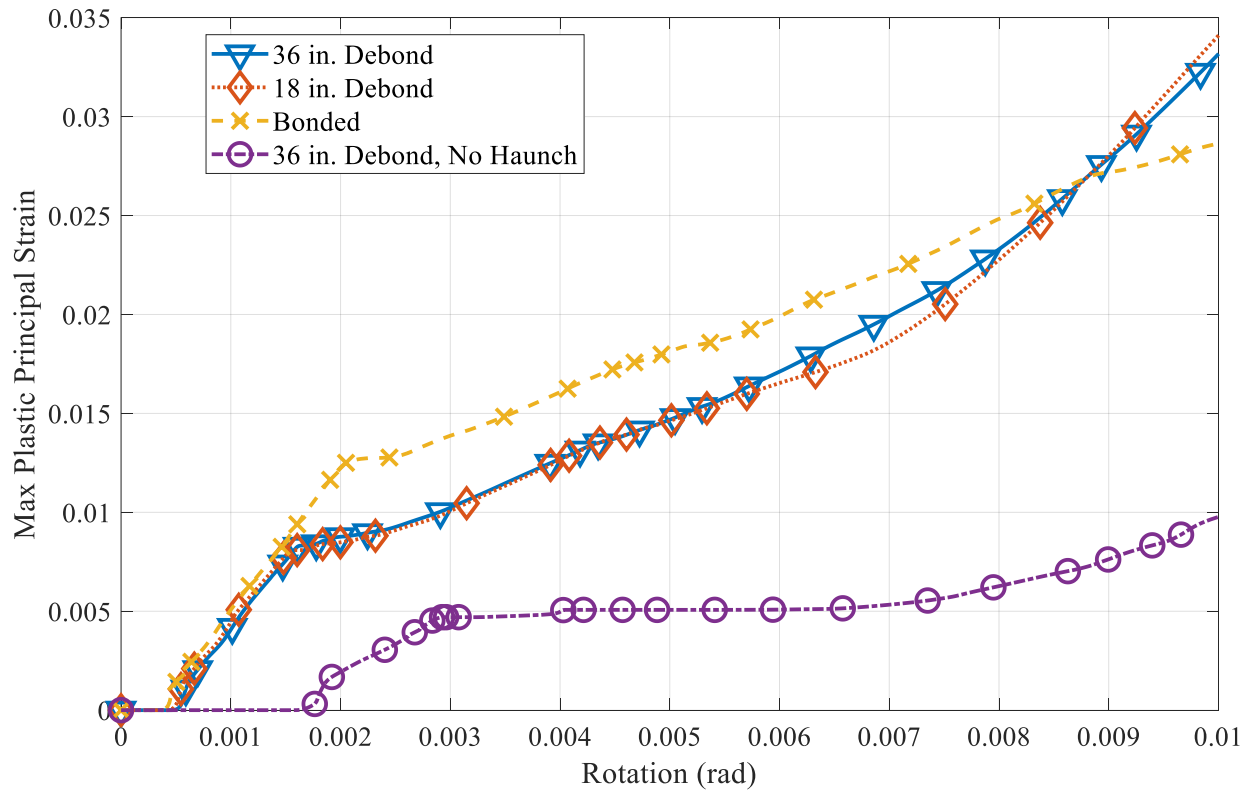
**Figure 8.46. Maximum plastic principal strains for different offset panel models at the location of first cracking.**

may be used as a proxy for crack width. The debonded model with a haunch gap was the most effective for limiting crack width.

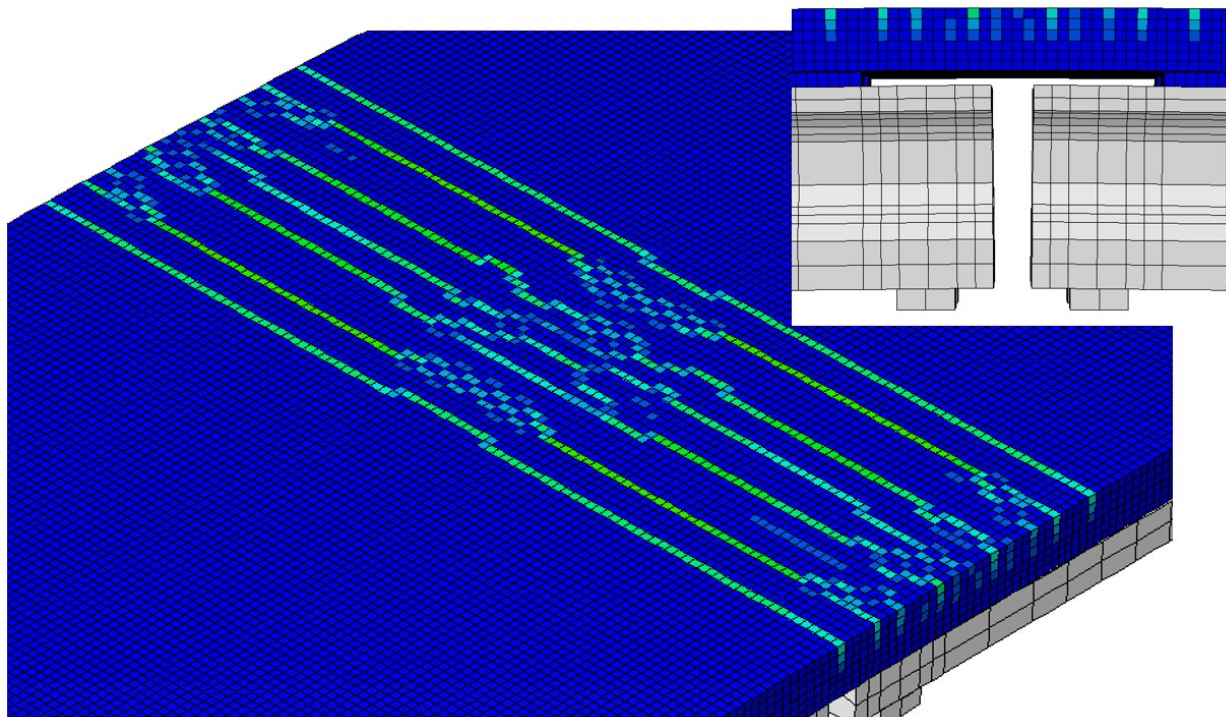
**Figure 8.47.** Cracking pattern for an offset precast panel model, debonded for 18 in. with a vertical gap along the debonded length, and squared ends of the debonded region.

Furthermore, the geometry of the vertical gap over the debonded length was investigated to determine whether a tapered end to the debonded zone would improve performance, perhaps by avoiding stress concentrations at the end of the debonded region. Figure 8.47 shows a simple squared end to the haunch gap and the corresponding deck cracking pattern. Figure 8.48 shows a tapered end to the haunch gap and the corresponding cracking pattern. Little difference in cracking behavior can be seen between the two models. Figure 8.49 shows the principal stress at the location of first cracking for both models. The tapered haunch gap model does not delay the onset of cracking.

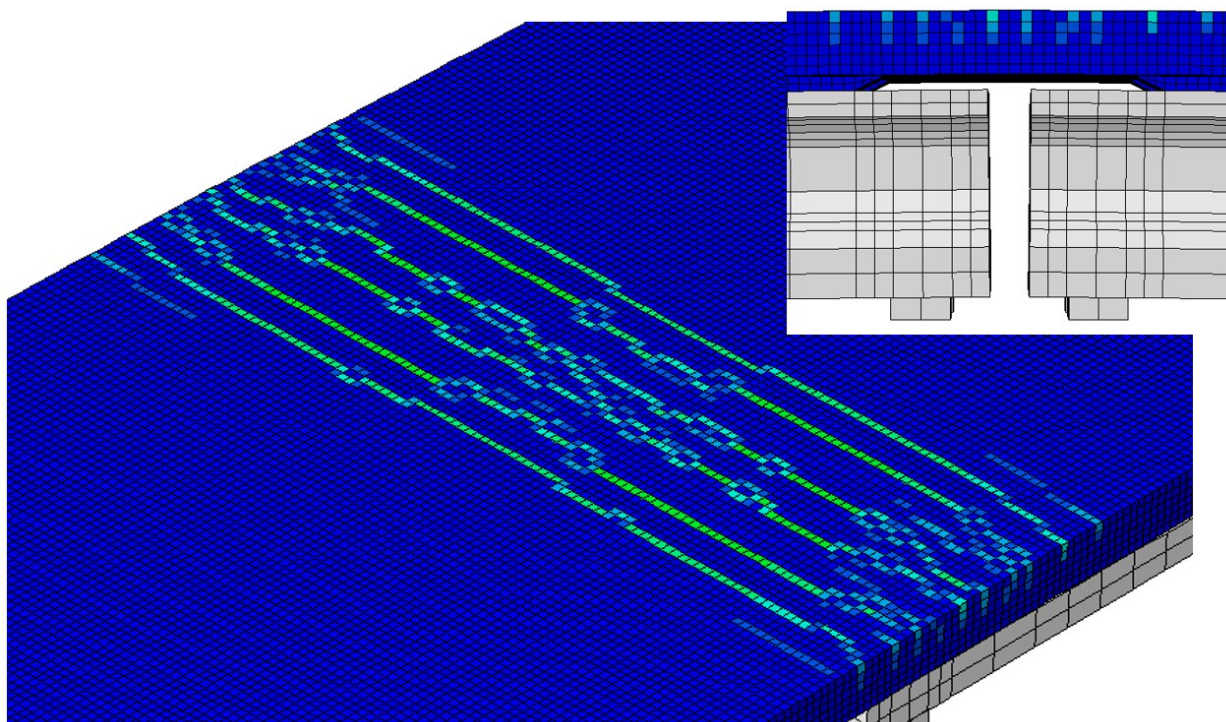
**Figure 8.48.** Cracking pattern for an offset precast panel model, debonded for 18 in. with a vertical gap along the debonded length, and tapered ends of the debonded region.

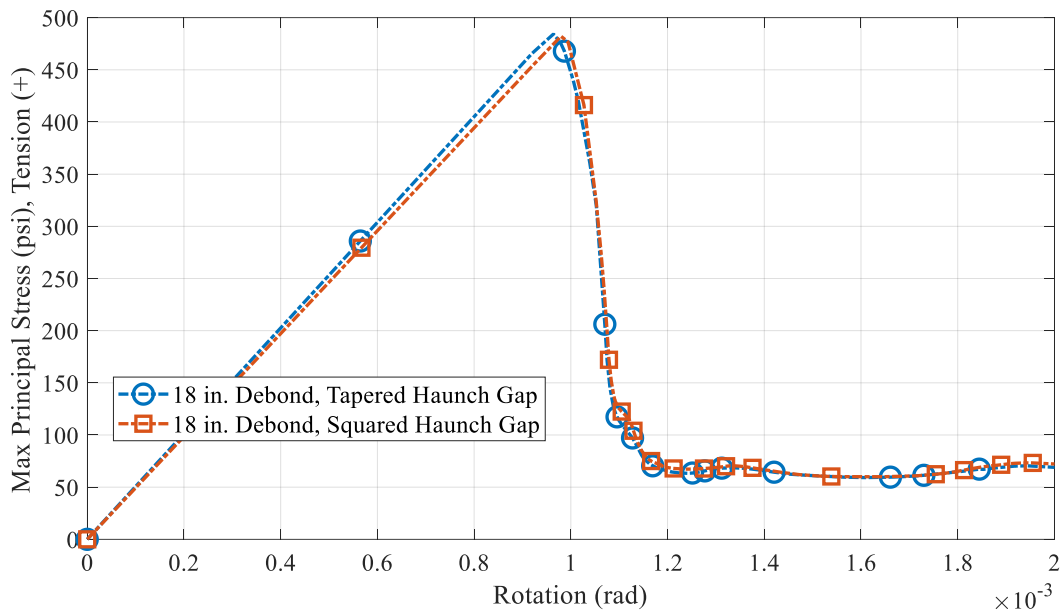
**Figure 8.49. Comparison of concrete principal stress at the location of first cracking for debonded offset precast panel models with different haunch gap end conditions.**

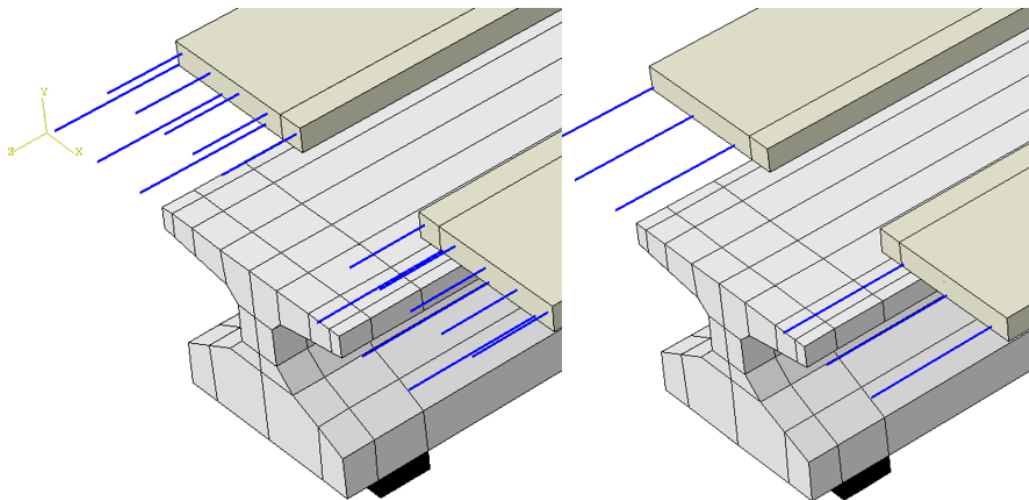
**Figure 8.50. Offset panel models with bars protruding from the panels (left) and without bars protruding from the panels (right).**

Some models were used to investigate the effects of specific reinforcement placement for testing. For test PBJ-OP1R, the PCPs did not have protruding longitudinal reinforcement as specified in standard drawings. Single-girder models, shown in Figure 8.50, were used to compare the behavior of the PBJ with and without protruding PCP bars. Results showed similar behavior between the two models, indicating that the test specimen would be acceptable with spliced reinforcement.

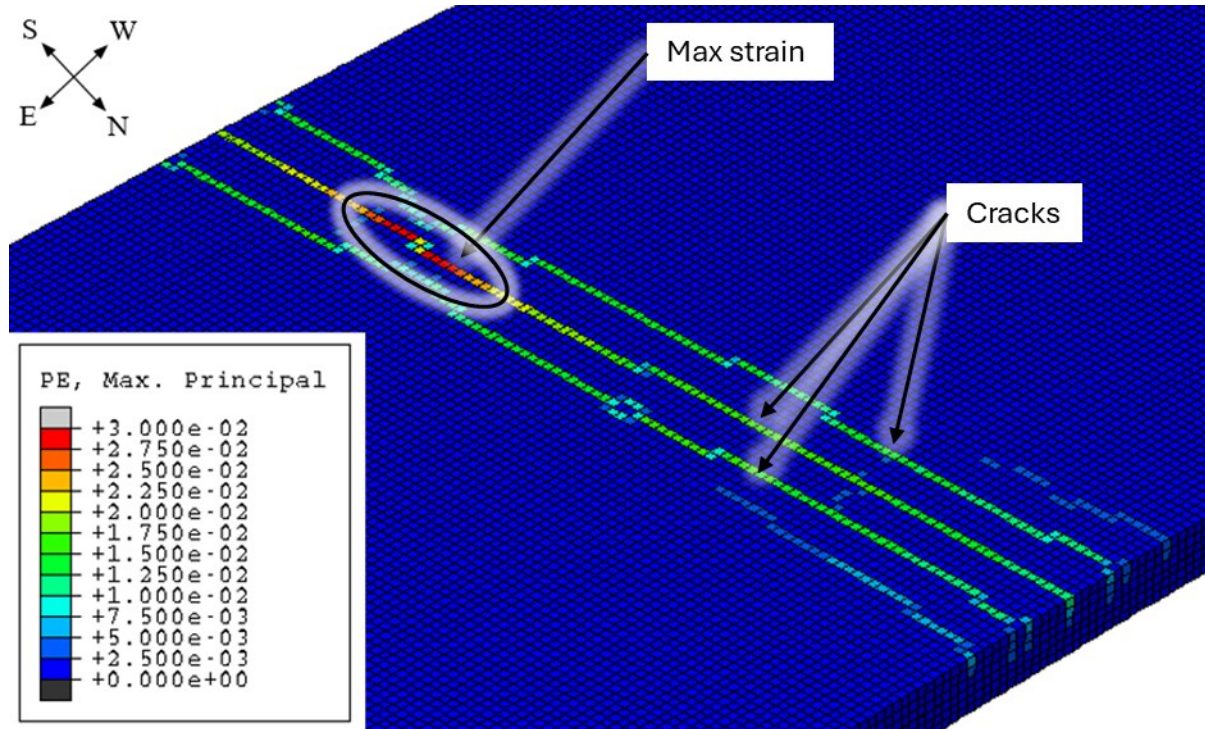
**Figure 8.51. Cracking pattern for a model simulating PBJ-OP2, with added longitudinal reinforcement in the north half of the deck.**

For test specimen PBJ-OP2, #4 bars were added to the north half of the deck in the longitudinal direction between existing longitudinal bars. A model matching this test setup, shown in Figure 8.51, indicated that the increased reinforcement in the north deck would cause a more distributed cracking pattern, while the south deck would see fewer, wider cracks.

Figure 8.52 shows the crack pattern for top longitudinal bar spacing of 4.5 in. over the girders. The crack pattern was not significantly more distributed than the pattern seen in the south end of the deck in Figure 8.51. Further increasing the amount of longitudinal reinforcement over the girders to 3-in. spacing over the south girder and 2.25-in. spacing over the north girder, shown in Figure 8.53, produced a modest improvement in crack distribution. However, the negligible difference in cracking behavior for the 2.25-in. spacing above the north girder and the 3-in. spacing above the south girder indicates that the benefit of adding reinforcement over the girders is limited.

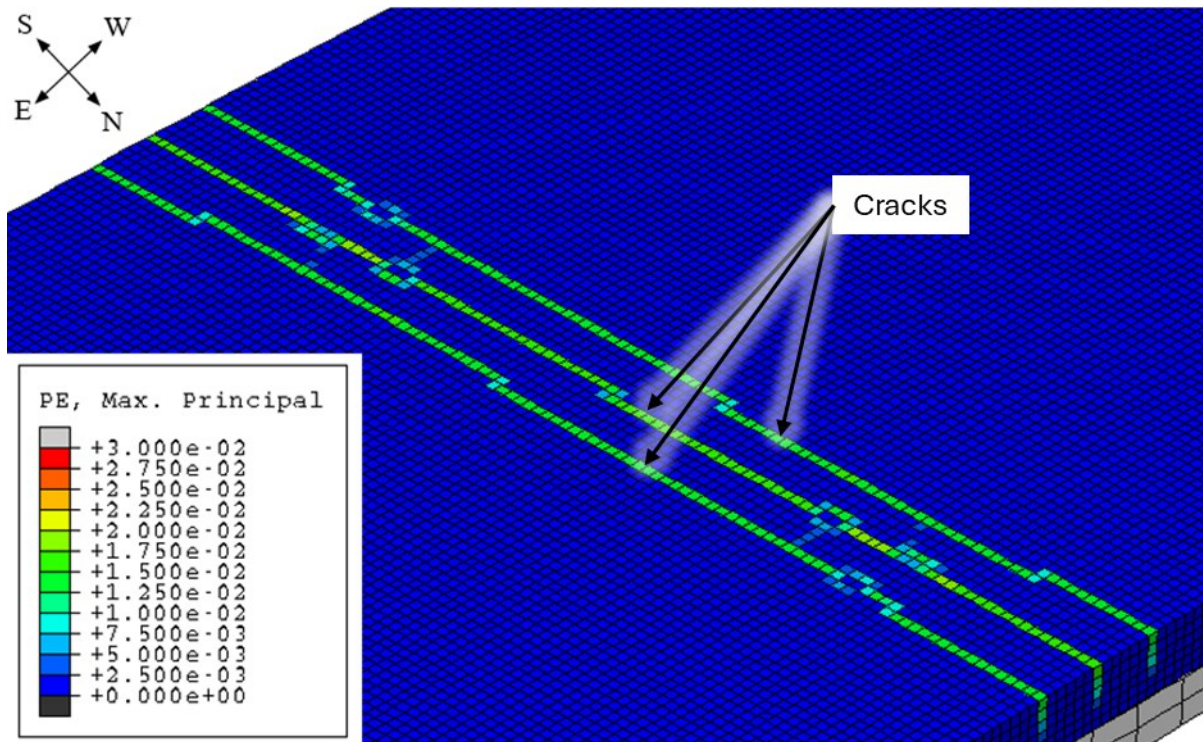
**Figure 8.52.** Offset precast panel model with longitudinal reinforcement added over the girders to provide 4.5-in. spacing.

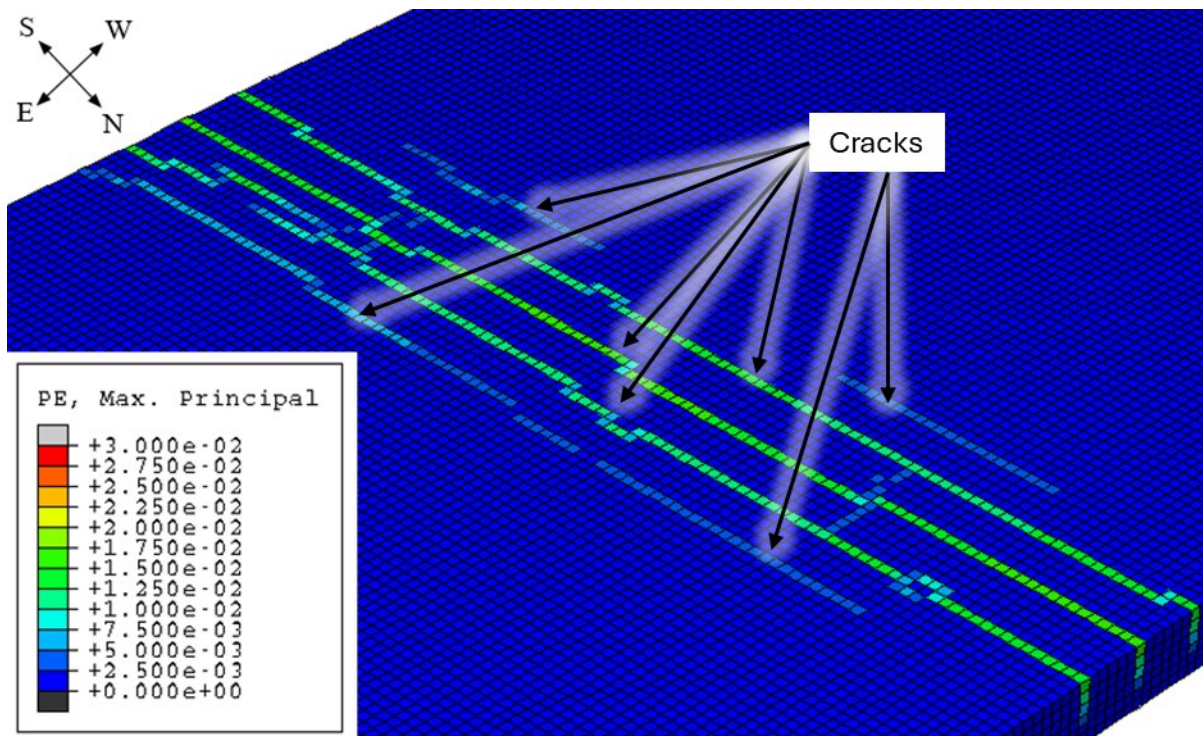
**Figure 8.53.** Offset precast panel model with longitudinal reinforcement added over the north girder to provide 2.25-in. spacing and over the south girder to provide 3-in. spacing.

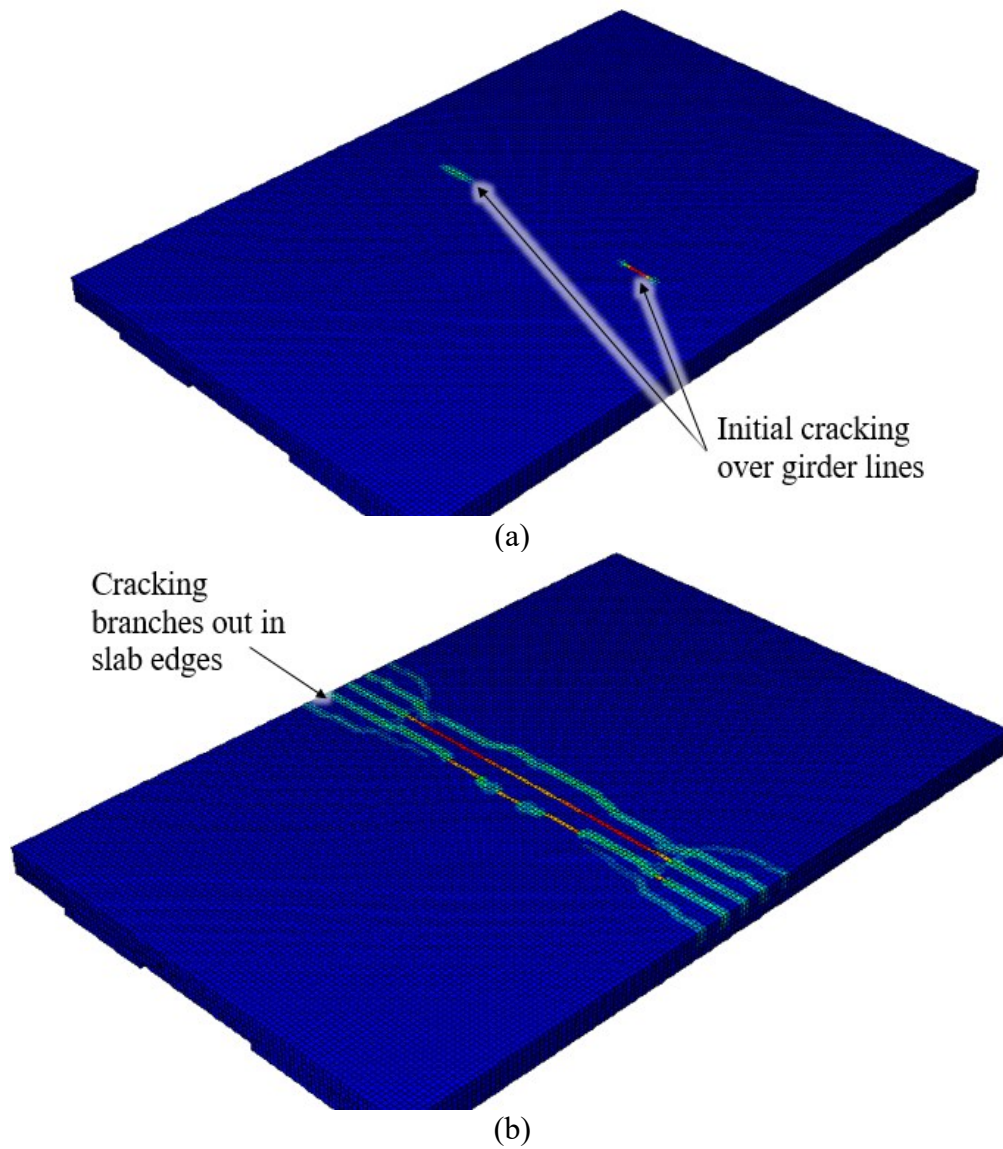
**Figure 8.54. Bonded continuous panel model crack behavior, showing (a) initial cracking over the girder ends and (b) crack propagation.**

The initial cracking behavior of the slab, shown in Figure 8.54(a), shows that initial cracking occurs between the girder ends in both girder lines. At high rotations (0.0068 rad), shown in Figure 8.54(b), cracks propagate over the width of the slab, branching out into secondary and tertiary cracks at the girder edges. Cracks are not full depth. The initial crack pattern appears to be more dispersed than flush panel details.
