# Performance and Improvement of Texas Poor Boy Continuous Bridge Deck Details: Final Report

Technical Report 0-7013-R1

TEXAS A&M TRANSPORTATION INSTITUTE  
COLLEGE STATION, TEXAS

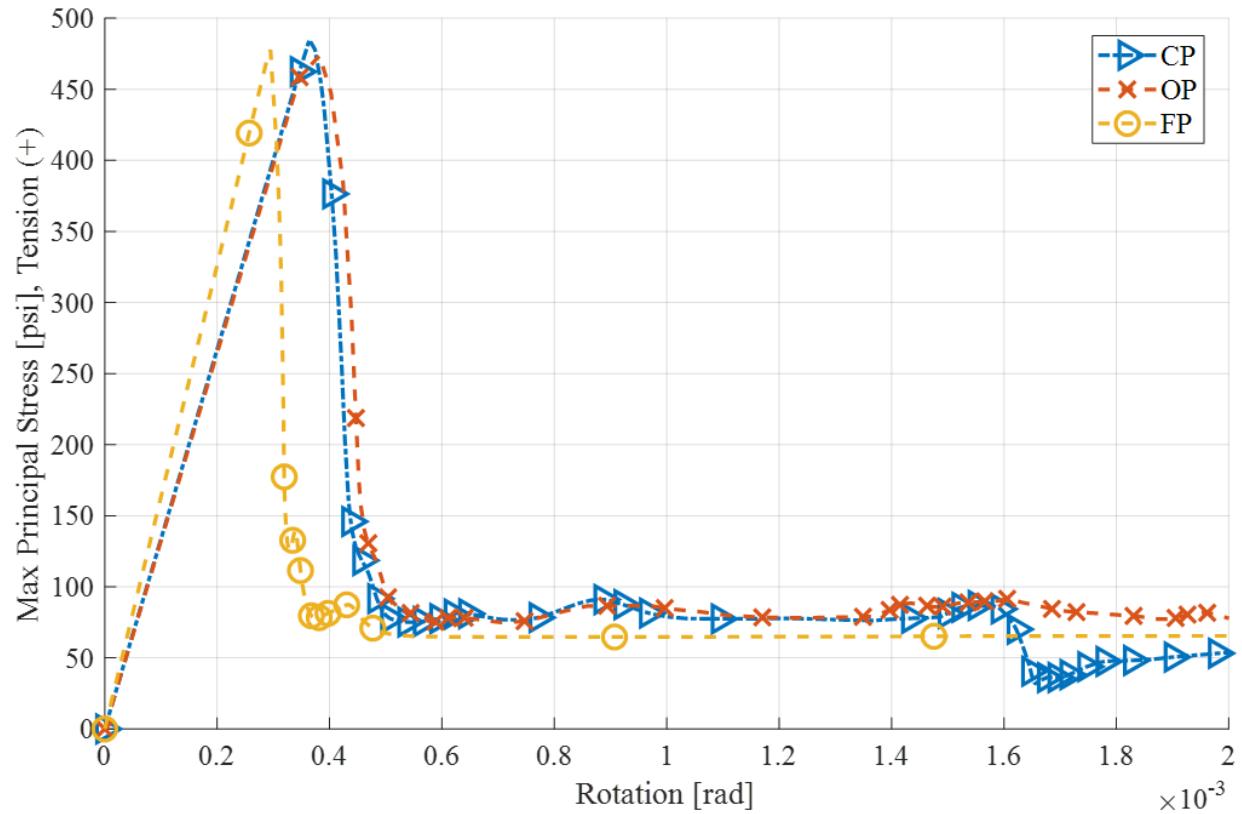
**Figure 8.55. Maximum principal stress in the concrete at the point of first cracking for the continuous panel model, compared to the bonded offset panel and flush panel models.**

Concrete stresses at the point of first cracking are shown in Figure 8.55, which compares the bonded continuous panel model to its offset panel and flush panel counterparts. All three models have very similar behavior at the point of first cracking, but the flush panel model cracks at a slightly lower rotation than the continuous panel model.

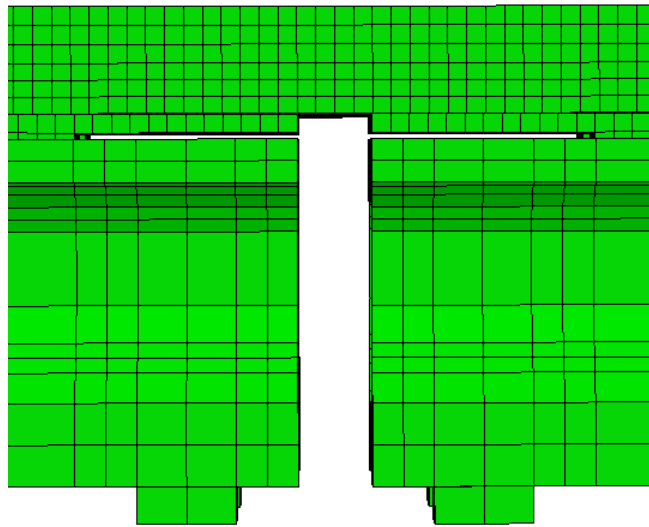
**Figure 8.56. Side view of the DLS for the continuous panel models, showing the 0.5-in. gap between the slab and top faces of the girders.**

Two debonded models were developed for the continuous panel detail. The first model utilizes an 18-in. debonded length with a 0.5-in. gap in the girder haunch between the top face of the girder and the link slab for the entire 18-in. length, as shown in Figure 8.56. The second model is similar, but with the same 0.5-in. haunch gap for 18 in. over each girder, but with a 36-in. debonded length. Thus, only half of the debonded length includes the haunch gap.

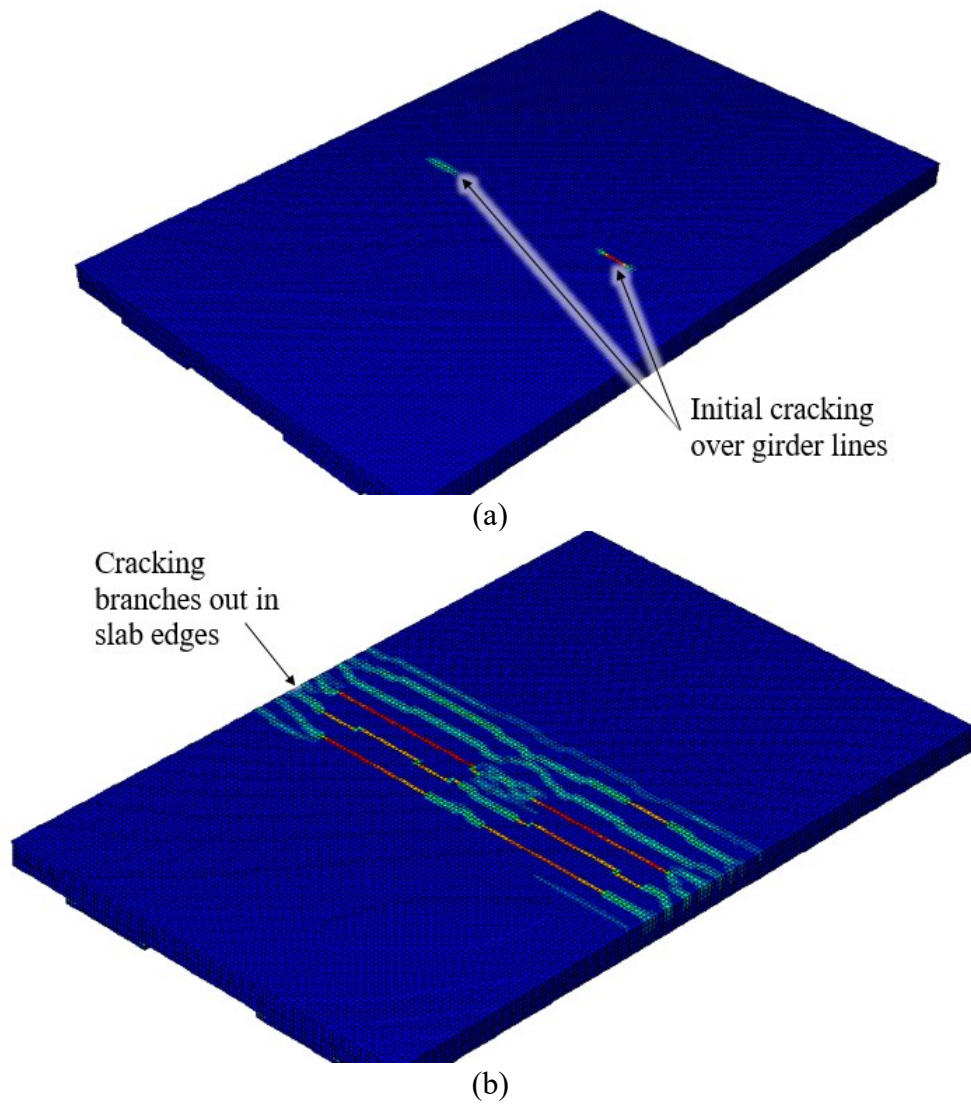
**Figure 8.57. 18-in. debonded continuous panel model crack behavior, showing (a) initial cracking over the girder ends and (b) crack propagation.**

The initial cracking behavior of the 18-in. debonded slab, shown in Figure 8.57(a), shows that cracking begins between the girder ends in both girder lines, as in the bonded model. At high rotations (0.0078 rad), shown in Figure 8.57(b), cracks propagate over the width of the slab, branching out into multiple layers of cracks at the girder edges. Cracks are not full depth. The crack pattern is significantly more dispersed than the pattern in the bonded model.

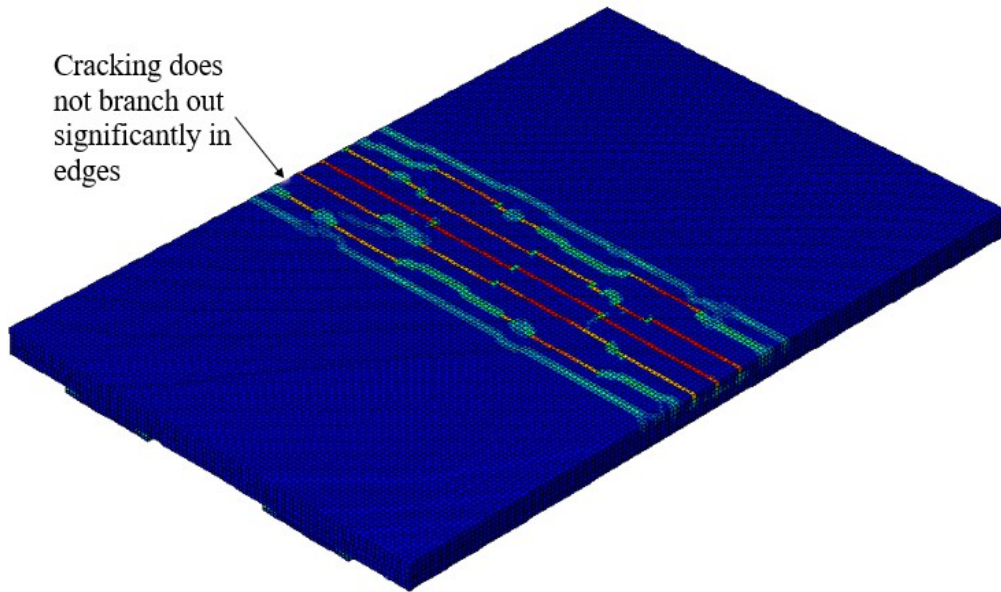
**Figure 8.58. 36-in. debonded continuous panel model crack behavior, showing crack propagation at high rotations.**

For the 36-in. debonded model with 18-in. length haunch gap, shown in Figure 8.58, the initial cracking also occurs between the girder ends. At high rotations (0.0072 rad), cracks propagate extensively over the width of the slab but do not branch out significantly in the deck edges. Instead, transverse cracks are mostly straight over the entire slab width. Cracks are not full depth. The crack pattern is again more dispersed than the pattern of the 18-in. bonded model.

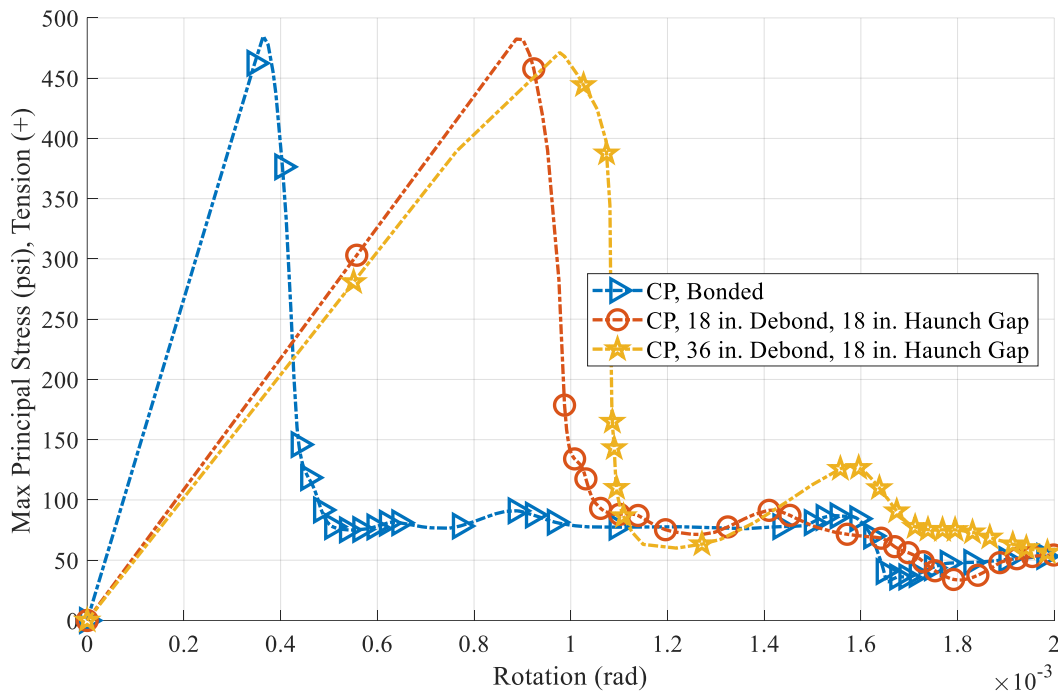
**Figure 8.59. Comparison of first cracking behavior for continuous panel models.**

The initial cracking behavior of the three continuous panel models is compared in Figure 8.59. Debonding the continuous panel model for 18 in. on each girder with a 0.5-in. haunch gap for the full 18-in. length delays cracking in the slab for 0.00052 rad of girder end rotation. An increased debonded length of 36 in., but with a haunch gap for only 18 in. along that length, gives a modest improvement of 0.00009 rad of rotation before cracking. Debonding is effective in delaying the onset of cracking, but not including the haunch gap for the debonded length limits the effectiveness of debonding.

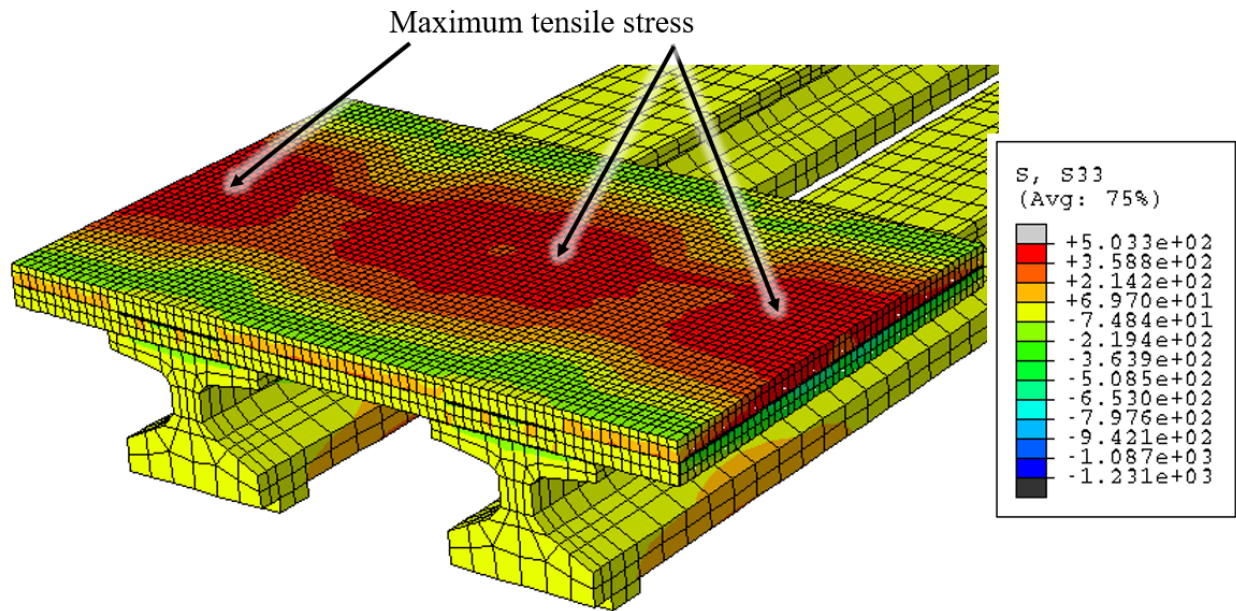
**Figure 8.60. Longitudinal concrete stresses formed by uniform shrinkage in the deck, causing potential cracking within the section.**

When evidence of cracking due to concrete shrinkage was noticed after fabrication of the flush panel laboratory specimens, a model was developed to investigate shrinkage. This model, shown in Figure 8.60, is built to mimic the laboratory test specimen with a flush precast panel detail. By imposing a uniform temperature change on only the CIP portion of the deck, it was possible to simulate the effect of drying shrinkage. Reducing the deck's temperature causes the deck to contract, which generates forces in the slab since the girders do not have a similar temperature change.

Results showed the potential for cracking in the deck, especially over the girders, which restrain the movement of the slab. Cracking initiates in the middle of the deck, rather than at the PBJ, suggesting that deformation at the supports prevents the buildup of stress in the deck between the girder ends. However, no such relief for deformation is possible at the interior of the slab since a perfect bond between the deck and girder is assumed.

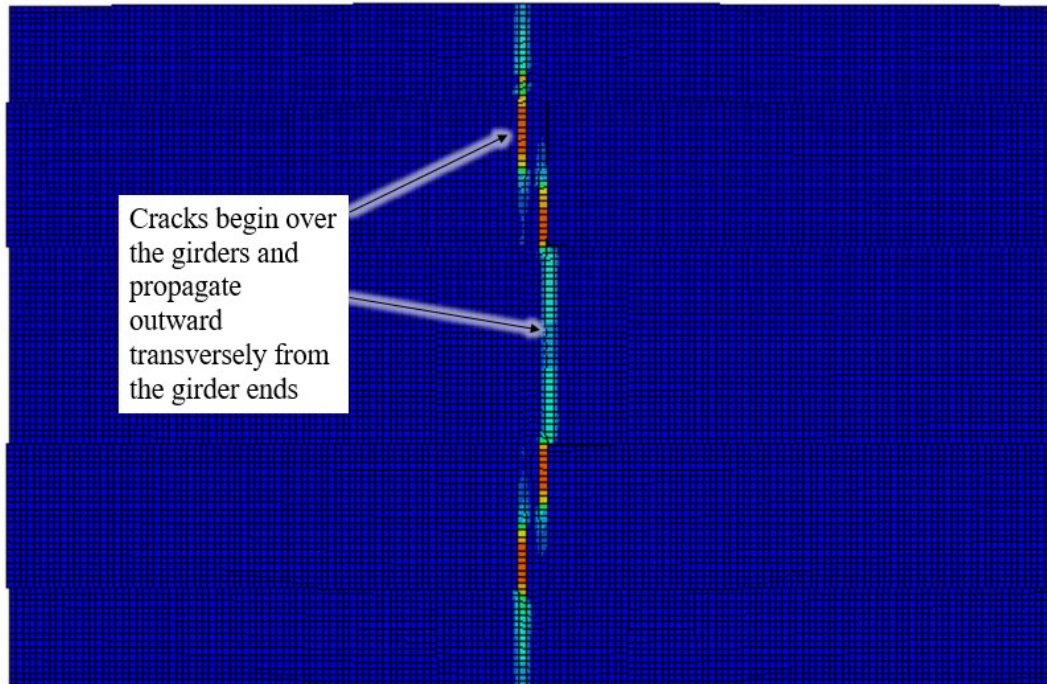
**Figure 8.62. The crack pattern in the bottom of the slab for an offset precast panel model loaded with negative temperature gradient.**

Figure 8.62 shows the cracking pattern for the bonded model. Cracking begins over the girder lines at the girder edge at the change in cross-section depth. These cracks propagate in the transverse direction between the girders and out to the slab edges. The cracks are not full depth.

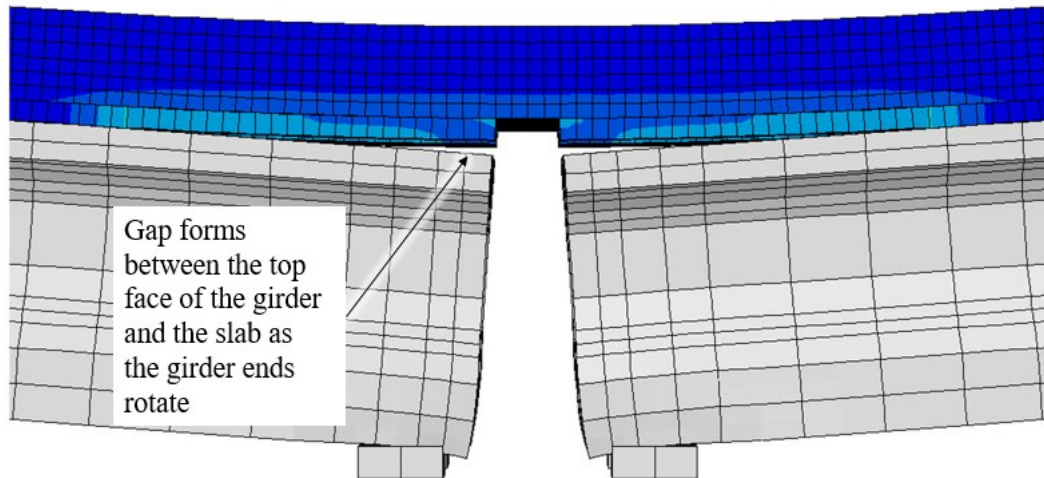
**Figure 8.63. Exaggerated deformation of the girder ends for the 36-in. debonded model, causing a natural gap between the bottom of the DLS and the top face of the girder.**

Debonded models were investigated with an 18-in. debonded length and a 36-in. debonded length, both without a vertical gap in the debonded region. As seen in Figure 8.63, a gap between the girder and the 36-in. debonded slab formed naturally due to negative bending of the girders. Debonding was so effective that the 36-in. debonded slab did not crack during the simulation. The bottom of the 18-in. debonded slab did crack, as shown in Figure 8.64. However, unlike for the bonded model, the cracks did not extend between the girders and out to the deck edges. Instead, cracks formed over the girder ends and at the end of the debonded region. These results show that even debonded details without vertical gaps are effective at reducing cracking under negative girder deformation.

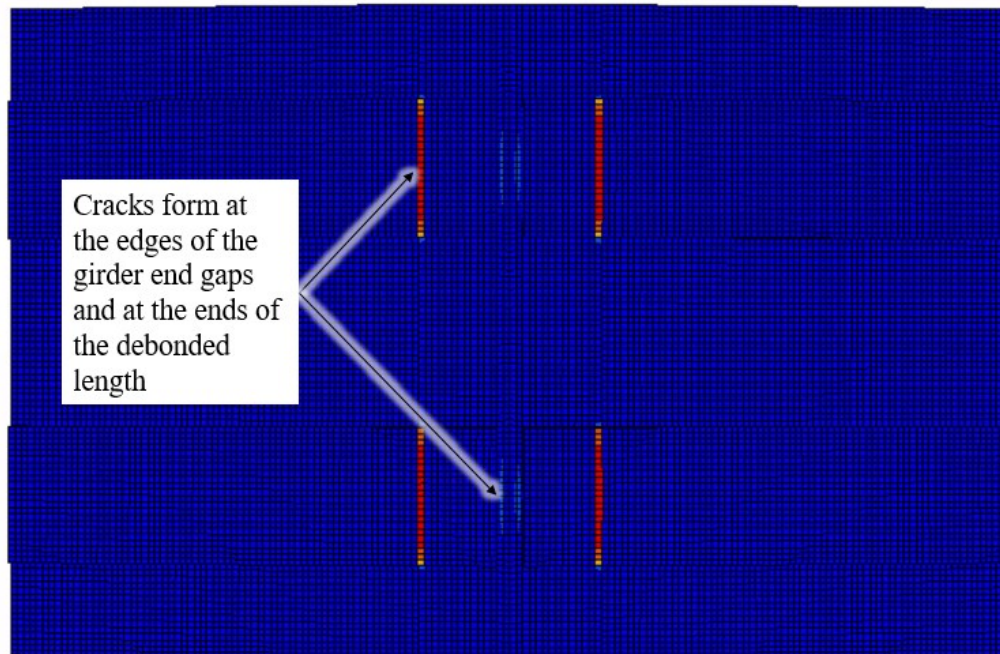
**Figure 8.64. Crack pattern in the bottom of the slab for an 18-in. debonded offset precast panel model loaded with negative temperature gradient.**

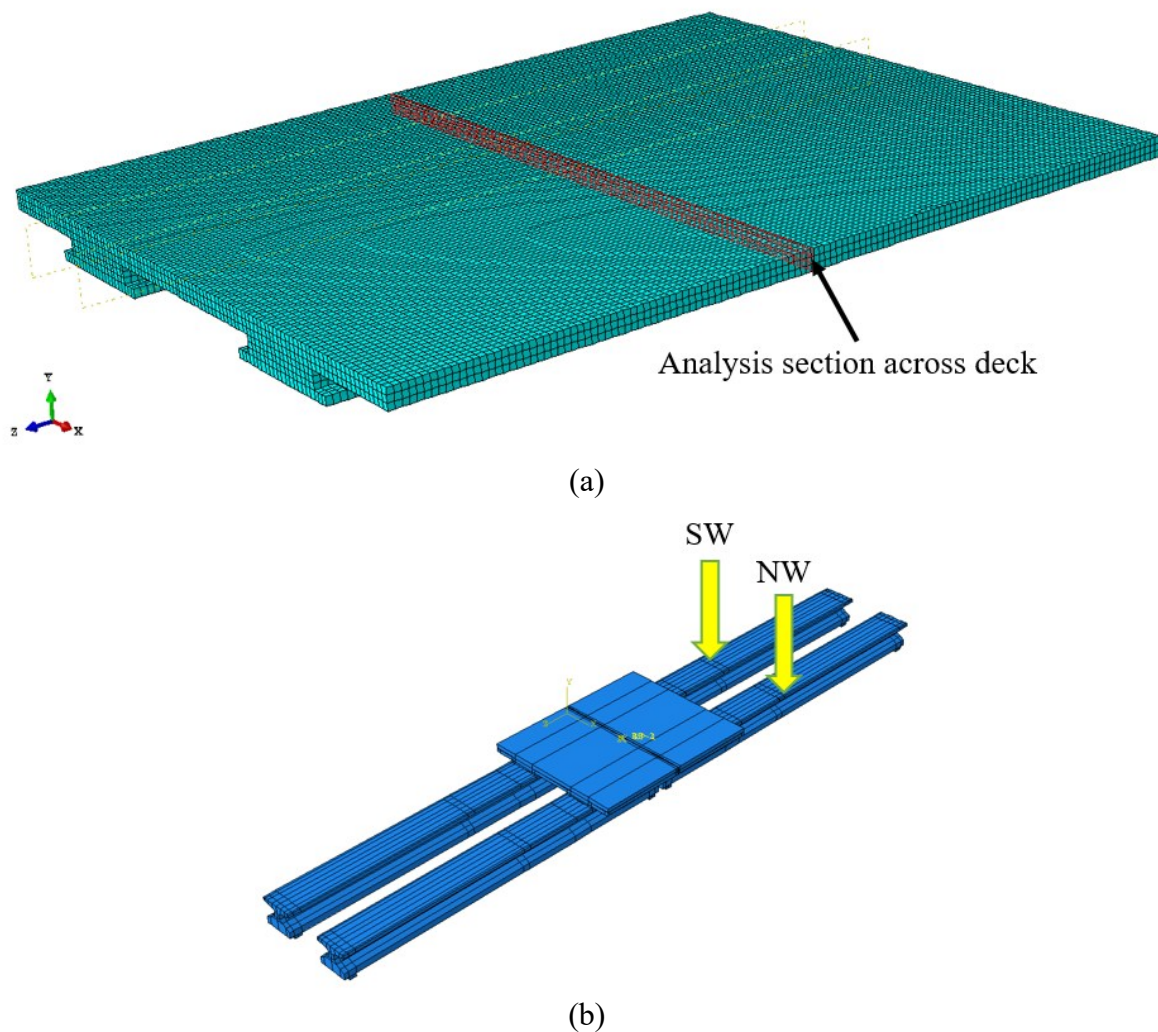
**Figure 8.65. (a) Deck model used to analyze tensile forces across the PBJ, and (b) loading diagram for the flush PCP model.**

A concern for PBJ behavior is that additional tensile forces in the deck may worsen cracking. In order to investigate the longitudinal tensile force through the PBJ, researchers drew an analytical section through the center of the PBJ region. The section through the deck, shown in Figure 8.65(a), was used to sum longitudinal forces across all concrete elements bisected by the plane. When summed with the longitudinal forces from all rebars bisected by the plane, a total

force in the deck could be calculated. The models were loaded on both girders in one span according to Figure 8.65(b).

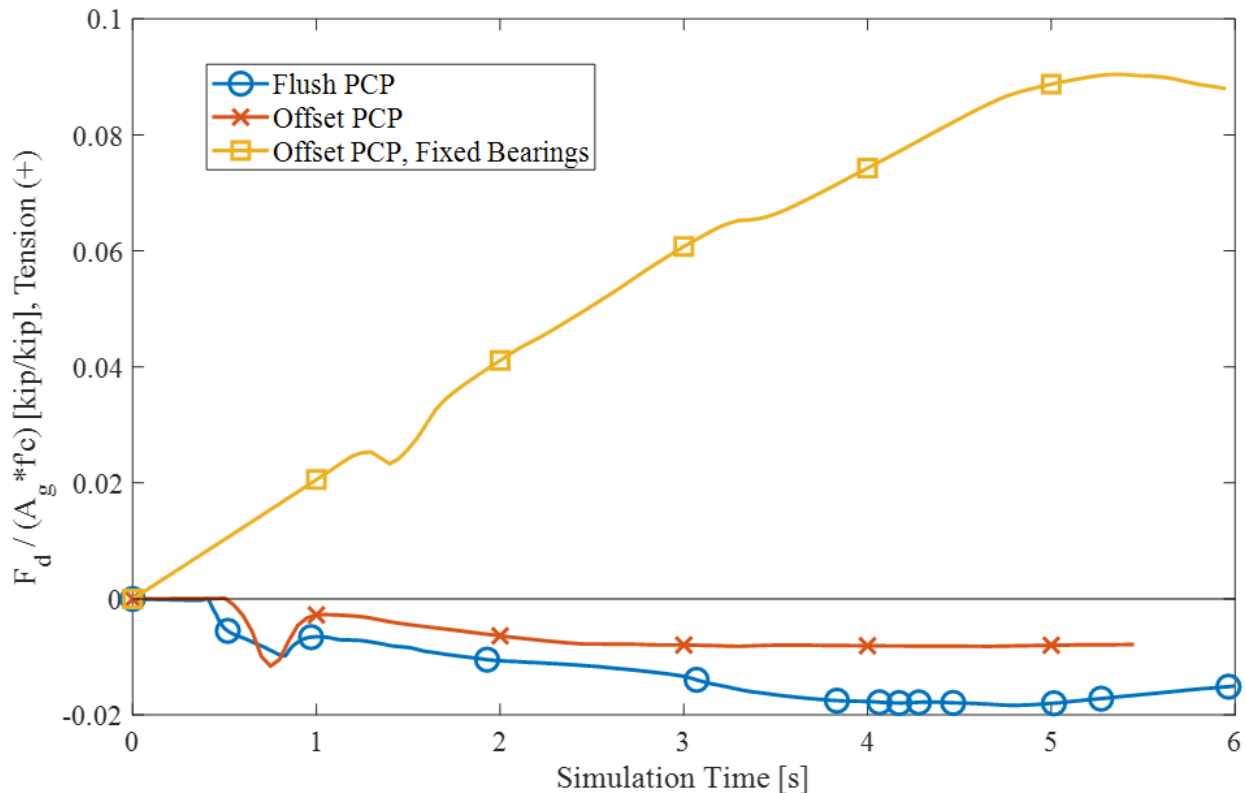
**Figure 8.66. Longitudinal force in the deck,  $F_d$ , across the PBJ normalized by the gross section area at the PBJ and concrete compressive strength ( $A_g * f'_c$ ) for models with flush PCP, offset PCP, and offset PCP with fixed bearings.**

The results of the analyses are shown in Figure 8.66. The simulations were taken to high rotations, up to 0.012 rad, in order to evaluate deck forces. Both the flush PCP and offset PCP models had net compression forces in the link slab with the support stiffness of a typical elastomeric bearing pad. However, large tensile forces were observed for the offset PCP model with pinned supports, simulating fixed or frozen bearing pads. This finding shows that typical support conditions do not result in deleterious tensile forces in the link slab. However, faulty bearing pad conditions that prevent the girder ends from translating longitudinally may cause significant tensile loads in the link slab, leading to deleterious cracking and subsequent damage.

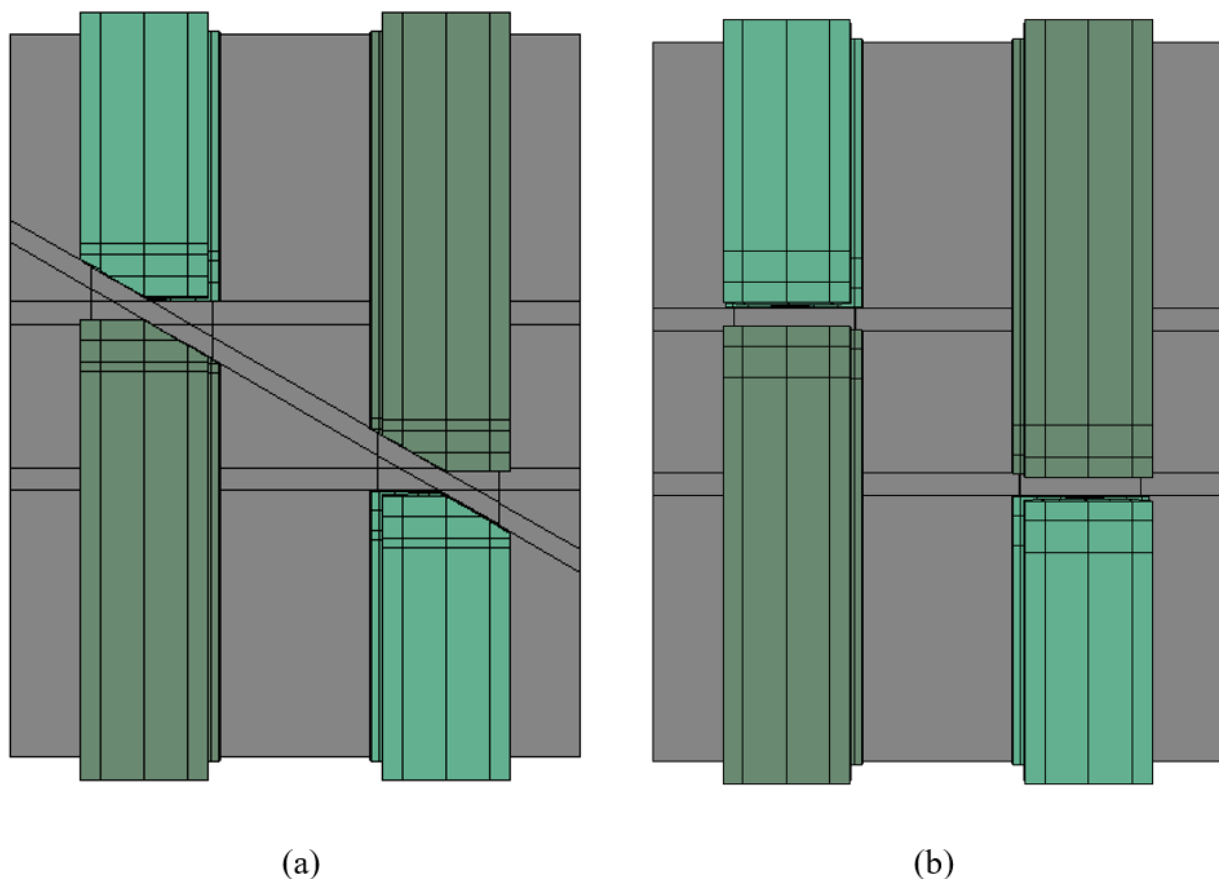
**Figure 8.67. Underside of skewed stub models, showing (a) a skewed girder end condition and (b) a flat girder end condition.**

Two primary girder stub model types were developed: with and without coped girder ends. TxDOT design standards call for the use of either skewed girder ends or foam filler above girder ends above skewed supports. These standards provide clearance between the girder end and the slab in the adjacent span, preventing contact between the girder end and slab that could result in damage under repeated loading. However, field investigations in the Bryan, Lubbock, and Atlanta Districts showed that some existing structures used neither skewed girder ends nor foam inserts above the girder end corners. Case (a) in Figure 8.67 shows a model with skewed girder ends, while case (b) shows a model without skewed ends or inserts. These two models allowed for comparisons between the different conditions for skewed girder ends. Both models had a skew of 30 degrees. Each stub model included standard longitudinal and transverse reinforcement within a CIP slab.

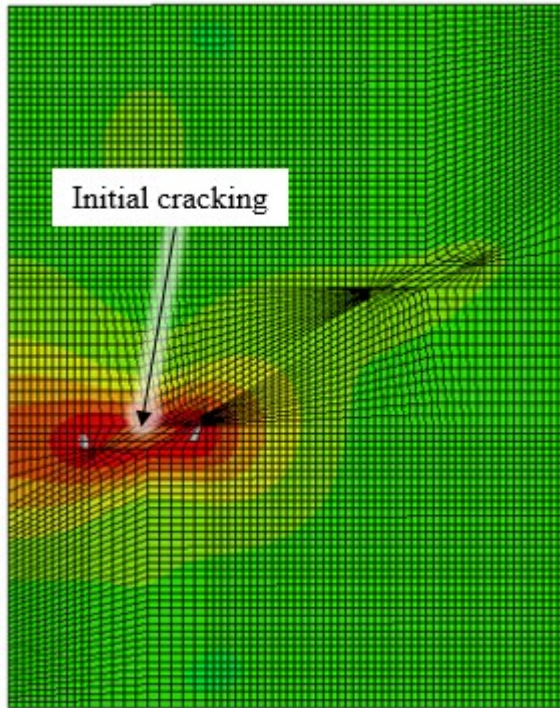
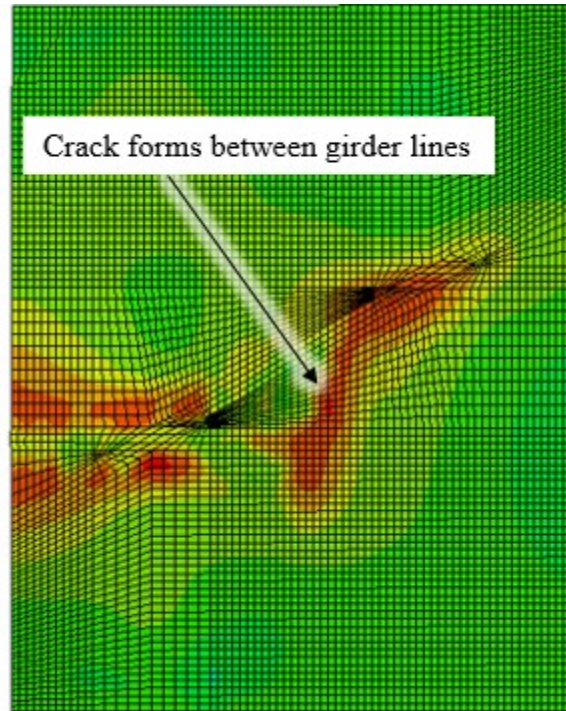
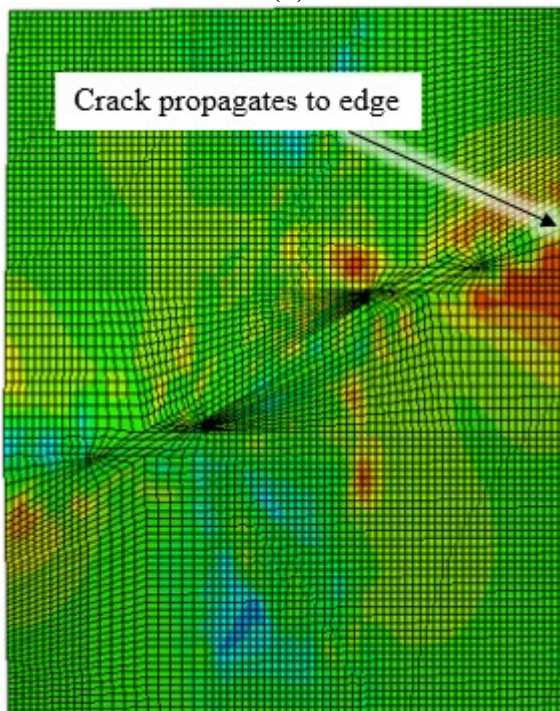
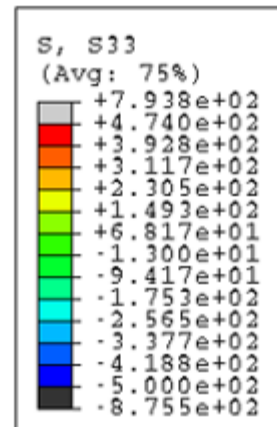
Figure 8.68. Longitudinal stress propagation in the deck of the skewed girder end model.

The stress propagation for the skewed girder end model is shown in Figure 8.68. As illustrated in Figure 8.68 (a), the left girder line's displacement produces initial cracking between the girder ends. Cracking initiates between the girder ends and propagates outward toward the other girder line and the edge of the deck. In Figure 8.68 (b), the movement of the left girder line causes crack propagation toward the right girder line. However, the cracking pattern does not directly follow the skew of the support but rather causes nearly longitudinal cracking between the girder lines. In Figure 8.68(c), the right girder line is rotated, causing cracking from between the girder ends to the edge of the slab. Isolated pockets of tensile stress develop over the longitudinal reinforcement in the cracked deck.

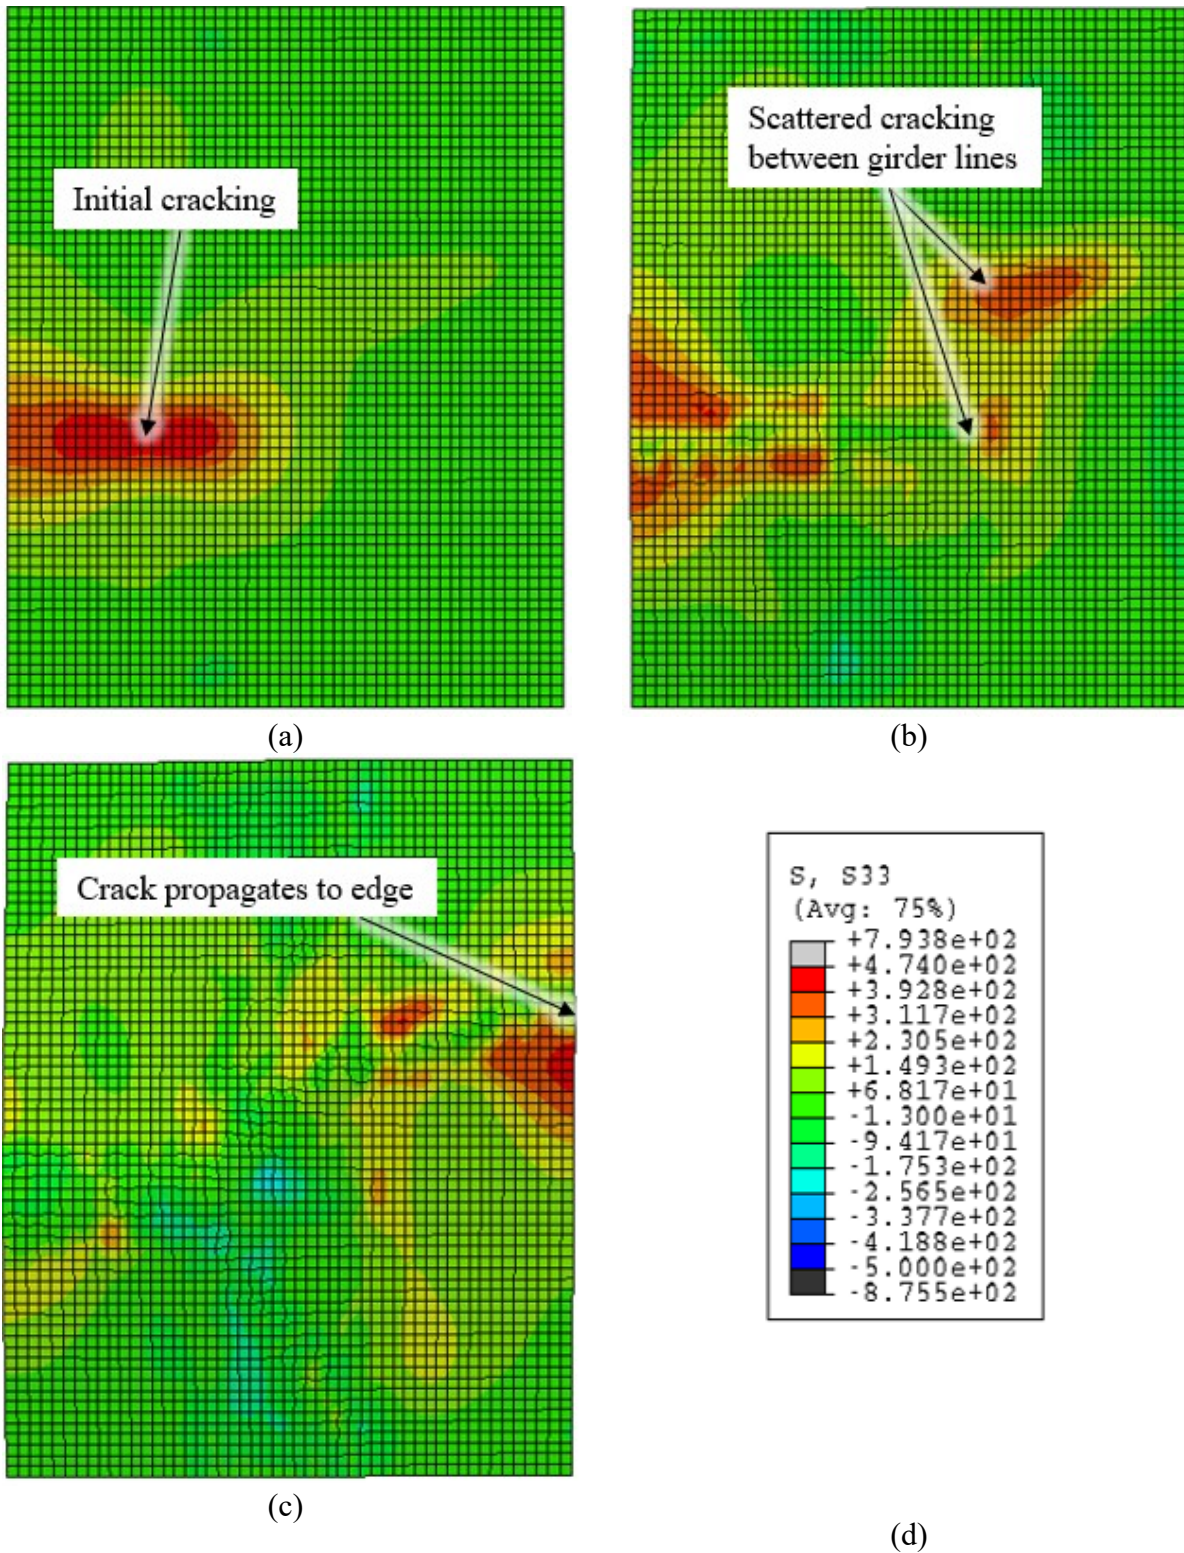
Figure 8.69. Longitudinal stress propagation in the deck of the non-skewed girder end model.

The non-skewed girder end model shows different cracking behavior, as displayed in Figure 8.69. Figure 8.69(a) shows that the initial cracking proceeds similarly to the skewed end model, with the left girder causing tensile stresses that spread out in the transverse direction from between the girder ends. In Figure 8.69(b), however, cracking begins between the right girder line, with scattered cracking stresses forming between the two girder lines rather than a distinct line of stress like that shown in the skewed girder end model. In Figure 8.69(c), the right girder line is displaced, causing cracking to spread to the right edge of the slab.

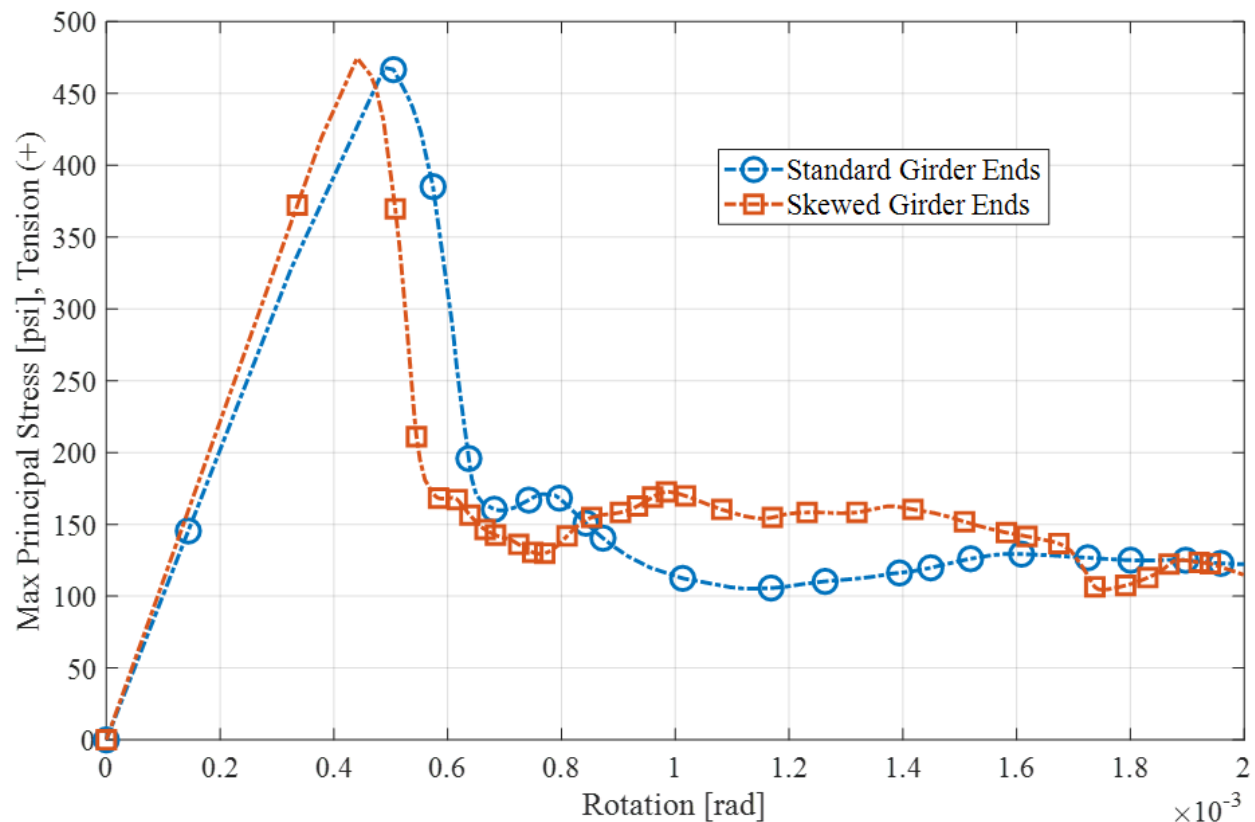
**Figure 8.70. Comparison of maximum principal stresses at the point of first cracking for the skewed girder stub models with standard girder ends and skewed girder ends.**

Comparisons of deck concrete and steel stresses at the point of first cracking did not reveal significant differences in initial cracking behavior between the two models. The use of skewed girder ends did not delay cracking, as shown in Figure 8.70. The girder stub model with standard girder ends reached first cracking slightly after the model with skewed ends. Longitudinal stresses in the top longitudinal reinforcing bars adjacent to the location of first cracking, shown in Figure 8.71, exhibited similar behavior between the two models. The reinforcing bars in both the skewed and non-skewed girder end models began increasing in stress and reached their yield stress at approximately equivalent girder end rotations.

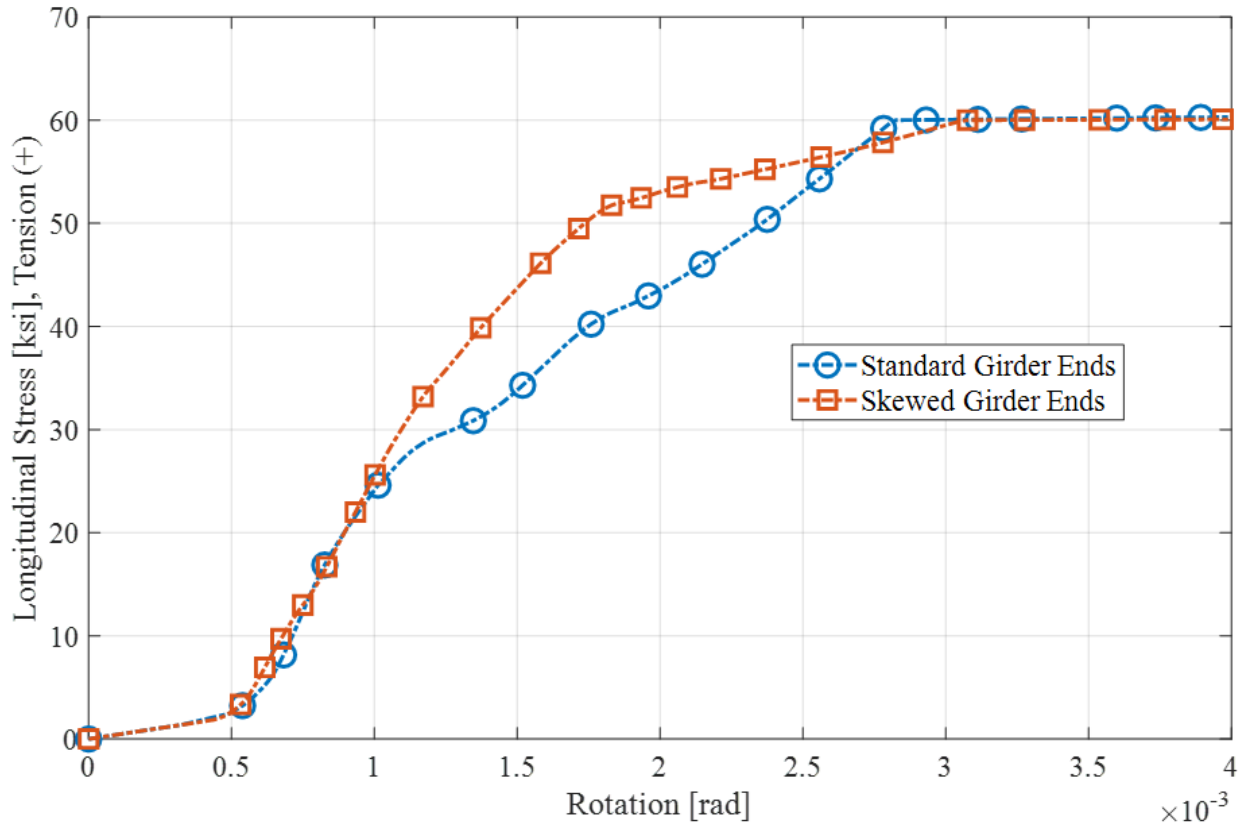
**Figure 8.71. Comparison of longitudinal stress in the top longitudinal reinforcement adjacent to the point of first cracking in the deck for the skewed girder stub models with standard girder ends and skewed girder ends.**

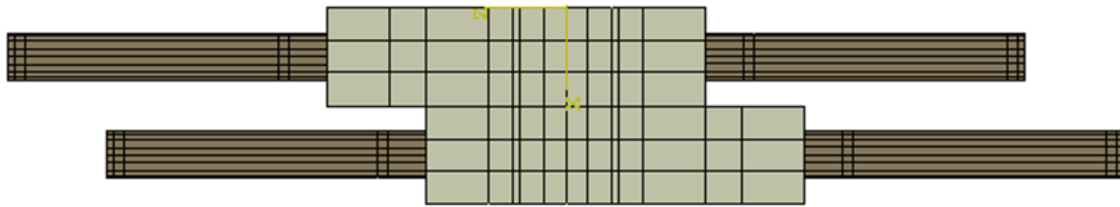
**Figure 8.72. Top view of the dual-girder skewed model.**

The dual-girder skewed model, seen in Figure 8.72, was set up in a similar fashion to the non-skewed laboratory setup, with four girders loaded with span loads at the top face of each girder. This model used the bonded offset panel detail with a 45-degree skew and no coped girder end details. The top of the deck, shown in Figure 8.73, used CIP concrete without a crack former. The standard reinforcement used in the deck is shown in Figure 8.74, while the precast panel locations are shown from beneath the deck in Figure 8.75.

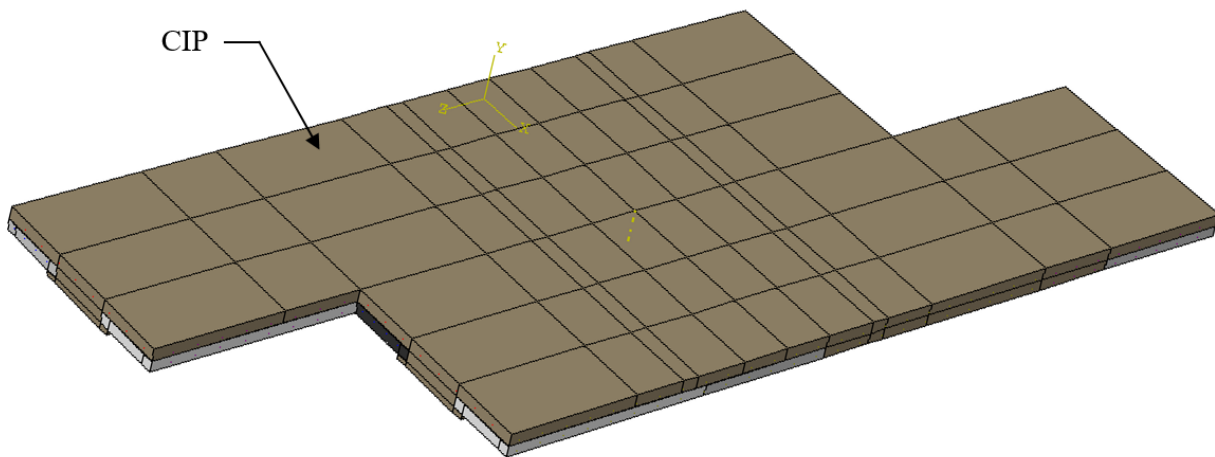
**Figure 8.73. Top view of the deck for the dual-girder skewed model.**

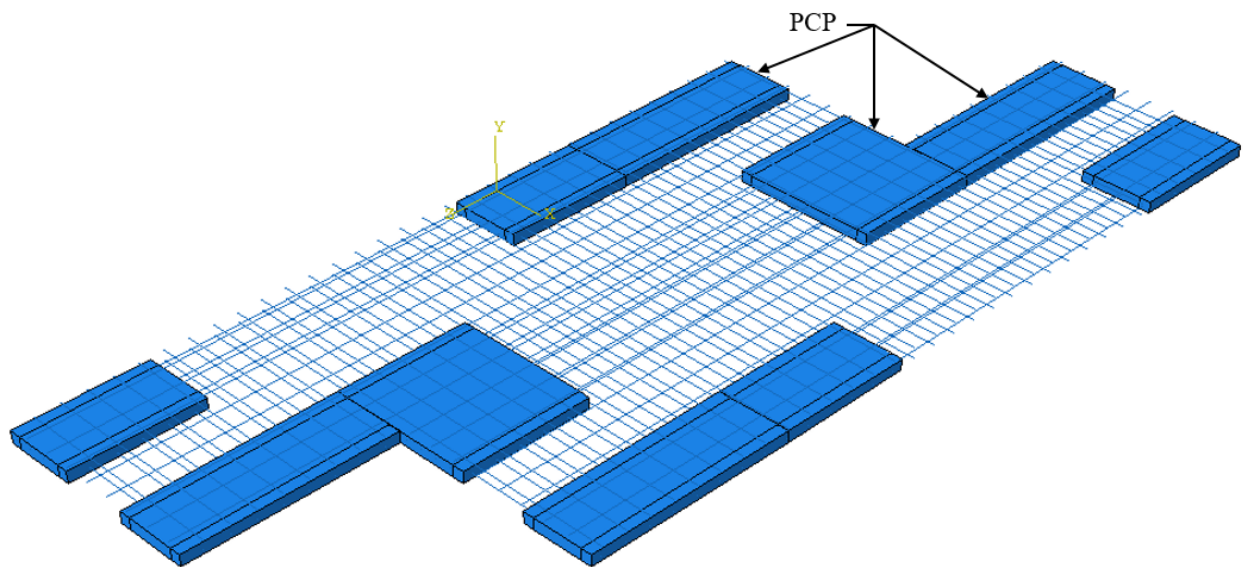
**Figure 8.74. Top view of the PCPs and reinforcement for the dual-girder skewed model with the offset panel detail.**

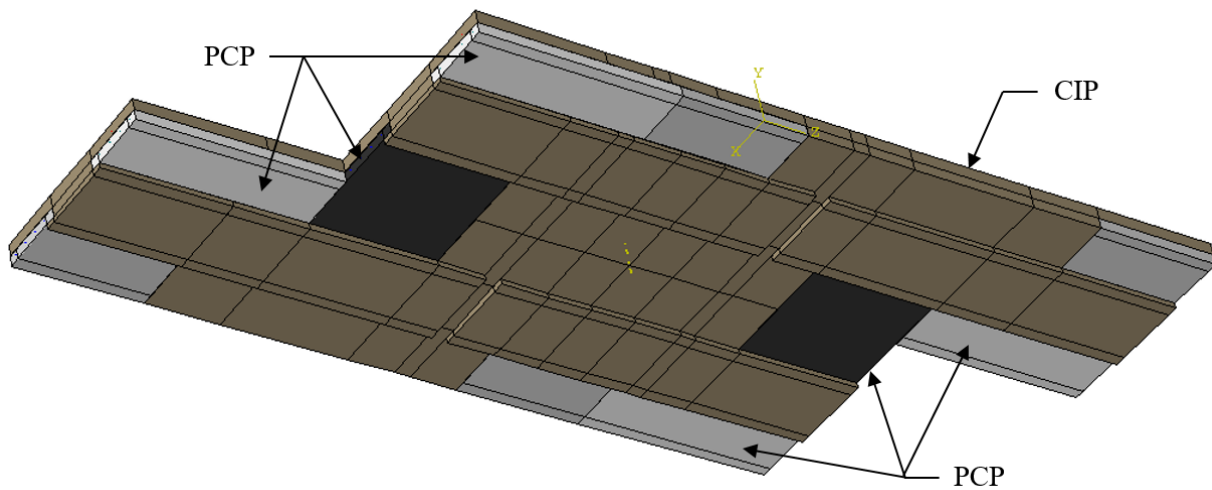
**Figure 8.75. Bottom view of the deck for the dual-girder skewed model with the offset panel detail.**

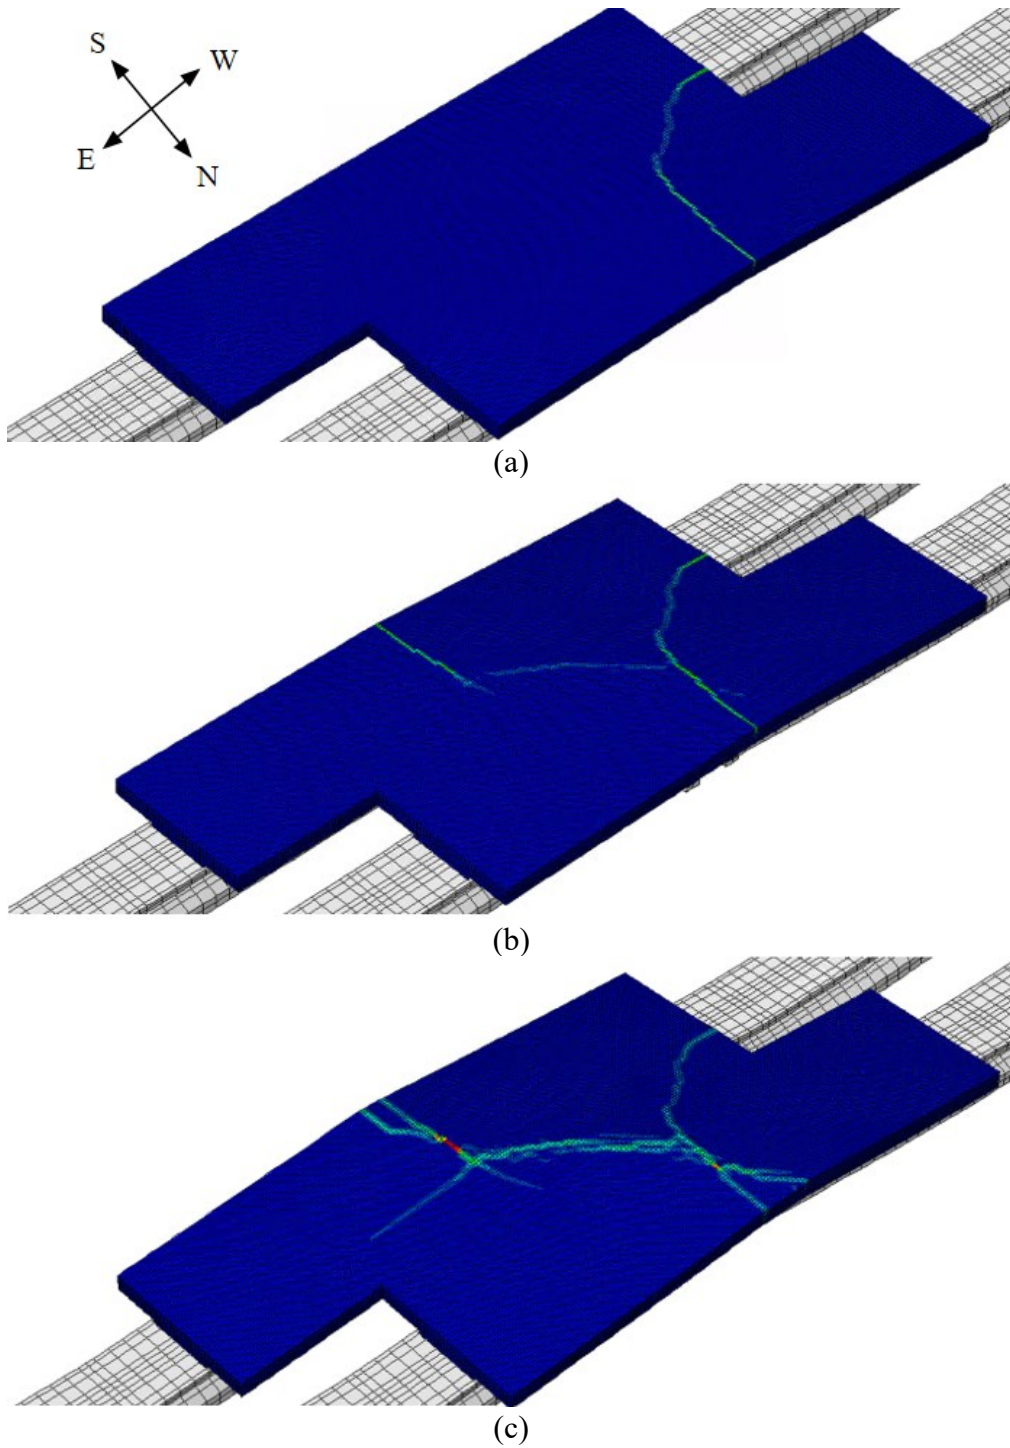
**Figure 8.76. Crack propagation in the dual-girder skewed model with offset panels for loading progressing from the (a) northwest girder, (b) southwest girder, and (c) southeast and northeast girders.**

The model was loaded in steps, starting with the northwest girder in Figure 8.76(a), then the southwest girder in Figure 8.76(b), and finally the northeast and southeast girders together in Figure 8.76(c). Load from the previous step was retained on the girder for subsequent load steps. The cracking pattern in step (a) begins between the girder ends, propagating to the north edge of the slab and curving in an L-shape above the edge of the precast panel to the west edge of the slab. Cracking continues in step (b) with a diagonal crack between the girder lines and a second horizontal crack between the girder ends that reaches the south edge of the slab. Finally, step (c) instigates a vertical crack toward the east end of the deck over the precast panel edge as well as Y-shaped secondary cracks at the slab edges.

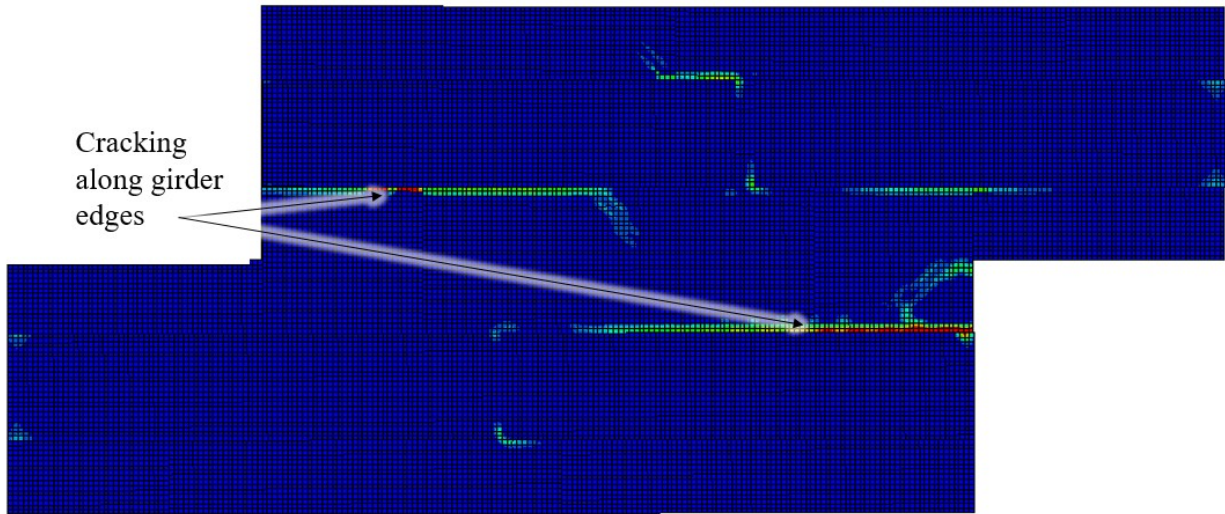
**Figure 8.77. Cracking in the bottom of the deck for the dual-girder skewed model, primarily along the girder edges.**

The bottom of the deck shows cracking primarily along the girder edges, which reach full depth at high rotations, as shown in Figure 8.77.
