# Performance and Improvement of Texas Poor Boy Continuous Bridge Deck Details: Final Report

Technical Report 0-7013-R1

TEXAS A&M TRANSPORTATION INSTITUTE  
COLLEGE STATION, TEXAS

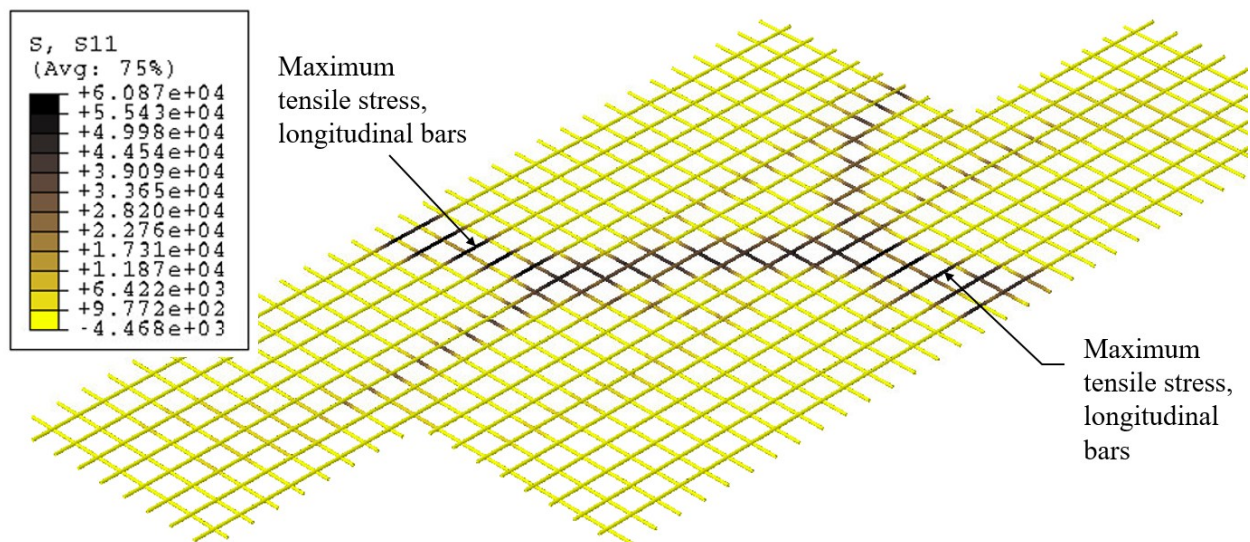
**Figure 8.78. Stress in the top longitudinal and transverse bars for the skewed model, showing maximum tensile stresses forming over the girder, with stresses extending diagonally between girder lines following the cracking pattern.**

Top reinforcement stresses follow the cracking pattern generally. Maximum stresses occur in the longitudinal bars over the girder lines, as shown in Figure 8.78. Cracking in the top slab forms diagonally between the girder lines, activating both the longitudinal and transverse bars. Transverse bar stresses also form along the girder edges. Bottom reinforcement stresses, shown in Figure 8.79, are much smaller in magnitude than top reinforcement stresses. Tensile stresses form in the transverse reinforcement along the girder edges.

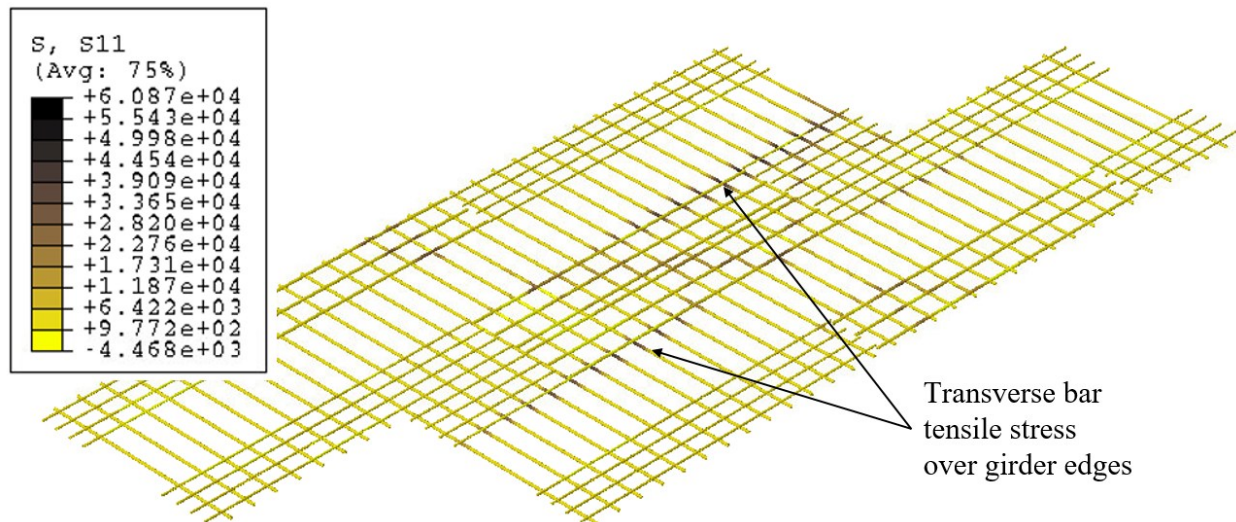
**Figure 8.79. Stress in the bottom longitudinal and transverse bars for the skewed model, showing maximum tensile stresses forming in the transverse reinforcement over the girder edges.**

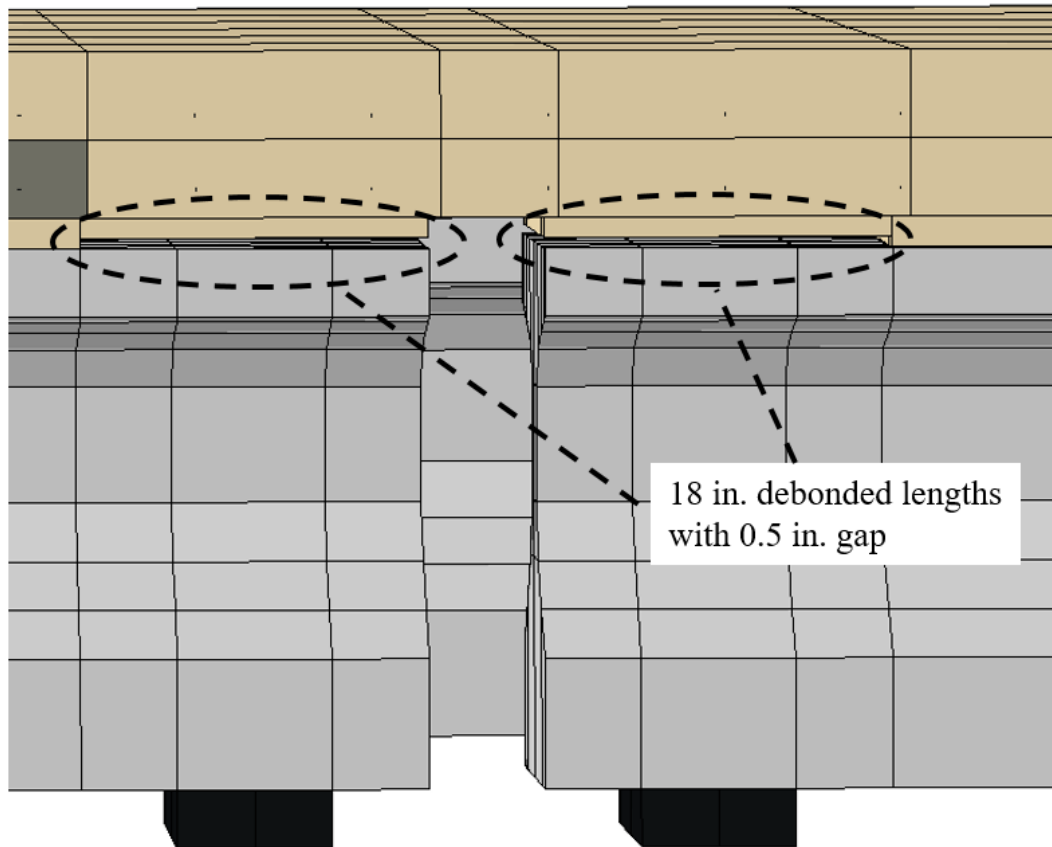
**Figure 8.80. Debonded regions of the skewed model, with an 18-in. debonded length and a 0.5-in. gap between the girder face and the bottom of the deck.**

A debonded version of the dual-girder skewed model was created to evaluate the effects of debonding on skewed bridges. Similar to other debonded models, an 18-in. debonded length was chosen along with a 0.5-in. gap in the deck haunch between the top face of the girder and the bottom face of the link slab, as shown in Figure 8.80. The 0.5-in. haunch gap was chosen to match the gap constructed during lab testing. Since 0.5 in. of clearance prevented contact between the girder face and slab at practical rotations, there was no difference in performance from the larger 2-in. vertical gap used in other models.

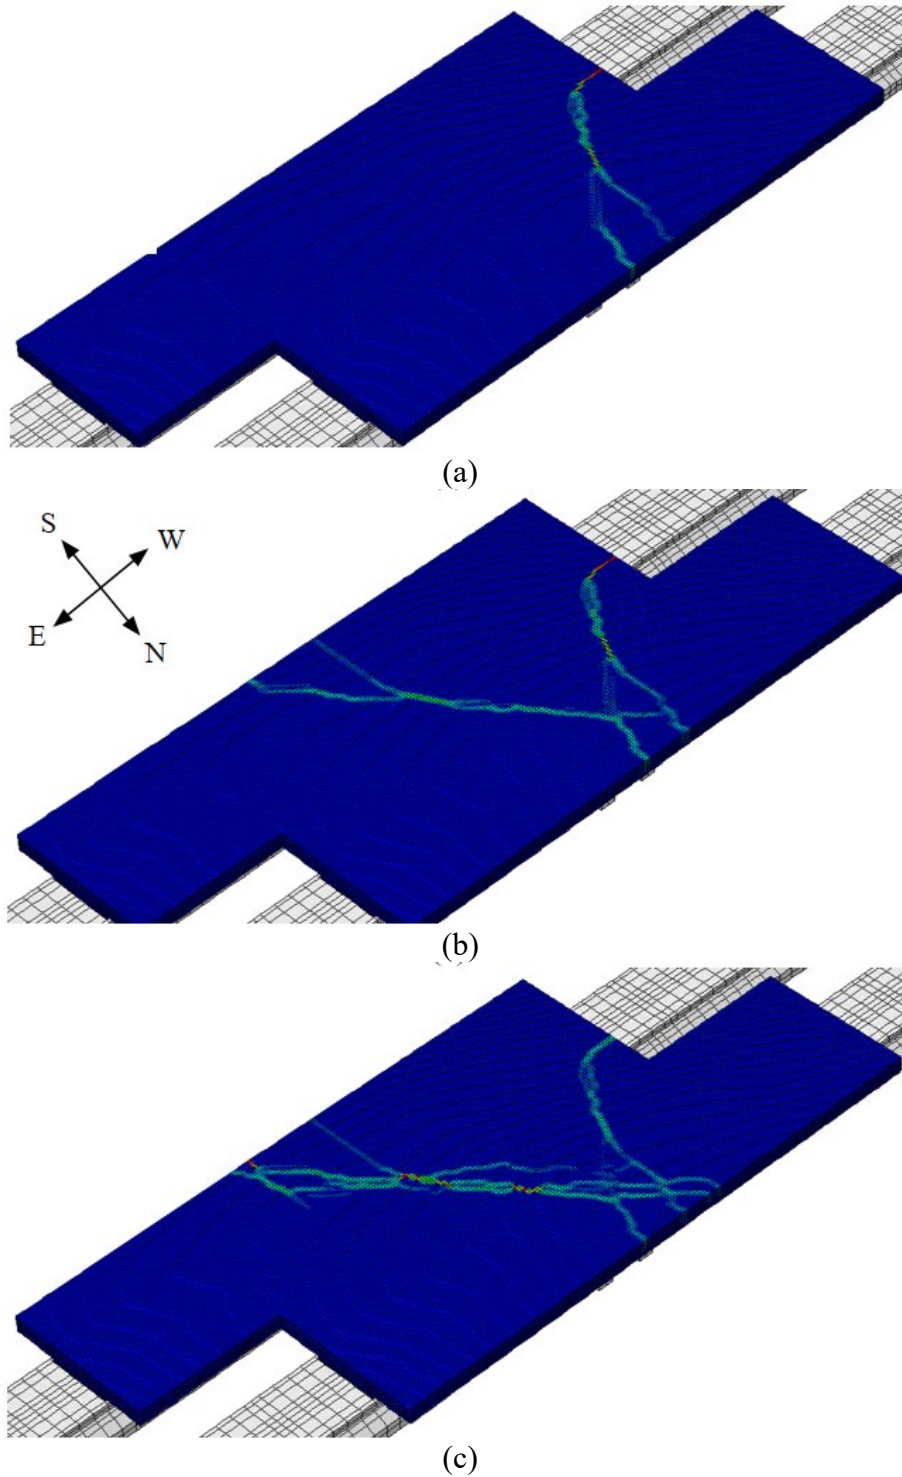
**Figure 8.81. Crack propagation in the debonded dual-girder skewed model with offset panels for loading progressing from the (a) northwest girder, (b) southwest girder, and (c) southeast and northeast girders.**

The debonded skewed model was loaded in the same steps as the bonded skewed model, starting with the northwest girder in Figure 8.81(a), then the southwest girder in Figure 8.81(b), and finally the northeast and southeast girders together in Figure 8.81(c). Load from the previous step was retained on the girder for subsequent load steps. The cracking pattern in step (a) began over the girder at the end of the debonded region, propagating to the north edge of the slab and curving in an L-shape above the edge of the precast panel to the west edge of the slab. Cracks formed independently on the west edge of the slab over the girder edge and joined with the crack emanating from the PBJ. A secondary crack also formed over the northeast girder in the debonded region. This crack propagated to the slab edge in one direction and southwest to join the initial crack. The crack branches on the north edge of the deck were on either side of the girder end gap in the debonded regions.

Cracking continued in step (b) with a diagonal crack between the girder lines and a second horizontal crack over the debonded region of the southwest girder, reaching the south edge of the slab. A secondary crack then formed over the southeast girder in the debonded region. This crack

ran diagonally across the deck to join the main PBJ crack. Finally, in step (c), additional secondary cracks formed on the north side of the slab past the northwest debonded region. Multiple branches also formed along the diagonal crack across the deck.

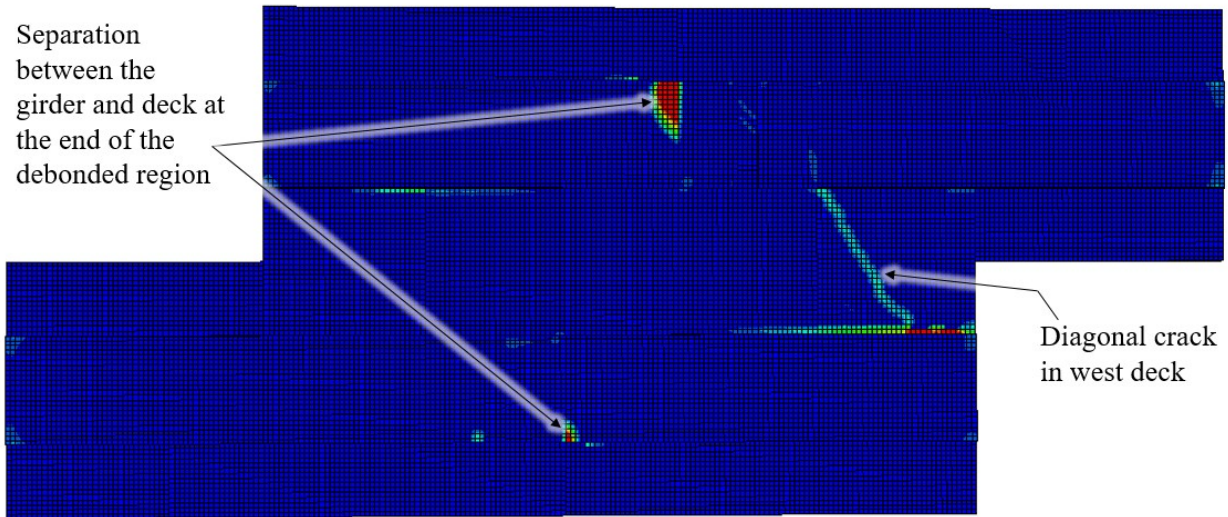
**Figure 8.82. Cracking in the bottom of the deck for the debonded dual-girder skewed model, including a full-depth diagonal crack in the west deck, with separation between the girder and deck occurring at the end of the debonded regions.**

The bottom of the deck showed cracking primarily in the west deck, following the diagonal crack at the top surface. This crack reached full depth at high rotations, as shown in Figure 8.82. Separation between the girder and deck occurred at the end of the debonded regions.

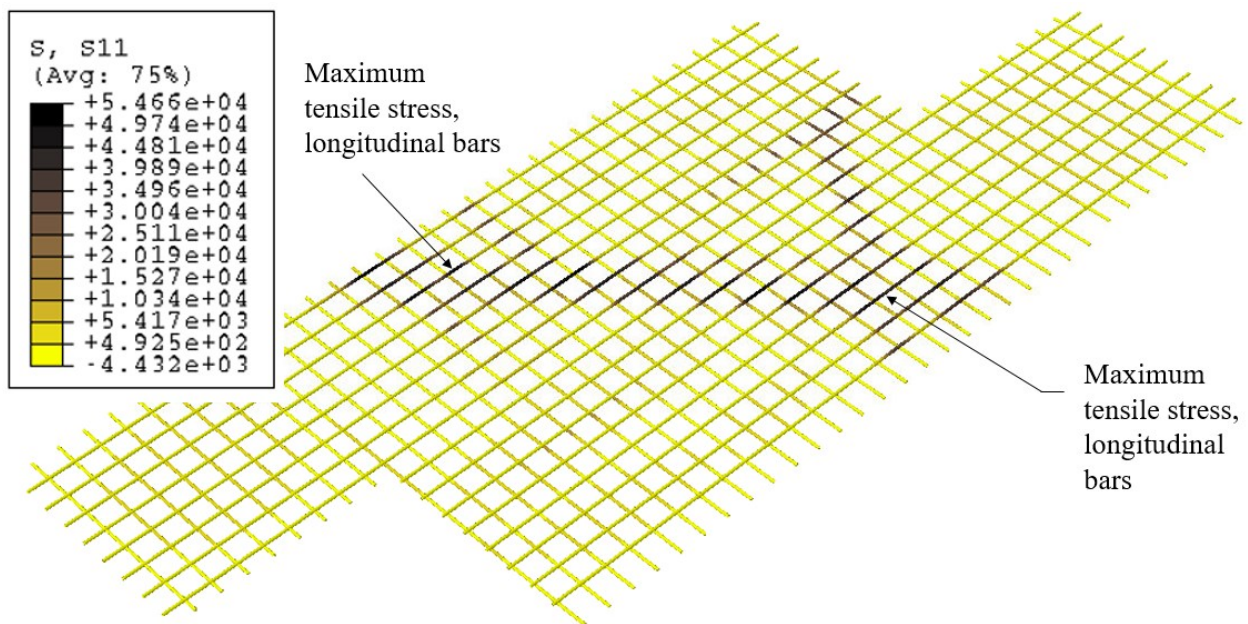
**Figure 8.83. Stress in the top longitudinal and transverse bars for the debonded skewed model, showing maximum tensile stresses forming over the girder, with stresses extending diagonally between girder lines following the cracking pattern.**

Top reinforcement stresses followed the cracking pattern generally. Maximum stresses occurred in the longitudinal bars over the girder lines, as shown in Figure 8.83. Cracking in the top slab formed diagonally between the girder lines, activating both the longitudinal and transverse bars. Transverse bar stresses also formed along the southwest girder edge. Bottom reinforcement stresses, shown in Figure 8.84, were much smaller in magnitude than top reinforcement stresses. Tensile stresses formed in the transverse reinforcement along the girder edges and in the longitudinal reinforcement along the PBJ.

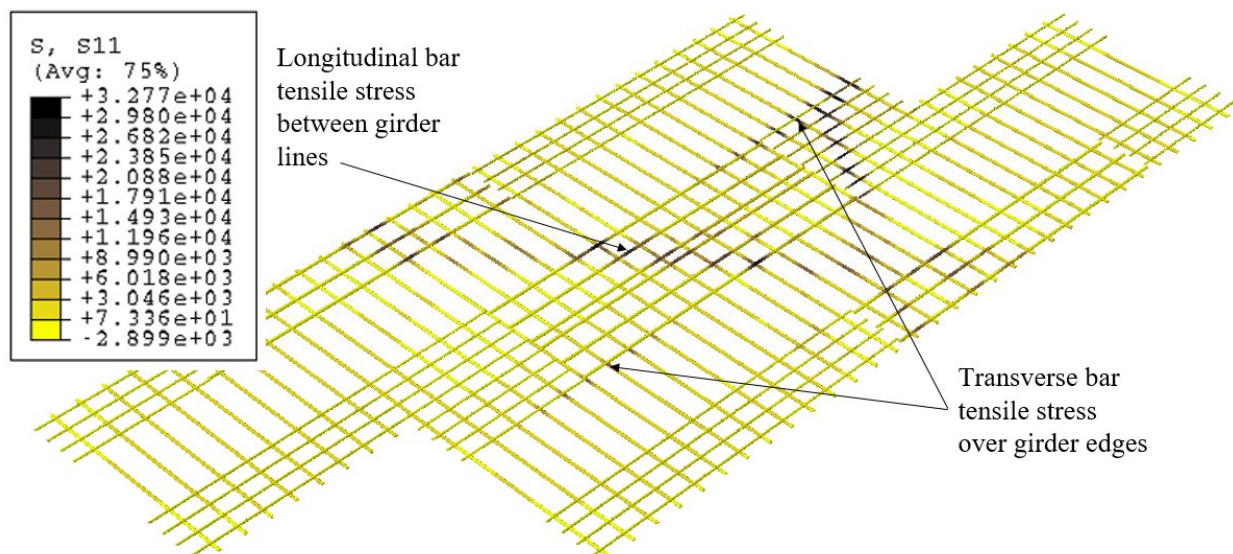
**Figure 8.84. Stress in the bottom longitudinal and transverse bars for the debonded skewed model, showing tensile stresses forming over the girder edges, with stresses extending diagonally between girder lines following the cracking pattern.**

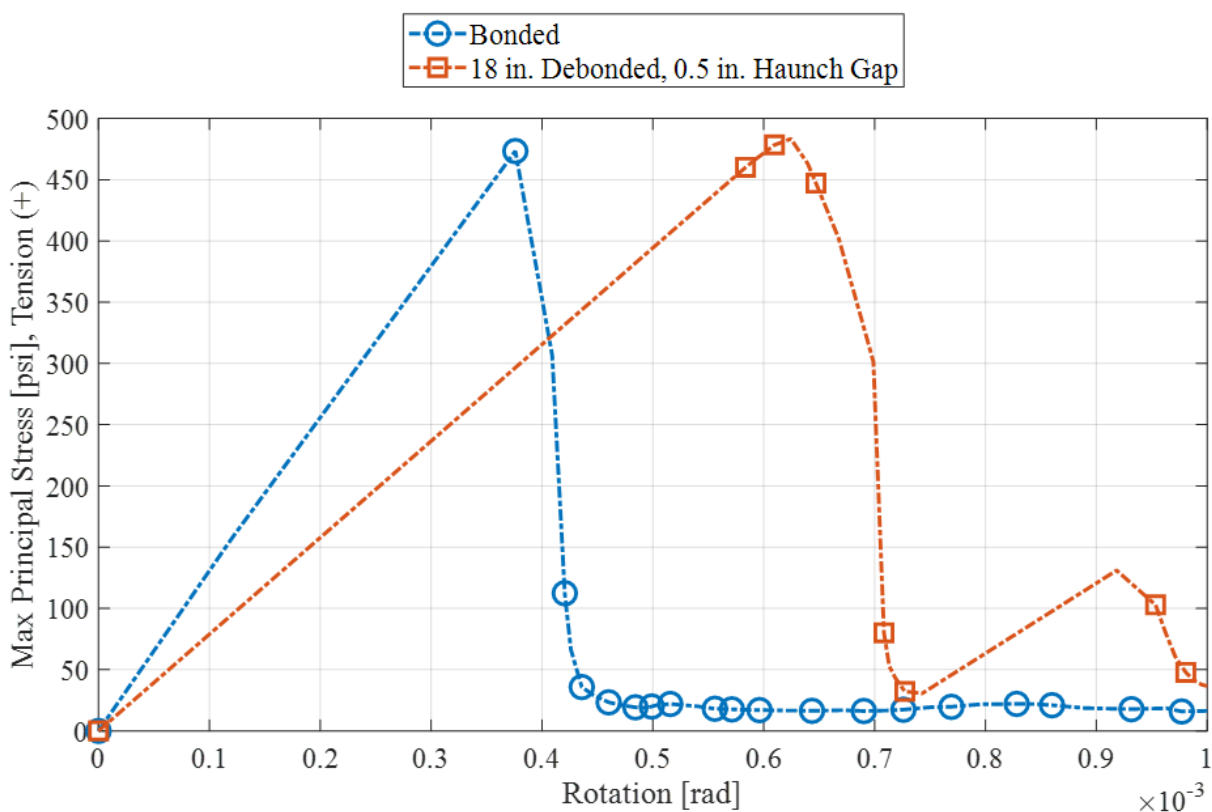
**Figure 8.85. Bonded and debonded comparison of dual-girder skewed models, showing maximum principal stress at the location of first cracking in each deck.**

A comparison of the initial cracking behavior of the bonded and debonded skewed models showed the effects of debonding. Figure 8.85 shows that the debonded model delayed initial cracking by 0.00025 rad of girder end rotation. Furthermore, examination of Figure 8.76(c) and Figure 8.81(c) shows that the overall cracking pattern at high rotations was more dispersed in the debonded model. Debonding the link slab, even for a modest length of 18 in., caused multiple additional cracks to form within and outside of the debonded region. In the bonded model, cracking was more consolidated, forming larger singular cracks. Figure 8.86 shows the longitudinal stress in the top longitudinal steel adjacent to the point of first cracking in the decks. At higher rotations, stress in the steel of the bonded model exceeded that of the debonded model by as much as 20 ksi, indicating that crack widths are reduced with the dispersed cracking pattern.

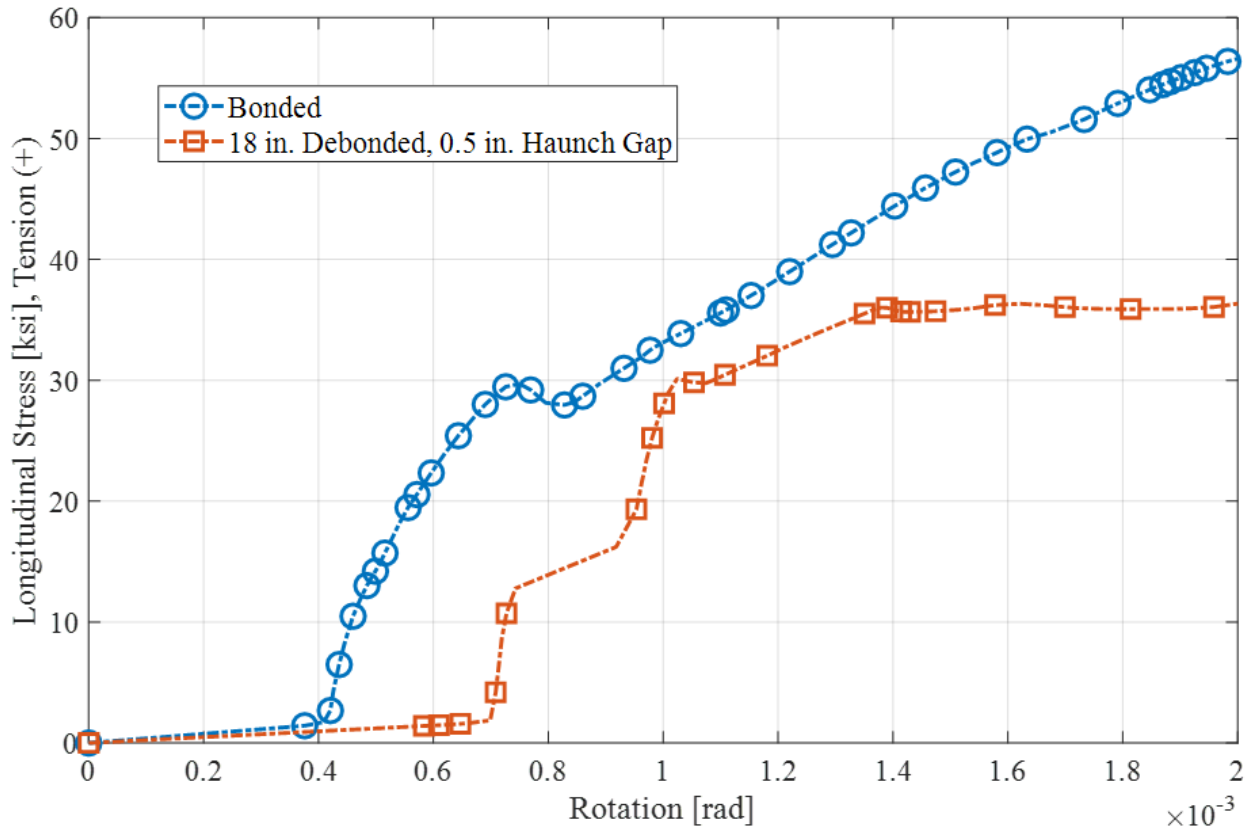
**Figure 8.86. Bonded and debonded comparison of dual-girder skewed models, showing longitudinal stress in the top longitudinal reinforcement at the location of first cracking in each deck.**

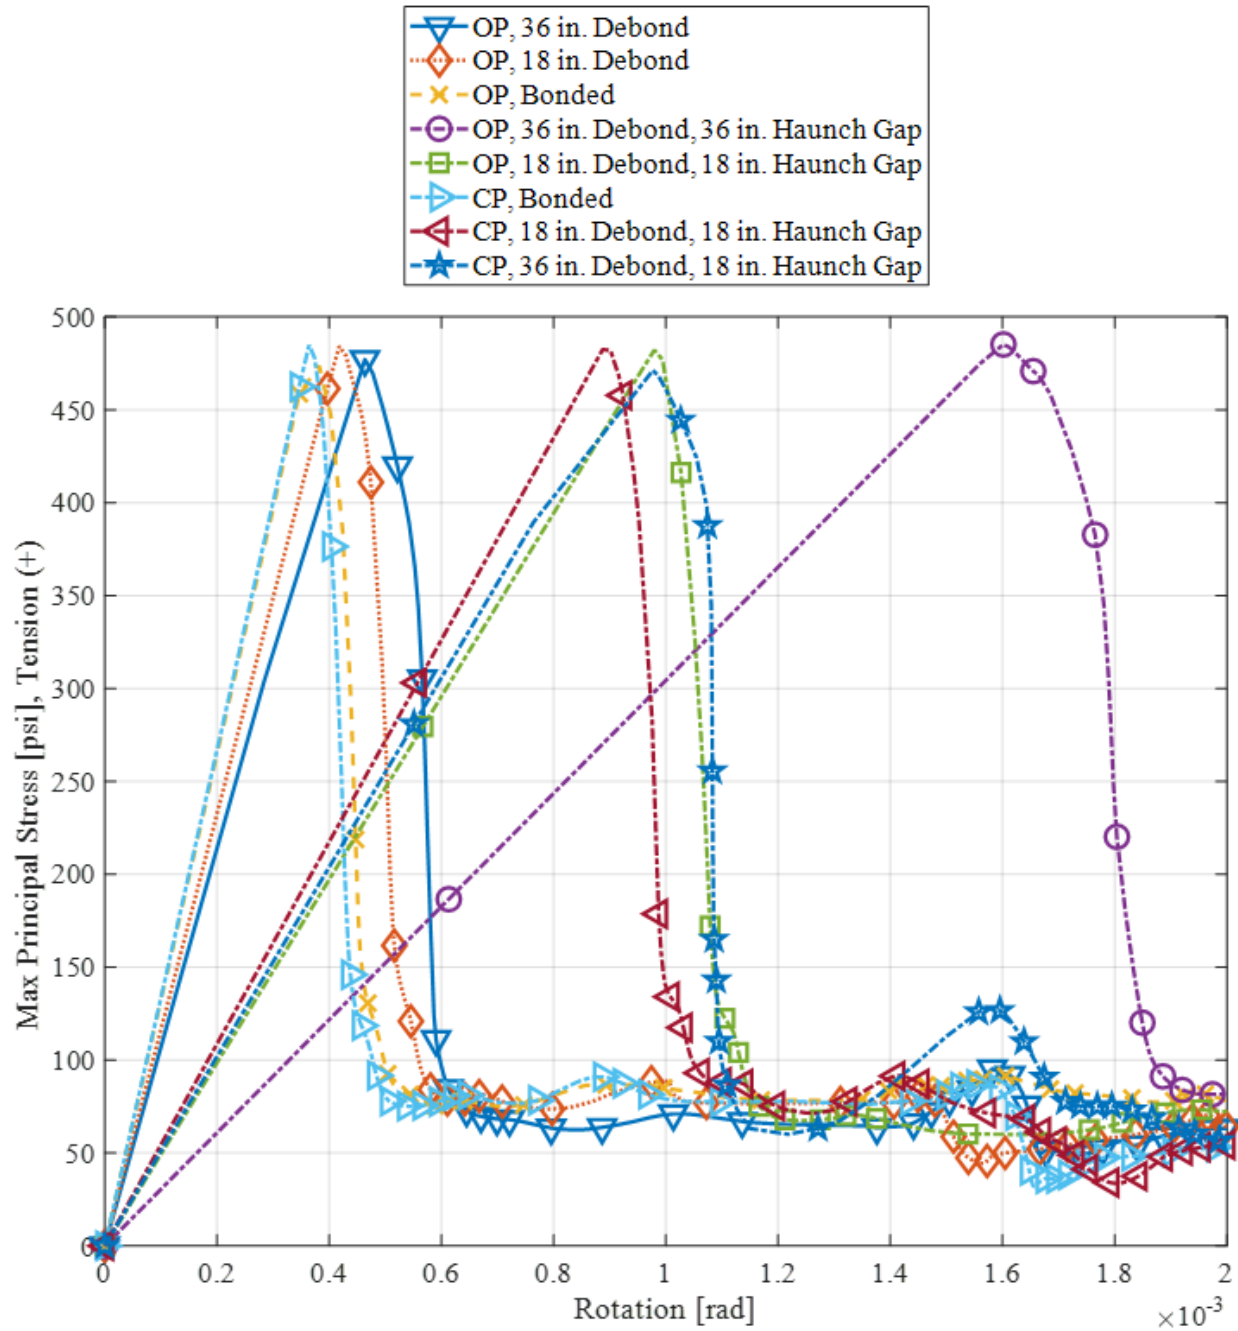
**Figure 8.87. Comparison of cracking behavior between offset and continuous panel models, bonded and debonded, with differing haunch gap details.**

Offset panel details showed modest improvement with simple debonding. However, when a vertical gap in the debonded region was combined with a 36-in. debonded length, the offset panel model realized the most significant gains, with the cracking point delayed by over four times that of the bonded model. With a debonded length of 18 in. and a vertical gap, the cracking point was delayed by 2.5 times the bonded cracking rotation. The continuous panel model showed a similar degree of benefit. Doubling the debonded length while maintaining the same length of the vertical gap further delayed cracking, but using a vertical gap for the entire debonded length is optimal. The benefit of debonding with a vertical gap in the debonded region is demonstrated visually in Figure 8.87.

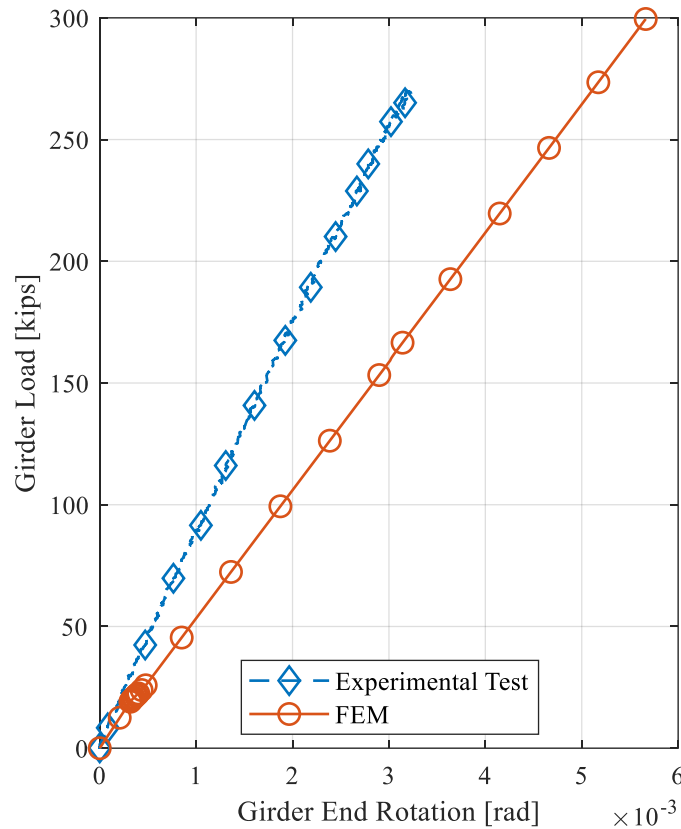
**Figure 8.88. FP1 girder end rotation versus girder loading for the experimental test and FEM.**

While the initial input of both experimental testing and FEMs is span loading on the girders, girder end rotation is a more suitable basis for comparing test behavior to model behavior in the PBJ region. This is because the difference in girder stiffness between the test specimens and models causes differing load-deformation behavior. The stiffness of the deck—and the rotation of the girder ends that drive the deformation behavior of the link slab—are of primary importance. Girder stiffness and overall girder deformation are relatively unimportant when comparing PBJ behavior. As such, simplified models were used for the girders with elastic material properties to promote computational efficiency. Figure 8.88 shows an example of the difference in girder stiffness between test FP1 and the corresponding FEM, where the girders in the experimental test were less stiff. For each test program, the FEM was continued to higher levels of girder end rotation than in the test.

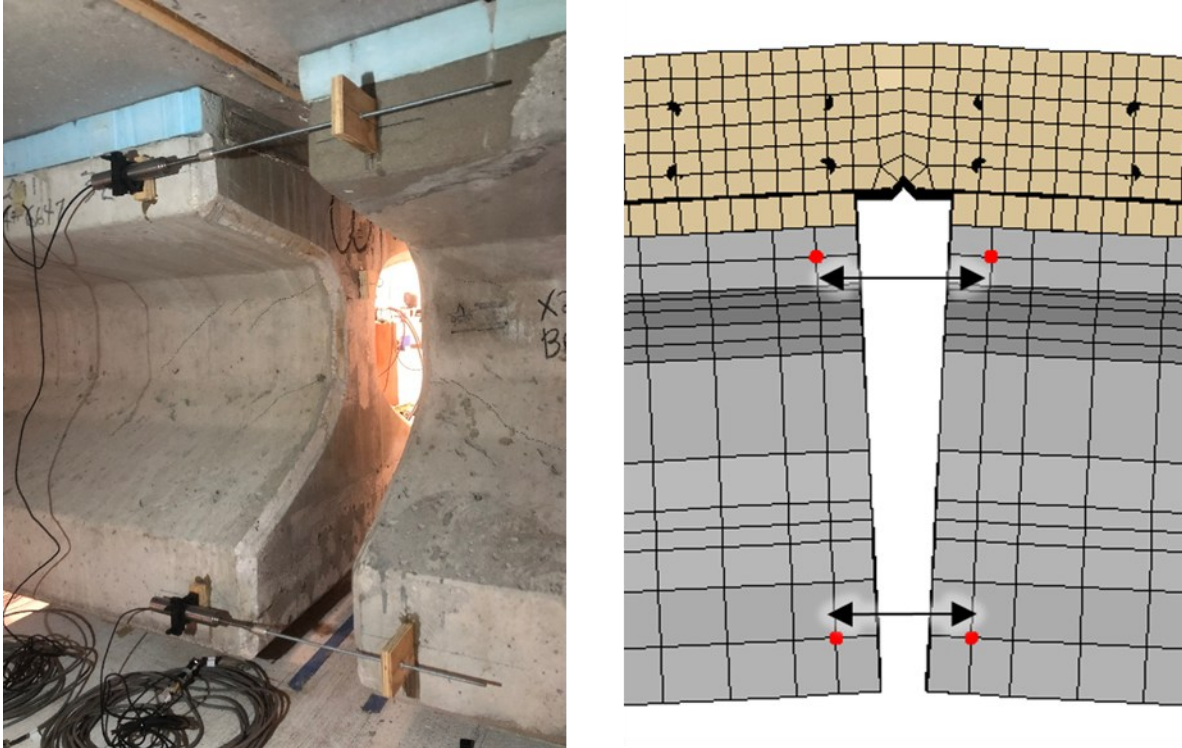
**Figure 8.89. LVDTs recording deformation at the girder ends (left) and nodes of matching LVDT connection points on the FEM (right).**

Since girder end rotation is the primary input for link slab deformation, comparing the deformation behavior in the PBJ region at different girder end rotations between the experimental test and FEM results reveals how well an FEM matches an experimental test. LVDTs installed at the girder ends, shown in Figure 8.89, may be used to make this comparison. The continuity provided by the link slab causes the girder ends to rotate about an axis in the link slab. If the stiffness properties and cracking behavior of the slab differ between the FEM and test, the location of this axis of rotation will also differ. Furthermore, differences in stiffness, cracking behavior, or support stiffness may cause differences in the axial deformation of the girder ends. These differences in the deformation characteristics of the link slab region cause different LVDT deformation values for a given rotation.

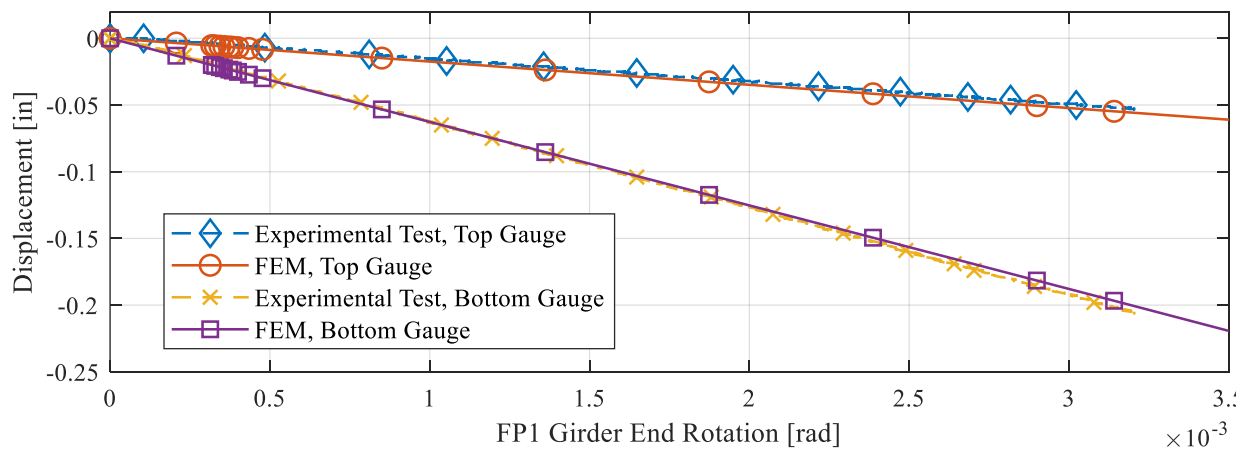
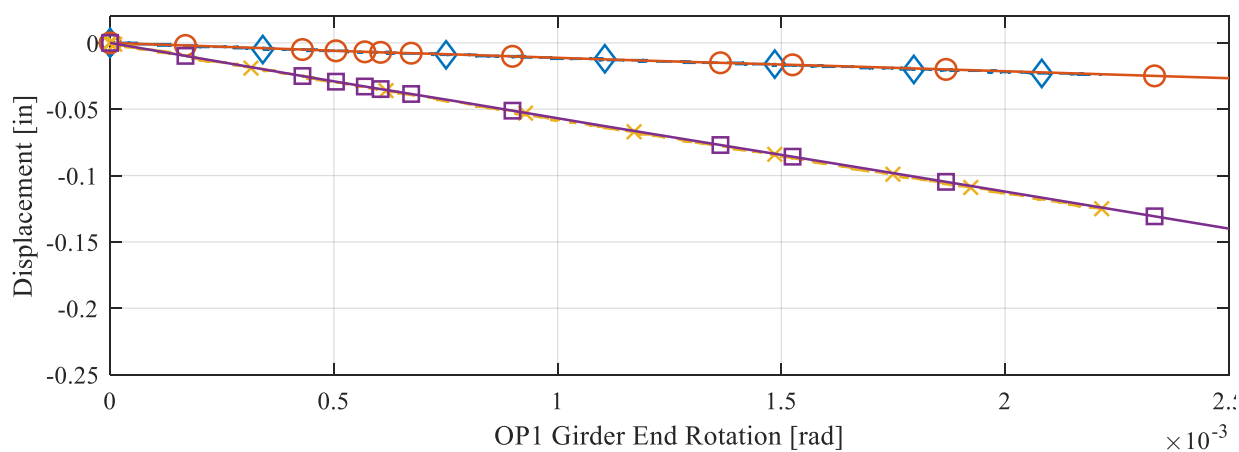
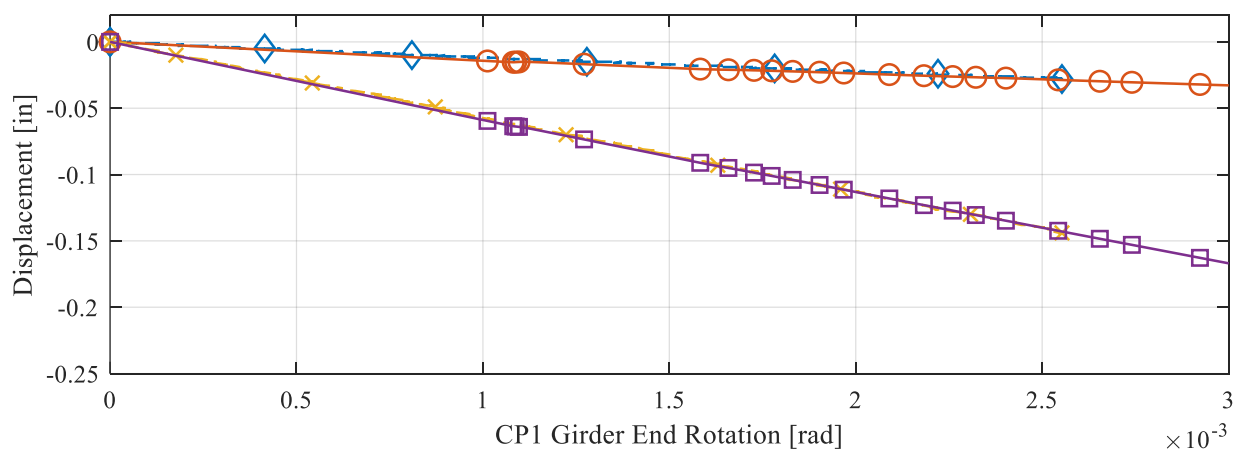
**Figure 8.90. Comparison of LVDT displacement at the girder ends for experimental tests FP1 (a), OP1 (b), and CP1 (c), with corresponding displacements from FEMs.**

To verify that the link slab region is deforming similarly in the experimental test and FEM, LVDT displacements were plotted alongside the corresponding deformations at the same locations on the FEM, as shown in Figure 8.90. The FEMs continued to higher rotations than the experimental test. For tests FP1 (a), OP1 (b), and CP1 (c), there was strong similarity between the LVDT displacement and FEM results. This finding indicates that the link slabs' stiffness and deformation characteristics, before and after cracking, were similar in the experimental tests and computational models.

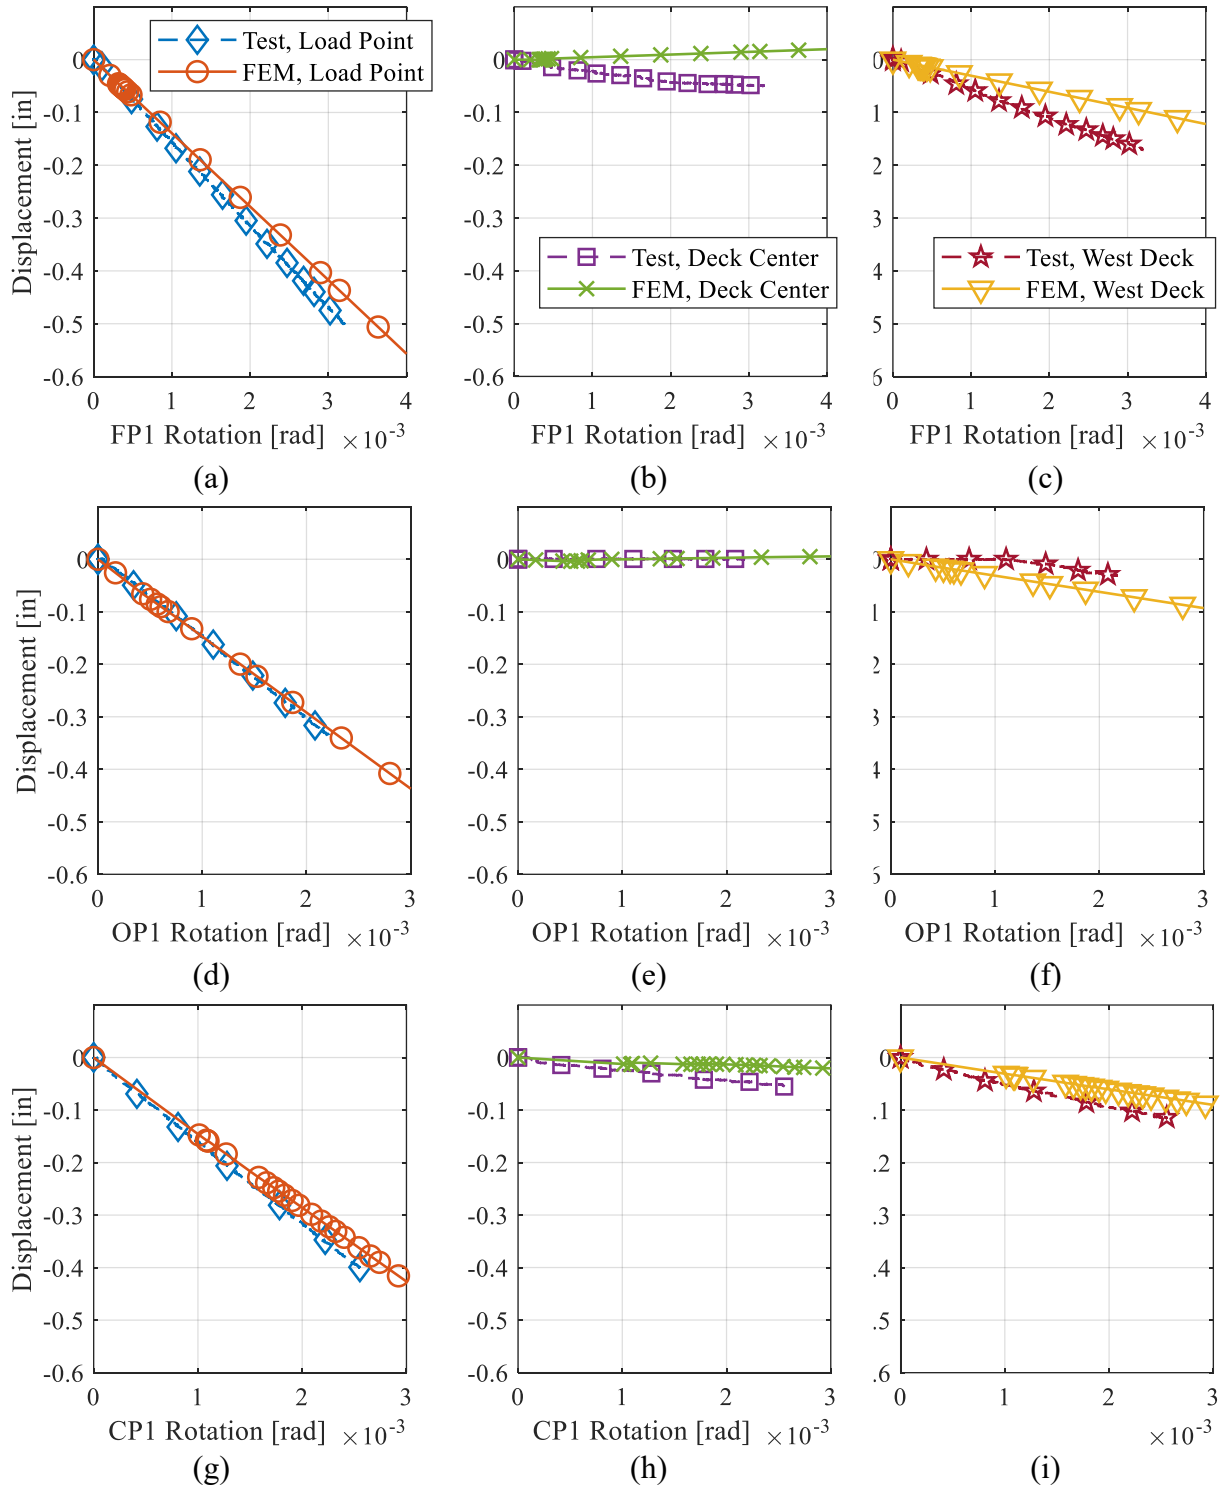
**Figure 8.91. Comparison of vertical displacement beneath the loading point of the girder, the deck center beneath the PBJ, and the deck center 3 ft west of the PBJ for tests FP1, OP1, and CP1.**

Comparisons between the vertical deflection of test specimens FP1, OP1, and CP1 and their corresponding FEMs at three separate locations are shown in Figure 8.91. Figure 8.91(a), (d), and (g) show the vertical deflection under the loading point of the girder at the corresponding girder end rotation. Figure 8.91(b), (e), and (h) examine the deflection under the center of the deck at the PBJ. Figure 8.91(c), (f), and (i) show the deflection under the center of the deck, offset 3 ft from the PBJ. Typically, there is either negligible difference in deflection or slightly more vertical deflection in the experimental test than in the FEM. However, Figure 8.91(f) shows more deflection in the FEM than in test OP1. Increased vertical deflection in the tests may be explained by added vertical deformation at the bearing pads. Vertical bearing pad stiffness was neglected in the FEM since horizontal stiffness primarily affects link slab behavior.

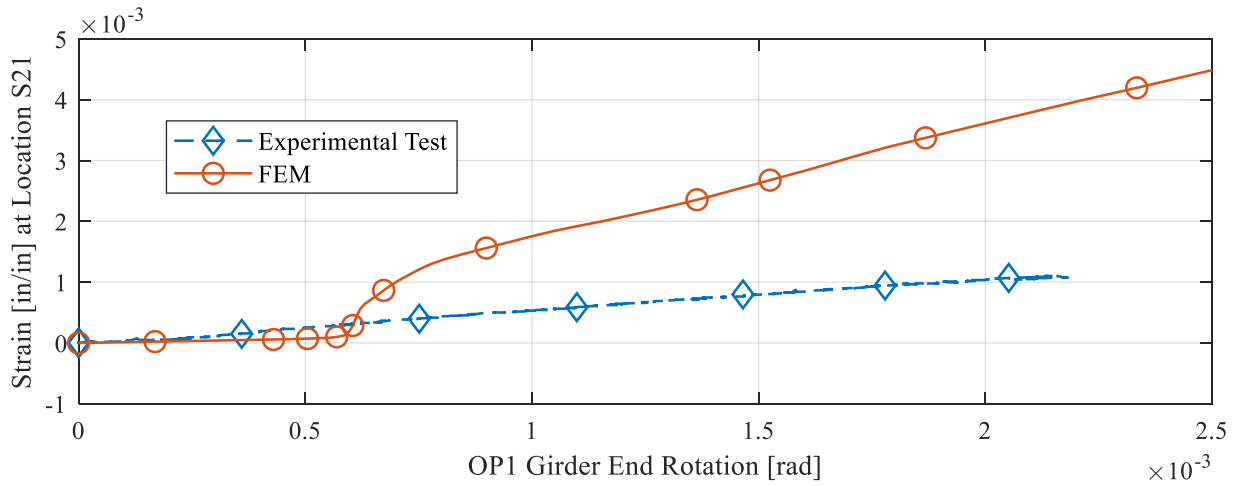
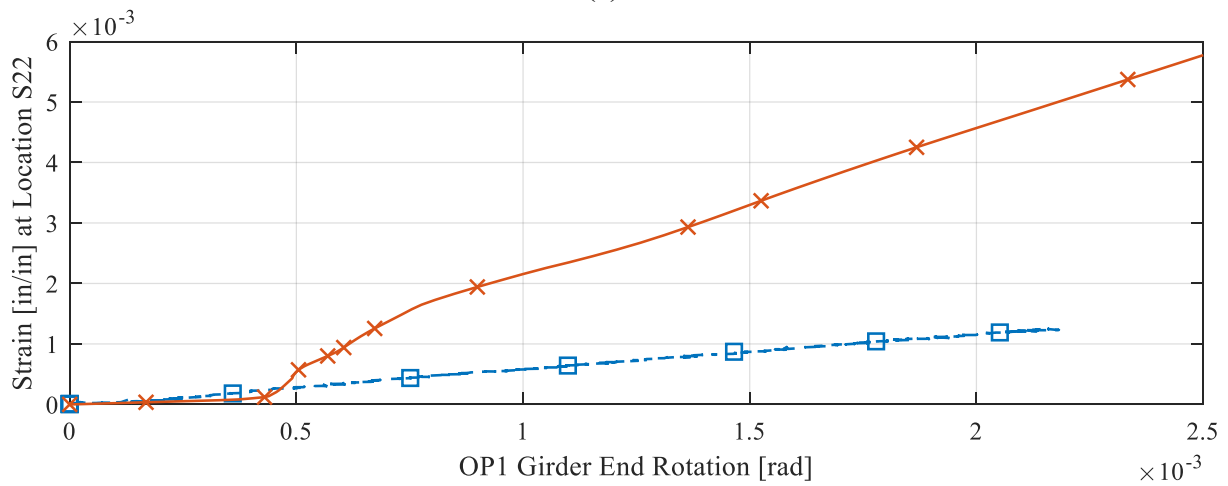
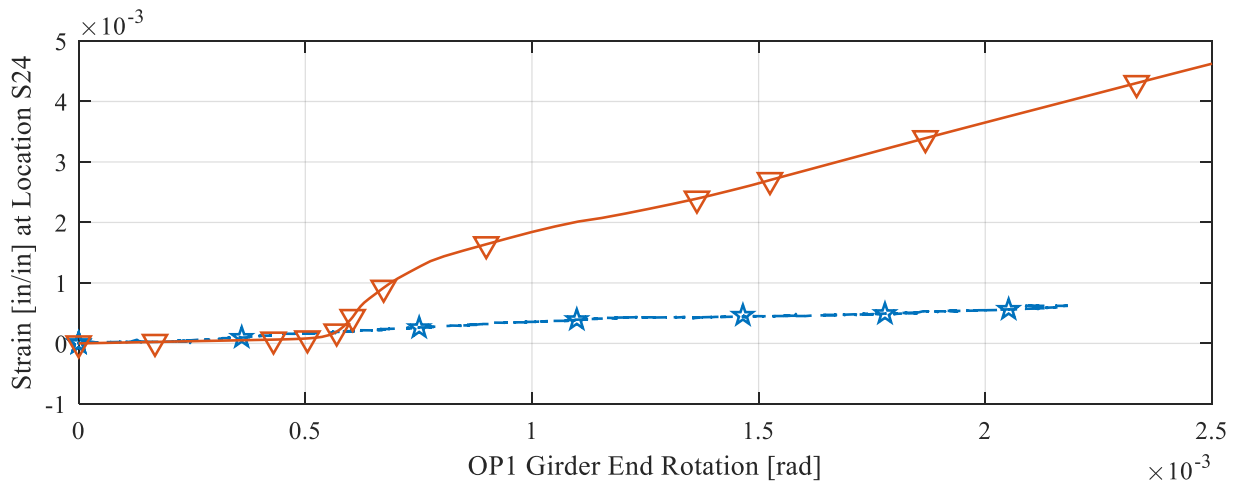
**Figure 8.92. Comparison of strains (a) at the center of the deck, (b) over the girder, and (c) in the overhang at the level of the top longitudinal reinforcement.**

Figure 8.92 shows a comparison of strains from embedded strain gages and from cracked elements in the FEM at the same locations: over the longitudinal reinforcement at the PBJ between the girder lines (a), over the girder line (b), and in the overhang (c). While the embedded gages showed a gradual increase in strains over the gage length, the FEM results showed nonlinear cracking behavior indicative of a crack opening at a specific element.

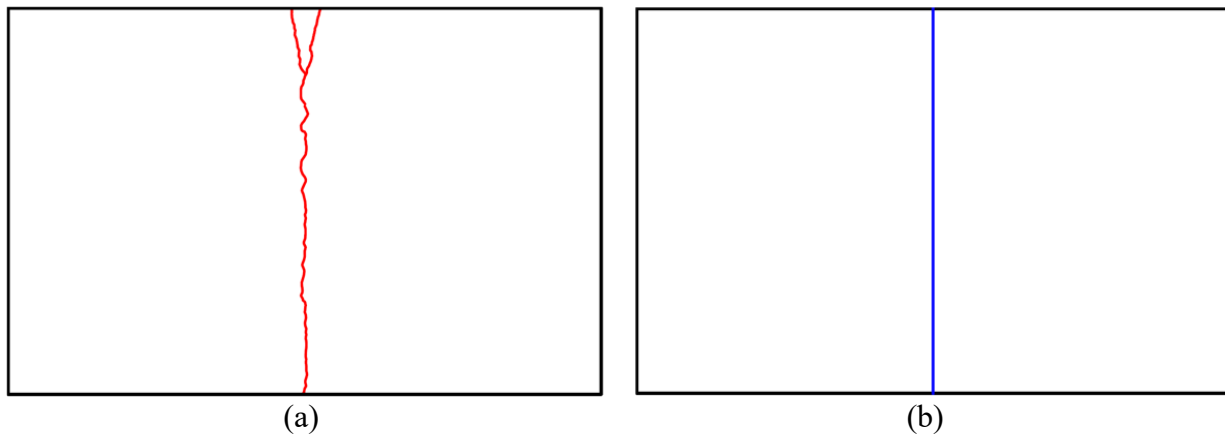
**Figure 8.93. Crack patterns of model FP1 for (a) the experimental test and (b) the FEM.**

Crack patterns may also be used to confirm that the FEM is accurately capturing test behavior. Cracking in the top of the deck for model FP1, presented in Figure 8.93, showed a crack above the timber board at the center of the PBJ reaching the full depth of the reduced CIP section above the board. The crack pattern was similar between the test and FEM, with the primary difference being a branched cracking pattern in the overhang of the experimental test deck.

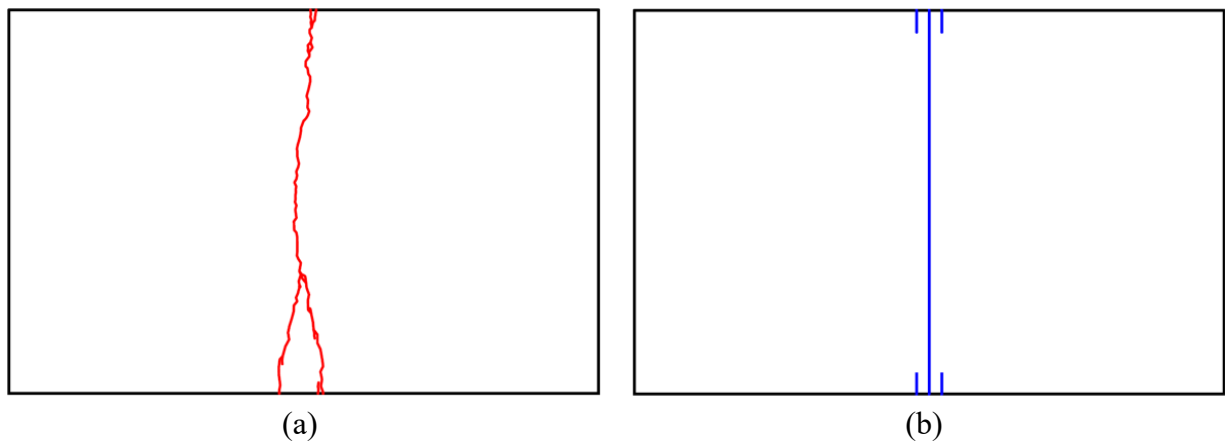
**Figure 8.94. Crack patterns of model OP1 for (a) the experimental test and (b) the FEM.**

Similarly, for test OP1, a main crack ran over the center of the PBJ, as shown in Figure 8.94. Branched cracks formed in the overhang for both the experimental testing and FEM. Cracks in the FEM did not reach the full depth of the deck, while the overhangs in the experimental test showed a full-depth main crack and branched cracks.

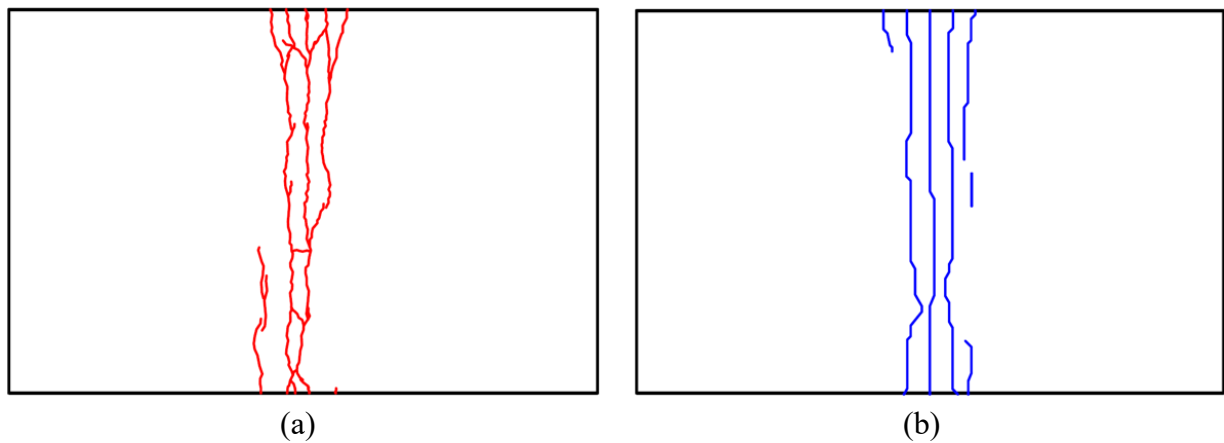
**Figure 8.95. Crack patterns of model OP2 for (a) the experimental test and (b) the FEM.**

Comparison of cracking patterns for OP2 in Figure 8.95 showed similar secondary and branched cracking patterns. The addition of top longitudinal reinforcement in the northern side of the deck created a more dispersed crack pattern in the north deck in both the test and the FEM. The crack depth in overhang for OP2 was consistent between the experimental test and the FEM. Cracks

did not reach full depth, and the center crack reached the deepest, while subsequent offset cracks were less deep.

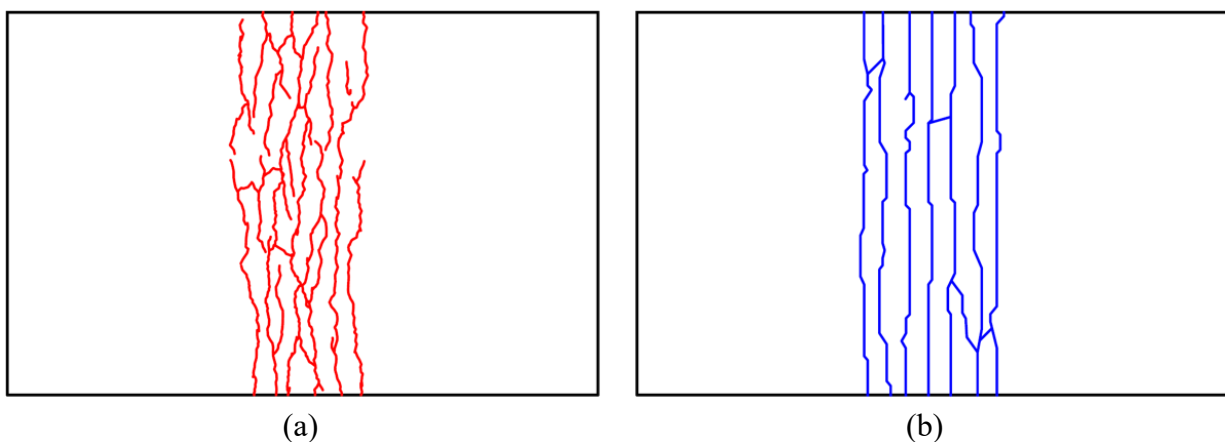
For test CP1, comparison of cracking patterns in Figure 8.96 showed a much more distributed pattern with secondary and tertiary cracks, as well as branches connecting these horizontal cracks. While cracks in the overhang did not reach full depth in the FEM, some full-depth cracks were visible in the experimental test. Furthermore, while offset tertiary cracks were not as deep as the primary and secondary cracks in the FEM, some tertiary cracks in the experimental test reached full depth.

**Figure 8.96. Crack patterns of model CP1 for (a) the experimental test and (b) the FEM.**

In general, the crack patterns were consistent between the FEMs and experimental tests. Secondary and tertiary cracks were generally less deep in the FEMs, but experimental results showed that these cracks may be full depth in practice. While FEMs showed a primary central crack in each simulation, tests FP1 and OP1 revealed that branched overhang cracking may be present without a central crack.
