# Performance and Improvement of Texas Poor Boy Continuous Bridge Deck Details: Final Report

Technical Report 0-7013-R1

TEXAS A&M TRANSPORTATION INSTITUTE  
COLLEGE STATION, TEXAS

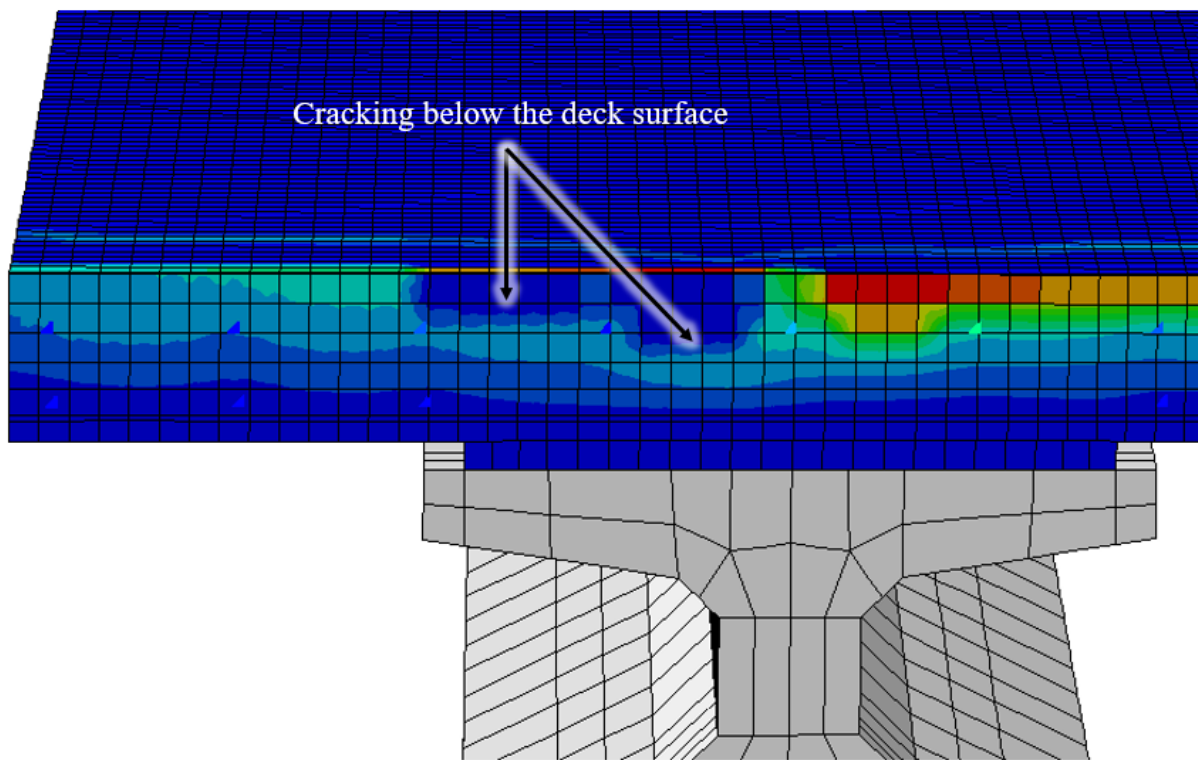
Finite element results for this test setup showed that taking a section cut at a slight angle to the top surface revealed similar behavior, as shown in Figure 8.97. Since the angle of cracks vary across the width of a specimen, taking an angled cross-section will intersect cracks beneath the surface while the concrete directly above is not visibly cracked.

**Figure 8.97. Angled section cut of the deck revealing cracking behavior below the deck surface similar to the behavior observed in laboratory testing.**

Experimental test specimen OP2 was observed to have peculiar cracking behavior over the girder edges at the poor boy joint. When the specimen was demolished after testing, a crack was observed on a cross-section of the deck that had formed below the top surface of the slab but did not extend to the top surface.

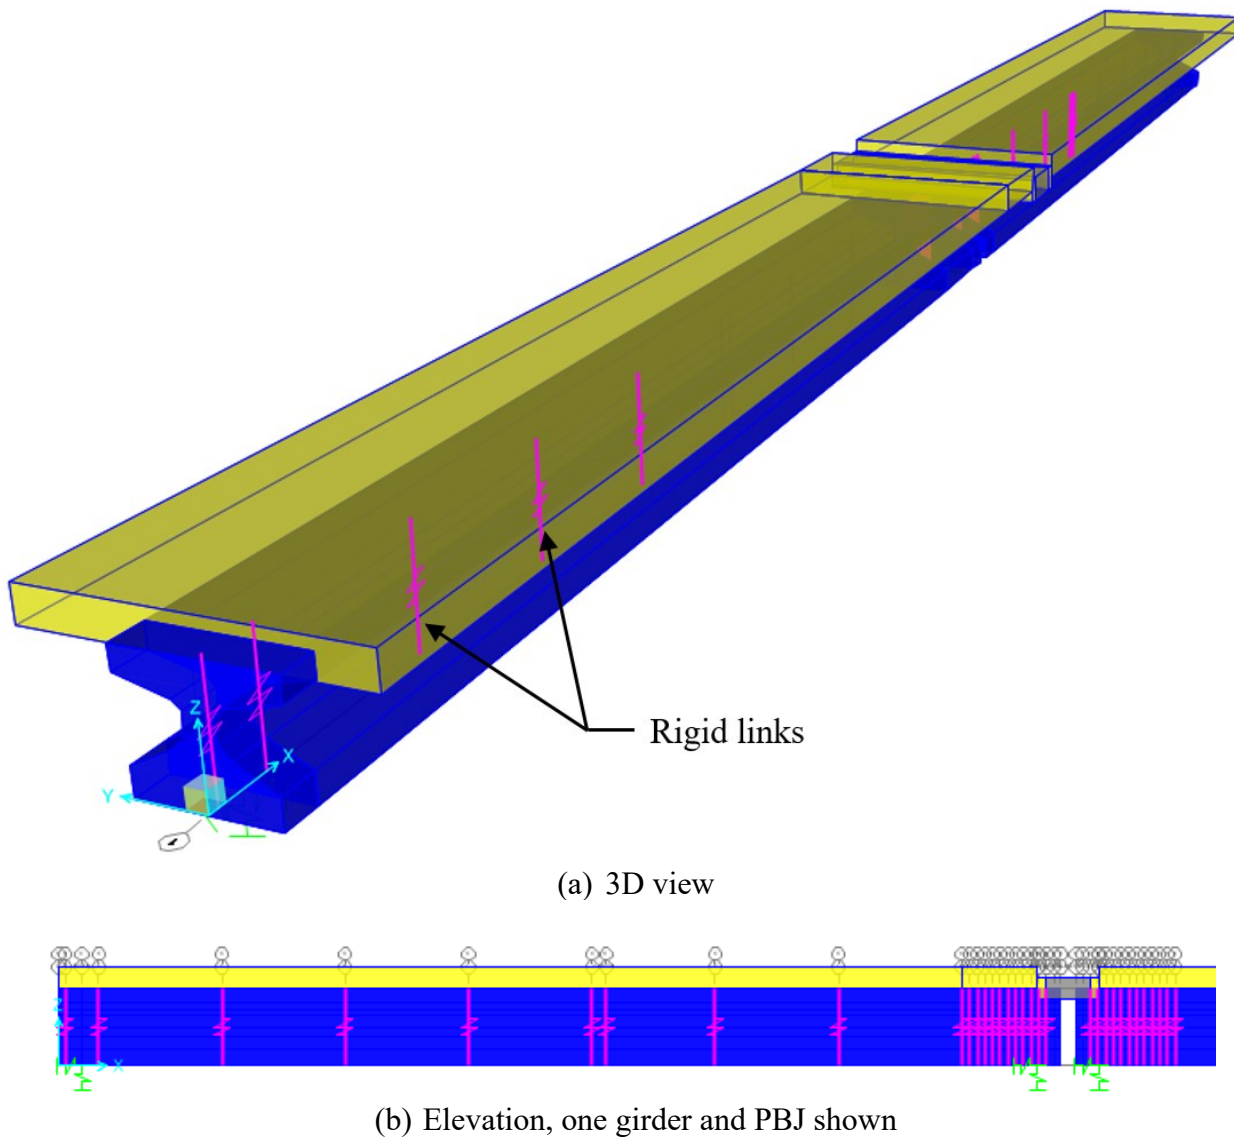
Simplified SAP2000 girder line models, such as the one shown in Figure 8.98, were used to verify elements of the laboratory test program and ABAQUS results. These models were limited to using concrete material properties in the elastic region (see Table 8.4) and therefore provided upper bounds for girder end deformation and slab rotation. SAP2000 models were not used to verify deck deformations and stresses from ABAQUS at high loads since material nonlinearity

would lead to dissimilar results. Both the deck and girder were modeled with beam elements. Continuity between the girder and slab was provided by rigid links.

**Figure 8.98. Simplified SAP2000 model using a single girder line with offset beam elements connected with rigid links.**

The purpose of this model was to estimate the location of bending inflection points in the girders and link slab, approximating the effective length of the link slab for comparison with the results of field monitoring. The inflection point in the link slab was estimated to be 5 in. away from the first shear connection, suggesting that the link slab with a physical length of 6 in. between the girder ends and 17 in. between the first rows of shear reinforcement has an effective length of 33 in. This much longer effective length than the physical link slab length coincides with findings from field monitoring, where calculated deformations at the girder ends suggested lengths between slab inflection points that were much longer than the physical length of the link slab between the girder ends.

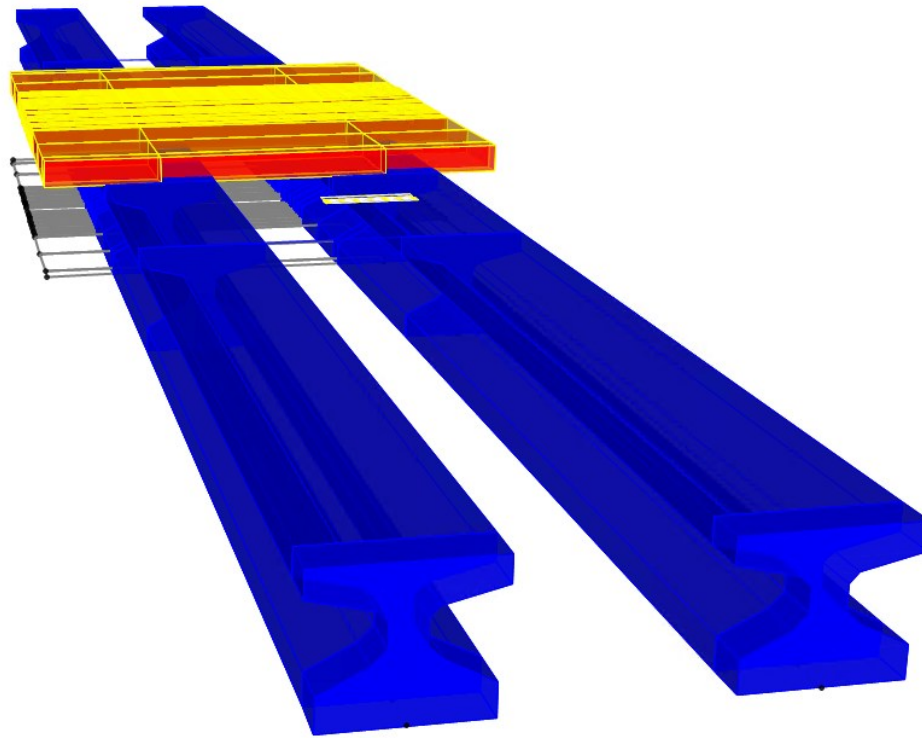
(a) 3D view

**Figure 8.99. Simplified SAP2000 model of experimental test setup with slab section modeled by offset shell objects at the PBJ region.**

A dual-girder model, shown in Figure 8.99, was used to investigate torsional effects from loading girder lines individually or off center. Since the model showed minimal torsional deformations under load, the laboratory test setup was deemed adequate without additional restraint against torsion effects. Figure 8.100 shows the deformed shape of the shell model.

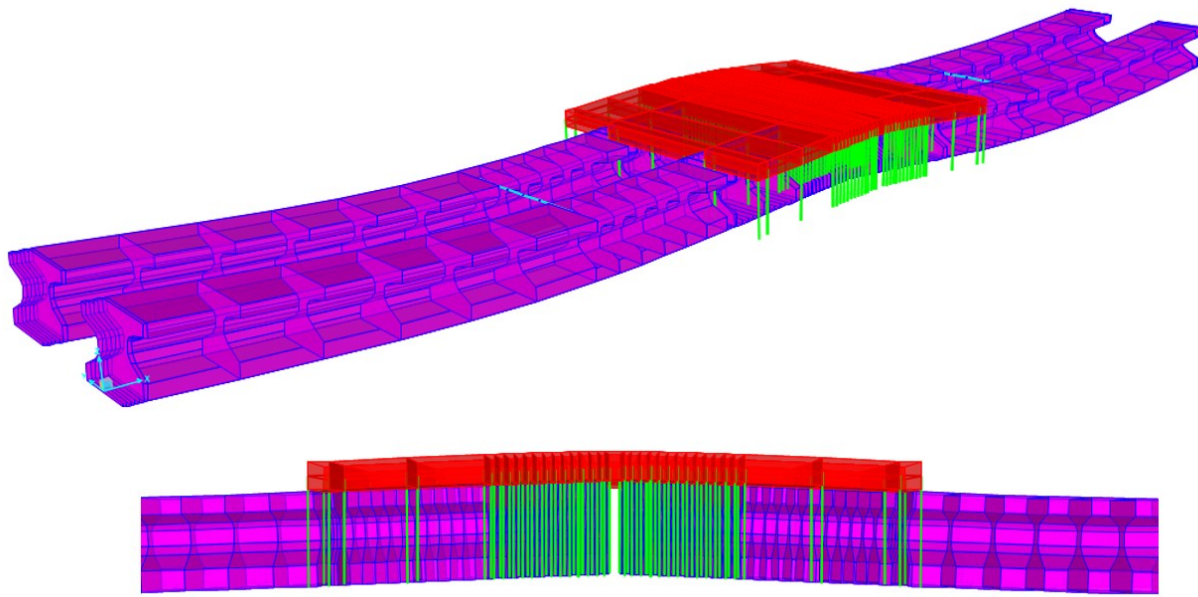
**Figure 8.100. Deformed shape of the dual-girder and shell model used to investigate torsional effects.**

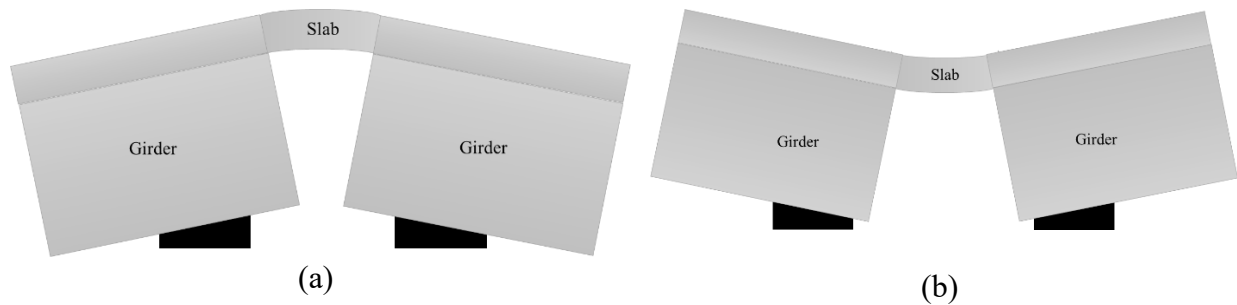
**Figure 9.1. Sign convention used for discussion of continuous deck demands: (a) positive bending and (b) negative bending.**

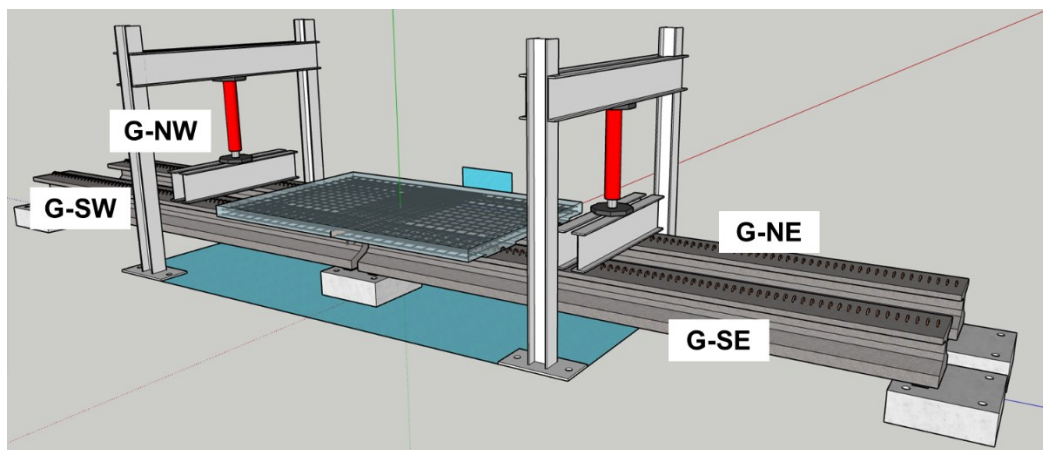
Figure 9.2 shows a schematic overview of the experimental test setup. The specimen was designed as a two-span, two-girder bridge with deck only in the central portion of the specimen. One actuator was used in each span, with a spreader beam transferring load to each individual girder. Figure 9.3 through Figure 9.5 show generic cross-section, plan, and elevation views of the setup to provide dimensions; specific details for each link slab test are provided in Section 9.2, with full drawings of each specimen provided in Appendix B.

**Figure 9.2. Schematic overview of test setup.**

The location of the actuators was determined to maximize the rotation at the interior end of the girders and fit within the laboratory constraints of tie-down locations. The location of the

actuator was 14 ft from the center of the interior bearing pad. The girder designs were based on a maximum applied load of 250 kips at the loading location. This resulted in a larger number of strands and transverse reinforcement than what would typically be found in a Tx28 girder.

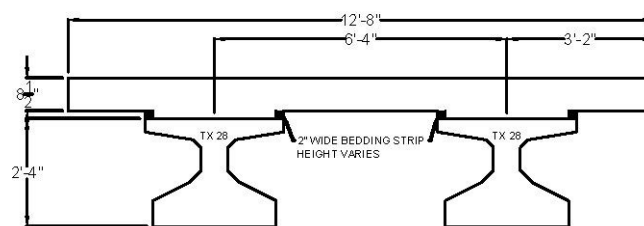
**Figure 9.3. Generic cross-section of specimen.**

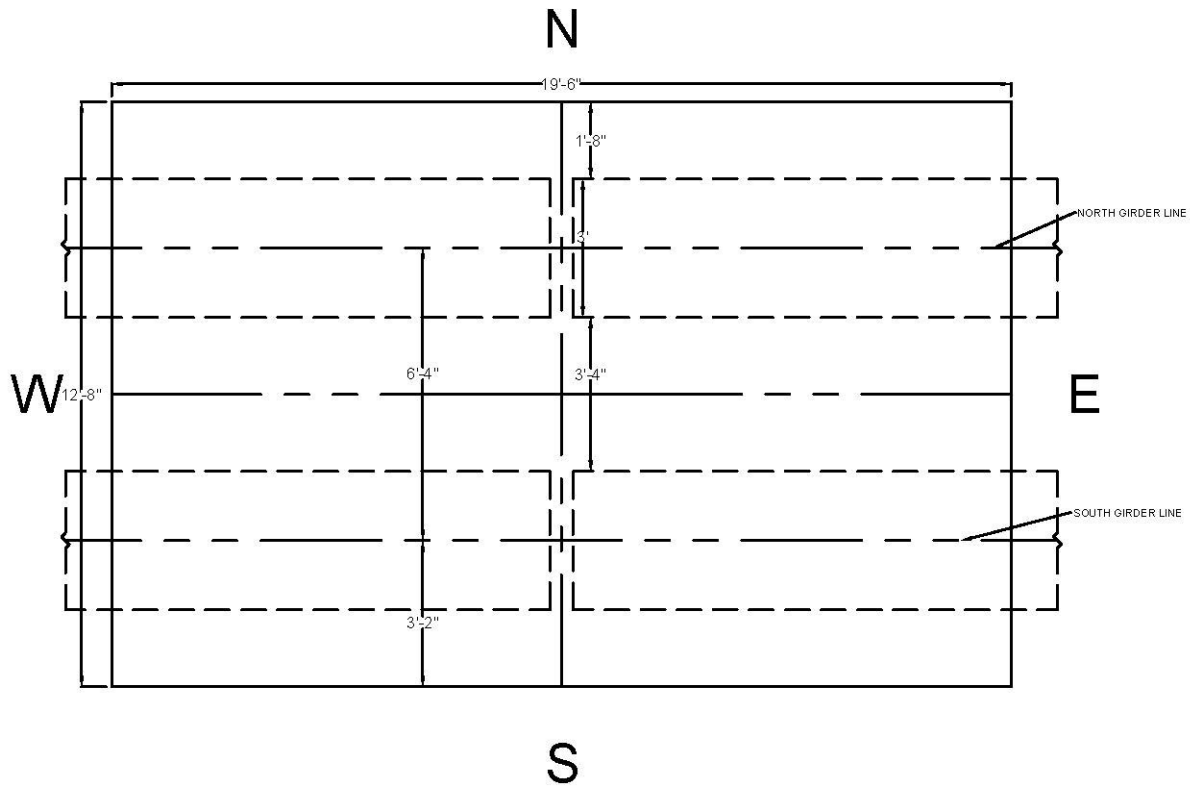
**Figure 9.4. Generic plan view of specimens showing geometry.**

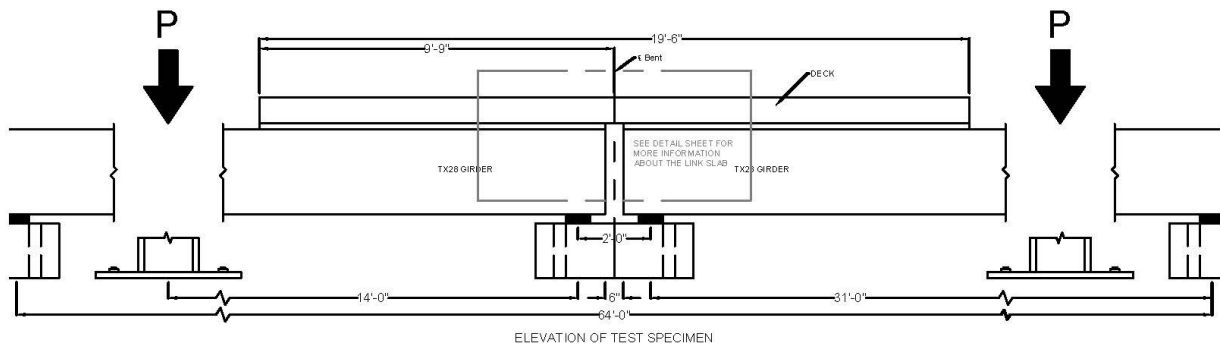
**Figure 9.5. Generic elevation of specimens showing geometry.**

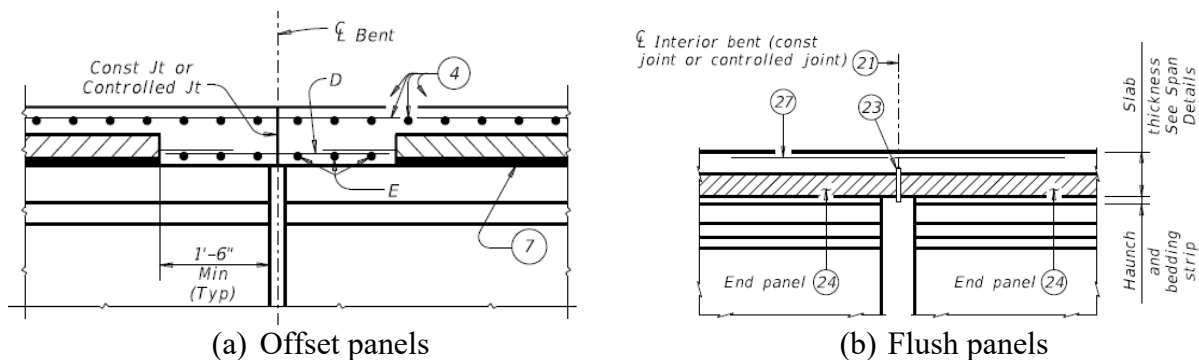
The details of the specimens are discussed here in relationship to the standard detail used by TxDOT at the time of this project. Figure 9.6(a) shows OP details that have been in place for many years. More recently, the use of the FP detailing shown in Figure 9.6(b) was introduced in response to preferences from contractors to avoid formwork for the CIP region.

**Figure 9.6. TxDOT standard drawing options for continuous deck details.**

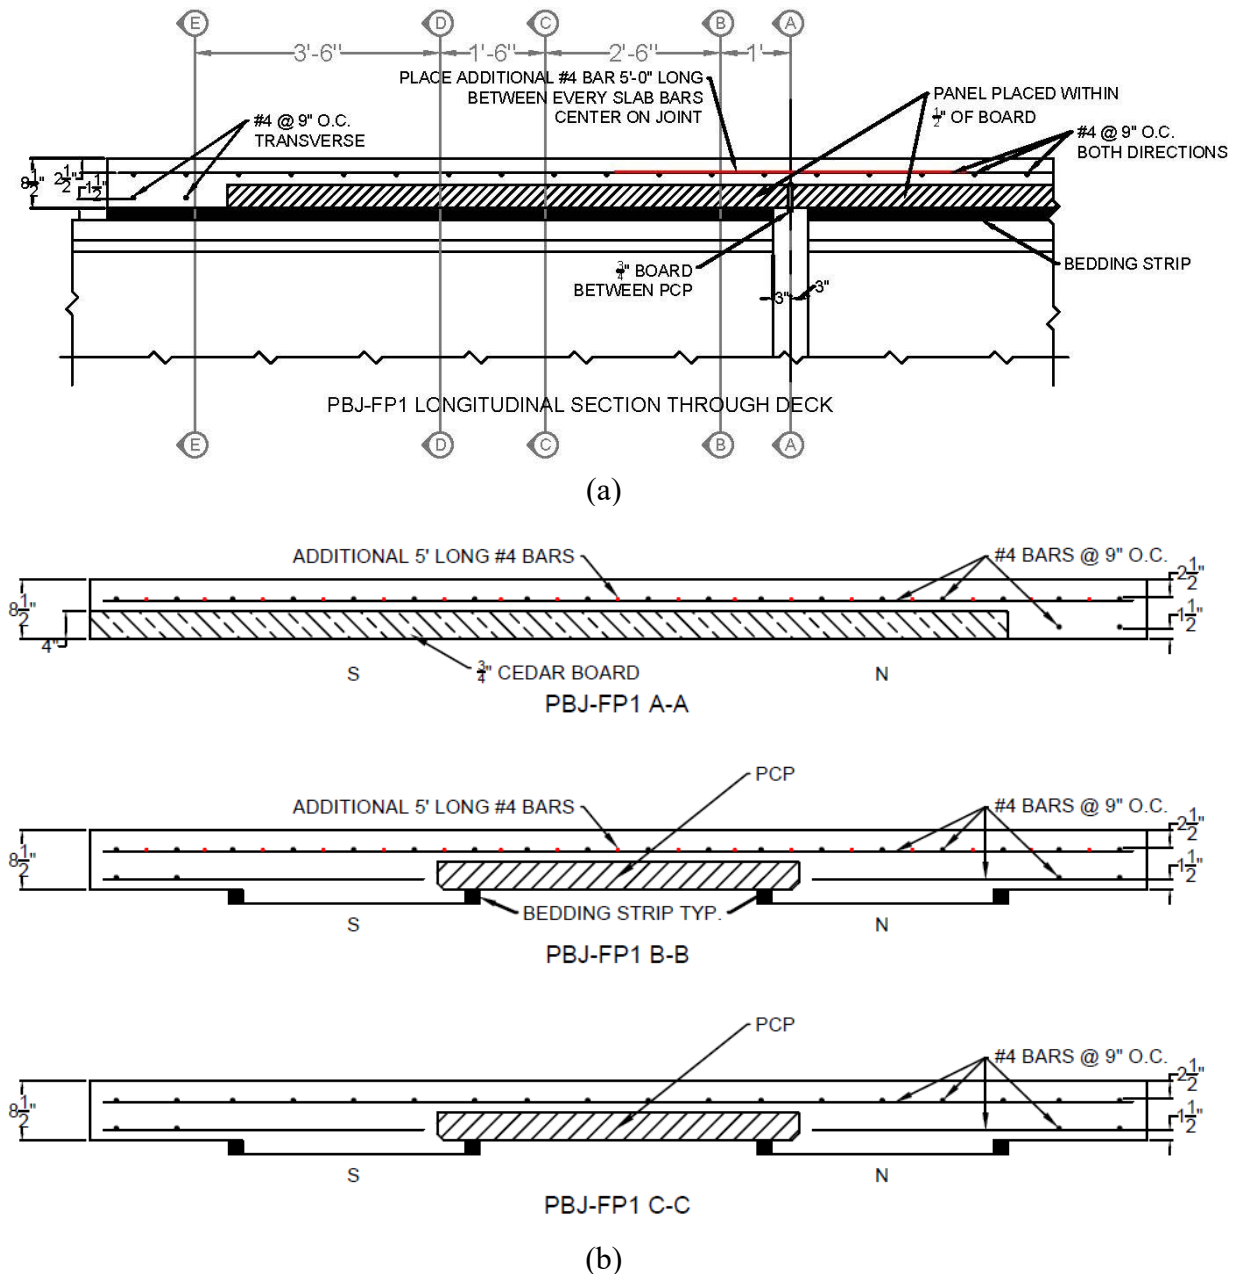
The flush panel reference specimen is named PBJ-FP1. Details are shown in Figure 9.7. The panels have a slight separation by a  $\frac{3}{4}$ -in. thick board placed vertically between the panels. In TxDOT standards, this is extended to the exterior face of the fascia girder. In other words, the board is present between the girder ends where the deck is full-depth CIP but not in the overhangs, which are full-depth CIP. According to the designs, the board should be redwood. Due to lack of local availability of a redwood board and because the bridge is not being exposed to the elements for decades, a cedar board was used instead.

The typical detailing with flush panels uses a zip strip as a crack former on the top center of the continuous deck along the transverse direction of the deck. The objective of the zip strip is to encourage the crack that is expected to form under applied loading to do so cleanly in a controlled location. The zip strip on the top was not included in PBJ-FP1 to allow for (a) investigation of when and where the main crack(s) form without any starter, and (b) clear measurements of crack widths. On the bottom side of the deck, the typical flush panel detail also encourages the formation of the crack at the center of the link slab. In the full-depth CIP portion of the deck (overhangs), this is a  $\frac{3}{4}$  in. notch. Where panels are present, this is in the form of a  $\frac{3}{4}$  in. notch on the top of the board separating the panels. In PBJ-FP1, this bottom detail was included. In the north overhang, this is a  $\frac{3}{4}$  in. notch. Elsewhere, a  $\frac{3}{4}$  in. chamfer is used at the top of the board.

The flush panel detail has, in the continuous slab region, twice as much top longitudinal reinforcement as the typical deck reinforcement. This is accomplished by adding 5 ft long #4 bars halfway between each of the longitudinal deck bars. The length is adapted from the standard TxDOT detail. In the cast-in-place portion of the deck between girders at outer portions of the deck, longitudinal reinforcement was not included in the bottom of the deck over the girders; this is consistent with the standard TxDOT detail.

**Figure 9.7. PBJ-FP1 geometry and reinforcement: (a) elevation view and (b) select cross-sections.**

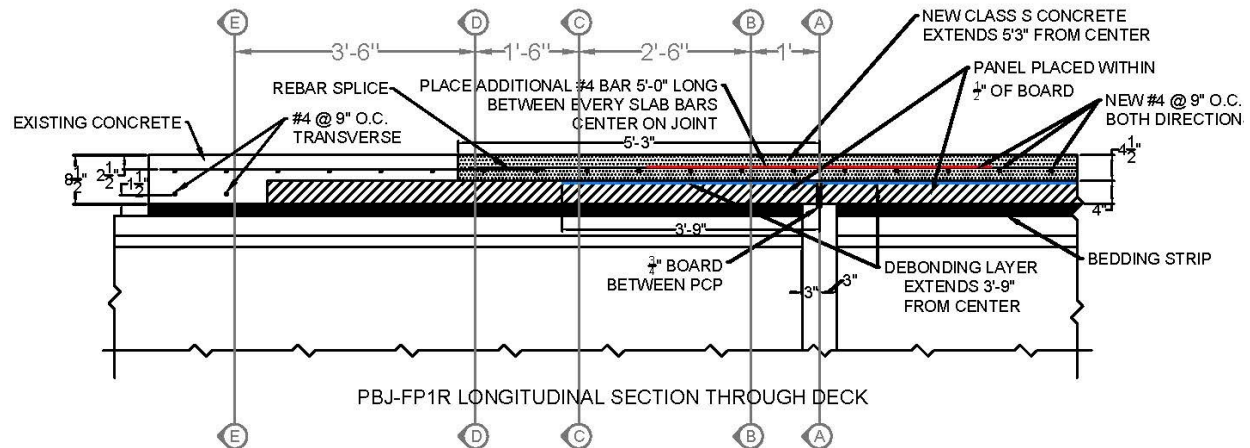
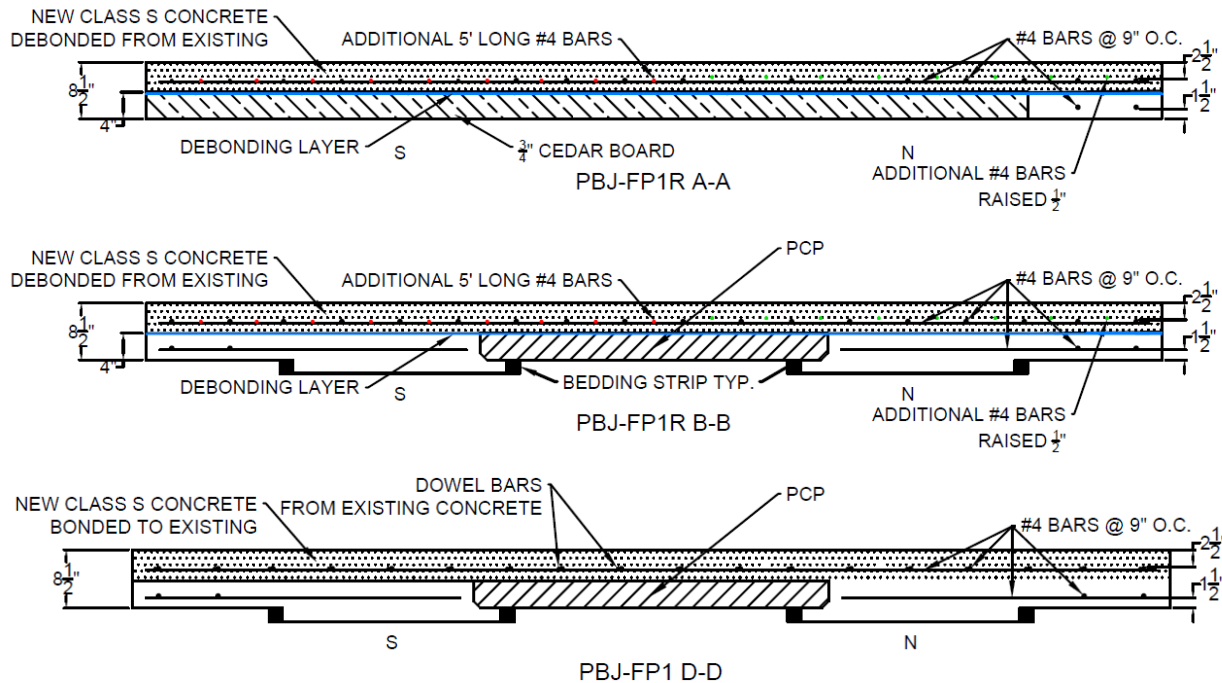
After testing, PBJ-FP1 was retrofitted to specimen PBJ-FP1R; details are shown in Figure 9.8. The full depth of the CIP concrete (4.5 in.) is removed from the center 10.5 ft of the deck. The top rebar is replaced, with a 1 ft 9 in. splice with the existing reinforcement. The new concrete is debonded from the existing concrete, with the exception of 1 ft 6 in. at each end. The bonded region is where the splice is located and is referred to as the transition zone. The objective of this retrofit is to explore the impact of a more flexible link slab.

Special consideration must be given to the reinforcement for the retrofit, since top portion of the non-composite slab will be only 4.5 in. thick, leaving the rebar very near the compression face. This introduces the potential for excessive crack width. Thus, two different reinforcement designs were used. In the south half of the deck, the reinforcement was the same as PBJ-FP1. In the north half of the deck, the supplemental #4 bars in PBJ-FP1 were raised closer to the surface. The original intent was to provide 1.5 in. clear cover for this upper layer of reinforcement; however, supply chain challenges meant that the reinforcement chair with the proper height was not available prior to casting the concrete. Instead, a slightly shorter chair was used, providing 1.75 in. cover. While the cover provided is not sufficient for ordinary reinforcing steel, it would be appropriate if FRP reinforcing bars or alternative steel reinforcement, such as stainless steel, were used. Although these are more expensive options, the limited use of these materials in a link slab, particularly for the retrofit of an older, thinner deck, may be a worthwhile application if demonstrated to improve performance. The presence of additional reinforcement near the surface provides better crack control, with the trade-off of a greater flexural stiffness, and thus the potential to attract greater demands. This trade-off can be investigated analytically but measured response can offer additional insight. Thus, it was deemed worthwhile to explore both options in the FP1R retrofit.

**Figure 9.8. PBJ-FP1R geometry and reinforcement: (a) elevation view and (b) select cross-sections.**

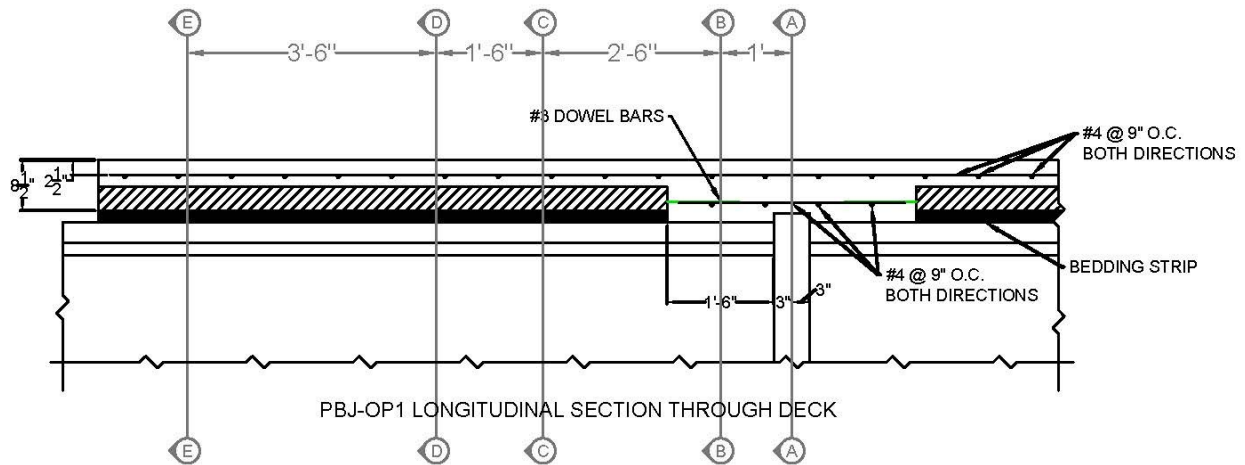
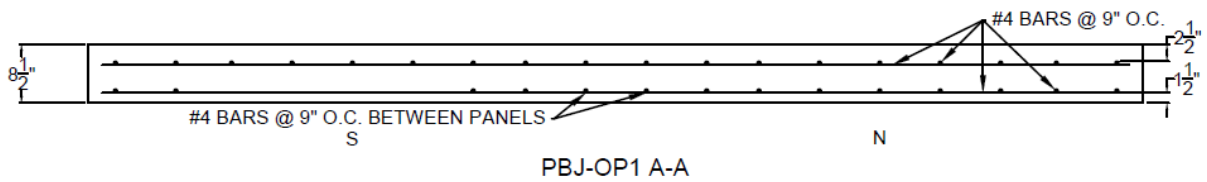
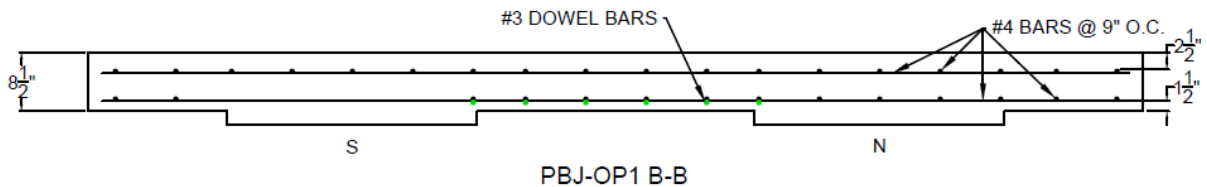
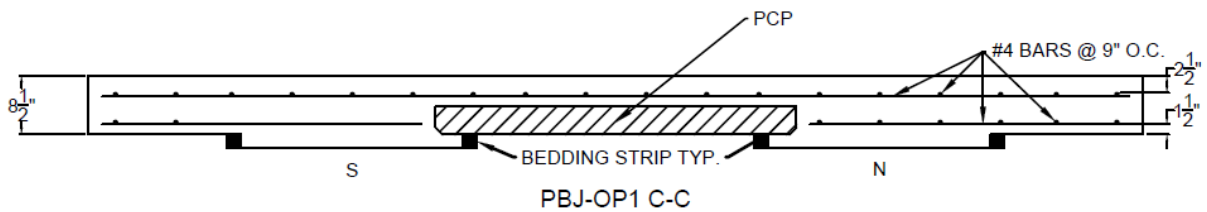
The offset panel reference specimen is named PBJ-OP1; details are shown in Figure 9.9. The panels are set 1 ft 6 in. from the end of the girder, with full-depth cast-in-place concrete in the deck between the ends of the panel. At the bottom of the slab, a preformed notch is located at the center of the continuous deck. The result is that the two overhangs are the same, unlike on FP1 and FP1R. As with prior tests, the bedding strip on the exterior of the girder is the only difference from the overhang detailing in standard TxDOT bridges.

The top reinforcement is the same as the longitudinal deck reinforcement, #4 @ 9 in. The same reinforcement is specified in the bottom of the CIP region. Over the south girder line, there is no longitudinal reinforcement, consistent with the TxDOT standard detail in place at the time of this research. Over the north girder line, bottom longitudinal reinforcement was included to consider design recommendation for inclusion of reinforcement for the purpose of positive bending in the link slab. A plane of weakness at the panel edges are avoided by providing #3 dowel bars extending from the panels, spaced at 6 in. Due to miscommunication with the fabricator, these dowels were not provided. Dowel bars were post-installed at 9 in. on center. While this is slightly different from the standard detail, it provides continuity with the bottom reinforcement in the CIP region. The post-installed dowels were confirmed to provide adequate capacity for demands expected during testing. On the north end of the panel, a dowel bar was included over the edge of the girder; this was not done on the south side.

The typical offset panel detail specifies a zip strip as a crack former on the top center of the continuous deck and a  $\frac{3}{4}$ -in. chamfer on the bottom. Similar to the PBJ-FP1 test, PBJ-OP1 does not include the zip strip but does include the chamfer on the bottom of the detail.

**Figure 9.9. PBJ-OP1 geometry and reinforcement: (a) elevation view and (b) select cross-sections.**

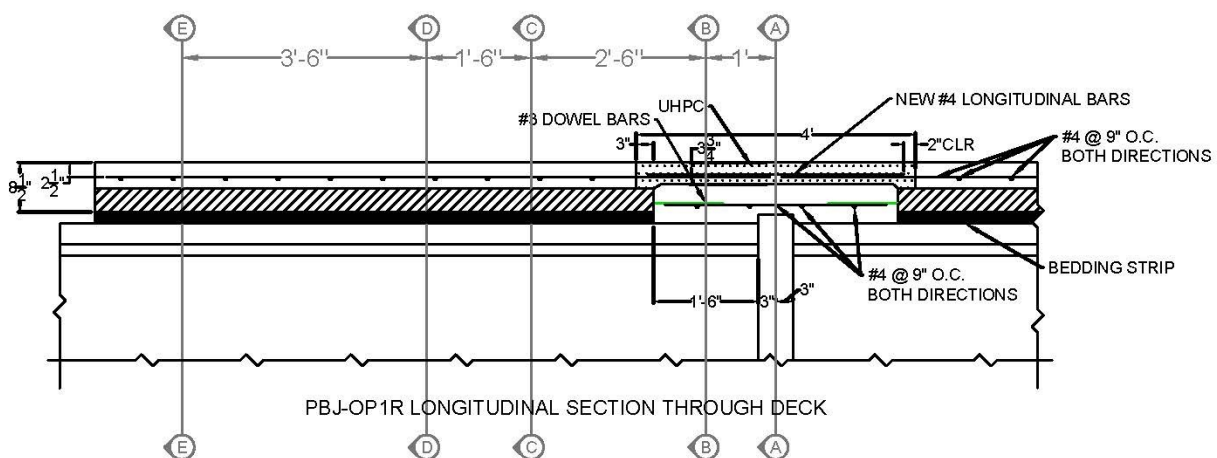
After testing, PBJ-OP1 was retrofitted to specimen PBJ-OP1R. Figure 9.10 shows the elevation view of the retrofit. Figure 9.11 shows the cross-section. The objective of this retrofit was to investigate the behavior of a link slab with HPC. Such a link slab is expected to be stiffer and form multiple small cracks compared to a single large crack. The details of the retrofit were intended to enable a quick investigation of the performance of a link slab using HPC while

The length of the retrofit region extended 3 in. beyond the edges of the panels. This ensured that damage from prior testing (cracks at edge of panel) was removed and did not influence the retrofit behavior. The depth of the retrofit was sufficient to install new longitudinal reinforcement given that yielding occurred in PBJ-OP1. The depth of the removal was 3.75 in., which provided 0.75 in. below the top reinforcement, a requirement of the TxDOT Concrete Repair Manual.

The existing longitudinal bars were retained except for a 2-in. section in the middle. This provided a splice between the new bar and the existing deck steel. The transverse reinforcement was removed for simplicity of demolition and construction. It was not replaced given the nature of the planned loading. HPC was bonded to the existing concrete. A nonproprietary mix developed for TxDOT Research Project 0-6982 was utilized.

**Figure 9.10. PBJ-OP1R elevation view.**

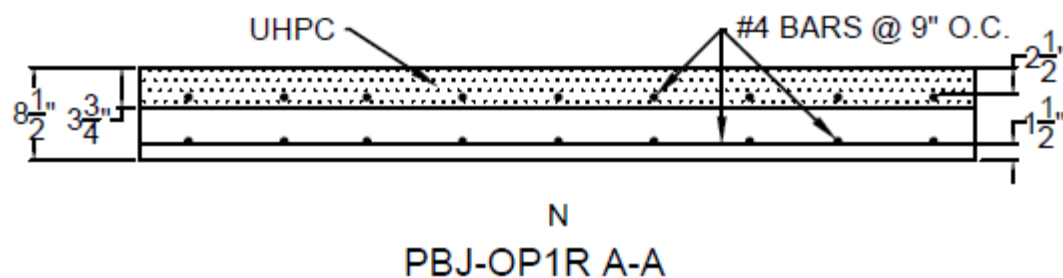
**Figure 9.11. PBJ-OP1R cross-section at center of link slab (Section A-A).**

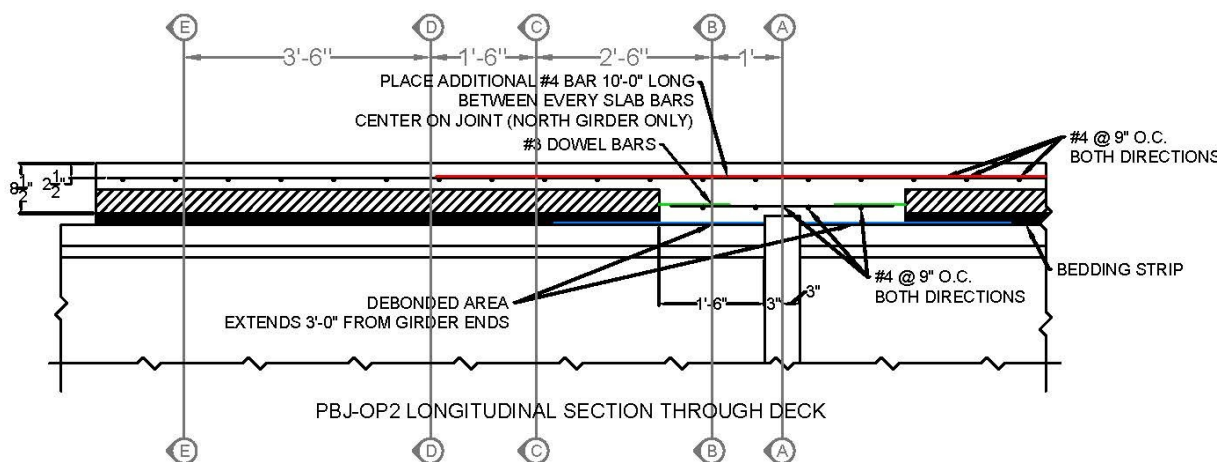
PBJ-OP2 is a proposed design alternative for link slabs with offset panel details. Figure 9.12 shows the elevation view of the design; drawings with full details are available in Appendix B. The objective here was to modify the existing offset panel design to improve the performance by increasing the length over which damage occurs and reduce stress. The design modification included debonding, increased reinforcement, and no chamfer on the deck bottom.

The reinforcement in PBJ-OP2 was different in the north and south halves of the deck. Both contained #4 @ 9 in. in both the transverse and longitudinal directions. The difference in the reinforcement was that in the north half, additional longitudinal #4 bars were added between the deck longitudinal reinforcement. This was notionally the same as the reinforcement in the flush panel details and was selected due to the smaller crack widths in PBJ-FP1 compared to PBJ-OP1. The PBJ-OP2 north reinforcement was different from PBJ-FP1 in that the bars extended 10 ft on each side of the center to ensure adequate development in the DLS. Over both girders, no bottom longitudinal reinforcement was provided in accordance with the existing standard.

Finite element modeling of debonded designs indicated that the chamfer found in the existing offset panel detail contributed to concentration of damage/stresses at the center of the slab. To ensure the best performance of the proposed design, this chamfer was not included in the construction.

Figure 9.12. PBJ-OP2 elevation view.

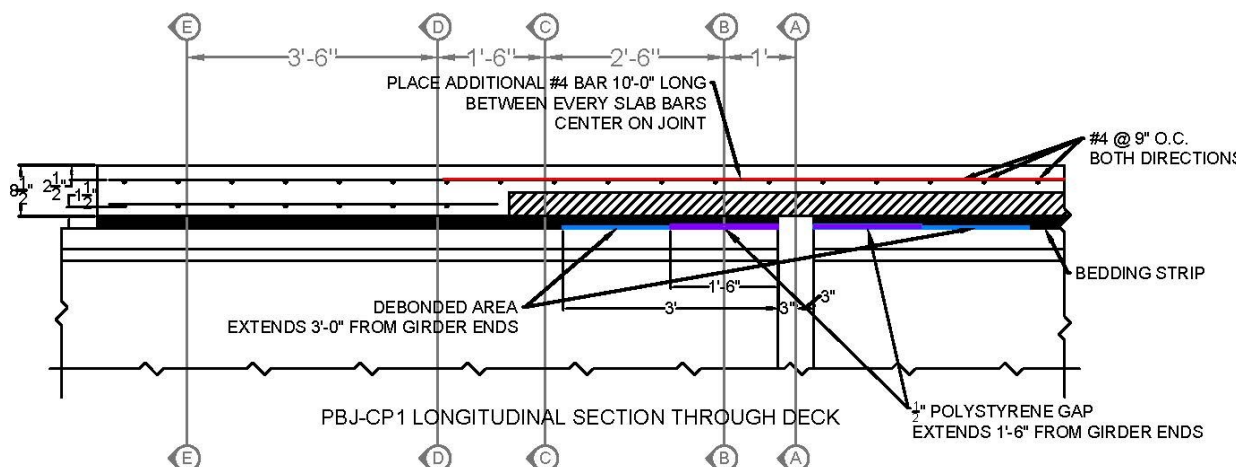
PBJ-CP1 is a proposed design alternative for link slabs with the precast panel continuous over the ends of the girders. This detail is referred to as the continuous panel detail. Figure 9.13 shows the elevation view of the design. The objective here was to eliminate aspects that contribute to the formation of cracks to allow for more distributed cracking. As a part of this, a small gap was included between the top of the girder and the haunch. The design modification included debonding, increased reinforcement, and no chamfer on the deck bottom. Figure 9.14 provides a cross-section at the gap; full drawings of the details can be found in Appendix B.

Two key features of the design differentiated it from the PBJ-OP2 proposed design alternative. The first was the continuous panel. The goal of this was to eliminate weak sections in the link slab that would provide a location for deformation, and therefore damage, to concentrate. A single panel was used in this test, with the panel length of 8 ft extending 4 ft on either side of the center of the link slab. The second was a 0.5-in. gap between the top of the girder and the haunch concrete. The goal was to eliminate the initiation of cracking from the girder end pushing into the deck concrete. Such detailing is used in standard details used by other jurisdictions. Since a physical gap is not practical to construct and provides potential location for water intrusion, the gap was formed with a weak polystyrene. The length of the polystyrene gap was 1.5 ft.

The reinforcement in PBJ-CP1 contained #4 @ 9 in. in both the transverse and longitudinal directions, with additional longitudinal #4 bars added between the deck longitudinal reinforcement. This was notionally the same as the reinforcement in the flush panel details and was selected due to the smaller crack widths in PBJ-FP1 compared to PBJ-OP1. The PBJ-CP1 north reinforcement was different from PBJ-FP1 in that the bars extended 10 ft on each side of the center to ensure adequate development in the DLS. The only difference in reinforcement in the north and south half of PBJ-CP1 was that the north girder line had longitudinal bottom reinforcement (proposed detailing), while the south did not (current TxDOT detailing).

**Figure 9.13. PBJ-CP1 details—elevation view.**

Like the PBJ-OP2 proposed design, a major distinguishing feature from existing tests was debonding the deck from the top of the girder. The debonding in PBJ-CP1 was the same as that for PBJ-OP2 and was done in the same manner. As with PBJ-OP2, the bottom chamfer was eliminated to support avoiding regions where deformation and therefore damage concentrate.

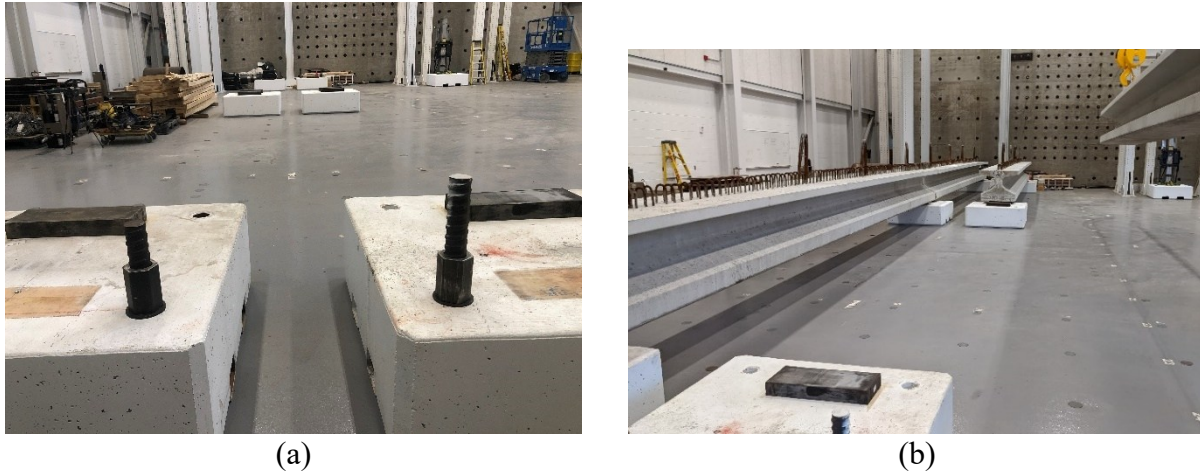
The bearing pad footprint was 21 in.  $\times$  8 in., consistent with that used for non-skewed Tx girders in standard bridge designs. Bearing pad thickness was approximately 3 in. and was selected based on the availability of eight similar pads in the inventory of the lab and through a donation of four pads by Heldenfels Enterprise in San Marcos, Texas. The location of the bearing pads measured from the edge of the pedestals was larger than the distance from the end of bent caps in standard bridge designs. This was governed by the capacity of the pedestals and did not impact the performance of the girders or deck. Figure 9.15(a) shows the placement of bearing pads prior to girder placement.

After placement of the girders (Figure 9.15[b]), the camber was measured and documented. Additionally, the distance between girder ends was measured and documented since the varying camber and placement tolerances led to slightly different gaps for the two girder lines.

**Figure 9.15. Placement of pedestals, bearing pads, and girders (shown for PBJ-FP1).**

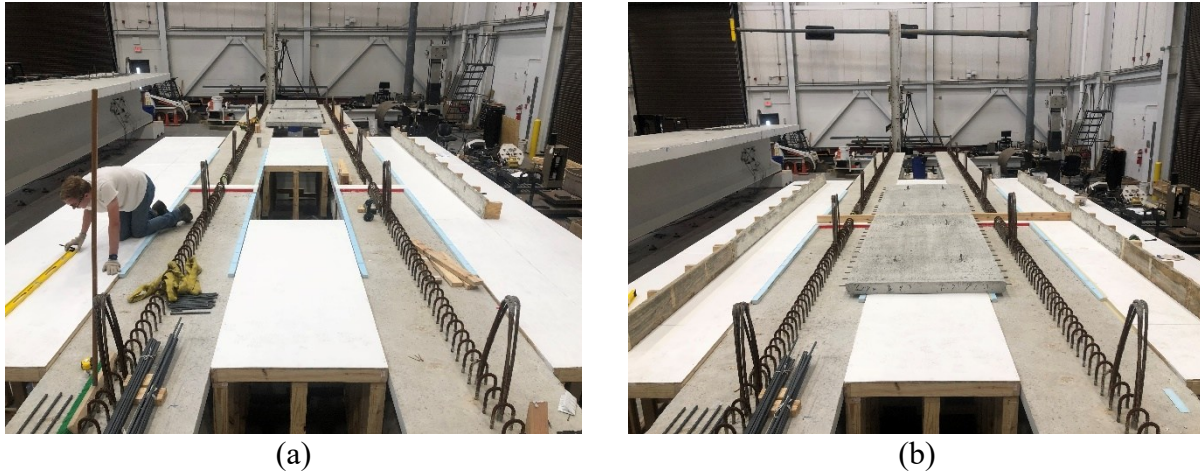
The PCPs served as stay-in-place formwork for most of the deck between the girders. In all decks, the overhang lumber formwork was constructed to support the concrete from below. For offset panel designs, this was also done for the continuous deck region between girders. In the flush panel designs, this formwork between girders was placed at the outer edges of the deck to support that CIP region. For simplicity of construction, this formwork was also placed under a portion of the PCPs; however, this support was not needed. The full set of bottom formwork, including panels, is shown in Figure 9.16 for PBJ-FP1.

**Figure 9.16. Installation of bottom formwork and placement of PCPs (shown for PBJ-FP1).**

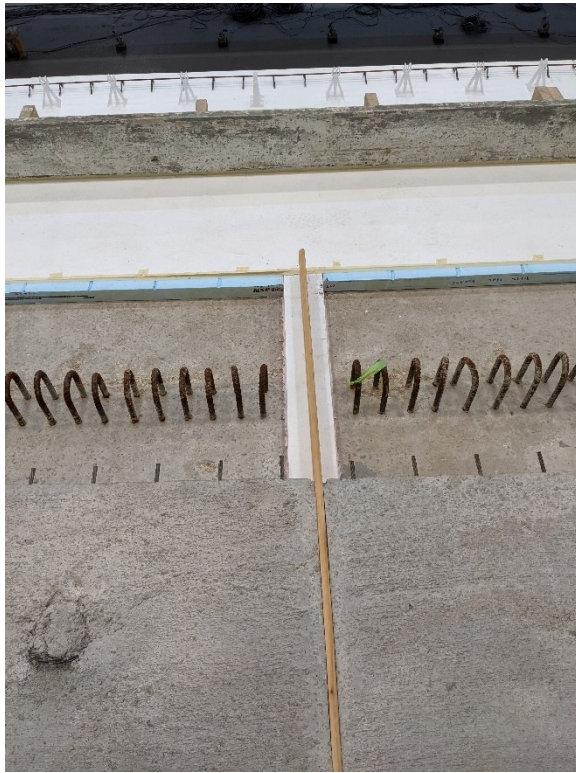
(a)

In the flush and offset designs, formwork was also needed between the ends of the girders. One challenge was fitting formwork in a narrow space with inconsistent dimensions while ensuring that concrete would not leak through a gap. Figure 9.17 shows the approach used in PBJ-FP1. A subassembly of 2×6s supported on a frame of 2×4s was placed between the girder ends. This left only a small gap between the formwork and the ends of the girders, which was filled with a backer rod with caulk above. This approach had been validated with a trial batch in a small mockup prior to casting concrete. However, when implemented in the actual specimen, there was significant difficulty in removing the formwork because the self-weight of the concrete and effects of shrinkage led to a small compressive force acting on the formwork. At the backer rods, the pressure from concrete caused a sag, contributing to the difficulty in removal. In offset panel construction (PBJ-OP1 and PBJ-OP2), the bedding strip foam was used instead (Figure 9.18). While compression was still present after casting and curing the deck, the foam was easier to remove.

**Figure 9.17. Formwork used between girder ends for PBJ-FP1.**

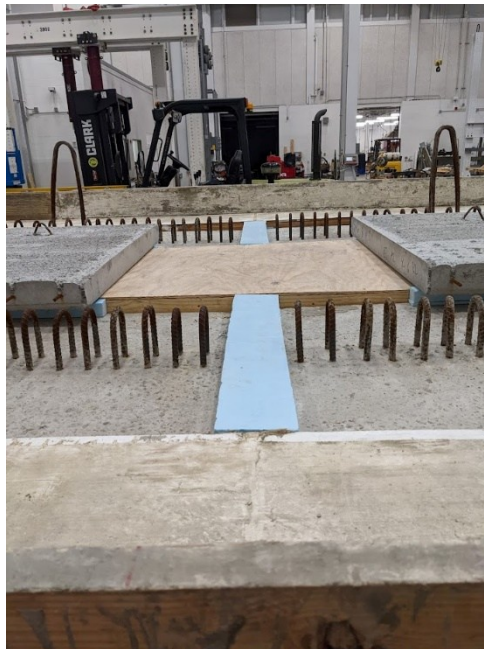
**Figure 9.18. Formwork used between girder ends for offset panel tests (PBJ-OP1 shown); post-installed dowel bars not present.**

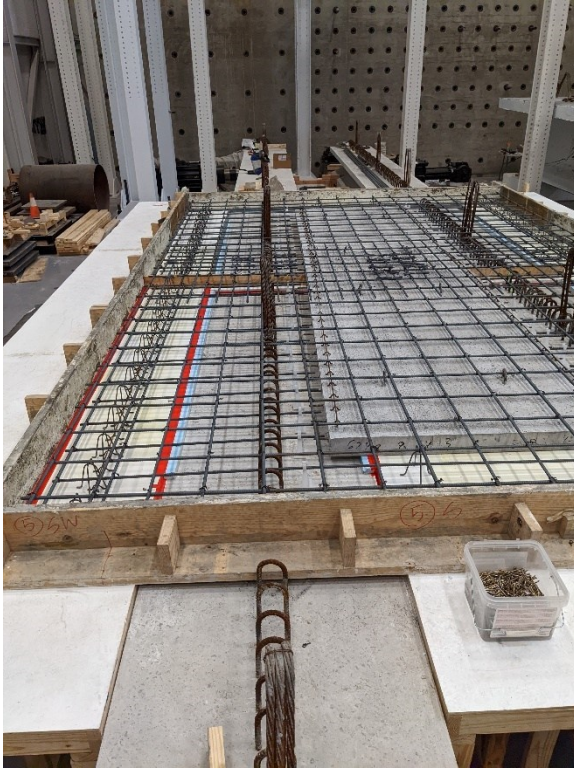
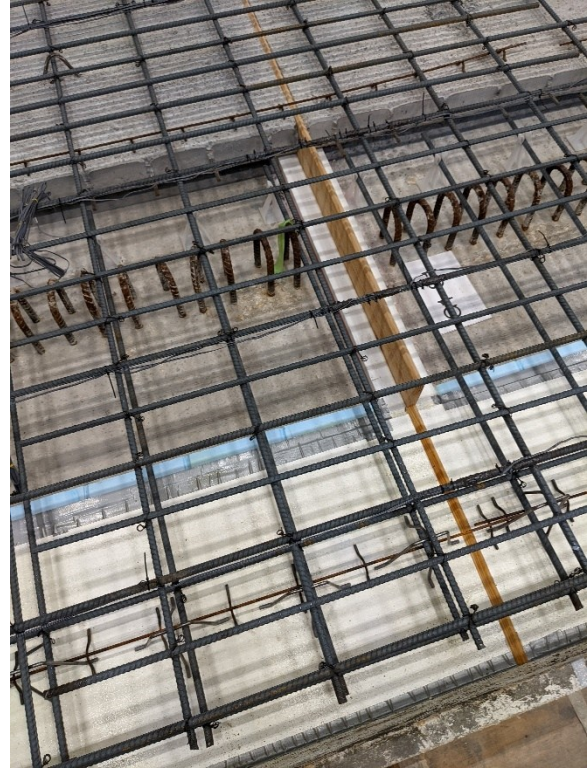
(a) Looking west

(b) North overhang

**Figure 9.19. FP1 prior to casting concrete.**

In the north overhang, the notch on the bottom of the deck was created by attaching a ¾-in. triangle-shaped piece of molding to the bottom formwork (visible in Figure 9.19[b]). This did not shift during placement and was successful in forming the notch seen in a typical overhang.
