# Performance and Improvement of Texas Poor Boy Continuous Bridge Deck Details: Final Report

Technical Report 0-7013-R1

TEXAS A&M TRANSPORTATION INSTITUTE  
COLLEGE STATION, TEXAS

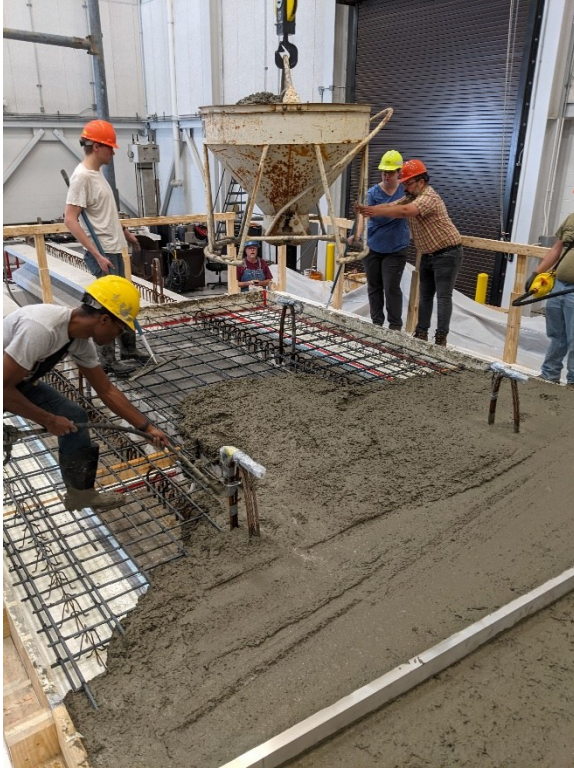
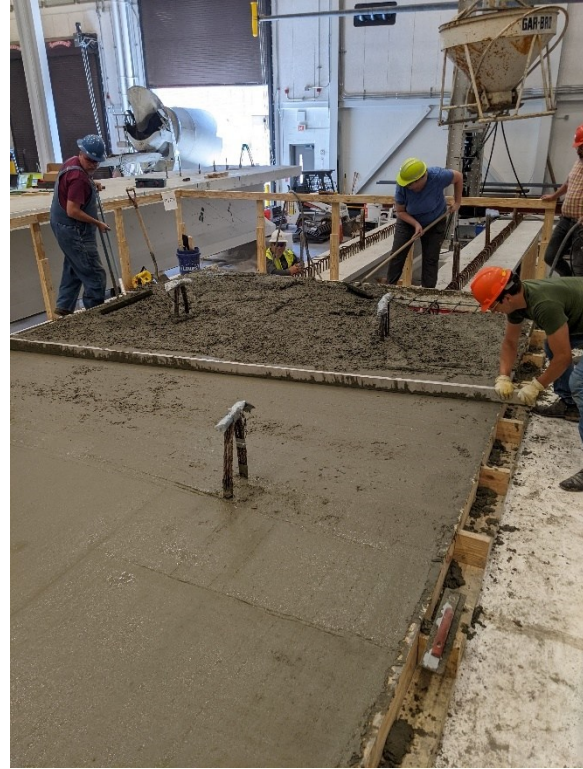
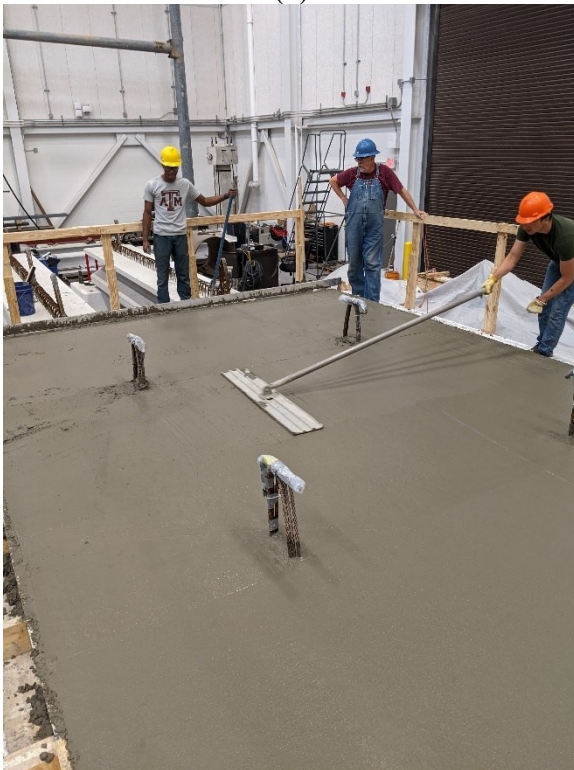
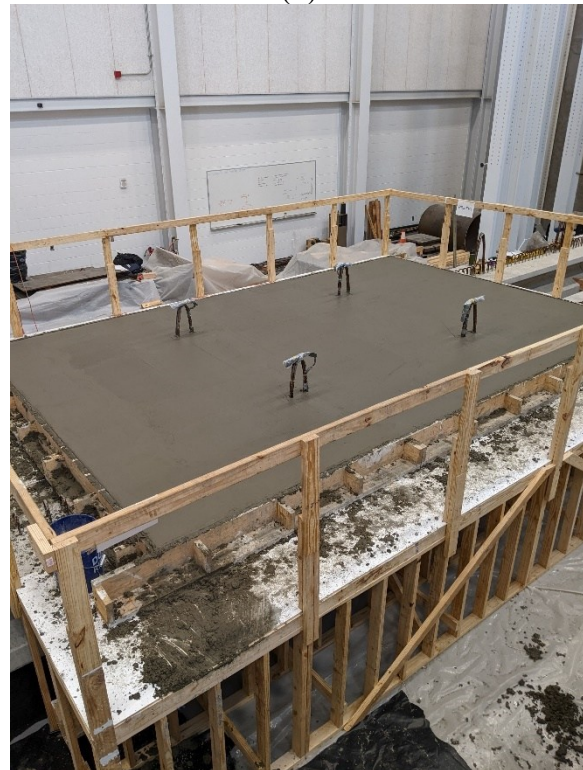
**Figure 9.20. Placement and finishing of concrete.**

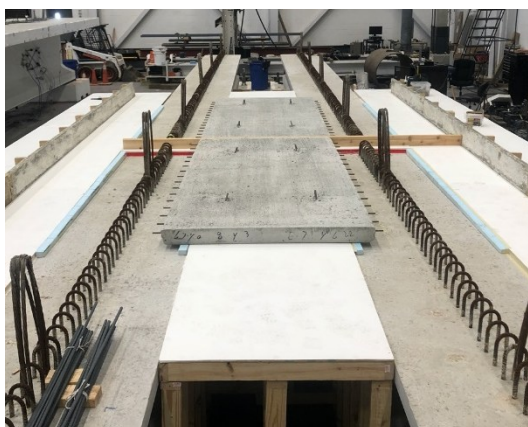
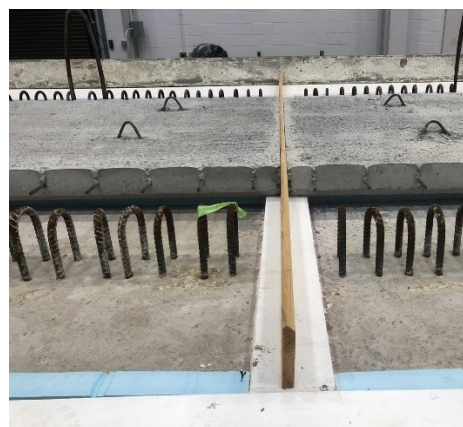
(a) Looking east

(b) Looking south

**Figure 9.21. FP1 board located between panels.**

The ¾-in. thick board between the PCPs was planned to form a notch at the top of the board to match the requirements in the TxDOT standard detail. Location of the board is shown in Figure 9.21. The board was epoxied to the panels. After the initial placement of the panels, the board was significantly off center between the girder ends. The accuracy of placement was limited due to the tolerance of the overhead crane. Following initial placement with the crane, a large crowbar was used to shift the panels slightly so that the board was approximately centered. This was not achieved perfectly in part due to the imperfect gaps between the girder ends in each girder line. During the adjustments, loud cracks were heard, indicating some cracking of the bedding strips or separation of the bedding strip from the girder. An inspection indicated no concerning damage. While the epoxy holding the board to the panel may also have been broken, there were no concerns given that this region would be in compression during the test.

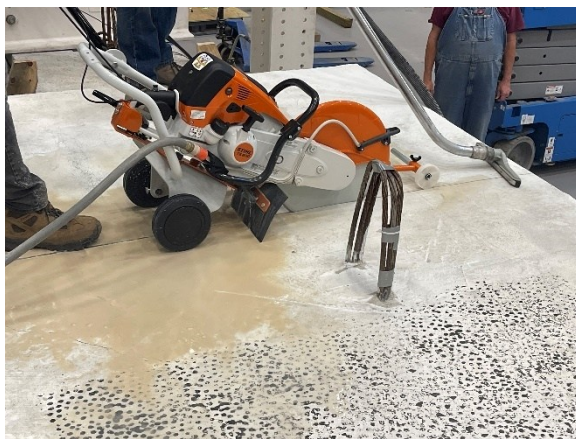
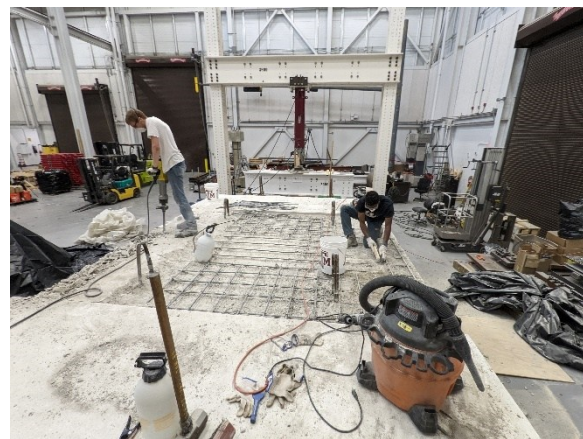
**Figure 9.22. Removal of concrete from FP1 in preparation for FP1R.**

PBJ-FP1R was constructed as a retrofit of PBJ-FP1. Figure 9.22 shows the removal of existing concrete. The top 4.5 in. of concrete was removed from the retrofit region. Two-inch deep saw cuts were made at the exterior of the retrofit region; existing reinforcement was not cut so as to allow for splicing with the new reinforcement. Two additional 4.5-in. deep cuts were made closer to the center to help with the removal. Most of the concrete was removed using a jackhammer, with work near the final surface completed using a smaller-impact hammer drill. Shoring was placed under overhangs to provide additional support during the demolition process.

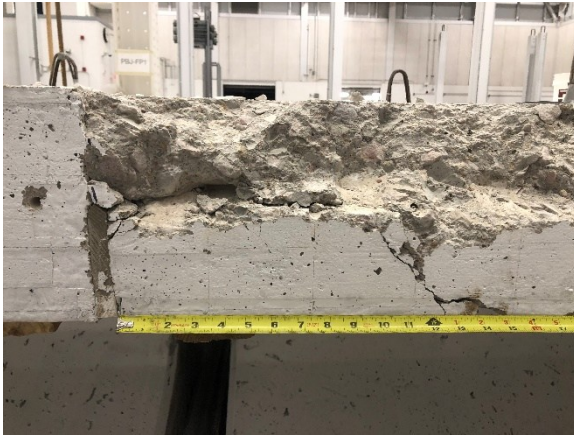
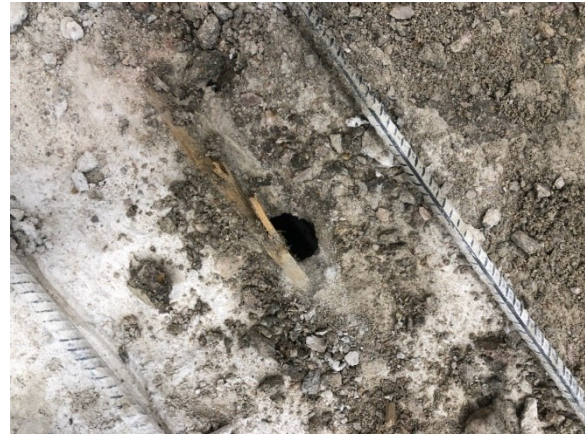
(a) Crack in southeast overhang

(b) Hole adjacent to board between north girders

(c) Patched hole

(d) PCP damage at board

**Figure 9.23. Damage to CIP concrete during demolition for FP1R.**

During removal of the concrete, some damage occurred to the bottom portion of the deck. In the south overhang, a diagonal crack formed, as shown in Figure 9.23(a). This crack was located 13 in. east (at the bottom) of the center of the link slab. While the crack formed during use of the jackhammer and may simply have been the result of the force applied to the unsupported deck, the location suggests the possibility that preexisting damage played a role. The distance from the center was approximately the same as the distance to where secondary cracks were located. The east secondary crack in the south overhang was not observed to extend to the edge of the deck following testing. It is possible that microcracks had formed and developed to a visible crack during demolition. Figure 9.23(b) shows a 2-in. diameter punch out adjacent to the west face of the board between the north girders. The hole was patched with a DOT-approved repair mix (Figure 9.23[c]). Figure 9.23(d) shows damage to PCPs adjacent to the board; the damage was unable to easily be removed without risk of further damage. Thus, no repair was completed.

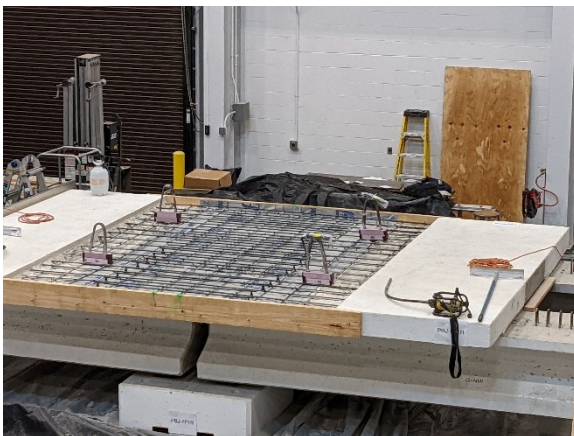
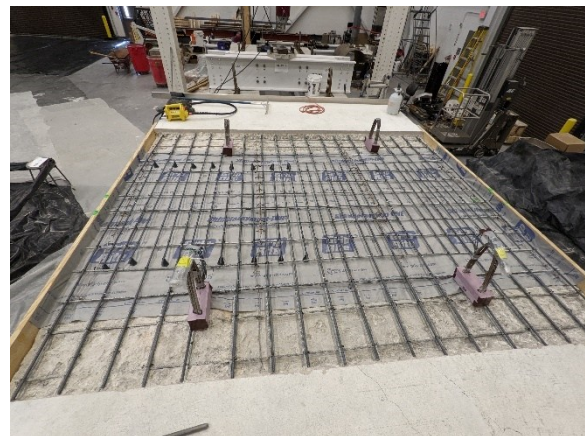
**Figure 9.24. Preparation for concrete for FP1R.**

Formwork was needed only on the sides of the deck, as shown in Figure 9.24(a). A 2×12 board was attached to each side of the deck using 8⅜-in. diameter, 8-in. long expansion anchors. Prior

Debonding of the new concrete was achieved using synthetic roofing underlayment (0.392 in. thick), as shown in Figure 9.24(b). Prior to use in the deck, the roofing paper was tested to confirm it was sturdy enough for use during the placement of the concrete and sufficient separation was achieved. The 48-in. wide underlayment was placed transversely. Two sheets were needed, with a 6-in. overlap at the continuous deck region. Since the lifting hooks were located partially in the debonded zone and partially in the bonded transition zone, polystyrene block-outs were used to ensure the lifting hooks did not provide any unintentional bond between new and existing concrete.

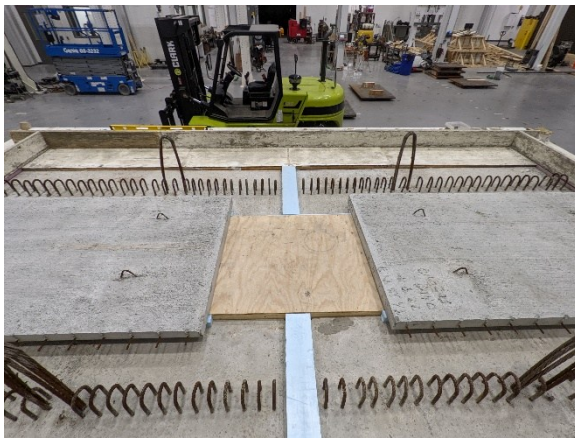
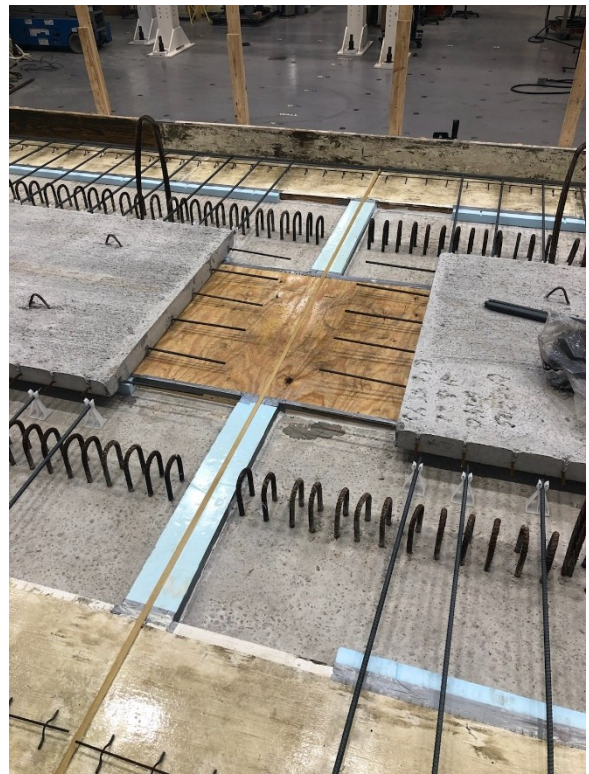
**(a) Without PCP dowels**

**(b) With post-installed PCP dowels**

**Figure 9.26. PBJ-OP1 panel placement.**

Figure 9.26 shows the panels in place before and after post-installation of the dowel bars. Half-inch diameter holes were drilled in the panel ends. Holes were located slightly below center to avoid drilling into the prestressing strands and were spaced at 9 in. to align with the CIP rebar spacing. Bars were #3, embedded 5 in. in the panels with Red Head C6+ epoxy. The strength was confirmed to provide adequate capacity for the loads applied in the tests. However, the capacity is not sufficient should the specimen be loaded such that the bottom reinforcement is in tension.

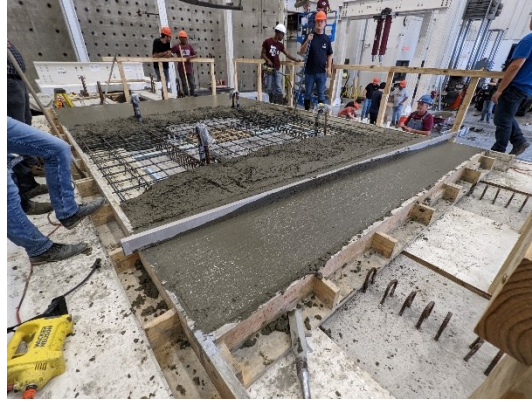
**Figure 9.27. PBJ-OP1 concrete sequence.**

The concrete was placed on October 2, 2022. Placement of concrete in PBJ-OP1 was sequenced similar to construction in the field, with the concrete placed first over the girders (Figure 9.27) and then in the link slab. The concrete was covered in plastic for several days prior to removal. No shrinkage cracks were observed.

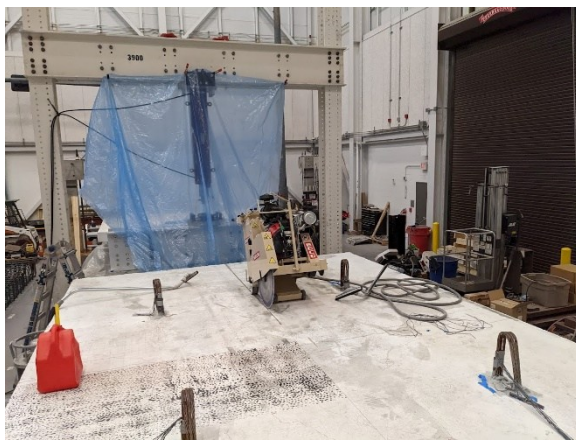
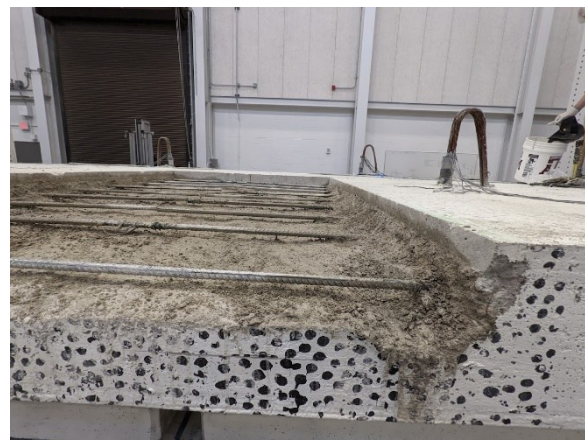
**Figure 9.28. (a) Saw cutting and (b) concrete removal from OP1 in preparation for OP1R.**

A full-depth, longitudinal saw cut was made on all deck regions (tested region and far ends of girders containing deck from PBJ-FP1 and PBJ-FP1R). This enabled retrofit and testing of only the north half without influence from the south half. Following cutting, the deck of the north girder tilted slightly such that the inner side was higher than the overhang. Partial-depth transverse saw cuts were made at the boundary of the retrofit region. The cut was approximately 2 in. deep to avoid cutting the reinforcement. The top 3.75 in. of concrete was removed by jackhammer and chipping hammer. Transverse reinforcement was removed to help accelerate the demolition. At the edges of the deck, minor damage occurred during removal, with the removal depth essentially being slightly larger in isolated locations. This is shown in Figure 9.28(b).

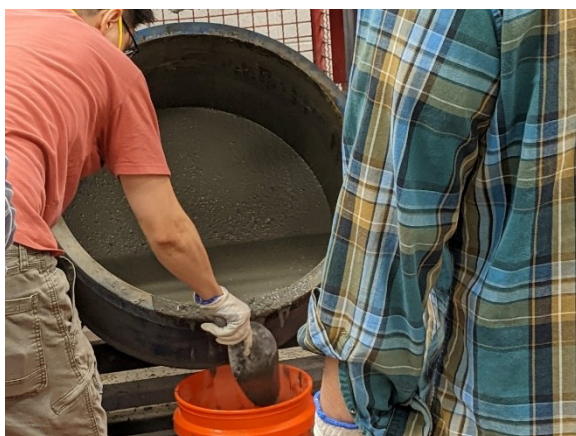
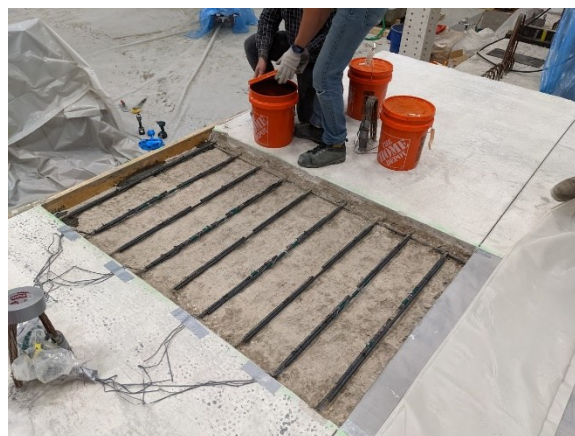
**Figure 9.29. PBJ-OP1R (a) mixing of HPC and (b) formwork with buckets staged for placement.**

Concrete was placed on December 6, 2022. Figure 9.29 shows photos from the mixing and placement. HPC was mixed in a high-shear mixer with a 1.9 ft<sup>3</sup> capacity, led by TxDOT 0-6982 team members. Small batches of approximately 1.25 ft<sup>3</sup> (less than 70 percent of the mixer capacity) were performed to ensure sufficient power to mix HPC. Seven batches were made,

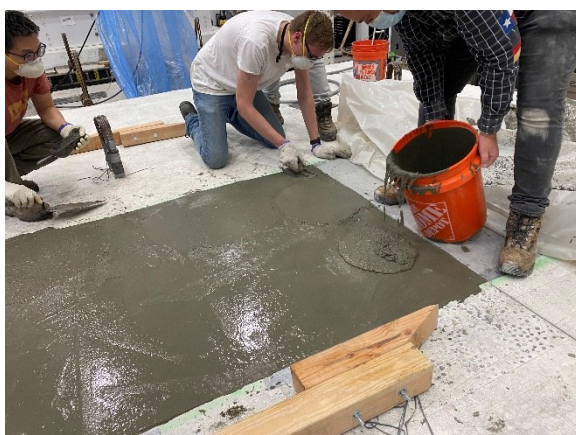
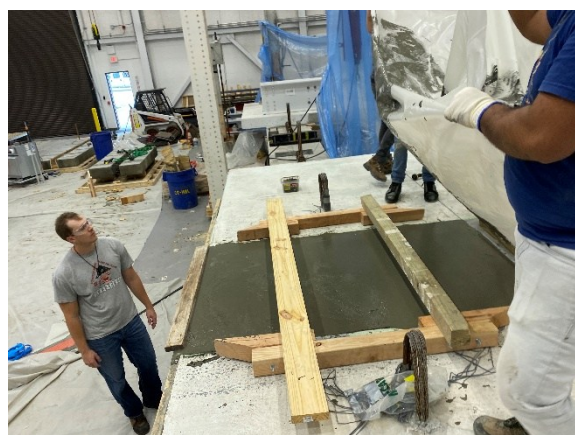
**Figure 9.30. Finishing of PBJ-OP1R.**

with the first 6.5 being used on the deck and the remaining used to make material samples. To reduce construction joints, the first three batches were placed in completely sealed 5-gal buckets until the fourth batch was mixed. While the fourth batch was mixed, the buckets were poured into the deck and allowed to flow to fill the void. The HPC was primarily added in the northeast corner and allowed to flow to fill the rest. Given the slant of the deck, the concrete from initial batches was thicker on the north and thinner on the south. In later batches, concrete was added near the southeast corner. In the first two batches, steel fibers settled near the bottom by the time the fresh HPC was stored temporarily in the buckets due to the high flow spread, leading to clumps of steel fibers. These were mainly located near the northeast corner and along the west edge. After the fourth batch, and following every subsequent batch, the concrete was covered with plastic to avoid surface drying that may cause elephant skin between placements. The formation of elephant skin causes issues of consolidation of concrete. Lumber was used to keep the plastic from sticking after the final batch (Figure 9.30[b]). Material samples were made from the final batch.

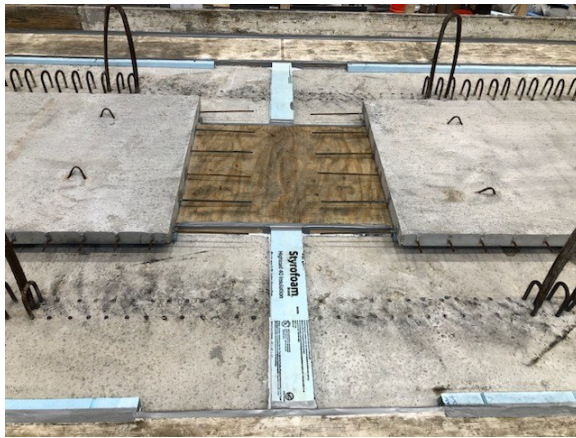
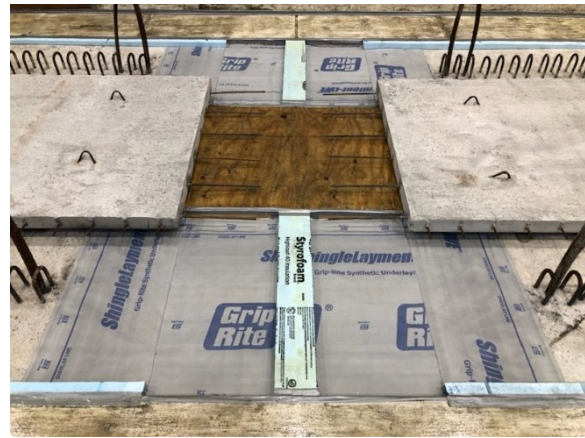
**Figure 9.31. PBJ-OP2 (a) R-bars removed in debonded region and (b) roofing paper to debonded deck concrete from top of girder.**

The R-bars were cut and ground flush with the top of the girders (Figure 9.31[a]) for the first 3 ft of each girder. The final bar cut was one prior to the lifting hook, allowing the lifting hook to be used as a reference point for the debonded region during testing. Roofing paper was placed on top of the girder (Figure 9.31[b]) to prevent bonding of the deck concrete to the girder. Two pieces were used on each girder to ensure the full surface was covered, accounting for the smaller width at the panel due to a bedding strip. A small amount of epoxy was used to keep the roofing paper in place on top of the girder. Figure 9.32 shows the completed formwork with rebar placed.

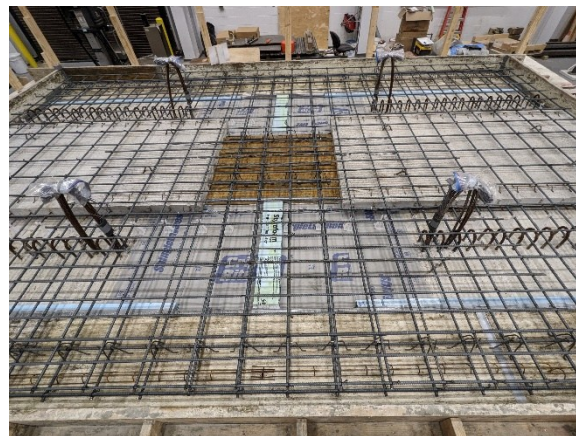
**Figure 9.32. PBJ-OP2 formwork with all rebar (the north girder is at bottom and has supplemental top bars).**

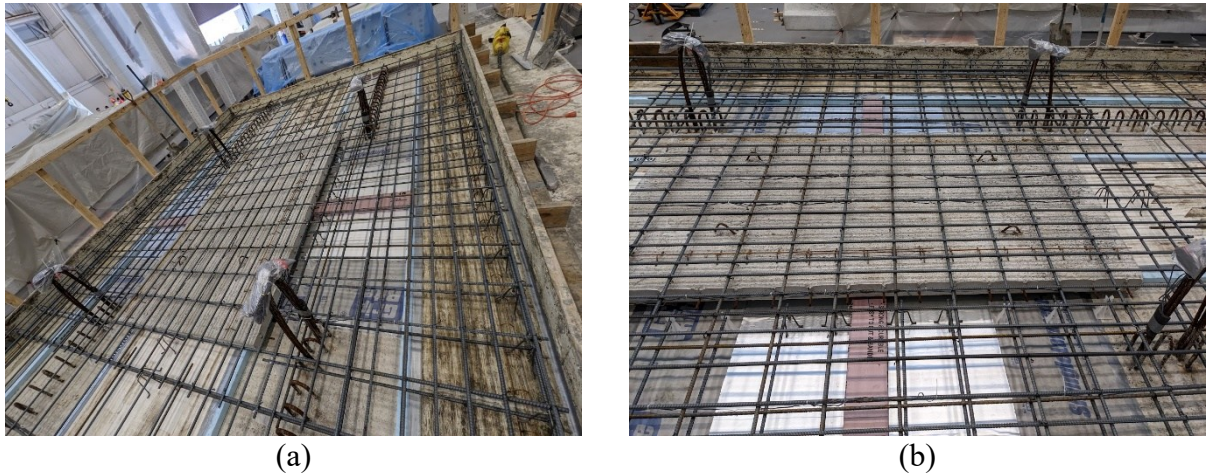
**Figure 9.33. PBJ-CP1 prior to concrete pour: (a) overall view and (b) close-up of link slab region.**

Figure 9.33 shows the panels and reinforcement in place prior to placement of the concrete. In Figure 9.33(a), the configuration of the single PCP panel, centered over the link slab region, is clear. Figure 9.33(b) shows a close-up of the link slab region. The debonded region was prepared the same as that for PBJ-OP2, with roofing paper epoxied to the girder to better prevent slippage that occurred during PBJ-OP2. For PBJ-CP1, the 0.5-in. thick polystyrene (white in the photo) was placed at 1.5 ft at the ends of each girder for the haunch gap.

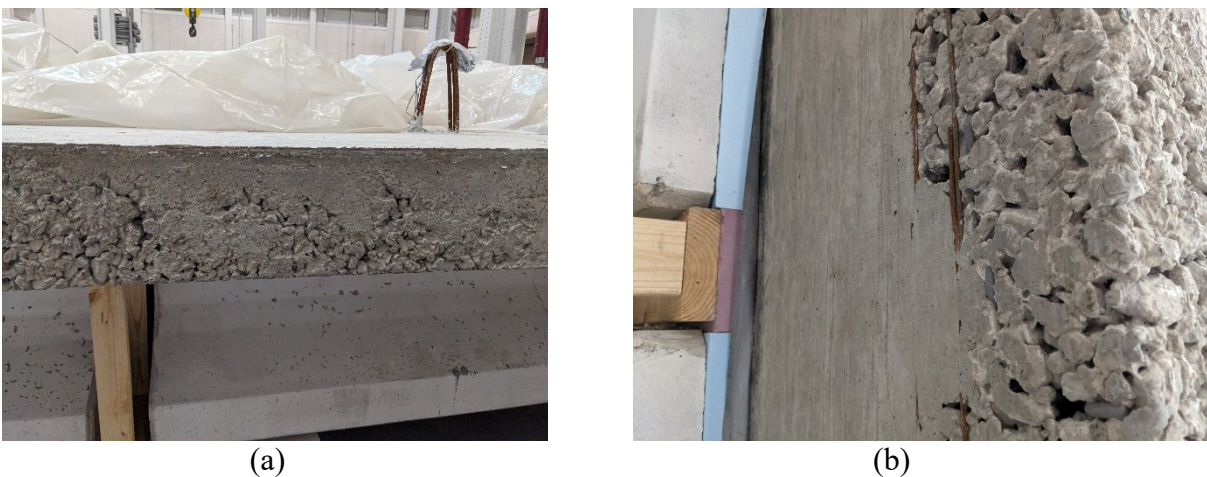
**Figure 9.34. PBJ-CP1 honeycombing in south overhang prior to repair.**

Concrete was placed on May 3, 2023. Concrete was placed from west to east for simplicity of construction. When formwork was removed, researchers saw that the south overhang at the link slab center was not well vibrated, leading to honeycombing. Figure 9.34 shows the honeycombing prior to repair following the specifications of the TxDOT Concrete Repair Manual (2021). During testing, no adverse effects of the repair were noted.

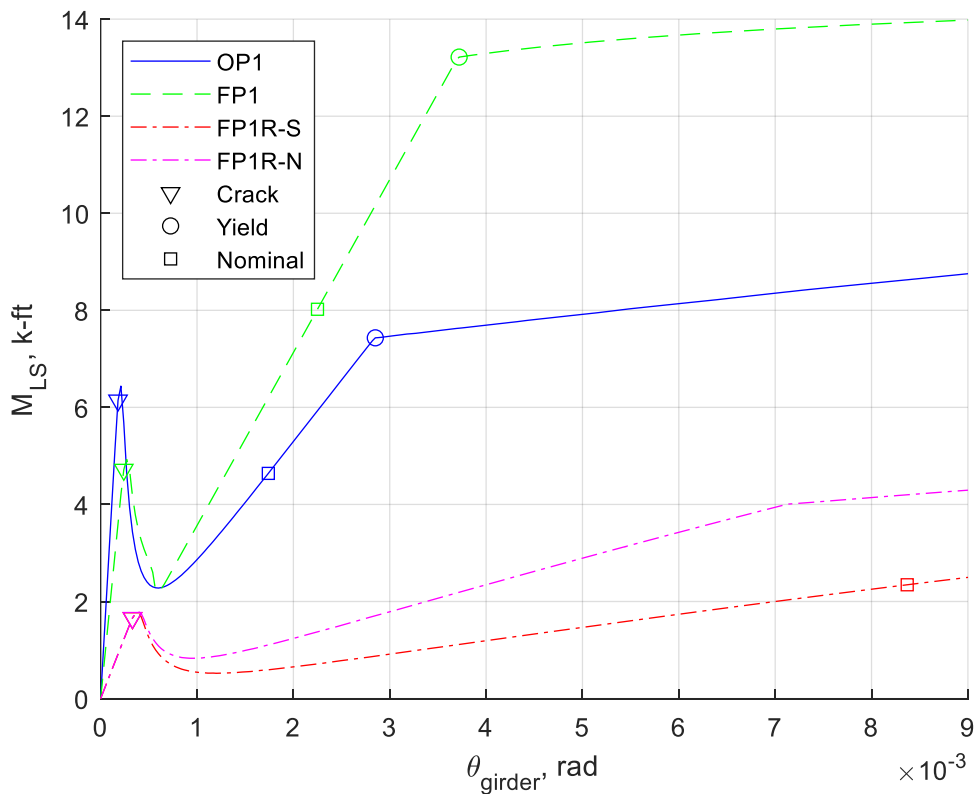
**Figure 9.35. Moment-rotation response of link slab for design material properties and assumed link slab length of 12 in.**

Figure 9.35 provides a preliminary analysis of the expected response of the link slab.

For each response, cracking was marked with a triangle marker, yield with a circle, and 60 percent of yield with a square. For FP1R-N, a yield point is not shown because the strain was not recorded in the supplemental steel. However, the change in stiffness around 0.007 rad was yield of the supplemental steel. Rotation limits were not the maximum capacity but were rather

limited for easy viewing of the difference of responses. All designs were under reinforced and not expected to have deformations approaching anywhere near the crushing limit of the concrete.

The OP1 and FP1 designs had similar cracking rotations, although the cracking moment was larger in OP1. After cracking, FP1 had greater stiffness than OP1, as well as a larger yield moment and rotation. This finding was a result of the supplemental reinforcing bars. In the FP1 responses, the strengths dropped significantly. However, since the design of link slabs is a deformation-controlled design, the strength was not a concern. Compared to OP1 and FP1, the cracking moment and rotation were only slightly larger. However, the post crack stiffness was much lower, resulting in large rotations before the key values for the strain in the steel were reached.

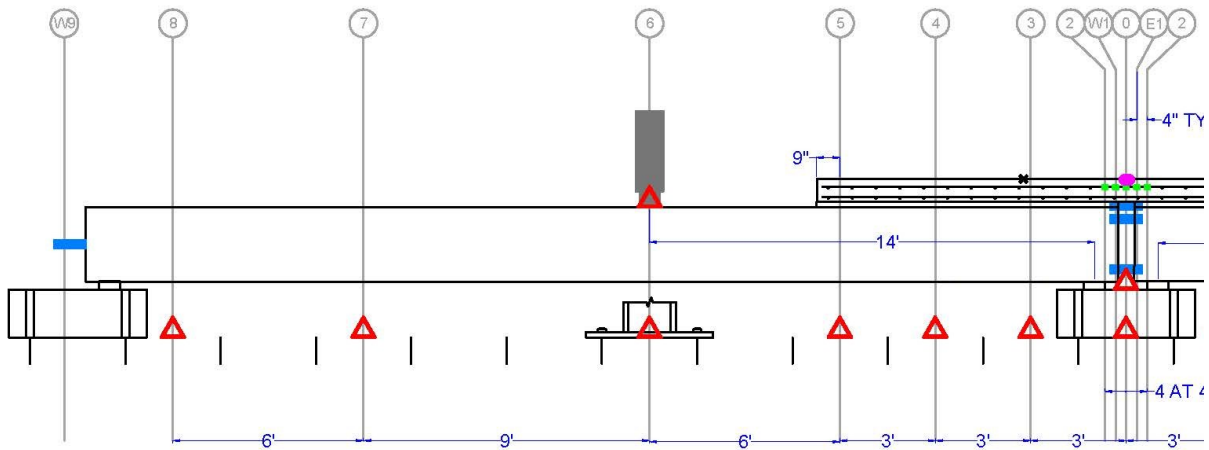
**Figure 9.36. Generic elevation for string pots and LVDTs (single full span shown with portion of other span; blue rectangles represent LVDTs, and red triangles represent string pots).**

Despite the rotation being the dominant response of interest, deformation of girders is the typical measure used to report results for link slab tests in previous literature, so this information was collected to provide a comparison to other tests. Girder deformation can also be useful in estimating the distribution of forces in the indeterminate system and can provide an additional estimate of girder end rotation. Figure 9.36 shows the general layout of string pots for a single girder in the setup.

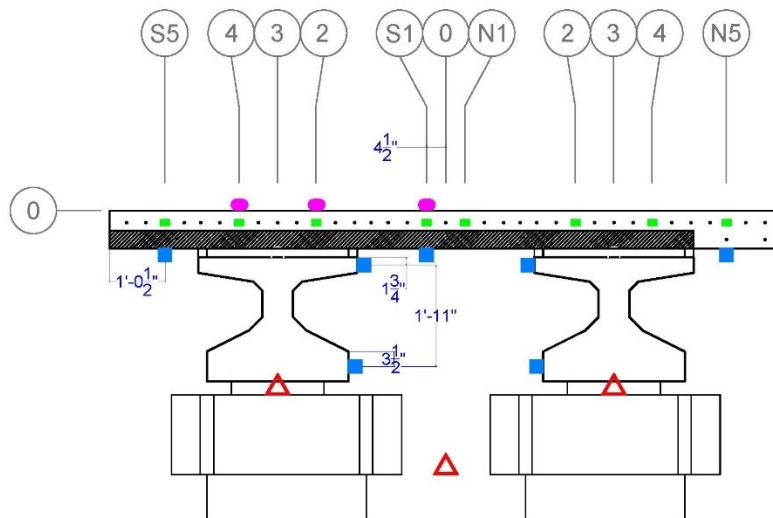
**Figure 9.37. Instrumentation on general cross-section (FP1 shown; blue rectangles represent LVDTs, pink ovals represent concrete surface gages, green rectangles represent steel strain gages, and red triangles represent string pots).**

Internal strain gages were placed on the longitudinal steel in the link slab region. General plans for offset and flush panel designs are shown in Figure 9.37. Exact plans varied for each specimen. Strain gages were provided on the top bars in both options, with bars instrumented over the girders, between the girder lines, and in the overhang. All instrumented bars had gages at the center of the continuous deck. Additional gages were located 4 in. and 8 in. from the center (except FP1R overhangs). However, these were not provided on both sides of all bars due to the need to limit strain gage channels. With the exception of one bar in PBJ-FP1R, all bars instrumented were main longitudinal bars; in PBJ-FP1R, one 5-ft long bar was instrumented. In the offset panel tests, reinforcement was also provided on bottom longitudinal reinforcement to provide additional information for developing strain profiles in the link slab.

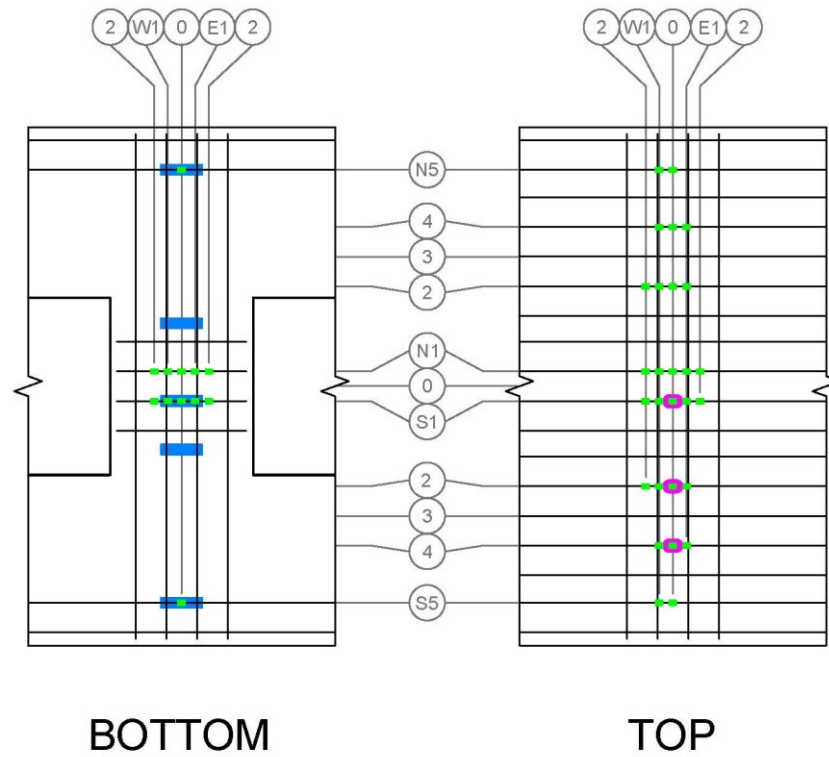
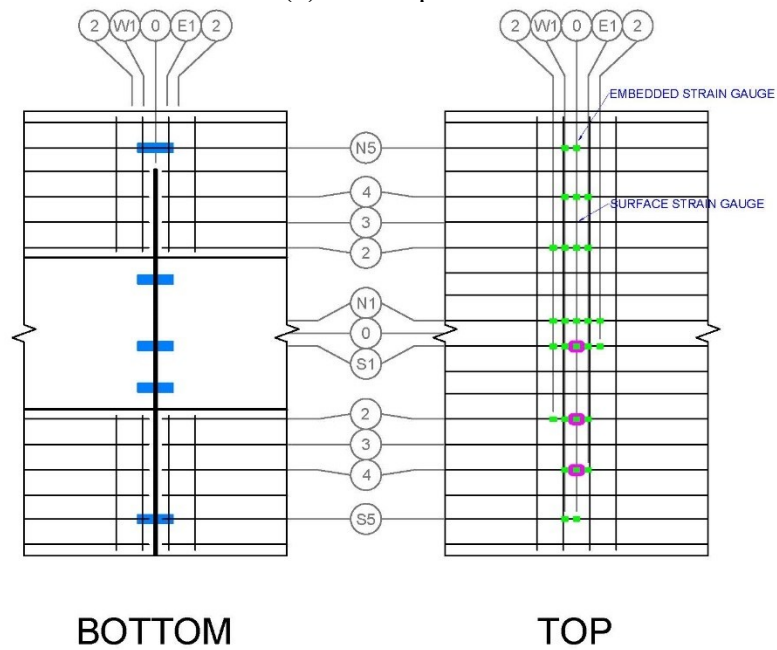
(a) Offset panels

(b) Flush panels

**Figure 9.38. Generic plan for concrete strain gages and LVDTs for surface strain and steel strain gages in (a) offset panel designs and (b) flush panel designs (blue rectangles represent LVDTs, pink ovals represent concrete surface gages, and green rectangles represent steel strain gages).**

Figure 9.38 provides generic plans for measuring surface strains. Figure 9.39 shows an example installation of a gage. As best possible, the surface strains were at the same transverse locations as the steel strain gages to allow for assessment of strain profile. Measurements were all at the longitudinal center of the continuous deck. On the top of the deck, strain gages were used accordingly. Strain gages were not practical on the bottom due to the board (flush panels) or notch (overhang and offset panels), so LVDTs were used to measure the relative displacement of either side of the center for use in estimating strain.

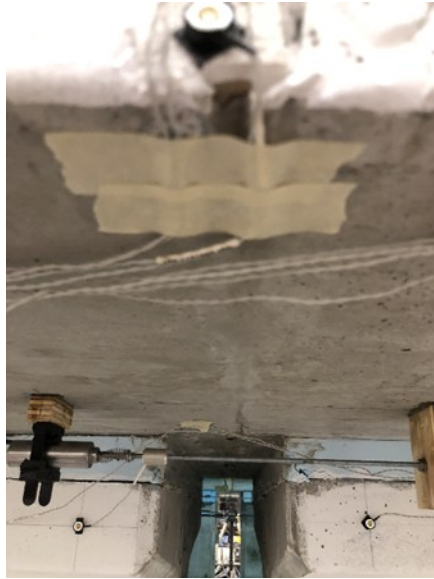
**Figure 9.39. Surface strain measurements on bottom of deck using LVDTs.**

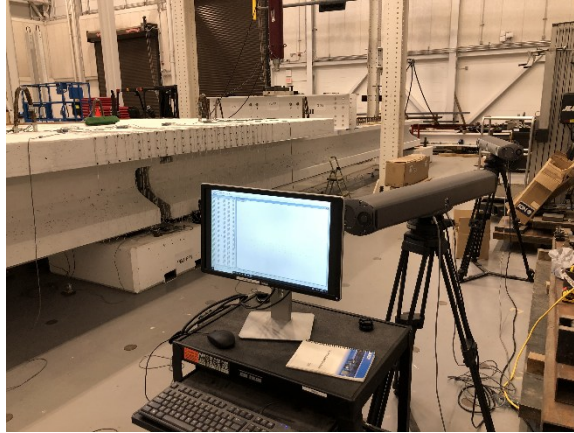
**Figure 9.40. Setup of Optotrak cameras (shown for PBJ-FP1).**

Figure 9.40 shows the general configuration of the cameras and the field of view. Two cameras were used with overlapping volume. When the cameras' fields of vision were registered together, they provided an expanded single field of view. The cameras were generally set up 9 ft apart at a distance 7 ft from the edge of the deck. This provided a coverage of 8.5 ft along the edge of the deck with an error of approximately 0.44 mm (0.017 in) (varied exactly based on each setup). The south overhang of the deck was monitored with the Optotrak.

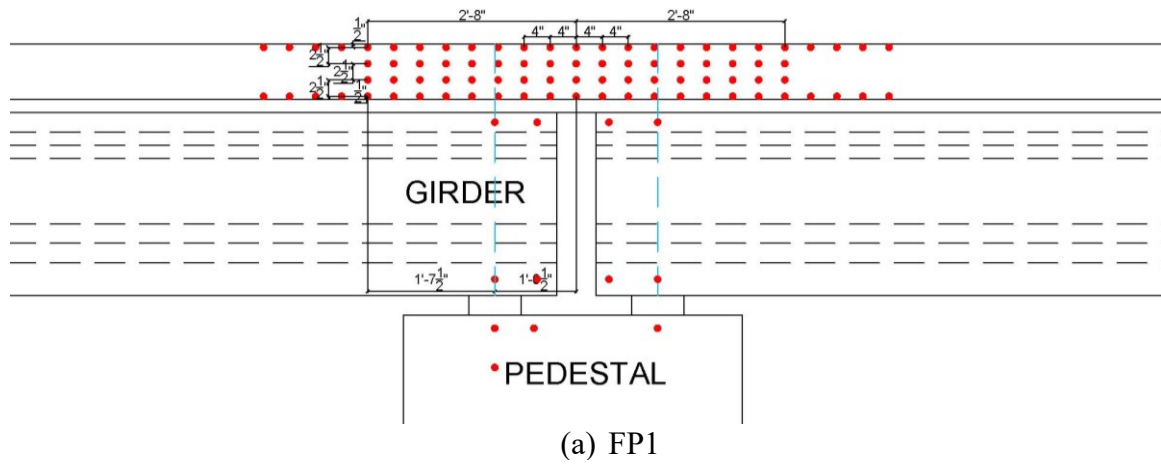
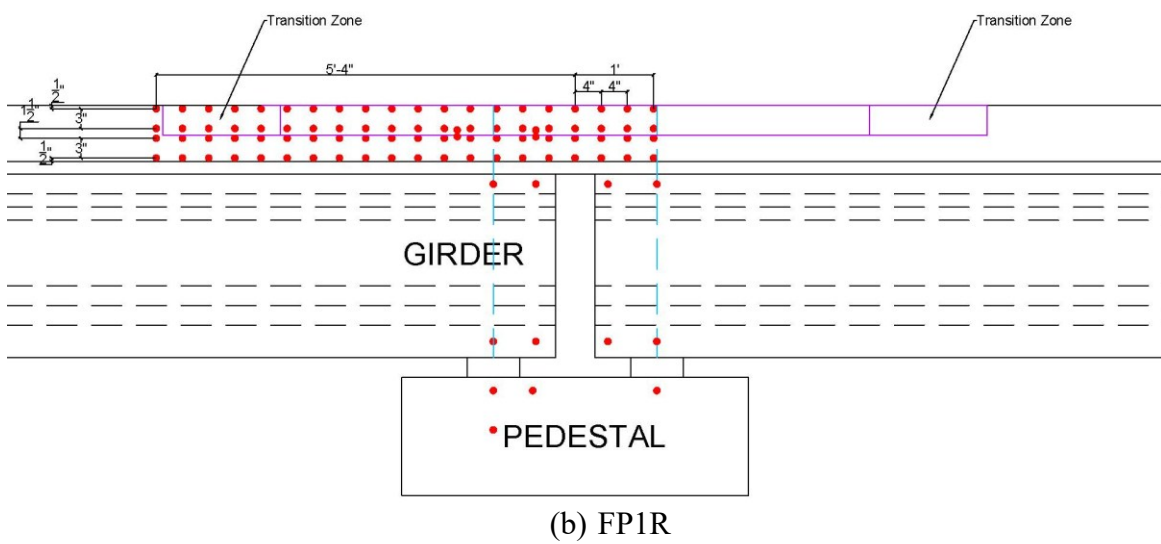
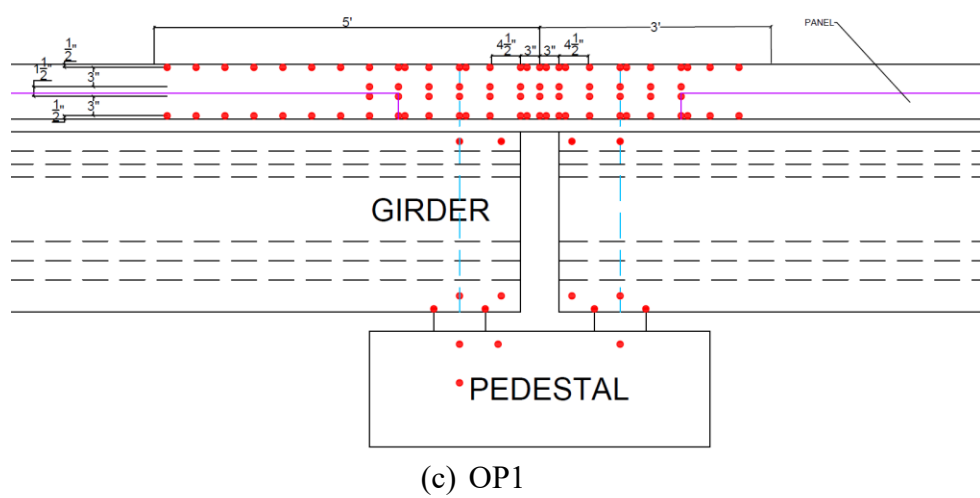
**Figure 9.41. Optotrak grid of targets for each test.**

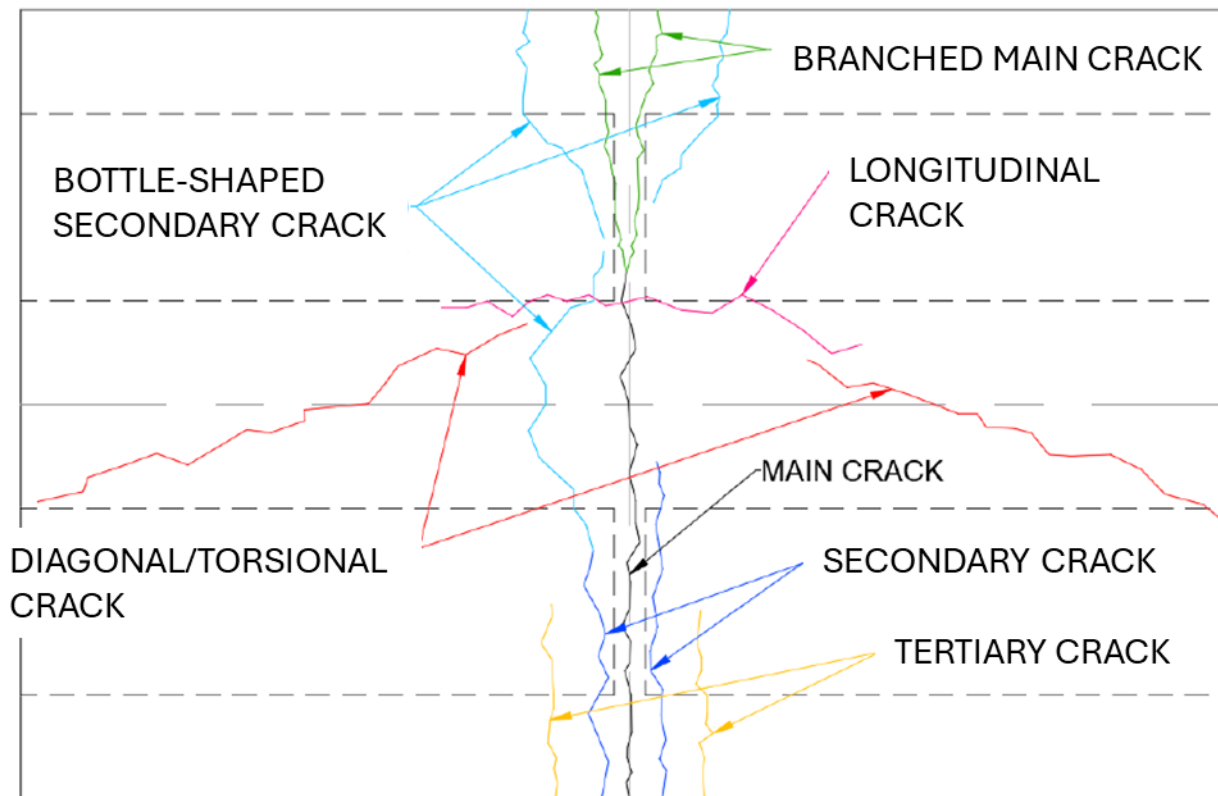
Figure 9.42 shows a generic drawing of a link slab with various types of cracks marked. Labels indicate the terminology used to describe each type of crack:

- **Main, or PBJ**—Main cracks are transverse cracks located at approximately the center of the continuous deck. These cracks are also referred to as poor boy joint cracks, or PBJ cracks, at various times in the project report.

- **Offset main**—Offset main cracks form in the continuous deck but are offset from the center, typically over the end of the girders. Often these are found in pairs, but they may be solo. If found in conjunction with a centered main crack, cracks over the ends of girders are considered to be secondary cracks.

- **Branched main**—In the overhangs, the main cracks can be angled slightly and have two branches; these are referred to as branched main cracks. In the discussion of each portion of the branch, the cardinal direction indicating side of the main crack is specified. In the case of the experimental tests, these are east branch or west branch.

- **Secondary**—Cracks that form parallel, or primarily parallel, to the main, offset main, or branched main cracks, are referred to generically as secondary cracks.

- **Bottle-shaped secondary**—These secondary cracks are at varying distances from main cracks and/or have portions that are at an angle relative to the original cracks

- **Longitudinal link slab, or longitudinal PBJ**—Cracks that form perpendicular to, or nearly perpendicular to, the main cracks are referred to as longitudinal link slab, or longitudinal PBJ cracks. In field observations, these are typically associated with skewed bridges. In documenting damage in the tests, these are primarily associated with asymmetric loading of girder lines.

- **Diagonal or torsion**—These cracks run diagonal (transverse and longitudinal components) between the interior edges of the girders. They are outside the main link slab region of interest. Diagonal cracks in the overhangs in or near the continuous deck are referred to more specifically by the prior definitions of cracks (branched main and/or secondary cracks).

**Figure 9.42. Examples of crack types used in describing damage in the link slabs.**

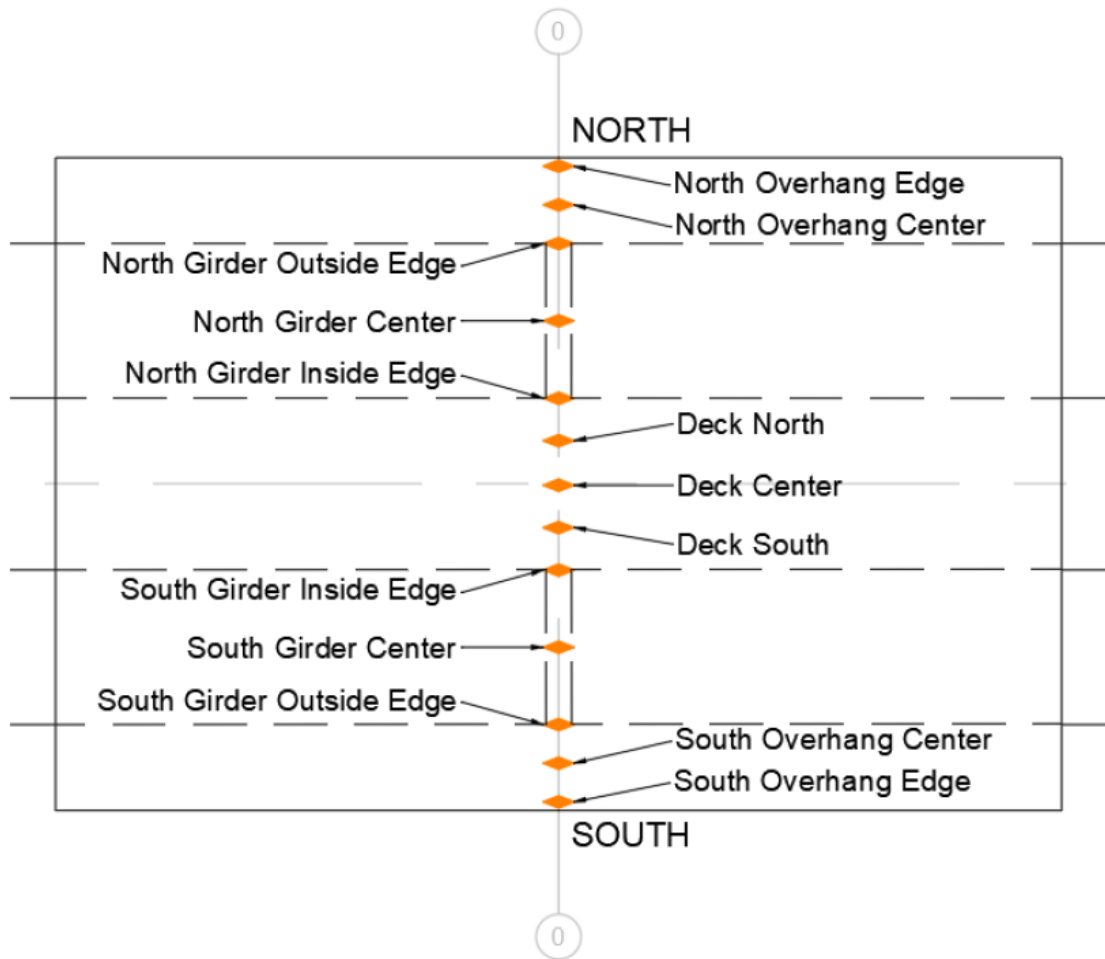
Figure 9.43 shows the locations of these measurements and the name used to describe them in presentation of the results. Primarily, the measurements were taken on the main crack. In overhangs where a branched main crack formed, measurements were taken at both branches. Where secondary, longitudinal, or diagonal cracks formed, more limited crack measurements were taken.

**Figure 9.43. Locations of crack width measurements on top of deck.**

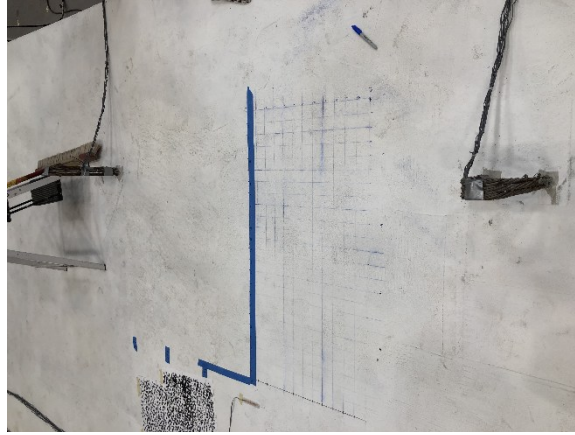
Prior to and/or after the tests, small regions of the decks were evaluated using nondestructive evaluation methods used in the prior part of the project. NDE methods used were GPR and UST. The goal was to try to capture how well the CIP concrete was bonded to the existing concrete prior to testing, and to see if there were any changes during the test. Figure 9.44 shows the location of NDE on each specimen.

In PBJ-FP1 and FP1R, a 2-ft by 4-ft grid was located over the northwest portion of the link slab. The edge was along the main crack and adjacent to the DIC region so that the grid would not interfere with the DIC processing. NDE data were collected prior to the first test and after the final test in FP1, and after the final test in FP1R.

**Figure 9.44. Locations of NDE grids.**

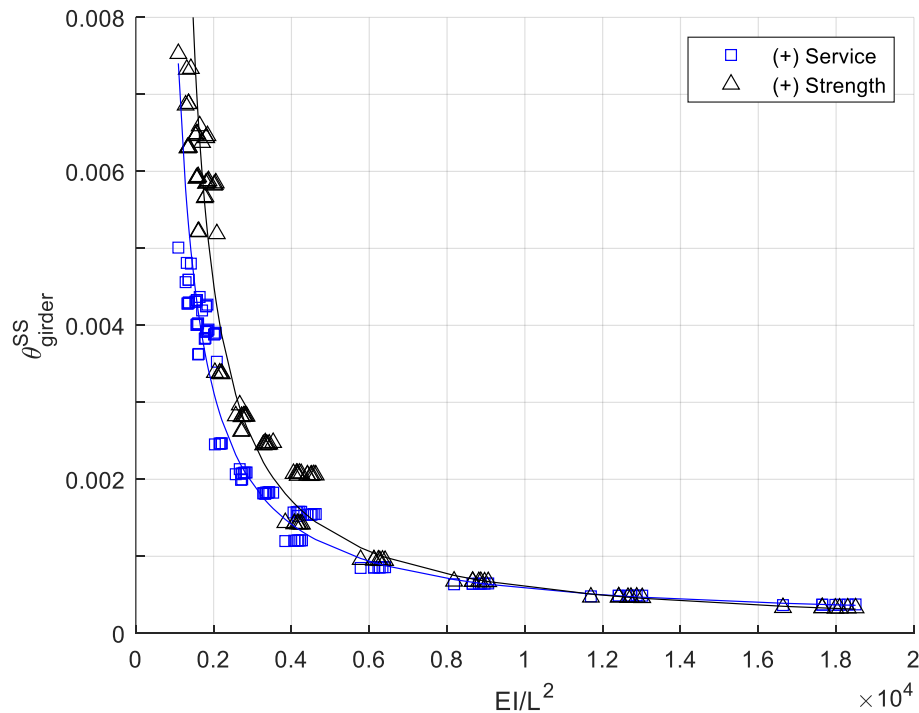
**Figure 9.45. Girder end rotations for design of TxDOT standard I-girder bridges (only positive bending shown).**

During the testing, decisions were made based on comparing the experimental rotations to the service design values. There is a gap of data points between rotations of about 0.0025 to 0.0035 rad. The larger values are generally associated with the longest practical spans for each girder size. A breakdown of values discussed in Section 7.1 indicates that these are due to large rotations that exceed what many researchers recommend as an upper bound of live load rotations (0.00375 rad). In many cases, the larger service rotations may not be the most realistic demands. Thus, two limits are considered. The first is 0.003 rad, which is referred to as the upper-bound design rotation for most practical bridges. The second is 0.005 rad, which is referred to as the upper bound for the full range of potential I-girder bridges.

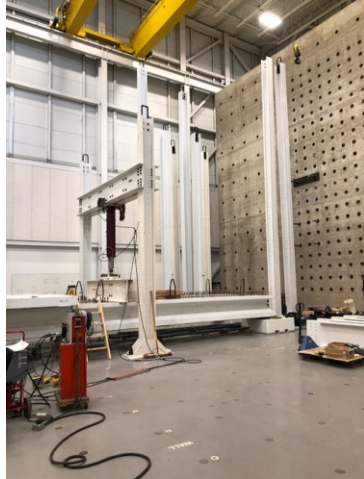
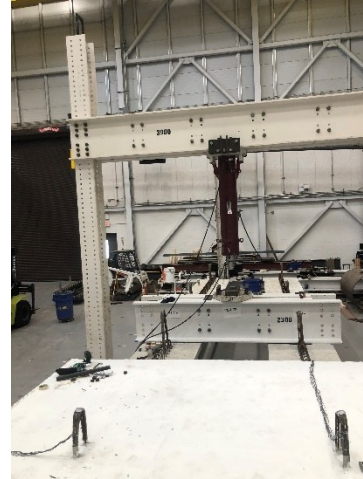
Loads were applied by a single actuator in each span. The west loading frame is shown in Figure 9.46(a). The load was transferred to each girder by a spreader beam, also shown in Figure 9.46(a). The R-bars were cut off in the load zone to provide a flat surface. A 12-in.  $\times$  24-in.  $\times$  1/4-in. 70 durometer pad was placed beneath the beam on each girder to protect the beam from the roughened surface at the top of the girder.

(a) West loading frame

(b) East loading frame with spreader beam

**Figure 9.46. Loading frame and spreader beams for application of loads to each girder.**
