# Performance and Improvement of Texas Poor Boy Continuous Bridge Deck Details: Final Report

Technical Report 0-7013-R1

TEXAS A&M TRANSPORTATION INSTITUTE  
COLLEGE STATION, TEXAS

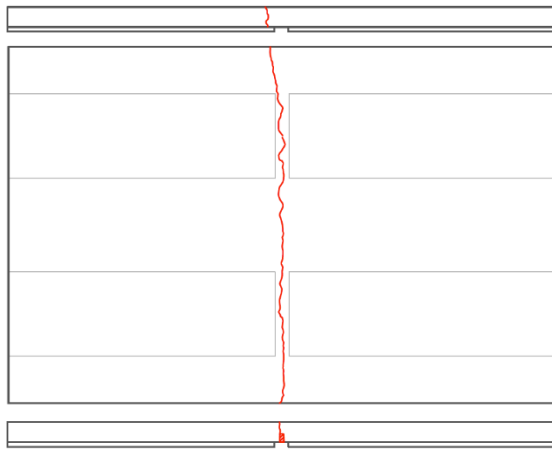
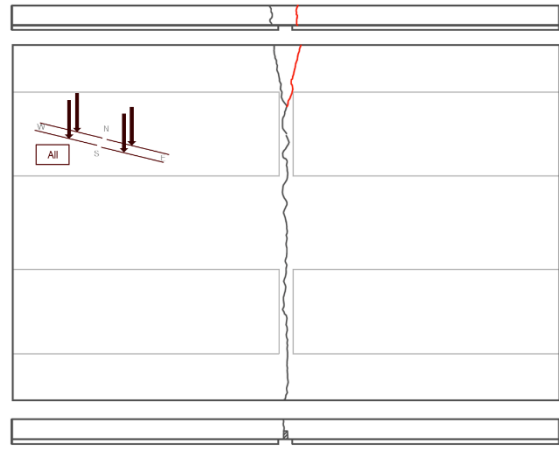
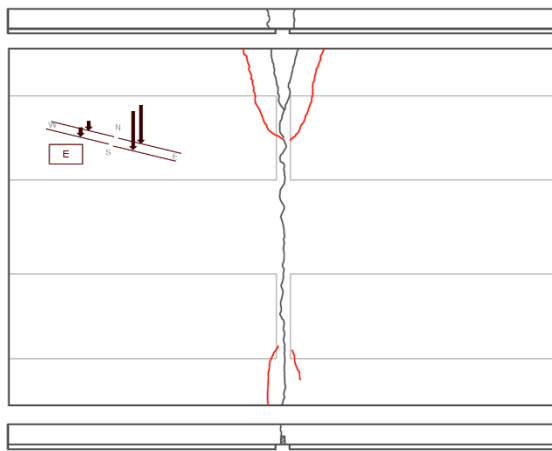
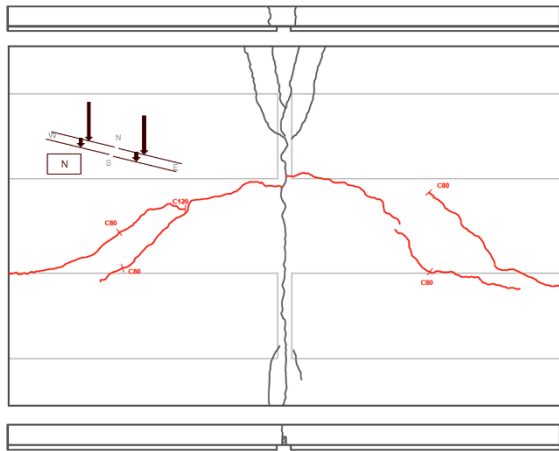
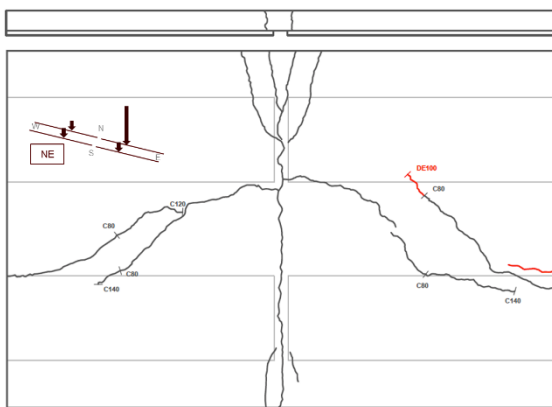
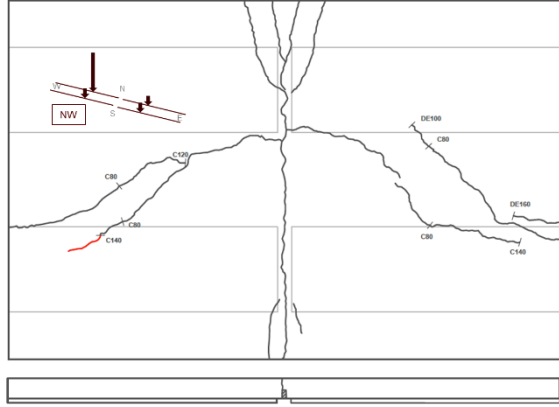
Damage during all load patterns applied to specimen PBJ-FP1 was limited to cracks. Figure 9.47 shows the crack patterns on the top and sides of the deck, with each subfigure showing the cracks at peak load of an individual pattern. Load patterns for which no new cracks formed are not shown. Red cracks are cracks that formed during the specified load pattern. Gray cracks had

formed in previous load patterns or prior to testing. Girder cracking, when it occurred, is noted in the written descriptions here, but since damage is not relevant to the behavior and performance of the link slabs, details such as widths and crack maps are not included.

**Figure 9.47. PBJ-FP1: Crack patterns at various stages of testing.**

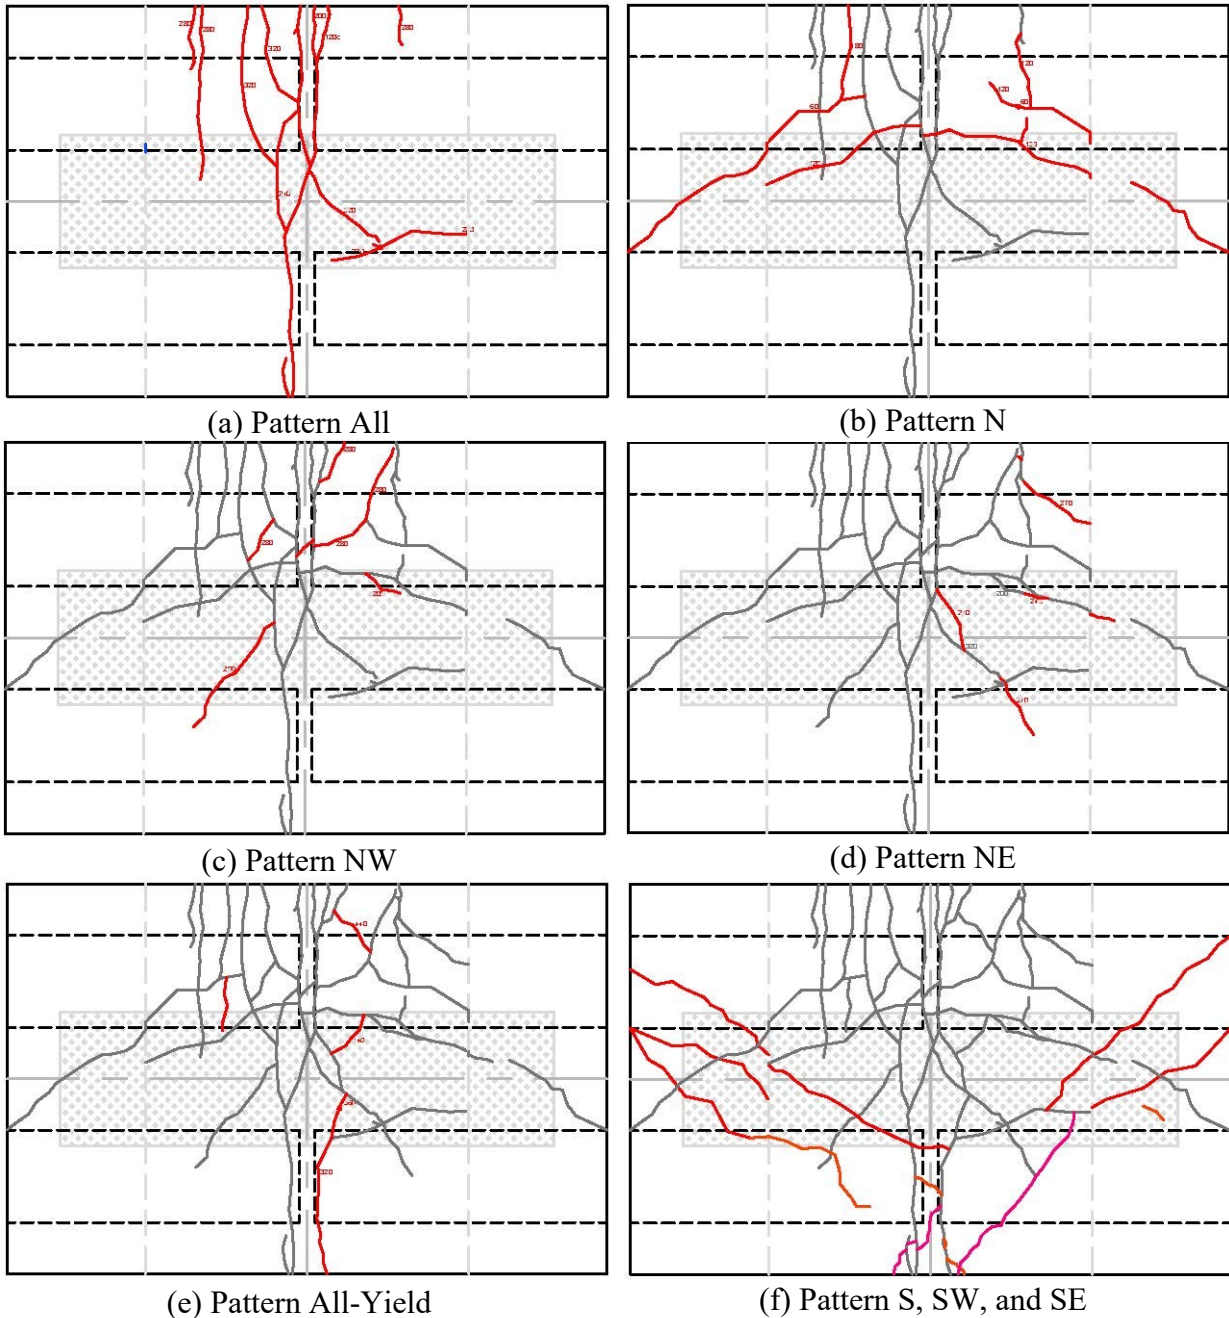
Figure 9.48 shows the crack pattern from all load patterns. Load patterns for which no new cracks formed are not shown. Girder cracking, when it occurred, is noted in the written descriptions here.

**Figure 9.48. PBJ-FP1R: Cracks for all load patterns.**

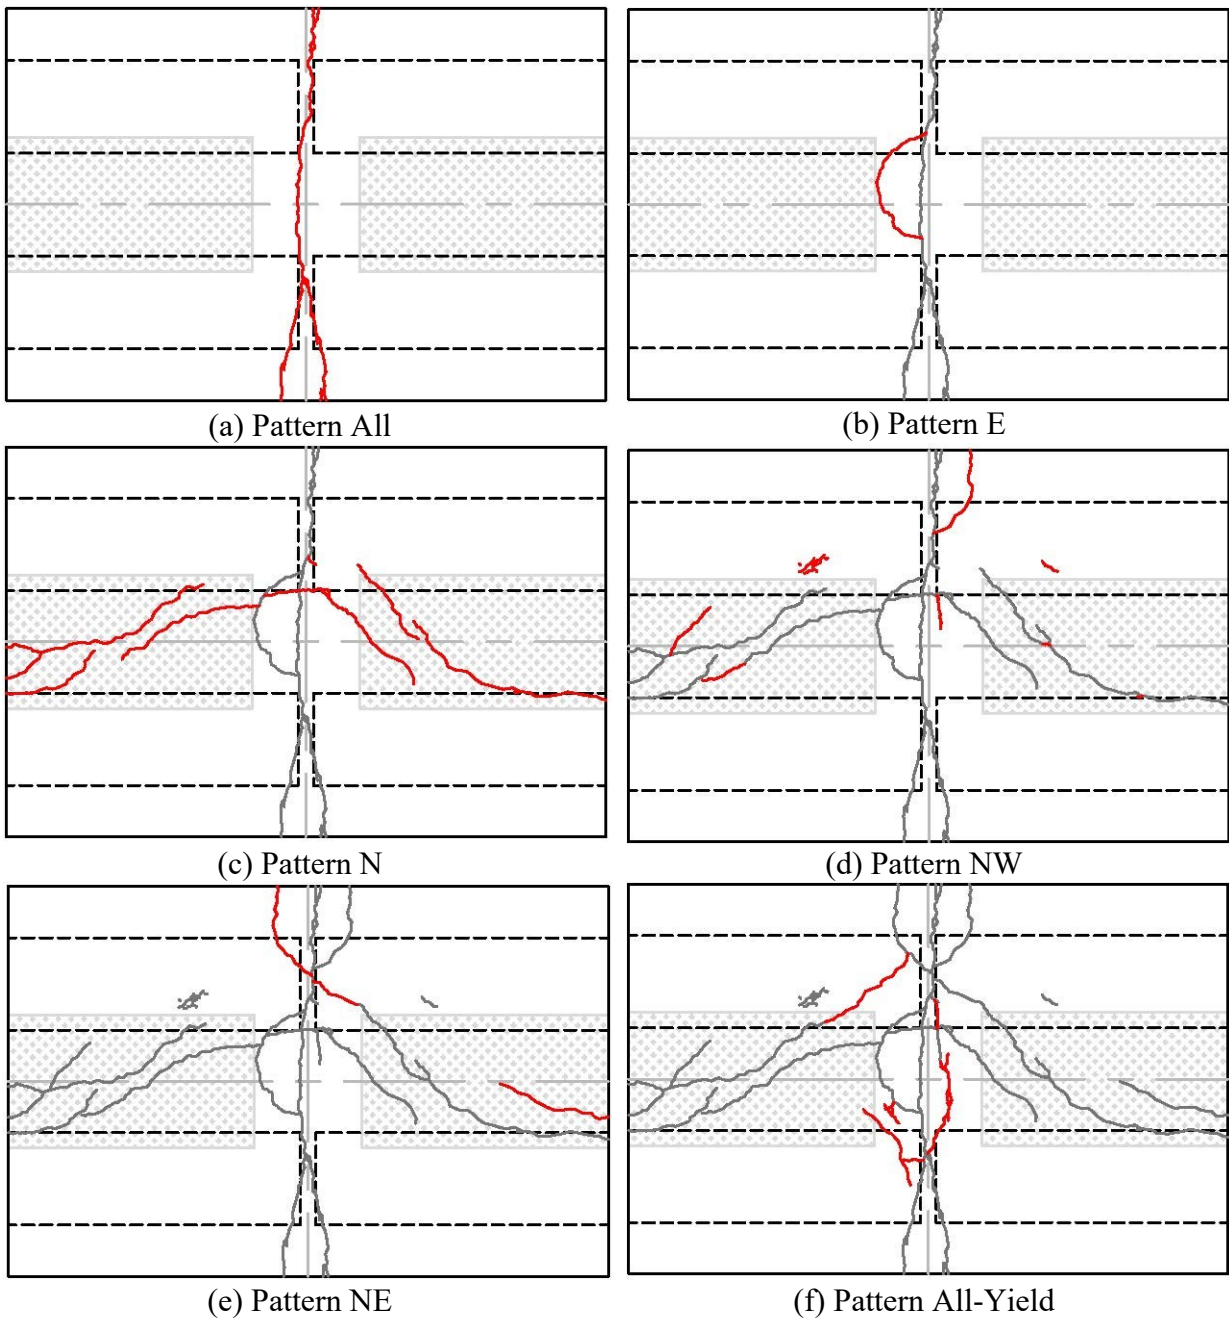
Figure 9.49 shows the cracks for all PBJ-OP1 load patterns. While there were no cracks present before testing, initial cracking occurred very early at a load less than 20 kips during the initial loading, Pattern All-1. The initial crack spanned the full width of the deck over the interior flanges of girders and between the girder lines. The crack angled inward at the center of the girders, crossing over the center of the link slab and continuing on the east side. On the south overhang, the crack presented as a portion of a branched main crack (angled near girder and transverse at edge). On the north overhang, the crack was an offset crack (primarily transverse). Both overhang cracks had a small branch or parallel crack adjacent to them. During the pause at 120 kips, another branched main crack formed on the south overhang, this time on the west side, at a distance farther from the center than the east branch crack.

**Figure 9.49. PBJ-OP1: Cracks for all load patterns.**

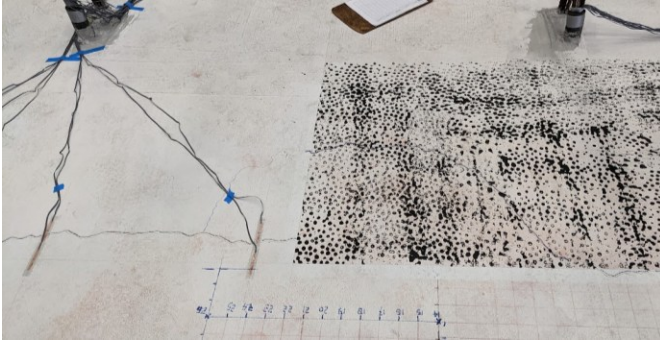
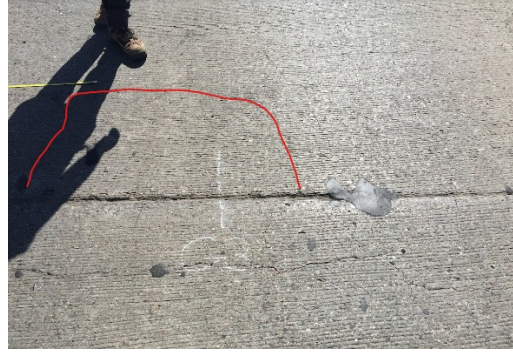
During the initial asymmetric patterns, only one new crack formed. In Pattern E-1, a D-shaped crack formed on the west side of the link slab center (Figure 9.50). The D was not centered transversely, with the north leg over the girder flange and the south leg slightly north of the south girder edge. The transverse portion of the D was located over the edge of the panel. The crack was hairline at formation and fully closed after unloading. This was the first such damage observed in the experimental test but was similar to damage that was seen on one bridge in field evaluations.

**Figure 9.50. PBJ-OP1 D-shaped crack: (a) formed during Pattern E-1 and (b) similar damage observed in LUB4.**

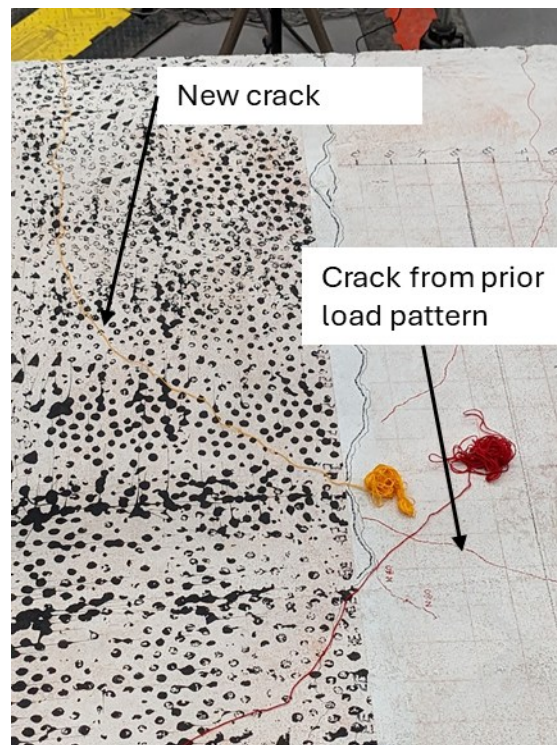
**Figure 9.51. PBJ-OP1: North overhang cracks formed during Pattern NW-1 (red sharpie) and Pattern NE-1 (gold string) (right edge of speckled region is center of link slab).**

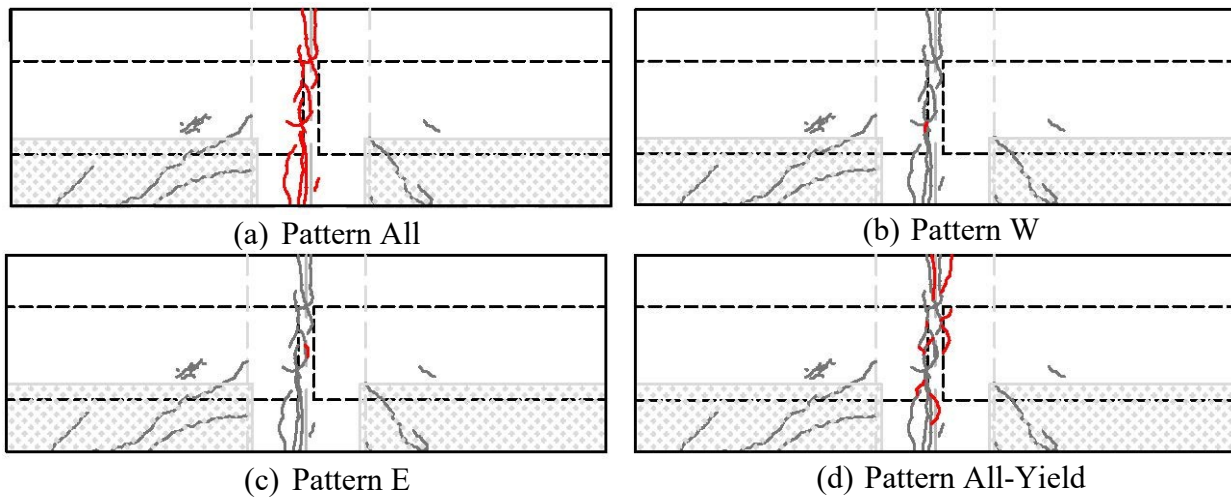
Figure 9.53 shows the cracks for all load patterns applied to PBJ-OP1R. Existing cracks, including those in the south half of the deck, are shown in gray.

**Figure 9.53. PBJ-OP1R: Cracks for all tests, with hatched region not tested (gray cracks are from prior test [PBJ-OP1]).**

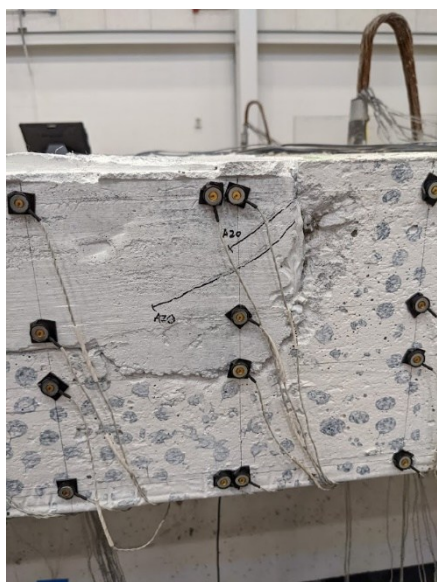
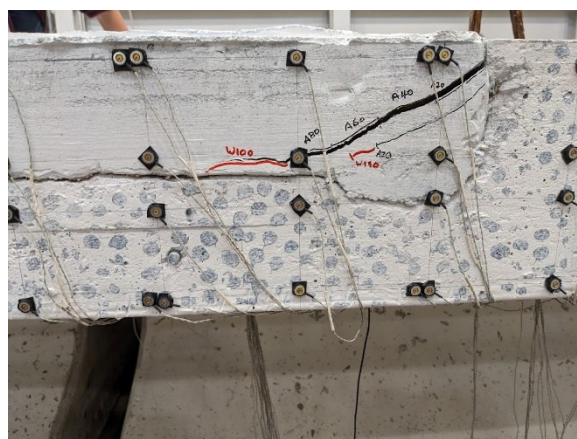
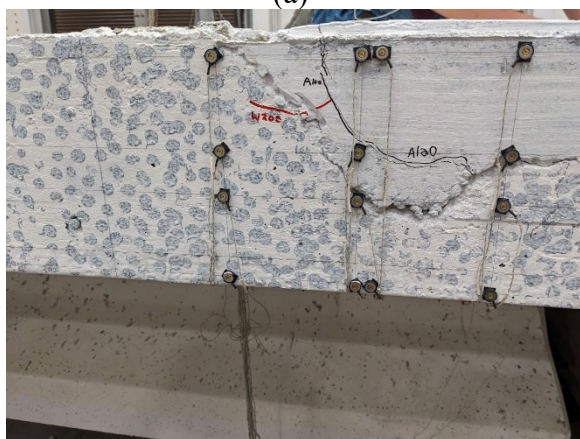
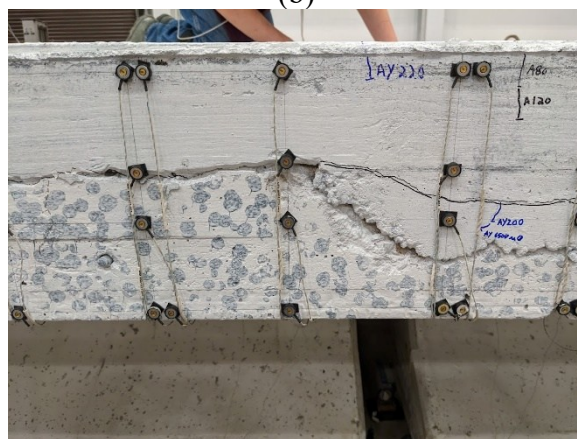
The deck edges were visible only on the north edge because the south girder and deck from PBJ-OP1 blocked the view of the south edge. On the north edge, a diagonal crack was observed on the west end of the HPC region (Figure 9.54[a]). The initial crack was observed at 20 kips in Pattern All-1, with a more dominate adjacent crack appearing in the subsequent 40-kip pause. Further extensions were observed throughout the remainder of the pattern. A similar crack was observed at the east end at loads of 100 kips and 120 kips. Also at 120 kips, a horizontal crack was observed at the interface between the new and existing concrete.

On the edge of the deck, the damage at ends increased in the west end (Figure 9.54[b]). In the east end, cracks formed near the interface widened to a much smaller extent (Figure 9.54[c]). Figure 9.54(d) show the depth of the surface cracks on the north edge extended only a couple of inches toward the bottom of the deck, with many much shallower. This was a noticeable improvement of performance over that of PBJ-OP1, where the depth of the cracks was nearly to the bottom of the deck. New cracks were observed at a depth consistent with the existing deck, but since the concrete was HPC that slipped through the formwork, it was not clear if the crack was in the existing concrete.

**Figure 9.54. PBJ-OP1R—north overhang of HPC retrofit region: (a) diagonal cracks formed at west end during loading to 20 kips of Pattern All-1; (b) west end after all loading; (c) east end after all loading; and (d) shallow vertical cracks at center of slab after all loading.**

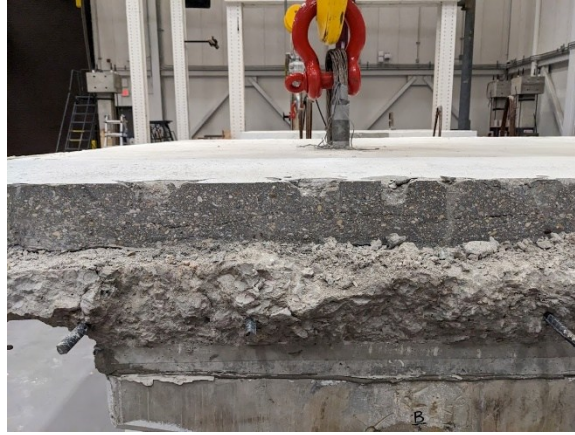
Following testing, the girders were separated for removal from the lab. A partial-depth saw cut was made on both sides of the center. The HPC concrete was sufficiently debonded from the bottom of the deck so that the section of HPC between the saw cuts could be removed by prying with a crowbar. The remaining concrete was removed with a jackhammer, which caused sufficient damage. A post-demo autopsy could not provide useful information on the damage in areas not visible during the testing. One area that was useful to examine post-demo was the cross-section of the east girder, shown in Figure 9.55. A horizontal crack was seen mid-depth of the HPC.

**Figure 9.55. PBJ-OP1R: Post-test demolition view of concrete over east girder showing horizontal crack at mid-depth.**

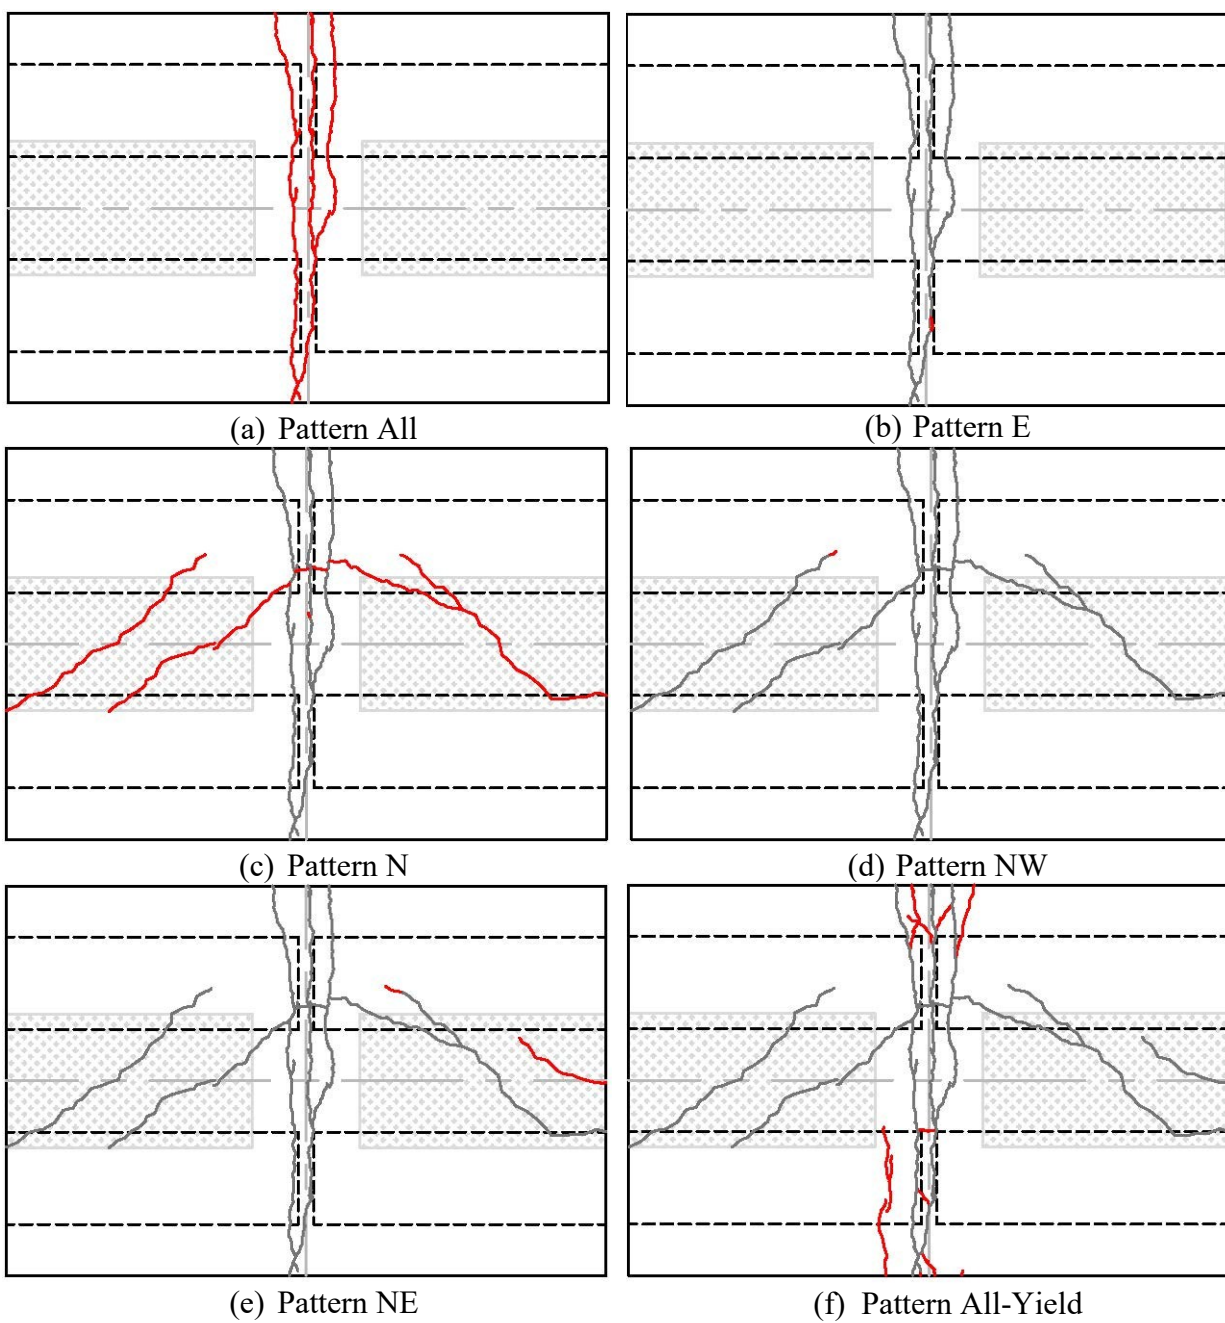
No cracks were present before testing PBJ-OP2. The initial cracks were observed at the 40-kip pause during Pattern All-1. This was a slightly larger demand than for PBJ-OP1. However, given the stiffer girders of the PBJ-OP2 specimen, it was necessary to evaluate initial cracking relative to girder rotations. The cracks on the top of the deck after all load patterns are shown in Figure 9.56.

**Figure 9.56. PBJ-OP2: Cracks for all load patterns.**

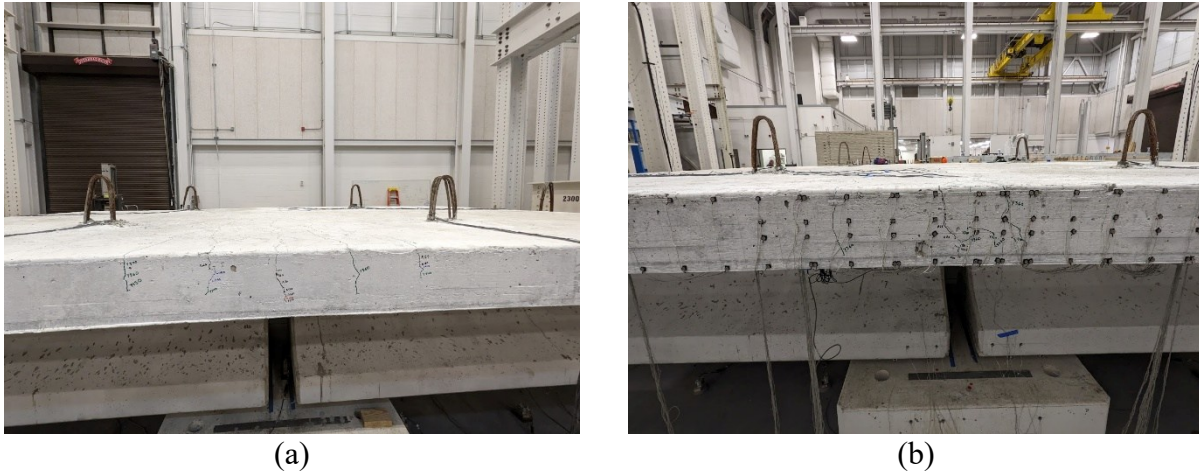
Cracks on the edges of the deck are shown in Figure 9.57. During the asymmetric patterns, cracks extended slightly toward the bottom on the north edge but did not extend on the south edge, although the overall depth was greater on the south edge following Patterns All-1, W, and E. During Pattern All-Yield, minor increases in depth occurred on the north main crack (to 2 in. from bottom of deck), with larger extensions on the north secondary/tertiary cracks (up to mid-depth). No extensions were seen on the south edge during Pattern All-Yield; however, after Pattern E-Yield, the crack became full depth. The load at which this occurred was not known; however, it provides evidence that full-depth crack occurrence may be caused by asymmetric span loading.

**Figure 9.57. PBJ-OP2: Deck edge cracks following Pattern All-Yield on (a) north half of deck and (b) south half of deck.**

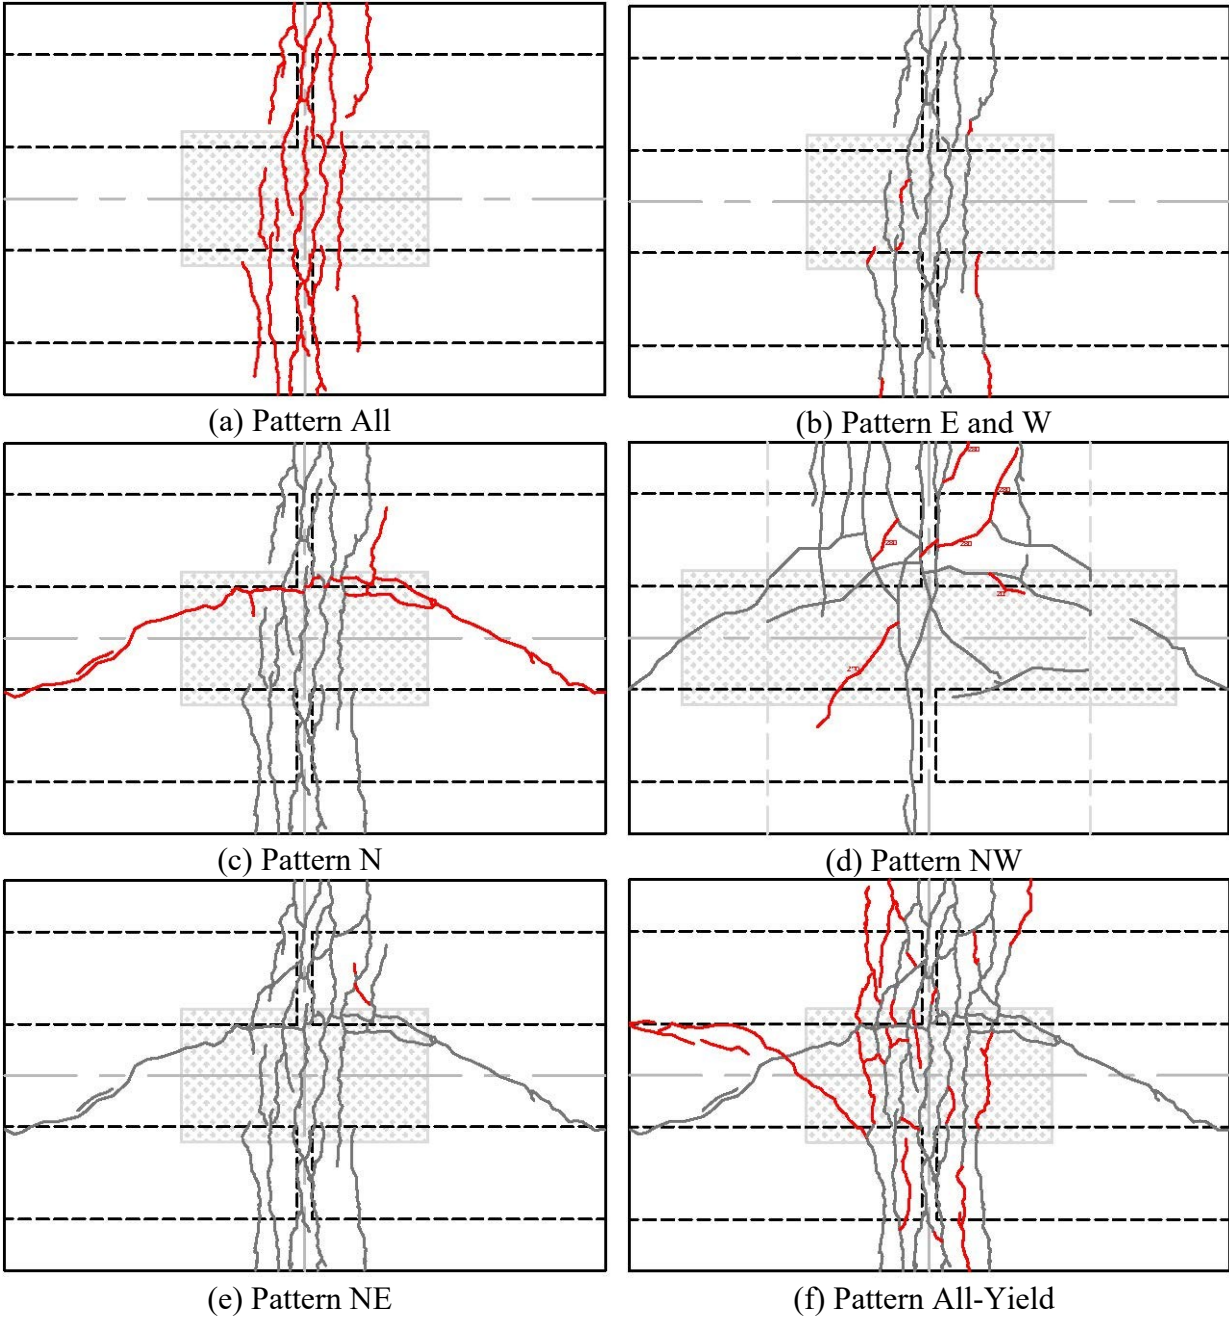
Figure 9.58 shows the cracks from all load patterns.

**Figure 9.58. PBJ-CP1: Cracks for all load patterns.**

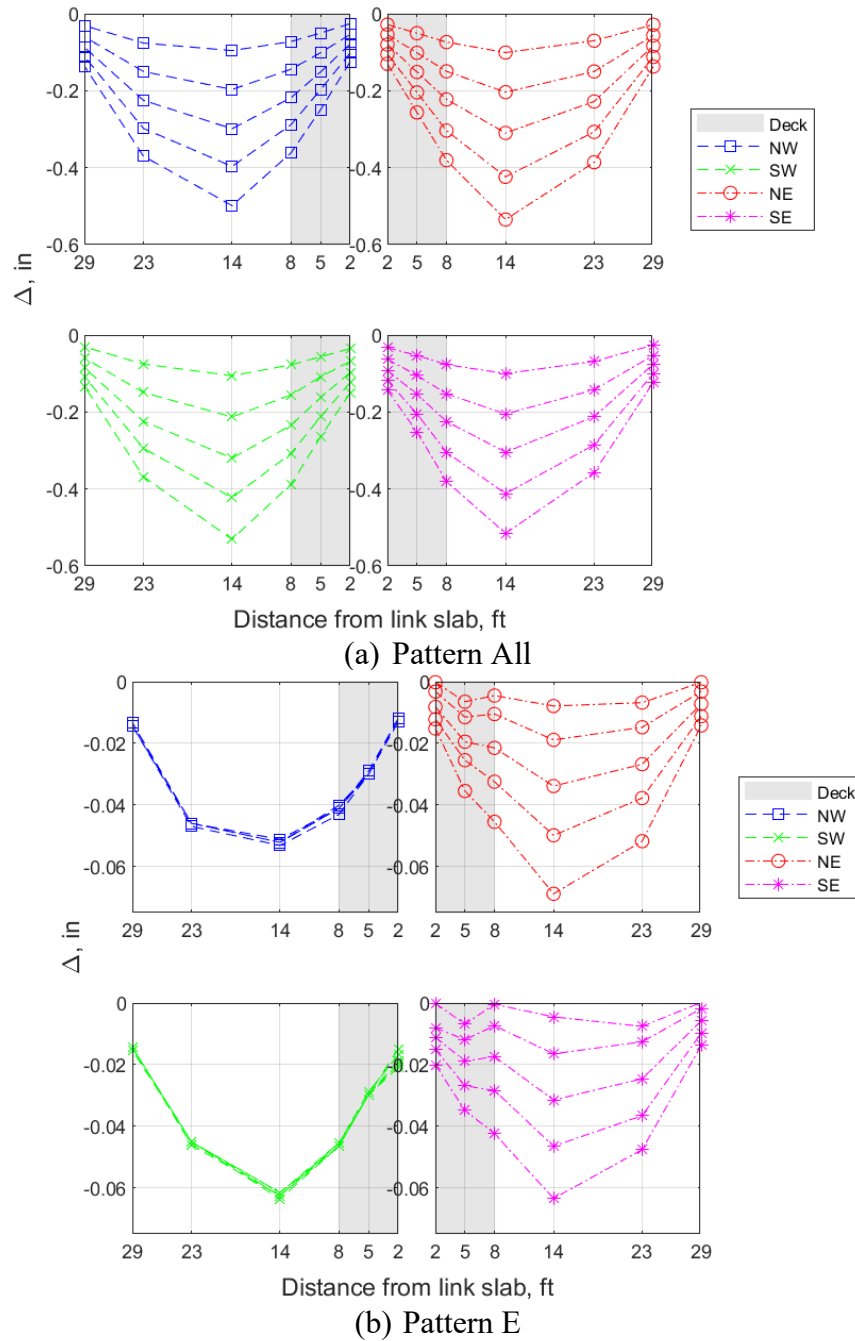
String pots were placed along the length of each girder to measure the vertical displacements. Displacements of the girders are not a quantity of interest in the understanding of the link slab response. However, an examination of the deformed shapes provides a validation that the system is responding as intended. Figure 10.1 shows the displacement profiles for PBJ-FP1 Pattern All-1 and Pattern E. Each subplot is a girder, with gray background showing the region with deck. Multiple lines are shown for each girder. These are arbitrarily selected at equal load increments throughout the test. After all tests are completed, displacement profiles will be examined to identify any unique behaviors. Finally, the displacements in each girder can be used to more accurately estimate the load in each girder. For Patterns All/E/W, the actuator is centered and should theoretically lead to one-half the load in each girder.

**Figure 10.1. PBJ-FP1: Girder displacement profiles at select loads.**

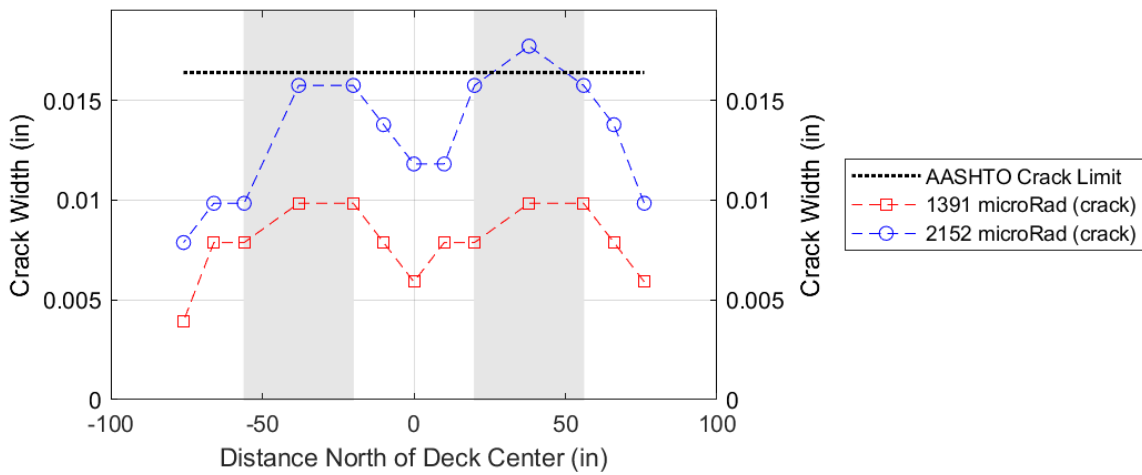
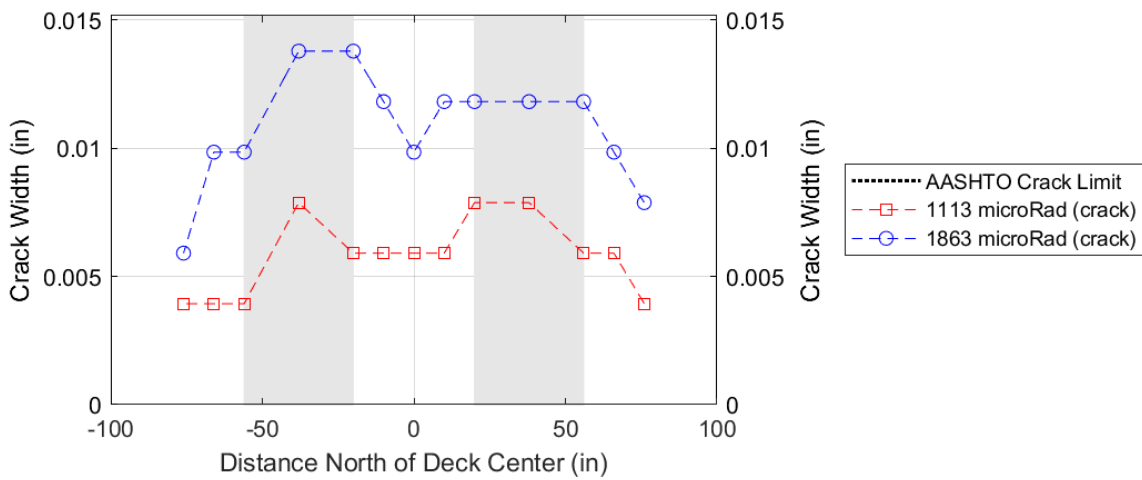
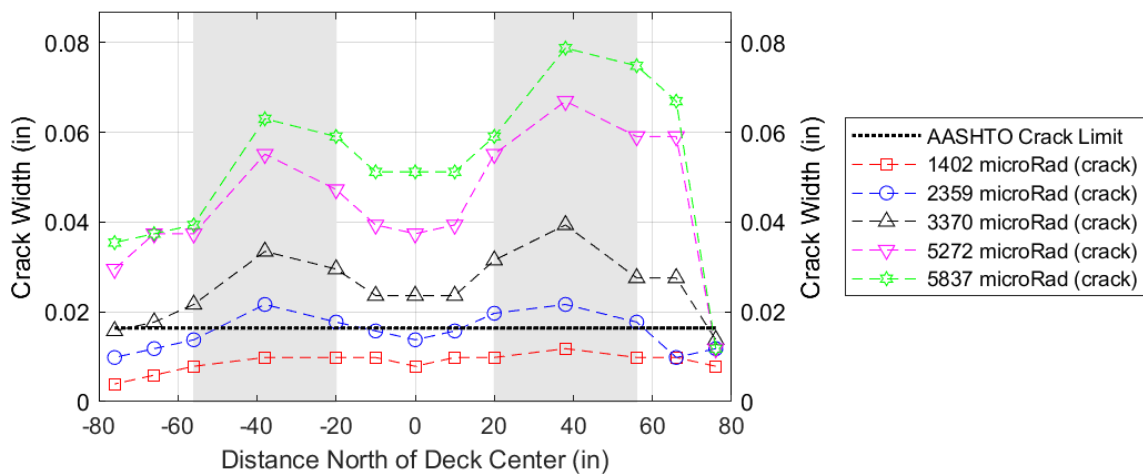
(a) Pattern All

(b) Pattern W

(c) Pattern All-Yield

**Figure 10.3. PBJ-OP1: Crack width profiles for select patterns.**

Figure 10.3 provides crack widths for PBJ-OP1, the design with the current TxDOT offset panel detail. Crack widths are generally the same shape for all patterns and rotations presented. The crack widths are larger over the girder than between the girders or in the overhangs; this is opposite that of PBJ-FP1. The widths are slightly larger over the north girder. While there are slight differences in the reinforcement (north girder has bottom bars over the girders, while the south does not), it is not believed that this influences the crack widths. Instead, the crack pattern shows that there is a single crack over the north girder line, while on the south side, the main crack in overhang is a branched main crack with the branch starting near the center of the girder line, so there are two locations for deformation to impact the crack width.

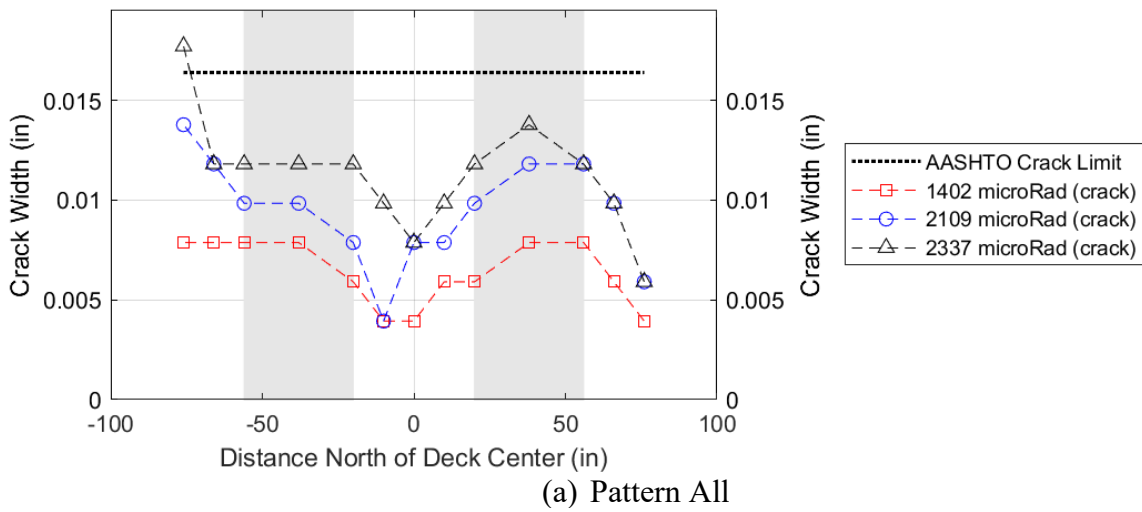
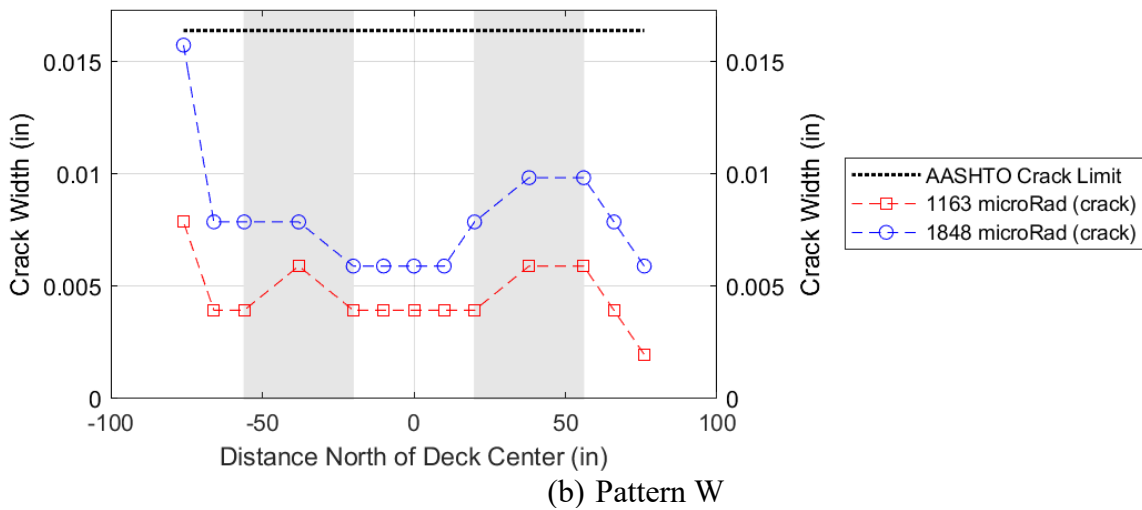
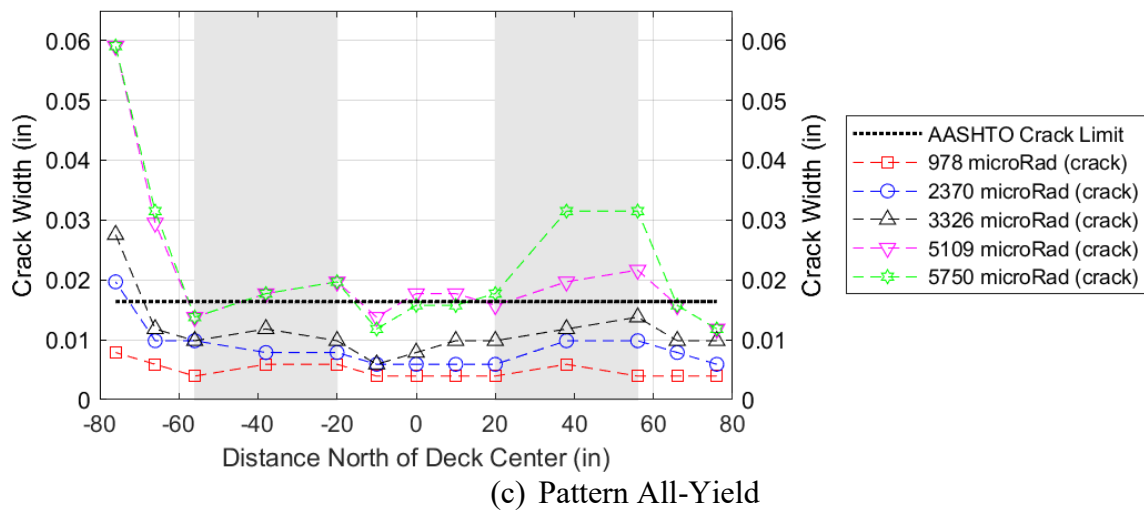
**Figure 10.4. PBJ-OP2: Crack width profiles for select patterns.**

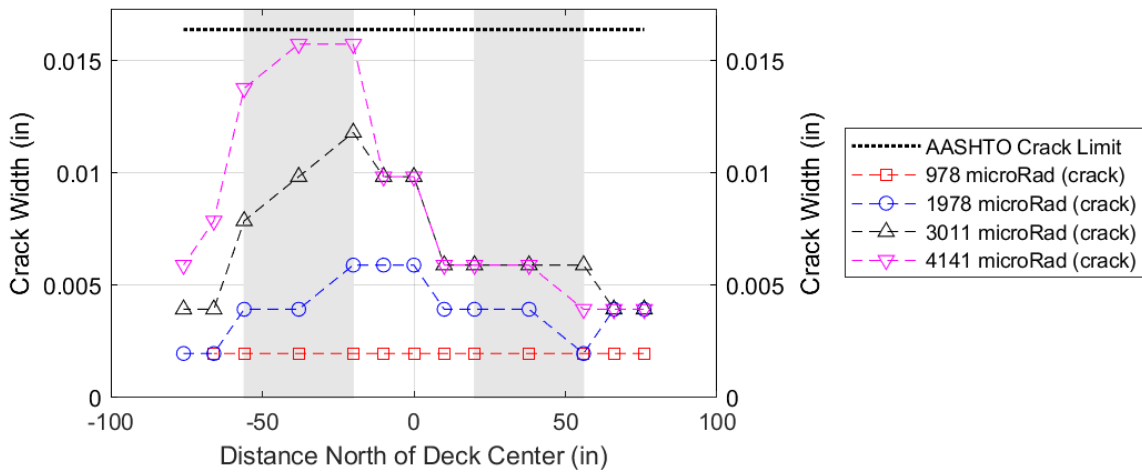
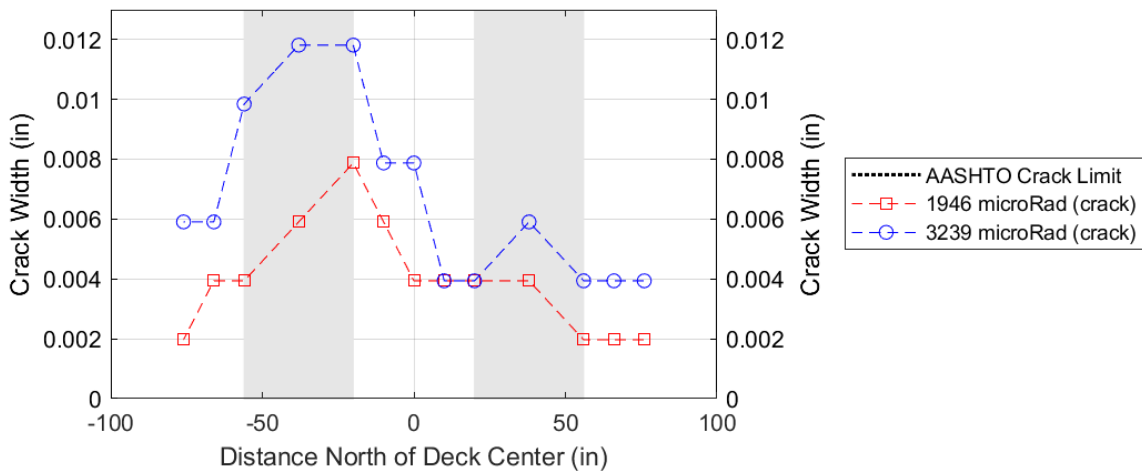
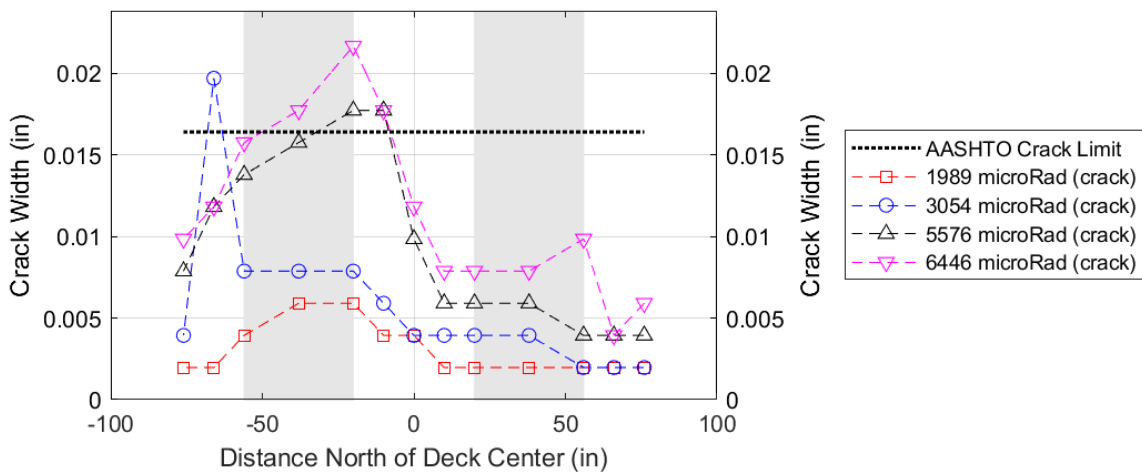
**Figure 10.5. PBJ-CP1: Crack width profiles for select patterns.**

(a) Pattern All

(b) Pattern W

(c) Pattern All-Yield

Figure 10.5 provides the crack widths for PBJ-CP1, which was a debonded link slab with continuous panel and a haunch gap. The reinforcement utilized supplemental bars between the main longitudinal reinforcement.

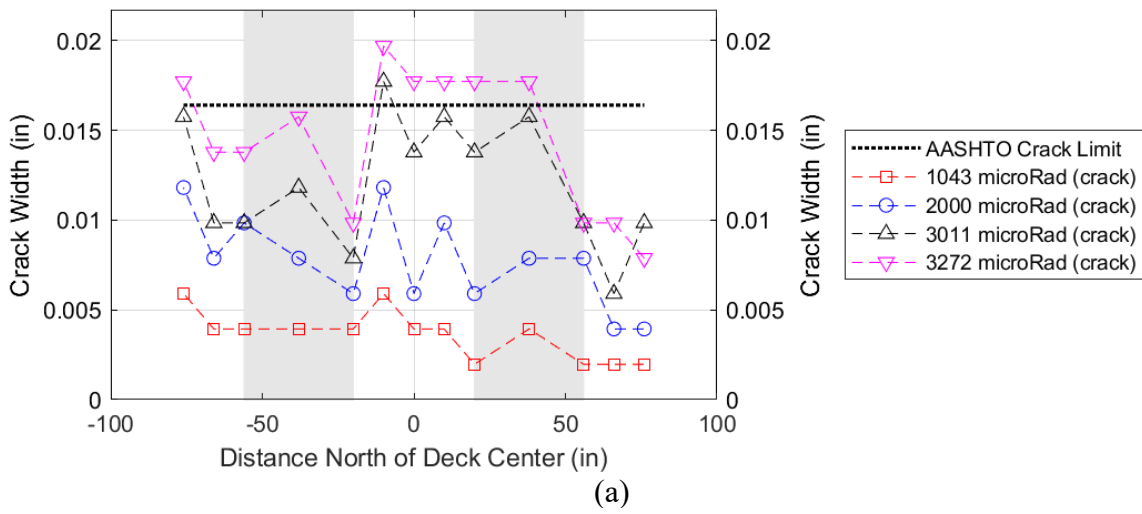
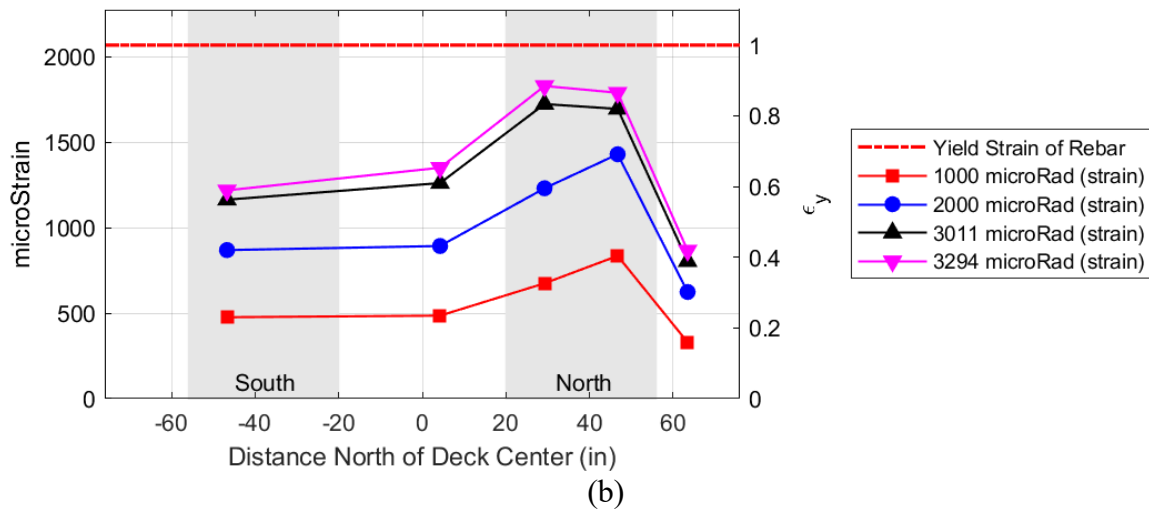
**Figure 10.8. PBJ-FP1: Pattern All comparison of (a) crack width profiles and (b) strain width profiles.**

Strain gages were installed on longitudinal reinforcing bars over the girders, in the overhangs, and in the deck between the girders. These strains provide additional insight to the response of the link slabs. Spatially, there is interest in the difference in strains (a) along the width of the deck and (b) along the length of an individual bar. Additionally, the changes in strain over the course of a load pattern are of interest. Two methods of presenting strain data are therefore considered. The first is strain profiles, in which a transverse section of the deck is considered, with all strain values plotted at a specific point in the loading history. These are comparable to the crack width profiles presented in the prior section. The second is strain maps, in which, for a single point in the loading history, Figure 10.8 through Figure 10.13 provide for each specimen a comparison of the crack width profiles (presented in previous section) and the strain width profiles for Pattern All. The crack widths and strains are presented at approximately the same rotations, but the strain rotations were determined based on actual measurements rather than being limited to the pauses, as is the case for the crack width measurements. Strain profiles are presented at the center of the link slab and thus are at approximately the same longitudinal location as the crack widths; however, since the cracks may have formed slightly off center, the strains and crack widths may be slightly misaligned, a factor that may contribute to inconsistencies between the two. For the strain profiles, horizontal red dashed lines indicate the expected yield strain of 0.00207 for Grade 60 steel.

In general, the shape of the strain profiles is similar to that of the crack width profiles. For the offset and continuous panel tests without retrofit, the strains are larger over the girder than between the girders, with the overhang strains sometimes being similar or slightly higher than over the girders. For the flush panel test (PBJ-FP1), limited good readings were available over the south girder and between the girders, making it more difficult to conclusively make observations relative to the more detailed crack width readings available. Deviations in the shape of the strain profile occur when strain gages yield, as shown in Figure 10.14 for PBJ-OP1 and PBJ-OP2. There are other instances of yielding occurring that do not produce changes in the shape, indicating that it is only large, localized strains associated with larger cracks that cause deviations in the trends seen.
