# Performance and Improvement of Texas Poor Boy Continuous Bridge Deck Details: Final Report

Technical Report 0-7013-R1

TEXAS A&M TRANSPORTATION INSTITUTE  
COLLEGE STATION, TEXAS

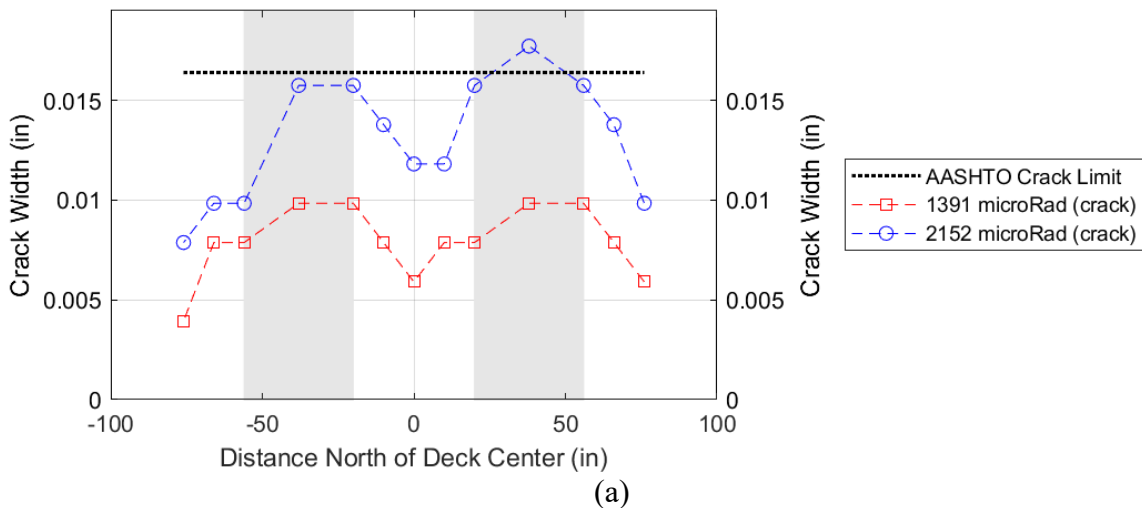
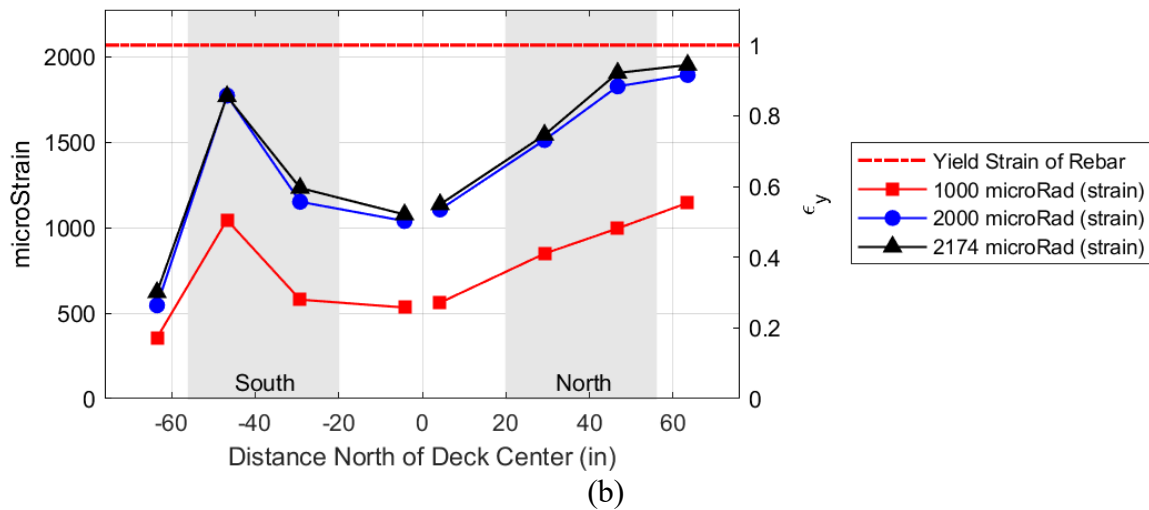
**Figure 10.9. PBJ-OP1: Pattern All comparison of (a) crack width profiles and (b) strain width profiles.**

In general, the shape of the strain profiles is similar to that of the crack width profiles. For the offset and continuous panel tests without retrofit, the strains are larger over the girder than between the girders, with the overhang strains sometimes being similar or slightly higher than over the girders. For the flush panel test (PBJ-FP1), limited good readings were available over the south girder and between the girders, making it more difficult to conclusively make observations relative to the more detailed crack width readings available. Deviations in the shape of the strain profile occur when strain gages yield, as shown in Figure 10.14 for PBJ-OP1 and PBJ-OP2. There are other instances of yielding occurring that do not produce changes in the shape, indicating that it is only large, localized strains associated with larger cracks that cause deviations in the trends seen.

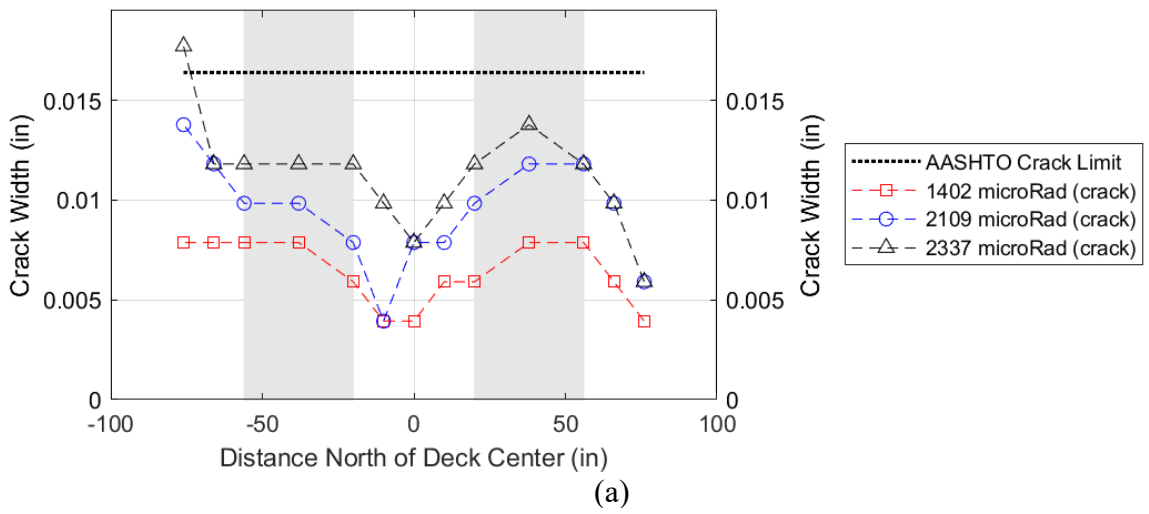
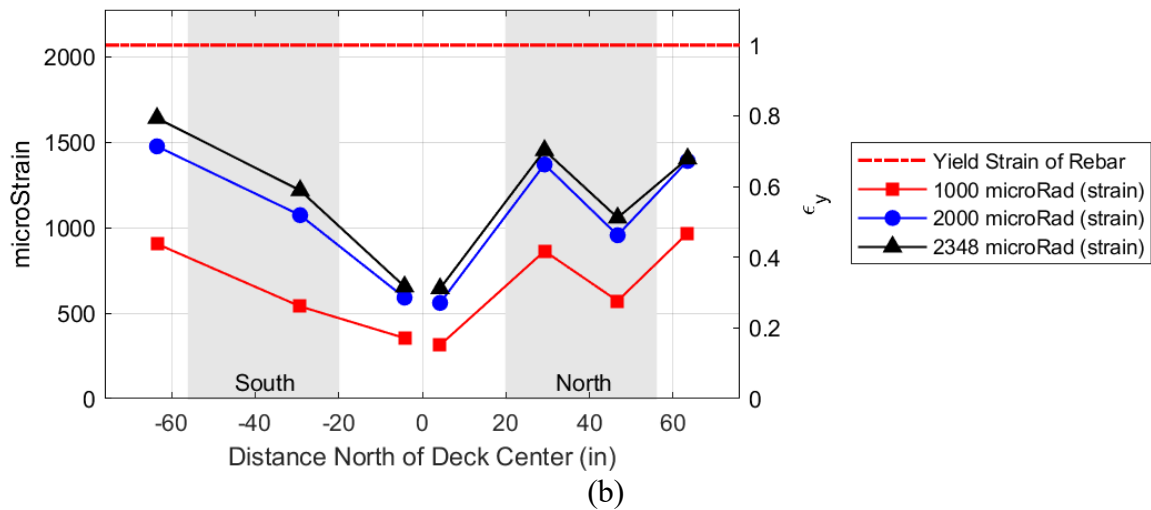
**Figure 10.10. PBJ-OP2: Pattern All comparison of (a) crack width profiles and (b) strain width profiles.**

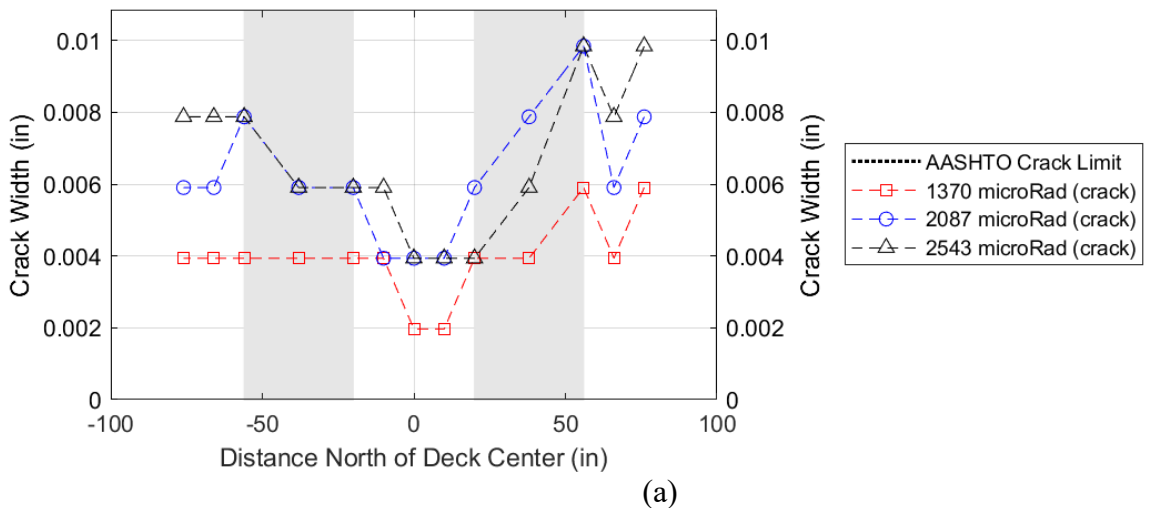
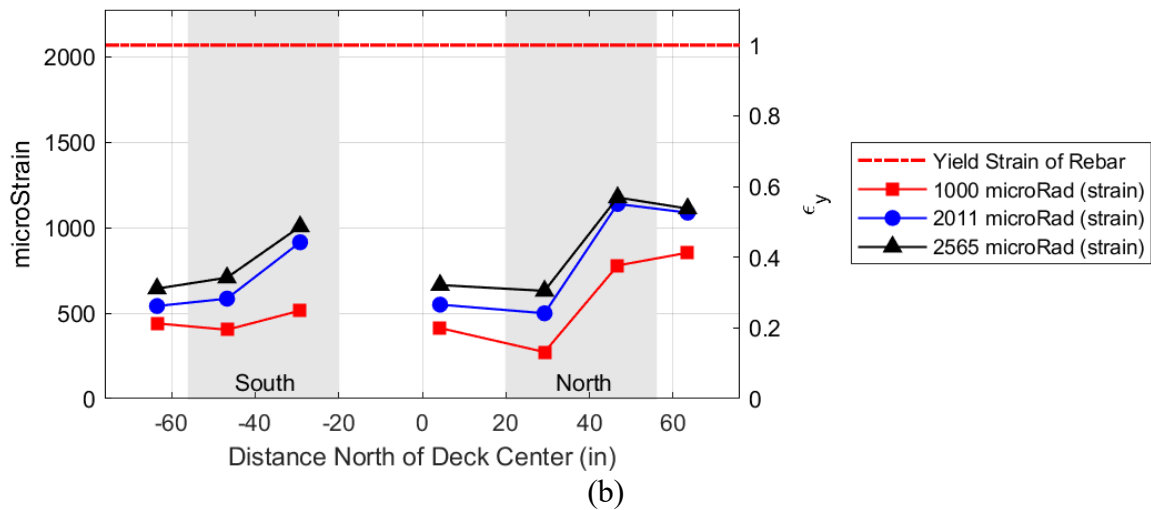
**Figure 10.11. PBJ-CP1: Pattern All comparison of (a) crack width profiles and (b) strain width profiles.**

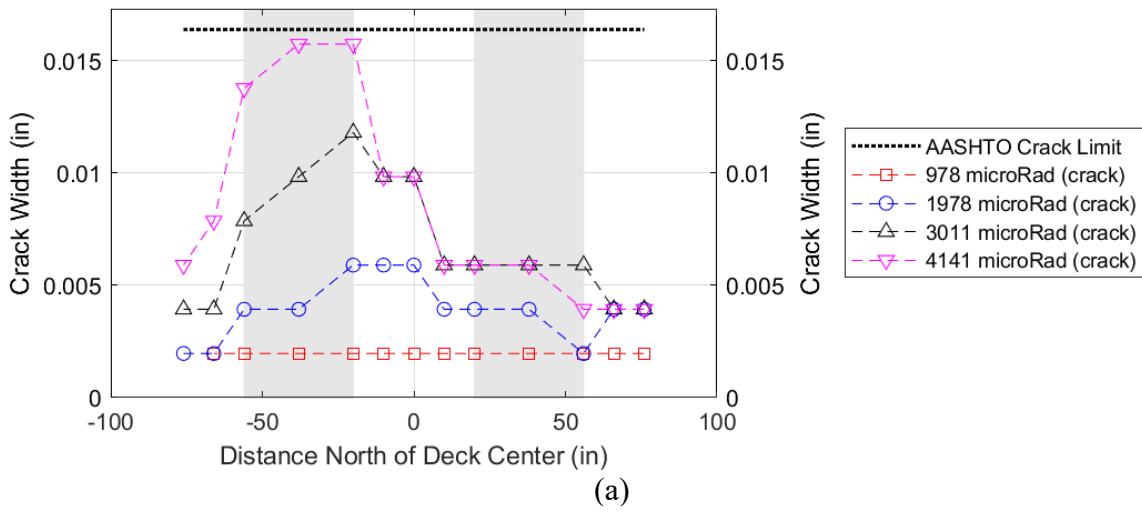
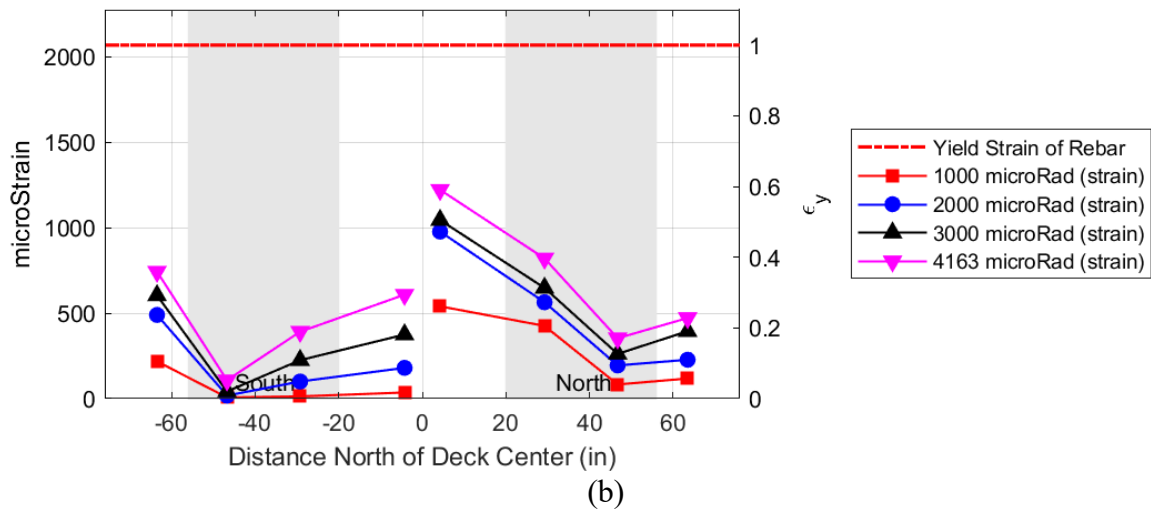
**Figure 10.12. PBJ-FP1R: Pattern All comparison of (a) crack width profiles and (b) strain width profiles.**

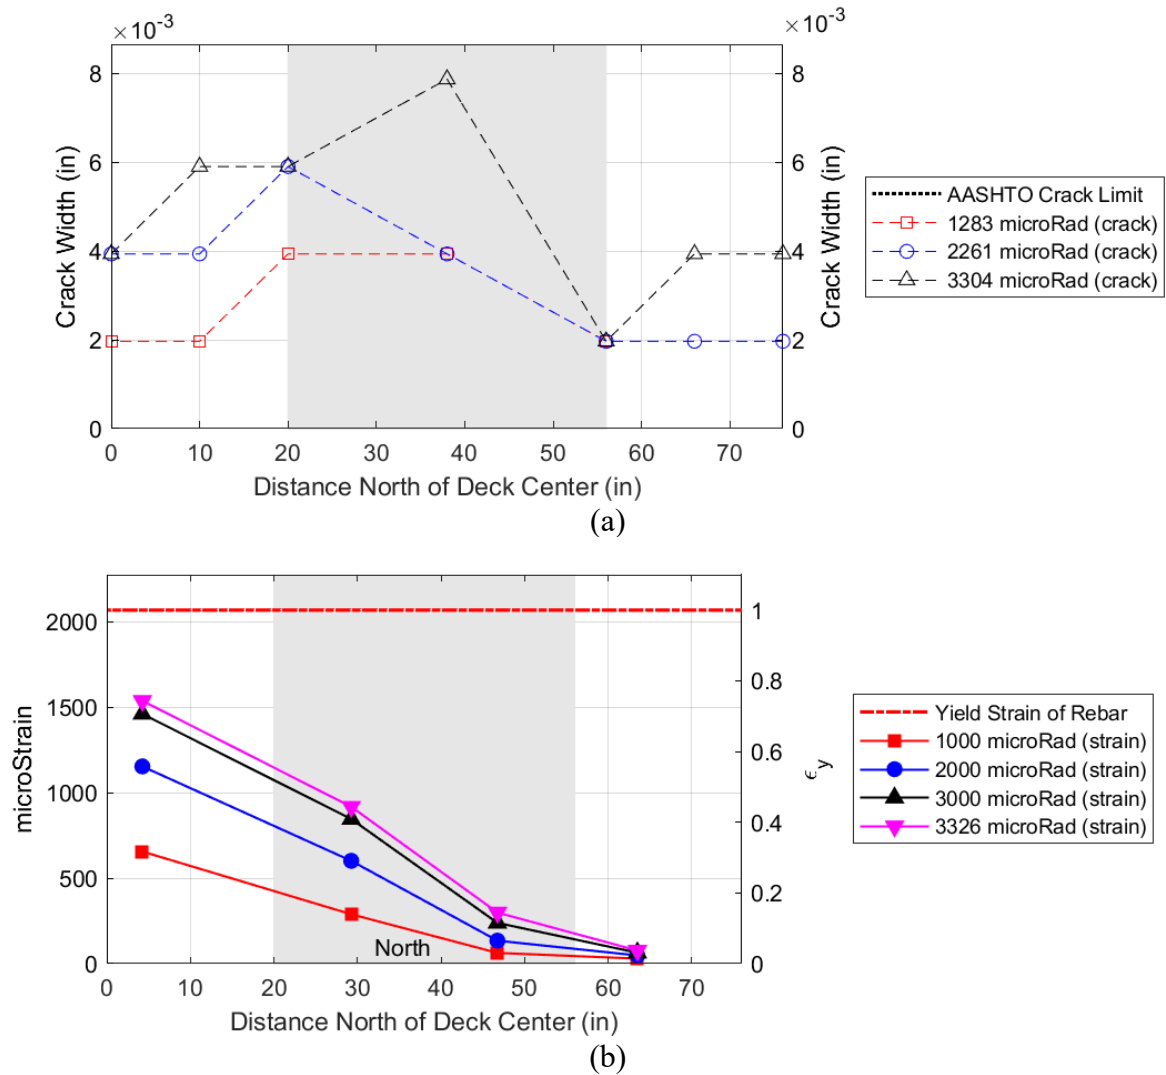
**Figure 10.13. PBJ-OP1R: Pattern All comparison of (a) crack width profiles and (b) strain width profiles.**

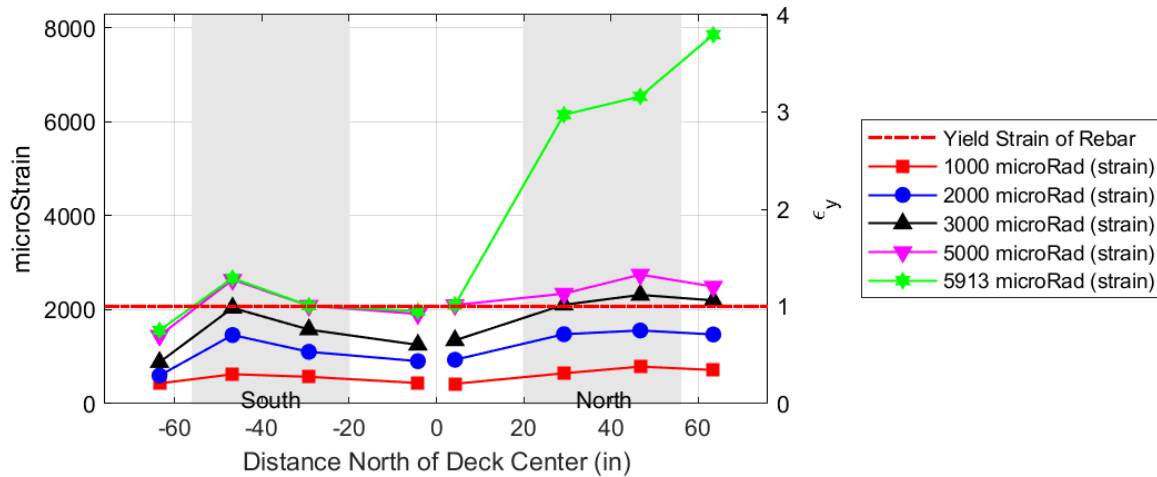
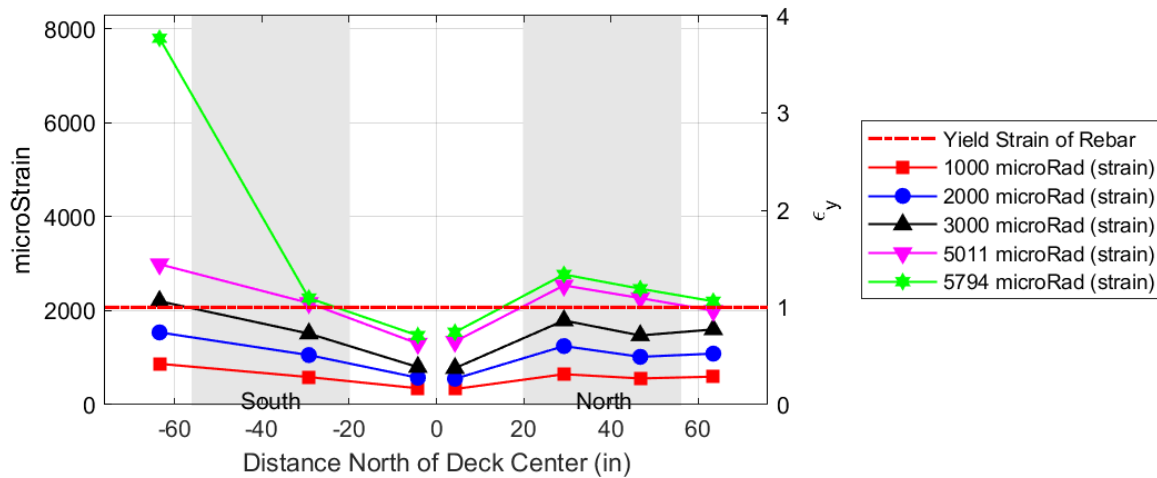
(a) PBJ-OP1 Pattern All-Yield

(b) PBJ-OP2 Pattern All-Yield

**Figure 10.14. Deviations in shape of strain profile associated with yielding.**

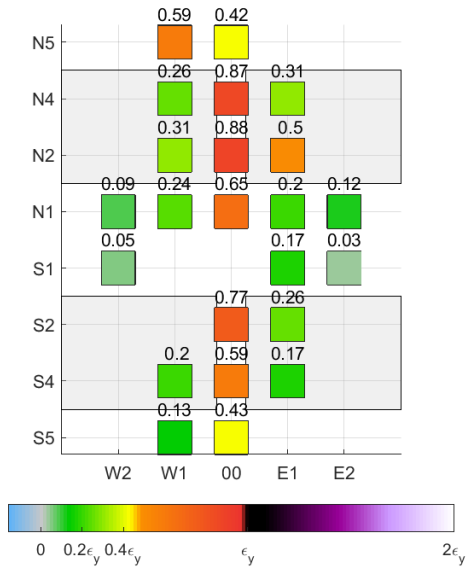
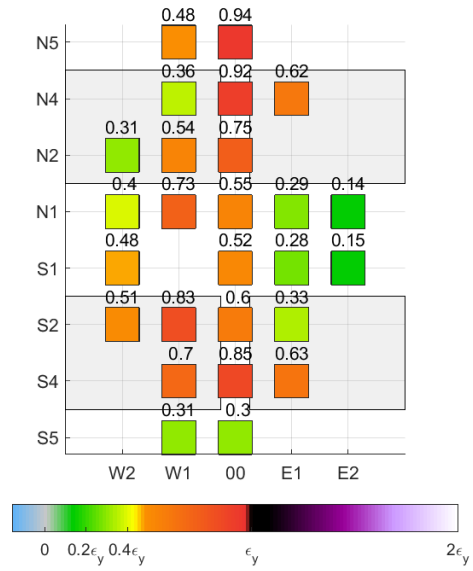
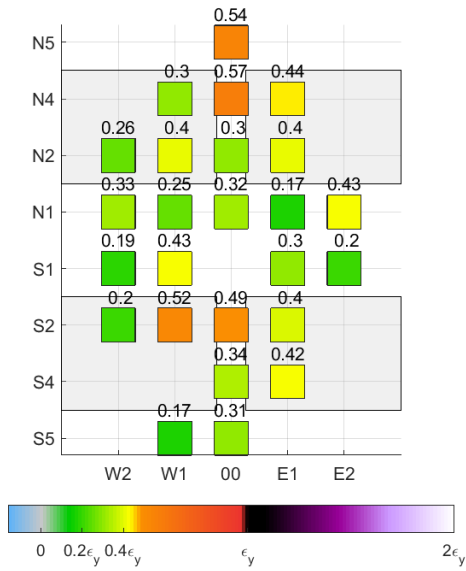
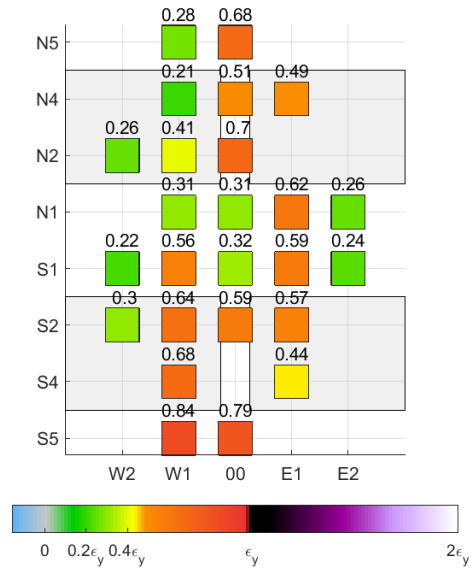
(a) PBJ-FP1 (3294 microradians)

(b) PBJ-OP1 (2174 microradians)

(c) PBJ-CP1 (2565 microradians)

(d) PBJ-OP2 (2348 microradians)

**Figure 10.15. Strain maps for non-retrofit designs at the peak load during Pattern All.**

In Figure 10.15, the top row shows the tests based on the current TxDOT details for flush panels (PBJ-FP1 in Figure 10.15[a]) and offset panels (PBJ-OP1 in Figure 10.15[b]). In assessing the relative values, consideration should be made for the differences in rotation at which each specimen is presented; the captions indicate the average girder rotation. When comparing the two current designs, the strains at the center of the link slab (Grid 00) are similar, but for PBJ-OP1, there is greater distribution of the strains at the gages farther from the center of the link slab. While two tests are presented at different rotations (higher for PBJ-FP1) and the amount of reinforcement is different (twice as much in PBJ-FP1), the relative colors on each horizontal grid line indicate the strains can better distribute in the offset panel design. This confirms what is seen in the crack patterns and in finite element models that indicate that deformation and damage is concentrated over the board in flush panel designs. However, in both tests, numerous gages exceed the service limit of  $0.4\epsilon_y$ . Both tests also exceed the crack width limit during Pattern All; however, the strain exceeds the limit by a greater amount.

The second row of Figure 10.15 shows the tests based on the proposed designs utilizing DLSSs (PBJ-CP1 in Figure 10.15[c] and PBJ-OP2 in Figure 10.15[d]). These are best compared to Figure 10.15(b) showing the offset panel reference test (PBJ-OP1). The debonded tests are presented at slightly larger rotations (around 2300–2500 microradians) than PBJ-OP1 (approximately 2200 microradians) but have lower strains. For PBJ-OP2, the strains have greater distribution of stresses than PBJ-OP1, with the W1 and E1 gages having strains similar in magnitude to those of the 00 gages. Farther away, the strains decrease significantly, similar to the drop off seen in PBJ-OP2. This may be a result of the girder ends bearing into the deck and not allowing full distribution of demands. In PBJ-CP1, the strains are still smaller at the gages farther from the center, but the distribution of the strains is much more uniform.

In the case of PBJ-CP1, the strains are below the desired limit of  $0.4\epsilon_y$  in most locations and only slightly higher where they are exceeded. In PBJ-OP2, there is twice as much longitudinal reinforcement in the north half of the deck. While limited conclusions can be drawn due to missing gage data at the 00 grid, examination of the strains farther from the center of the link slab indicates that the additional reinforcement is helpful in reducing the magnitude of the strains.

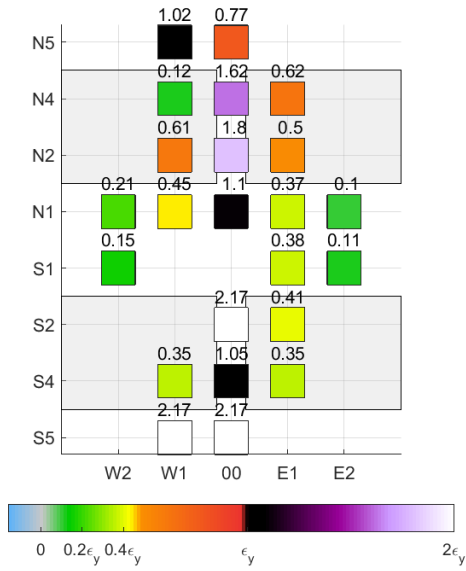
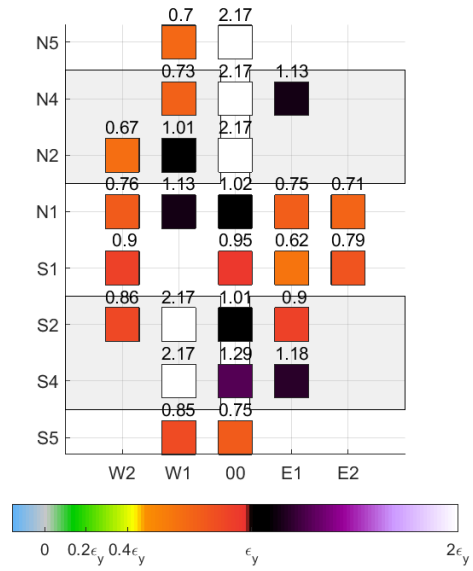
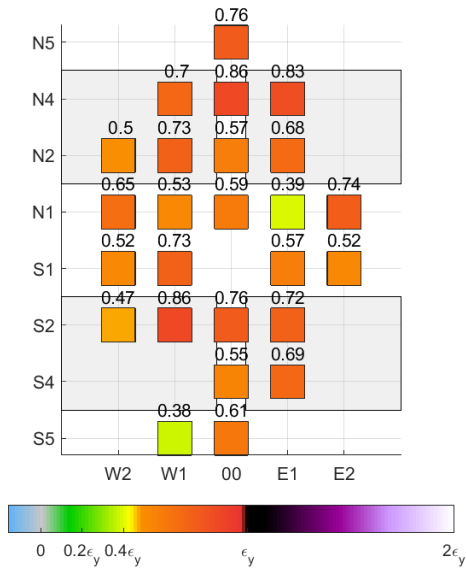
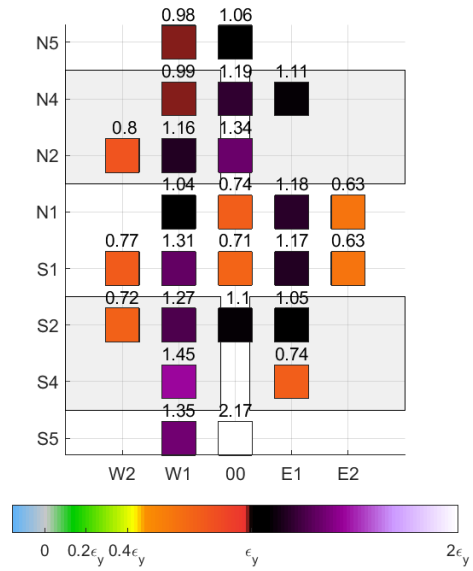
(a) PBJ-FP1 (6446 microradians)

(b) PBJ-OP1 (5913 microradians)

(c) PBJ-CP1 (5820 microradians)

(d) PBJ-OP2 (5794 microradians)

**Figure 10.16. Strain maps for non-retrofit designs at the peak load during Pattern All-Yield.**

Figure 10.16 provides the same comparisons as Figure 10.15, but for Pattern All-Yield; here, the rotation values are similar for the four tests. The relative patterns described above are seen again. The flush panel test (PBJ-FP1) has concentrated strains at Grid 00, with strains the next grid back generally not exceeding the  $0.4\epsilon_y$  limit, while in the offset panel test (PBJ-OP1) higher strains, including strains at yielding and above, being seen at the center at all gages. In the first debonded tests (PBJ-OP2), strains are reduced relative to the reference offset panel test, and strains are lower in the north half with more reinforcement. In the final design using continuous panels and a haunch gap (PBJ-CP1), strains do not exceed the yield strains at any point, although at nearly all gage locations, the  $0.4\epsilon_y$  limit is exceeded (AASHTO crack width limits are not exceeded).

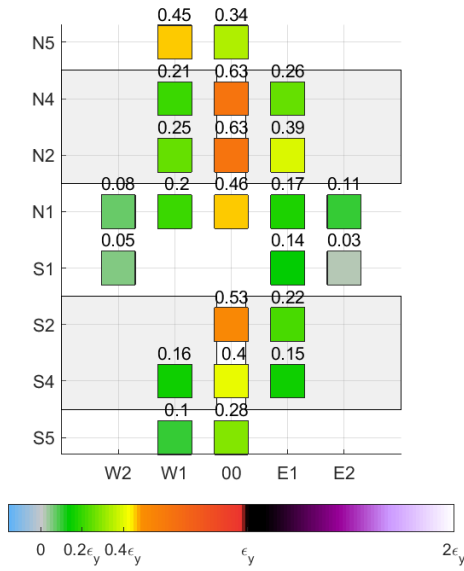
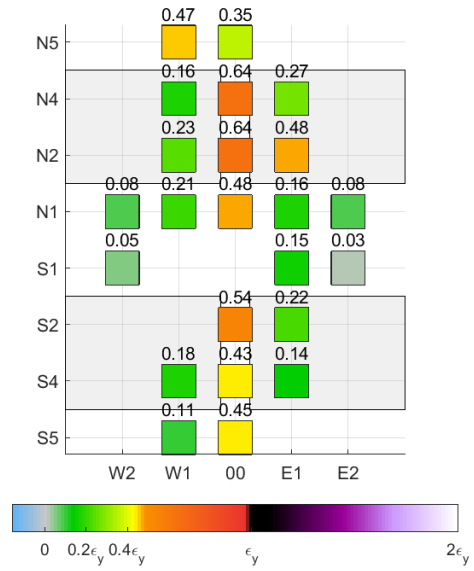
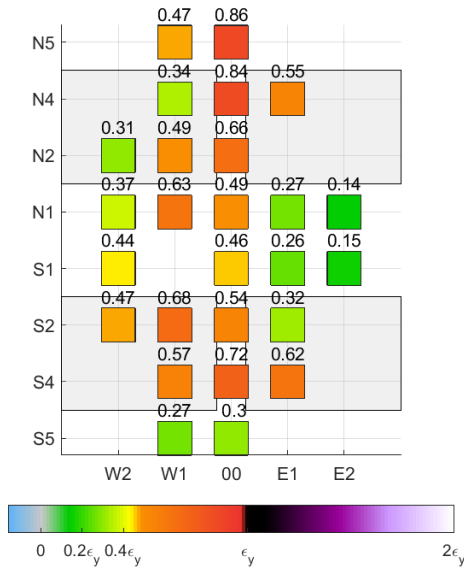
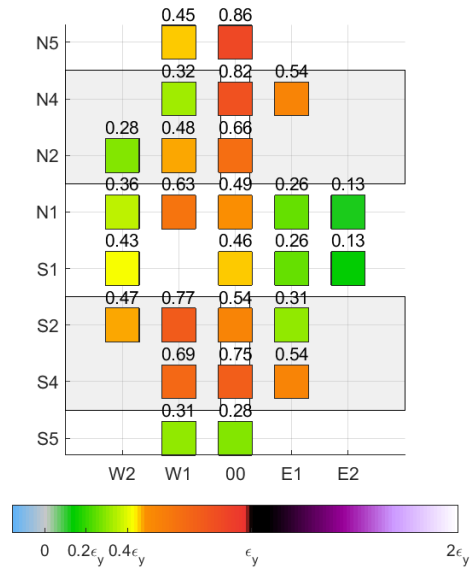
(a) PBJ-FP1 Pattern West

(b) PBJ-FP1 Pattern East

(c) PBJ-OP1 Pattern West

(d) PBJ-OP1 Pattern East

**Figure 10.17. Strain maps for PBJ-FP1 and PBJ-OP1 at the peak load during Pattern West and Pattern East.**

For load patterns that placed the spans under asymmetric loading (Pattern West and Pattern East), new cracks, if any, formed on the side of the span that was the secondary loading. As presented in Section 10.6.1, there was also a noticeable axial horizontal movement of the link slab toward the primary loaded span. From these observations, it was expected that the strain maps might also indicate asymmetric response of the deck. Figure 10.17 and Figure 10.18 present the strain maps for the bonded and debonded link slab specimens, respectively. The Pattern West strains are shown in the left column of the figures, and the Pattern East strains are shown in the right column of the figures. While the strains were not always equal on both sides of the center of the link slab, the strains at individual locations were essentially unchanged regardless of which span was the primary span.

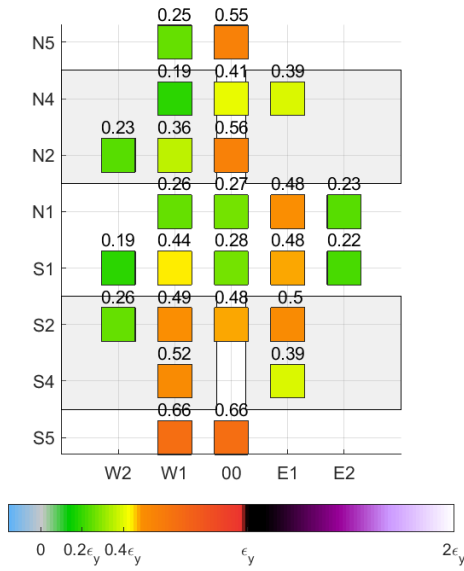
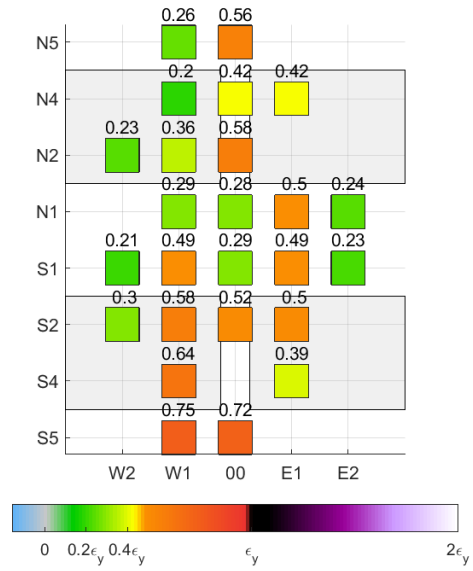
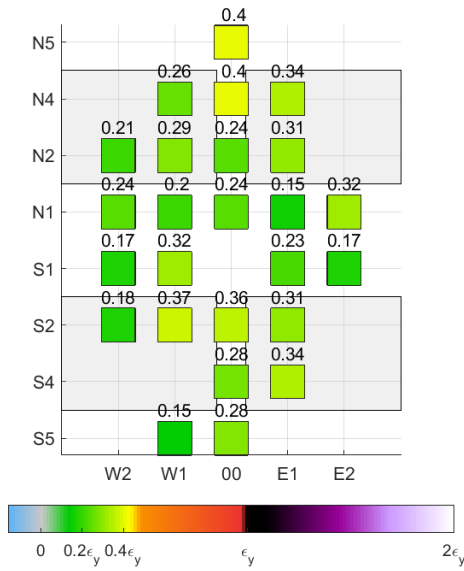
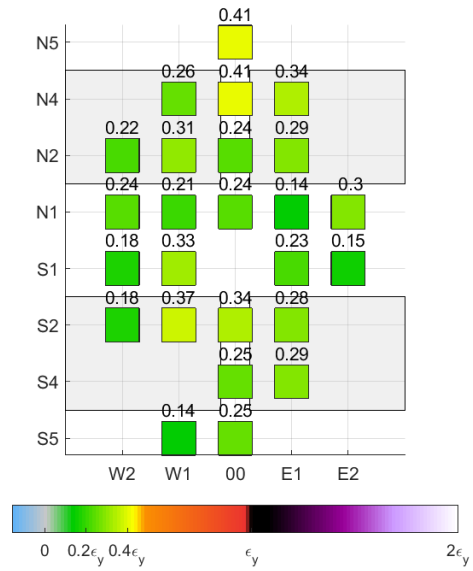
(a) PBJ-OP2 Pattern West

(b) PBJ-OP2 Pattern East

(c) PBJ-CP1 Pattern West

(d) PBJ-CP1 Pattern East

**Figure 10.18. Strain maps for PBJ-OP2 and PBJ-CP1 at the peak load during Pattern West and Pattern East.**

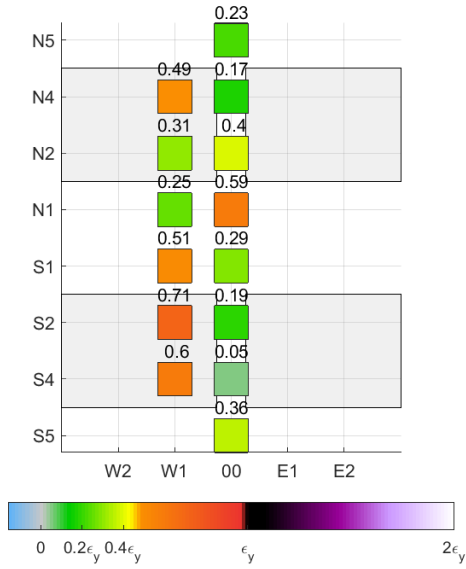
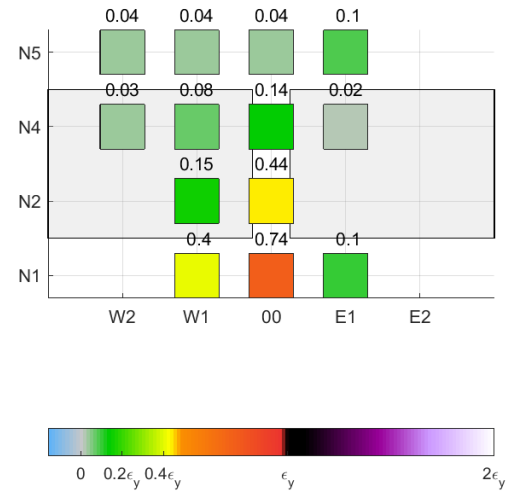
(a) PBJ-FP1R (4163 microradians)

(b) PBJ-OP1R (1663 microradians)

**Figure 10.19. Strain maps for retrofit designs at the peak load during Pattern All.**

Figure 10.19 and Figure 10.20 present the strain maps for the retrofit specimens (PBJ-FP1R and PBJ-OP1R) for Pattern All and Pattern All-Yield, respectively.

For PBJ-FP1R, the strains should be analyzed separately for the north and south half due to the different reinforcement. While the PBJ-FP1 test had strains larger between the girders, the PBJ-FP1R test had strains larger over the girders like most other specimens. The overhang strains were larger in the south half; however, this observation should consider that not only was the reinforcement different, but also the board between the panels extended into the south overhang. Most notably for PBJ-FP1R, the strains did not exceed yield strains at any point during the tests, including the final pattern that went to rotation demands of nearly 0.0065 rad, higher than any design values for bridges considered in this study.

For PBJ-OP1R, larger strains were observed in the south portion of the deck. In the north portion of the deck, strains were nearly zero. Note that debonding of the interface between new and existing concrete may be a factor, and strain gages were not available on bottom reinforcing bars to see if demand was present in that portion of the deck. However, Section 10.6.2 presents concrete surface strains in the north overhang that support the theory that load transfer is happening more in the bottom portion of the deck. Looking at the strains in the south portion of the deck shows that strains are larger at the center of the link slab.

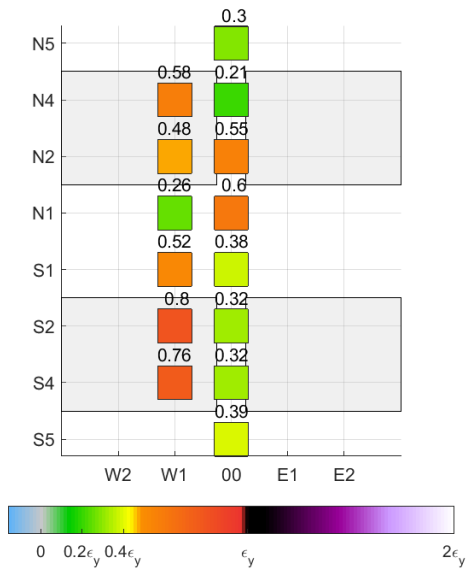
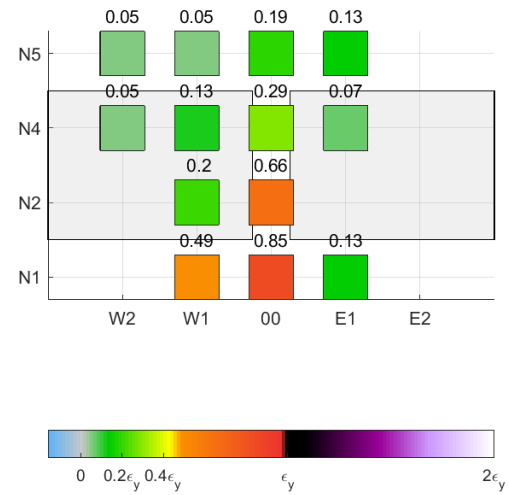
(a) PBJ-FP1R (6478 microradians)

(b) PBJ-OP1R (3457 microradians)

**Figure 10.20. Strain maps for retrofit designs at the peak load during Pattern All-Yield.**

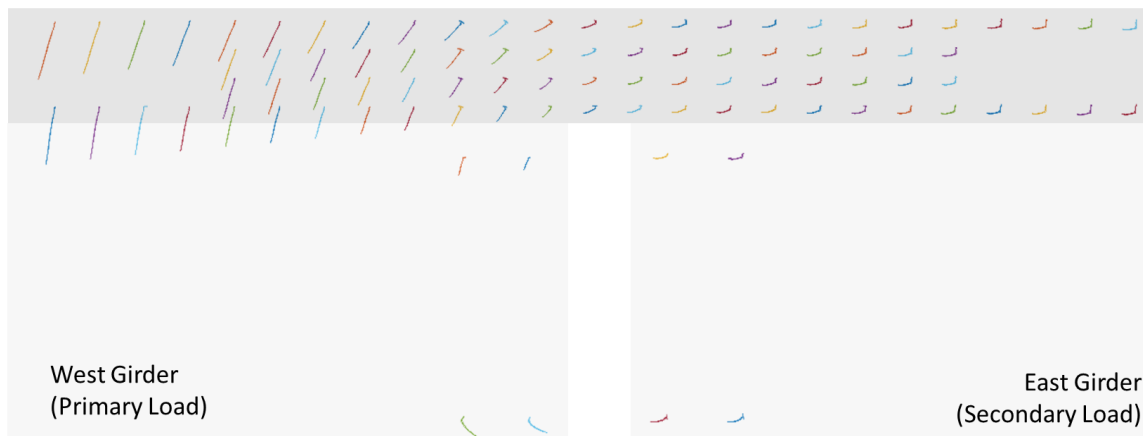
Figure 10.21 shows the displacement history of each target on PBJ-FP1 during Pattern W. The girder and deck are shown as gray rectangles. Each colored line represents a target and is a series of points showing the position over the course of loading, with displacement magnified 50 times to be easily viewable. On the deck over the west girder (primarily loaded girder), the lines are mostly vertical, with the target starting at the top of the line and moving toward the ground as the test progresses. This is expected given the expected displaced shape confirmed by the displacement profiles presented in Figure 10.1.

The findings are more interesting in the deck over the east girder, where the path history is an L-shape laying on its side. The shorter vertical leg of the path history occurs when the 40-kip load is placed in the secondary girder (east in this case). At higher loads in the primary girder (west), the east load is held constant. During that portion of the load pattern, the east deck targets have the longer horizontal leg of the L response. This observation is referred to as drag or tug of the deck on the secondary girder. It suggests an axial deformation of the deck that may explain the offset and secondary cracks that form during the asymmetric loading and are observed in the field. Such a behavior has not been suggested as a design considered in the literature. Further exploration of this behavior, including for other tests, is needed. It is worth mentioning that these findings have been compared to results from finite element models, and it was shown that the behavior matched.

**Figure 10.21. PBJ-FP1: Optotrak target displacement history for Pattern W.**

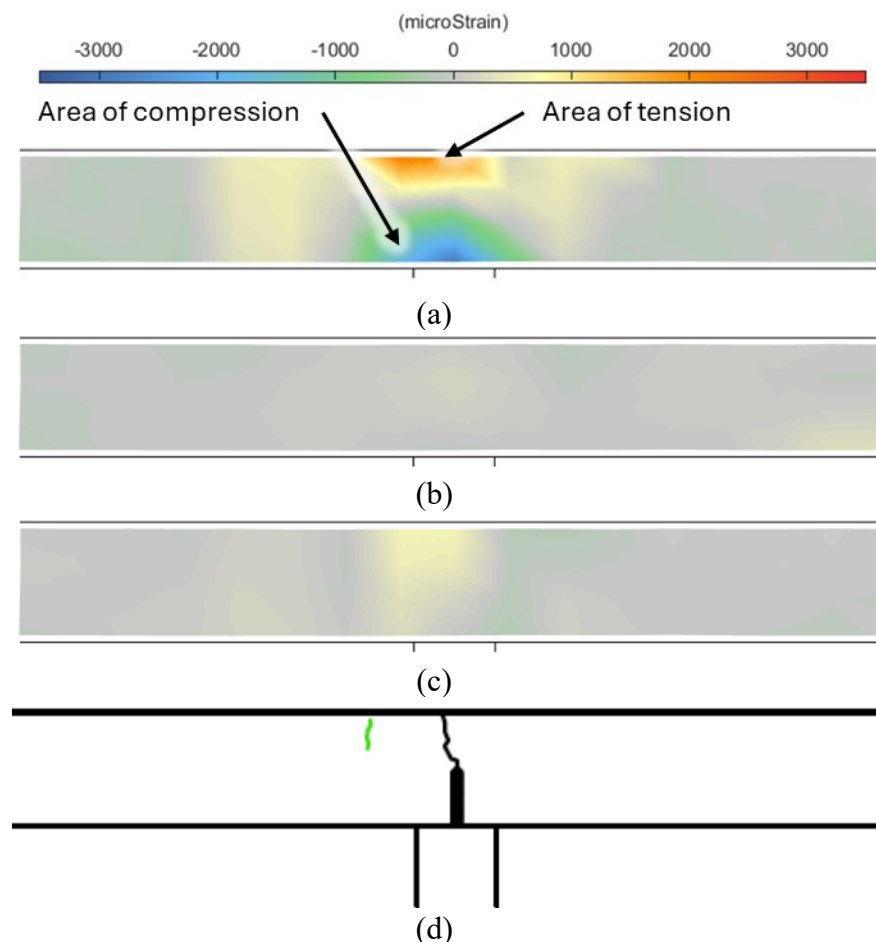
For PBJ-FP1 (Figure 10.22), tensile strains developed on the top of the deck and concentrated primarily at the center of the link slab above the timber board. Compression strains also developed. Smaller regions of tension are seen approximately over the bearing pads. On the west girder (left), this region is a bit farther out than the observed crack. This suggests that the link slab has a tendency to develop a greater distribution of cracks but is unable to overcome the concentration of the damage over the board. Also noteworthy is that the secondary regions of tensile strain concentration are equally distributed over the depth of the slab, suggesting that axial load and deformation may be a greater factor in flush panel designs since such an observation is not made in other specimens except where full-depth cracks develop. For PBJ, compressive stresses are concentrated in the region around the board. For tests without boards, such a concentration is not seen, with compressive strains provided with a greater distribution, as would be expected when considering the compressive stress block of a slab in flexure.

**Figure 10.22. Optotrak strains for PBJ-FP1 Pattern All: (a) horizontal, (b) vertical, (c) shear strain, and (d) crack pattern.**

In Figure 10.22 through Figure 10.27, the results of Pattern All-1 for each specimen are presented. Select results from other load patterns are provided in Figure 10.28 through Figure 10.31. In each figure, three strain values: (a) the horizontal strain (x-direction), (b) vertical strain (y-direction), and (c) shear strain. The letters (a), (b), and (c) are used in each figure presenting Optotrak strain fields. For all three types of strains, the same colormap is used, with gray indicating strains around zero, warm colors indicating tensile strains, and cool colors indicating compression strains. Except for PBJ-OP1R, the figures show the south edge of the deck, with the right girder being the east girder and the left being the west girder. For PBJ-OP1R, the Optotrak was collected on the north edge of the deck, with the right side of the figure being the west girder and the left side the east girder. Below each set of strain fields, the cracks on the edge of the deck in the Optotrak region are included to allow comparison of the strains to the observed cracks (crack maps are final crack maps). On the strain fields and crack maps, small vertical lines are present to indicate the edge of the girders. When comparing the strain fields between different specimens, this aspect is particularly important to consider since different configurations of targets were used on each test. A discussion of each specimen is presented in the following paragraphs. In general, the observations made for all are consistent with those from other load patterns; thus, not all strain fields are included. Where interesting observations can be made for other load patterns, additional strain fields are presented. The horizontal strains are associated with flexural cracks and present the most useful data to interpret. Vertical and shear strains are generally negligible and thus are only discussed when the data are of value to interpreting the behavior of the specimen.

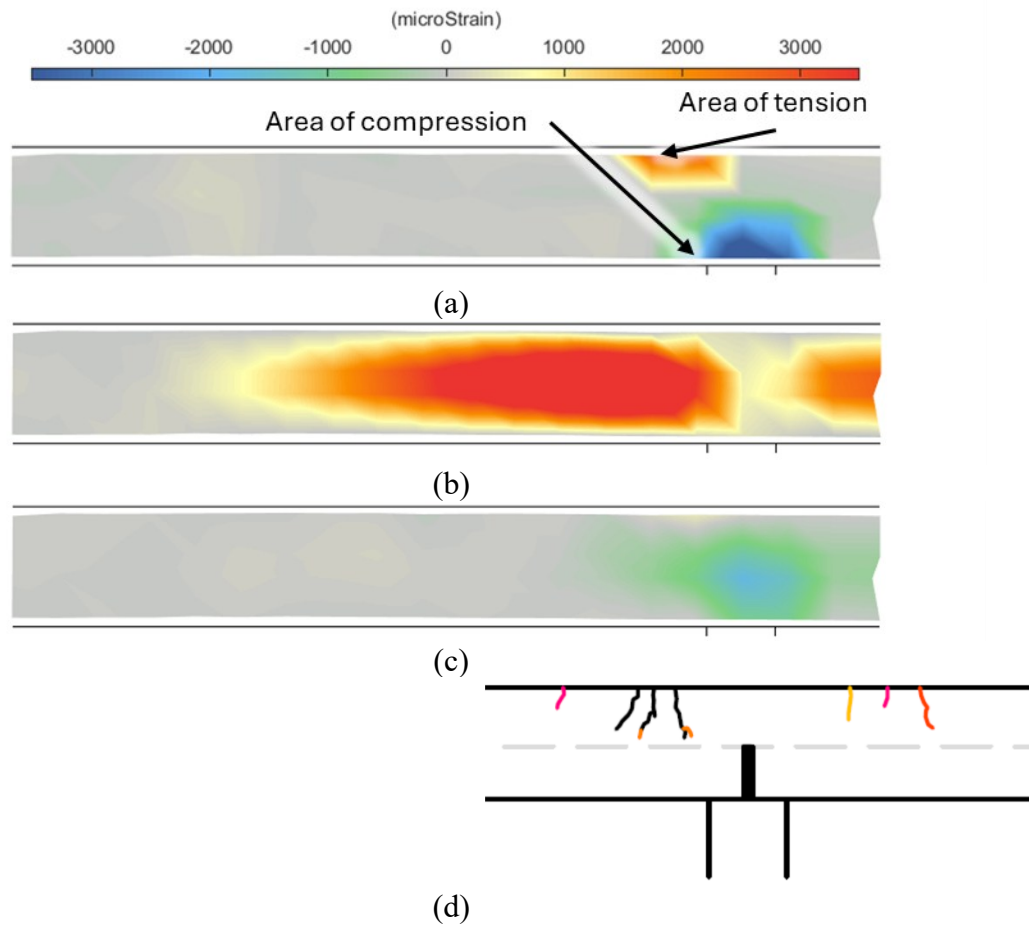
In PBJ-FP1R, shown in Figure 10.23, compressive stresses are again seen concentrated around the board and a distinct tension region located over the end of the west (left) girder. This is offset from the board slightly but is consistent with the location of observed cracks. Cracks over the east (right) girder occurred during Pattern All-Yield, with the tensile strains becoming significant during that pattern, as seen in Figure 10.29. While shear and vertical strains were minor in PBJ-FP1, significant strains were seen for PBJ-FP1R. For vertical strains, the values confirm that the debonding is effective in allowing the top and bottom portion. Under asymmetric loading, the vertical and shear strain effects are more pronounced, as shown in Figure 10.30 for Pattern East, where vertical strains are larger on the east (right) girder that is loaded and smaller over the secondary west (left) girder. Compressive vertical and shear strains in the region of the board indicate that consideration must be made for how forces are transferred through the top and bottom portions of the deck.

**Figure 10.23. Optotrak strains for PBJ-FP1R Pattern All: (a) horizontal, (b) vertical, (c) shear strain, and (d) crack pattern.**

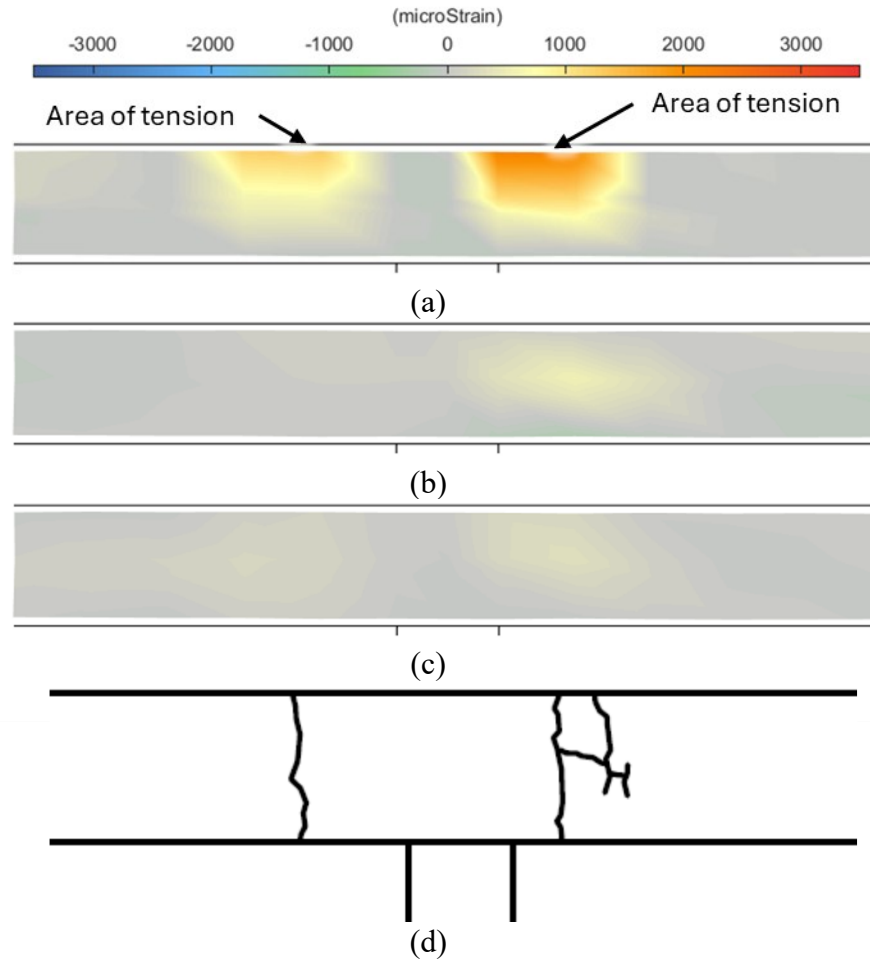
In PBJ-OP1, shown in Figure 10.24, two distinct regions of concentrated tension strains are seen at approximately the same locations of the vertical cracks. The strains were of greater magnitude over the east (left) girder, which is consistent with the development of two cracks in that region. Also seen is a small amount of vertical and shear strains in the area where a horizontal crack formed. While the results for Pattern All-1 do not show compressive strains (cool colors) this is due to the small values calculated. In other load patterns, compressive strains are visible in the strain fields; an example of this is shown in Figure 10.28 for Pattern All-Yield. While full-depth cracks occur, full-depth regions of tension strains were not observed as was the case for PBJ-FP1.

**Figure 10.24. Optotrak strains for PBJ-OP1 Pattern All: (a) horizontal, (b) vertical, (c) shear strain, and (d) crack pattern.**

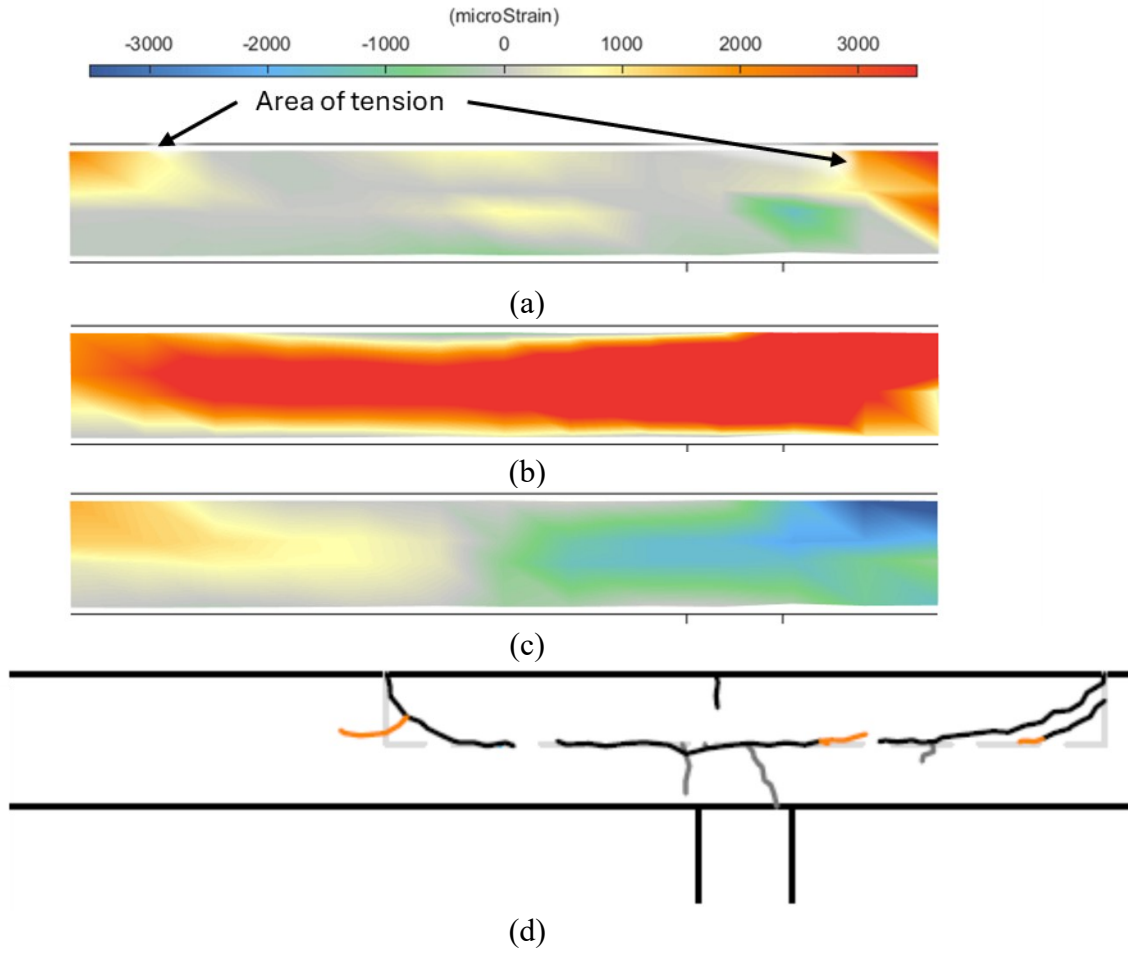
In PBJ-OP1R, shown in Figure 10.25, significant shear strains and vertical strains are present in the repaired region and the interface with the existing concrete. This is consistent with the observed damage at the interface. Horizontal strains are more limited, but a distinct tension region is seen at the top of the existing and new concrete, indicating that the slab is behaving as debonded in the north overhang.

**Figure 10.25. Optotrak strains for PBJ-OP1R Pattern All: (a) horizontal, (b) vertical, (c) shear strain, and (d) crack pattern.**

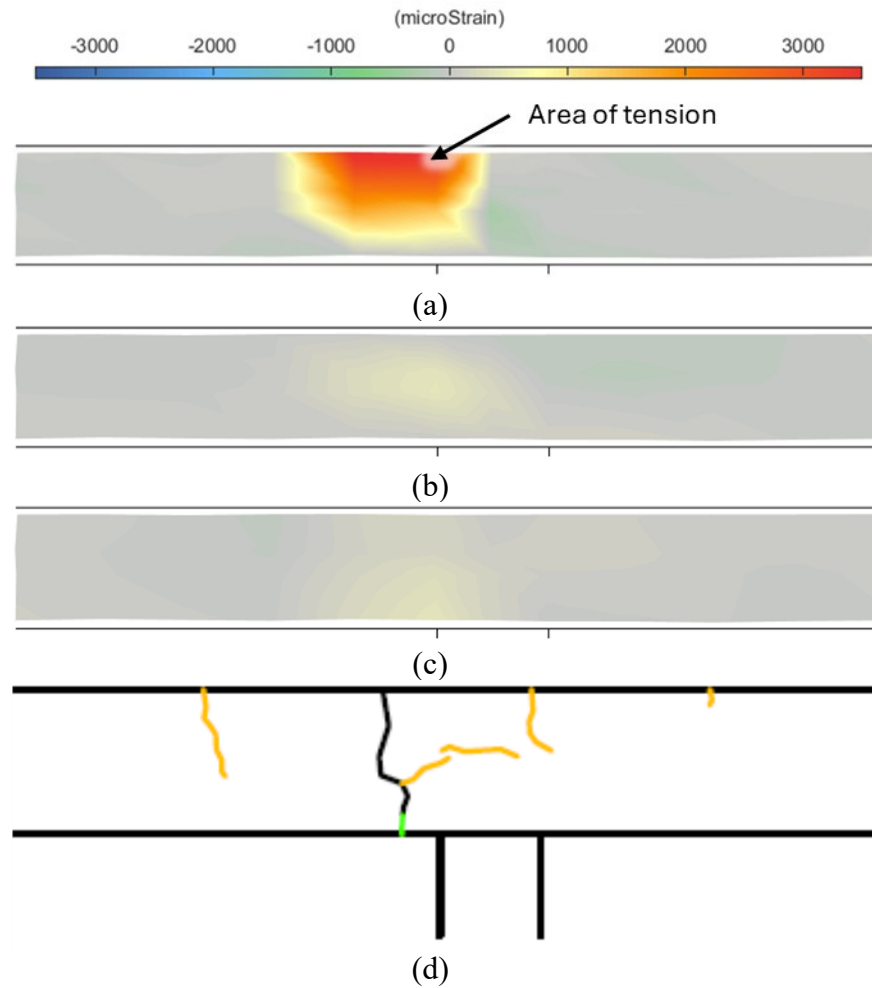
In PBJ-OP2, shown in Figure 10.26, the region of concentrated tensile strains is located where the single crack forms. Regions of light concentration of horizontal and shear strain are seen where the horizontal cracks form during later patterns. In Figure 10.31, the strains are shown for Pattern All-Yield, in which the areas of greater intensity of the strains are located in the region of cracks and where the location of the secondary crack over the west (left) girder has a concentrated region of tension strain.

**Figure 10.26. Optotrak strains for PBJ-OP2 Pattern All: (a) horizontal, (b) vertical, (c) shear strain, and (d) crack pattern.**
