# Performance and Improvement of Texas Poor Boy Continuous Bridge Deck Details: Final Report

Technical Report 0-7013-R1

TEXAS A&M TRANSPORTATION INSTITUTE  
COLLEGE STATION, TEXAS

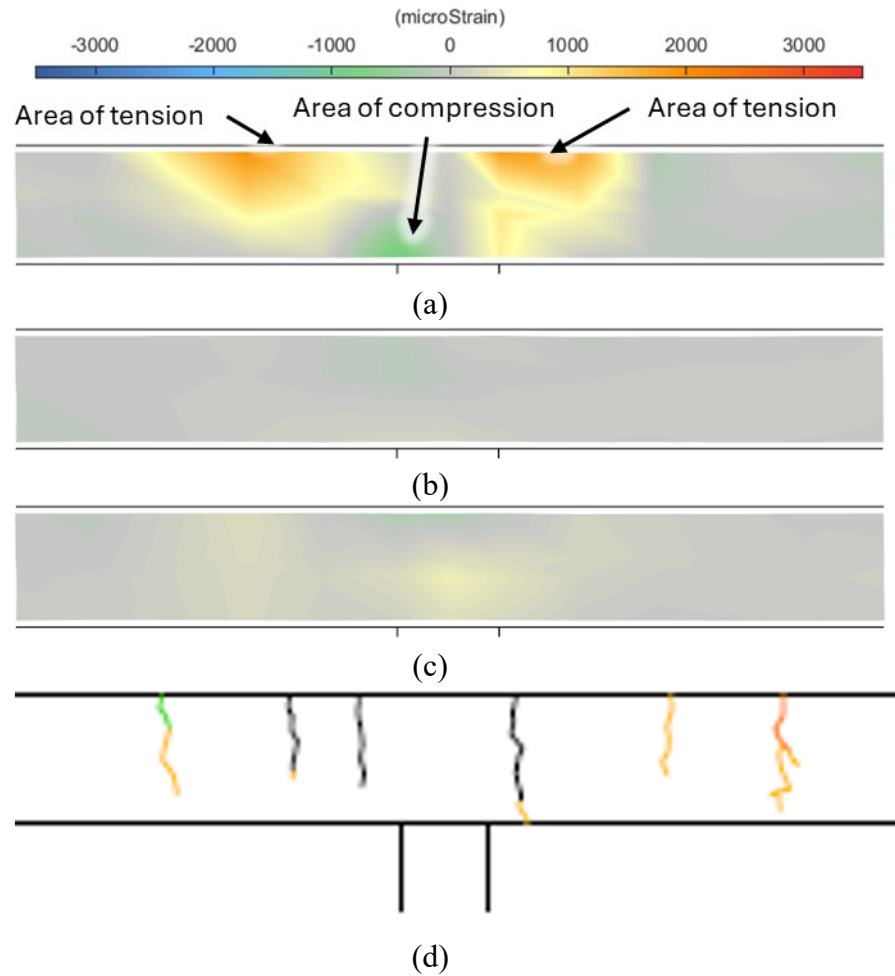
In PBJ-CP1, shown in Figure 10.27, there is a region of tension strain in the bottom of the deck where a full-depth crack formed in later load patterns. This is in the region where honeycombing occurred and was patched, which was likely the reason for the strain concentration. It is notable that on the opposite girder, there is a region of compression concentration not seen in other tests, indicating a redistribution of demands due to the imperfection and highlighting of the sensitivity of link slab performance to the detailing near the ends of the girders and panels.

**Figure 10.27. Optotrak strains for PBJ-CP1 Pattern All: (a) horizontal, (b) vertical, (c) shear strain, and (d) crack pattern.**

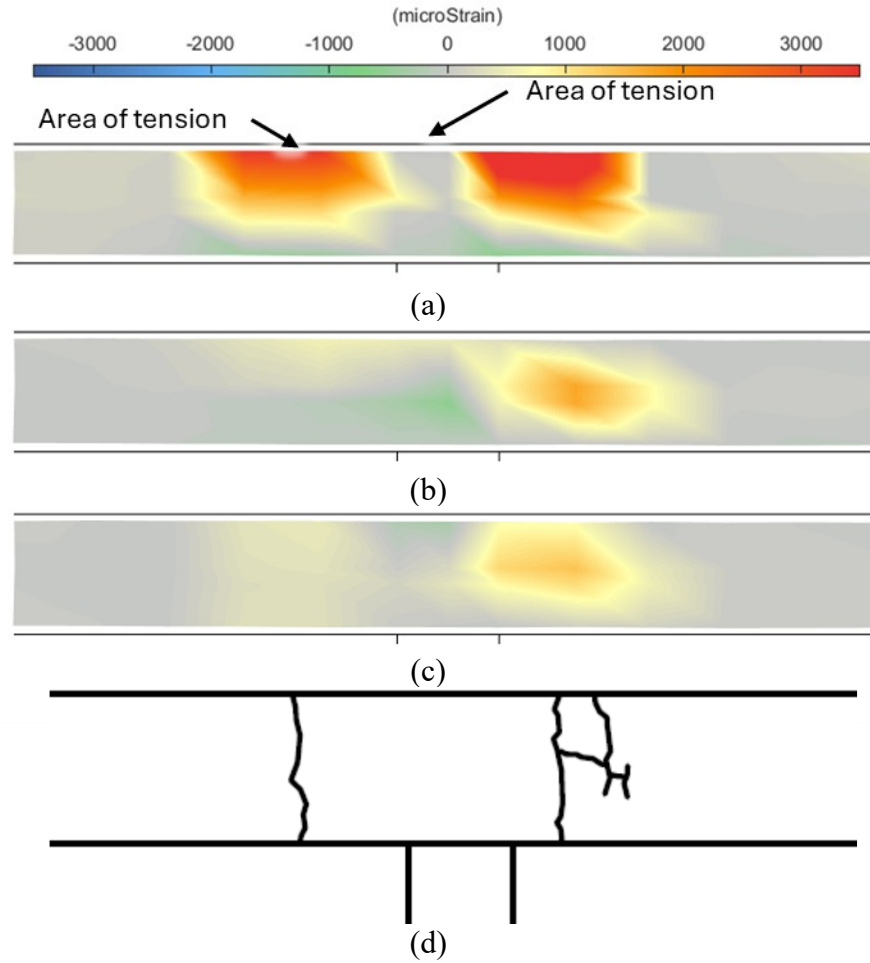
**Figure 10.28. Optotrak strains for PBJ-OP1 Pattern All-Yield: (a) horizontal, (b) vertical, (c) shear strain, and (d) crack pattern.**

In Figure 10.22 through Figure 10.27, the results of Pattern All-1 for each specimen are presented. Select results from other load patterns are provided in Figure 10.28 through Figure 10.31. In each figure, three strain values: (a) the horizontal strain (x-direction), (b) vertical strain (y-direction), and (c) shear strain. The letters (a), (b), and (c) are used in each figure presenting Optotrak strain fields. For all three types of strains, the same colormap is used, with gray indicating strains around zero, warm colors indicating tensile strains, and cool colors indicating compression strains. Except for PBJ-OP1R, the figures show the south edge of the deck, with the right girder being the east girder and the left being the west girder. For PBJ-OP1R, the Optotrak was collected on the north edge of the deck, with the right side of the figure being the west girder and the left side the east girder. Below each set of strain fields, the cracks on the edge of the deck in the Optotrak region are included to allow comparison of the strains to the observed cracks (crack maps are final crack maps). On the strain fields and crack maps, small vertical lines are present to indicate the edge of the girders. When comparing the strain fields between different specimens, this aspect is particularly important to consider since different configurations of targets were used on each test. A discussion of each specimen is presented in the following paragraphs. In general, the observations made for all are consistent with those from other load patterns; thus, not all strain fields are included. Where interesting observations can be made for other load patterns, additional strain fields are presented. The horizontal strains are associated with flexural cracks and present the most useful data to interpret. Vertical and shear strains are generally negligible and thus are only discussed when the data are of value to interpreting the behavior of the specimen.

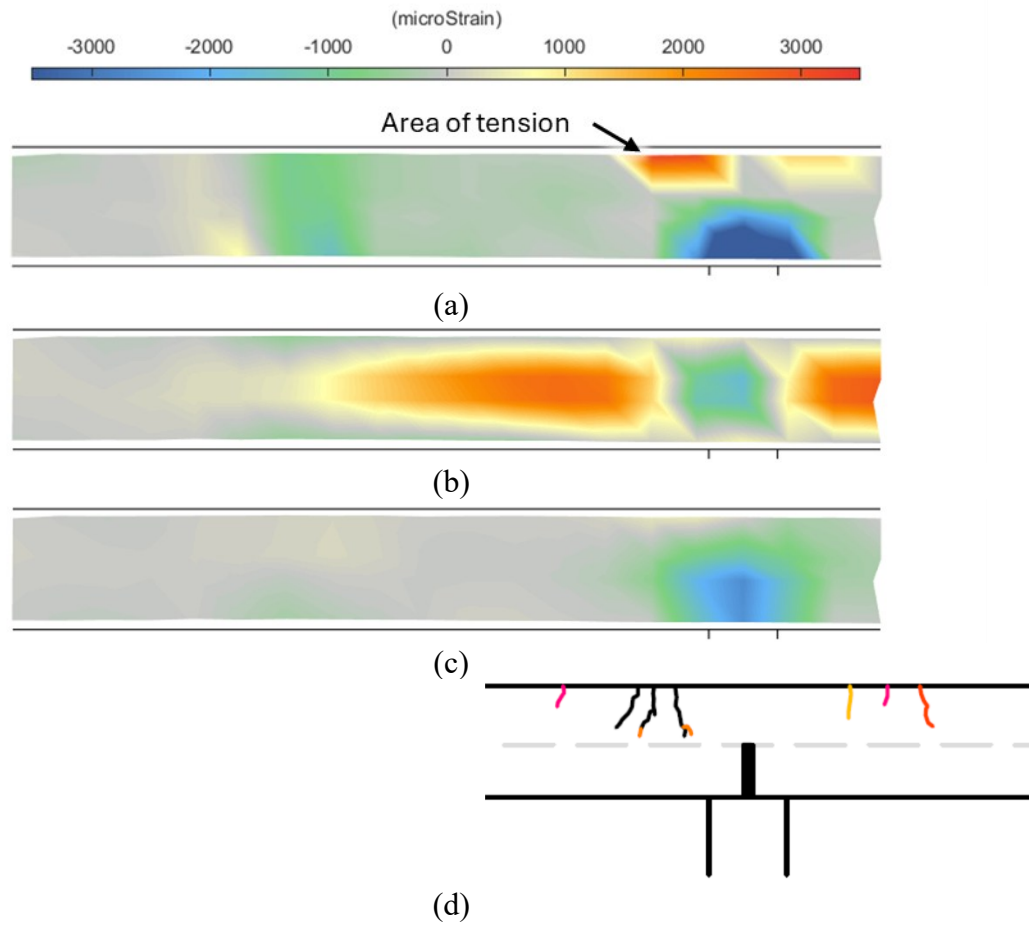
**Figure 10.29. Optotrak strains for PBJ-FP1R Pattern All-Yield: (a) horizontal, (b) vertical, (c) shear strain, and (d) crack pattern.**

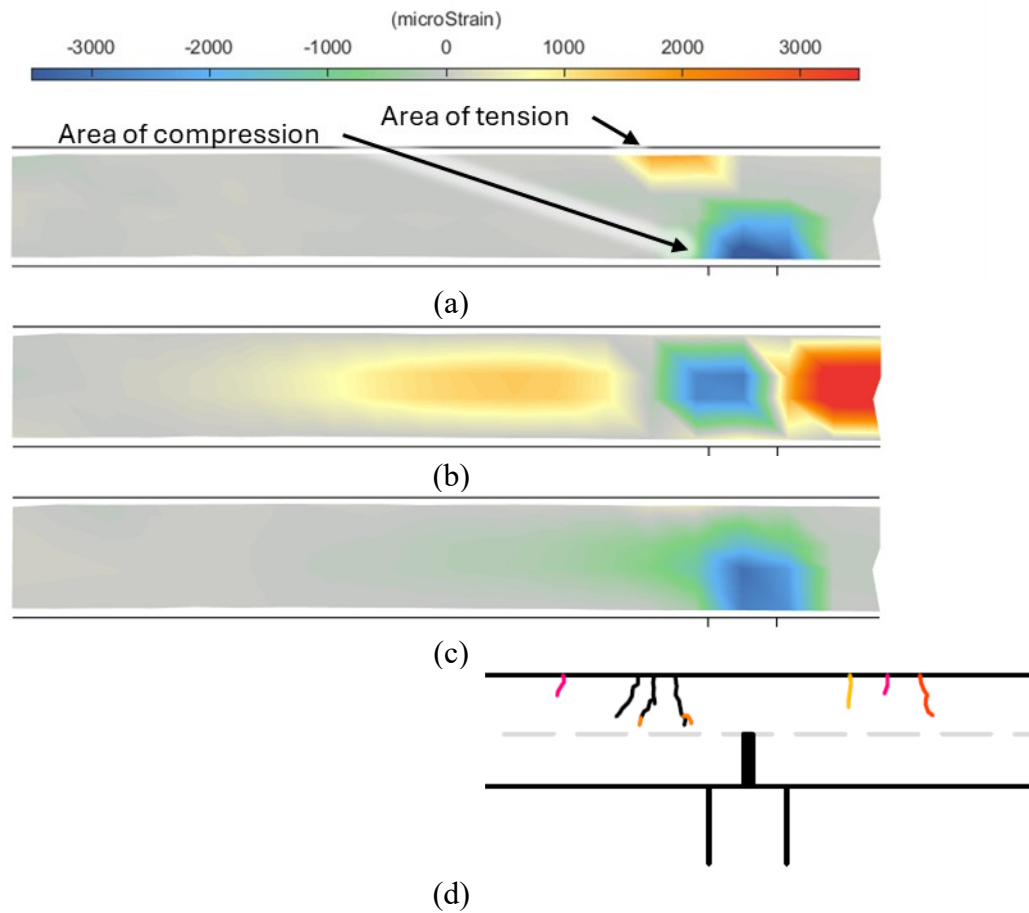
**Figure 10.30. Optotrak strains for PBJ-FP1R Pattern East(a) horizontal, (b) vertical, (c) shear strain, and (d) crack pattern.**

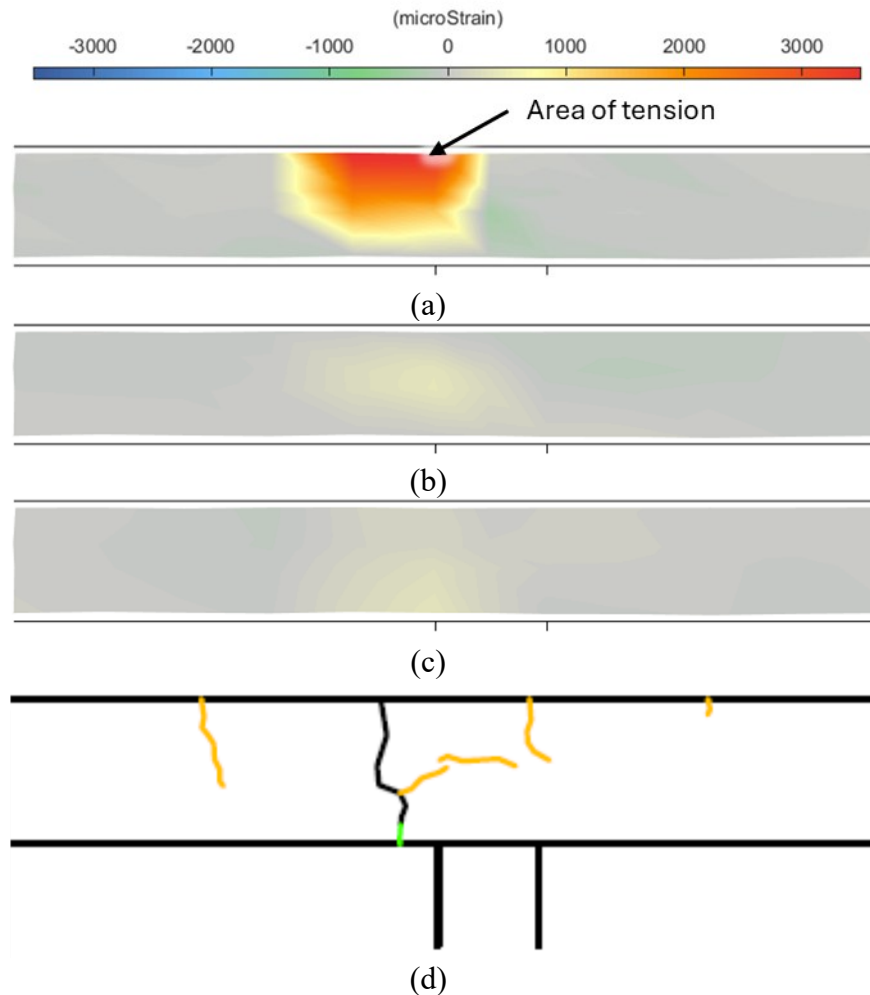
**Figure 10.31. Optotrak strains for PBJ-OP2 Pattern All-Yield: (a) horizontal, (b) vertical, (c) shear strain, and (d) crack pattern (cracks formed during the load pattern are shown as yellow lines).**

In PBJ-OP2, shown in Figure 10.26, the region of concentrated tensile strains is located where the single crack forms. Regions of light concentration of horizontal and shear strain are seen where the horizontal cracks form during later patterns. In Figure 10.31, the strains are shown for Pattern All-Yield, in which the areas of greater intensity of the strains are located in the region of cracks and where the location of the secondary crack over the west (left) girder has a concentrated region of tension strain.

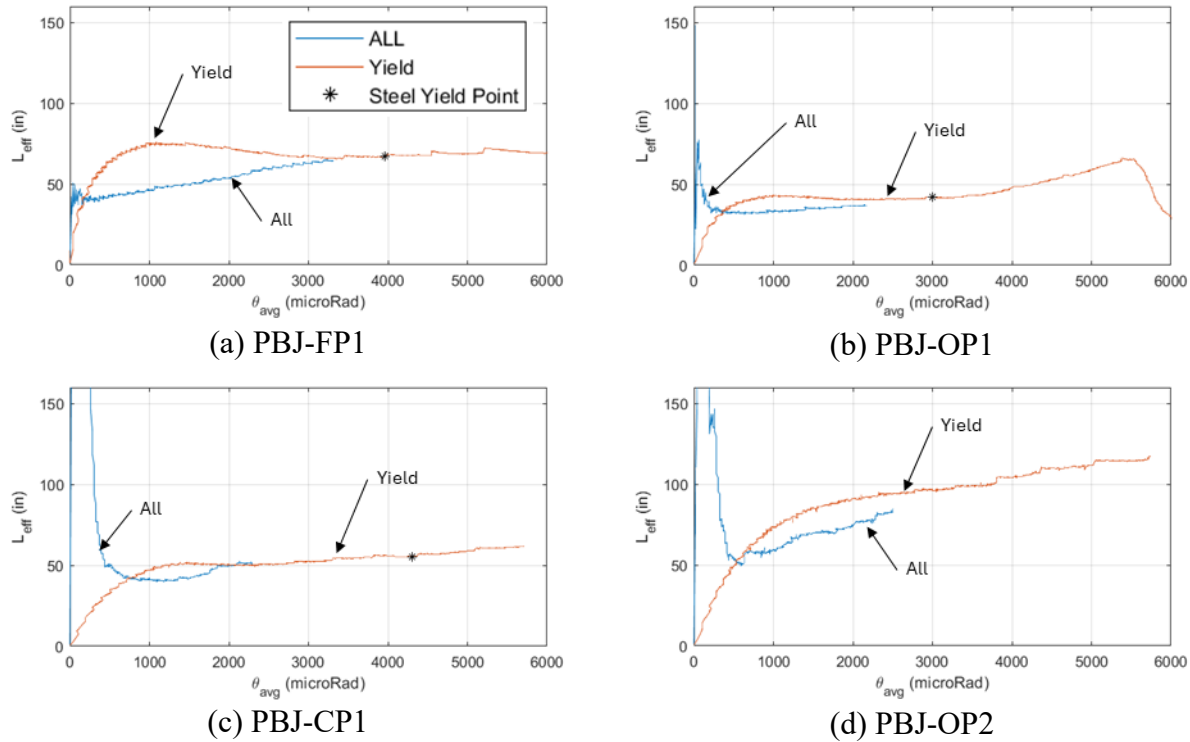
Method 2 was a slight variation to Method 1 but considered the effective length of the link slab at each individual rotation reading rather than the full rotation history. In other words, instead of finding a single value for the full test, an effective length was found at each time step. This variation was necessary because the deck damage evolved during testing, with the formation and growth of additional cracks in the link slab region. The minimum error and corresponding effective length were found for each rotation value. Method 2 used the higher-resolution steel strain data instead of the lower-resolution bottom strain data, and thus is best compared to Method 1b values.

Figure 10.32 shows the effective link slab length versus rotation for the four experimental tests of non-retrofitted specimens for Pattern All and Pattern All-Yield. For Pattern All, shown by the blue lines, there is a drop in the effective length between 0 and 1000 microradians, indicating the formation of microcracks in most decks. This does not occur on PBJ-FP1 because the initial crack had formed during the curing of the concrete and was not a result of the loading of the deck. As the rotation increases, the effective length also increases due to additional crack formation and strain redistribution. In Pattern All-Yield, shown by the orange lines, the effective length initially climbs sharply until reaching a plateau, often matching the length near the end of the Pattern All test. This plateau continues until the rebar yields, indicated by black stars, after which the length increases again. For PBJ-OP1 (Figure 10.32[b]), a notable drop is present due to a strain gage exceeding its limit at high rotation and strain.

**Figure 10.32. Effective link slab lengths calculated with Method 2 for Pattern All and Pattern All-Yield.**

Considering the values from each method and the full history presented in Figure 10.32, recommendations for use in design can be made to provide lengths that err to the shorter potential values, thus producing conservative designs. For debonded designs that include a gap in the haunch at the end of the girder, the debonded length is an appropriate value when considering demands large enough to develop full cracking of the link slab. From the load history, a length of 60 percent of the effective length is the conservative lower bound to use for designs not expected to develop full cracking and would be appropriate for bridge rotation demands found for typical TxDOT bridges. The same 60 percent is a reasonable lower bound for debonded designs without a gap in the haunch. For bonded slabs, consideration for the effective length is less clear because the field and experimental data provide conflicting results. In part, this is complicated by the differences in detailing of the flush panel decks in the field and in the lab. However, damage observed in the lab confirms that damage is more concentrated in the bonded link slabs, so there is a trade-off between the continuity provided by the slab and the potential for concentrated damage. A very conservative approach is to take the effective length as the distance between the center of the bearing pads; however, a more realistic approach would be to determine effective length using a simple continuous beam model with the cracked stiffness of the models.

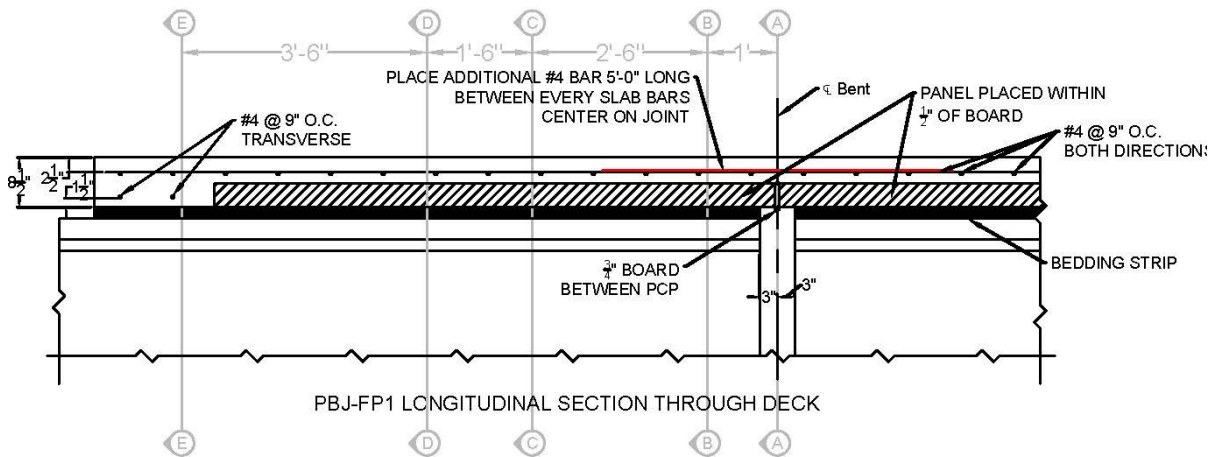
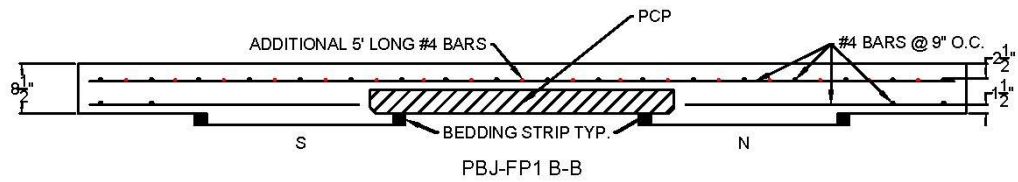
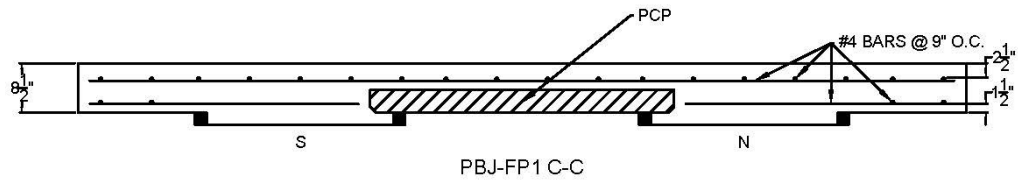
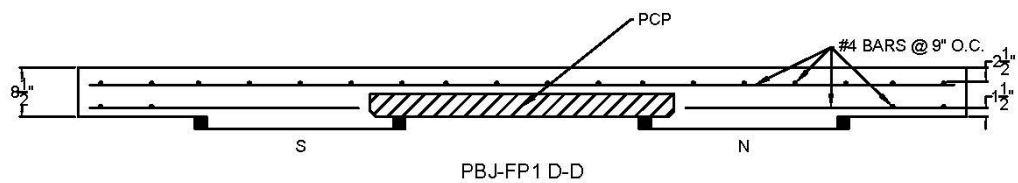
For individual specimens, detailed construction drawings are provided in this appendix. Cross-section views are available at consistent locations. Section A-A is located at the center of the continuous deck and has a consistent 8.5-in. thickness for the full width. The remaining sections are located over the girders and have the additional haunch on top of the girder shown (haunch dimension is generic). Section B-B is located at the center of the bearing pads and thus within the full-depth CIP region for offset panel designs.

**Figure B.1. PBJ-FP1: construction drawings.**

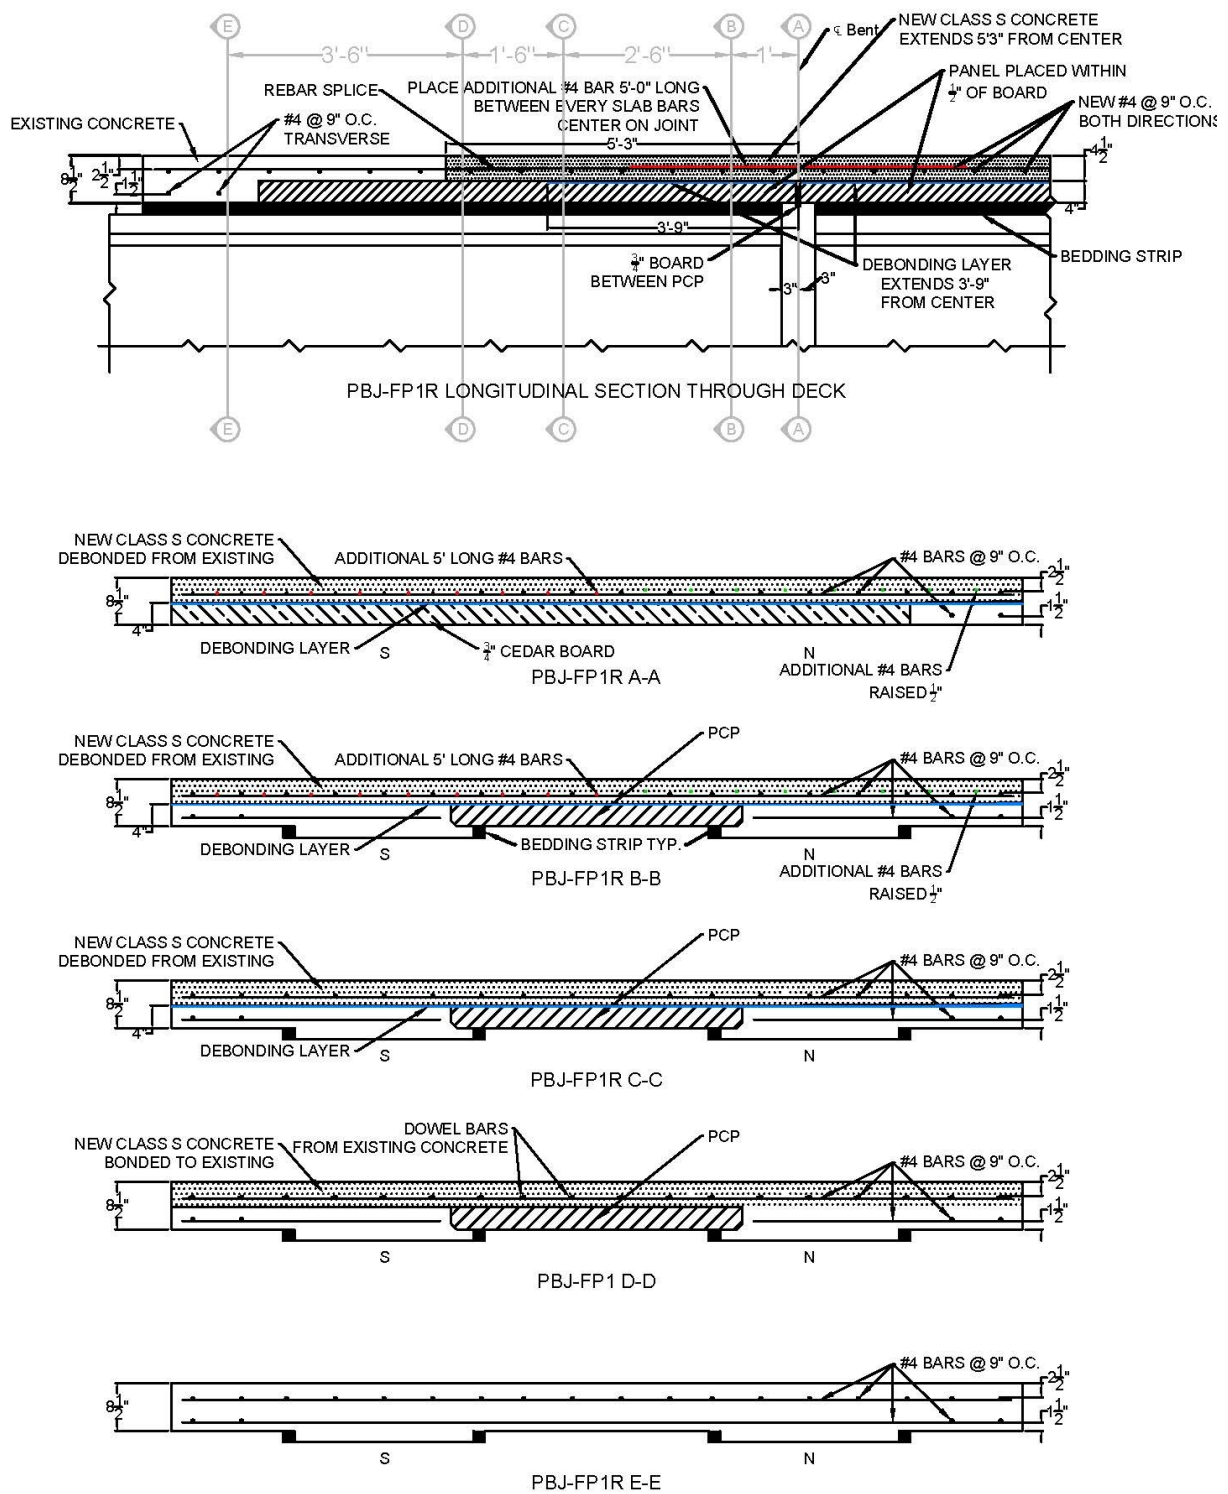
**Figure B.2. PBJ-FP1R: construction drawings.**

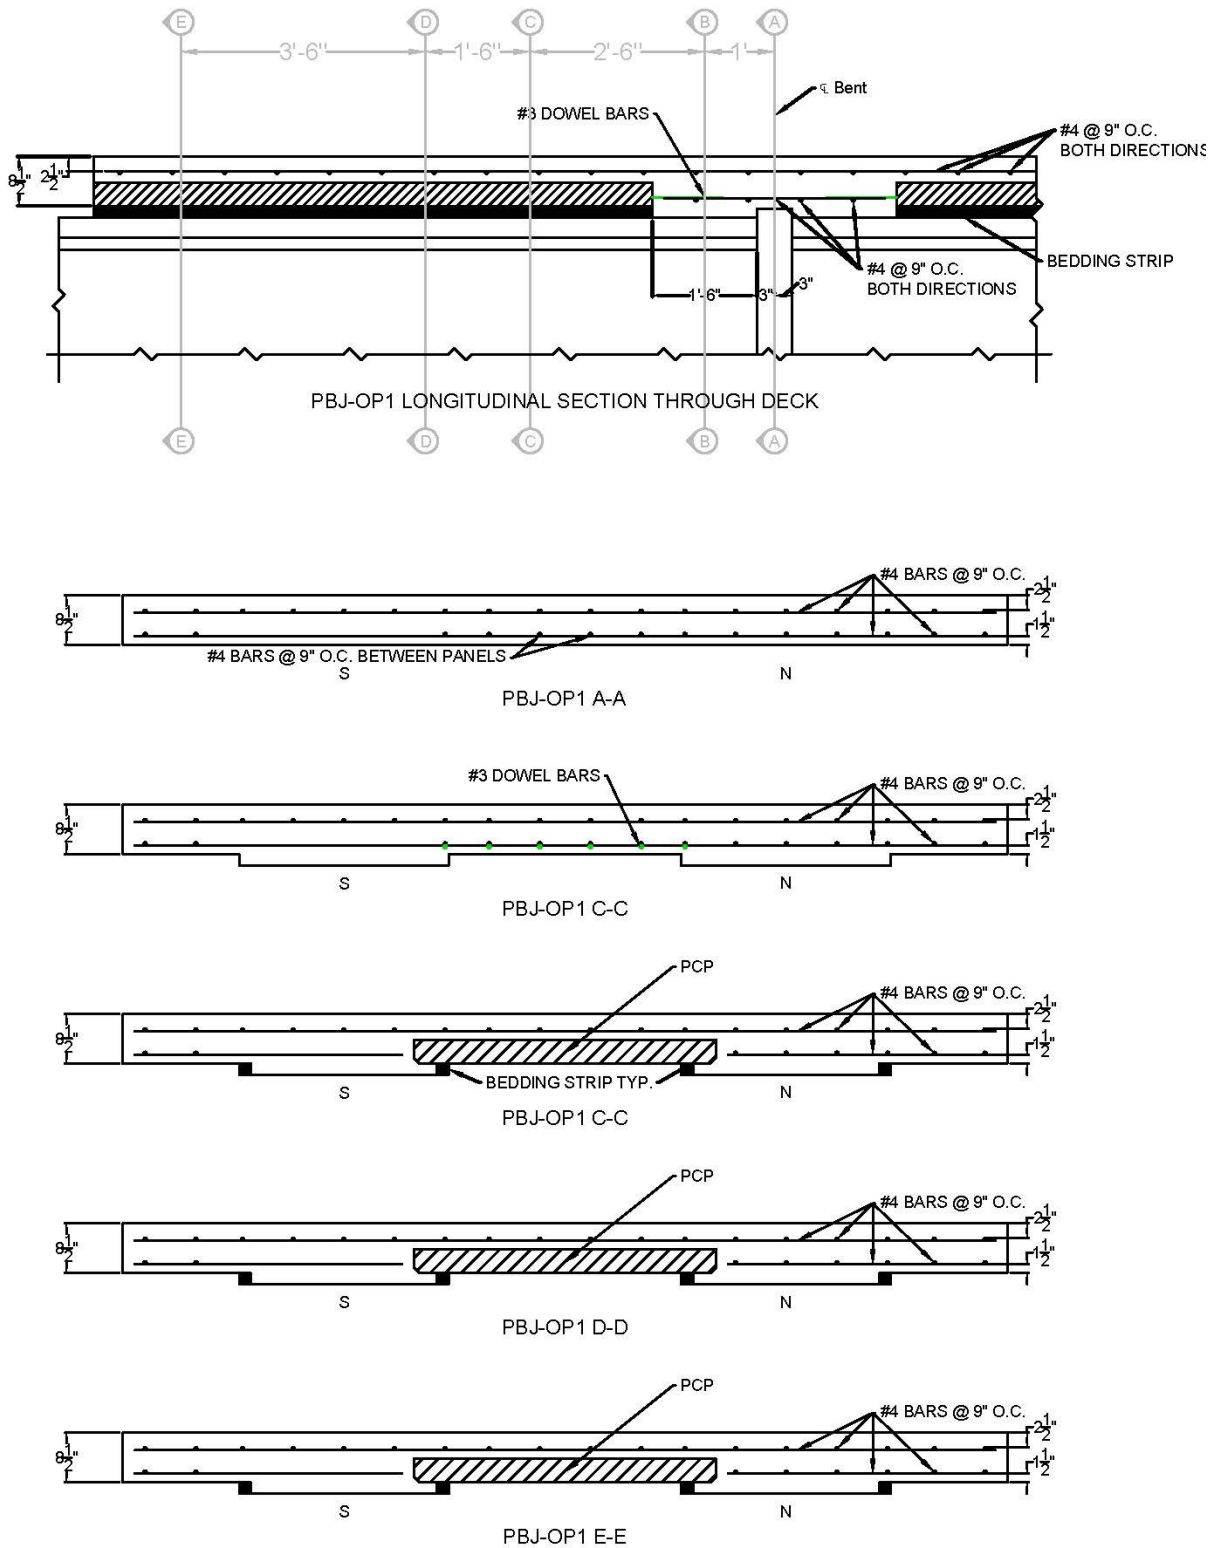
**Figure B.3. PBJ-OP1: construction drawings.**

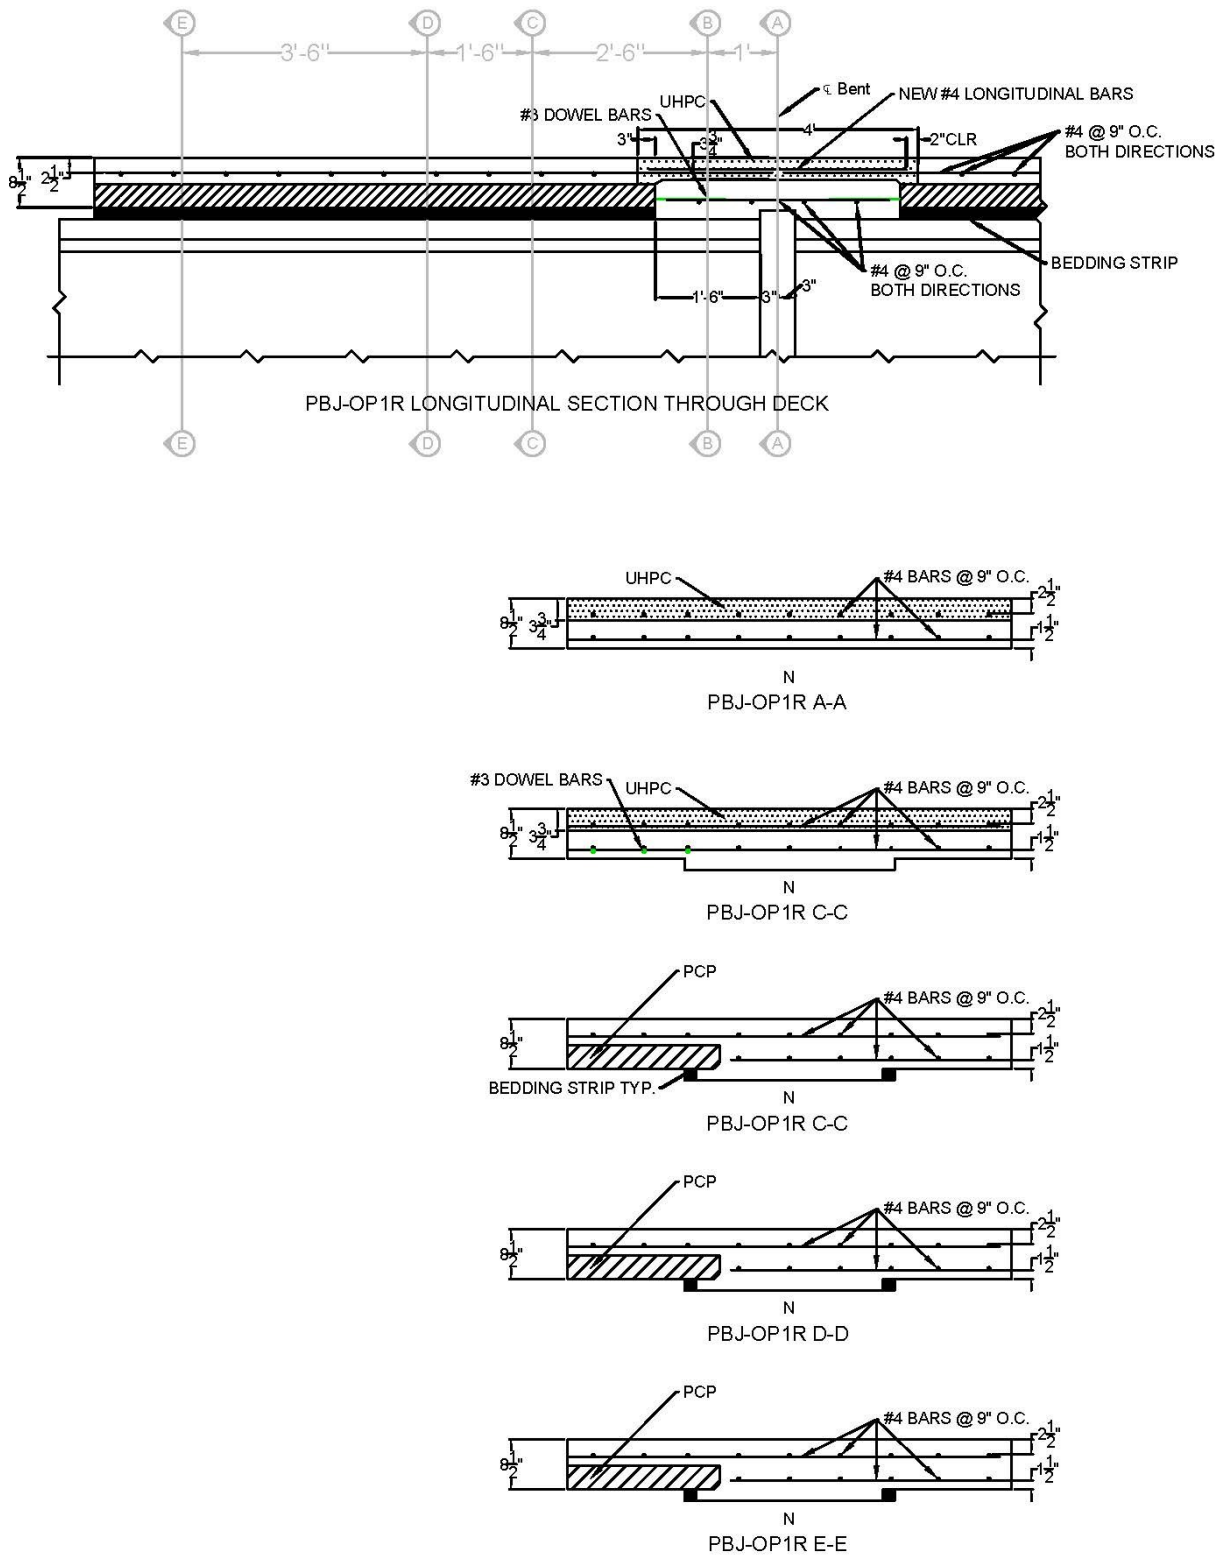
Figure B.4. PBJ-OP1R: construction drawings.

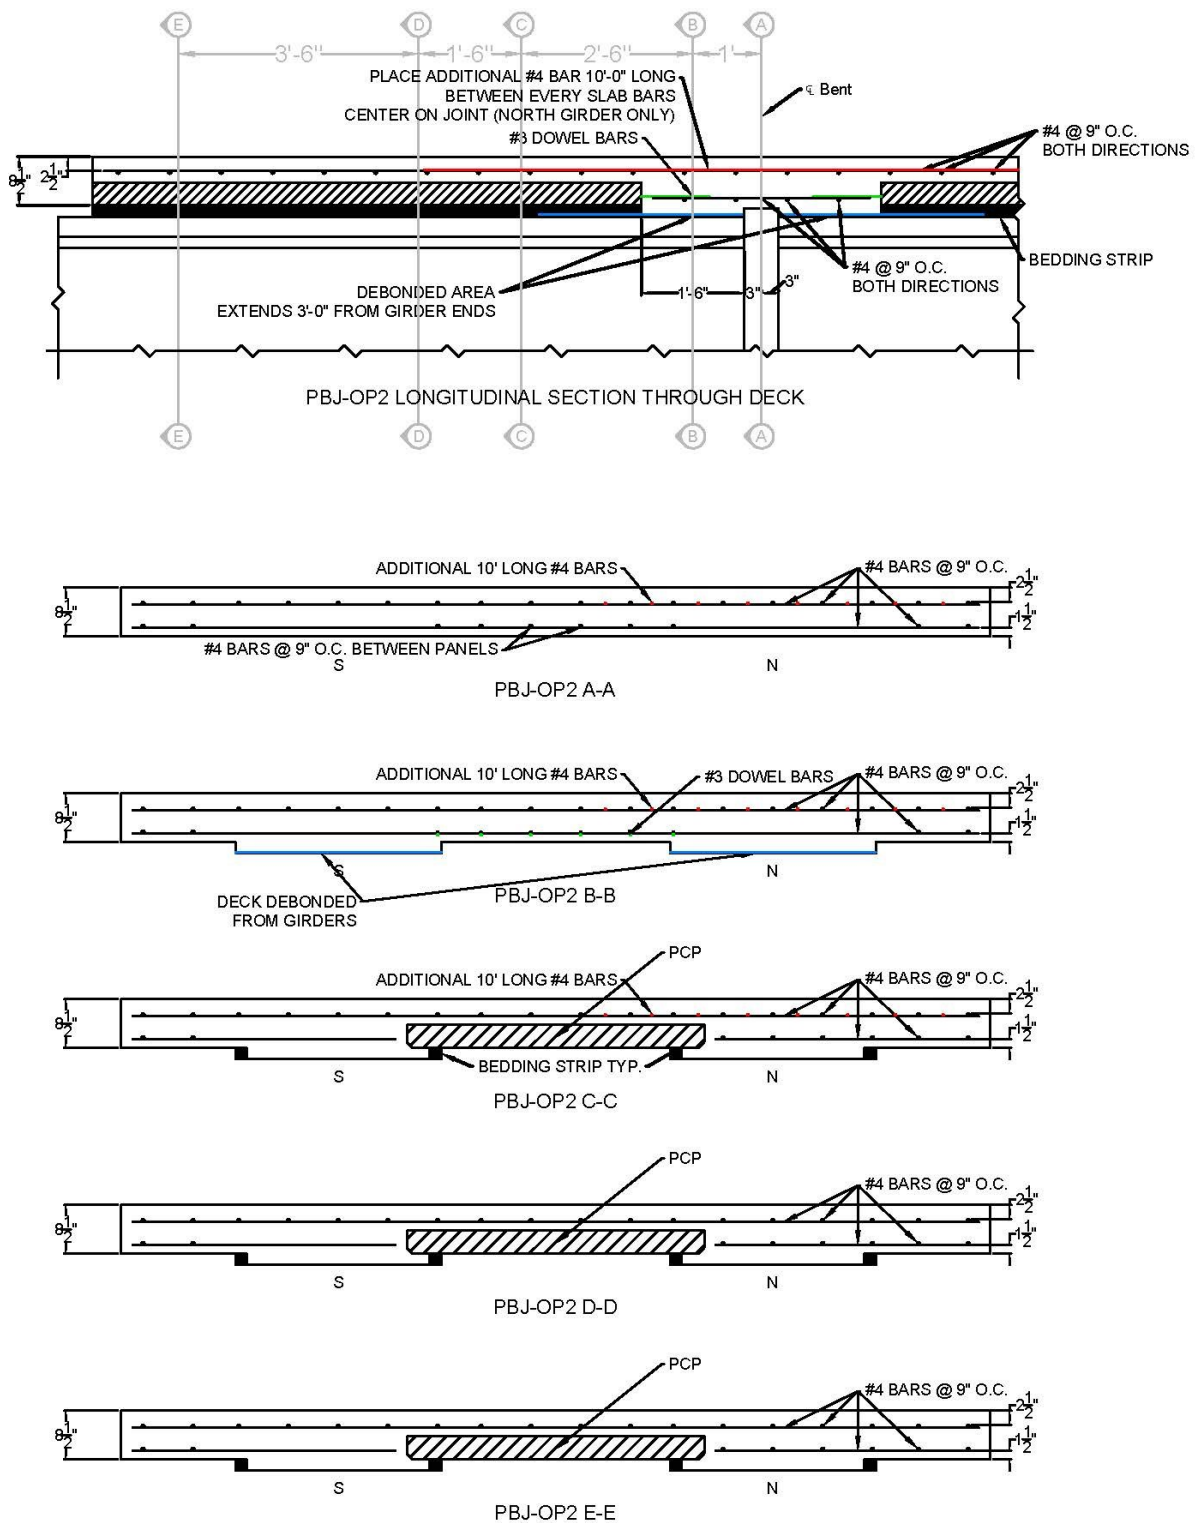
**Figure B.5. PBJ-OP2: construction drawings.**

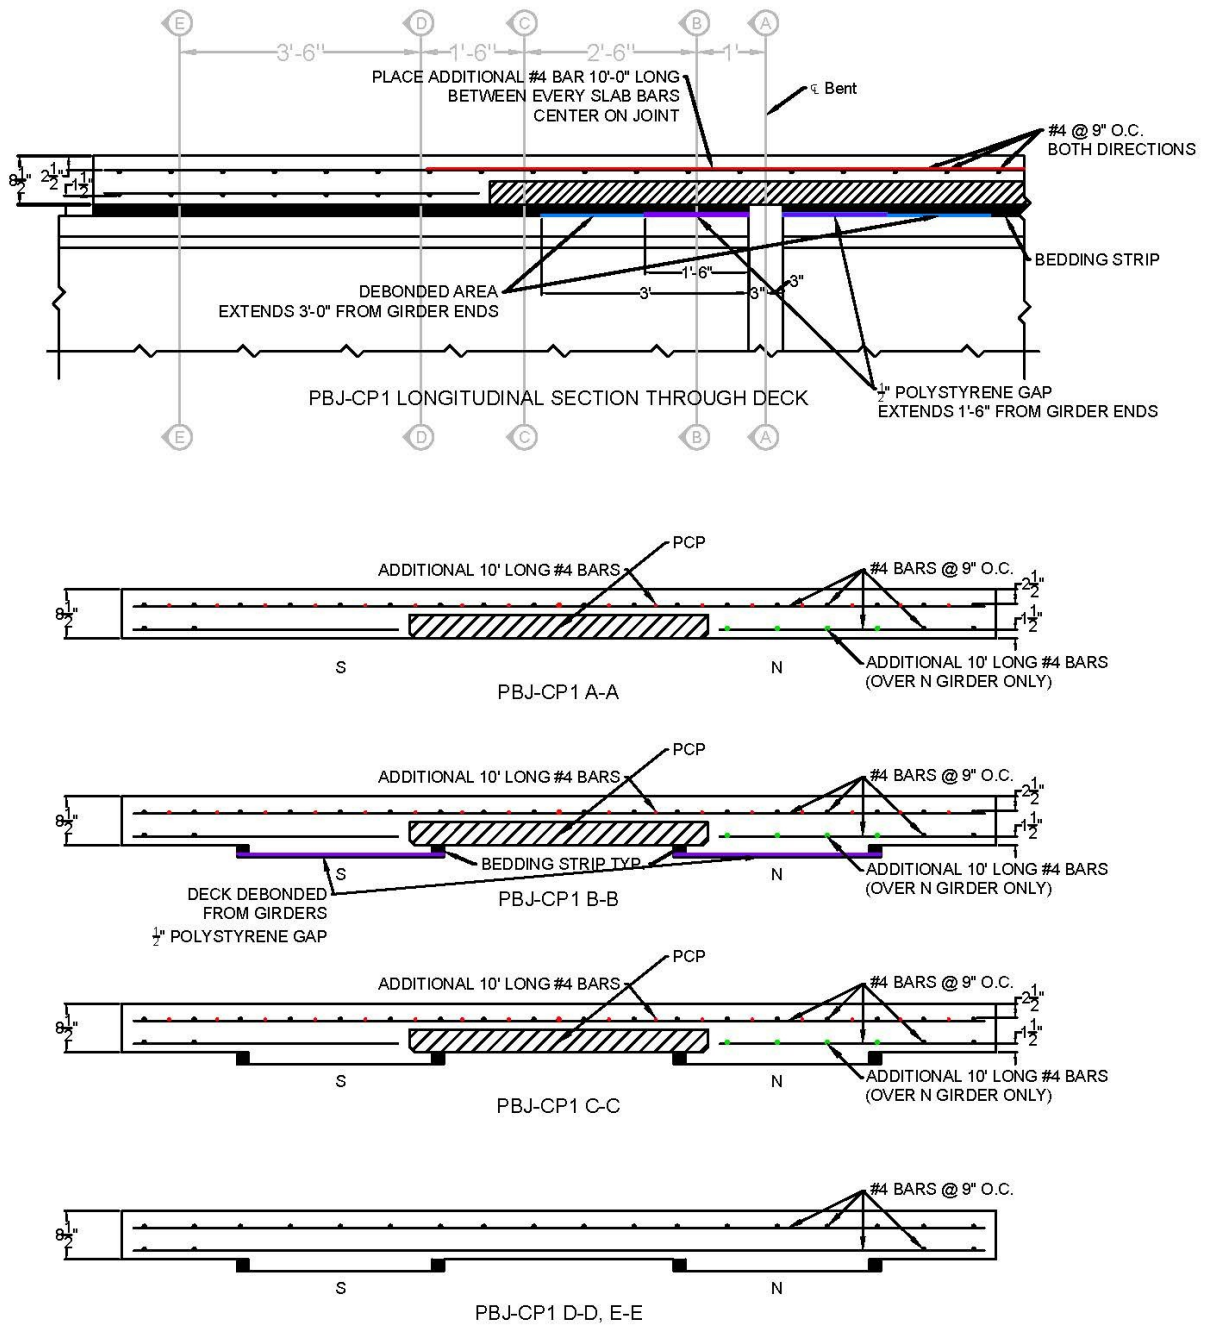
**Figure B.6. PBJ-CP1: construction drawings.**
