FLIGHT TESTS OF THE UNITED AIR LINES STALL WARNING SYSTEM

Technical Development Report No 50

April 1945

U S DEPARTMENT OF COMMERCE
CIVIL AERONAUTICS ADMINISTRATION
WASHINGTON, D. C.

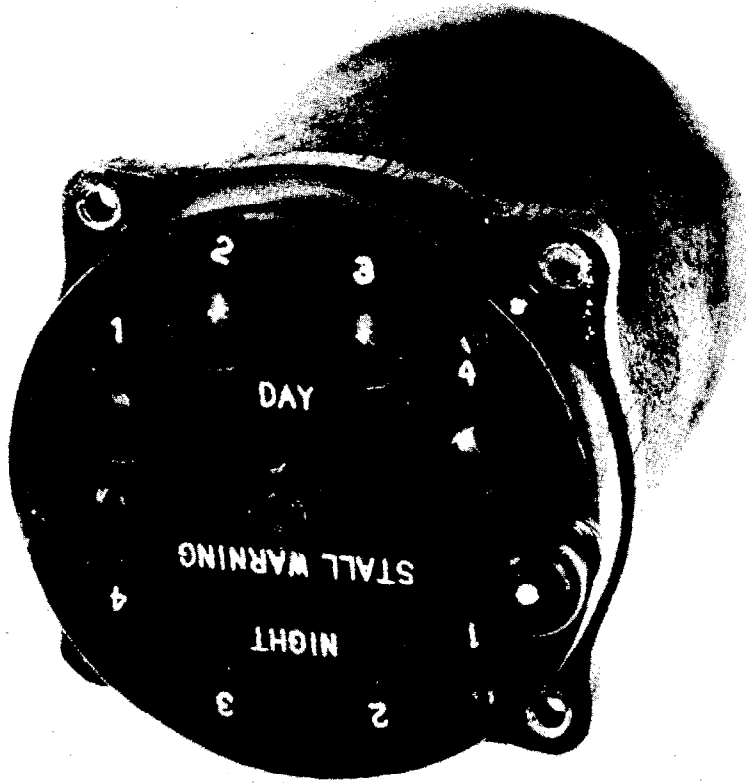
Figure 6. Warning Indicator.

The warning indicator shown in figure 6 consists of a group of four lights arranged in a semicircle and mounted on a standard 2-3/4-inch diameter instrument case. The lights are numbered 1 through 4 to correspond with the stall detector units. Each light is covered with an amber-colored jewel to prevent undue glare. The light bulbs are General Electric Mazda, single contact bayonet base, rated at 0.20 amperes at 12 to 16 volts.
