# **AN AUTOMATIC MONITOR SYSTEM FOR RADIO RANGES**

**J M Lee**

**Technical Development Report No 51**

**January 1947**

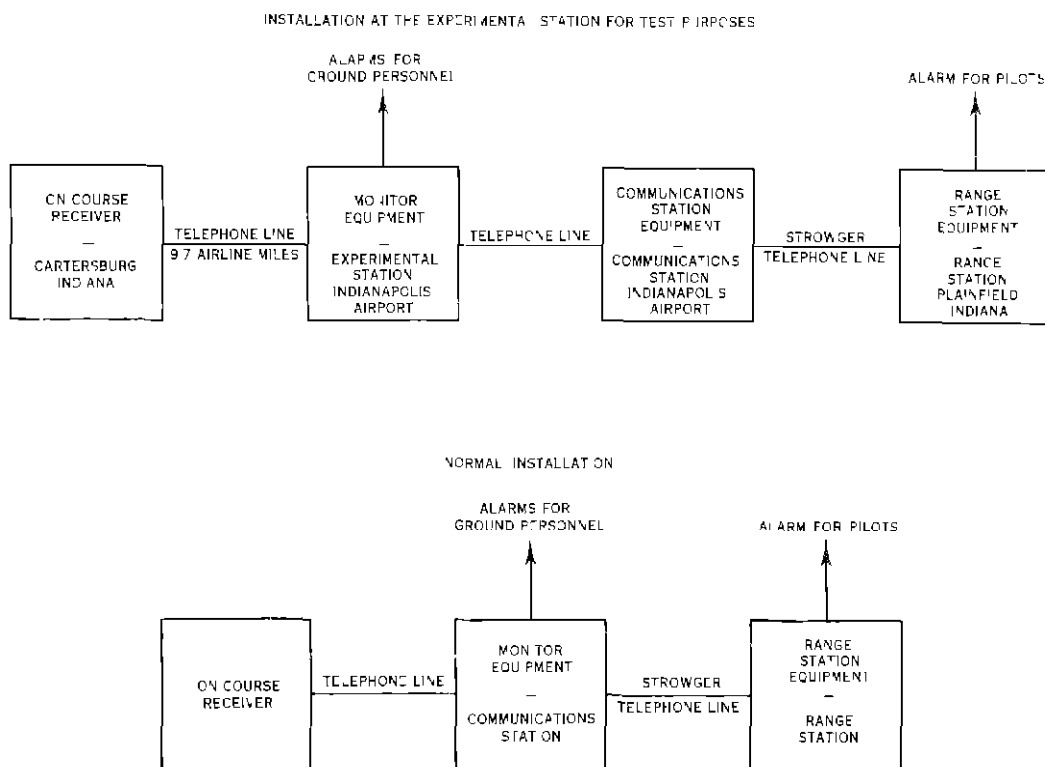
Figure 2 Block Diagrams of Indianapolis and Normal Installations

The equipment that would normally be installed in the Communications Station was installed in the Experimental Station at Indianapolis in order that extensive tests could be carried on without disturbing operating personnel. This installation required the use of an extra telephone line from the Experimental Station to the Communications Station that would not be required in a normal installation. Figure 2 is a block diagram showing a normal installation and the installation at Indianapolis. Figure 5 is a more complete block diagram of the Indianapolis installation.

As indicated in figures 2 and 5, the output of the remote receiver was connected to a telephone line extending from the remote receiver site to the laboratory of the Experimental Station. The output of the line at the Experimental Station was connected to the range monitor equipment shown in figure 13. A rear view of the assembled monitor equipment is shown in figure 14.

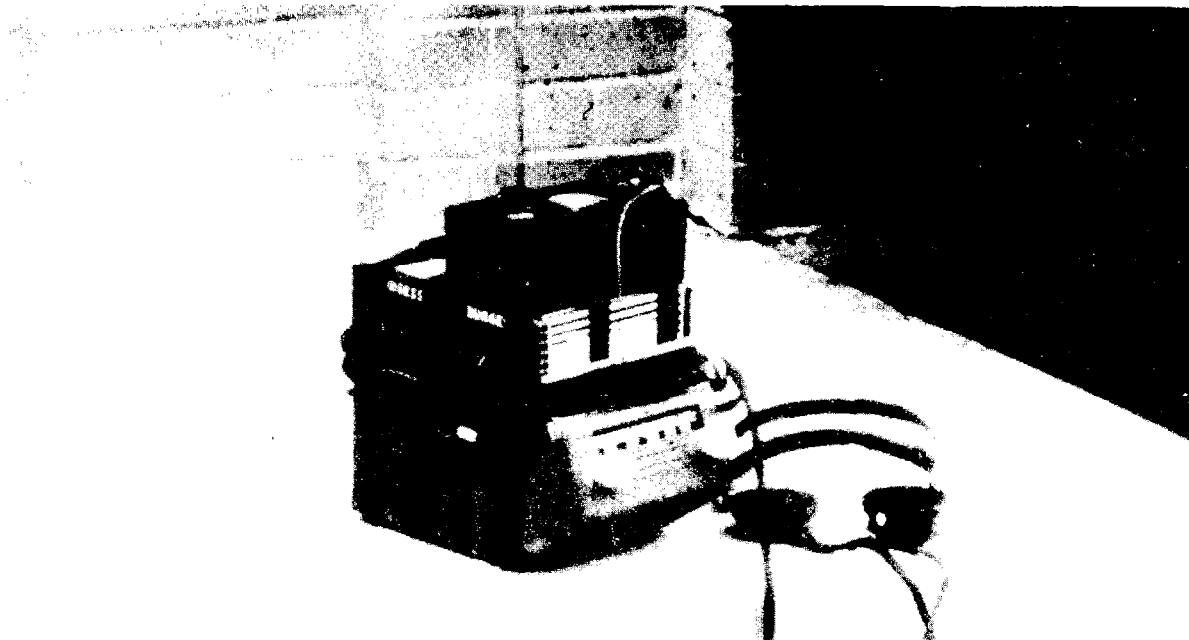
Figure 3. Portable Field Detector.

All ground checks made to locate the site were made using the equipment shown in figure 3. The equipment consisted of a portable aircraft receiver operating from 12 volts direct current, two six-volt batteries in series to provide the required 12-volt power supply, a Weston output meter, a vertical whip-type antenna and a pair of headphones. The complete assembled equipment was of a convenient size and weight as to provide an excellent portable field detector. Course deviations of approximately  $1^{\circ}$  could be distinguished by noting differences between A and N voltages on the output meter when this amount of deviation could not possibly be distinguished by ear with the headphones. The location of the center of the course was found by determining the location of the points  $5^{\circ}$  on either side of the course, and dividing the distance between these points by two to obtain the point mid-way between them. This method was more accurate than attempting to locate the actual mid-point with the field detector since  $5^{\circ}$  deviations can be much more easily observed on the output meter than the on-course point. Upon completion of the ground check with the portable detector unit, a flight check was made to determine if the course as observed on the ground was in the same position as that observed in normal flight. Complete agreement between the ground check and the flight check was obtained.

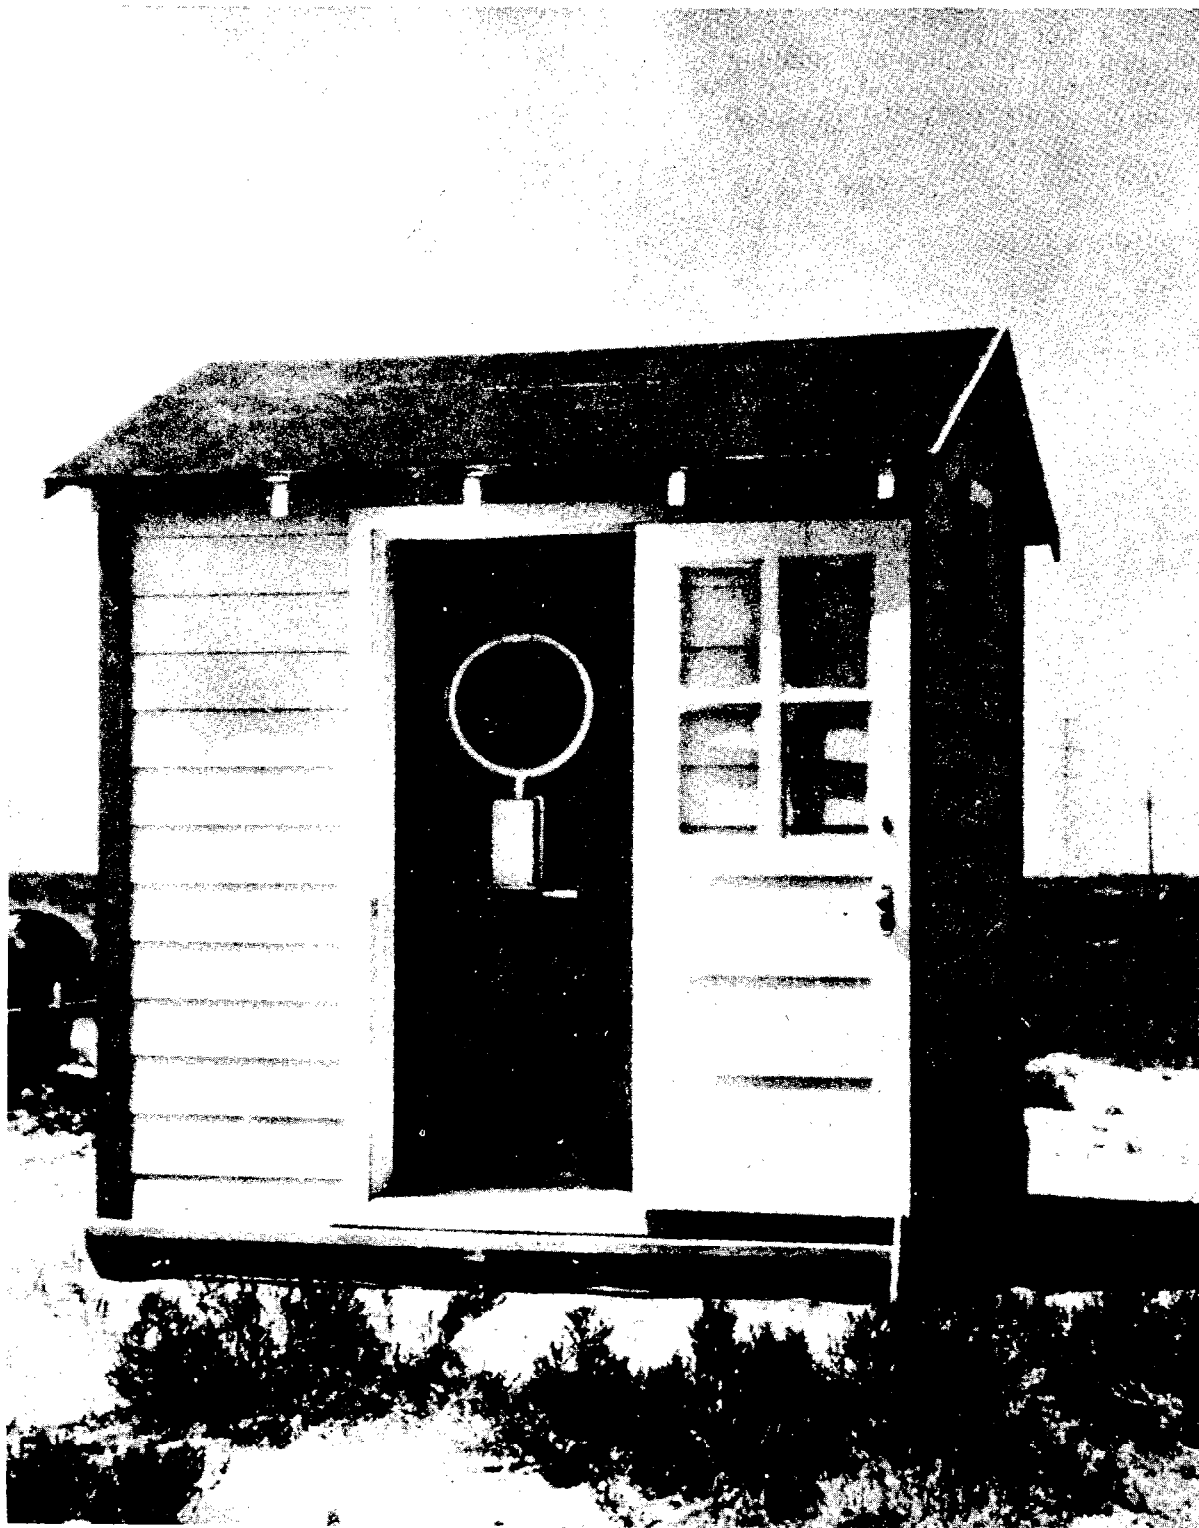
Figure 43. On-Course Receiver Installation at Salt Lake City.

The monitor system was installed at Salt Lake City during the first part of July, 1943. Figure 42 shows the location of the range station and monitor with respect to the airport. Figure 43 shows on-course receiver installation while figure 44 shows the monitor installation at the Communications Station. Remote indicator-alarm units were installed in the offices of United Air Lines and Western Air Lines. The equipment was adjusted and tested during the period of July 12 to July 24, 1943. Further adjustments were made from August 1 to August 3, 1943. The operation of the equipment was substantially identical to that obtained at Indianapolis. Copies of the recordings made during the tests at Salt Lake City are shown in figure 45. The recorder chart speed was increased from 12 inches per hour to three-quarters of an inch per minute at the request of maintenance personnel. Later the chart speed was again changed to a rate of 12 inches per hour in order to avoid frequent winding of the recorder spring mechanism and excessive use of the recorder chart.
